### **REPAIR AND STRENGTHENING OF BEAM-TO-COLUMN CONNECTIONS SUBJECTED TO EARTHQUAKE LOADING**

February 28, 1989

Technical Report NCEER-89-0013

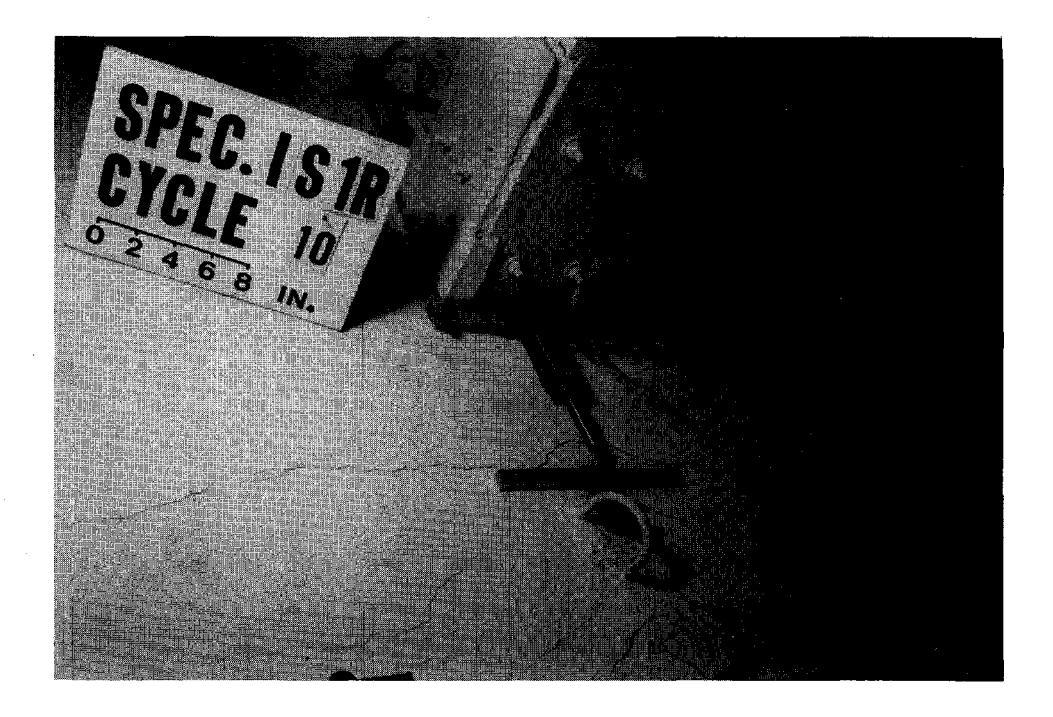
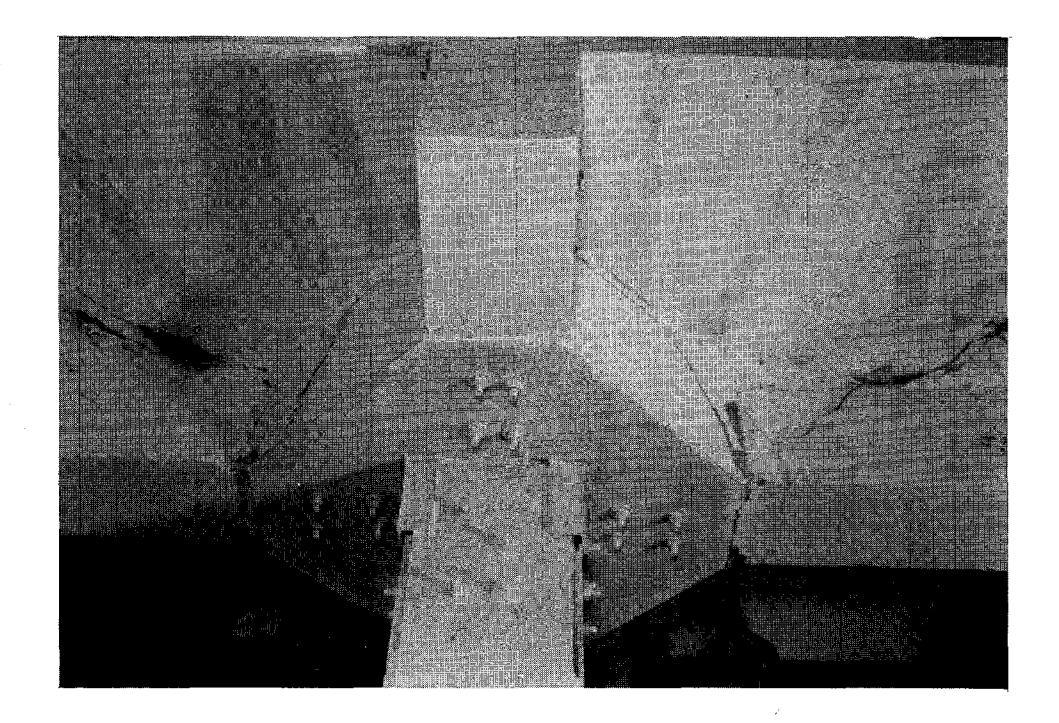
## FIGURE 4-44 Damage Detail in Repaired Specimen IS1R

a) Cracking in the slab

b) Damage at the end of the test
