GEOTECHNICAL AND LIFELINE ASPECTS OF THE OCTOBER 17, 1989 LOMA PRIETA EARTHQUAKE IN SAN FRANCISCO

T. D. O'Rourke, H. E. Stewart, F. T. Blackburn, and T. S. Dickerman

Technical Report NCEER-90-0001

January, 1990

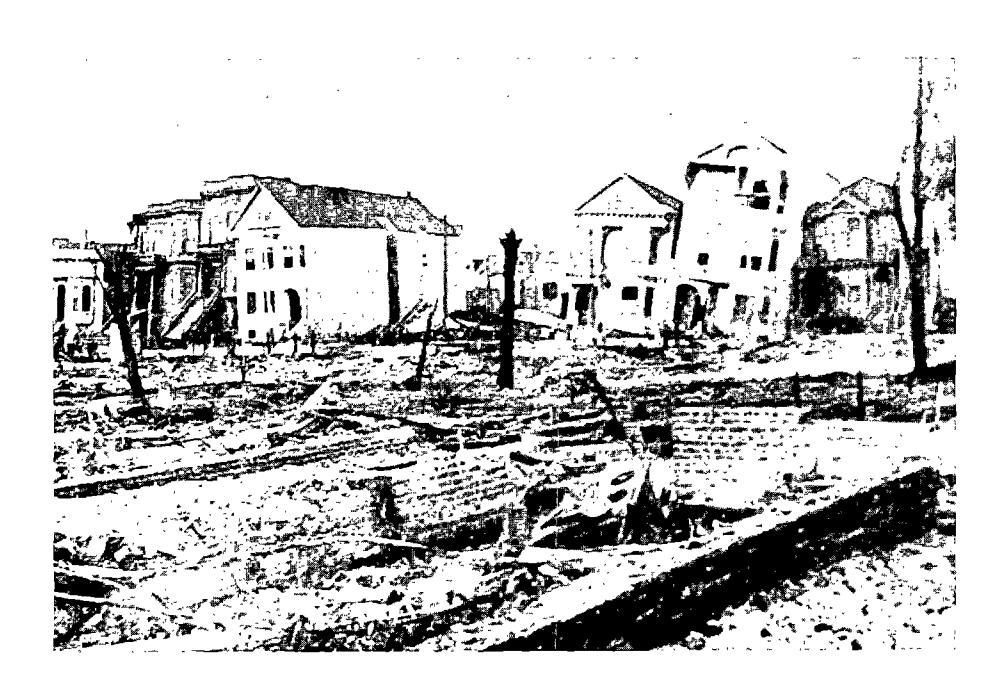
FIGURE 2-2. Racking and Settlement of Houses on South Van Ness Between 17th and 18th Sts. in 1906 [after Lawson, et al., 1908]

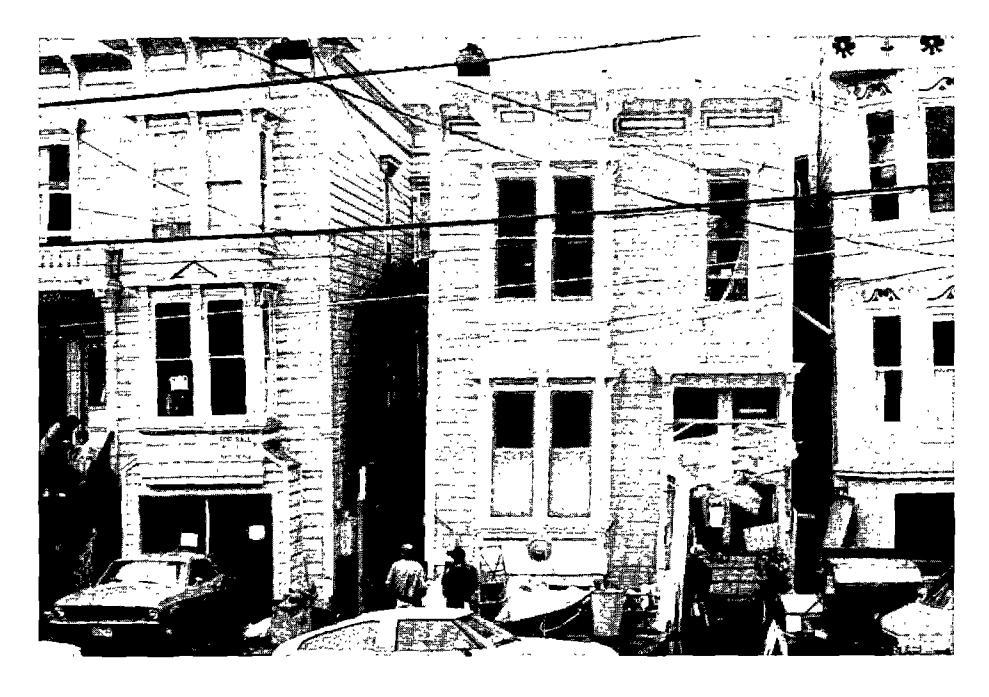
FIGURE 2-3. Racking and Settlement of Houses on Shotwell St. Between 17th and 18th Sts. in 1989. These Houses are Directly Behind the Location of Houses in Figure 2-2 (photograph by T. D. O'Rourke) sand boils were apparent along the curb line. The occupants of these structures claimed that settlement had continued for as long as four days after the earthquake.

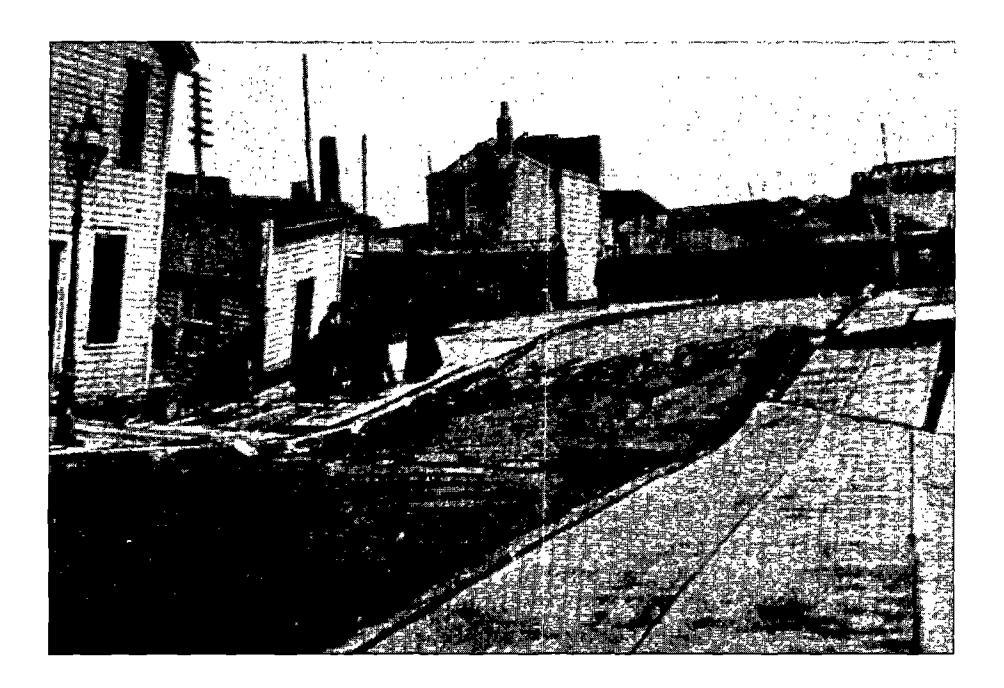
FIGURE 2-4. Large Differential Settlement on Dore St. Between Bryant and Brannon Sts. in 1906 [after Lawson, et al., 1908]

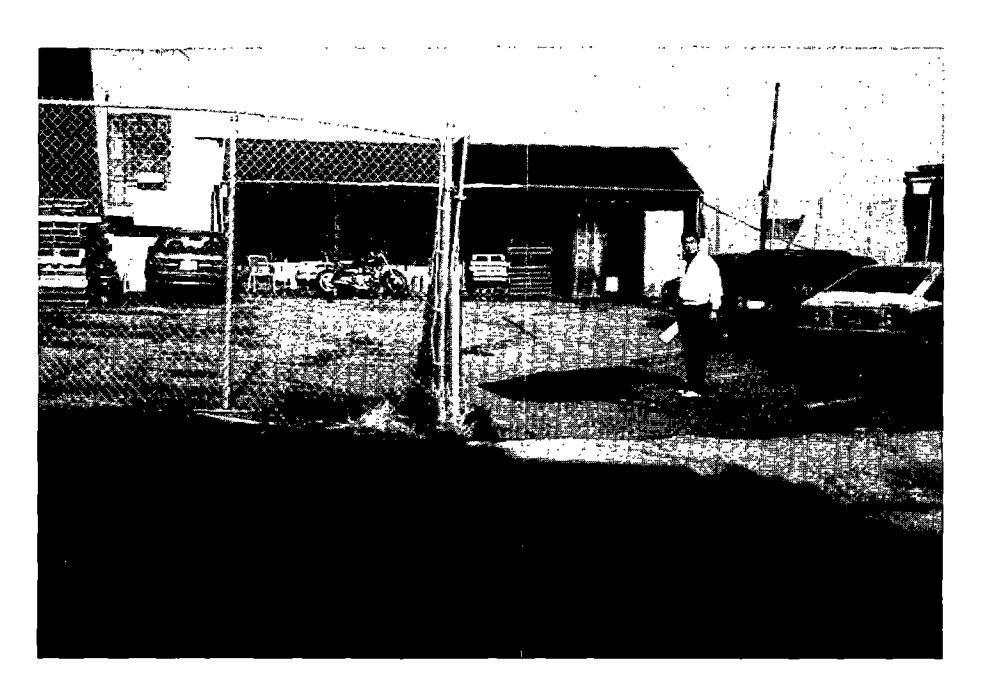
About 0.3 m of subsidence was observed in a parking lot off Dore St. approximately 30 m north of its intersection with Bryant St. This was a location of substantial settlement and lateral spreading in 1906. There was about 100 mm of settlement of the sidewalk adjacent to the building on the northeast corner of Dore and Bryant Sts. and differential settlement of the structure. The sidewalk along Bryant St. adjacent to the building was buckled and a water service had been ruptured. Figure 2-4 shows differential settlement of 1.5 m on Dore St. in 1906 compared with approximately 0.3 m of differential settlement on Dore St. in 1989, as shown in Figure 2-5.

FIGURE 2-5. Differential Settlement Along Dore St. Just North of Bryant St. in 1989 (photograph by T. D. O'Rourke)

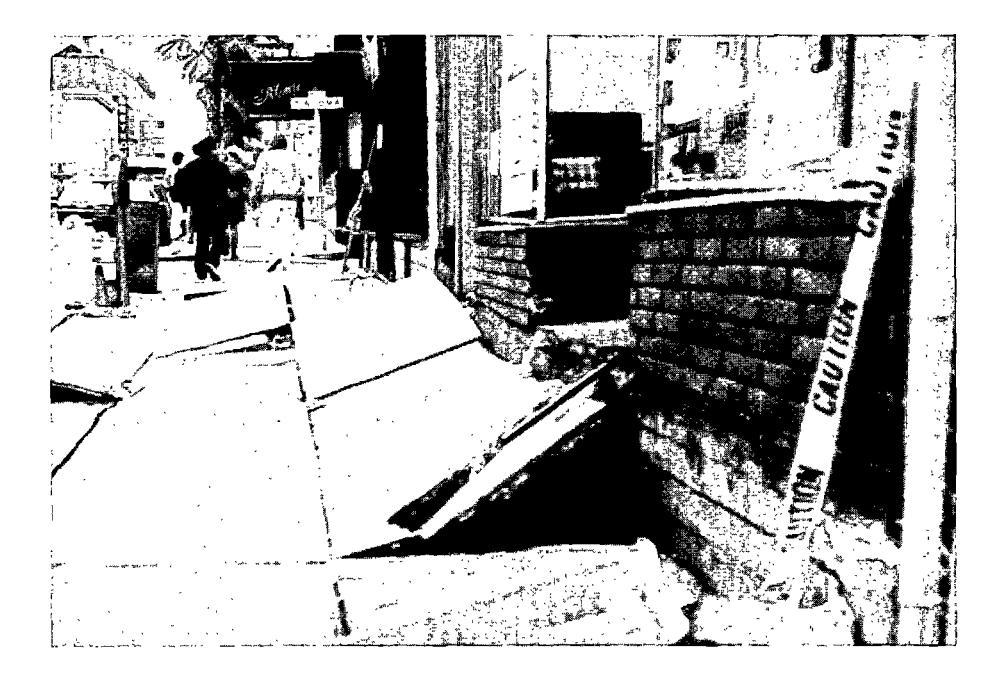
FIGURE 2-6. Differential Settlement of 0.1 to 0.3 m Adjacent to Building at Corner of 7th St. and Natoma St. (photograph by T. D. O'Rourke)

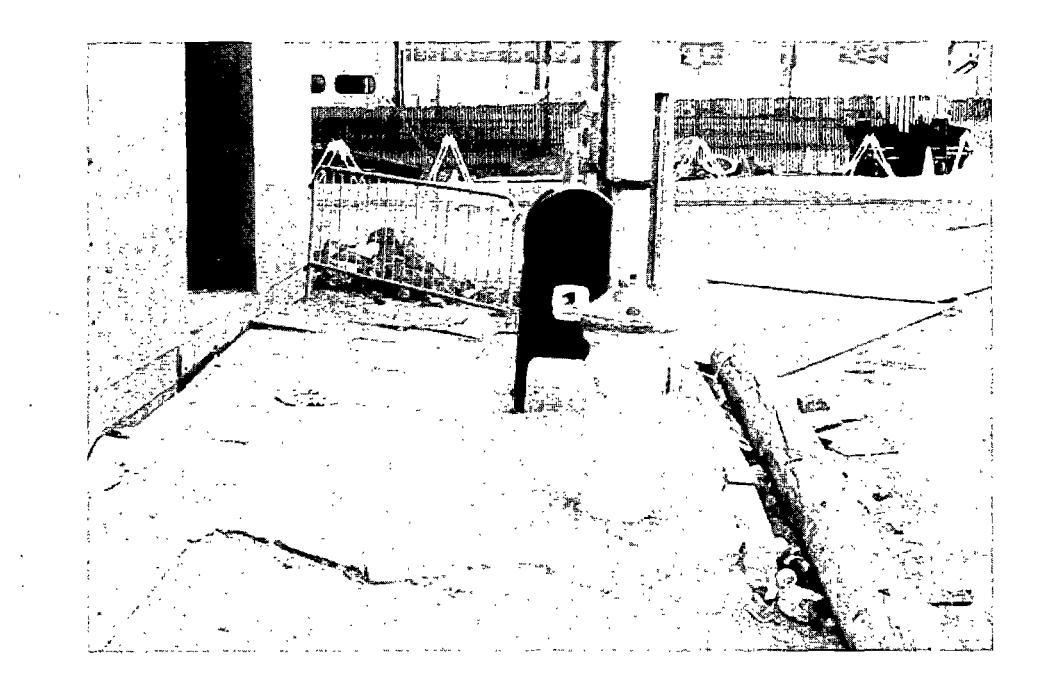
FIGURE 2-7. Differential Settlement at Corner of 6th St. and Townsend St. (photograph by T. D. O'Rourke)

sewer centerline. Figure 2-7 shows local differential settlement of roughly 150 mm adjacent to the building at the northeast corner of 6th and Townsend Sts. Differential settlements of 150 to 250 mm were observed adjacent to pile-supported columns of the Rt. 280 highway ramp at this location. Abrupt settlement with a maximum vertical offset of 200 mm was measured to the west of the pilesupported sewer beneath the Rt. 280 ramp. Recent differential settlements were apparent along the north side of Townsend St. for a distance of about one block to the east and west of its intersection with 6th St. Sand boils were observed beneath the Rt. 280 highway ramp. No sand boils or differential settlements were observed in the vicinity of the rail yard immediately south of Townsend St.

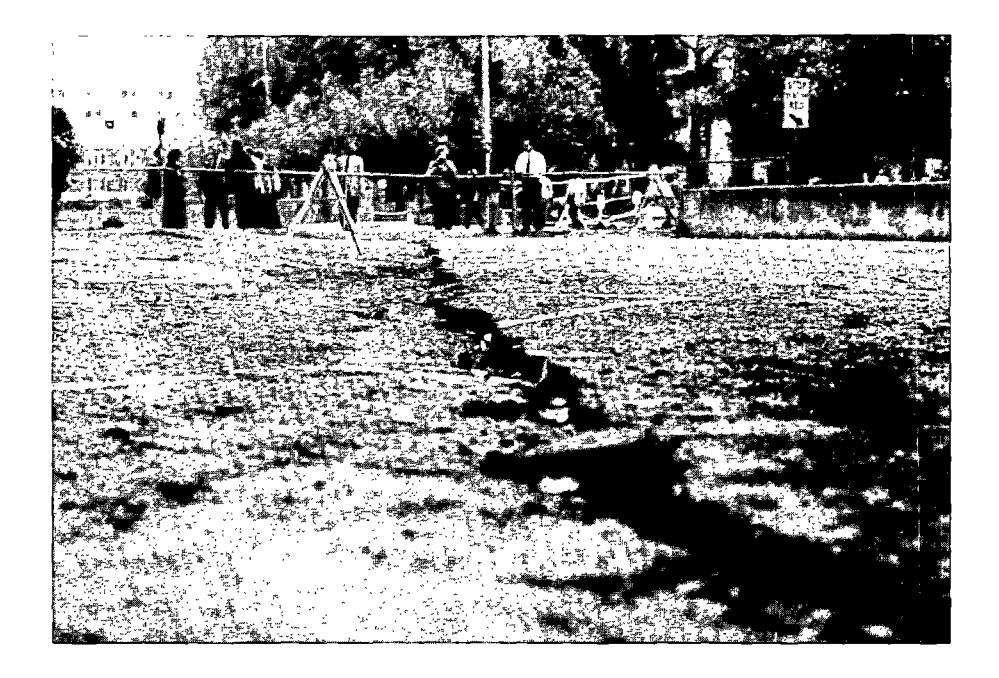
FIGURE 2-9. Differential Settlement on the Embarcadero Near the Intersection of Market St. in 1989 (photograph by T. D. O'Rourke)

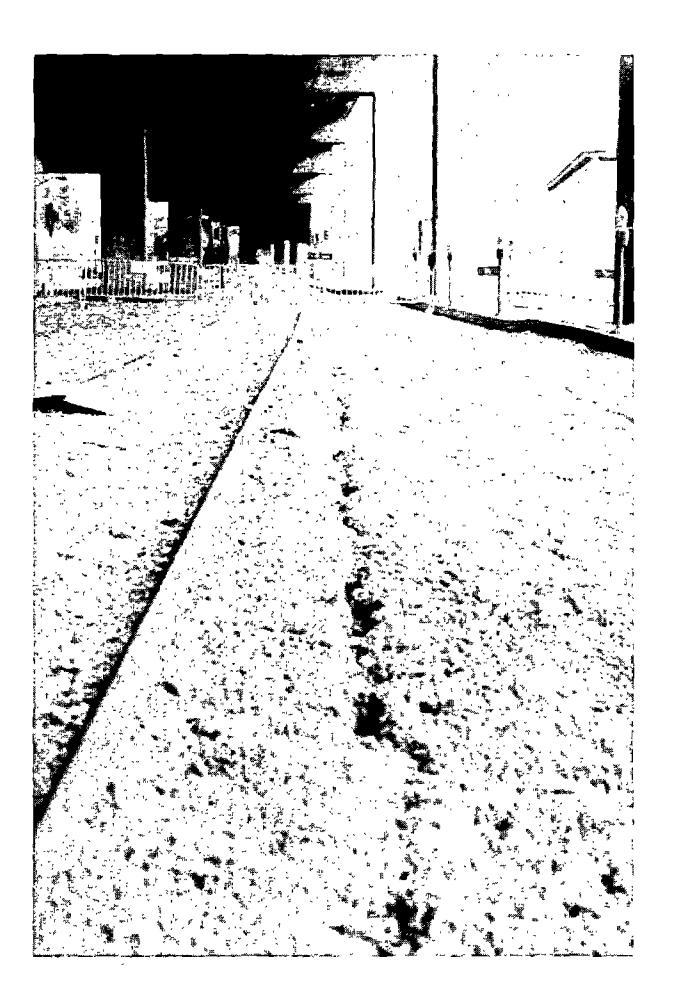
Figure 2-10 shows a prominent 25-mm-wide crack which opened beneath the Embarcadero Skyway, running parallel to the seawall for the full distance between Howard and Mission Sts. The crack indicates lateral movement toward the bay at a distance of about 20 m behind the seawall. Differential settlements of 25 to 100 mm were observed adjacent to the pile-supported columns of the Embarcadero Skyway, as shown in Figure 2-11.

FIGURE 2-10. Open 25-mm Crack Beneath the Embarcadero Skyway Between Howard and Mission Sts. Showing Movement Toward the Bay (photograph by T. D. O'Rourke)

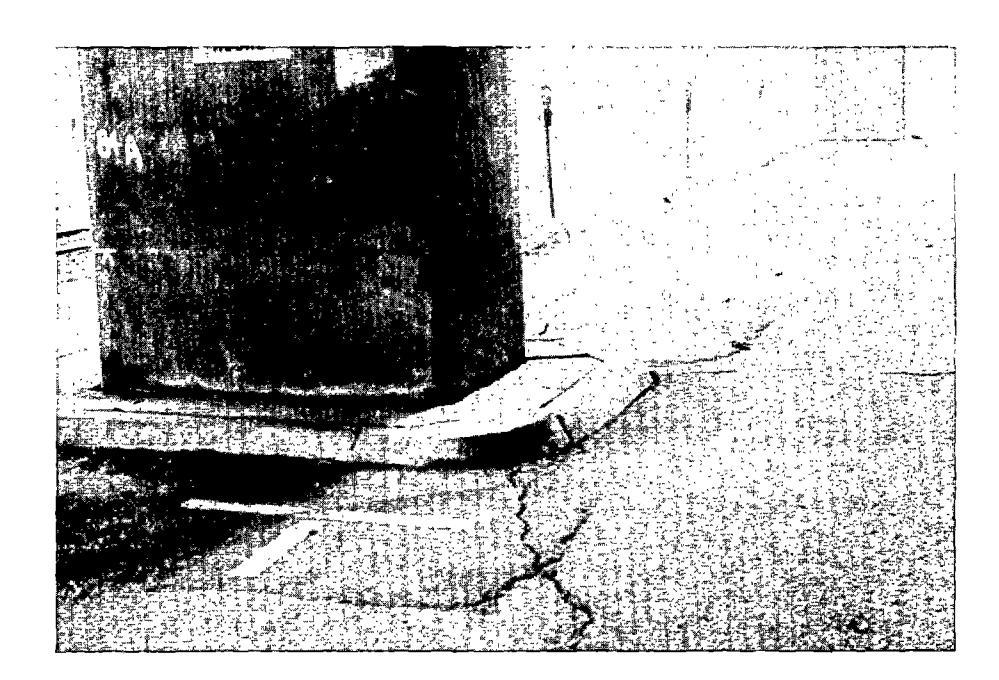
FIGURE 2-11. Differential Settlement Adjacent to Pile-Supported Column of Embarcadero Skyway Near Mission St. (photograph by T. D. O'Rourke)

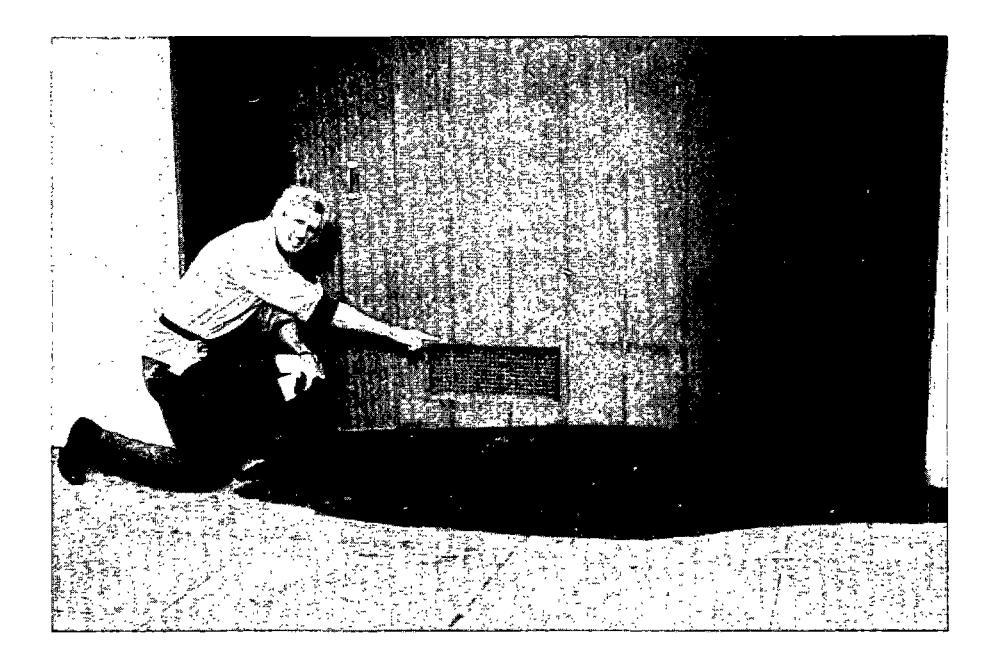
FIGURE 2-12. Sand Ejected from Garage of Building on Scott St. (photograph by H. E. Stewart)

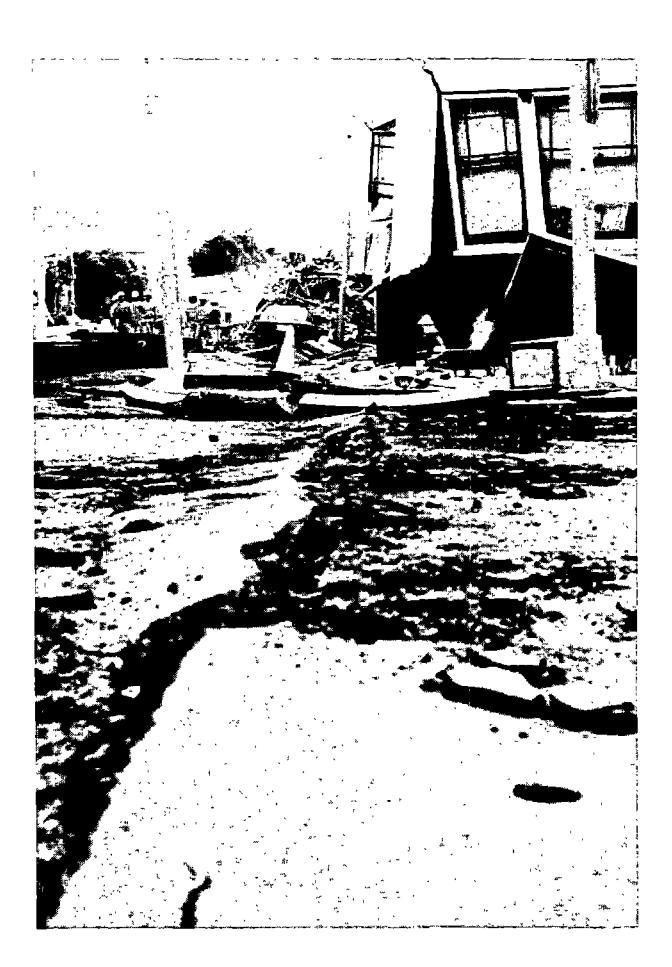
FIGURE 2-13. Buckled Pavements and Ground Deformations at Corner of Divisadero St. and Jefferson St. (photograph by T. D. O'Rourke) away from the main clubhouse. Some deformation could be seen in the 400-mm concrete piles supporting the main building. There was a distinct inclination of each pile beneath the northern building line, indicating that underlying sections of the piles had rotated outward relative to the pile caps.

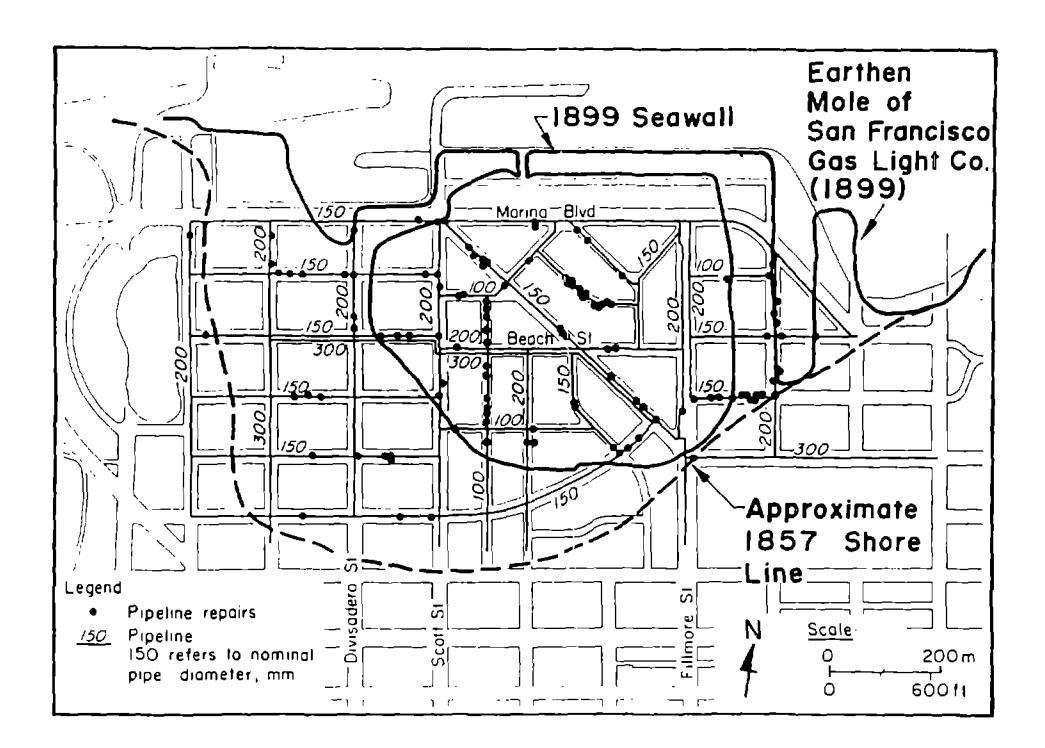
Figure 2-16 shows a plan view of MWSS pipeline repairs relative to the current street system, 1899 shoreline, and approximate 1857 shoreline. Most repairs were concentrated in the area of hydraulic fill within the lagoon bounded by the 1899 seawall or along the eastern margins of the seawall and 1857 shoreline. There were about 120 repairs in the Marina, more than three times the number of repairs in the entire MWSS outside the Marina. Repairs were made at locations of sheared or disengaged service connections with mains, flexural round cracks in mains, and leaking joints. The predominant mode of damage was associated with the first two categories.

FIGURE 2-16. Pipeline Repairs in Municipal Water Supply System (MWSS) in the Marina District

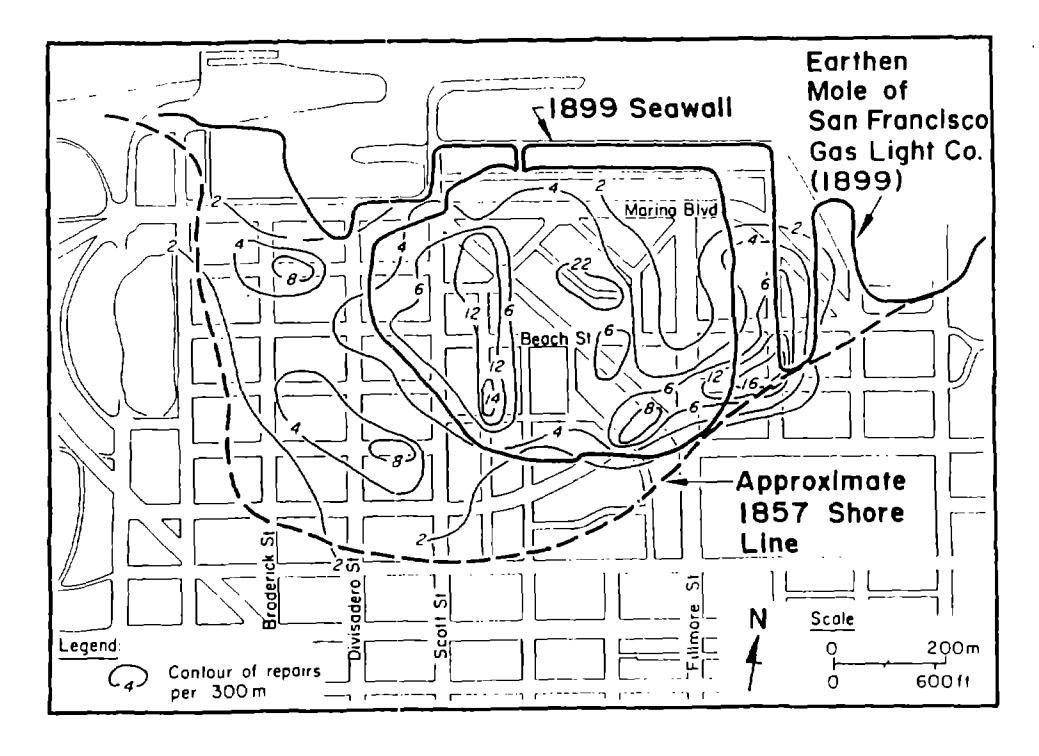
To represent the distribution of damage, the Marina was divided into a grid of approximately 40 cells, and the number of repairs per length of pipeline in each cell was counted. Each repair rate then was normalized with respect to a reference length of 300 m to provide a consistent basis for evaluation. Contours of equal repairs per 300 m of pipeline were drawn and superimposed on the street system and previous shorelines, as illustrated in Figure 2-17. The contours of pipeline repair rates are related closely to the 1857 shoreline, with virtually all pipeline damage falling within this boundary. Higher concentrations of pipeline repair fall within the area of hydraulic fill, with the heaviest repair concentration at the junction of the hydraulic fill, 1899 seawall embankment, and 1857 shoreline.

FIGURE 2-17. Contours of Pipeline Repairs per 300 m for MWSS in the Marina District

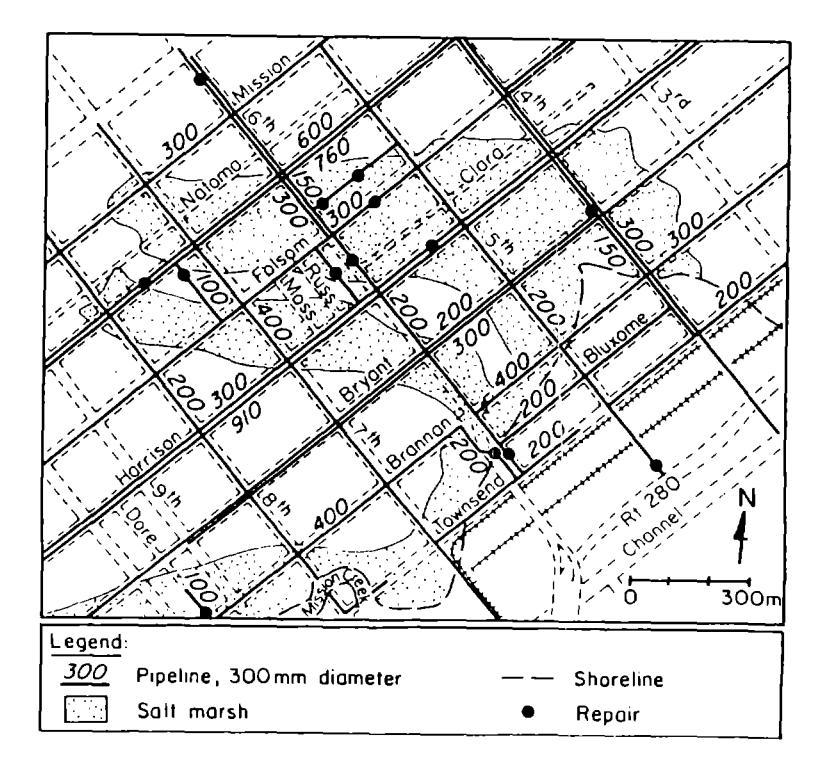
The highest concentration of pipeline repairs was in the area bounded by 8th, Mission, 5th, and Harrison Sts. As described in the preceding section, differential settlements and fractured pavements (indicating lateral movement) were observed throughout this area. Although the level of damage was much more severe in 1906, it is interesting to note that some of the pipeline damage in 1989 occurred in the same general area as in 1906. For example, Reynolds [1906], in

FIGURE 3-4. MWSS Pipeline Repairs in South of Market Area

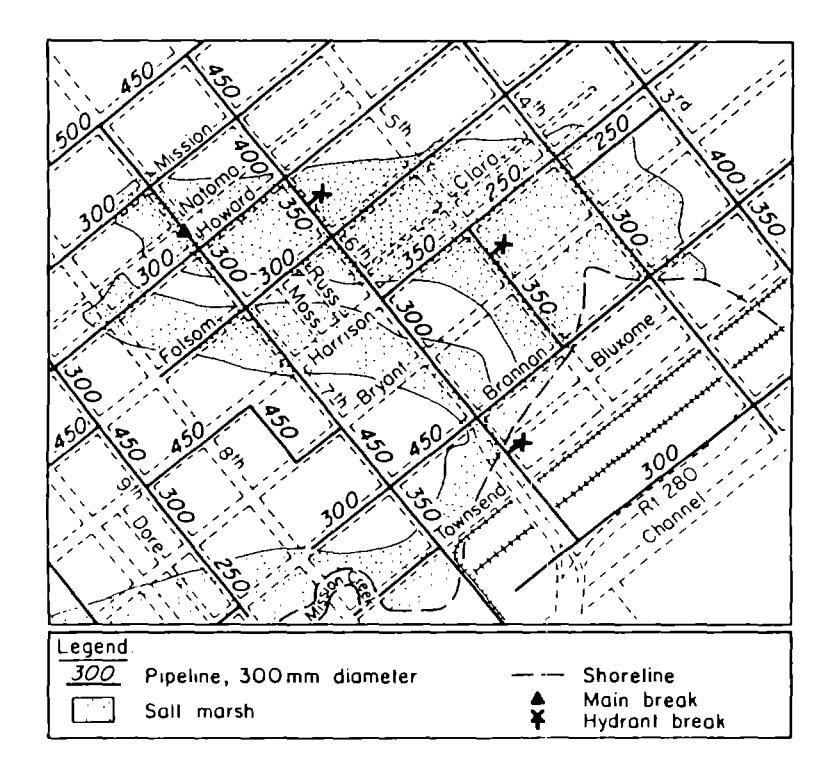
The most serious damage was the break of a 300-mm-diameter cast iron main on 7th St. between Mission and Howard Sts. Water flow through this break, supplemented by losses at broken hydrants, emptied the Jones St. Tank (see Figure 3-3) of its entire storage of 2.8 million liters in approximately 20 to 30 minutes. Loss of this reservoir supply led to the loss of water and pressure throughout the lower zone of the AWSS. This resulted in an especially sensitive condition in

FIGURE 3-5. AWSS Pipeline and Hydrant Repairs in South of Market Area
