Seismic Considerations— Hotels and Motels

SEISMIC CONSIDERATIONS: HOTELS AND MOTELS

**Developed by the
Building Seismic Safety Council
for the
Federal Emergency Management Agency**

**BUILDING SEISMIC SAFETY COUNCIL
Washington, D.C.
1990**

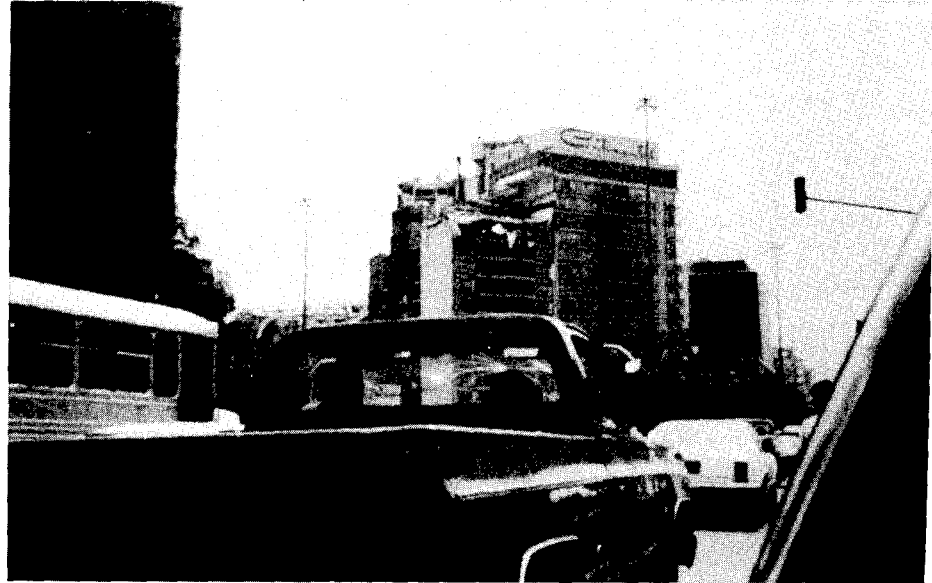
Irregularity of building form has contributed to a number of hotel earthquake failures. During the 1985 earthquake, several floors in two wings of the Hotel Continental in Mexico City collapsed. The plan of the building was very irregular forming a "V" between two wings of dissimilar size (Figure 6). The torsion caused by the noncoincident centers of mass and rigidity contributed greatly to the building's failure to withstand the seismic forces. Another hotel in Mexico City, the relatively new Hotel Romano, suffered total collapse during the earthquake--probably due in large part to an eccentric bearing wall on the ground floor that caused major rotational forces to be applied to another part of the structure consisting only of columns, not walls.

FIGURE 6
Hotel Continental
after 1985 Mexico
City earthquake
(EQE, Inc., San
Francisco).

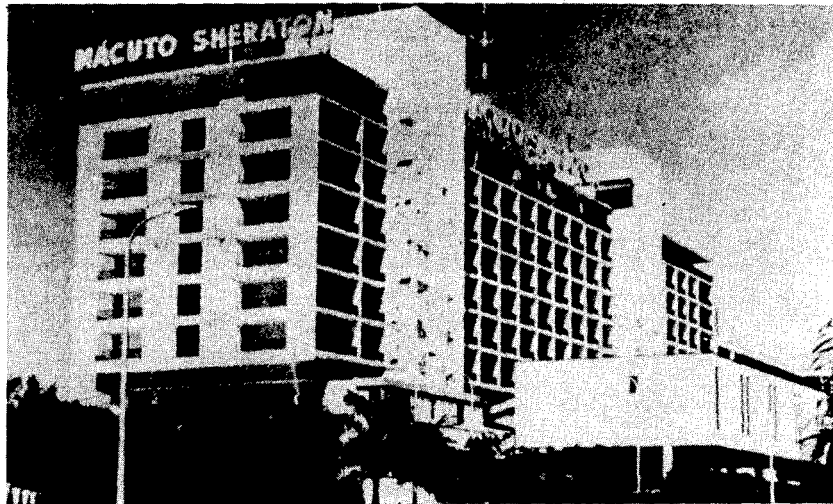
*FIGURE 10
Hotel Macuto
Sheraton in
Caracas after
1967 earthquake.*

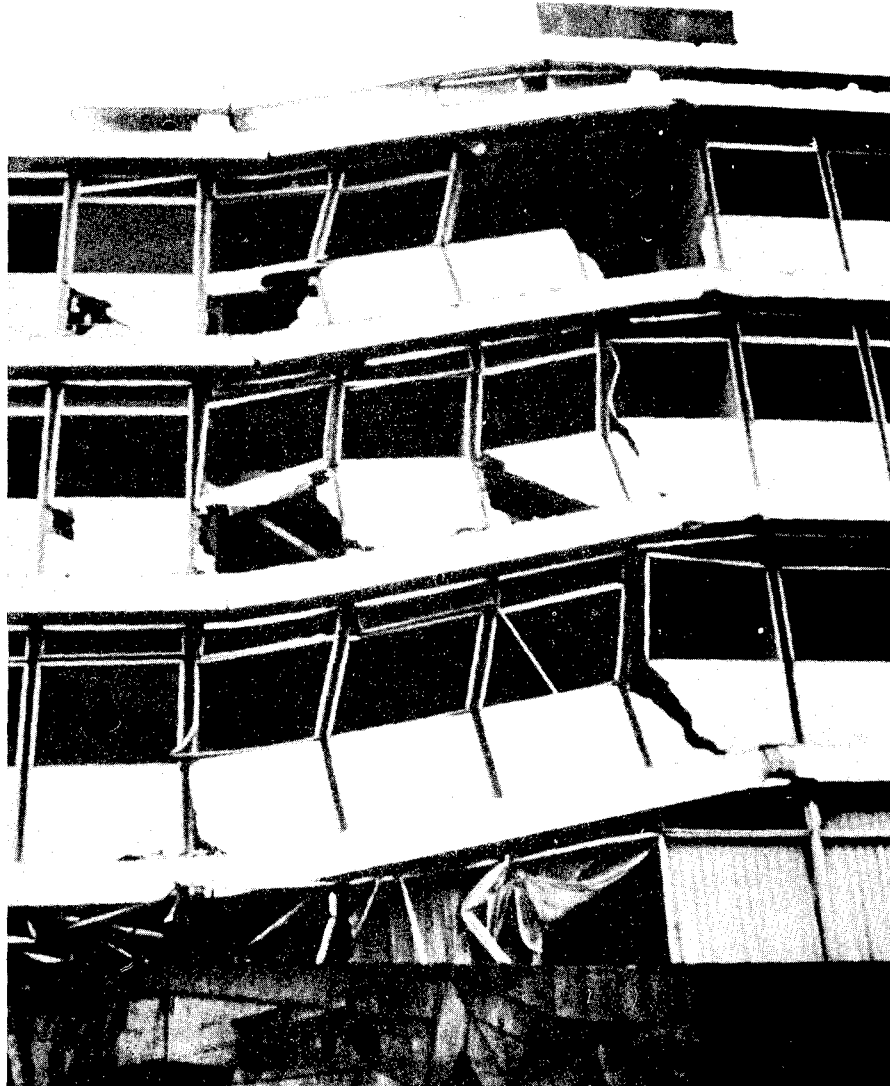
The Terminal Hotel in Guatemala City experienced major structural collapse during the 1973 earthquake due to discontinuity of strength between two areas (Figure 11). The tower portion of the hotel had a kitchen on one end and a restaurant dining area on the other. The kitchen was closed in by structural walls while the dining portion was surrounded only by glass. In response to the earthquake ground motion, the building acted very much like a horizontal pendulum with the base of the pendulum at the kitchen end. The excessive lateral motion sheared off the columns at the restaurant portion leading to collapse on that side of the building.

*FIGURE 11
Hotel Terminal
after 1986
earthquake.*

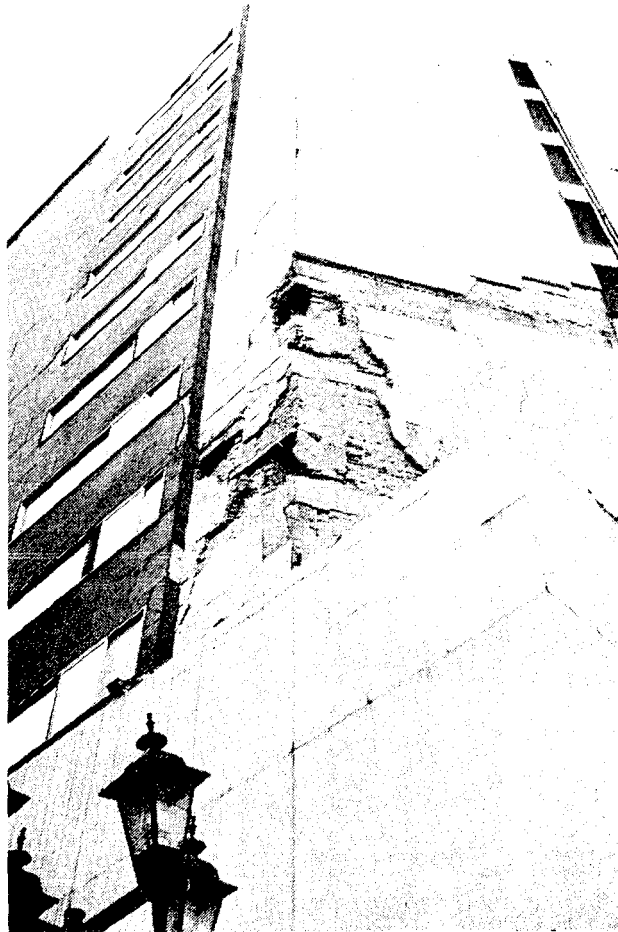
During the 1985 Mexico City earthquake, the construction joints of the columns at the floor levels of the Hotel El Presidente were sheared as the infill walls resisted any horizontal deflection of the columns (Figure 17). The Krystal Hotel also suffered major cracking of infill panels during the same earthquake (Figure 18). The panels apparently were not designed to take the loads transferred to them by the columns restrained by the panels.

*FIGURE 17
Hotel El Presidente
after 1985 Mexico
City earthquake
(Masonry Institute of
America).*

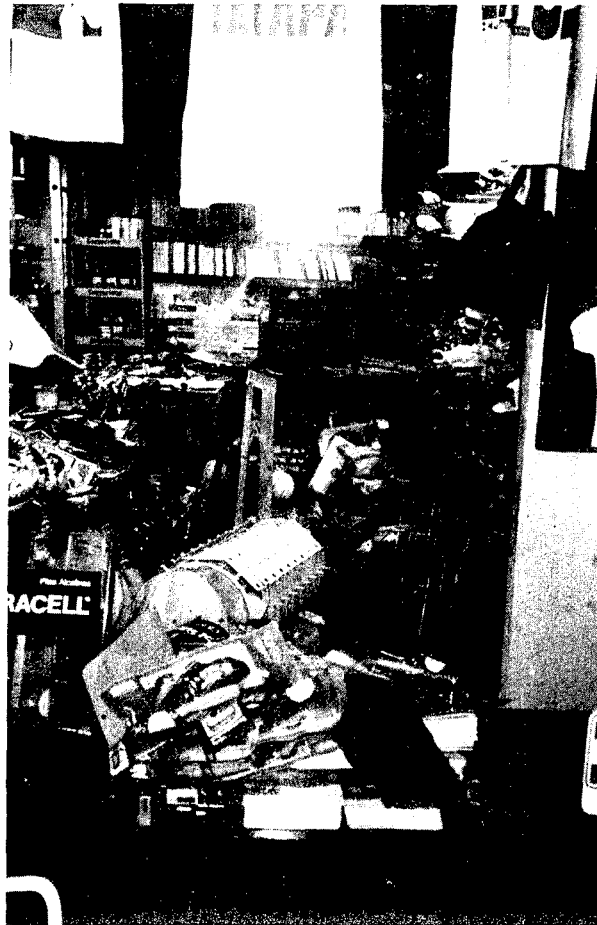
*FIGURE 23
Holiday Inn in
Ixtapa after 1985
earthquake (EQE,
Inc., San Francisco,
California).*

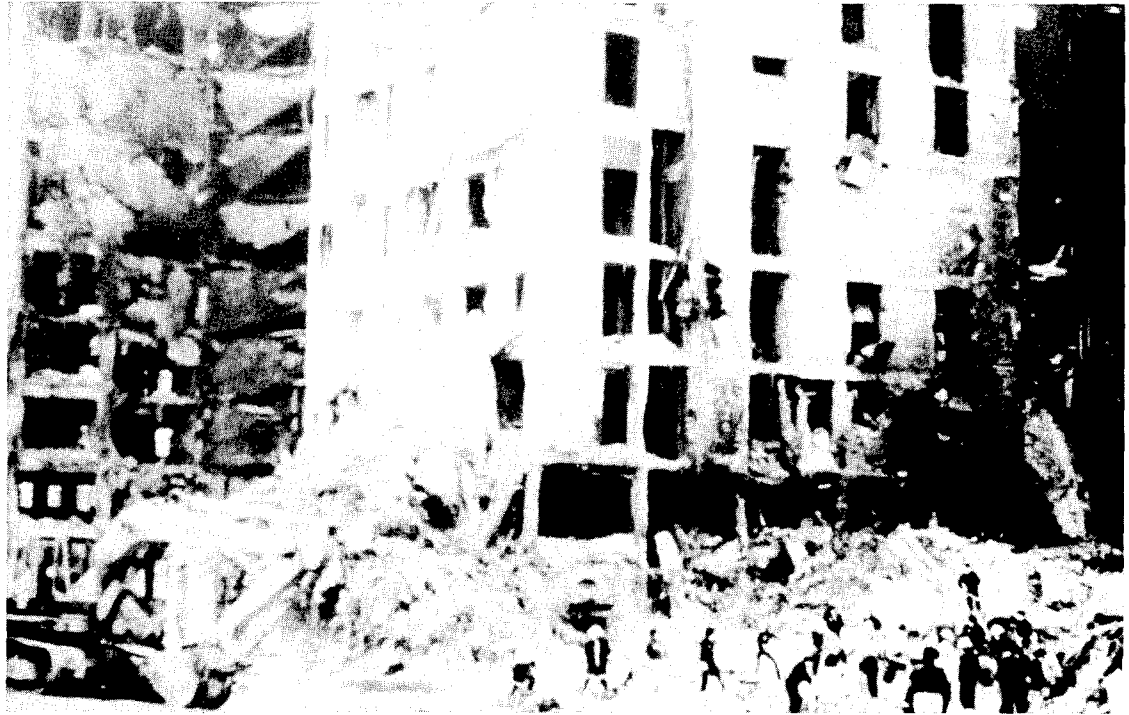
*FIGURE 24
Hotel Regis after
1985 Mexico City
earthquake and
subsequent fire.*

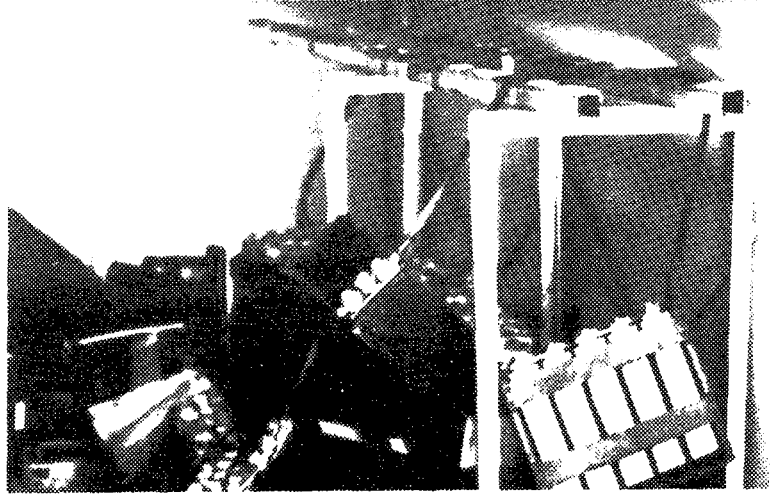
*FIGURE 25
Collapse of
emergency electrical
equipment.*

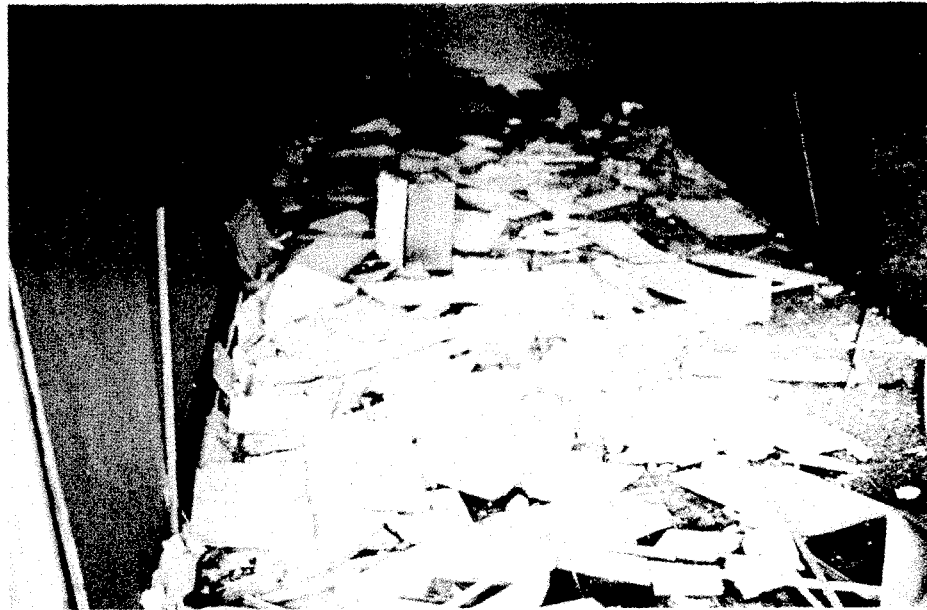
*FIGURE 36
Obstructed
egress area.*

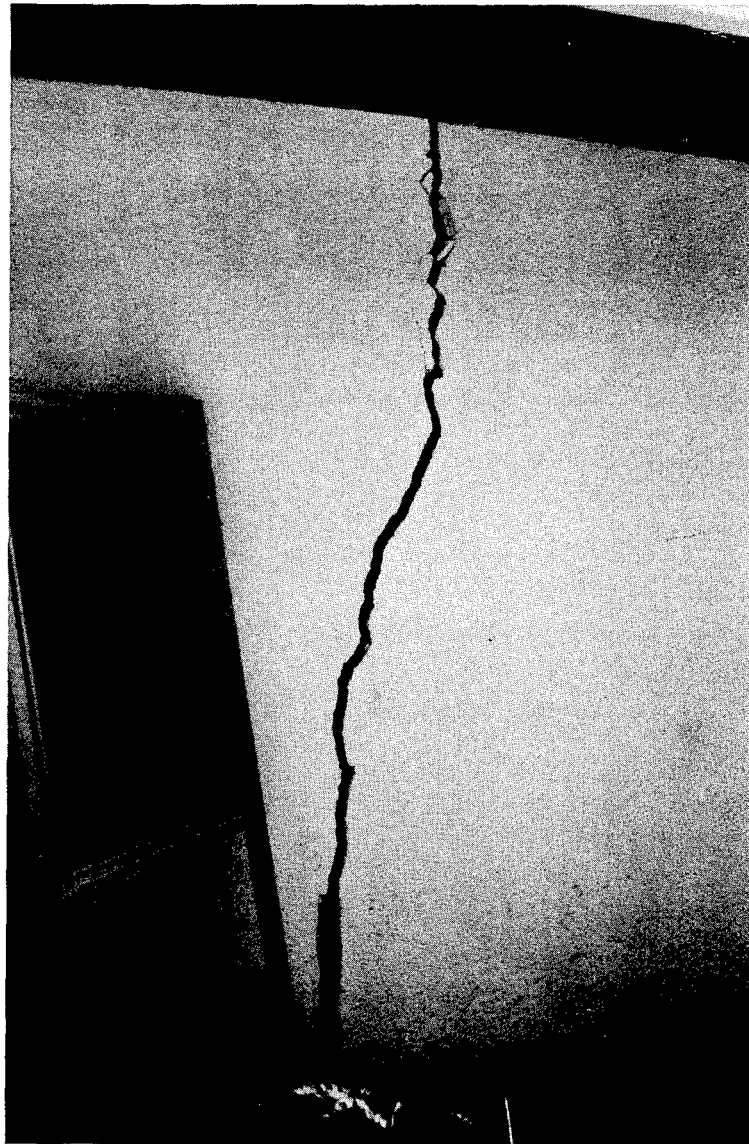
Hotel Playa Linda is a 360-room motel type development of 12 two-story buildings. The facility experienced damage to the foundation, structural elements, prefabricated walls, and mechanical/electrical system (Figures A-4). Much of the damage was due to the penetration of seawater into the building through cracks in the foundation and walls. Although the facility underwent extensive repairs, because of the number of individual buildings the entire complex did not have to close down. Of course, many of the rooms were unusable for long periods of time during this repair period.

*FIGURE A-4
Hotel Playa
Linda-Ixtapa.*
