# A Policy Guide to Steel Moment Frame Construction

# **A Policy Guide to Steel Moment-frame Construction**

## **SAC Joint Venture**

**Prepared for SAC Joint Venture by  
Ronald O. Hamburger**

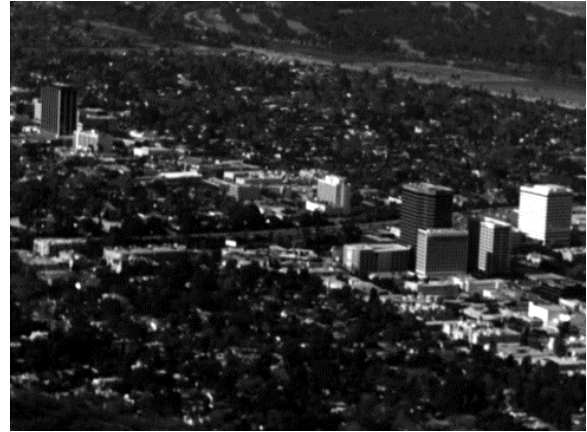
***Ventura Boulevard in the San Fernando Valley. Many of these buildings had hidden damage.***

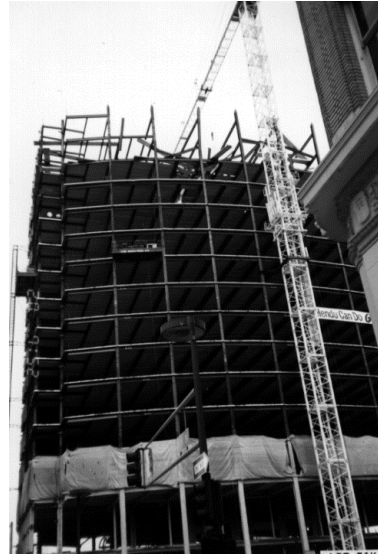
***Construction of a modern steel frame building in which the ends of beams are rigidly joined to columns by welded connections.***

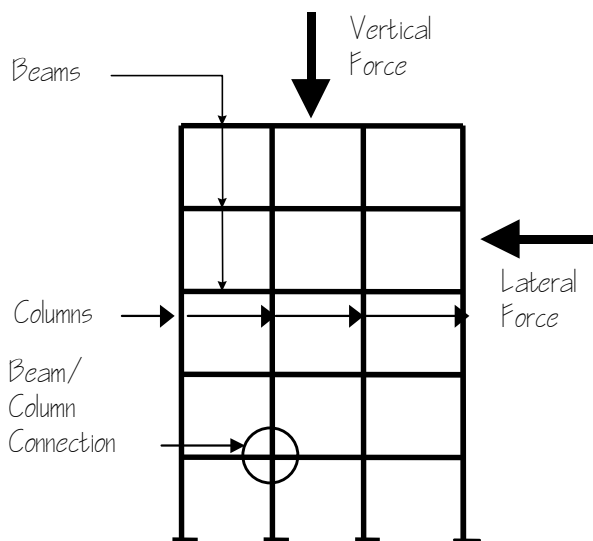
***A steel moment-frame is an assembly of beams and columns, rigidly joined together to resist both vertical and lateral forces.***

All steel-framed buildings derive basic structural support for the building weight from a skeleton (or frame) composed of horizontal steel beams and vertical steel columns. In addition to being able to support vertical loads, including the weight of the building itself and the contents, structures must also be able to resist lateral (horizontal) forces produced by wind and earthquakes. In some steel frame structures, this lateral resistance is derived from the presence of diagonal braces or masonry or concrete walls. In steel moment-frame buildings, the ends of the beams are rigidly joined to the columns so that the buildings can resist lateral wind and earthquake forces without the assistance of additional braces or walls. This style of construction is very popular for many building occupancies, because the absence of diagonal braces and structural walls allows complete freedom for interior space layout and aesthetic exterior expression.

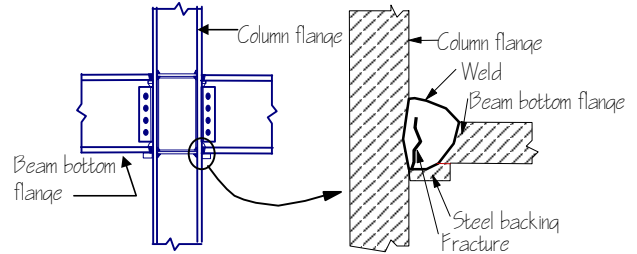
**Damage consists of fractures or cracks that initiate in the welded joints of the beams to columns.**

The damage discovered in WSMF buildings consists of a fracturing, or cracking, of the welded connections between the beams and columns that form the frame, or skeleton, of the structure. This damage occurs most commonly at the welded joint between a column and the bottom flange of a beam. Once a crack has started, it can continue in any of several different patterns and in some cases has been found to completely sever beams or columns.

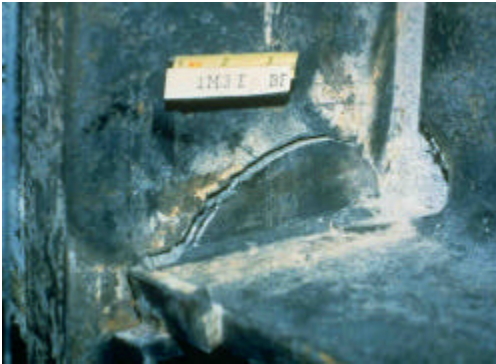
**Damage ranges from small cracks that are difficult to see, to much larger cracks. Here, a crack began at the weld and progressed into the column flange, withdrawing a divot of material.**

There are several common types of damage, each of which looks somewhat different. The most common cracks initiate in the weld itself or just next to the weld. These cracks often are very thin and difficult to see. In a few cases, cracks cannot be seen at all. In some cases, cracks cause large scoop-like pieces of the column flange, called divots, to be pulled out. In still other cases, the cracks run across the entire column, practically dividing it into two unconnected pieces.

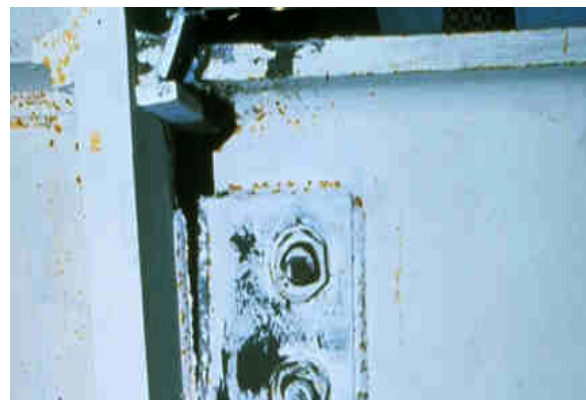
**Fracturing of welded connections can lead to damage to the bolted connections that hold the beams onto the columns, creating potential for localized collapse.**

WSMF buildings rely on the connections between their beams and columns to resist wind and earthquake loads. When the welded joints that form these connections break, the building loses some of the strength and stiffness it needs to resist these loads. The magnitude and significance of this capacity loss depends on the unique design and construction attributes of each building, as well as the extent and type of damage sustained. Few buildings were damaged so severely in the Northridge earthquake that they represented imminent collapse hazards. However, significant weakening of some buildings did occur. Once the welded joints fracture, other types of damage can also occur including damage to bolted joints. Damage that results in the complete severing of beams or columns or their connections poses a serious problem and could result in the potential for localized collapse.

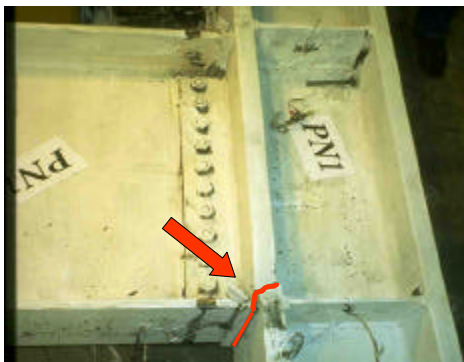
**Fractures commonly initiate at the welded joint of the beam bottom flange to column.**

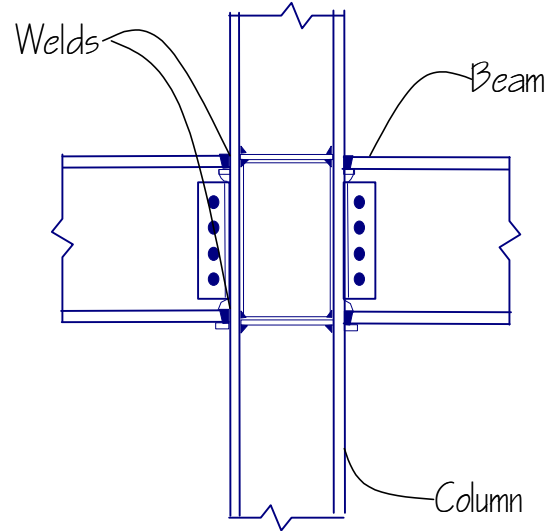
**The typical connection used prior to 1994. Severe stress concentrations inherent in its configuration were not considered in the design.**

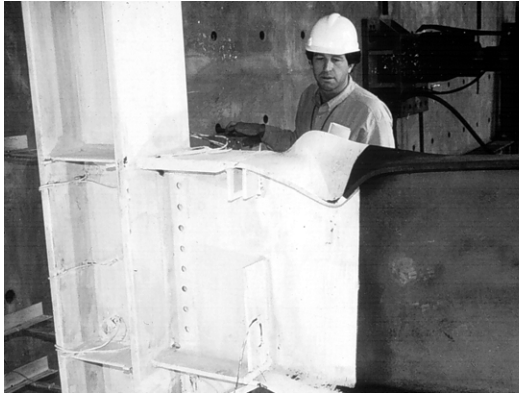
***Engineers expect steel to be ductile, capable of extensive bending and deformation without fracturing, as shown in this test specimen. The development of cracks in the steel at relatively low levels of loading was unexpected.***

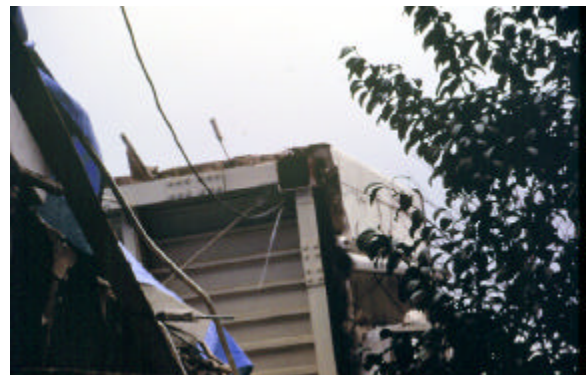
***Many steel moment-frame buildings were damaged in the 1995 Kobe earthquake. The building shown here, lying on its side, is one of more than 50 older steel buildings that collapsed.***

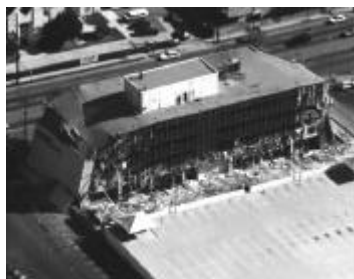
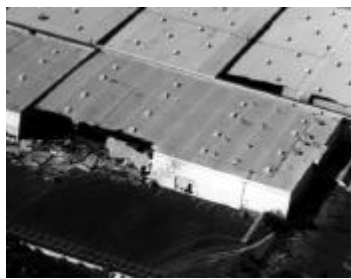
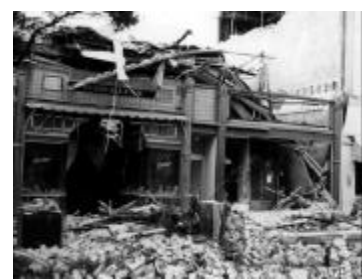
***Older concrete frame, tilt-up and masonry buildings are generally more prone to earthquake-induced collapse than WSMF buildings.***

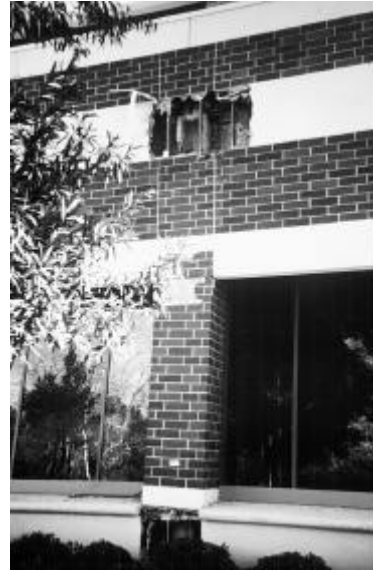
***The most severely damaged buildings will often lean to one side. However, there may be no obvious indications of the damage in some buildings.***

Some damaged WSMF buildings permanently lean to one side after an earthquake and have severe damage to finishes, providing a clear indication that the building has sustained structural damage. However, many WSMF buildings do not exhibit any obvious signs of damage. To determine if these buildings are damaged, it is necessary to conduct an engineering inspection of the framing and connections. To conduct these inspections, it is necessary first to remove building finishes and fireproofing. These inspections can be disruptive of occupancy and very expensive, ranging from a few hundred dollars to more than one thousand dollars per connection. Large buildings may have several thousand connections. The presence of asbestos, sometimes used in fireproofing in buildings constructed prior to 1979, substantially increases the inspection costs.

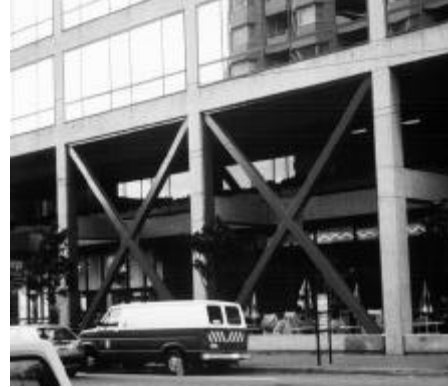
***Buildings can be upgraded by modifying connections, adding braces and other methods.***

It is technically feasible to upgrade an existing steel moment-frame building and improve its probable performance in future earthquakes. The most common methods are upgrades of the individual connections, addition of steel braces, concrete or masonry walls, or addition of energy dissipation systems. Each of these approaches may offer advantages in particular buildings.

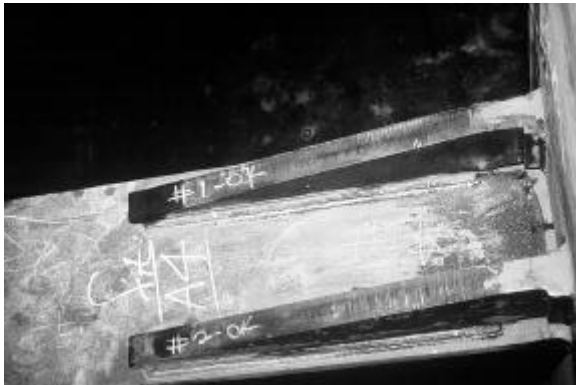
***Connections can be upgraded by welding or bolting new plates onto the beams and columns to change the connection shape and reduce stress concentrations. In some cases, it may also be appropriate to replace defective welds and welds with low toughness with welds with improved toughness and workmanship.***

Connection upgrades are the most direct approach to improving the seismic performance of an existing steel moment-frame structure. As previously discussed, existing connections can fracture because their shape results in the development of large stress concentrations; some welds have large defects that reduce their strength and the weld metal itself may be of low toughness and unable to resist the large stresses imposed on it. Connection upgrades address these problems directly by modifying the shape of the connection to reduce the stress concentrations. In addition, depending on the approach used, the upgrade may include replacement of defective welds and welds with low toughness with new welds that have improved toughness and better workmanship. FEMA 351 provides information and design criteria for a number of alternative methods of upgrading connections.

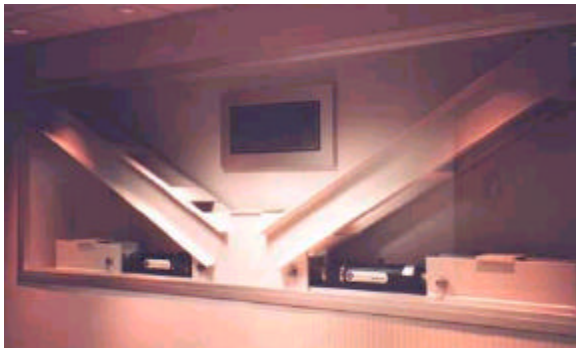
***Energy dissipation systems are typically installed in buildings as part of a vertical bracing system that extends between the building's floors.***

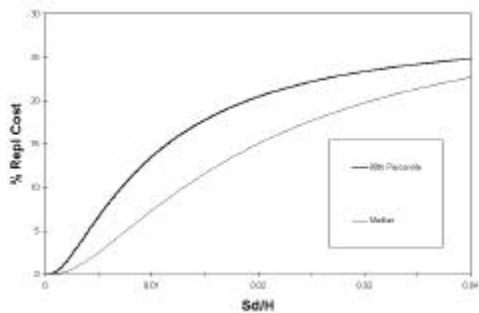
**The Simplified Loss Estimation Methodology uses a series of graphs to relate probable earthquake losses to ground motion intensity.**

The Simplified Loss Estimation Methodology contained in *FEMA 351* consists of a series of graphs that indicate the probability that WSMF buildings will experience various levels of damage if they are subjected to certain levels of ground motion. These graphs were compiled from data obtained for buildings in the Los Angeles area following the 1994 Northridge earthquake. To use these graphs, an engineer must estimate an intensity of ground motion to which a building will be subjected. Using the graph, an engineer can obtain an estimate of the percentage of the building's connections that will be damaged and the probable cost of connection repairs, if the building experiences an earthquake of a certain intensity. These graphs do not take into account the individual characteristics of a building, except in an approximate manner and, therefore, do not provide precise estimates. Rather, they provide an indication of the potential range of damage and repair costs and the probability that damage and repair costs will exceed certain amounts, based on the behavior of the buildings that were affected by the Northridge earthquake.

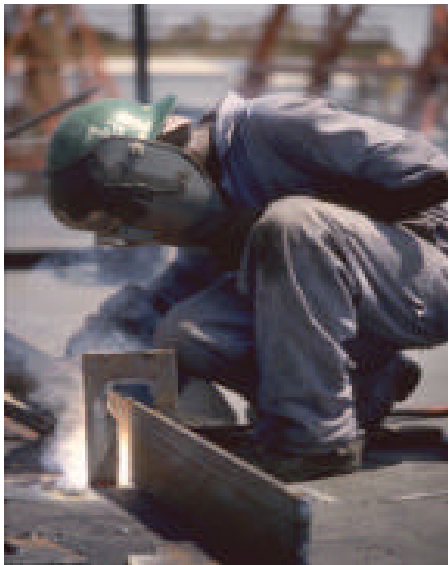
***If inadequately constructed, welded joints in moment-frames can be weak links that fail prematurely. FEMA 350 recommends careful control of the materials, workmanship and procedures used to make these joints and verify their adequacy.***

*FEMA 350* and its companion document, *FEMA 353*, present extensive new recommendations for welding of moment-resisting connections in frames designed for seismic applications. The new recommendations address the types of materials that may be used for this work, the welding processes and procedures that should be followed, the environmental conditions under which welding should be performed, and the level of training and workmanship required of welders and inspectors engaged in this work. In addition, *FEMA 353* provides detailed recommendations for quality control, quality assurance and inspection procedures that should be put into place to assure that this critical work is properly performed. These new recommendations affect all segments of the design and construction process and require designers, producers, fabricators, welding electrode manufacturers, welders and inspectors, among others, to adopt new practices. These recommendations have been submitted to the American Welding Society for incorporation into the structural welding code.

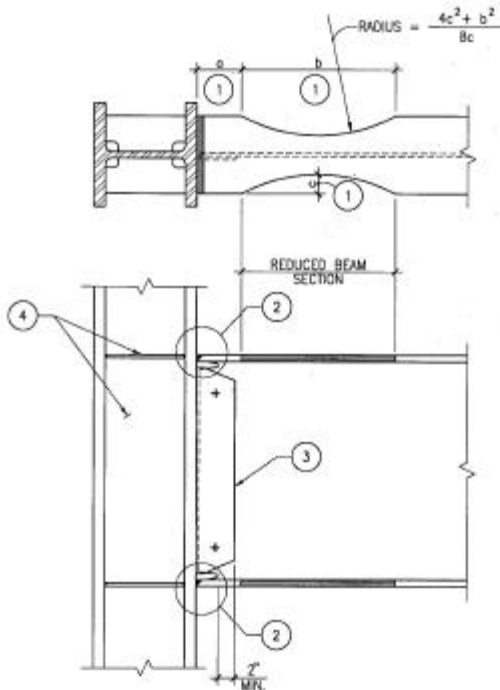
***The Reduced Beam Section, or “dog bone” connection is one of 12 different types of prequalified connections that engineers can specify without project-specific testing.***

*FEMA 350* contains design criteria for twelve different types of prequalified, welded and bolted beam-to-column connections. Each prequalification includes specification of the limiting conditions under which the connection design is valid, the materials that may be used, and the specific design and fabrication requirements.
