SECOND EDITION
Rapid Visual Screening of
Buildings for Potential
Seismic Hazards:
A Handbook

This FEMA 154 Report, *Rapid Visual Screening of Buildings for Potential Seismic Hazards: A Handbook*, is the first of a two-volume publication on a recommended methodology for rapid visual screening of buildings for potential seismic hazards. The technical basis for the methodology, including the scoring system and its development, are contained in the companion FEMA 155 report, *Rapid Visual Screening of Buildings for Potential Seismic Hazards: Supporting Documentation*. Both this document and the companion document are second editions of similar documents published by FEMA in 1988.

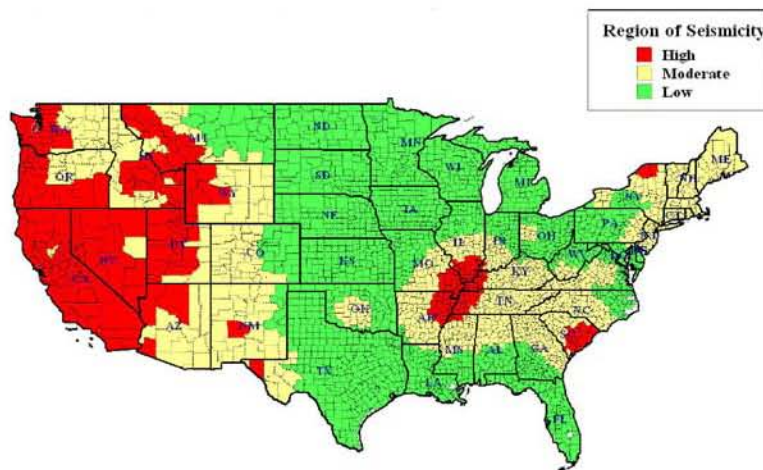
Note: Seismicity regions are based on ground motions having a 2% probability of exceedance in 50 years.

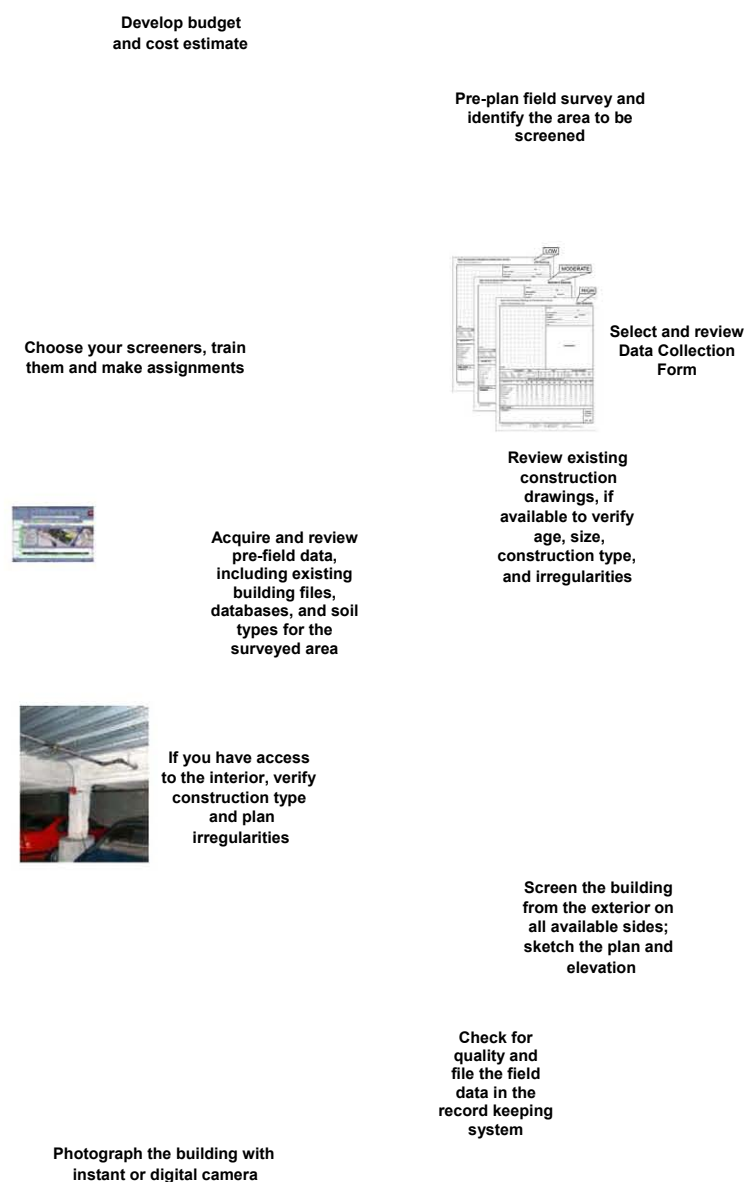
Figure 2-1 Rapid visual screening implementation sequence.

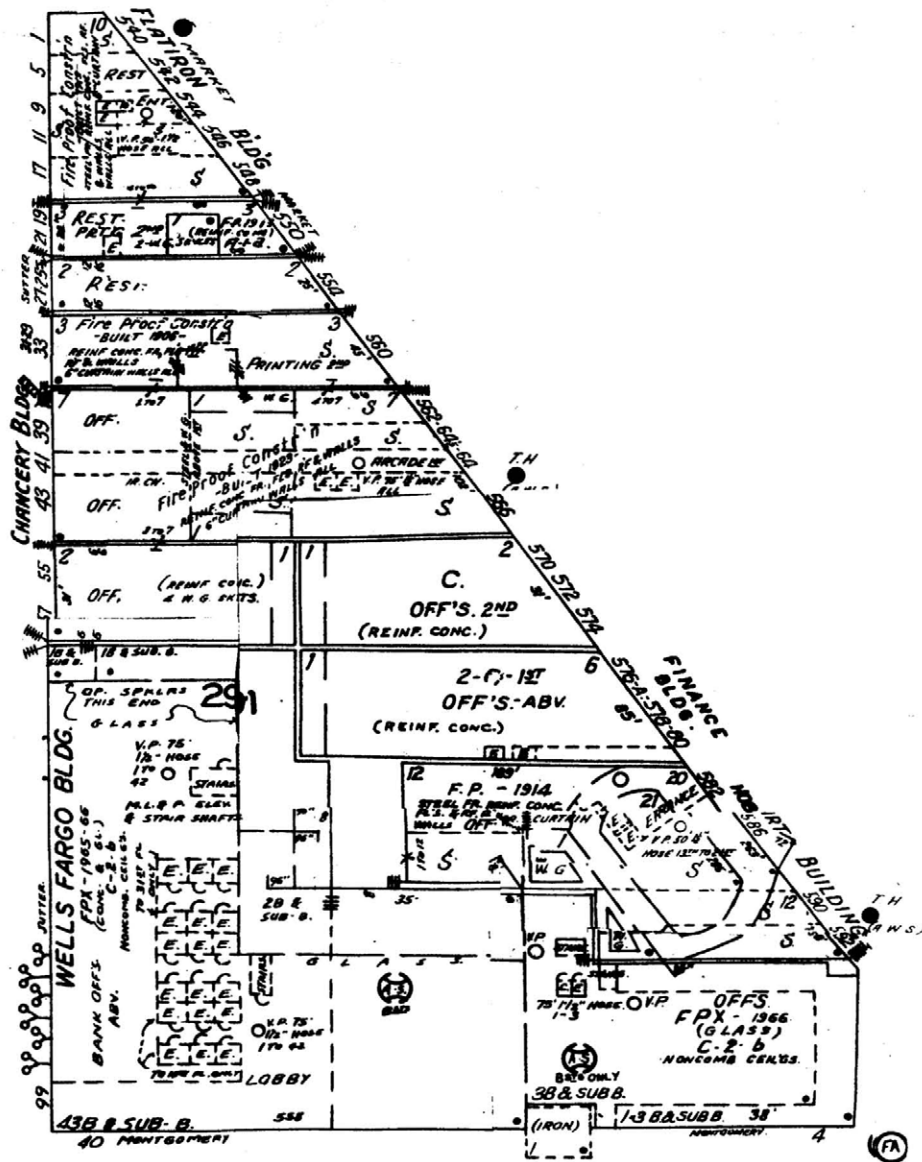
Figure 2-5 Example Sanborn map showing building information for a city block.

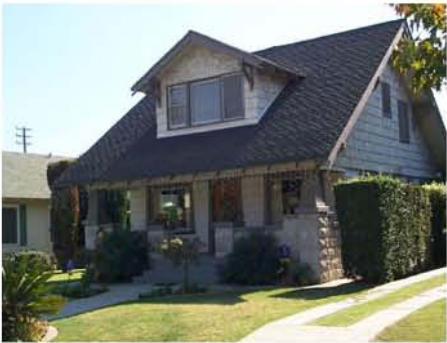
<i>Building Identifier</i>	<i>Photograph</i>	<i>Basic Structural Hazard Score</i>	<i>Characteristics and Performance</i>
<p>W1 Light wood frame residential and commercial buildings equal to or smaller than 5,000 square feet</p>

<p>H = 2.8 M = 5.2 L = 7.4</p>	<ul style="list-style-type: none"> • Wood stud walls are typically constructed of 2-inch by 4-inch vertical wood members set about 16 inches apart (2-inch by 6-inch for multiple stories). • Most common exterior finish materials are wood siding, metal siding, or stucco. • Buildings of this type performed very well in past earthquakes due to inherent qualities of the structural system and because they are lightweight and low rise. • Earthquake-induced cracks in the plaster and stucco (if any) may appear, but are classified as non-structural damage. • The most common type of structural damage in older buildings results from a lack of connection between the superstructure and the foundation, and inadequate chimney support. • These are large apartment buildings, commercial buildings or industrial structures usually of one to three stories, and, rarely, as tall as six stories.

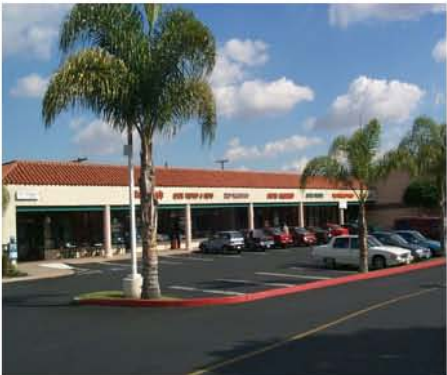
<p>W2 Light wood frame buildings greater than 5,000 square feet</p>

<p>H = 3.8 M = 4.8 L = 6.0</p>

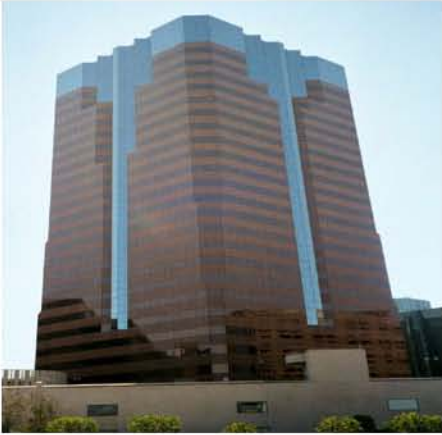
<i>Building Identifier</i>	<i>Photograph</i>	<i>Basic Structural Hazard Score</i>	<i>Characteristics and Performance</i>
<p>S1 Steel moment-resisting frame</p>

<p>H = 2.8 M = 3.6 L = 4.6</p>	<ul style="list-style-type: none"> • Typical steel moment-resisting frame structures usually have similar bay widths in both the transverse and longitudinal directions, around 20-30 ft. • The floor diaphragms are usually concrete, sometimes over steel decking. This structural type is used for commercial, institutional and public buildings. • The 1994 Northridge and 1995 Kobe earthquakes showed that the welds in steel moment-frame buildings were vulnerable to severe damage. The damage took the form of broken connections between the beams and columns. • These buildings are braced with diagonal members, which usually cannot be detected from the building exterior.
<p>S2 Braced steel frame</p>

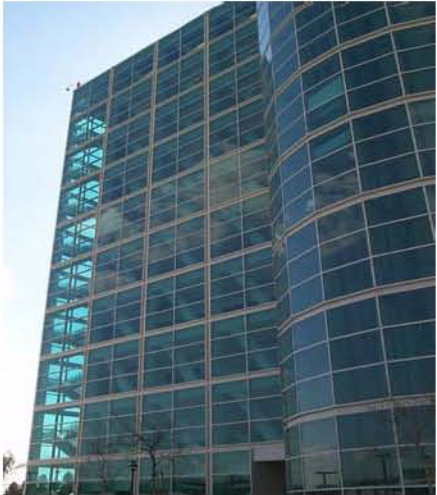
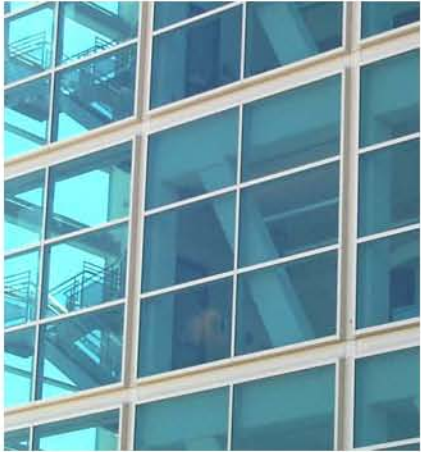
<p>H = 3.0 M = 3.6 L = 4.8</p>	<ul style="list-style-type: none"> • Braced frames are sometimes used for long and narrow buildings because of their stiffness. • From the building exterior, it is difficult to tell the difference between steel moment frames, steel braced frames, and steel frames with interior concrete shear walls. • In recent earthquakes, braced frames were found to have damage to brace connections, especially at the lower levels.

<p>Zoom-in of upper photo</p>

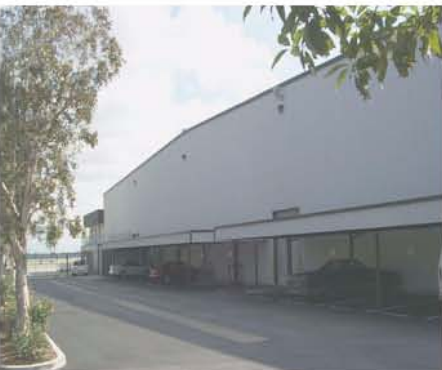
<i>Building Identifier</i>	<i>Photograph</i>	<i>Basic Structural Hazard Score</i>	<i>Characteristics and Performance</i>
<p>S3 Light metal building</p>

<p>H = 3.2 M = 3.8 L = 4.6</p>	<ul style="list-style-type: none"> ● The structural system usually consists of moment frames in the transverse direction and braced frames in the longitudinal direction, with corrugated sheet-metal siding. In some regions, light metal buildings may have partial-height masonry walls. ● The interiors of most of these buildings do not have interior finishes and their structural skeleton can be seen easily. ● Insufficient capacity of tension braces can lead to their elongation and consequent building damage during earthquakes. ● Inadequate connection to a slab foundation can allow the building columns to slide on the slab. ● Loss of the cladding can occur.
<p>S4 Steel frames with cast-in-place concrete shear walls</p>

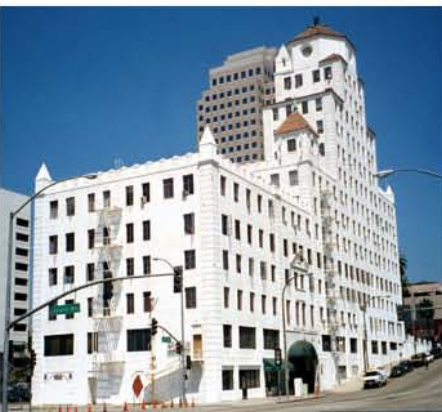
<p>H = 2.8 M = 3.6 L = 4.8</p>	<ul style="list-style-type: none"> ● Lateral loads are resisted by shear walls, which usually surround elevator cores and stairwells, and are covered by finish materials. ● An interior investigation will permit a wall thickness check. More than six inches in thickness usually indicates a concrete wall. ● Shear cracking and distress can occur around openings in concrete shear walls during earthquakes. ● Wall construction joints can be weak planes, resulting in wall shear failure below expected capacity.

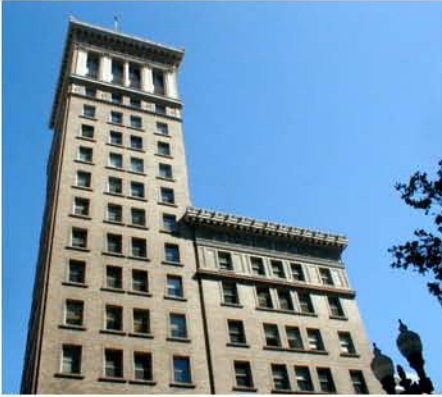
<i>Building Identifier</i>	<i>Photograph</i>	<i>Basic Structural Hazard Score</i>	<i>Characteristics and Performance</i>
<p>S5 Steel frames with unreinforced masonry infill walls</p>

<p>H = 2.0 M = 3.6 L = 5.0</p>	<ul style="list-style-type: none"> • Steel columns are relatively thin and may be hidden in walls. • Usually masonry is exposed on exterior with narrow piers (less than 4 ft wide) between windows. • Portions of solid walls will align vertically. • Infill walls are usually two to three wythes thick. • Veneer masonry around columns or beams is usually poorly anchored and detaches easily.
<p>C1 Concrete moment-resisting frames</p>

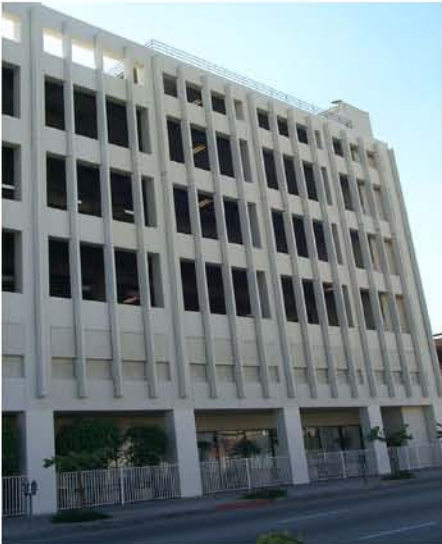
<p>H = 2.5 M = 3.0 L = 4.4</p>	<ul style="list-style-type: none"> • All exposed concrete frames are reinforced concrete (not steel frames encased in concrete). • A fundamental factor governing the performance of concrete moment-resisting frames is the level of ductile detailing. • Large spacing of ties in columns can lead to a lack of concrete confinement and shear failure. • Lack of continuous beam reinforcement can result in hinge formation during load reversal. • The relatively low stiffness of the frame can lead to substantial nonstructural damage. • Column damage due to pounding with adjacent buildings can occur.

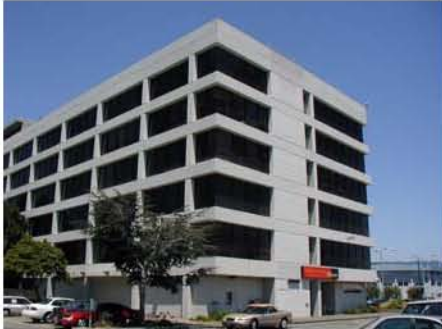
<i>Building Identifier</i>	<i>Photograph</i>	<i>Basic Structural Hazard Score</i>	<i>Characteristics and Performance</i>
<p>C2 Concrete shear wall buildings</p>

<p>H = 2.8 M = 3.6 L = 4.8</p>	<ul style="list-style-type: none"> ● Concrete shear-wall buildings are usually cast in place, and show typical signs of cast-in-place concrete. ● Shear-wall thickness ranges from 6 to 10 inches. ● These buildings generally perform better than concrete frame buildings. ● They are heavier than steel-frame buildings but more rigid due to the shear walls. ● Damage commonly observed in taller buildings is caused by vertical discontinuities, pounding, and irregular configuration.
<p>C3 Concrete frames with unreinforced masonry infill walls</p>

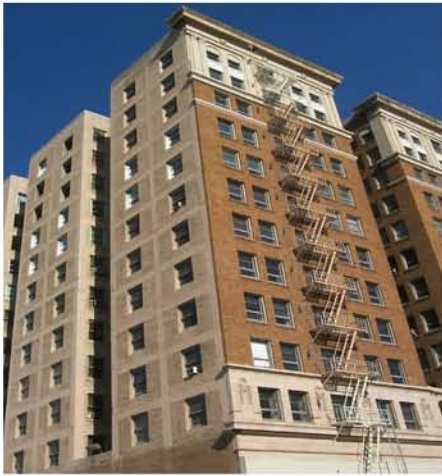
<p>H = 1.6 M = 3.2 L = 4.4</p>	<ul style="list-style-type: none"> ● Concrete columns and beams may be full wall thickness and may be exposed for viewing on the sides and rear of the building. ● Usually masonry is exposed on the exterior with narrow piers (less than 4 ft wide) between windows. ● Portions of solid walls will align vertically. ● This type of construction was generally built before 1940 in high-seismicity regions but continues to be built in other regions. ● Infill walls tend to buckle and fall out-of-plane when subjected to strong lateral out-of-plane forces. ● Veneer masonry around columns or beams is usually poorly anchored and detaches easily.

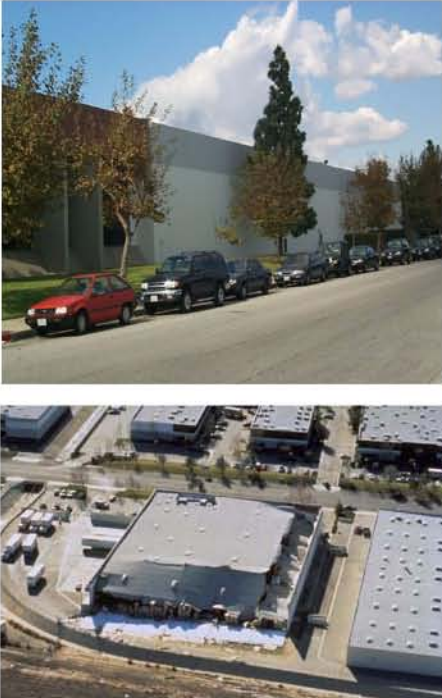
<i>Building Identifier</i>	<i>Photograph</i>	<i>Basic Structural Hazard Score</i>	<i>Characteristics and Performance</i>
<p>PC1 Tilt-up buildings</p>

<p data-bbox="397 1060 812 1121">Partial roof collapse due to failed diaphragm-to-wall connection</p>	<p>H = 2.6 M = 3.2 L = 4.4</p>	<ul style="list-style-type: none"> ● Tilt-ups are typically one or two stories high and are basically rectangular in plan. ● Exterior walls were traditionally formed and cast on the ground adjacent to their final position, and then “tilted-up” and attached to the floor slab. ● The roof can be a plywood diaphragm carried on wood purlins and glulam beams or a light steel deck and joist system, supported in the interior of the building on steel pipe columns. ● Weak diaphragm-to-wall anchorage results in the wall panels falling and the collapse of the supported diaphragm (or roof).

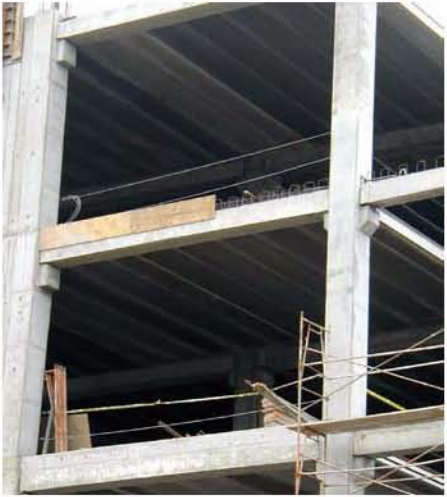
<p data-bbox="349 646 657 676">Building under construction</p>	<p>H = 2.4 M = 3.2 L = 4.6</p>	<ul style="list-style-type: none"> ● Precast concrete frames are, in essence, post and beam construction in concrete. ● Structures often employ concrete or reinforced masonry (brick or block) shear walls. ● The performance varies widely and is sometimes poor. ● They experience the same types of damage as shear wall buildings (C2). ● Poorly designed connections between prefabricated elements can fail. ● Loss of vertical support can occur due to inadequate bearing area and insufficient connection between floor elements and columns. ● Corrosion of metal connectors between prefabricated elements can occur.

<p data-bbox="349 1234 716 1264">Detail of the precast components</p>

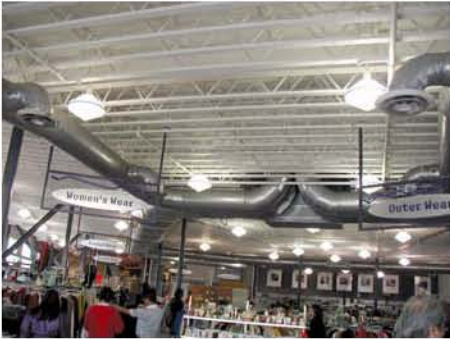
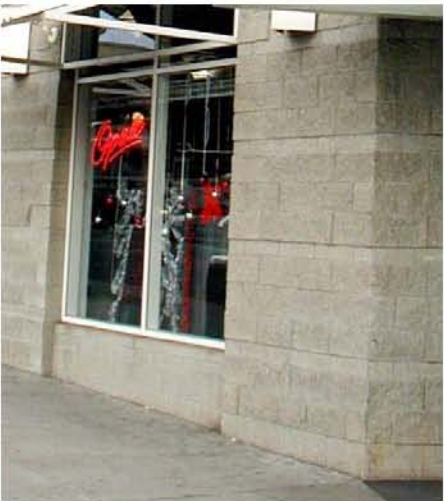
<p>H = 2.8 M = 3.6 L = 4.8</p>	<ul style="list-style-type: none"> ● Walls are either brick or concrete block. ● Wall thickness is usually 8 inches to 12 inches. ● Interior inspection is required to determine if diaphragms are flexible or rigid. ● The most common floor and roof systems are wood, light steel, or precast concrete. ● These buildings can perform well in moderate earthquakes if they are adequately reinforced and grouted, with sufficient diaphragm anchorage. ● Poor construction practice can result in ungrouted and unreinforced walls, which will fail easily.

Truss-joists support plywood and light-weight concrete slab

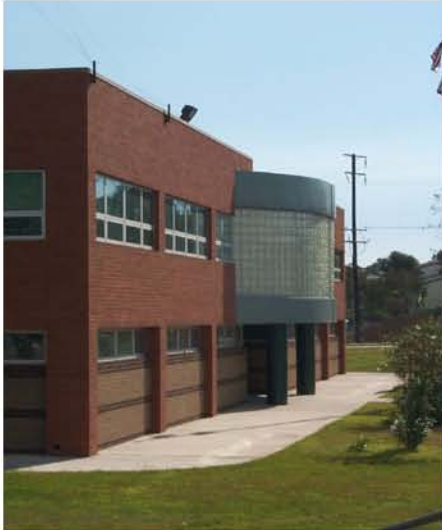
<i>Building Identifier</i>	<i>Photograph</i>	<i>Basic Structural Hazard Score</i>	<i>Characteristics and Performance</i>
<p>RM2 Reinforced masonry buildings with rigid diaphragms</p>

<p>H = 2.8 M = 3.4 L = 4.6</p>	<ul style="list-style-type: none"> ● Walls are either brick or concrete block. ● Wall thickness is usually 8 inches to 12 inches. ● Interior inspection is required to determine if diaphragms are flexible or rigid. ● The most common floor and roof systems are wood, light steel, or precast concrete. ● These buildings can perform well in moderate earthquakes if they are adequately reinforced and grouted, with sufficient diaphragm anchorage. ● Poor construction practice can result in ungrouted and unreinforced walls, which will fail easily.
<p>URM Unreinforced masonry buildings</p>

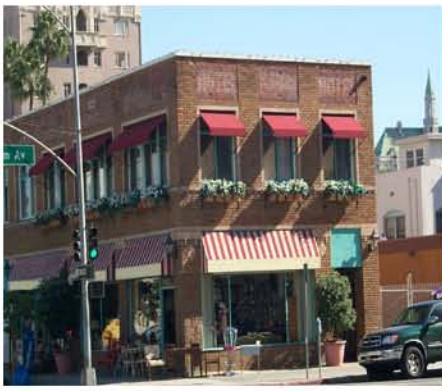
<p>H = 1.8 M = 3.4 L = 4.6</p>	<ul style="list-style-type: none"> ● These buildings often used weak lime mortar to bond the masonry units together. ● Arches are often an architectural characteristic of older brick bearing wall buildings. ● Other methods of spanning are also used, including steel and stone lintels. ● Unreinforced masonry usually shows header bricks in the wall surface. ● The performance of this type of construction is poor due to lack of anchorage of walls to floors and roof, soft mortar, and narrow piers between window openings.

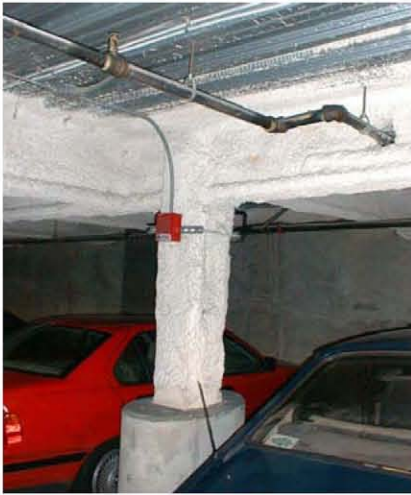
Figure 3-11 Interior view showing fire-proofed columns and beams, which indicate a steel building (S1, S2, or S4).

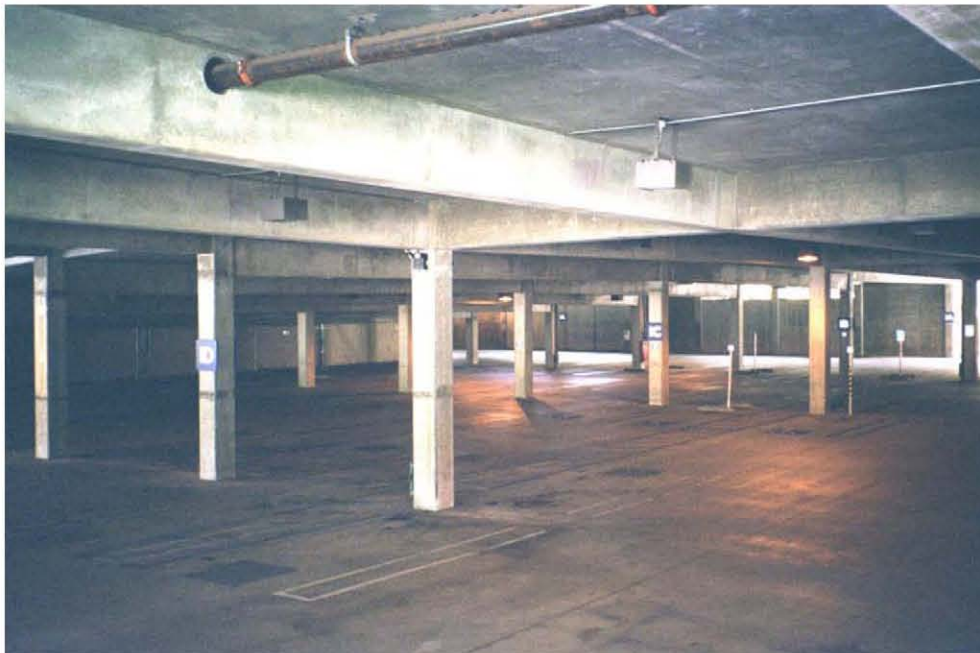
Figure 3-12 Interior view showing concrete columns and girders, which indicate a concrete moment frame (C1).

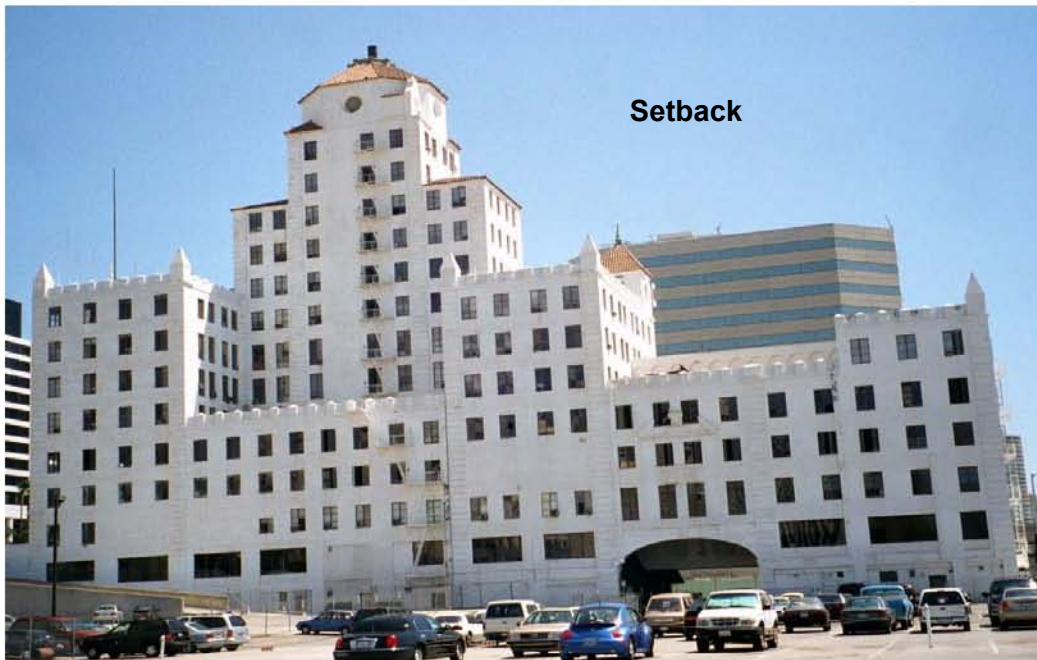
Figure 3-15 Example of setbacks (see Figure 3-14) and a soft first story.

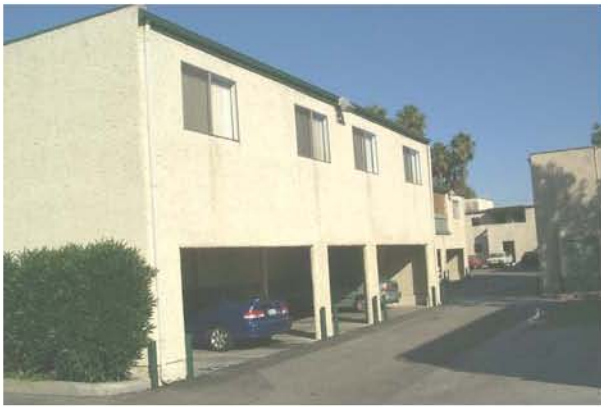
Figure 3-16 Example of soft story conditions, where parking requirements result in large weak openings.

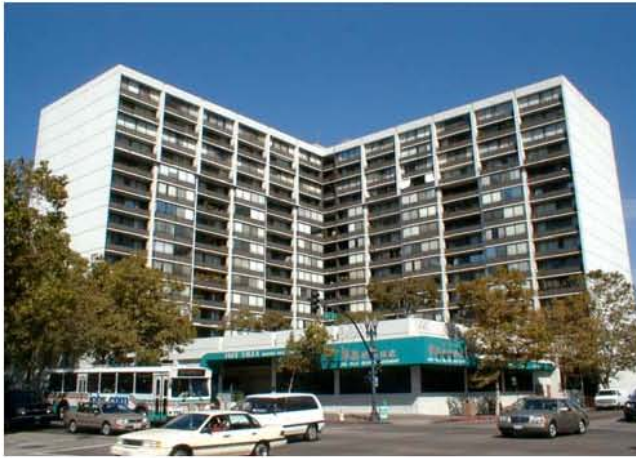
Figure 3-18 Example of a building, with a plan irregularity, with two wings meeting at right angles.

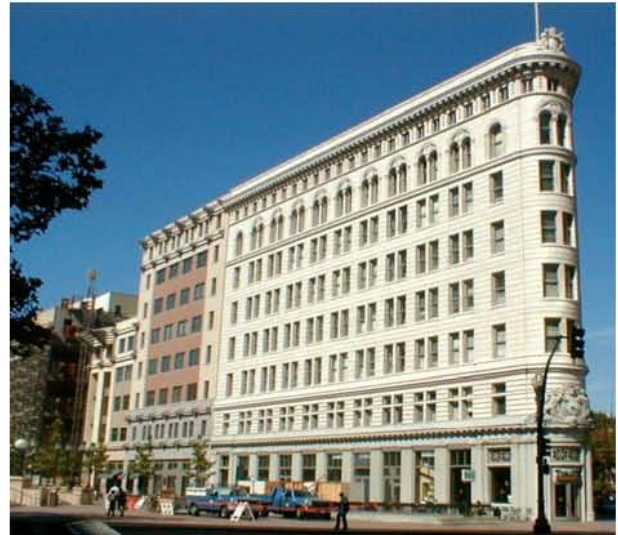
Figure 3-19 Example of a building, triangular in plan, subject to torsion.

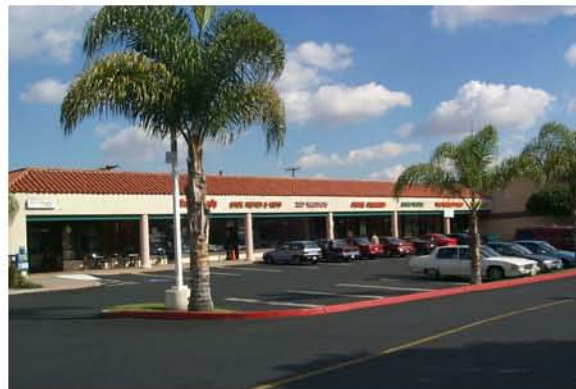
Figure E-2 Larger wood-framed structure, typically with room-width spans (W2, light, wood-frame buildings greater than 5000 square feet).

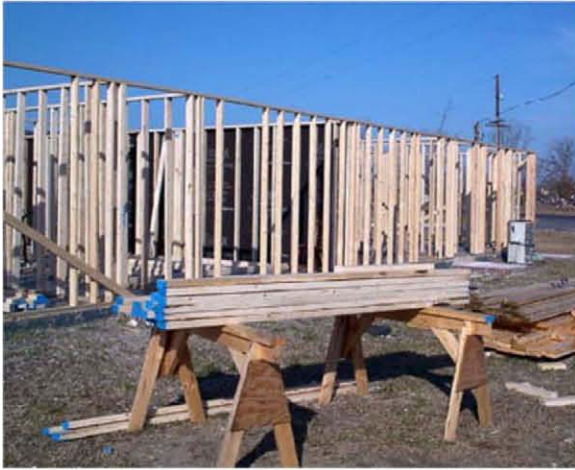
Figure E-4 Stud wall, wood-framed house.

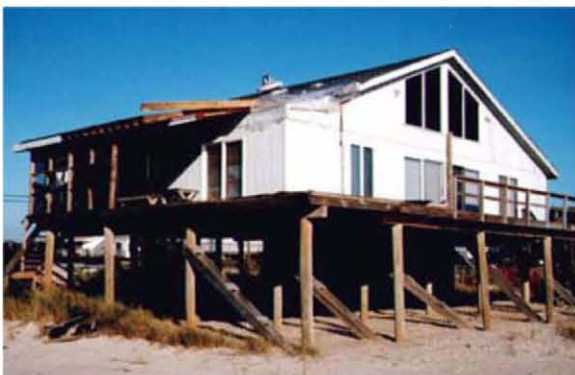
Figure E-6 Timber pole framed house.

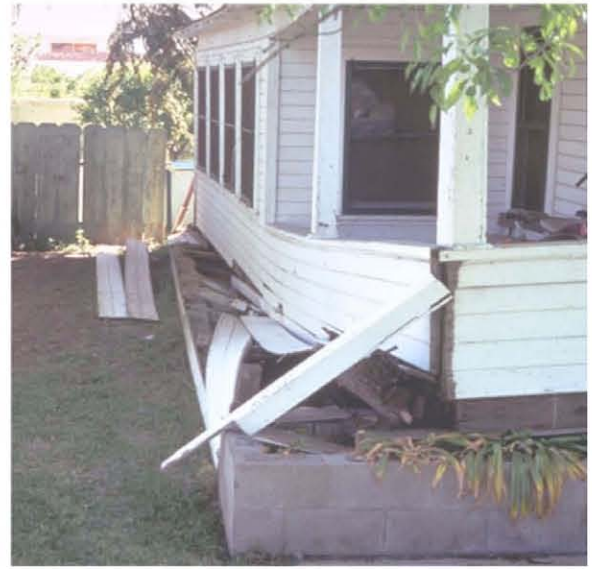
Figure E-7 House off its foundation, 1983 Coalinga earthquake.

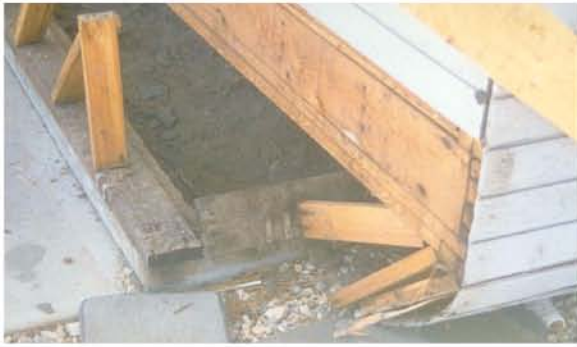
Figure E-8 Failed cripple stud wall, 1992 Big Bear earthquake.

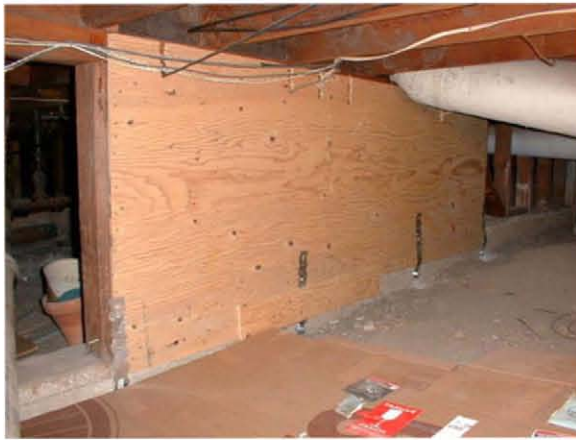
Figure E-10 Seismic strengthening of a cripple wall, with plywood sheathing.

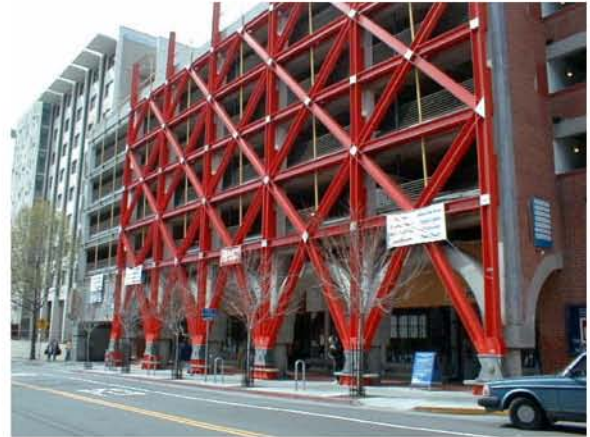
Figure E-15 Rehabilitation of a concrete parking structure using exterior X-braced steel frames.

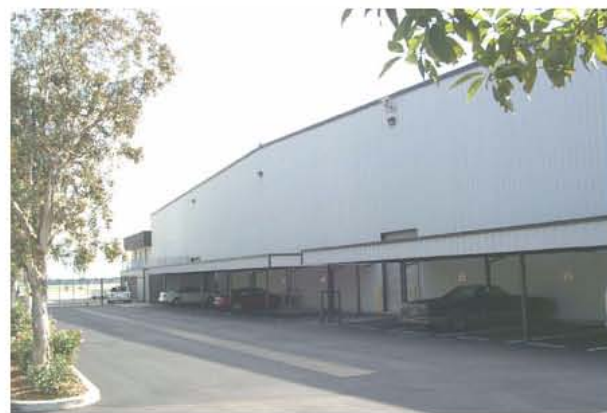
Figure E-19 Prefabricated metal building (S3, light metal building).

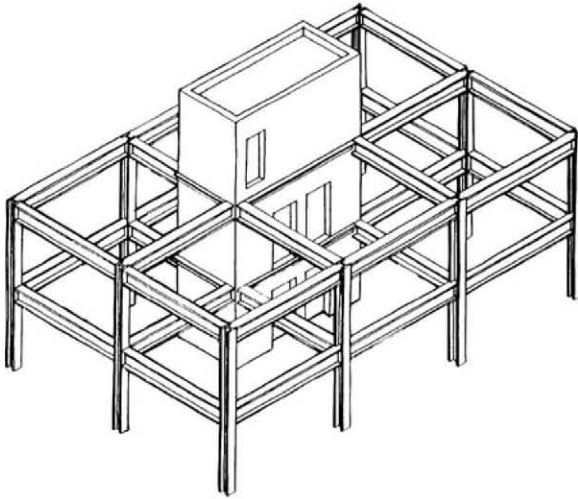
Figure E-20 Drawing of steel frame with interior concrete shear-walls.

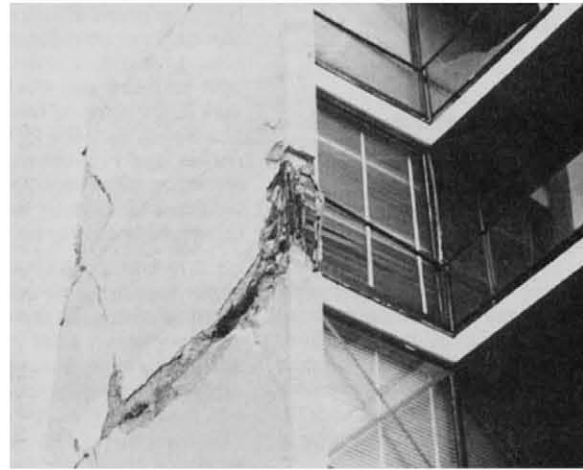
Figure E-22 Close-up of exterior shear wall damage during a major earthquake.

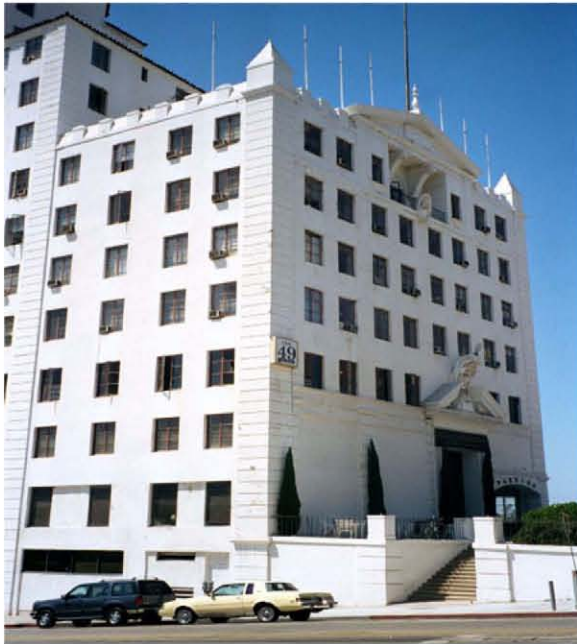
Figure E-21 Concrete shear wall on building exterior.

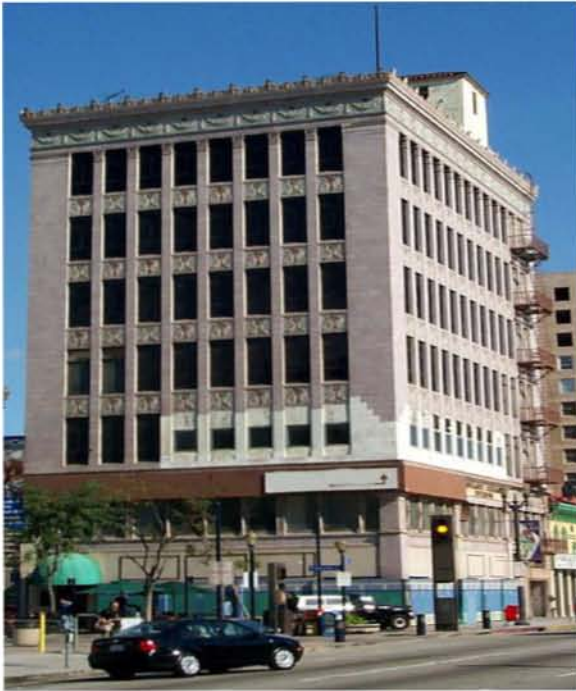
Figure E-24 Example of steel frame with URM infill walls (S5).

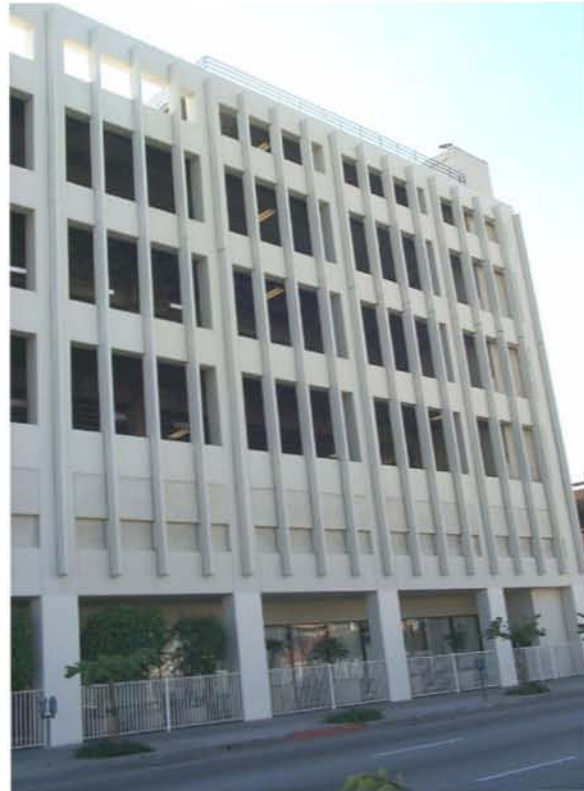
Figure E-28 Concrete moment-resisting frame building (C1) with exposed concrete, deep beams, wide columns (and with architectural window framing).

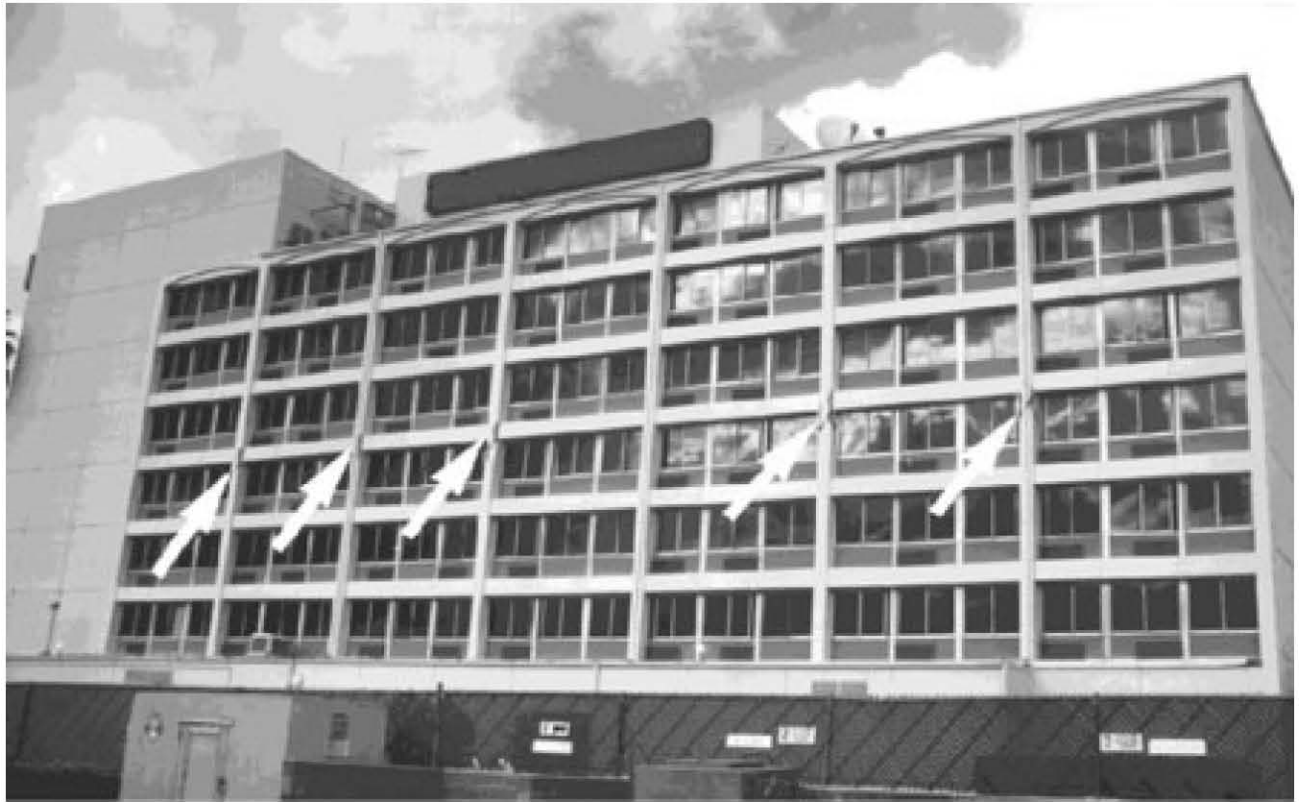
Figure E-29 Locations of failures at beam-to-column joints in nonductile frames, 1994 Northridge earthquake.

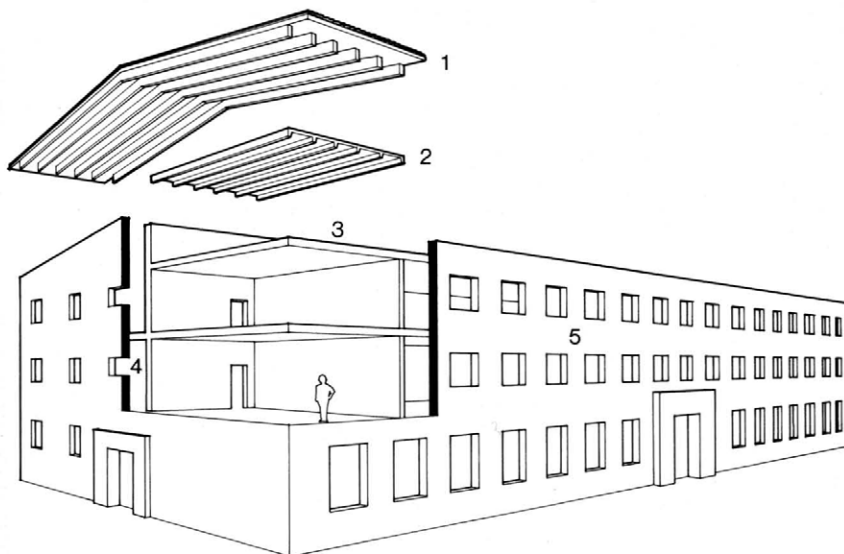
Figure E-30 Drawing of concrete shear-wall building.

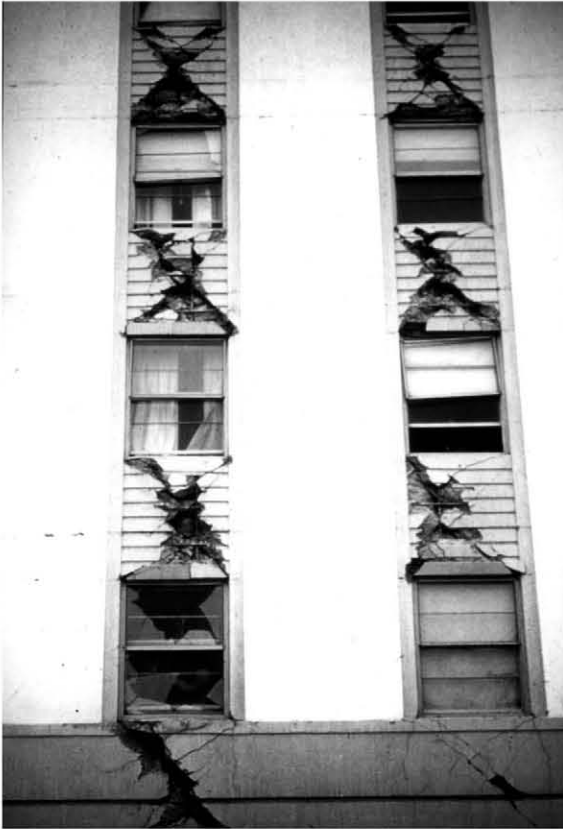
Figure E-31 Tall concrete shear-wall building: walls connected by damaged spandrel beams.

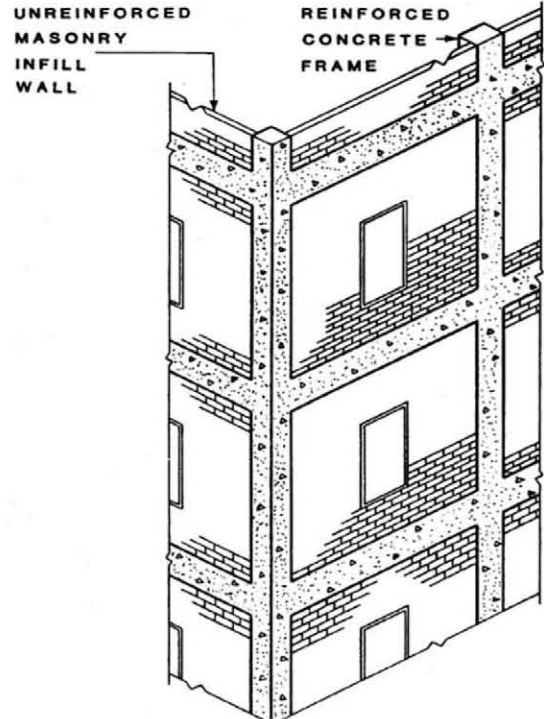
Figure E-33 Concrete frame with URM infill.

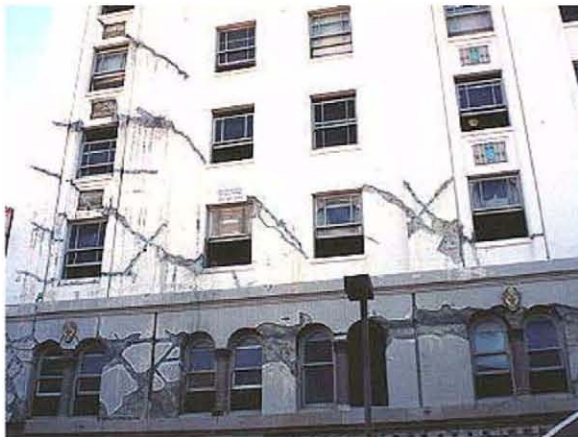
Figure E-32 Shear-wall damage, 1989 Loma Prieta earthquake.

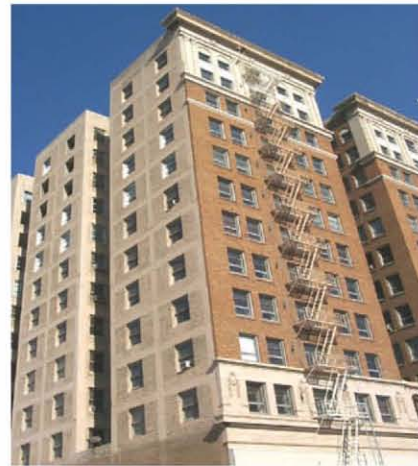
Figure E-34 Blow-up (lower photo) of distant view of C3 building (upper photo) showing concrete frame with URM infill (left wall), and face brick (right wall).

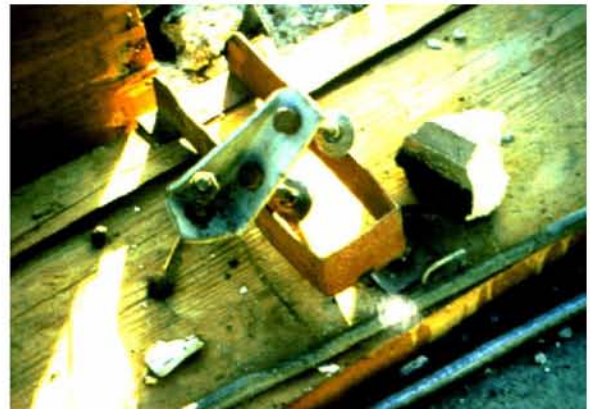
Figure E-38 Tilt-up construction anchorage failure.

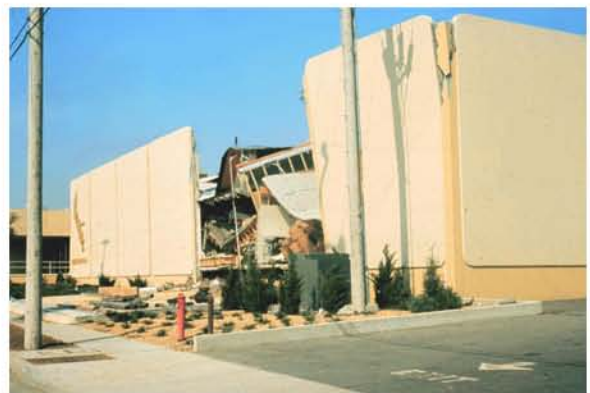
Figure E-39 Result of failure of the roof beam anchorage to the wall in tilt-up building.

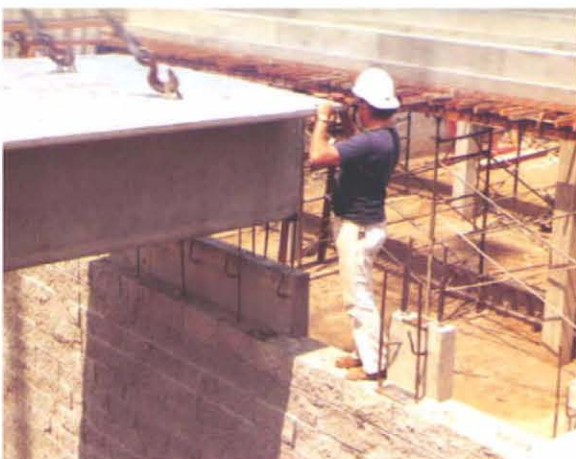
Figure E-44 Example of precast double-T section during installation.

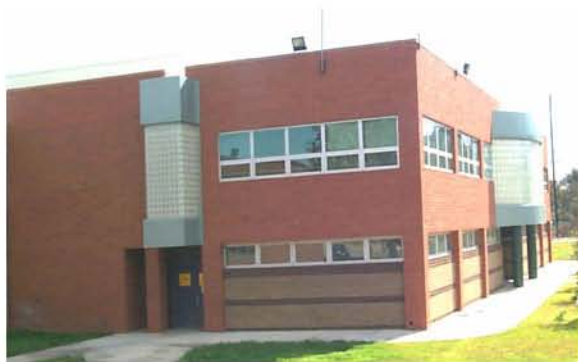
Figure E-46 Modern reinforced brick masonry.

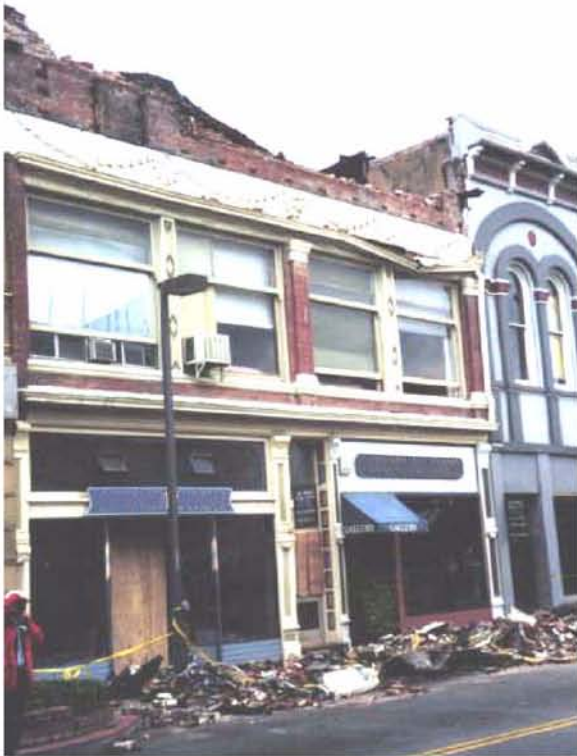
Figure E-53 Parapet failure leaving an uneven roof line, due to inadequate anchorage, 1989 Loma Prieta earthquake.

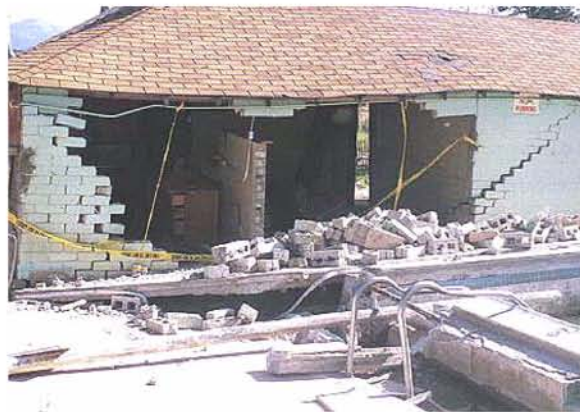
Figure E-54 Damaged URM building, 1992 Big Bear earthquake.

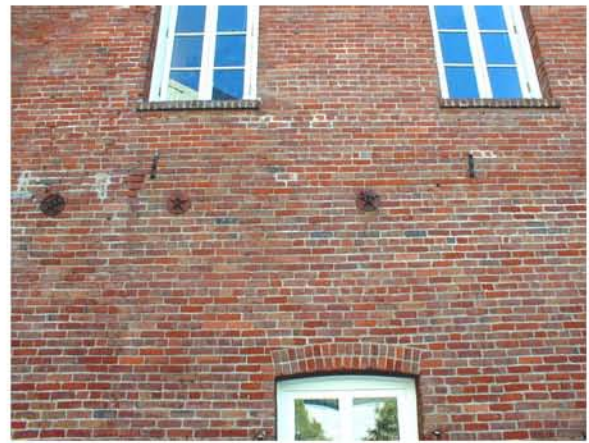
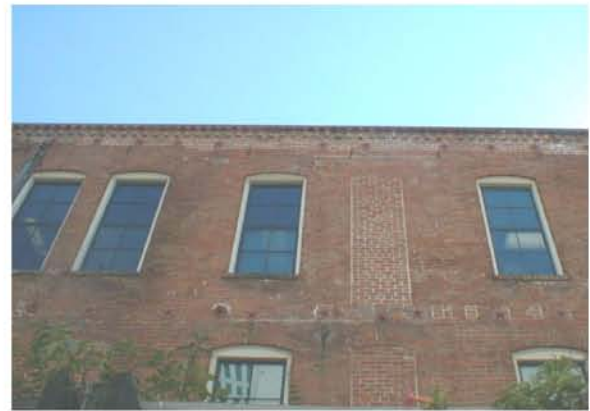
Figure E-55 Upper: Two existing anchors above three new wall anchors at floor line using decorative washer plates. Lower: Rehabilitation techniques include closely spaced anchors at floor and roof levels.

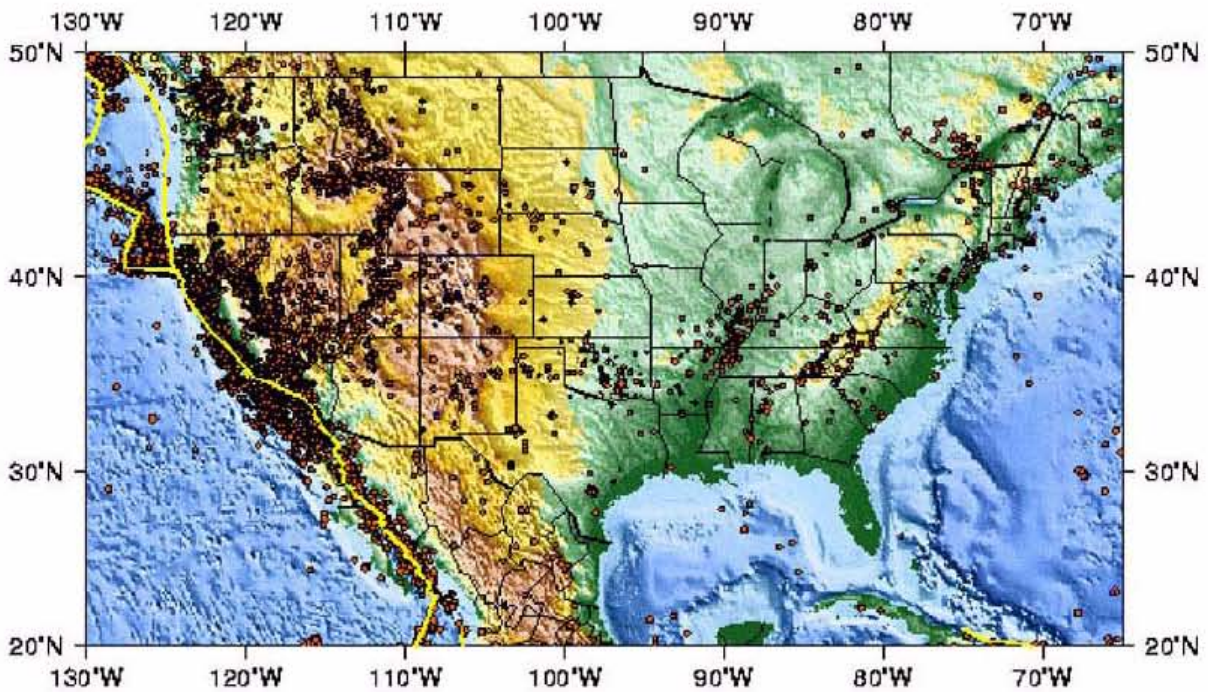
Figure F-2 Seismicity of the conterminous United States 1977 – 1997 (from the website at <http://neic.usgs.gov/neis/general/seismicity/us.html>). This reproduction shows earthquake locations without regard to magnitude or depth. The San Andreas fault and other plate boundaries are indicated with white lines.

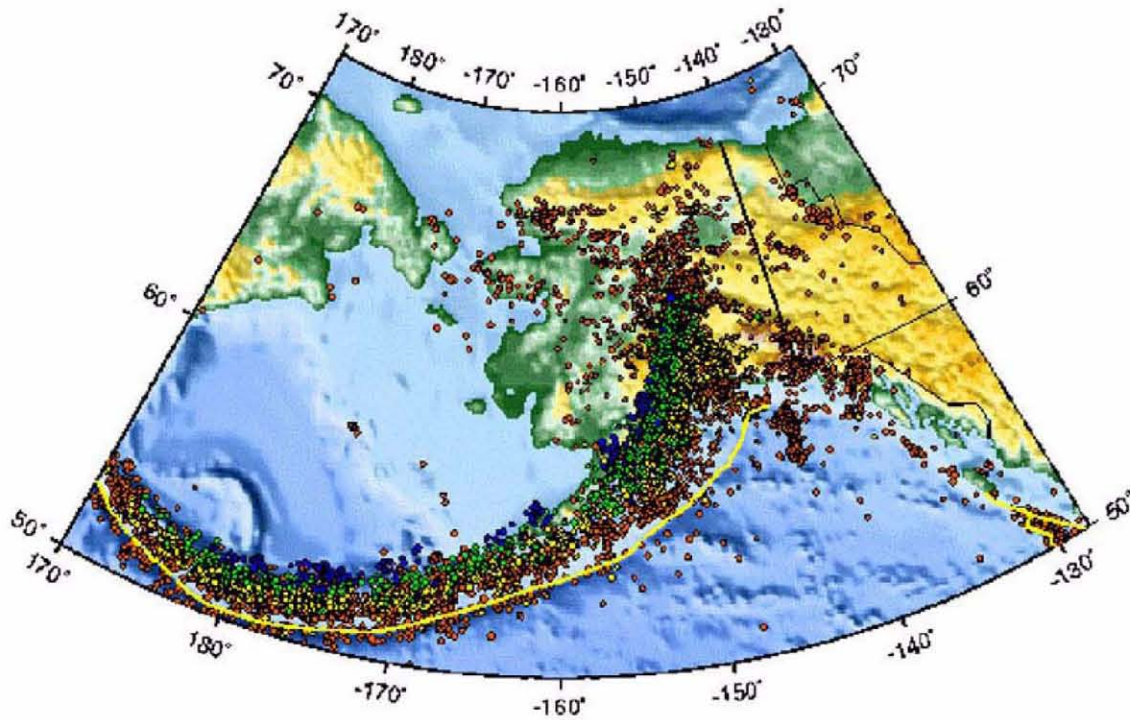
Figure F-3 Seismicity of Alaska 1977 – 1997. The white line close to most of the earthquakes is the plate boundary, on the ocean floor, between the Pacific and North America plates.

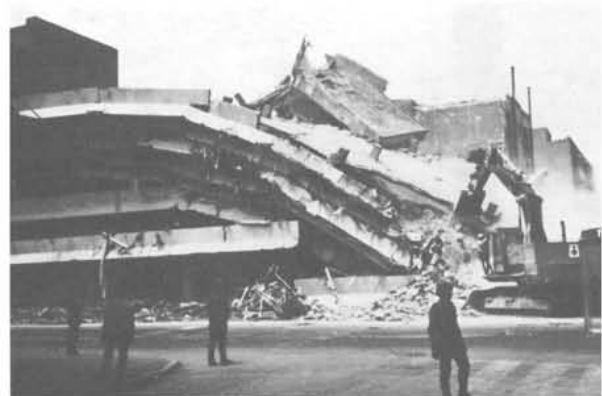
Figure F-5 Mid-rise building collapse, 1985 Mexico City earthquake.
