SECOND EDITION
Rapid Visual Screening of
Buildings for Potential
Seismic Hazards:
A Handbook

This FEMA 154 Report, *Rapid Visual Screening of Buildings for Potential Seismic Hazards: A Handbook*, is the first of a two-volume publication on a recommended methodology for rapid visual screening of buildings for potential seismic hazards. The technical basis for the methodology, including the scoring system and its development, are contained in the companion FEMA 155 report, *Rapid Visual Screening of Buildings for Potential Seismic Hazards: Supporting Documentation*. Both this document and the companion document are second editions of similar documents published by FEMA in 1988.

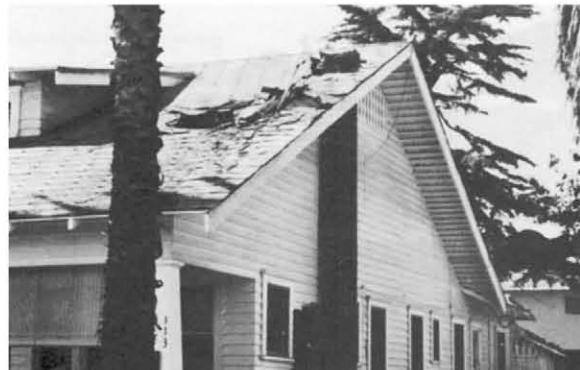
Figure F-7 Collapsed chimney with damaged roof, 1987 Whittier Narrows earthquake.

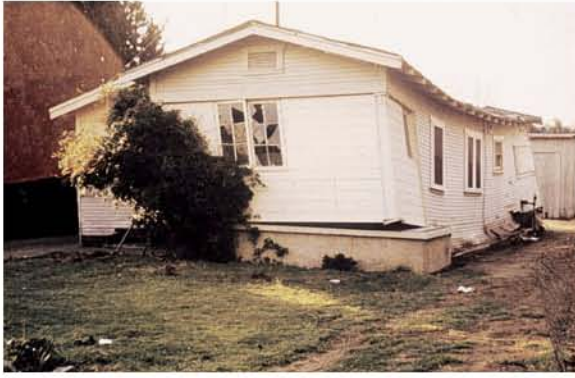
Figure F-8 House that slid off foundation, 1994 Northridge earthquake.

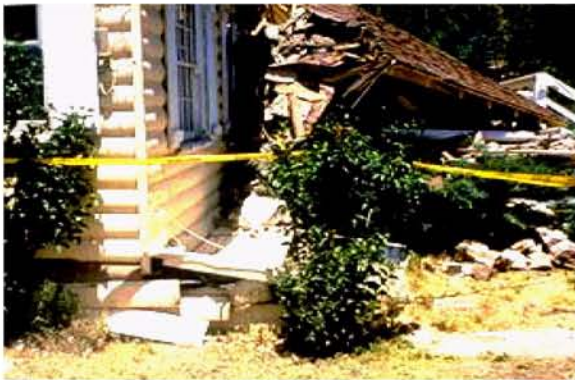
Figure F-9 Collapsed cripple stud walls dropped this house to the ground, 1992 Landers and Big Bear earthquakes.

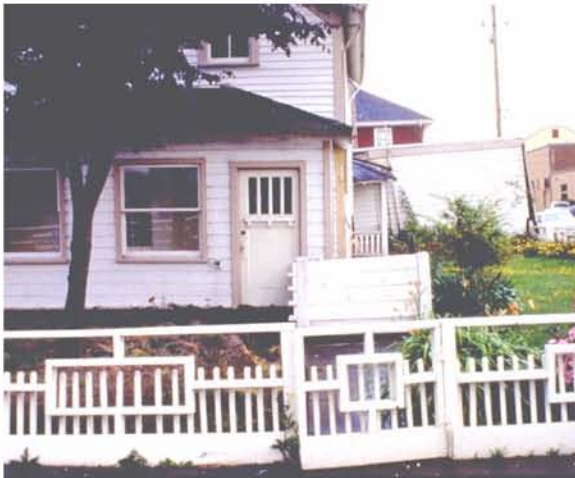
Figure F-10 This house has settled to the ground due to collapse of its post and pier foundation.

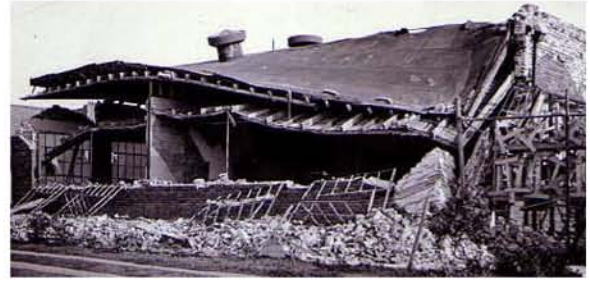
Figure F-11 Collapse of unreinforced masonry bearing wall, 1933 Long Beach earthquake.

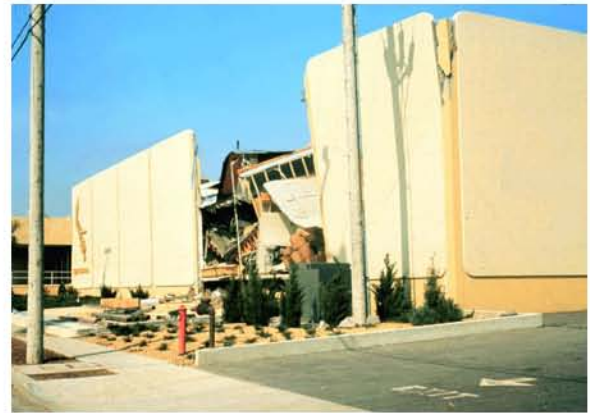
Figure F-12 Collapse of a tilt-up bearing wall.
