# **Reducing the Risks of Nonstructural Earthquake Damage**

## **A Practical Guide**

**FEMA 74/September 1994  
Supersedes 1985 Edition**

**WISS, JANNEY, ELSTNER ASSOCIATES, INC.**

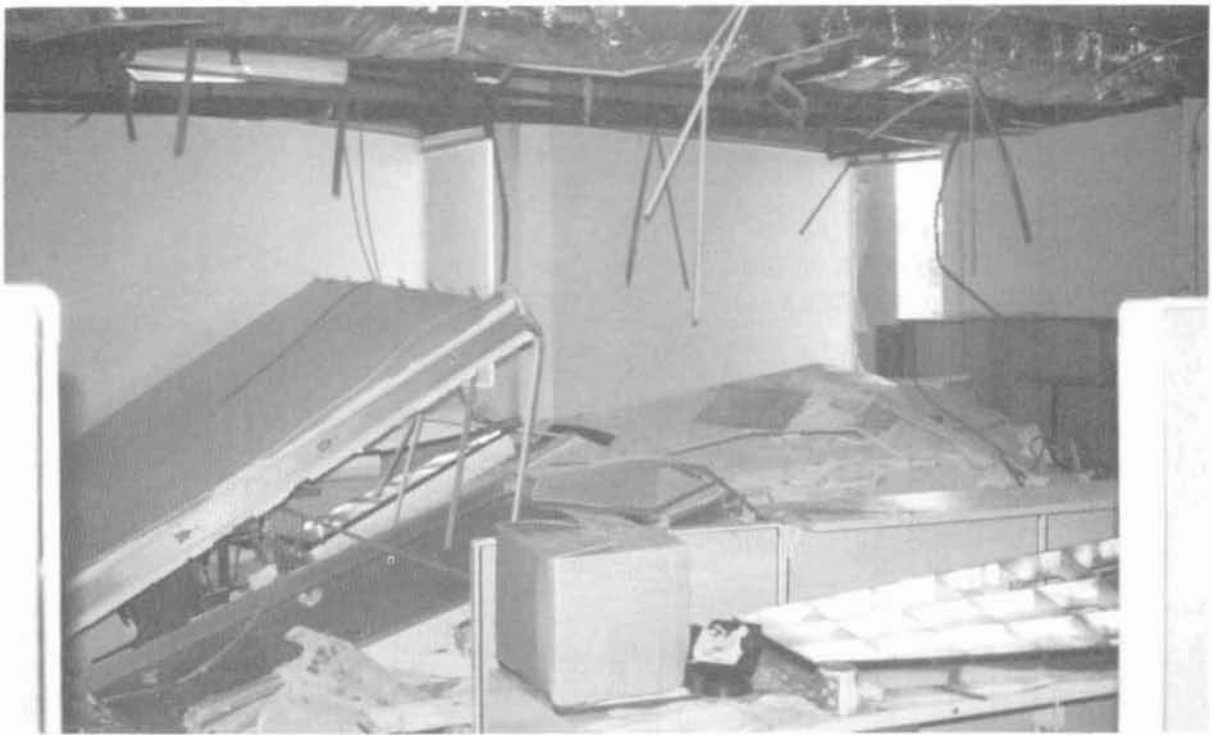
Failure of office partitions, ceilings, and light fixtures  
Earthquake Damage: 1994, Northridge, California  
Photo Credit: Wiss, Janney, Elstner Associates, Inc.

has occurred during past earthquakes include broken glass, overturned tall and heavy cabinets or shelves, falling ceilings or overhead light fixtures, ruptured gas lines or other piping containing hazardous materials, damaged friable asbestos materials, falling pieces of decorative brickwork or precast concrete panels, and collapsed masonry walls or fences. (Figures 2 and 3).

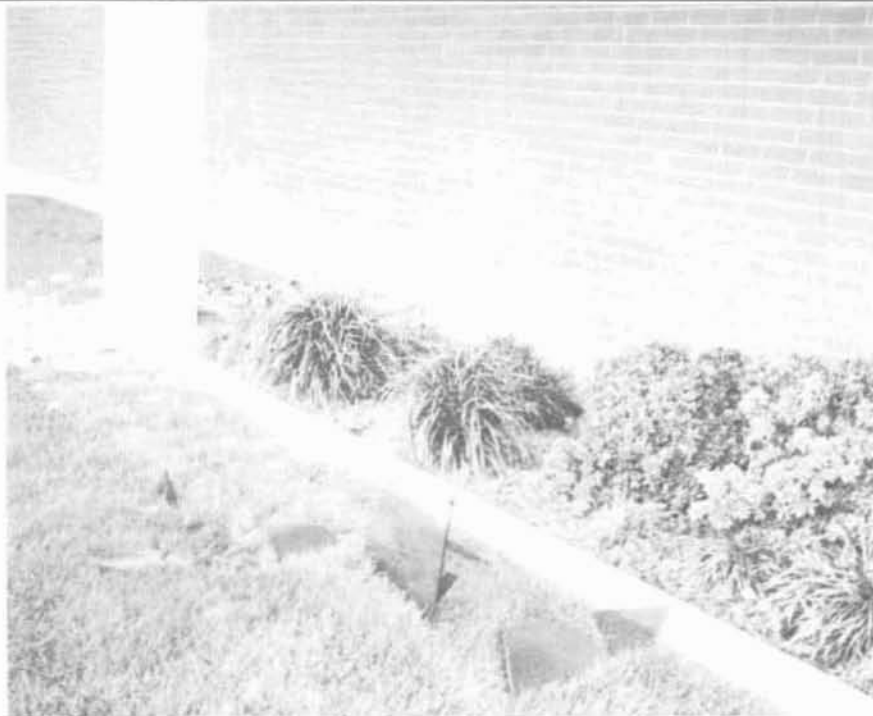
Shard of broken nontempered glass that fell several stories from a multistory building  
Earthquake Damage: 1994, Northridge, California  
Photo Credit: Wiss, Janney, Elstner Associates, Inc.

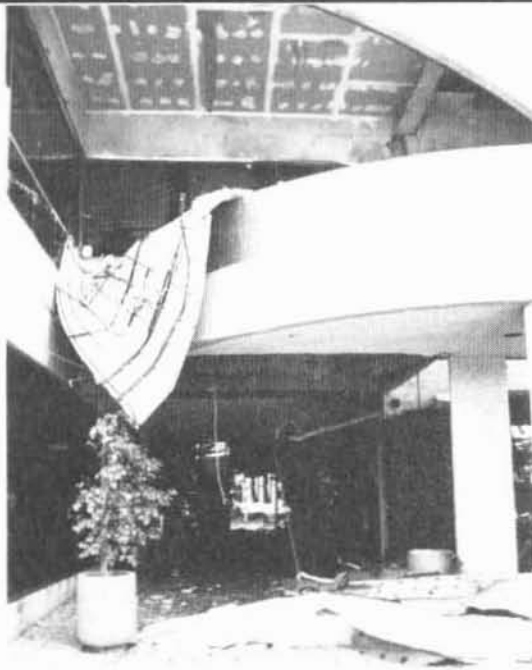
Failure of heavy stucco soffit at building entrance  
Earthquake Damage: 1994, Northridge, California  
Photo Credit: Robert Reitherman

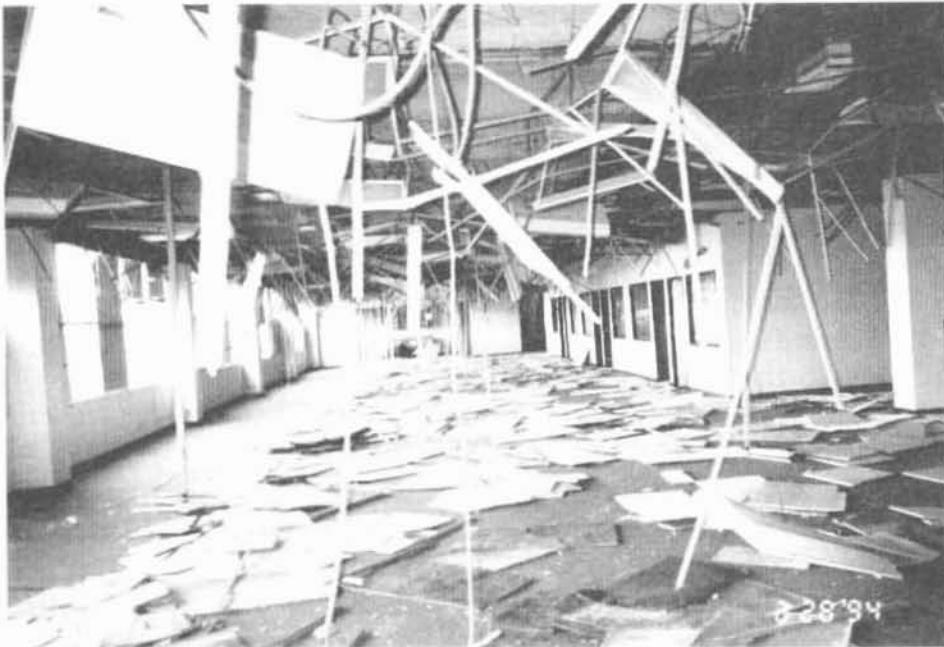
Complete loss of suspended ceiling and light fixtures  
Earthquake Damage: 1994, Northridge, California  
Photo Credit: Wiss, Janney, Elstner Associates, Inc.

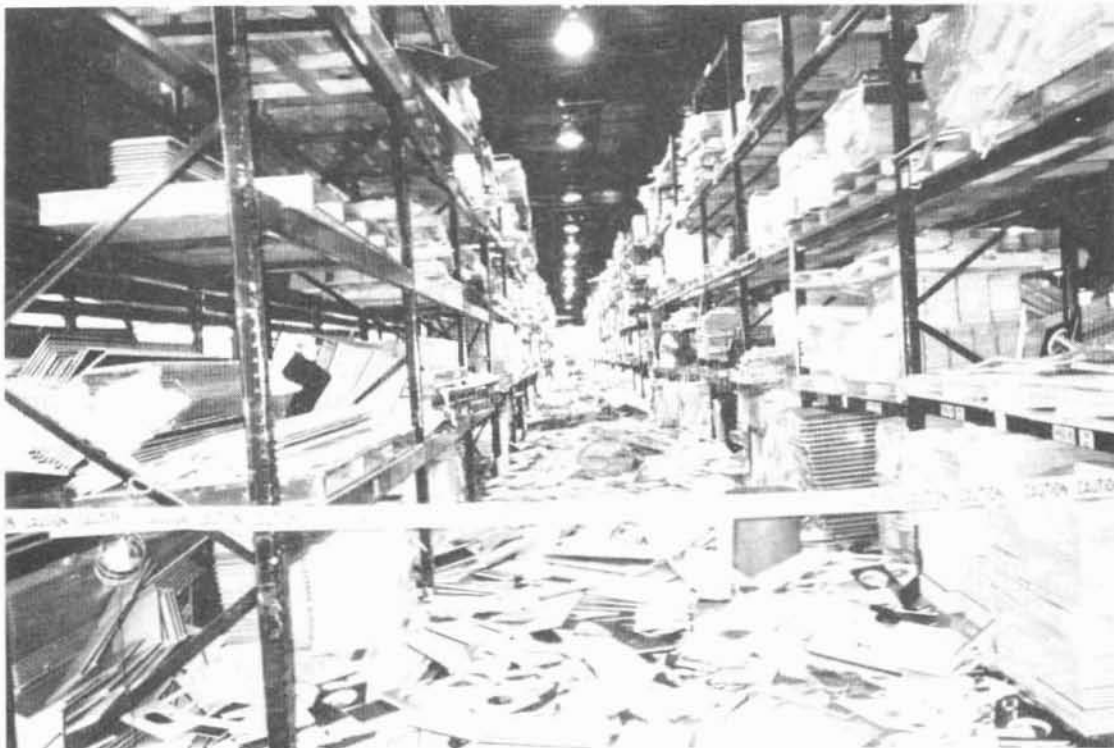
Damage to inventory on industrial storage racks  
Earthquake Damage: 1994, Northridge, California  
Photo Credit: Wiss, Janney, Elstner Associates, Inc.

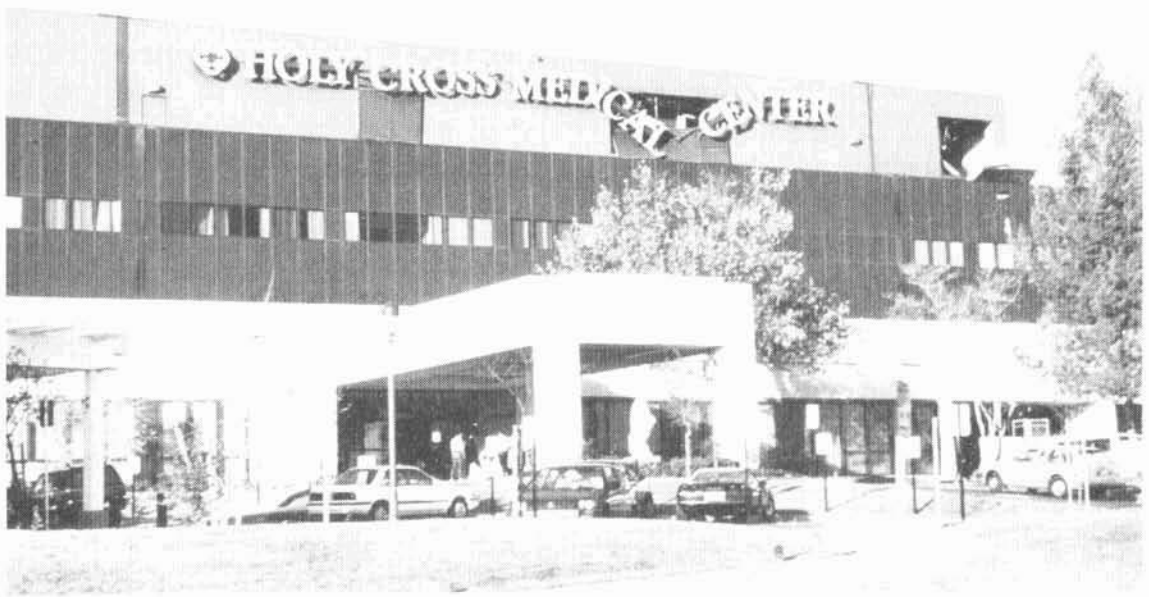
HVAC damage at Holy Cross Medical Center in Sylmar—damage to signage and louvers caused when suspended fans in the mechanical penthouse swung and impacted the louver panels. HVAC service outage caused the temporary evacuation of all patients.  
Earthquake Damage: 1994, Northridge, California  
Photo Credit: Robert Reitherman

in some cases water was flowing for many hours. At one facility, water up to 2 feet deep was reported at some locations in the building as a result of damage to the domestic water supply tank on the roof. At another, the emergency generator was disabled when its cooling water line broke where it crossed a separation joint. Other damage at these facilities included broken glass, dangling light fixtures, elevator counterweight damage, and lack of emergency power due to failures in the distribution or control systems. Two of these facilities, Los Angeles County Olive View Medical Center and Holy Cross Medical Center, both in Sylmar, California, had suffered severe structural damage or collapse during the 1971 San Fernando earthquake and had been demolished and entirely rebuilt [3]. (See Figure 5).
