Wind and Seismic Effects

PROCEEDINGS OF THE 22ND JOINT MEETING OF THE U.S.-JAPAN COOPERATIVE PROGRAM IN NATURAL RESOURCES PANEL ON WIND AND SEISMIC EFFECTS

Issued September 1990

Noel J. Raufaste, EDITOR

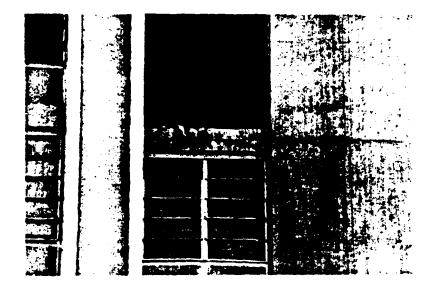
Figure 10. Damaged edge beams, concrete highrise buildings Fajardo, Puerto Rico

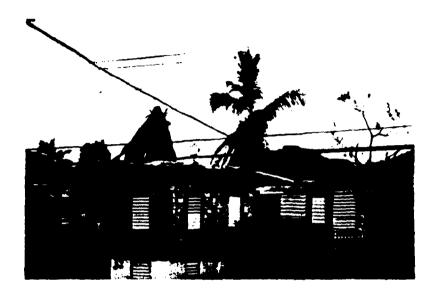
Figure 12. Failed corrugated steel sheet roofing, Puerto Rico

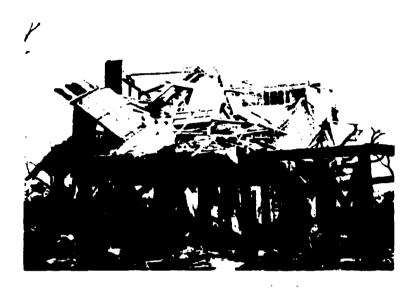
Figure 2. Heavily Damaged House, Bull Bay.

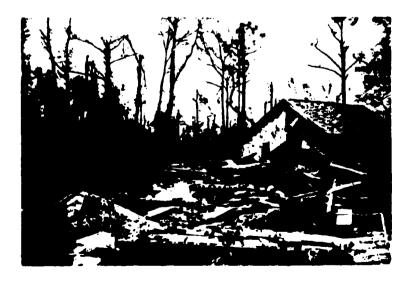
Figure 3. Shear Failure of House, Bull Bay.

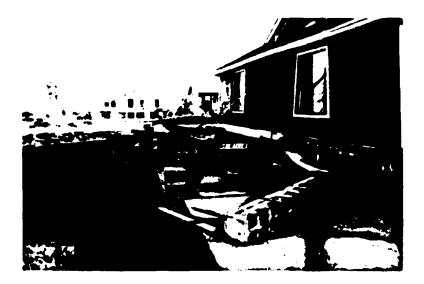
Figure 4. Masonry Pier Failure, Isle of Palms.

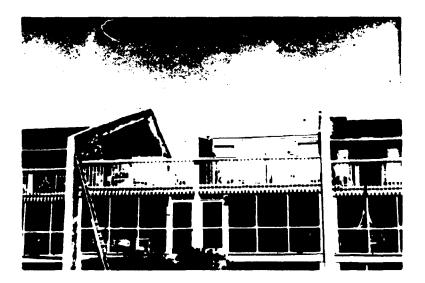
Figure 5. Condominium Roof Failure, Isle of Palms.

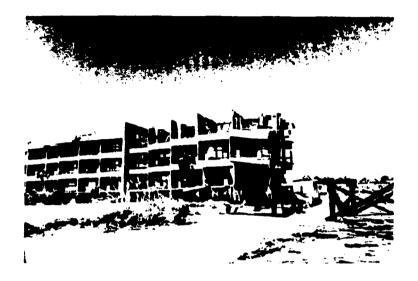
Figure 6. Wind and Surge Damage to Condominium, Isle of Palms.

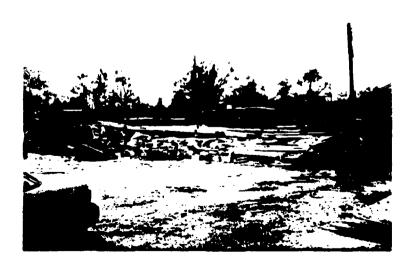
Figure 7. Collapse of Masonry Commercial Structure, North Charleston

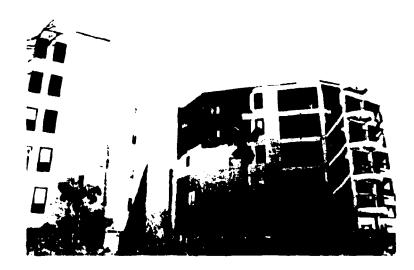
Figure 10. Typical Cladding Failure, Isle of Palms.
