**NISTIR 4515**

Proceedings of a Workshop on Evaluation,  
Repair, and Retrofit of Structures—U.S.-Japan  
Panel on Wind and Seismic Effects, UJNR,  
Gaithersburg, MD, USA, May 12–14, 1990

This report is the Proceedings of an international workshop on Evaluation, Repair, and Retrofit of Structures. The workshop was a joint effort of Task Committees C and D, "Repair and Retrofit of Existing Structures" and "Evaluation of Structural Performance" respectively of the U.S.-JAPAN Panel on Wind and Seismic Effects. The workshop was hosted by the National Institute of Standards and Technology during May 12-14 1990. The National Science Foundation provided the financial support. The subjects addressed included: evaluation of structures; performance of existing structures their repair and strengthening; and research on techniques for repairing and retrofitting structures.

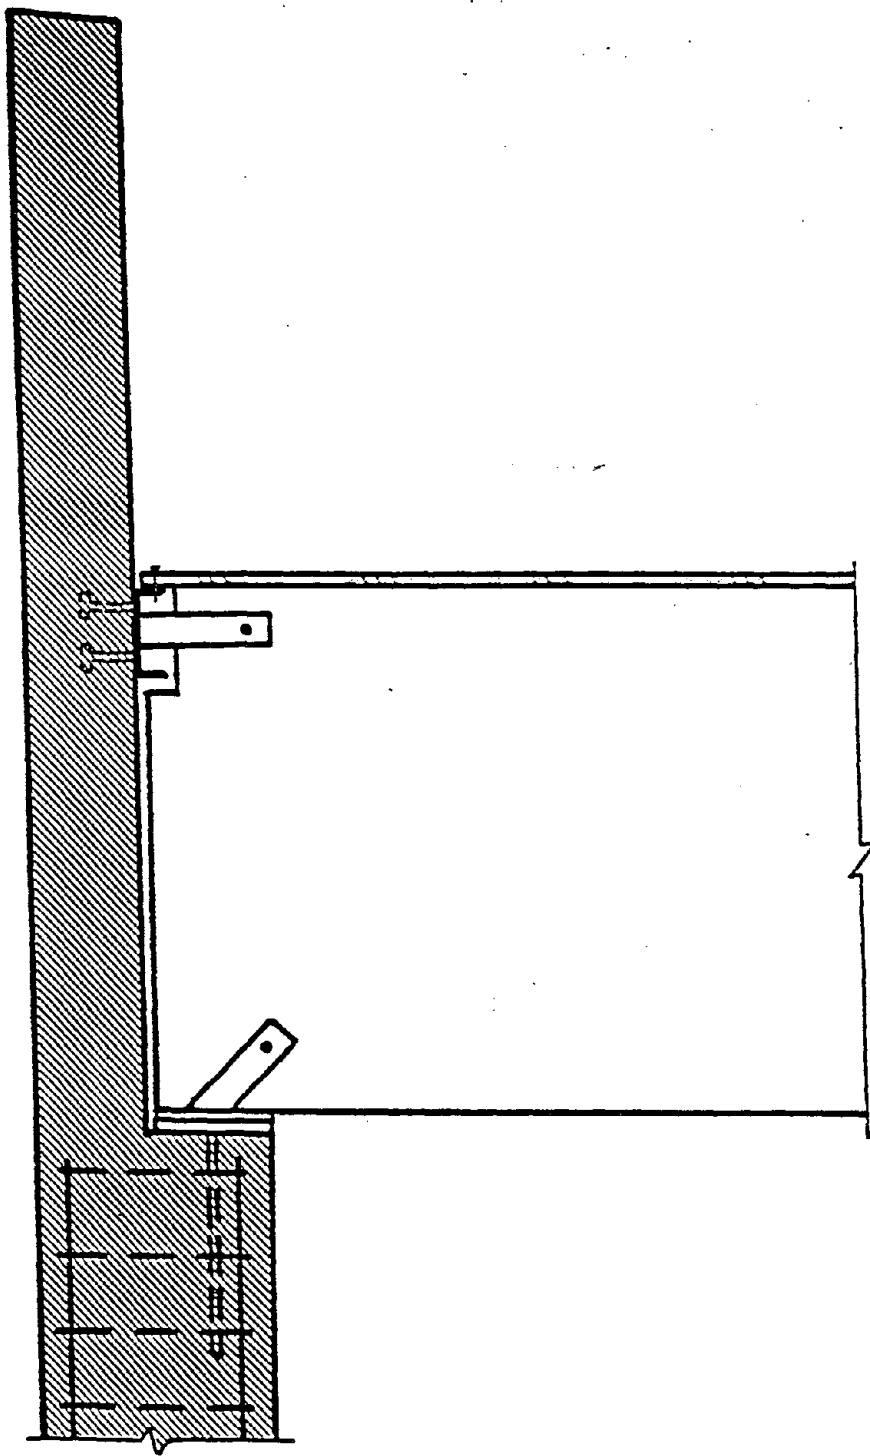
FIGURE 2 - ORIGINAL CONNECTION BETWEEN GLULAM BEAM AND TILT-UP WALL

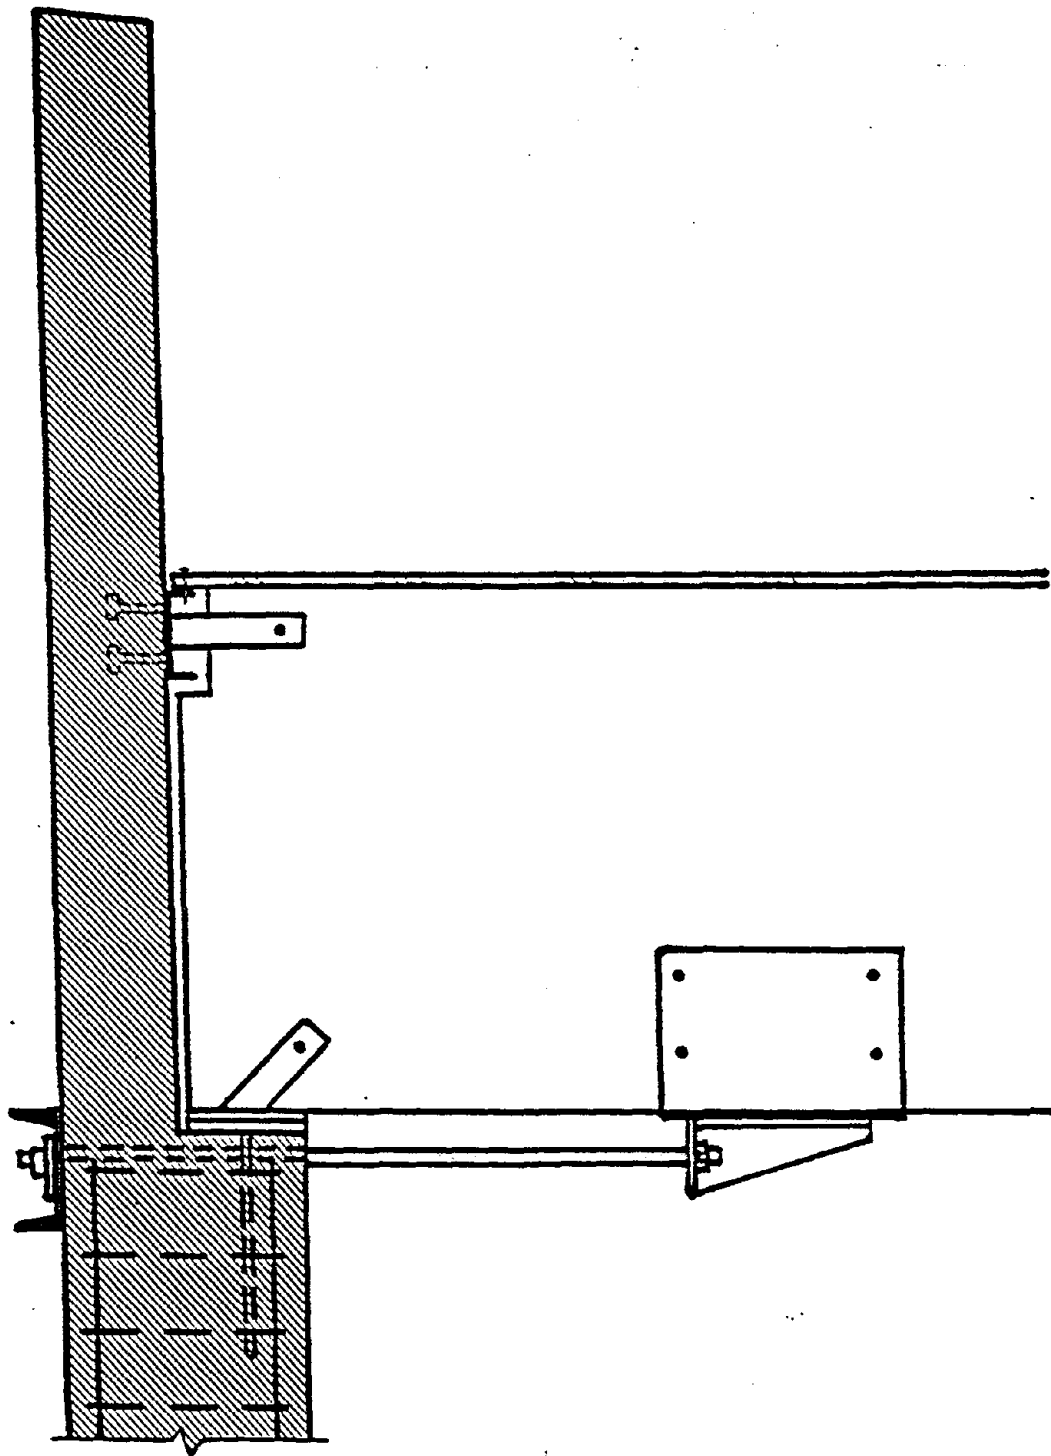
FIGURE 3 - RETROFITTED CONNECTION BETWEEN GLULAM BEAM AND TILT-UP WALL

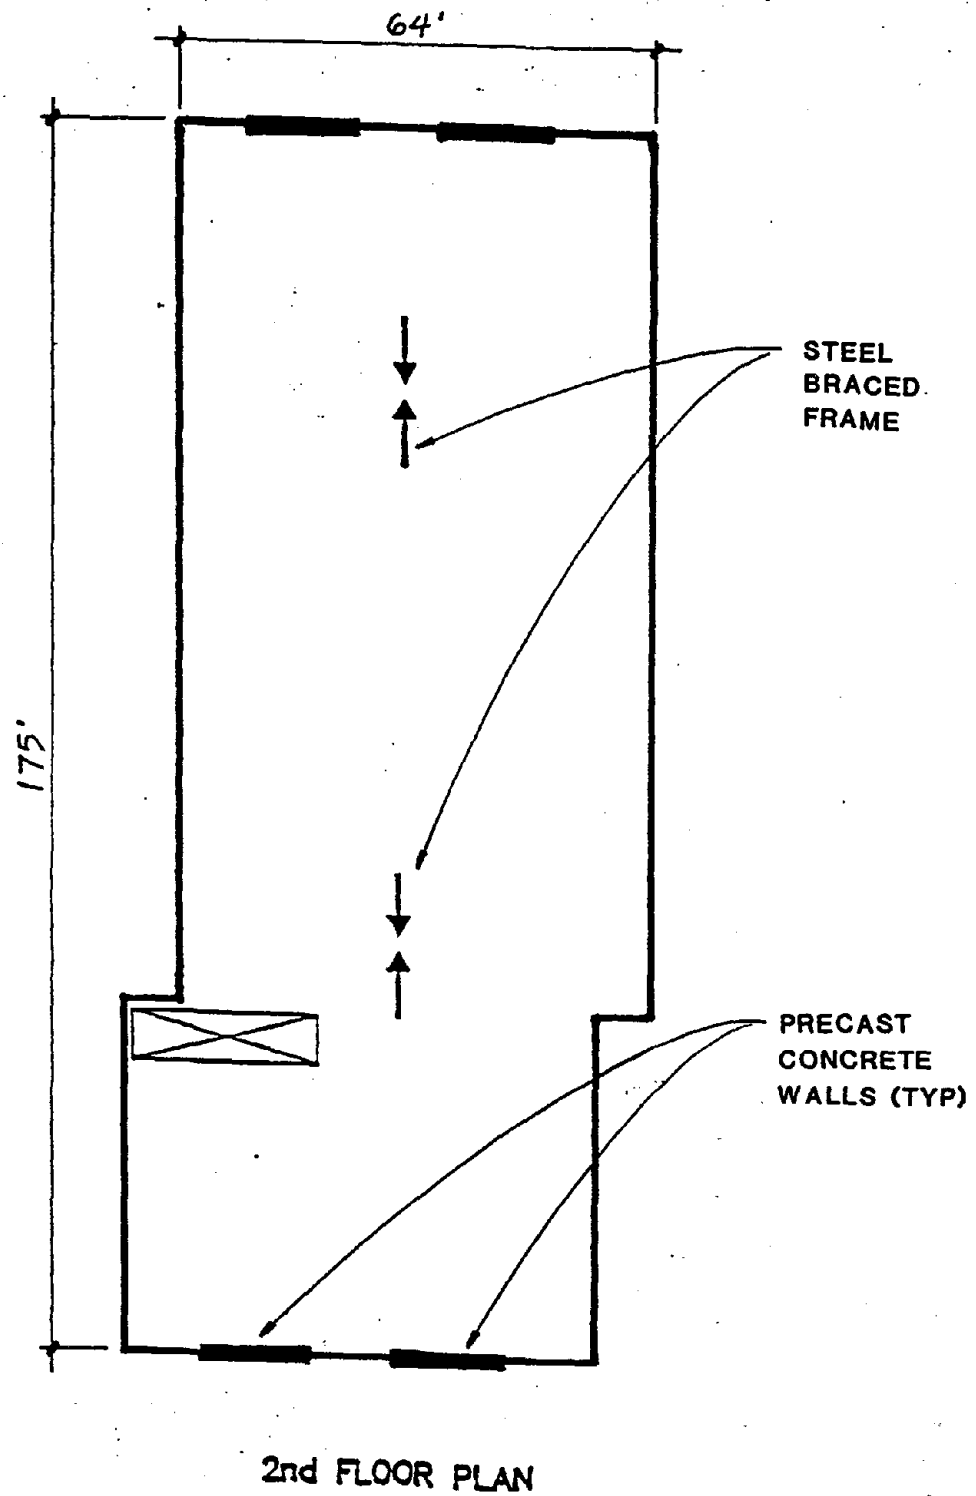
FIGURE 4 - FLOOR PLAN OF BUILDING DAMAGED DURING THE LOMA PRIETA EARTHQUAKE

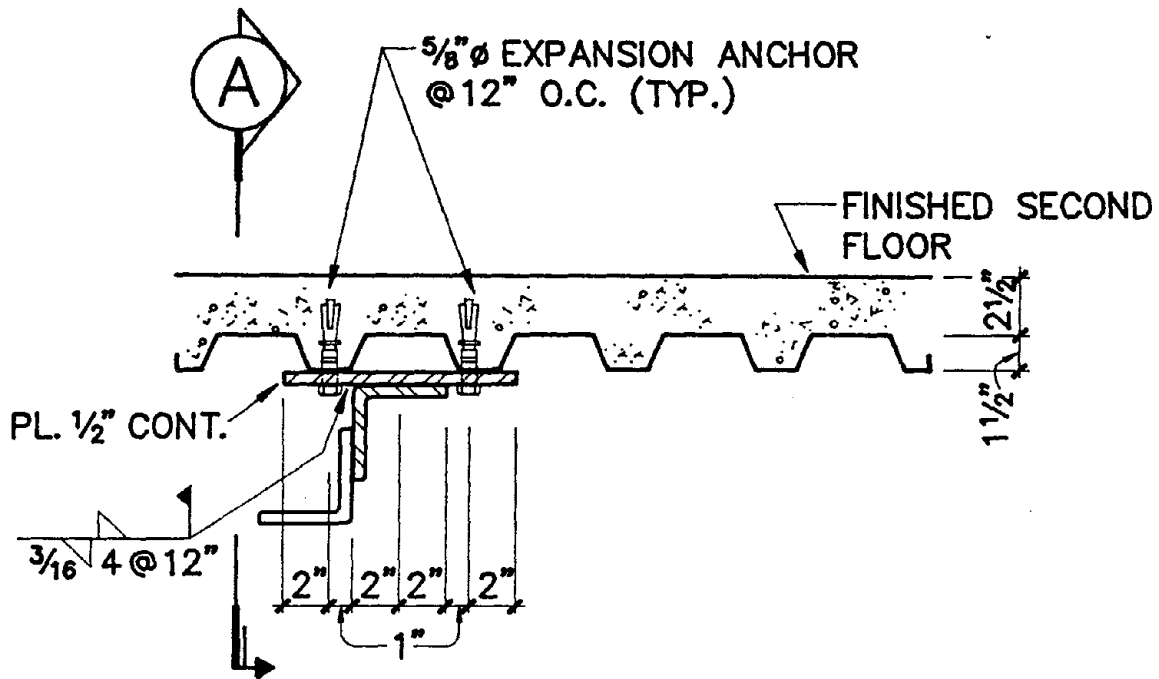
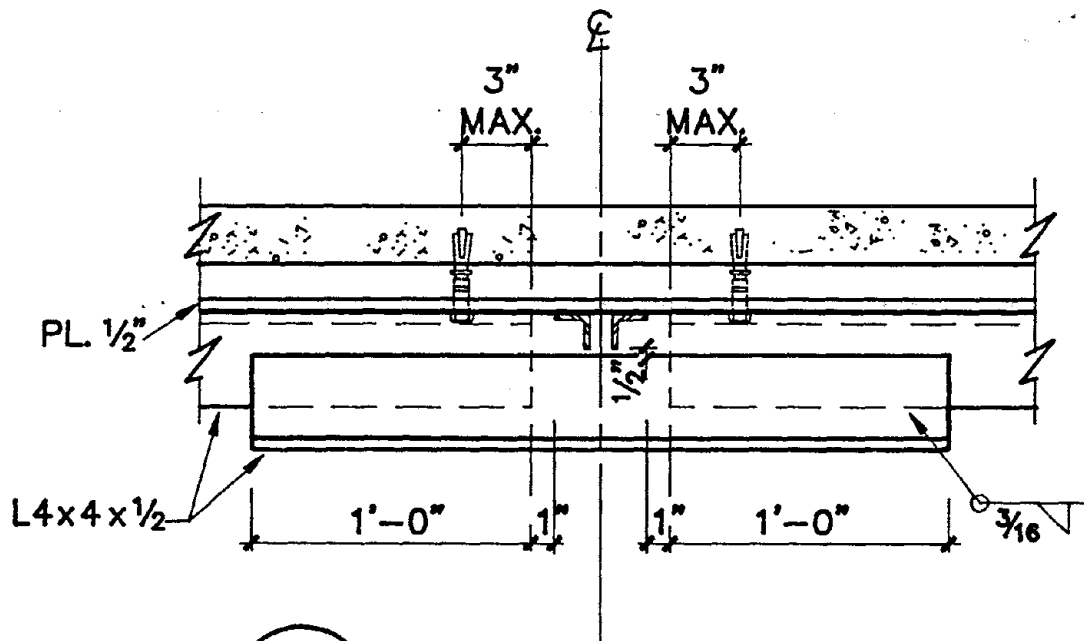
FIGURE 5 - RETROFIT OF SECOND FLOOR DIAPHRAGM  
TO ACCOMMODATE MISSING CHORD BARS  
2-2-12

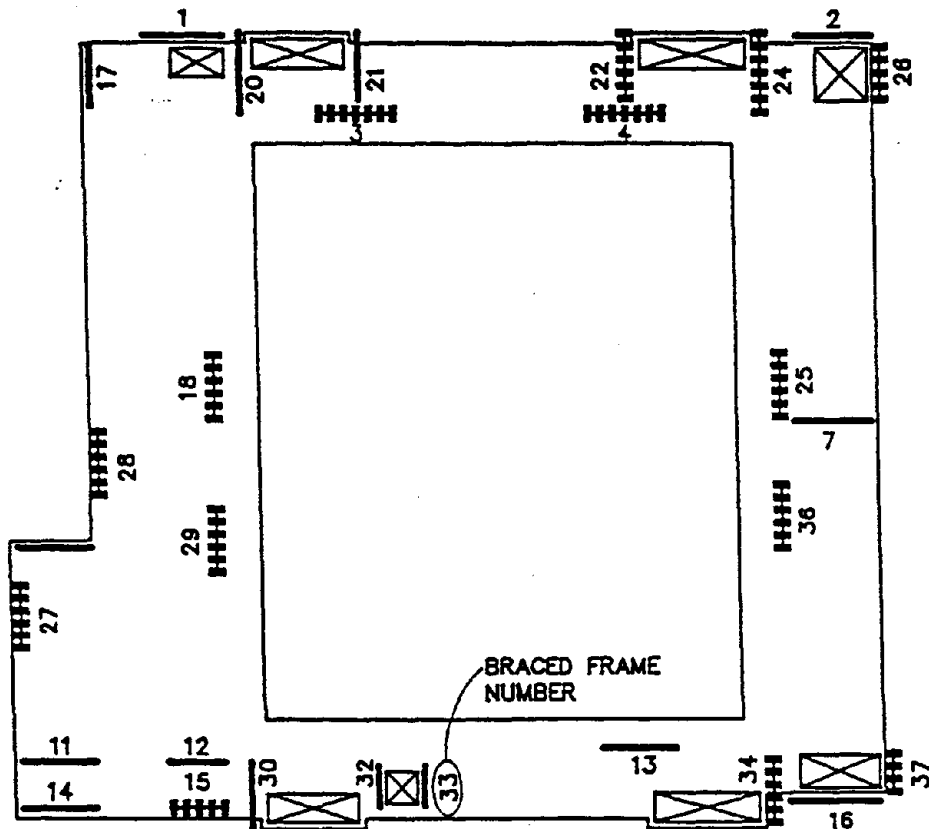
KEY:  
 — BRACED FRAME  
 HHH DAMAGED BRACED FRAME

FIGURE 7 - BRACED FRAME LAYOUT

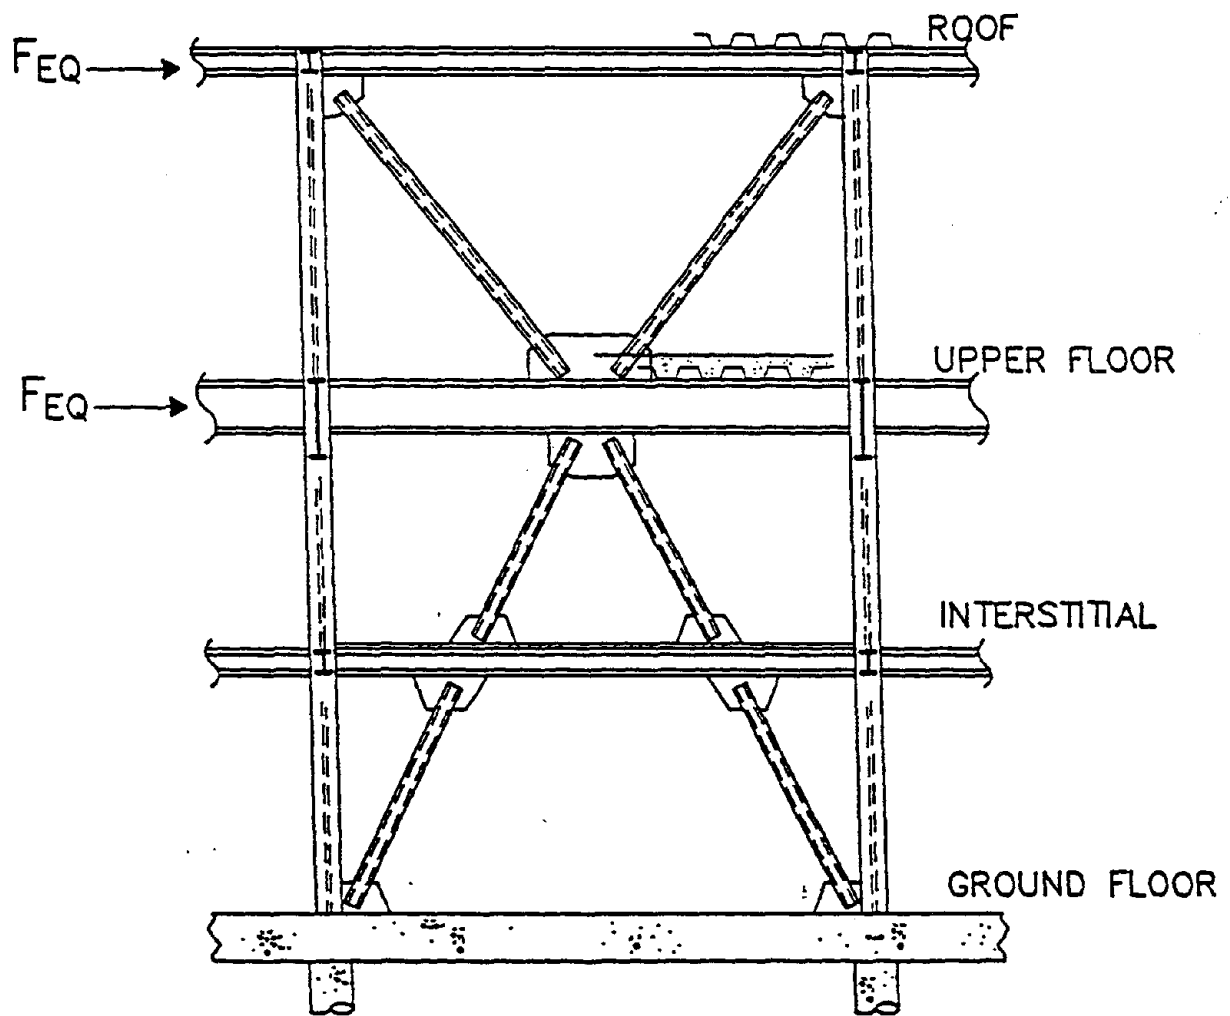
FIGURE 8 - BRACED FRAME DAMAGED DURING THE LOMA PRIETA EARTHQUAKE

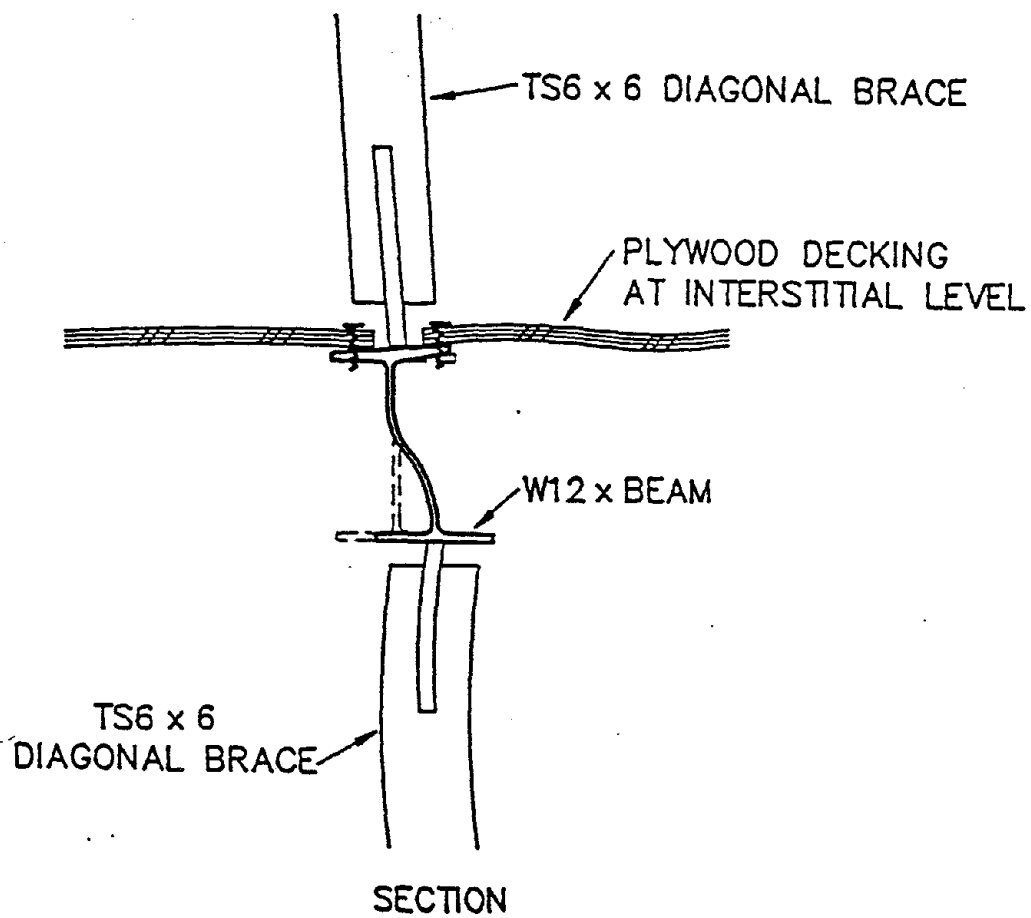
**FIGURE 9 - FAILED CONDITION OF BRACED FRAME DAMAGED  
IN THE LOMA PRIETA EARTHQUAKE**

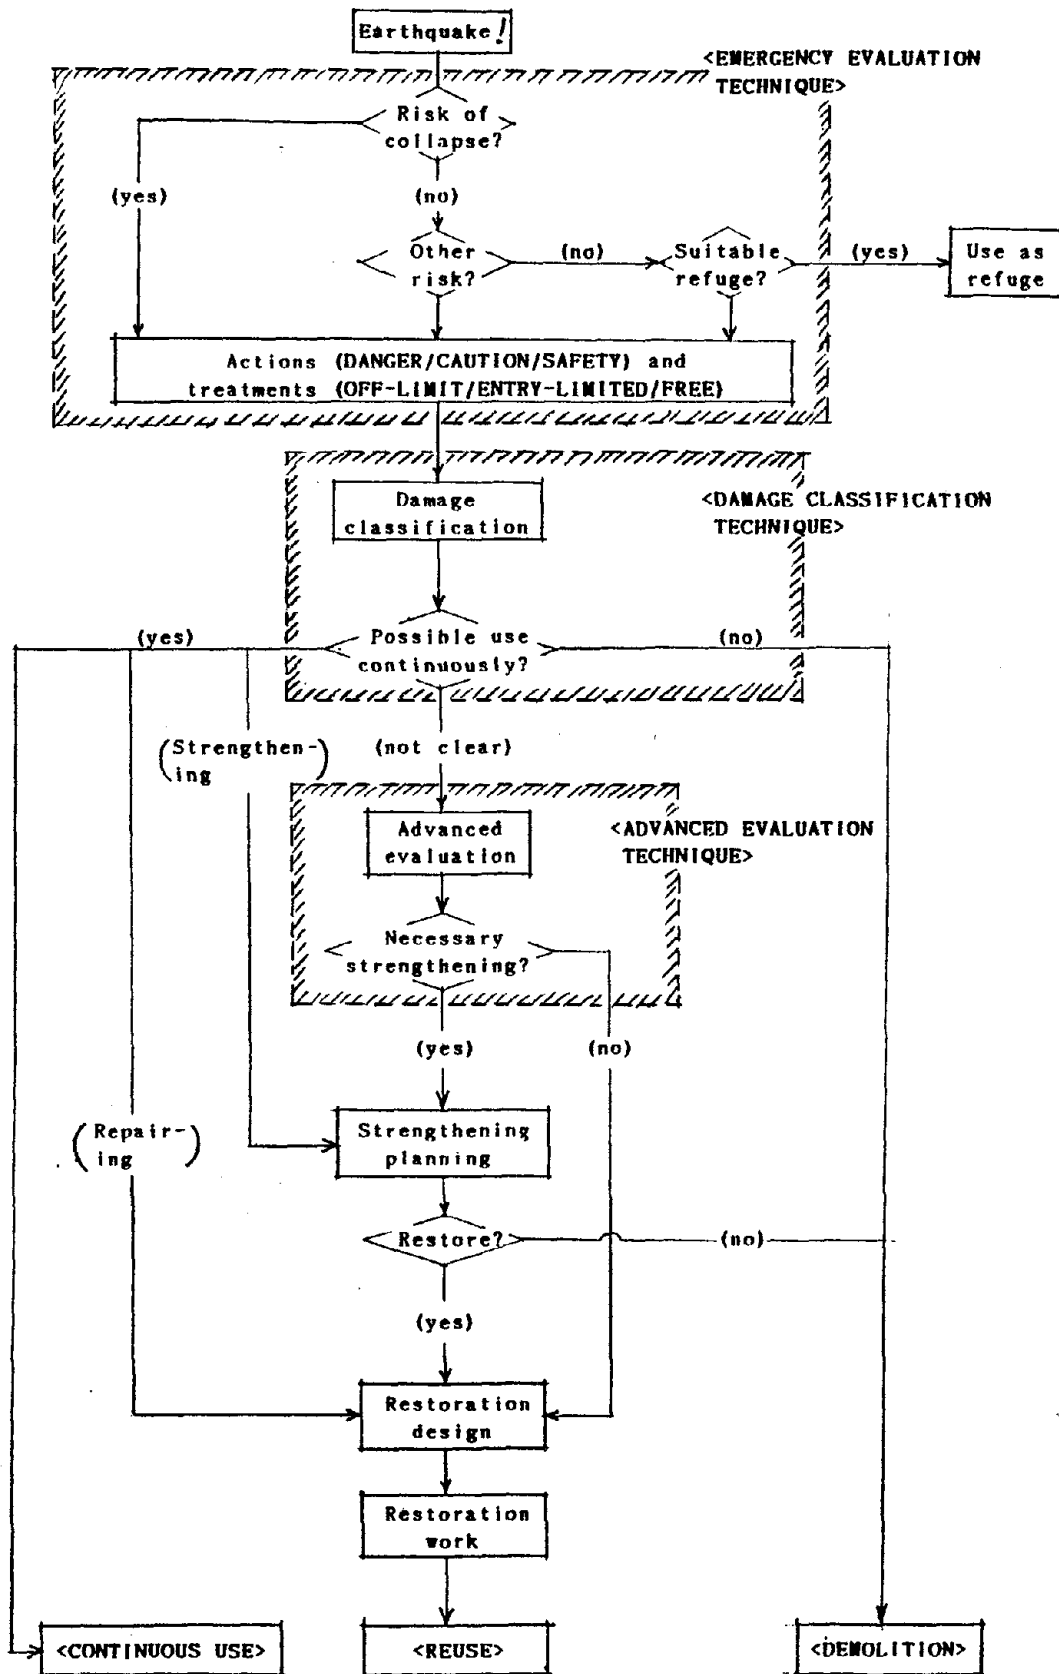
Fig.1 : GENERAL FLOW-DIAGRAM FOR POST-EARTHQUAKE DAMAGE INSPECTION, EVALUATION AND RESTORATION

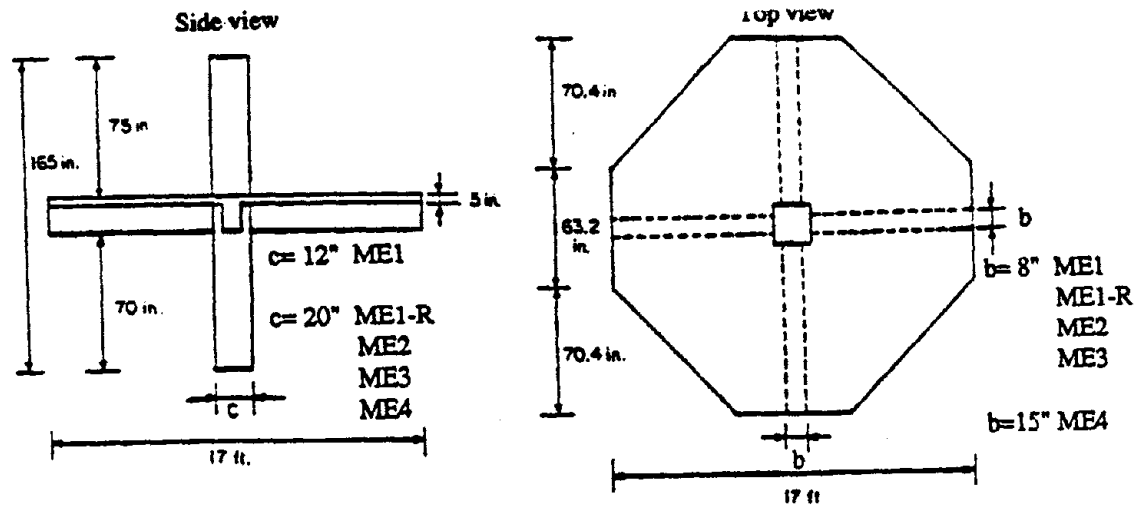
Figure 1. Dimensions of the specimen

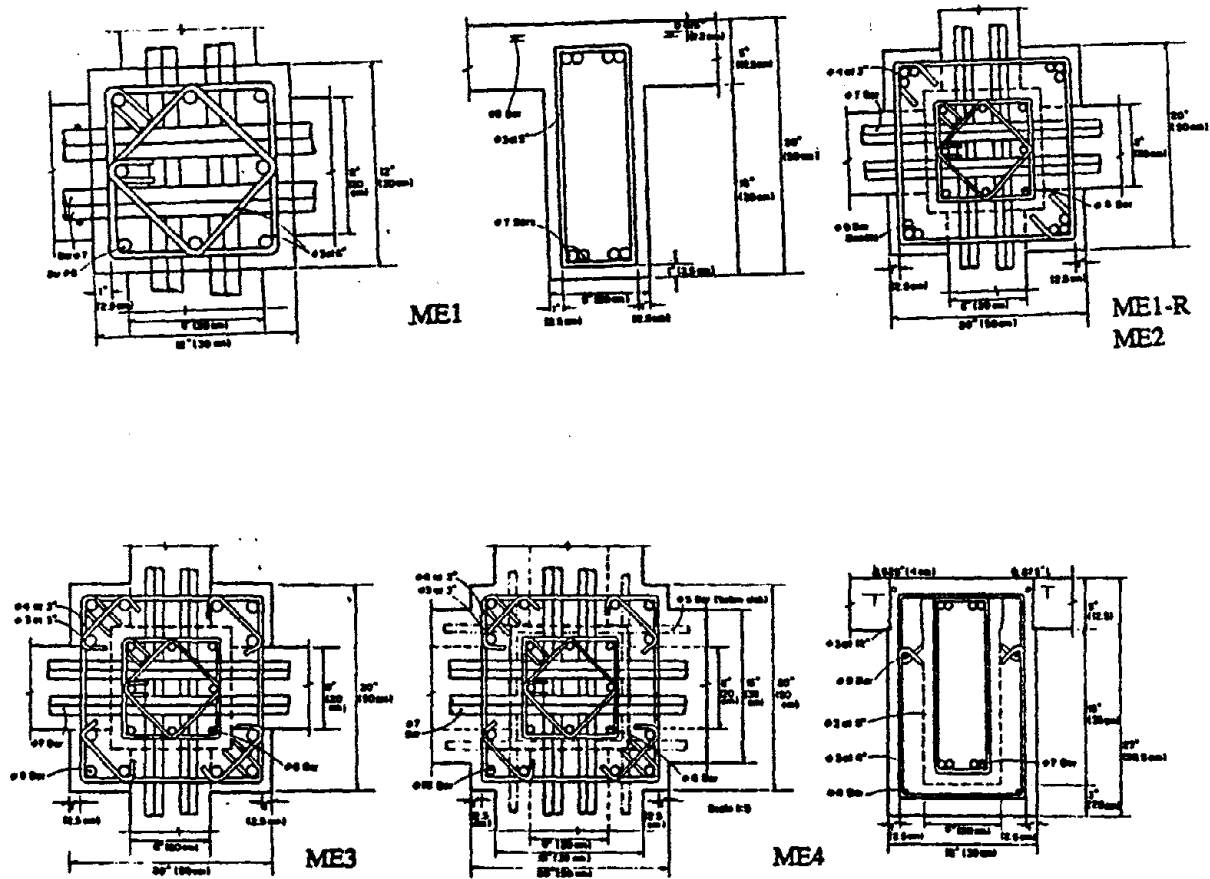
Figure 2. Details of the reinforcement

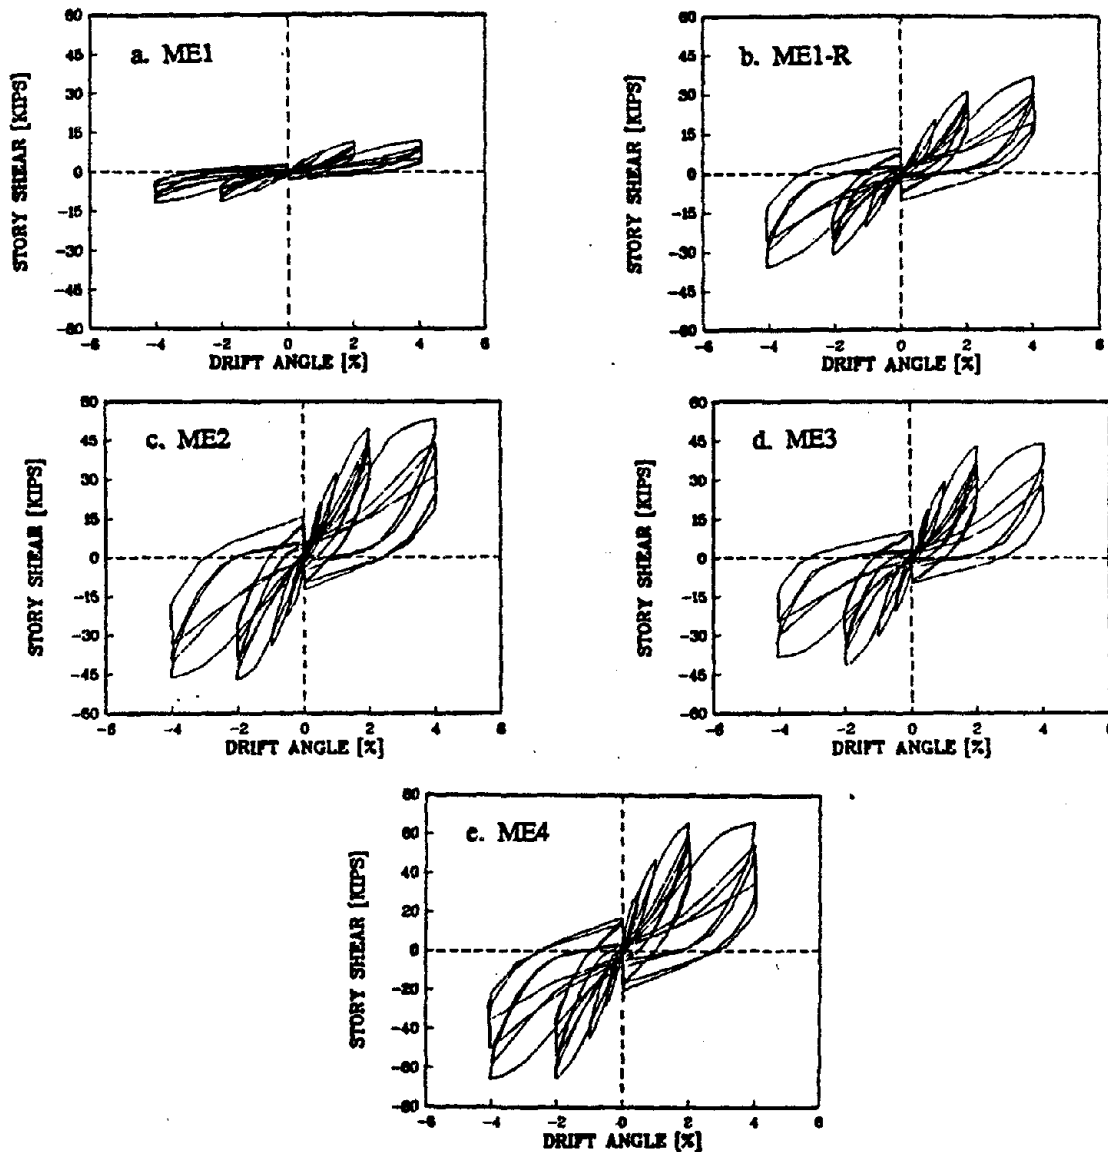
Figure 4. Hysteretic response of the specimens (EW direction).

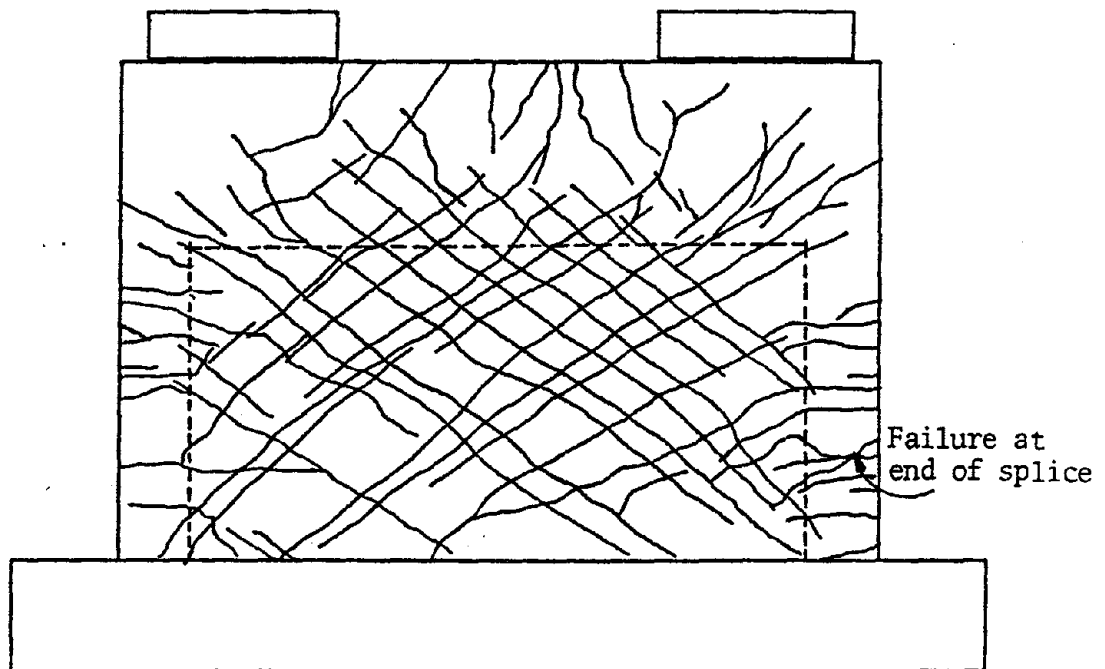
Figure 11. Crack pattern at failure, SC-S

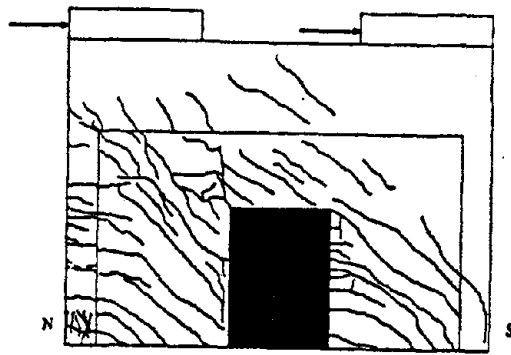
Figure 12. Crack pattern at failure, SC-D, south loading

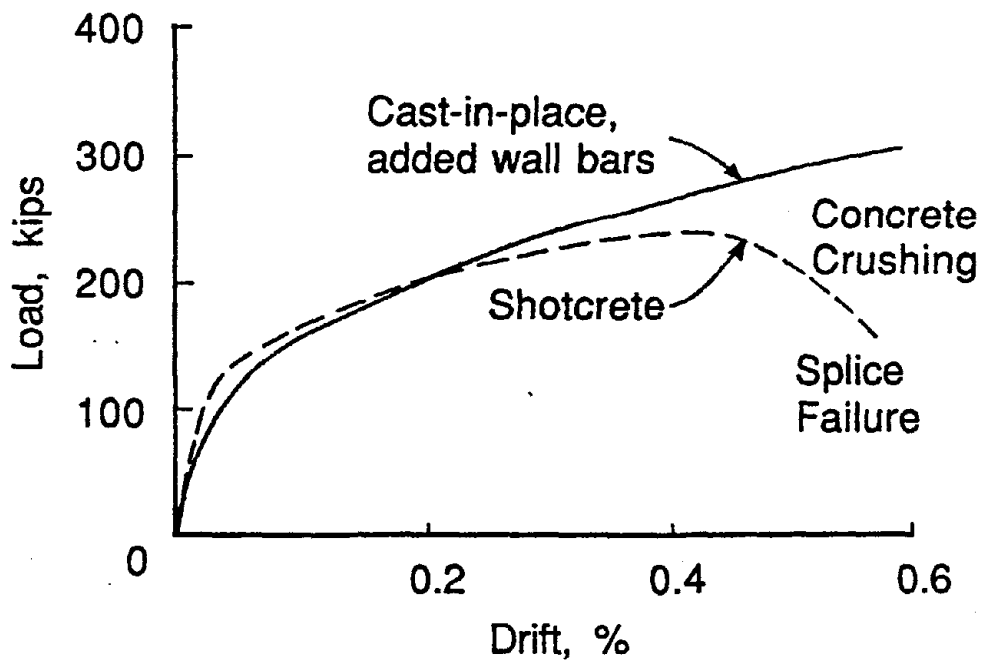
Figure 13. Envelope curves for tests CIP-D and SC-D

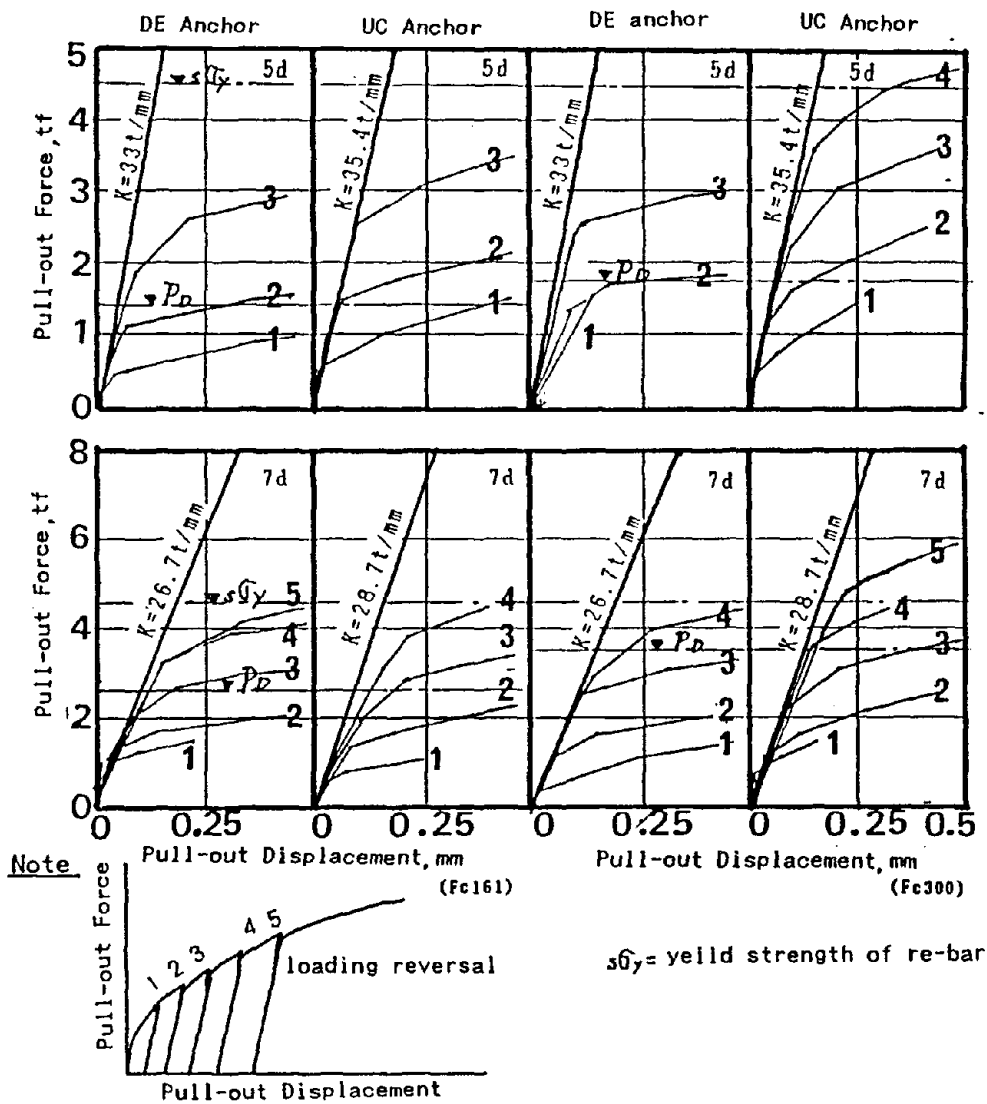
Fig. 9 Comparison of stiffening for Restoring Force

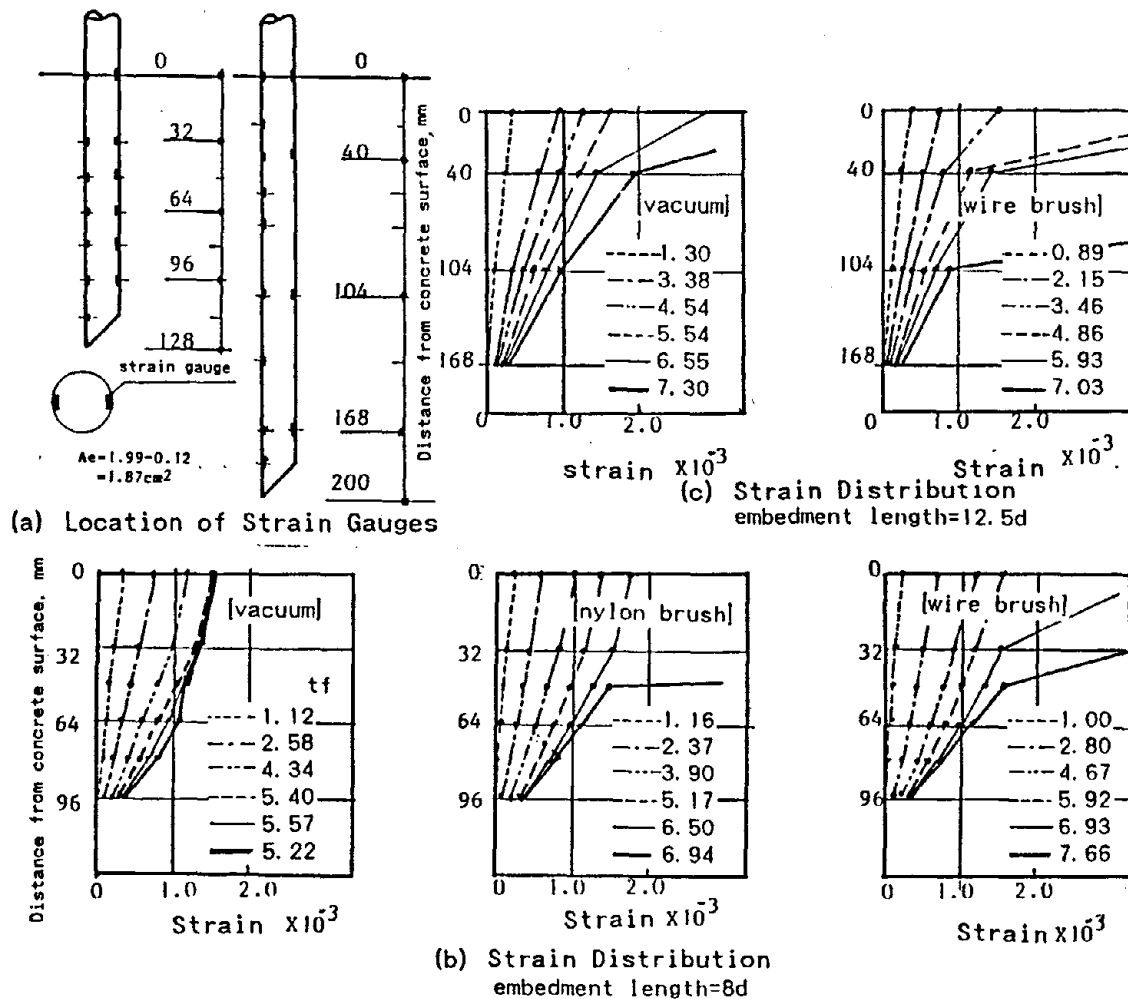
Fig. 14 Strain Distribution in an Embedded Re-bar

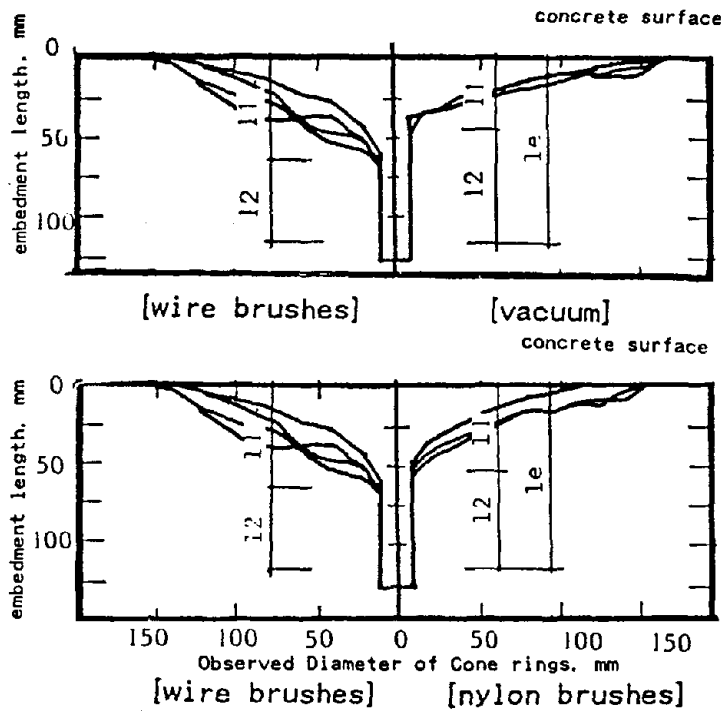
Fig. 16(a) Observed Failure Patterns for Each Cleaning Methods

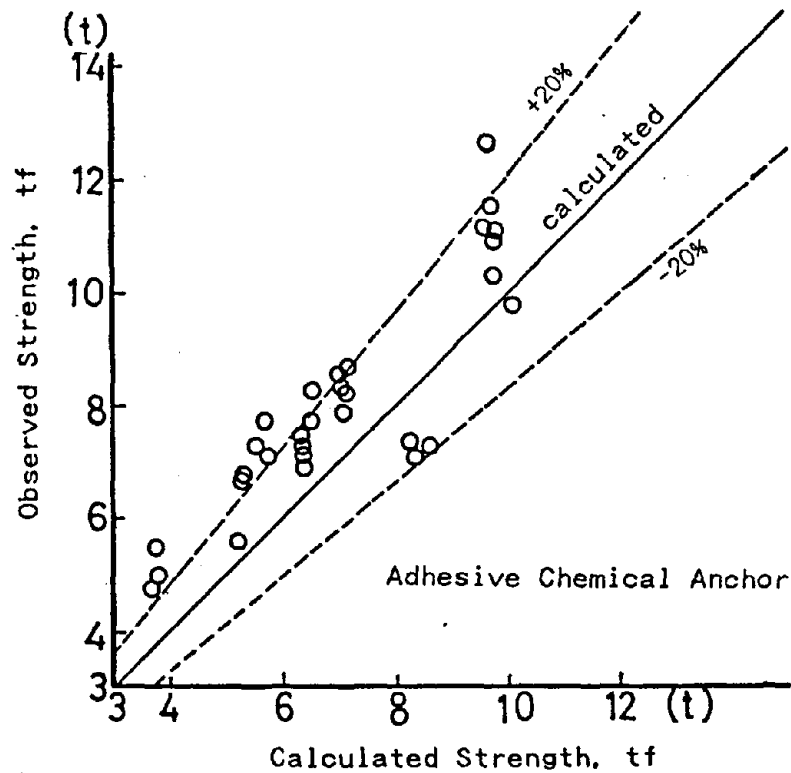
Fig. 17 Comparison between Calculated Strength and Observed Strength

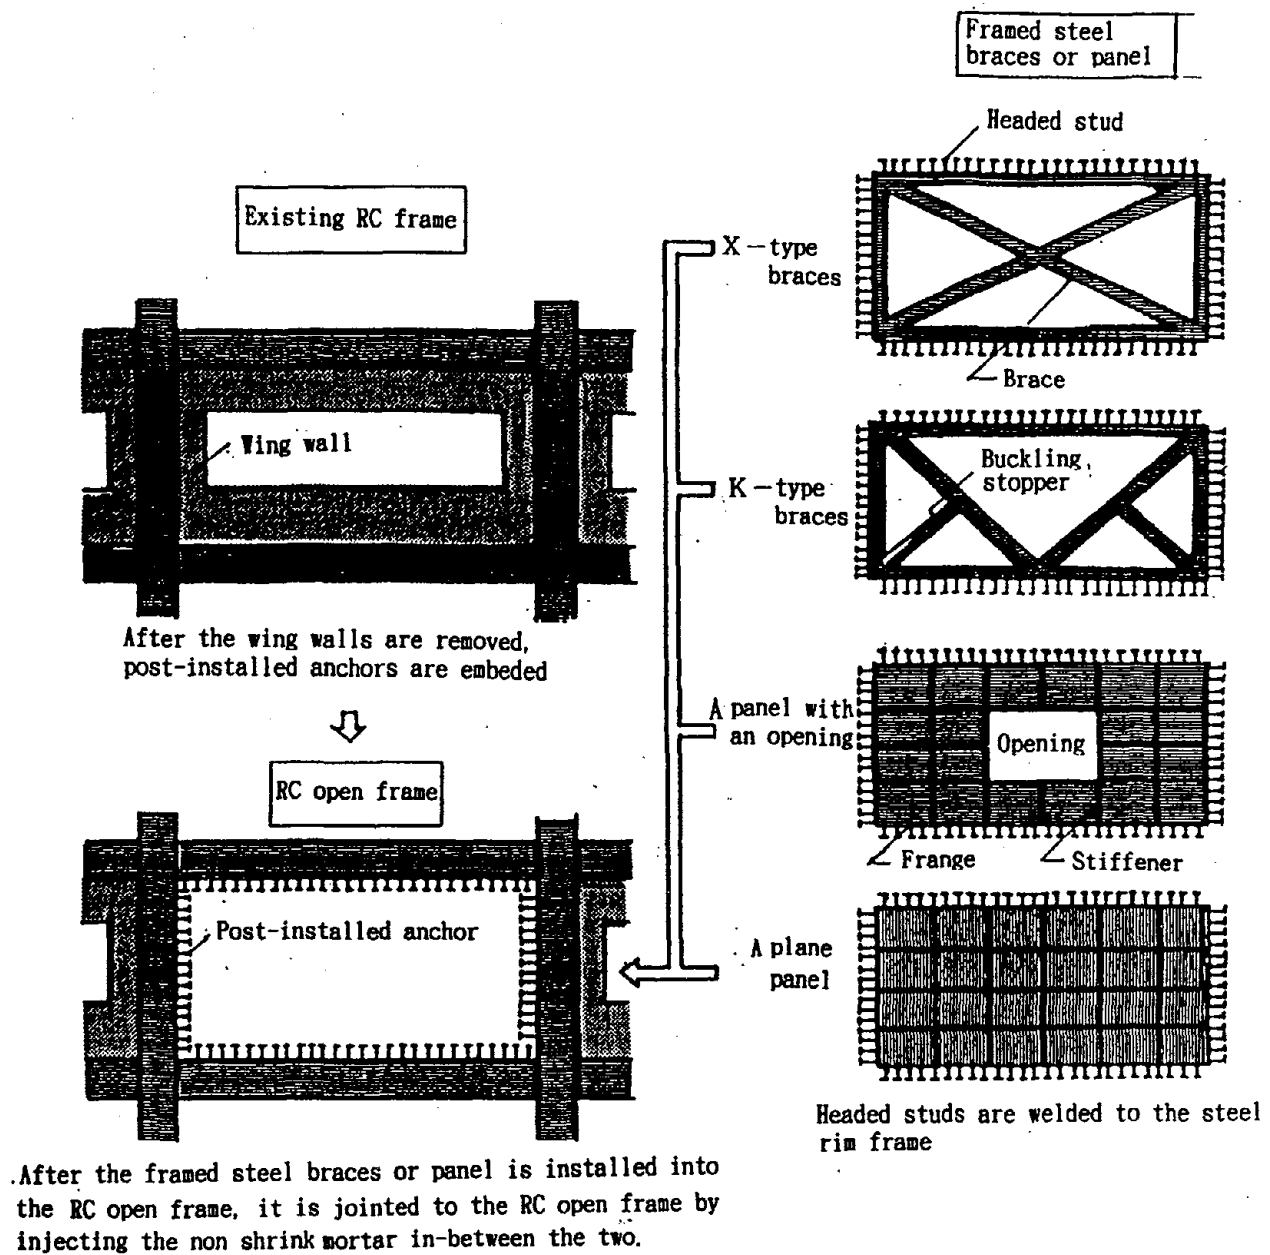
Fig. 1.1 Examples of RC open frames strengthened with framed steel(strengthened with rims frames)

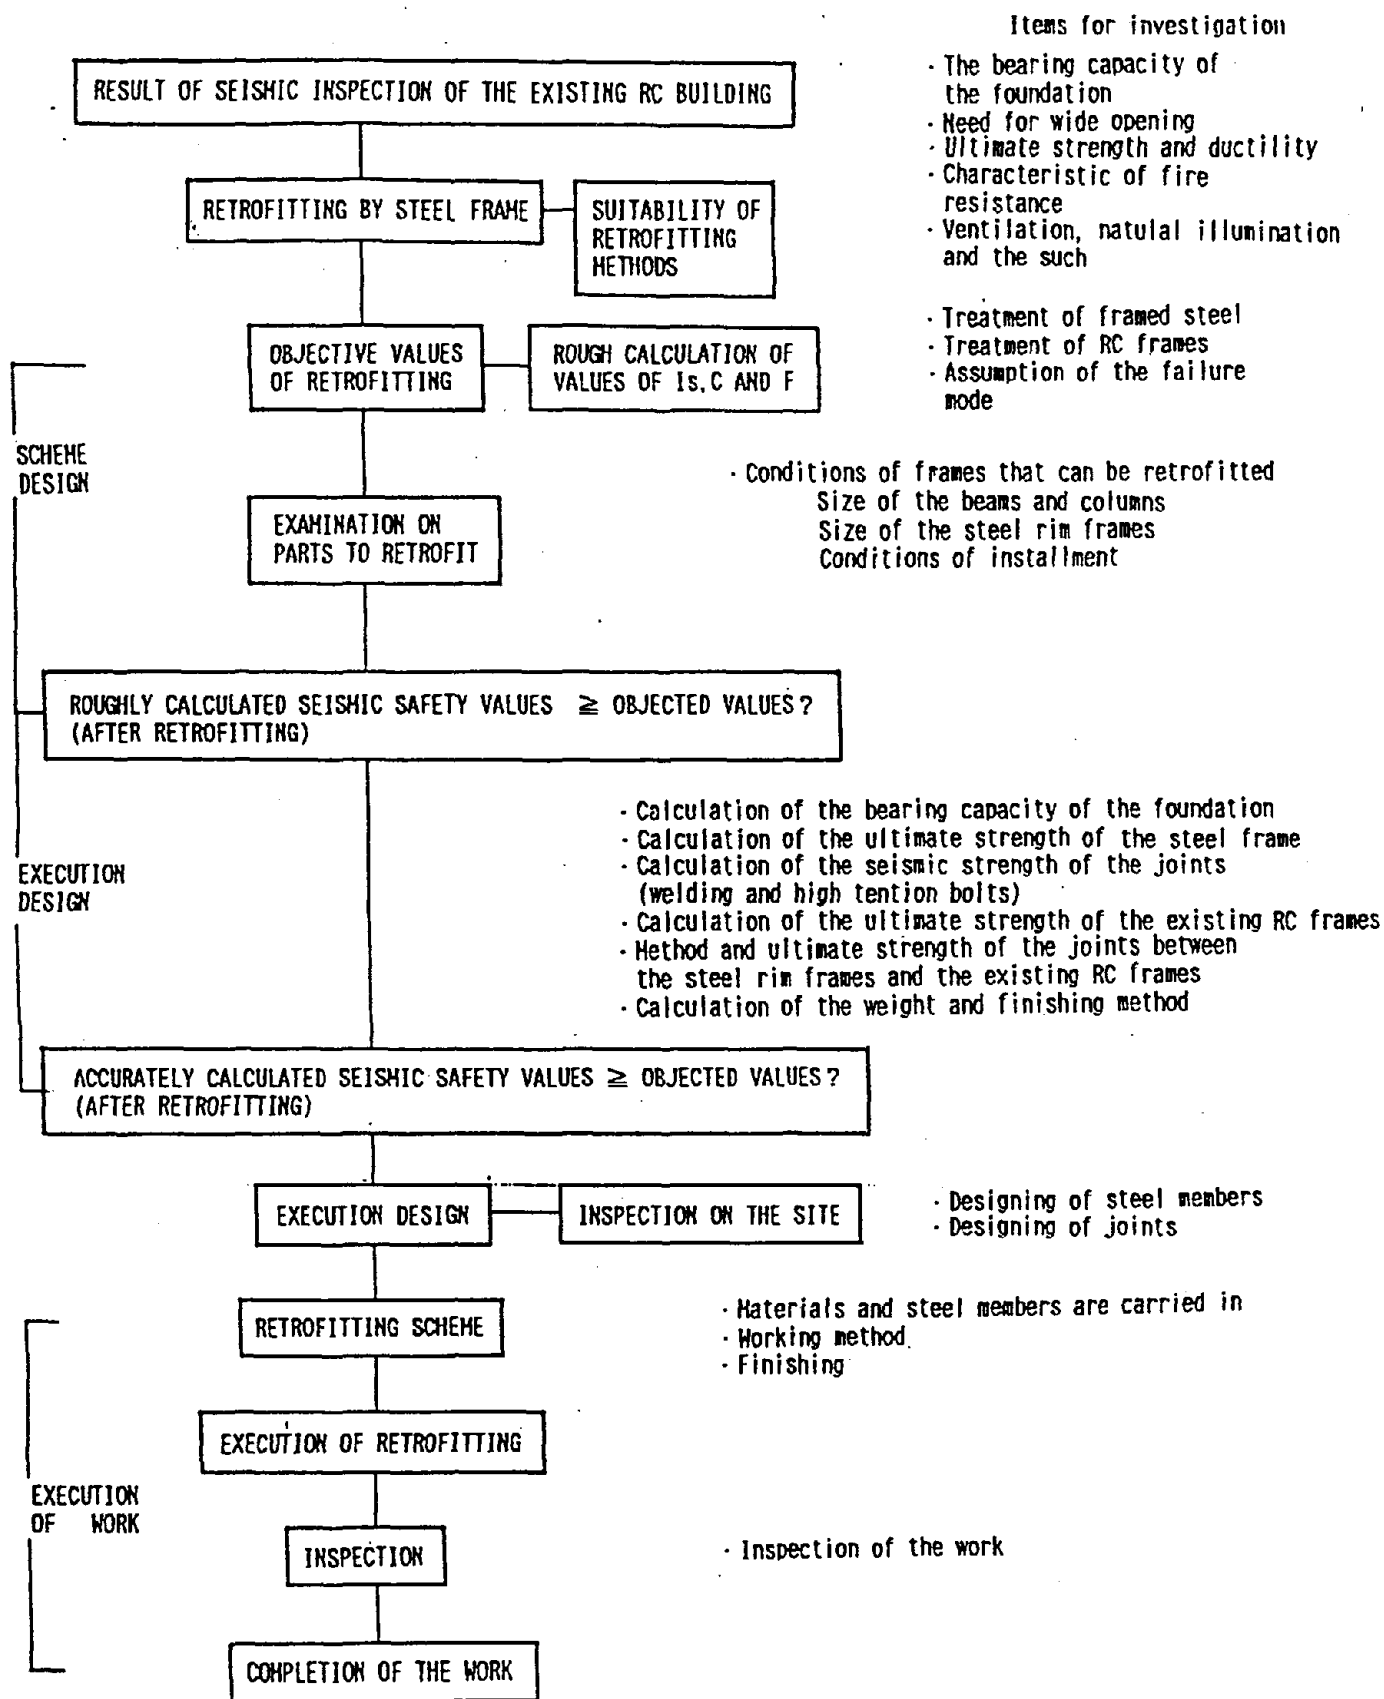
Fig. 2.1 Flow chart of designing and execution of retrofitting with framed steel
