**NISTIR 4515**

Proceedings of a Workshop on Evaluation,  
Repair, and Retrofit of Structures—U.S.-Japan  
Panel on Wind and Seismic Effects, UJNR,  
Gaithersburg, MD, USA, May 12–14, 1990

This report is the Proceedings of an international workshop on Evaluation, Repair, and Retrofit of Structures. The workshop was a joint effort of Task Committees C and D, "Repair and Retrofit of Existing Structures" and "Evaluation of Structural Performance" respectively of the U.S.-JAPAN Panel on Wind and Seismic Effects. The workshop was hosted by the National Institute of Standards and Technology during May 12-14 1990. The National Science Foundation provided the financial support. The subjects addressed included: evaluation of structures; performance of existing structures their repair and strengthening; and research on techniques for repairing and retrofitting structures.

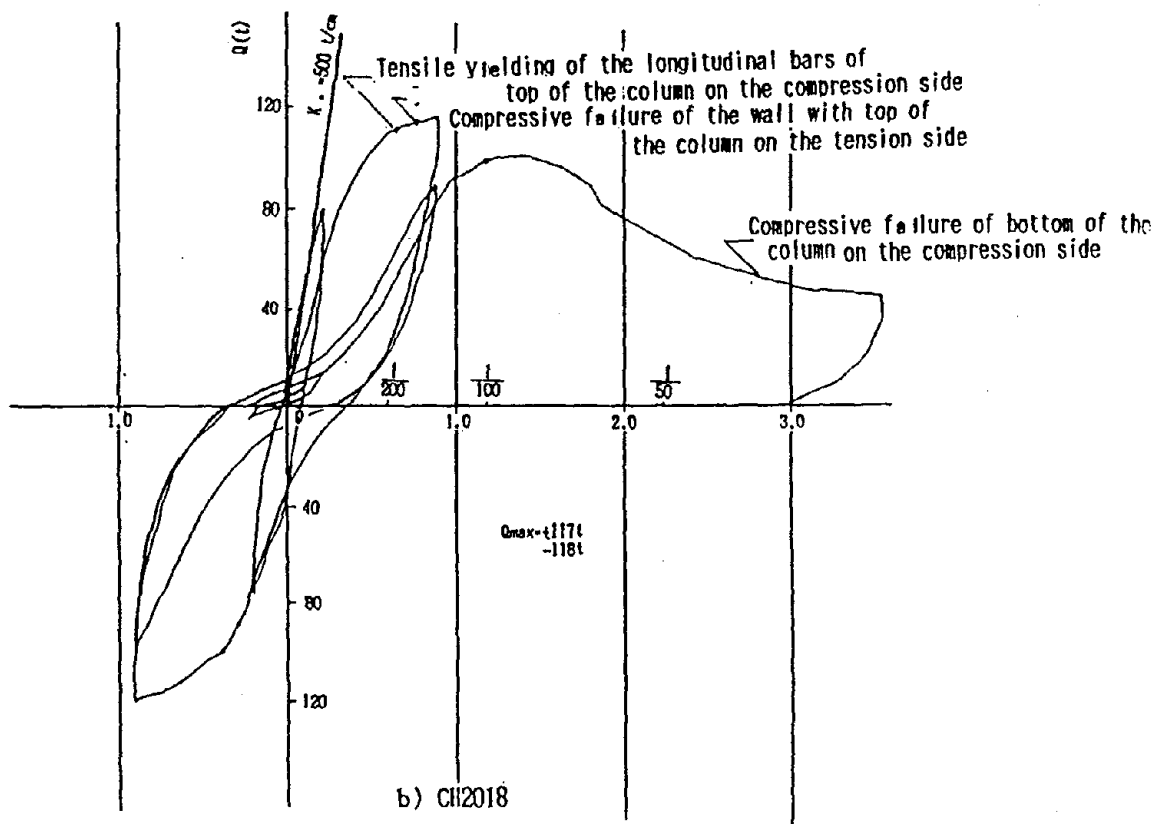
Fig. 8.1 Comparison between the hysteretic characteristics of framed steel and that of post-cast RC walls

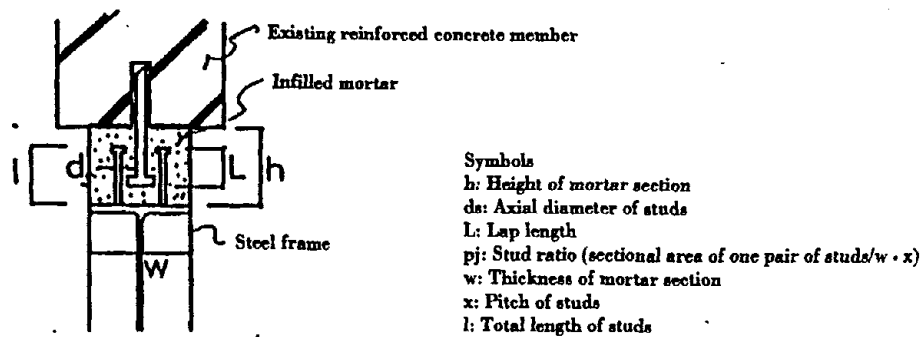
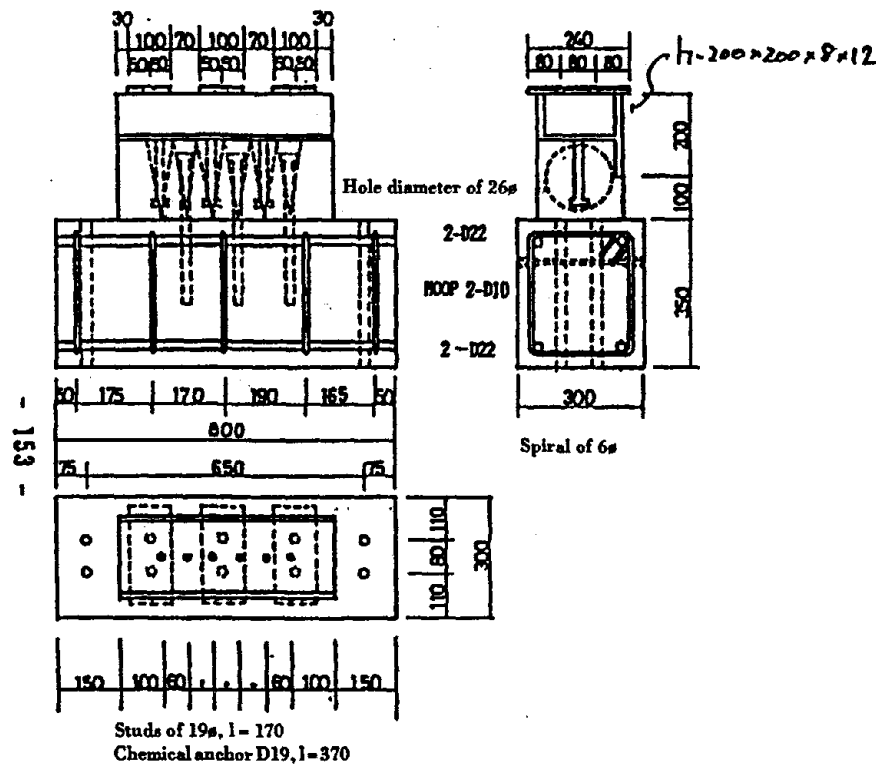
Figure 1. Details of specimens of BP-120S-0, -C and -T

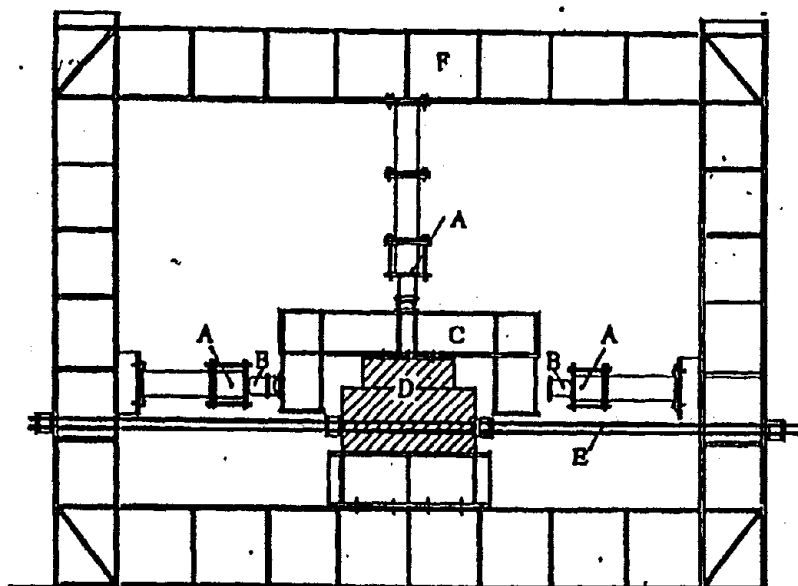
A: 50 tf oil ram      D: Specimen  
B: 30 tf load cell    E: PC steel rod  
C: Loading frame     F: Reaction frame

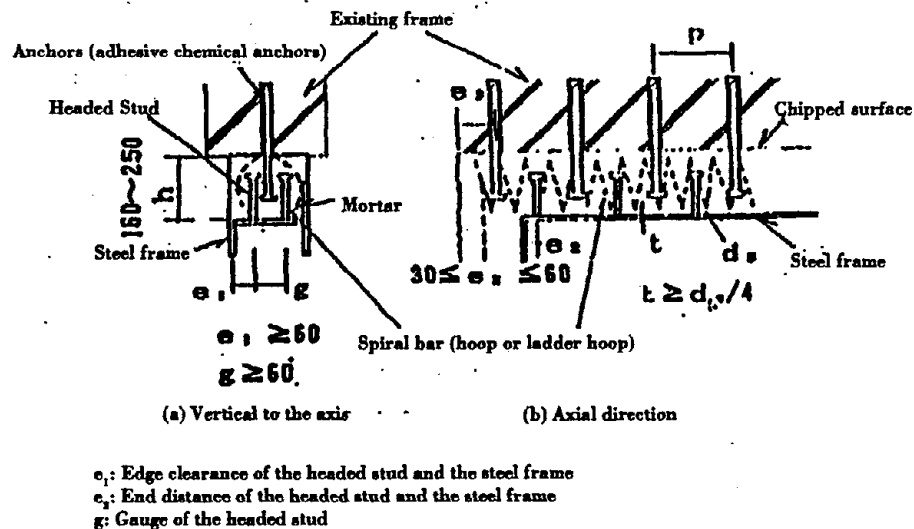
Figure 3. Indirect mortar joint with steel frame for strengthening

Based on the test results mentioned in section 2, details of the structure, which were adopted in the draft of the Design Guide for Retrofitting, are described below. For details of the structure of the indirect mortar joint with framed steel brace, the example in Figure 3 is recommended. Performance of this joint was confirmed through testing, and a number of actual work examples are available. The details include items of the steel frame, anchor bolts, headed studs, strength of infilled mortar, spiral hoop, hoop and ladder hoop for crack prevention.

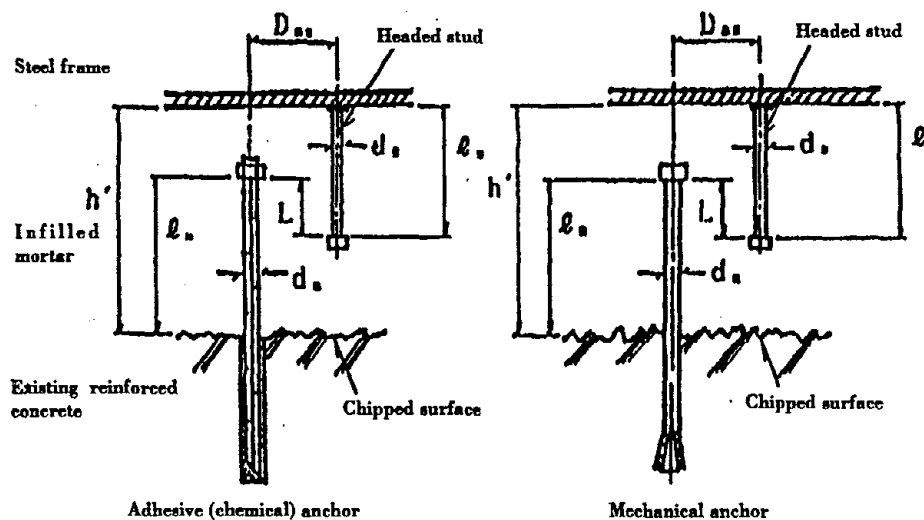
Figure 4.

$D_s$ : Diameter of the stud  
 $D_a$ : Diameter of the anchor  
 $h'$ : Height of the infilled mortar  
 $l_s$ : Fixing length of the anchor  
 $L$ : Lap length of the stud and anchor

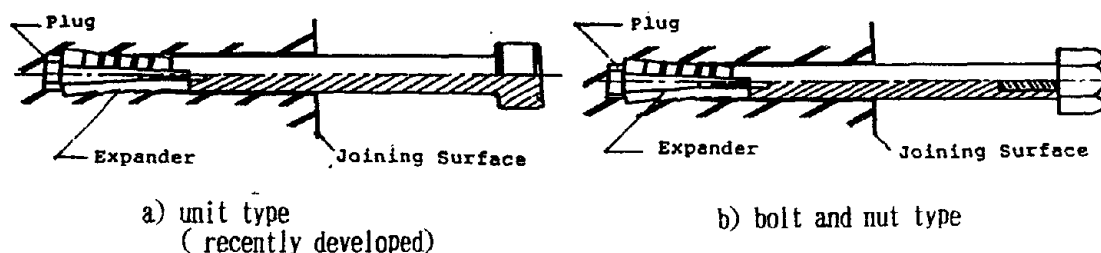
Figure 5. Mechanical anchor to strengthen steel frame

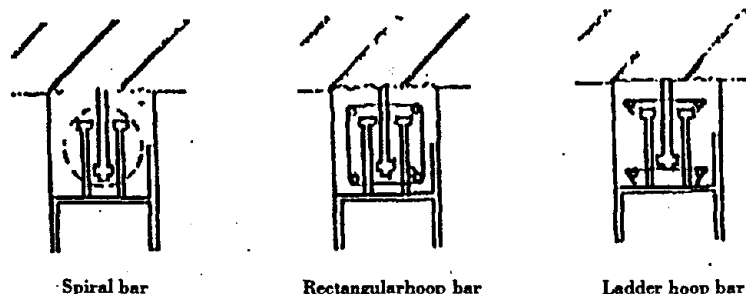
Figure 6 Reinforcement for preventing crack expansion

Insert the spiral hoop, rectangular hoop and ladder hoop into the mortar to distribute cracks in the mortar (Fig. 6). When a large stress is applied to the mortar joint for strengthening, the spiral hoop and rectangular hoop are particularly effective in restraining the mortar and transferring stress to the anchors and studs. The reinforcing bar ratio  $p_s$  in the mortar should be larger than 0.4%. The formula is  $p_s = a_s / h' \times x_s$  ( $x_s$ : pitch of the reinforcing bars,  $a_s$ : sectional area of one set of the reinforcing bars,  $h'$  = height of the infilled mortar).

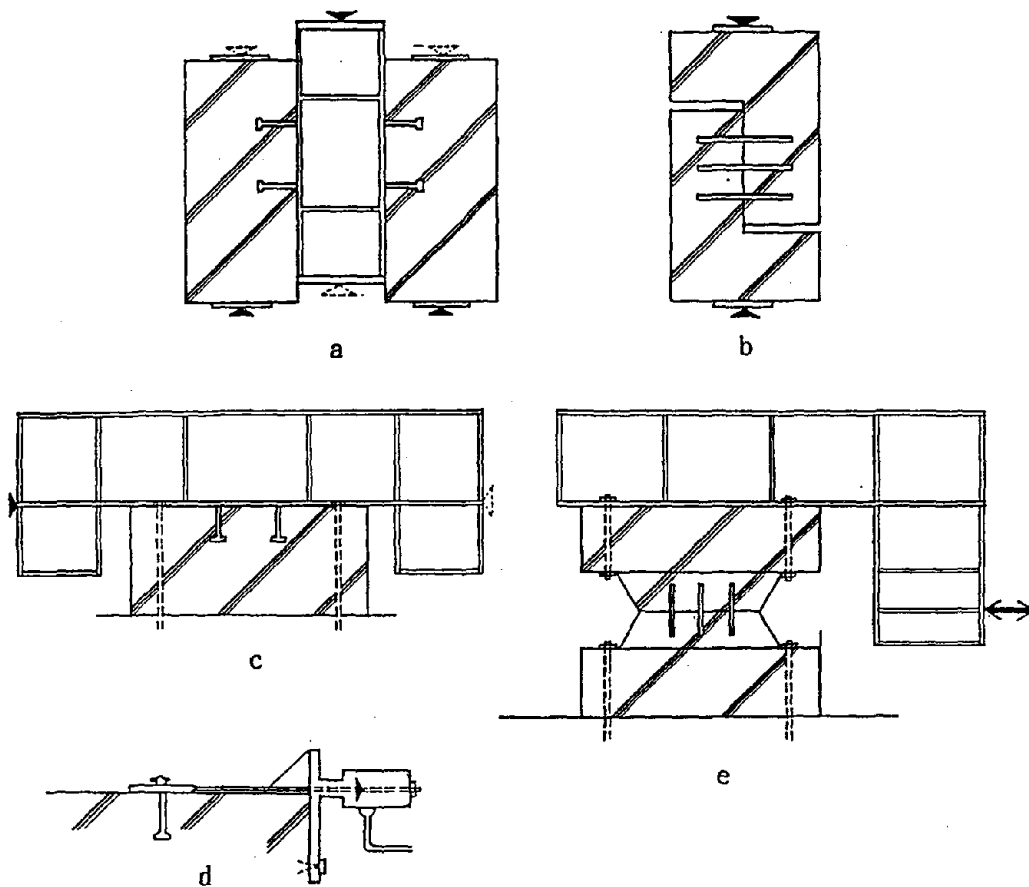
Fig. 1 Method of direct shear tests

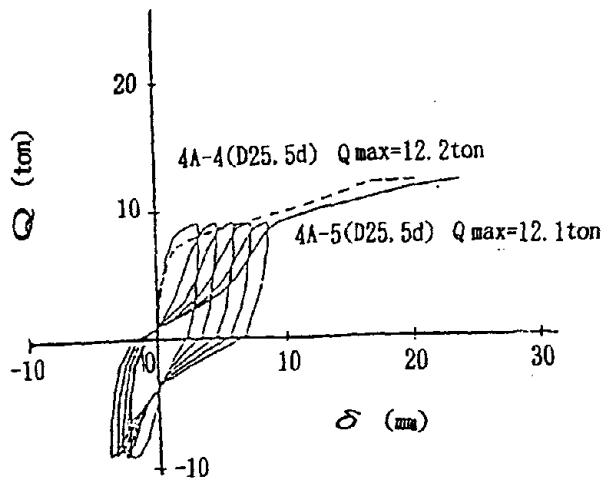
Fig. 7 Load-deflection curves (effect of one-way loading and cyclic loading)

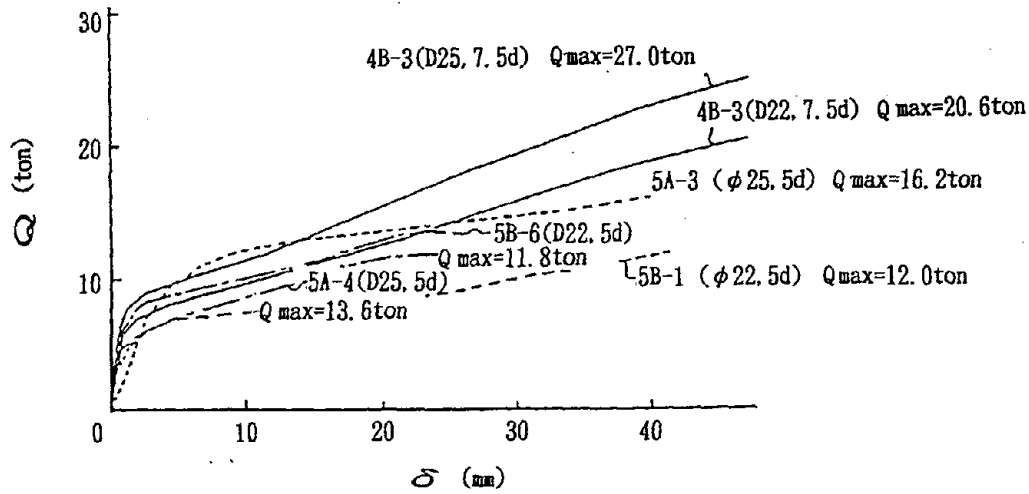
Fig. 8 Load-deflection curves for typical specimens

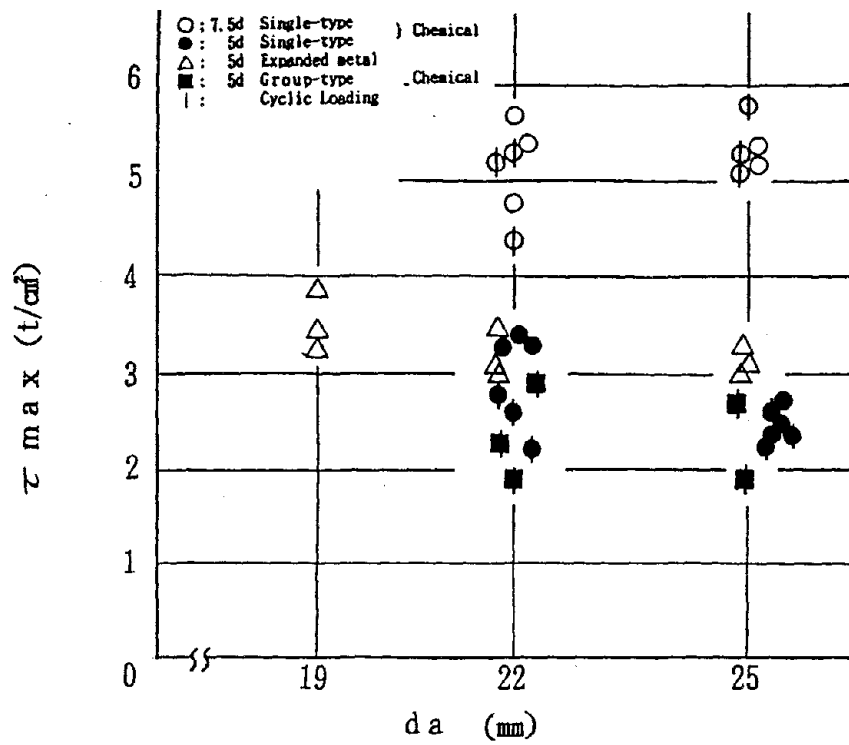
Fig. 9 Relationship between diameter of anchor and average shear stress at maximum strength ( $\tau_{max}$ )

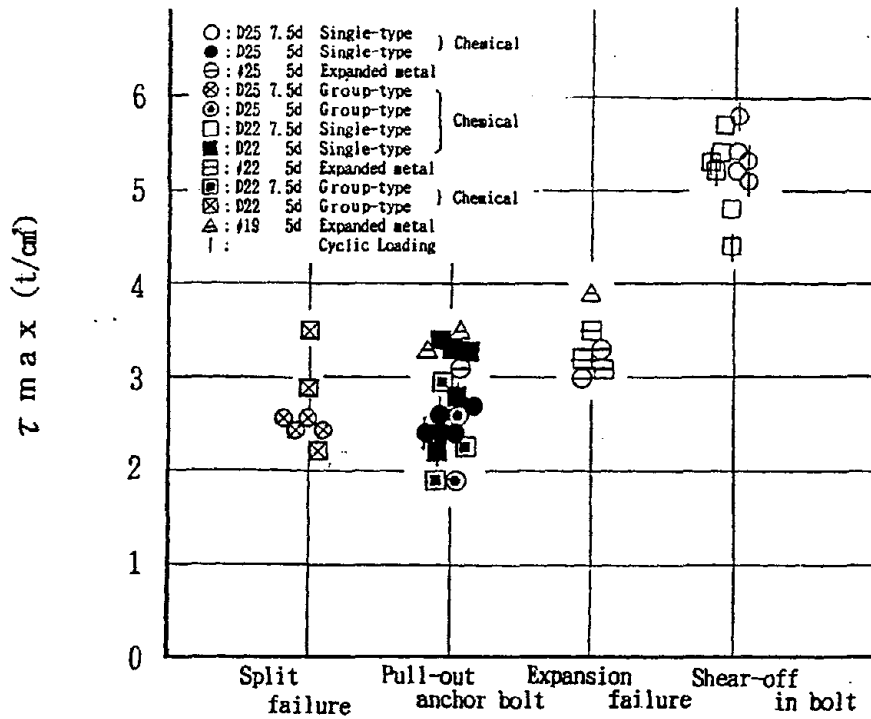
Fig. 10 Relationship between failure mode and average shear stress at maximum strength ( $\tau_{max}$ )

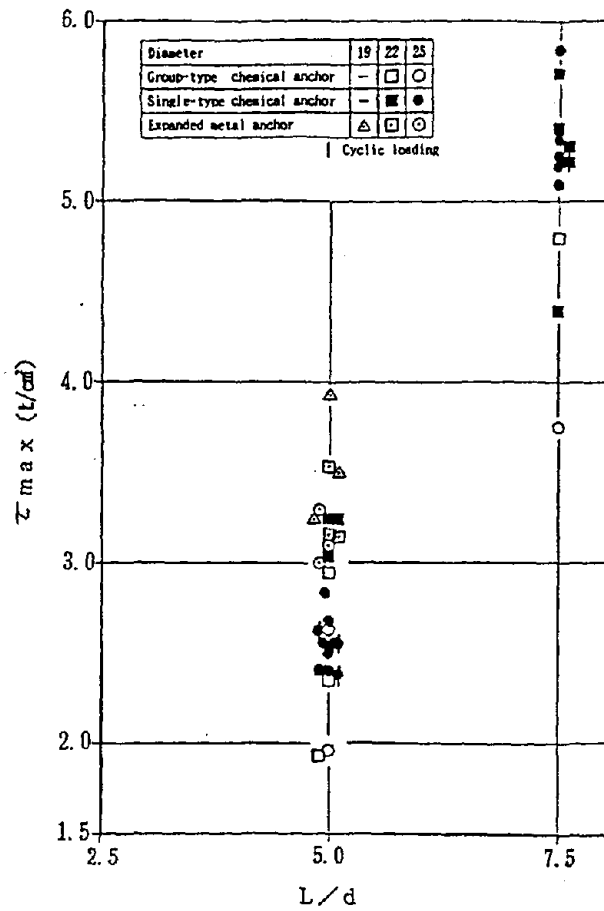
Fig. 11 Relationship between maximum shear strength ( $\tau_{max}$ ) and depth of embedment ( $\ell / d_a$ )

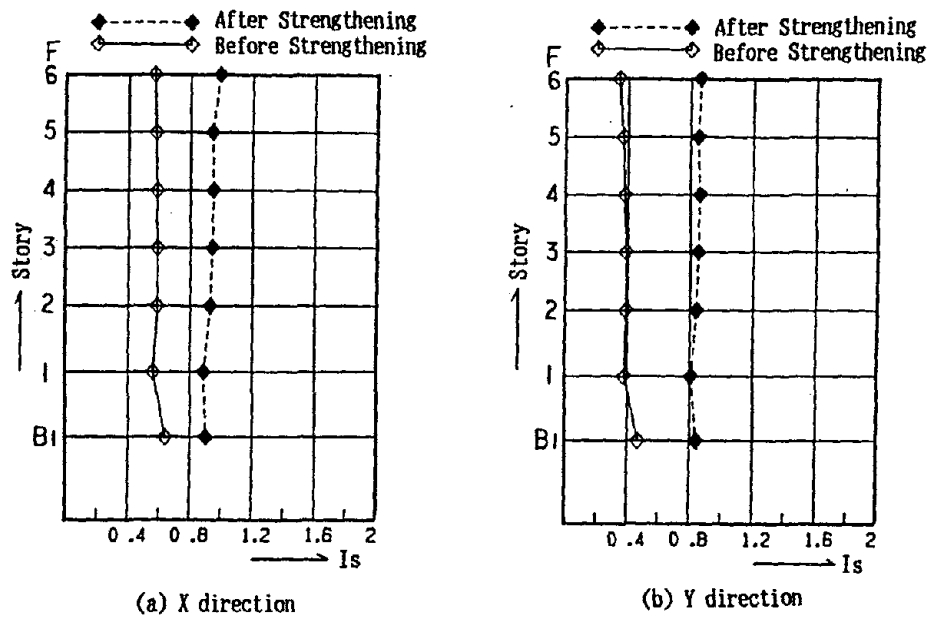
Fig.3 Distribution of Seismic Structure Index ( $I_s$ ) Before and After Strengthening

The fundamental natural period of 0.44-0.51 sec. was observed which had been 0.54 sec. before the strengthening. To verify the increase of the stiffness, the measurement will be carried out after the completion of the strengthening.

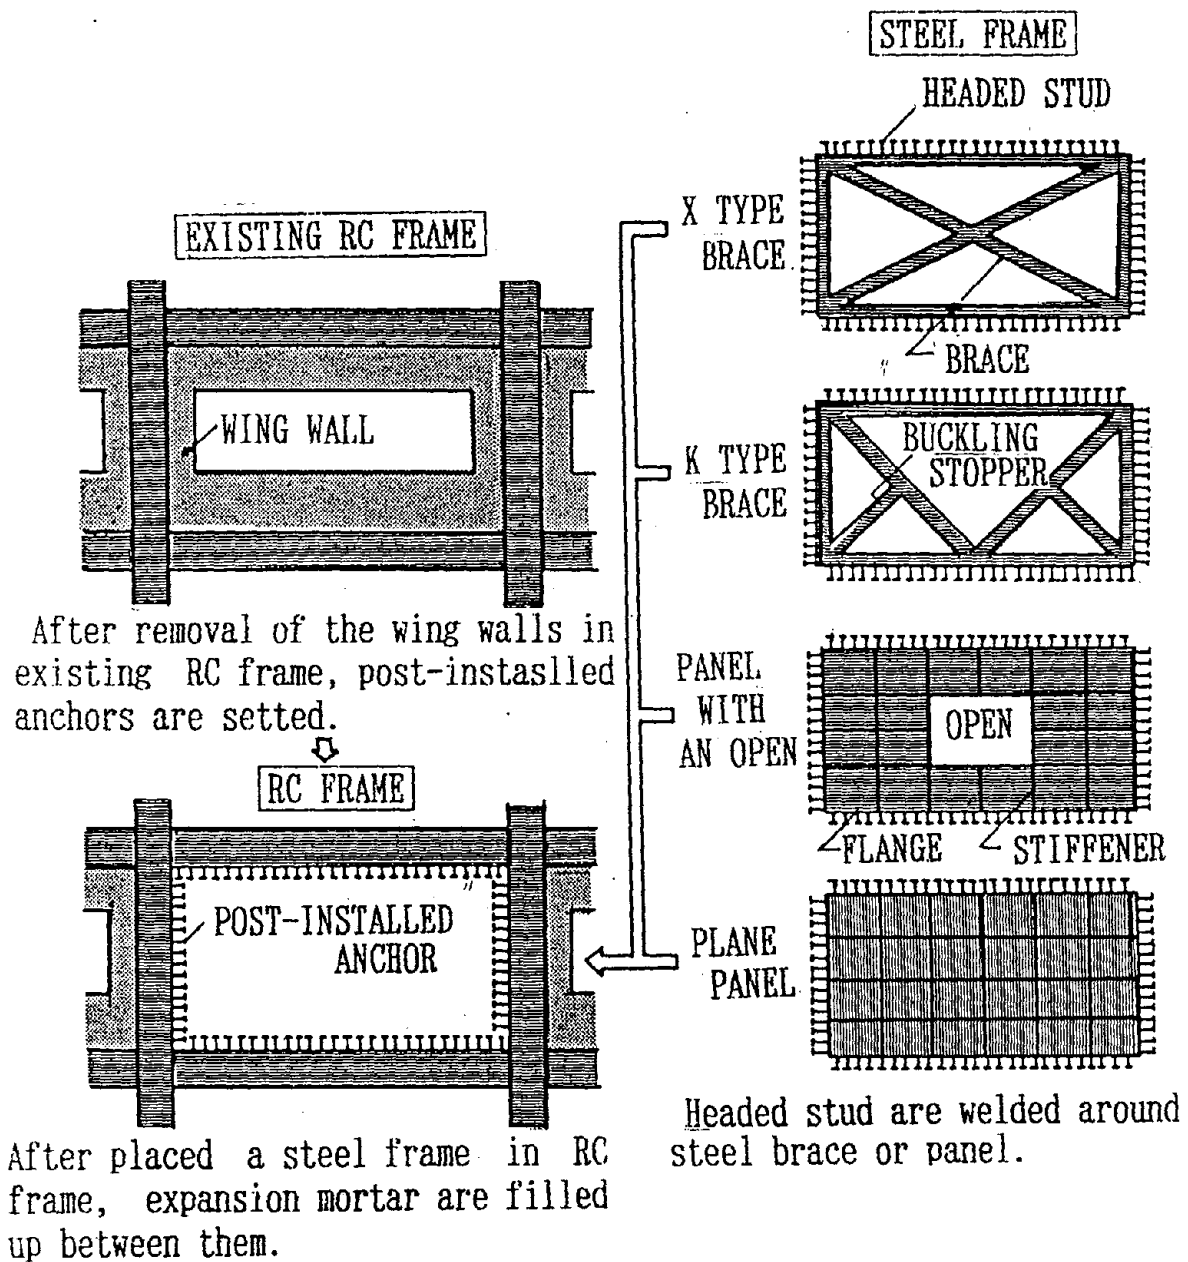
Figure 2. EXAMPLES OF STEEL BRACE STRENGTHENING METHOD

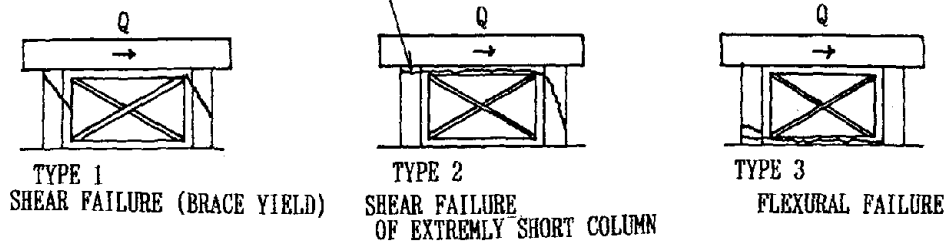
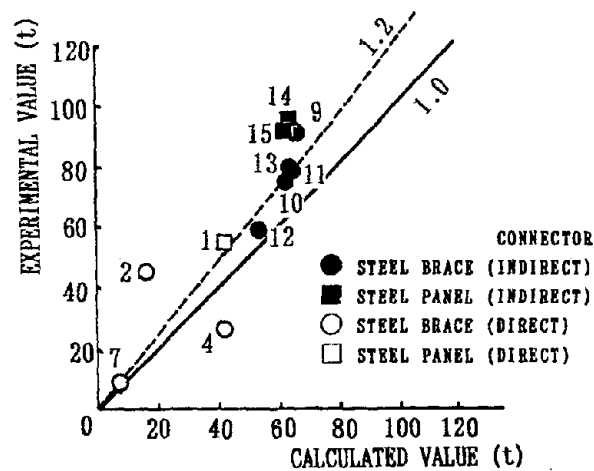
Figure 3. MAXIMUM STRENGTH  $Q_{max}$  OF STRENGTHENED BY STEEL BRACE

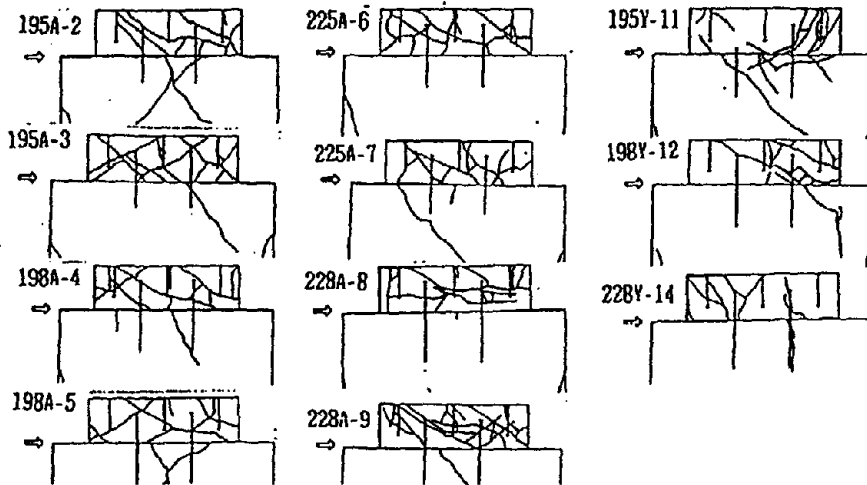
Figure 7 Breaking (failure) status at end  
Arrow indicates the direction of pressurization

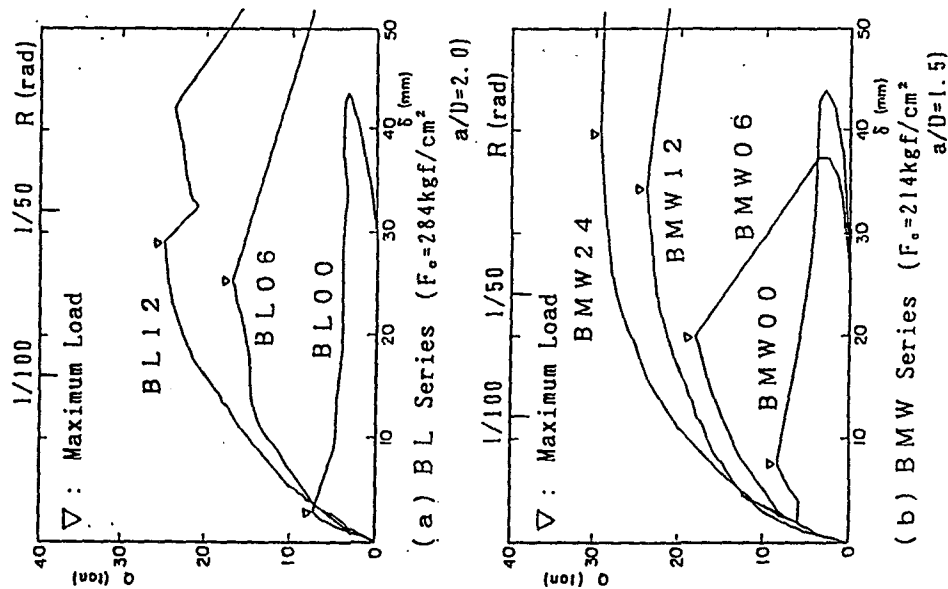
Fig. 11 Relationship of Shear Force vs. Displacement

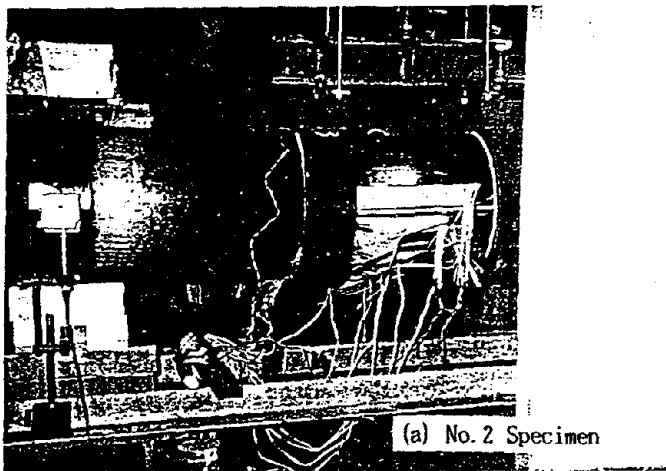
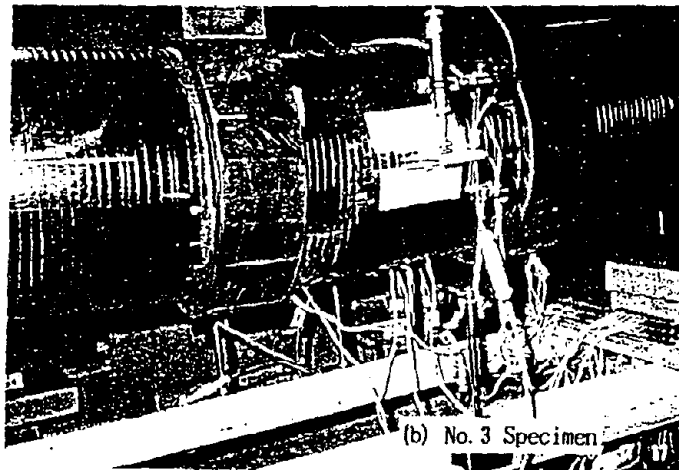
Photo. 3 Failure Pattern
