3. PUBLICATION DATE
4. TITLE AND SUBTITLE Proceedings of the First U.S.-Japan Workshop on Seismic Retrofit of Bridges				
5. AUTHOR(S) Kazuhiko Kawashima and M.J. Nigel Priestley

## **SEISMIC DESIGN, SEISMIC STRENGTHENING AND REPAIR OF HIGHWAY BRIDGES IN JAPAN**

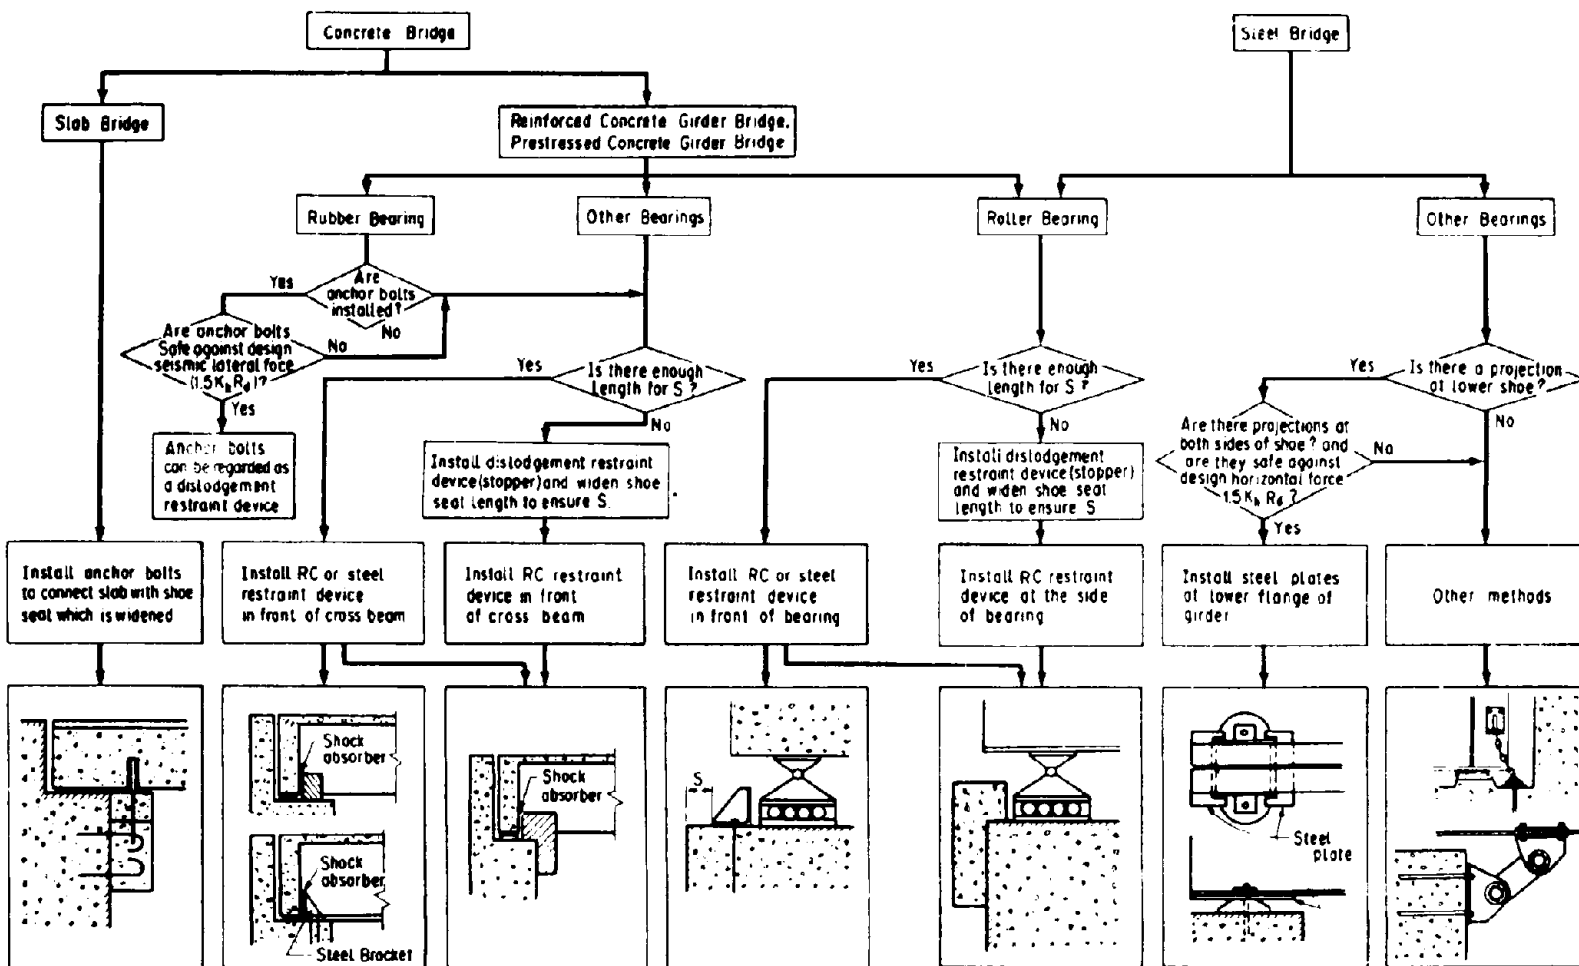
Fig. 14 Installation of Stopper at Movable Bearings for Existing Bridges

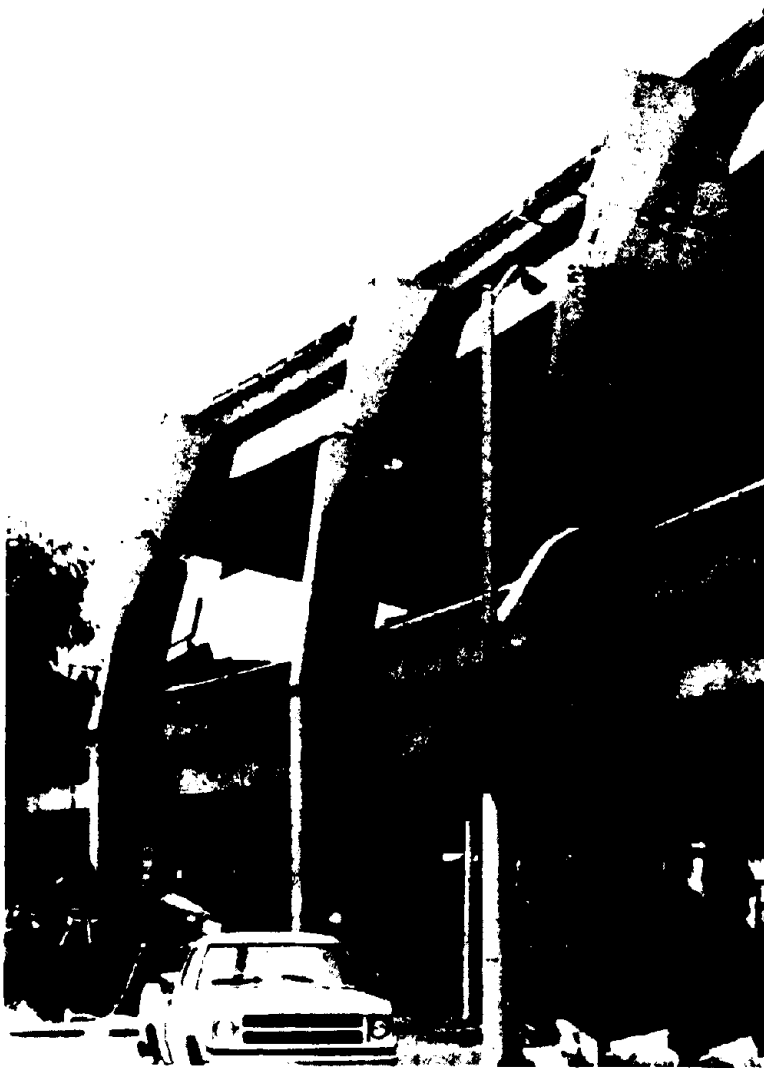
Figure 10 Failure of Type 2 bents

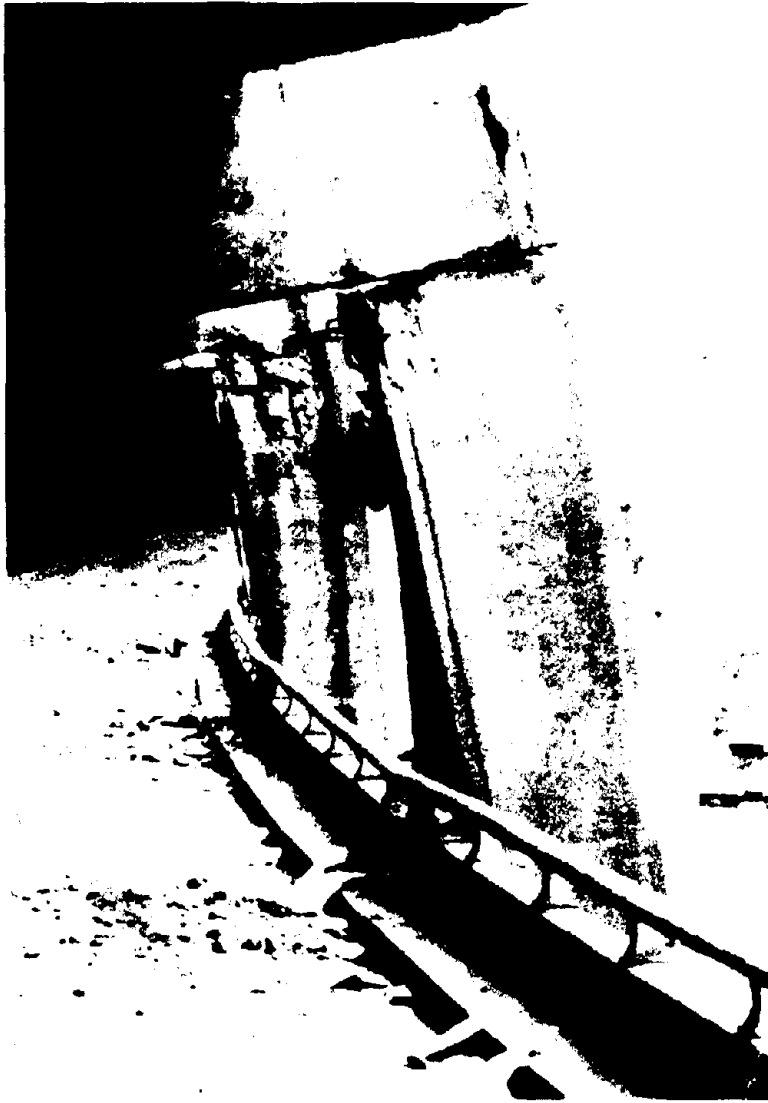
Figure 11 A close-up view of failure of Type 2 bents

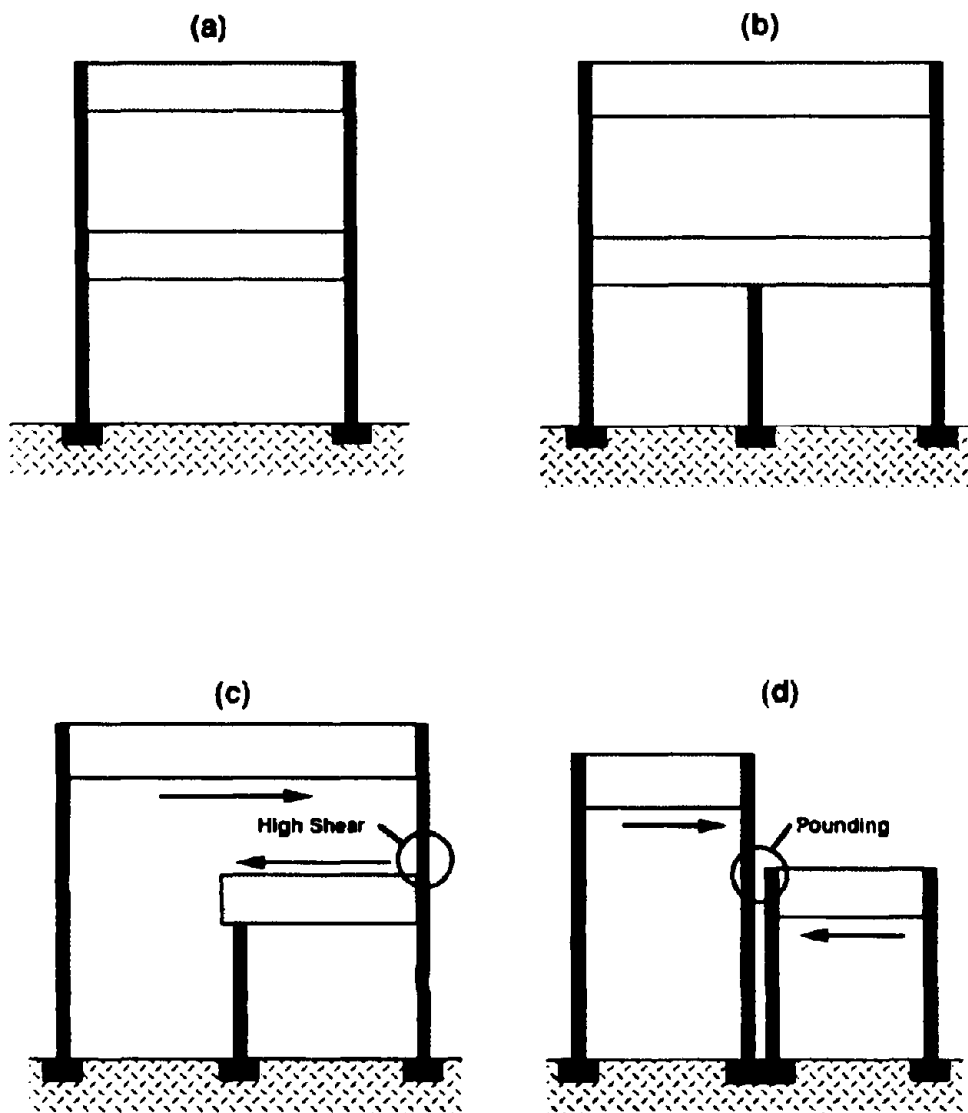
Figure 20 Schematic illustration of the various structural configurations of I-280.

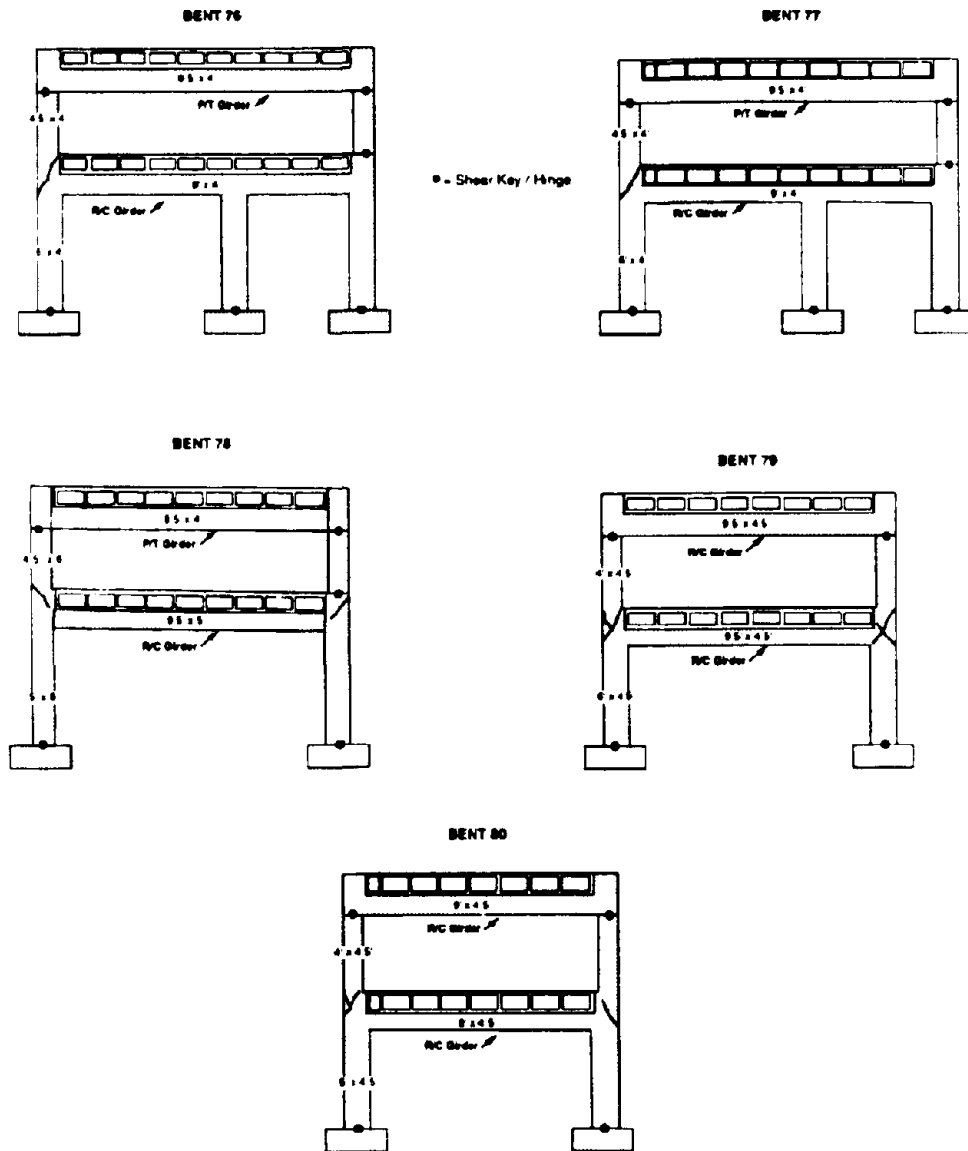
Figure 26 Schematics of bent configurations and damage at lower girder-column joints

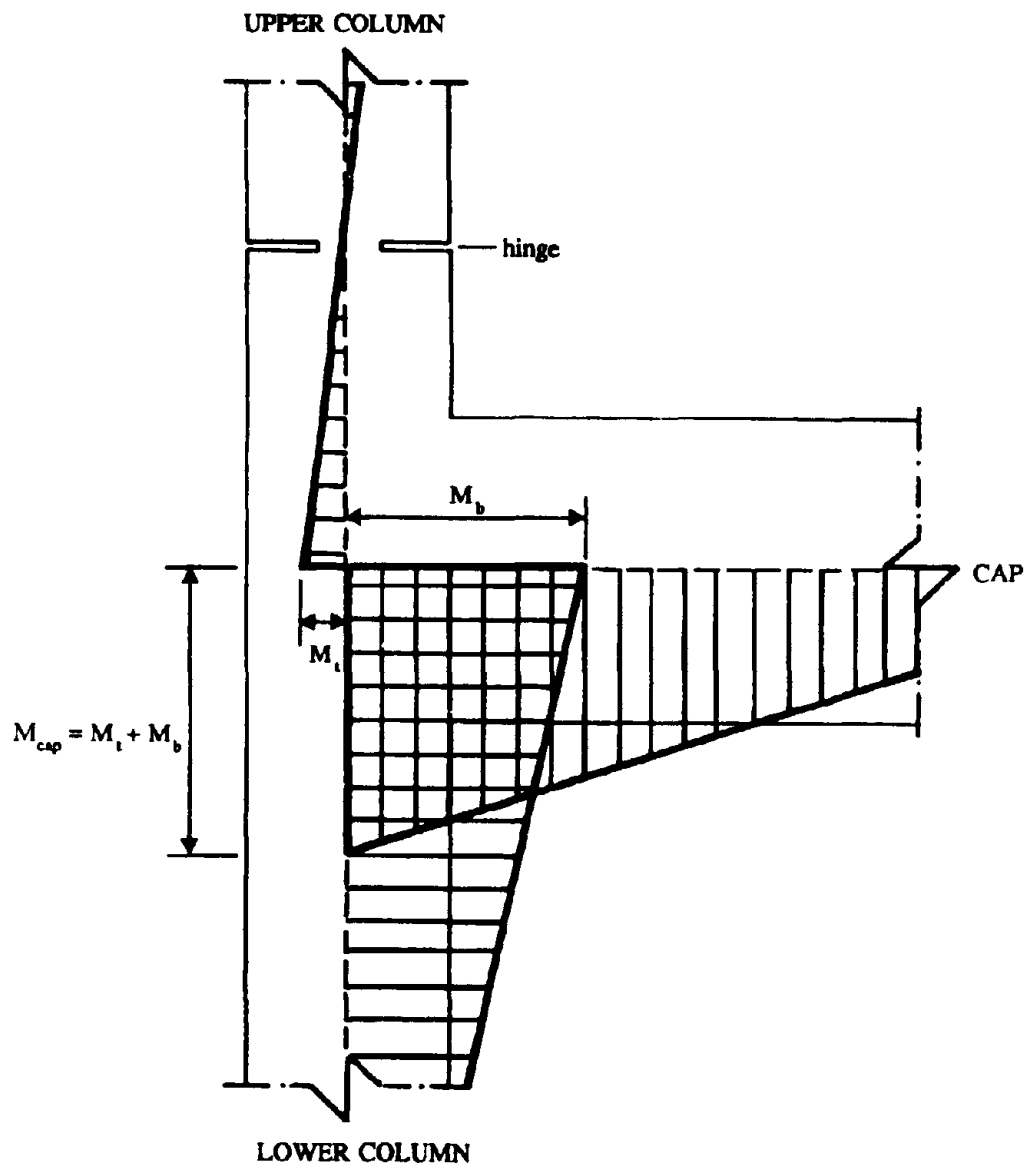
**Fig. 2 Lower Joint Seismic Moment Demands**

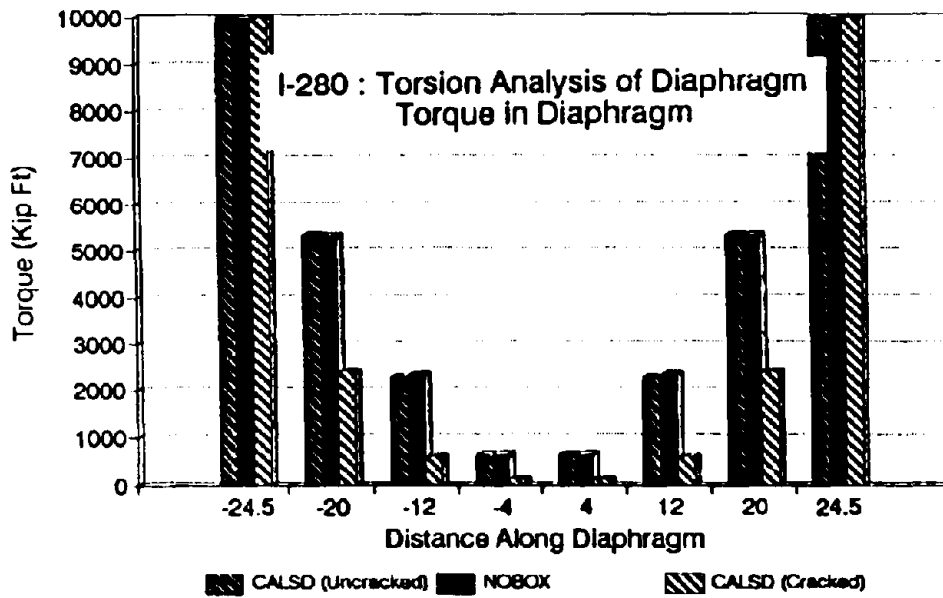
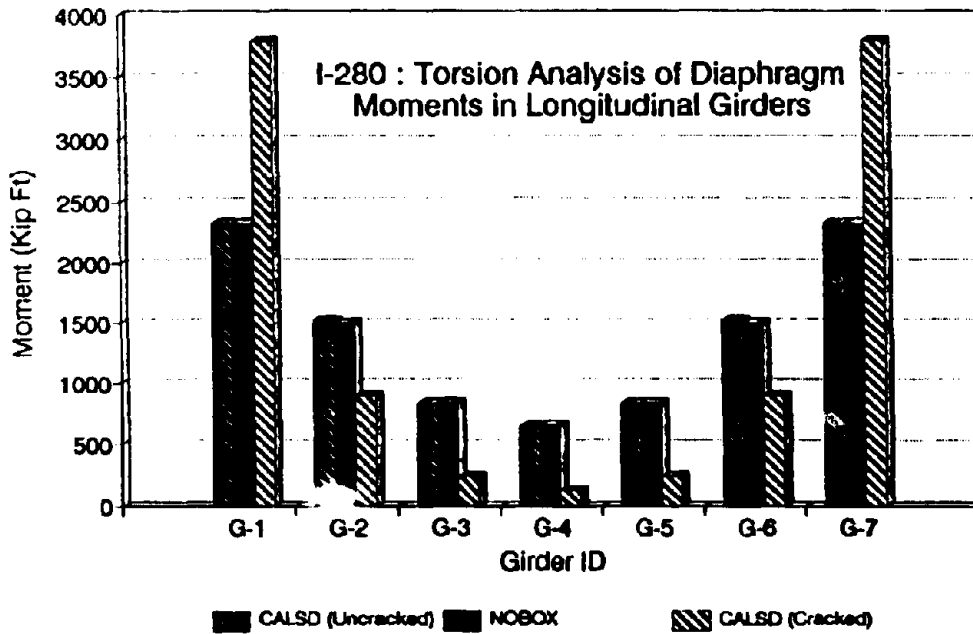
**Fig. 4** Transverse Distribution of Longitudinal Action

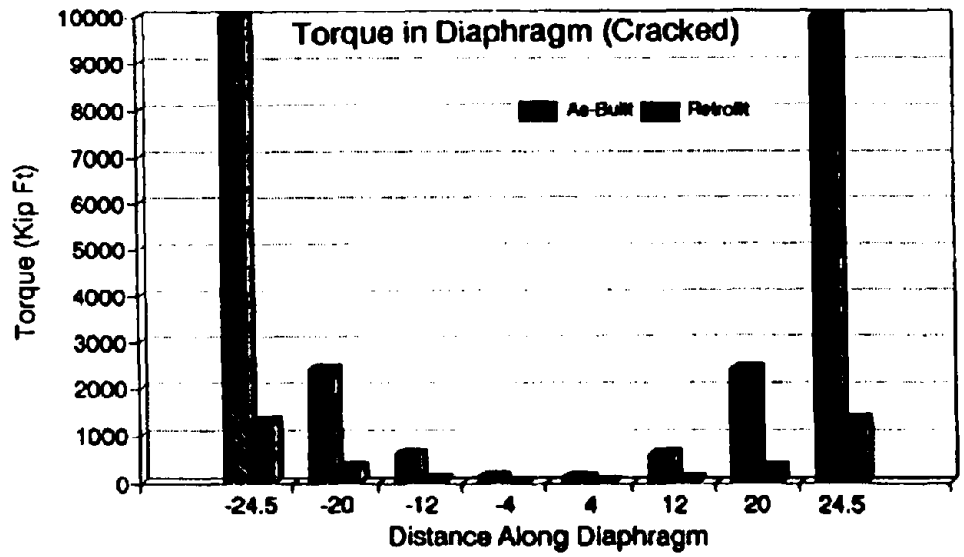
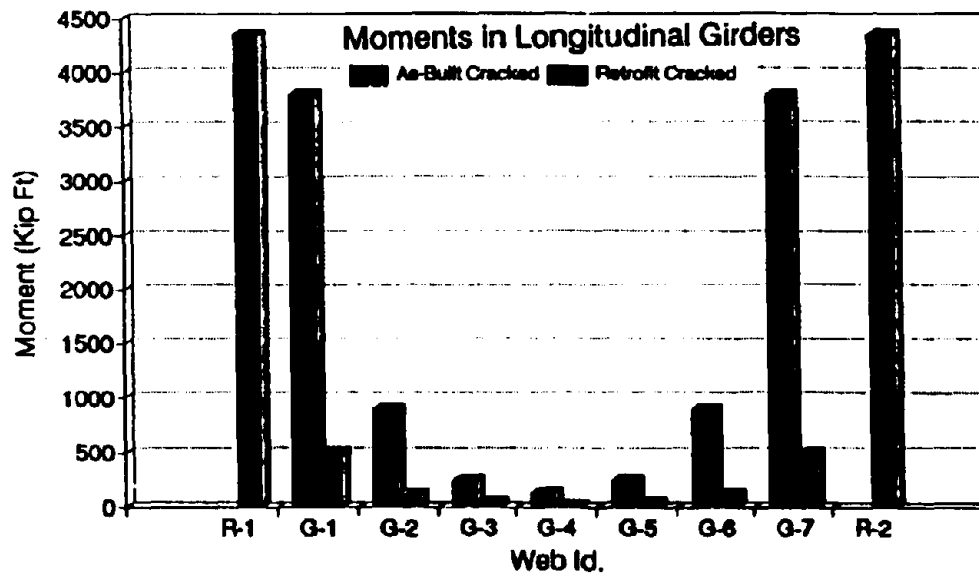
**Fig. 8** Transverse Distribution of Longitudinal Action - Retrofit and Cracked Diaphragm

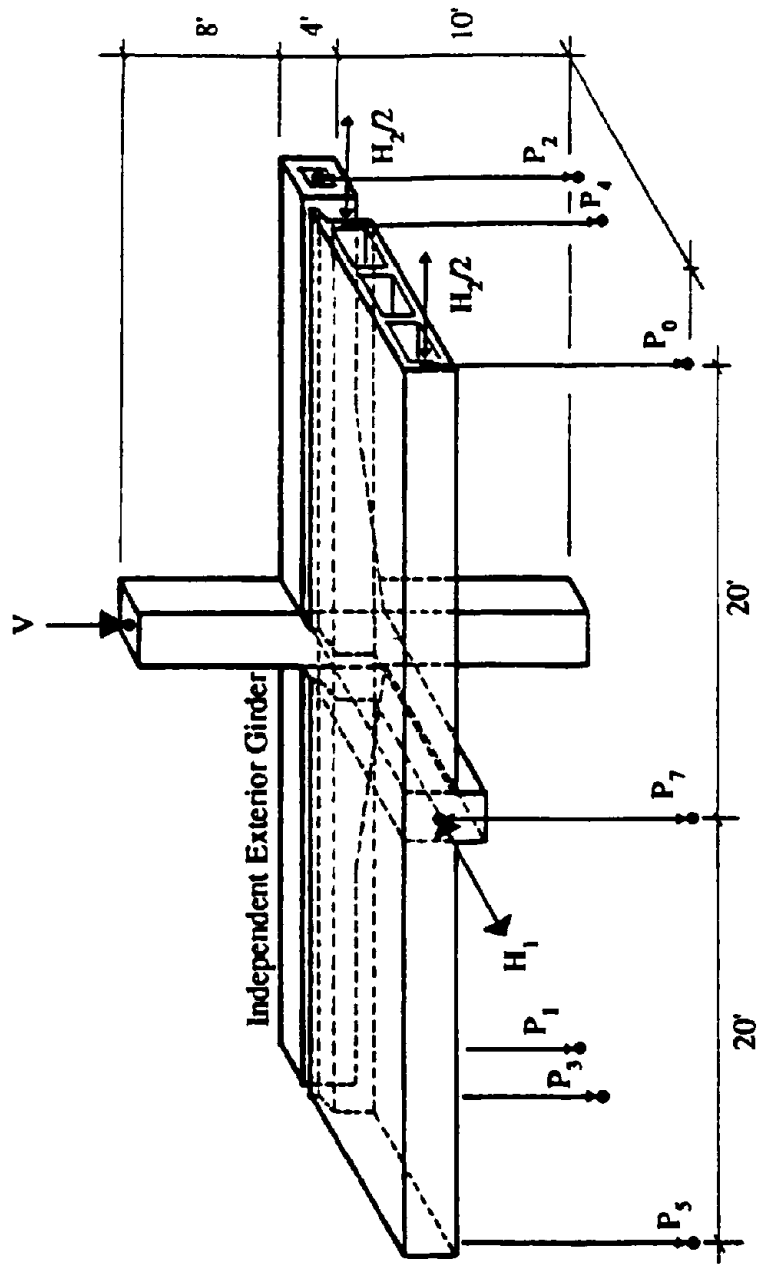
**Fig. 2 Proposed Proof Test Setup**

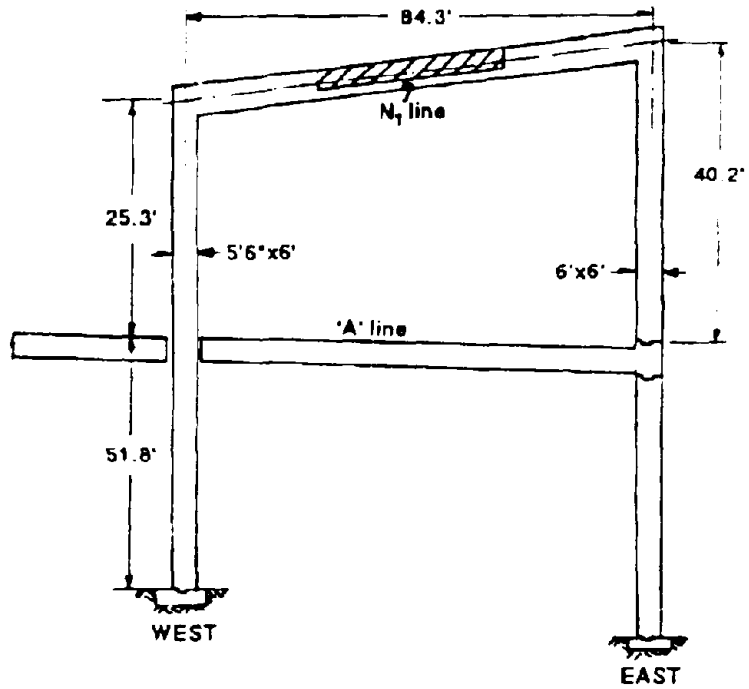
**Fig. 5** Elevation, bent N<sub>1</sub>-35, China Basin Viaduct  
[1 ft = 0.305 m]

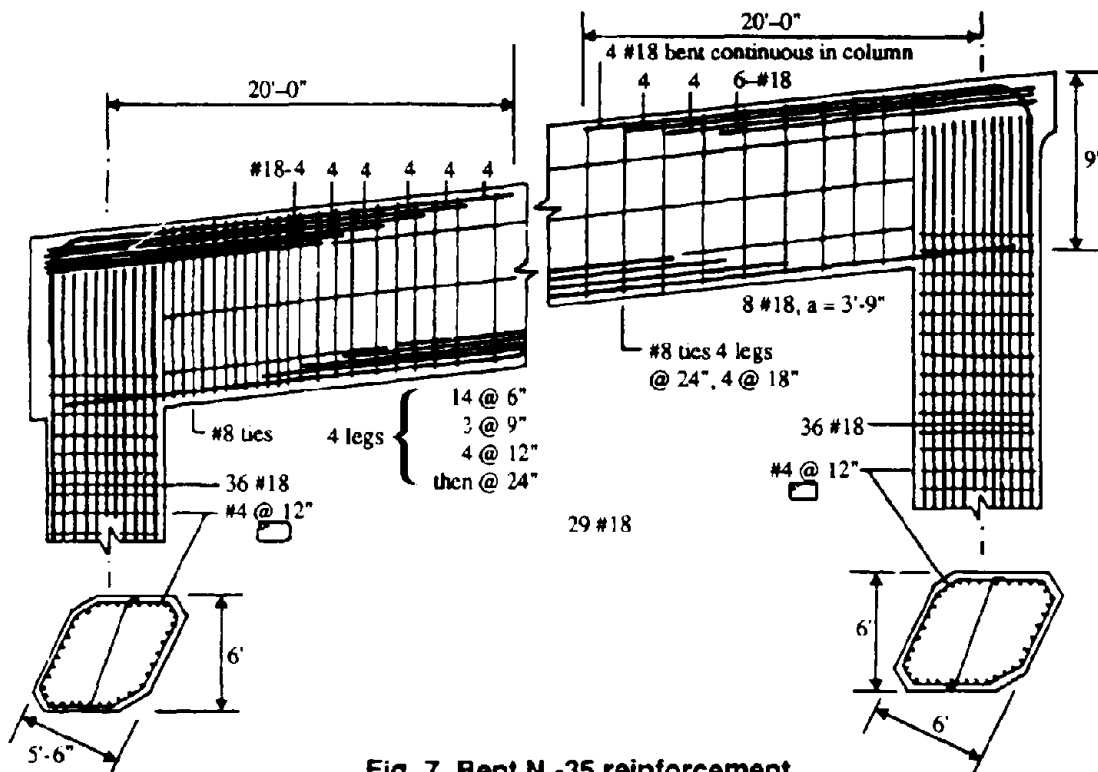
Fig. 7 Bent N<sub>1</sub>-35 reinforcement

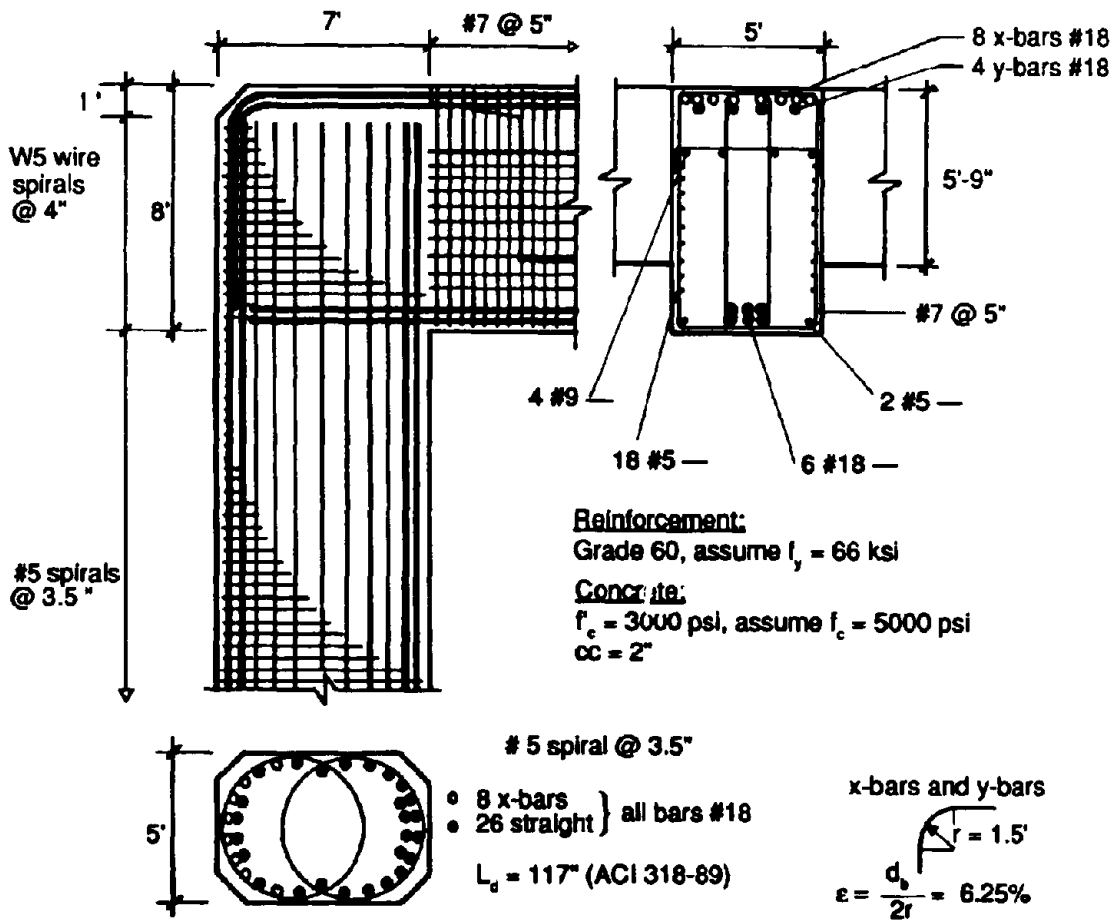
**Fig. 10** I-980, bent #38 reinforcement details

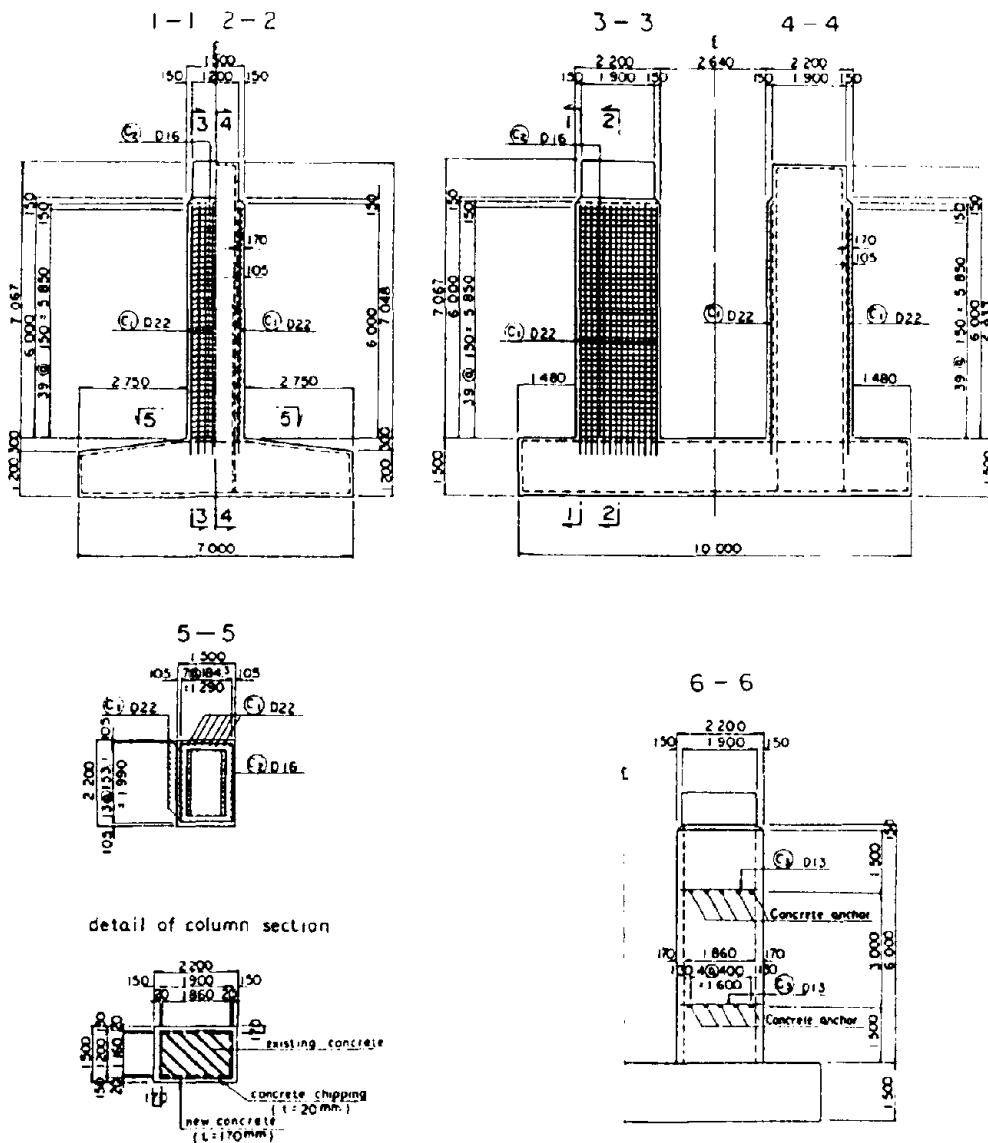
The purpose of retrofitting the main steel-reinforced concrete cut-off points is to ensure that they are not damaged before damage occurs at the base sections. The retrofitting work consists of a steel-reinforced concrete lining applied around the pillar cross-section so that the flexural capacity ( $M_u$ ) after the retrofit will be greater than the acting flexural moment ( $M$ ). This means that the condition  $M_u > M$  is met. The 150mm thick concrete lining around the pillar has upright D22 steel inserts. The space between the concrete lining and the old concrete forms the joint and has been prepared with chipping 20mm of the thickness of the surface of the old concrete. Fig. 7 shows an example of the RC lining retrofit work.

Fig. 7 Example of Seismic Retrofit Using an RC Lining

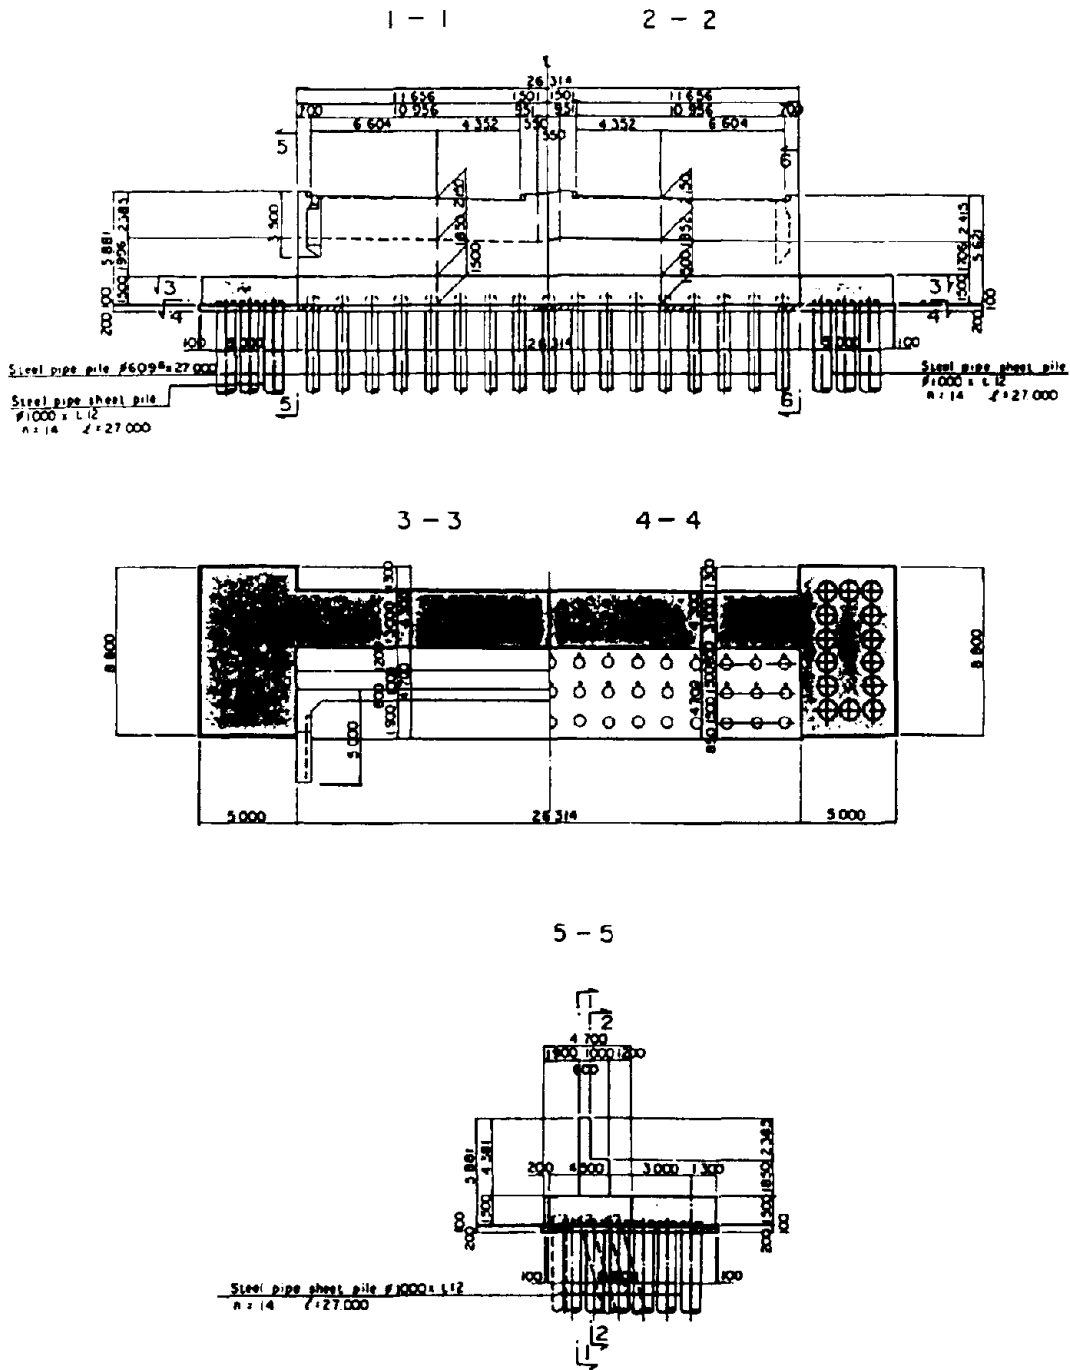
Fig. 12 Example Seismic Retrofit Using Piles Increase

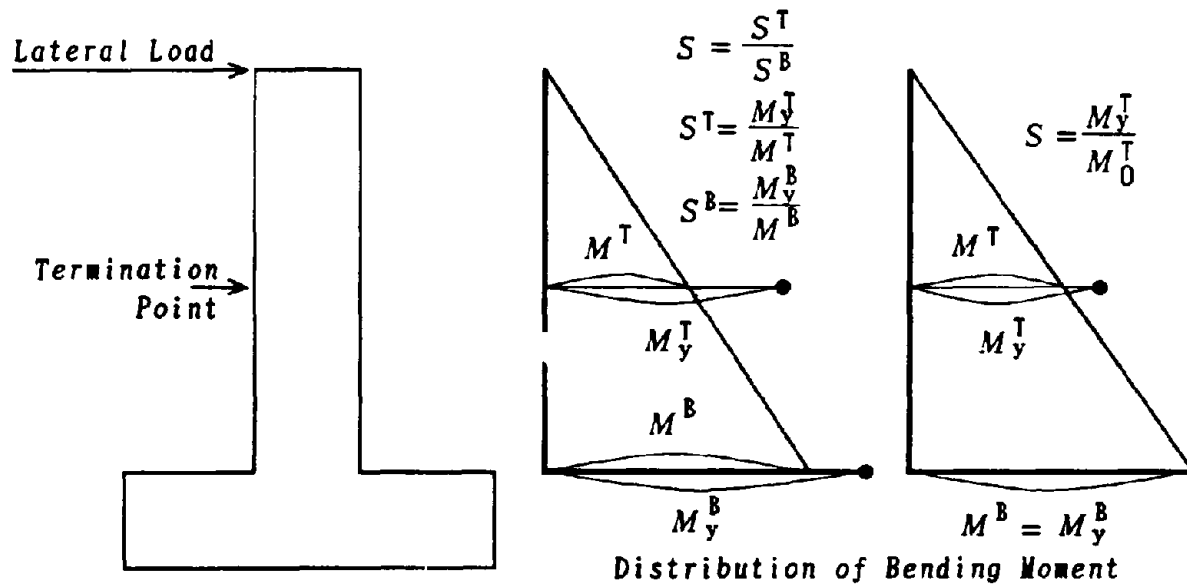
**Fig.16 Definition of Failure Mode Factor to Evaluate Vulnerability of Reinforced Concrete Piers with Termination of Main Reinforcement**

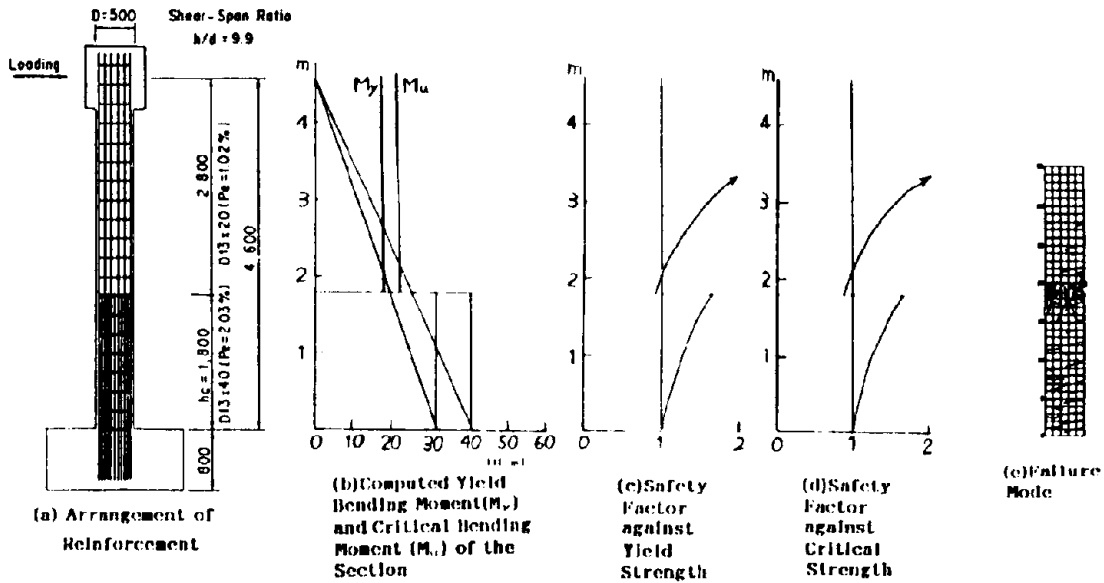
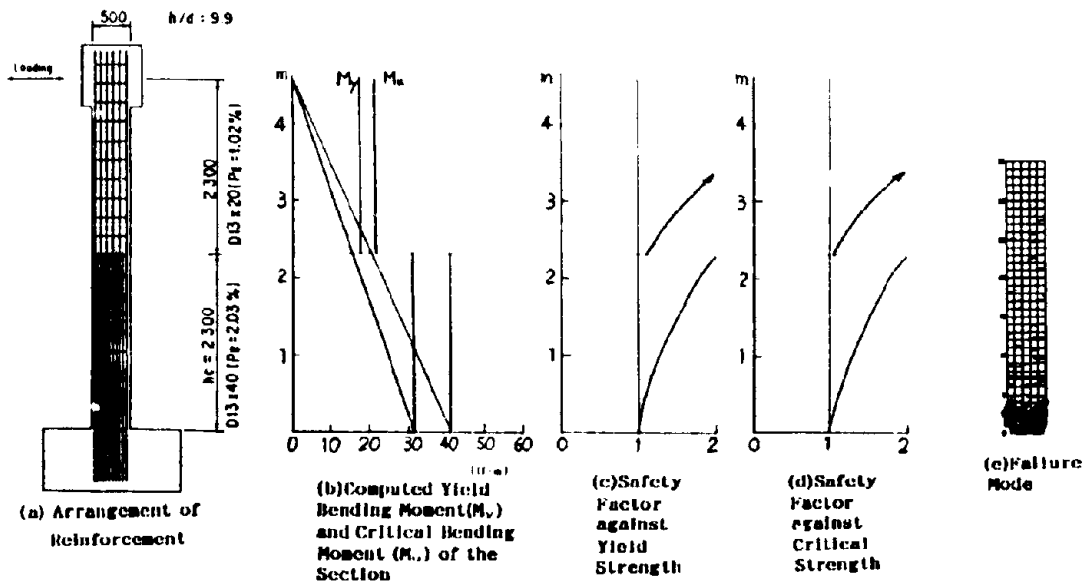
Fig.17 Evaluation of Failure Mode Factors for Specimens 1 and 3

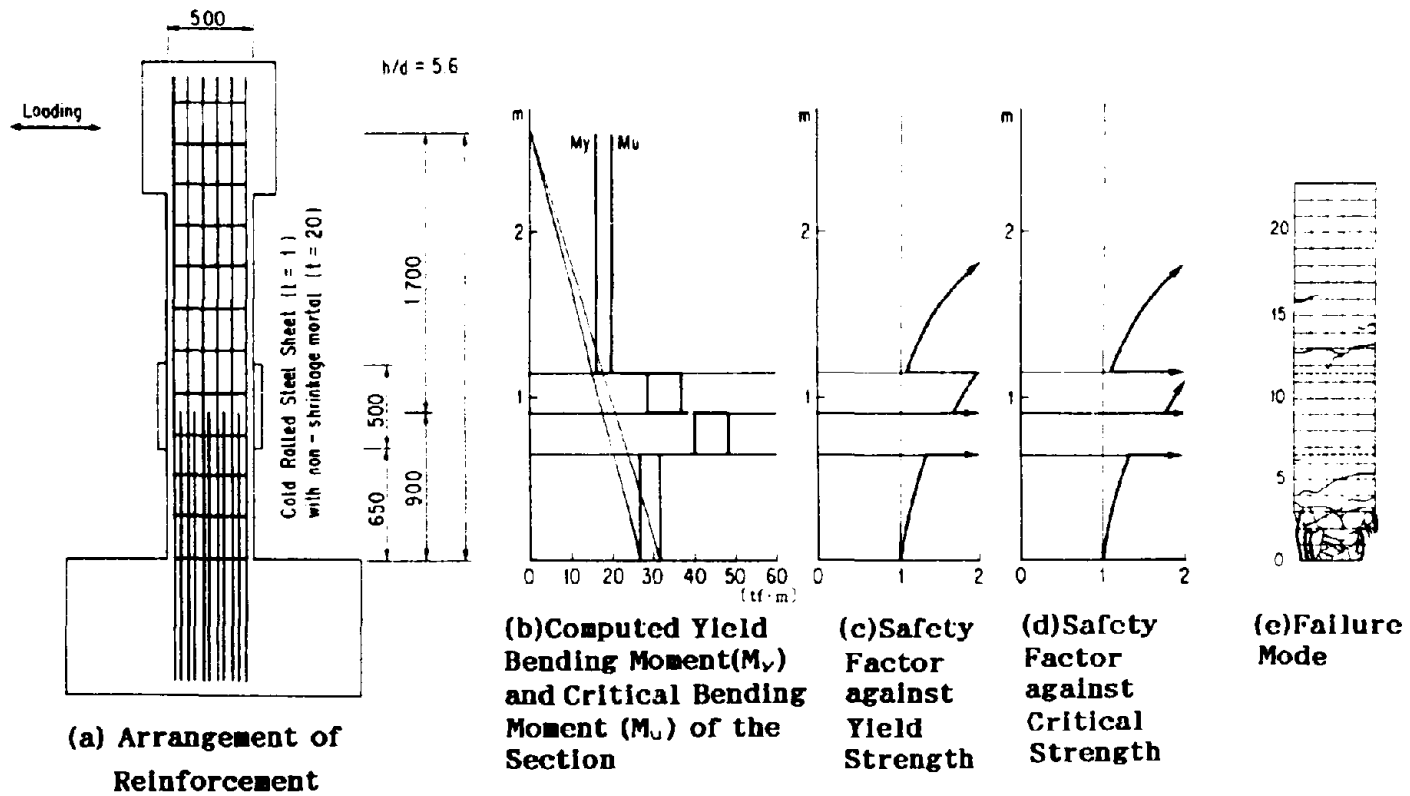
Fig.19 Evaluation of Failure Mode Factors for Specimen 13

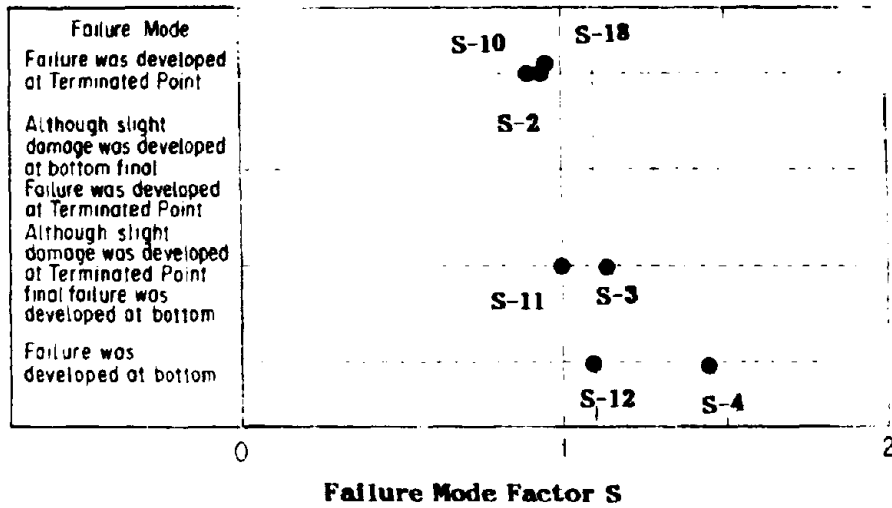
**Fig.18 Evaluation of Failure Mode In Terms of Failure Mode Factor**

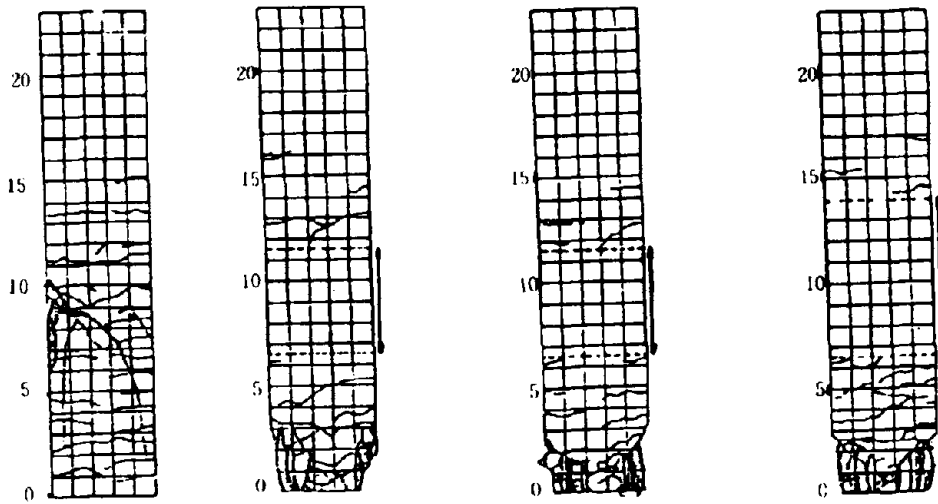
Fig. 2 shows fracture modes of the test columns after the loading tests ended.

(1) Test Specimen 1 (2) Test Specimen 2 (3) Test Specimen 3 (4) Test Specimen 4  
 (after static test) ( after 78 y loading )

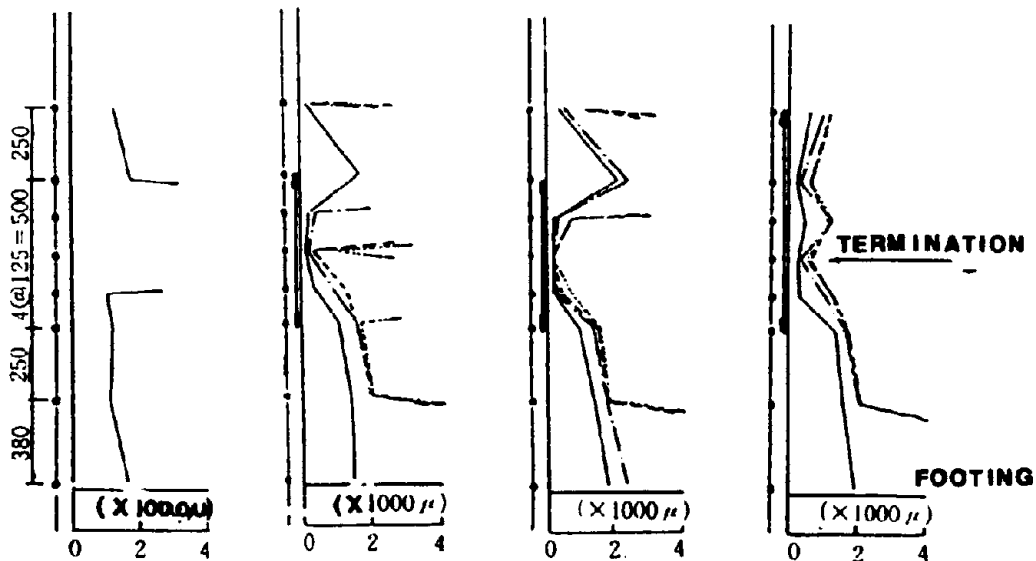
The distribution of strains in axial rebars of the Test Columns is shown in Fig. 4. Since No. 1 Test Column without the reinforcement by a steel plate had failed at the static test, the dynamic test of No. 1 Column was not carried out.

(1) Test Specimen 1 (2) Test Specimen 2 (3) Test Specimen 3 (4) Test Specimen 4  
(Static Test)

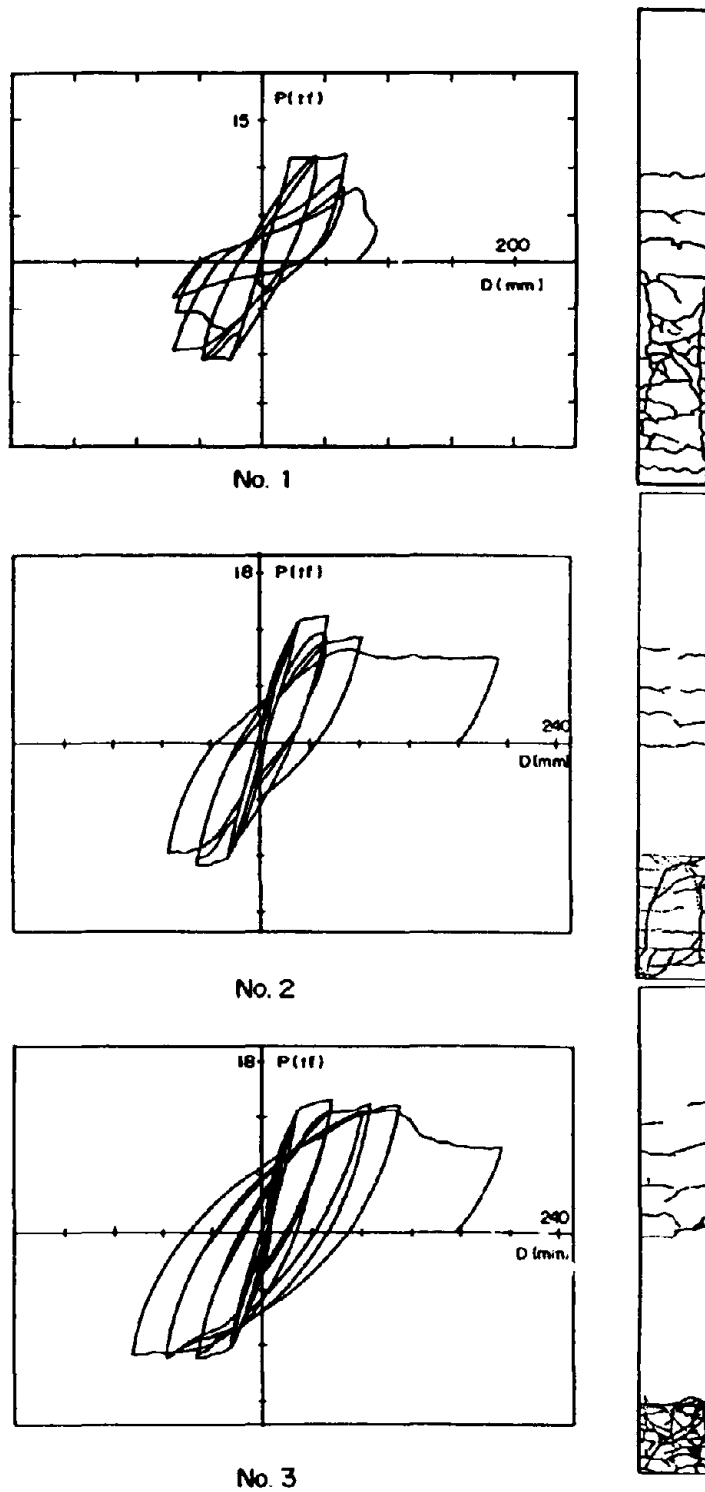
Fig.13(a) Load-deformation relationship and cracks at the end of the experiment

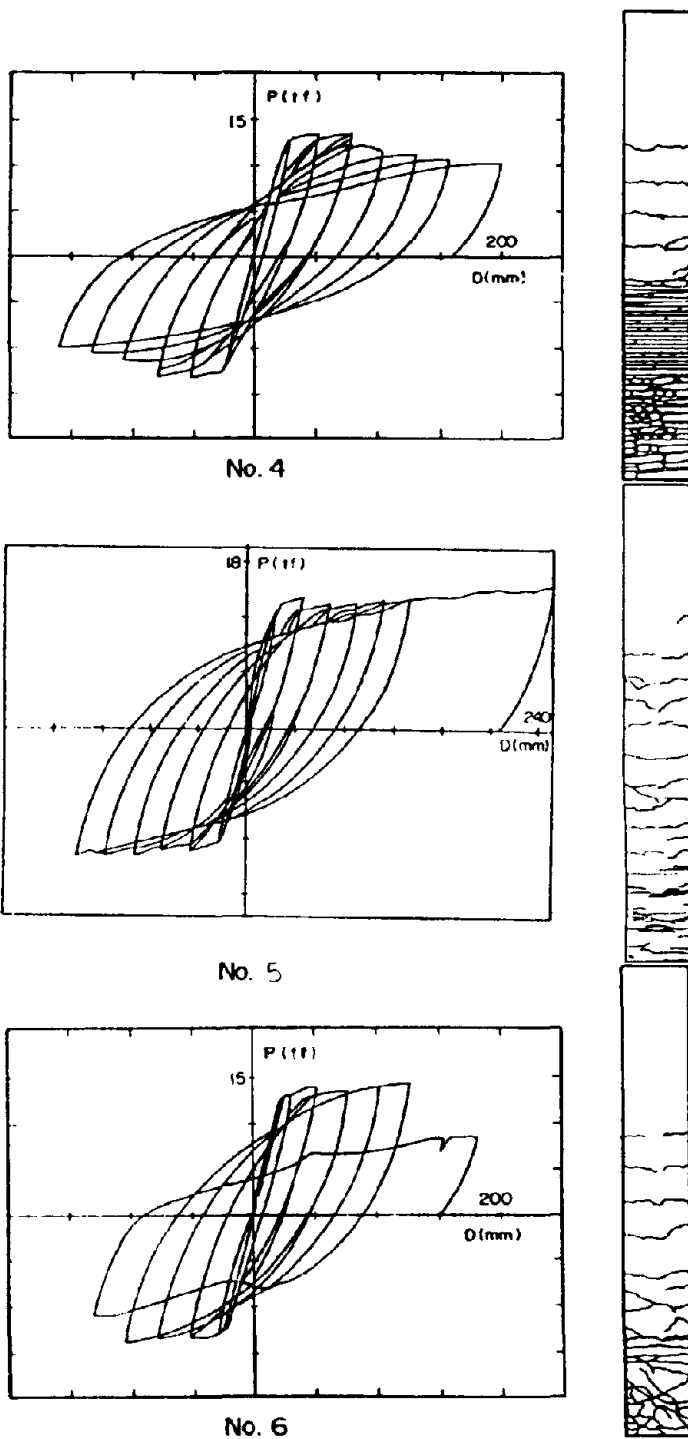
Fig.13(b) Load-deformation relationship and cracks at the end of the experiment

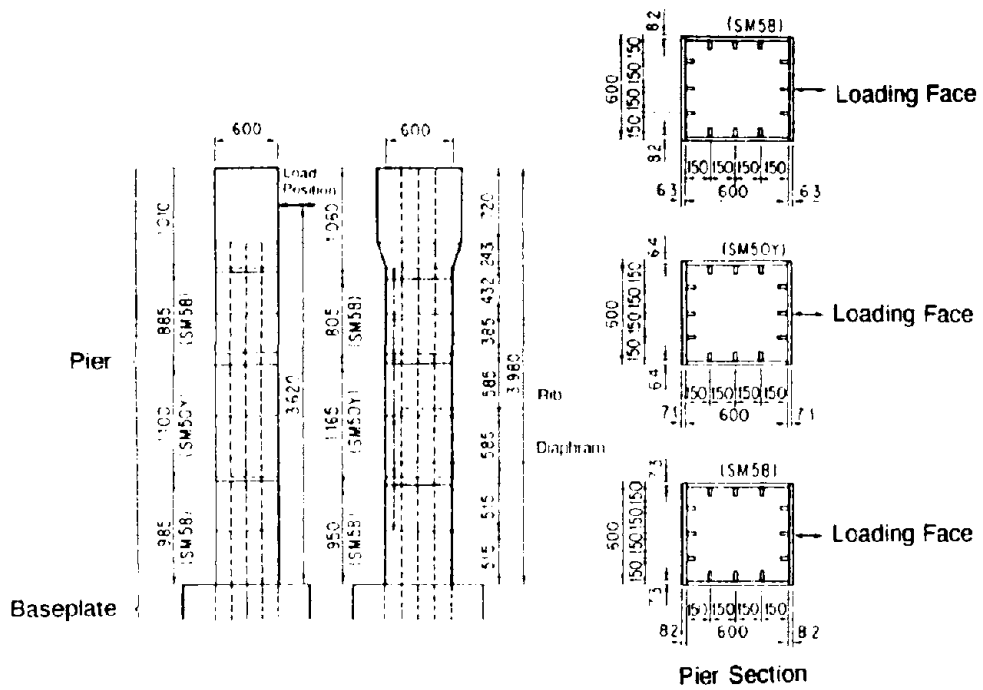
Figure 4. Piers Tested
