3. PUBLICATION DATE
4. TITLE AND SUBTITLE Proceedings of the First U.S.-Japan Workshop on Seismic Retrofit of Bridges				
5. AUTHOR(S) Kazuhiko Kawashima and M.J. Nigel Priestley

## **SEISMIC DESIGN, SEISMIC STRENGTHENING AND REPAIR OF HIGHWAY BRIDGES IN JAPAN**

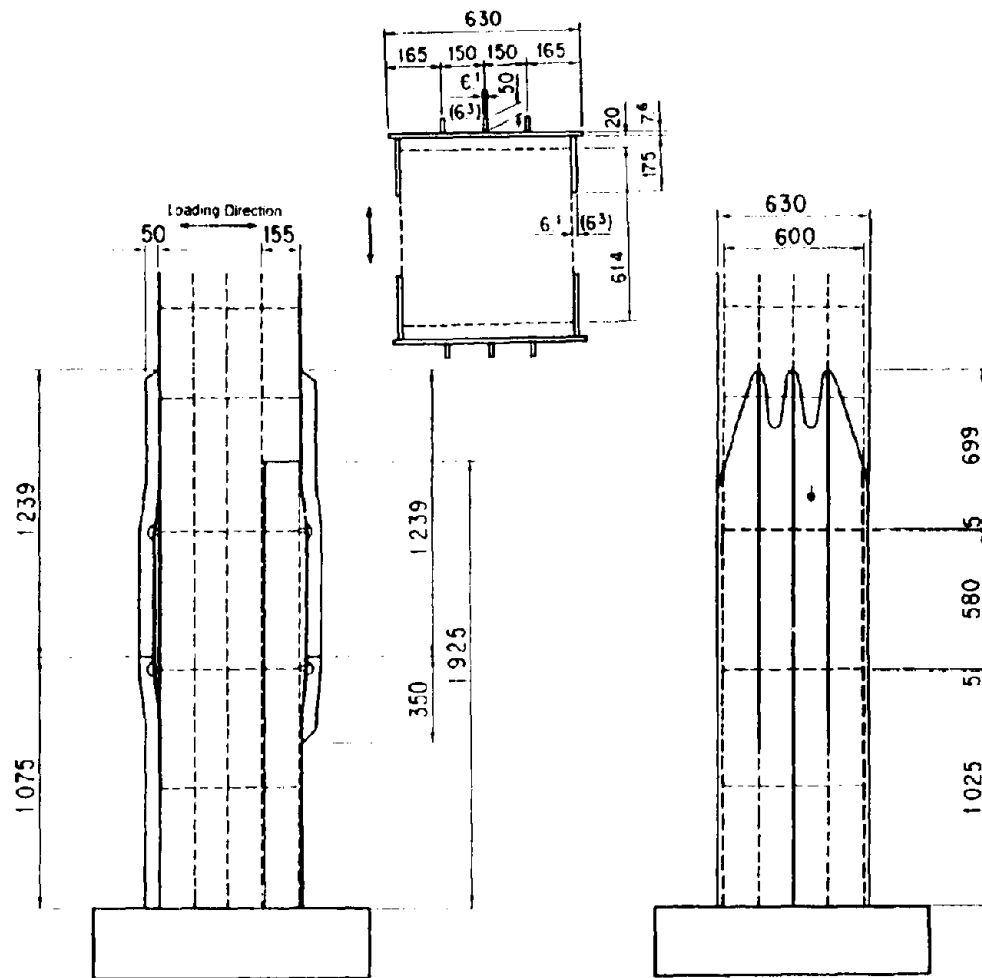
Figure 9. Strengthening Plate Repair Method

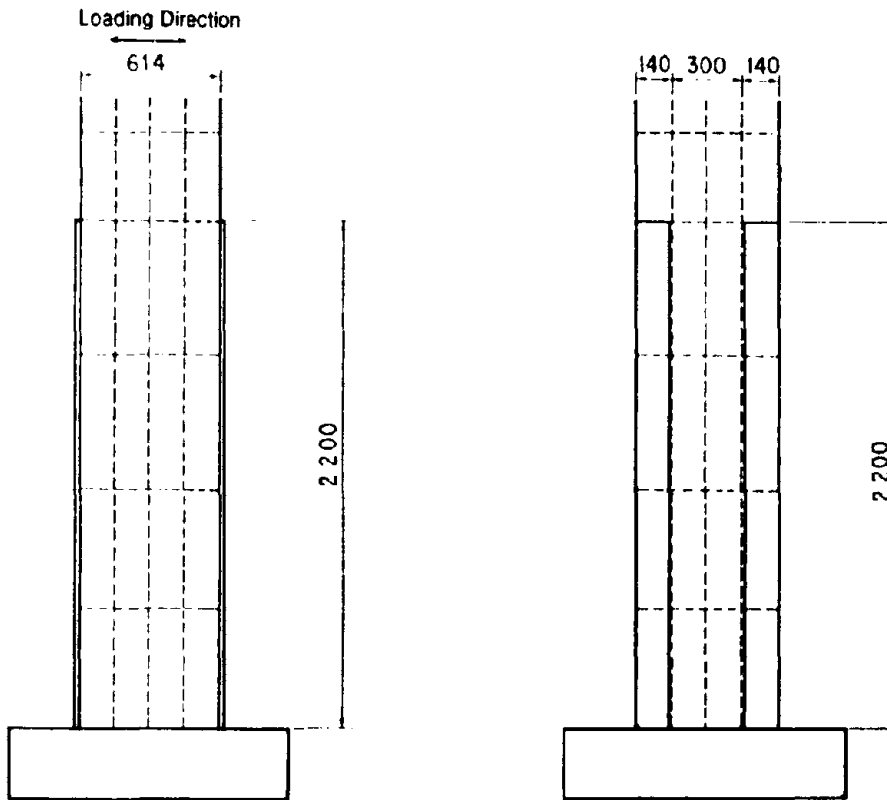
Figure 11. Contact Plate Repair Method

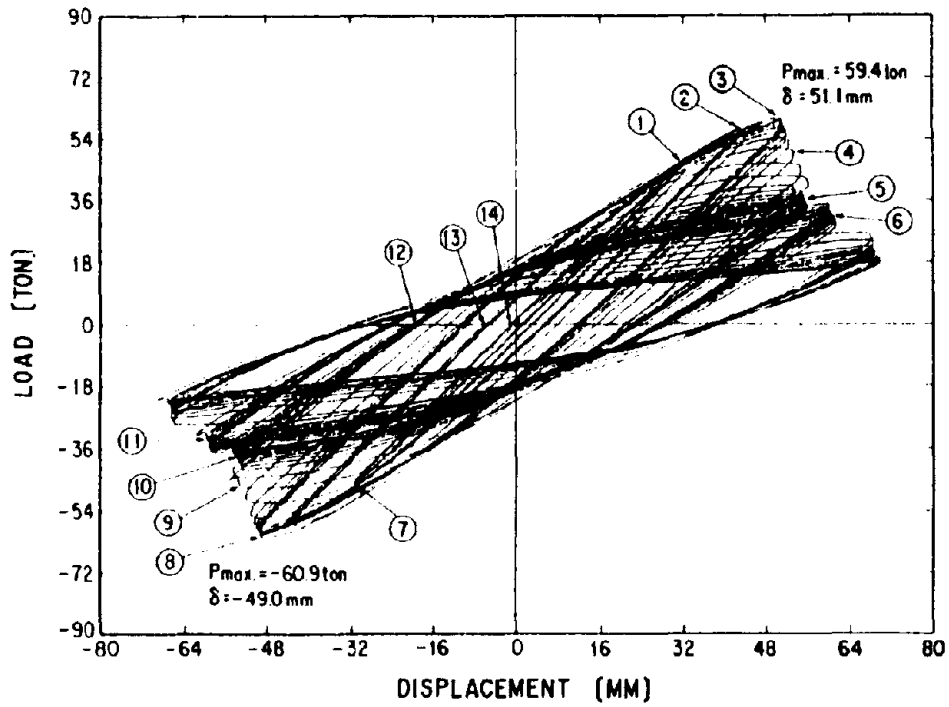
Figure 12. Hysteresis Loops of Specimen I

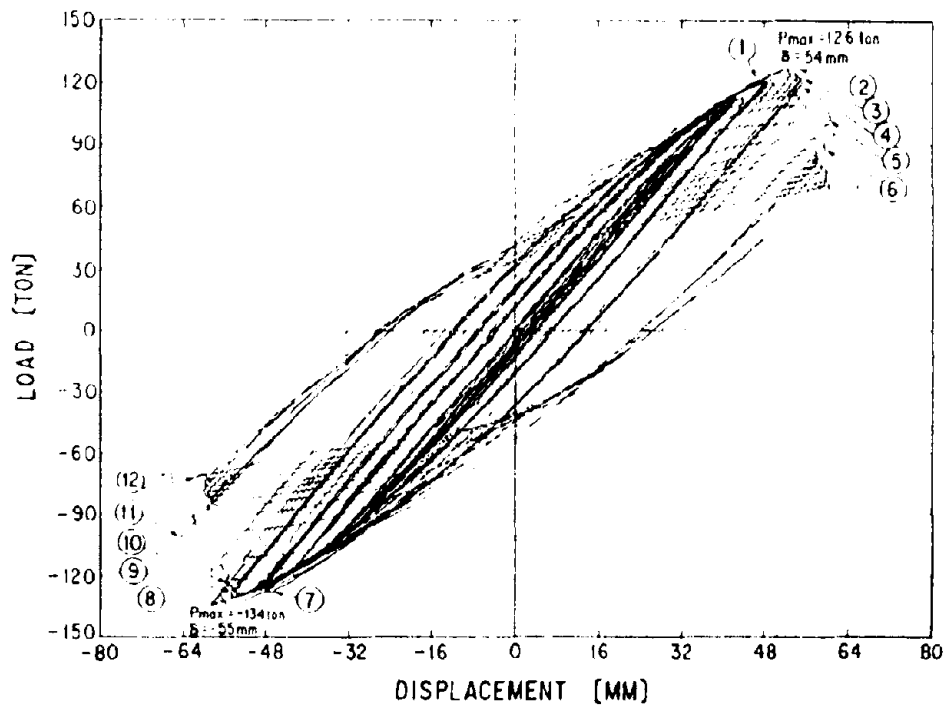
Figure 17. Specimen 3R Hysteresis Loops
