A Summary of the Structural Performance of  
Single-Family, Wood-Frame Housing

Charles W. Yancey  
Geraldine S. Cheok  
Fahim Sadek  
Bijan Mohraz

September 1998  
Building and Fire Research Laboratory  
National Institute of Standards and Technology  
Gaithersburg, MD 20899

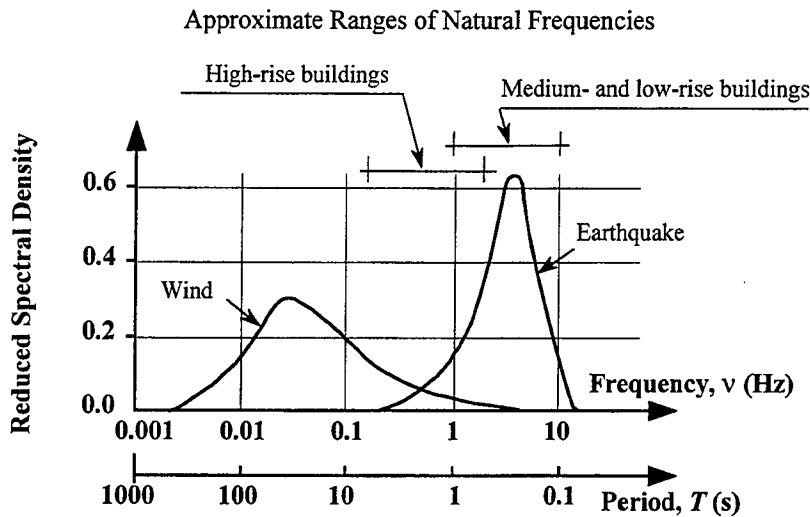
Figure 2.1 Ranges of Natural Frequencies (after Foliente, 1994).

loads as most of the energy from the wind speed fluctuations is distributed at frequencies lower than the natural frequency for wood structures [1.2 Hz to 18 Hz (Foliente, 1997)]. On the other hand, seismic motion is transmitted from the foundation to the structure, creating inertial forces which have to be transferred back to the foundation. Unlike wind loading, seismic loads are considered dynamic loads as the predominant frequencies of earthquake motion is within the range of those for low-rise wood structures as shown in Figure 2.1.

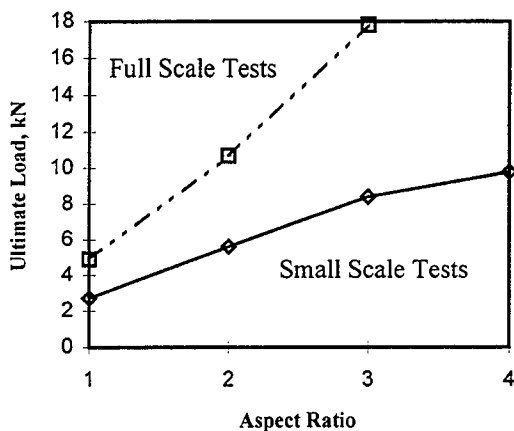
Figure 3.15 Ultimate Load versus Aspect Ratio for Gypsum Sheathing on One Side (after Patton-Mallory, Wolfe and Soltis, 1985).

Figure 3.15 shows that for both full-scale and small-size wall panels, the ultimate strength of walls sheathed on one side with gypsum wallboard was linearly proportional to wall length for aspect ratios between 1 and 3. In addition, Figure 3.16 shows that a linear relationship between strength and aspect ratio was obtained for small-size walls sheathed on: both sides with plywood, both sides with gypsum wallboard, one side with plywood and the other with gypsum and a single side only with plywood.

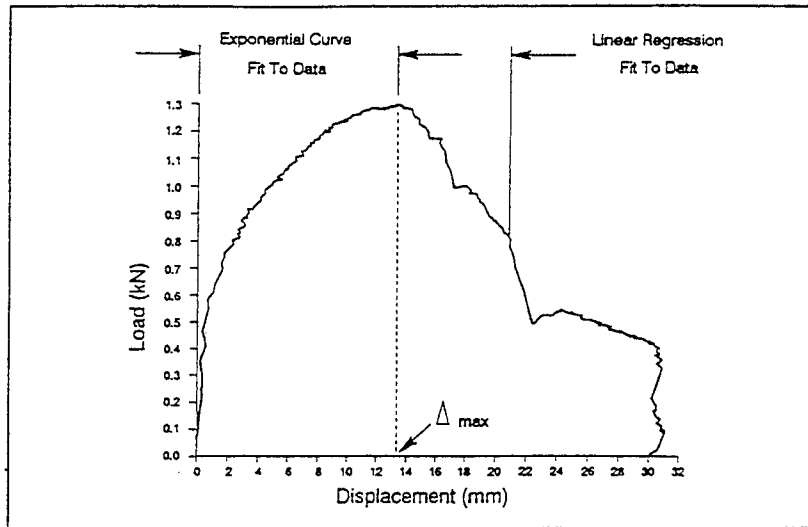
Figure 3.21 Typical Load-Displacement Curve for Static One-Directional Test (after Dolan, 1989).

to the data, up to the peak load. In the equation,  $F_{\text{con}}$  represents the connection force and  $\Delta$  is the slip displacement between the sheathing and the framing.  $K_o$ ,  $K_2$ , and  $P_o$  are parameters shown in Figure 3.22a. Linear regression was applied to the post-peak data to obtain the descending slope of the load-deflection curve (refer to Figure 3.21).

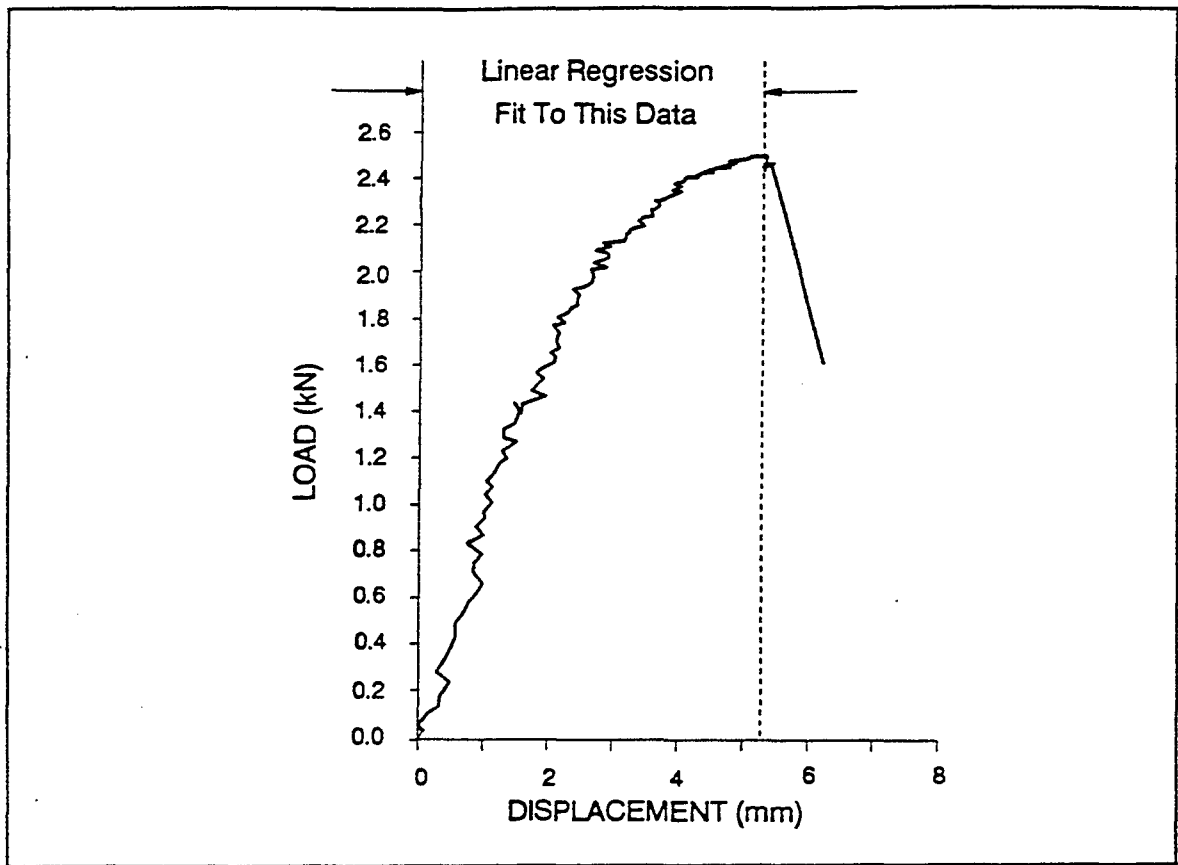
Figure 3.25 Typical Load-Displacement Curve from Corner Connection Test (after Dolan, 1989).

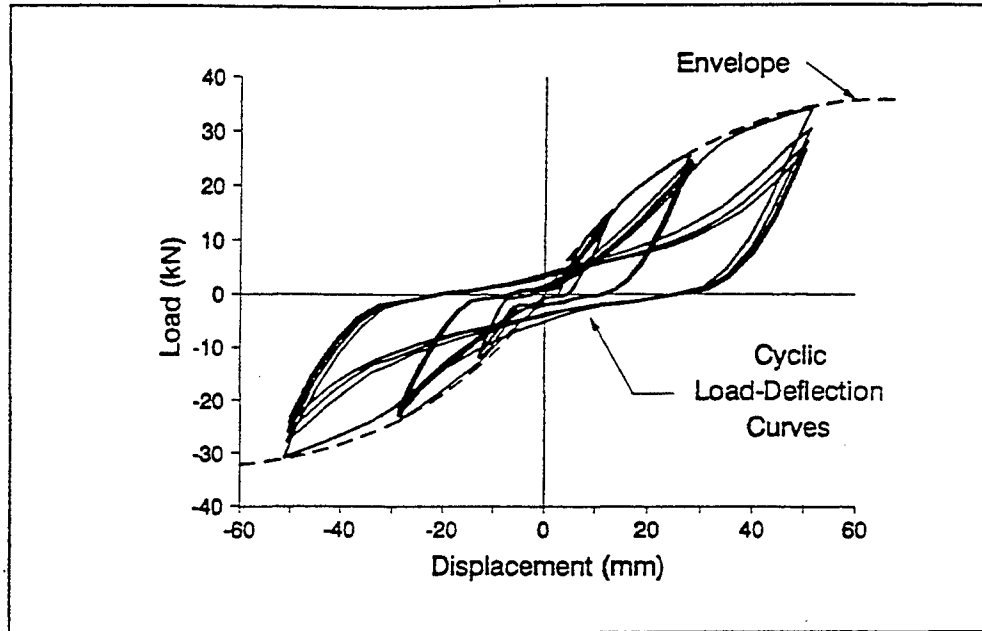
Figure 3.27 Typical Hysteresis Curves for Static Cyclic Tests of Walls (after Dolan, 1989).

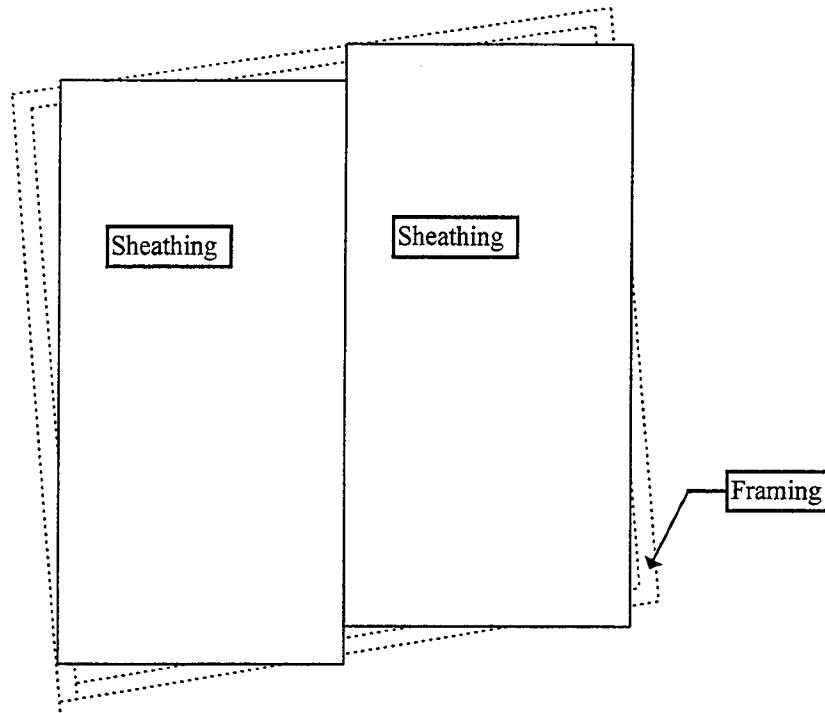
Figure 3.34 Deformation Pattern for Racking Displacement of Typical Shear Wall (after Dolan and Madsen, 1992a).
