A Summary of MCEER
Reconnaissance Efforts

ADVANCED TECHNOLOGY FOR RAPID TORNADO DAMAGE ASSESSMENT FOLLOWING THE 'SUPER TUESDAY' TORNADO OUTBREAK OF FEBRUARY 2008

Anneley McMillan, Beverley J. Adams, Amber Reynolds, Tanya Brown, Daan Liang and J. Arn Womble

ImageCat Ltd. and Wind Science and Engineering Research Center, Texas Tech University

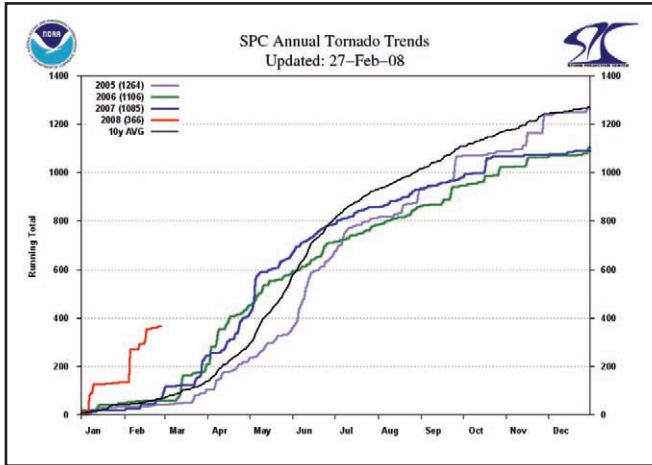
Figure 1. SPC Annual Tornado Trends

tornado activity using advanced technologies. First, the most recent tornadoes are the first EF-4 tornadoes to hit north Alabama in February. Second, it is already a much more significant year for the frequency of tornadoes than the last few years, and more significant than the long term average. This trend is shown in Figure 1. The tornado outbreak between February 5-10, 2008 was also the deadliest outbreak in the U.S. since May 1985, when 76 were killed in Ohio and Pennsylvania.

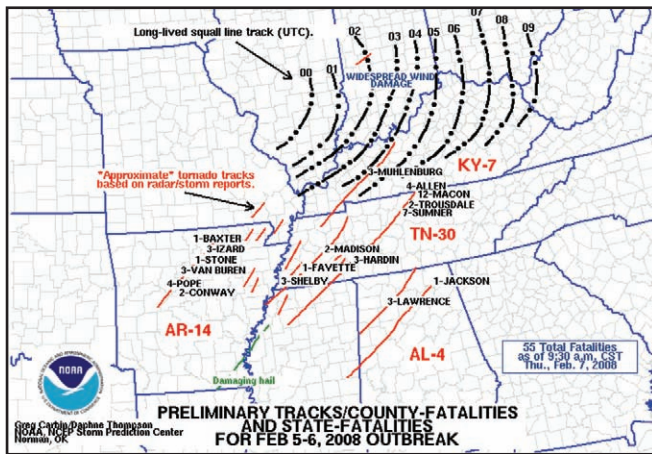
Figure 2. Preliminary Tornado Tracks

The combination of moisture, a source of lift, instability and wind shear created perfect conditions for tornado formation, focused around Memphis, Tennessee, on the afternoon of the outbreak. Throughout the evening, the system moved further east. The 'Super Tuesday' storm produced numerous tornadoes crossing six states (Mississippi, Arkansas, Tennessee, Alabama, Kentucky, Missouri and Illinois). Figure 2 shows approximate tracks of tornadoes based on radar and storm reports.

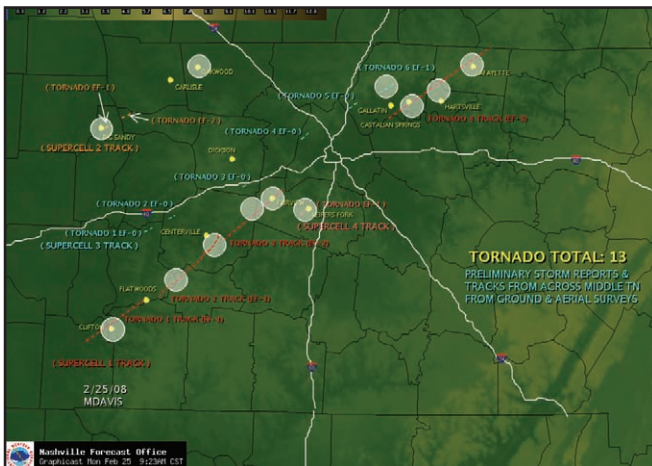
Figure 3. Revised Tornado Tracks for 'Supercells 1 and 2'

The aim of this study was to capture a range of damage states, tracking the variability of the storms as they develop. The deployment required a focus of attention onto a few key areas, to gain maximum detail of the event. In this case, it was decided to focus on two main tornado tracks, examining the variability in force and damage along its length. The first track chosen for this investigation was the large supercell that hit middle Tennessee and Kentucky. In the radar report, it is shown as one long track. Subsequent ground damage reports helped to better characterize where the storm had produced a tornado that made contact with the ground. This is shown in Figure 3.

The second track chosen was named as 'Supercell 2'. This again struck Tennessee, hitting the counties of Shelby, Fayette, Madison and Benton. Along the track multiple tornadoes were spawned, estimated at various EF ratings, giving a good breadth of study. This supercell is also mapped in Figure 3.

Along the central portion of the 'Supercell 1' track, the VIEWS system was deployed in Hickman and Williamson Counties along 'Tornado 2' track and 'Tornado 3' track, southwest of Nashville. 'Tornado 2' and 'Tornado 3' are shown along the 'Supercell 1' track in Figure 3. Along this area of the storm track, the damage was quite variable, and in most cases was not extensive (see Figures 16-19). Based upon ground observations gathered with VIEWS, this portion of the storm track would be rated EF-0 or EF-1. The types of damage generally seen in this area include small trees snapped and uprooted, some small debris impacts to structures, and shingles removed from roofs. Some older and poorly maintained storage, barn, and shed buildings were collapsed or destroyed, which is thought to be more a function of the quality of construction rather than the strength of the storm. (Note that the EF Scale accounts for variation in damaging windspeeds due to construction quality (WISE, 2006)). The damage paths resulting from tornadoes in this area were quite narrow, and in many cases the storm path was difficult to locate because the damage was minor.

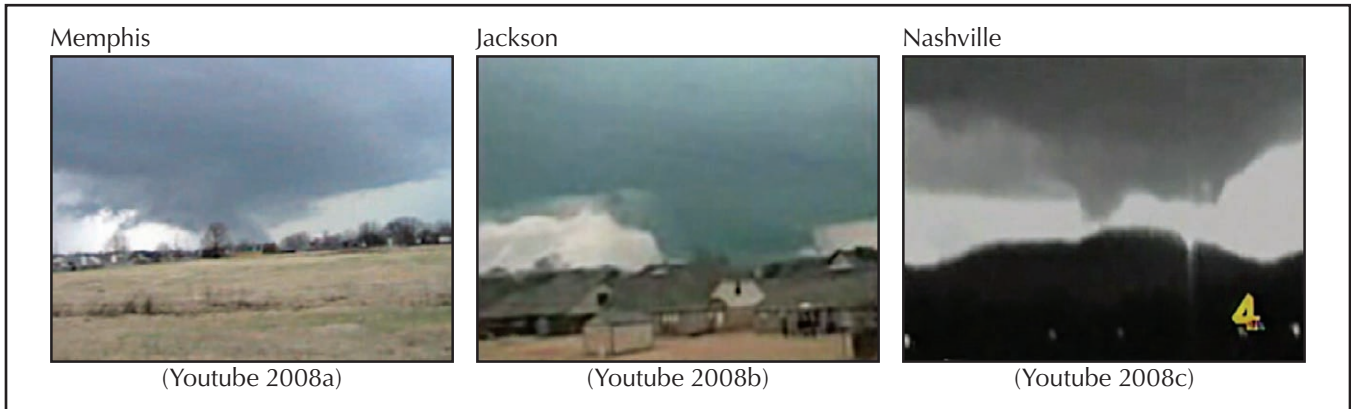
Figure 4. Tornadoes spawned from 'Supercell 1' as it moved northeast.

The tornadoes spawned from this supercell were caught on camera at various times over the course of the evening. Figure 4 shows the storm as it developed. The tornado was still intensifying when it passed over Memphis. Reports indicate an EF-1 level of damage. In Jackson, TN the tornado intensified and produced up to EF-4 level damage. In Nashville, this rare video footage shows the funnel as it has lifted over Davidson County.

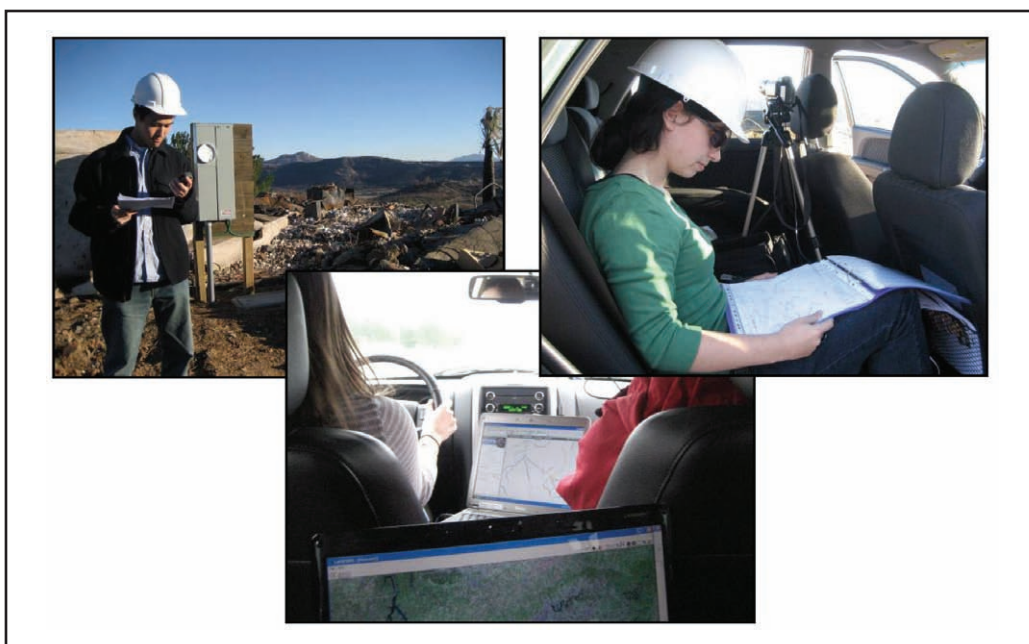
Figure 5. Deployment of the VIEWS System

To fully document the aftermath of a natural disaster, especially when considering perishable building damage, quick response from scientists and engineers is necessary. To address this need for quick and accurate data collection, the VIEWS system was utilized. This is a notebook-based system, which integrates GPS-registered digital video footage, digital photographs and observations with high-resolution satellite imagery collected before and after a disaster (see Figure 5). VIEWS was

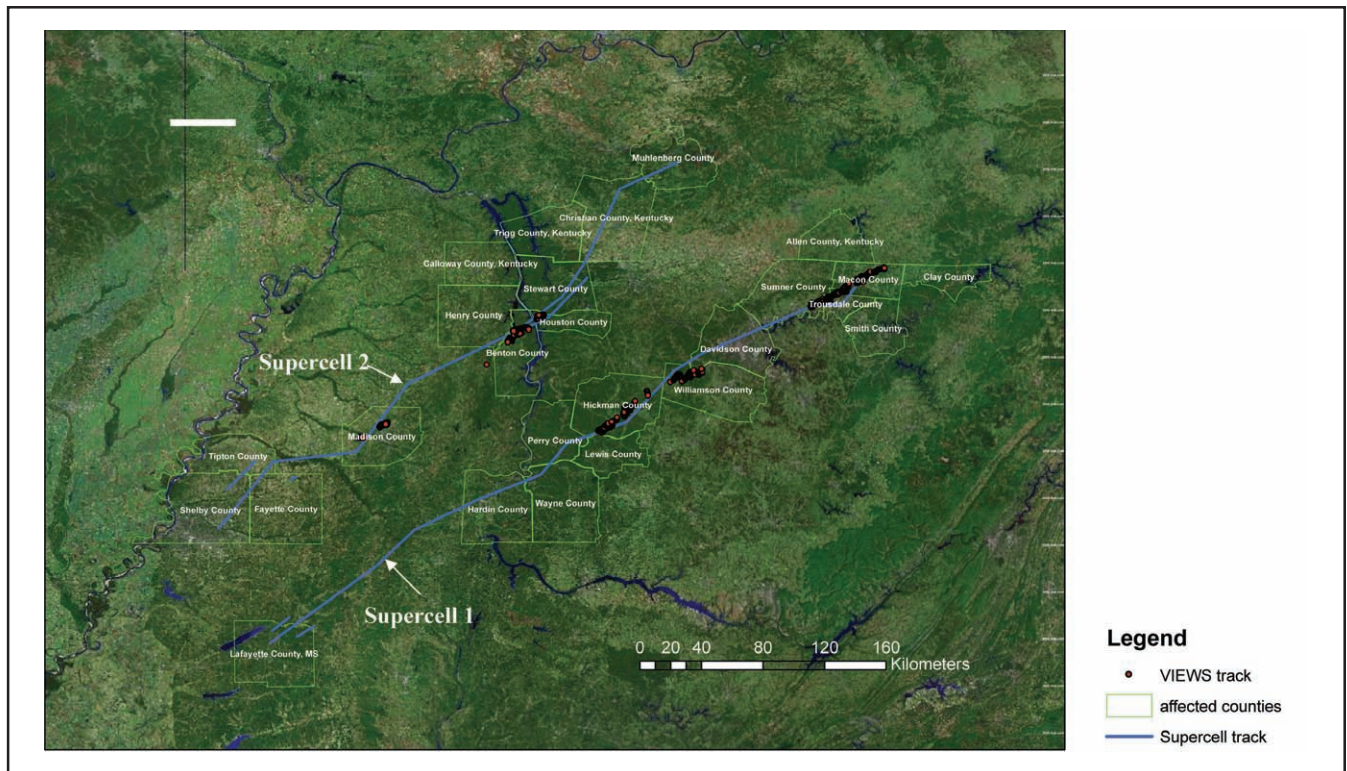
Figure 8. Two preliminary supercell tracks, affected counties and VIEWES footage collected.

The study site chosen includes portions of the two main storm tracks, 'Supercells 1 and 2', which passed through middle Tennessee on February 5-6. Figure 8 shows the general path that these storms took. The long track supercell storm marked 'Supercell 1' on Figure 8 tracked from Oxford, Mississippi through Tennessee to Kentucky, over 200 miles. Considering Figure 3, the NOAA report has this supercell spawning four different tornadoes. Examining the damage reports, the level of damage reached was EF-0 to EF-1 in Mississippi, an EF-2 to EF-3 in Hickman and Williamson Counties in Tennessee, and an EF-3 to EF-4 in Sumner, Trousdale and Macon Counties in Tennessee. Thus, the tornadoes spawned by 'Supercell 1' increased in strength as the storm moved northeast across Tennessee.

'Supercell 2' passed through Shelby County, TN causing EF-2 level damage, EF-0 through Tipton County and EF-3 in Fayette County, TN. The supercell then moved north, spawning a tornado which

created heavy damage in Madison County (EF-4), before moving northeast again. More tornado damage was noted in Benton County, however weaker than Madison County, before the storm dissipated.

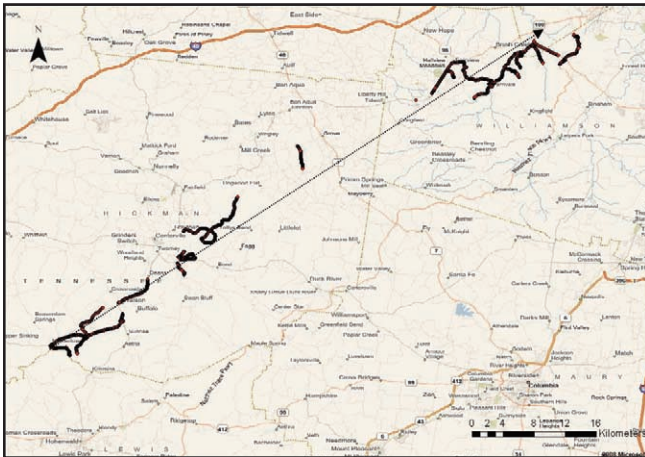
Figure 9. Overview map of Hickman and Williamson Counties, with collected VIEWS routes. Arrow shows general path of storm.

County, TN, a few miles northeast of the end of the previous tornado track. This tornado remained on the ground as the storm moved across northwest Lewis County and into Hickman County. The tornado struck the Brushy community, then turned toward the left just east of Centerville before dissipating. The first area of 'Supercell 1' to be surveyed by VIEWS footage was Hickman and Williamson counties, where damage was generally found to be at the EF 0-1 level. Figure 9 shows the track of the VIEWS footage that was collected. Tables 1 and 2 show the GPS tracks in more detail.

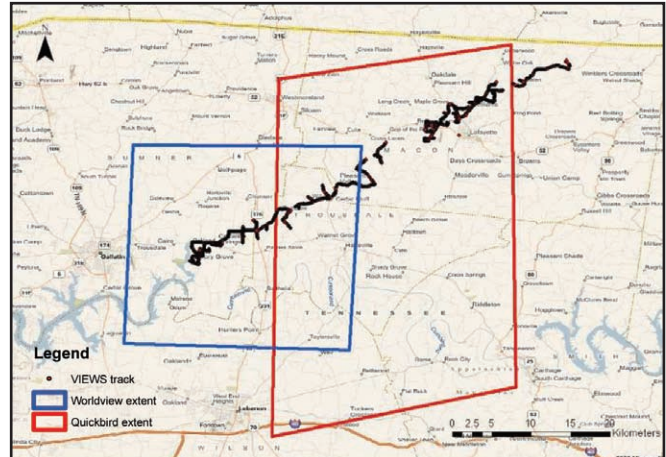
Figure 10. VIEWS track recorded through Sumner, Trousdale and Macon Counties, as well as Worldview and QuickBird satellite imagery from just after the tornado.

NOAA reports that the supercell thunderstorm continued to move northeast, across Nashville, before spawning a fourth tornado, which dropped down on the south side of Gallatin, near the Cumberland River. This tornado moved through Castalian Springs, extreme northwestern Trousdale County, across Macon County, striking the northwest side of Lafayette, before moving into Kentucky, where it finally lifted northeast of Tompkinsville. The path length of this tornado was approximately 51 miles. Much of the damage along this path was rated EF-2, although some areas received EF-3 damage. This long track tornado had winds in the 110 to 140 mph range and caused damage three quarters of a mile wide (NOAA 2008c). Figure 10 shows an overview of Sumner, Trousdale, and Macon Counties, with the GPS routes plotted, and available satellite coverage. Table 3 shows a section of the GPS track in more detail.

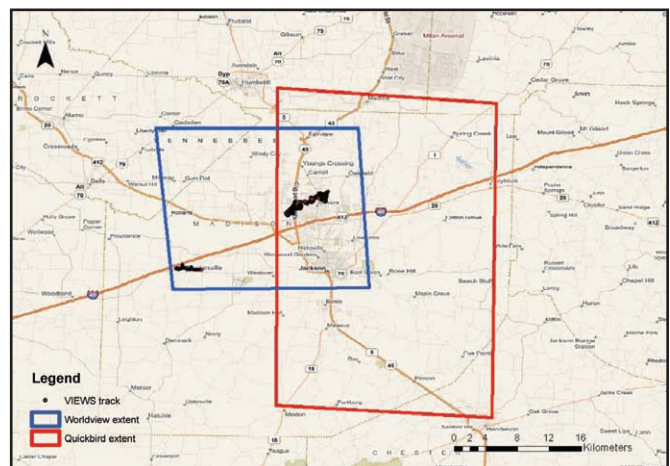
Figure 11. VIEWS track recorded through Madison County, as well as Worldview and QuickBird satellite imagery from just after the tornado.

The first VIEWS footage from this supercell was recorded in Jackson (Madison County, TN) where EF-4 damage was recorded. Figure 11 shows a general overview map of the Madison County area, with the GPS tracks recorded, along with available satellite coverage. Table 5 shows the GPS tracks in more detail.

width will be a future direction for research based on the collected data. The video footage confirmed the storm reports that there was variable damage in Madison County, with the worst hit area being Union University. This contained some EF-4 damage, which will be expanded upon later in the report.

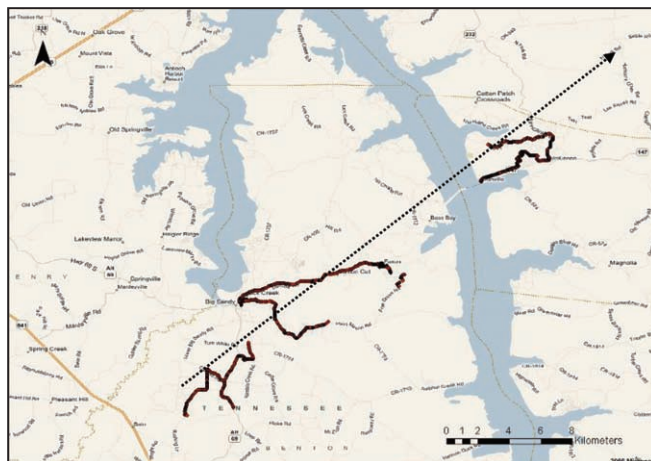
Figure 12. VIEWS tracks in Benton and Houston County. Black arrow marks rough track of tornado.

The second track from this supercell was recorded around northeast Benton County, pushing into Houston County. The level of damage seen here was generally EF-1. Figure 12 shows the overview map of these counties, while Table 6 shows the GPS tracks in more detail. Figures 13-15 show photos typical of the damage observed.

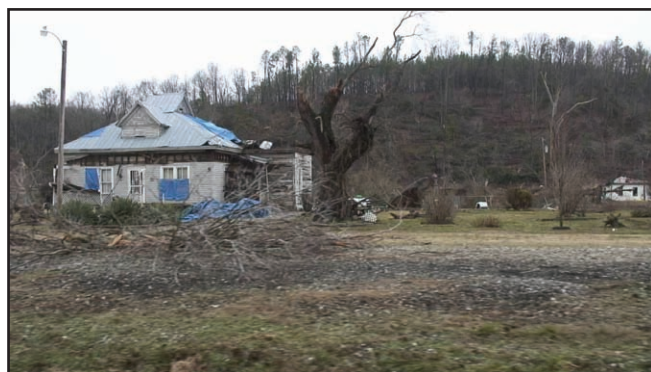
Figure 13. Older construction with damage to roof covering and windows. An overhanging porch has also been removed (Faxton, TN, Benton County).

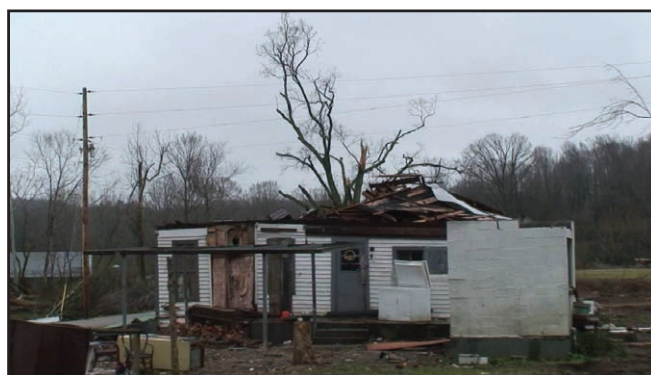
Figure 14. An example of likely substandard construction with higher degree of damage than surrounding structures in Faxton, TN (Benton County).

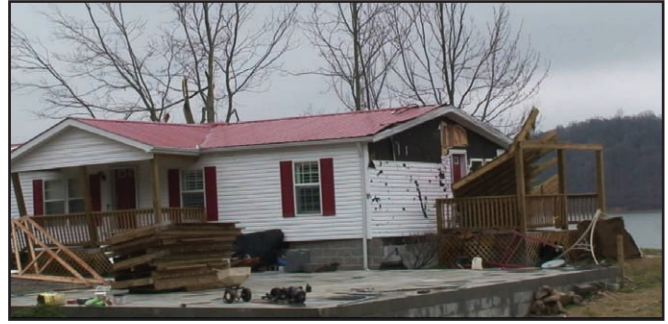
Figure 15. An example of damage consistent with EF-0 rating near McKinnon, TN (Houston County). From Table 7, loss of awnings and siding is expected for DOD 2, with an expected wind speed of 79 mph. The image was taken looking west with Tennessee River in the background.

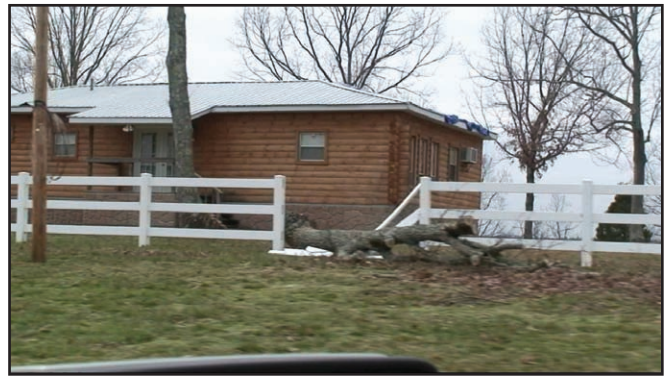
Figure 16. A log home with minor roof damage in Hickman County.

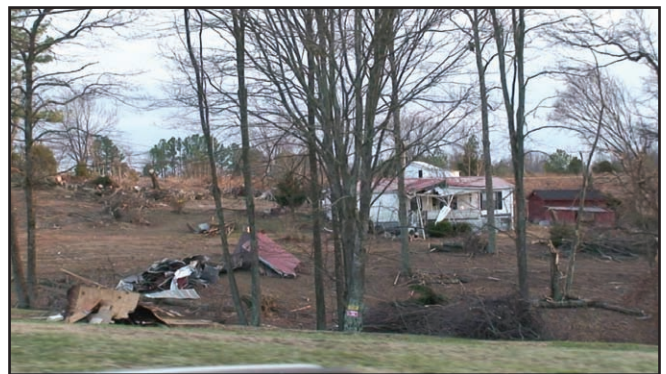
Figure 17. Snapped trees and minor residential damage in NE Macon County. The tornado appears to have weakened in this region, when comparing level of damage seen here in contrast to that seen in Lafayette.

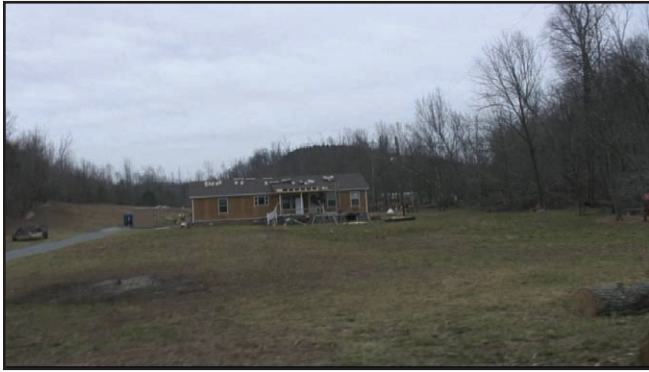
Figure 19. An example of minor roof damage in Hickman County. The degree of damage is somewhat uncertain in this case because construction efforts were already started.

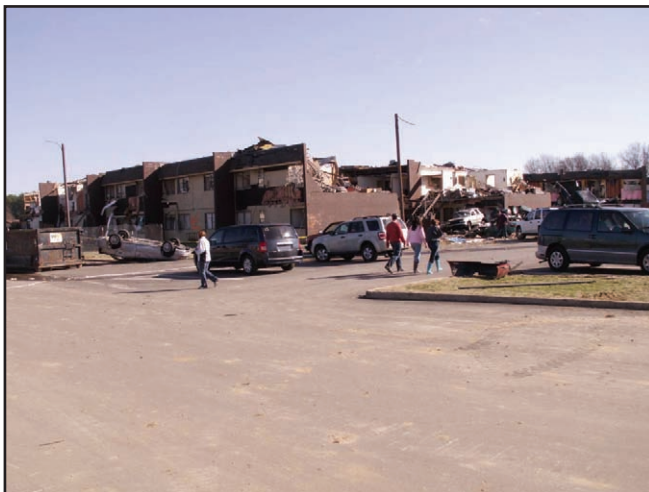
Along the ‘Supercell 2’ track, the VIEWS system was deployed in Madison County, in Jackson, TN and the surrounding areas. The most extensive damage recorded along this portion of ‘Supercell 2’ was observed on the campus of Union University in Jackson. Several residence halls were destroyed or severely damaged. A number of photos from this area are shown in Figures 20-23. A large number of vehicles were damaged, moved, or even flipped over on the campus. While the residence halls suffered extensive damage, the academic halls suffered minor damage, which was mostly cosmetic, with the exception of one building which had damage to the gable roof structure. Based on the severity of the damage to the engineered structures in this area,

Figure 20. Residence halls in southwest portion of Union University campus.

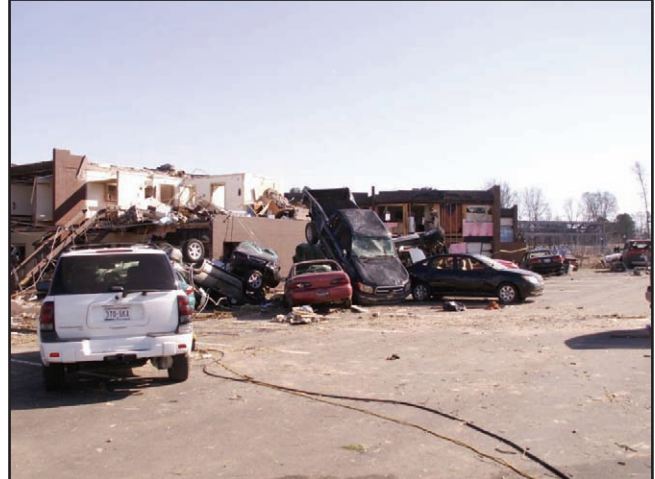
Figure 21. Cars pushed or rolled multiple times in residence hall parking lots.

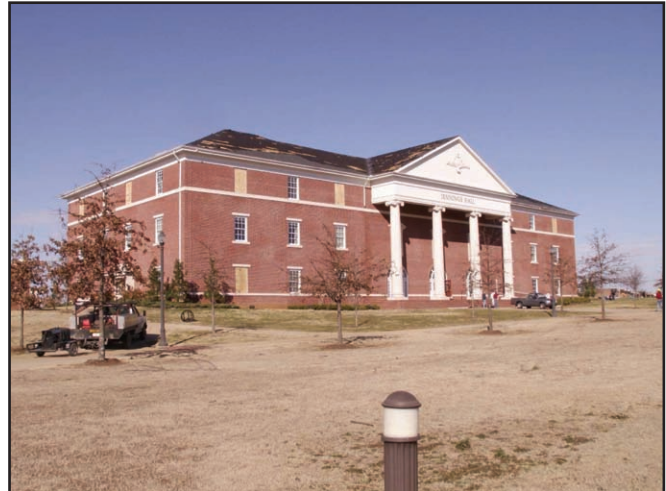
Figure 22. Minor damage to windows and roof shingles at Jennings academic hall. Residence halls in previous pictures are in the background.

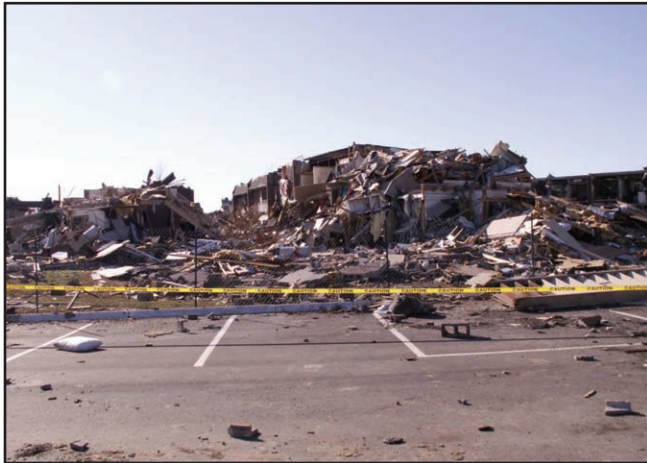
the team rated this storm as an EF-4 tornado. As this tornado progressed, the strength decreased, with the most severe damage located at Union University and in a neighborhood just on the other side of US 45 bypass, northeast of the university. By the time the tornado reached the western side of the city to the west of US 45, most of the damage observed was minimal, with some tree damage, shingles removed, and debris impacts, but little structural damage.

Figure 23. Worst damage to residence halls on Union University campus. Taken at approximately the center of campus looking west.

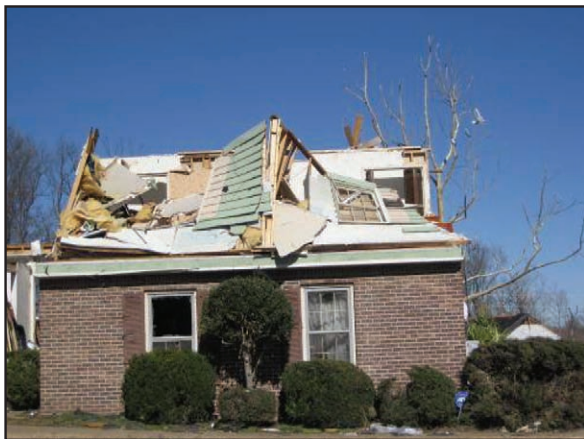
Figure 24 shows two properties in Jackson, TN, where the tornado passed through at around a level EF-3. Figure 24(a) shows structural damage on the upper floors, and a broken window on the

ground floor. This building is observed to have a wood-framed upper story structure, whereas the lower story is covered with brick veneer cladding (likely atop conventional wood-stud framing). Figure 24(b) shows that the wood frame part of this building again collapses, whereas the brick built structure remains more intact. It is possible to start to investigate the trends and correlations between building materials and structural integrity once a classified database is created from the VIEWS footage. Figure 24(c) shows another interesting case where the building was lifted from its foundations and moved a considerable distance, without losing structural integrity. It is thought the building used to be parallel

Figure 24. (a) and (b) VIEWS footage showing two partially devastated buildings recorded in Jackson showing increased building damage in wood frame construction than brick; (c) House blown from its foundations; (d) Missiles imbedded in roof.

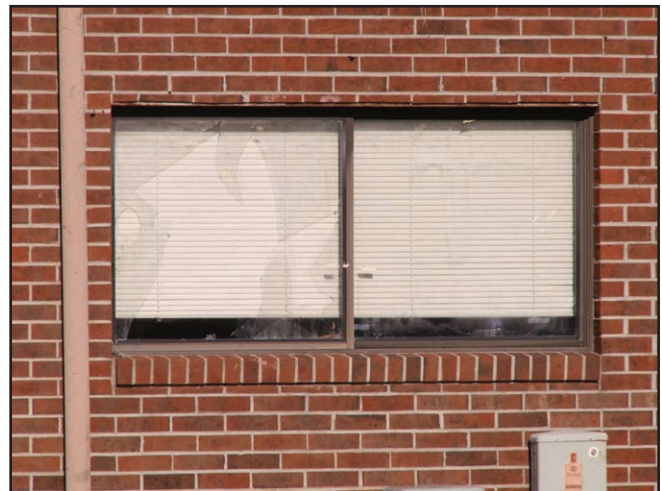
- Those homes with double-paned windows (see Figure 25) often had the outer "sacrificial" pane broken by debris impacts, while the inner pane remained undamaged, reducing the chance for internal pressurization which often leads to roof uplift and further damage to the structure.
- The walls of structures with a brick veneer exterior finish performed better than those with wood board and vinyl finishes. Numerous log-cabin style homes were observed in the region, and because of the thickness of the wall material, no debris punctures were observed in these structures.
- Shingle removal was common on homes located even a large distance from the storm track.
- Improperly and/or poorly anchored mobile homes were flipped and destroyed, leaving twisted undercarriages. These structures were often carried some distance from their original location.

Figure 25. An example of a double-paned glass window in a residence hall of Union University. The exterior pane on the left side has broken, whereas the panes on the right side appear to be intact. The amount of damage to blinds would be expected to be higher if only one pane of glass was used with these windows.

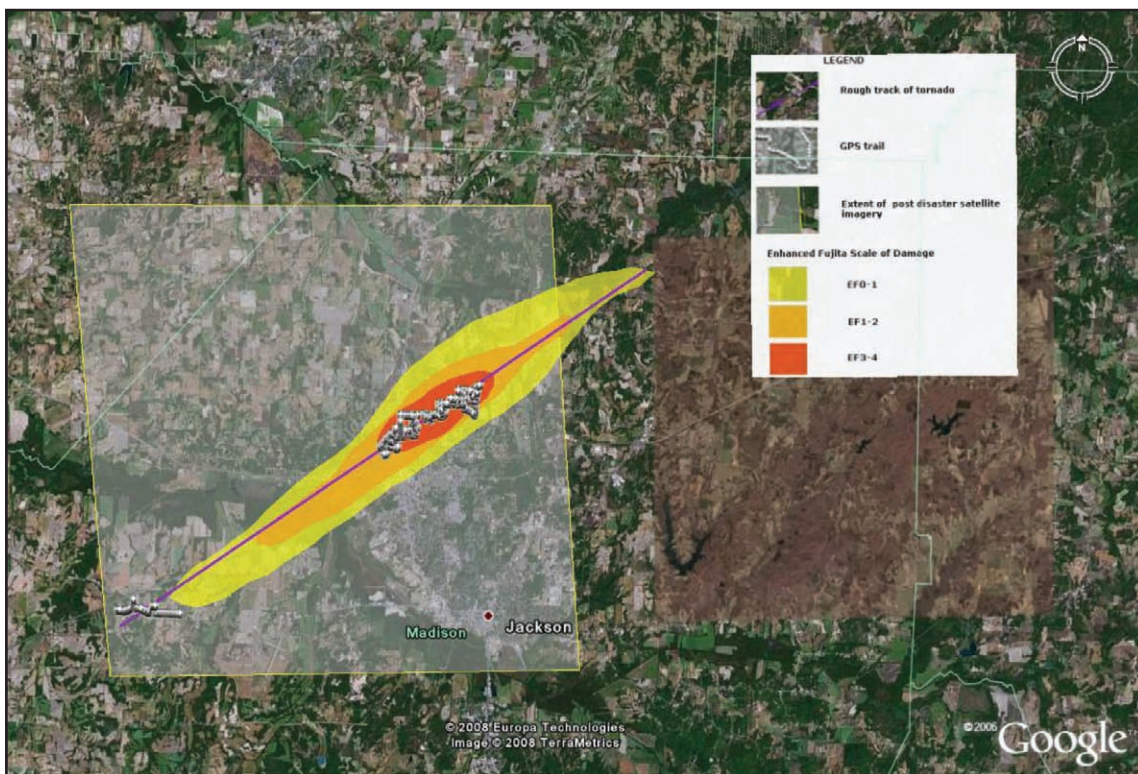
Figure 26. Prototype Google Earth API showing overview vector layers of tornado track, optical satellite imagery extent for post-disaster view, and rough map of EF rating zones (mock up, not real data).

This concept will be developed using one of the most widely used pieces of geographic software at the present time, Google Earth. Figure 26 shows the geographically extensive mode of the API, with tornado tracks and damage states recorded as vector

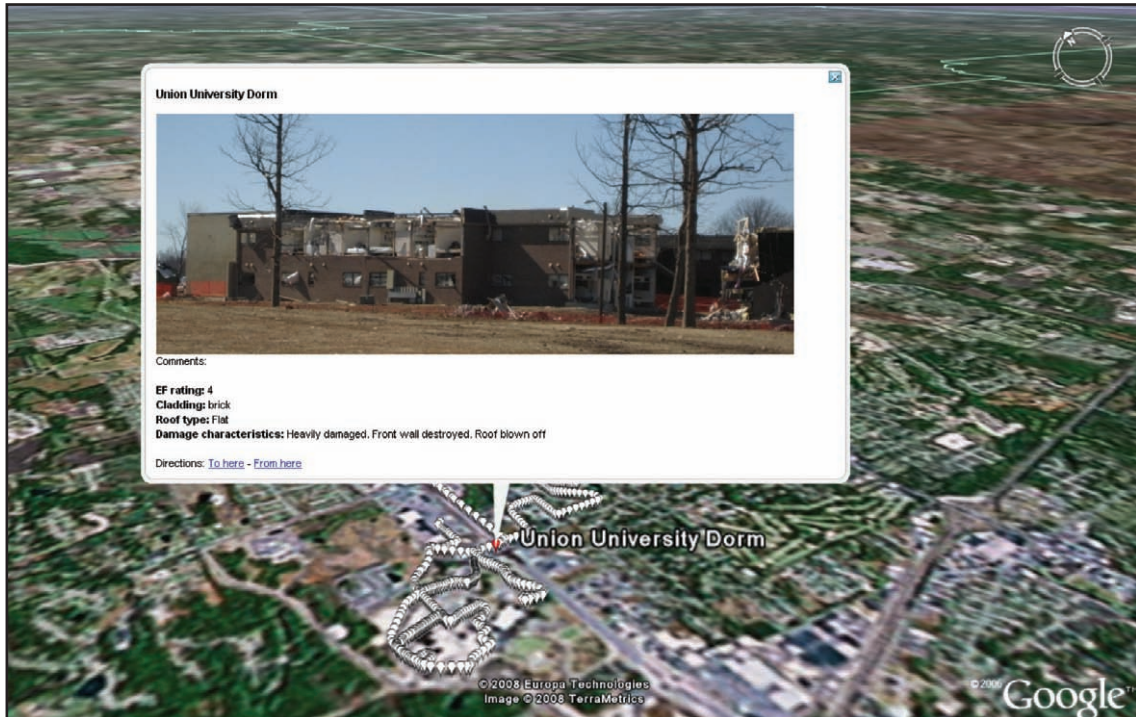
Figure 27. Prototype Google Earth API showing damage to structure and attributes for GPS point. The finished Google Overlay will be available to download from <http://mceer.buffalo.edu/research/Reconnaissance/tornado02-08/default.asp>.

layers. Satellite coverage can also be overlain. Figure 27 shows the geographically intensive mode, where GPS points can be clicked, and damage photos along with attributes appear. Other derived layers that could be added are tornado width and damage state layers, as well as storm reports, news articles etc. These disparate sources can be combined together to give a coherent overview of the disaster to the end user.
