A Summary of MCEER
Reconnaissance Efforts

COLLECTION AND PRELIMINARY ANALYSIS OF AERIAL AND IN-FIELD BUILDING DAMAGE INFORMATION IN THE AFTERMATH OF THE 2007 CALIFORNIA WILDFIRES

Anneley McMillan, Beverley J. Adams, Shubharoop Ghosh and Charles K. Huyck
ImageCat Inc.

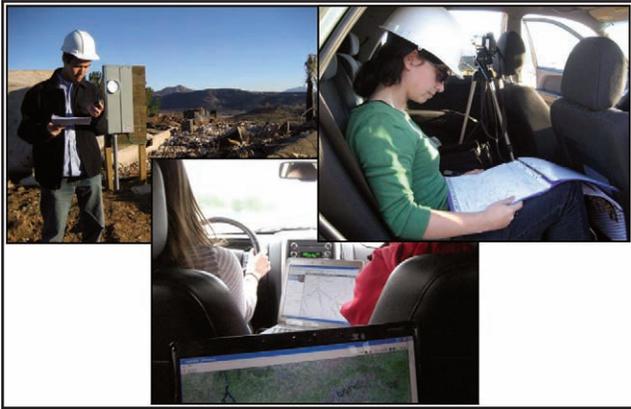
Figure 1. Deployment of the VIEWS™ system.

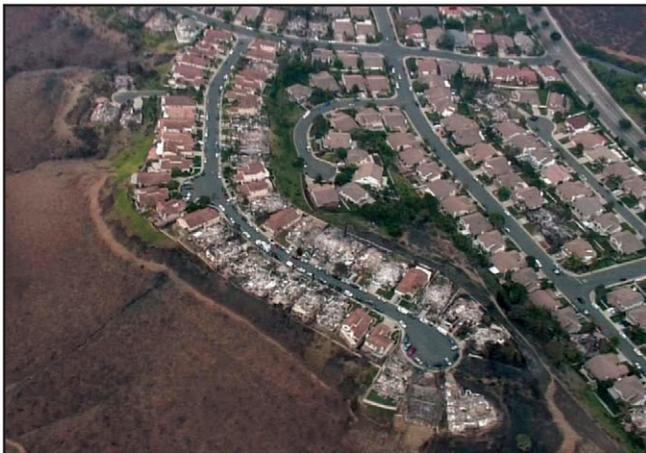
Figure 3. Example of aerial imagery, showing a partially destroyed neighborhood in San Diego.

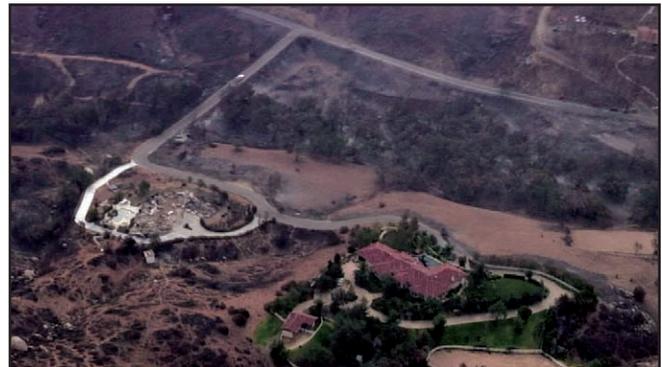
Figure 6. Chaparral burn in Poway, and the patchy nature of the damage to ranch style properties.

damage in this area is very variable and patchy. For instance, Figure 6 shows the burned chaparral around one neighborhood. Buildings are seemingly destroyed at random. The factors determining whether a house in this type of environmental situation is subject to burn or not clearly depends on a number of factors, which may include: ember travel; the quality of house construction; vegetation clearance; and fire management techniques.

There are a couple of distinctive types of construction within the Witch fire area. The first type commonly encountered is shown in Figure 6, ranch type structures, where homes are separated by considerable distances, and are fairly large in size. The second type is the more densely populated areas of Rancho Bernardo, as shown in Figure 7. Again, a fairly random distribution of burned buildings was seen here.

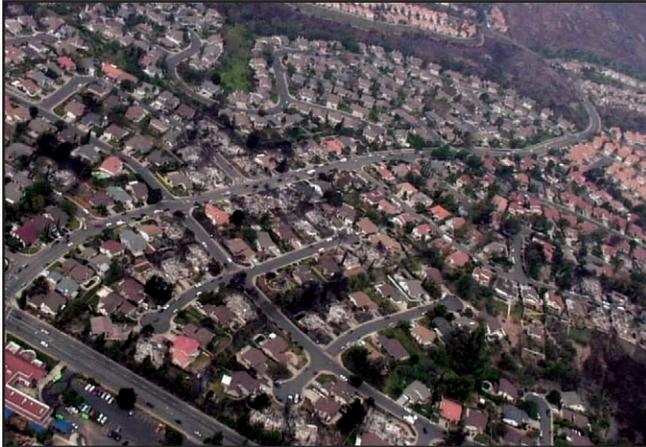
Figure 7. The patchy nature of house destruction through Rancho Bernardo.

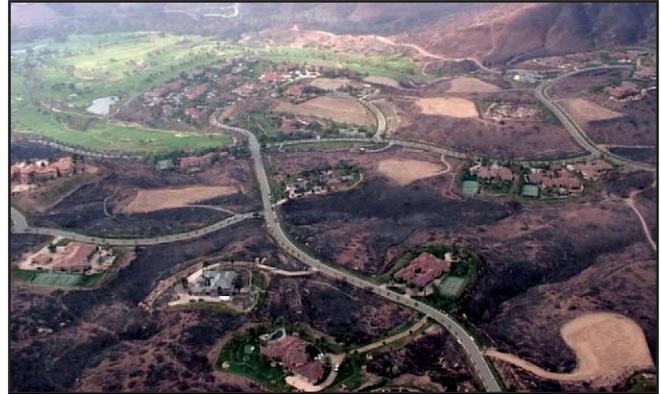
Figure 8. Good vegetation clearance practices helped to avoid house destruction.

The VIEWS™ footage in Figure 8 shows the difference that a well maintained clearance zone around a property can make. The irrigated lawns act as a barrier between the chaparral burn and the property

(i.e., the empty spaces of land are thought to be new construction areas, not destroyed parcels). A large part of fire protection activities involves vegetation clearance. Organizations such as Cal Fire disseminate regulations and information on vegetation clearance parameters around properties. For instance, the current defensible space clearance regulation is 100 feet around properties in California. A defensible

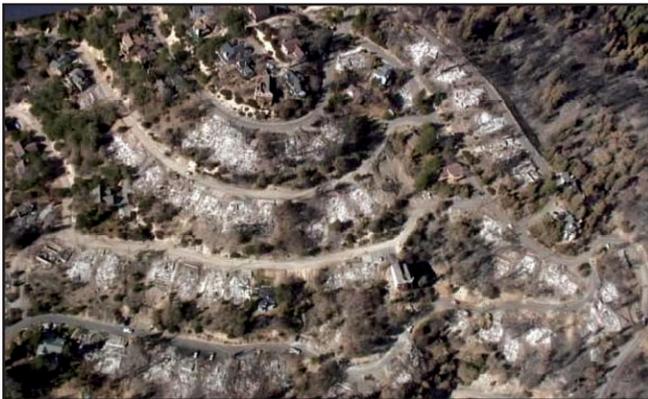
Figure 23. Destruction of houses in the Grass Valley area.

Recalling Table 2, the fuels for the Slide and Grass Valley Fires were different from those that fed the Witch Fire. Rather than the chaparral and grassland that characterized the Witch fires, these fires occurred in the pine forests of the San Bernardino Mountains. Figure 23 shows how the difference in environment affected the type of burn experienced in the area. It shows a group of destroyed houses after the Grass Valley fire. It is possible to see the 'domino' effect of fires spreading through a community, from one home to the next. The homes in this area were in close proximity to trees, which empha-

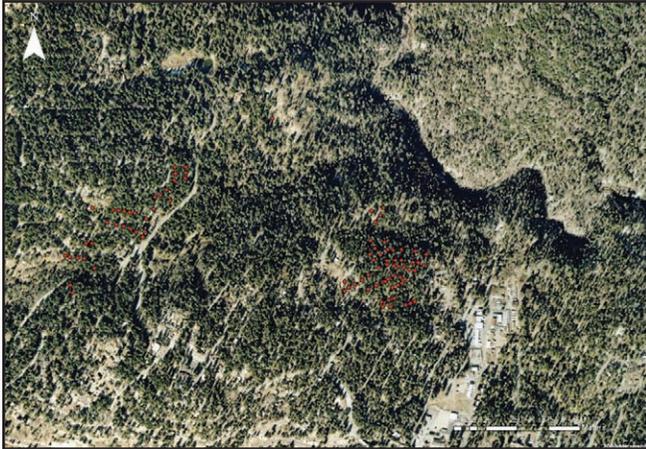
Figure 26. Distribution of burned buildings in Slide Fire.

Figures 25 and 26 show that the distribution of building burn within the Grass and Slide fires differs from that of the Witch fires. They are a lot more concentrated in their destruction, suggesting that the fire front passed through the whole neighborhood, with the ‘domino’ effect of houses setting the next one on fire. That stated, when ground VIEWS™ surveys were taken, even though the rate of building destruction looks high, there are still many homes in between burned buildings that were not touched by the fire.

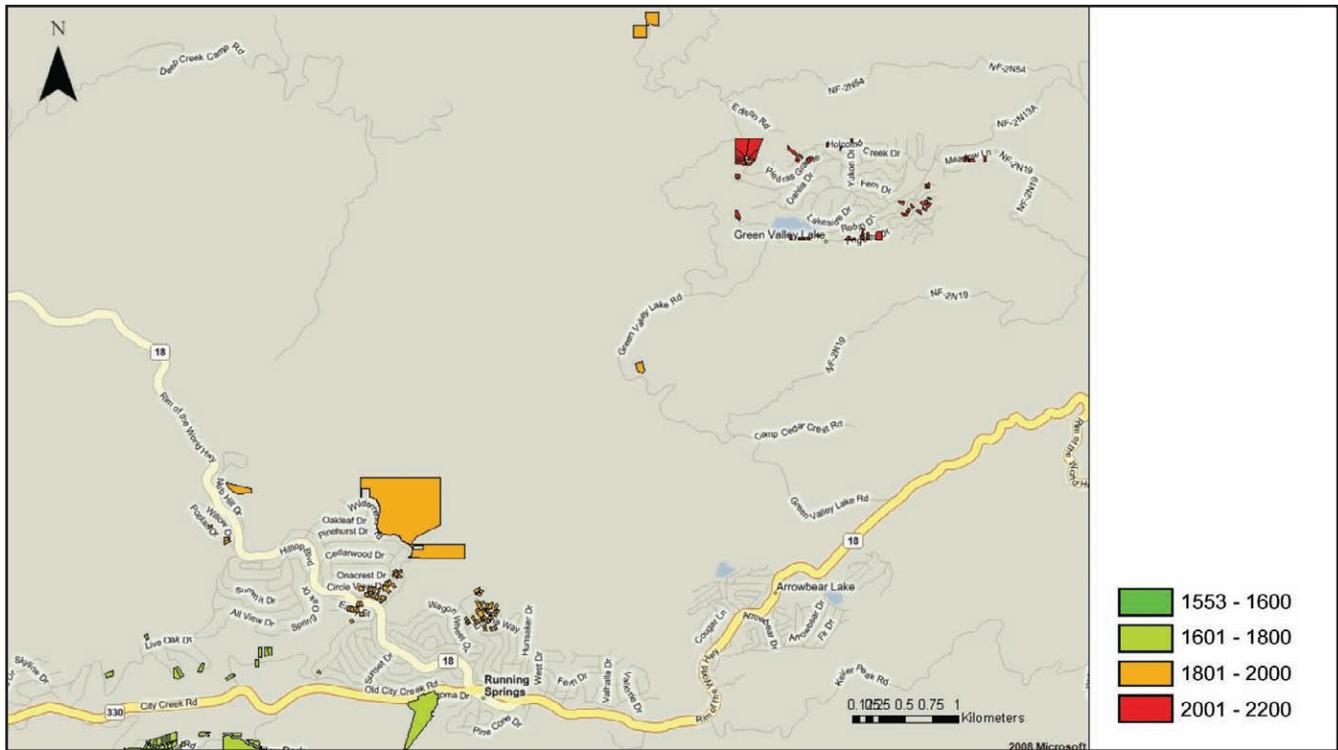
Figure 29. Close up of Slide fire destroyed parcels, showing elevation distribution.
