A Summary of MCEER
Reconnaissance Efforts

HURRICANE GUSTAV RECONNAISSANCE: DAMAGE SURVEY USING THE VIEWS™ SYSTEM

Walter Svekla and Enrica Verrucci, ImageCat, Inc.

Special Report MCEER-08-SP08

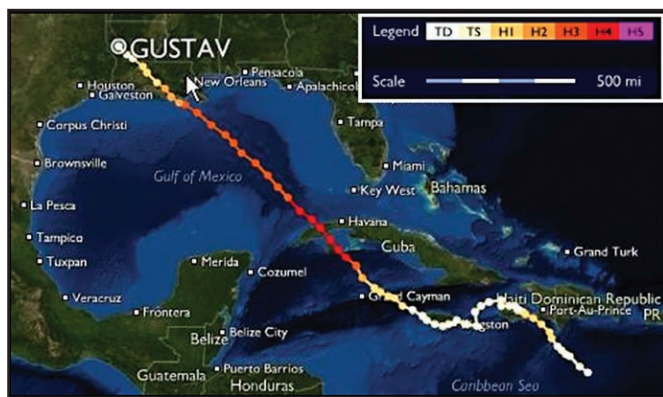
Figure 1. Path of Hurricane Gustav from August 25 through September 2, 2008.

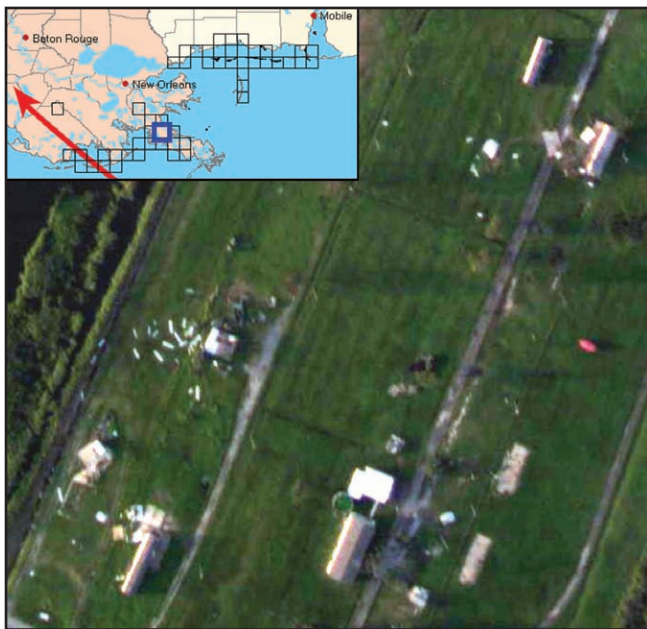
Though Gustav made landfall with wind speeds just below those of a category 3 hurricane, it rapidly weakened to a category 1 storm within four hours. Expectations for wind-induced damage were not realized, though wind damage was observed. Figure 3 displays some relatively small structures damaged by extreme winds.

Figure 3. Triumph, LA NOAA image C24702090

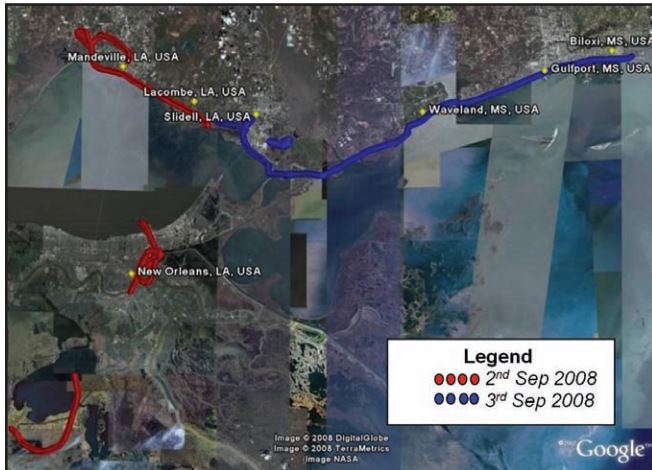
Figure 5. ImageCat aerial deployment routes.

coastal erosion induced by Hurricanes Katrina and Rita during the 2005 hurricane season. Figure 5 displays ImageCat's aerial deployment tracks.

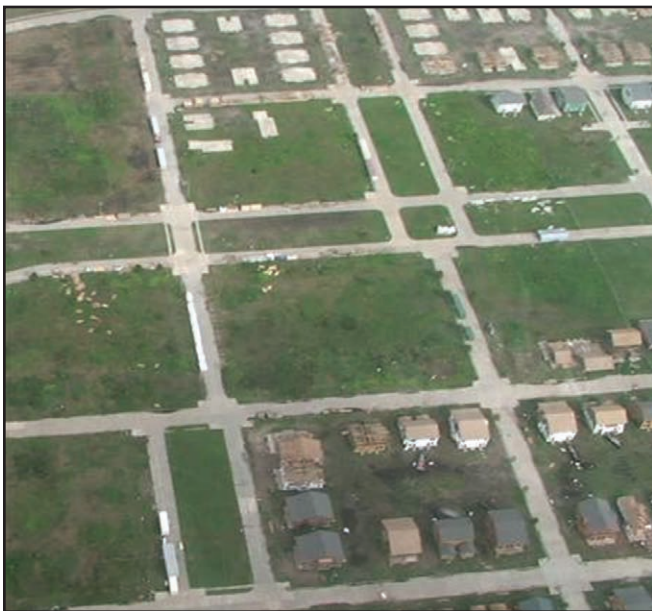
The storm and following heavy rains forced water over the top of some levees; other levees also experienced seepage. Nevertheless, no major wind-induced damage or flooding was observed in this area. The Industrial canal in the city's Ninth Ward neighborhood (figure 6), whose failure after Katrina contributed to major flooding in the city (approximately 80 percent), held up well against Hurricane Gustav's extreme winds and surge.

Figure 6. New Orleans 9th Ward - Minor wind-induced damage.

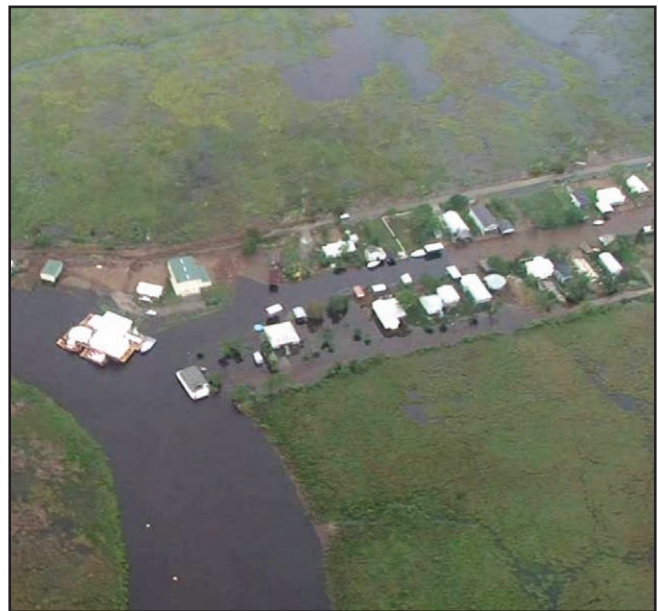
These areas experienced limited flooding, both in urban and rural areas. VIEWS™ aerial data, acquired the day after the hurricane made landfall, showed many flooded areas (Figure 7). The storm surge penetration and resulting inundation were due mostly to topography. This area is widely characterized by wetlands and therefore is prone to flooding. Even so, no evidence of soil erosion was visible in this imagery.

Figure 7. Lacombe, LA - example of flooded urban area.
