EARTHQUAKE RESISTANT STRUCTURAL WALLS -
TESTS OF ISOLATED WALLS

BIBLIOGRAPHIC DATA SHEET		1. Report No. NSF/RA-760815	2.	3. Recipient's Accession No. PB-271 467
4. Title and Subtitle Earthquake Resistant Structural Walls-Tests of Isolated Walls; Appendix A - Experimental Program; Appendix B- Test Results			5. Report Date November 1976

7. Author(s) R. G. Oesterle, A. E. Fiorato, L. S. Johal, J. E. Carpenter, H. G. Russell, and W. G. Corley			8. Performing Organization Repr. No. PCA R/D Ser.1571

Report to
NATIONAL SCIENCE FOUNDATION
(RANN)
Grant No. GI-43880

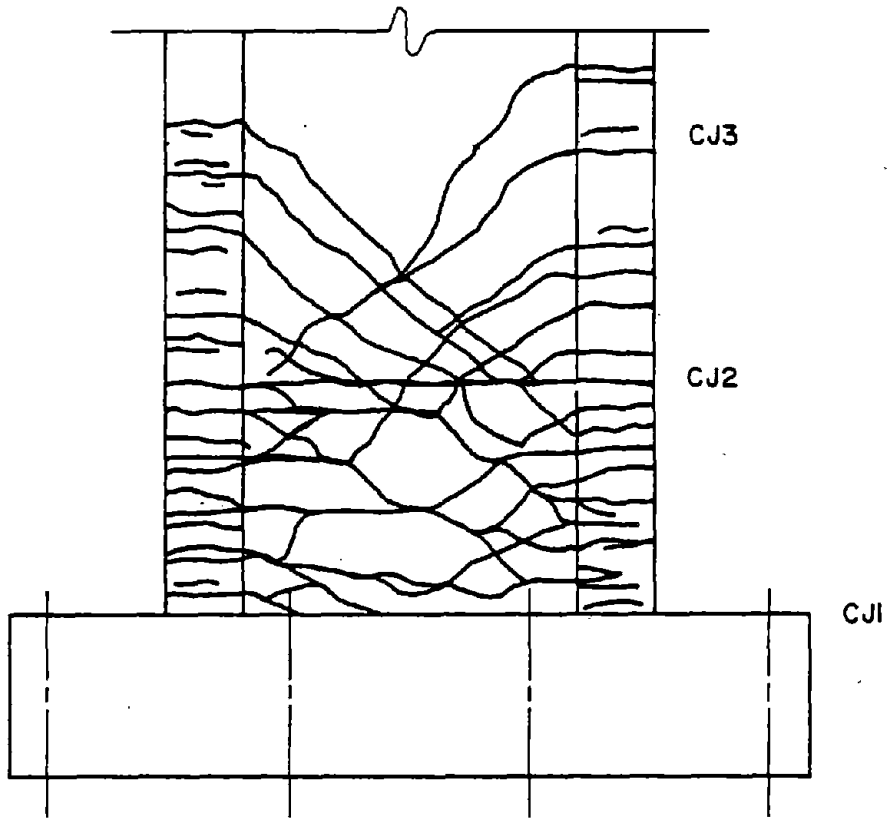
Fig. 5 Crack Pattern in Lower Portion of Specimen B3

For walls with low nominal shear stress, cracks started as horizontal flexural cracks in the boundary element, usually at level where horizontal reinforcement was located. Closely spaced confinement hoops caused these cracks to be finely distributed. The horizontal cracks progressed into coarsely distributed inclined cracks in the web. The cracks crossed the web until they intercepted a crack from the previous loading in the opposite direction. By the time the yield increment was reached the cracks had segmented the web into large pieces with several predominantly horizontal cracks completely traversing the lower 3 ft (0.91 m) of the wall. These cracks sliced the lower wall region into several horizontal layers as illustrated in Fig. 5. Because the loading was always applied in the same direction first, the cracks were usually somewhat more angular and jagged on the right side of the wall.

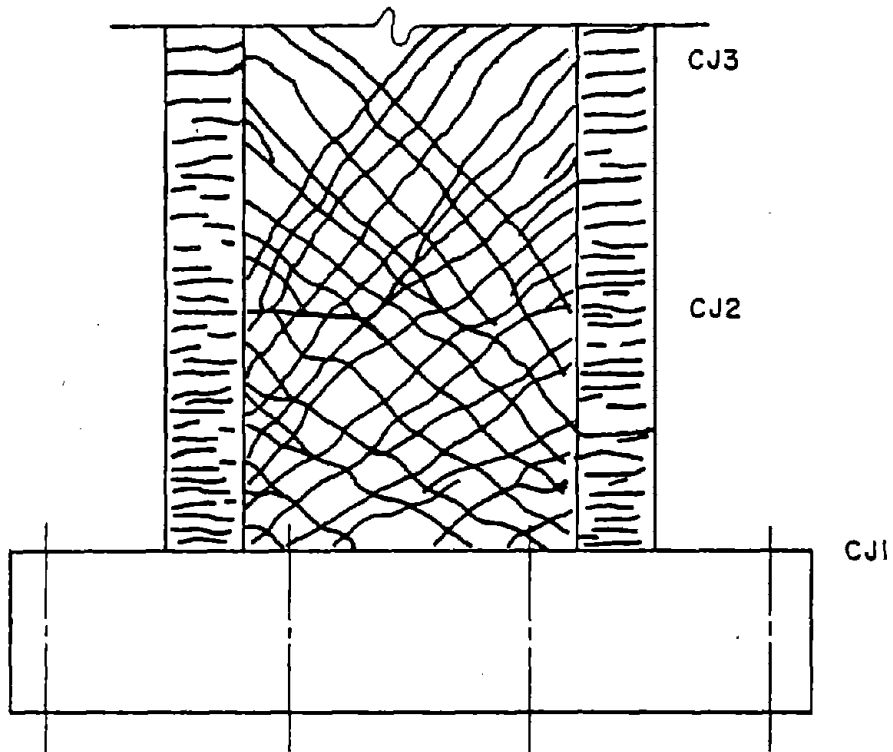
Fig. 6 Crack Pattern in Lower Portion of Specimen B5

As shown in Table 2, four specimens were subjected to maximum nominal shear stresses greater than $7.0\sqrt{f'_c}$ ($0.58\sqrt{f'_c}$, MPa). The crack pattern that developed in these

specimens is illustrated in Fig. 6. Closely spaced flexural cracks were first observed in the boundary elements. When they reached the web, the cracks became inclined with a steeper angle than those in the specimens with low shear stress. The direction of these cracks was not altered by cracks caused by forces from the opposite direction. The inclined cracks crisscrossed the web forming relatively symmetrical compression strut systems for each direction of loading. Each compression strut was segmented into parallelogram shaped pieces of concrete. The crack pattern along any horizontal plane was sawtooth shaped.

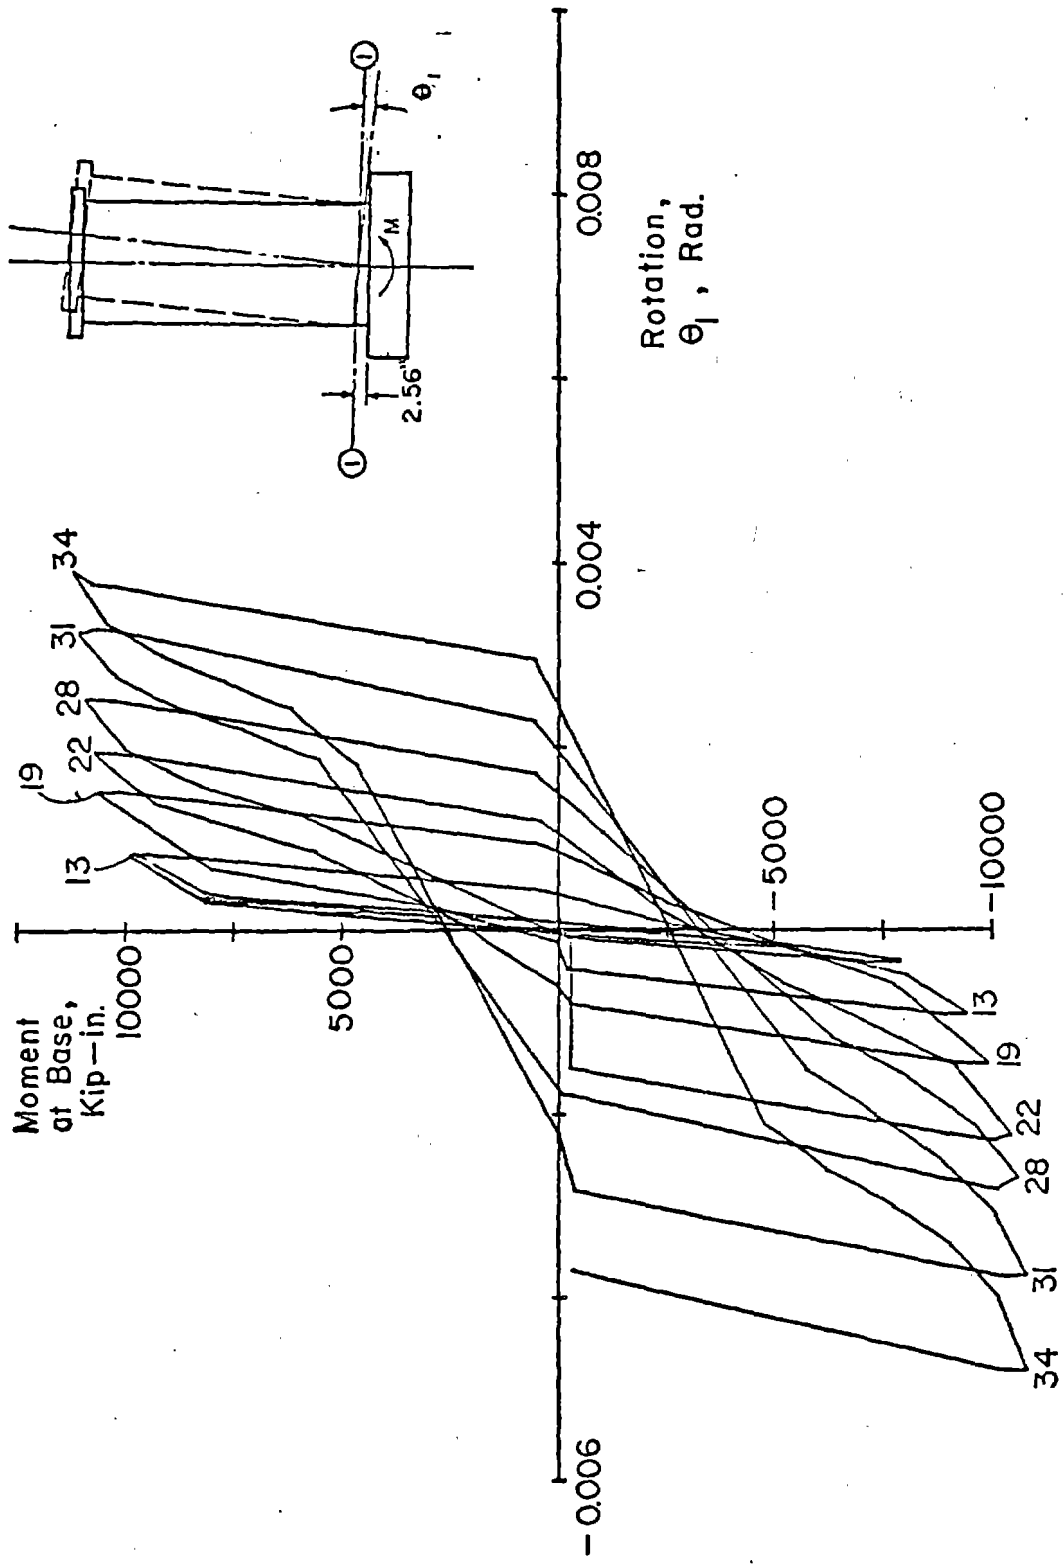
Fig. 9 Example of "pinching" in Moment-Rotation Loops

As observed by other investigators, ^(6,7,8) alternate tensile yielding of the reinforcing steel causes a "growth" in the hinging region. As a specimen was loaded beyond yield in one direction and then unloaded, permanent deformations remained in the tension steel. As the specimen was loaded in the opposite direction, prior to crack closure, only the reinforcement was effective in resisting moment. This steel section had a lower stiffness than the combined concrete-steel section. As the cracks closed the stiffness increased. This accounts for "pinching" observed in the moment-rotation loops. An example of "pinched" loops is shown in Fig. 9.

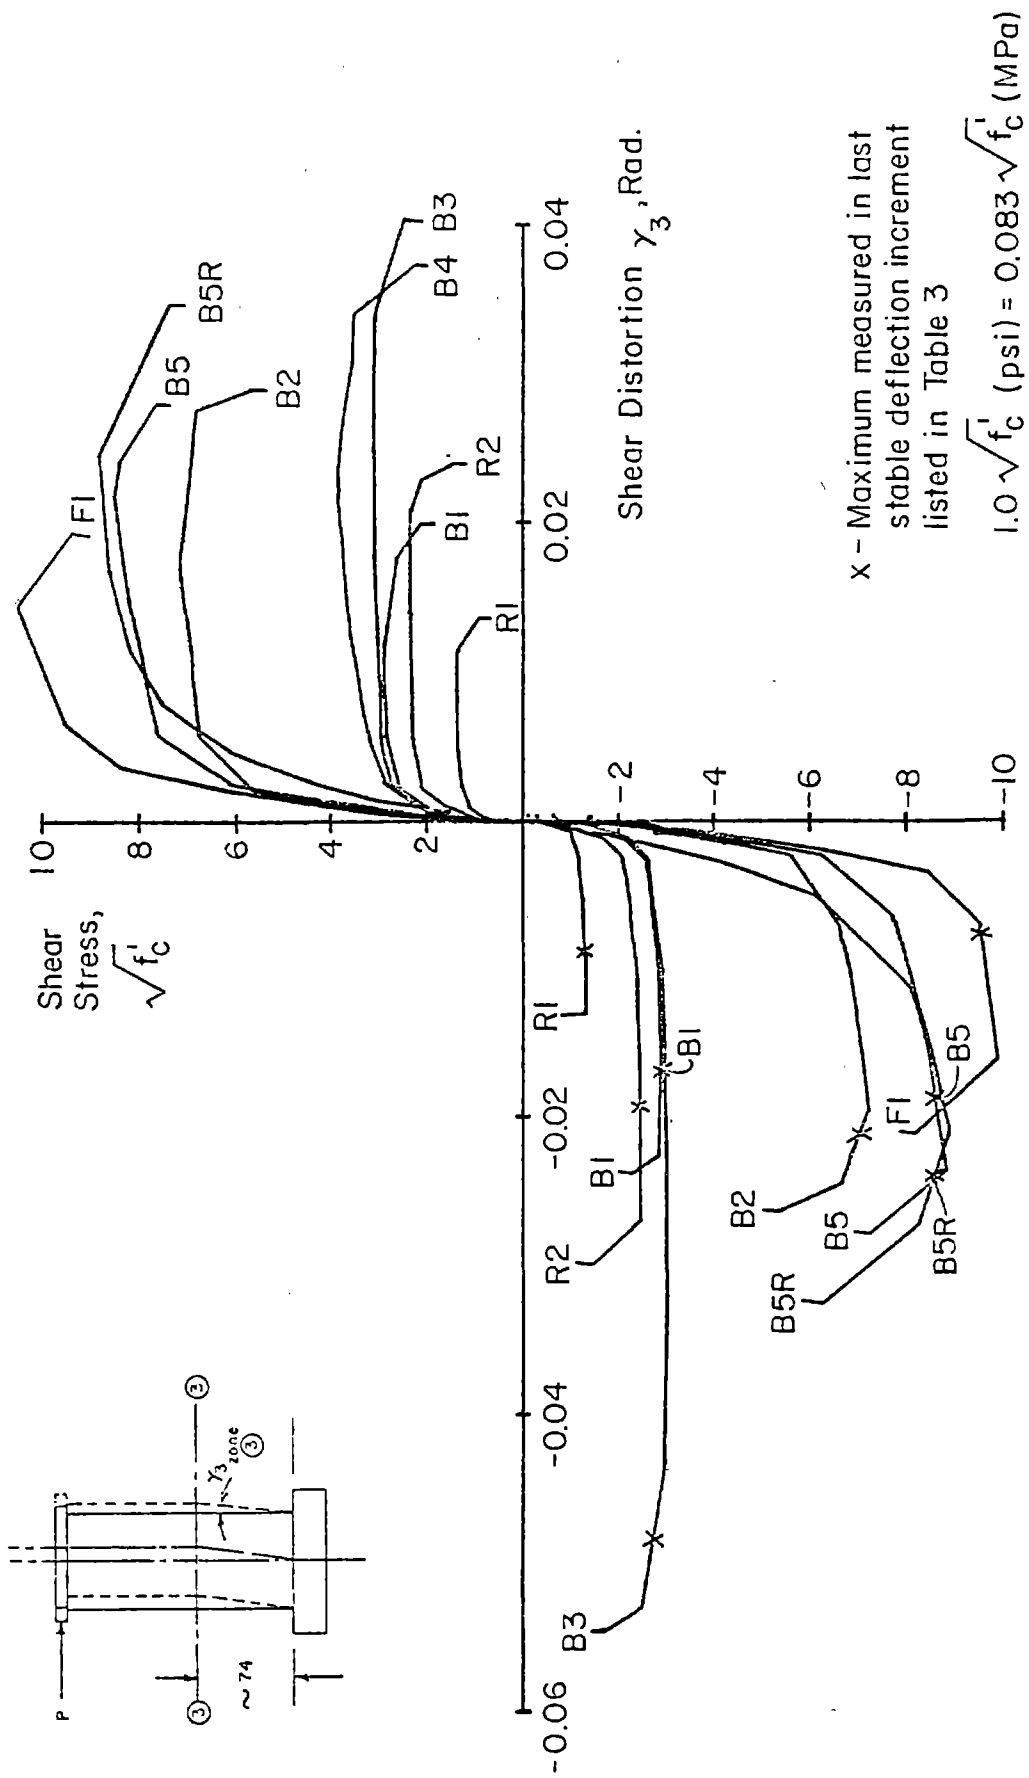
Fig. 10 Shear-Distortion Envelopes

Load versus shear distortion envelopes for all specimens are shown in Fig. 10. The envelopes indicate that a shear "yielding" occurred in each specimen during the same load

stages that flexural yielding occurred. Shear "yielding" is defined as a large increase in shear distortion corresponding to a small increase in load. This shear "yielding" was observed in all the specimens including the specimens over-reinforced for shear and the monotonically loaded Specimen B4. Yielding of the horizontal reinforcement did not necessarily coincide with "yielding" observed in the shear-distortion data.

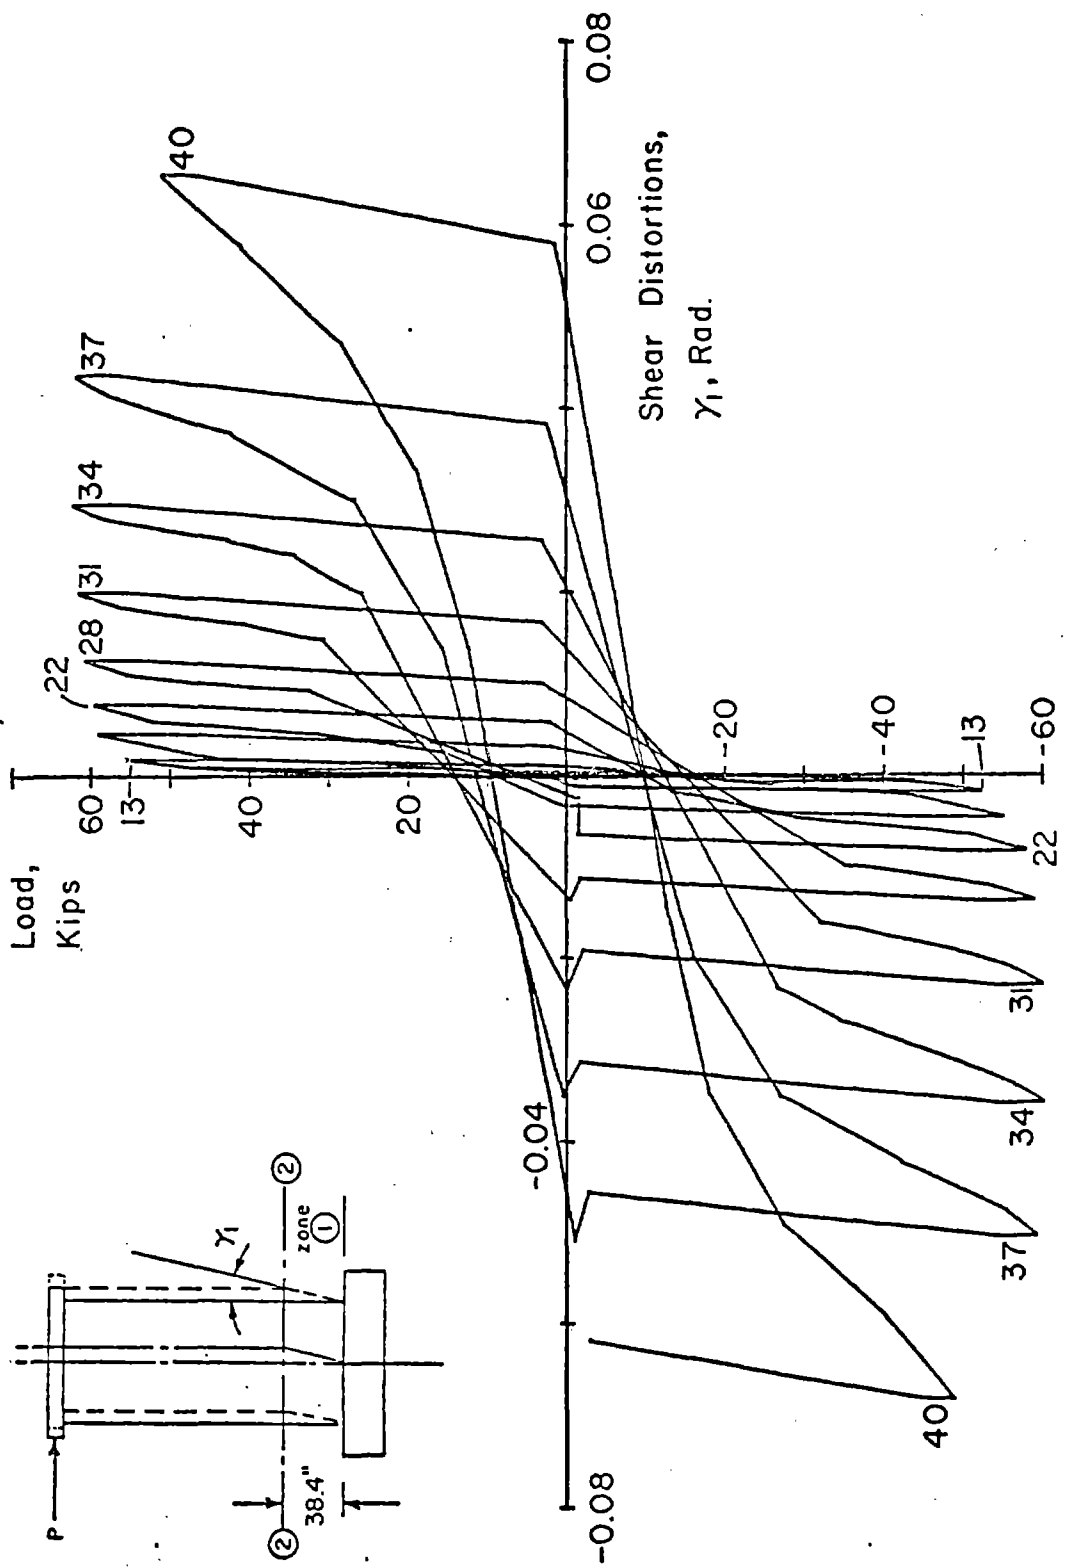
Fig. 11 Example of "pinching" in Shear-Distortion Loops

In addition to the "yielding" described above, a reduction of shear stiffness occurred in the specimens subjected to cyclic loading. This has also been observed by other investigators. (5,6,7) It was attributed to alternate tensile yielding of the reinforcing steel. As the specimen was loaded beyond yield in one direction and then unloaded, permanent deformations remained in the tension steel. As the specimen was loaded in the opposite direction the shear was transferred predominantly by dowel action prior to crack closure. This dowel action had a relatively low stiffness. As the cracks closed, interface shear transfer plus some

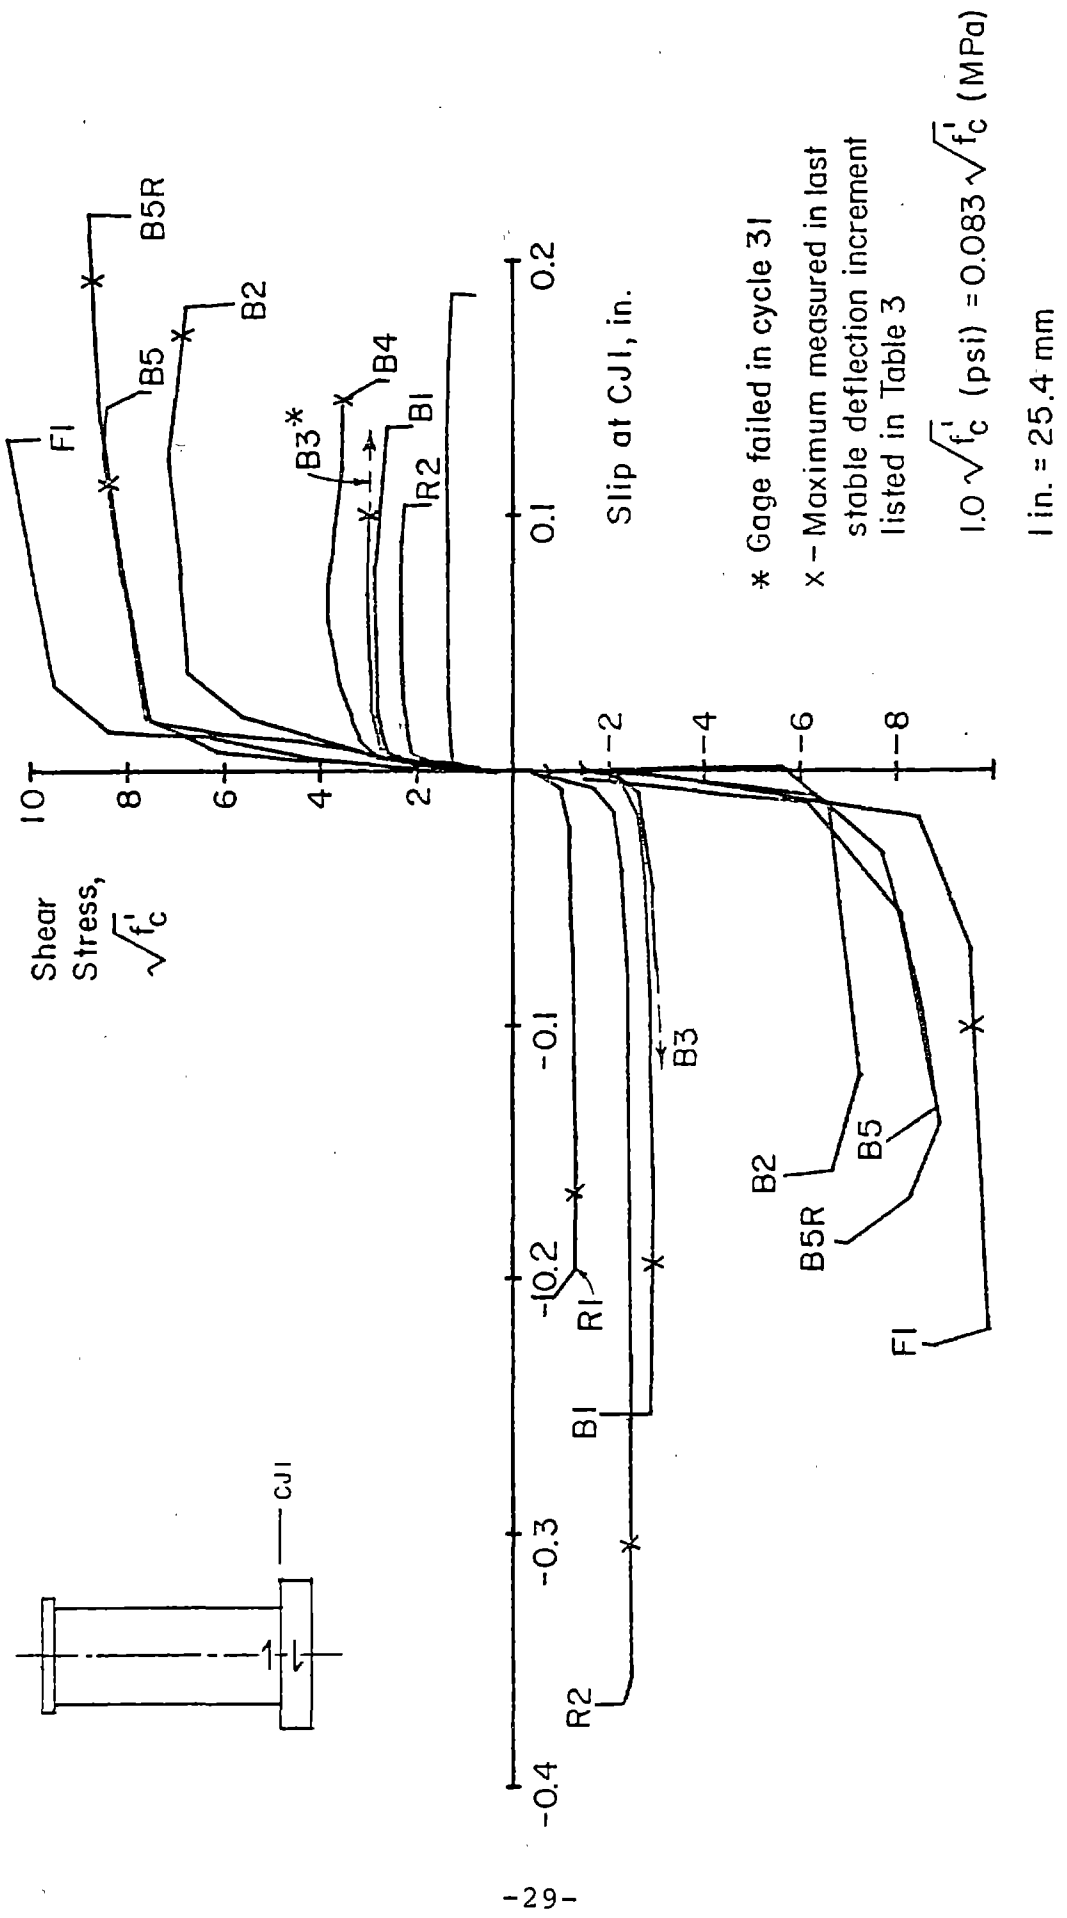
Fig. 12 Load versus Base Construction Joint Slip Envelopes

The performance of two specimens was affected by the behavior of construction joints. In the test of Specimen B5, deterioration of a portion of the joint at the 3-ft level caused by improper construction methods may have precipitated early web crushing. In the test of Specimen B5R, a sliding-crushing failure in the joint at the 3-ft

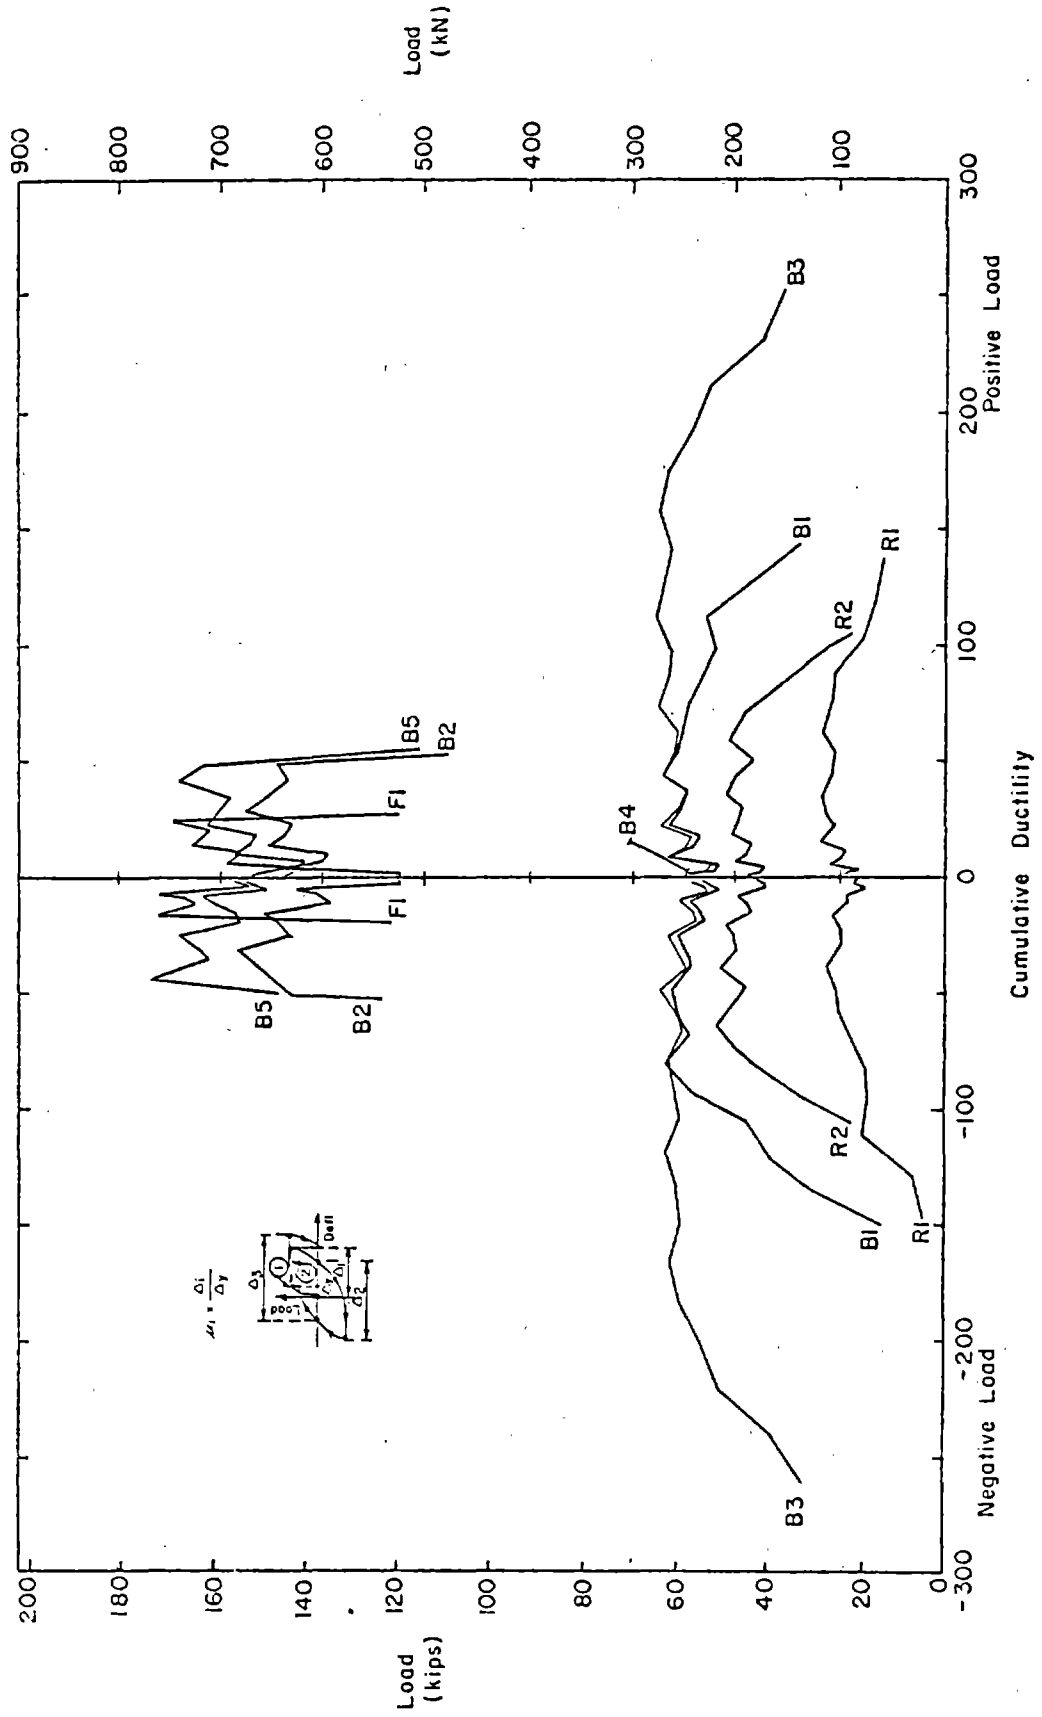
Fig. 13 Load versus Cumulative Top Displacement Ductility

Figure 13 shows the cumulative top deflection ductility ratio^(10,11) versus load for each specimen. The full yield deflection was used to calculate the ductilities. From the inset in Fig. 13, it is apparent that the ductility ratio is very sensitive to the definition of the yield deflection.

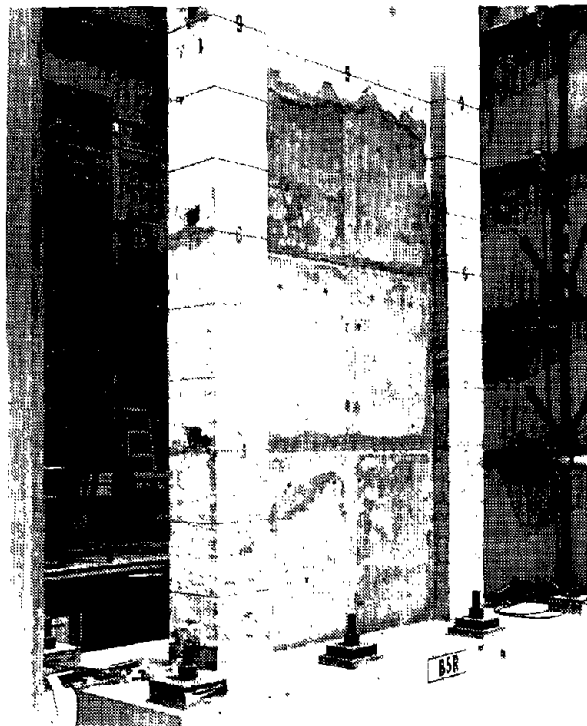
Fig. A-28 Specimen B5R After Completion
of Repairs

Specimen B5R was a retest of Specimen B5. Following the test of B5, damaged web concrete was removed up to a height of about 9 ft (2.74 m). New web concrete was cast in three lifts. The columns were repaired with a surface coating of neat cement paste.

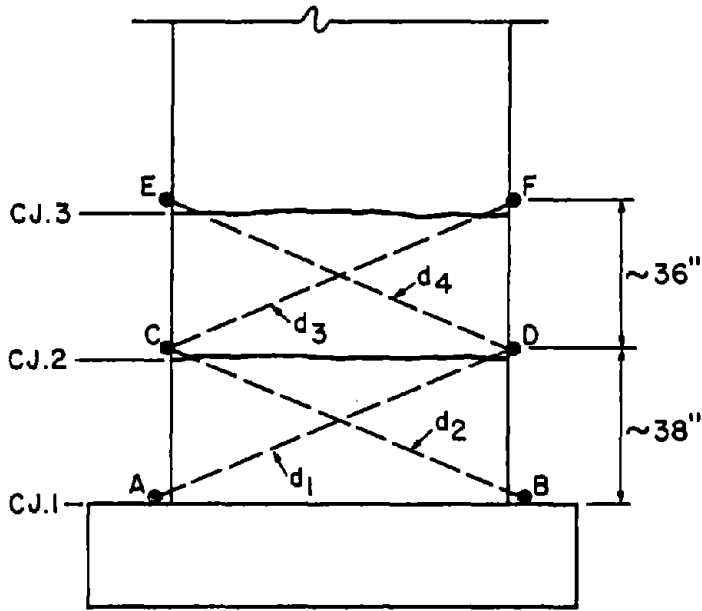
Fig. A-32 Points Measured for Shear Distortions

Shear distortions calculated as described above cannot be considered exact values in a reinforced concrete element. Because of cracking, plane sections not remaining plane, and the existence of a moment gradient across the element, these shear distortions can only be considered as approximate values.

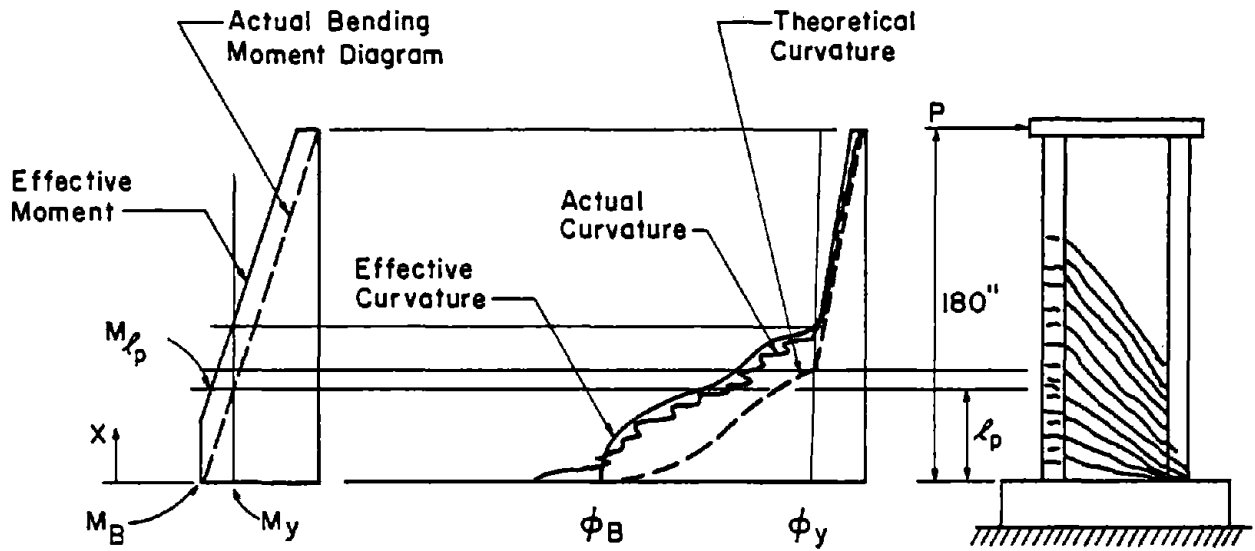
Fig. B-1 Curvature Distribution for Specimens With Inclined Cracking

Two different methods were used to determine an effective curvature distribution. One method shown in Fig. B-1 was used to include the effect of diagonal shear cracking on the spread of the hinging region. It was used for specimens B1, B2, B3, B4, B5 and F1. A hinge length, ℓ_p , was determined visually from the crack pattern of each specimen. This was the height at which the steepest diagonal crack extending from the base compression zone intercepted the centroid of the tension boundary element as shown in Fig. B-1. Based on equilibrium of the forces in the hinge region, Bachmann^(20,21) presented a relationship for determining force in the tensile reinforcement. Using this relationship, the effective moment for flexural steel tension is:

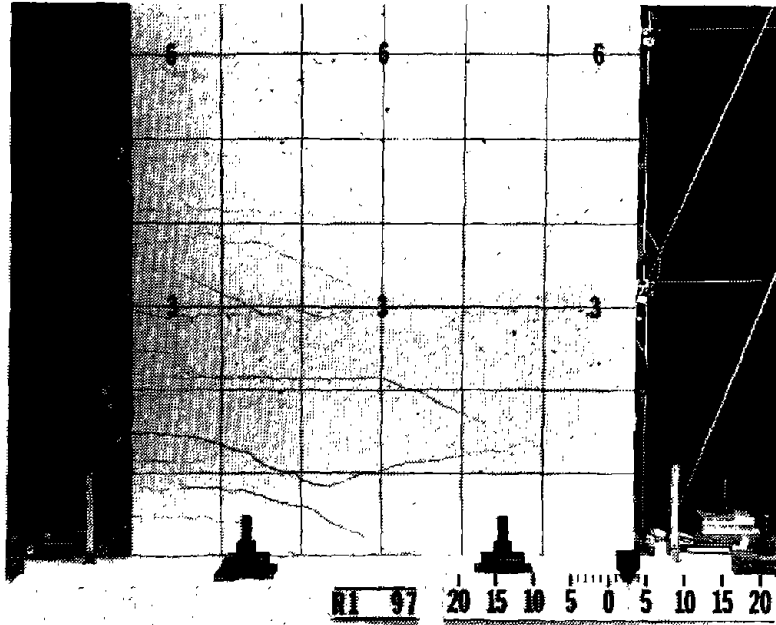
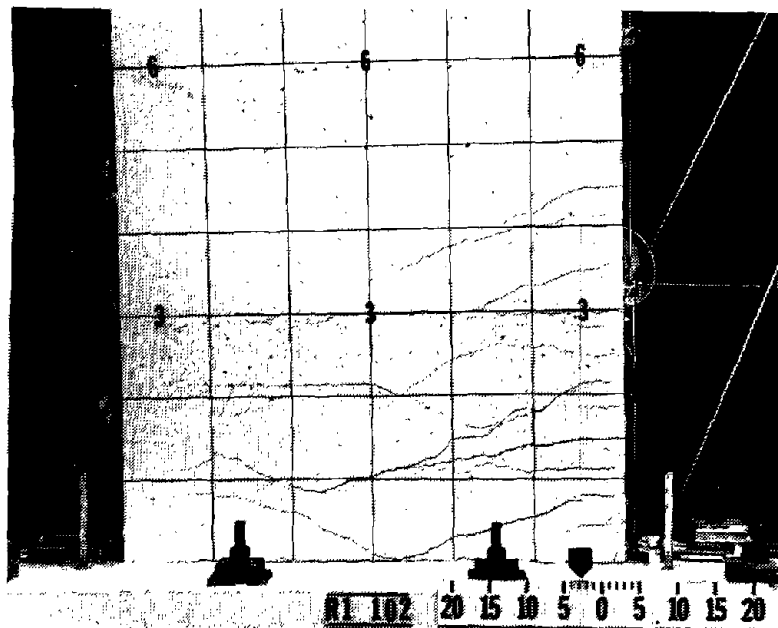
The cracking pattern in the lower 6 ft (1.83 m) of the wall is shown in Figs. B-10 and B-11. The photographs were taken in Cycle 19 at a top deflections of +3 in. (76.2 mm) and -3 in., respectively. The cracks started in a horizontal

Fig. B-10 Cracking Pattern at +3 in. Deflection for Specimen R1

Fig. B-11 Cracking Pattern at -3 in. Deflection for Specimen R1

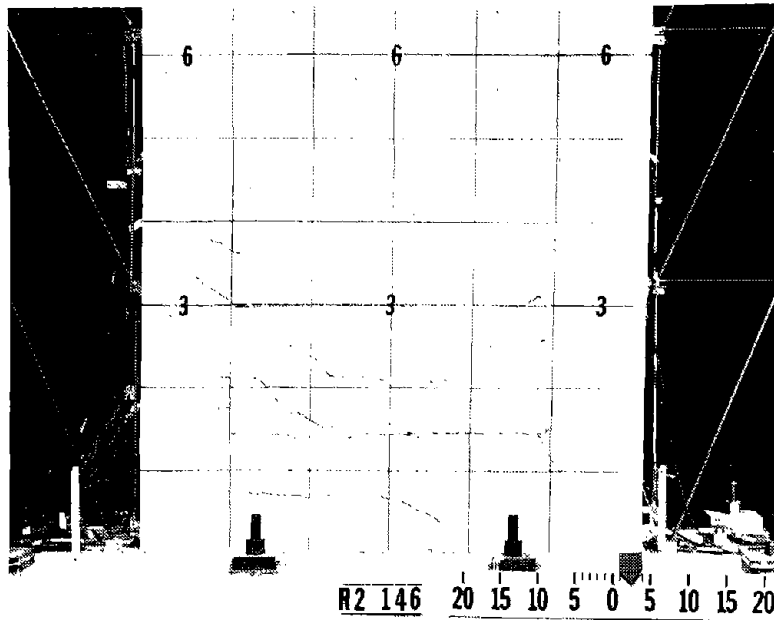
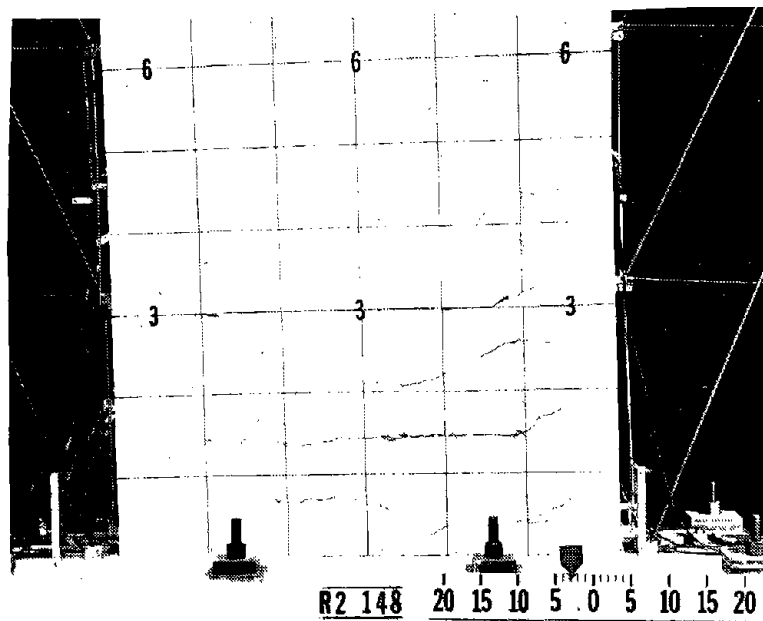
The cracking pattern in the lower 6 ft (1.83 m) of the wall is shown in Figs. B-31 and B-32. These photographs were taken during Cycle 25 at a top deflection of +3 in. (76.2 mm) and -3 in., respectively. As these figures show, the flexural cracking in the end regions was very finely distributed due to the close spacing of confinement steel. These flexural cracks progressed into coarsely distributed diagonal and horizontal cracks in the web. The cracks from

Fig. B-31 Cracking Pattern at +3 in. Deflection for Specimen R2

Fig. B-32 Cracking Pattern at -3 in. Deflection for Specimen R2

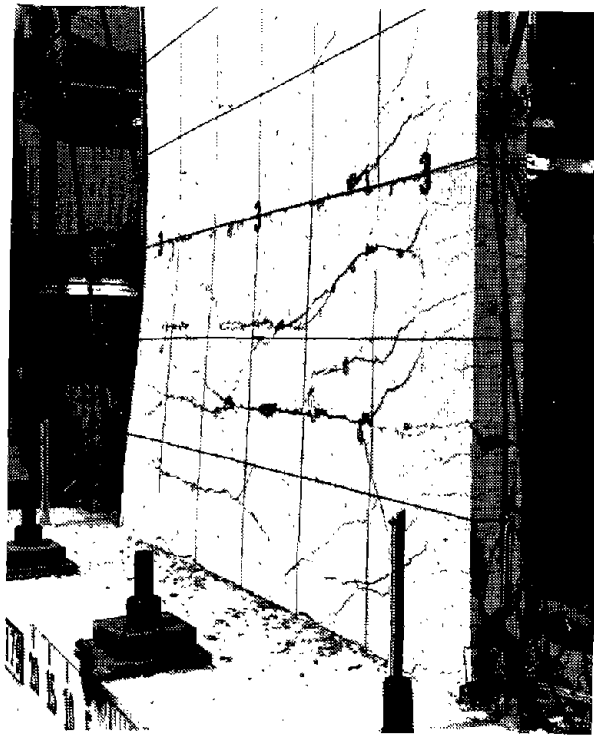
Fig. B-33 Lateral Displacement of Compression Zone
After 4 in. Deflection for Specimen R2

The test was stopped after Cycle 32 and lateral bracing was added to the test set-up. An omni-direction ball caster was placed against the face of the each boundary element at a level 3 ft 6 in. above the base. This simulated lateral support at approximately the first story height.

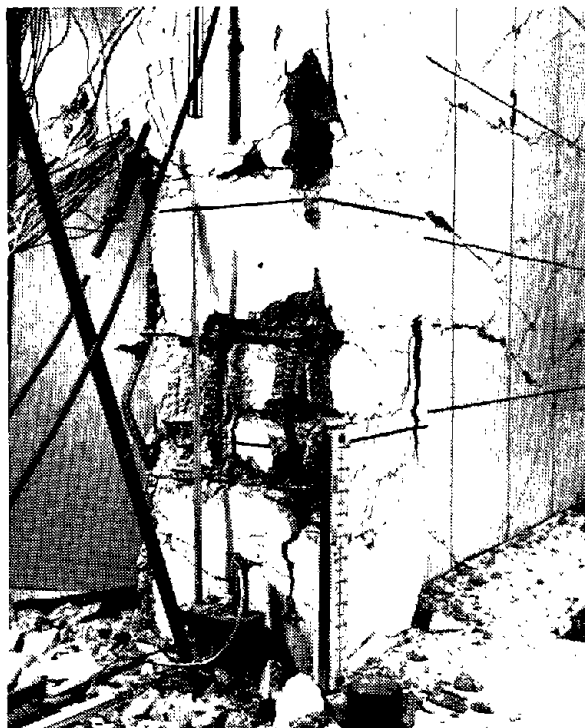
Fig. B-55 Buckling of Reinforcing Bars for Specimen B1

After first buckling of flexural bars, the boundary elements started to deteriorate. The outer shell spalled off and small pieces of concrete would fall out of the core when the element was in tension. However, the load carrying capacity did not reduce during several additional cycles. The maximum load measured, 61.0 kips (271.3 kN), occurred in Cycle 28 at a -4-in. (101.6 mm) deflection. This load corresponded to a nominal shear stress. $v_{\max} = 2.9\sqrt{f'_c}$ (0.24 $\sqrt{f'_c}$, MPa). The end hooks of the horizontal steel started to open during Cycle 28.

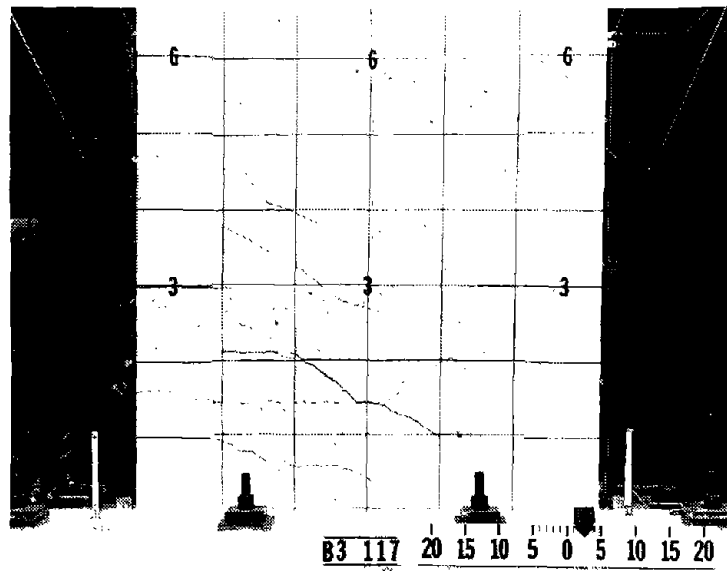
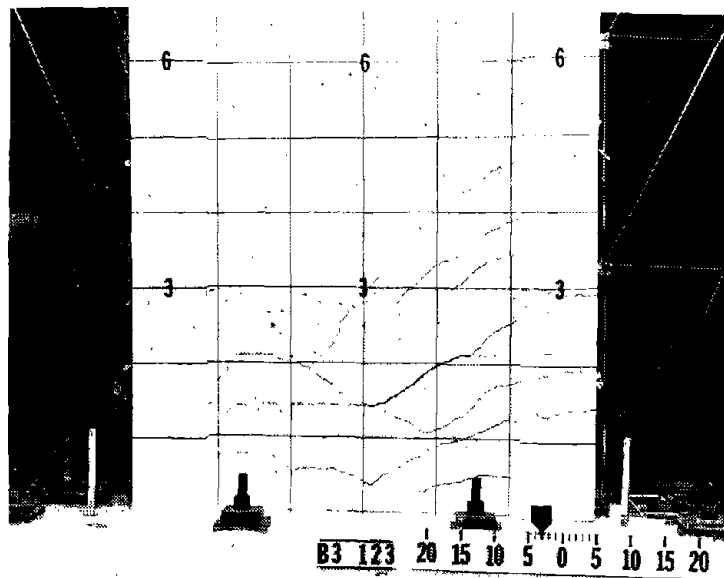
The behavior of Specimen B3 was very similar to the behavior of B1 through the first 21 cycles. However, where as flexural buckling of vertical bars occurred in Cycle 22 for B1, no significant distress was observed in the boundary elements of B3 until Cycle 38. Significant crushing and grinding progressively deteriorated the web concrete after Cycle 28. However, the confinement hoops in the columns

Fig. B-75 Cracking Pattern at +3 in. Deflection for Specimen B3

Fig. B-76 Cracking Pattern at -3 in. Deflection for Specimen B3

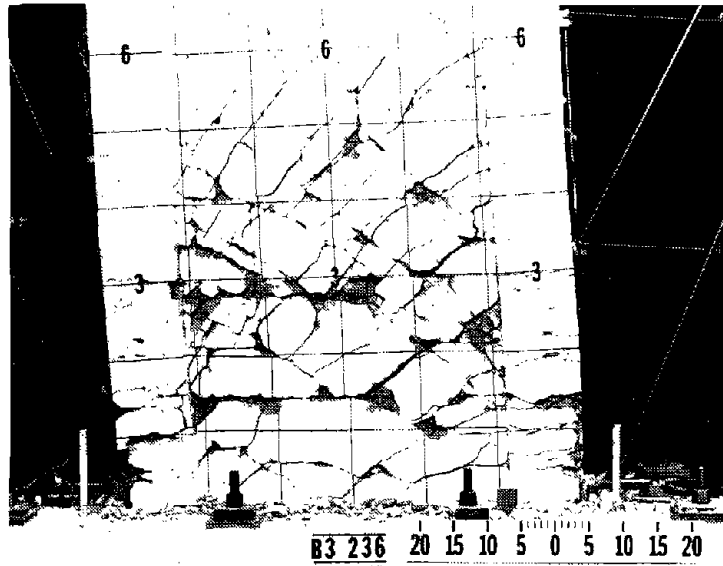
Fig. B-77 Specimen B3 Prior to Bar Fracture

In Cycle 39, a vertical bar fractured at the base while loading the specimen to +7-in. (177.8 mm) deflection. The fractured bar still had concrete cover and no evidence of previous distress, such as buckling, was present. While

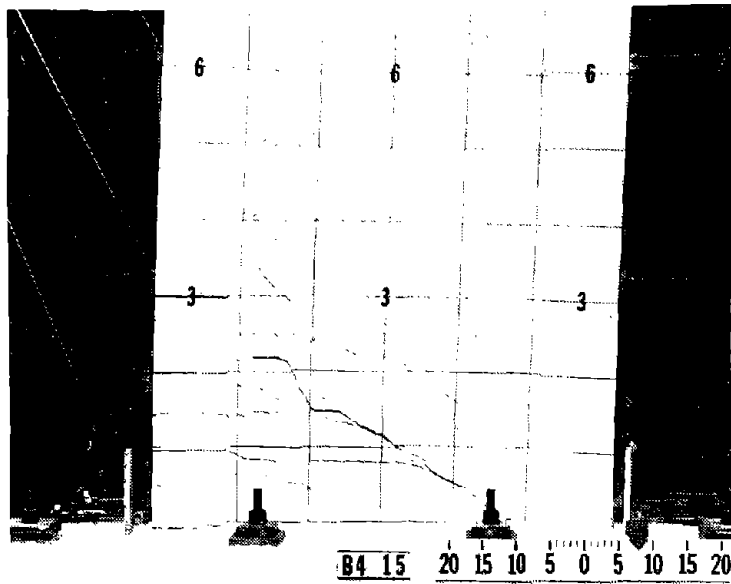
Fig. B-96 Cracking Pattern at +8 in. Deflection for Specimen B4

After Load Stage 10, one diagonal crack started to predominate. As seen in Fig. B-96, this crack extended from

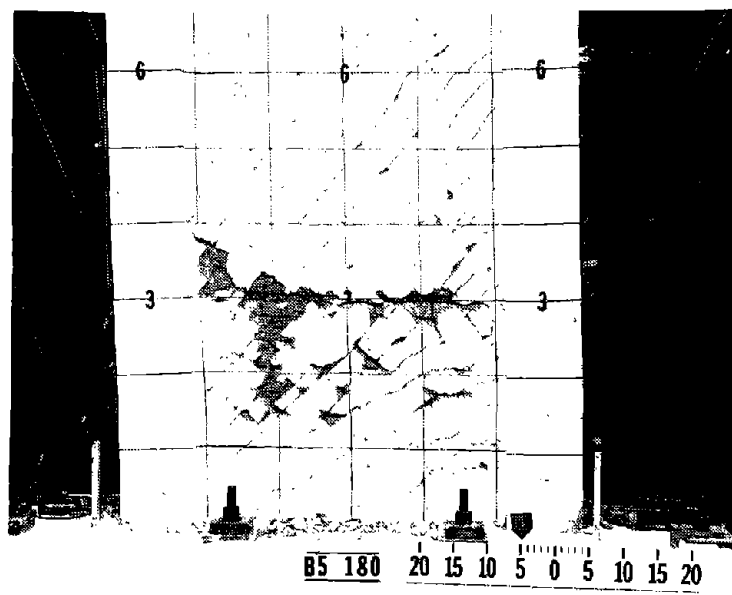
Fig B-139 Specimen B5 After Web Crushing

The maximum load measured, 171.3 kips (761.9 kN), occurred in Cycle 28 at a -5-in. (127.0 mm) deflection. This load corresponds to a nominal shear stress, $v_{\max} = 8.8 \sqrt{f'_c}$ ($0.73 \sqrt{f'_c}$, MPa). As the specimen was being loaded to a -5-in. deflection in Cycle 29, several compression

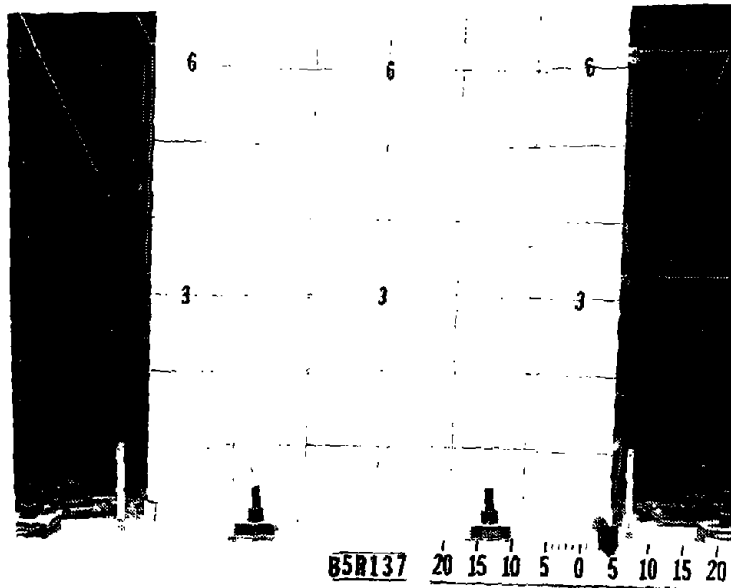
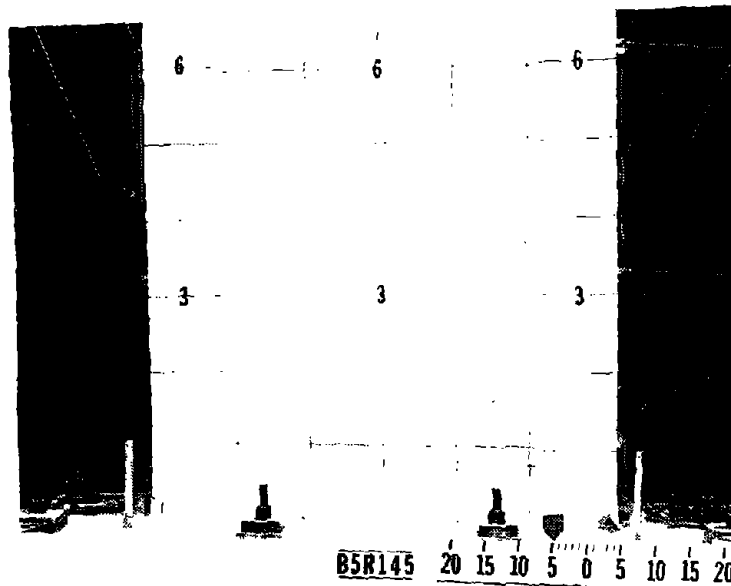
As the concrete was spalling and grinding in Cycles 16 through 28 the maximum measured load in each new increment continued to increase. The maximum measured load, 167.8 kips (746.8 kN), occurred in Cycle 28 at a +6-in. (152.4 mm) deflection. This load was 98% of the maximum measured load in the test of B5. It corresponds to a nominal shear stress, $v_{\max} = 8.9\sqrt{f'_c}$ ($0.74\sqrt{f'_c}$, MPa).

Fig. B-158 Cracking Pattern at +5 in. Deflection for Specimen B5R

Fig. B-159 Cracking Pattern at -5 in. Deflection for Specimen B5R

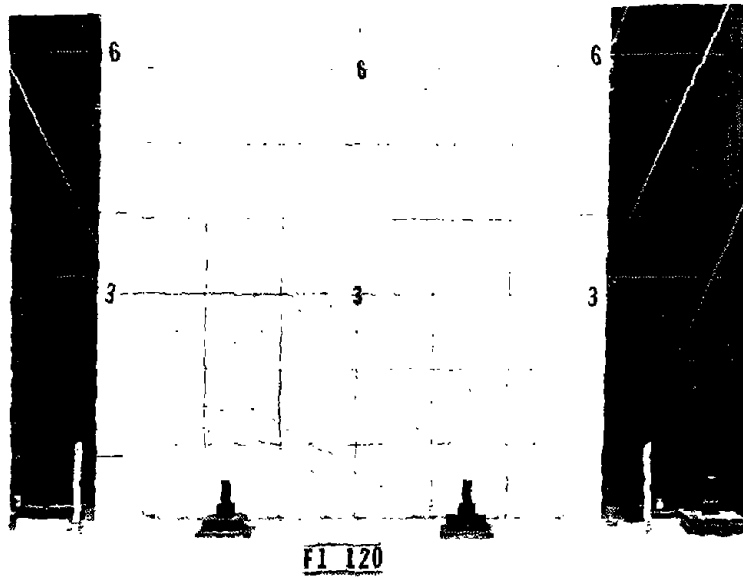
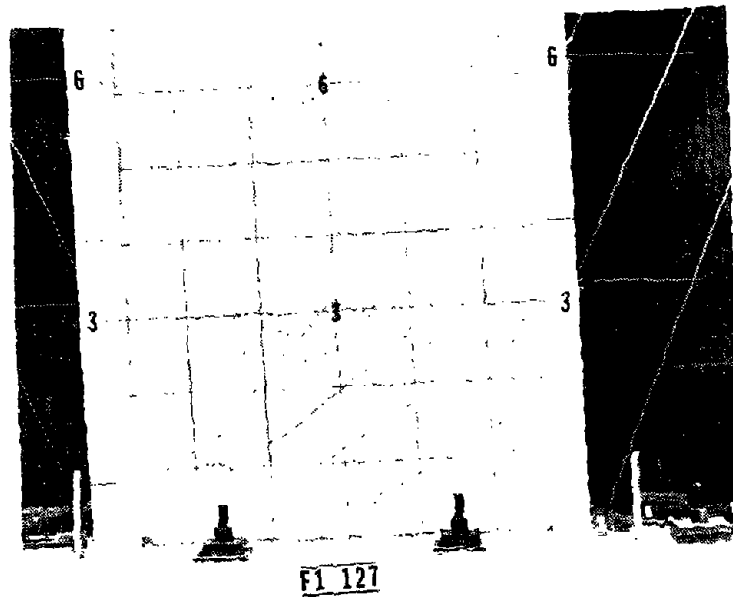
The crack pattern that developed in the lower 6 ft (1.83 m) was similar to the patterns in B2, B5 and B5R with the following exception. The focal point of the "fan" pattern was slightly lower in F1. Also, the cracks in F1 converged closer together in the 4-in. (101.6 mm) web near the base than did the cracks in the barbell sections. The crack pattern is shown in Figs. B-171 and B-172 at +3-in. (76.2 mm) and -3-in. deflection, respectively.

Fig. B-171 Cracking Pattern at +3 in. Deflection for Specimen F1

Fig. B-172 Cracking Pattern at -3 in. Deflection for Specimen F1

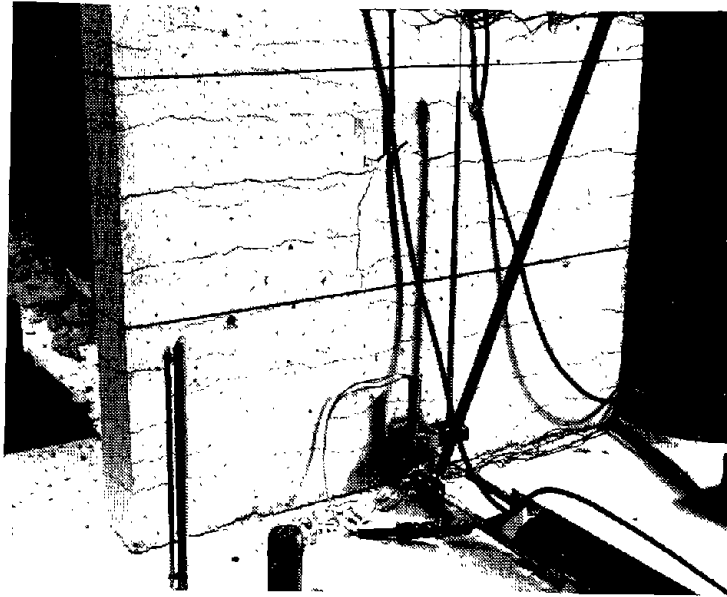
Fig. B-173 Cracking Pattern in Flange of Specimen F1

While loading the specimen to a -4-in. deflection, the steepest diagonal strut that intercepted the base crushed and slipped along a crack from the opposite direction loading at a point 1 ft (0.30 m) above the base. The flange hinged to allow this slip. This immediately transferred additional load to lower struts. These struts then simultaneously slipped and crushed along a horizontal plane 1 ft above the base. The wall immediately before and after web crushing is shown in Figs. B-172 and B-174.
