CALIFORNIA INSTITUTE OF TECHNOLOGY
EARTHQUAKE ENGINEERING RESEARCH LABORATORY

ENGINEERING DATA AND ANALYSES OF THE WHITTIER,
CALIFORNIA EARTHQUAKE OF JANUARY 1, 1976

Ahmed M. Abdel-Ghaffar

EERL 77-05

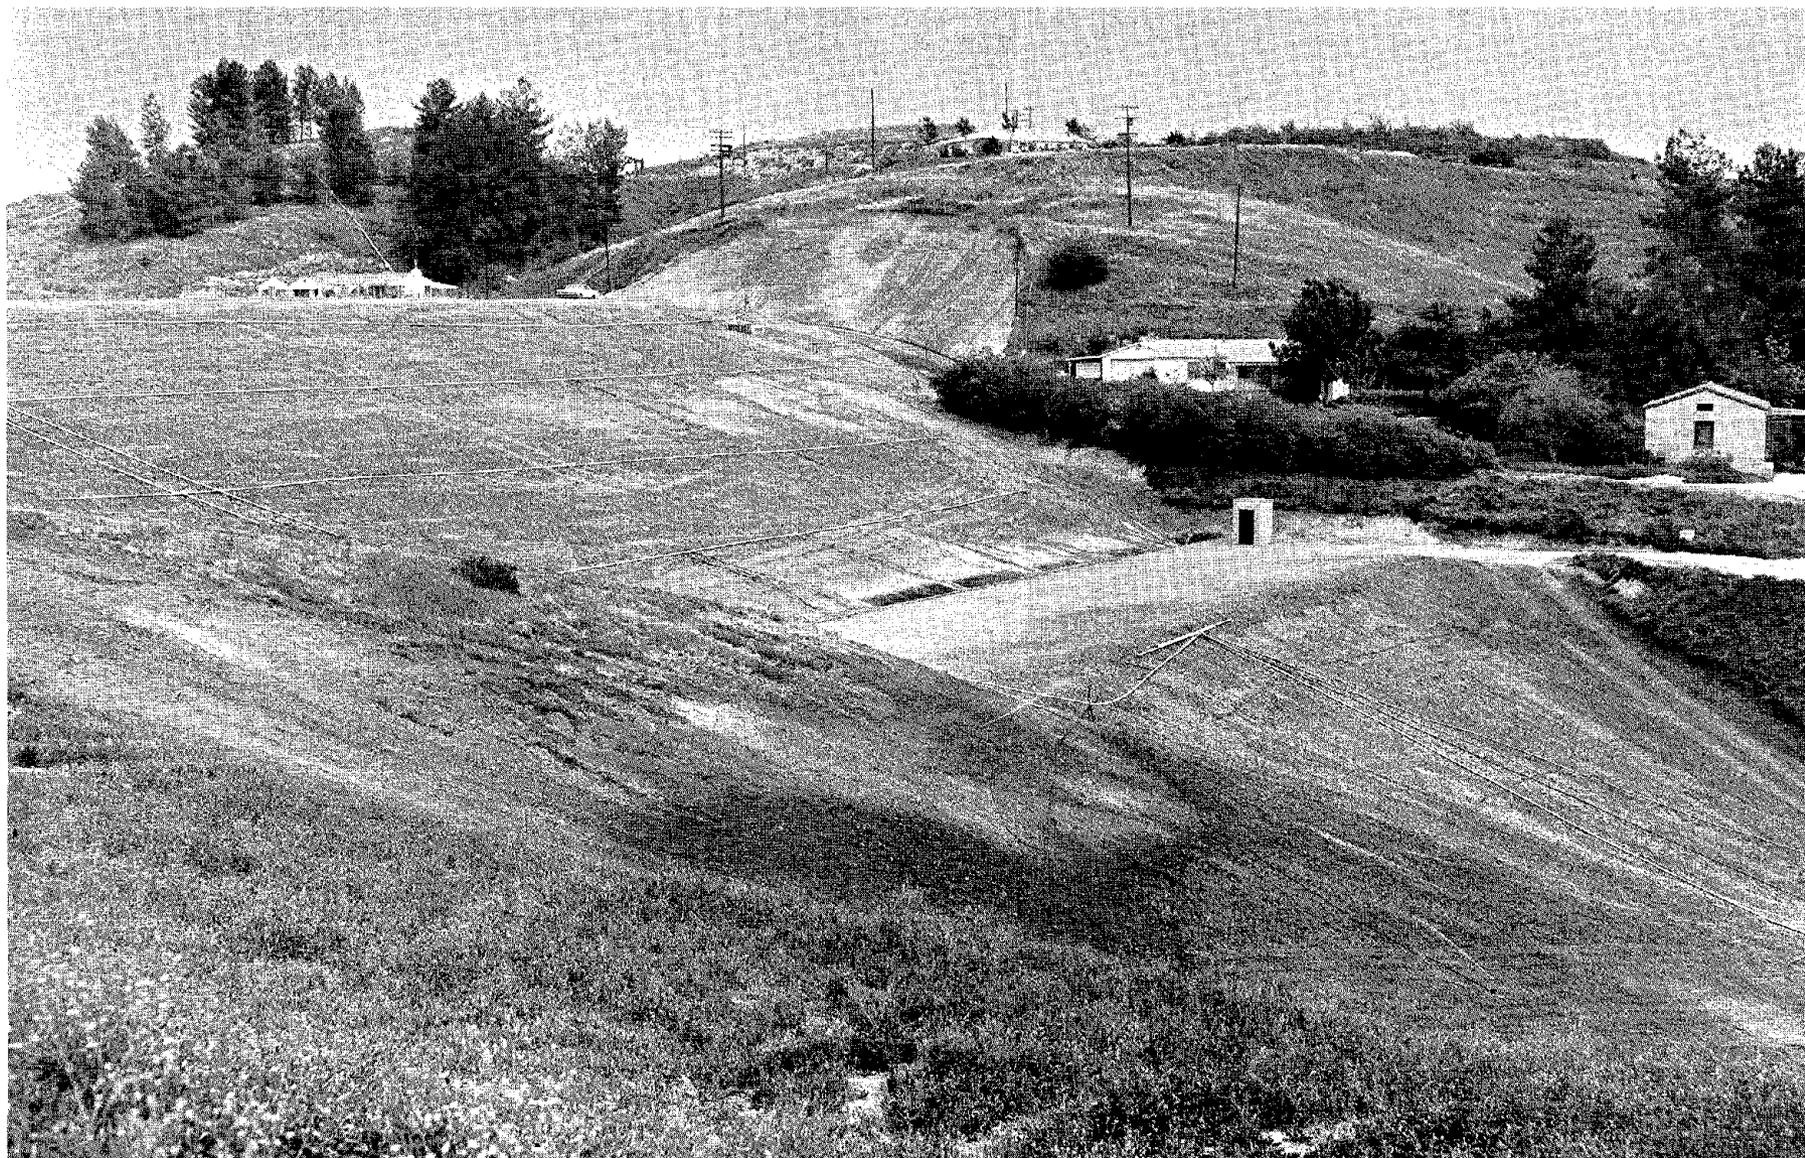
Fig. 104 Orange County Reservoir, Accelerograph in Small
White House on the Berm
