DYNAMIC TESTS OF A REINFORCED CONCRETE BUILDING

T. V. Galambos and R. L. Mayes

Final Report to the National Science Foundation

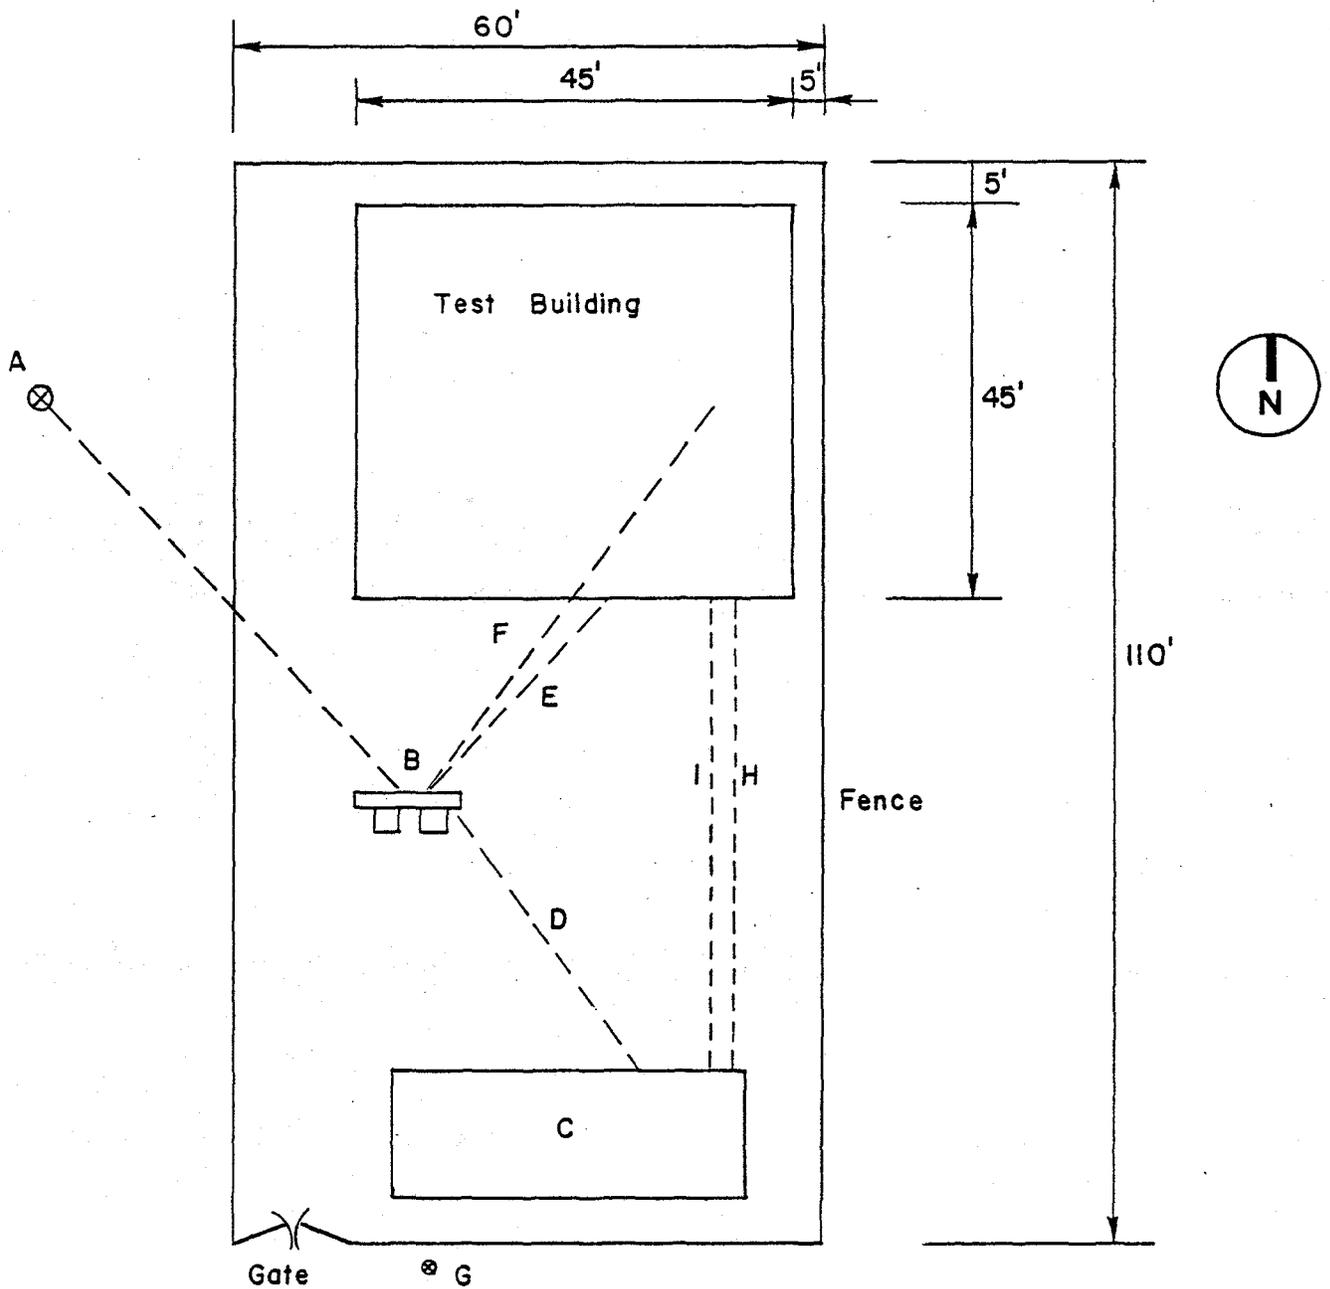
Fig. 45 The Test Site

- A : Union Electric power terminal and transformer
- B : Sachs Electric switch boxes and support on ground level
- C : Instrumentation trailer
- D : 110/220V lines to trailer
- E : 440V line to 11th floor, outside of building
- F : 110/220V lines to building, running up stair-well
- G : Telephone terminal
- I, H : Control, communication and accelerometer connections to building

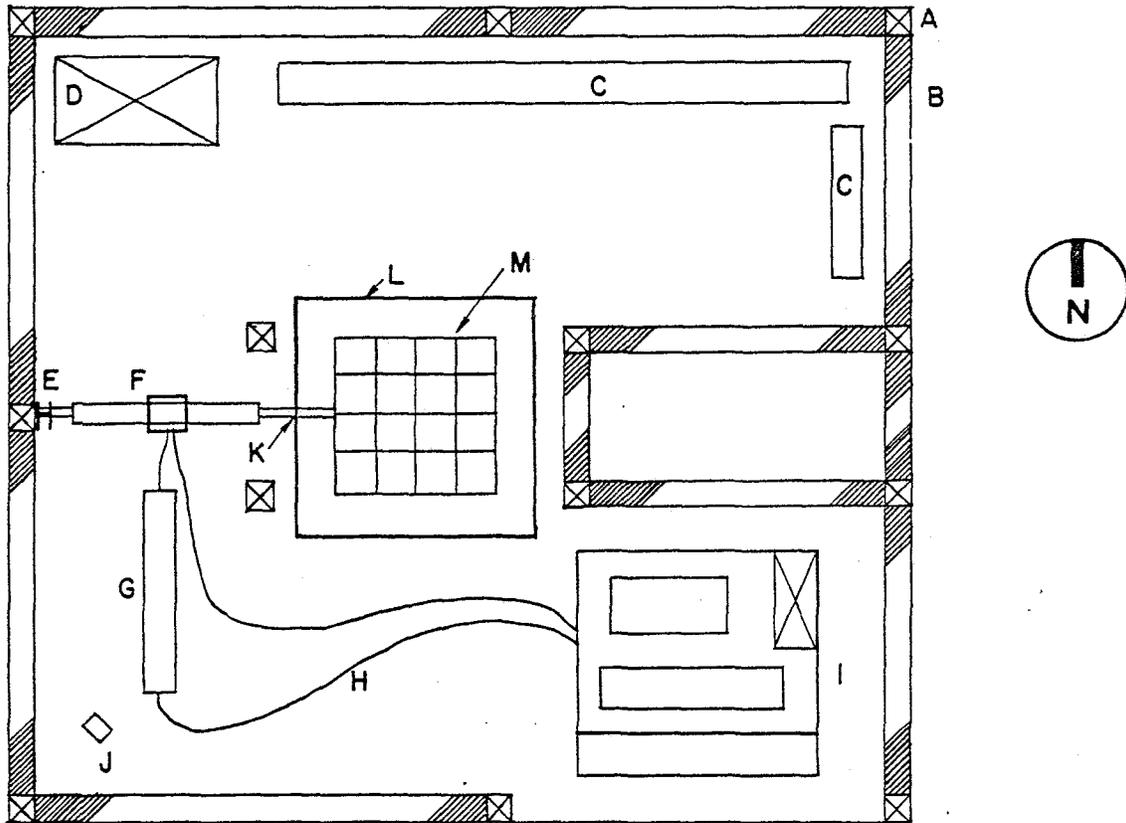
Fig. 46 Large Amplitude Shaker Assembly on 11th Floor, E-W Shaking

- A : Column
- B : Wall
- C : Stored lead ingots
- D : Tool storage
- E : Hydraulic actuator attachment to Building
- F : Hydraulic actuator
- G : Accumulator
- H : Hydraulic lines
- I : Pump-motor assembly
- J : TV Camera
- K : Piston
- L : Stiffened base plate
- M : Moving mass box

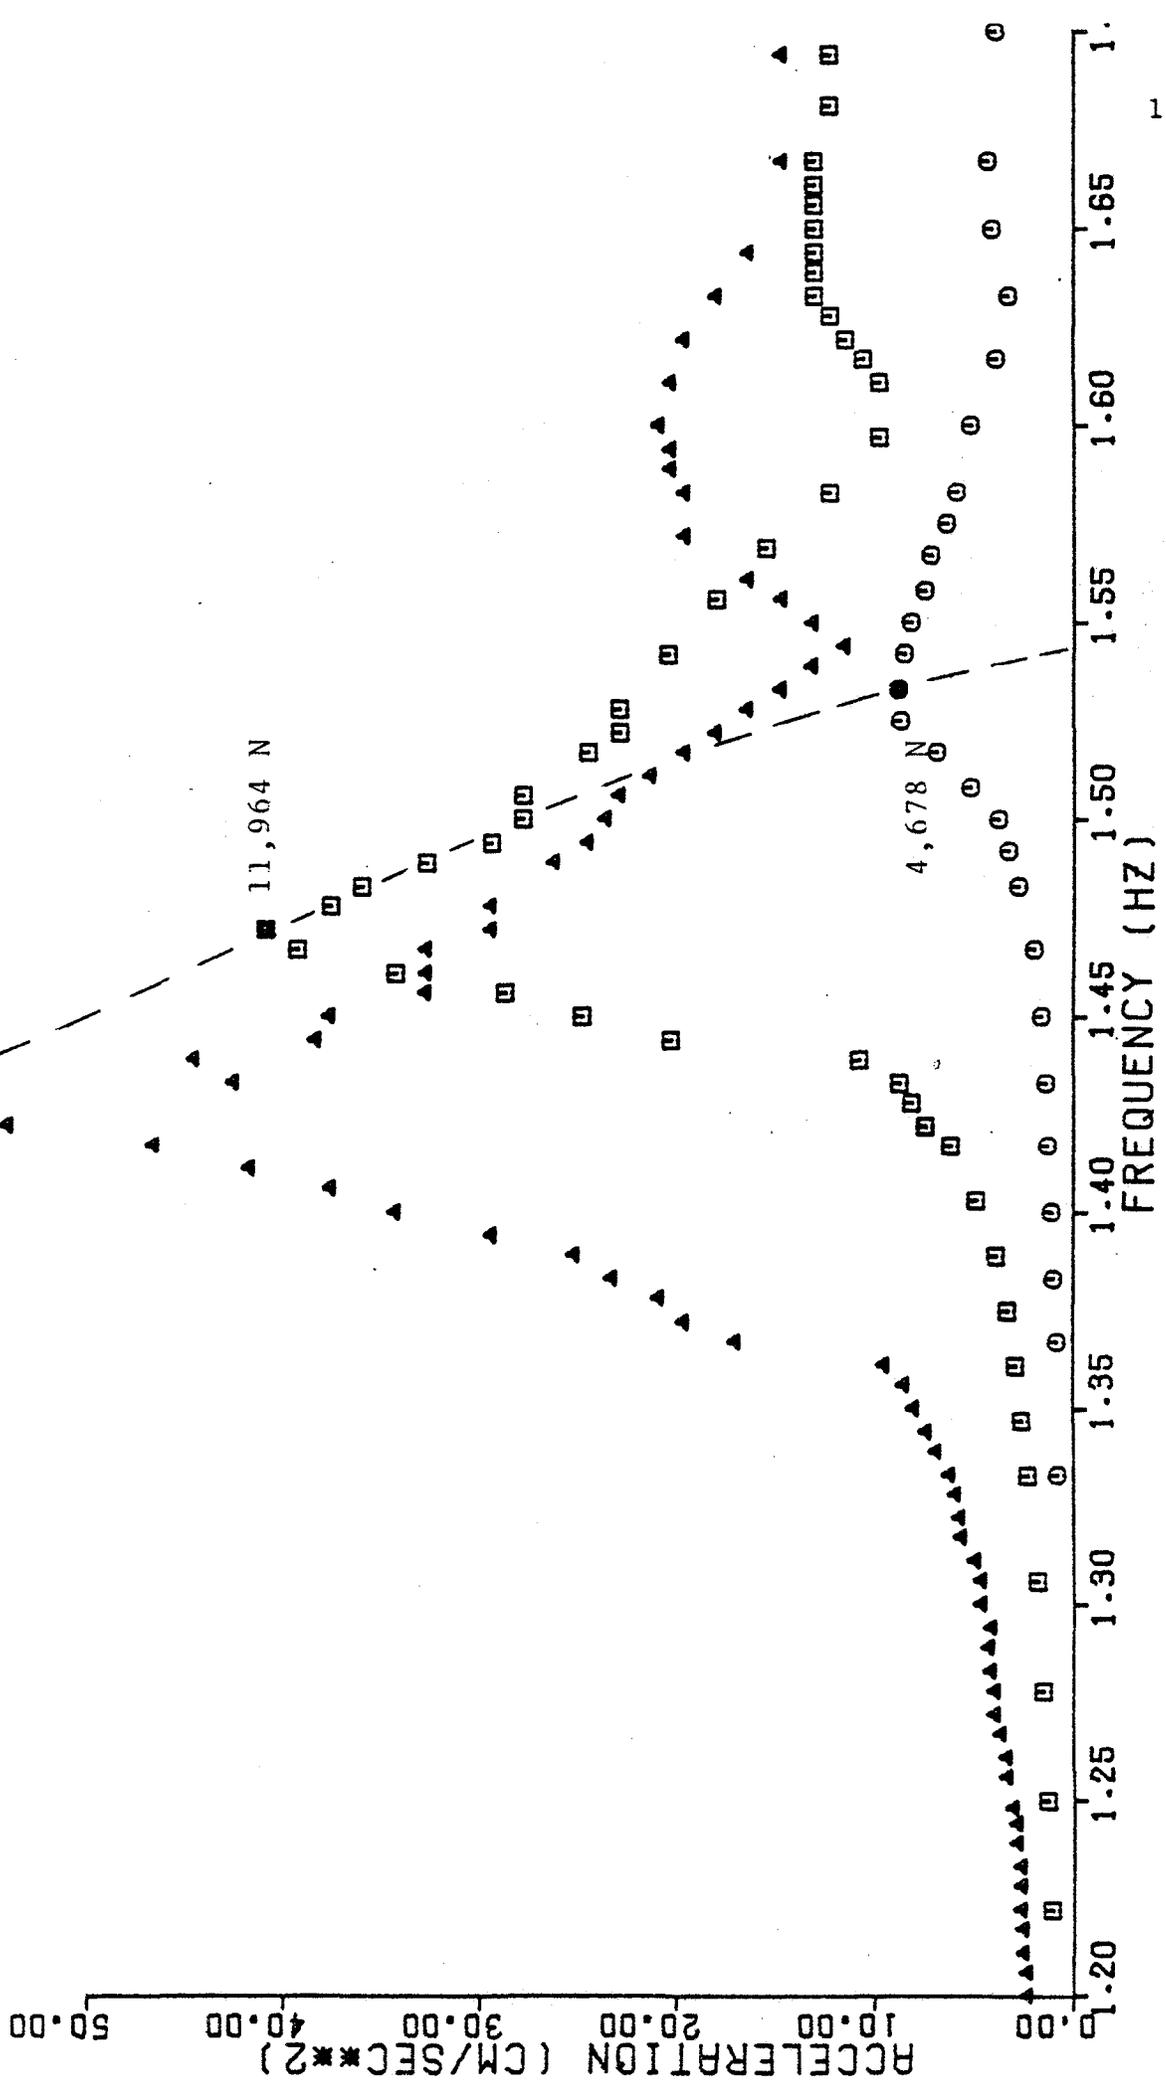
- CHANNEL NO. 4. TEST 1. RUN 1
- CHANNEL NO. 4. TEST 1. RUN 2
- ▲ CHANNEL NO. 4. TEST 7. RUN 2

Fig. 102 E-W Resonant Frequency Trends at Various Force Levels (Small Amplitude Shaking).

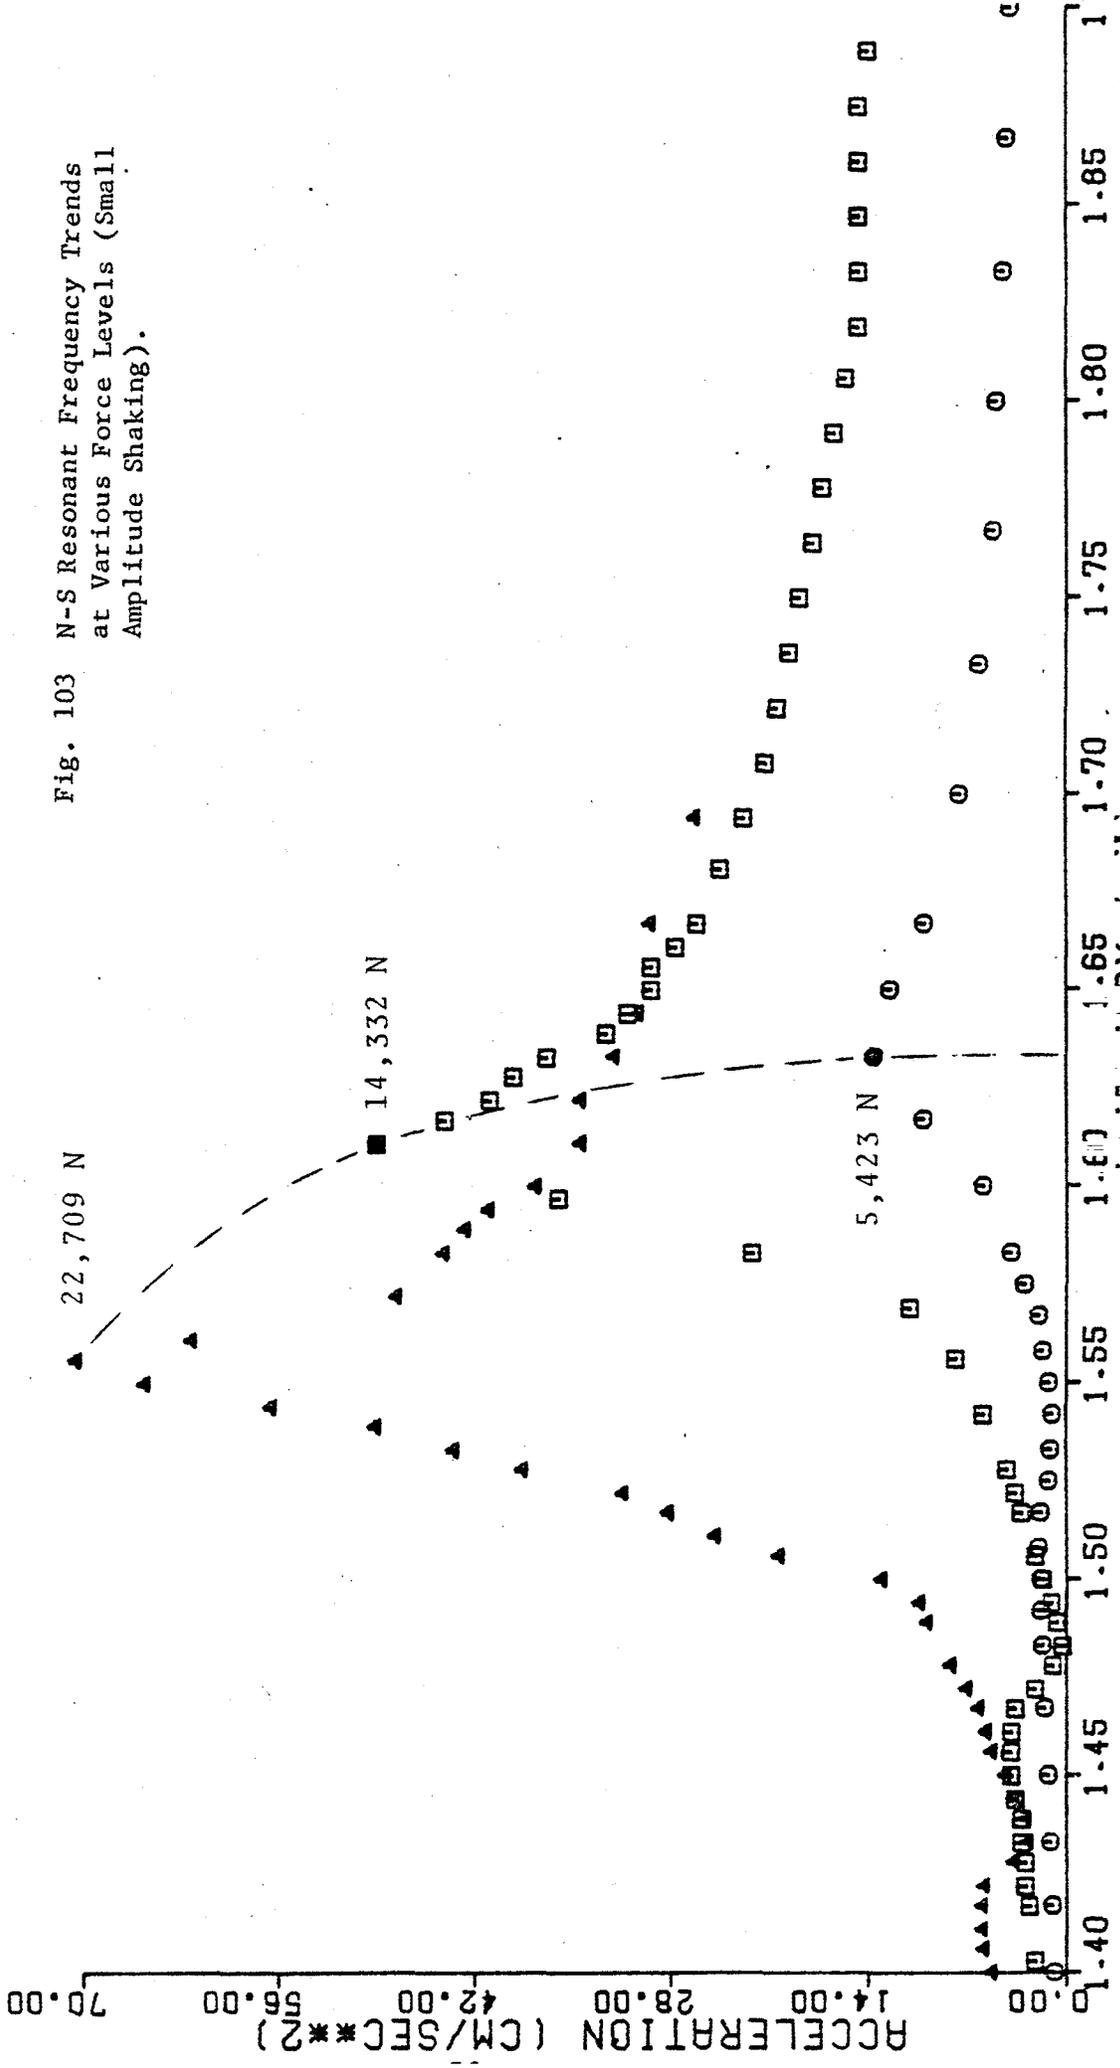
- CHANNEL NO. 3. TEST 1. RUN 1
- CHANNEL NO. 3. TEST 1. RUN 2
- ▲ CHANNEL NO. 3. TEST 7. RUN 2

Fig. 103 N-S Resonant Frequency Trends at Various Force Levels (Small Amplitude Shaking).

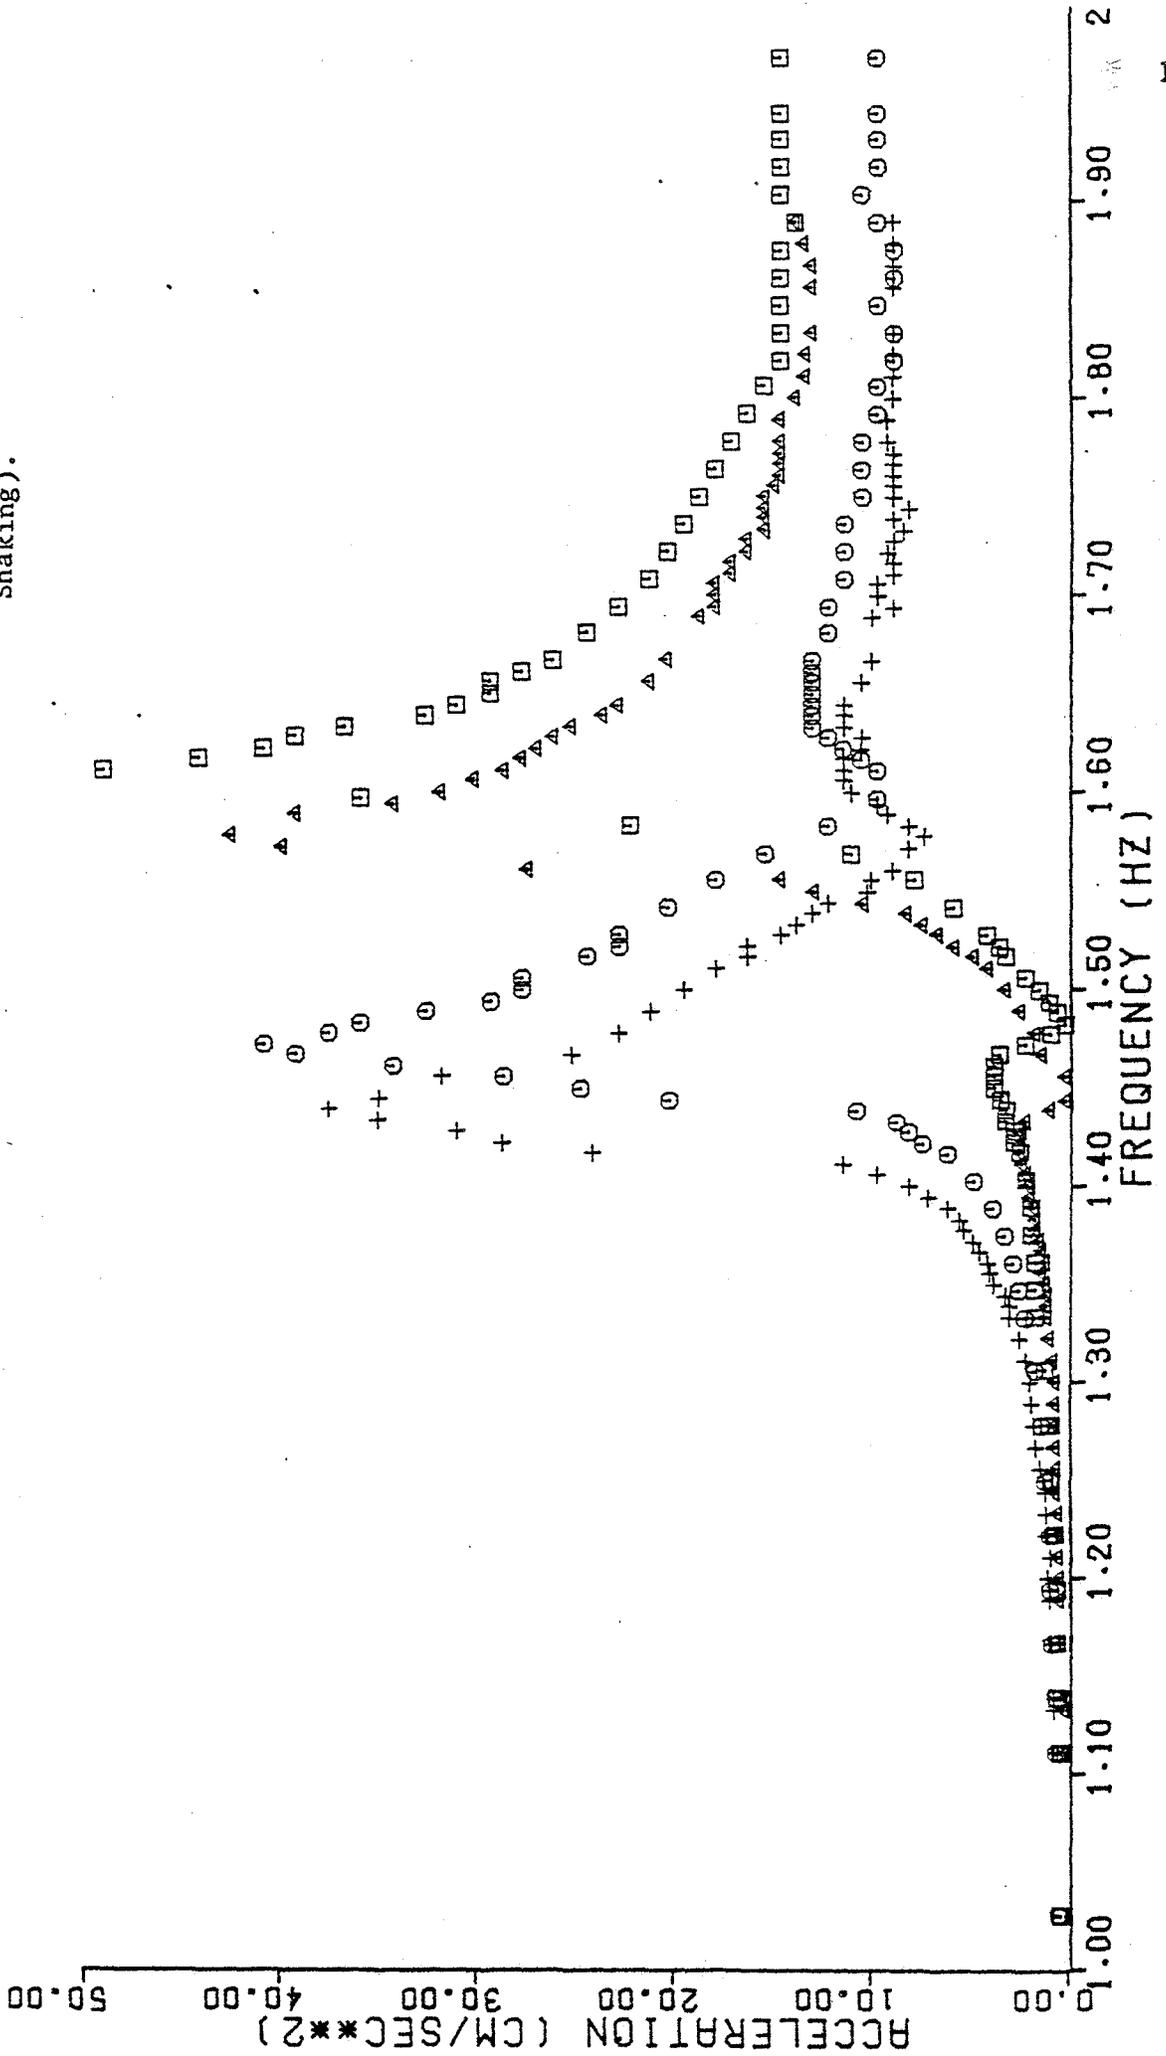
- CHANNEL NO. 3. TEST 1. RUN 1
- CHANNEL NO. 4. TEST 1. RUN 1
- △ CHANNEL NO. 3. TEST 7. RUN 1
- + CHANNEL NO. 4. TEST 7. RUN 1

Fig. 104 E-W and N-S First Mode
Resonant Frequency Trends
over Time (Small Amplitude
Shaking).

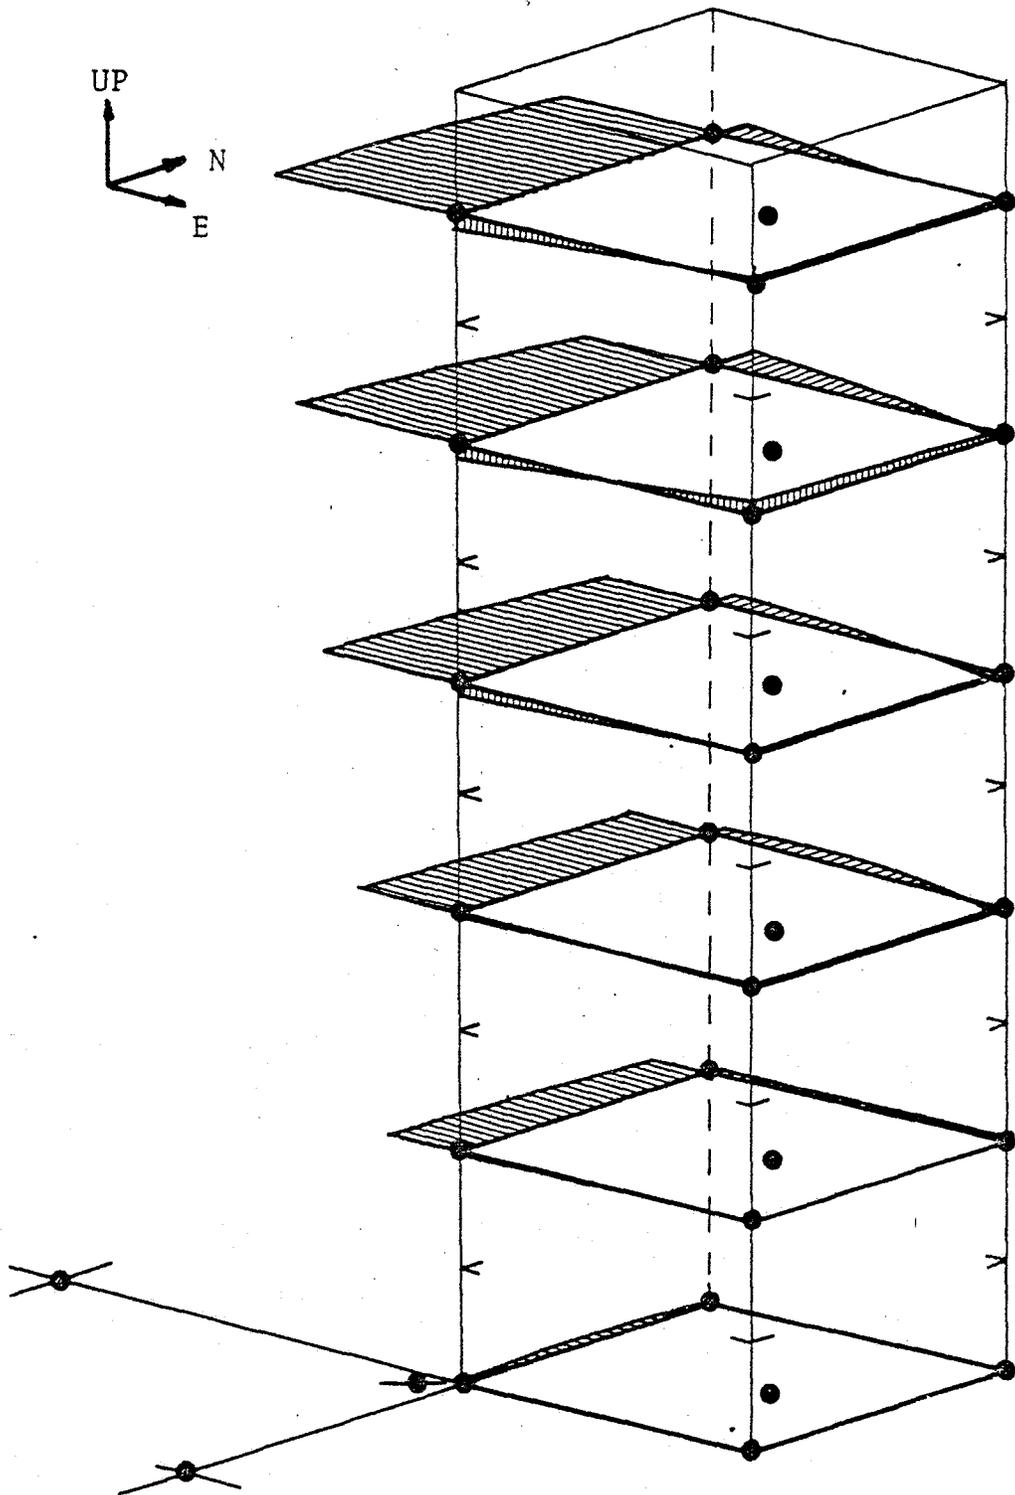
Fig. 105. Response Shape at 1.51 Hz
(Small Amplitude Tests).

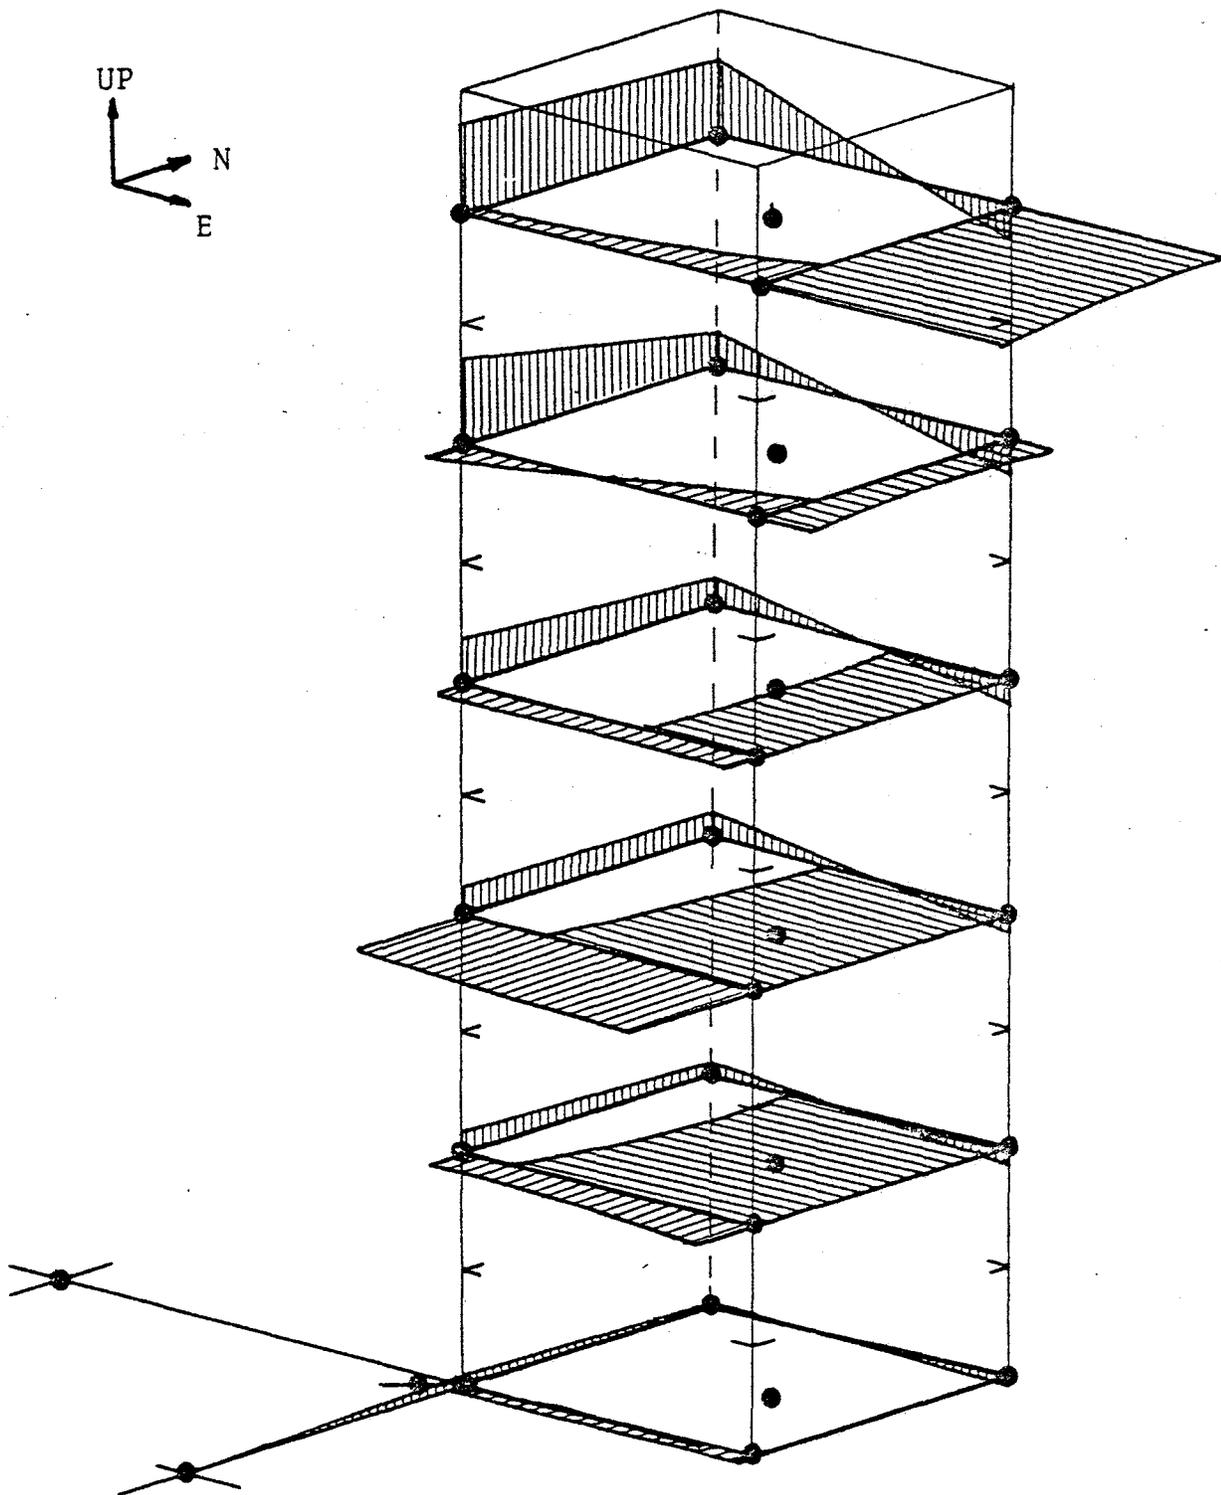
Fig. 106 Response Shape at 4.7 Hz
(Small Amplitude Tests)

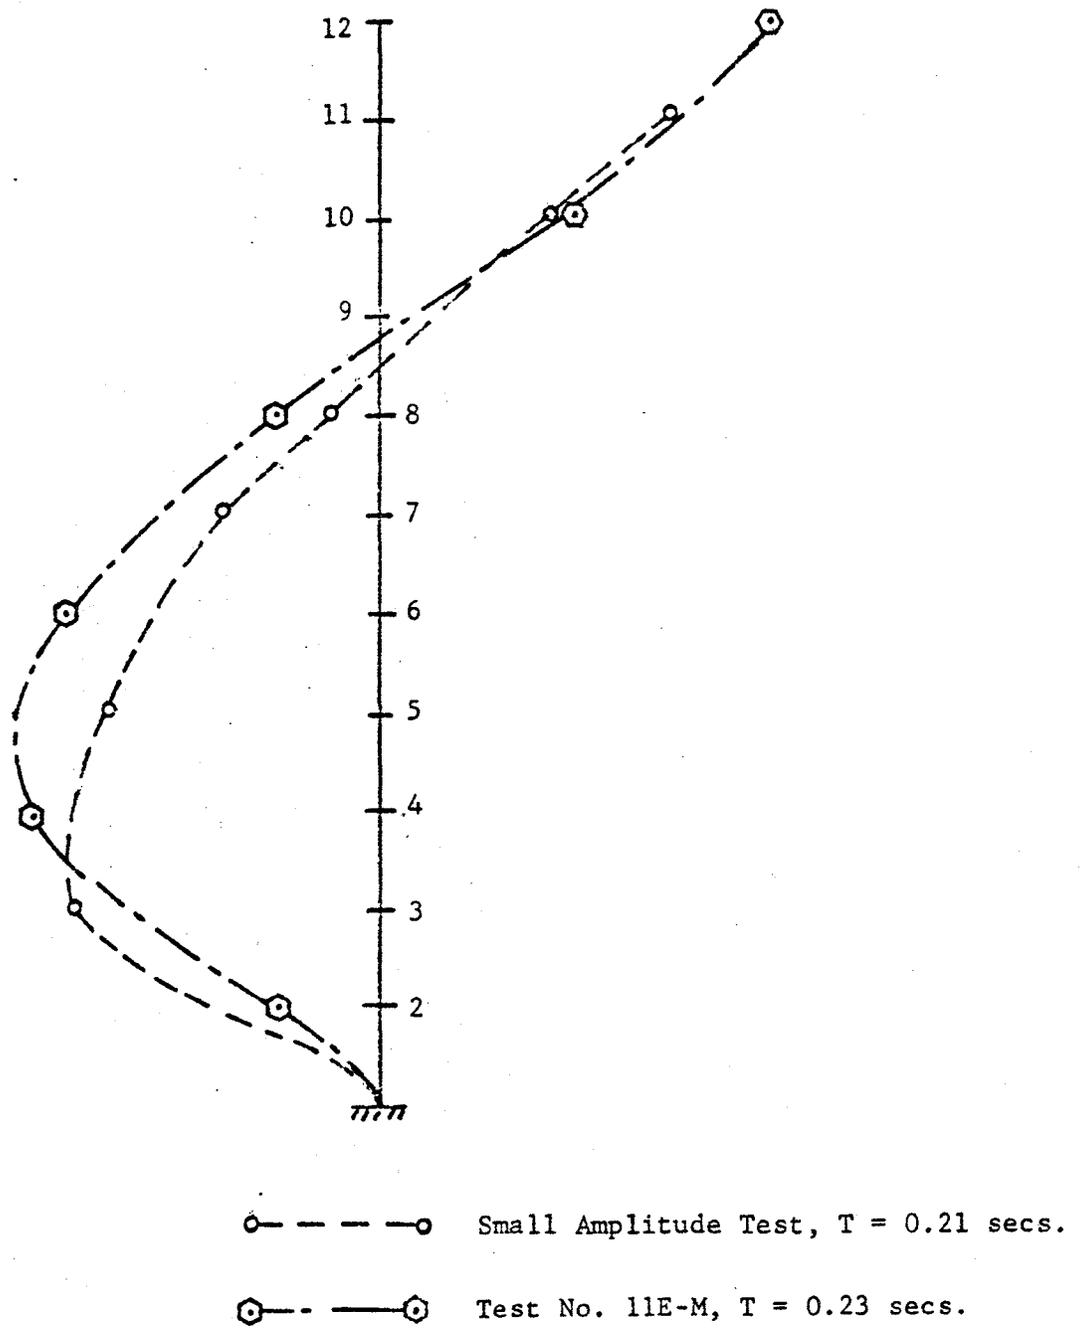
Fig. 107 Comparison of Small and Large Amplitude Mode Shapes - Second EW Translational Mode.

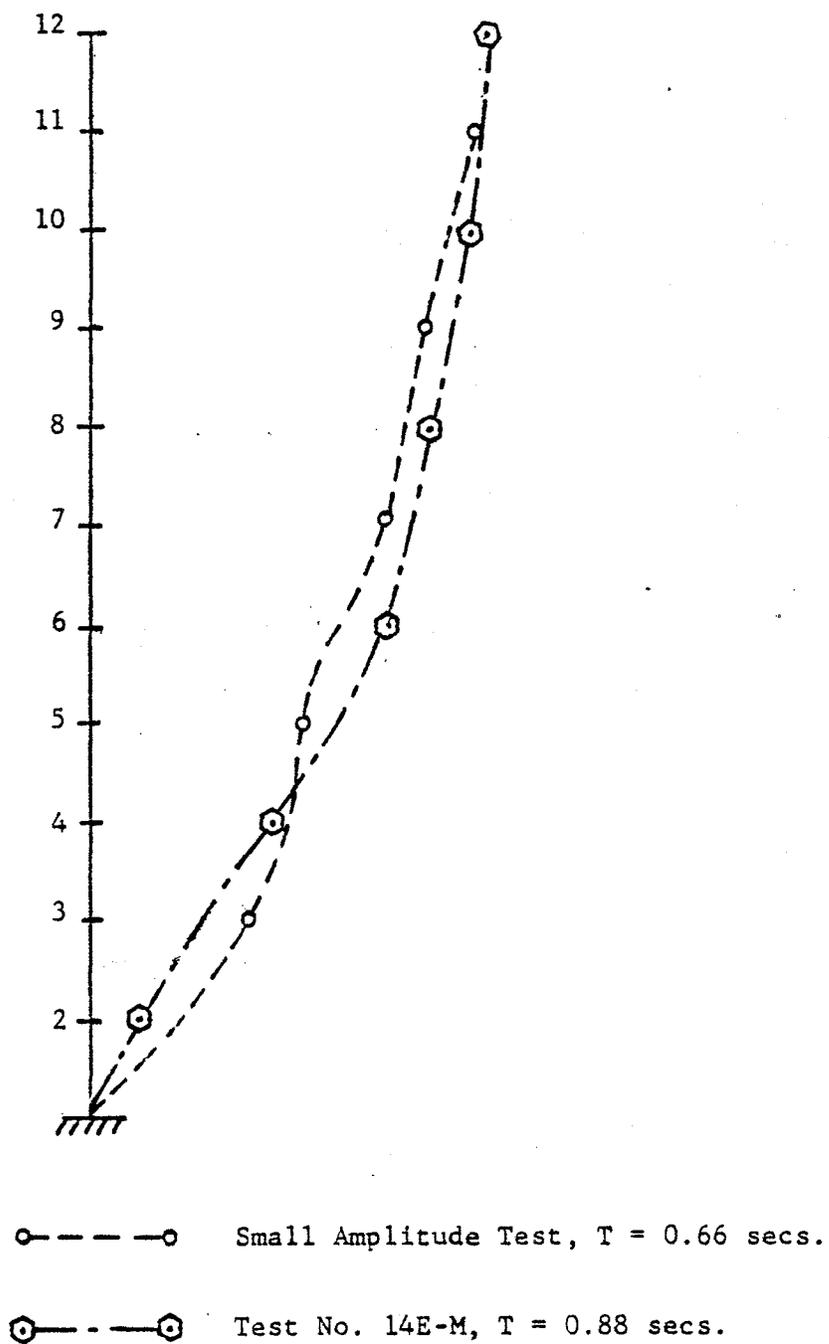
Fig. 108 Comparison of Small and Large Amplitude Mode Shapes - First EW Translational Mode.

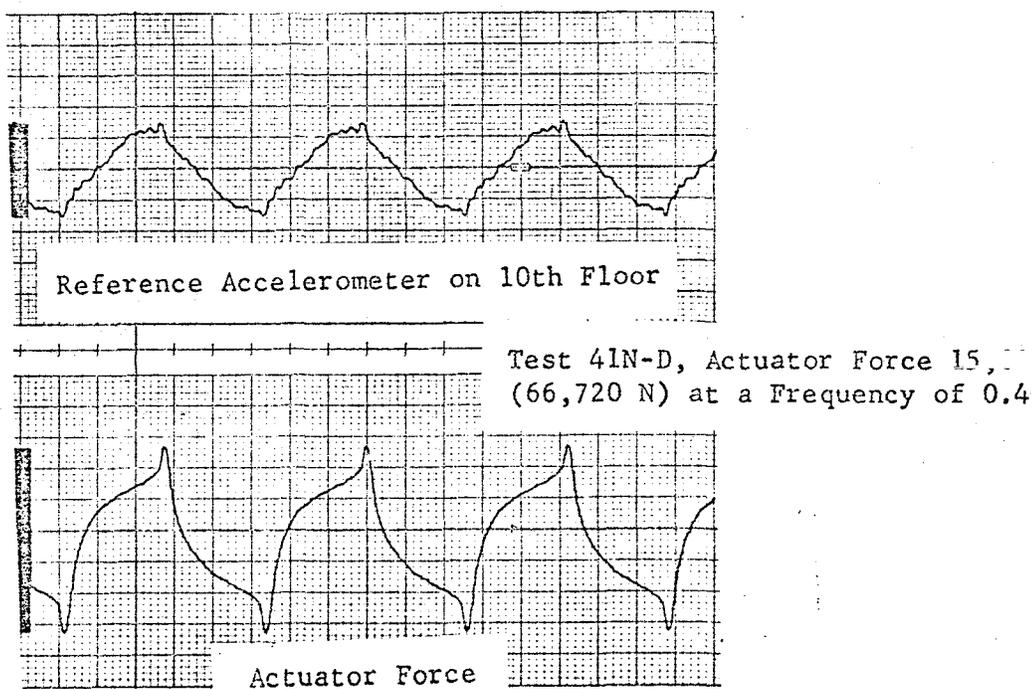
Test 41N-D, Actuator Force 15,000 lb
(66,720 N) at a Frequency of 0.4 Hz.

Fig. 117 Shape of Actuator Force and Measured 10th Floor Acceleration Response for Large Amplitude First Mode Tests.

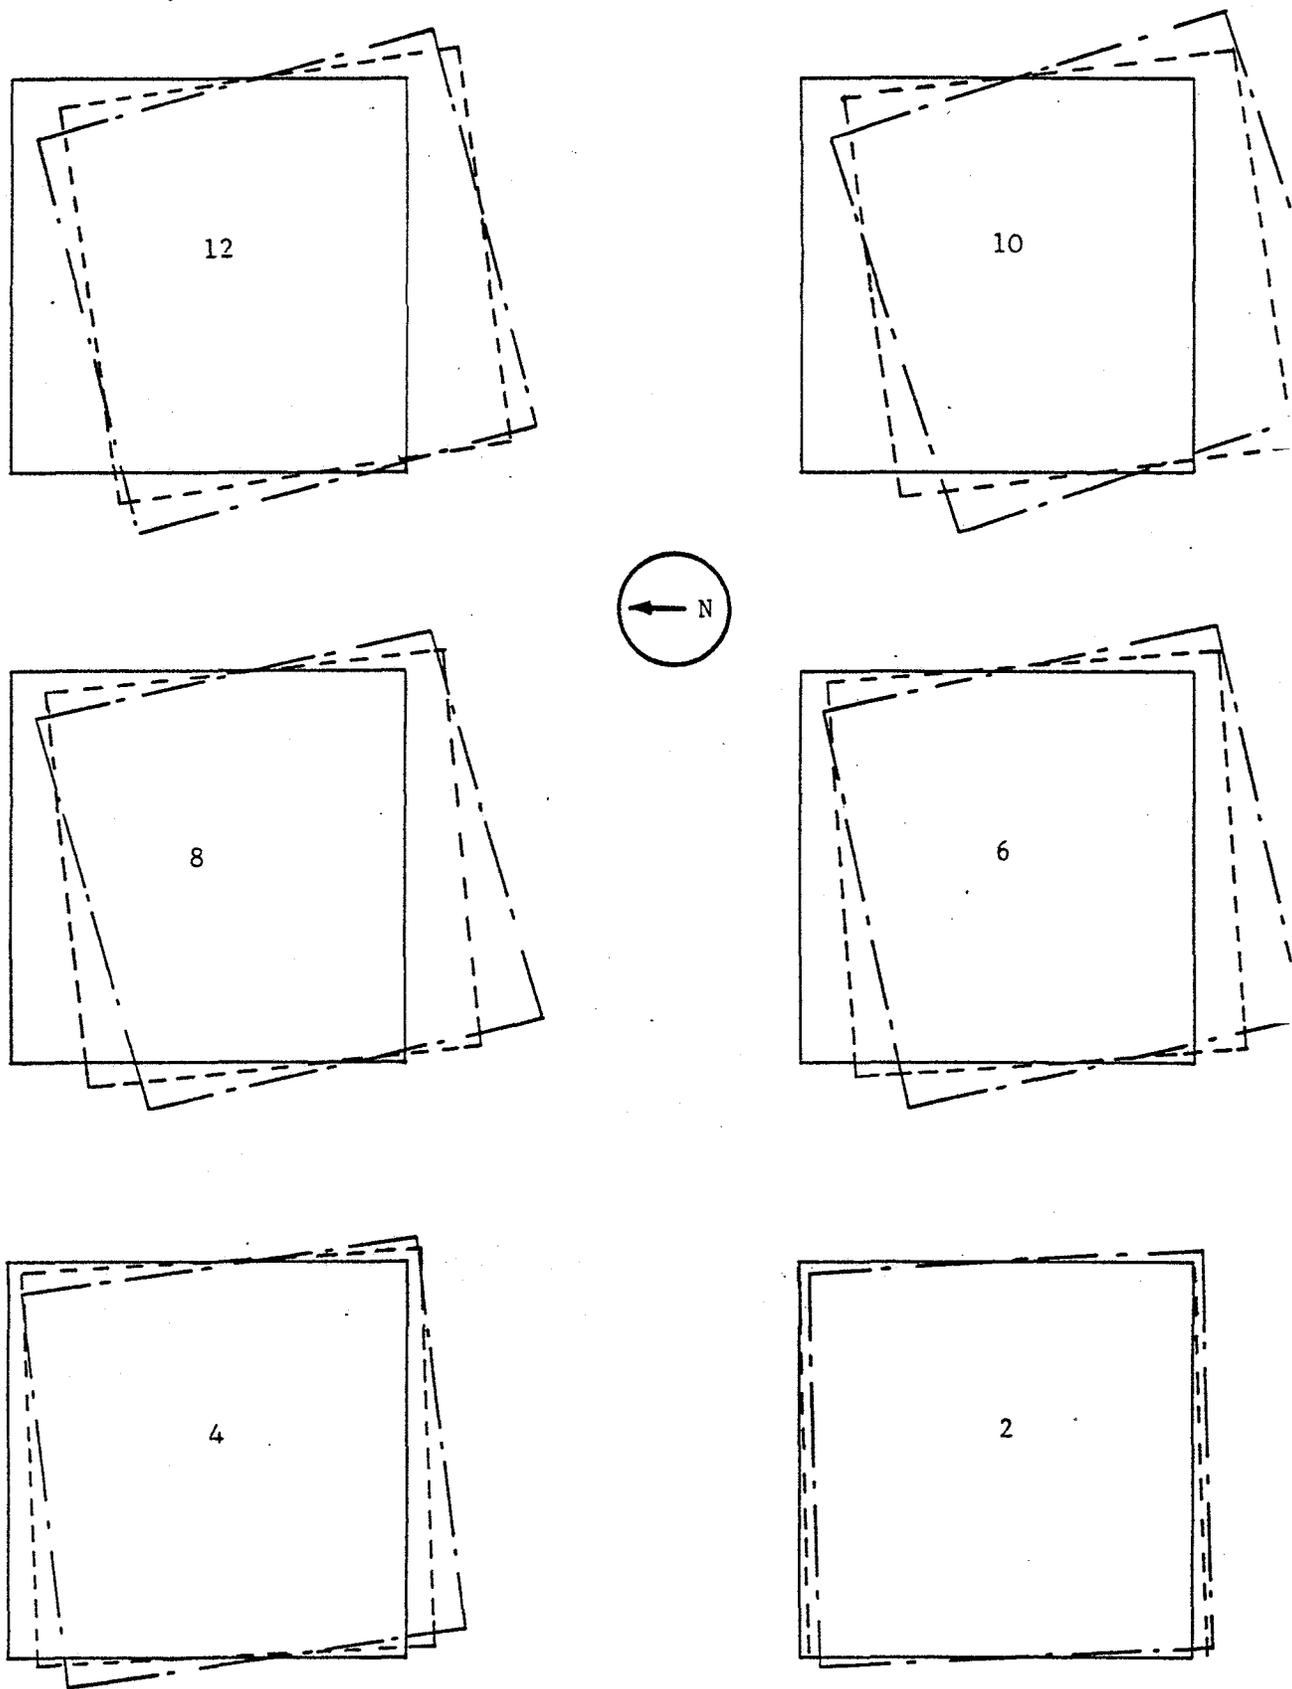
Test 5N-M; T=1.22sec ————

Analytical; T=0.93sec - - - - -

Fig. 124 (a); Comparison of Experimental and Analytical Results.
First NS Translational Mode -- Floor Components.

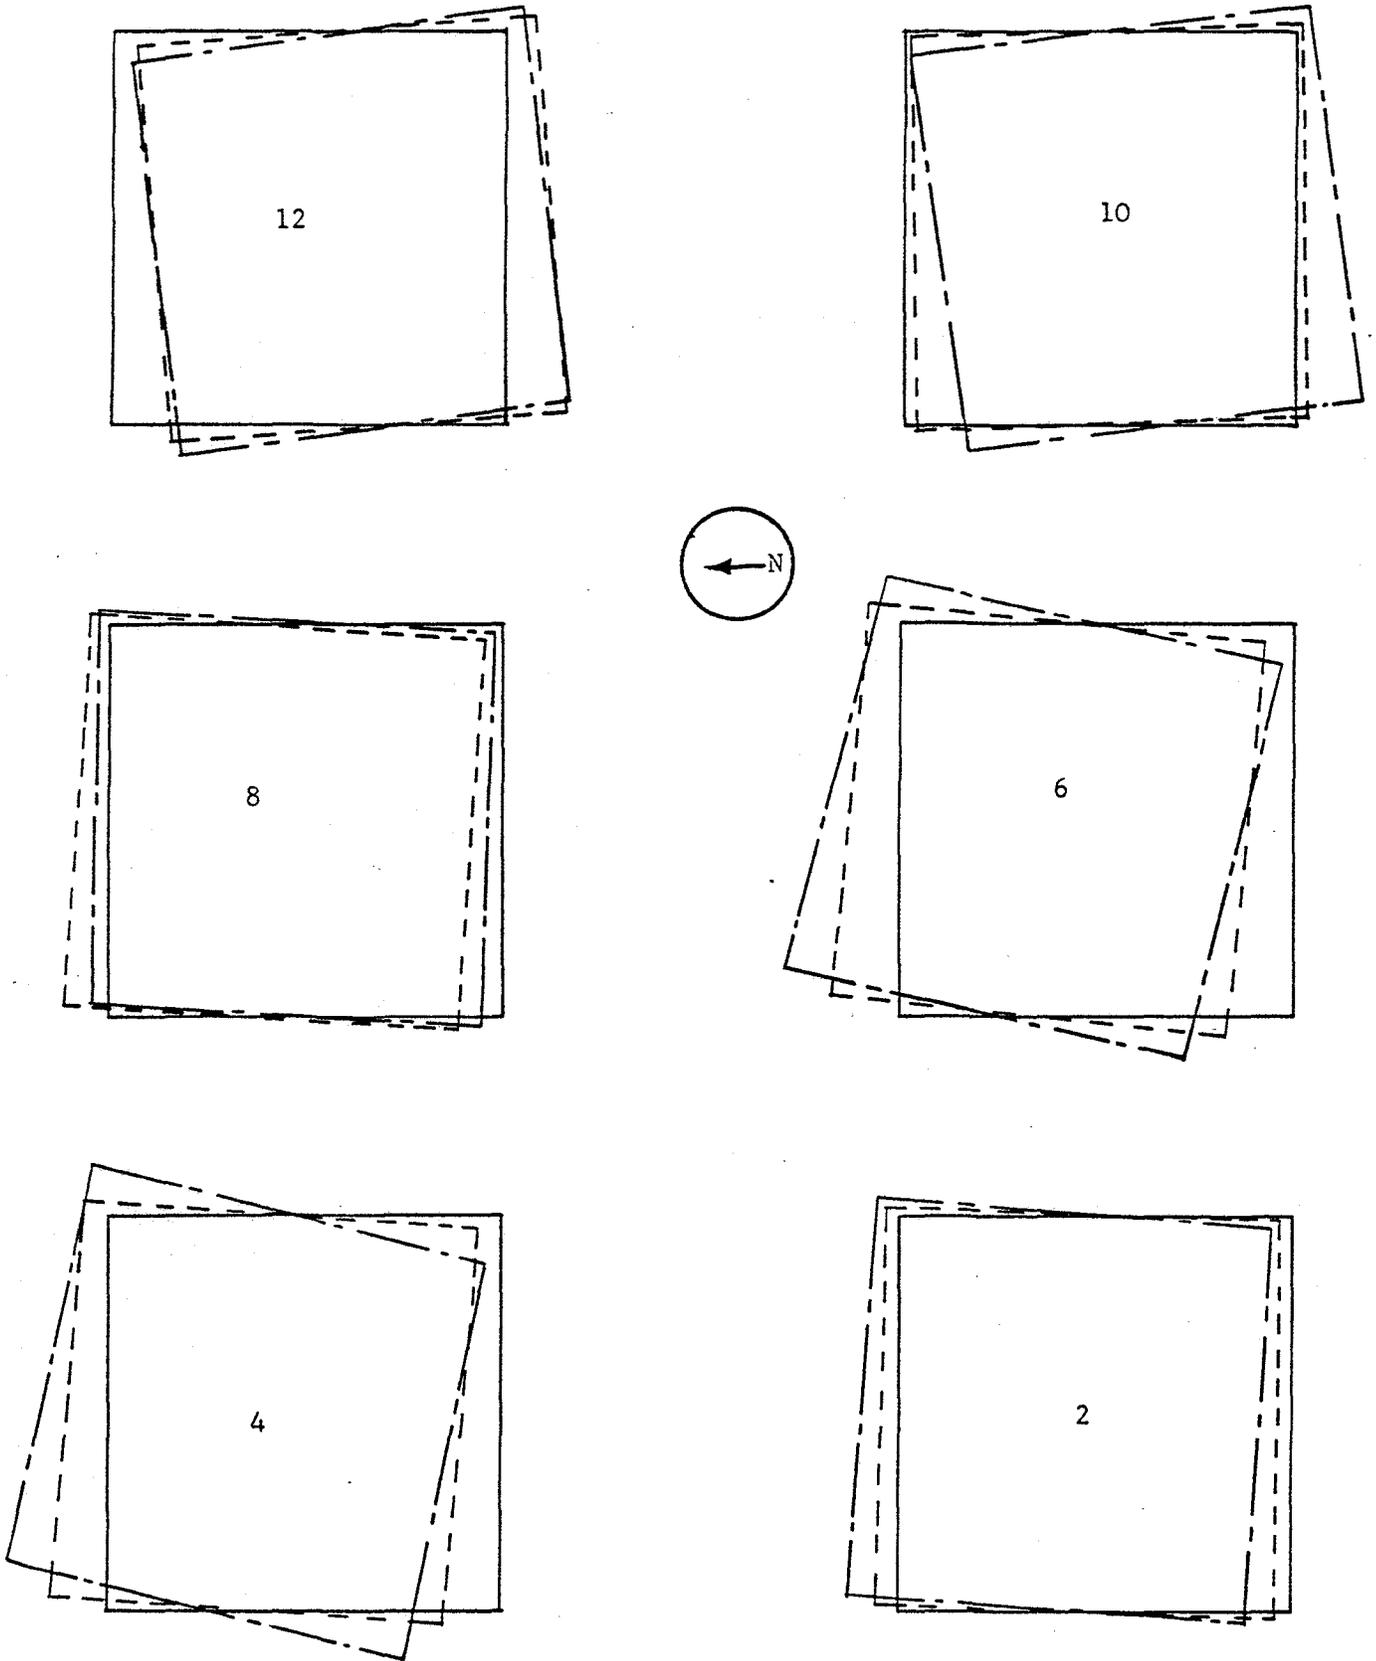
Fig. 126 (a) Comparison of Experimental and Analytical Results.
Second NS Translational Mode -- Floor Components
