STRENGTHENING OF REINFORCED CONCRETE COLUMNS  
FOR EARTHQUAKE RESISTANCE

Lawrence F. Kahn  
School of Civil Engineering  
Georgia Institute of Technology  
Atlanta, Georgia 30332

June 1979

Final Report

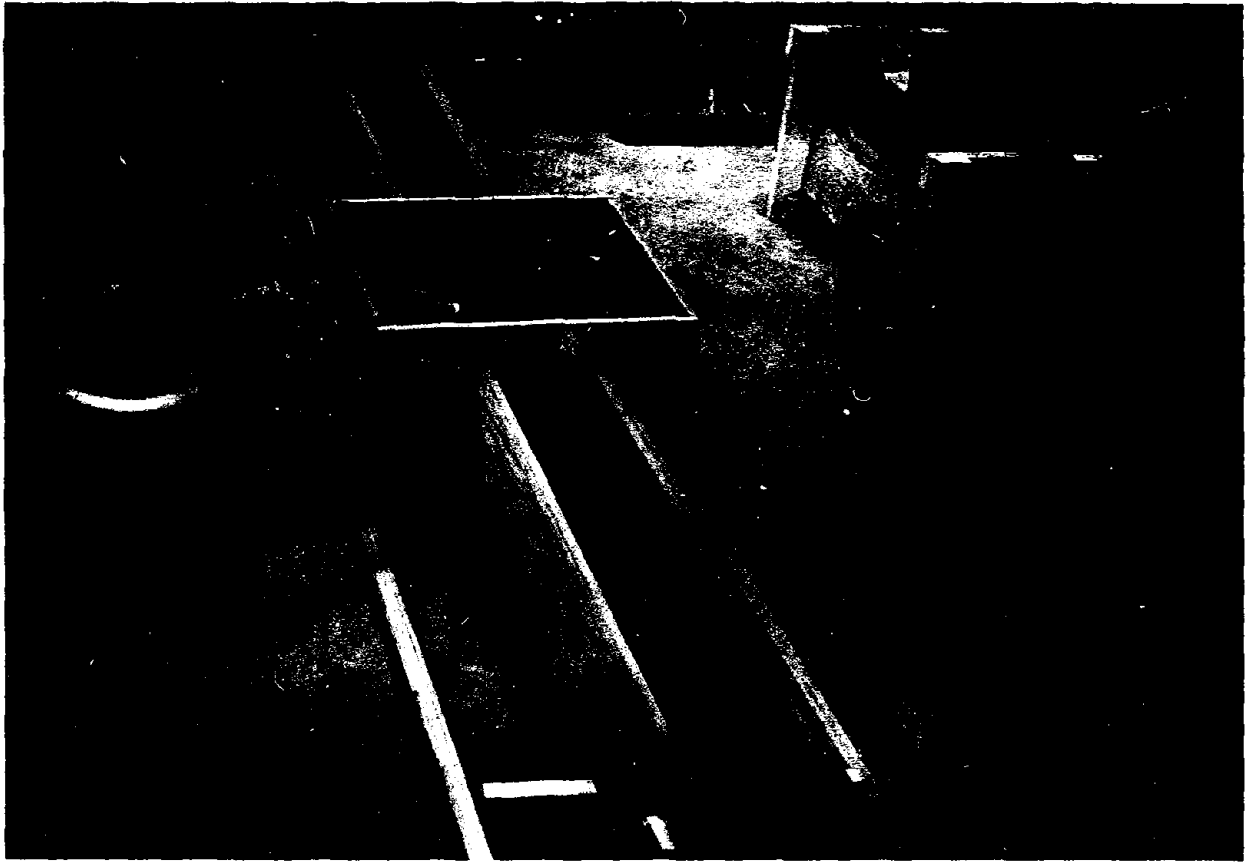
Figure 2.3 Typical form for column specimens.

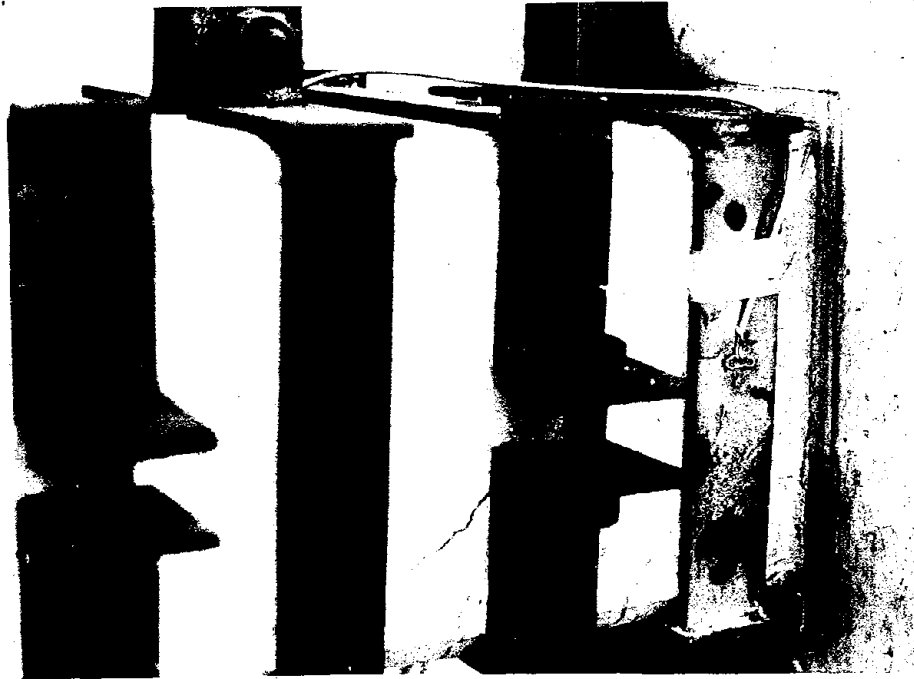
Figure 2.15 Specimen 4, strain gage on U-clamp nearest the joint face. Photograph was taken after deflection sequence was completed.

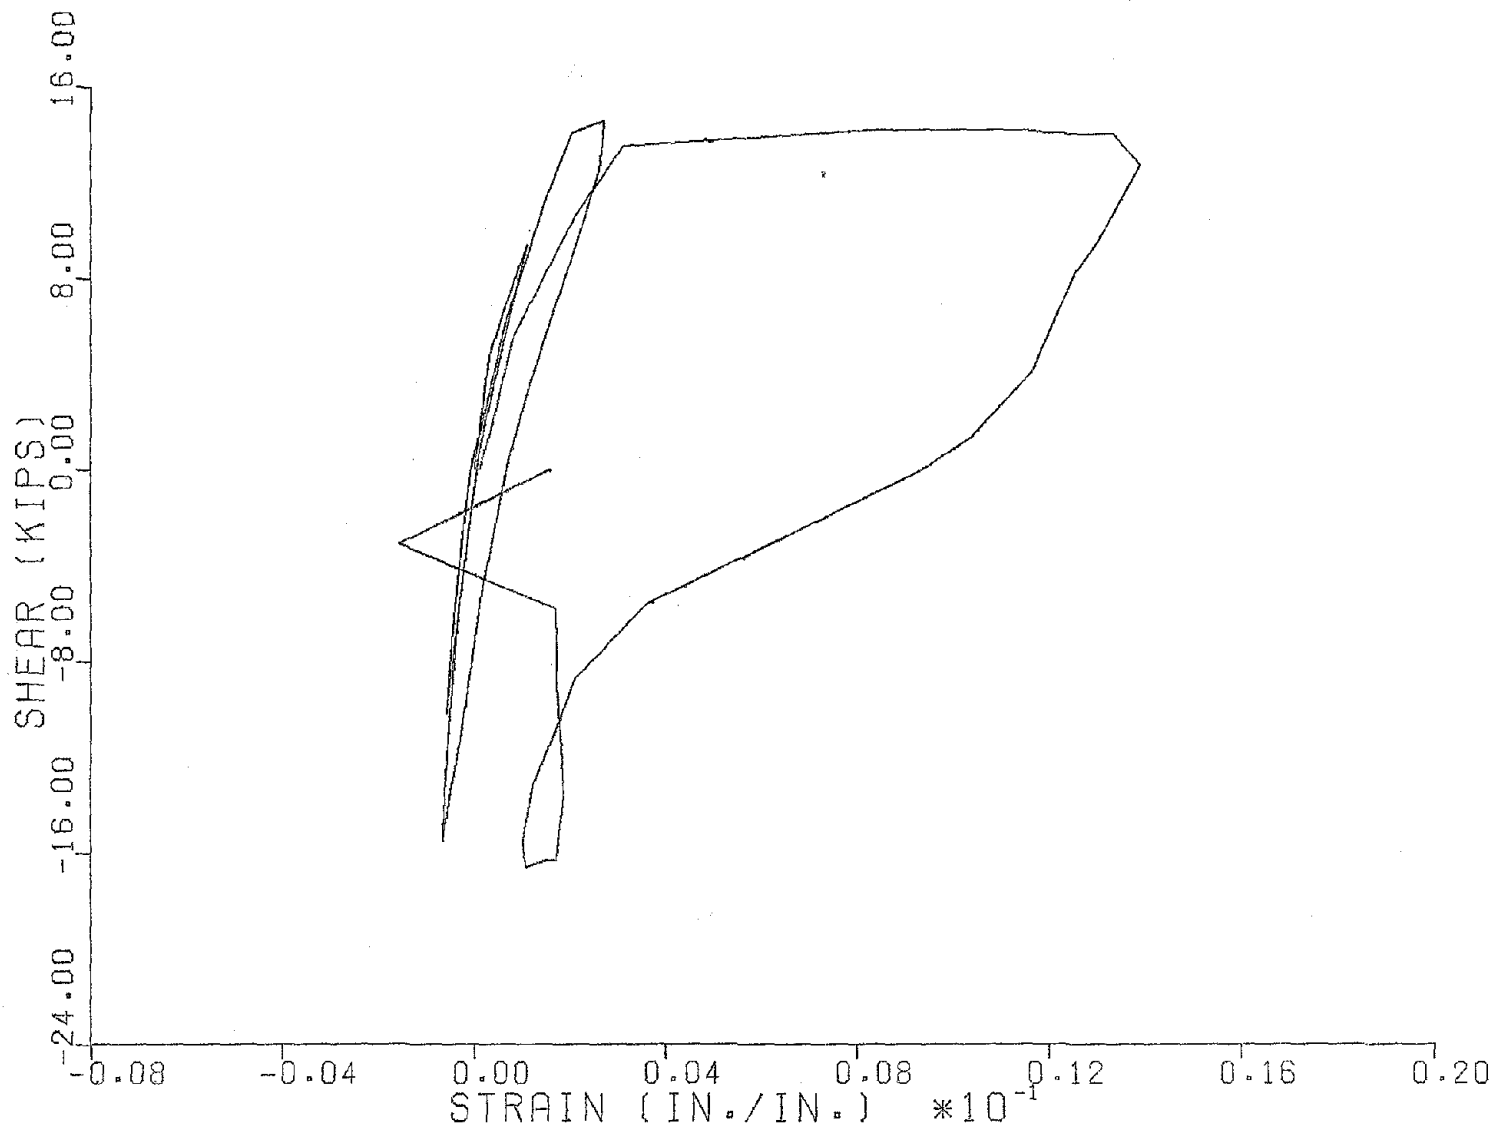
Figure 3.18 Specimen 2, average strain on bottom No. 7 bars, 1-in. from joint for deflection cycles 1, 4, and 7.

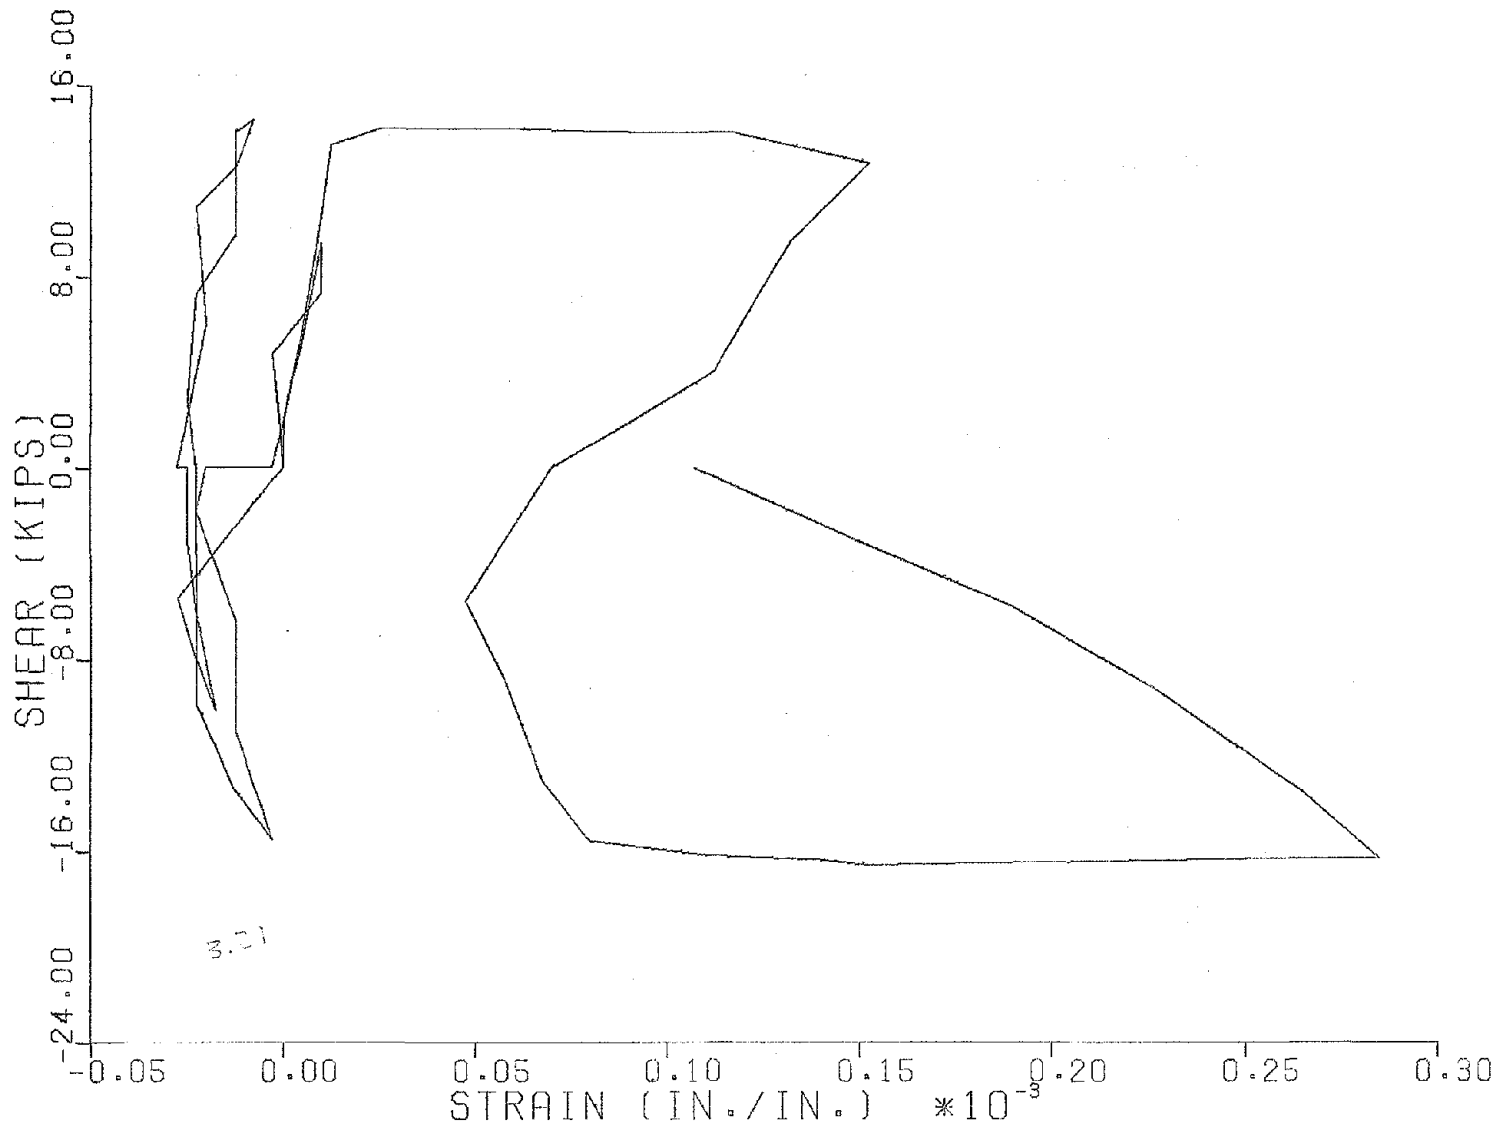
Figure 3.21 Specimen 2, strain on packaging band next to joint for deflection cycles 1, 4, and 7.

The band next to the joint in Specimen 2 and the U-clamp next to the joint in Specimen 4 were instrumented with strain gages. For the band the maximum tensile strain readings was less than 300 micro-inch/inch in the deflection cycles to  $\Delta y$ ,  $2\Delta y$ , and  $4\Delta y$ . This low strain represented a stress less than 9000 psi in the band. For the U-clamp the maximum tensile strain was less than 30 micro-inch/inch, a stress less than 1000 psi. These stresses represent forces in the band of about 800 lbs and in the U-clamp of about 600 lbs.

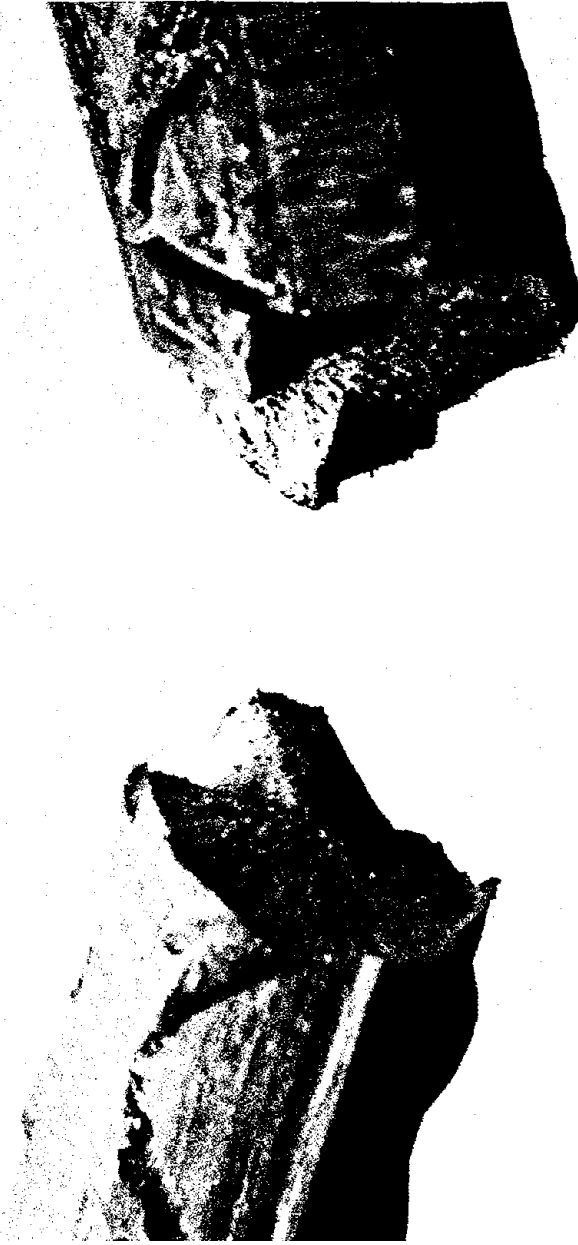
Figure A.2 - Cup-Cone Fracture of No. 7 Reinforcing Bar Specimen

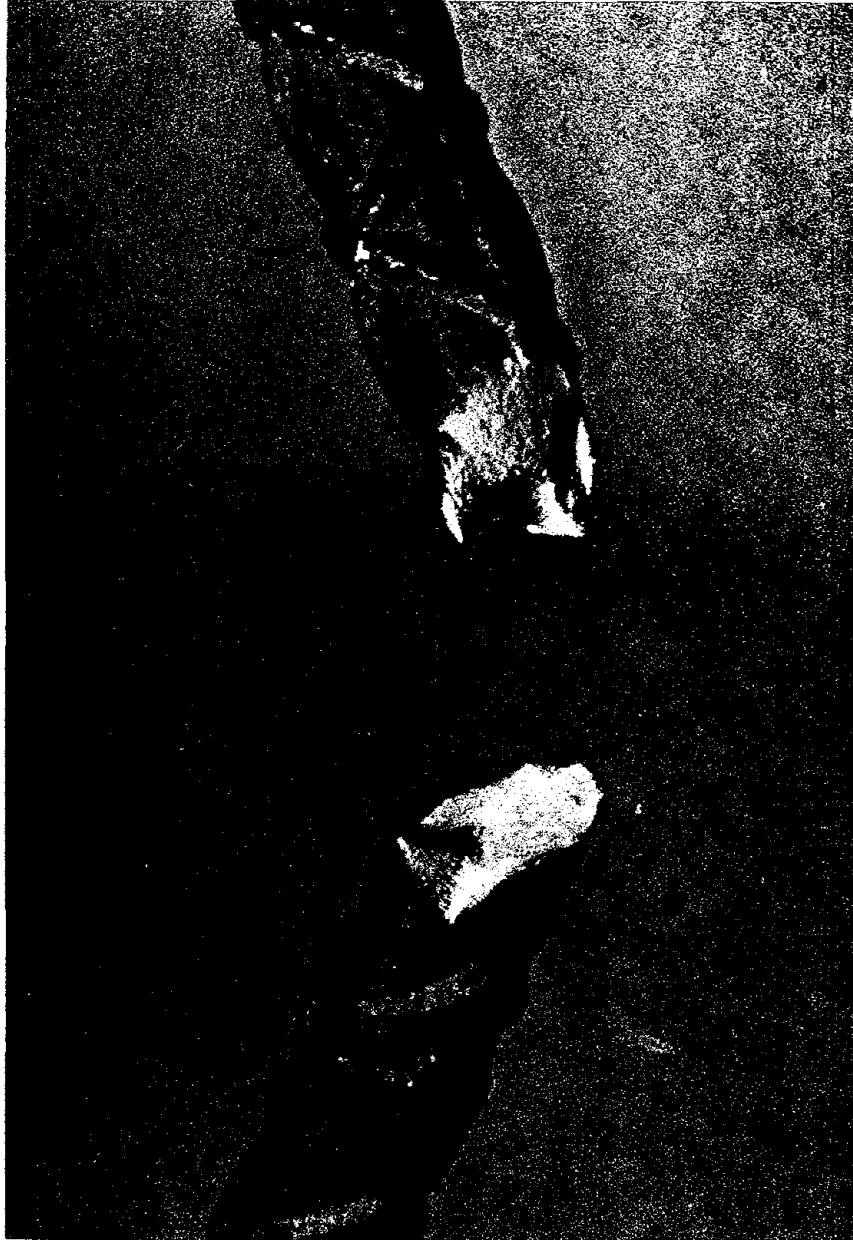
Figure A.4 - Cup-Cone Fracture of No. 4 Reinforcing Bar Specimen

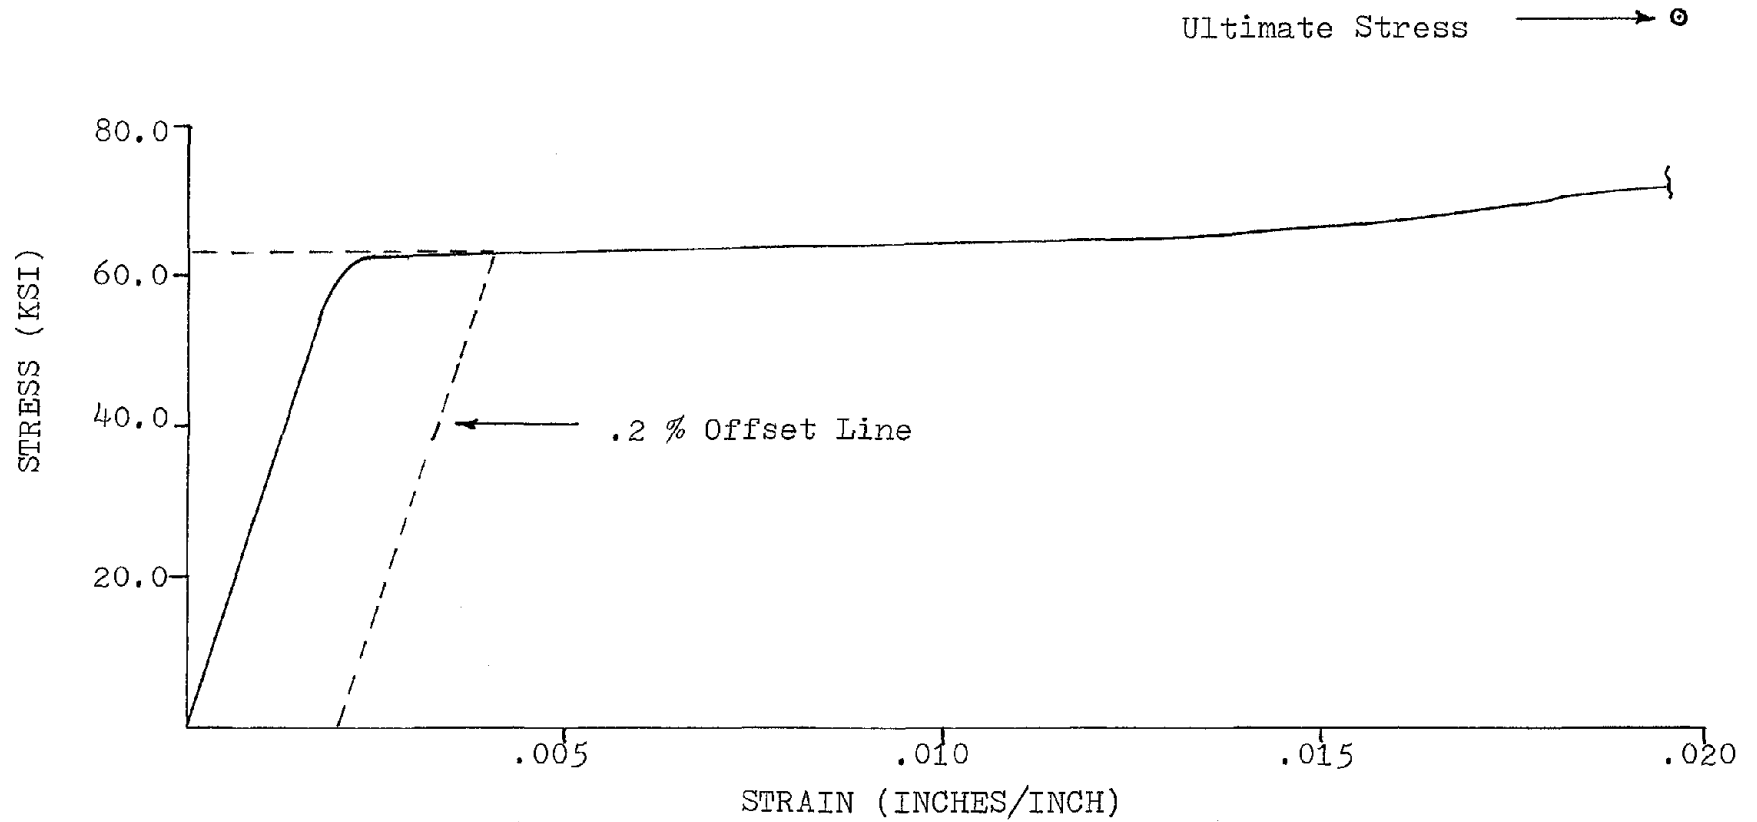
Figure A.5 - Average Stress-Strain Curve for No. 3 Reinforcing Steel Bar
