EARTHQUAKE RESISTANT STRUCTURAL WALLS -
TESTS OF ISOLATED WALLS - PHASE II

R.G. Oesterle
J.D. Aristizabal-Ochoa
A.E. Fiorato
H.G. Russell
W.G. Corley

Submitted by
CONSTRUCTION TECHNOLOGY LABORATORIES
A Division of Portland Cement Association
5420 Old Orchard Road
Skokie, Illinois 60077

October 1979

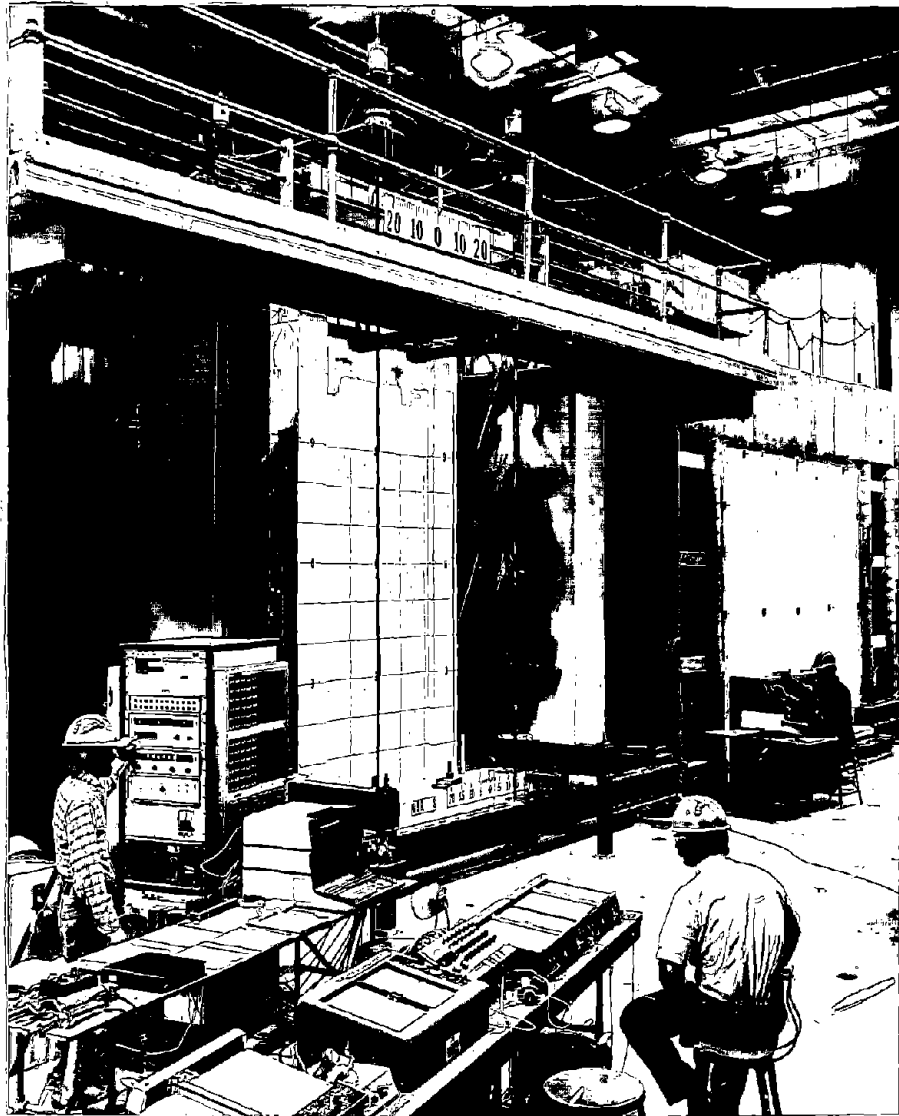
Fig. 4 Test Setup

Test Procedure

The test setup for the walls is shown in Fig. 4. Each specimen was loaded as a vertical cantilever with forces applied through the top slab. The shear span was 2.4 times the

horizontal length of the wall. For all specimens, except B4, B9, B9R, and B10, reversing horizontal loads were applied in a series of increasing increments (IR loading). Each increment consisted of three completely reversed cycles. About three increments of force were applied prior to initial yielding. Subsequent to initial yielding, loading was controlled by deflections in 1.0 in. (25 mm) increments.

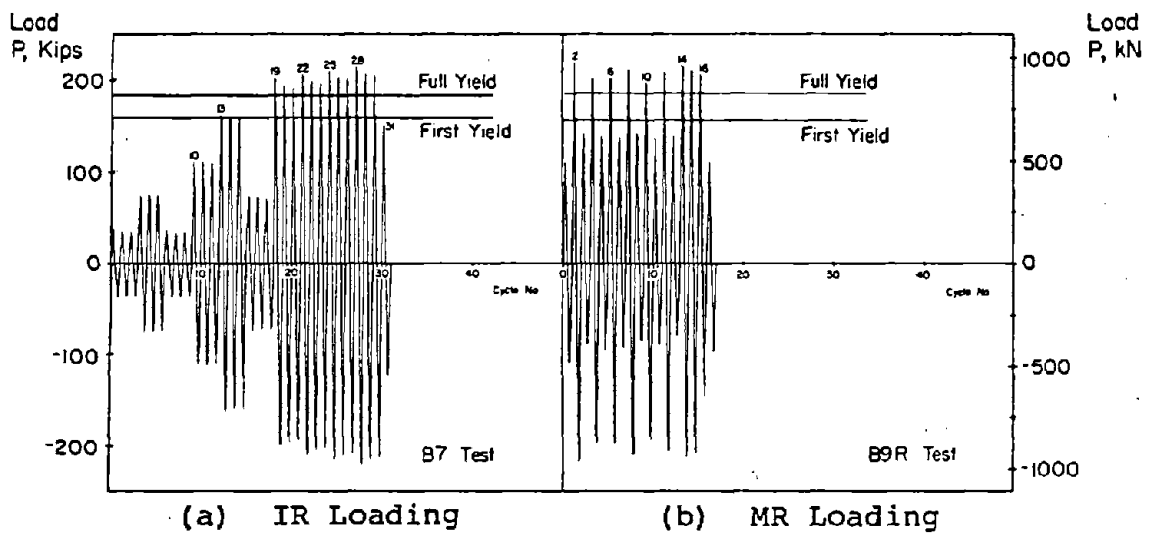
Fig. 5 Typical Loading Histories

Constant axial compressive loads were maintained on Specimens B6, B7, B8, B9, B9R, B10 and F2. These loads were applied such that the resultant axial force remained vertical throughout the horizontal load cycles.

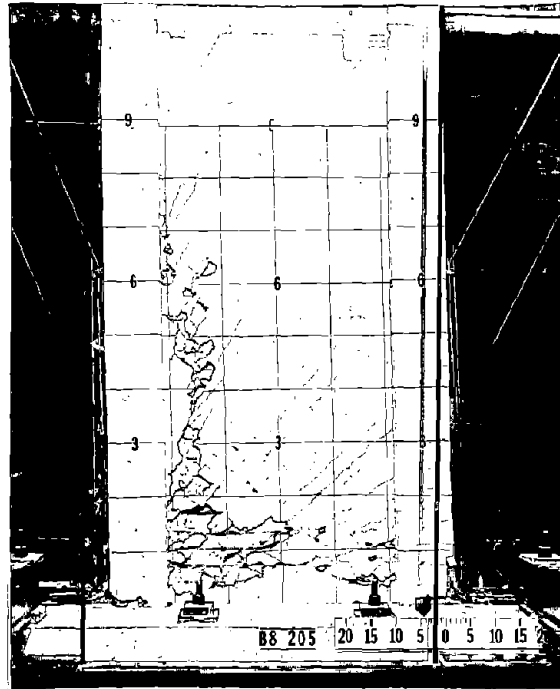
Fig. B-67 - Specimen B8 After Web Crushing

As the load capacity was dropping the specimen was "caught" by closing the deflection control valve in the hydraulic system. The measured load at this stage had decreased to 41% of the maximum measured load.

The fourth mode is denoted as web crushing. This mode is common in beams or girders with large flanges and relatively thin webs subjected to high shear stresses. It was observed in all but one of the specimens subjected to maximum nominal shear stresses greater than $7.0 \sqrt{f'_c}$ ($0.58 \sqrt{f'_c}$ MPa).
