Land Use Planning After Earthquakes

William Spangle and Associates, Inc.
with
H. J. Degenkolb & Associates
Earth Sciences Associates
National Science Foundation Grant
ENV 76-82756

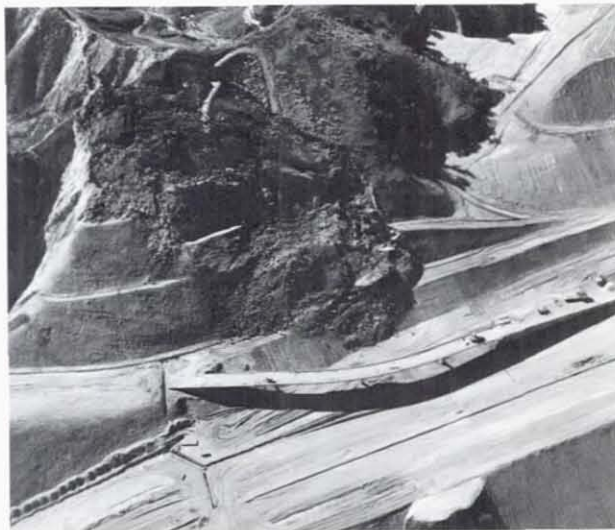
Figure 11. Landslide near the interchange of the Golden State Freeway and Foothill Freeway (Source: Jennings, P.C., ed., 1971, p. 315)

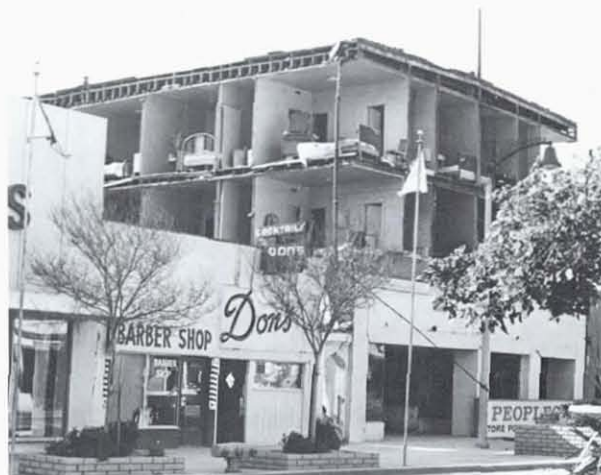
Figure 12. Damaged masonry building in downtown San Fernando. The brick walls collapsed leaving floors supported on interior wood and plaster partitions. (Source: Jennings, P.C., ed., 1971, p. 281)

Forty-seven people lost their lives in the collapse of buildings, constructed between 1925 and 1939, at the Veterans Administration Hospital. Isolated instances of damage to old buildings occurred as far away as downtown Los Angeles. However, most construction in the impacted area was post-World War II and fared quite well. In the downtown area of San Fernando, many pre-1940 unreinforced masonry buildings failed (Figures 10 and 12). Walls and parapets, not adequately tied to roofs and floors, fell out and caused the floors and roofs to collapse. Where walls did not fall out, they were cracked and broken.

Table 1 illustrates the vulnerability of this type of structure. Of 180 mercantile buildings examined in downtown San Fernando, the 19 considered severely damaged were constructed before 1940 and 18 of the 19 were constructed of unreinforced brick or hollow concrete block. Only 10 of the 74 pre-1940 unreinforced brick buildings were undamaged. In this case, damage is clearly related to structural deficiencies and ground shaking. No surface fault rupture or other forms of ground failure occurred in downtown San Fernando. Buildings constructed to modern codes in the area survived well.

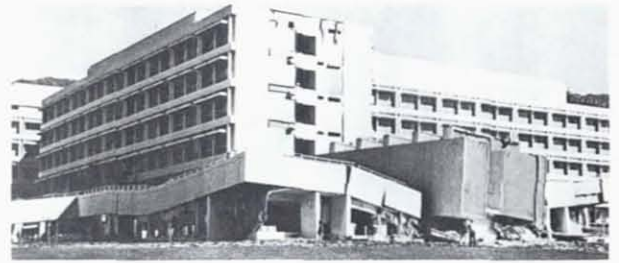
Figure 15. Collapsed stairwell and elevator shaft, main building, Olive View Hospital
(Source: Steinbrugge and others, 1971, p. 45)

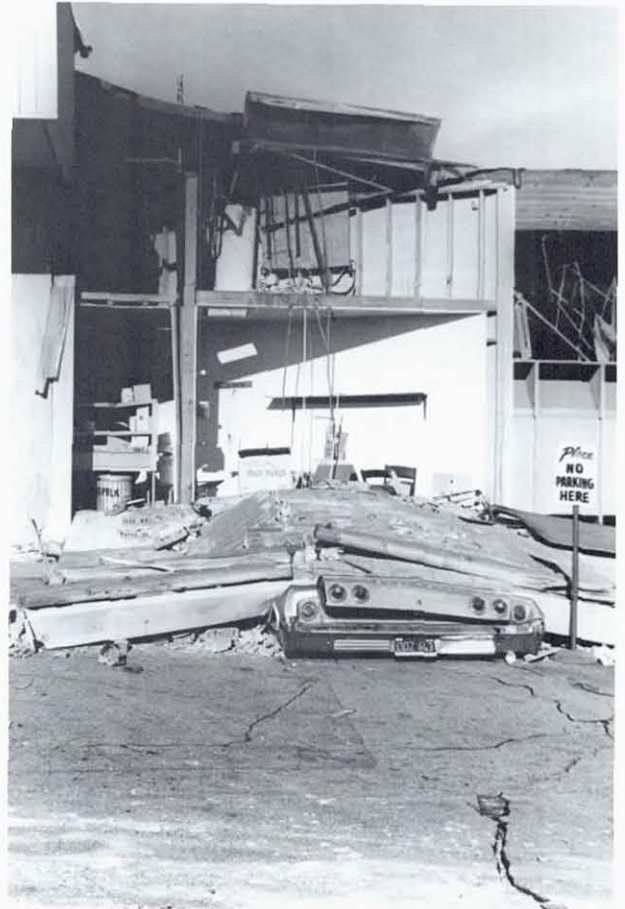
Figure 22. Collapsed Boys Market, corner of Glenoaks Boulevard and Hubbard Avenue
(Source: Jennings, P.C., ed., 1971, p. 475)

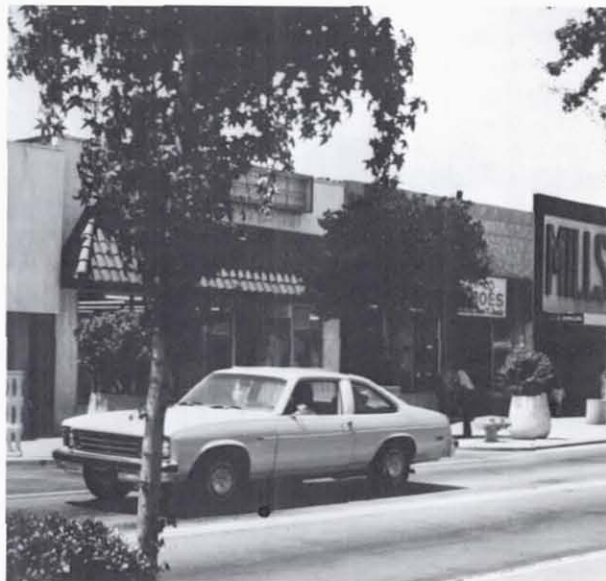
Figure 23. View of the mall, downtown San Fernando, Spring 1978

reconstructed. Figure 23 shows a portion of the mall as it appeared in 1978. Parking lots have been built at the periphery of the mall on sites where buildings were razed. The three remaining lots are in a single ownership. Negotiations with the owner to achieve reconstruction on these parcels are in process. The city chose not to exercise the right of eminent domain in this project which is being carried out under California State law with tax increment financing.

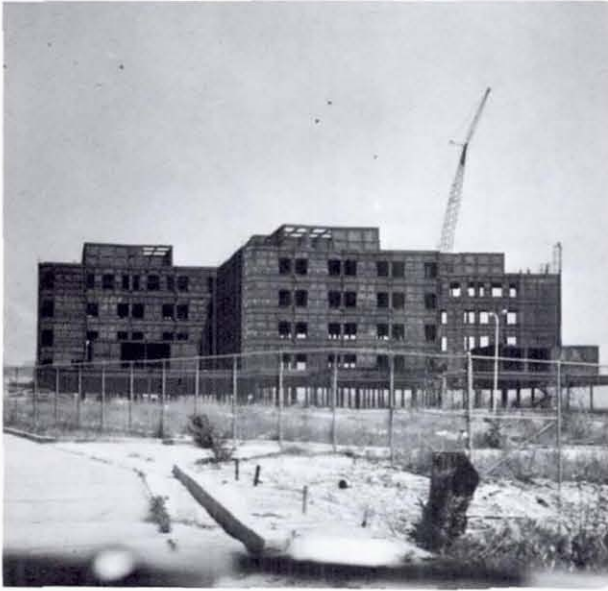
Figure 24. Olive View Hospital building under construction, Spring 1978

veloped by Los Angeles County as a park. Following extensive geologic and engineering analyses of both sites, decisions were made to reconstruct Olive View Hospital and Juvenile Hall at their existing sites. Juvenile Hall has been rebuilt and Olive View Hospital is currently under construction (Figure 24).

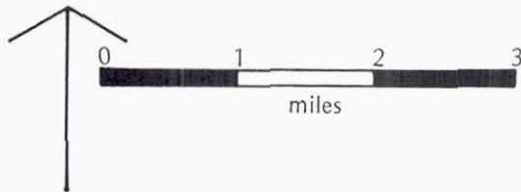
- NOMINAL RISK AREA**
 Little likelihood of landslides except for small slumps, largely in artificial fill. In all other respects risks are no greater than is normally expected in the construction industry. Current Uniform Building Code, as identified with Seismic Zone 3, applies.
- HIGH RISK AREA**
 Requires further study before final determination can be made as to stability.

Figure 7. Map showing risk areas in Anchorage and vicinity, May 19, 1964
 (Source: from Scientific and Engineering Task Force, 1964, reprinted in Hansen and others, 1966, p. 56)

The field team of the Scientific and Engineering Task Force (Task Force 9), established by the Federal Reconstruction Commission, drew upon the work of the Engineering Geology Evaluation Group in its initial mapping of high-risk areas in Anchorage. The Federal Reconstruction Commission, accepting the recommendations of the Scientific and Engineering Task Force, designated high-risk areas in Anchorage on May 19, 1964 (Figure 7). An immediate effect of the release of this map was to encourage repair and reconstruction in the major part of Anchorage designated "nominal risk." Federal aid was available for rebuilding in this area, but the Federal Reconstruction Commission withheld federal funds for rebuilding in the high-risk areas pending further study. The boundaries of the high-risk areas were drawn conservatively to prevent reconstruction until additional studies could be completed and possible stabilization measures and building design criteria developed.

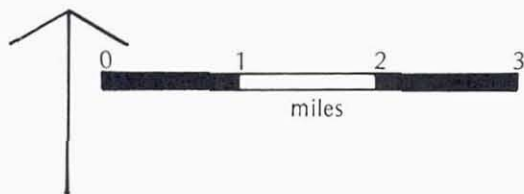
Figure 8. Map showing risk areas in Anchorage and vicinity, July 27, 1964 (Source: from Federal Reconstruction Commission, 1964, p. 61)

NOMINAL RISK AREA

Little likelihood of landslides except for small slumps, largely in artificial fill. In all other respects risks are no greater than is normally expected in the construction industry where structures are built on a thick sequence of unconsolidated sediments. Current Uniform Building Code for Seismic Zone 3 applies both to new buildings and to plans for rehabilitation of earthquake-damaged structures. Special engineering consideration should be given to construction near the top, at the base, and on steep slopes, especially wherever the Bootlegger Cove Clay is present. No filling, cutting, or construction should be permitted that will steepen or increase the load on or above these slopes.

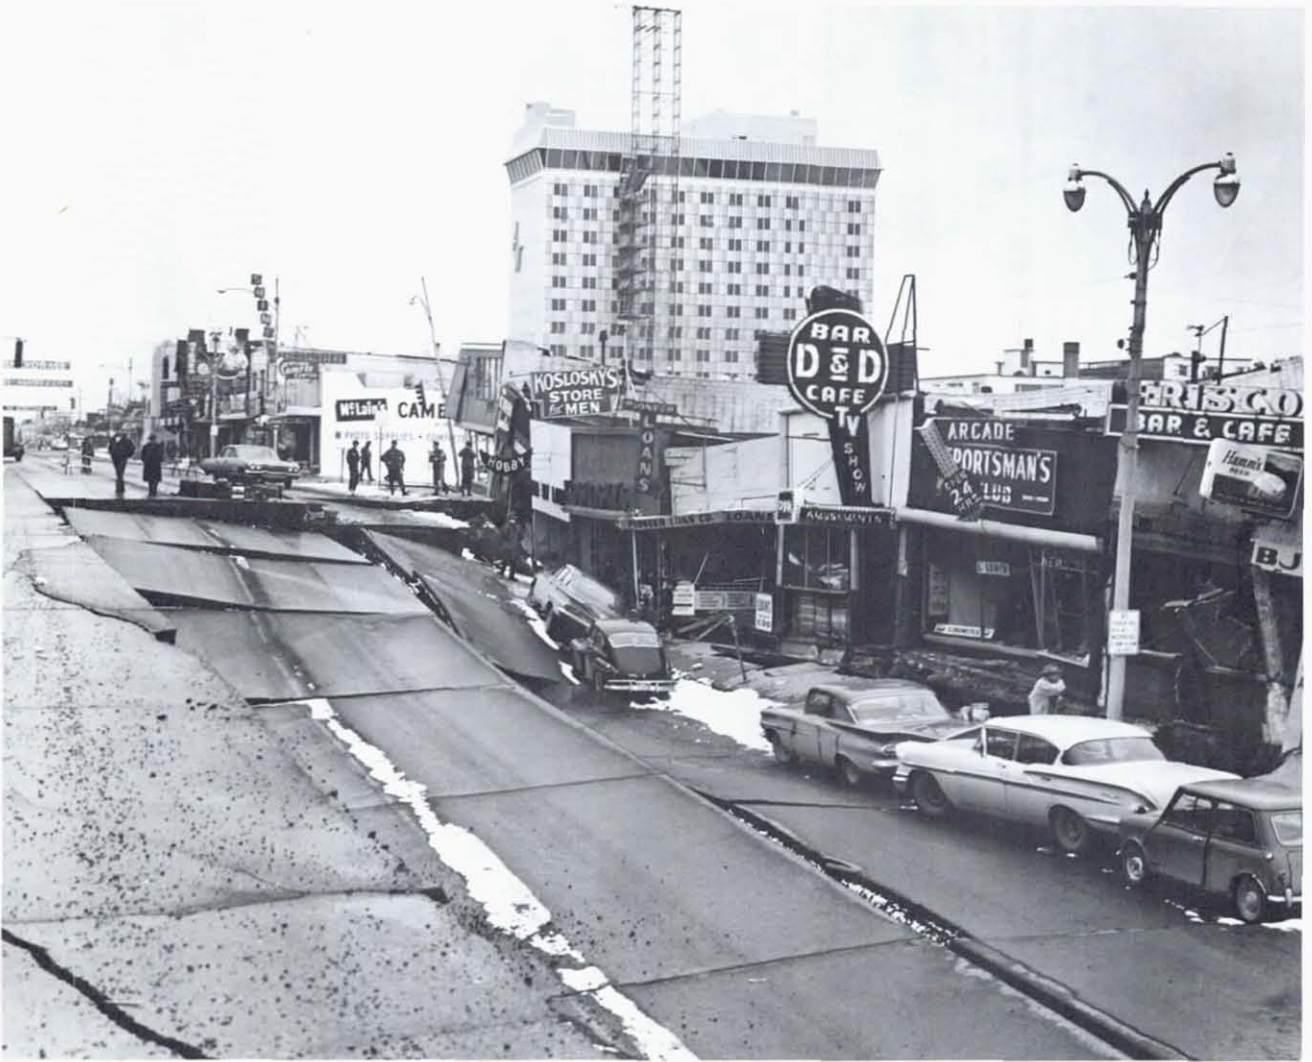
Figure 11. Building damage along Fourth Avenue caused by the slide. The 14-story Anchorage-Westward Hotel, still under construction, is a few feet from the slide area in the right background. (Source: Norton and Haas, 1970, p. 258) Photo Credit: U.S. Army

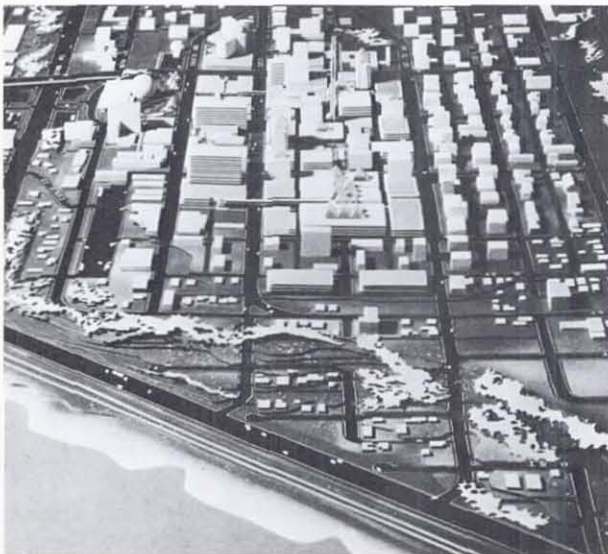
Figure 13. Model of CBD redevelopment proposed by Alexander and Crittenden
 (Source: Selkregg and others, 1970, p. 196)

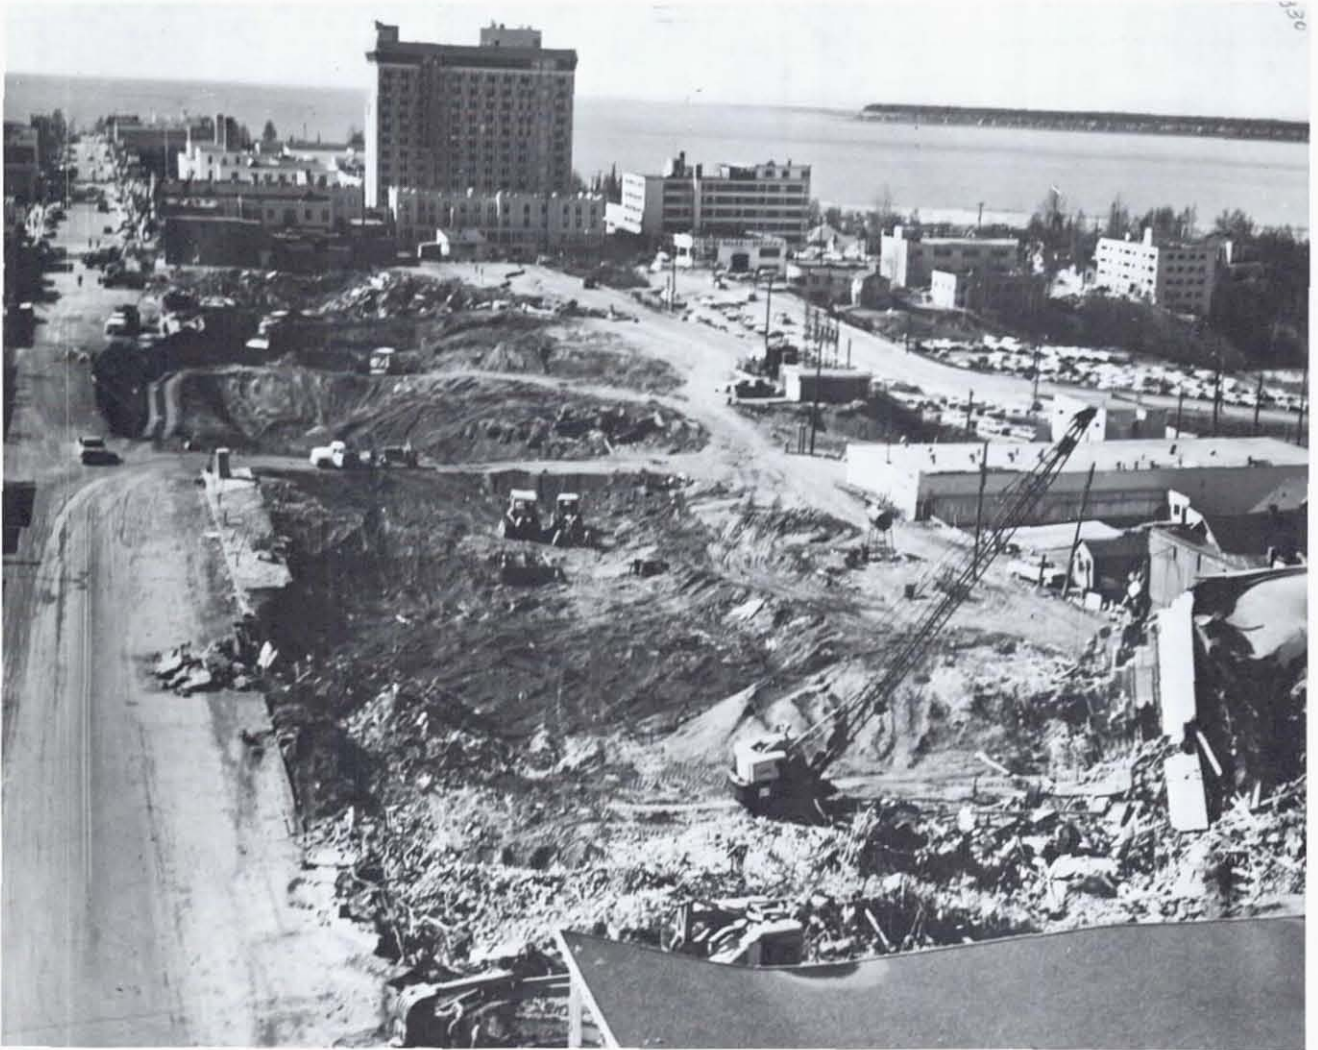
Figure 14. Debris clearance from the Fourth Avenue slide area. Fourth Avenue is on the left; the slide moved toward the right. The high-rise building in the background is the Anchorage-Westward Hotel.
(Source: Eckel and Schaeni, 1970, p. 173) Photo Credit: U.S. Army Corps of Engineers

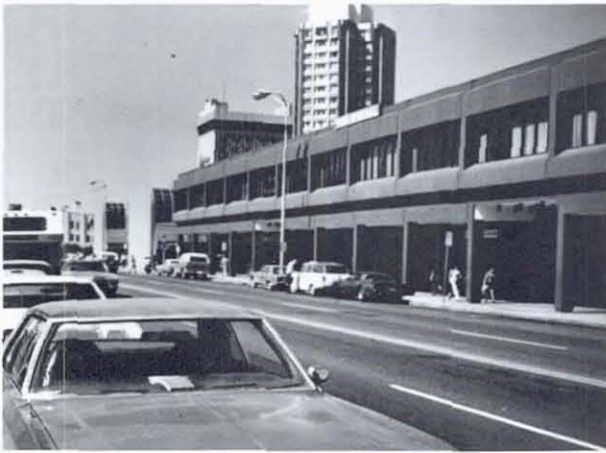
Figure 17. Shopping malls on north side of Fourth Avenue at top of buttress. Anchorage-Westward Hotel in background, Summer 1978.

So far, the recommendations of the Corps of Engineers governing construction on the buttress have been followed, and there appears to be great confidence in the safety of the buttressed area. Some concern has been expressed that large scale development in the areas adjacent to the buttress may affect stability through overloading. One approach has been to excavate soil equivalent in weight to the weight of the building prior to construction, however, the need for such measures is determined on case by case basis. Also, questions have been raised by geologists about the present stability of the area, but a recent consultant's report requested by the Corps of Engineers concludes that ripples observed in the parking lot pavement at the Alaska Railroad depot (at the base of the buttress) are the result of frost action and do not indicate

any instability within the buttress (Schmoll, Ferrians, Long, 1978 telephone conversations). Instruments were installed to monitor the behavior of the buttress but there is some concern that there may be inadequate monitoring of stability conditions in the area.

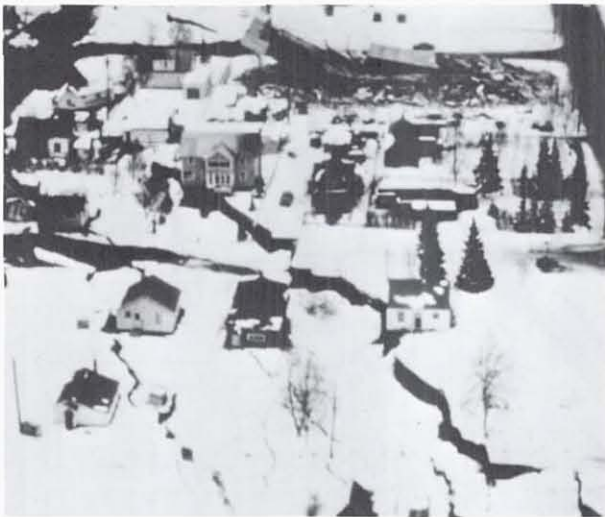
Figure 20. Aerial view of L Street slide. Center right shows collapsed Four Seasons apartment building.
Photo Credit: U.S. Geological Survey

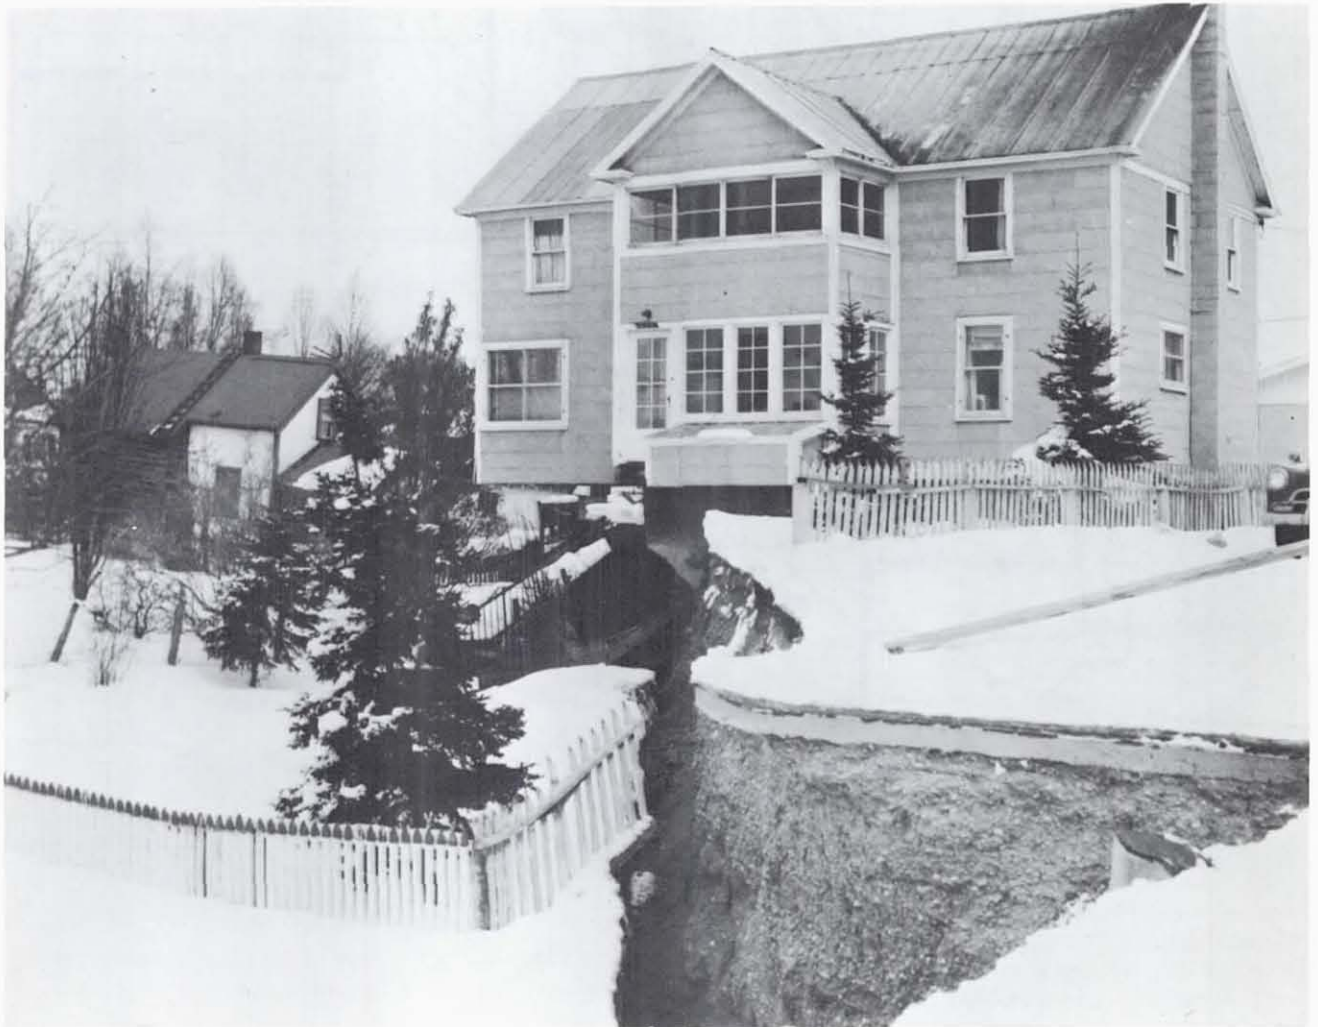
Figure 21. Relatively undamaged house at edge of graben, L Street slide
Photo Credit: Stewart's Photo Shop, Anchorage

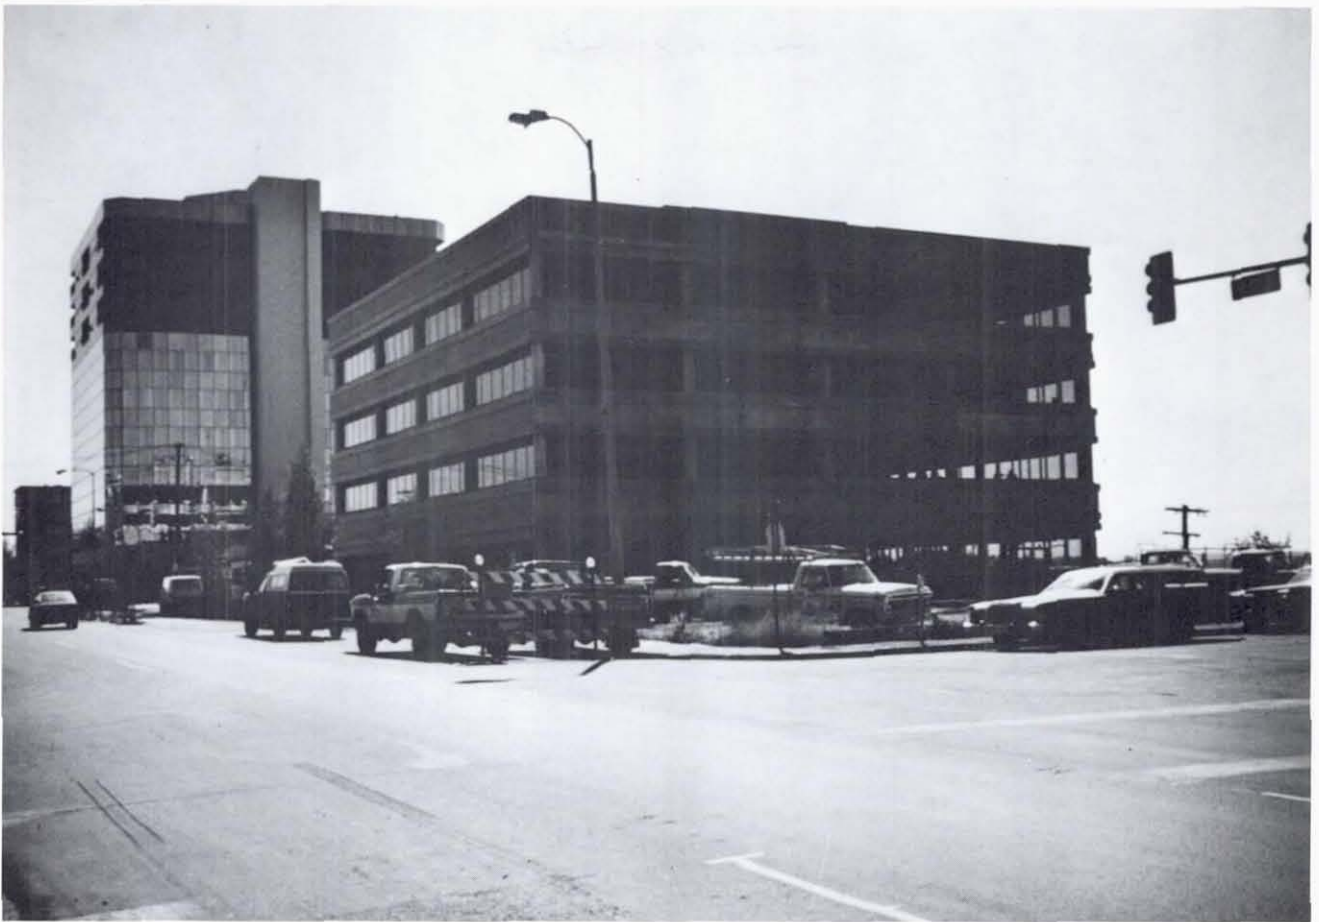
Figure 23. Two new high-rise buildings on L Street slide. See Figure 22 for location, Summer 1978

Since 1964, extensive new construction, including five new high-rise buildings, has occurred on or adjacent to the slide. About a year after the earthquake, the Anchorage City Council voted to rezone the area to permit higher residential densities (Makinson, 1977). In addition, previously designated multiple-family residential areas were rezoned to allow offices uses and, hence, high-rise construction. The Anchorage Comprehensive Development Plan permits residential development at densities ranging from 1 to 40 units per acre. The present (1978) zoning at the L Street slide area is shown in Figure 22. There is no height limitation in the R-O district which spans part of the graben of the slide, and several buildings have been constructed there (Figure 23). New

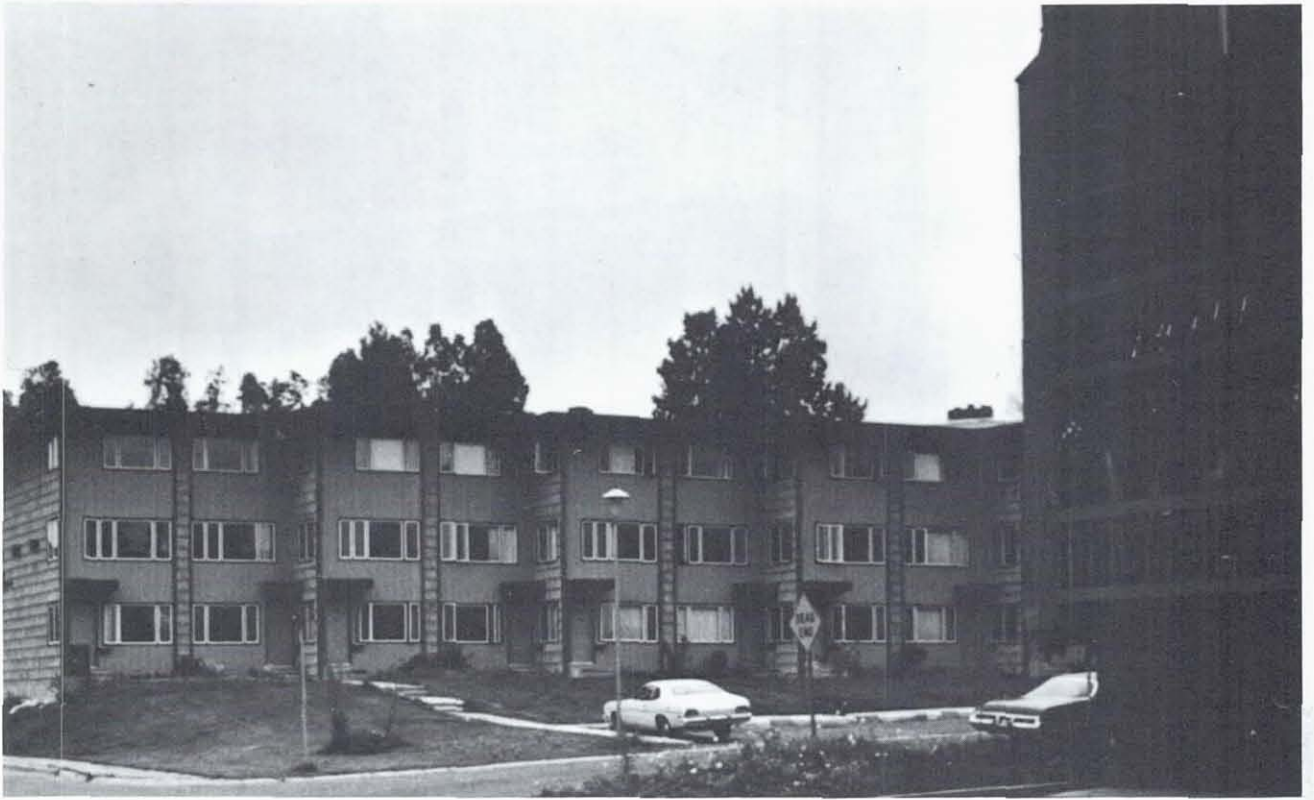
Figure 24. New apartments below bluff line at the end of 8th Avenue, L Street slide, Summer 1978. See Figure 22 for location

apartments are being built below the bluff in the R-3 zone (Figure 24). No restrictions on development have been imposed in the area to reduce seismic risk and the zoning changes have certainly increased the potential for casualties and property damage in future earthquakes.

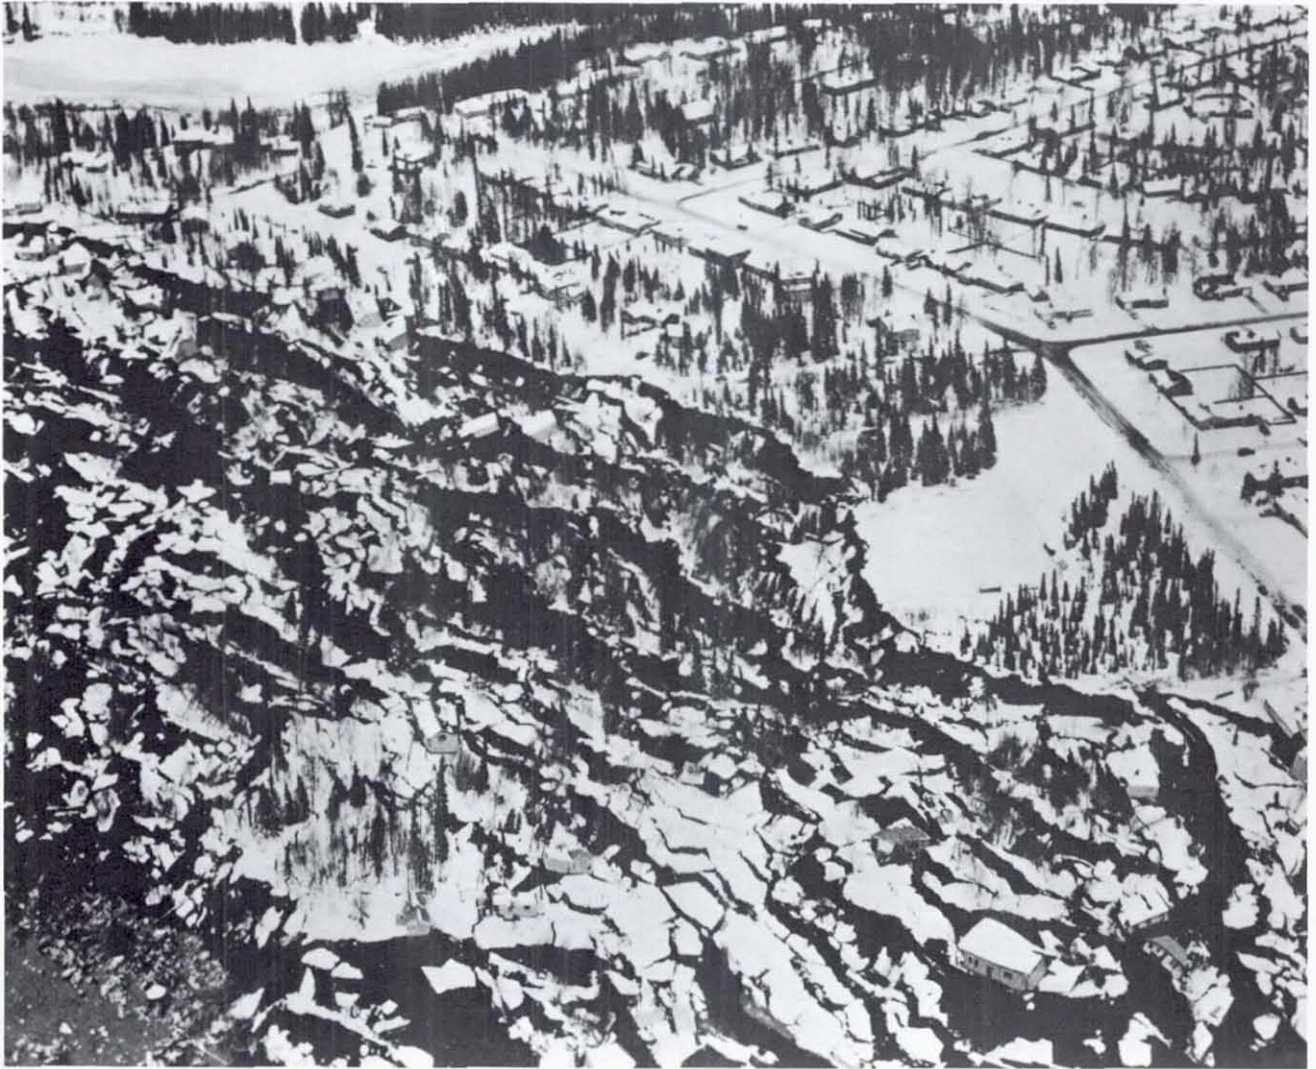
Figure 26. Aerial view of Turnagain Heights slide
 (Source: Krauskopf, 1970, p. 252)

The Turnagain slide was the largest and most spectacular of the Anchorage landslides. It involved 130 acres and destroyed 75 homes (Figure 26). The slide extended 8,000 feet along the coastline and extended inland approximately 600 feet at the east end and about 1,200 feet at the west end (Figure 27). Failure occurred within a weakened zone within the Bootlegger Cove Clay and resulted in a progressive "peeling off" of blocks of

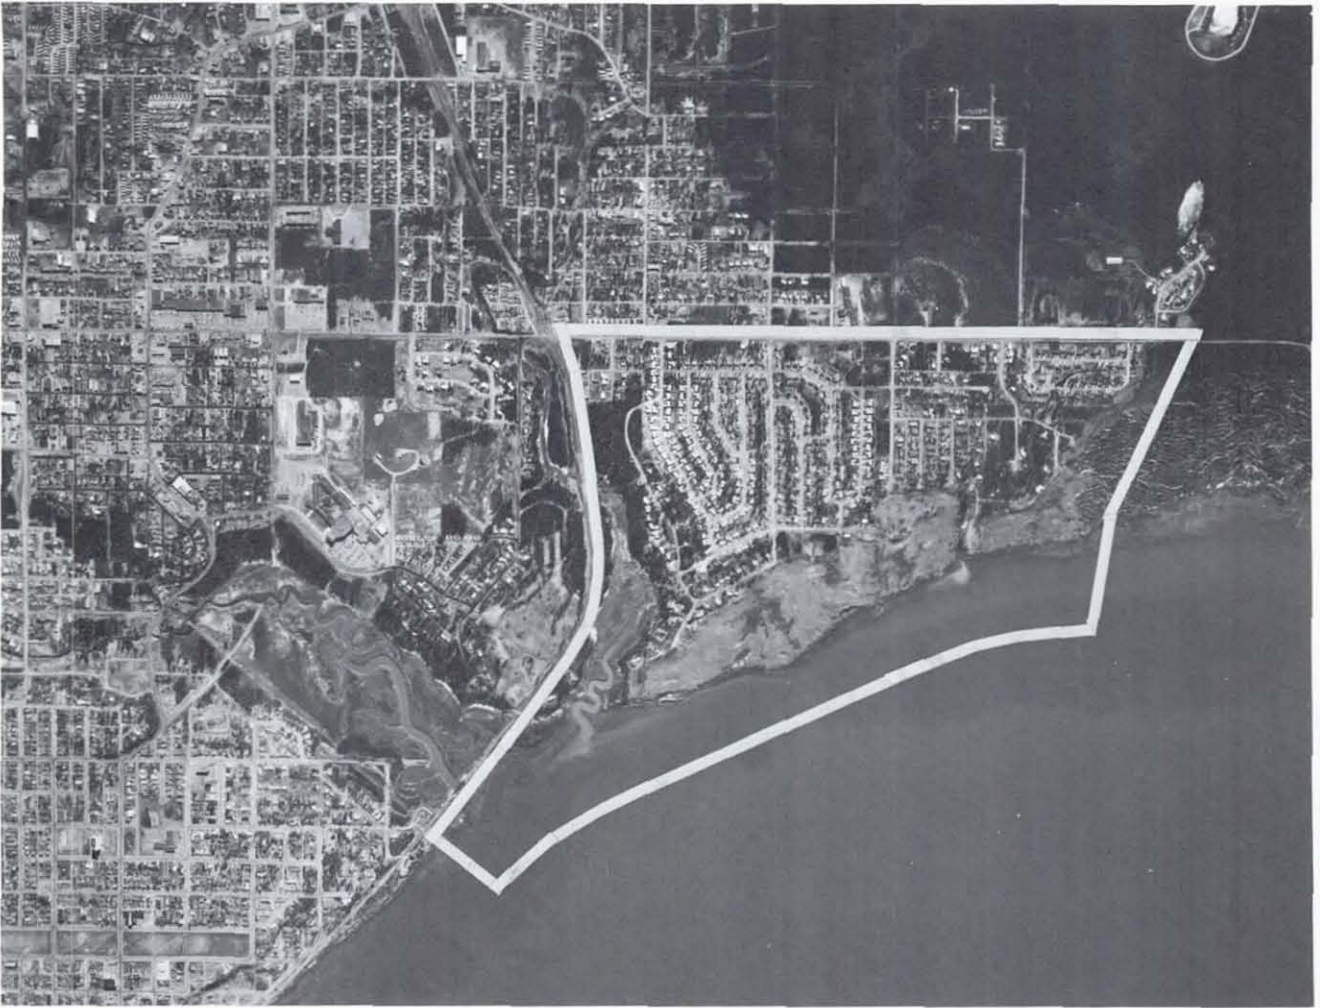
*Figure 29. Aerial photo of Turnagain taken in May 1964 after grading of part of the slide. Proposed urban renewal boundary added.
Photo Credit: Air Photo Tech, Inc., Anchorage*

Based on the Corps recommendations, the Alaska State Housing Authority prepared a redevelopment plan for the area seaward of the new bluffline (new escarpment on Figure 27) calling for park and recreation uses, erosion control measures and a road along the waterfront (Figure 29). The Anchorage Council voted against the plan in June 1967 and moved to consider applications for building permits in the slide area (Selkregg and others 1970). The Federal Housing Administration agreed to insure loans for purchase of property landward of the escarpment with the stipulation that buyers be informed that FHA would not cover losses from another earthquake (Selkregg and others, 1970).

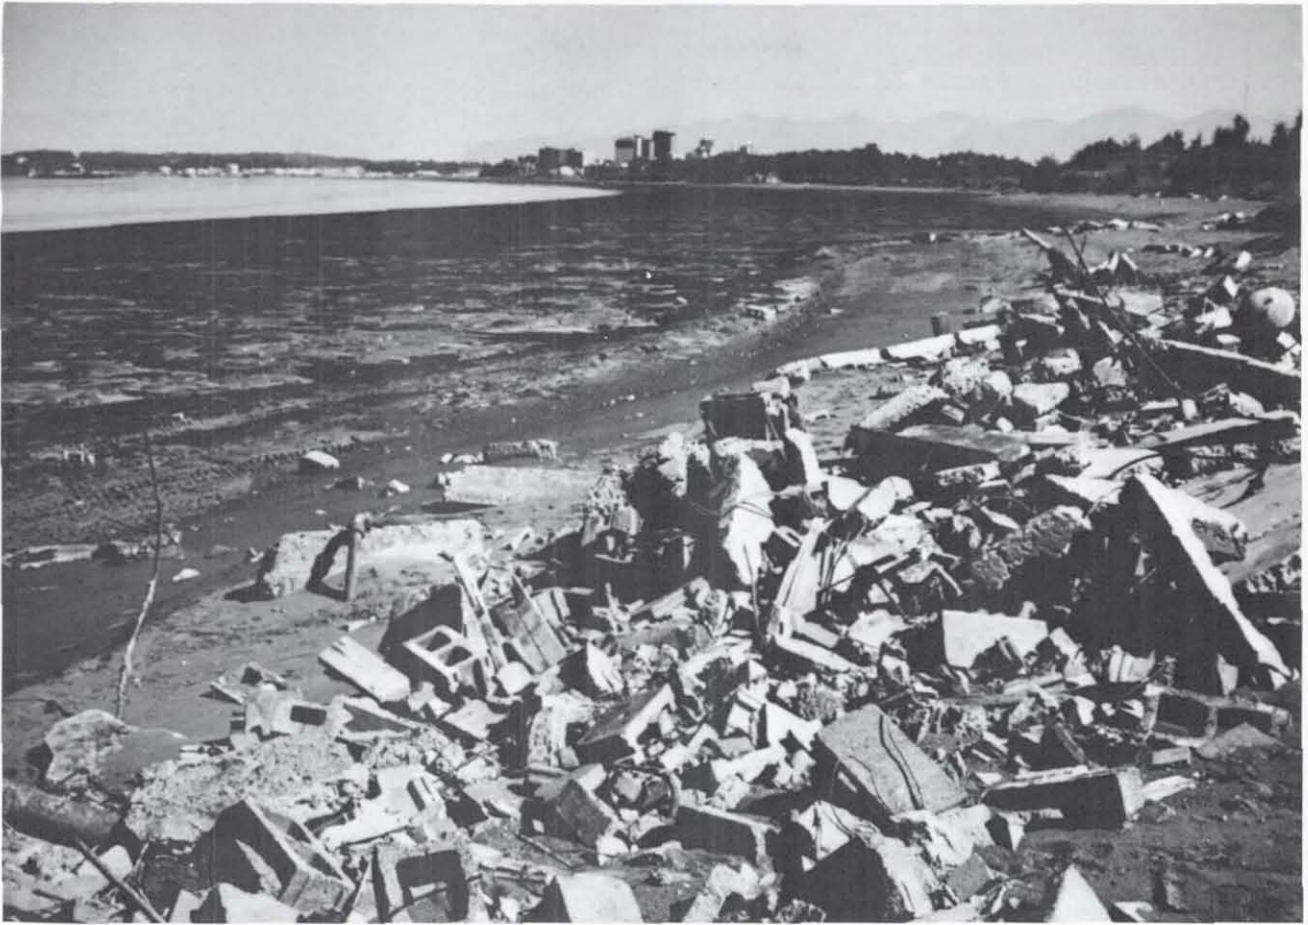
Figure 30. Rubble from houses destroyed in the 1964 Turnagain landslide exposed at low tide, Summer 1978

The failure to seek public ownership of the slide area immediately after the earthquake probably was simple oversight coupled with the supposition, as described by Mayor Sullivan, that nobody would ever again be foolish enough to build in such a hazardous location. The passage of time after a major disaster, however, has a way of eroding concern for safety. Most people now living in Anchorage were not there during the earthquake and even the reminder of debris from shattered houses still on the beach fails to deter those who would build there.

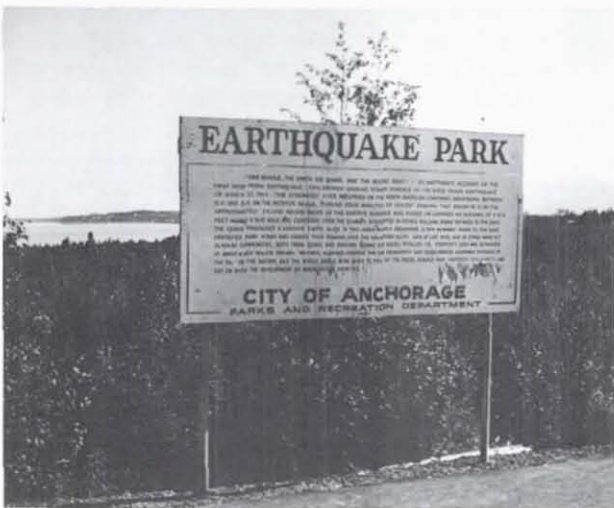
Figure 31. Earthquake Park — western portion of Turnagain landslide left in its post-earthquake condition

After the earthquake, the publicly-owned and undeveloped land comprising the western portion of the slide was designated Earthquake Park and was left in its post-earthquake condition as a reminder of the 1964 disaster (Figure 31). The rest of the Turnagain area is shown on the land use plan as residential with a permitted density of 1-10 units per acre. Most of the area is zoned R-1A with a minimum lot size of 8,400 sq. ft. An area bounded by Iliamna Avenue, Clay Products Drive, McKenzie Drive and Marston Drive is zoned for duplexes (R-2A). Figure 27 shows street locations. The Municipality of Anchorage has no zoning district for open space or conservation uses on privately-owned land; the PLI district, which applies to Earthquake Park, is used only for public and quasi-public lands and institutions.

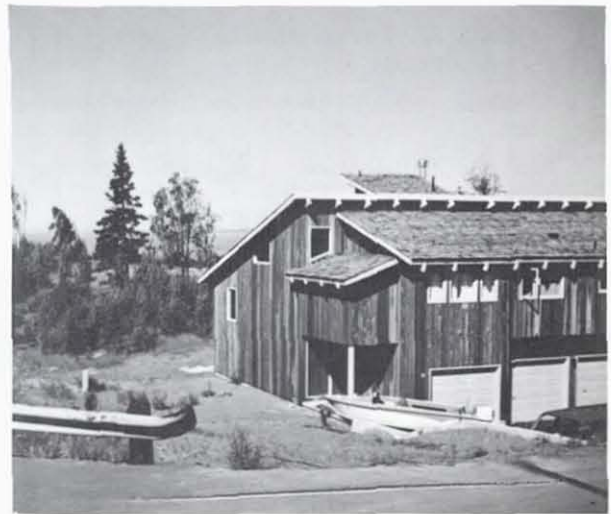
Figure 32. Duplex under construction at end of McKenzie Drive on the Turnagain landslide, Summer 1978. See Figure 27 for location.

utility lines and roads in the slide area. Assessments could be as much as \$28,000 per lot under such a scheme. Because of this high cost, there appears to be pressure to permit higher density residential construction than presently allowed, greatly increasing the potential exposure to seismic hazards. Otherwise, housing built on the slide would be prohibitively expensive for most families. The first structure built on the slide itself is a duplex under construction in August 1978 (Figure 32).

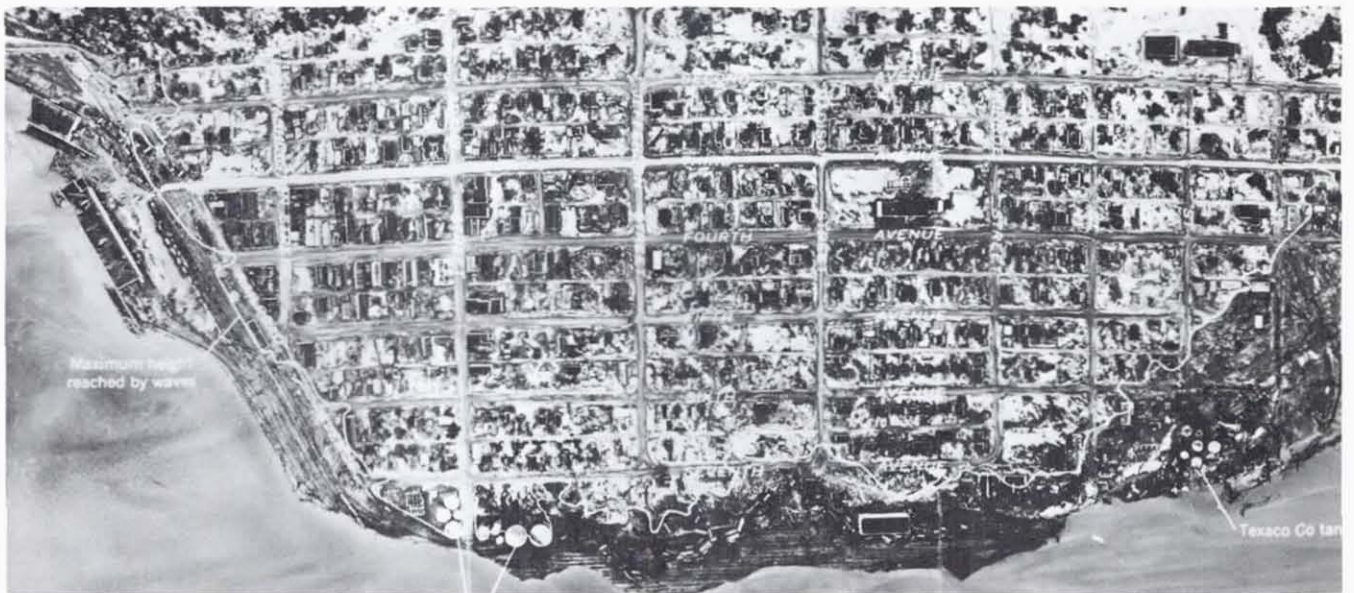
Figure 35. Aerial photo of Seward, Alaska taken after the earthquake. White line shows maximum wave runup.
 (Source: Lemke, 1967, p. E6, E7)

Parts of Seward subsided about 3 1/2 feet during the earthquake rendering over 50 acres of waterfront land unusable. Strong ground motion lasted three to four minutes triggering rockfalls and avalanches in the canyons and valleys around Seward. The most damaging effects of the earthquake were along the waterfront. Thirty to forty-five seconds after violent shaking began the edge of the Seward alluvial fan began sliding seaward as a result of large-scale offshore landsliding. Slice after slice of land, in an area extending from the Standard Oil Company dock to beyond the San Juan dock, slid into the bay. A 40 acre area 50-500 feet wide disappeared under water. Large fractures, some at least 20 feet deep, broke the ground surface behind the slide area. Some fractures near the Texaco tanks reportedly opened and closed repeatedly during the shaking alternately filling with water and spewing forth muddy water. Figures 34 and 35 are aerial photos of Seward taken before and after the earthquake. When shaking ended, the shoreline had receded to the position shown in Figure 35 (Lemke, 1967, p. E4).

bay from which waves radiated in all directions, causing much damage along the Seward waterfront and at the head of the bay. These waves, caused by continued submarine sliding or by seiche action, were followed by tsunamis. The first tsunami hit about 25 minutes after shaking stopped. It was 30-40 feet high and carried burning oil into the town. A series of waves followed at approximately 1/2 hour intervals with the third generally acknowledged to be the highest. The white line on Figure 35 shows the maximum height reached by any wave (Lemke, 1967, p. E4).

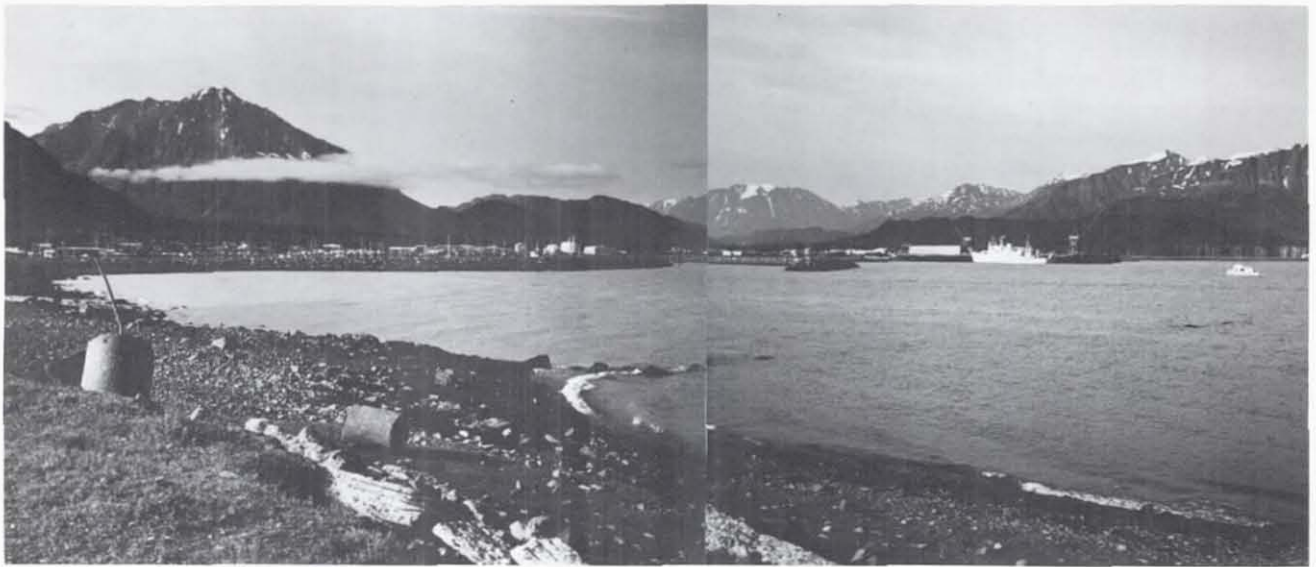
Figure 39. View of portion of cleared waterfront, Resurrection Bay and, in background, the new city dock and small boat harbor at end of Bay, Summer 1978

application for urban renewal, the project boundaries had been changed to exclude all but the damaged waterfront area (Figure 38). This plan called for relocation of the city dock, railroad terminus and small boat harbor to an area near the head of the bay with better stability than the pre-earthquake locations, but subject to flooding. Park and recreation use was planned for the high-risk waterfront area. The renewal project cost, excluding the construction of federal facilities, was pared down from over \$6,500,000 to \$1,591,828 (1964 dollars).

The new location of the docks and harbor provides space, lacking at the former location, for associated industrial expansion. However, the location may be subject to flooding from the glacial-fed Resurrection River and future tsunamis (Selkregg and others, 1970). The Alaska Railroad facilities were reconstructed, and a new city dock and small boat harbor were built by the Corps of Engineers (Figure 39). The harbor berths 500 boats and is too small for the present demand for about 1,300 spaces. No disaster relief funds were made available to Seward to improve harbor facilities over their pre-earthquake condition. The high-risk area remains free of new construction. Most of the area was publicly-owned so that land acquisition posed little problem. The Standard Oil and Texaco facilities were on land leased from the federal government. The approved urban renewal project R-21 contains the following statement concerning use of the high-risk area:

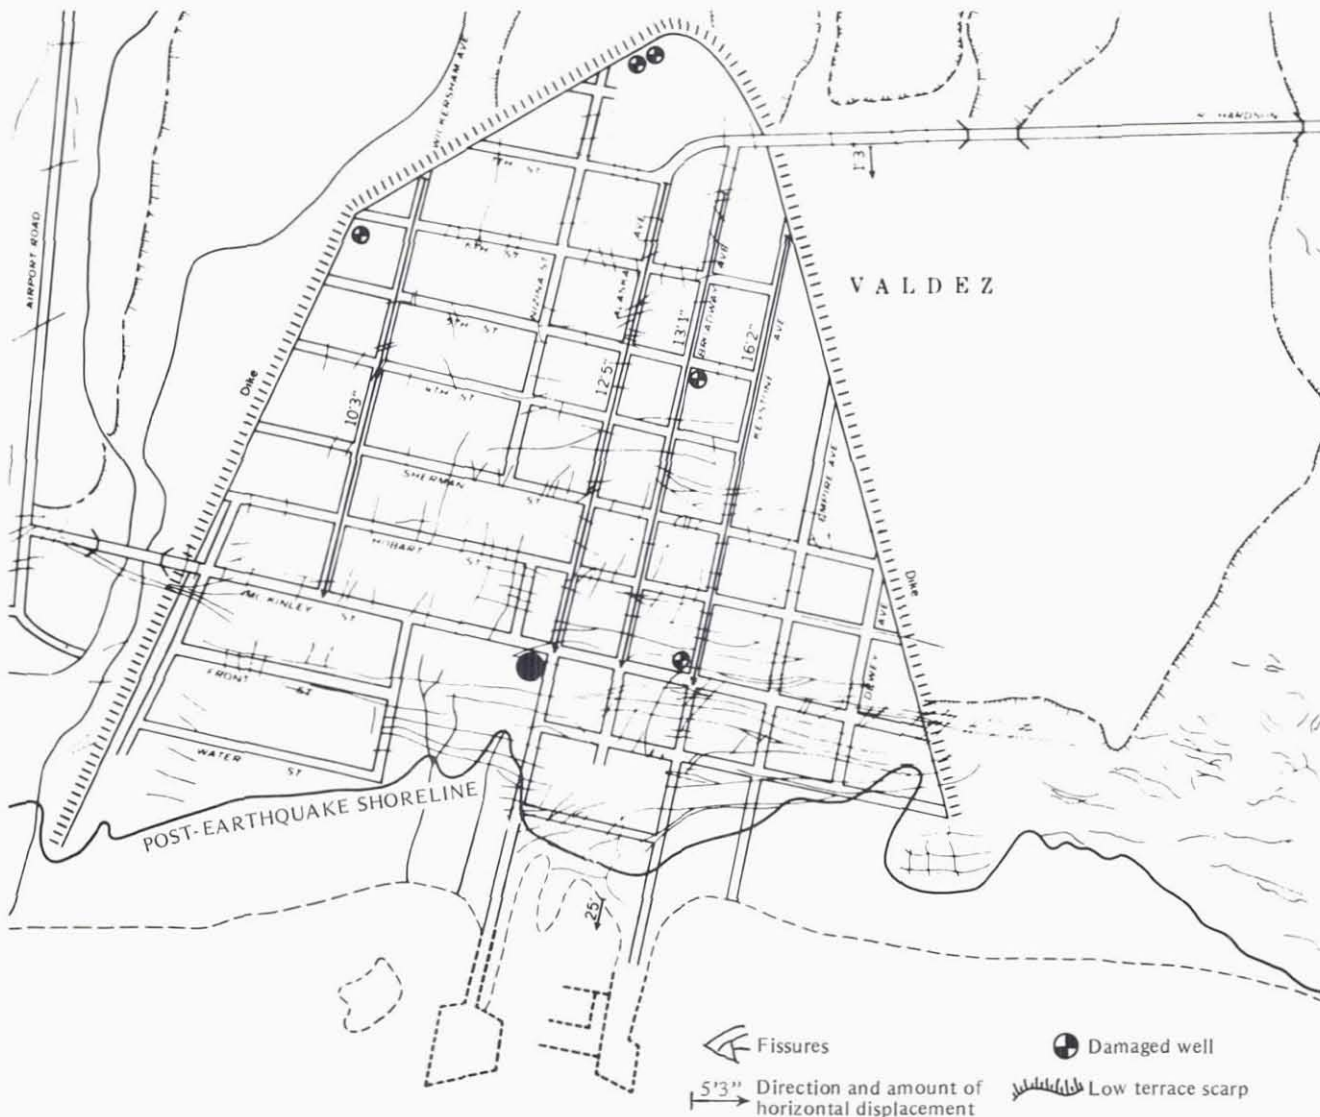
Figure 40. Earthquake effects at Valdez
 (Source: Coulter and Migliaccio, 1966)
