Land Use Planning After Earthquakes

William Spangle and Associates, Inc.
with
H. J. Degenkolb & Associates
Earth Sciences Associates
National Science Foundation Grant
ENV 76-82756

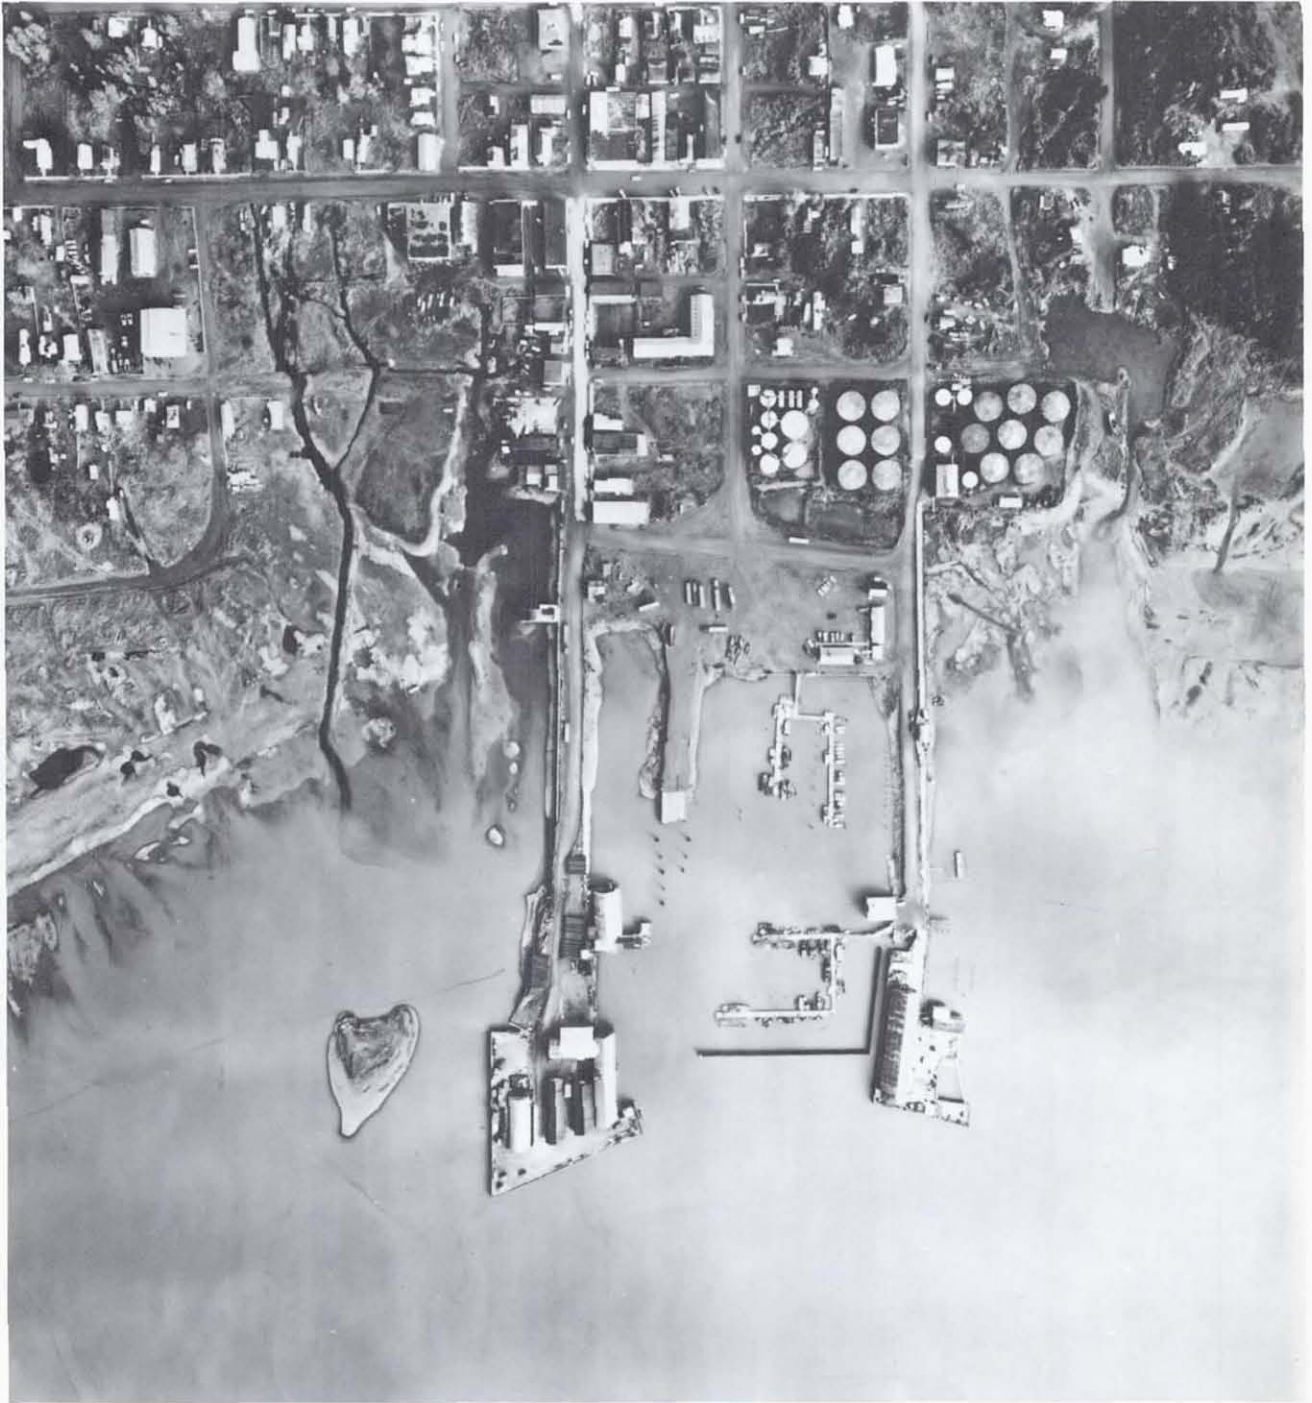
*Figure 42. Aerial photo of Valdez dock area, September 23, 1963
(Source: Coulter and Migliaccio, 1966, p. C12)*

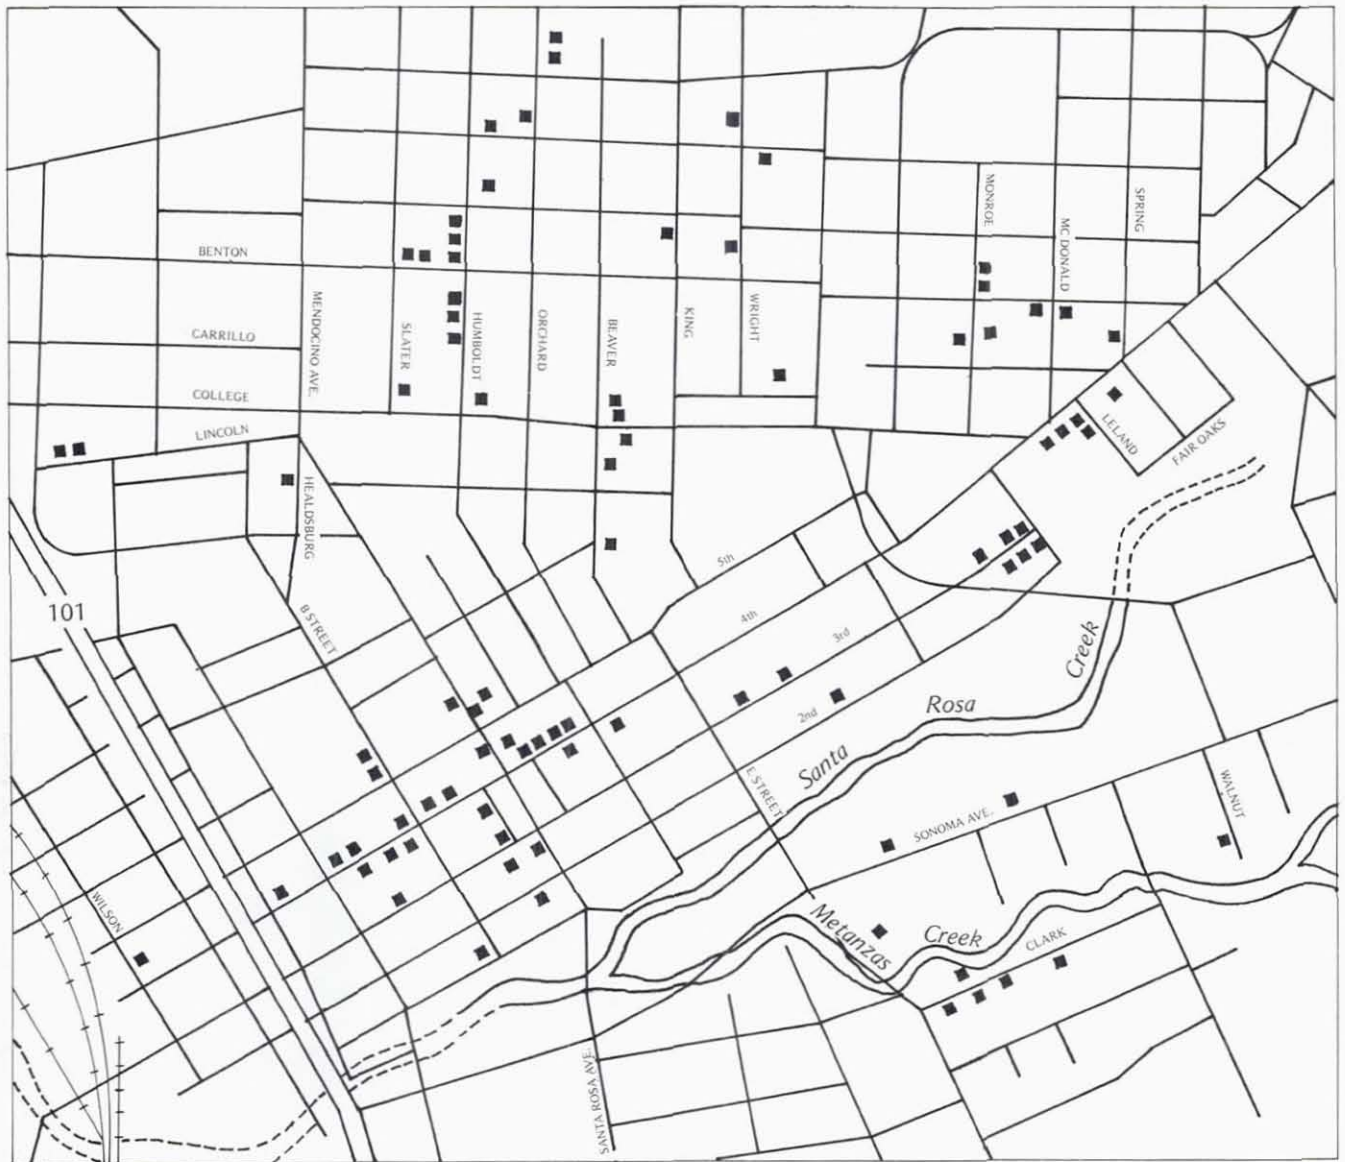
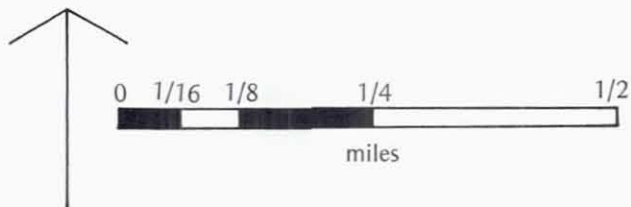
■ Severely damaged buildings

Figure 3. Distribution of buildings in central Santa Rosa severely damaged by the 1969 earthquakes
 (Source: from Cloud and others, 1970, p. 53)

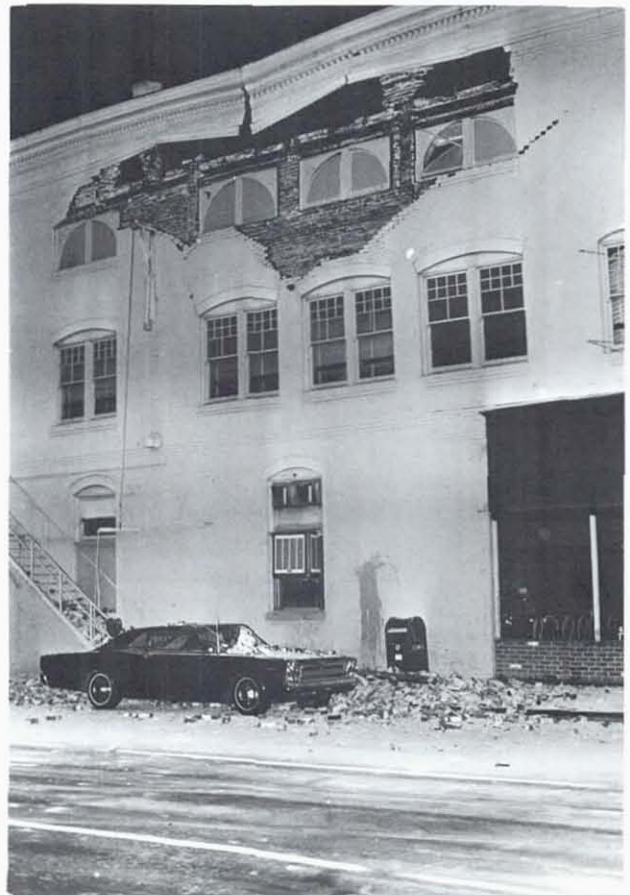
Figure 4. Unreinforced brick masonry failure, Third Street at Mendocino Avenue.

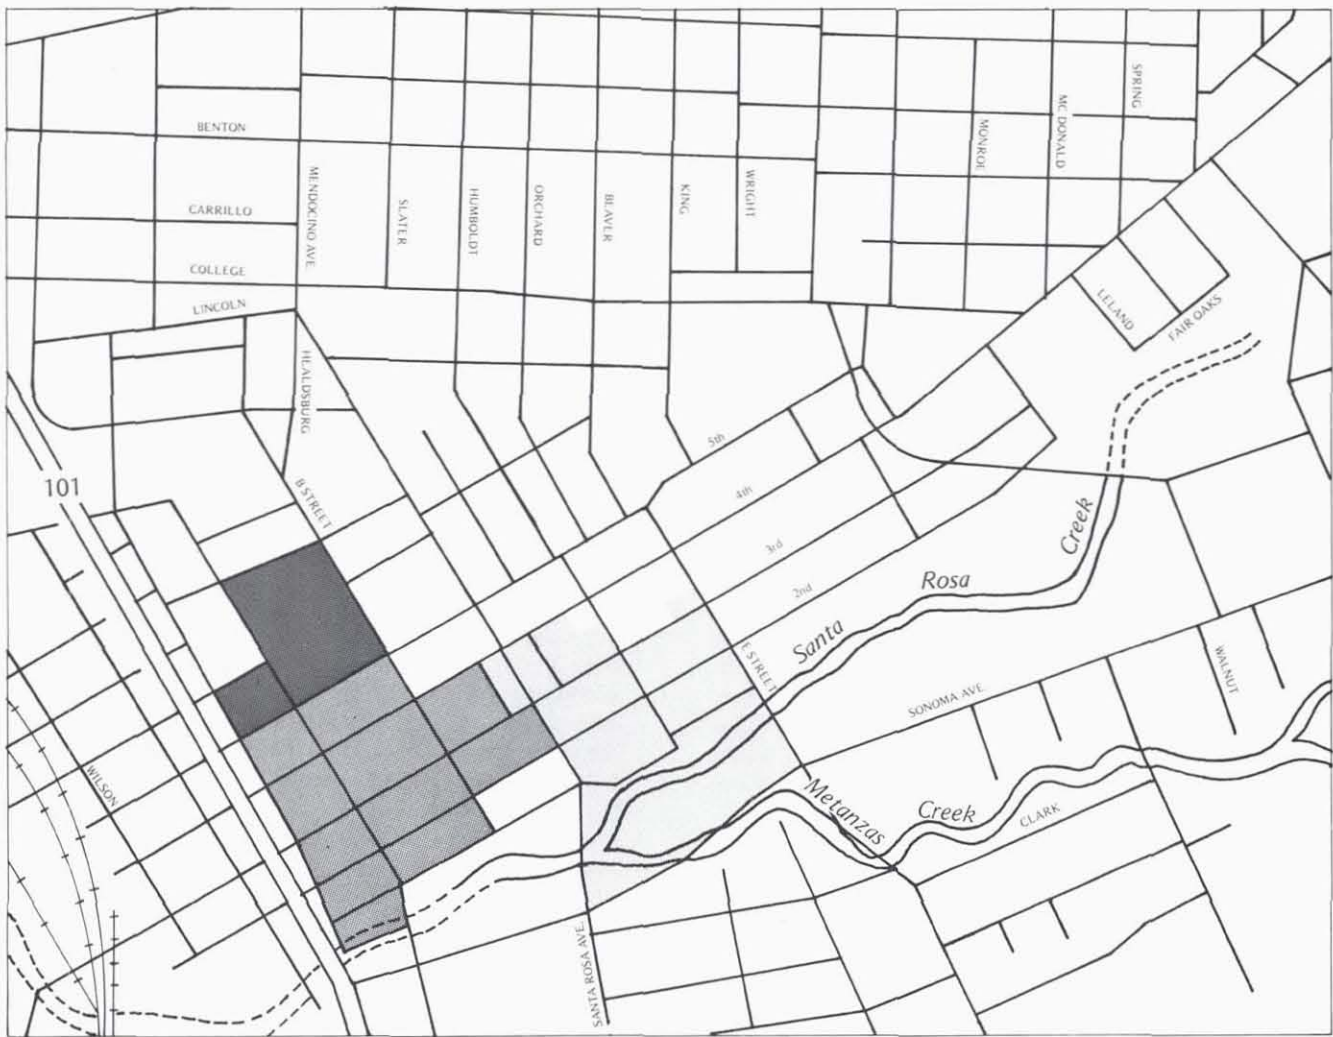
- I Phase I — Original project area
- II Phase II — Area added following 1969 earthquakes
- III Phase III — Survey area of additional land required for regional shopping center

Figure 7. Santa Rosa Urban Renewal Project Area
 (Source: Santa Rosa Redevelopment, Annual Report, undated, modified by William Spangle & Associates, Inc., 1979)

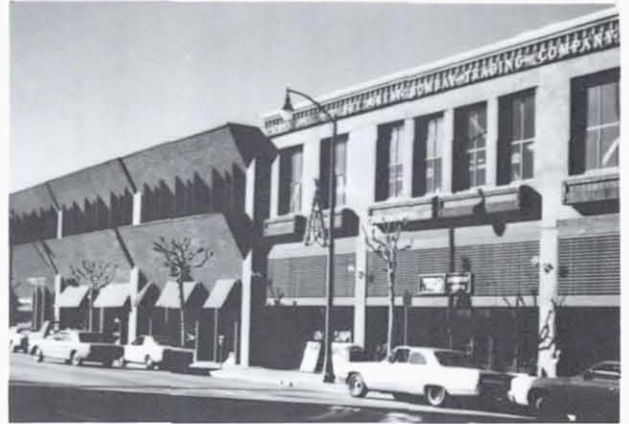
Figure 12. Part of the 500 block of 4th Street showing, in the background, the first successful commercial rehabilitation project involving three old buildings and, in the foreground, rehabilitation underway of three more buildings, Fall 1978

Business Administration disaster assistance loan to cover some of the cost of rehabilitation (one of the fewer than 6 SBA loans granted in Santa Rosa after the earthquakes). Work started in 1974 and today is complete except for the second floor of one building. The success of this project has been instrumental in encouraging other owners on the block to undertake rehabilitation of their buildings (Figure 12).

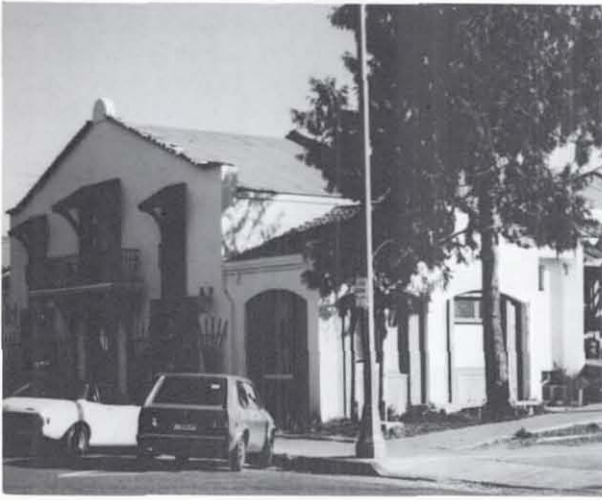
Figure 13. Restaurant in part of rehabilitated warehouse, Railroad Square, Fall 1978

Similar rehabilitation is beginning to occur in an area called Railroad Square, west of the freeway, and in other areas in and near downtown Santa Rosa (Figure 13). In all cases, the structural safety of the buildings is being significantly improved. Although the process is slow, Santa

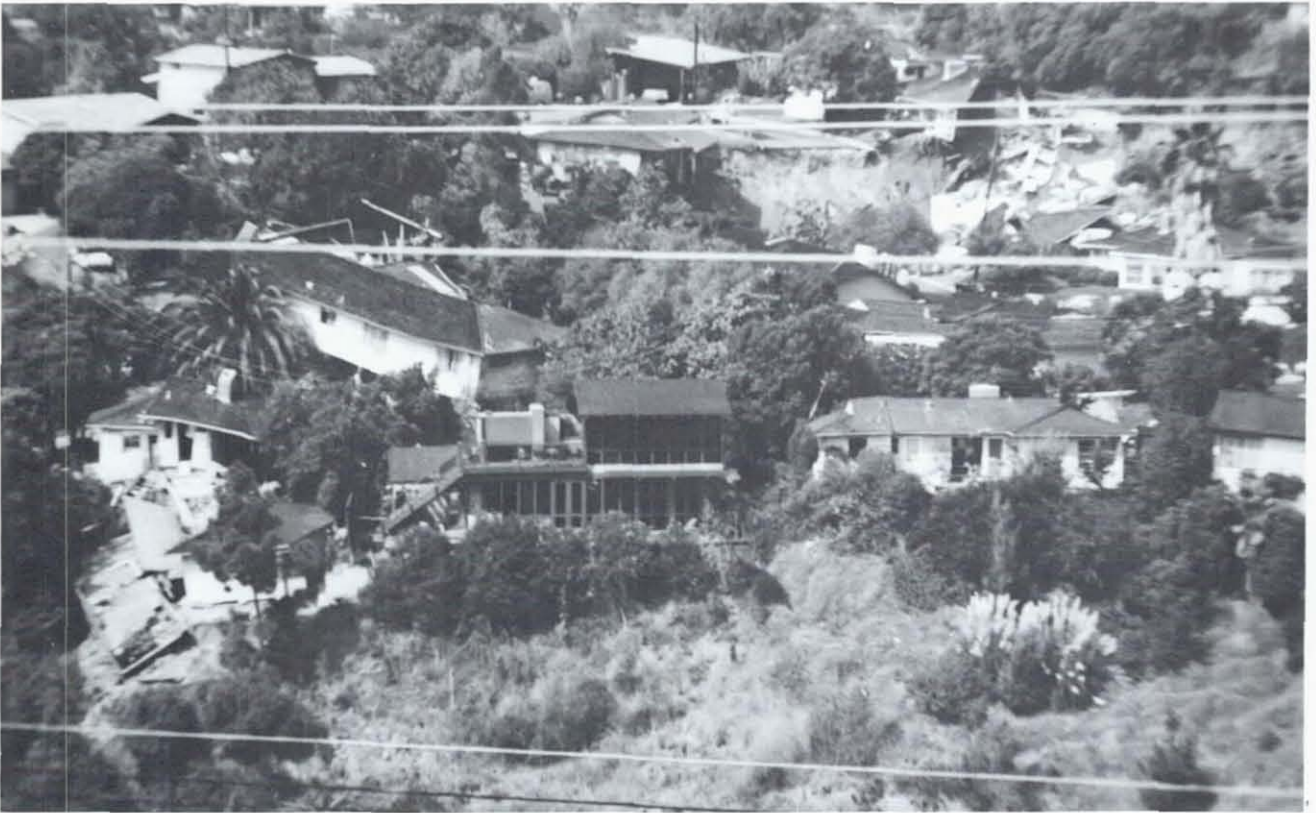
Figure 6. Overview of Bluebird Canyon landside and damaged houses, October 5, 1978

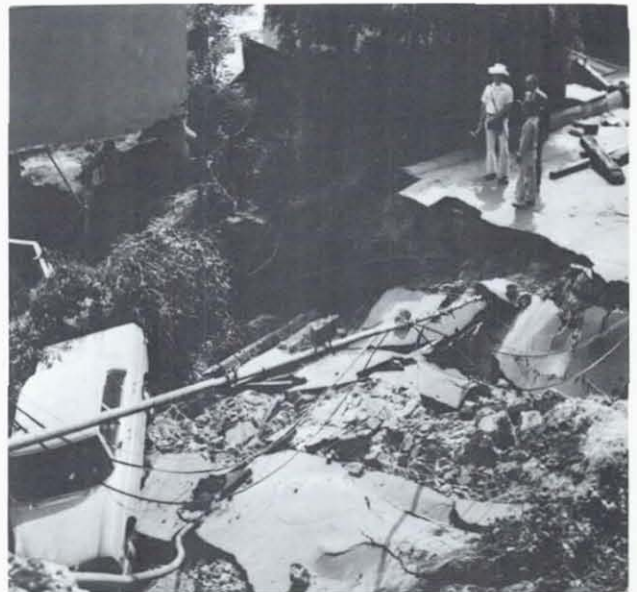
Figure 8. Graben at Meadowlark Drive. Pavement dropped 20-25 feet, October 5, 1978.

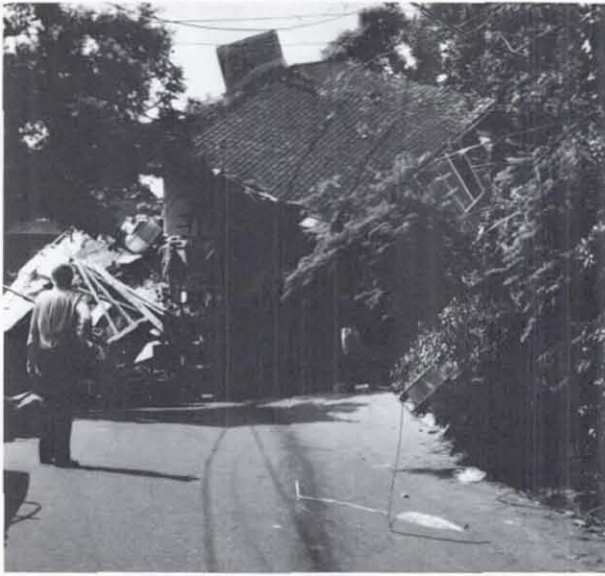
Figure 9. House fallen onto Meadowlark Drive, October 5, 1978

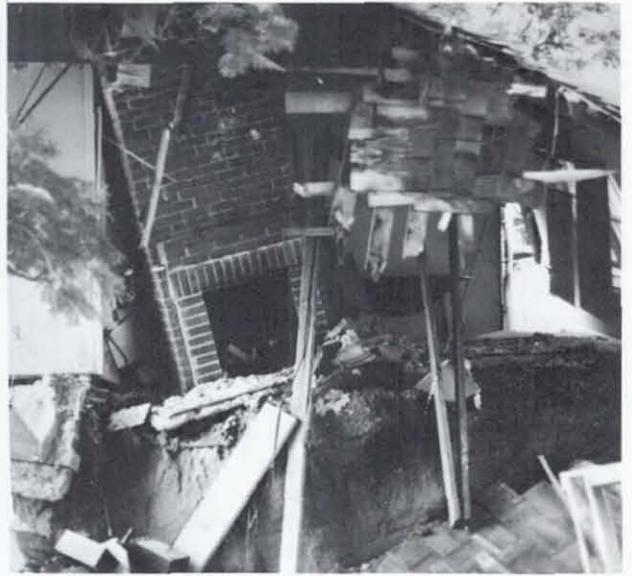
Figure 10. Interior of house shown in Figure 9, October 5, 1978

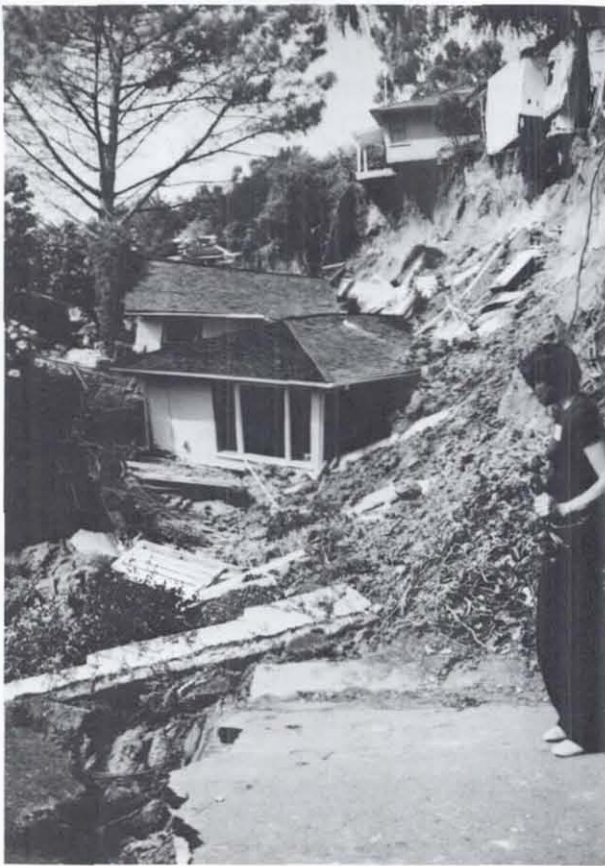
Figure 11. Headscarp below Oriole Drive viewed from the break in Meadowlark Drive, October 5, 1978

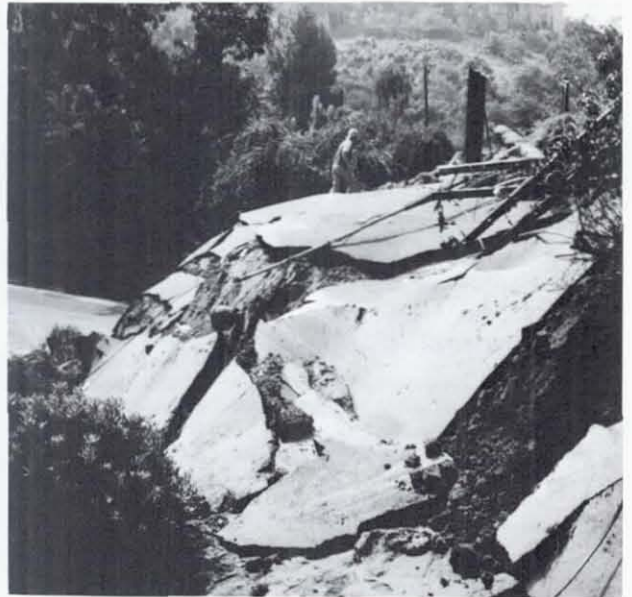
Figure 12. Toe of the landslide at Oriole Drive, October 5, 1978

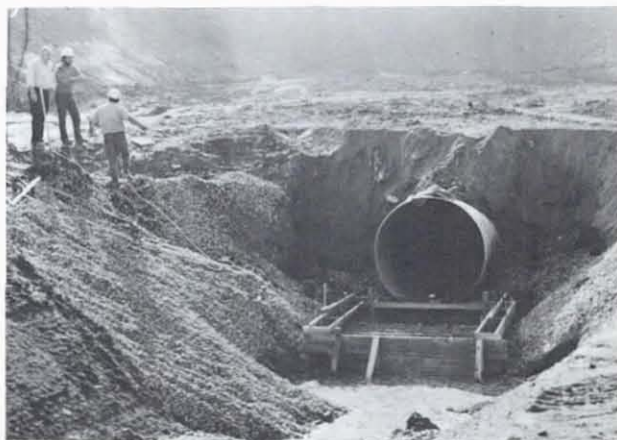
Figure 15. Storm drain installed in channel at the bottom of Bluebird Canyon, December 1978

time in November. The toe of the landslide had, in effect, created a dam in the existing drainage channel at the bottom of Bluebird Canyon. Runoff impounded behind this dam could back up and flood upstream properties and, if the dam were to break, flooding would occur downstream, potentially washing away part of Bluebird Canyon Road, the only means of access to hundreds of homes in the canyon. To solve this problem, Leighton and Associates proposed construction of a drainage pipe through the dam. On November 6, to clear the way for construction work on private property, the City Manager declared that the obstruction of the natural drainage channel constituted a public nuisance. Installation of the storm drain was completed several weeks later (Figure 15).

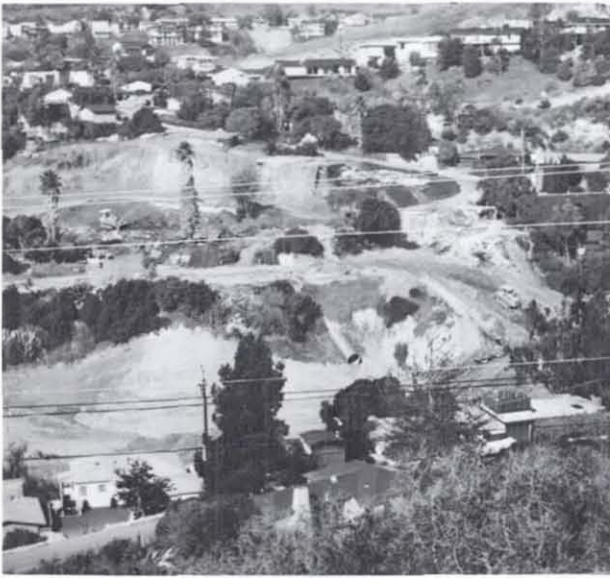
Figure 16. Bluebird Canyon landslide after demolition and removal of houses, December 1978

To control runoff and erosion on the slide and prevent further sliding, emergency grading was recommended which required the demolition and removal of 22 damaged homes. The owners of the houses designated for removal were asked to sign agreements allowing the houses to be demolished. They refused, indicating that they wanted to confer with their attorneys before authorizing the demolitions. On November 7, 1978, the City Council adopted an ordinance suspending Municipal Code provisions which allow persons aggrieved by any administrative decision in a matter of abatement to appeal to the City Council. This action was taken because the Council felt that appeals by slide victims could prolong actions needed to protect habitable properties surrounding the slide area from the effects of approaching winter rains. With the possibility of time-consuming appeals removed, on November 8, 1978, the City Manager, with confirmation from the City Council, declared a nuisance to exist in Bluebird Canyon and ordered the demolition of the 22 houses. Demolition began two weeks later and was completed by December 12, 1978 (Figure 16).

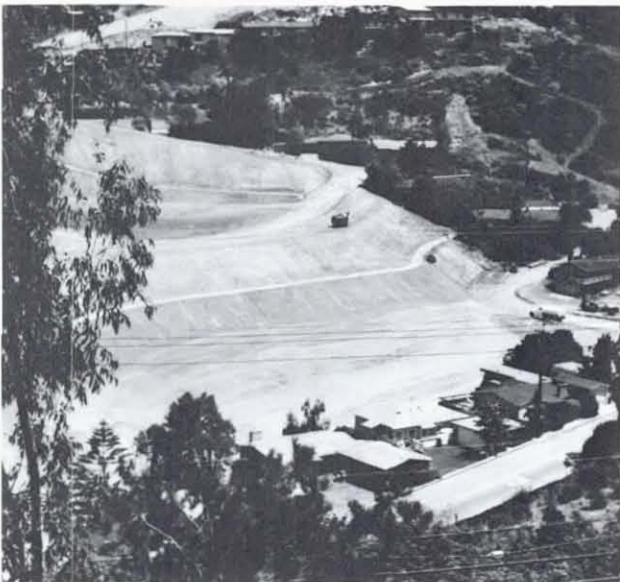
Figure 19. Landslide area with buttressing essentially complete and rough grading for roads and utilities underway, July 1979

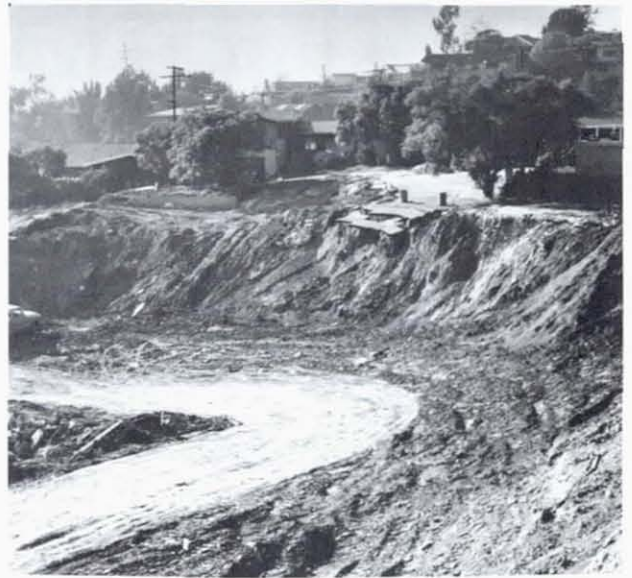
Figure 18. Rough grading of headscarp just prior to work on the shear-key buttress, December 1978

The upper buttress, just below Oriole Drive, was designed as a 70-80 foot wide, all-earth, shear-key buttress located 40-70 feet below and roughly parallel to the headscarp of the landslide (Figure 18). During the excavation phase of the buttress construction, a steep backcut with a high potential for failure would be exposed endangering construction workers. To reduce this risk, Leighton and Associates recommended carrying out the backcut excavation in relatively small sections and installing a row of 48 reinforced-concrete shoring "soldier" piles 10-50 feet above and parallel to the headscarp of the landslide.

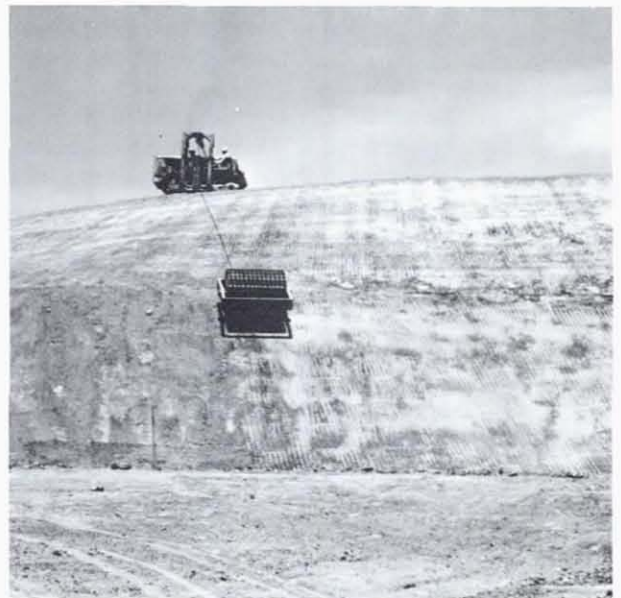
Figure 20. Compaction of lower gravity buttress, July 1979

scarp of the landslide, and the other, an earth gravity buttress, at the toe of the slide to improve the overall stability of the active slide mass and to protect the drainage work (Figure 17). Although alternative stabilization measures were considered, Leighton and Associates determined the buttressing project to be the most economical way to provide a reasonable level of safety against future earth failure. Total construction cost was estimated in December 1978 to be about \$650,000 (Leighton and Associates, December 1978).
