Report to
THE NATIONAL SCIENCE FOUNDATION
Washington, D.C.
Grant No. ENV77-15333

EARTHQUAKE RESISTANT STRUCTURAL WALLS -
TESTS OF WALLS WITH AND WITHOUT
OPENINGS

CONSTRUCTION TECHNOLOGY LABORATORIES
A Division of the Portland Cement Association
5420 Old Orchard Road
Skokie, Illinois 60077

July, 1981

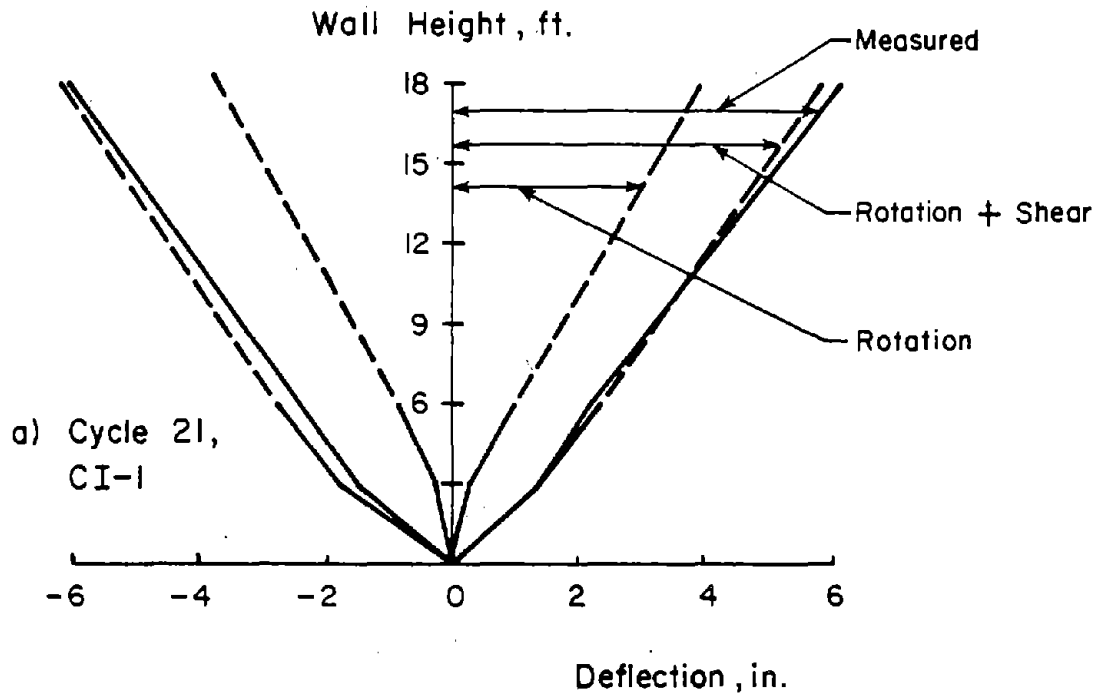
Fig. 22 Deflection Components

Deflection profiles of both wall specimens, as shown in Fig. 22 by solid lines, were found to be very similar. Deflection within the lower 6 ft (1.83 m) of the walls was primarily attributed to shear deformations. Above the 6-ft (1.83 m) level, shear distortion remained relatively constant and rotational deformations increased. Large shear distortions observed at the 3-ft (0.92 m) level indicated that shear was significant in the behavior of both specimens. The presence of the openings had little effect on the relative magnitudes of deflection components.
