THE SHARPSBURG, KENTUCKY EARTHQUAKE
OF JULY 27, 1980

ARCHITECTURAL AND STRUCTURAL DAMAGE, AND GROUND EFFECTS
 RESULTING FROM THE JULY 27, 1980 SHARPSBURG, KY
 EARTHQUAKE

R. Street and W. Foley

Dept. of Geology
University of Kentucky
Lexington, KY 40506

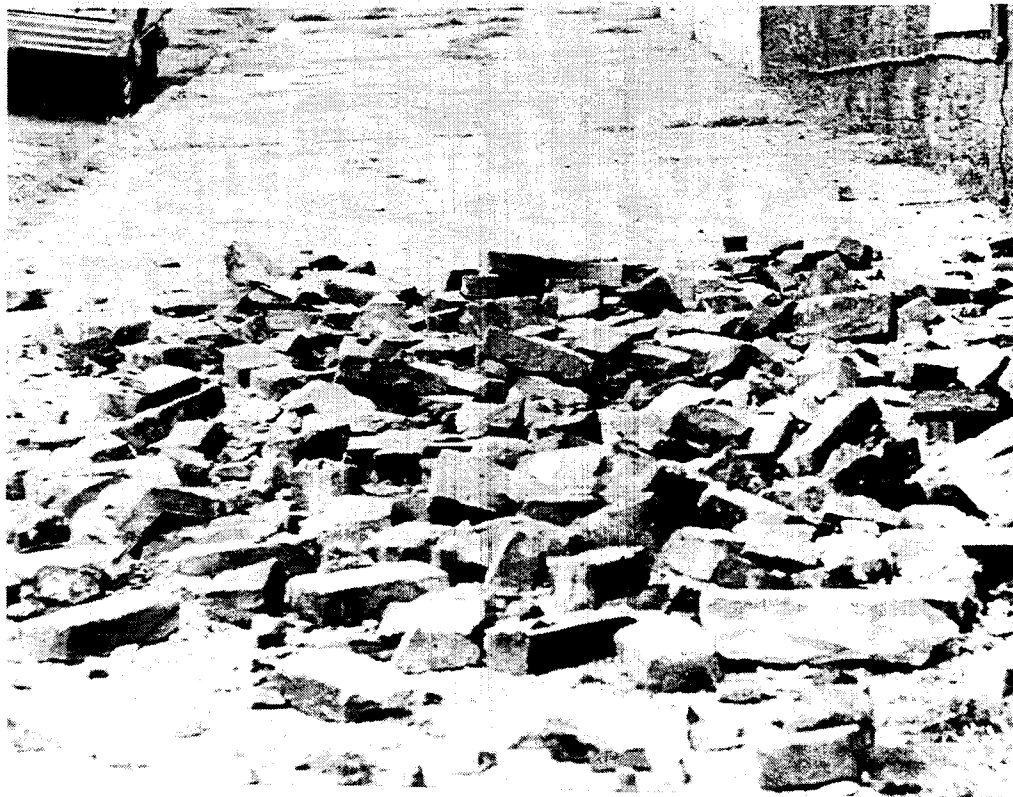
There were numerous and widespread instances of minor architectural damage, such as broken glass, cracked or fallen plaster, and damage to decorative brickwork, reported throughout the meizoseismal area. Figures 2 and 3 illustrate examples of this type of damage in Maysville, Kentucky; Figure 2 shows a broken 1/2 inch plate glass bank window, while Figure 3 is of a brickfall from a damaged parapet. Figure 4 shows a window in the courthouse at Flemingsburg, Kentucky from which the cornice was shaken loose, while Figure 5 shows the cracked cornice on the two-story Perfect Lady Beauty Shop in Owingsville, Kentucky.

Figure 3. Brick fall from broken parapet in downtown Maysville, KY. Photo by courtesy of J. Parker.

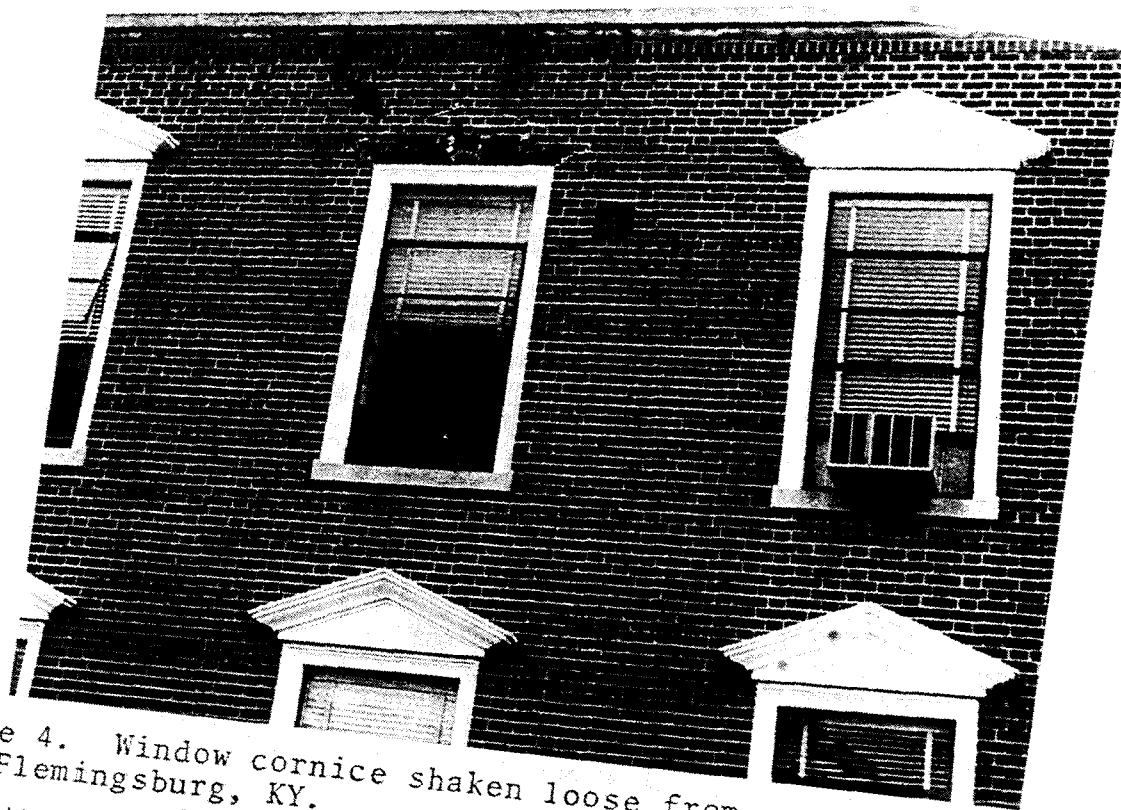
Figure 4. Window cornice shaken loose from courthouse, in Flemingsburg, KY.

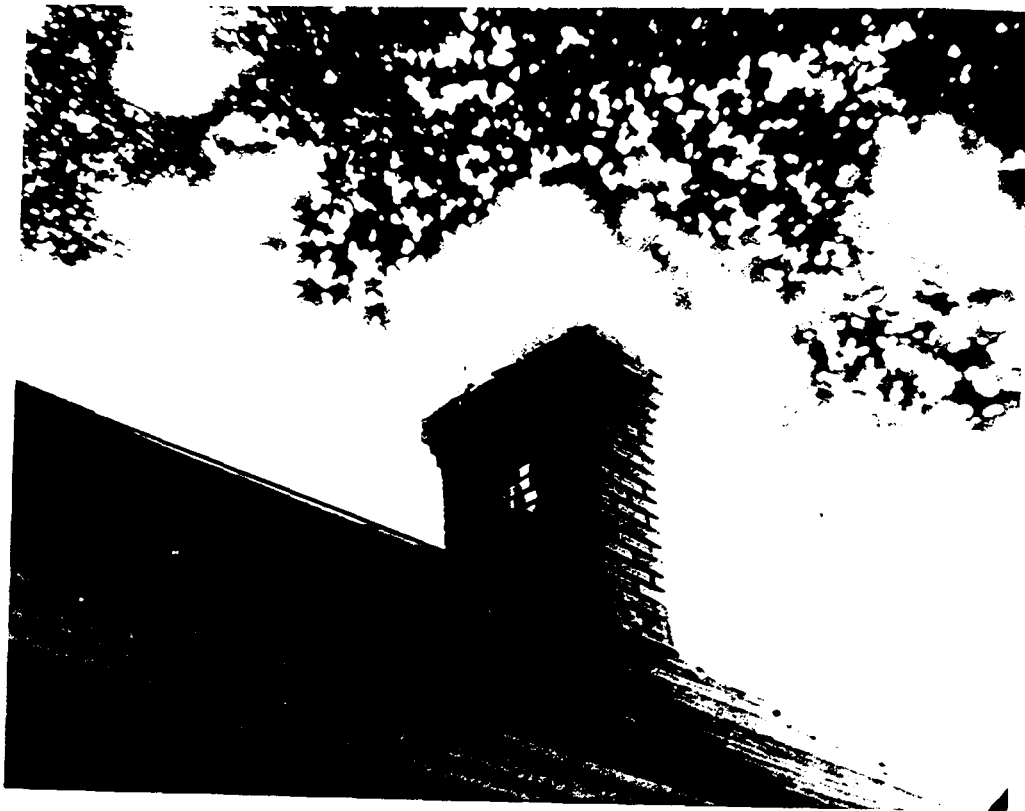
Figures 6 thru 12 illustrate the range of chimney damage sustained. In Figure 12, approximately three feet of the chimney was broken off. Bricks from the chimney were scattered about the yard with some being found as far as fifteen feet away from the side of the house.

Figure 6. Chimney damage at Robert's residence in Sharpsburg, KY.

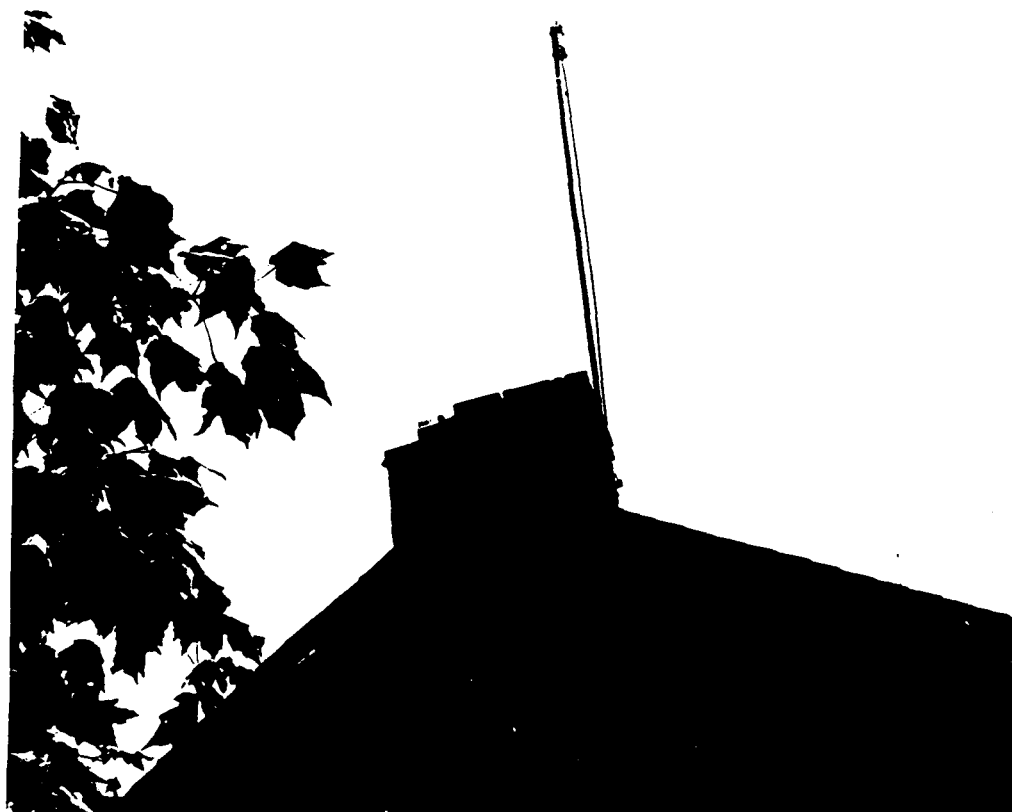
Figure 7. Broken chimney at the top of the west wall of the two story Toy residence near Sharpsburg, KY.

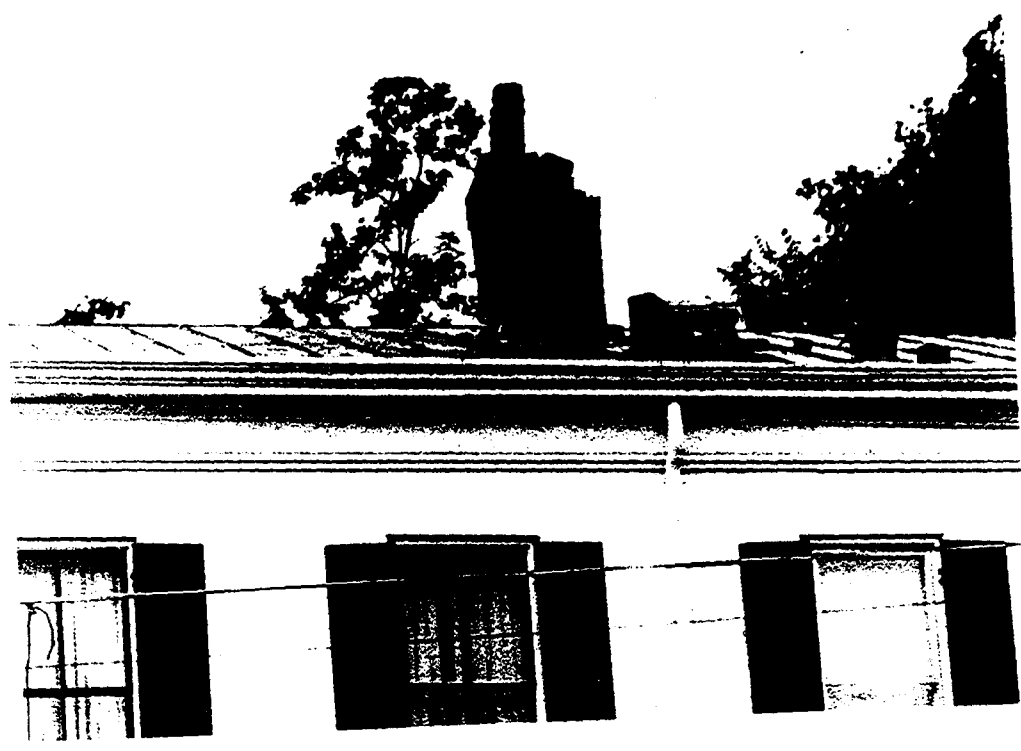
Figure 8. Typical chimney damage in downtown Maysville.
Photo by courtesy of J. Parker.

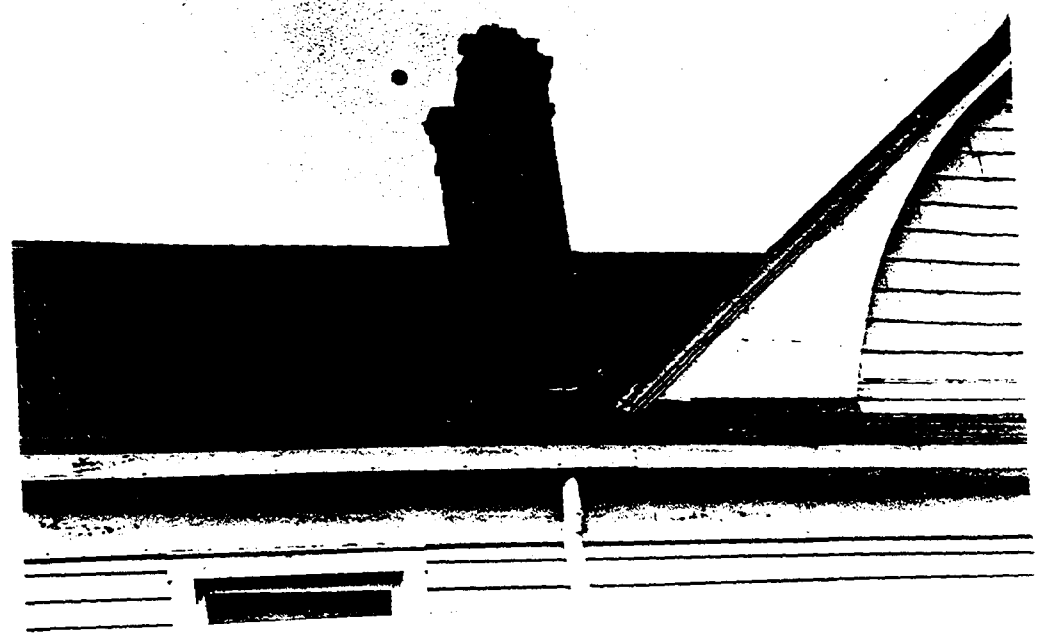
Figure 9. Chimney damage at abandoned residence on Route 11
south of Moorefield, KY.

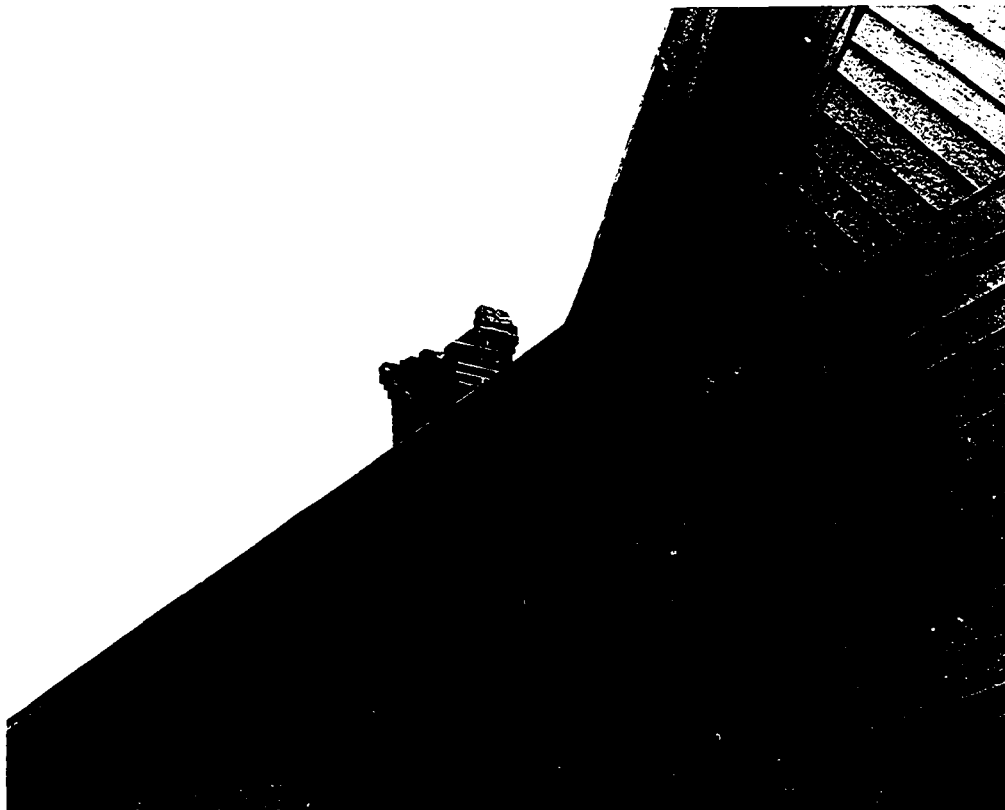
Figure 10. Chimney damage at 152 Main Street, Owingsville, KY.

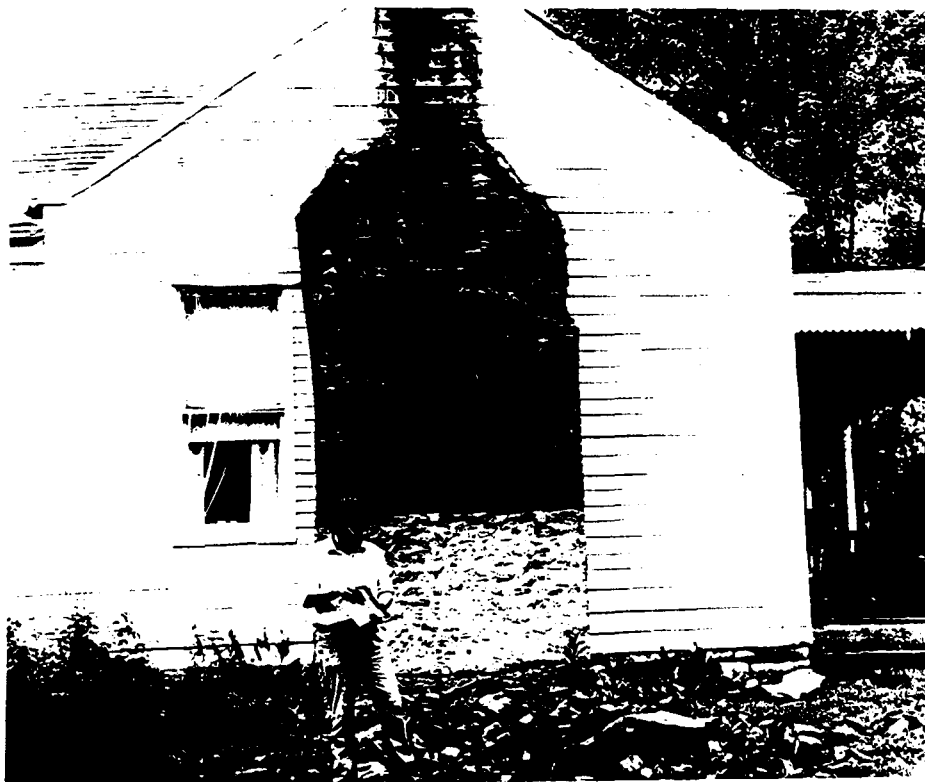
Another factor that contributed to the extensive chimney damage in the meizoseismal area, is the nearly uniform lack of chimney flues in the construction of the older homes. Not only were the chimneys without flues subject to greater damage above the roofline than those with flues, but many such chimneys were cracked well below the rooflines and became potential fire hazards.

Figure 11. Chimney fall at one story frame structure at Sherburn, KY. Notice that the chimney has no flue for internal support, and that the mortar is in poor condition.

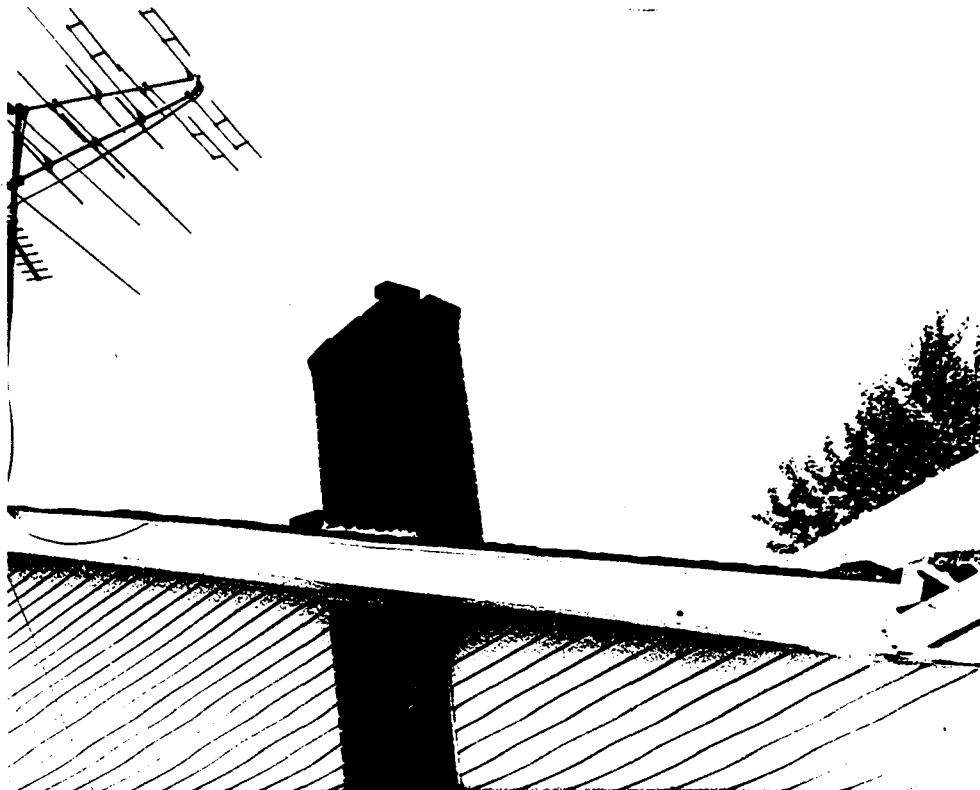
Factors that contributed to the extensive chimney damage were (1) the age and type of mortar used between the chimney brickwork, and (2) the lack of chimney flues in many of the older homes. Homes with chimney damage were generally built before World War II, with many dating back to the turn of the century. Mortar used between the bricks of the chimneys of the older homes consists of a locally produced limestone based mortar that is susceptible to weathering. Figure 13 shows dislodged bricks from the damaged chimneys on the two story wood-frame Hall residence in Mt. Sterling, KY. Severe weathering of the mortar used in the construction of the chimney is indicated by the deep grooves between the bricks, and by the lack of mortar on the brick faces of the dislodged bricks; mortar shows up in the figure as white patches on the brick faces.

Figure 12. Chimney damage at Brewer residence on Route 11 north of Sharpsburg. Notice the condition of the mortar.

the cost of repairing a chimney ranged from a low of \$80 for minor repairs involving chimney tops, to \$500 for those repairs to chimneys cracked below the roofline. The latter type of damage was generally repaired by inserting a linear into the chimney and filling the void between the linear and chimney with cement.

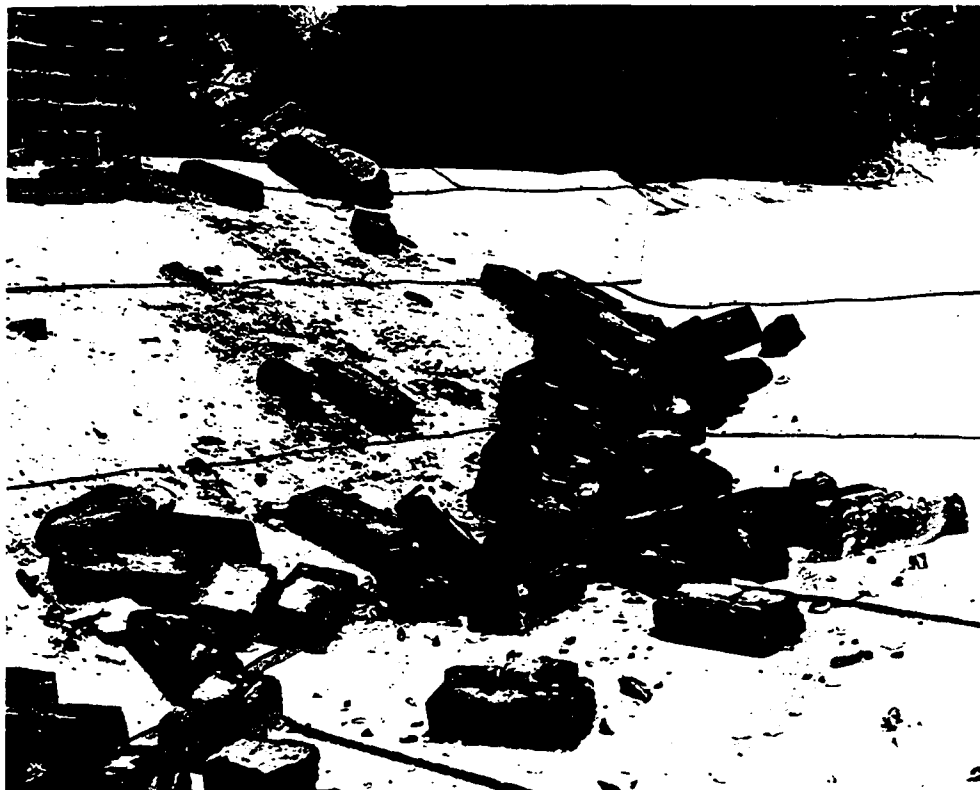
Figure 13. Chimney damage at two story frame Hall residence in Mt. Sterling. Notice poor condition of mortar.

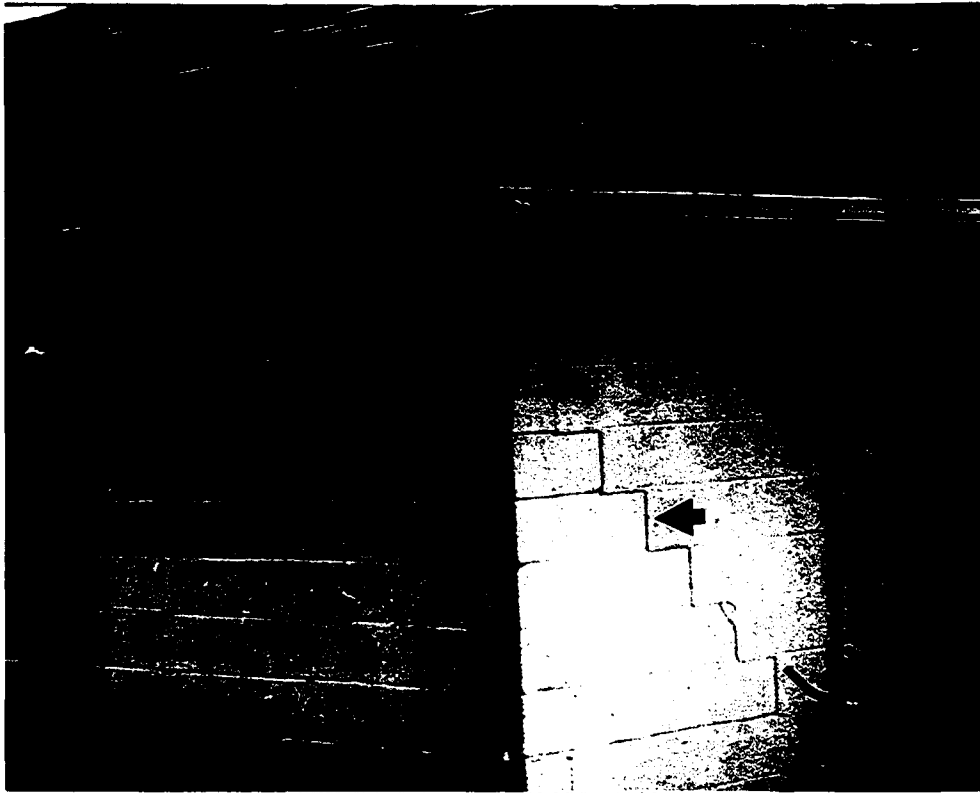
Numerous examples of brick walls being cracked along mortar joints were observed and reported throughout the meizoseismal area. Figures 14, 15 and 16 illustrate three such instances of cracking. Figures 14 and 15 are of buildings in Aberdeen, Ohio and Lewisburg, Kentucky respectively, which are towns, in the northern extremity of the meizoseismal area. At the southern edge of the meizoseismal area, Figure 16 shows a similar type of cracking in a concrete block structure on the Mt. Sterling Golf Course.

Figure 16. Cracks in concrete block structure at golf course in Mt. Sterling, KY. Photo by courtesy of J. Zollweg.

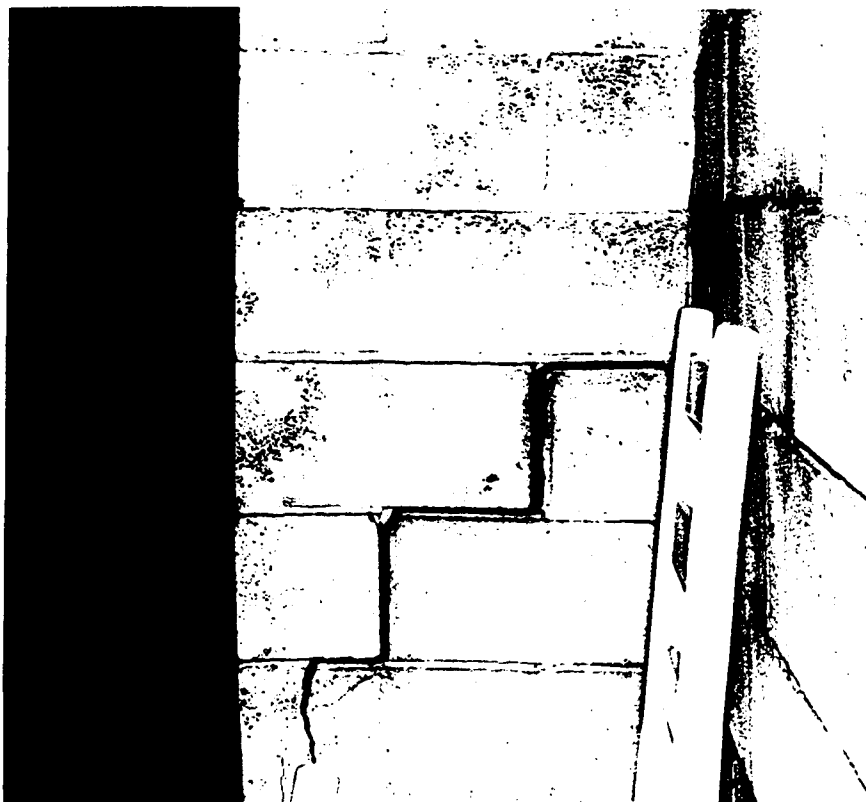
Several instances of severe damage to cisterns and basement walls in the southern and central portions of the meizo-seismal area were reported. Figure 19 shows the basement wall at the Cooper's residence in Flemingsburg, KY that was both cracked and bowed by the ground-motions of the earthquake. Figure 20, also from the Flemingsburg area, shows the cracked boiler room stairwell in the basement of the Fleming County Hospital. Severely cracked basement walls were also observed in the North Middletown, Sherburne, Owingsville, Sharpsburg, and Little Rock, KY localities.

Figure 19. Cracked and bowed concrete block basement wall at Cooper residence in Flemingsburg, KY.

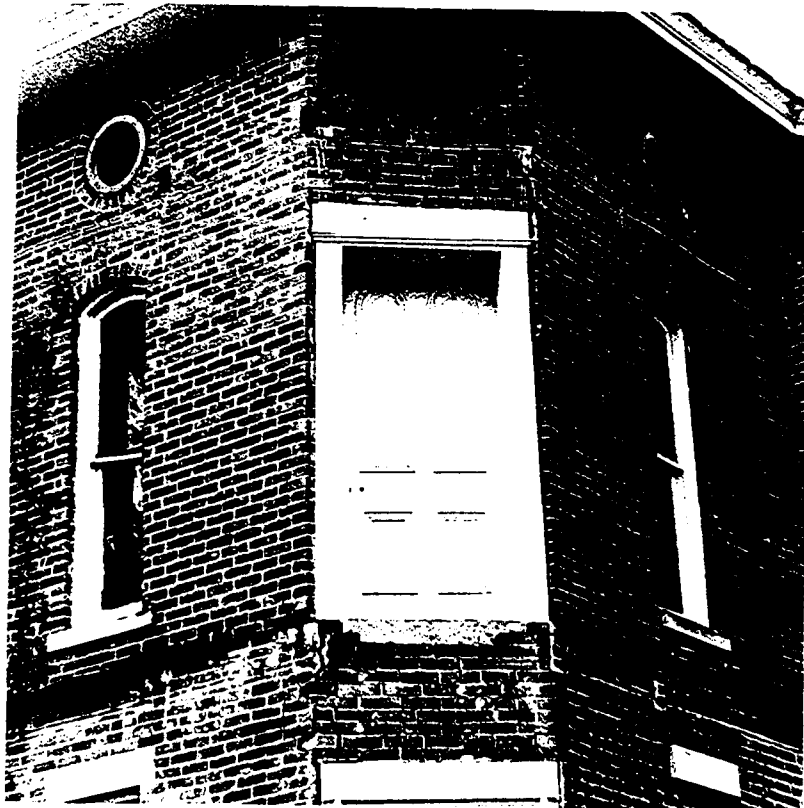
Figure 23 is a picture of a badly damaged 150 year old Purvis residence one kilometer south of Sharpsburg. The damage to the Purvis house is an example of a building that sustained severe damage primarily as a result of a structural foundation that had been seriously weakened by age and weathering. The cracks about the door frames in the figure are typical of the cracking that occurred throughout the exterior and interior walls of the house. Some of the cracks were large enough

As a point of interest, the reason the windows in the Purvis house shown in Figure 23 were not broken, is that they were of Plexiglass instead of glass.

Figure 23. Extensive cracking in the 150 year old brick Purvis home on the outskirts of Sharpsburg, KY.

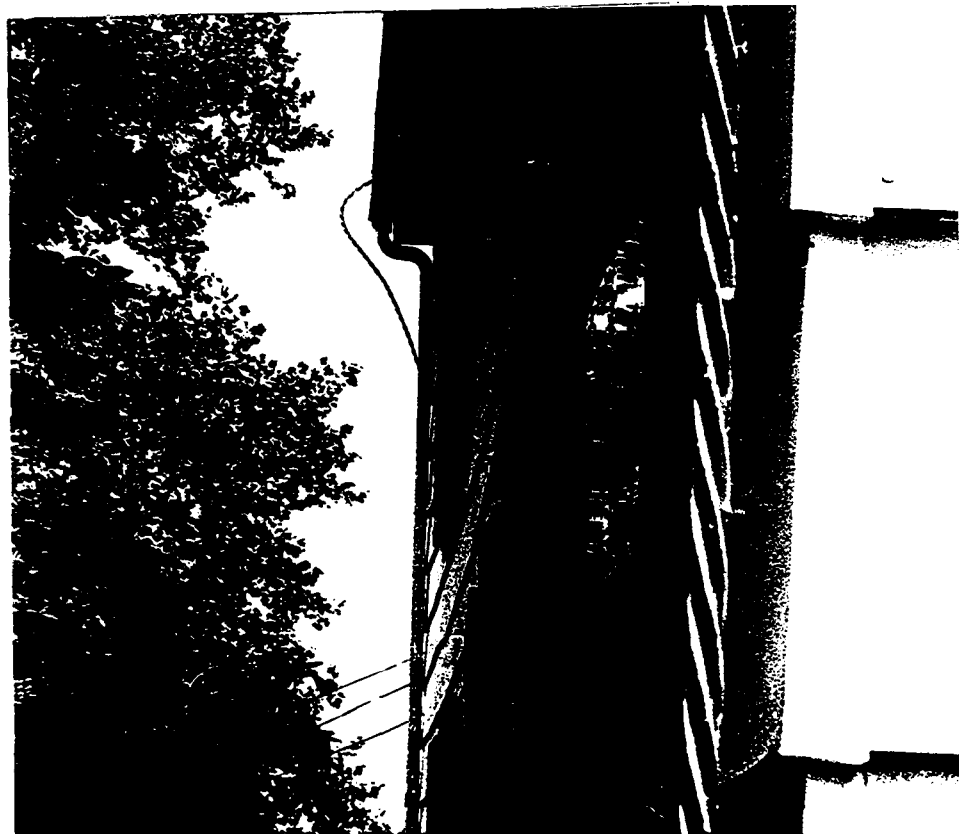
The Toy residence, about 5 kilometers southeast of Sharpsburg on the Bennett Branch road, also suffered extensive damage from the earthquake. Figure 29 shows the west side of the house that was buckled inwards; the east side wall was buckled outwards. Figure 30 shows the cracked concrete blocks in the well house that sets on naturally level terrain on the east side of the house. Figure 31 shows the severed water pipe that went from the well house through the basement wall to the hotwater heater that was overturned during the earthquake. Figure 32 shows one side of the two-story concrete block garage on the Toy farm. And, as in the case with the concrete block well house, the crack passes through the concrete blocks, not just along the mortar joints. Unlike the house and well house though, the garage was built into the side of a hill with a gentle slope off to the right of the wall shown in Figure 32. The motion inside of the house, as a result of the earthquake, is described by Mr. Toy as being ". . . so bad that I and my family found it difficult to stand".

Figure 29. View of the west wall of the Toy structure near Sharpsburg, KY. Notice how the wall is bowed inwards (see arrow); east wall of the structure was bowed outwards in a like manner.

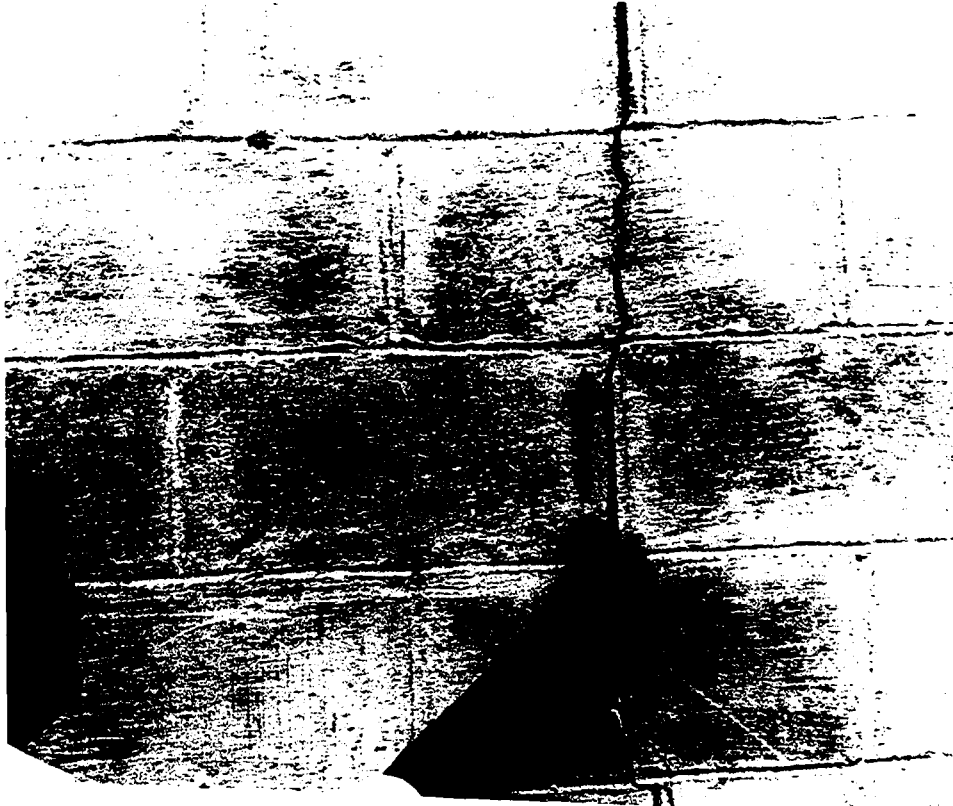
Figure 30. Cracked cement block well house on the Toy farm near Sharpsburg, KY.

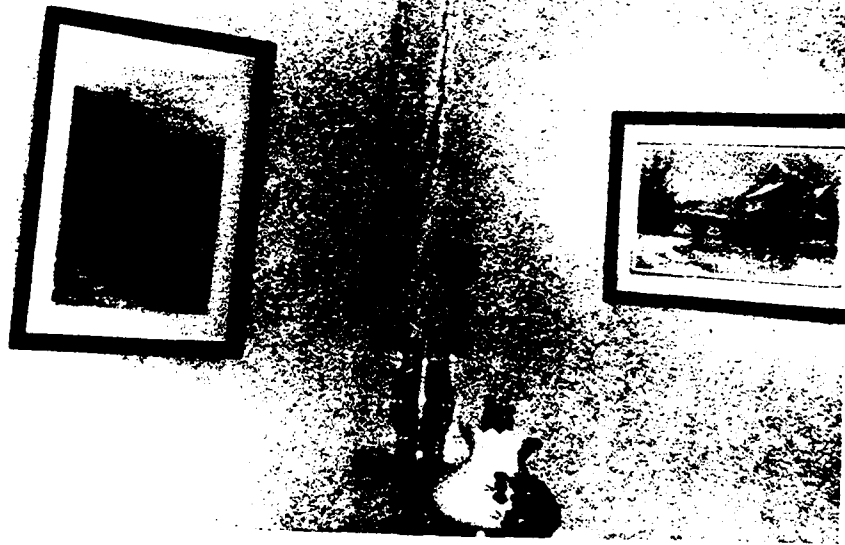
outwards 7 to 8 inches, the three chimneys on the house were damaged - with the chimney on the west side of the house being split from the roofline to the fireplace, while the screws holding the mantle to the wall over the fireplace on the east side of the house were pulled out of the wall about 2 inches. Damage to the house also included a room on the first floor of the east end of the house that was noticeably twisted out of alignment with the rest of the house; the wallpaper in this room was torn in a manner suggesting a twisting or shear-type of motion. In addition, cupboards were emptied of their contents, pictures were knocked off walls, and Mrs. Stull and her daughter, who were in the house during the earthquake, reported that they were unable to stand during the event. Figures 33 and 34 illustrate a portion of the damaged limestone foundation along the front of the Stull residence, and crumpled and torn wallpaper in the corner of the first floor room at the east of the house.

Figure 34. View of the torn wallpaper along the corner of the first floor east end room of the Stull home near Sharpsburg, KY. Photo by courtesy of Mrs. R. Stull.

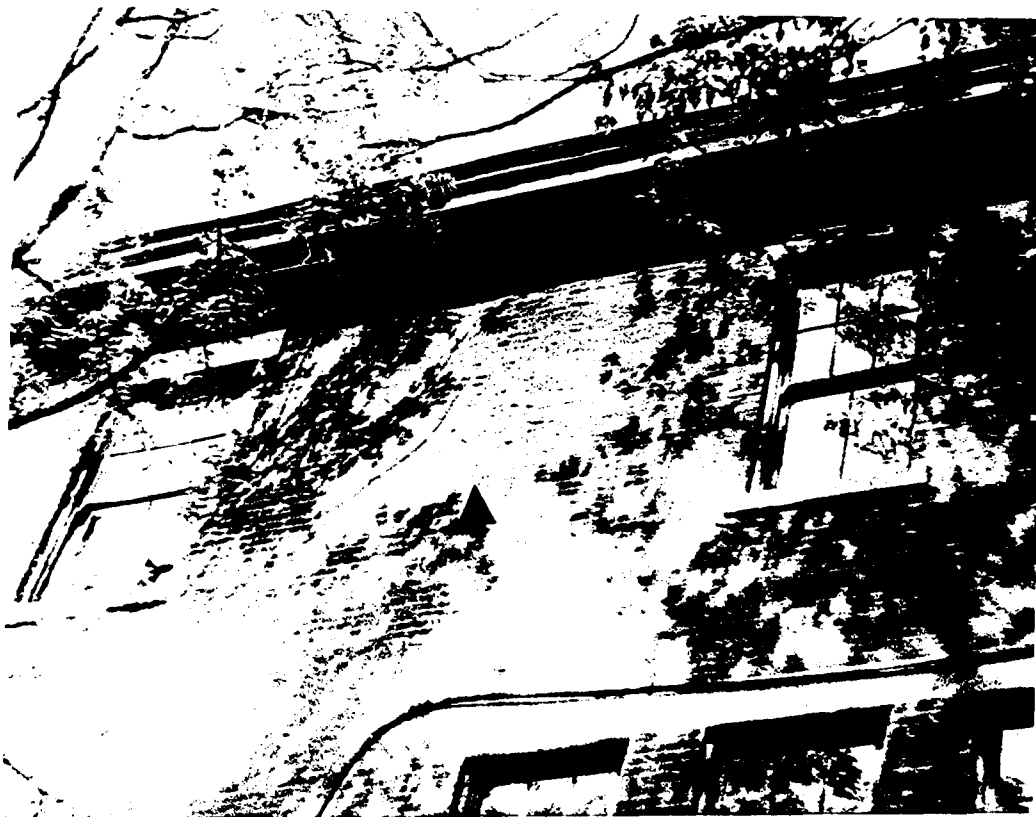
Another structure that was severely damaged by the earthquake, was the Mt. Sterling Middle School on Kentucky Rt. 11 in Mt. Sterling, KY. The three-story brick building was completed in the early 1930's and appears to have been kept in a good state of repair. Figure 35 shows the third floor of the south wall which was so badly damaged that one window was removed and bricked over, and the lintel over the window to the right was knocked out about 2 inches from the wall. This section of the exterior wall required \$22,000 dollars in repairs immediately after the main shock, in order to stabilize the

Figure 35. Damaged exterior south wall of the middle school in Mt. Sterling, KY. One window was removed and bricked in, as was the stone lintel over the window to the right (see arrows).

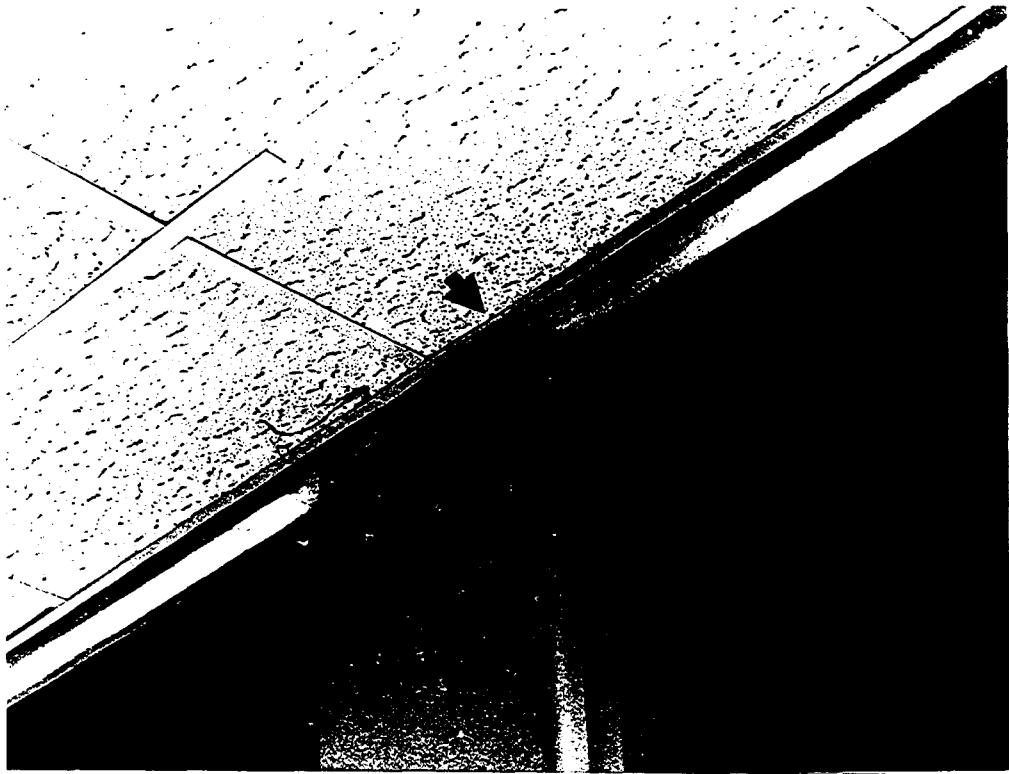
wall from further movement. Figure 36 is an interior shot of the typical type of damage done to the window pillars on the south side of the second floor of the building, while Figure 37 shows the type of interior damage typically found along the north wall of the building. Total damages to the structure was estimated by the city's architect to be on the order of \$325,000.

Figure 36. Damaged to one of several window pillars on the second floor of the middle school in Mt. Sterling, KY.

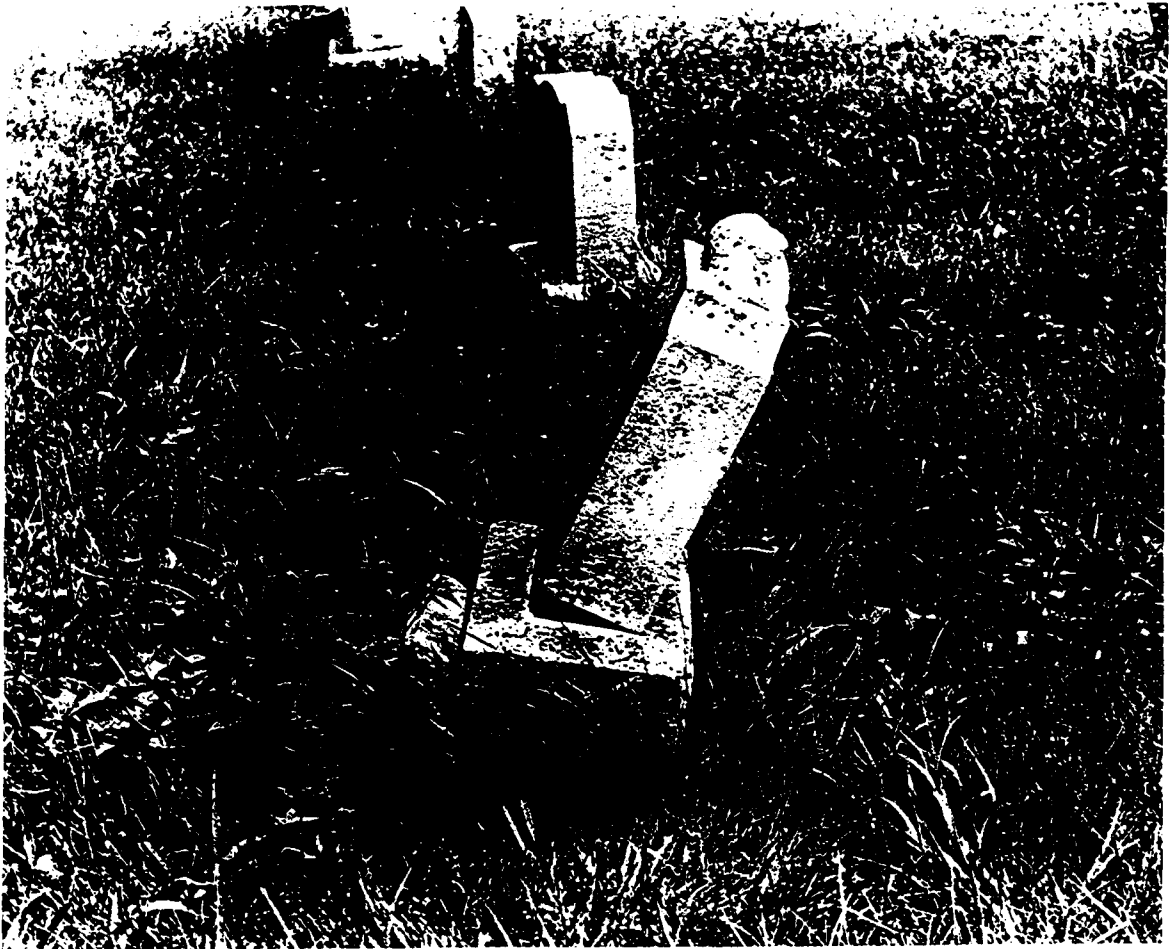
Tombstones throughout the meizoseismal area were effected by the ground-motion of the earthquake. Based on our observations, the movement of the tombstones was random; that is, we observed tombstones - in the same cemetery - that had rotated clockwise, counterclockwise or shifted on their pedestal with somewhat equal regularity. Figures 38, 39 and 40 illustrate three tombstones in the Sharpsburg valley cemetery that give evidence of rotation, displacement, and partial overturning, respectively. A few tombstones in the cemetery were completely overturned by the earthquake, but were righted by the ground-keeper the day after the event.

Figure 40. Example of a tombstone in the Sharpsburg cemetery that would have fallen if not for the metal rods connecting the top to the base.

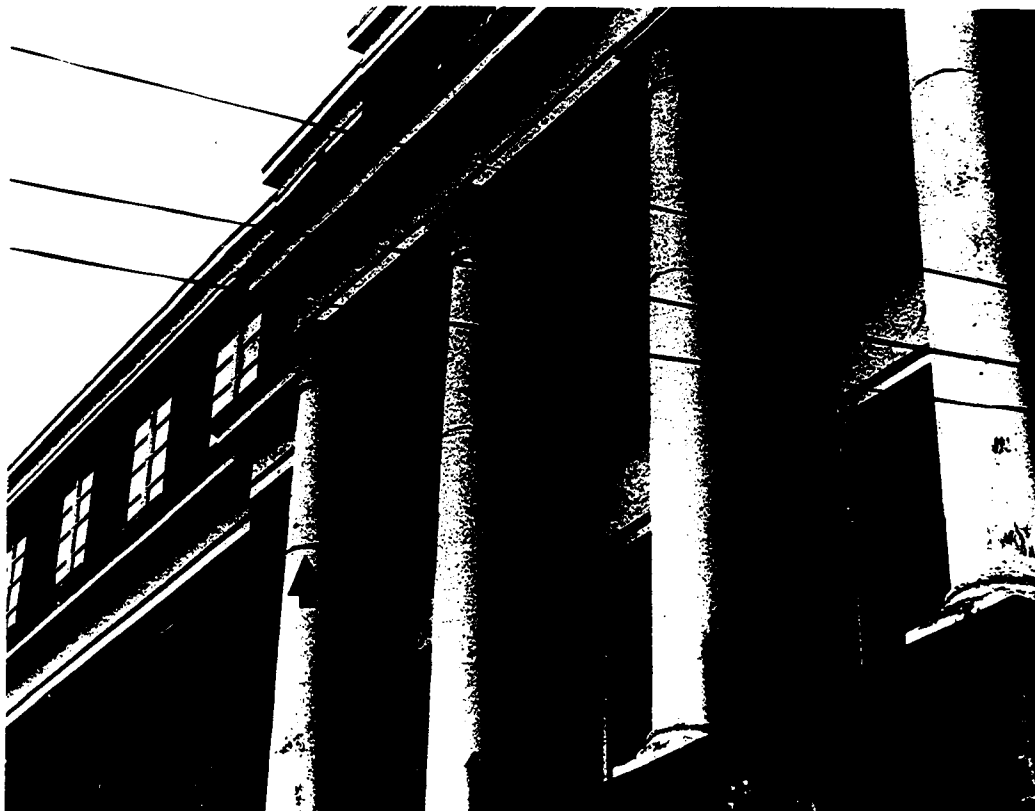
Figure A3. Columns at the front of the Hayswood Hospital in Maysville, KY that were displaced by as much as one inch at the joints.

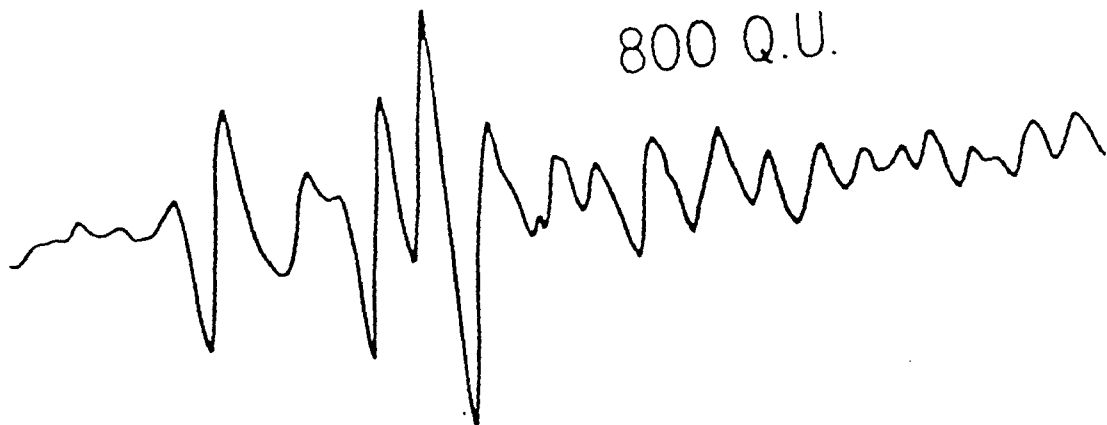
Figure 5. Observed (top) P waveform at NORSAR with synthetic waveforms (below). Crustal model, dip, strike and rake angles are given for each synthetic. Zero-to-peak amplitude for the observed trace is in quantized units (Q. U.). For NORSAR sensors, there are 0.0427 nm/ Q. U. at 1.0 Hz.

800 Q.U.

NORSAR
SUM

$\delta = 70^\circ$
 $s = 30^\circ$
 $\lambda = 180^\circ$
CRUST A

Figure 5. Observed (top) P waveform at NORSAR with synthetic waveforms (below). Crustal model, dip, strike and rake angles are given for each synthetic. Zero-to-peak amplitude for the observed trace is in quantized units (Q. U.). For NORSAR sensors, there are 0.0427 nm/ Q. U. at 1.0 Hz.
