**METHODOLOGY FOR
MITIGATION OF SEISMIC HAZARDS
IN EXISTING UNREINFORCED
MASONRY BUILDINGS:
CATEGORIZATION OF BUILDINGS**

ABK A Joint Venture
250 North Nash Street
El Segundo, California 90245

**Topical Report 01
December 1981**

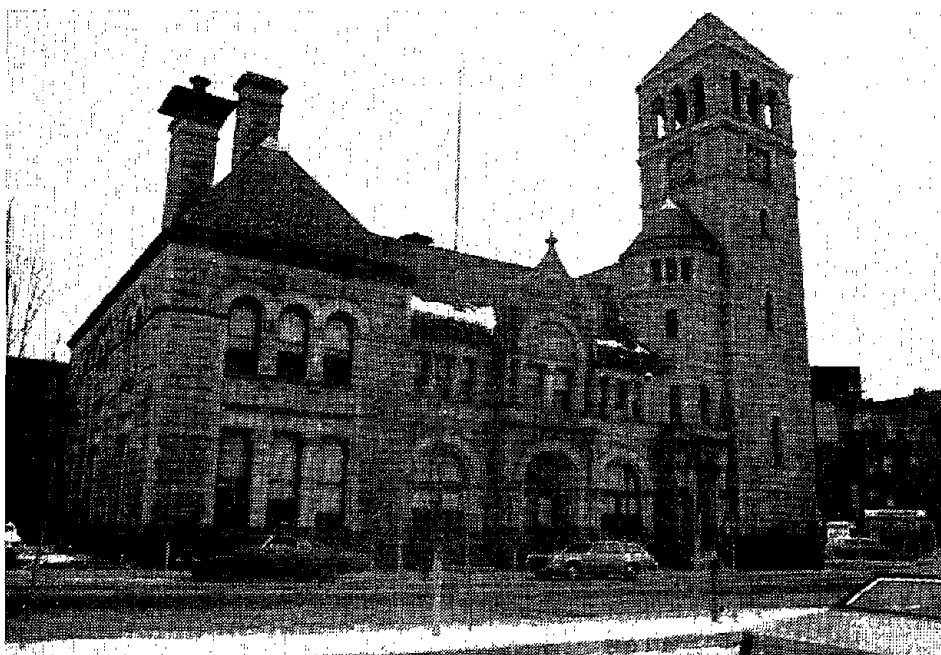
FIGURE 3-8. URM CHURCH WITH BELL TOWER
NEW ENGLAND ZONE

Churches in this region are unique in that their size is commonly larger than in other regions. The plan and elevations are more complex and elaborate in stonework and masonry detailing. Towers, steeples, and similar modifications to a rectangular plan and a common height are almost universal for the churches (Fig. 3-8).

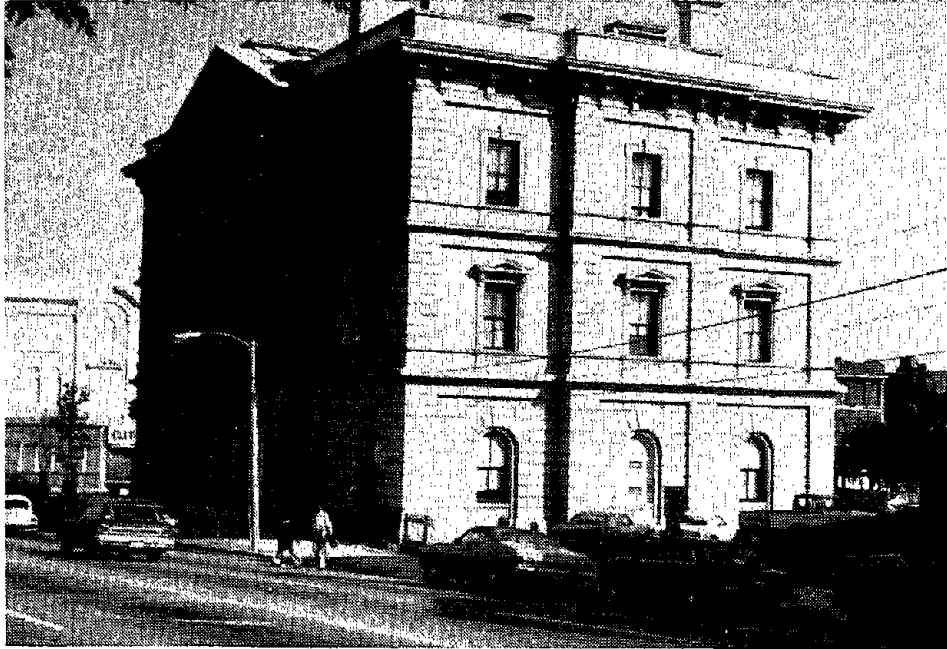
FIGURE 3-9. URM COURTHOUSE-SOUTH CAROLINA
INLAND ZONE

The urban areas surveyed were Columbia SC to represent the inland cities, and Charleston SC to represent the variety of historical structures in the old seacoast cities. Columbia has a large number of URM public buildings (Fig. 3-9), a typical commercial zone with URM buildings (Figs. 3-10 and 3-11), and a moderate amount of industrial URM buildings (Fig. 3-12). Charleston has special significance in that some buildings date from the 17th and 18th centuries and many predate the major earthquake of 1886 (Figs. 3-13 and 3-14). Preservation of these URM buildings within the historical city has been public policy. The city archives have records of descriptions and photographs of damage caused by the 1886 event. The repaired and reconstructed buildings can be examined to ascertain original construction and 1886 reconstruction. Many buildings that were undamaged by the 1886 event can also be examined.

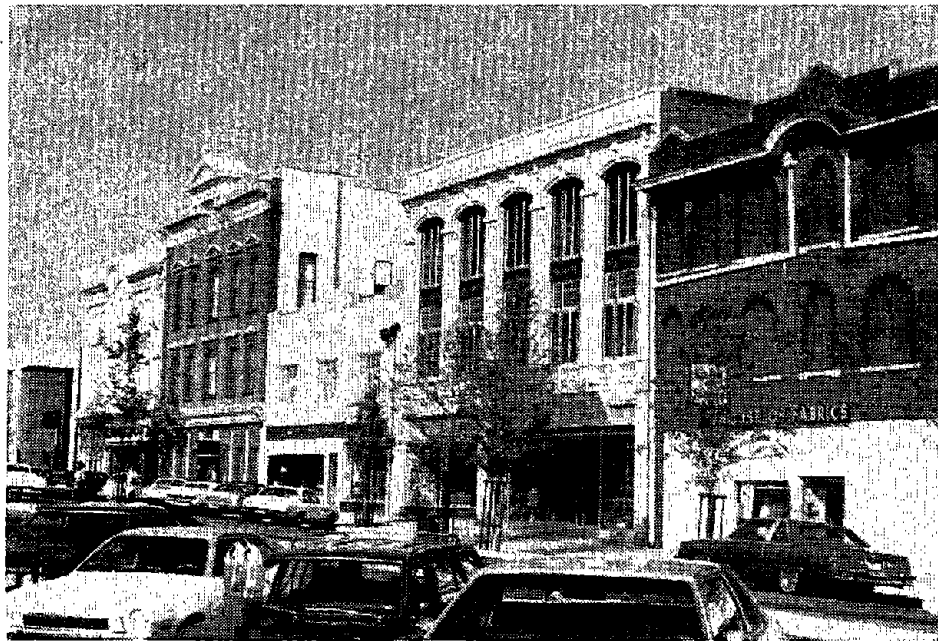
FIGURE 3-10. URM COMMERCIAL BUILDING
SOUTH CAROLINA INLAND ZONE

England region (Figs. 3-12 and 3-13), but are fewer in number. Commercial buildings generally have open fronts on the public way and generally do not exceed five stories in height (Figs. 3-10, 3-11, 3-13, 3-14, and 3-17). Wood floors and roofs are generally used in these URM buildings.

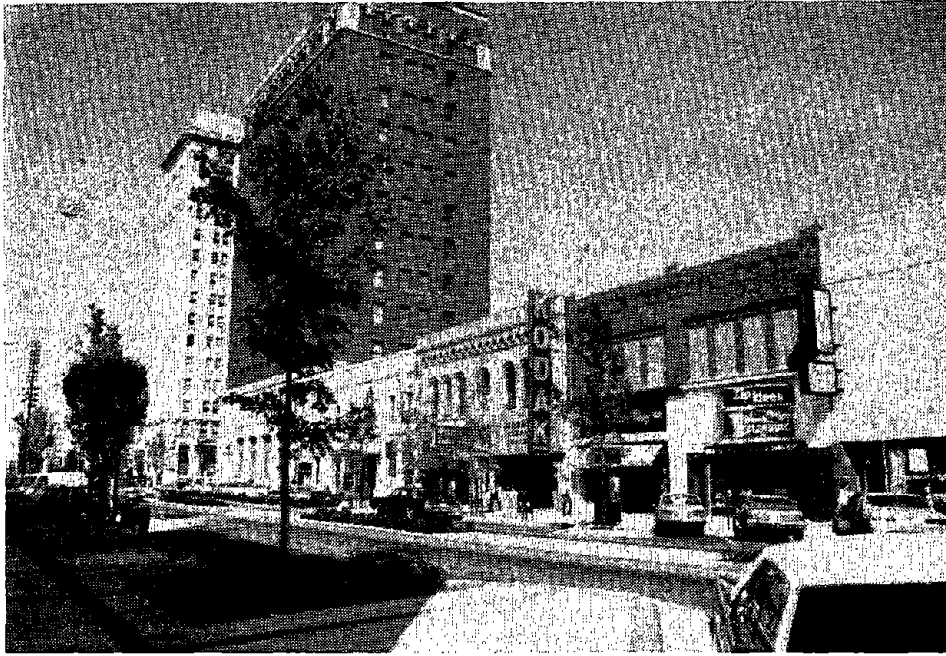
FIGURE 3-11. URM COMMERCIAL BUILDINGS
SOUTH CAROLINA INLAND ZONE

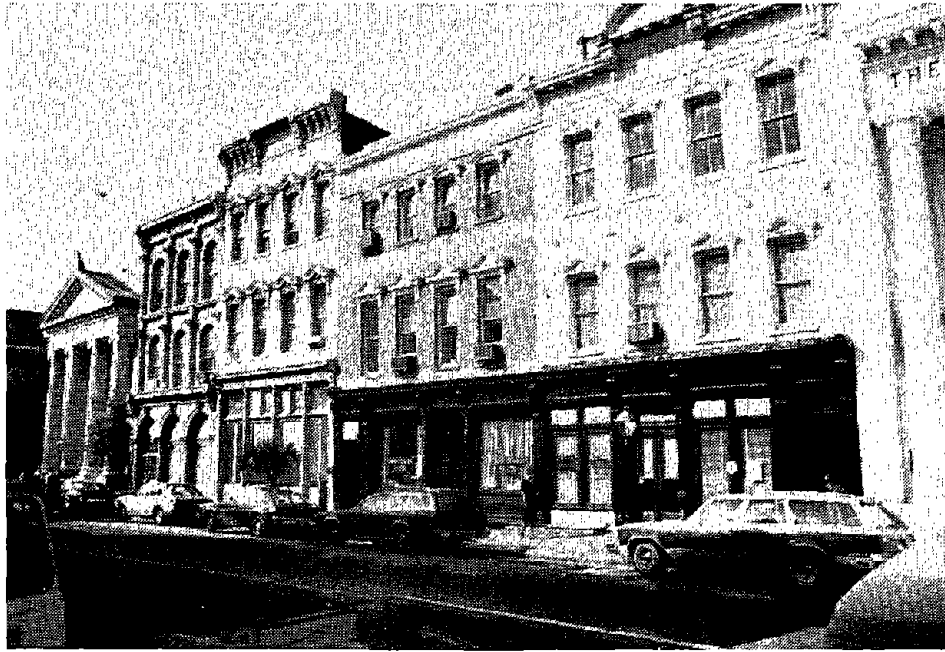
FIGURE 3-13. URM COMMERCIAL BUILDINGS PREDATING 1886 EARTHQUAKE IN CHARLESTON, SC.

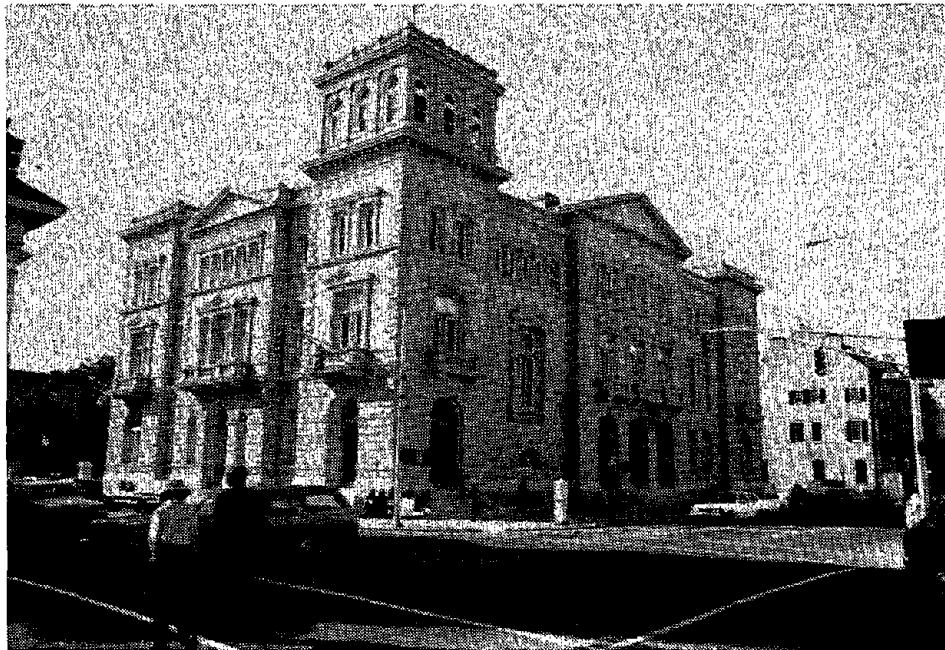
FIGURE 3-14. URM CHURCH PREDATING 1886 EARTHQUAKE IN CHARLESTON, SC.

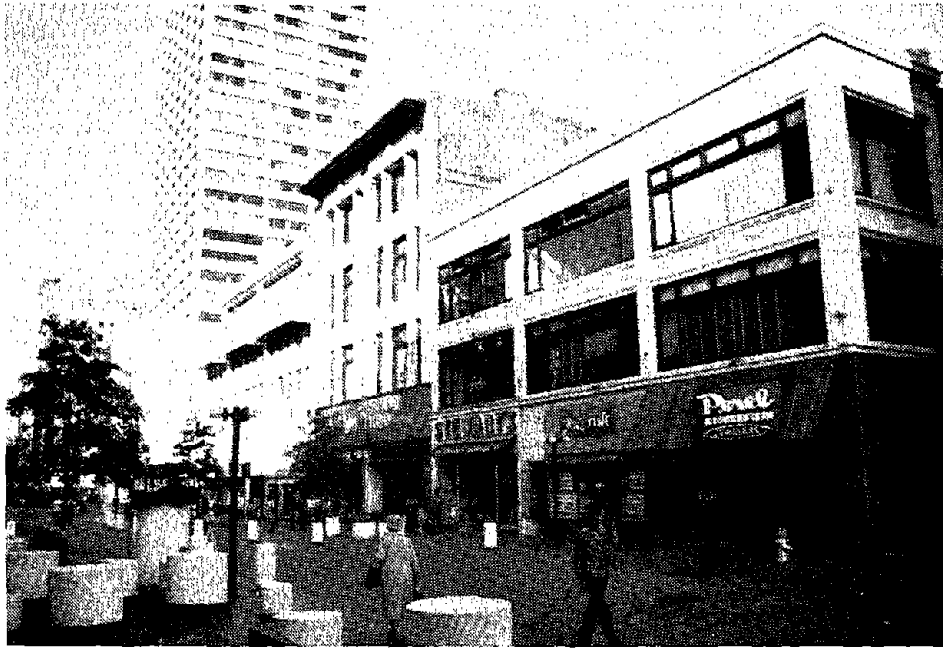
FIGURE 3-19. URM BUILDINGS, COMMERCIAL DISTRICT, MEMPHIS, TN.

The city of Memphis TN is within the higher seismic risk area of this seismic zone (EPA of 0.2 g). The present city center has many large commercial URM buildings incorporated in its city plan (Figs. 3-19 and 3-20). This and an adjacent industrial district include most of the URM buildings (Figs. 3-21 through 3-24). Suburban commercial centers and multiple residential structures comprise the remainder of the existing URM buildings. Current URM construction is generally used for small commercial structures or single-story industrial structures.

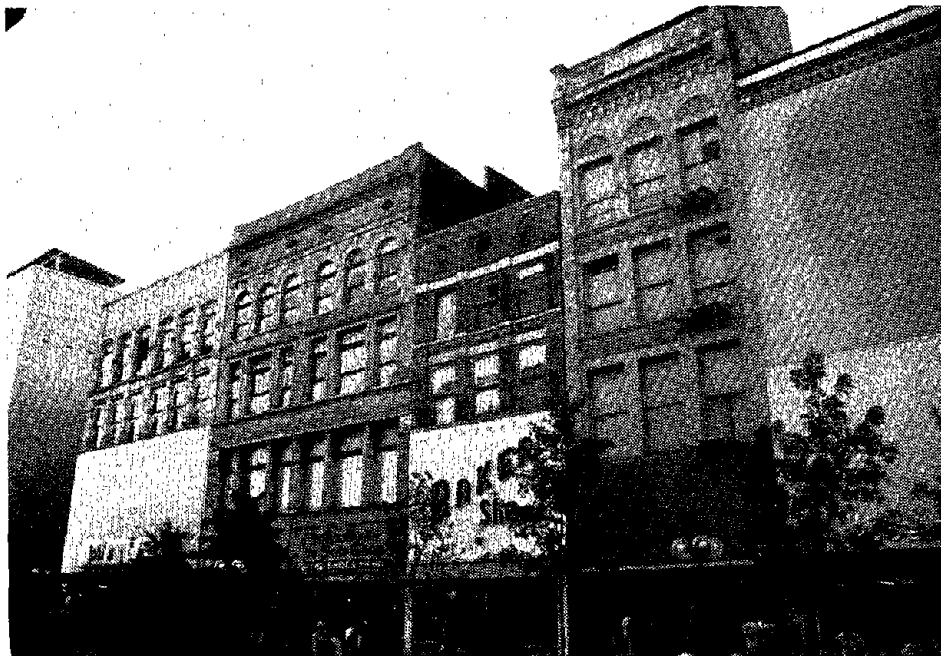
FIGURE 3-20. URM BUILDINGS, COMMERCIAL DISTRICT, MEMPHIS, TN.

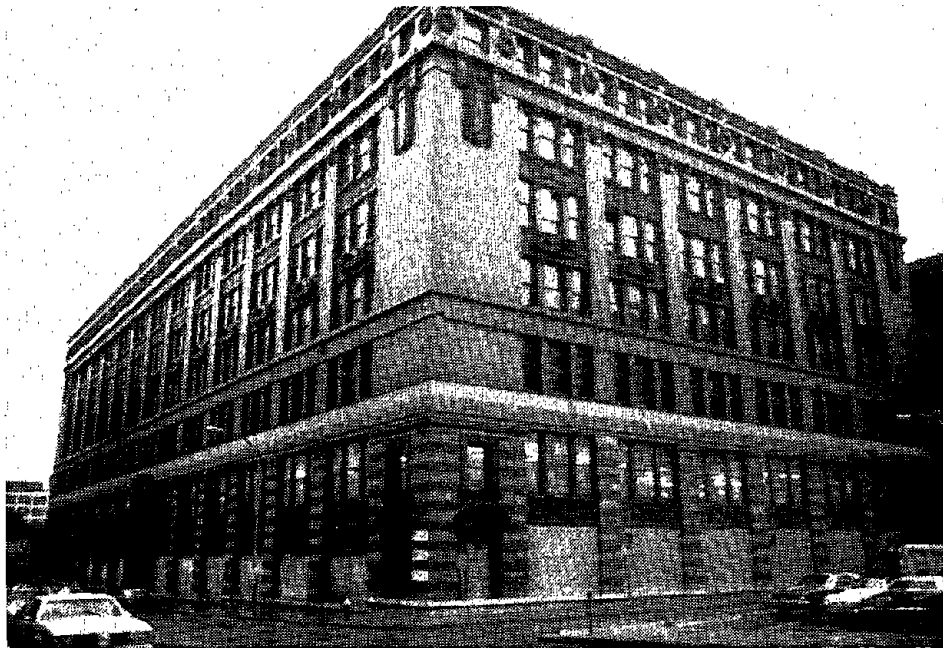
FIGURE 3-36. URM COMMERCIAL BUILDING WITH INTERNAL
FRAME OF STRUCTURAL STEEL AND CONCRETE

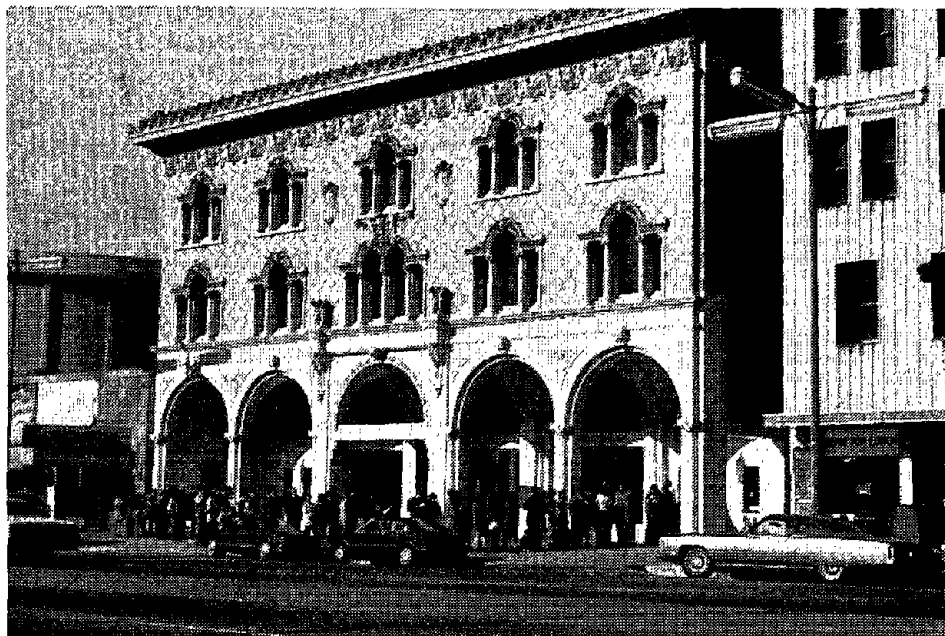
FIGURE 3-47. HISTORIC PRESERVATION OF URM THEATRE
SALT LAKE CITY, UT.

Preservation and restoration of buildings with historical qualities are common, and the interviews indicated that this trend will continue (Figs. 3-47 and 3-48). Strengthening for seismic forces by traditional methods has been undertaken for hospital facilities (Figs. 3-49 and 3-50). A public policy for seismic hazard reduction for private buildings has not been codified, and structural modifications of buildings converted to increased occupancy levels have been based on professional judgments by architects and engineers.

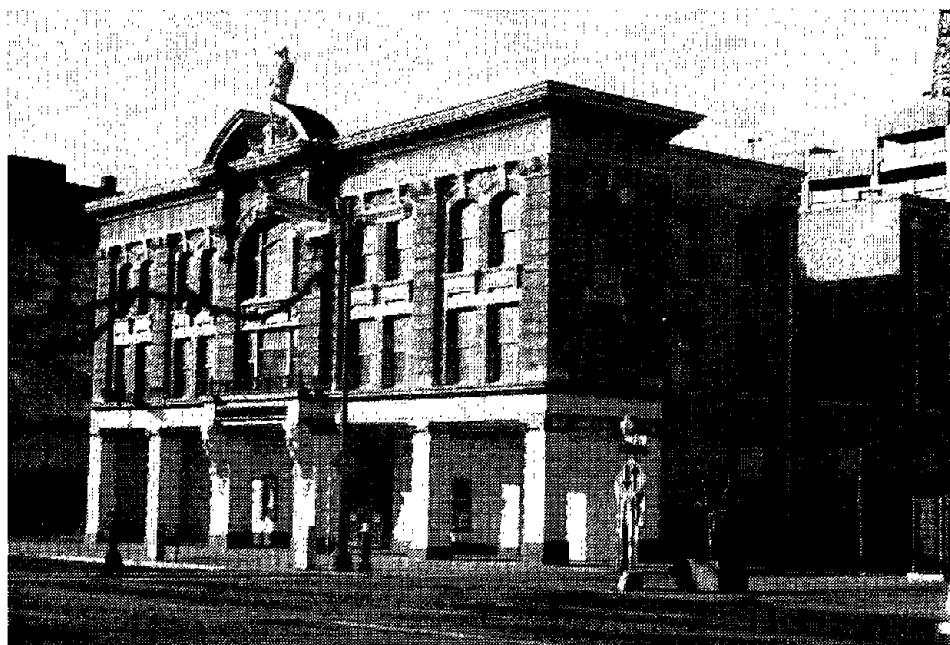
FIGURE 3-48. HISTORIC PRESERVATION OF URM THEATRE
SALT LAKE CITY, UT.

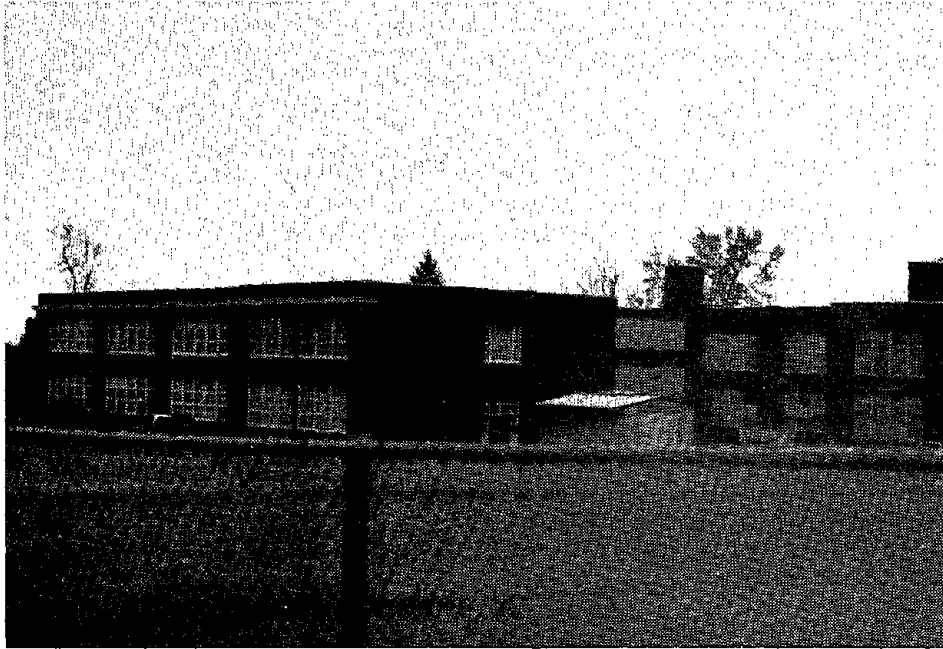
FIGURE 3-55. URM PUBLIC SCHOOL BUILDING,
SALT LAKE CITY, UT.

Public school buildings constructed with URM walls are currently being utilized. Large areas of fenestration are common in these buildings (Fig. 3-54). These schools are in use only in the area immediately adjacent to the central city; however, post-1940 buildings do have URM in-filled walls (Fig. 3-55). Demolition of an existing school building in this area indicates that the URM has substantial tensile capacity (Fig. 3-56).

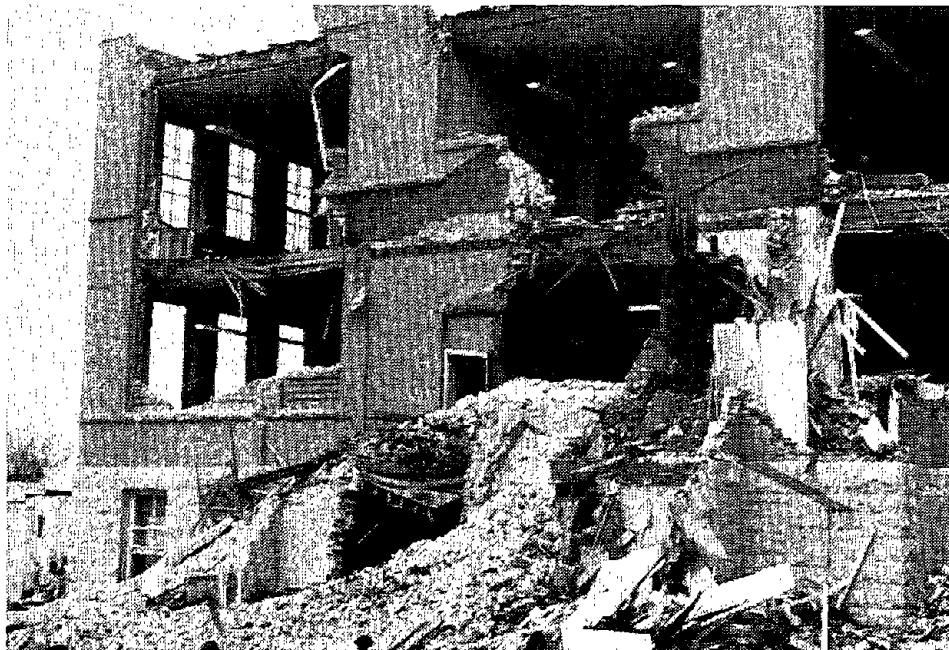
FIGURE 3-56. DEMOLITION OF URM SCHOOL
SALT LAKE CITY, UT.

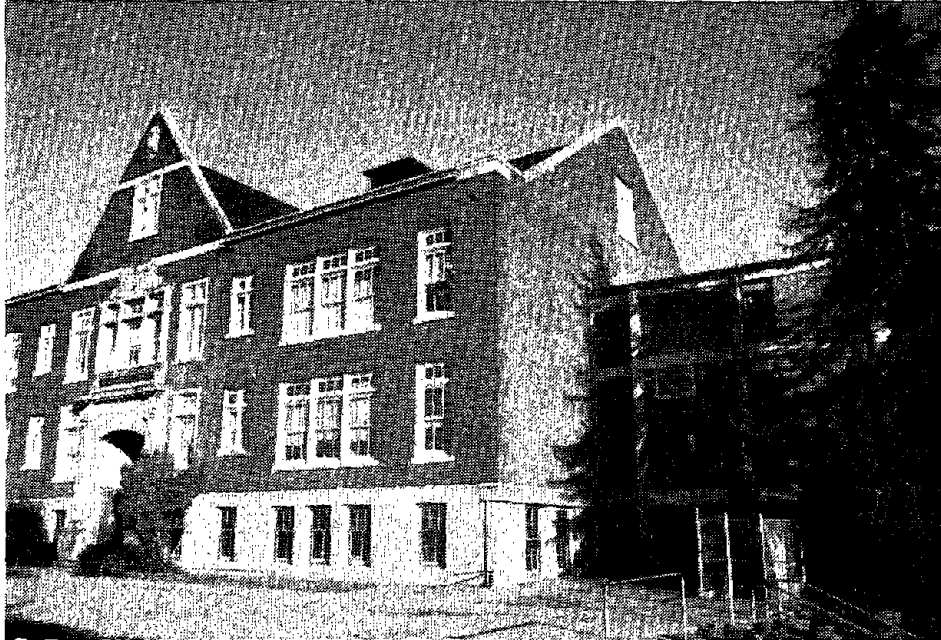
FIGURE 3-63. URM SCHOOL BUILDING,
SEATTLE, WA.

These schools are large and have extensive fenestration in some walls (Fig. 3-62). Many are characterized by high-pitched roofs and large gable ends (Figs. 3-63 and 3-64). Through-wall anchors of the gable end to the roof framing are visible in Figure 3-63. These anchors were installed after separation was caused by a recent earthquake.

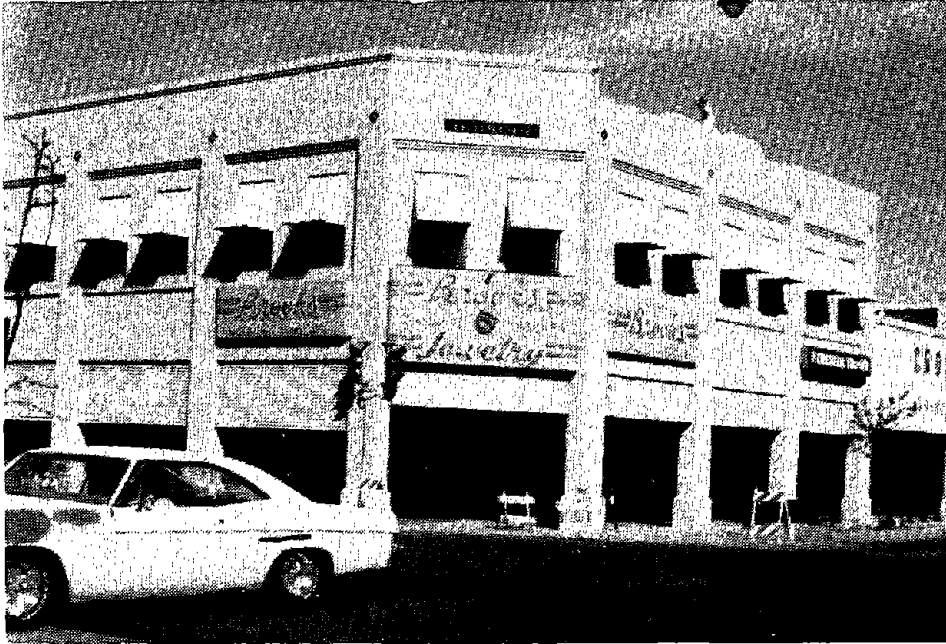
FIGURE 3-70. URM COMMERCIAL BUILDING,
EL CENTRO, CA.

Buildings that have been shaken by a seismic intensity somewhat greater than an EPA of 0.2 g are typical of the occupancy use surveyed throughout the United States. The response spectra shown in Figures 3-65, 3-66, and 3-67 (CIT, 1972) were obtained from recordings in the basement of the URM Eureka Federal Building, shown in Figure 3-68. For comparison with the design seismic input (ABK, 1981a) of a region with an EPA of 0.2 g, a dashed line to be compared with the 5% damped spectra is superimposed. A typical office building immediately adjacent to this accelograph site is shown in Figure 3-69. One- and two-story commercial buildings shaken by both the 1940 Imperial Valley earthquake (CIT, 1972) and the 1979 Imperial Valley earthquake (EERI, 1980) are shown in Figures 3-70 and 3-71.

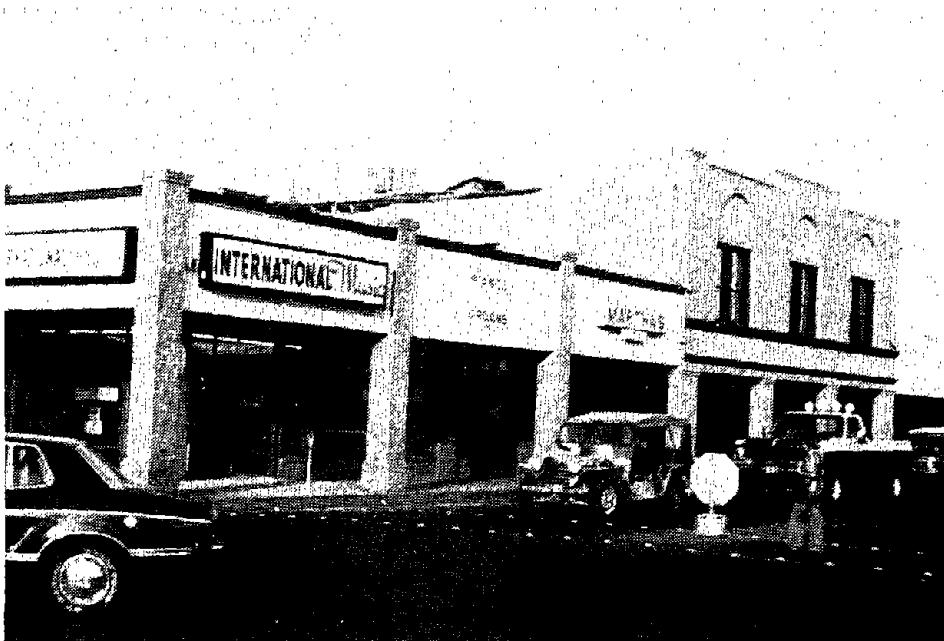
FIGURE 3-71. URM COMMERCIAL BUILDING,
EL CENTRO, CA.

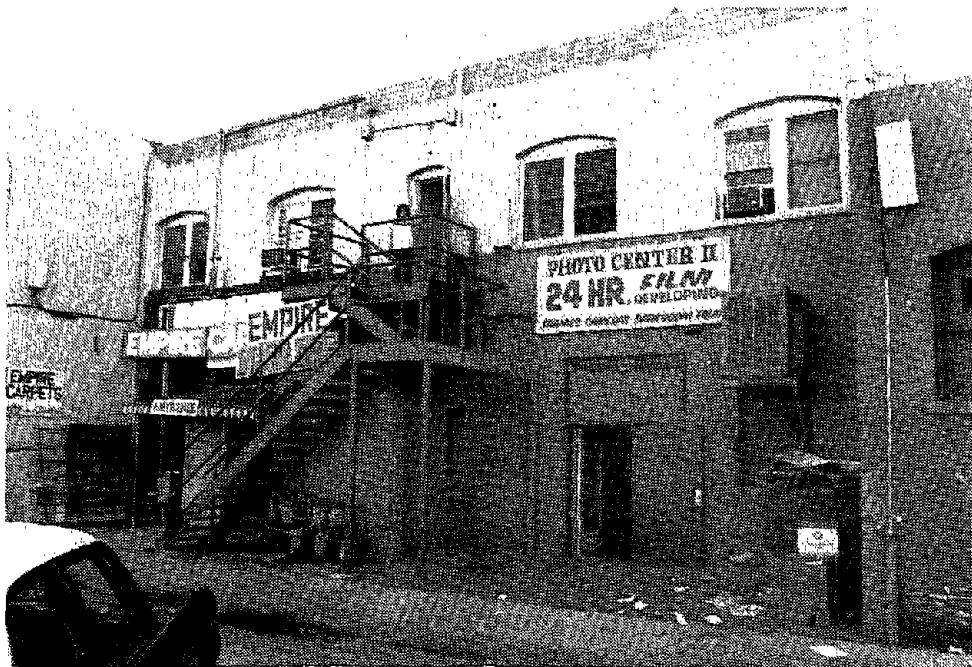
FIGURE 3-73. REAR OF URM BUILDING,
SAN FERNANDO, CA.

Observed damage reports on URM buildings in this region comprise the majority of available information. However, the reports generally focus on damage and do not investigate the probable reasons for occurrence of damage. Moreover, these reports do not discuss buildings that were not damaged. Buildings photographed for this study have been shaken with the same intensity as those reported with visible damage. In many cases, a quick survey of these buildings would report no damage, or plaster cracking only. Surprisingly, structural deficiencies such as the complete lack of a lateral load carrying system on one or two sides of the building do not cause unsatisfactory performance in regions of strong shaking. Commercial buildings with open fronts such as that shown in Figure 3-72 in the City of San Fernando, as well as all the other open front buildings up and down the block, appear to have been stable when subjected to significant ground displacements. The rear wall of this building, shown in Figure 3-73, does not exhibit damage patterns that would be normally predicted.

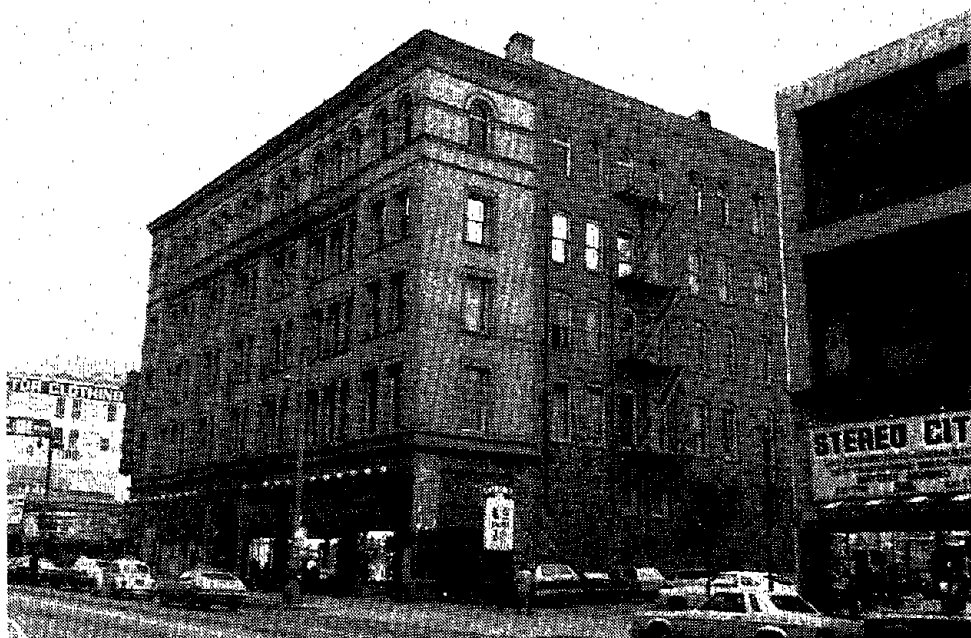
FIGURE 3-77. MEDIUM SIZE OFFICE BUILDING WITH URM WALLS, LOS ANGELES, CA.

Office buildings in this region range from large to moderate in height and floor space when compared with the eastern half of the United States (Figs. 3-76 and 3-77). Commercial facilities are equal in size and diversity of materials to those examined in the other regions. Figures 3-78 through 3-81 illustrate commercial buildings that are found up and down the entire length of the seismic zone on the Pacific coast. The buildings shown are in San Diego, Los Angeles, San Francisco, and Eureka.

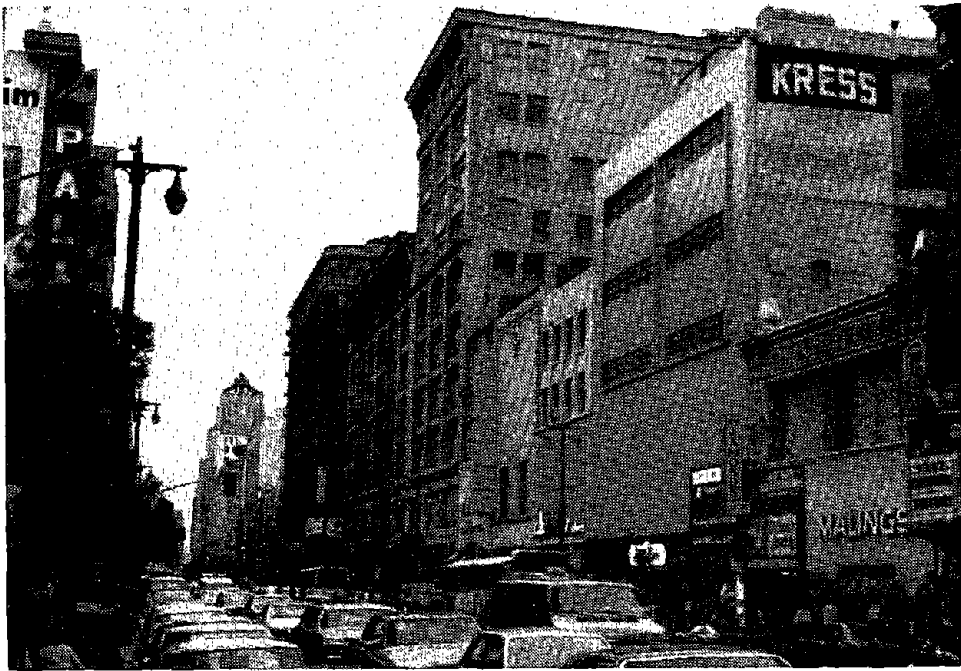
FIGURE 4-3. POST 1920 URBAN CENTER
OF URM BUILDINGS

office buildings (Fig. 4-3) are rectangular with the larger dimension exceeding the smaller by about a factor of three. Large hotels and offices may be rectangular at grade but are divided into wings above the lower floors to provide light and ventilation to interior space (Figs. 4-7 and 4-8).

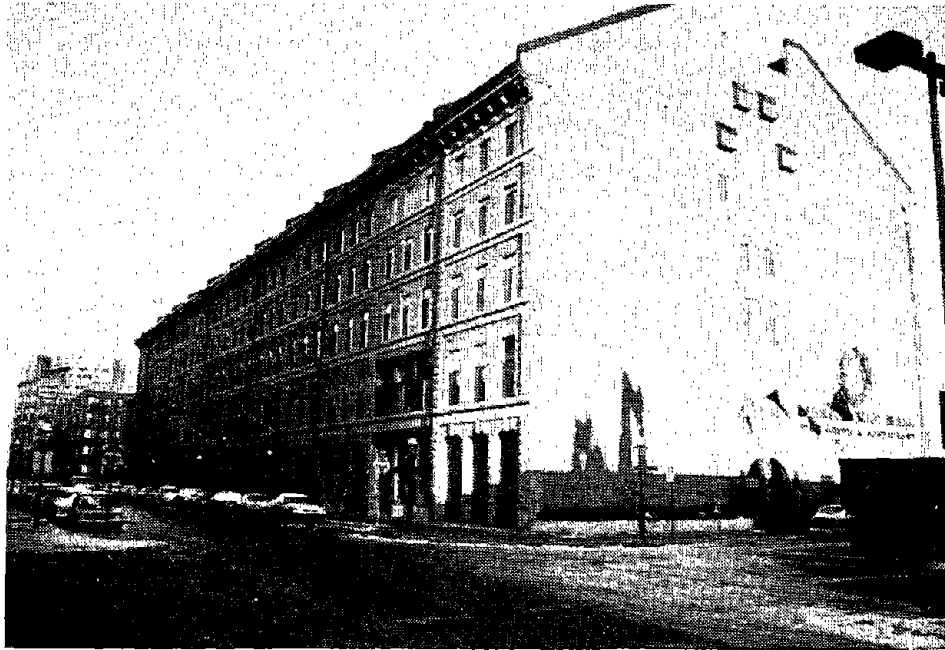
FIGURE 5-1. CONVERTED URM LOFT BUILDING
NEW ENGLAND REGION

Two six-story industrial buildings, similar in plan, size, and height to the one shown in Figure 5-1, have been selected for analysis to determine the seismic hazards. The plan size of the buildings selected is 70 by 360 ft (21 by 110 m), and the story height is 11 ft (3.3 m). A moderately pitched wood-framed roof is assumed. Heavy plank floors on wood beams, girders, and columns will be used as one example. A concrete floor will also be considered as a common floor construction alternative to the wood framing. URM fire walls will subdivide the building into 45 to 70 ft (14 to 21 m) bays. Anchorage of the exterior walls to only the girders and floor beams framing into the bearing URM walls will be assumed. Spacing of the typical rod anchors of 8 ft (2.4 m) will be assumed.

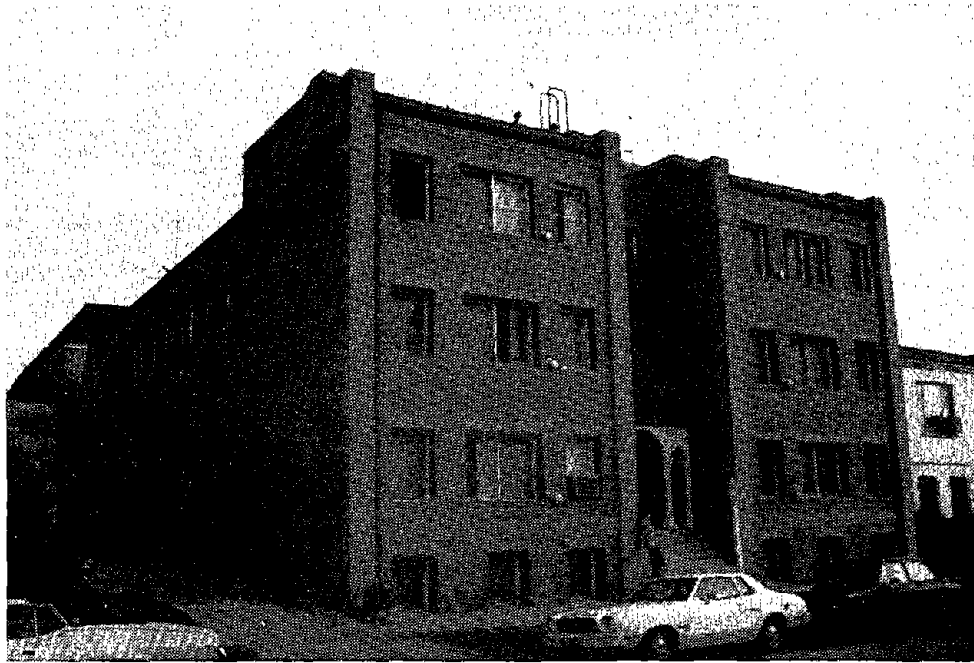
FIGURE 5-5. REPRESENTATIVE URM APARTMENT BUILDING OF MODERATE SIZE

The moderate size apartment building (Fig. 5-5) will be considered as sited in seismic zones of EPA of 0.2 g and 0.4 g. The larger building (Fig. 5-6) will be studied in the seismic zone of 0.4 g only.
