REPORT NO.  
UCB/EERC-82/15  
SEPTEMBER 1982

# THE PERFORMANCE OF STAIRWAYS IN EARTHQUAKES

CATHERINE ROHA  
JAMES W. AXLEY  
VITELMO V. BERTERO

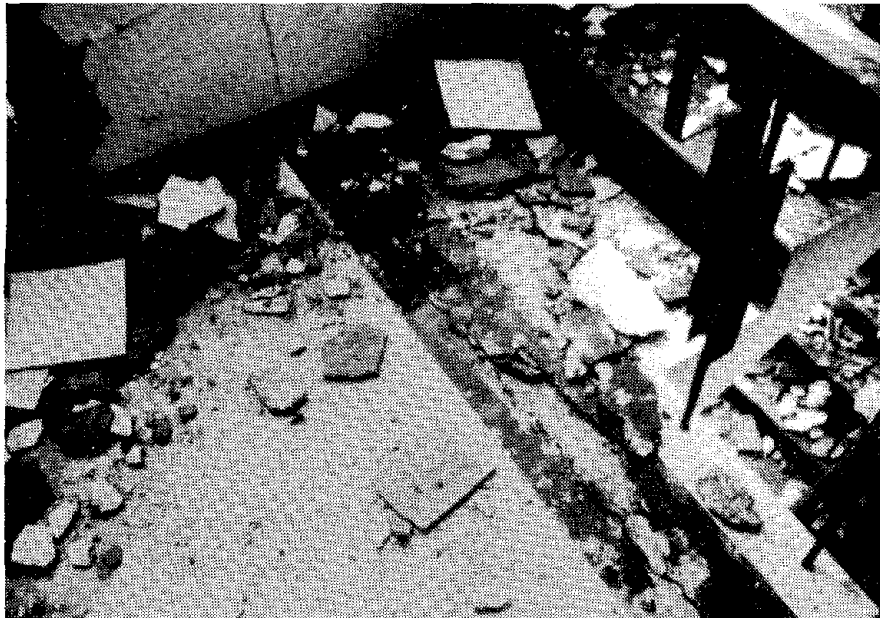
Fig. 2.2 Floor cracking at stair core, Banco Central, 1972 Managua Earthquake. (See also Fig. 2.10) (Photo courtesy of Loring A. Wyllie, Jr.)

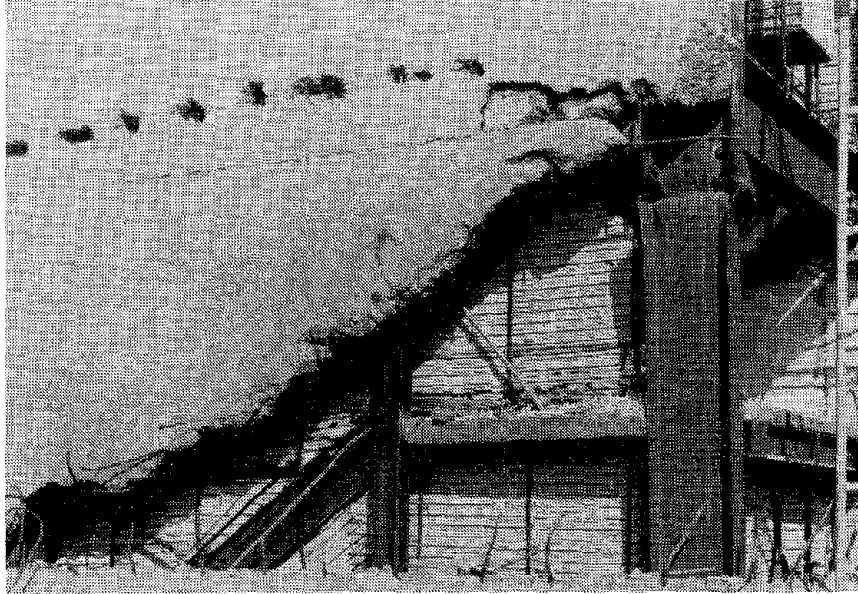
Fig. 2.3 Steel column failure at stair landing, Cordova Building, 1964 Alaska Earthquake. (See also Fig. 2.9) (Photo courtesy of the American Iron and Steel Institute.)

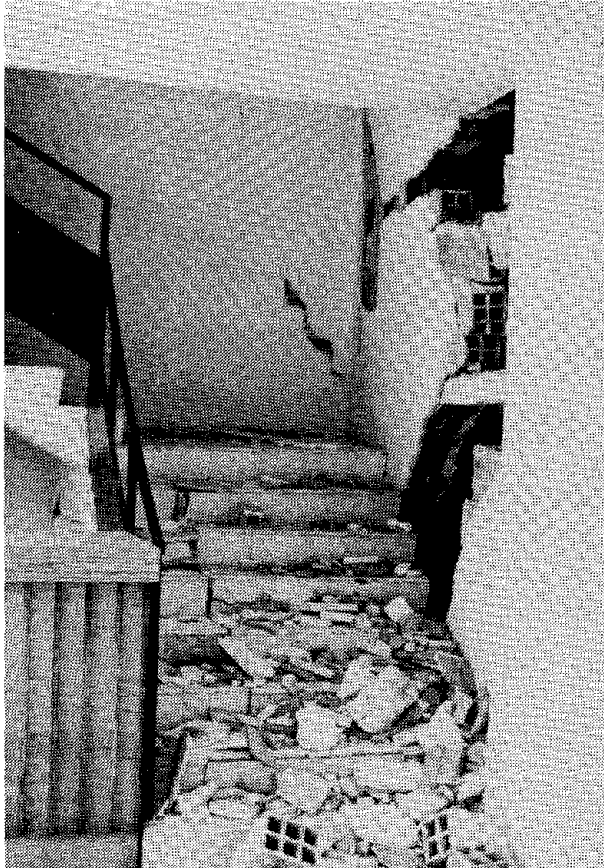
Fig. 2.6 Shattered tile enclosure wall, American School, 1972 Managua Earthquake. (Photo courtesy of Henry J. Degenkolb.)

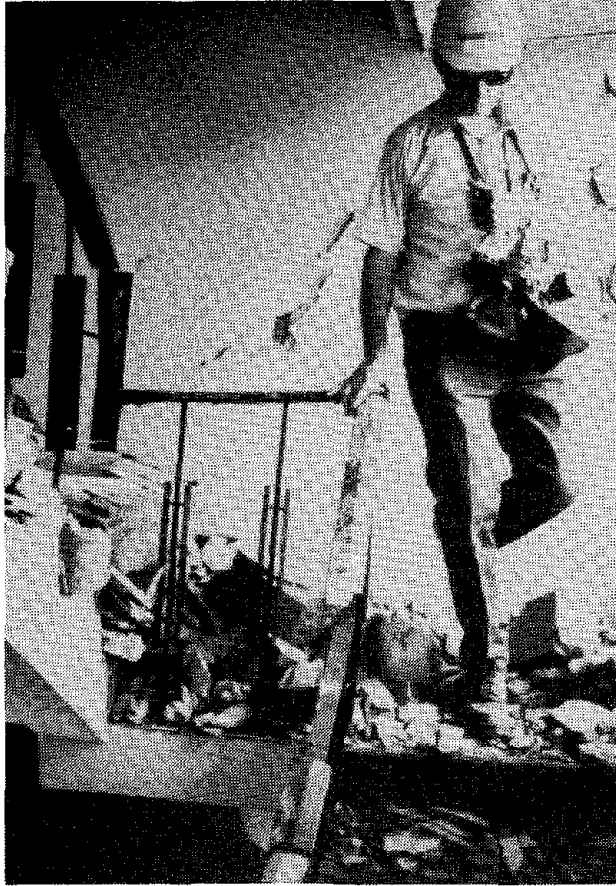
Fig. 2.10 Stairway hazards from debris and broken handrails, Banco Central, 1972 Managua Earthquake. (See also Fig. 2.2) (Photo courtesy of Henry J. Degenkolb.)

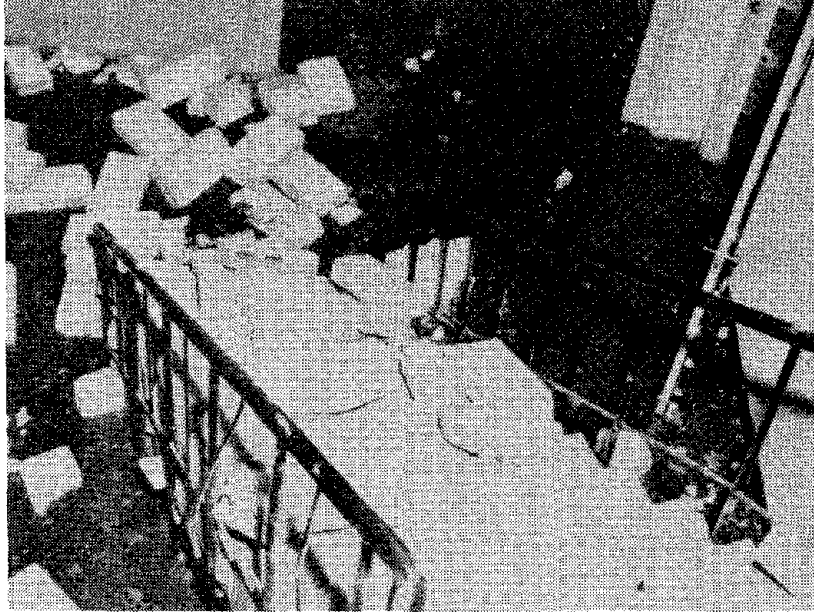
Fig. 2.11 Fatal collapse of masonry walls into stairway, Enlisted Men's Service Club, 1964 Alaska Earthquake. (Reproduced from The Great Alaska Earthquake of 1964--Engineering with permission of the National Academy of Sciences, Washington, D.C.)

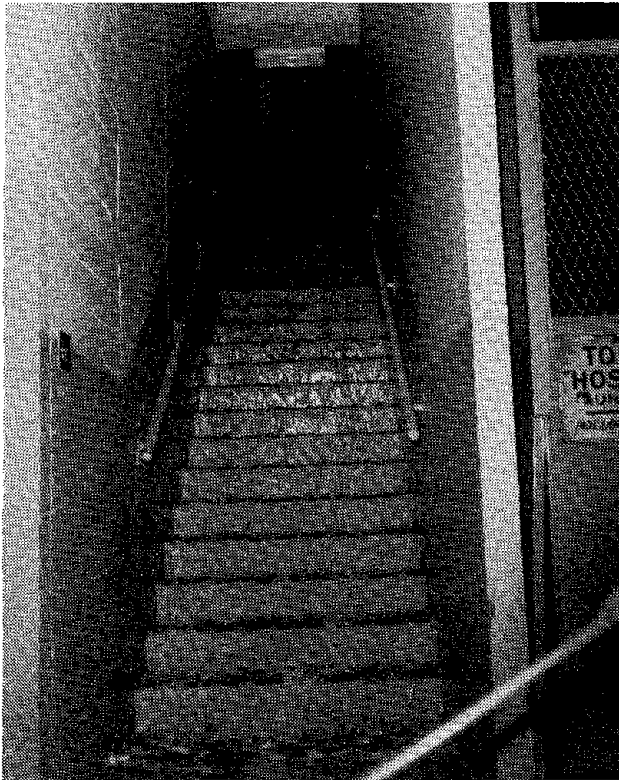
Fig. 2.12 Stairway flooded by broken sprinkler line, Lockheed Building 147, 1971 San Fernando Earthquake. (Photo courtesy of the Lockheed-California Company.)

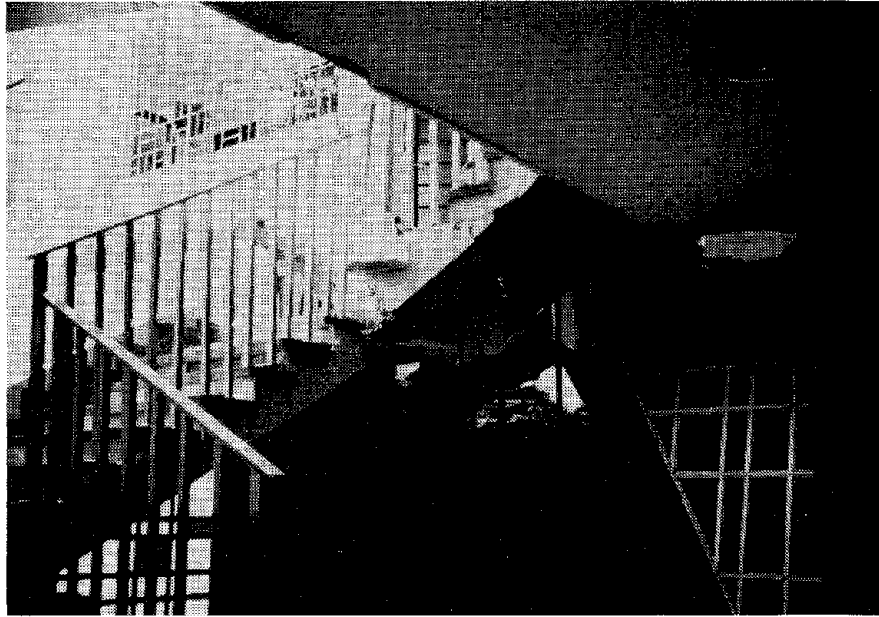
Fig. 4.2 Stair flight damage, San Bosco Building, 1967 Caracas Earthquake. (Photo courtesy of Henry J. Degenkolb.)

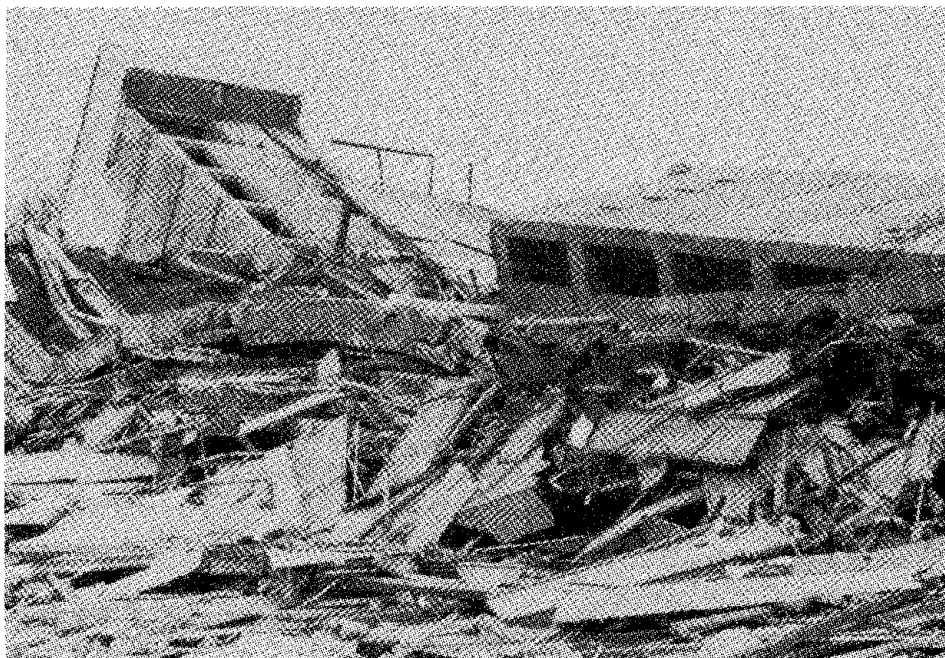
Fig. 5.4 Collapsed structural stair cores, Four Seasons Apartment Building, 1964 Alaska Earthquake. (Ward W. Wells photograph, reproduced with permission from the American Iron and Steel Institute.)

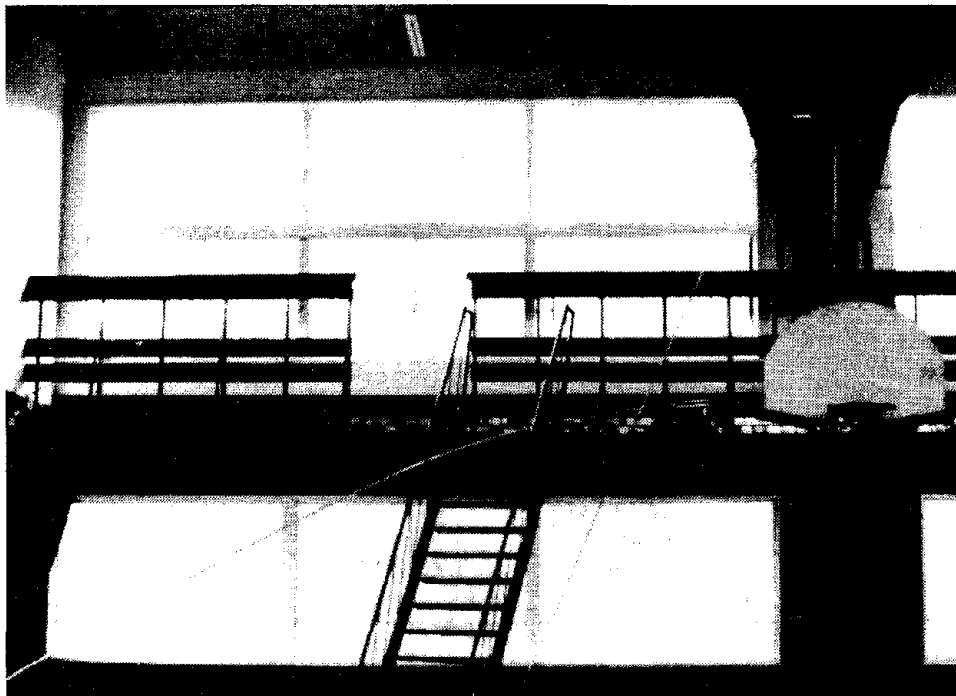
Fig. 5.7 Displaced gallery stair, Shichihyaku Primary School Gymnasium, 1968 Tokachi-Oki Earthquake. (Photo reproduced with permission from General Report on the Tokachi-Oki Earthquake of 1968.)
