UMEE 82R5

# BEHAVIOR OF EXTERNAL REINFORCED CONCRETE BEAM TO COLUMN CONNECTIONS SUBJECTED TO EARTHQUAKE TYPE LOADING

Mohammad Reza Ehsani  
James K. Wight

The University of Michigan      Department of Civil Engineering

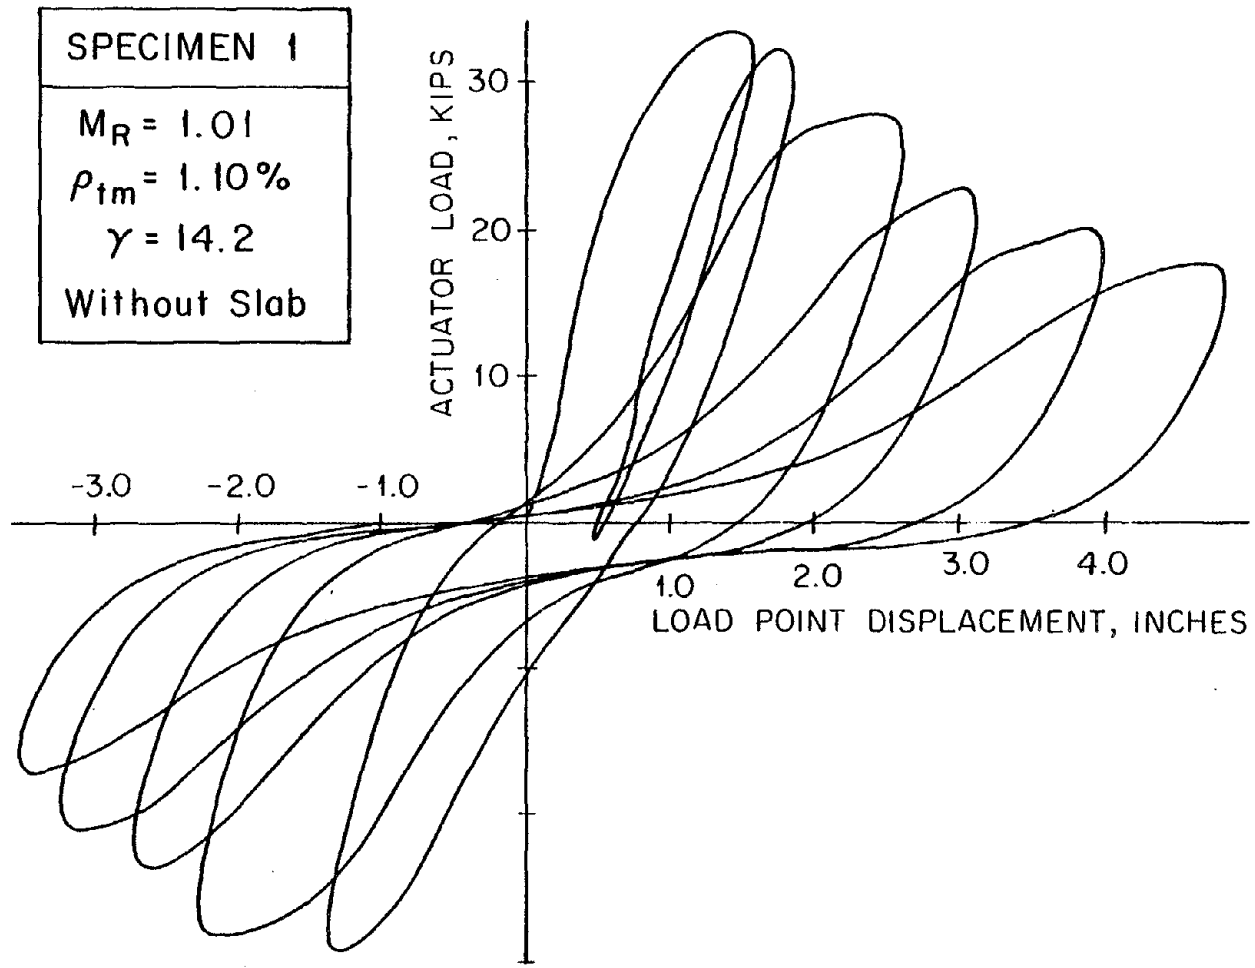
Fig. 3.1(a). Load vs. Deflection Response of Specimen 1.

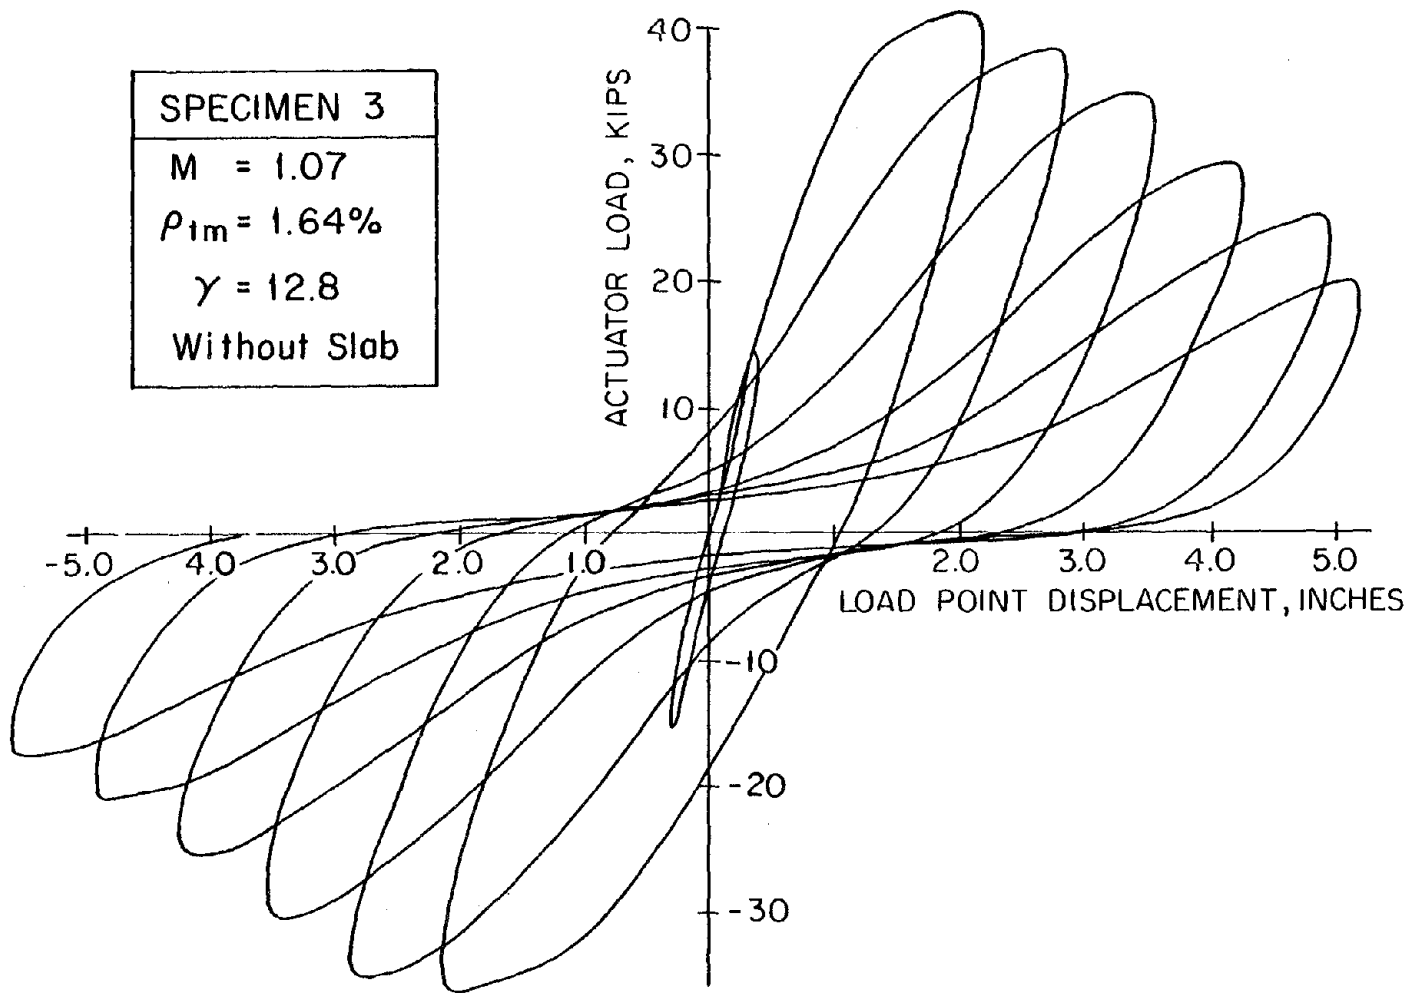
Fig. 3.1(c). Load vs. Deflection Response of Specimen 3.

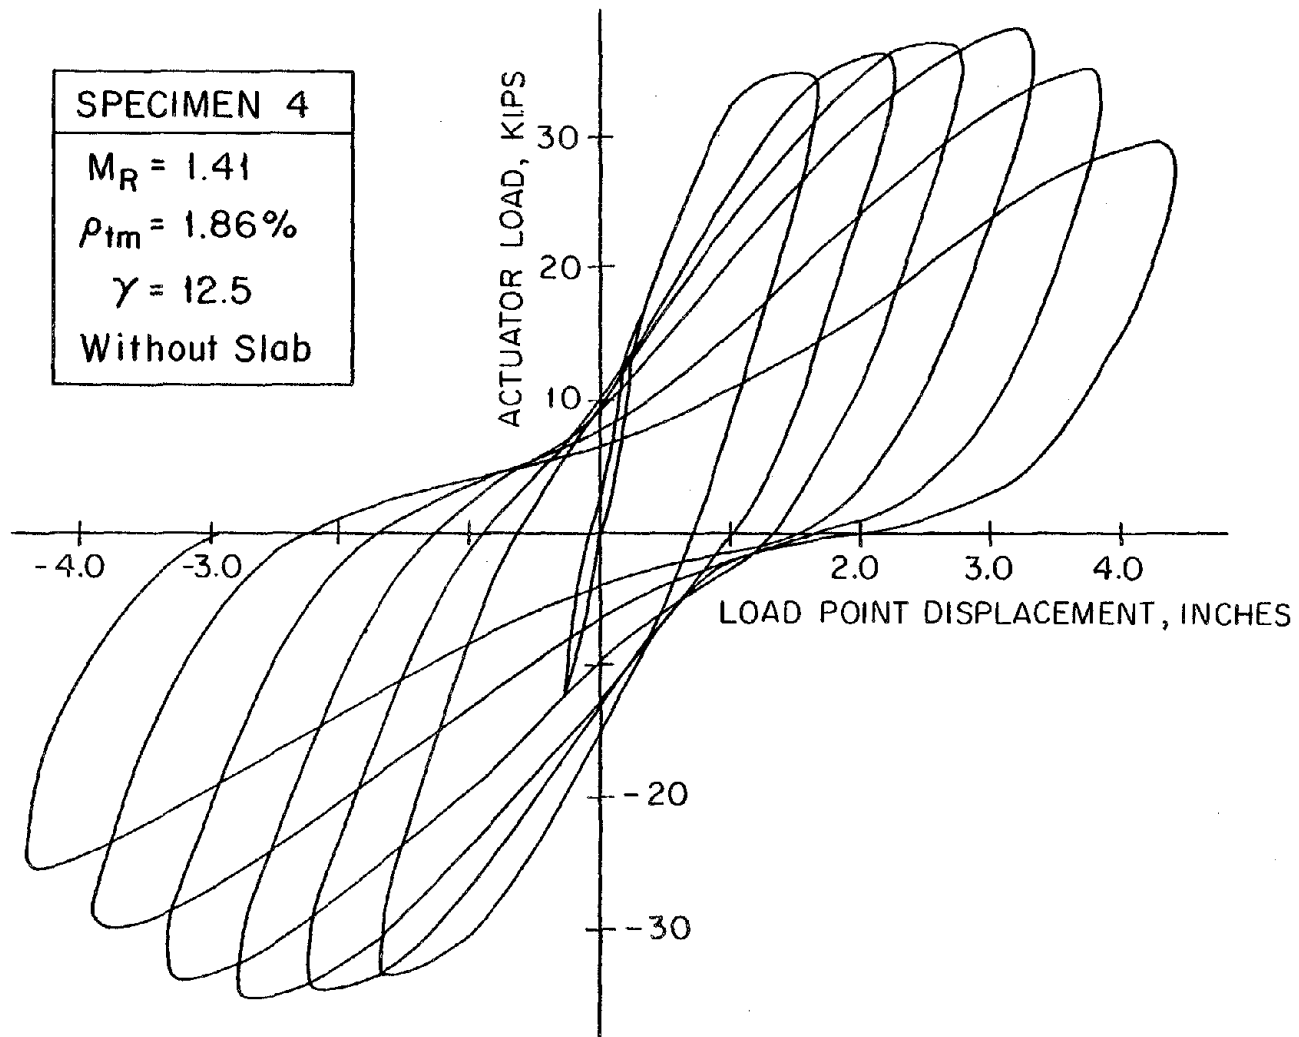
Fig. 3.1(d). Load vs. Deflection Response of Specimen 4.

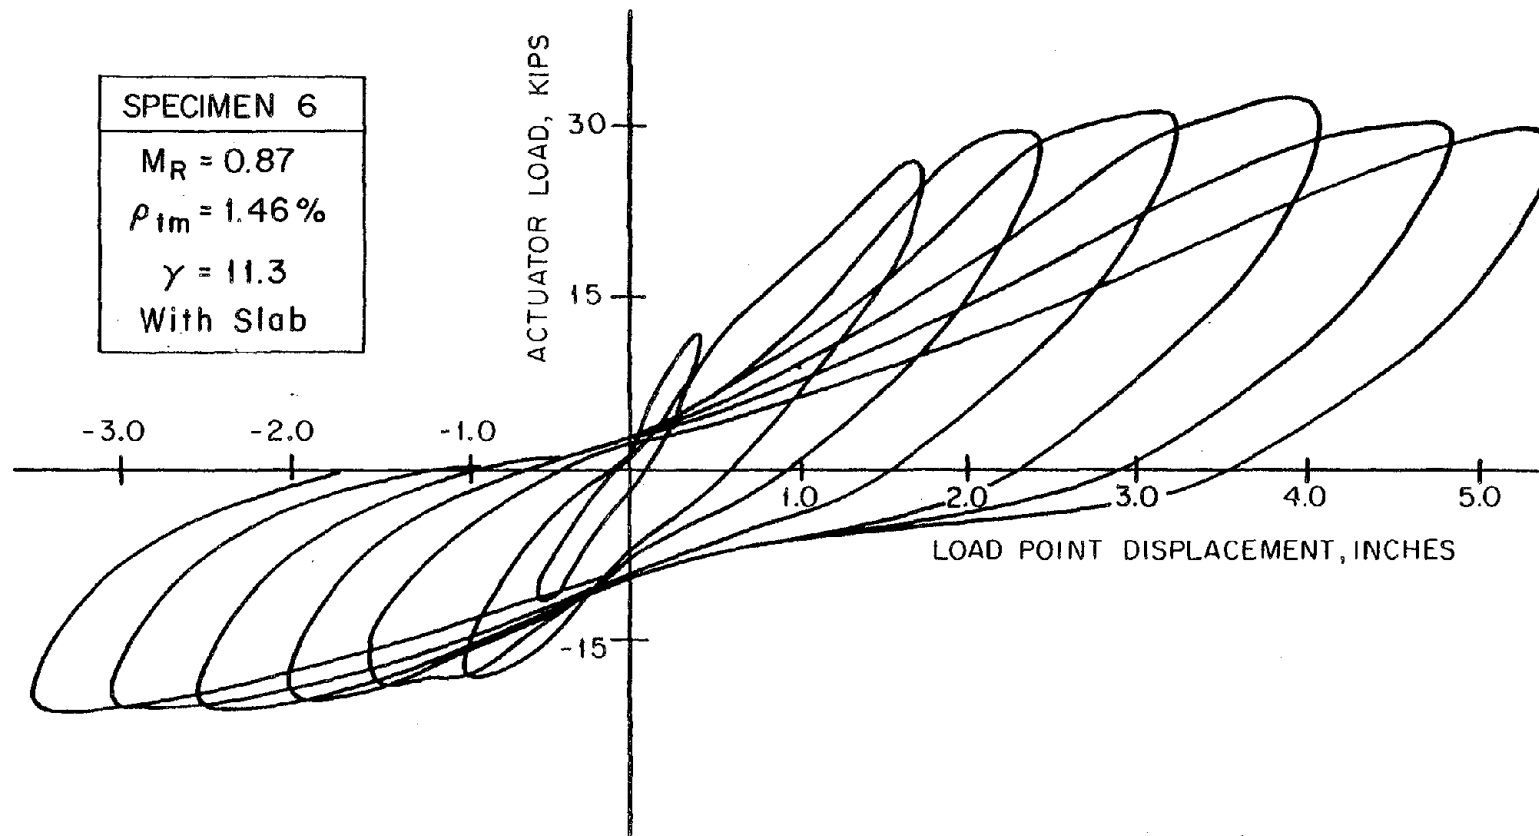
Fig. 3.1(f). Load vs. Deflection Response of Specimen 6.

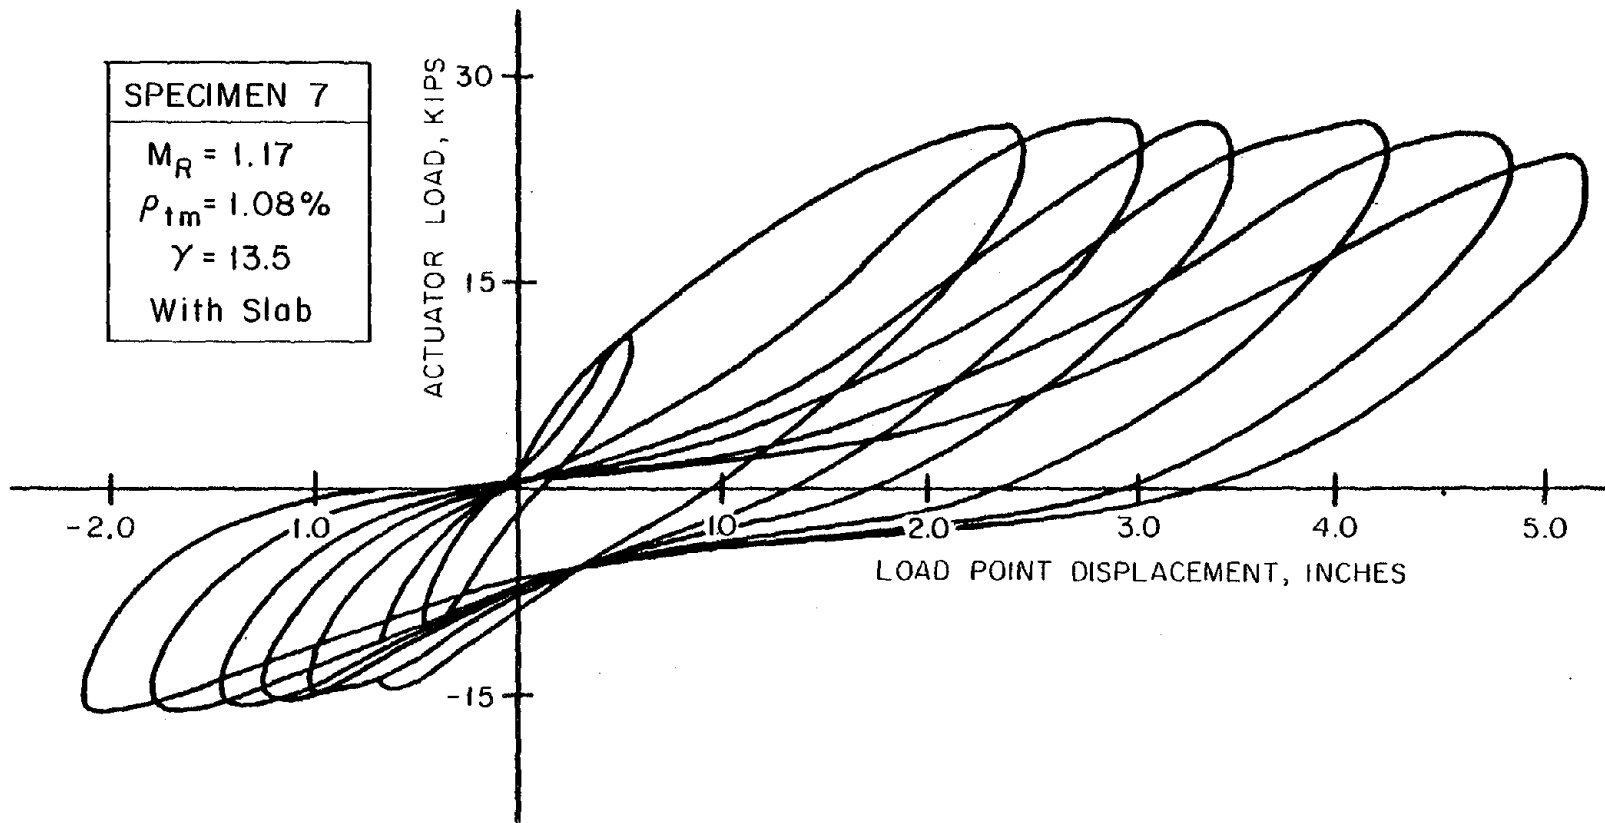
Fig. 3.1(g). Load vs. Deflection Response of Specimen 7.

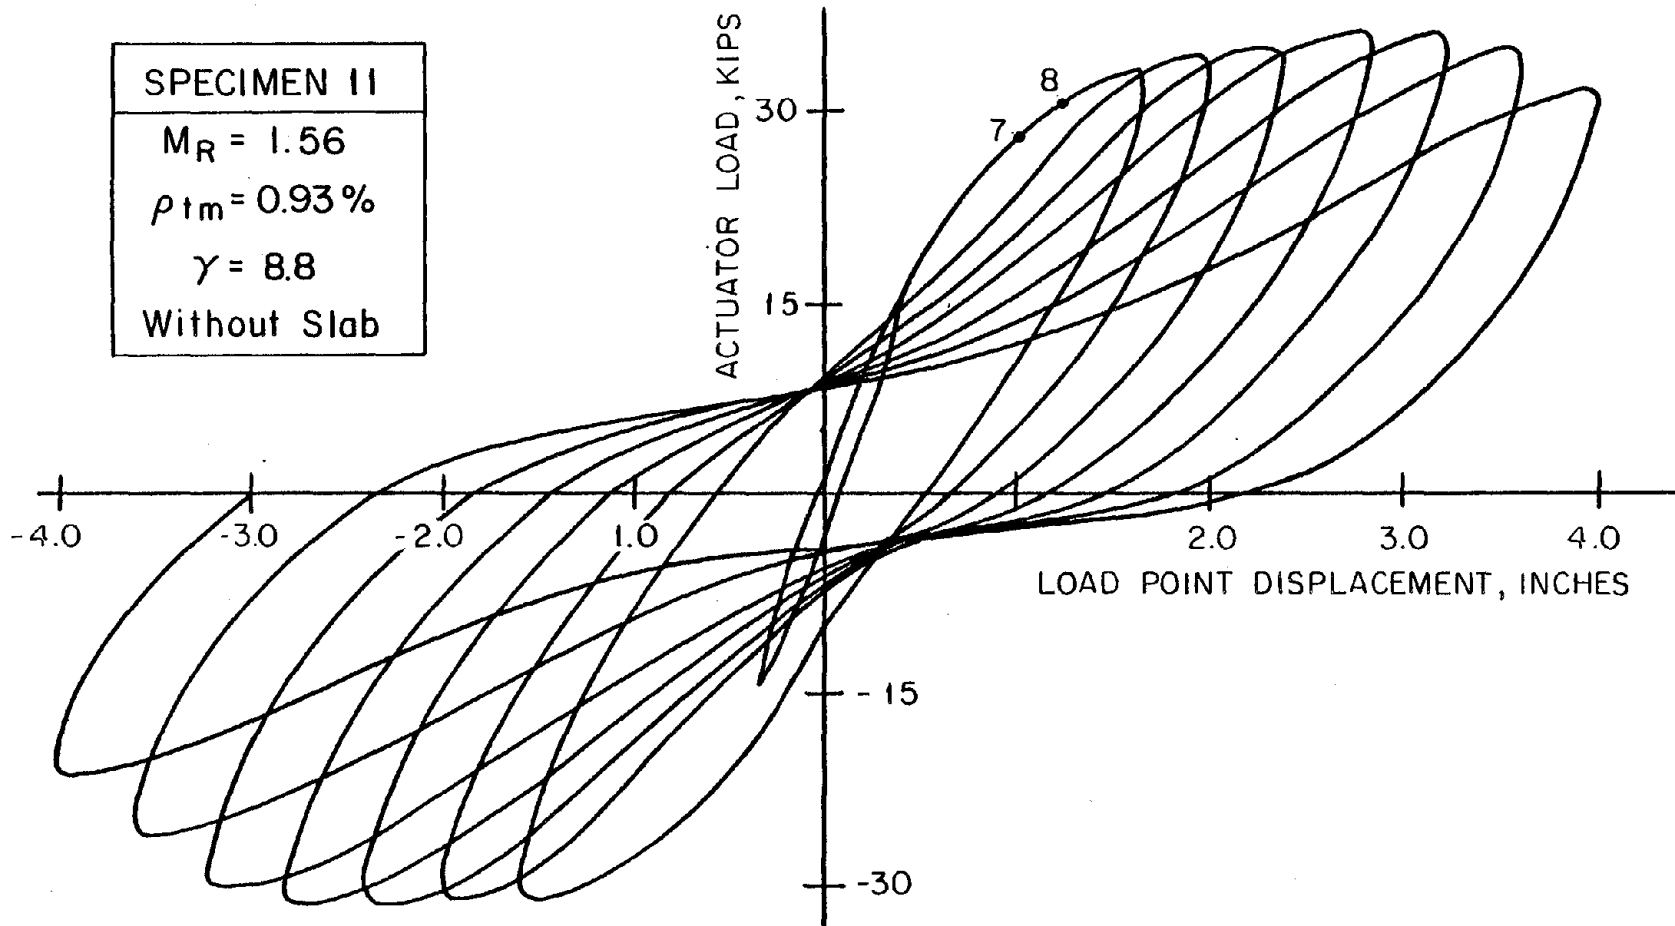
Fig. 3.1(k). Load vs. Deflection Response of Specimen 11.

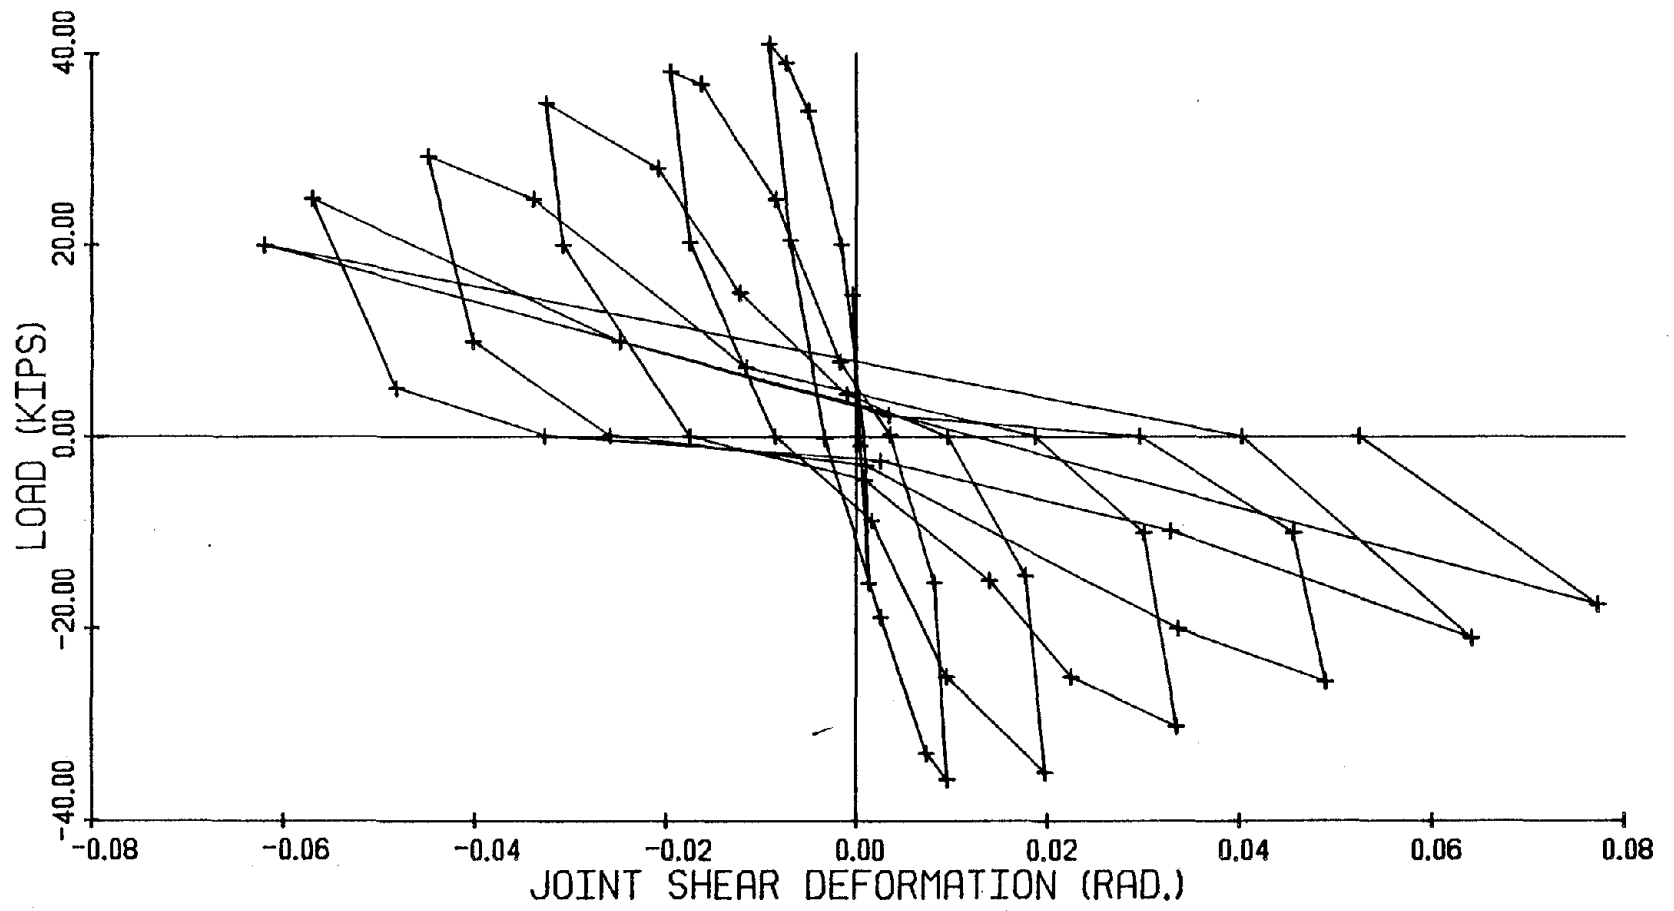
Fig. 3.16. Applied Load vs. Joint Shear Deformation - Specimen 3.

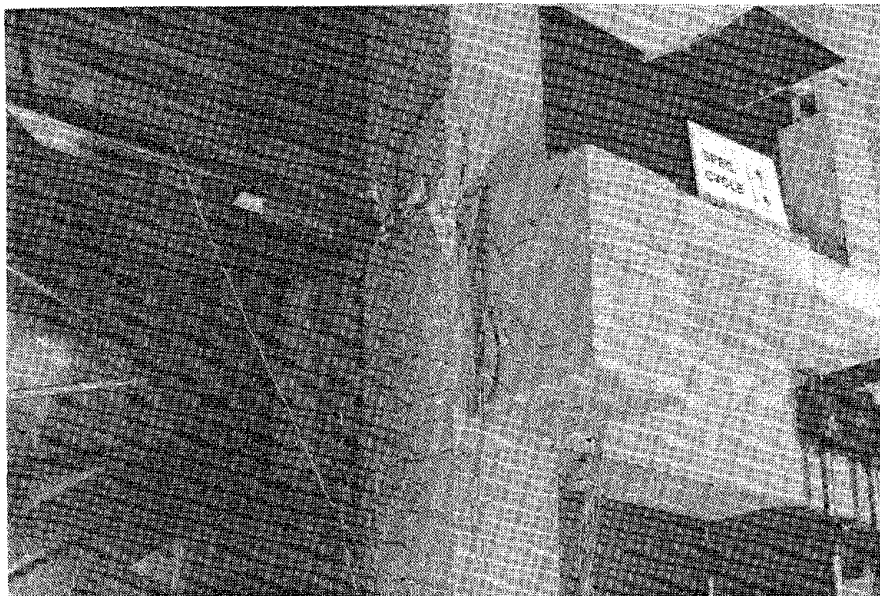
Fig. 3.29. Crushing of the Concrete Due to the Hinging of the Upper Column Half - Specimen 6.

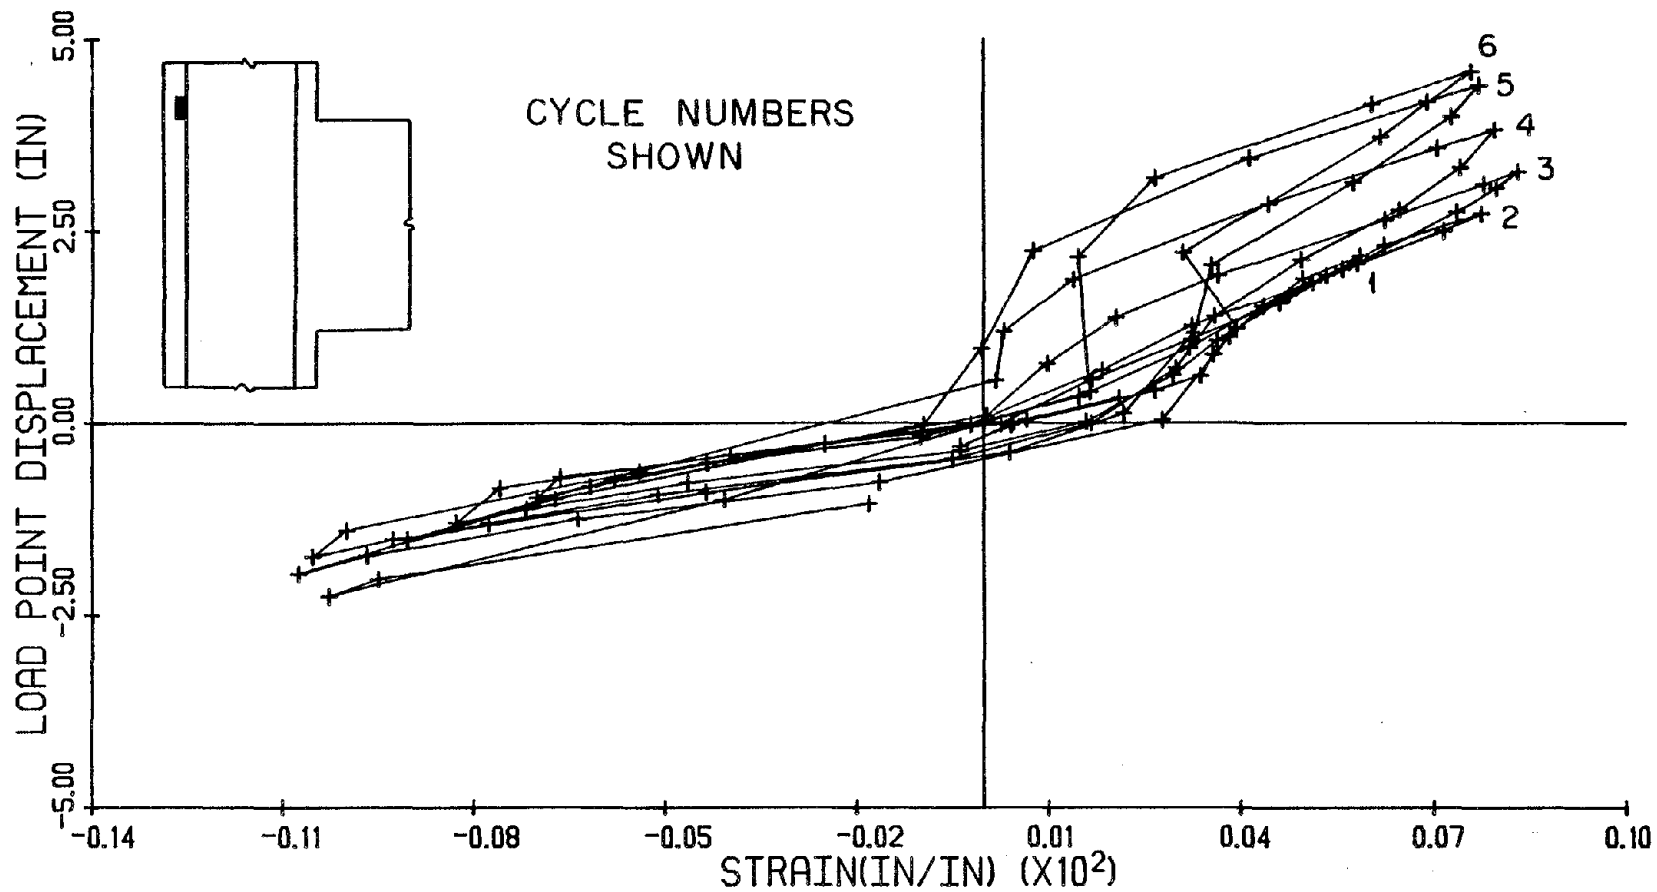
Fig. 3.53. Load Point Displacement vs. Strain in the Column Longitudinal Reinforcement - Specimen 12.
