# VIBRATION TESTING OF AN EPOXY-REPAIRED REINFORCED CONCRETE TEST STRUCTURE

G. Norman Owen  
Ike O. Egbuonye  
Onder Kustu  
Roger E. Scholl

prepared by  
URS/John A. Blume & Associates, Engineers  
130 Jessie Street (at New Montgomery)  
San Francisco, California 94105

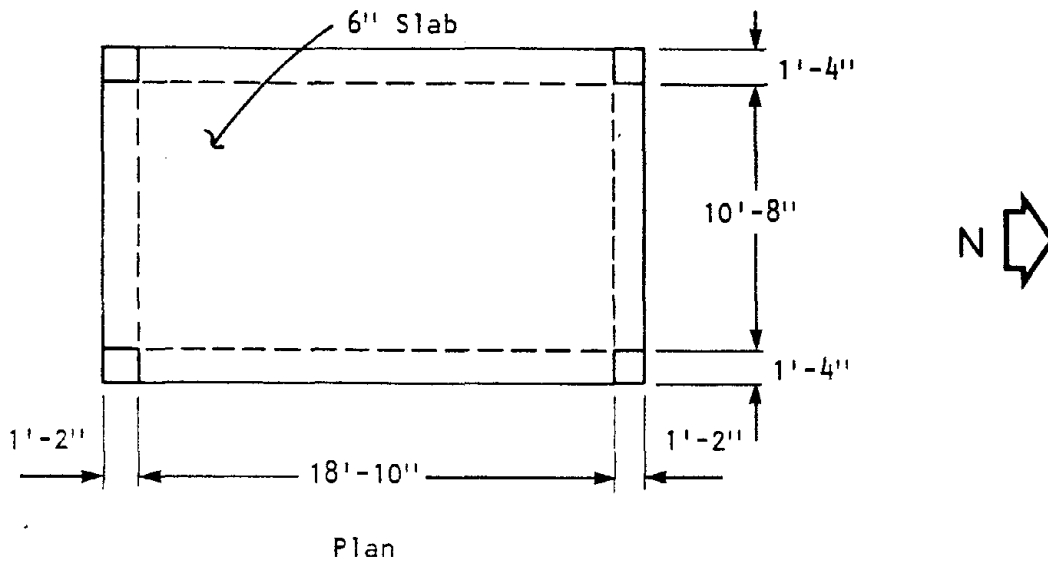
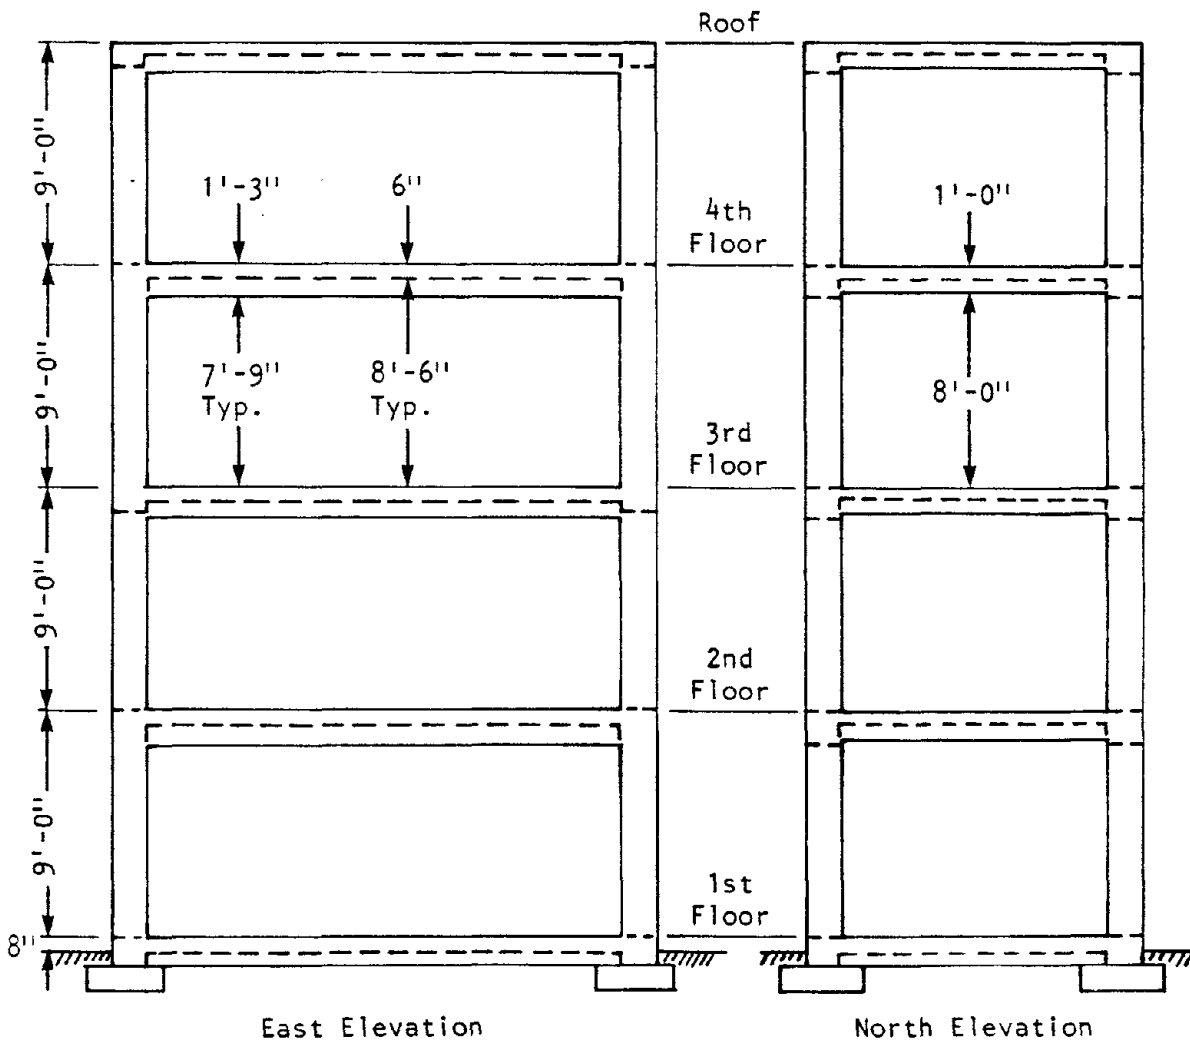
FIGURE 1 4-STORY CONCRETE TEST STRUCTURE

Prior to the 1974 tests, a 3-ft-thick concrete pad was poured onto the existing ground floor slab to prevent overturning during the destructive test. This pad was in place for the 1979 tests as well. A 2-in. gap between the concrete pad and the columns prevented contact between the pad and the columns during the testing.

The test structure was deliberately damaged by forced vibrations in the 1974 test program. A year later, the structure was repaired by injection of a high-strength epoxy compound into all significant cracks. A sealer was first used to cover each crack, leaving gaps at selected locations to serve as injection and relief ports. When the sealer had set, the epoxy compound was injected into the cracks at the injection ports until it was expressed at the relief ports. The sealer was sanded off after the epoxy had hardened.

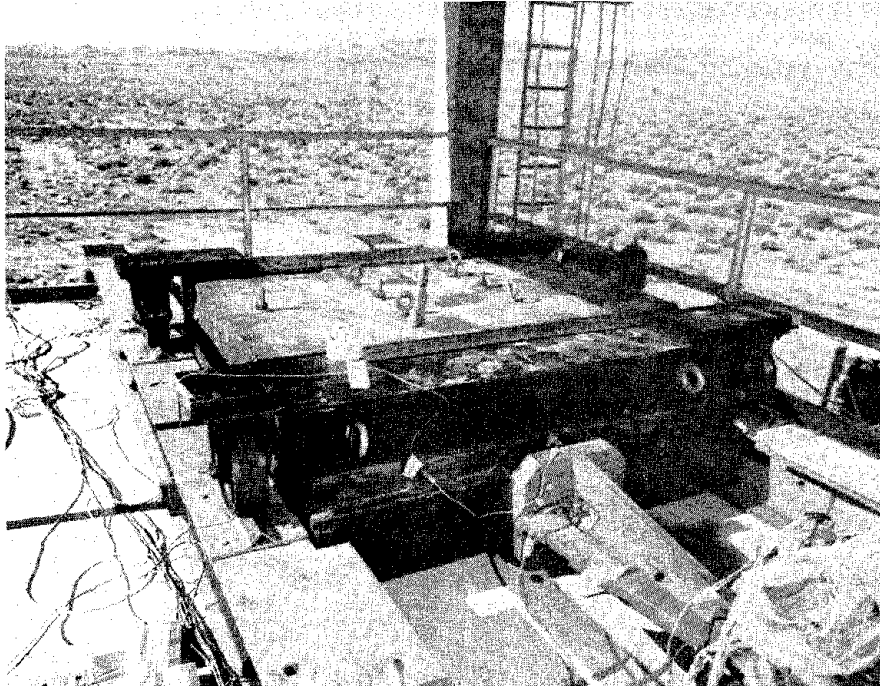
FIGURE 2 VIBRATION GENERATOR IN PLACE ON THE TEST STRUCTURE

The same vibration generator used in the 1974 tests of the original structure was used in the 1979 tests of the epoxy-repaired structure. The generator used a hydraulic piston to move a large reaction mass through reciprocating motion, thereby creating an oscillating driving force on the structure. This apparatus was designed and assembled by Sandia National Laboratories (Sandia), Albuquerque, New Mexico. Figures 2 and 3 show the vibrator in place on the structure.

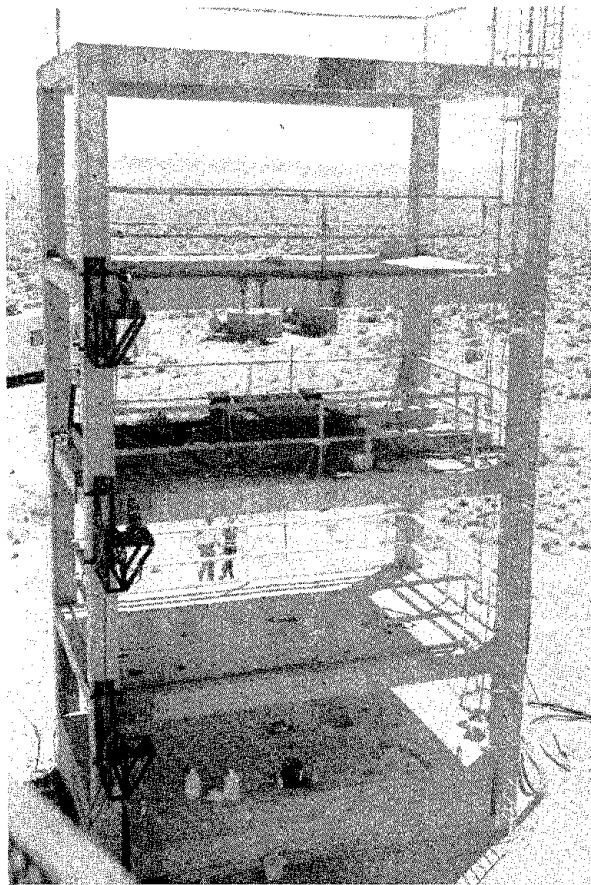
FIGURE 3 VIBRATION GENERATOR ON THE THIRD FLOOR  
OF THE TEST STRUCTURE

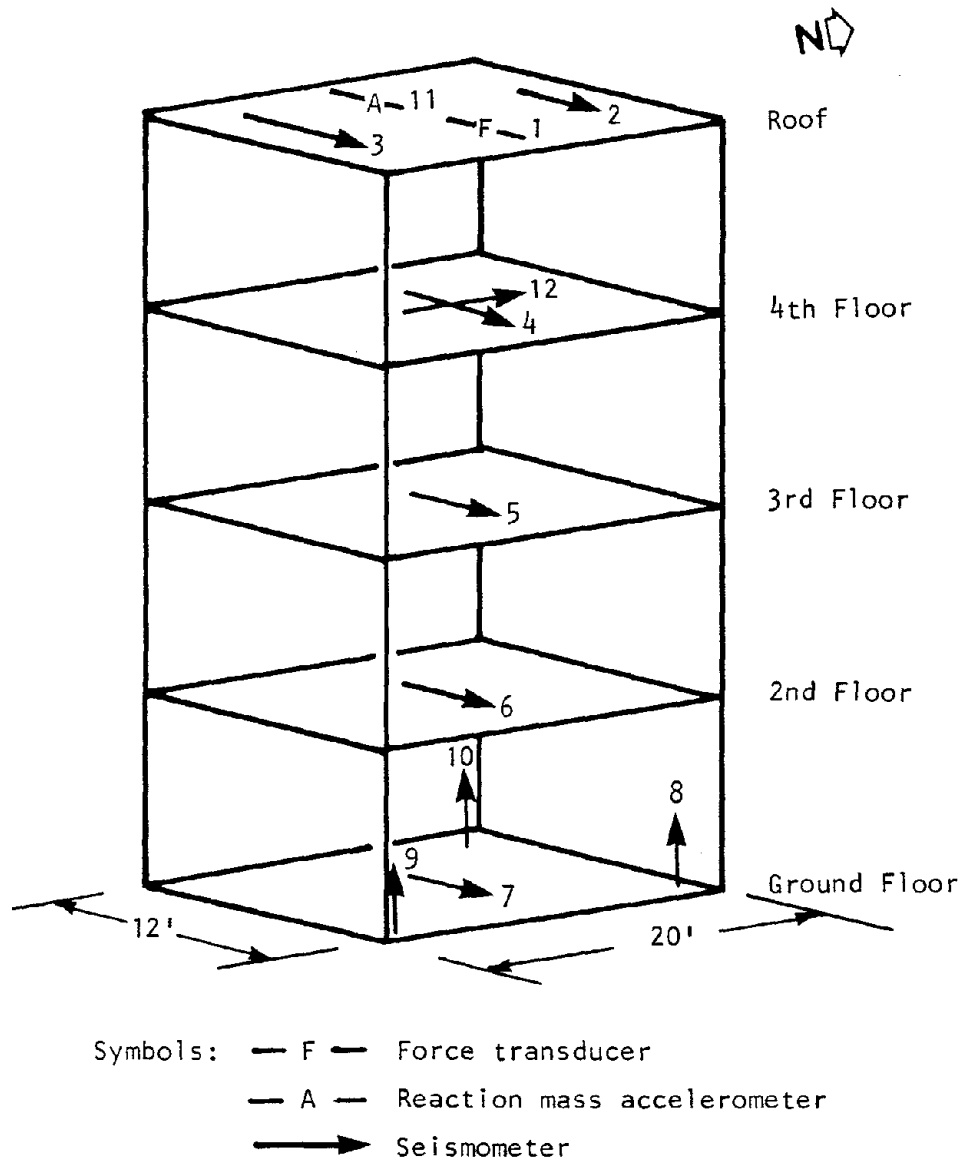
FIGURE 4 INSTRUMENT LOCATIONS AND AXIAL ORIENTATIONS FOR NONDESTRUCTIVE TESTS, TRANSVERSE DIRECTION

Ten L-7 velocity meters measured the principal structural responses during each test at locations and in the directions indicated in Figures 4, 5, and 6. Figures 4 and 5 represent the configurations used in the nondestructive tests with forced vibrations in the 12-ft direction (transverse) and the 20-ft direction (longitudinal), respectively. Figure 6 represents the

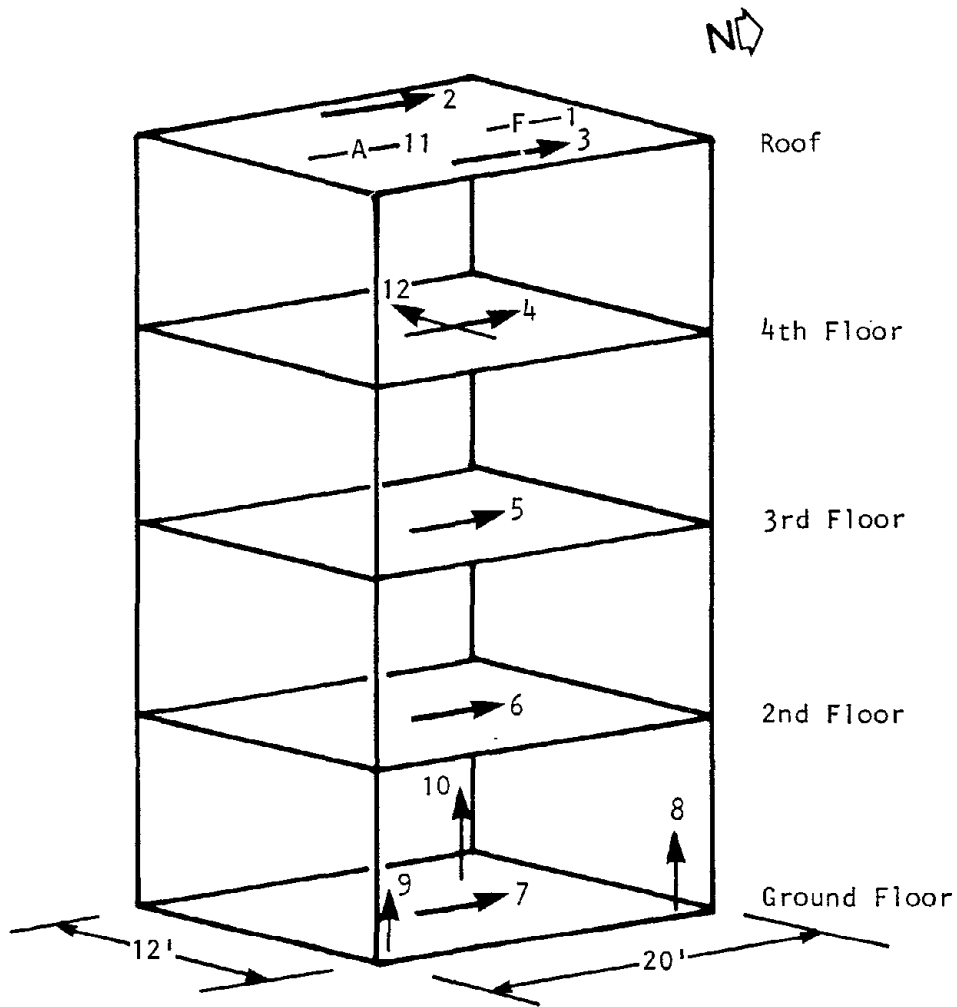
Symbols: —F— Force transducer  
 —A— Reaction mass accelerometer  
 —> Seismometer

FIGURE 5 INSTRUMENT LOCATIONS AND AXIAL ORIENTATIONS FOR NONDESTRUCTIVE TESTS, LONGITUDINAL DIRECTION

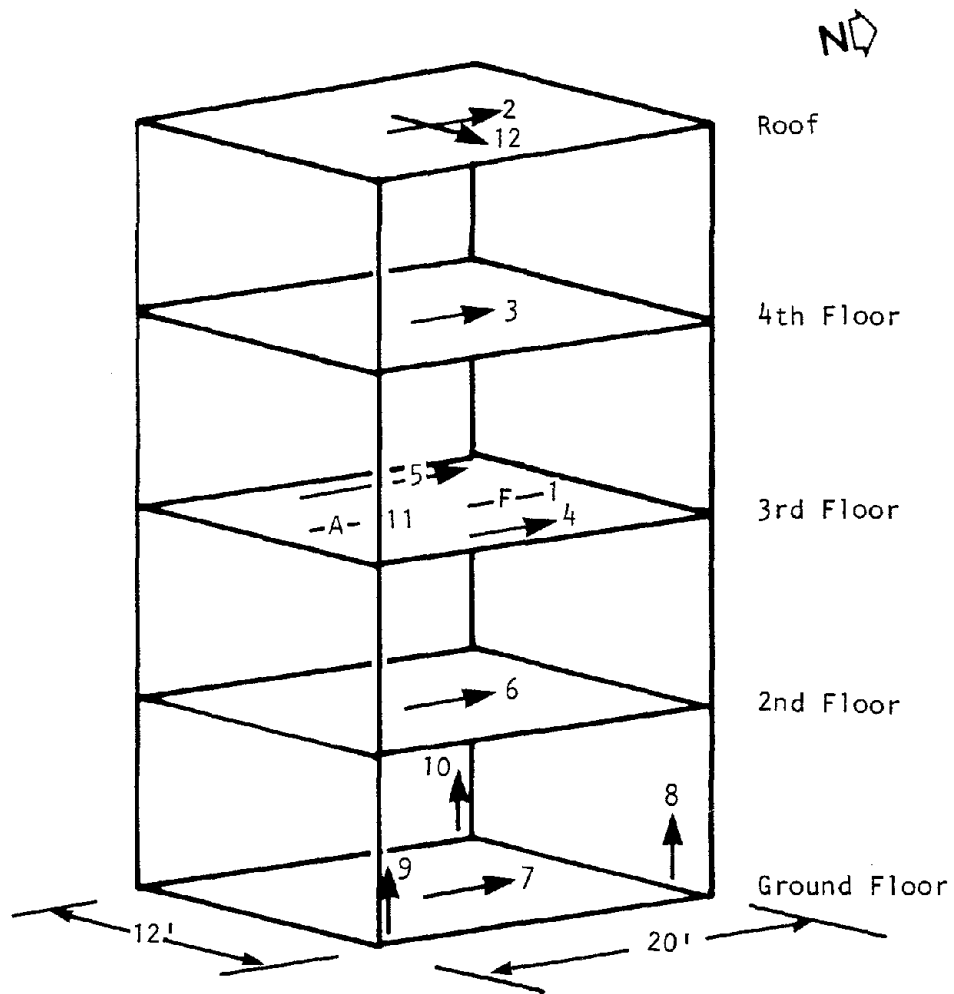
Symbols: —F— Force transducer  
 —A— Reaction mass accelerometer  
 —> Seismometer

FIGURE 6 INSTRUMENT LOCATIONS AND AXIAL ORIENTATIONS FOR DESTRUCTIVE AND POSTDESTRUCTIVE TESTS

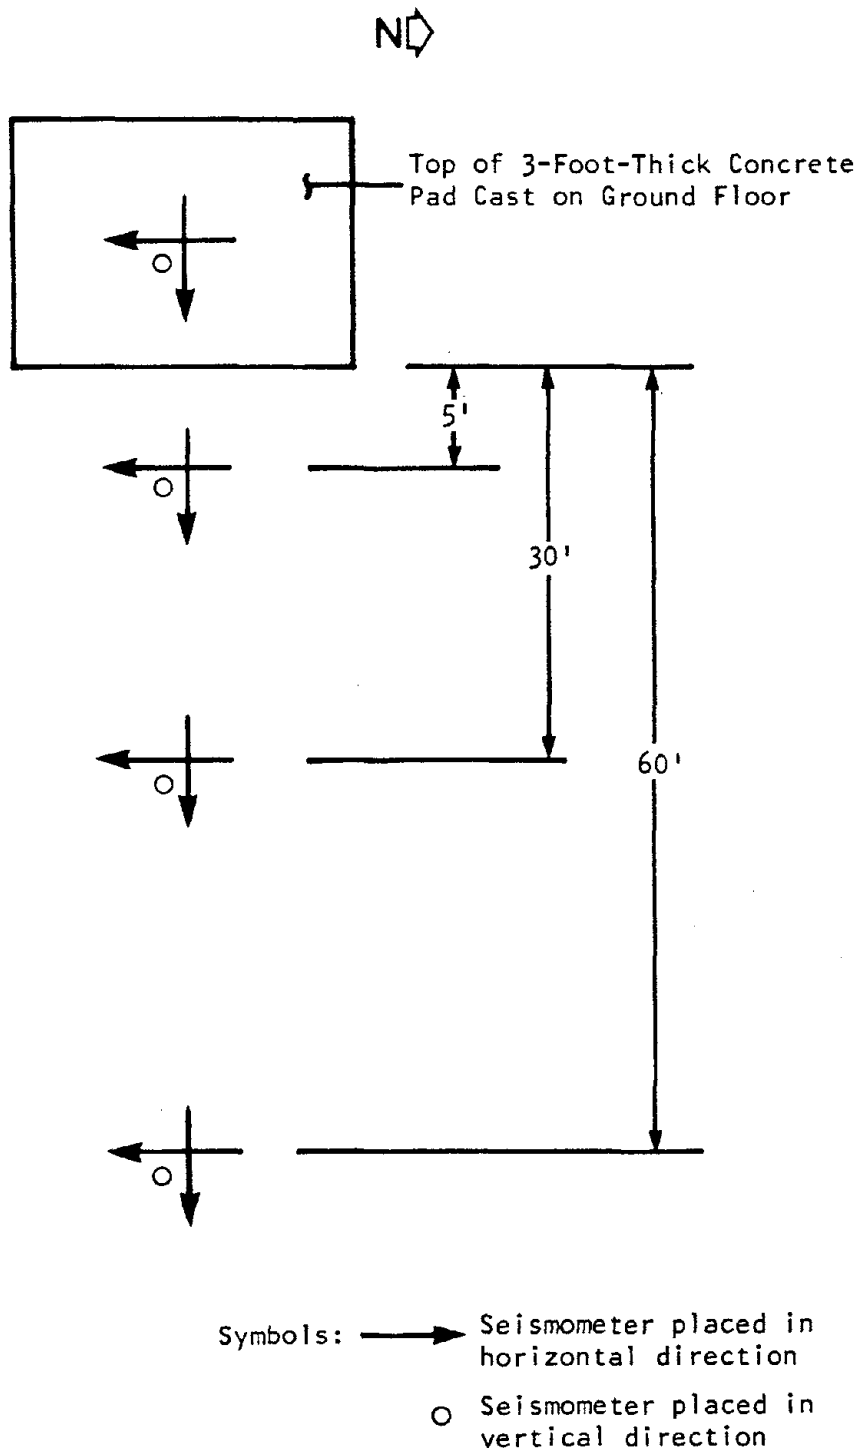
FIGURE 7 GROUND SURFACE INSTRUMENTATION FOR NONDESTRUCTIVE TESTS, TRANSVERSE DIRECTION

the two horizontal directions (longitudinal and transverse to the structure) and the vertical direction. Seismometer locations for the various tests are indicated in Figures 7 and 8. The signals from this network were recorded on magnetic tape, along with the FM compensation and the IRIG-E time code.

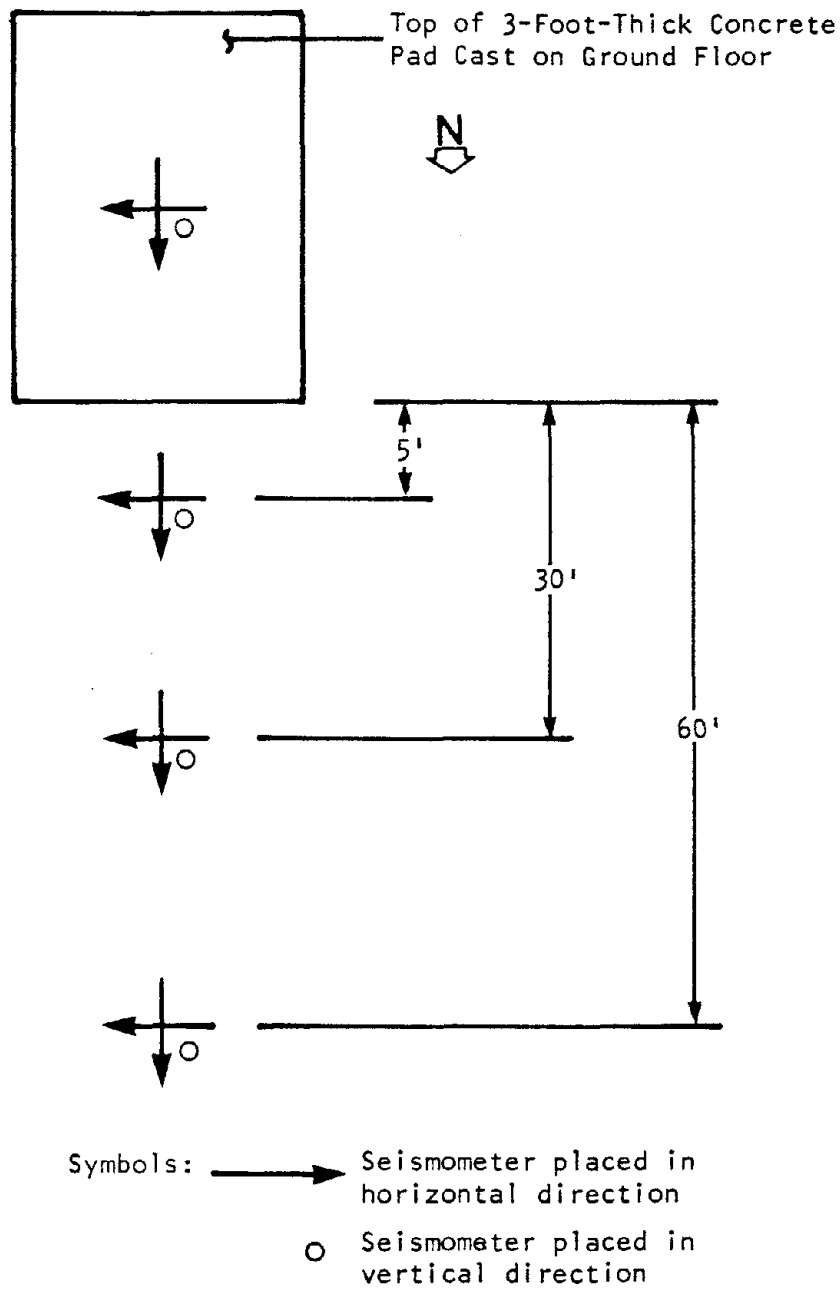
FIGURE 8 GROUND SURFACE INSTRUMENTATION FOR ALL TESTS IN THE LONGITUDINAL DIRECTION

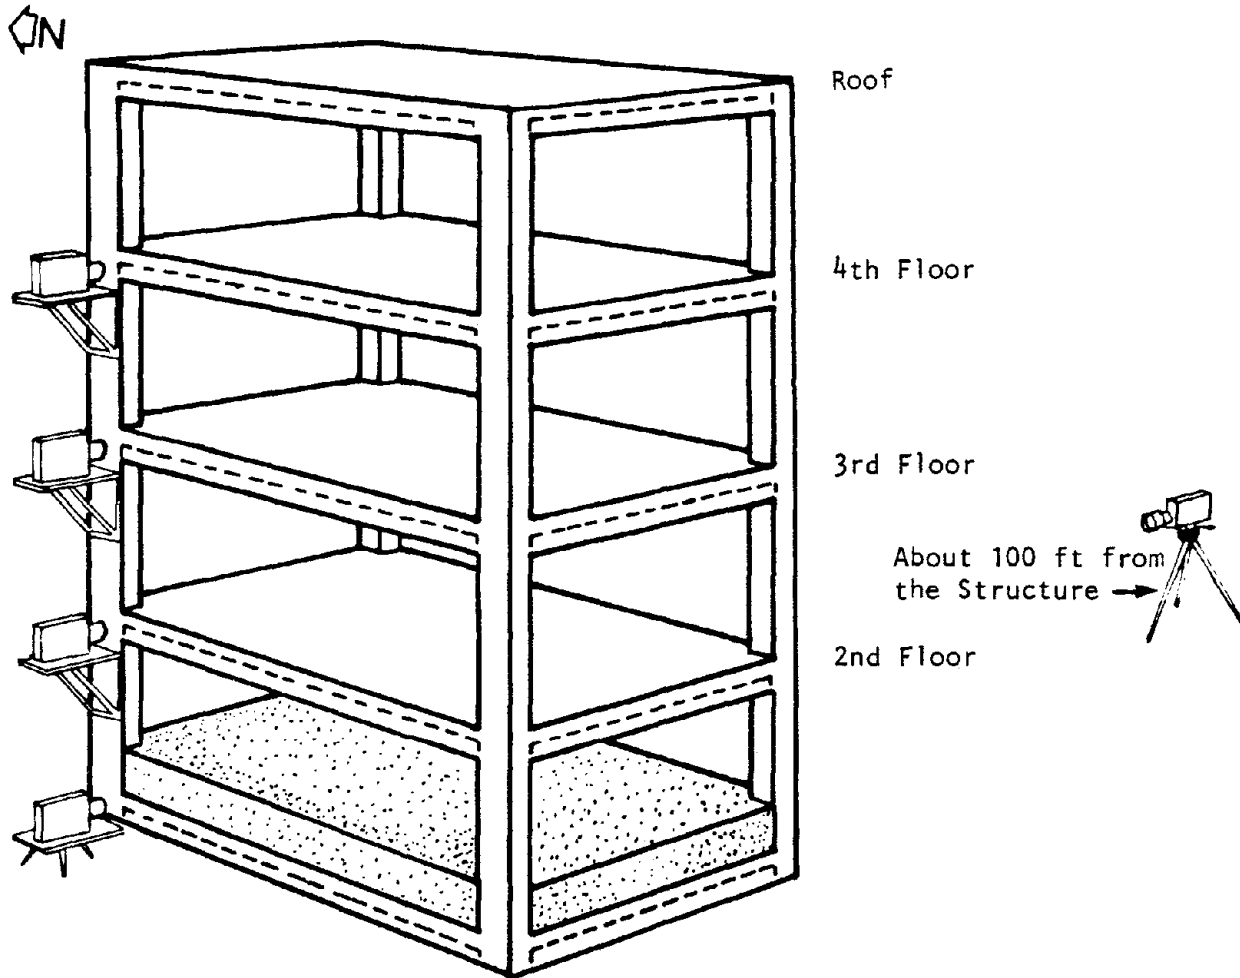
Note: An additional camera moved from place to place.

FIGURE 9 PLACEMENT OF MOTION PICTURE CAMERAS ON THE TEST STRUCTURE

Photographic Coverage. Six motion picture cameras were installed to provide permanent documentation of the damage done to the structure during the destructive test. Four cameras were mounted on the test structure as shown in Figure 9, and one was located about 100 ft away from the structure to record overall motion of the structure. The sixth camera was a roving unit used to capture close-up views of various parts of the structure during the destructive test. In addition to motion pictures, many still photographs were taken before and after the destructive test.

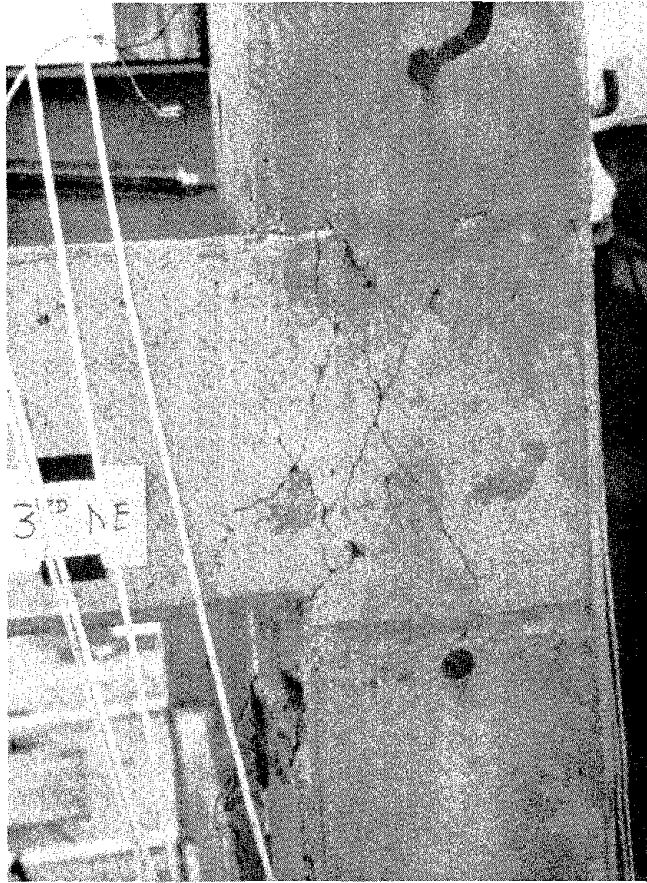
FIGURE 10 DAMAGE FROM THE 1974 TEST AT THE NORTHEAST CORNER OF THE THIRD FLOOR OF THE ORIGINAL STRUCTURE

In general, the epoxy-repaired structure was less severely damaged than the original structure. The cracking in the epoxy-repaired structure was more widely dispersed than in the original structure, with less concentrated damage at joints. This suggests that the epoxy procedure may have created better joints, probably through improved bonding between the reinforcing bars and the concrete.

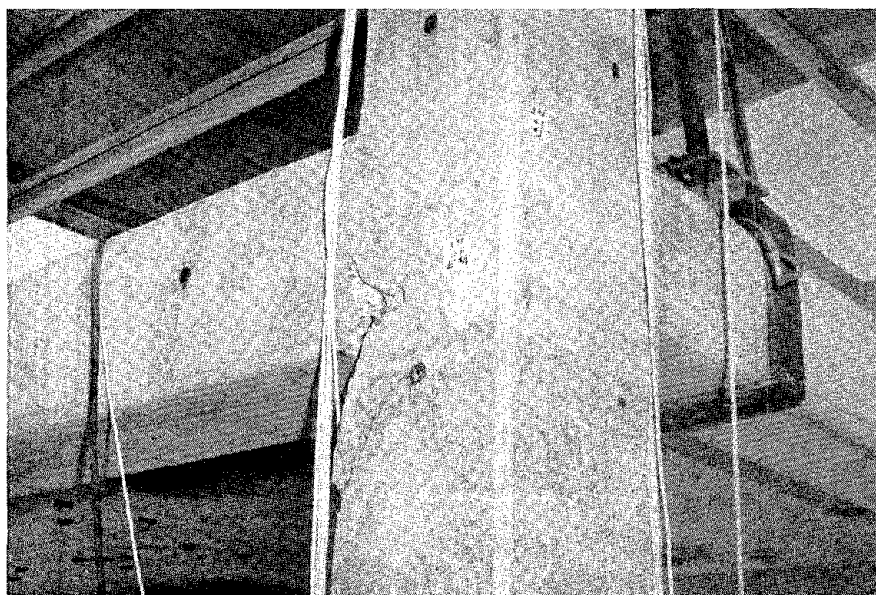
FIGURE 11 DAMAGE FROM THE 1979 TEST AT THE NORTHEAST CORNER OF THE THIRD FLOOR OF THE EPOXY-REPAIRED STRUCTURE

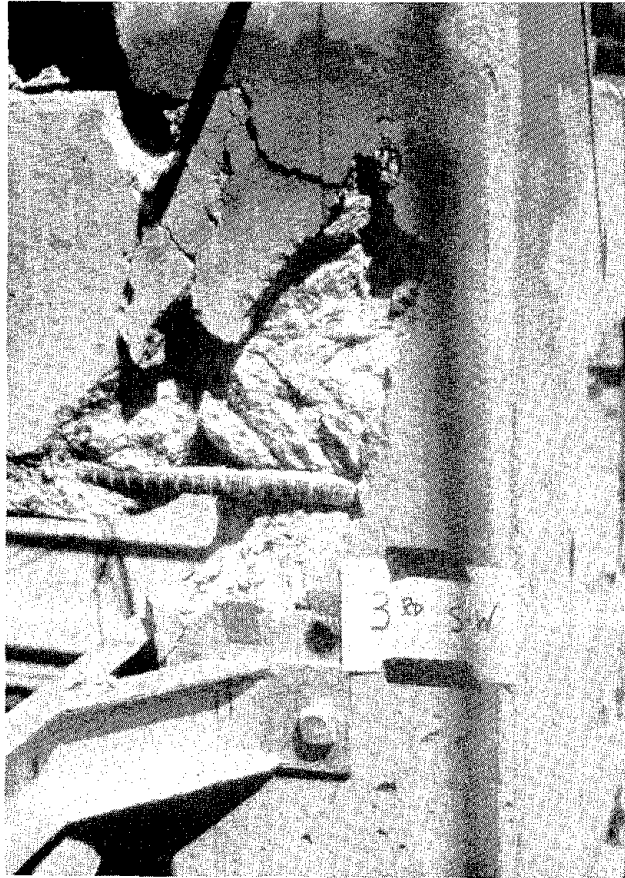
FIGURE 12 DAMAGE FROM THE 1974 TEST AT THE SOUTHWEST CORNER OF THE THIRD FLOOR OF THE ORIGINAL STRUCTURE

Nonsymmetrical damage occurred in both the original and epoxy-repaired structures, indicating torsional vibrations during the destructive tests. Evidence of this was cited in the report on the 1974 tests<sup>17</sup> and remained the same in the 1979 tests, although the damage was less.

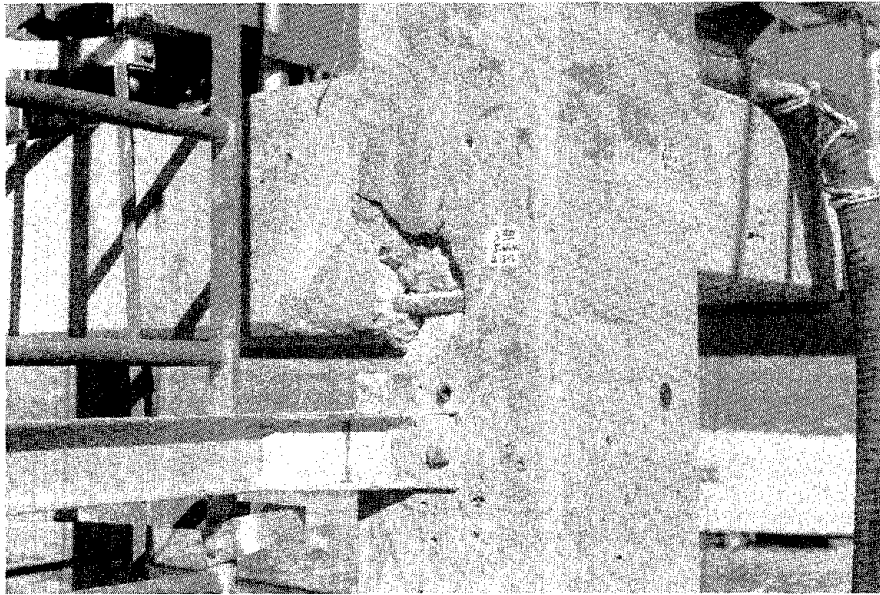
FIGURE 13 DAMAGE FROM THE 1979 TEST AT THE SOUTHWEST CORNER OF THE THIRD FLOOR OF THE EPOXY-REPAIRED STRUCTURE

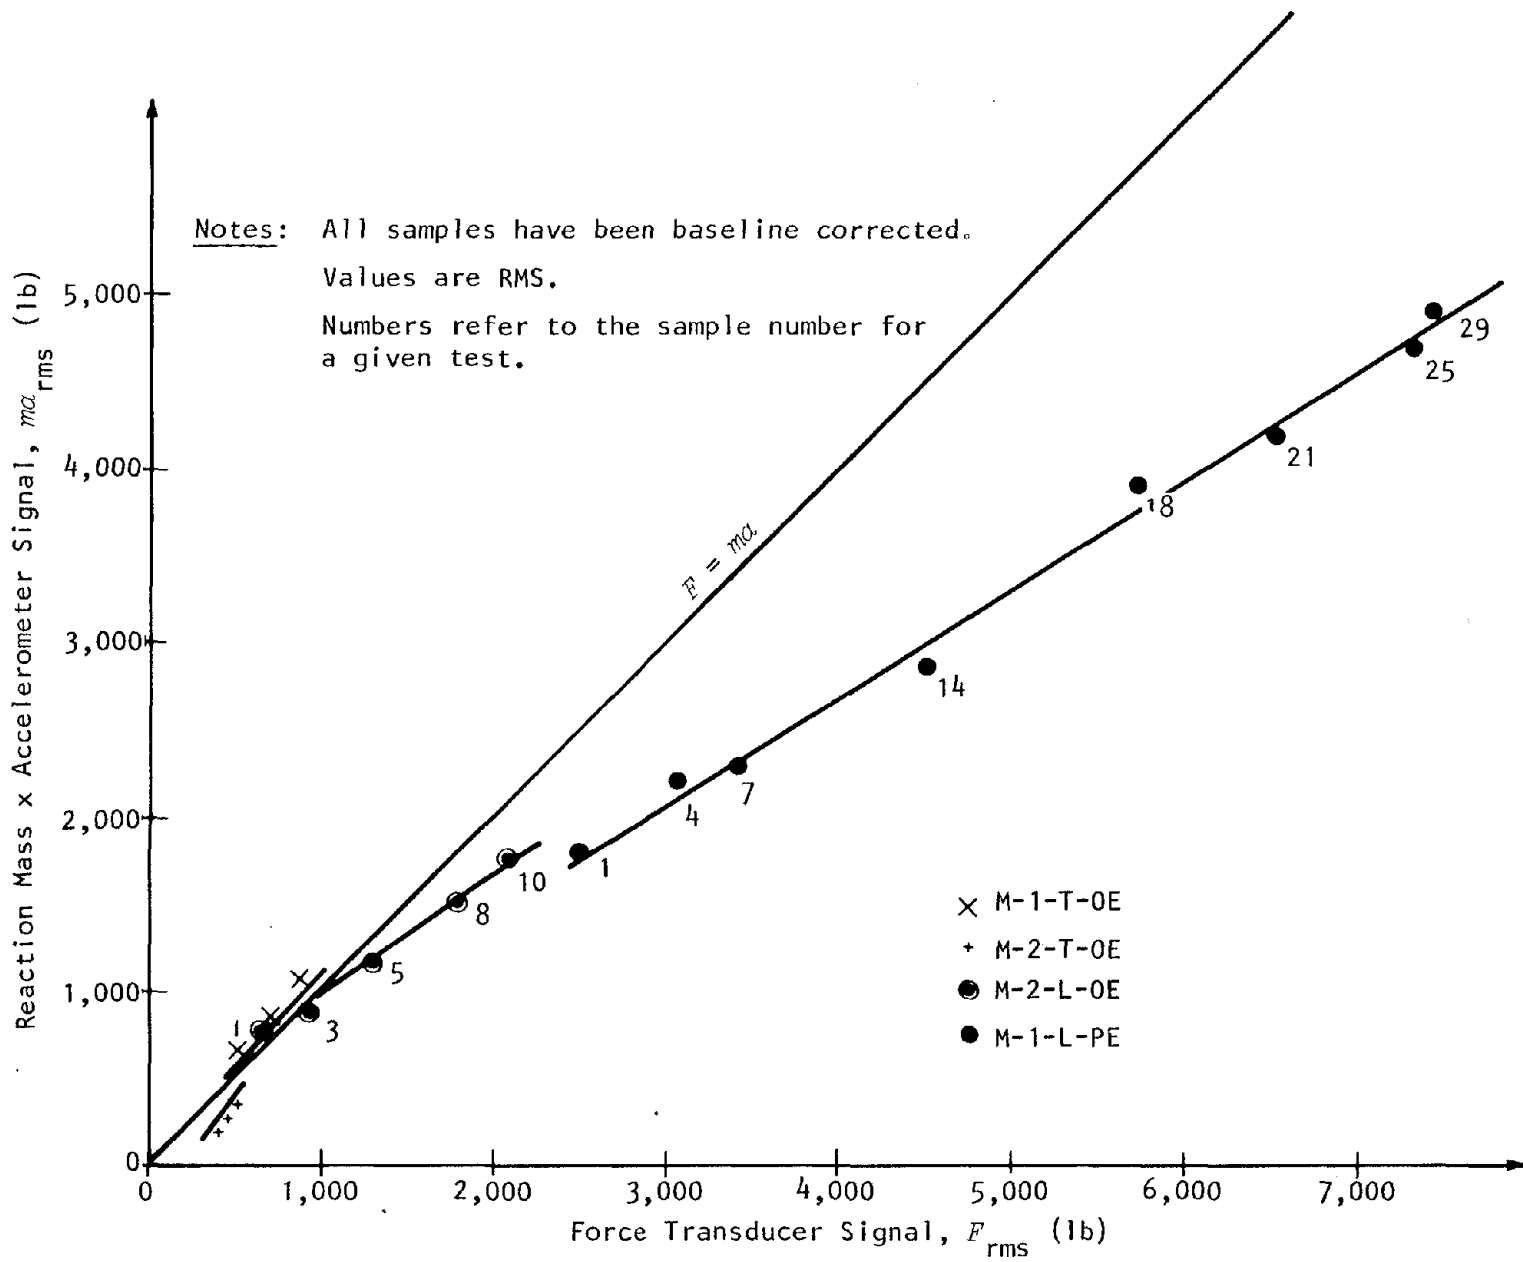
Figure 14 shows the relationship between the RMS amplitudes of the two measures of the driving force — the reaction mass times the accelerometer signal ( $ma$ ) versus the force transducer signal ( $F$ ) — over a range of force levels. The behavior in the low-amplitude transverse vibration tests (M-1-T-OE and M-2-T-OE) was as expected:  $ma$  was smaller than  $F$  for low values

FIGURE 14 RELATIONSHIP BETWEEN TWO MEASURES OF THE DRIVING FORCE

where friction was most significant, and  $\dot{m}a$  approached  $F$  as the force level increased. But this relationship did not hold in the longitudinal tests. In both the low-amplitude test (M-2-L-OE) and the high-amplitude destructive test (M-1-L-PE), the relationship between  $\dot{m}a$  and  $F$  was linear, but  $\dot{m}a$  was less than  $F$ .

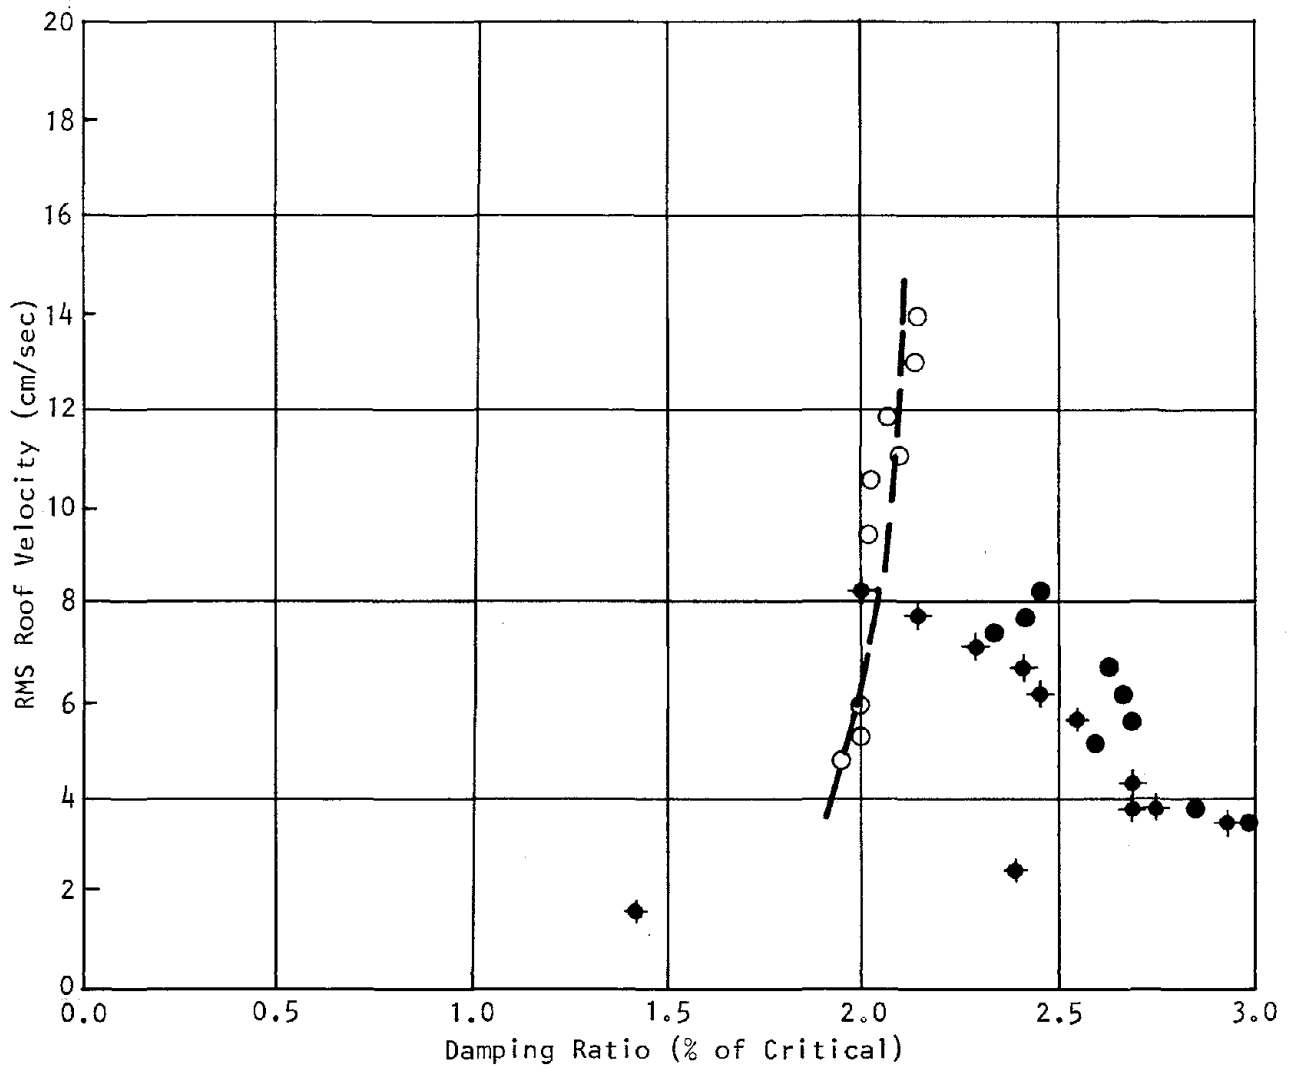
1974 Data ○ M-2-L-0, force transducer

1979 Data { ● M-2-L-0E, force transducer  
 ◆ M-2-L-0E, mass x acceleration

In the low-amplitude, second-mode, longitudinal test (M-2-L-OE), the damping values obtained using the accelerometer signal were only somewhat smaller than those obtained using the force transducer (see Figure 16). The exception to this observation occurred at very low amplitudes (RMS roof velocities on the order of 2 cm/sec), where damping values obtained using acceleration were a great deal smaller. The negative slope in the general trend for damping values with increasing roof velocity in this low-amplitude test is not logical and raises doubts about the validity of the data from this test.

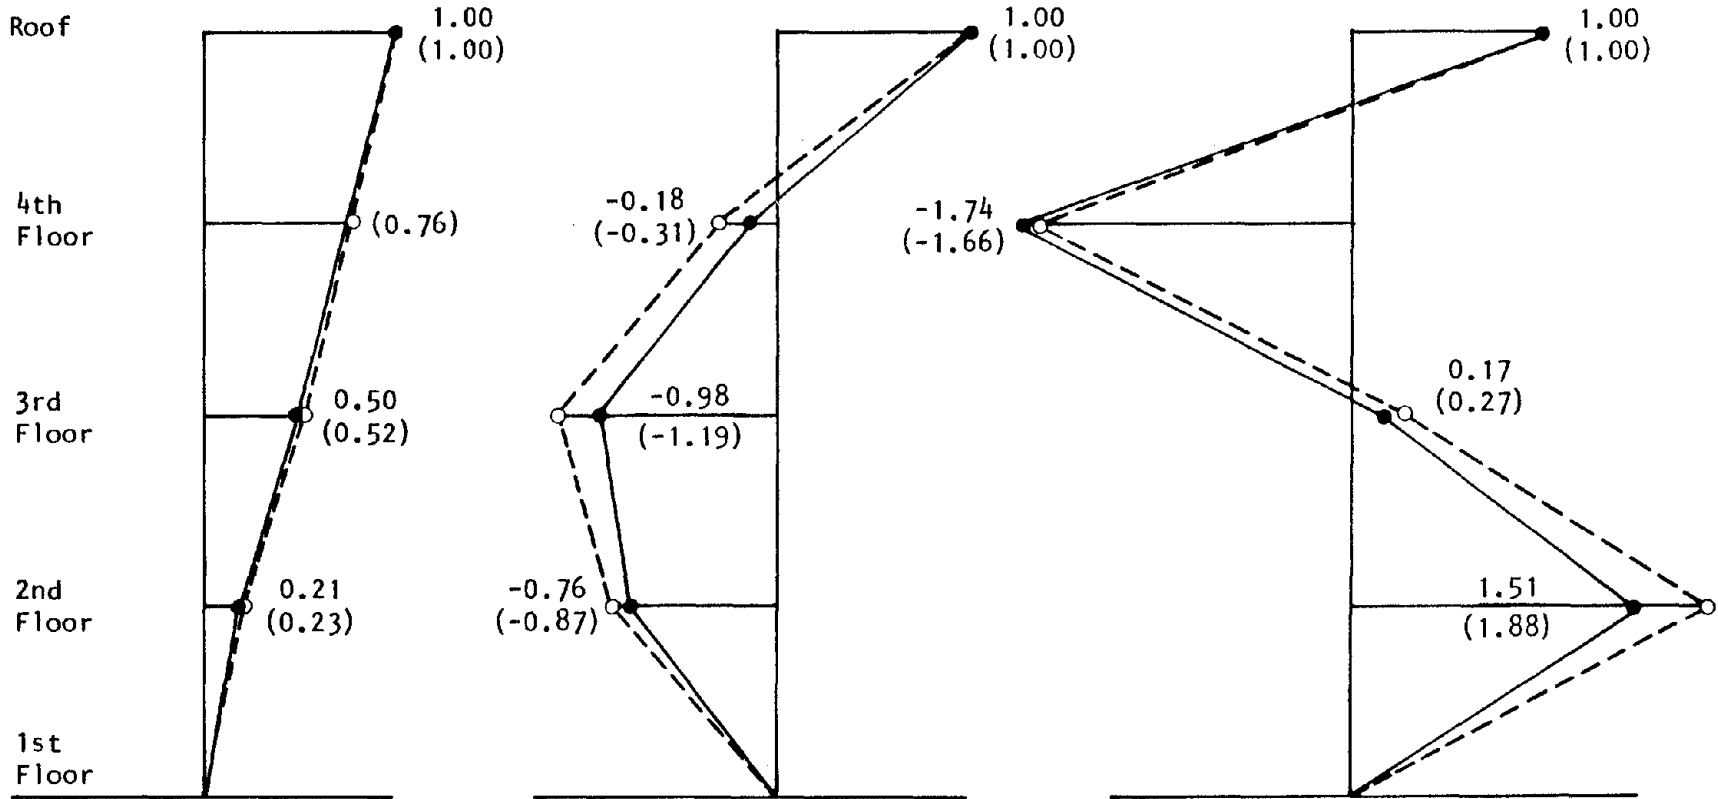
$T_1 = 0.54-0.55$  sec  
 (0.45-0.51)

FIGURE 17 NORMALIZED MODE SHAPES FOR THE NONDESTRUCTIVE TEST, TRANSVERSE DIRECTION

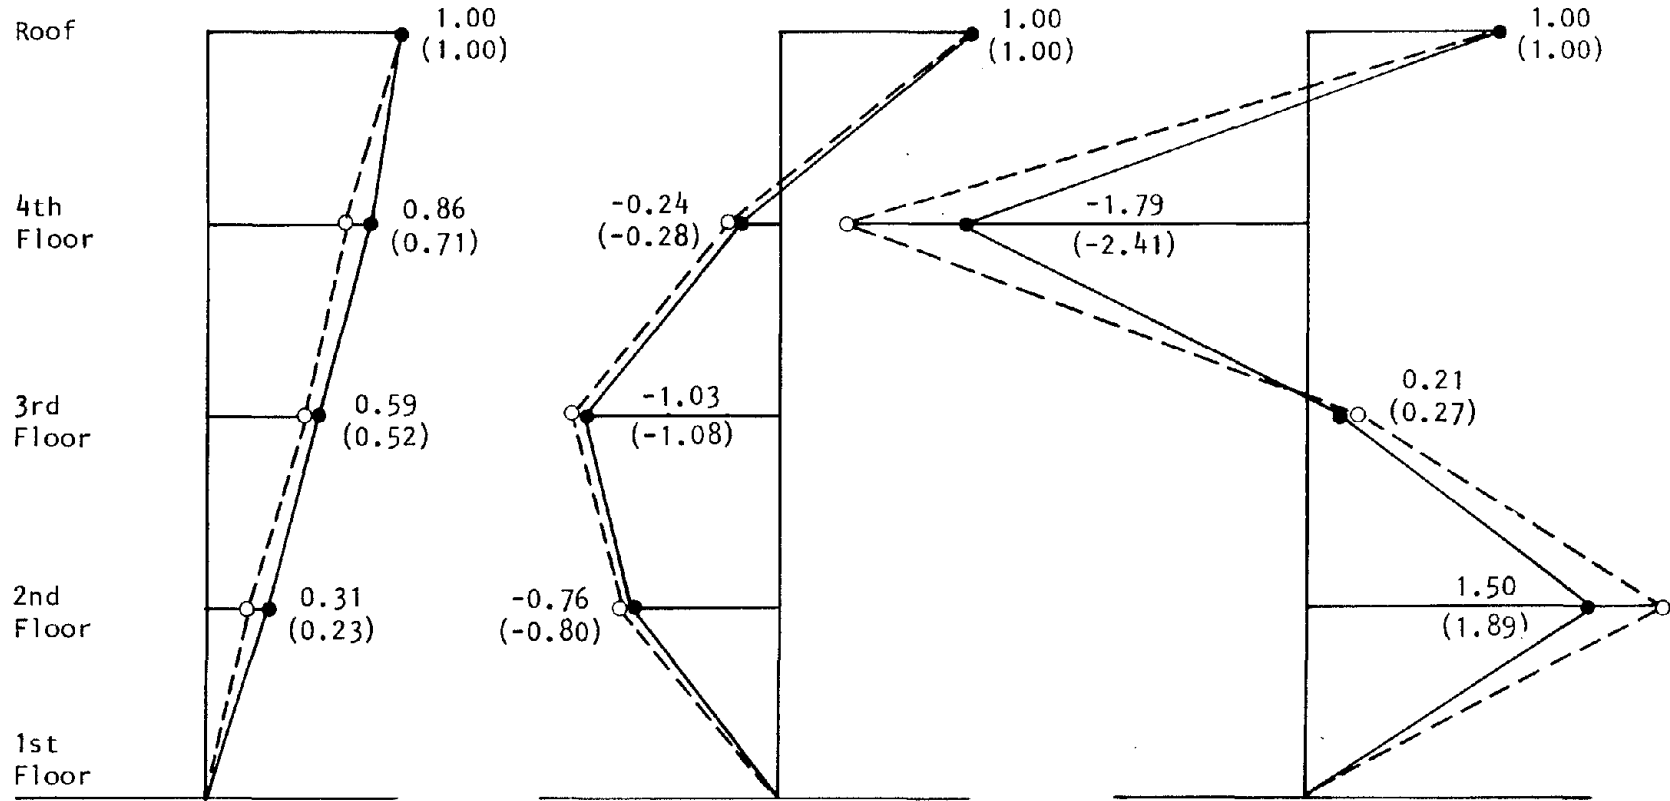
$T_1 = 0.418-0.517$  sec  
 (0.430-0.532)

FIGURE 18 NORMALIZED MODE SHAPES FOR THE NONDESTRUCTIVE TEST, LONGITUDINAL DIRECTION

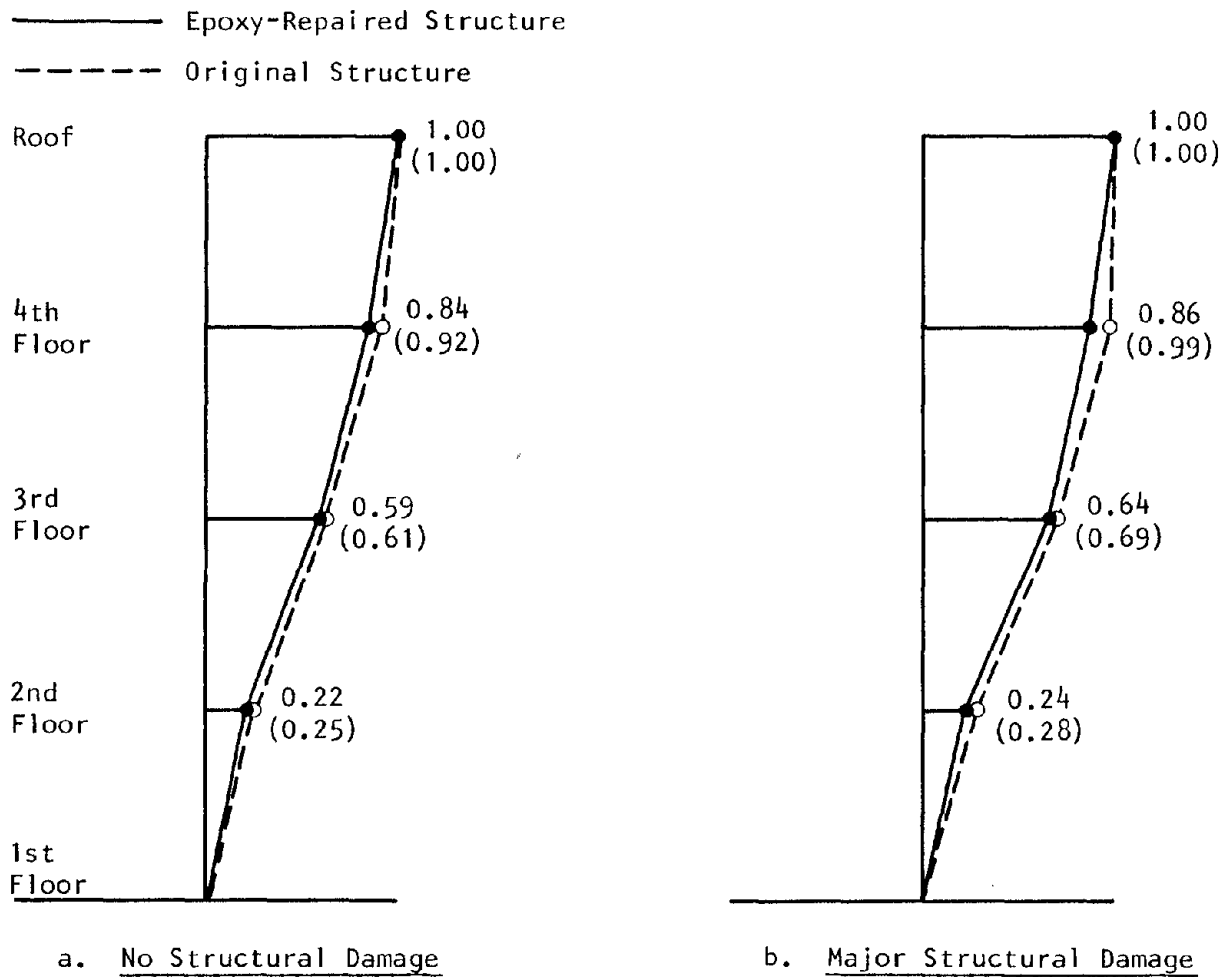
FIGURE 19 NORMALIZED FIRST-MODE SHAPES FOR DESTRUCTIVE TEST, NO DAMAGE AND MAJOR DAMAGE, LONGITUDINAL DIRECTION

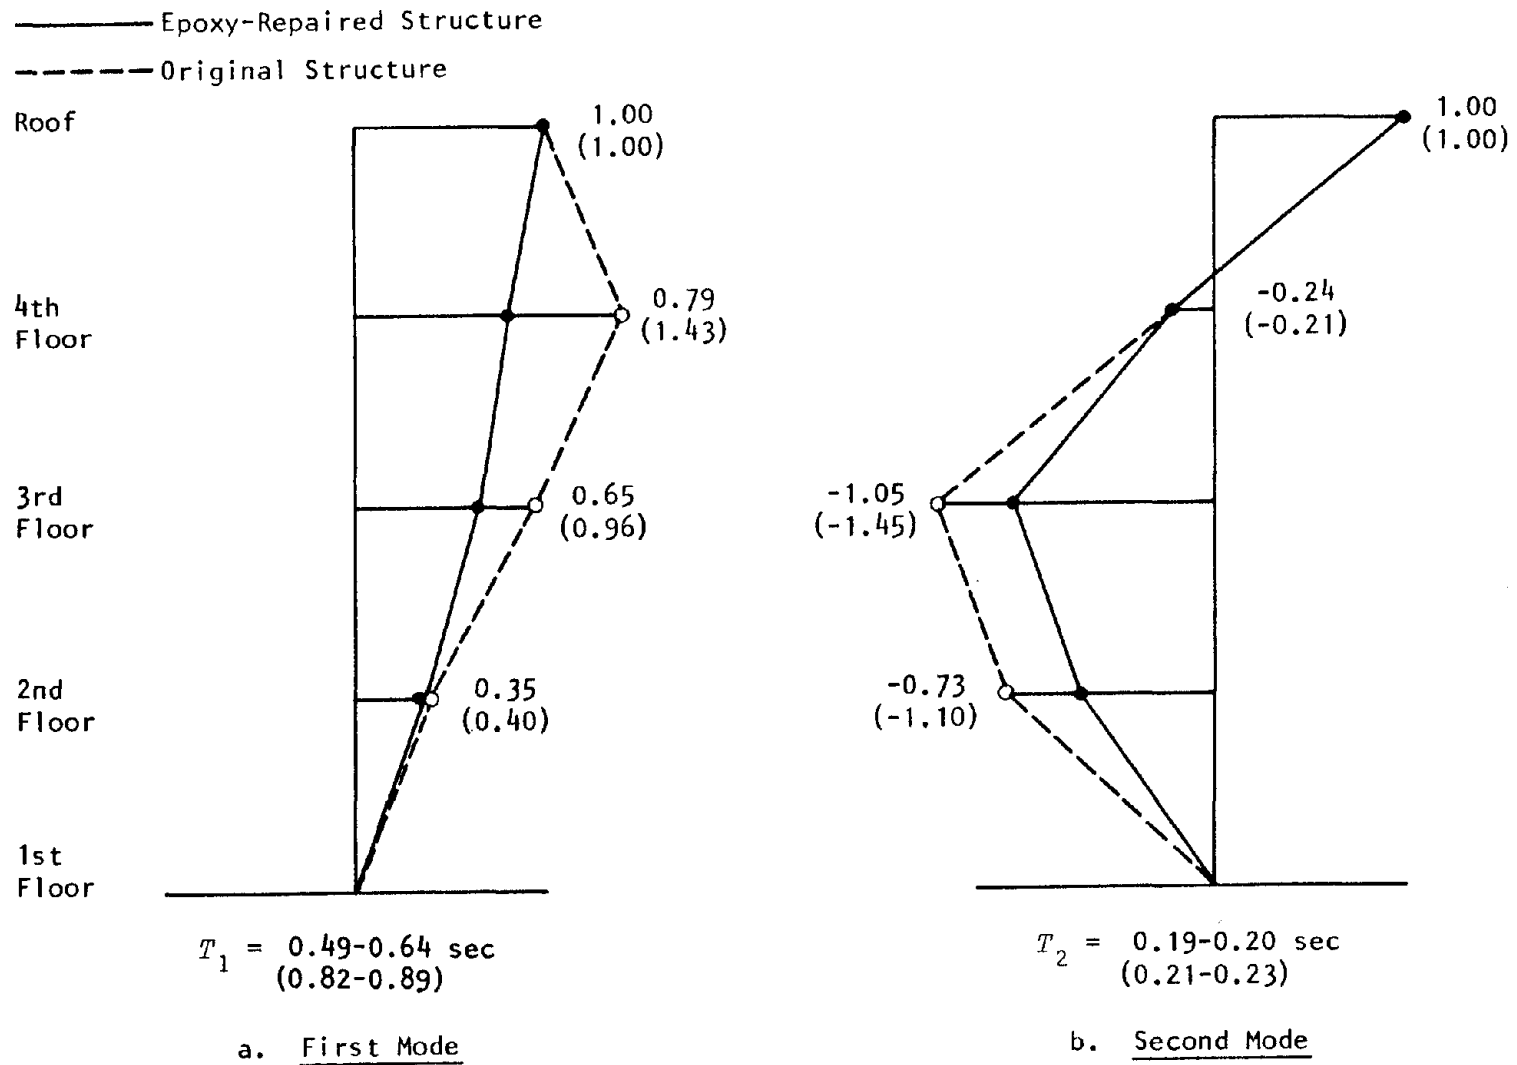
FIGURE 20 NORMALIZED MODE SHAPES FOR THE POSTDESTRUCTIVE TEST, LONGITUDINAL DIRECTION

The first two mode shapes for the longitudinal direction obtained from the postdestructive test are plotted in Figure 20. A comparison with the same
