# VIBRATION TESTING OF AN EPOXY-REPAIRED REINFORCED CONCRETE TEST STRUCTURE

G. Norman Owen  
Ike O. Egbuonye  
Onder Kustu  
Roger E. Scholl

prepared by  
URS/John A. Blume & Associates, Engineers  
130 Jessie Street (at New Montgomery)  
San Francisco, California 94105

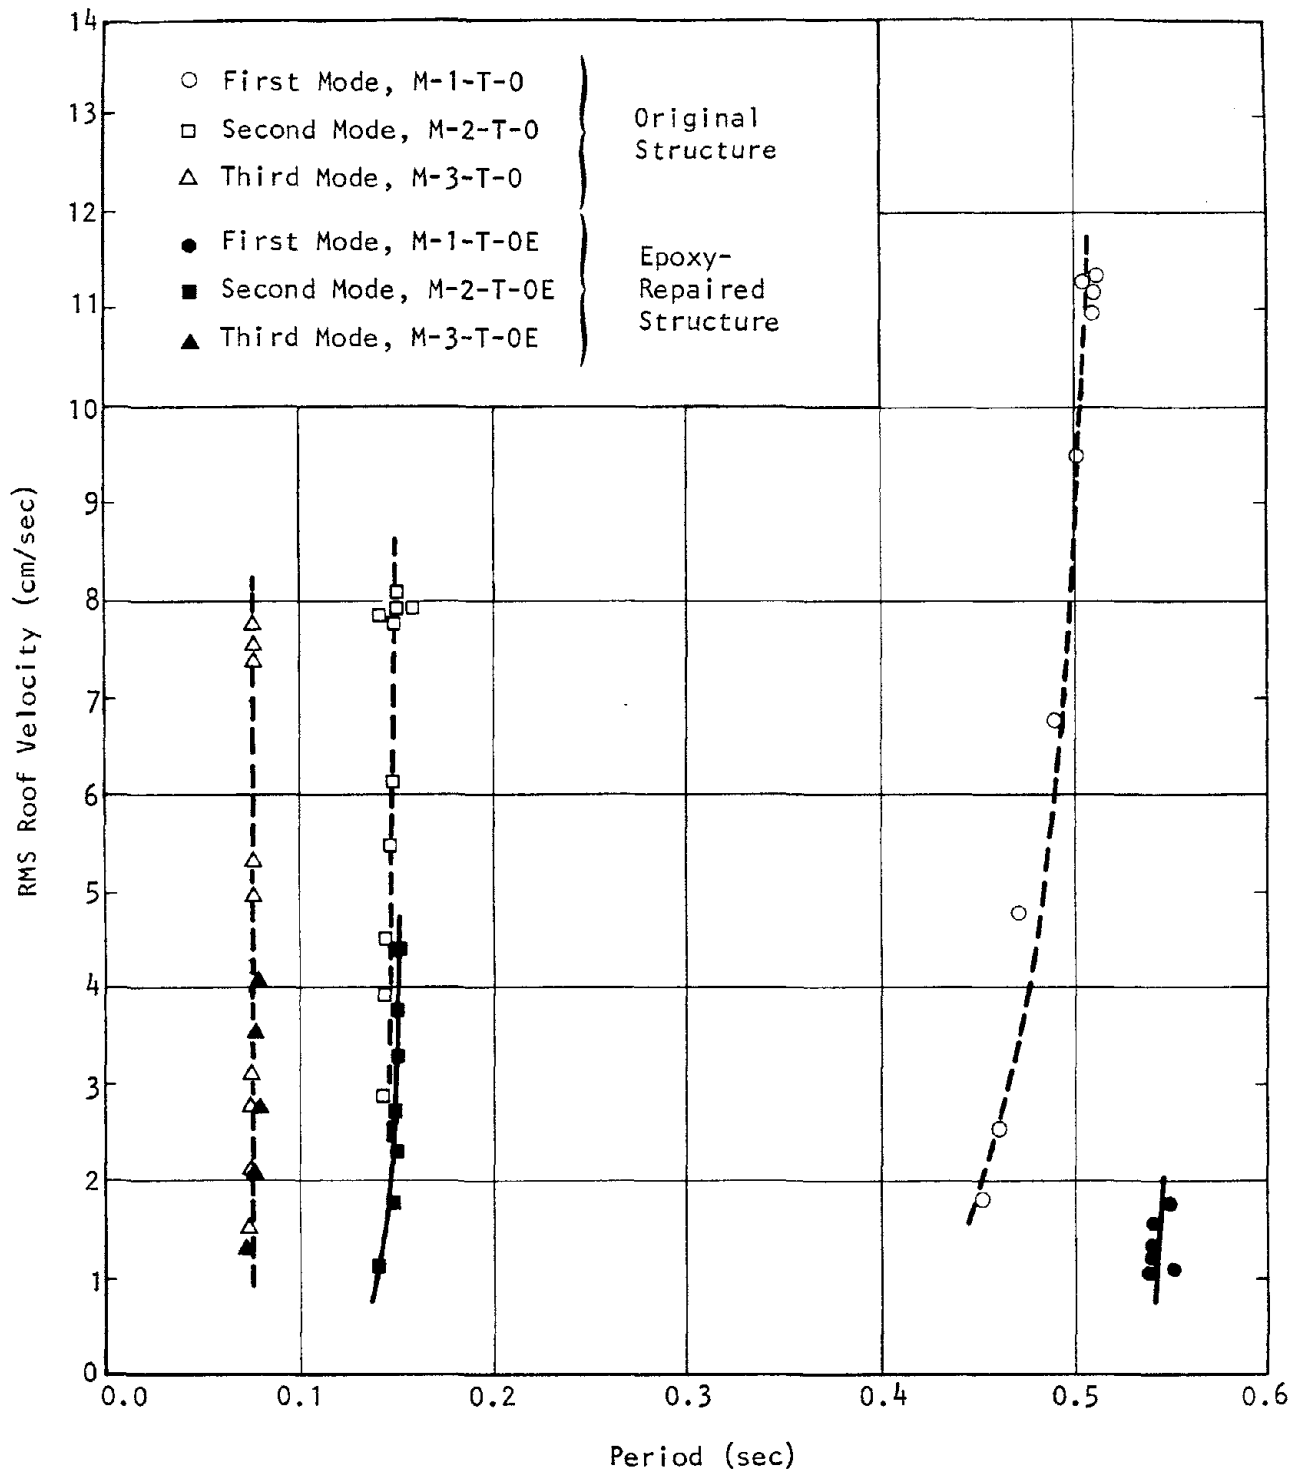
FIGURE 21 VELOCITY VERSUS PERIOD FOR THE NONDESTRUCTIVE TEST, TRANSVERSE DIRECTION

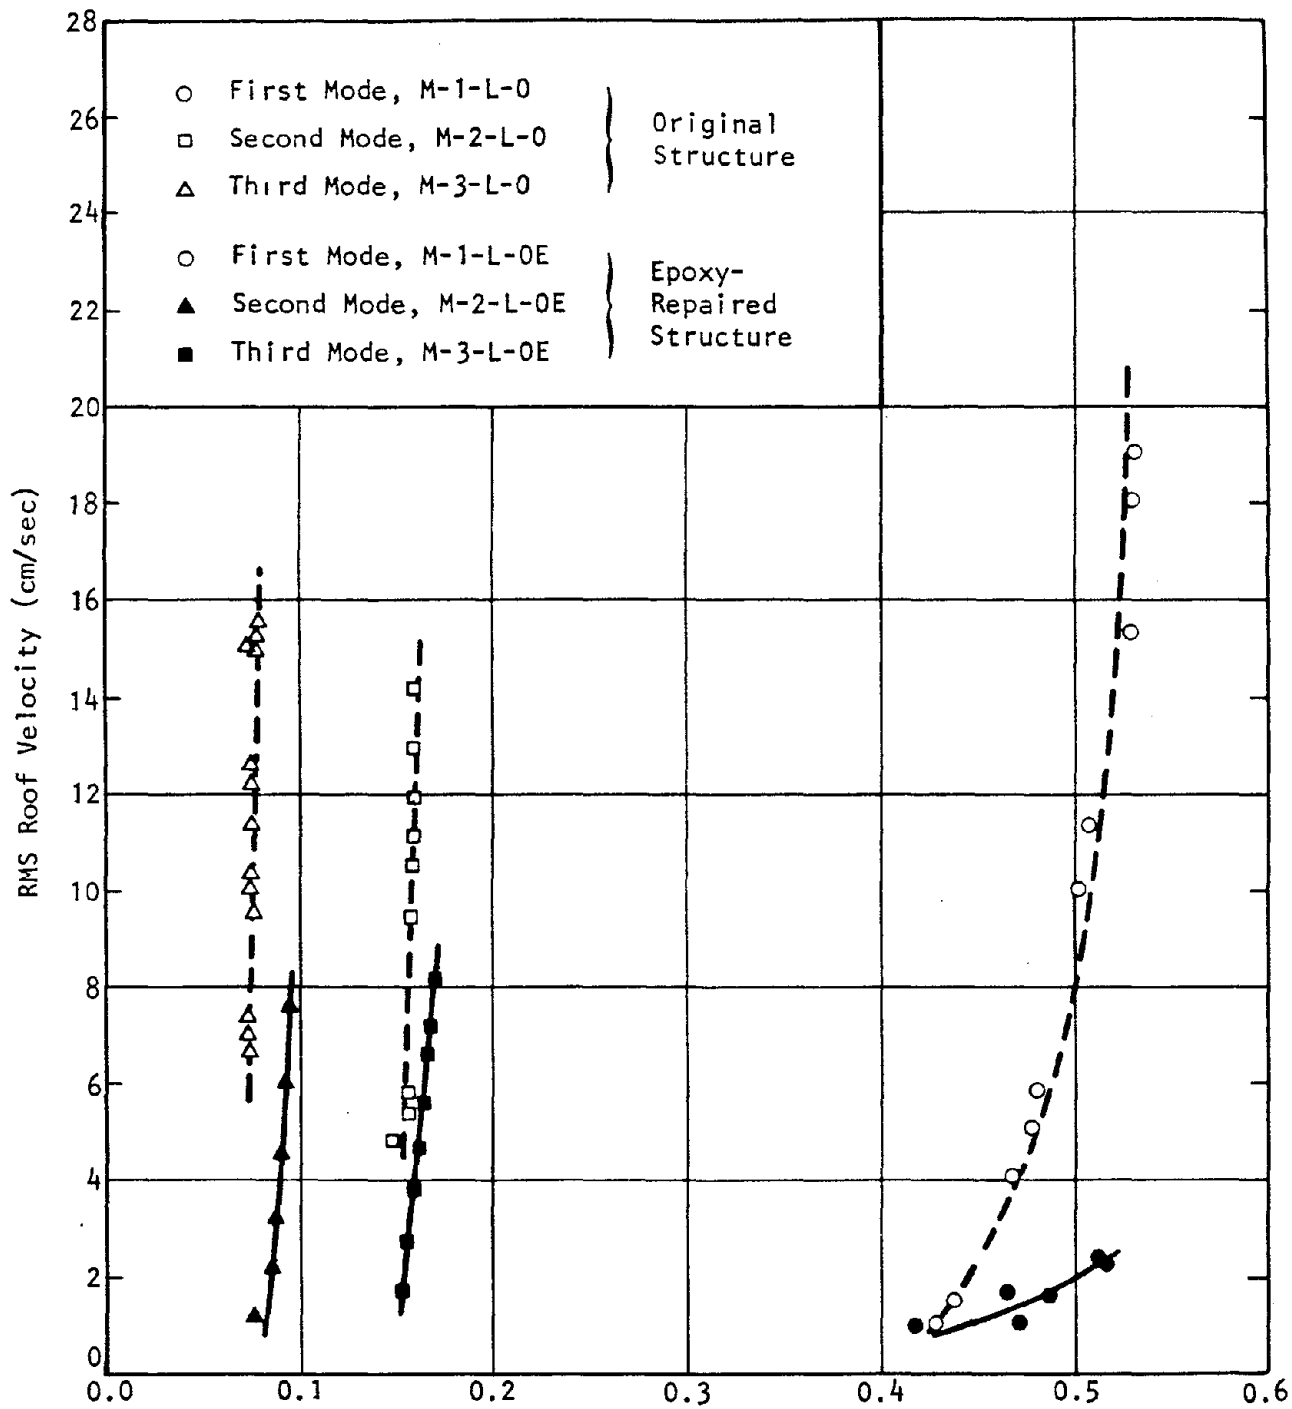
FIGURE 22 VELOCITY VERSUS PERIOD FOR THE NONDESTRUCTIVE TEST, LONGITUDINAL DIRECTION

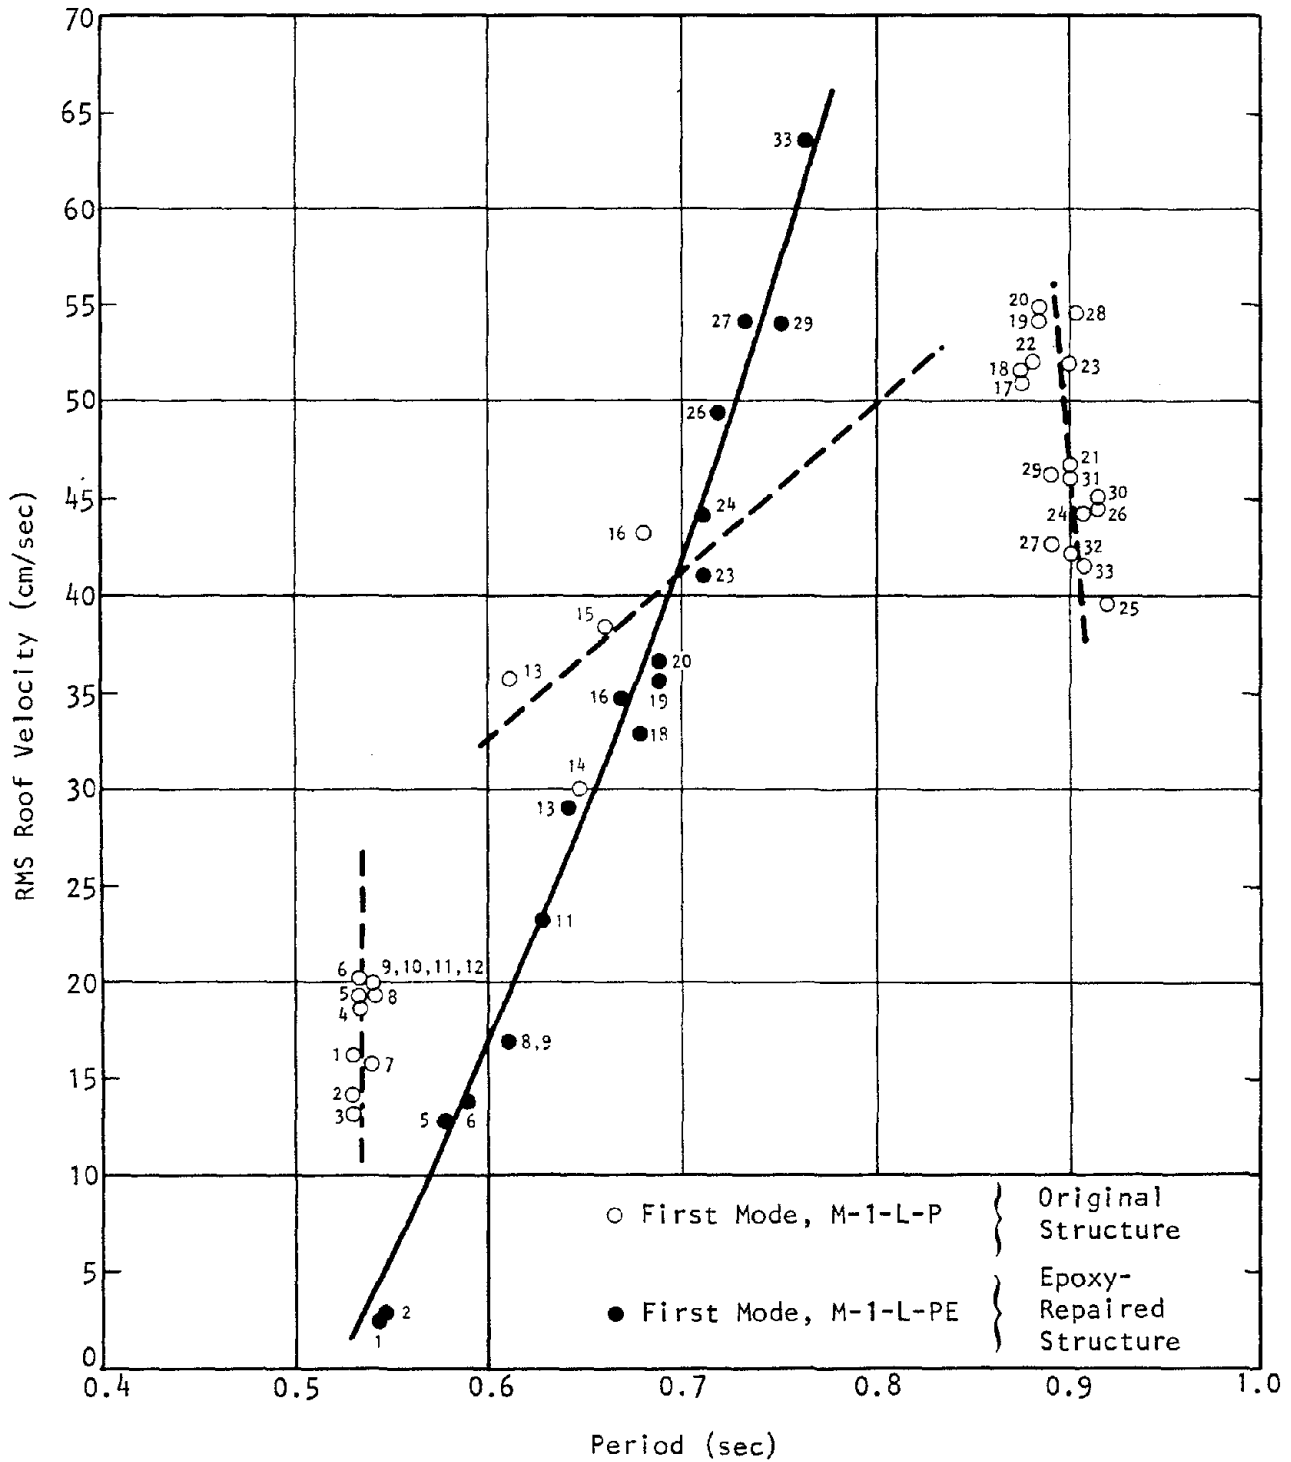
Note: The data points are numbered in the order of their occurrence, and the numbers correspond to the sample numbers.

FIGURE 23 VELOCITY VERSUS PERIOD FOR THE DESTRUCTIVE TEST, LONGITUDINAL DIRECTION

The changes in the fundamental longitudinal period during the destructive test are illustrated in Figure 23. At low amplitudes of motion at the start of the test, the period of the epoxy-repaired structure was greater than that of the original structure, indicating a less stiff structure. As the driving force was increased (represented in this plot by an increase in roof velocity), the period of the epoxy-repaired structure increased while the period of the original structure remained constant. However, as the driving force imparted roof velocities exceeding about 30 cm/sec, the period of the original structure began to lengthen at a much faster rate than that of the epoxy-repaired structure. By the end of the destructive tests, the period of the epoxy-repaired structure was not as great as the period of the original structure. This means that the stiffness of the epoxy-repaired structure did not degrade as much as that of the original structure, a conclusion supported by the damage observation.

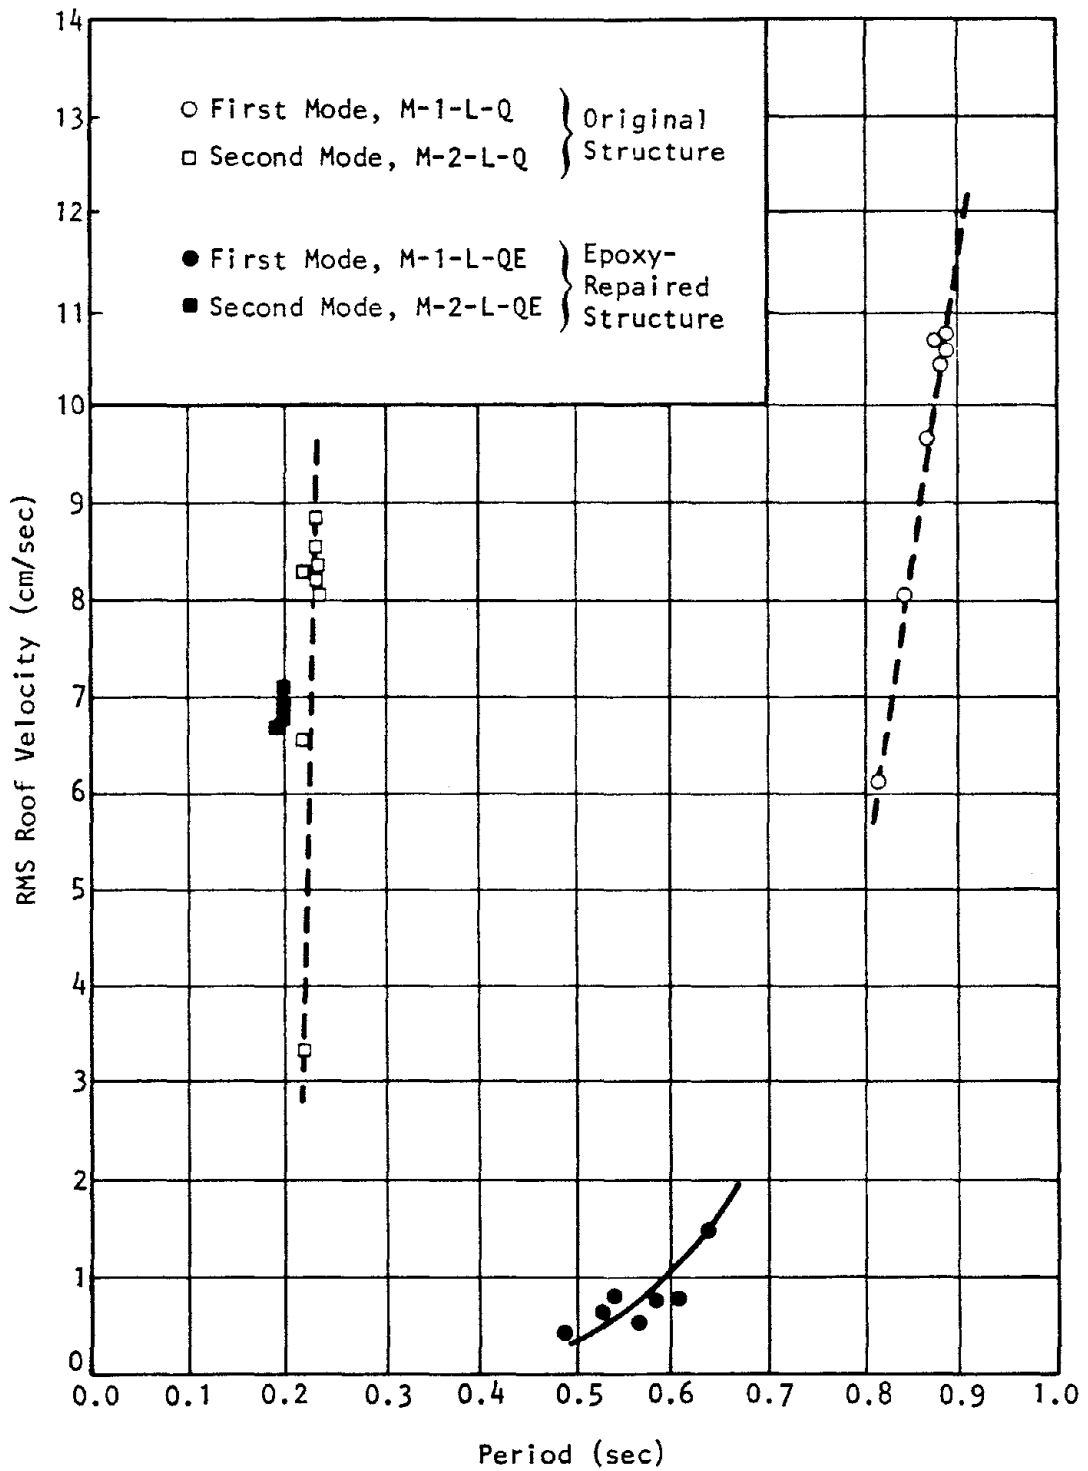
FIGURE 24 VELOCITY VERSUS PERIOD FOR THE POSTDESTRUCTIVE TEST, LONGITUDINAL DIRECTION

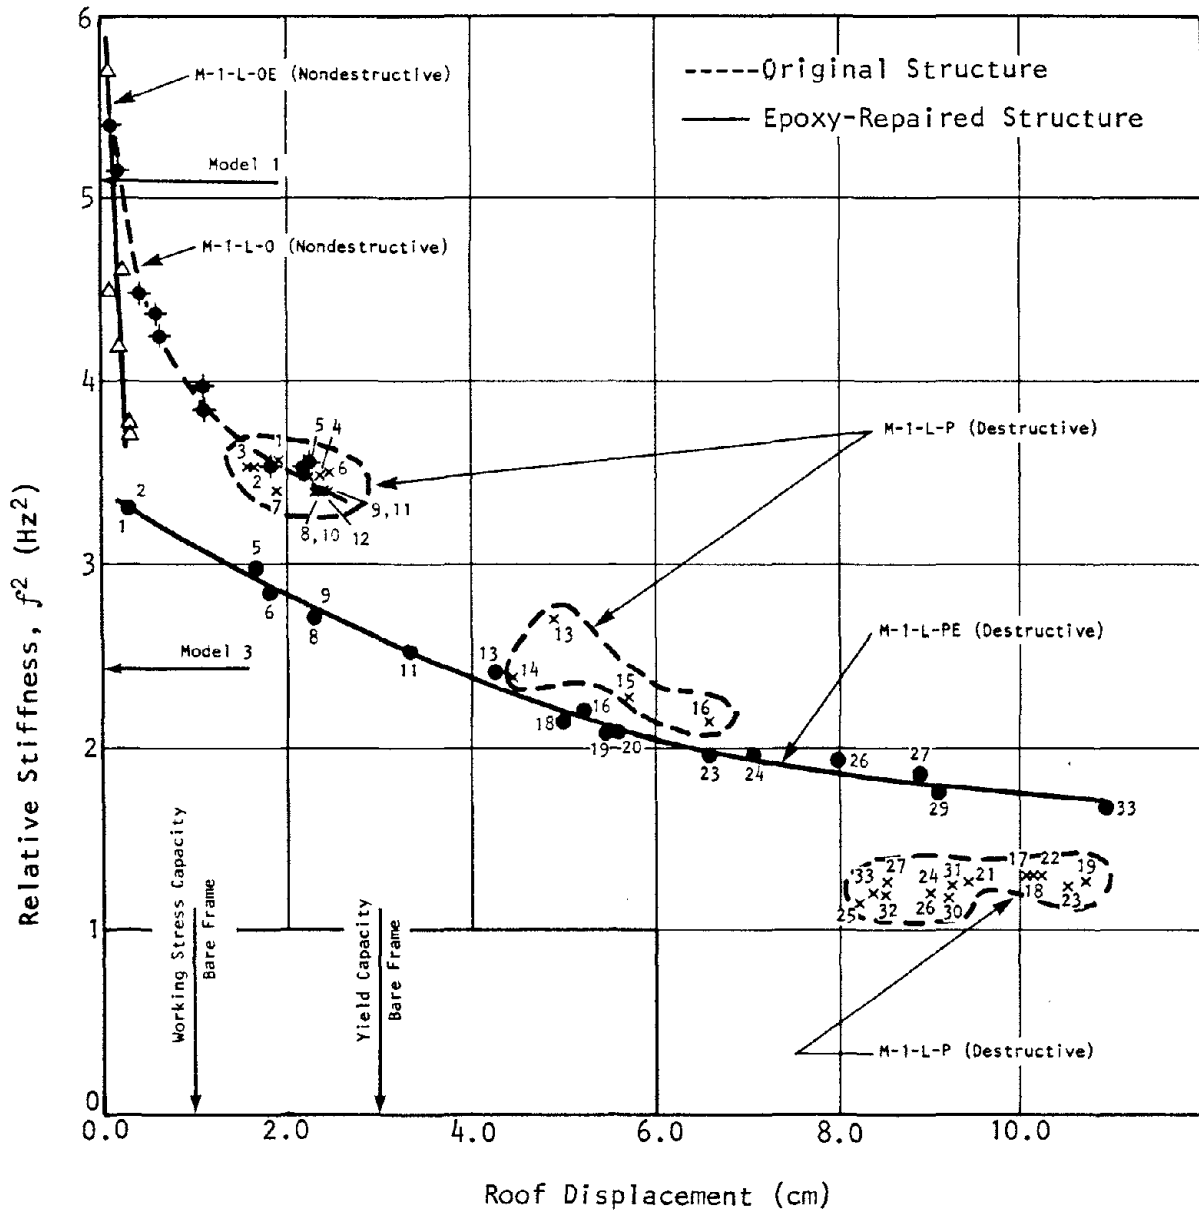
FIGURE 25 STIFFNESS VERSUS ROOF DISPLACEMENT FOR THE NONDESTRUCTIVE AND DESTRUCTIVE TESTS OF THE ORIGINAL AND EPOXY-REPAIRED STRUCTURES, FIRST MODE

References to model number and capacity in Figure 25 are discussed in Chapter 6.

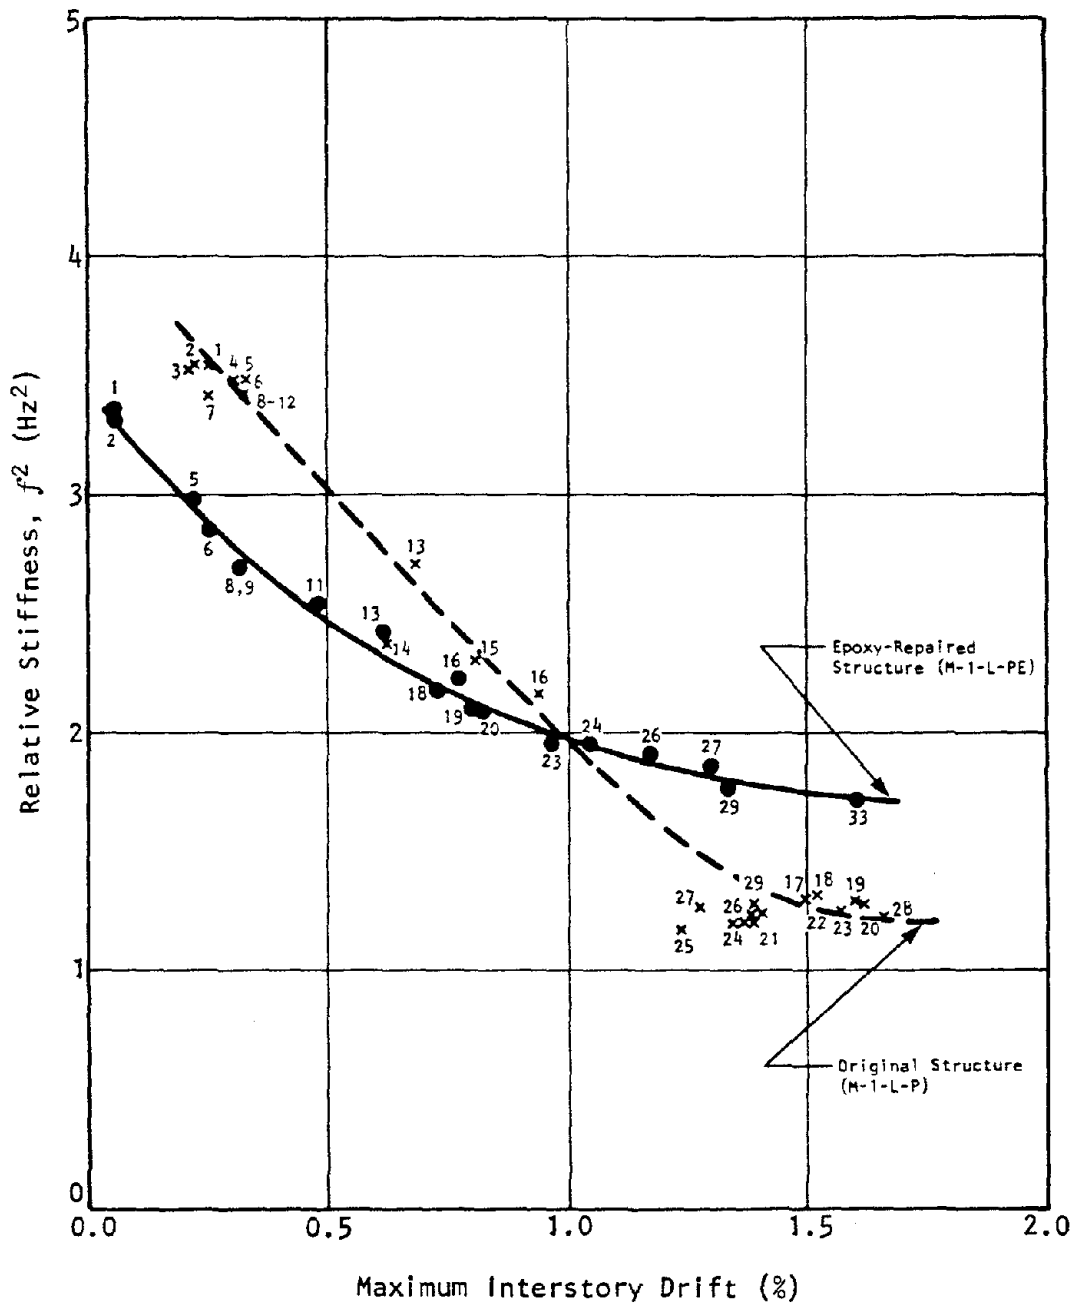
FIGURE 26 STIFFNESS VERSUS MAXIMUM INTERSTORY DRIFT FOR THE DESTRUCTIVE TESTS OF THE ORIGINAL AND EPOXY-REPAIRED STRUCTURES, FIRST MODE

This plot provides a more direct representation than Figure 23 of the changes in the stiffness of the structure in the original and epoxy-repaired states as it was subjected to the destructive test program. The two structures had essentially the same stiffnesses at very low roof displacements; however, the stiffness of the epoxy-repaired structure fell dramatically with respect to the original structural stiffness as the roof displacement increased to about 1 cm. As the roof displacement increased further, the difference decreased. At a roof displacement of about 7 cm, the stiffness of the original structure underwent a significant degradation; the epoxy-repaired structure continued to degrade in a very gradual fashion. This is further evidence that the epoxy-repaired structure possessed better beam-column connections than the original structure.

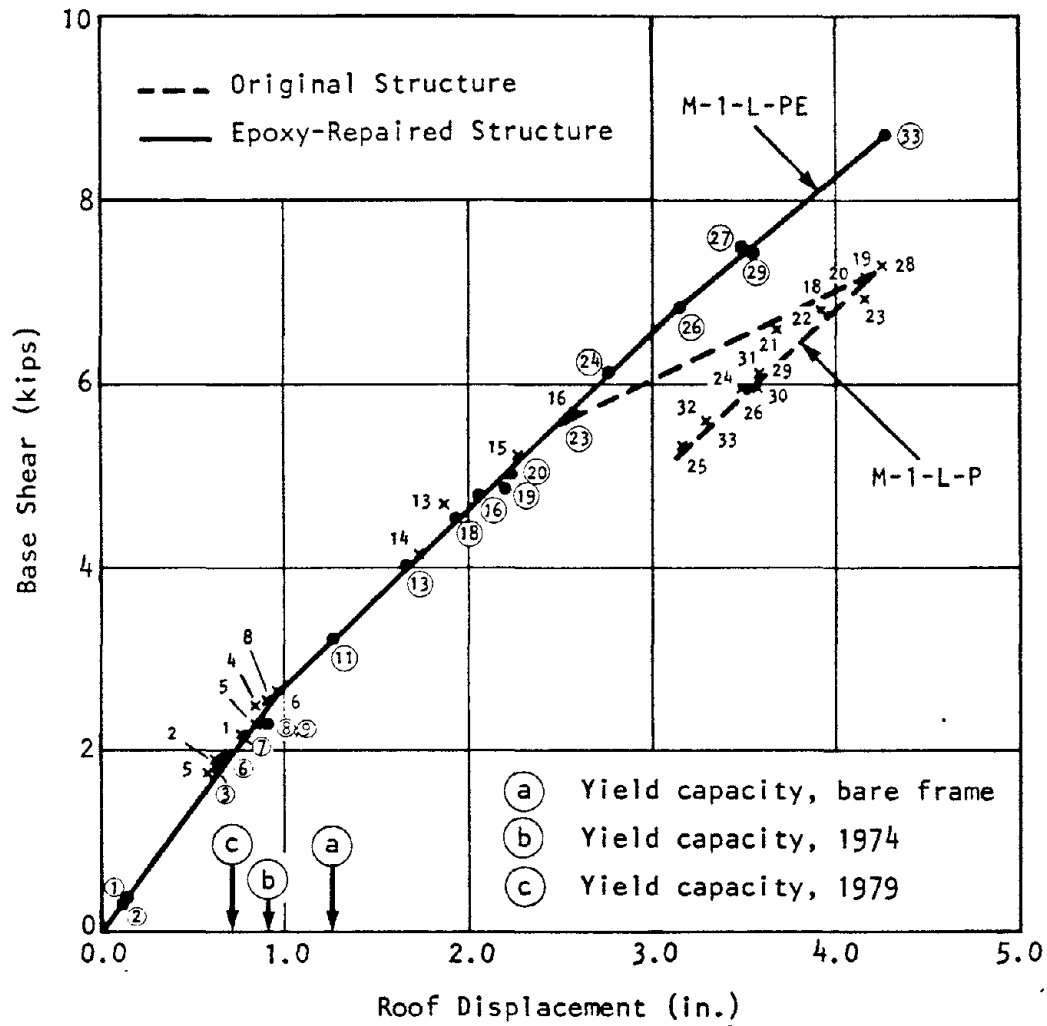
The curves from both tests seem to be identical up to a roof displacement of 2.5 in. The curves are bilinear in that range, with a well-defined change in slope at a roof displacement of about 1.0 in. It is hypothesized

FIGURE 27 BASE SHEAR VERSUS ROOF DISPLACEMENT FOR THE DESTRUCTIVE TESTS OF THE ORIGINAL AND EPOXY-REPAIRED STRUCTURES

that this point may represent the transition from uncracked to cracked section properties. This hypothesis was tested against published data on damage to beam-column connections.

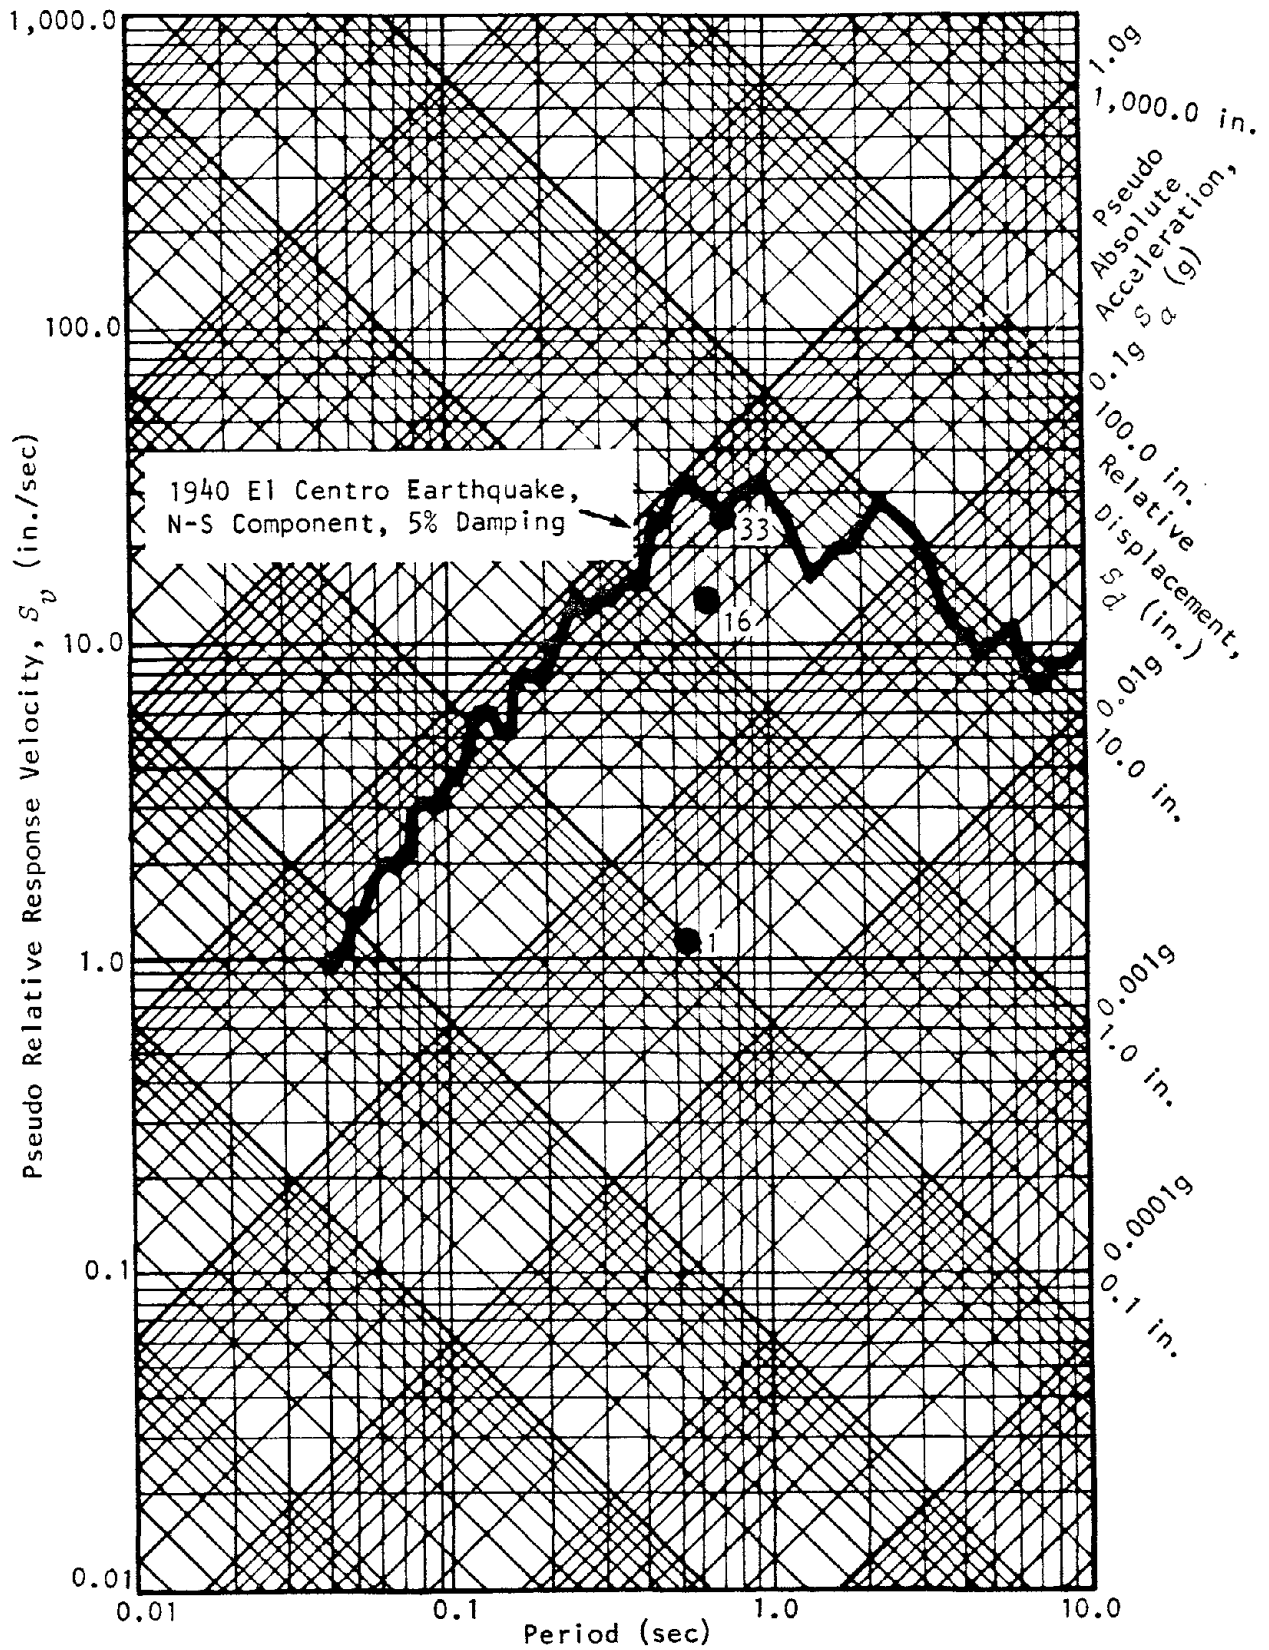
FIGURE 28 EQUIVALENT SPECTRAL VELOCITIES OF SELECTED SAMPLES FROM THE 1979 DESTRUCTIVE DWELL TEST

Since the maximum velocity of story  $i$  in mode  $j$ ,  $v_{ij \max}$ , is equal to  $\omega_j d_{ij \max}$ , Equation (5.4) can be reversed to calculate the spectral velocity from known floor velocity. Using the amplitude of the roof velocity recorded at Samples 1, 16, and 33 during the destructive test, and assuming that the entire motion was in the first mode, the values for the equivalent spectral velocity are 1.1 in./sec, 15.2 in./sec, and 27.7 in./sec, respectively. In Figure 28, these values are compared with the 5%-damped response spectrum for the north-south component of the 1940 El Centro earthquake.

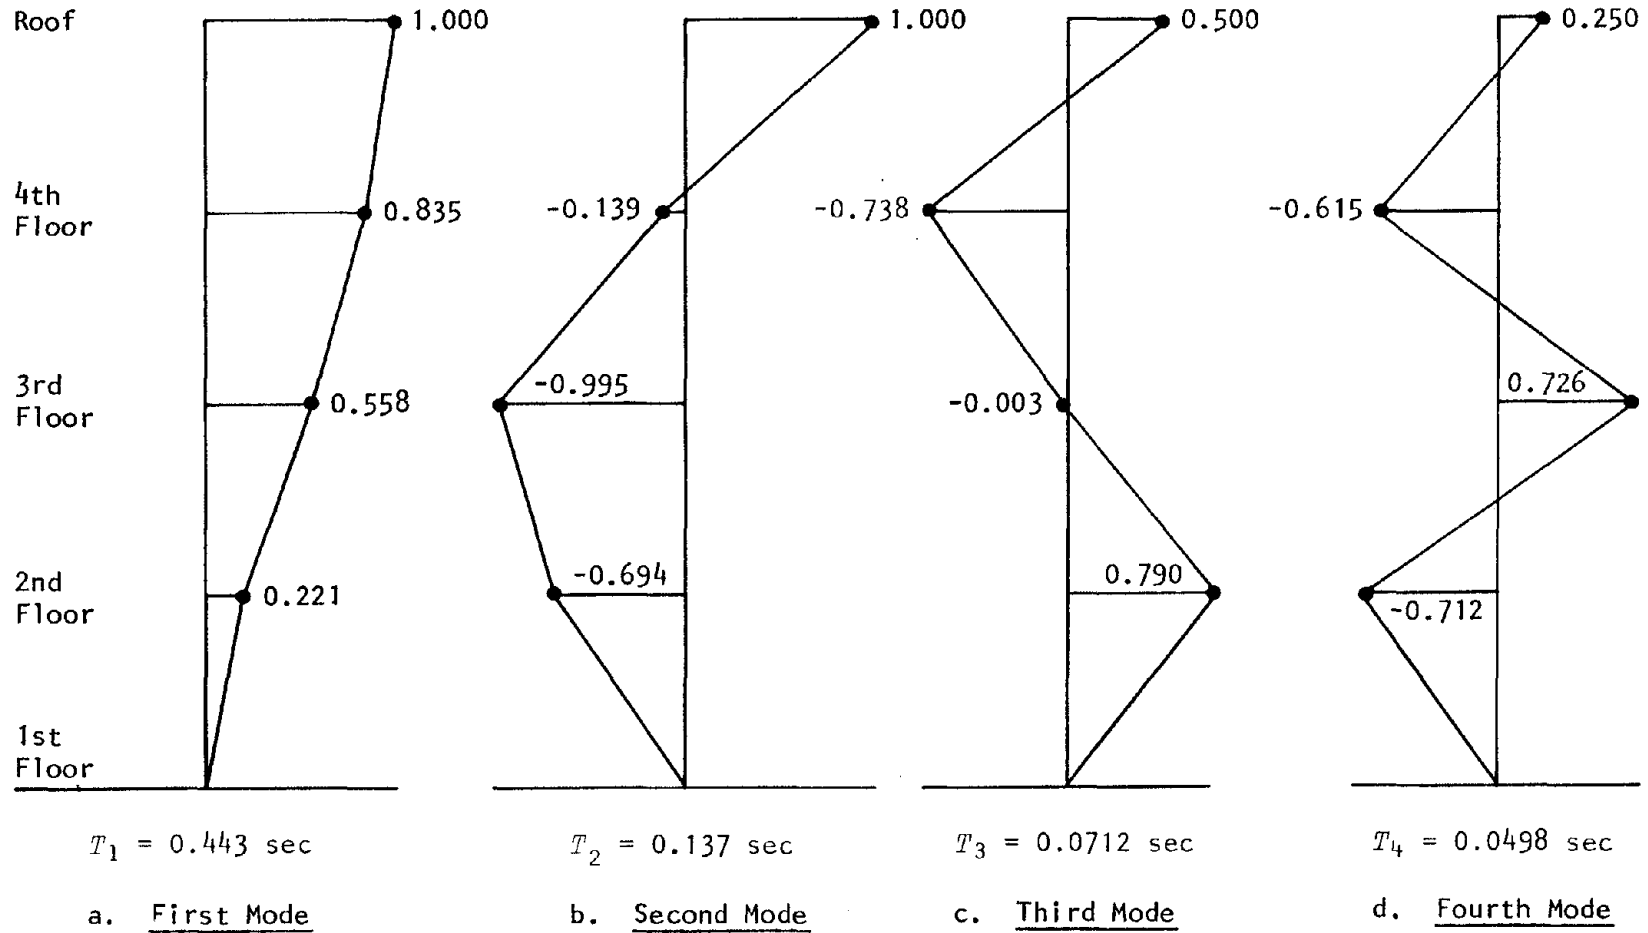
FIGURE 29 MODE SHAPES AND PERIODS DEVELOPED USING THE SAP IV PROGRAM, MOMENTS OF INERTIA BASED ON GROSS AREA

The moments of inertia for members in Model 1 were based on gross areas of the cross sections. The longitudinal beams were 15 in. deep by 16 in. wide, providing a moment of inertia,  $I_{gb}$ , equal to 4,500 in.<sup>4</sup>. Columns were 14 in. deep by 16 in. wide with a moment of inertia,  $I_{gc}$ , of 3,659 in.<sup>4</sup>. The shapes and periods for the first four modes of this model were determined using the SAP IV program and are presented in Figure 29.

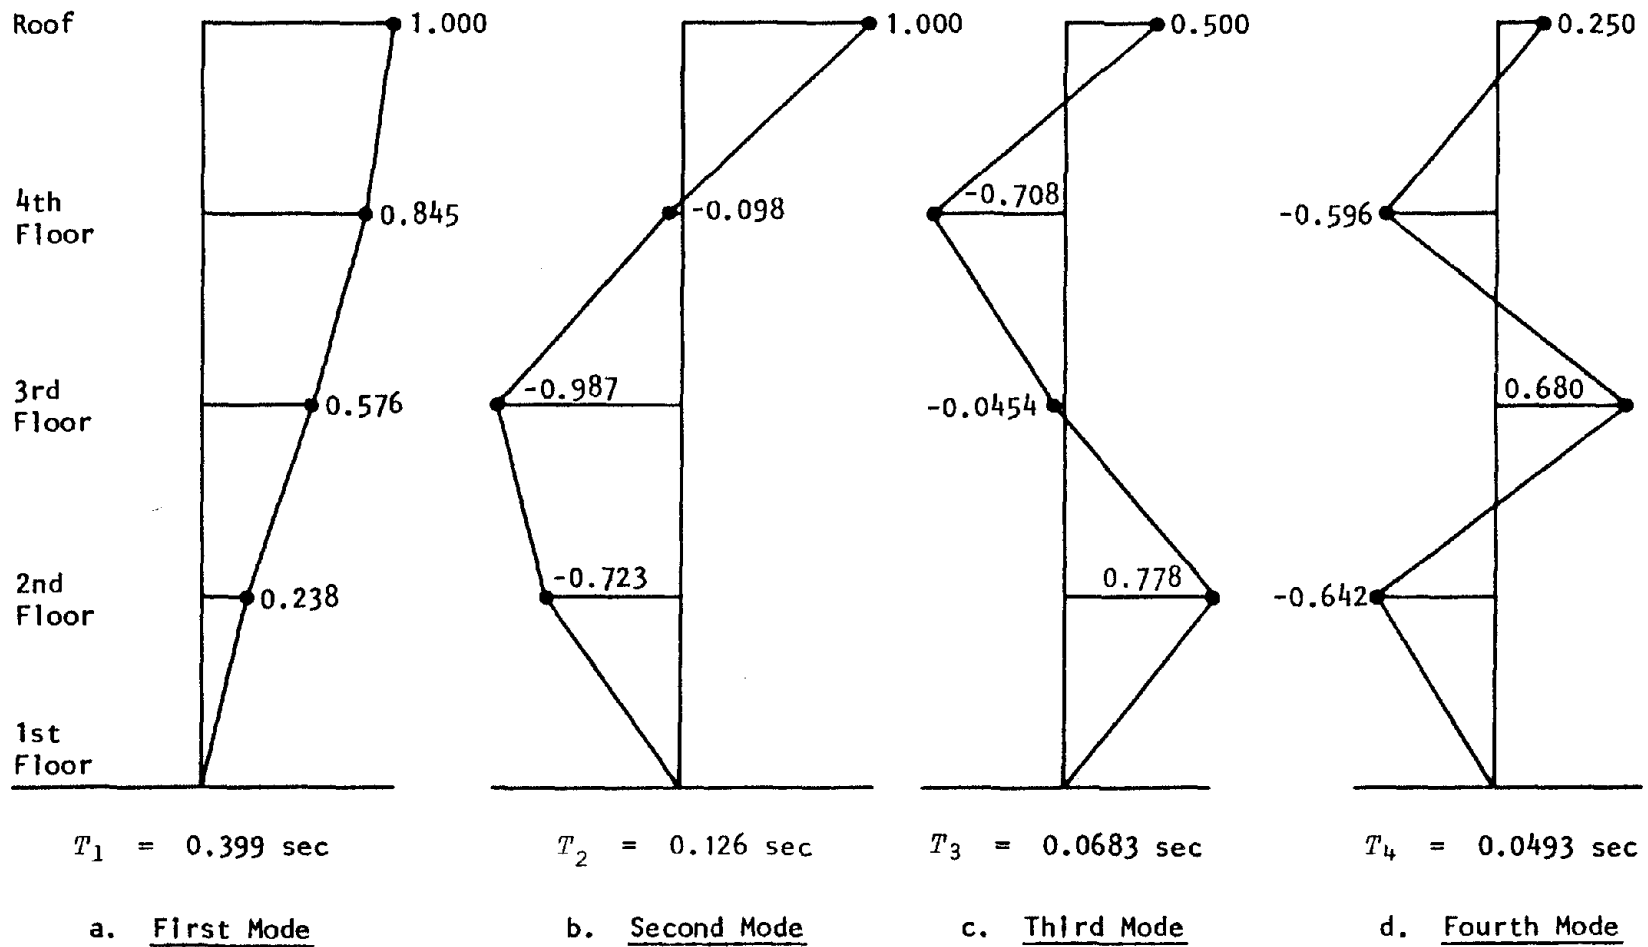
FIGURE 30 MODE SHAPES AND PERIODS DEVELOPED USING THE SAP IV PROGRAM, WITH MOMENTS OF INERTIA BASED ON GROSS AREA AND A PORTION OF THE FLOOR SLAB INCLUDED IN THE BEAMS

In Model 2, portions of the floor slabs were included in the calculations for beam moments of inertia, according to the provisions of Section 8.10.3 of the ACI 318-77 Code.<sup>6</sup> It should be noted that these guidelines were really intended for gravity load calculations and are not necessarily applicable to lateral force calculations. The beam moments of inertia in this model were 6,480 in.<sup>4</sup>, or 1.44 $I_{gb}$ . Column moments of inertia remained the same as in Model 1. Mode shapes and periods were determined using the SAP IV program and are presented in Figure 30.

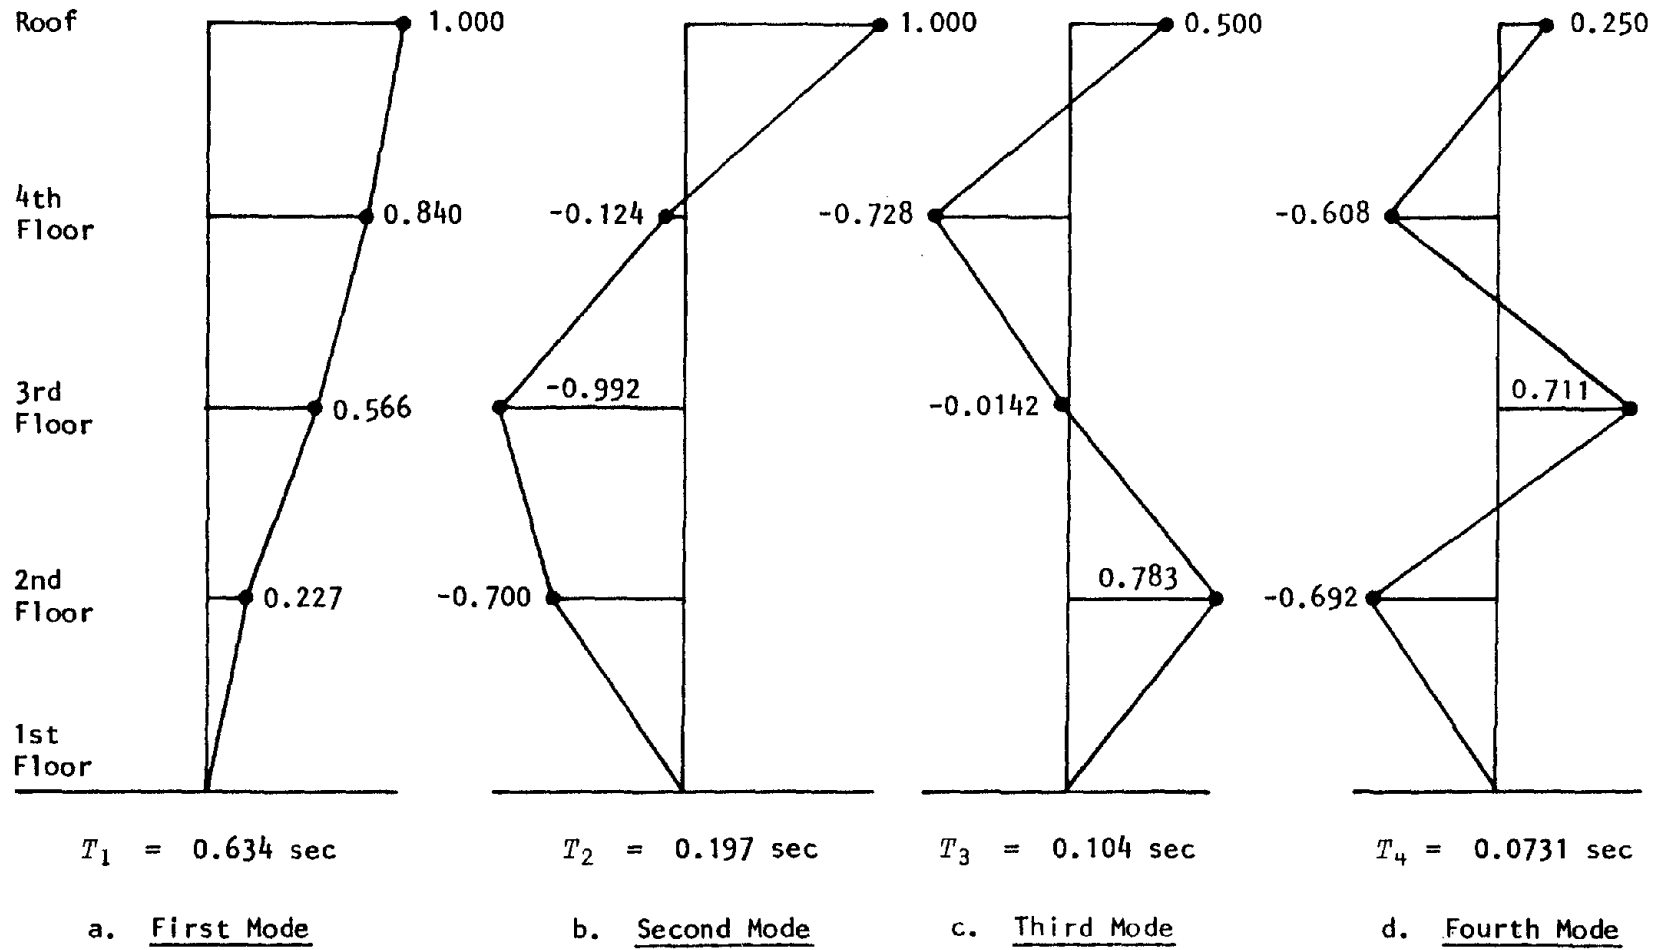
FIGURE 31 MODE SHAPES AND PERIODS DEVELOPED USING THE SAP IV PROGRAM, MOMENTS OF INERTIA BASED ON SECTION 10.10.1 OF THE ACI 318-77 COMMENTARY

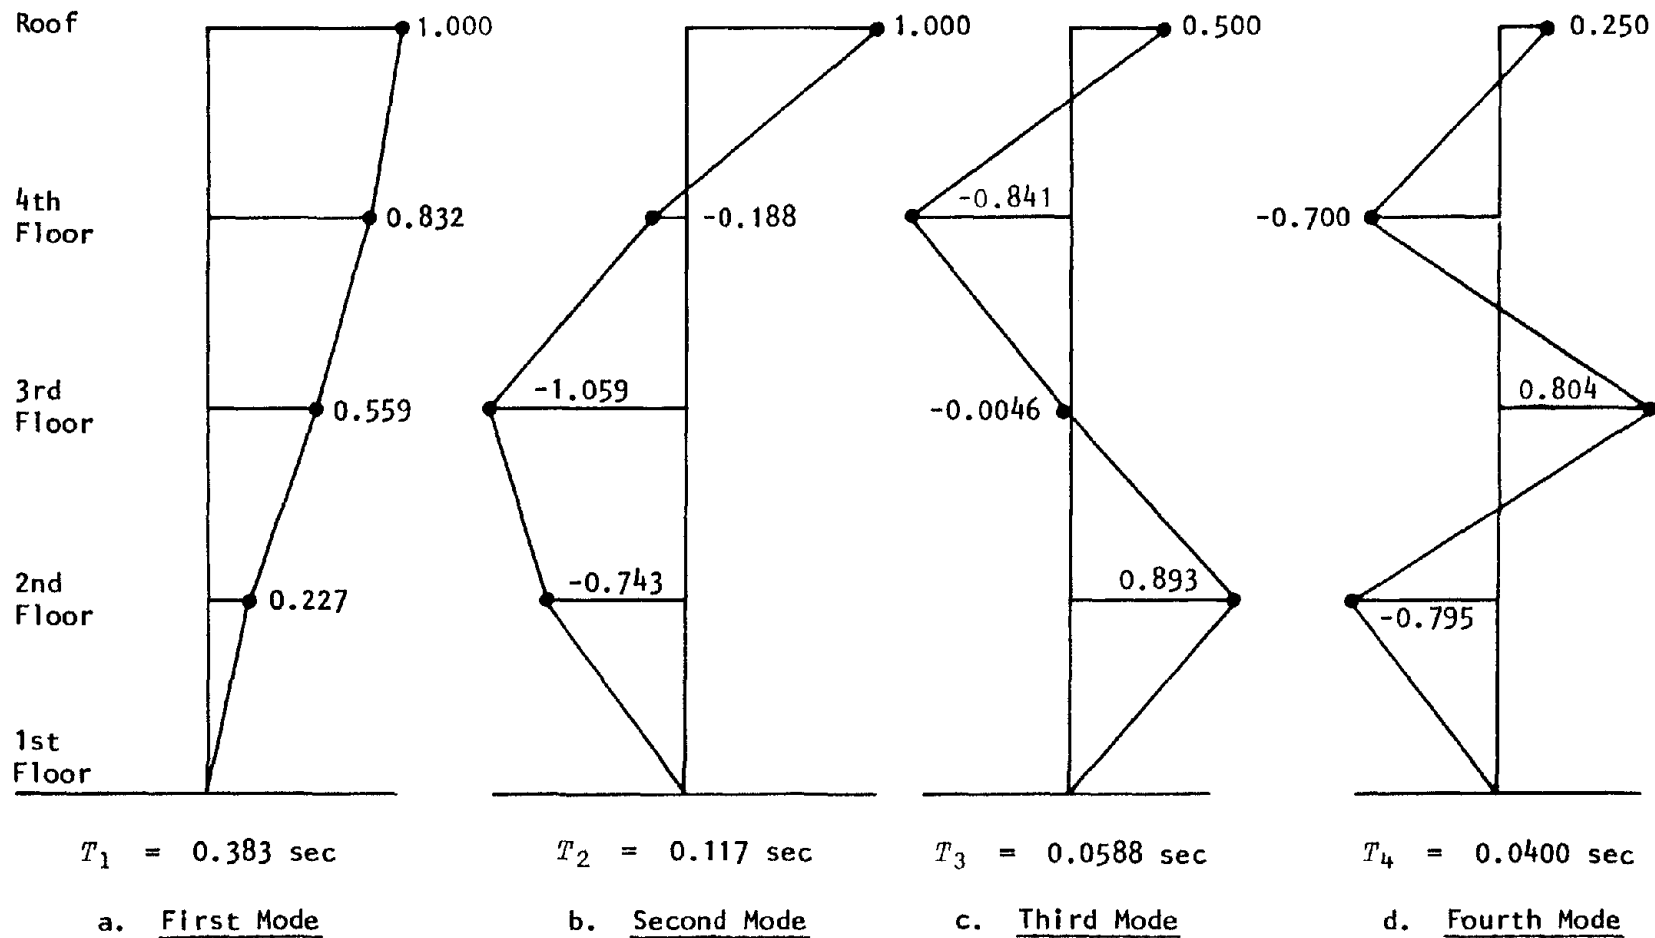
FIGURE 32 MODE SHAPES AND PERIODS DEVELOPED USING THE TABS 80 PROGRAM, WITH RIGID LINKS REDUCED BY 25% OF THE MEMBER DEPTHS

beam is the distance from the intersection of the beam and column center-lines to the column face, less one-fourth the beam depth. A rigid link at the end of a column is computed in the converse manner. Prior TABS programs did not reduce the lengths of the links by one-fourth the member depths, a procedure which tended to overestimate joint rigidity. In order to estimate the effect of joint rigidity on the models, the parameters used for Model 1 were used in TABS 80 to create Model 4. The results are illustrated in Figure 32.
