Proceedings of an International Conference on

REHABILITATION OF BUILDINGS & BRIDGES INCLUDING INVESTIGATIONS

Held on December 21, 22 and 23, 1981

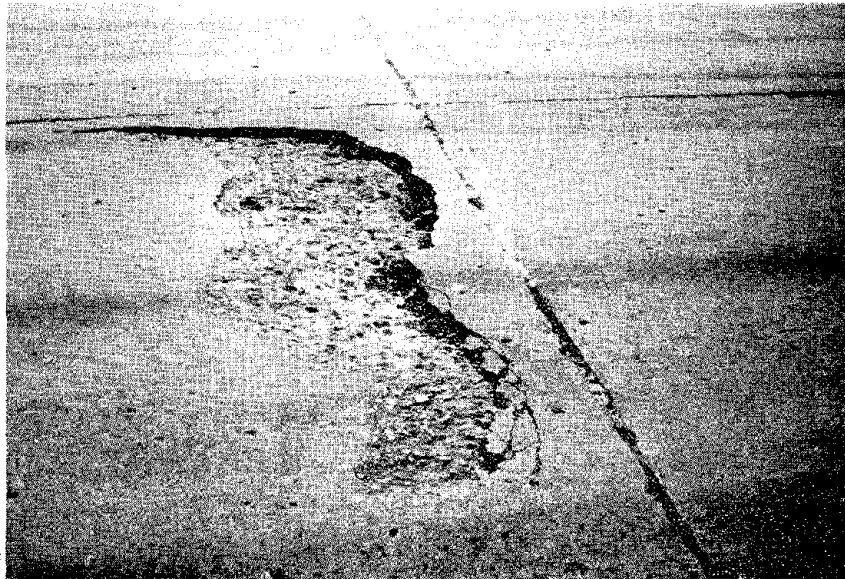
Photo No. 2

A small hole caused from chirping has continued to grow to a major pothole. Freeze-thaw damage exilerated the original problem and now traffic will continue to break off the edges of the pothole increasing the size of the hole everyday.

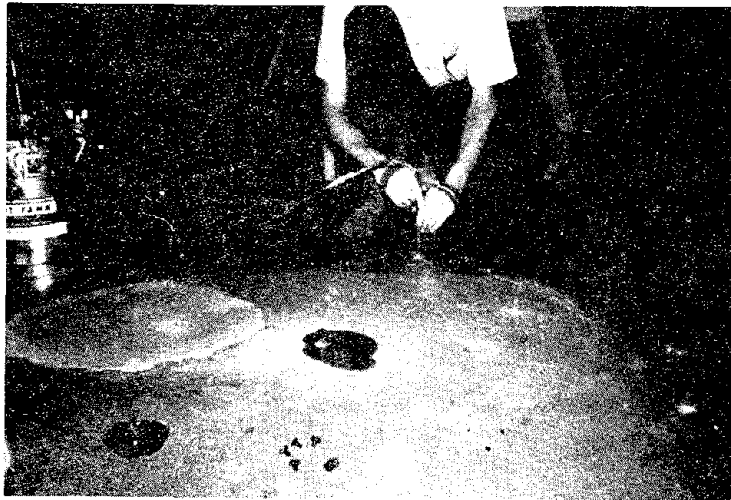
Photo No. 4

A delamination just above the reinforcement steel called hollow planing, is being welded together with a two component 100% solid epoxy resin system. The repair will be considered permanent.

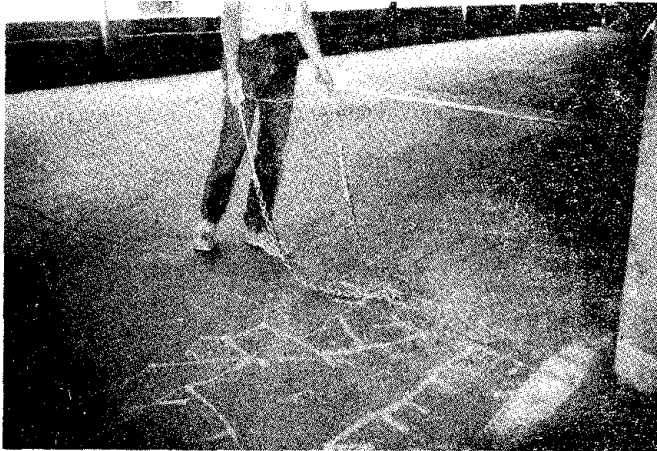
Figure 1 - Chain Drag to Determine Delamination by Sound

The condition survey includes a careful visual examination supplemented by pachometer tests (electromagnetic type cover meter) to locate reinforcement and determine the concrete cover, and electrical half-cell potential tests (ASTM C876) to determine corrosion activity on reinforcement. All findings should be recorded on plan and elevation drawings of the structure.

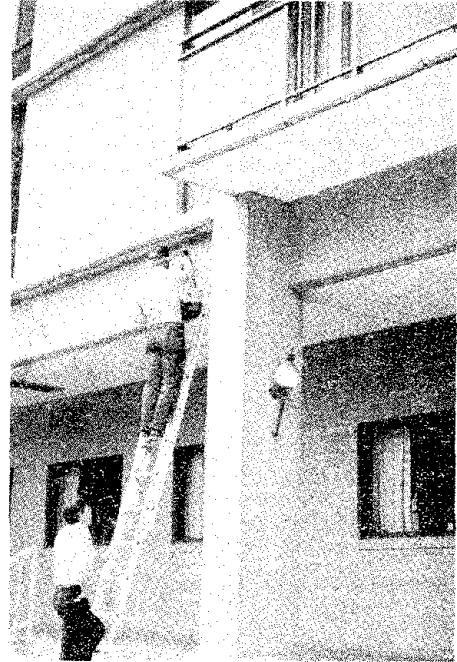
Figure 3 - Locating Reinforcement by Pachometer

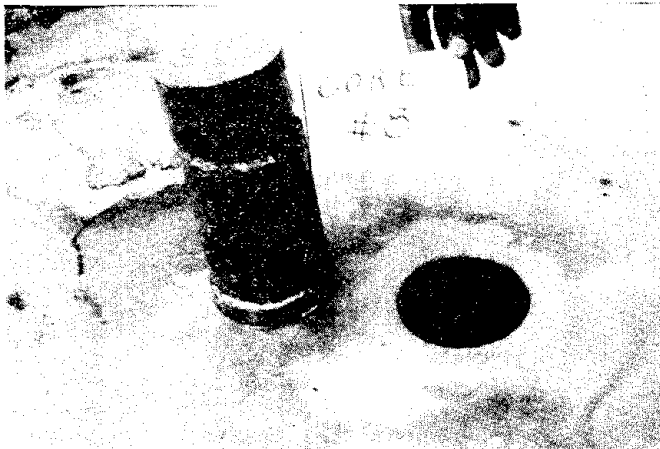
Figure 5 - Delamination Due to Corrosion of Reinforcement

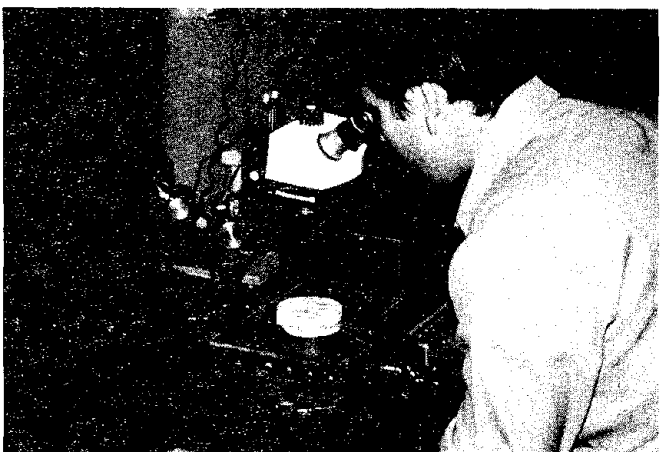
Figure 8 - Petrographic Analysis

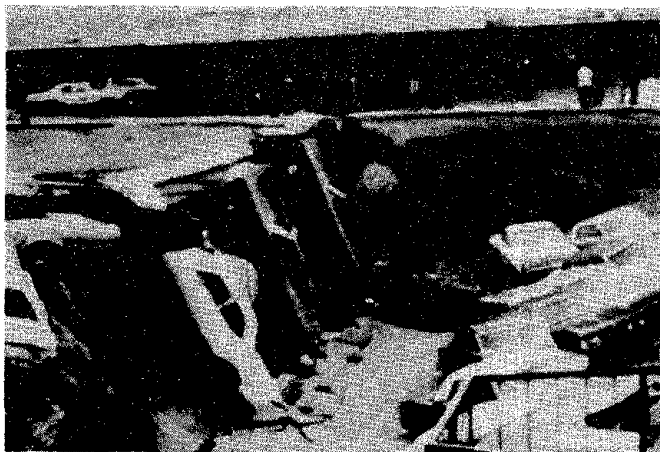
Figure 10 - Parking Deck Beyond Repair

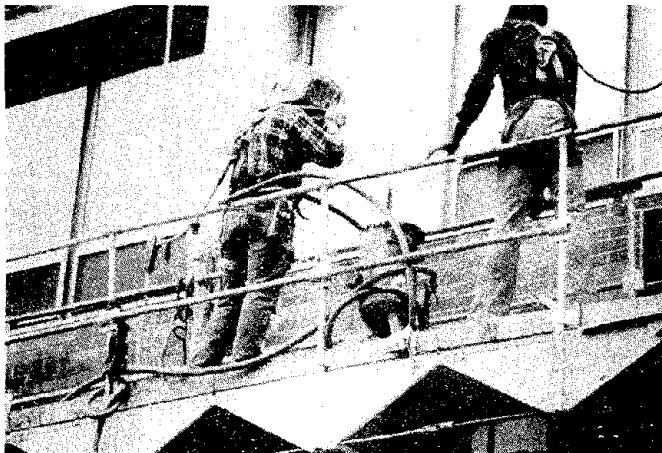
b. Cleaning by Sand Blasting

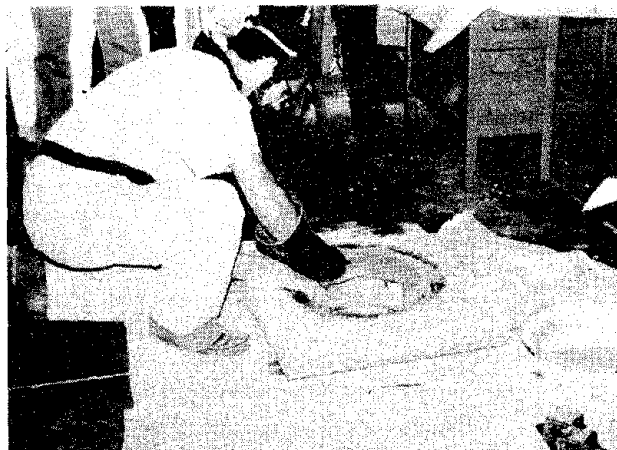
Fig. V Leveling of the mix after placing.

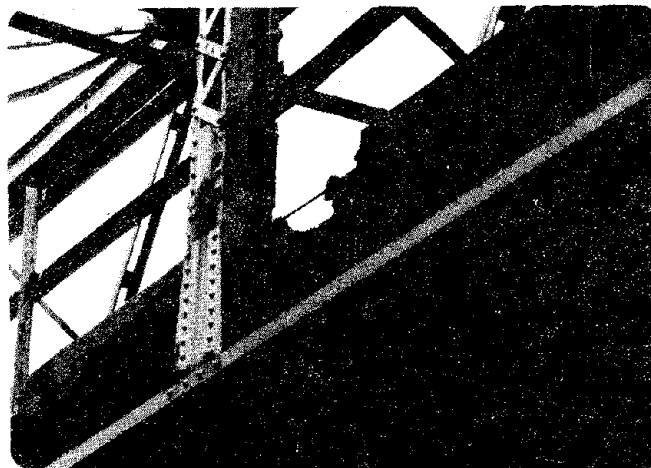
ELAMORE BRIDGE
DETERIORATED CURB

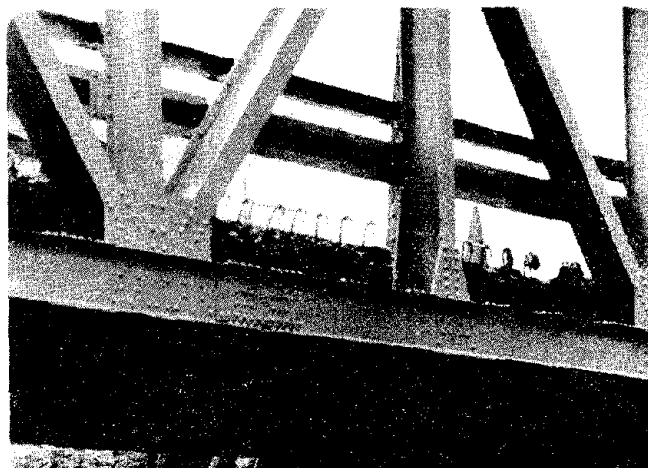
HARMON BRIDGE
DETERIORATED CURB
