***EFFECTS OF TRANSVERSE REINFORCEMENT
ON SEISMIC PERFORMANCE OF COLUMNS - A
PARTIAL PARAMETRIC INVESTIGATION***

September 1988

NATIONAL SCIENCE FOUNDATION
Washington, D.C.
Grant No. PFR-7902611

CONSTRUCTION TECHNOLOGY LABORATORIES, INC.
5420 Old Orchard Road
Skokie, Illinois 60077

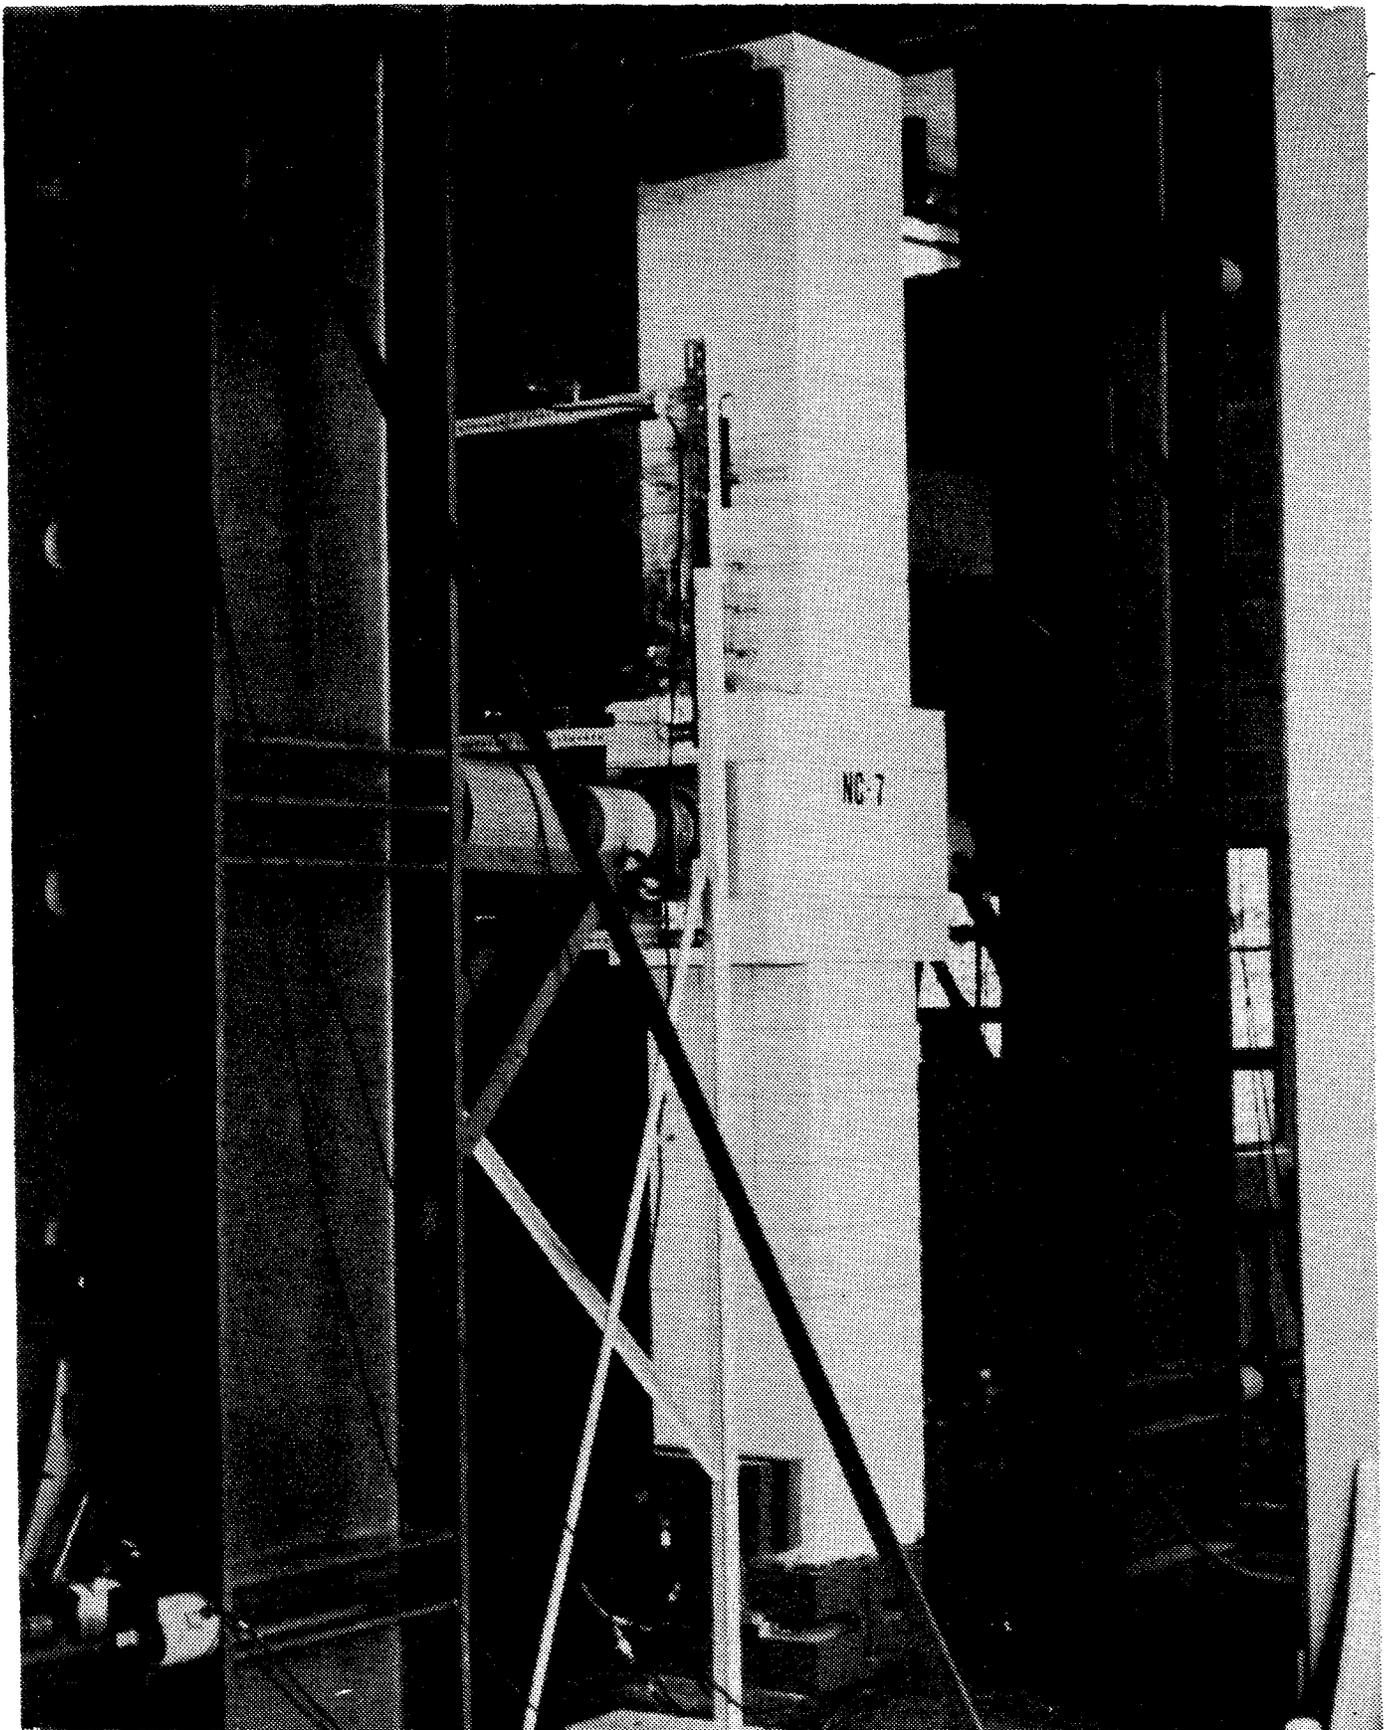
FIG. 4-9 TEST SETUP

with little deflection. These beams were strengthened by welding web stiffening plates at the horizontal load points. Lateral load was applied at beam stub centers of the specimen with a 200-ton (1779-kN) hydraulic ram on each side. The hydraulic ram and the load cell assembly were supported on a bracket attached to a flange of each reaction beam. The load was transferred to the specimen through a spherical bearing and a flat loading plate assembly. This allowed rotation of the beam stub at load point. The reaction frames were connected to the specimen by four 1-in. diameter (25.4-mm) threaded bars, two each at top and bottom as shown schematically in Fig. 4-8. Vertical and lateral loads were controlled by two independent loading systems.

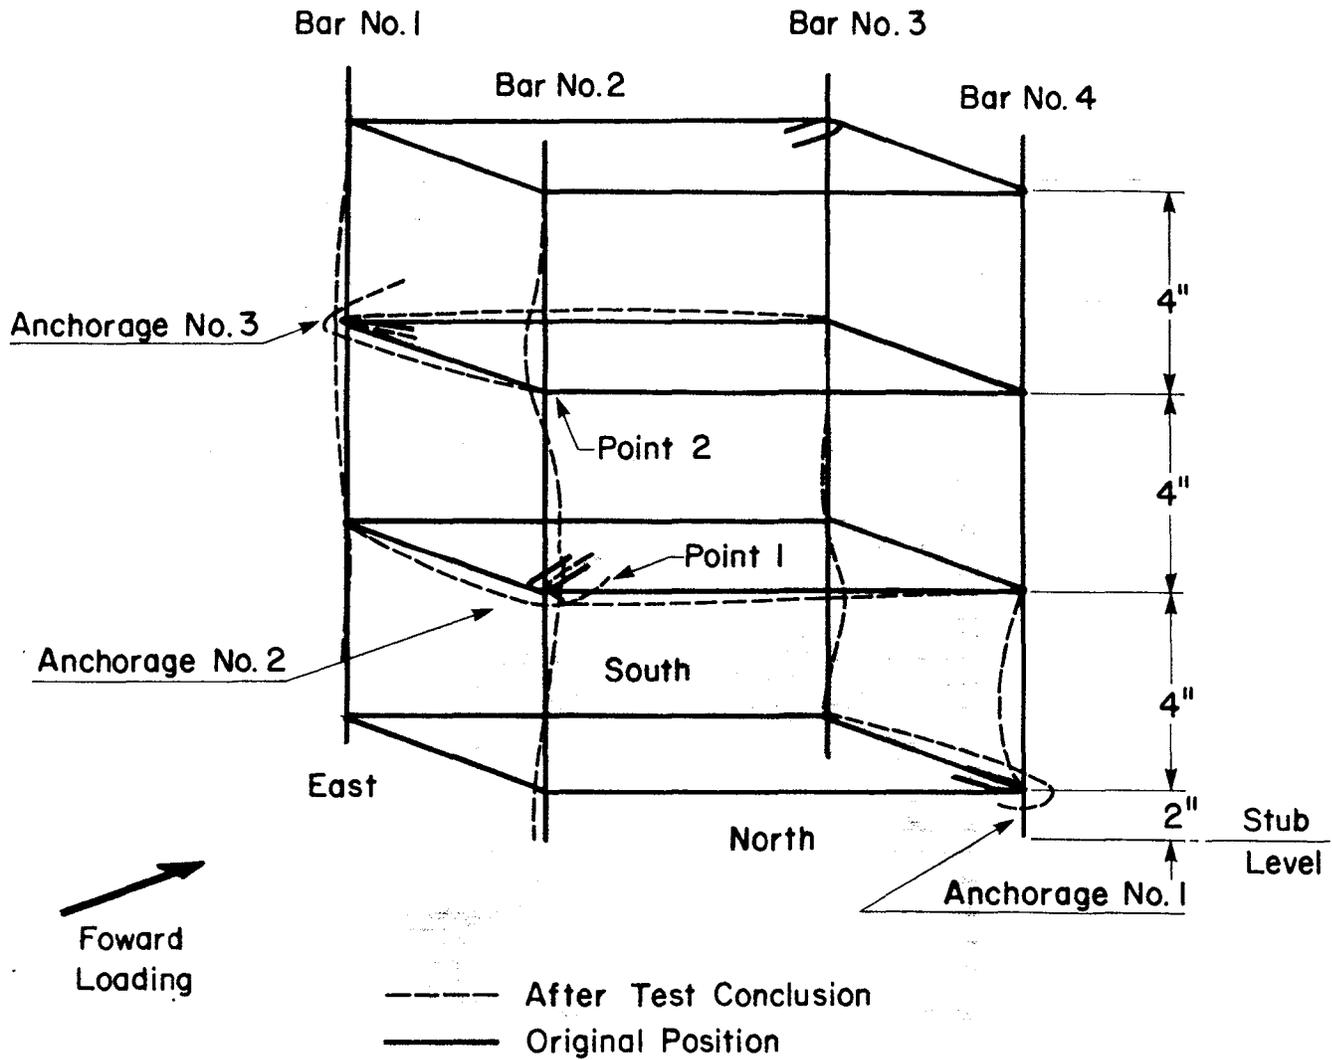
FIG. 5-1 SKETCH OF THE CORNER LONGITUDINAL BARS, BEFORE AND AFTER TESTING, SPECIMEN NC-2

Loss of anchorage of peripheral hoops influenced buckling of longitudinal bars. For discussion, the sketch in Fig. 5-1 shows the first four layers of peripheral hoops and the corner bars for Specimen NC-2. Also shown in Fig. 5-1 are anchorage locations and their final shape at conclusion of testing. The location of the anchorage was alternated at each

level. The length of longitudinal bars engaged in buckling was influenced by the anchorage location as is evident from Fig. 5-1. As the anchorages for the peripheral hoops were lost, the laterally unbraced length of the longitudinal bars increased, thereby expediting buckling. The pattern of locating the anchorages for peripheral hoops also influenced the shape and length of the longitudinal bar engaged in buckling. As an example, referring to Fig. 5-1, as anchorage locations numbered 2 and 3 were lost, the longitudinal bar located at the northeast corner lost complete lateral support at point 1 and partial support at point 2 due to the loss of anchorage number 3.

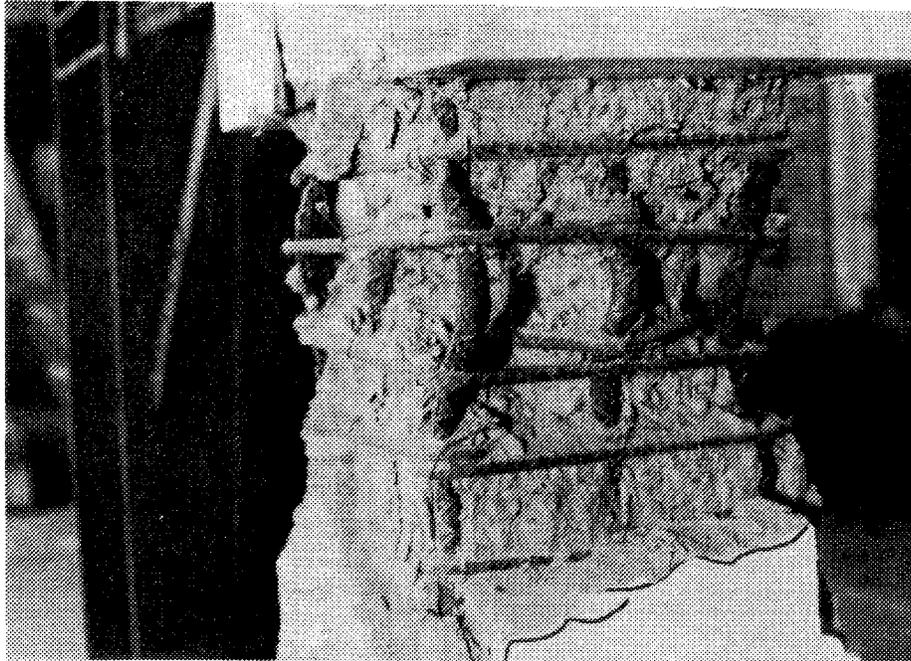
FIG. 5-2 TEST SPECIMEN NC-1 AFTER TEST CONCLUSION

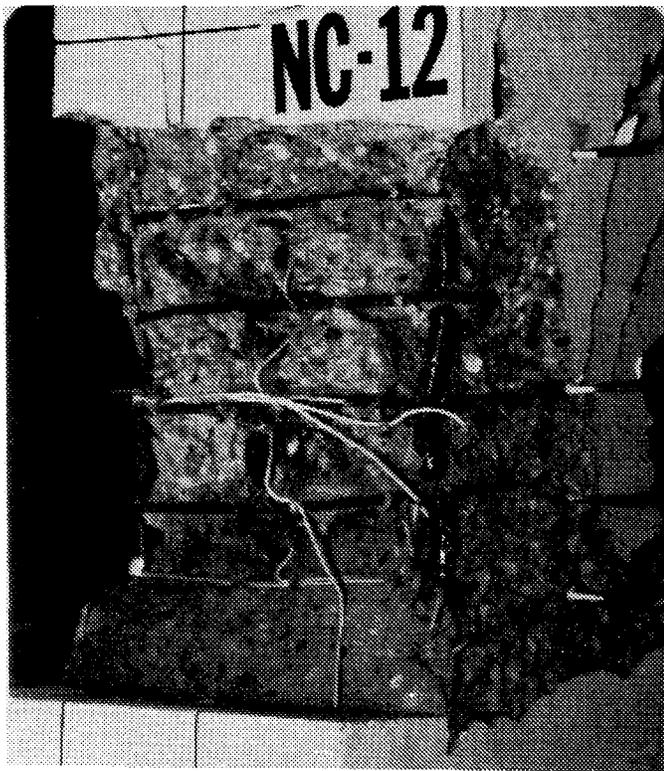
FIG. 5-13 TEST SPECIMEN NC-12 AFTER TEST CONCLUSION

5. Specimens NC-9 and NC-10 failed by buckling of the longitudinal bars located away from the corners. Addition of crossties in Specimen NC-12 resulted in simultaneous buckling of the middle and corner longitudinal bars.

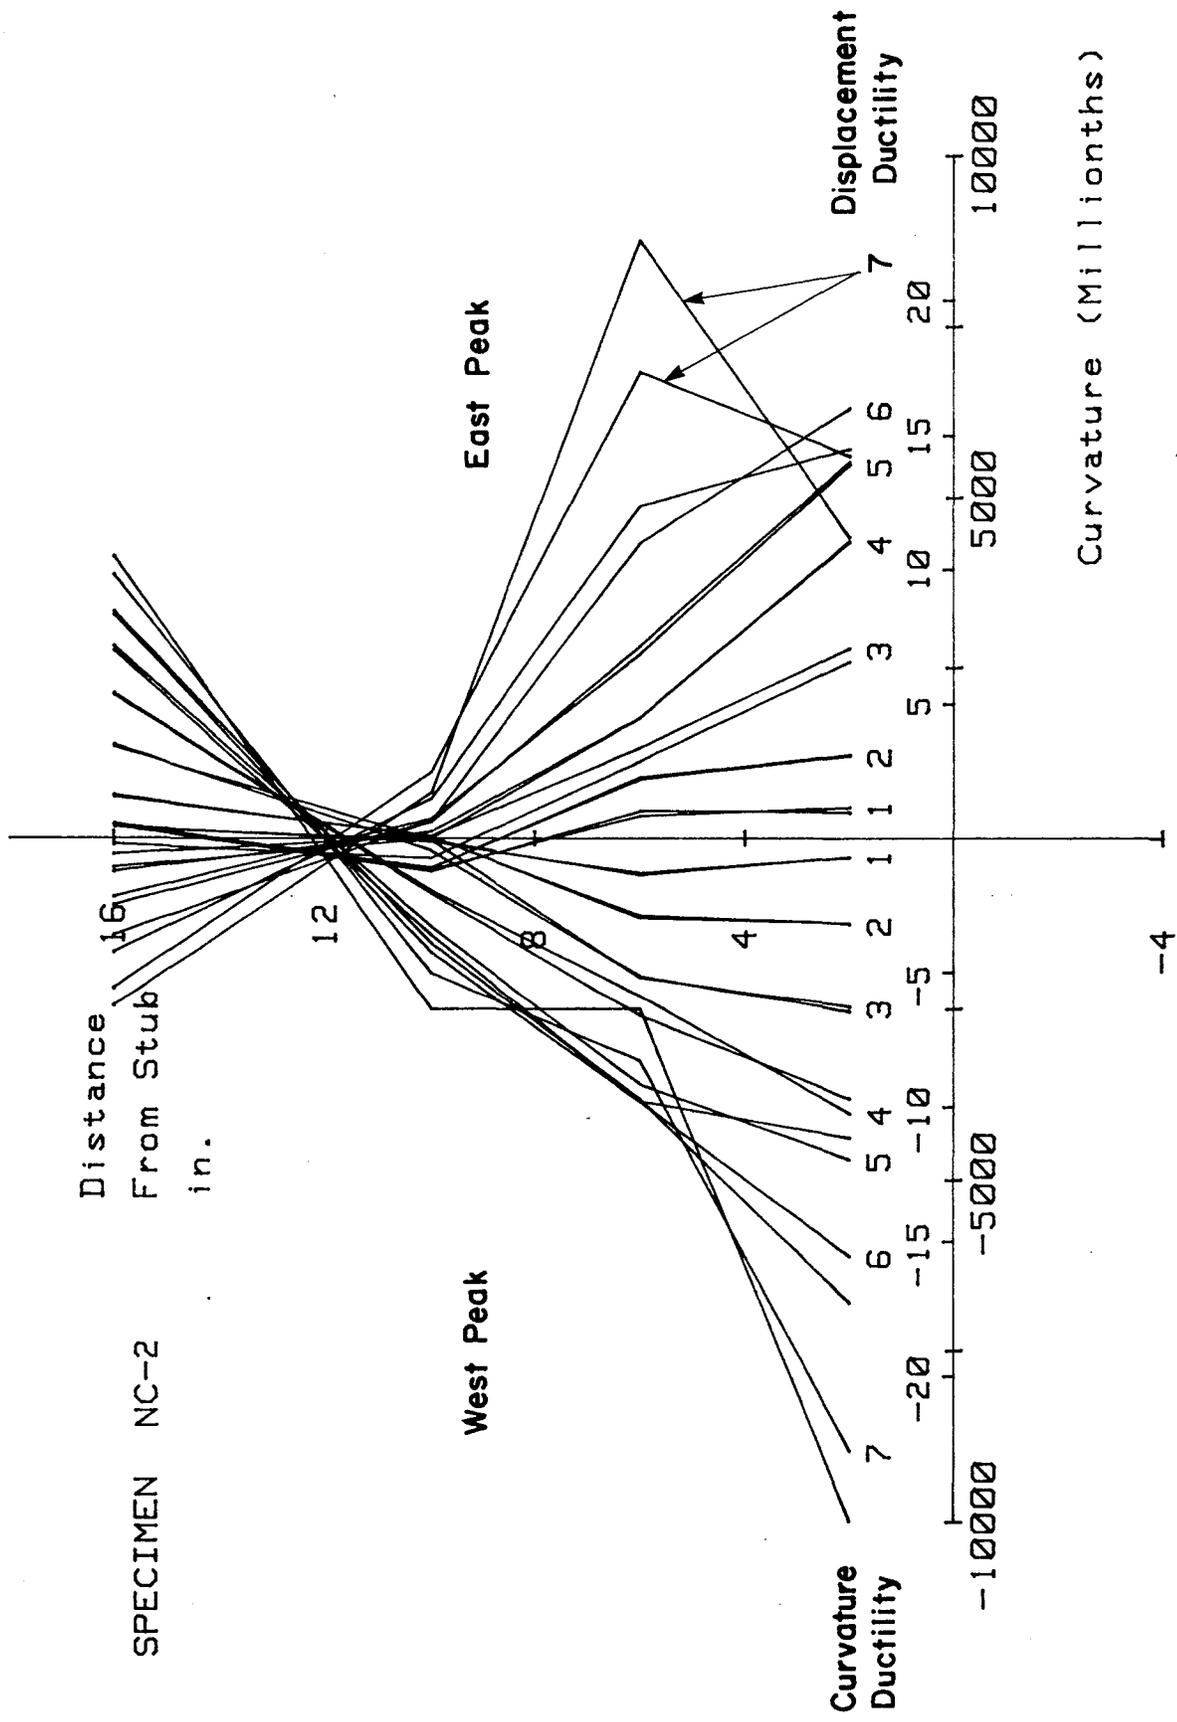
FIG. 5-17 CURVATURE DISTRIBUTION ALONG UPPER COLUMN, SPECIMEN NC-2

Representative plots of curvature distribution along the upper column are shown in Figs. 5-17 through 5-20. The curvature ductilities shown in these figures were calculated based on the procedure outlined in Section 4.8.2 and are based on the peak curvature observed during cycle #2 within a gage length including the first four inches above the stub. In these figures, each line at a particular displacement level is formed by joining four points, each point representing curvature at a given distance from the stub and at a particular loading stage. Curvatures measured over gage length within the first 4 in., 4 to 8 in., 8 to 12 in., and 12 to 20 in. from the stub are plotted along the vertical axis at the average gage

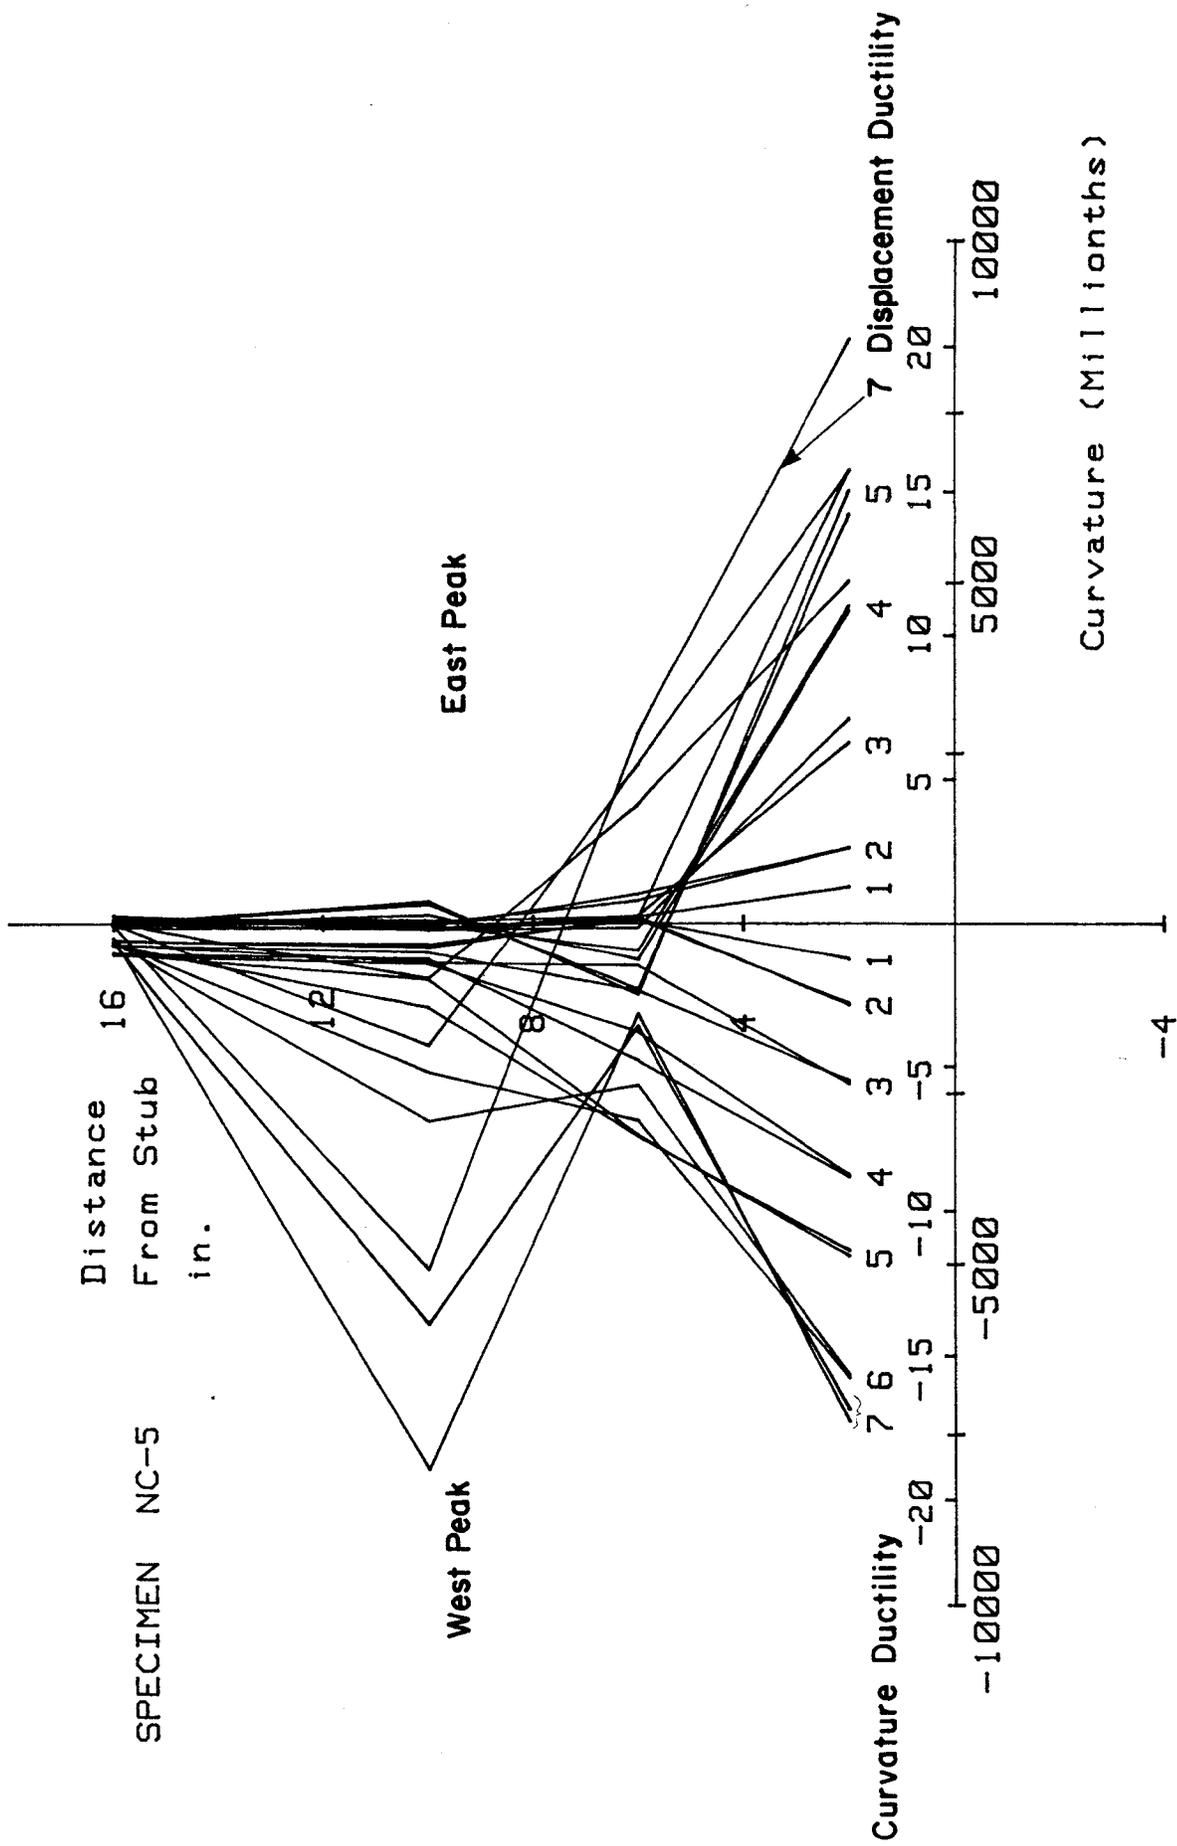
FIG. 5-18 CURVATURE DISTRIBUTION ALONG UPPER COLUMN, SPECIMEN NC-5

Three distinct curvature distributions were observed. Figure 5-18 represents an example of the first category for which maximum curvature occurred at the first gage length above the stub throughout loading.

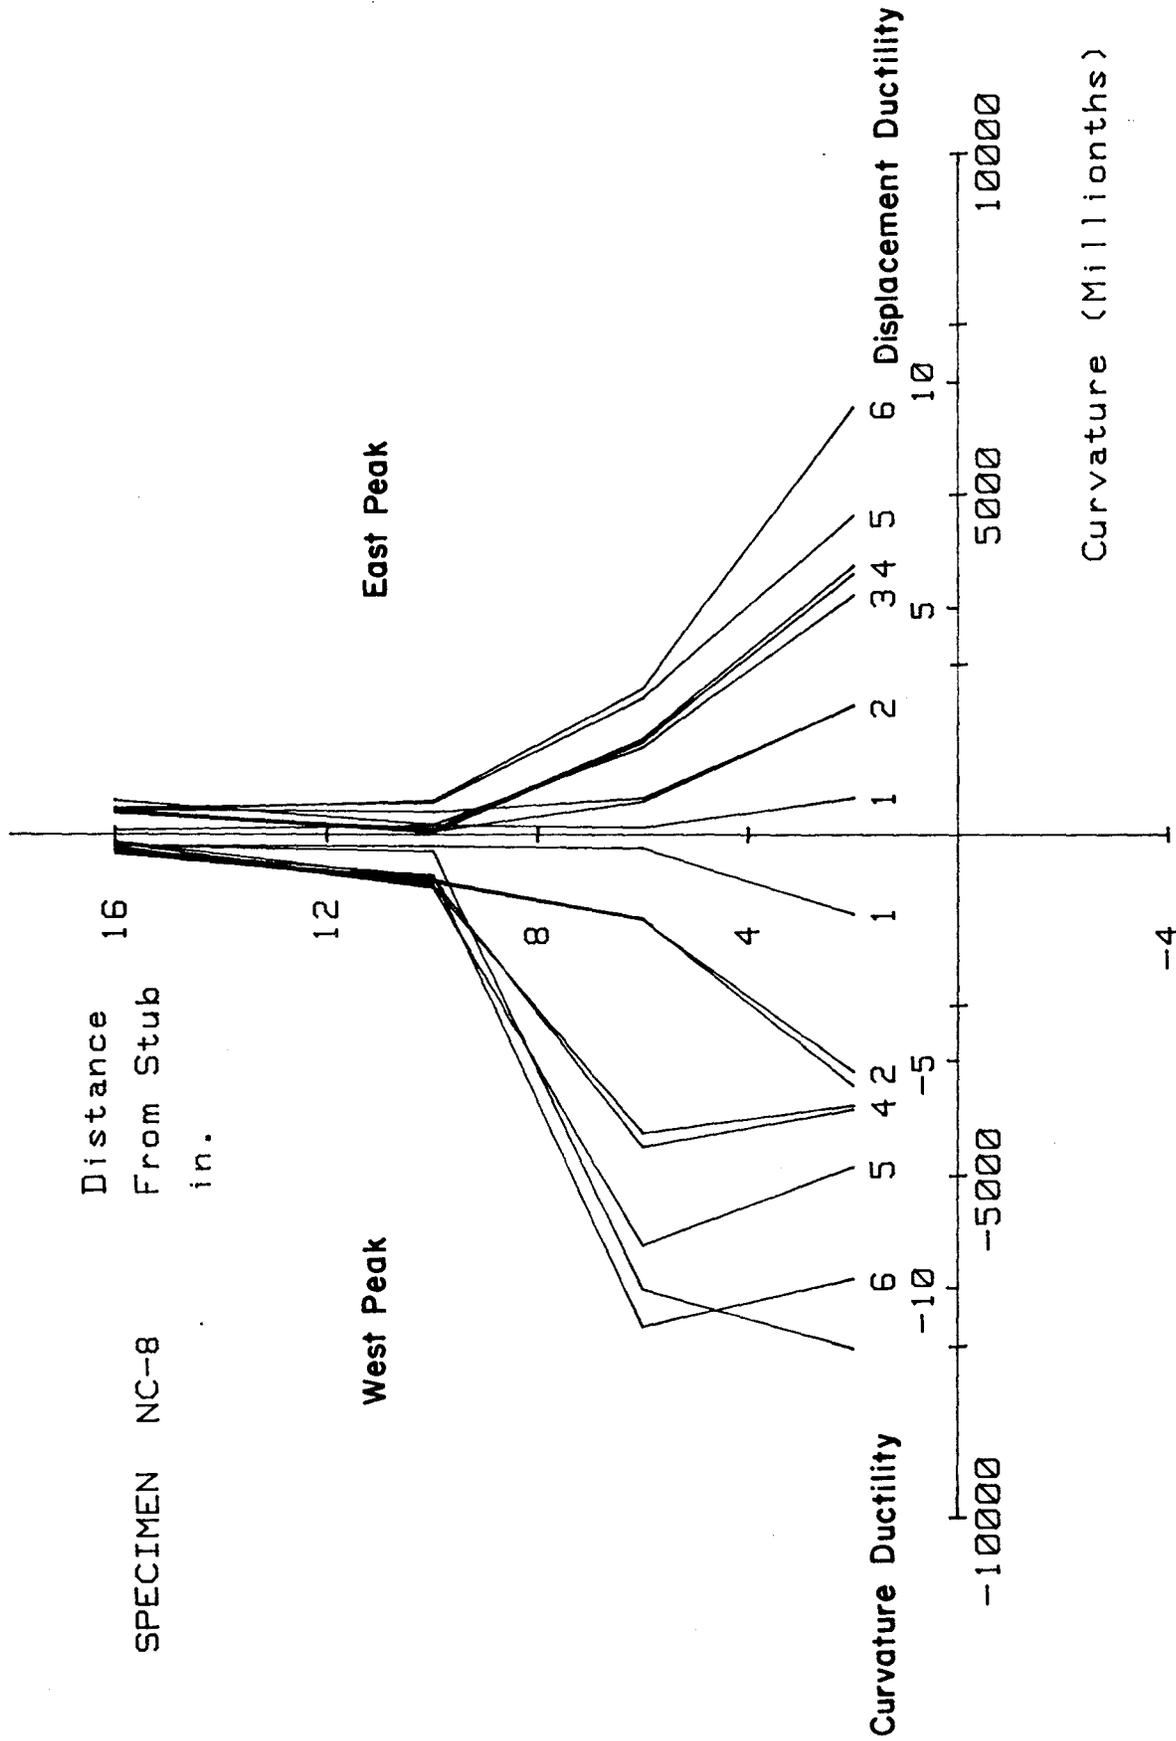
FIG. 5-19 CURVATURE DISTRIBUTION ALONG UPPER COLUMN, SPECIMEN NC-8

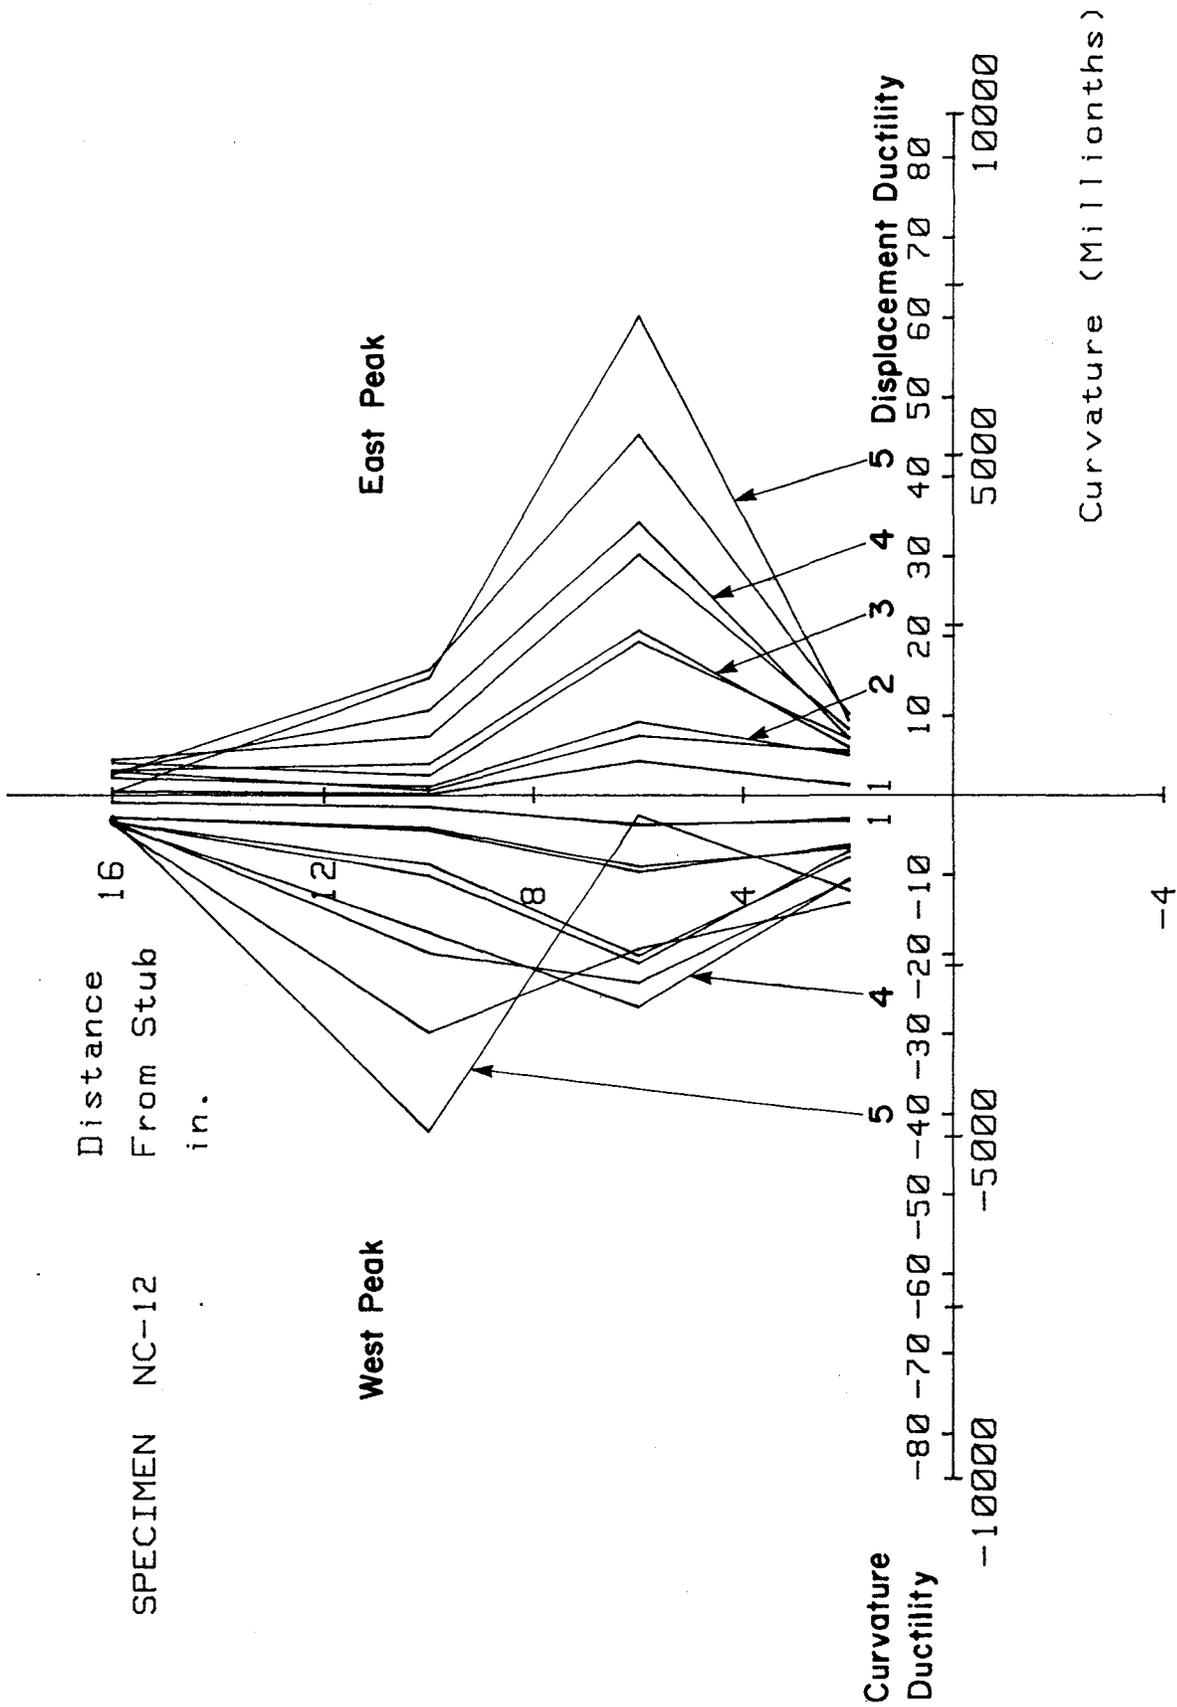
FIG. 5-20 CURVATURE DISTRIBUTION ALONG UPPER COLUMN, SPECIMEN NC-12

Figure 5-20 shows that maximum curvature ductility at displacement ductility ratio of five is approximately 60 within the second gage length above the stub. However, it should be noted that reported curvature ductility ratios are relative to the first yield curvature within the gage length directly above the stub. For Specimen NC-12, that reference curvature was surprisingly small, so the calculated ductility ratio values are inflated. A recalculation of curvature ductility ratios relative to the measured curvature at first yield within the second gage length reduces the maximum ratio from 60 to 16.8. This reduced value is a better representation of the available curvature ductility of Specimen NC-12.

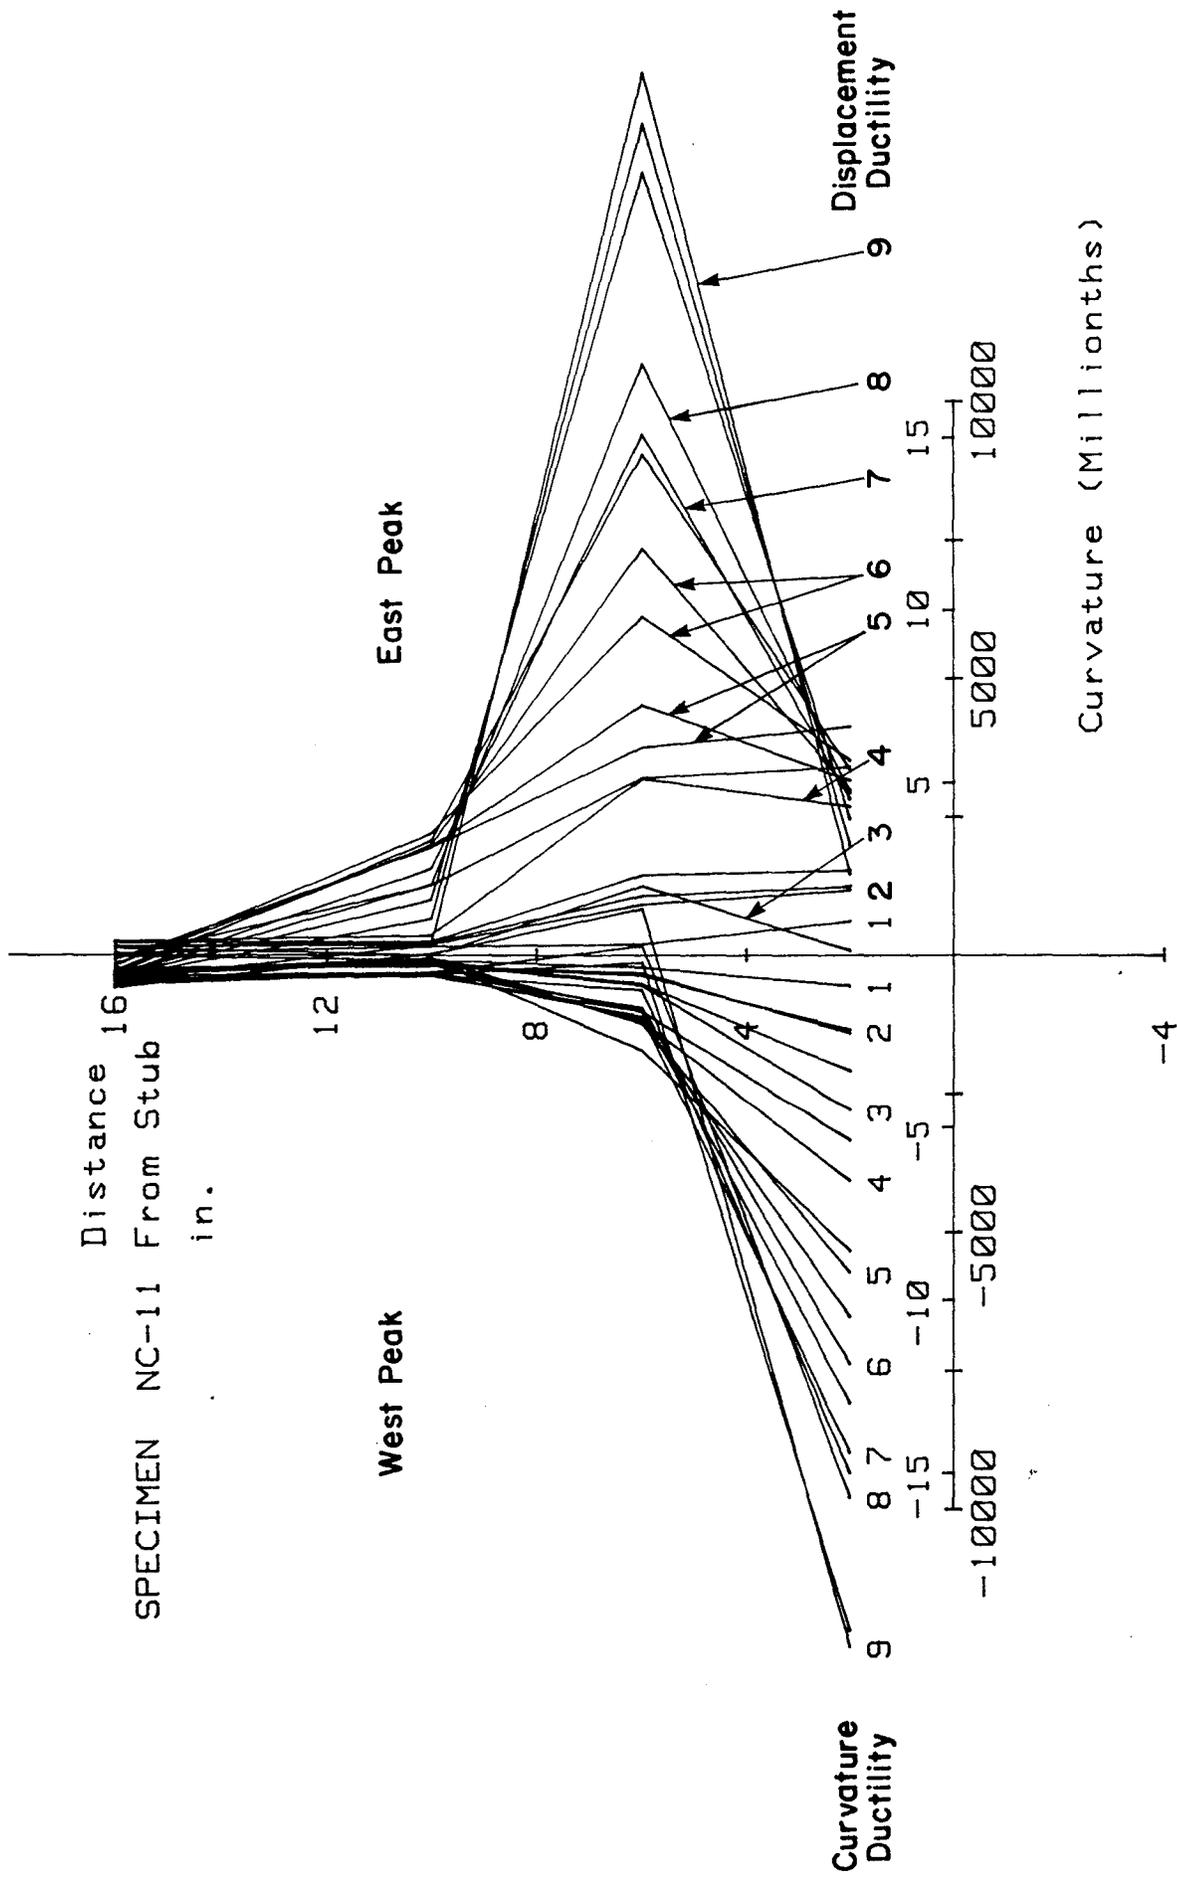
FIG. 5-21 CURVATURE DISTRIBUTION ALONG UPPER COLUMN, SPECIMEN NC-11

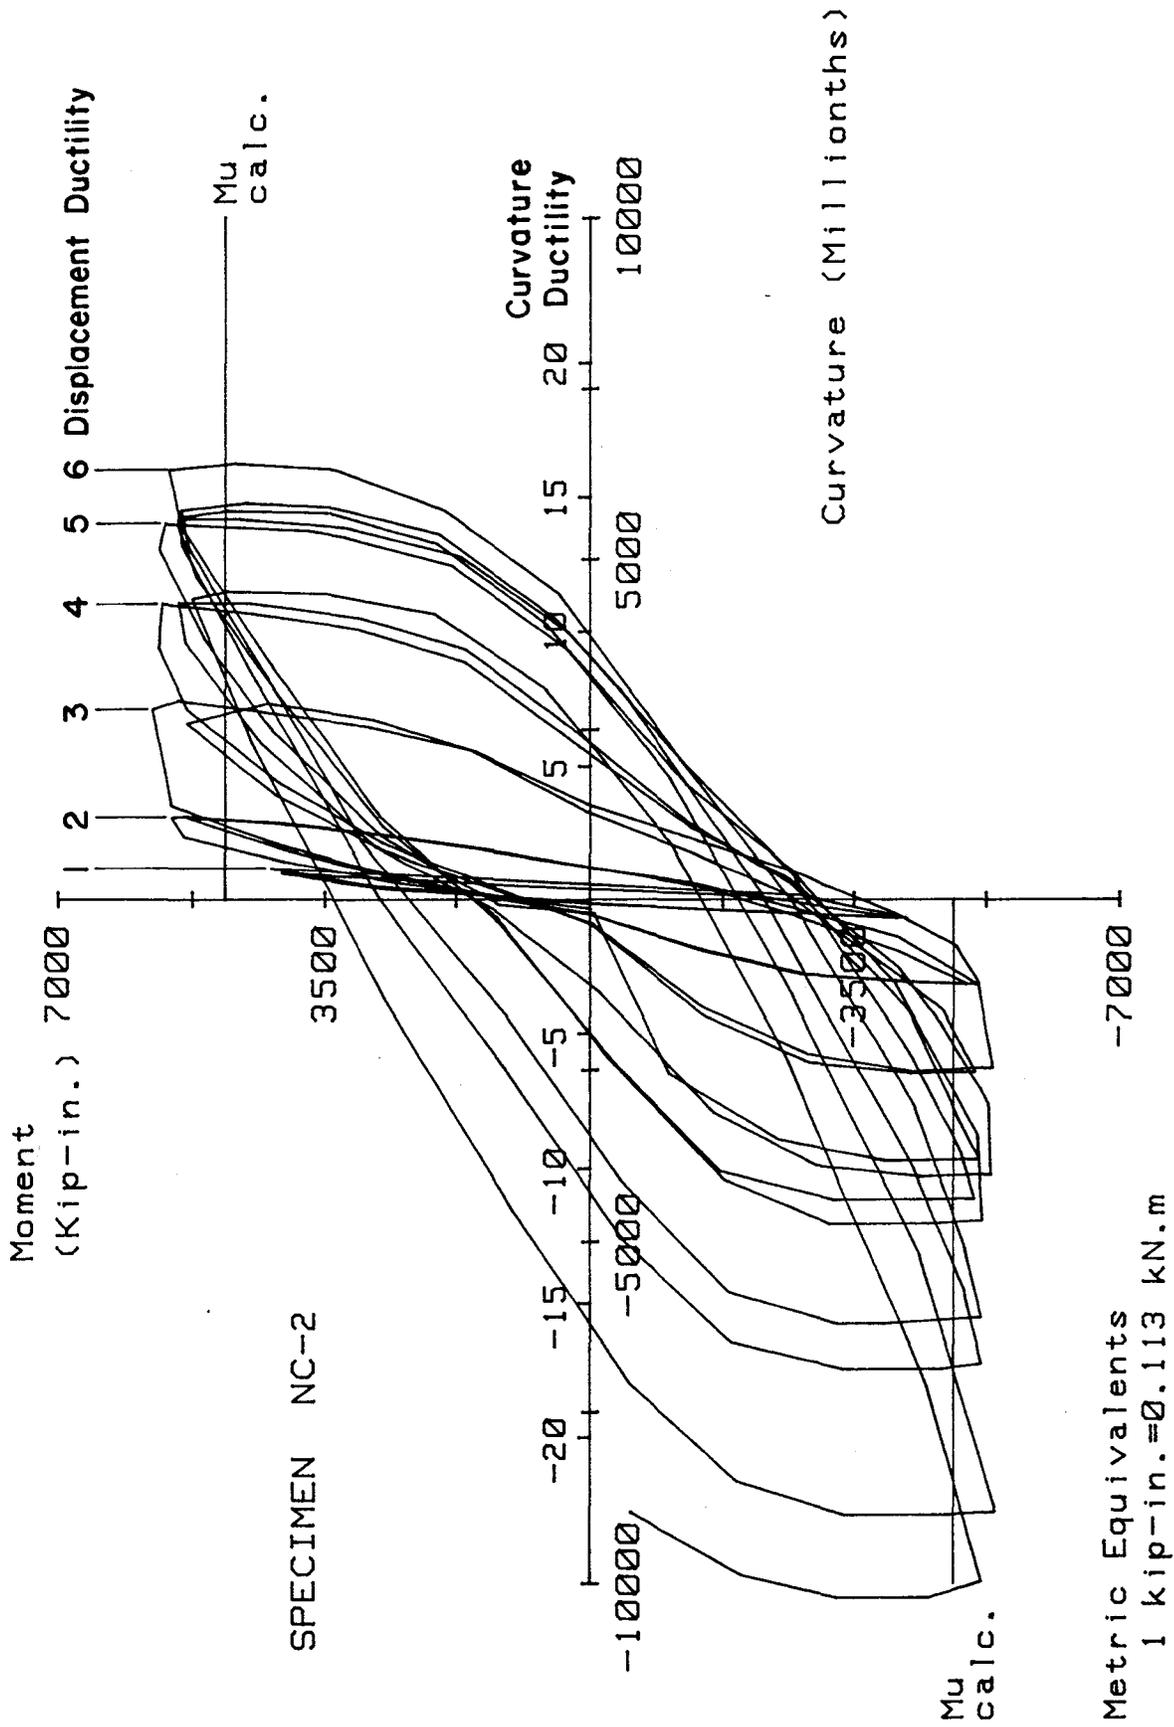
FIG. 5-22 MOMENT VERSUS CURVATURE FOR SPECIMEN NC-2

Representative plots of moment vs. curvature for Specimens NC-2, NC-5, NC-8, and NC-12 are shown in Figs. 5-22 through 5-25. These plots include total moment at the upper column-stub beam interface. The calculated moment capacity, M_u , indicated in these figures, was determined using provisions of the 1983 ACI Building Code. Capacity reduction factor, ϕ , was taken

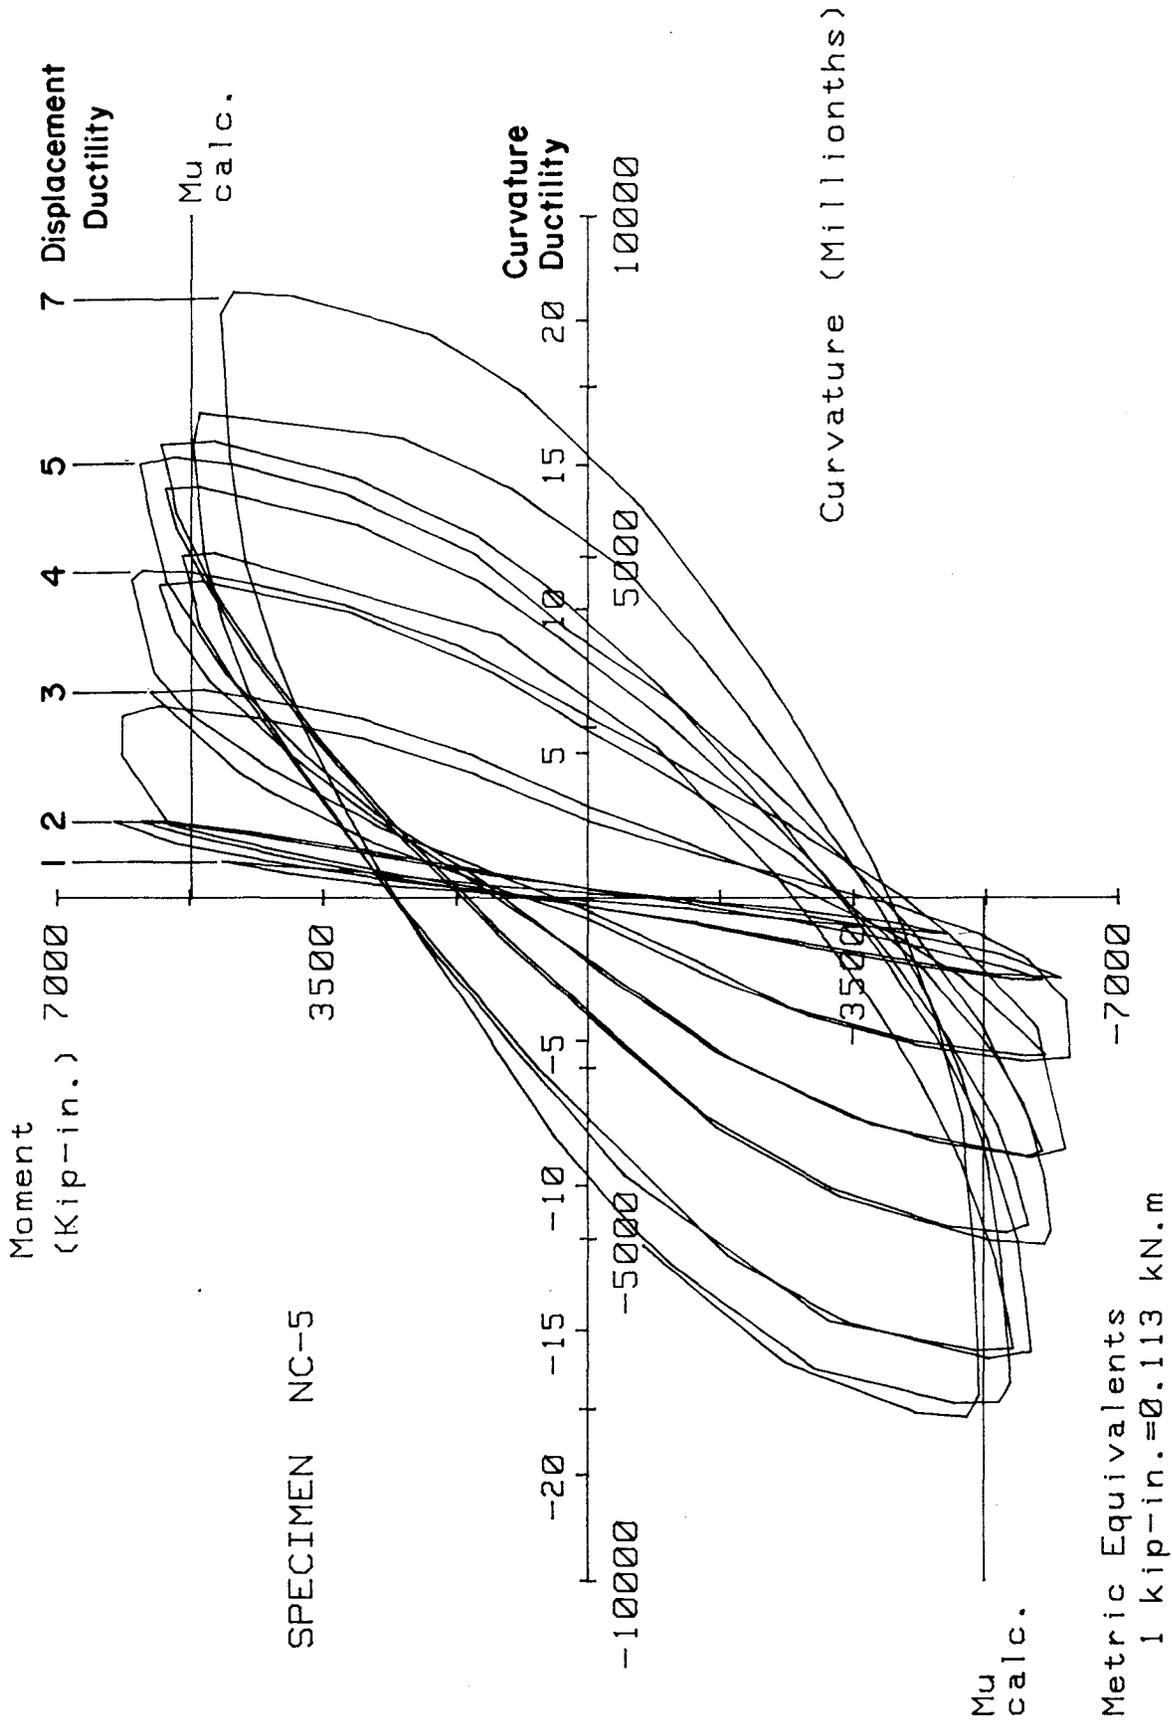
FIG. 5-23 MOMENT VERSUS CURVATURE FOR SPECIMEN NC-5

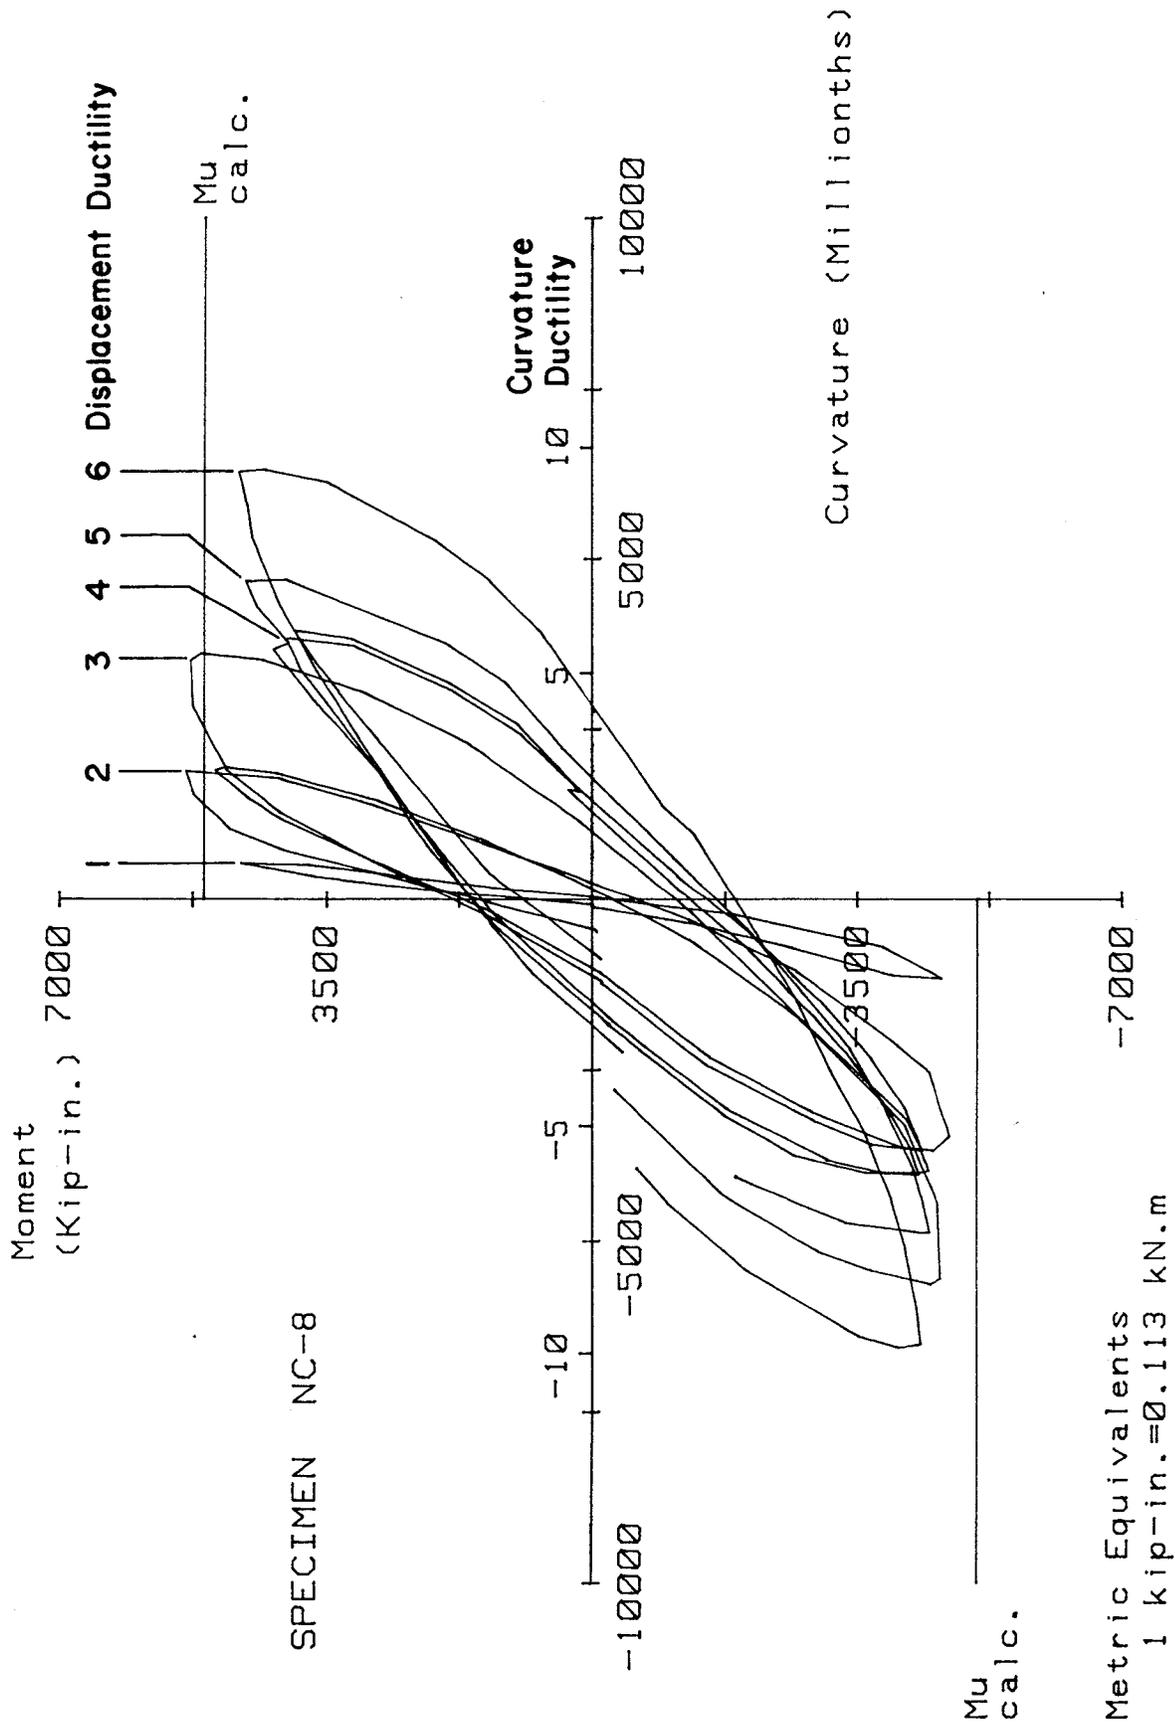
FIG. 5-24 MOMENT VERSUS CURVATURE FOR SPECIMEN NC-8
