***EFFECTS OF TRANSVERSE REINFORCEMENT
ON SEISMIC PERFORMANCE OF COLUMNS - A
PARTIAL PARAMETRIC INVESTIGATION***

September 1988

NATIONAL SCIENCE FOUNDATION
Washington, D.C.
Grant No. PFR-7902611

CONSTRUCTION TECHNOLOGY LABORATORIES, INC.
5420 Old Orchard Road
Skokie, Illinois 60077

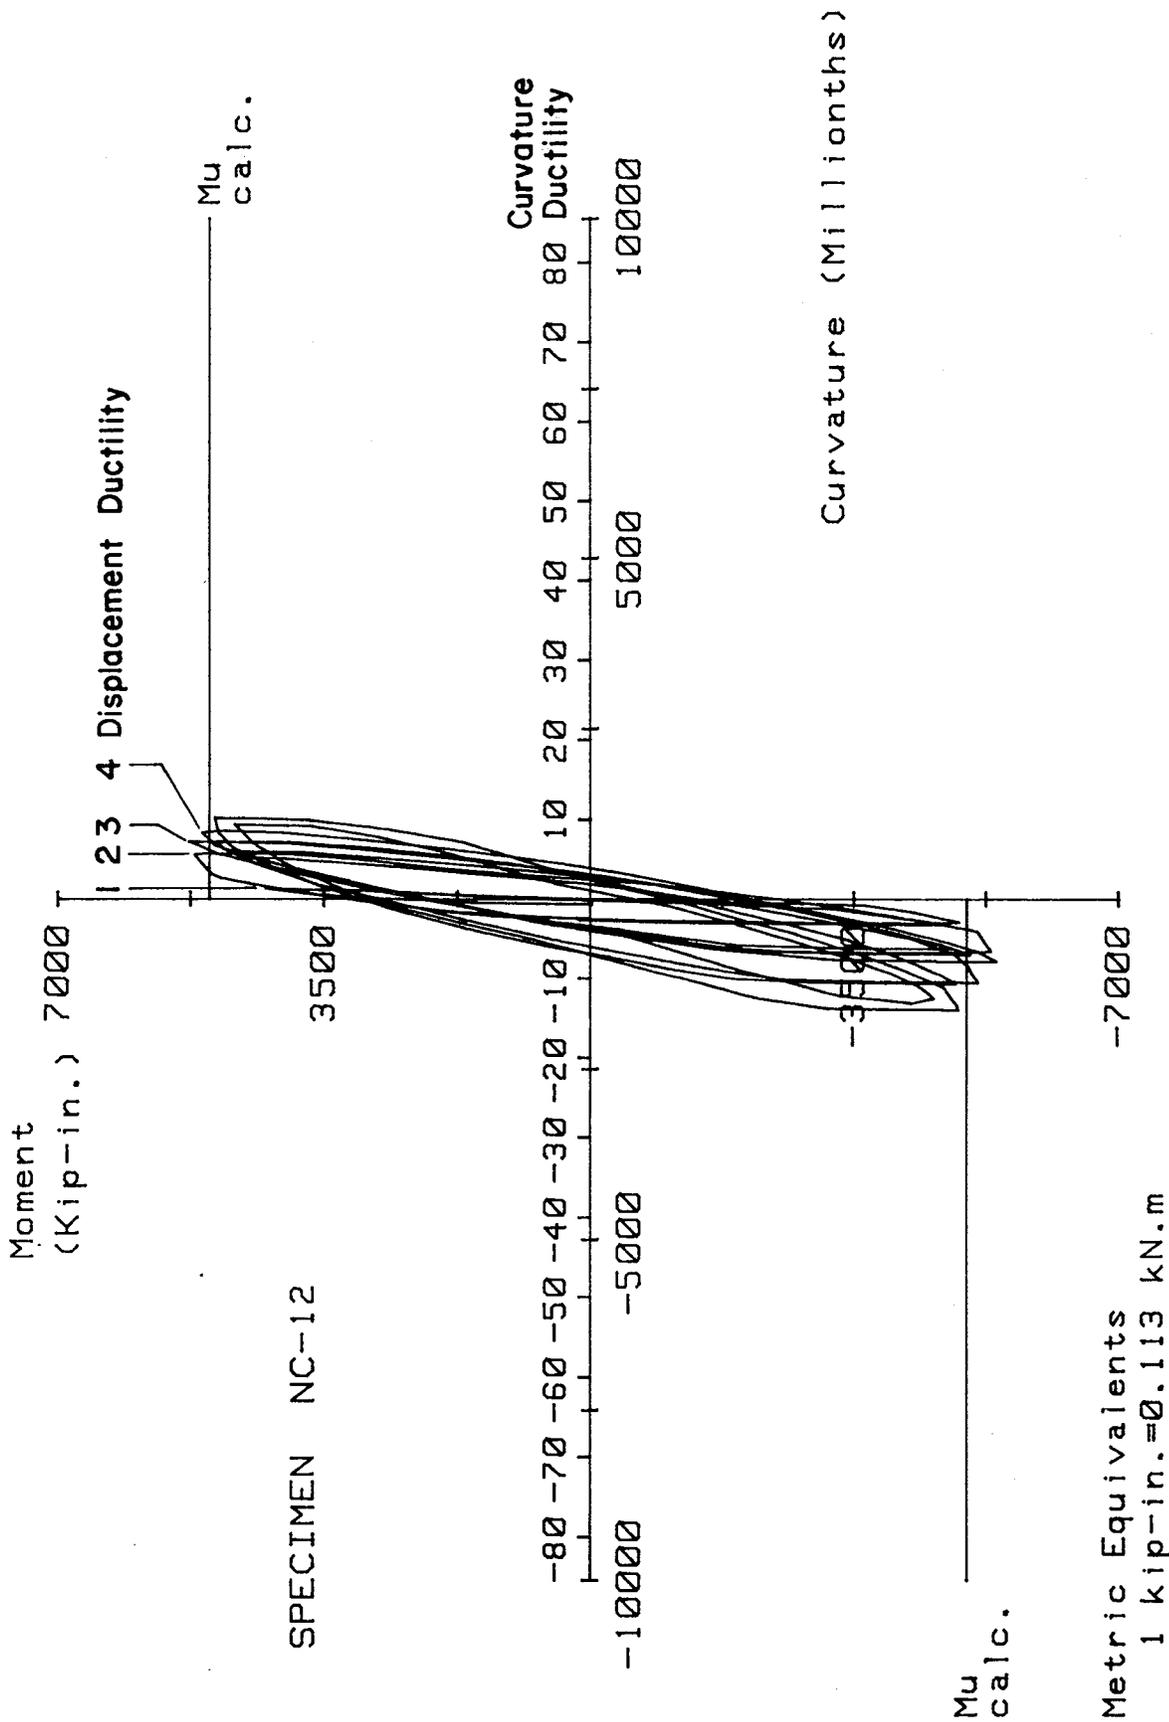
FIG. 5-25 MOMENT VERSUS CURVATURE FOR SPECIMEN NC-12

Representative plots of moment vs. curvature for Specimens NC-2, NC-5, NC-8, and NC-12 are shown in Figs. 5-22 through 5-25. These plots include total moment at the upper column-stub beam interface. The calculated moment capacity, M_u , indicated in these figures, was determined using provisions of the 1983 ACI Building Code. Capacity reduction factor, ϕ , was taken

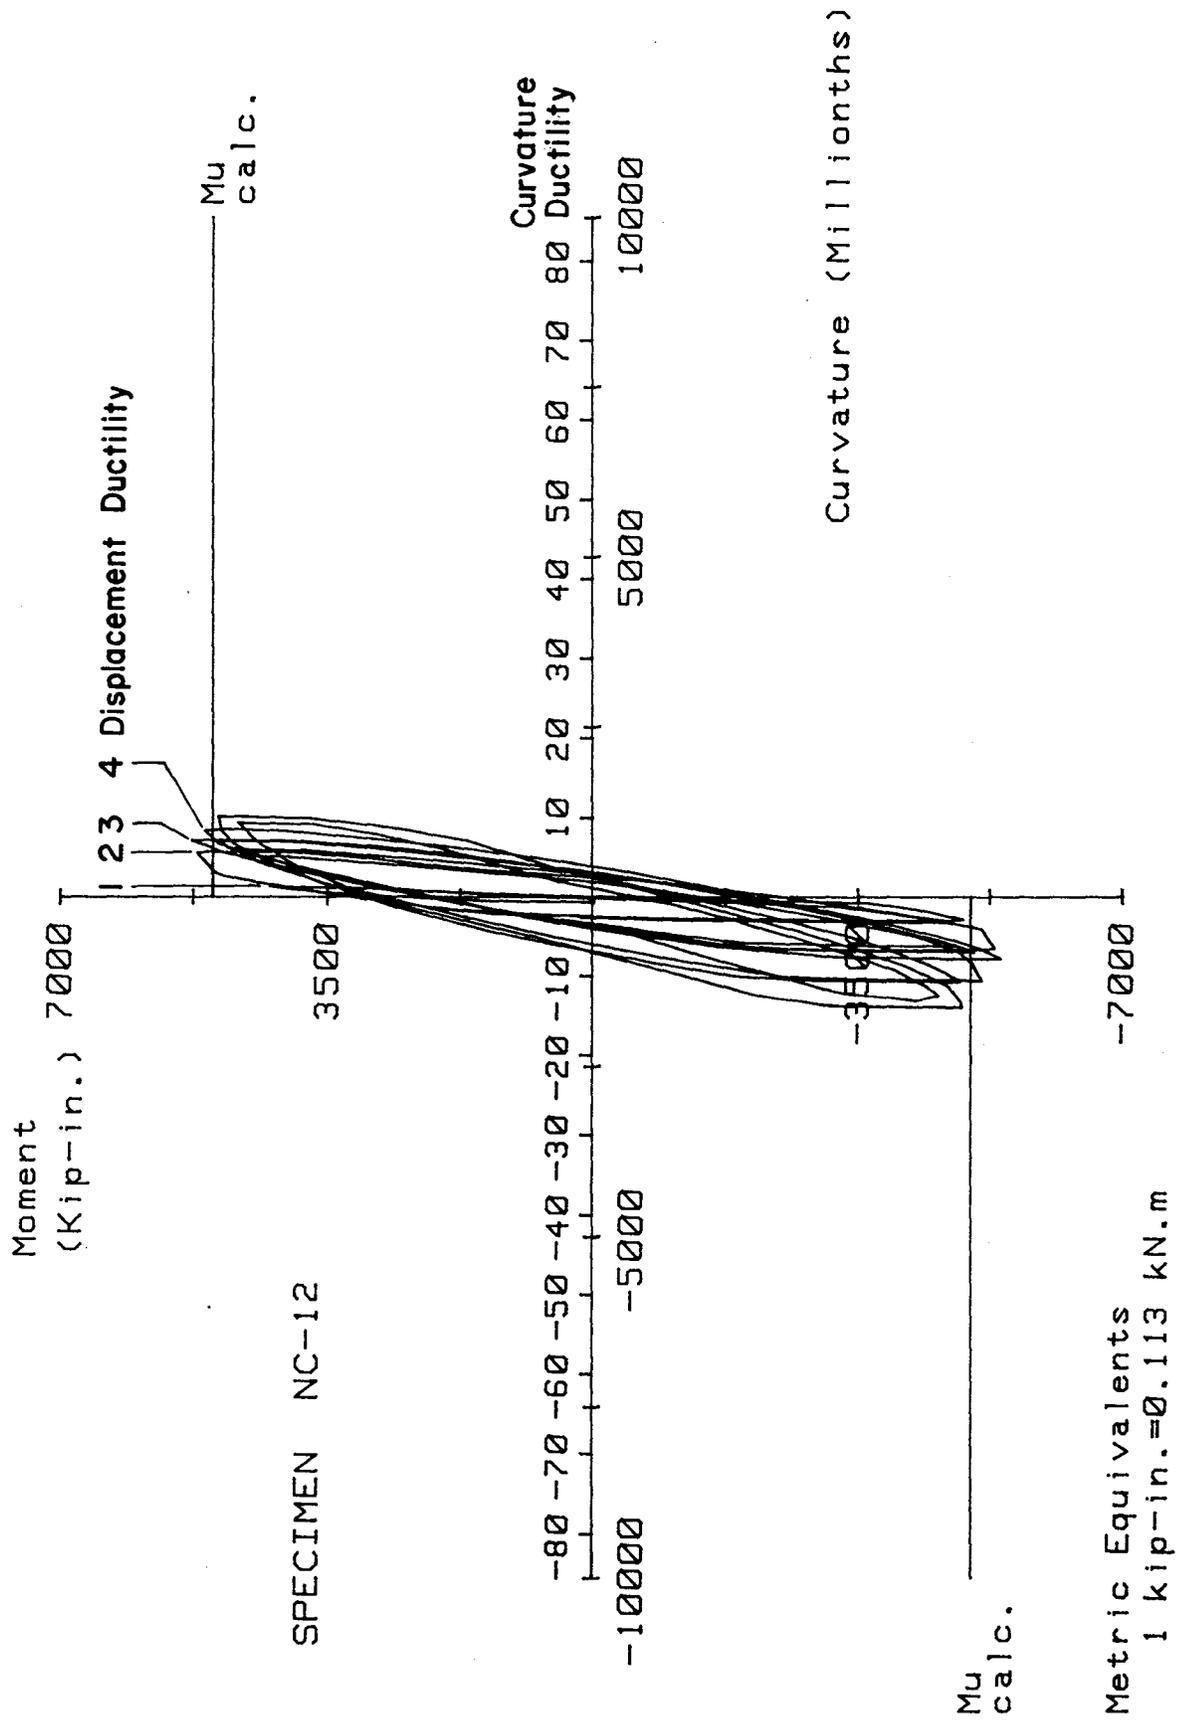
FIG. 5-26 MOMENT VERSUS CURVATURE FOR SPECIMEN NC-12 AT THE UPPER COLUMN STUB LEVEL

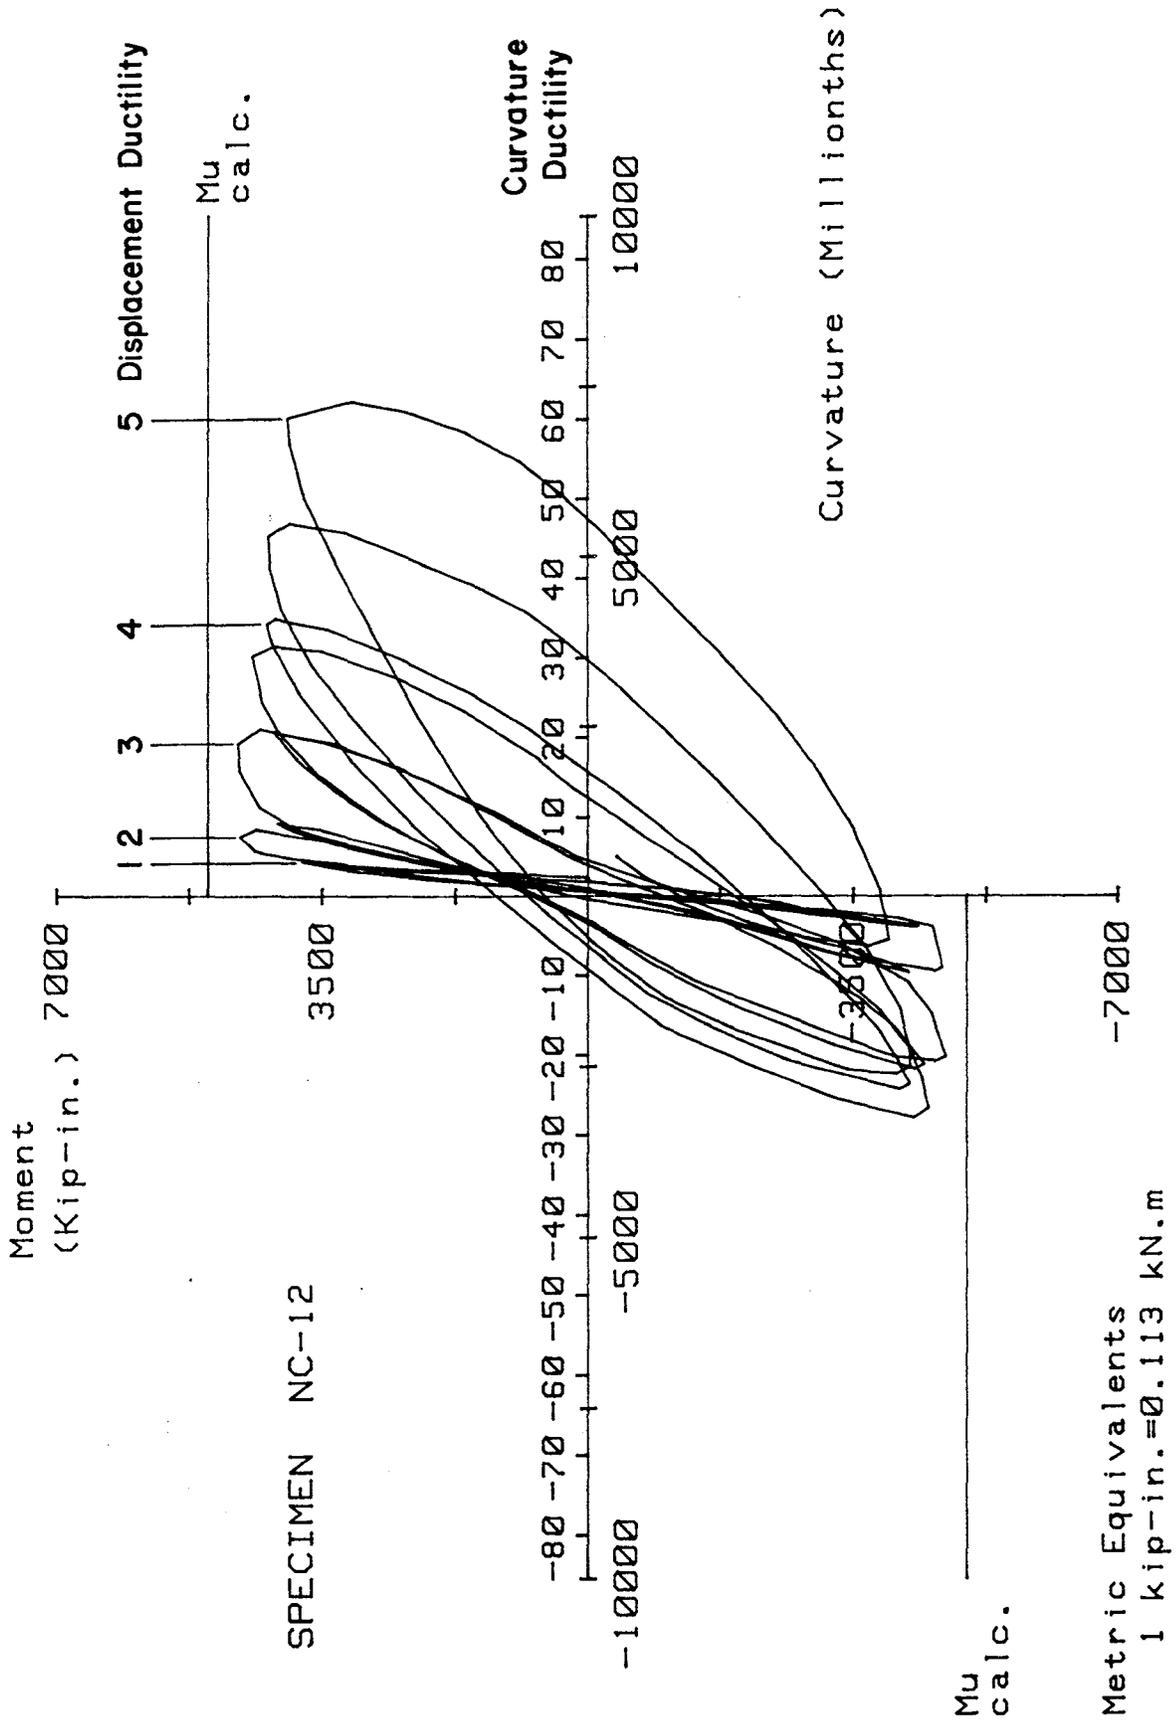
FIG. 5-27 MOMENT VERSUS CURVATURE FOR SPECIMEN NC-12 AT 6 IN. ABOVE THE STUB

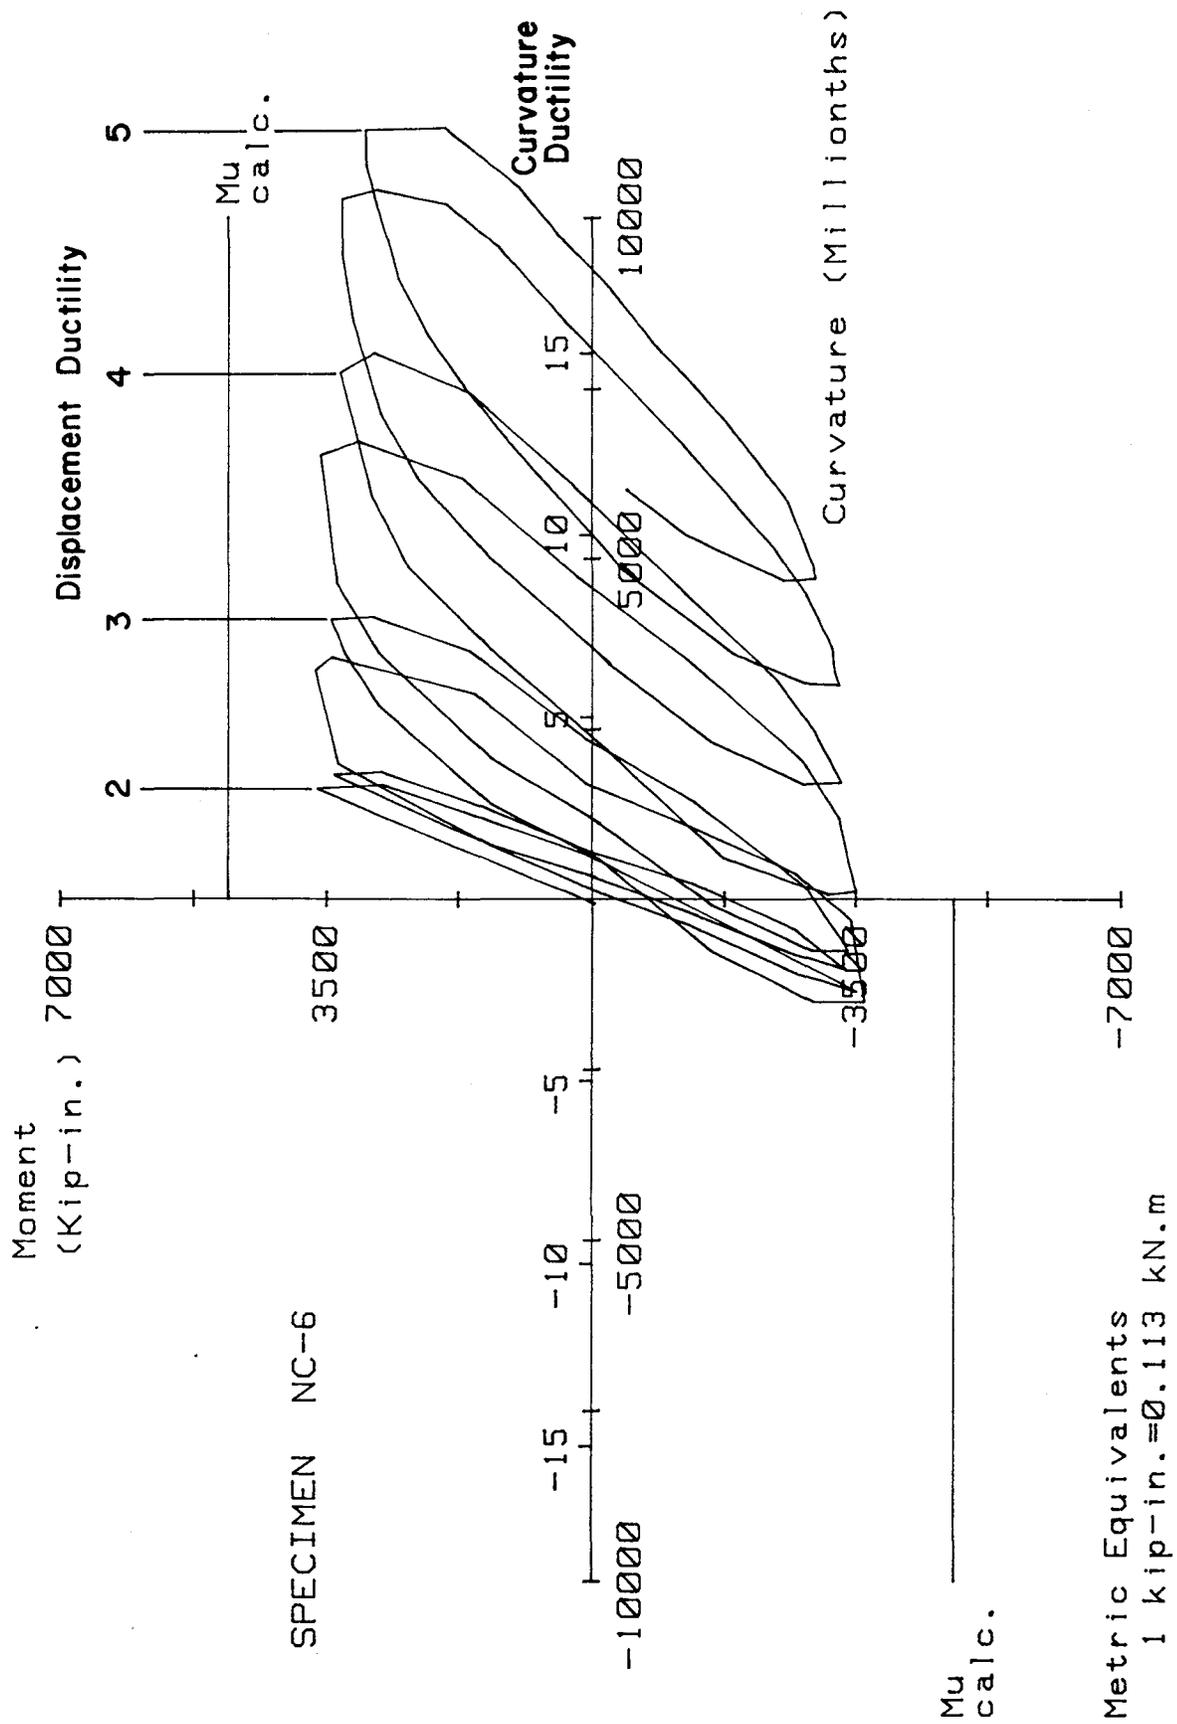
FIG. 5-28 MOMENT VERSUS CURVATURE FOR SPECIMEN NC-6

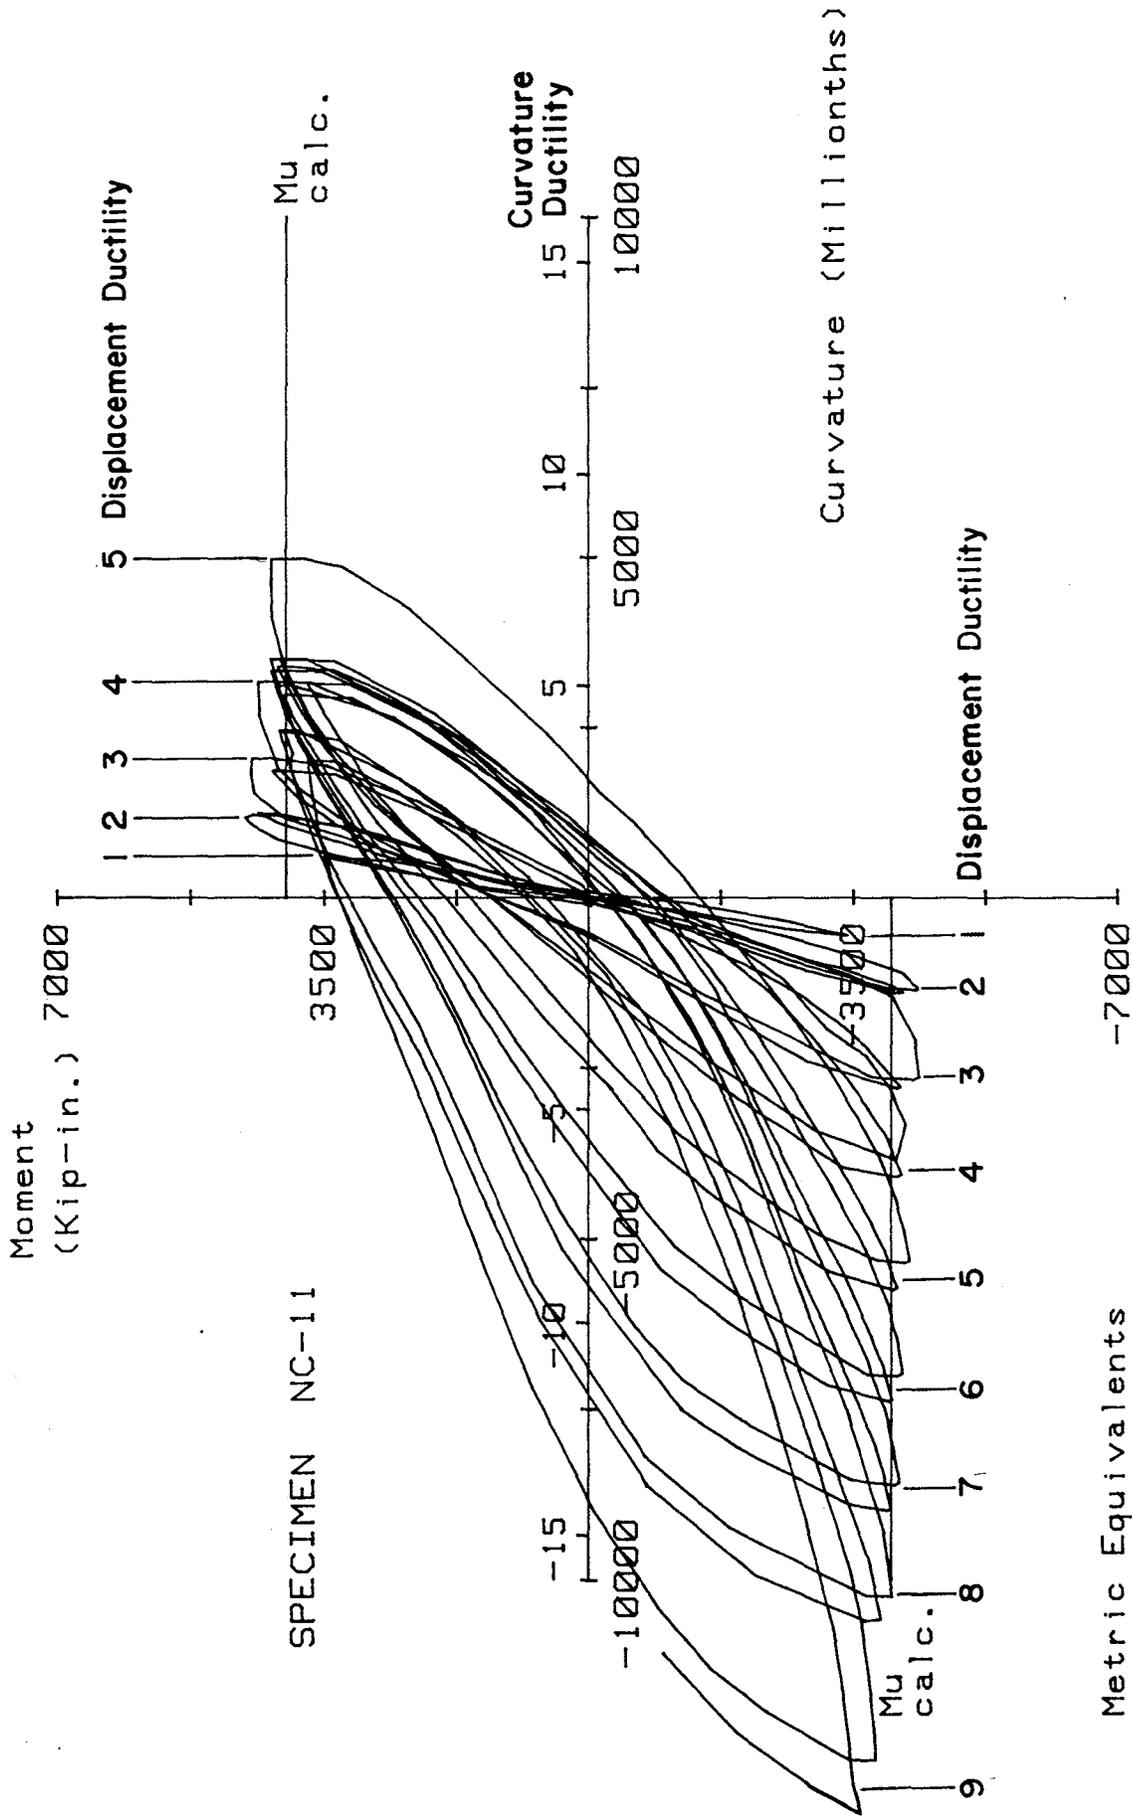
FIG. 5-29 MOMENT VERSUS CURVATURE FOR SPECIMEN NC-11

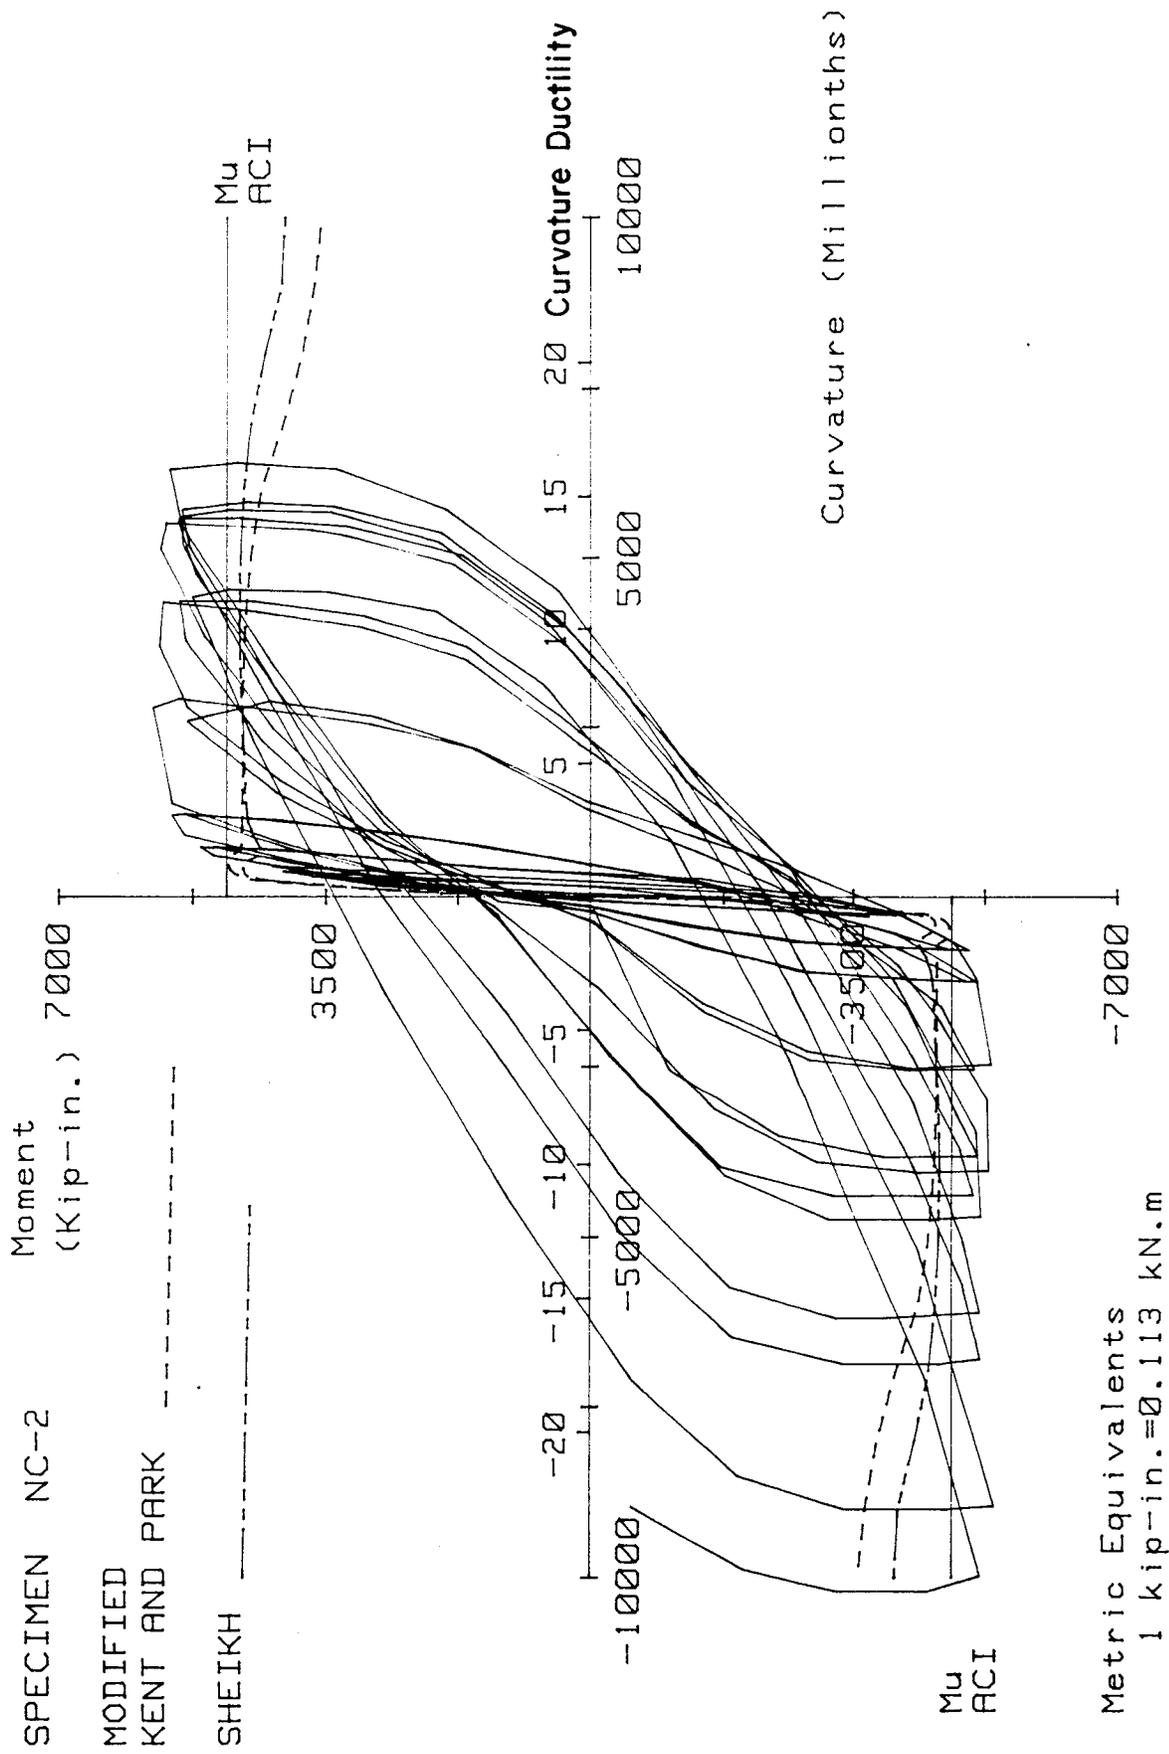
FIG. 6-9 MOMENT VERSUS CURVATURE FOR SPECIMEN NC-2

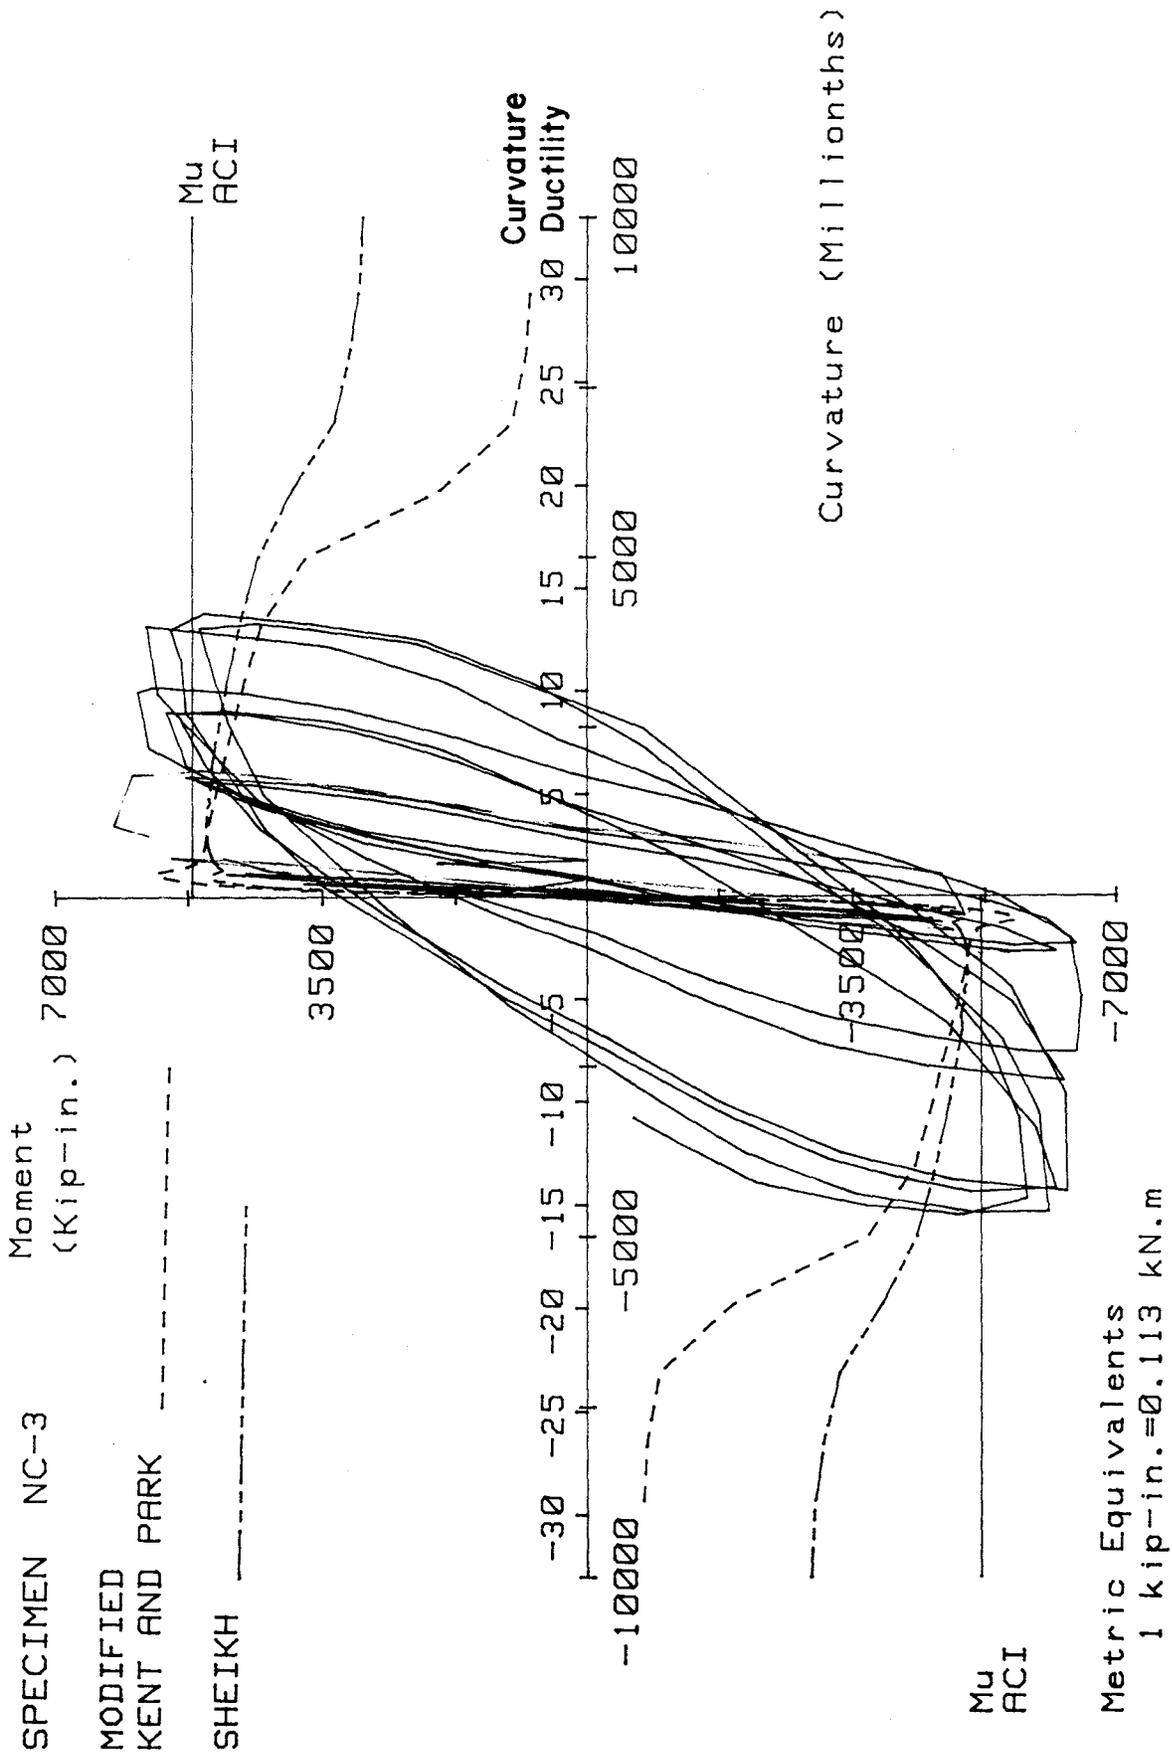
FIG. 6-10 MOMENT VERSUS CURVATURE FOR SPECIMEN NC-3

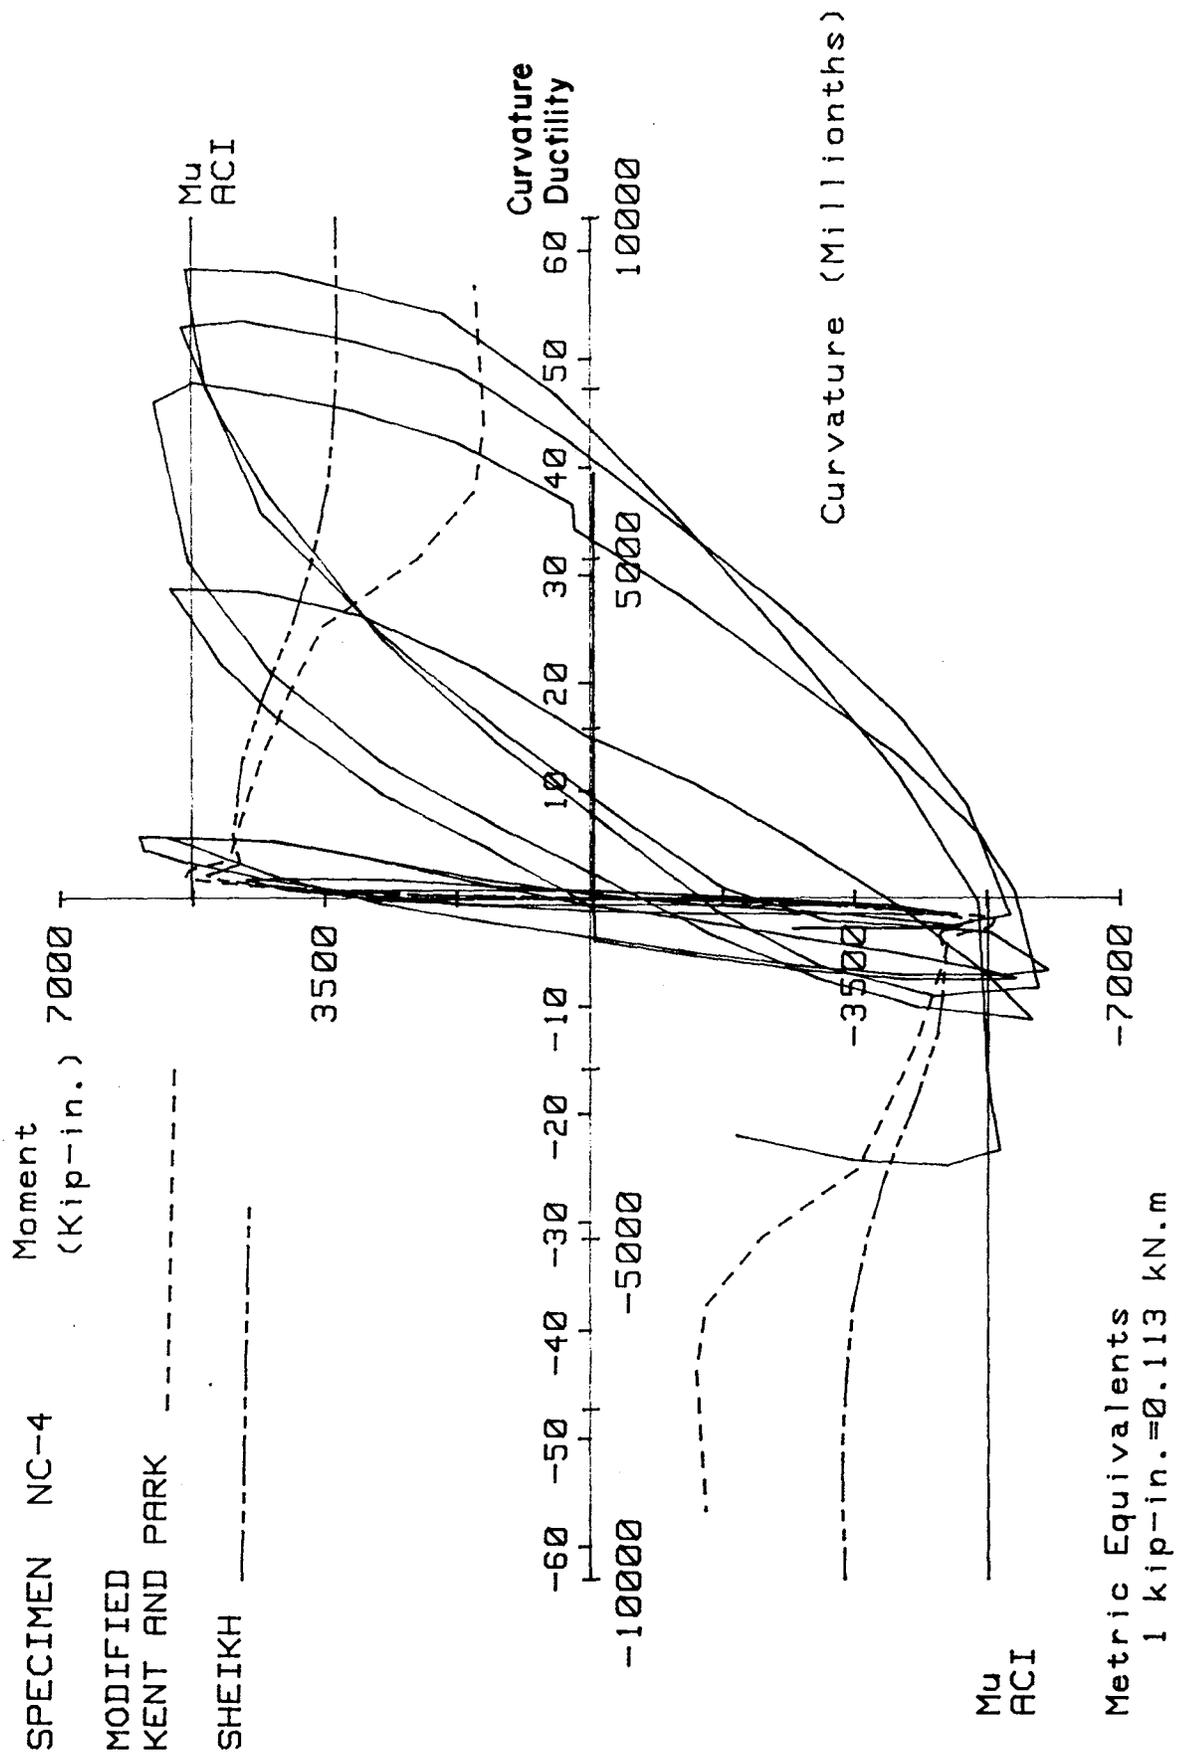
FIG. 6-11 MOMENT VERSUS CURVATURE FOR SPECIMEN NC-4

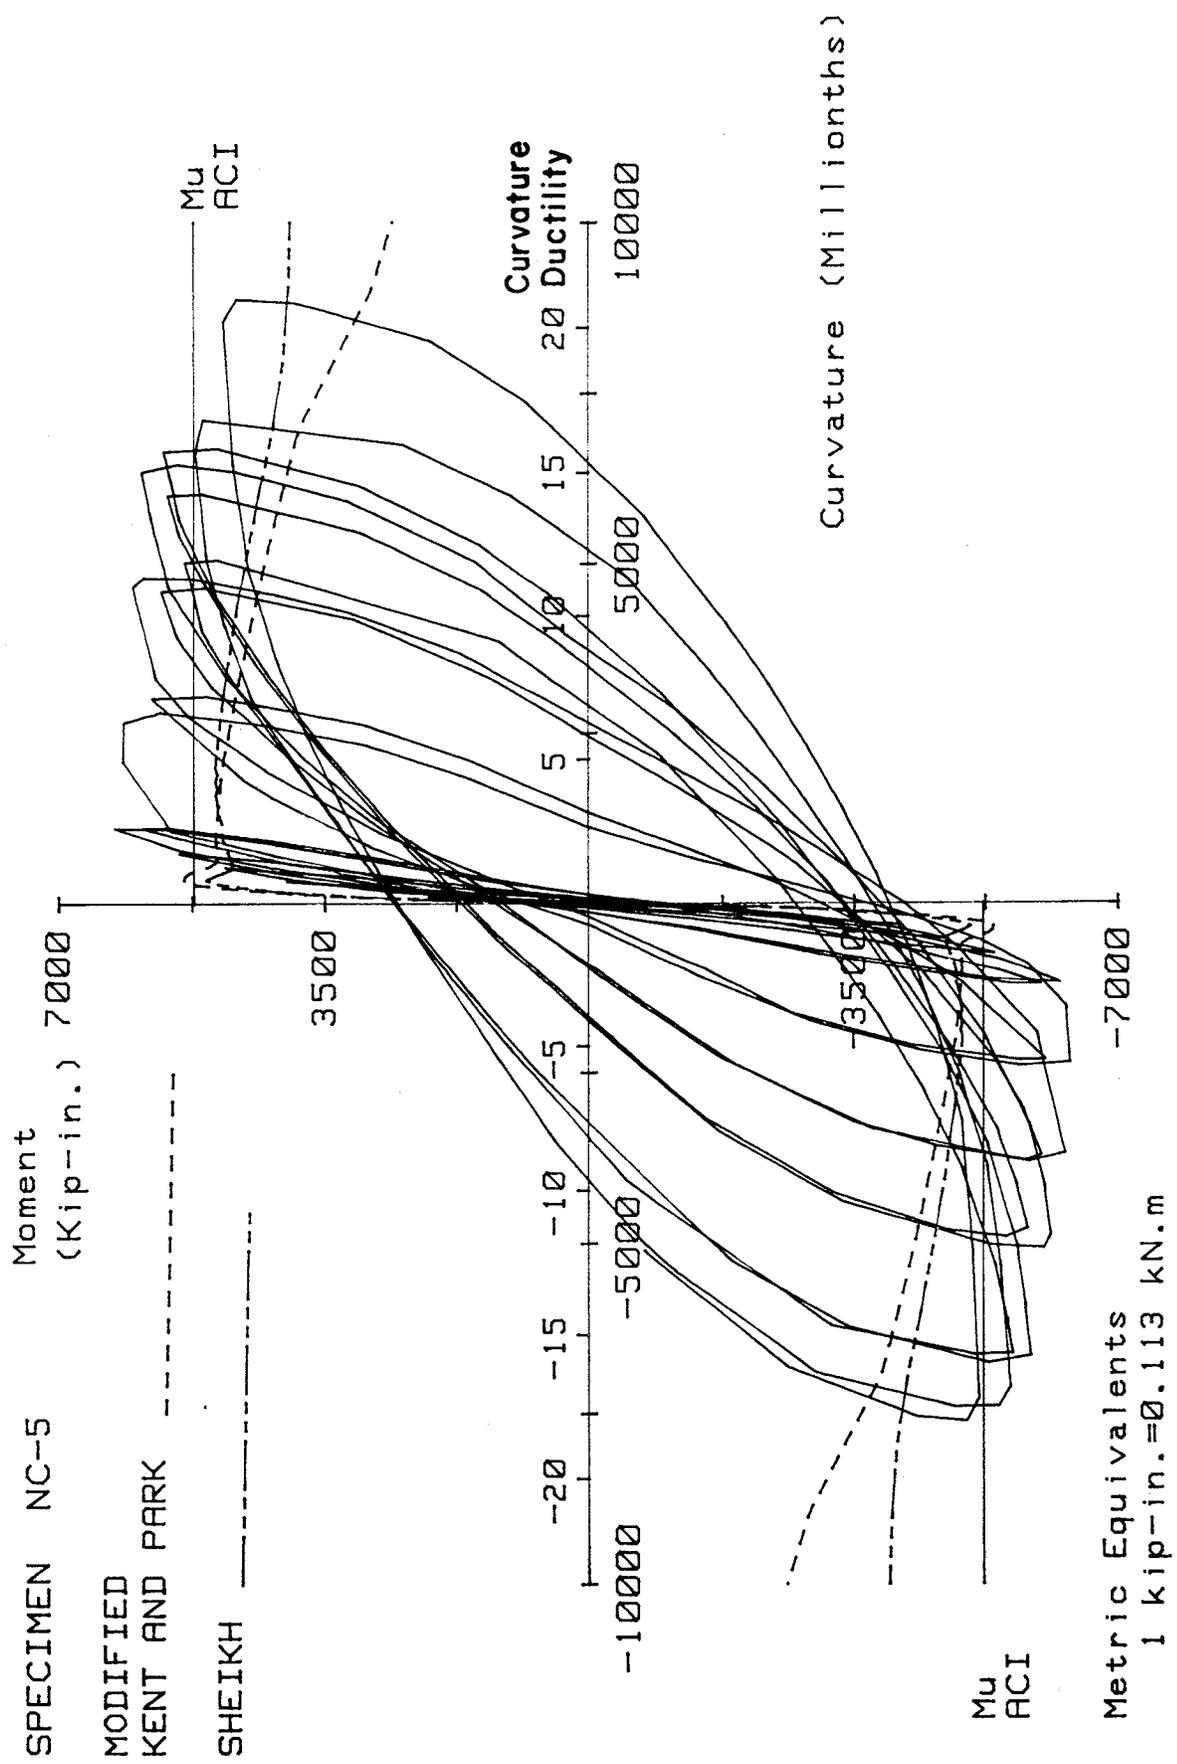
FIG. 6-12 MOMENT VERSUS CURVATURE FOR SPECIMEN NC-5

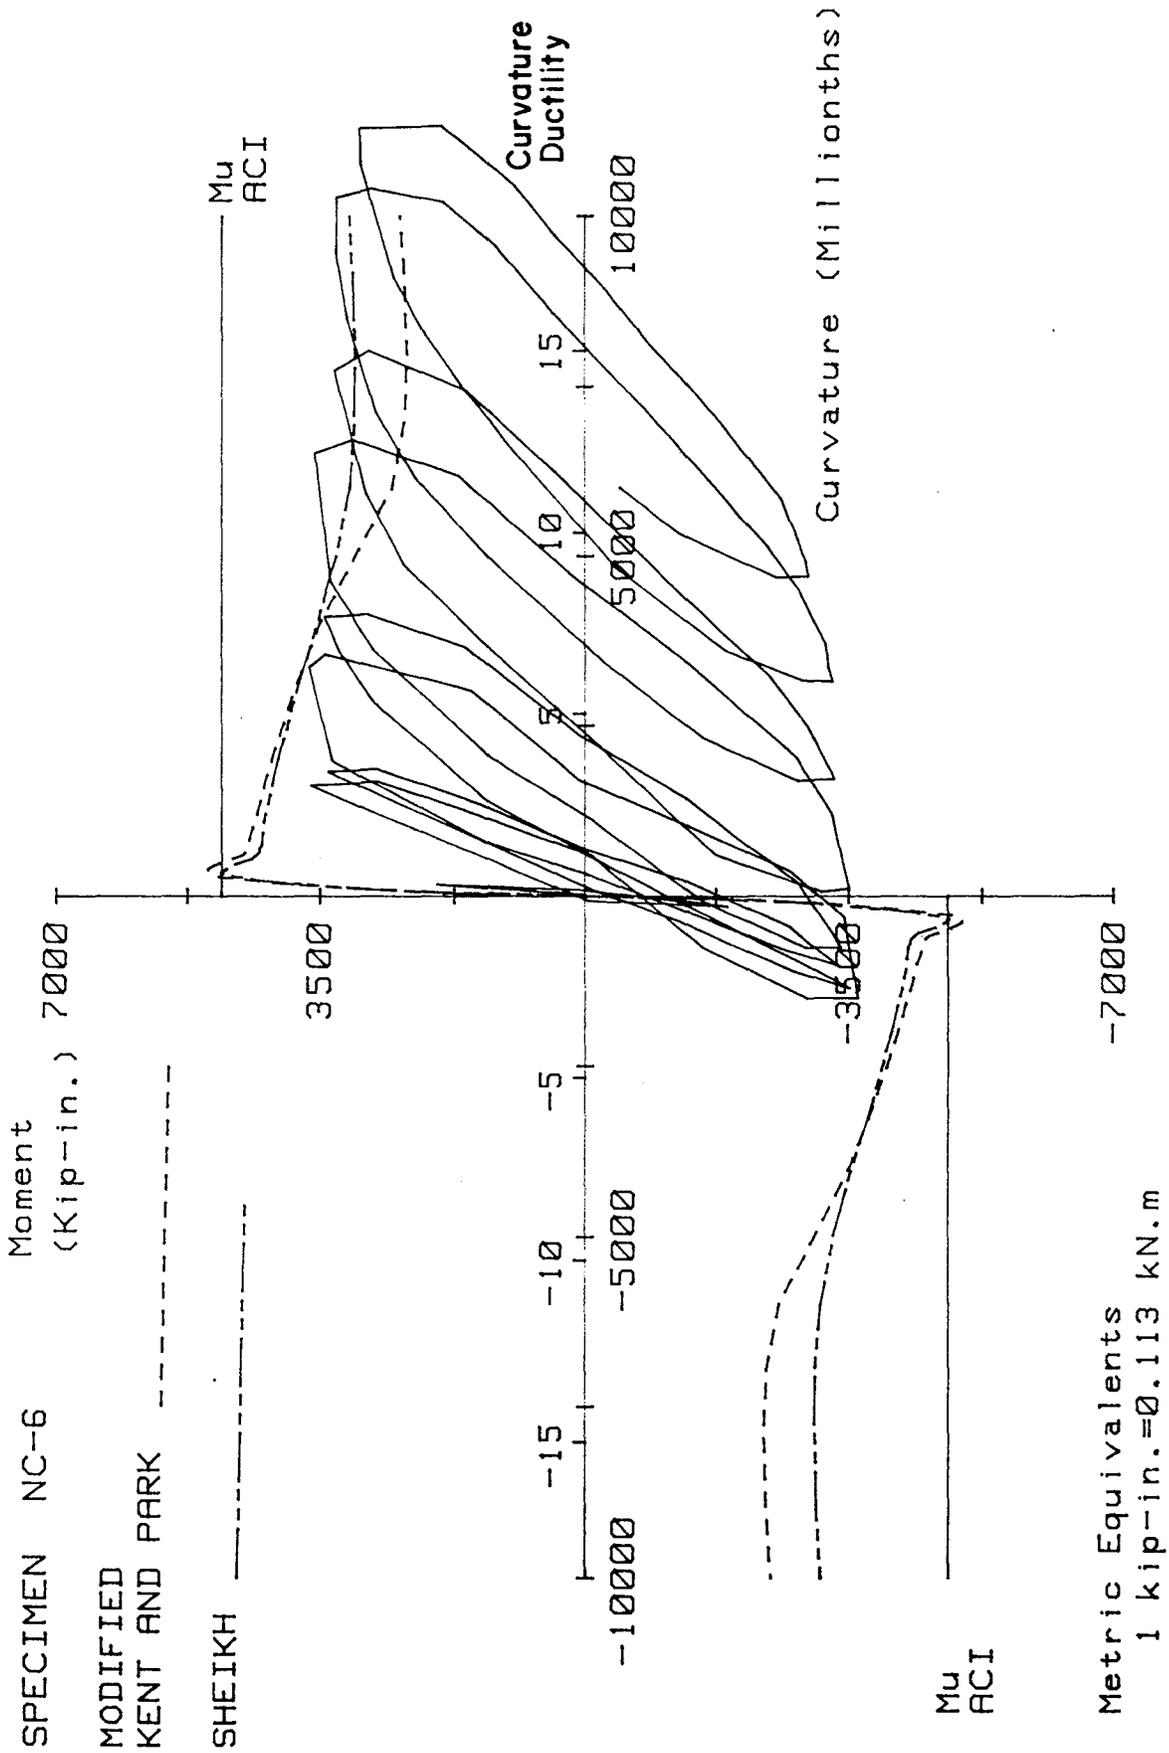
FIG. 6-13 MOMENT VERSUS CURVATURE FOR SPECIMEN NC-6

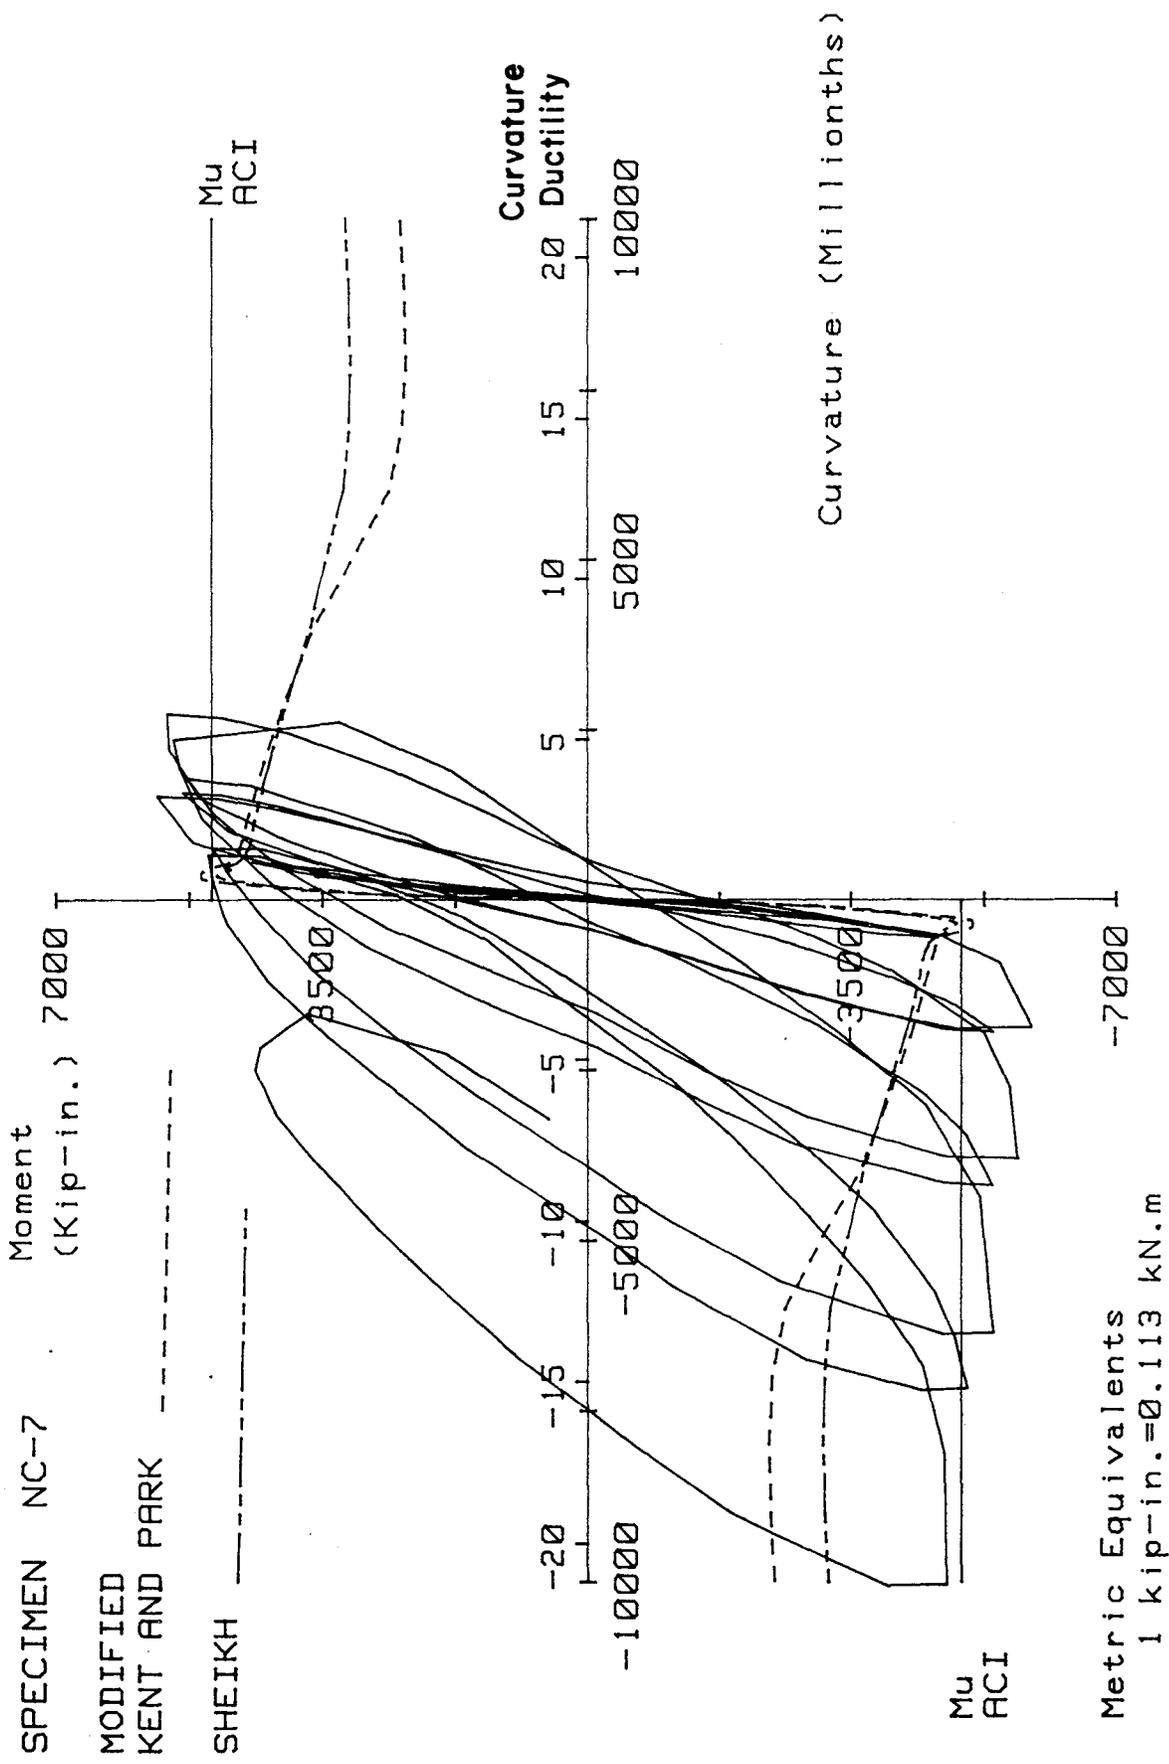
FIG. 6-14 MOMENT VERSUS CURVATURE FOR SPECIMEN NC-7
