***EFFECTS OF TRANSVERSE REINFORCEMENT
ON SEISMIC PERFORMANCE OF COLUMNS - A
PARTIAL PARAMETRIC INVESTIGATION***

September 1988

NATIONAL SCIENCE FOUNDATION
Washington, D.C.
Grant No. PFR-7902611

CONSTRUCTION TECHNOLOGY LABORATORIES, INC.
5420 Old Orchard Road
Skokie, Illinois 60077

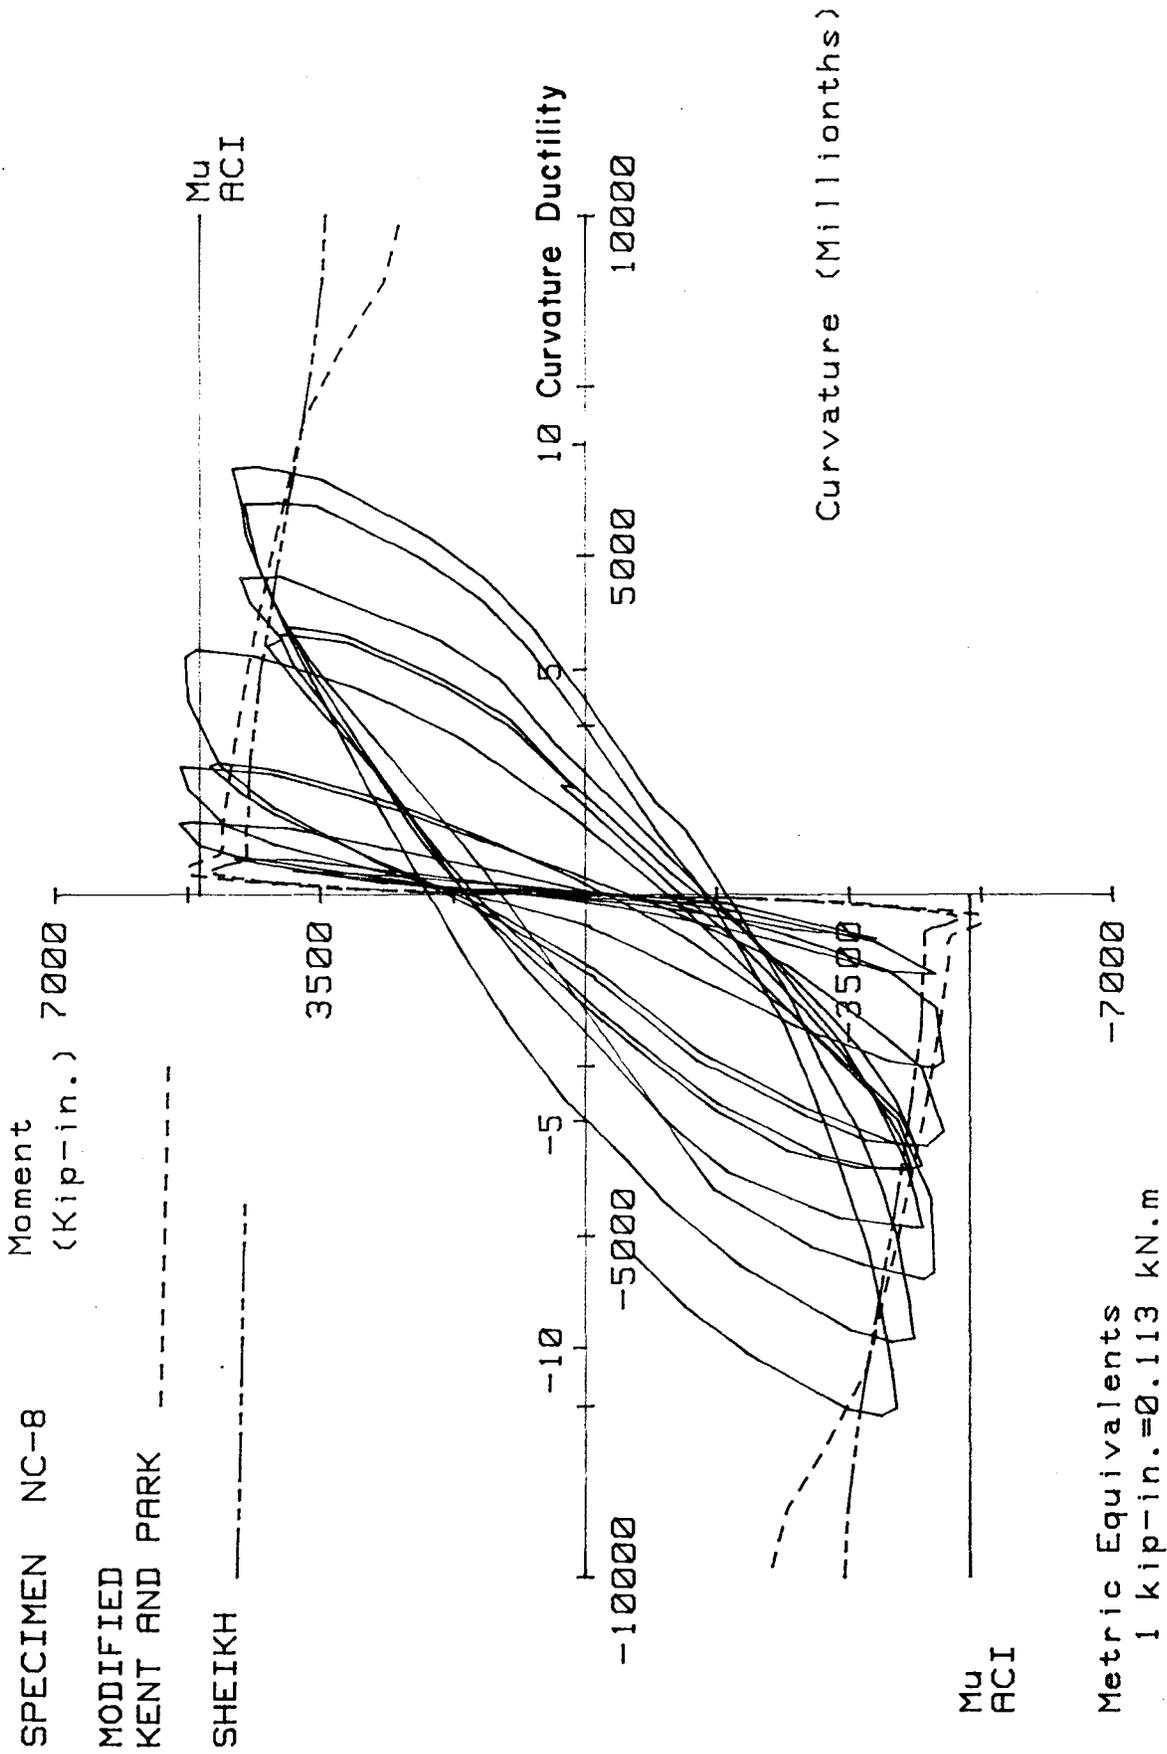
FIG. 6-15 MOMENT VERSUS CURVATURE FOR SPECIMEN NC-8

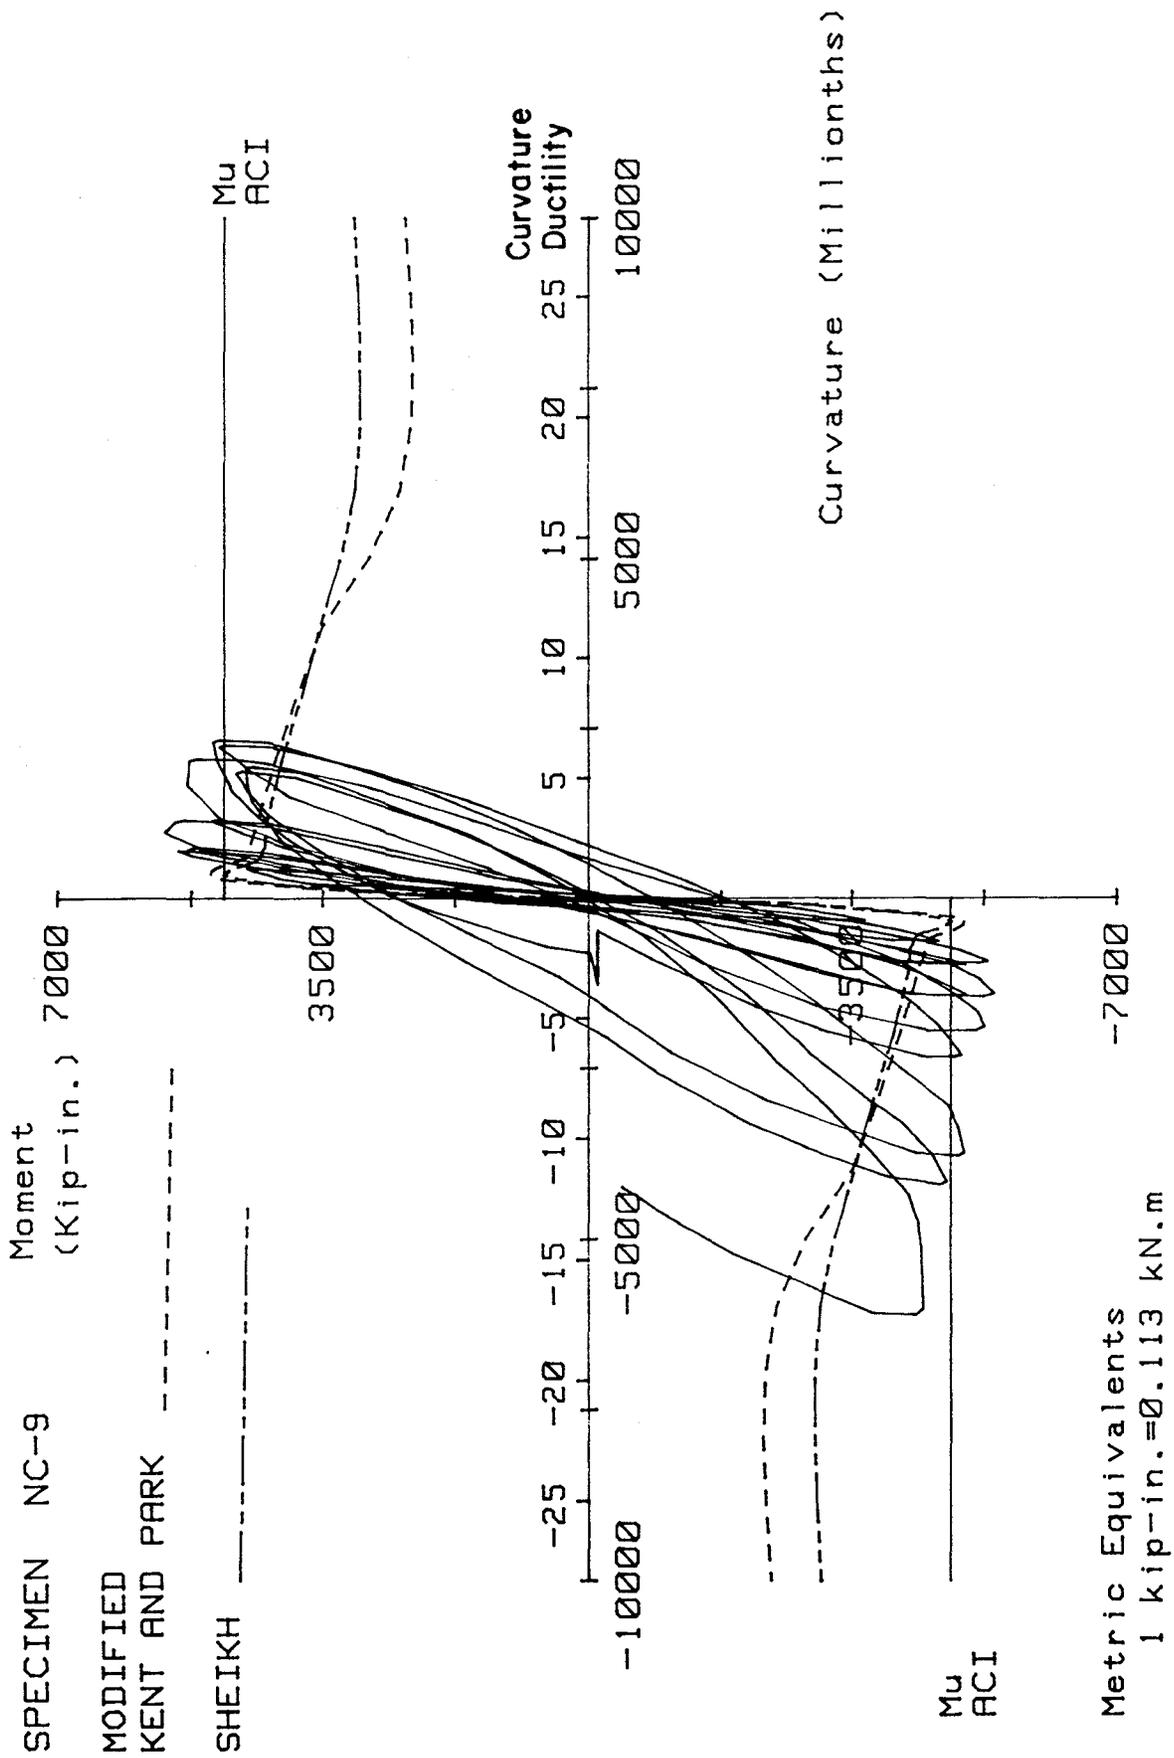
FIG. 6-16 MOMENT VERSUS CURVATURE FOR SPECIMEN NC-9

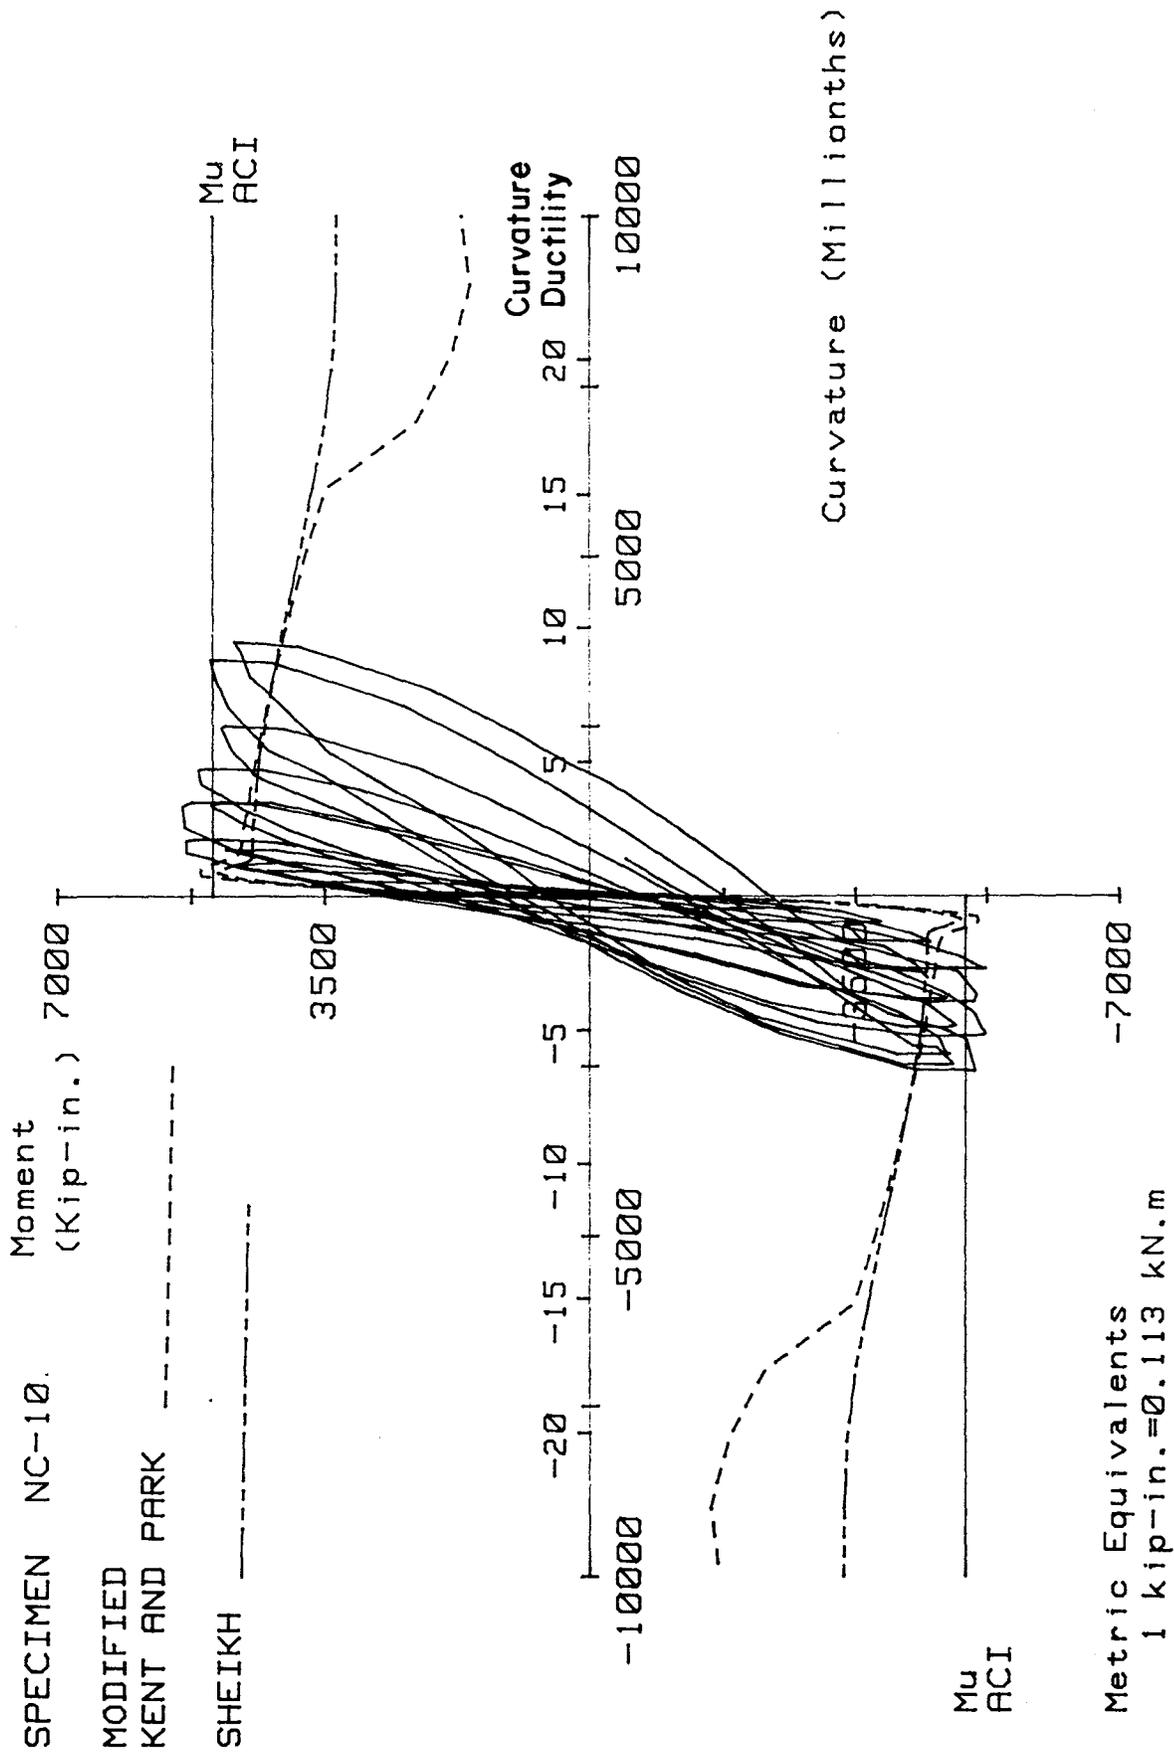
FIG. 6-17 MOMENT VERSUS CURVATURE FOR SPECIMEN NC-10

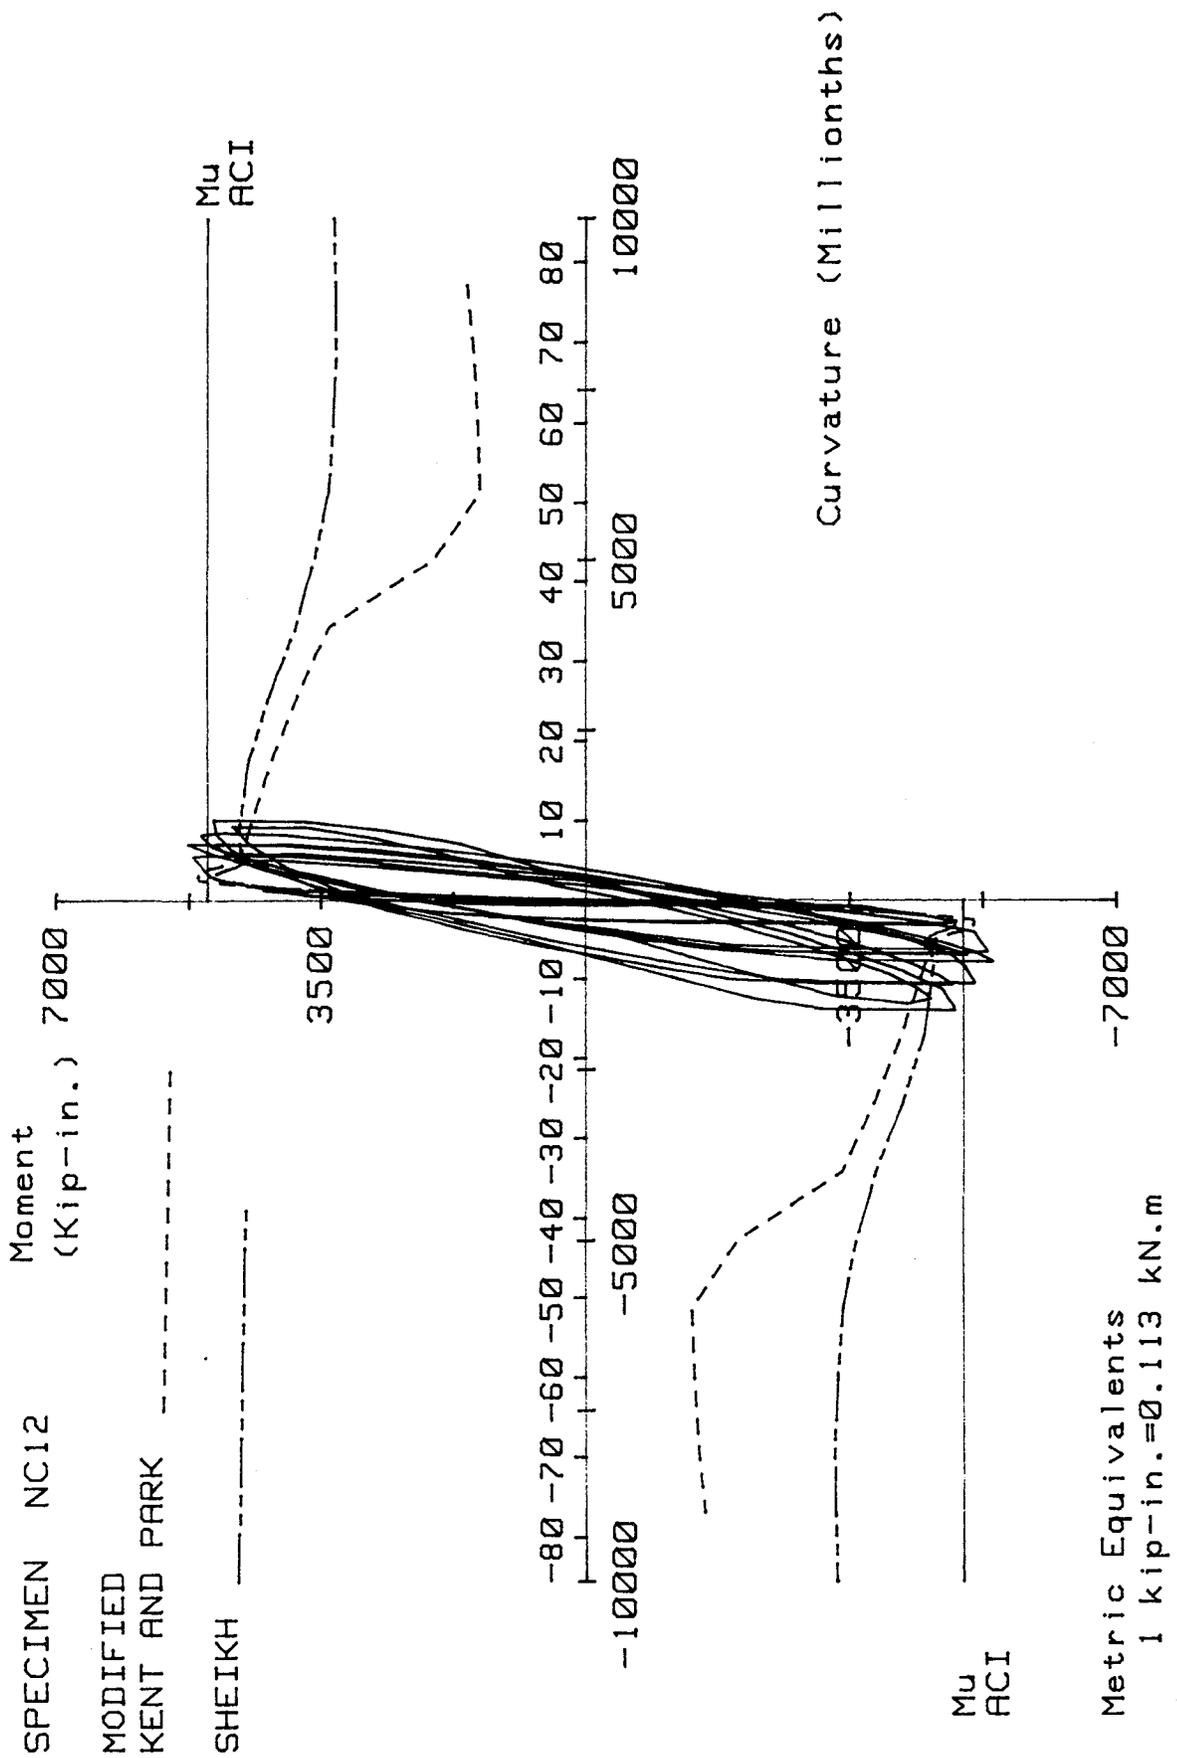
FIG. 6-18 MOMENT VERSUS CURVATURE FOR SPECIMEN NC-12

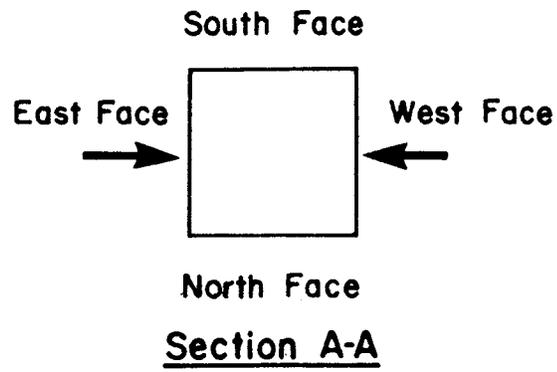
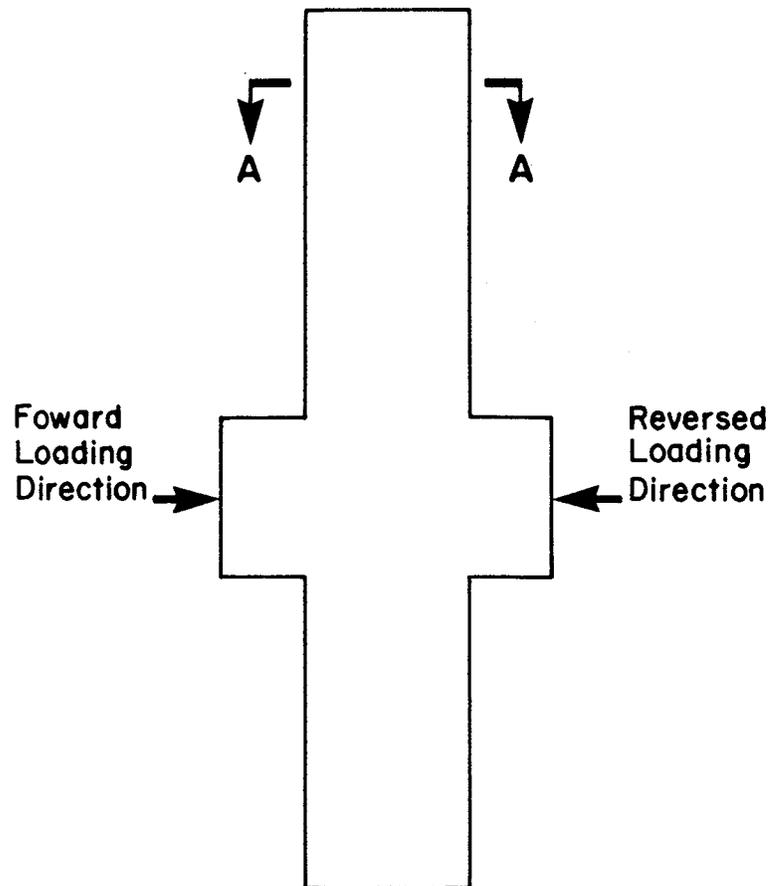
FIG. A-1 SPECIMEN ORIENTATION

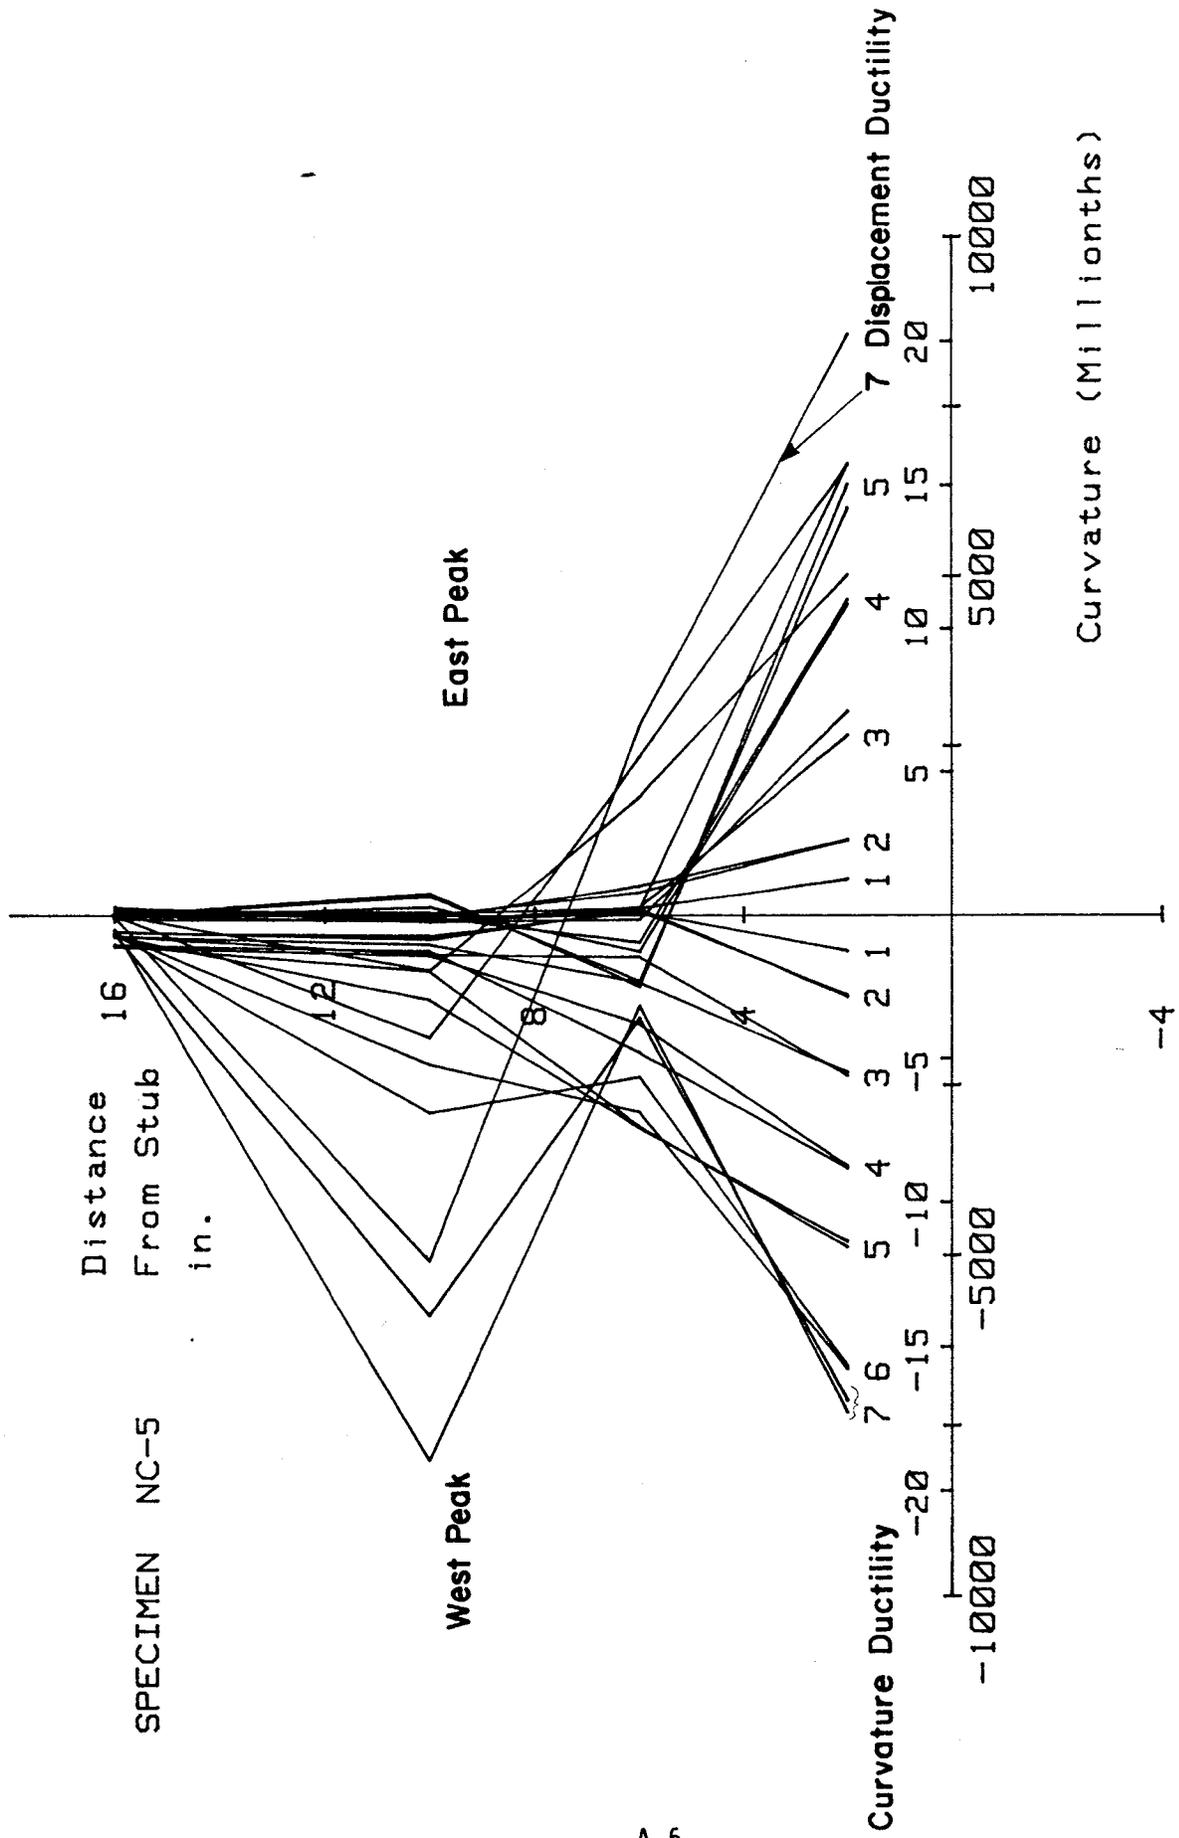
FIG. A-3 CURVATURE DISTRIBUTION, SPECIMEN NC-5

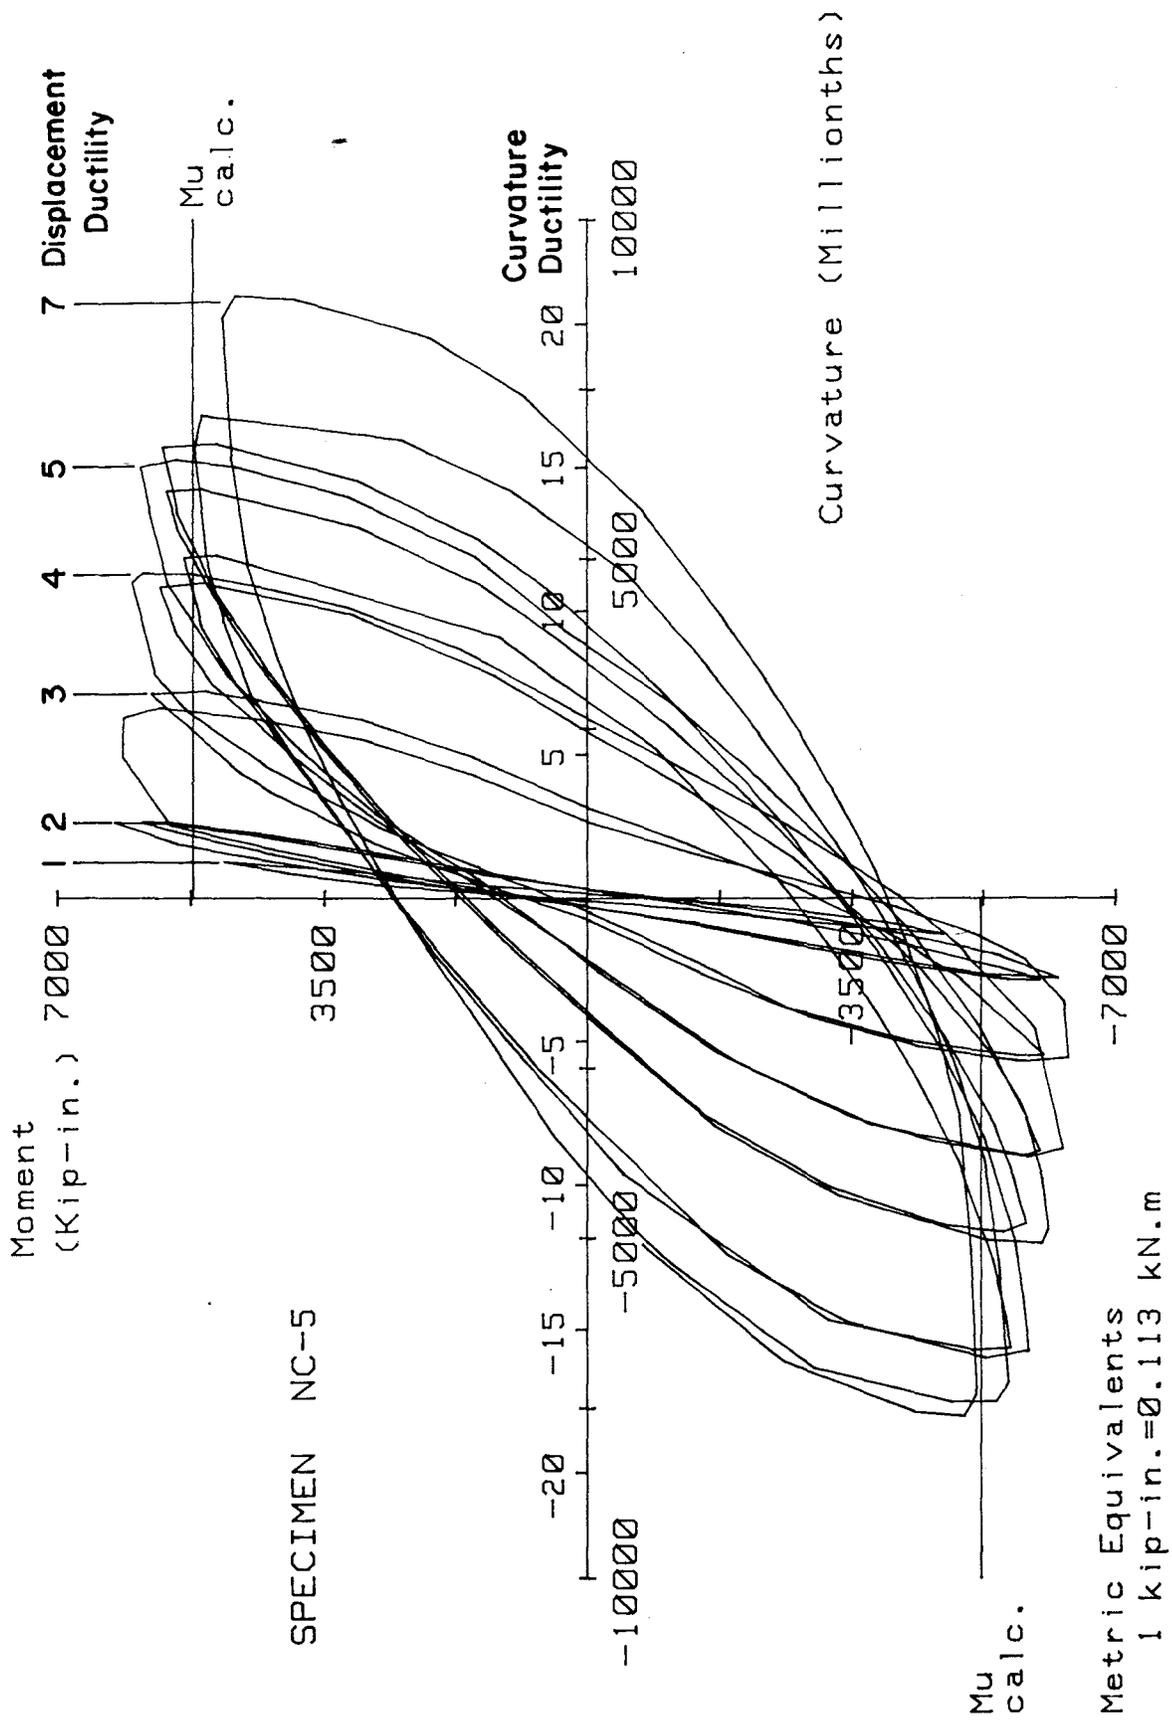
FIG. A-4 MOMENT VERSUS CURVATURE, SPECIMEN NC-5

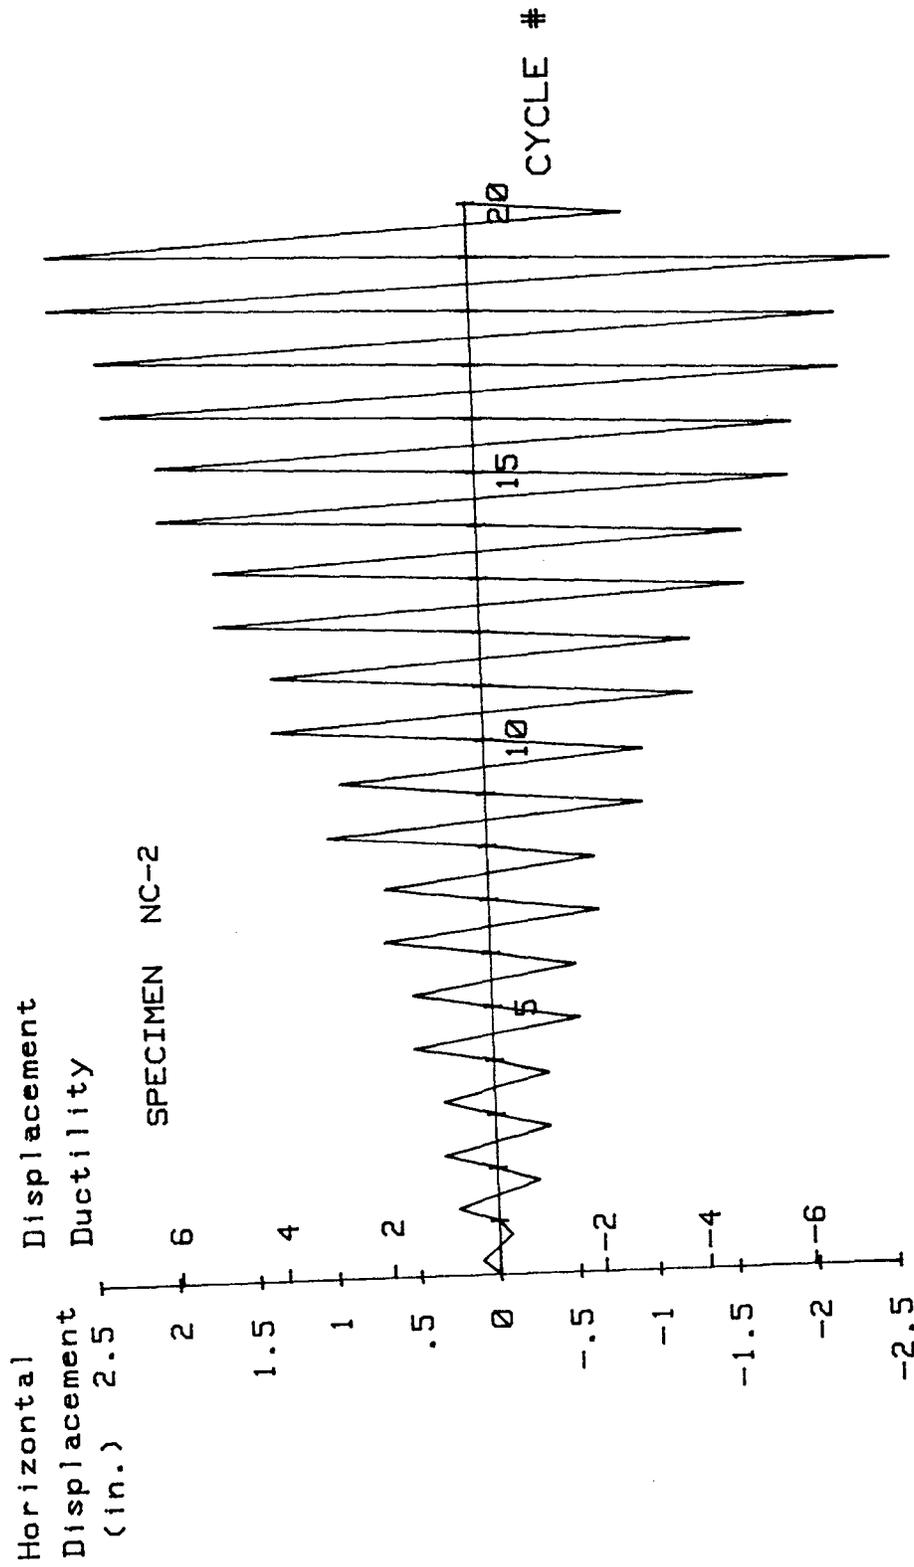
FIG. A-9 LOADING SCHEDULE, SPECIMEN NC-2

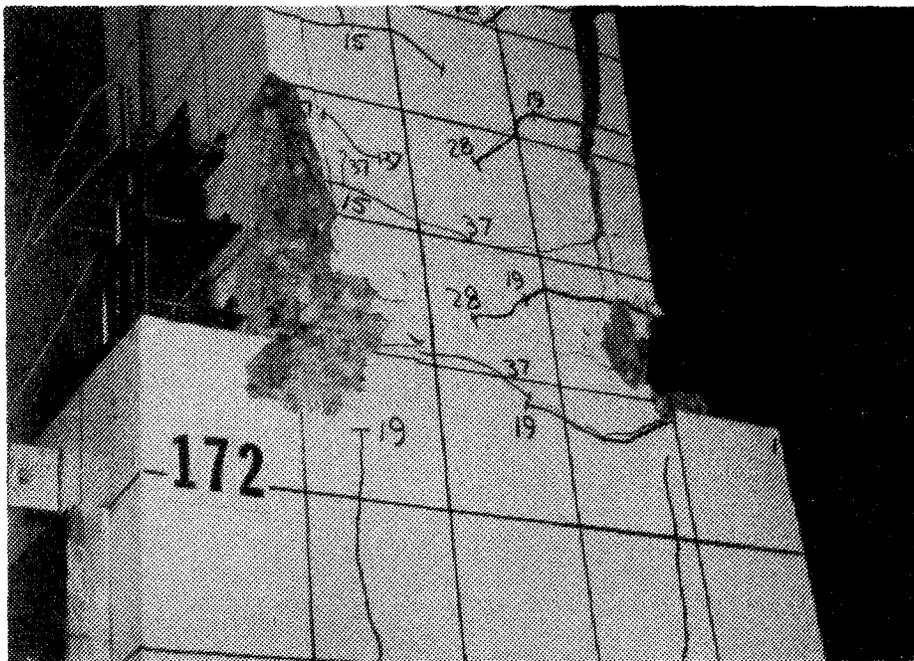
FIG. A-11 TEST SPECIMEN NC-2 AFTER CYCLE #13

The loss of cover concrete was gradual. At cycle #17 ($\mu=7$) the cover concrete was partially spalled on both the east and west faces. However, the transverse reinforcement was still not visible. After completion of two cycles at a displacement ductility ratio of eight, an attempt was made to apply a cycle at the next higher displacement level ($\mu=9$). During that

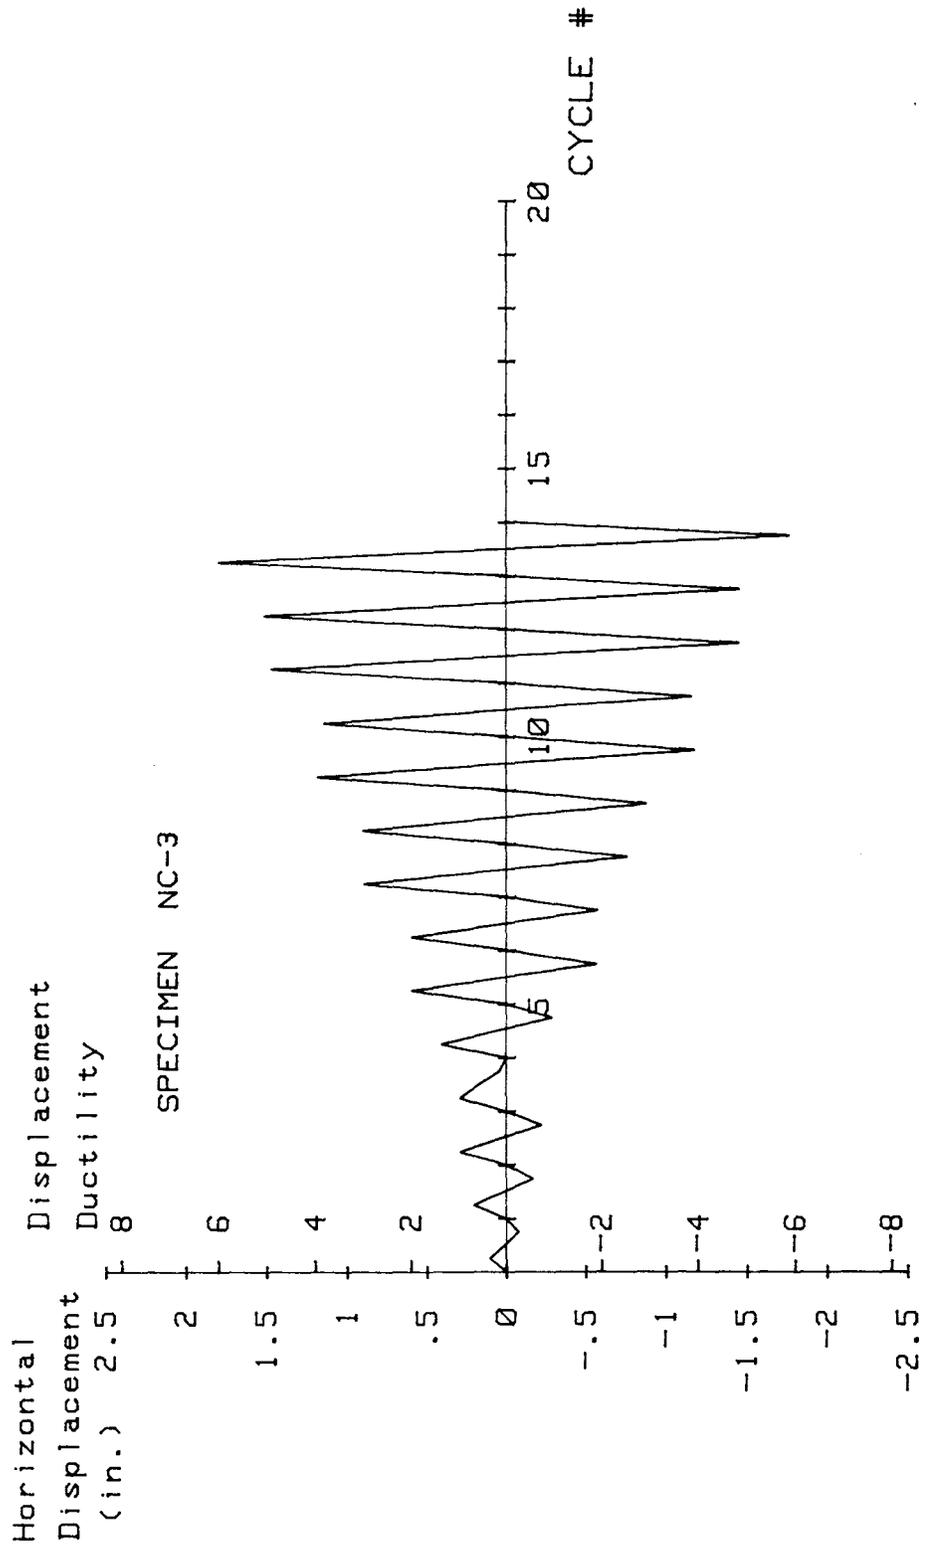
FIG. A-42 LOADING SCHEDULE, SPECIMEN NC-3

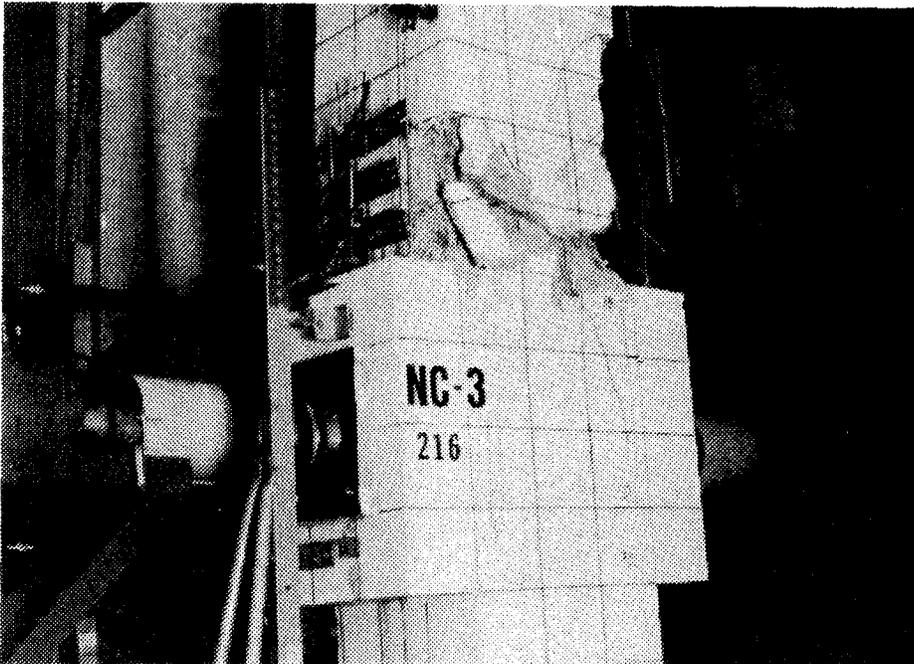
FIG. A-46 TEST SPECIMEN NC-3 AFTER CYCLE #13

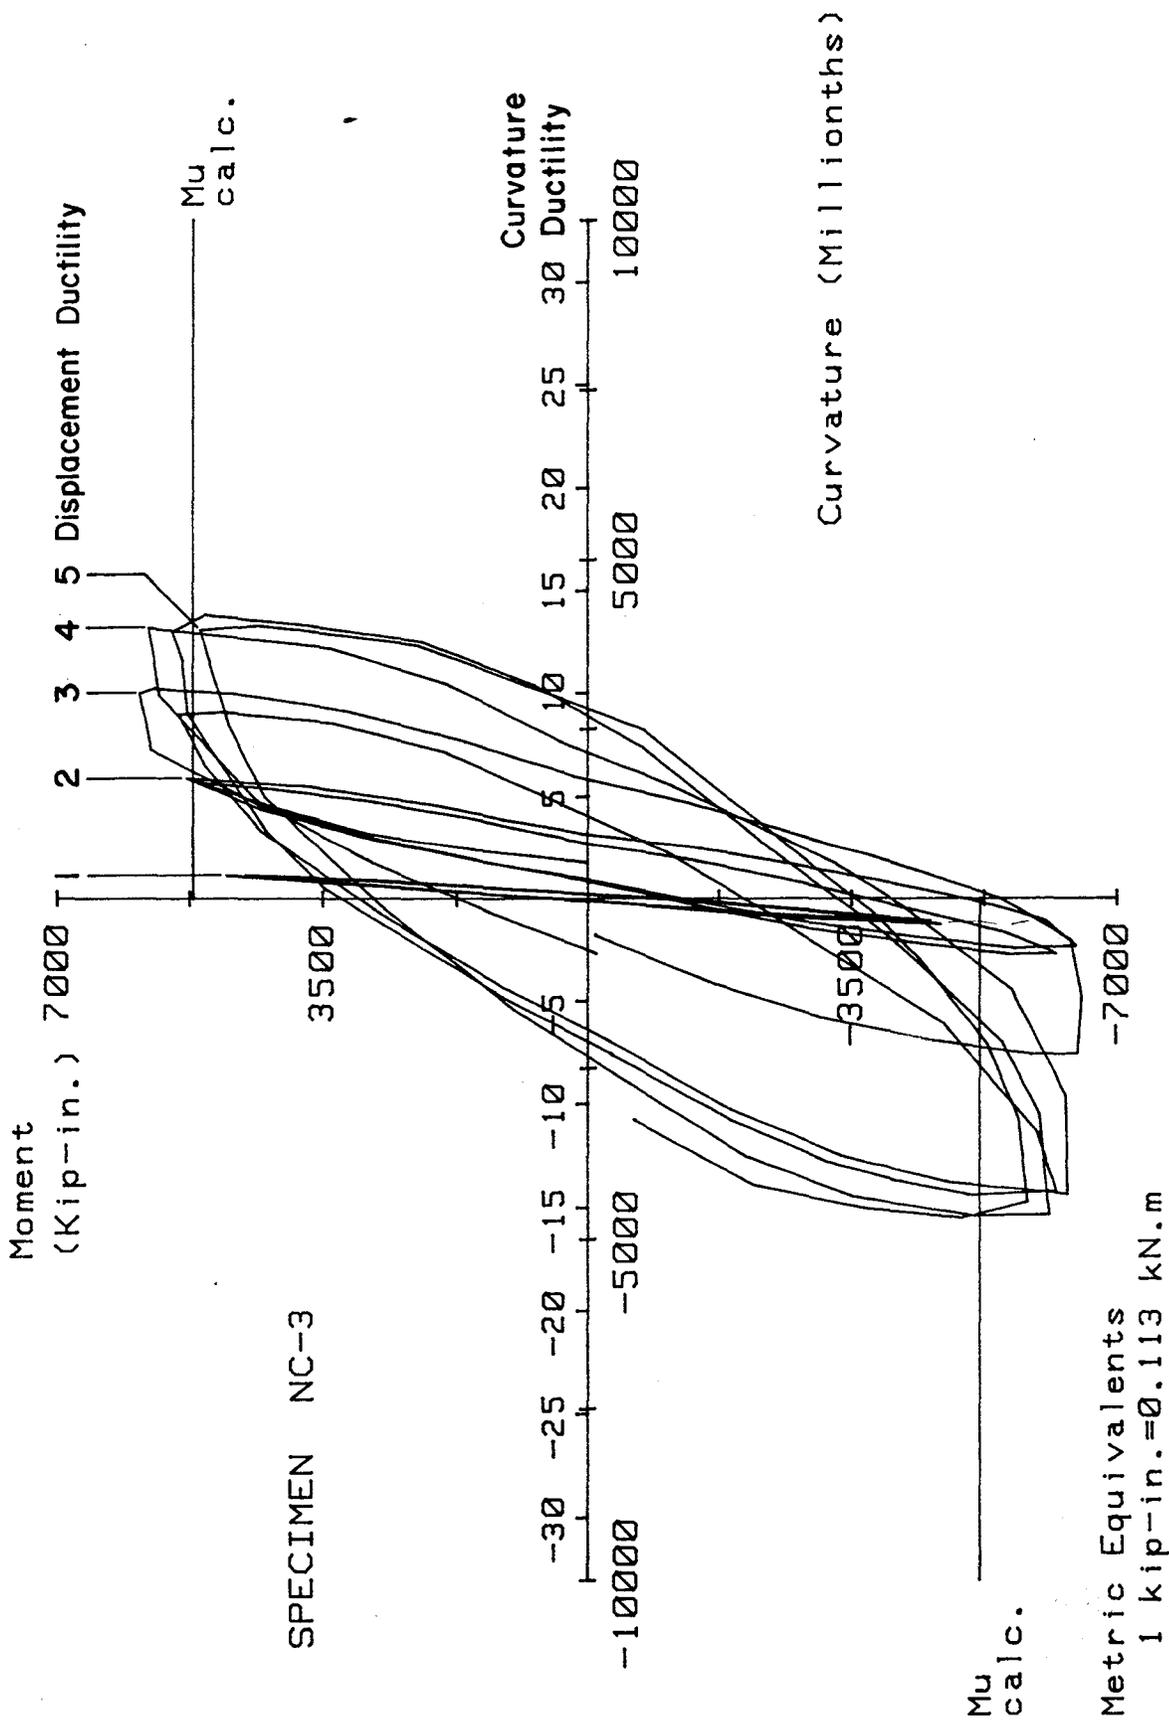
FIG. A-57 MOMENT VERSUS CURVATURE FOR SPECIMEN NC-3

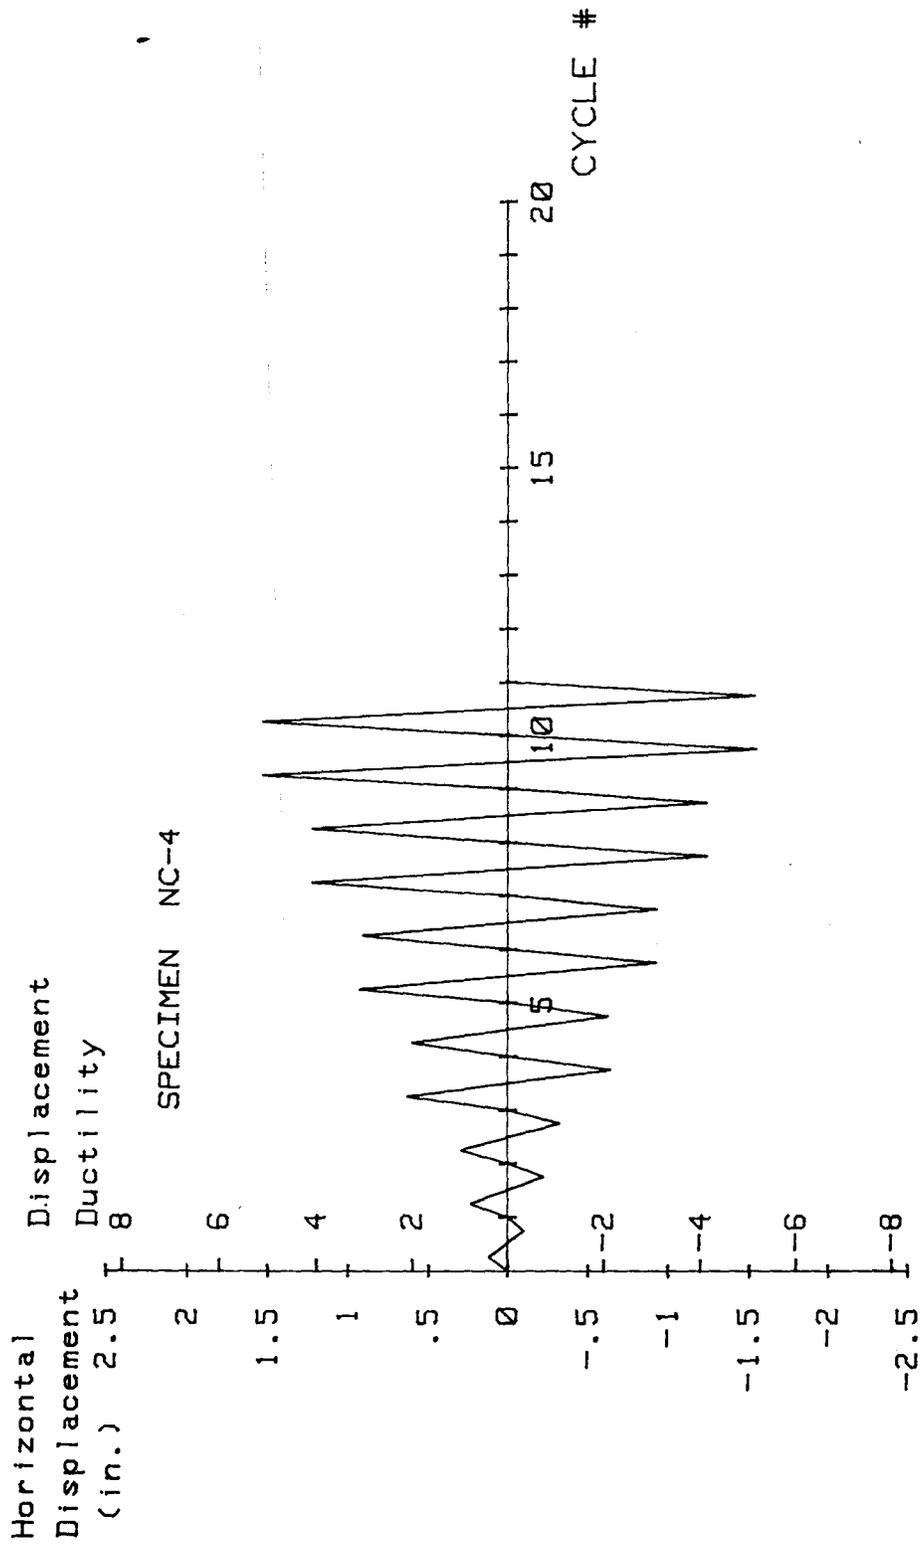
FIG. A-74 LOADING SCHEDULE, SPECIMEN NC-4

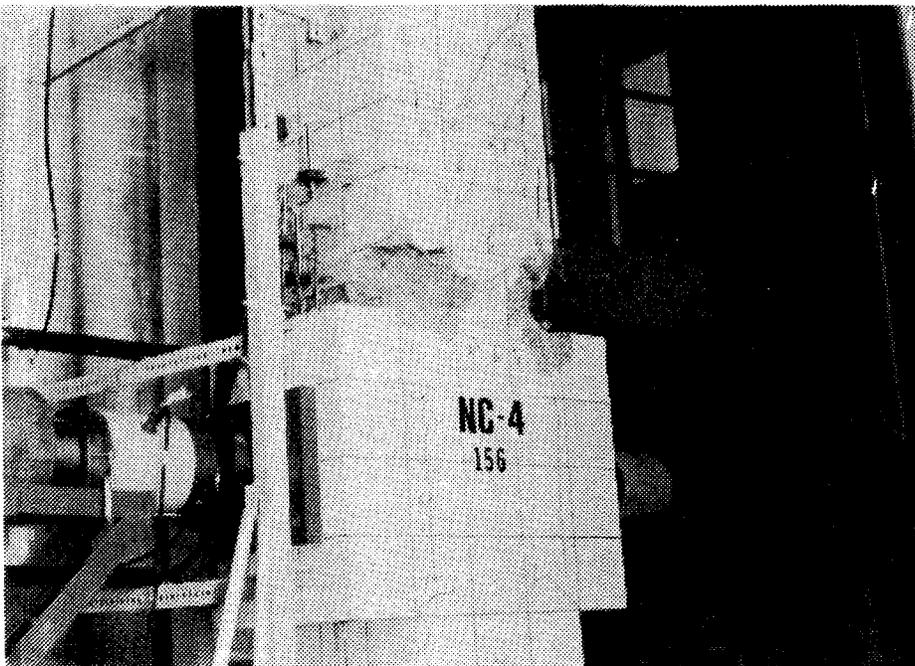
FIG. A-78 TEST SPECIMEN NC-4 AFTER CYCLE #9

Figure A-77 shows the specimen at the end of cycle #7 ($\mu=3$) where cover concrete had spalled to approximately 6 in. above the stub. However, no longitudinal or transverse reinforcement was visible at this point. Increasing the horizontal displacement ductility ratio to four resulted in more visible damage to the region just 6 in. above the stub as shown in Fig. A-78).
