***EFFECTS OF TRANSVERSE REINFORCEMENT
ON SEISMIC PERFORMANCE OF COLUMNS - A
PARTIAL PARAMETRIC INVESTIGATION***

September 1988

NATIONAL SCIENCE FOUNDATION
Washington, D.C.
Grant No. PFR-7902611

CONSTRUCTION TECHNOLOGY LABORATORIES, INC.
5420 Old Orchard Road
Skokie, Illinois 60077

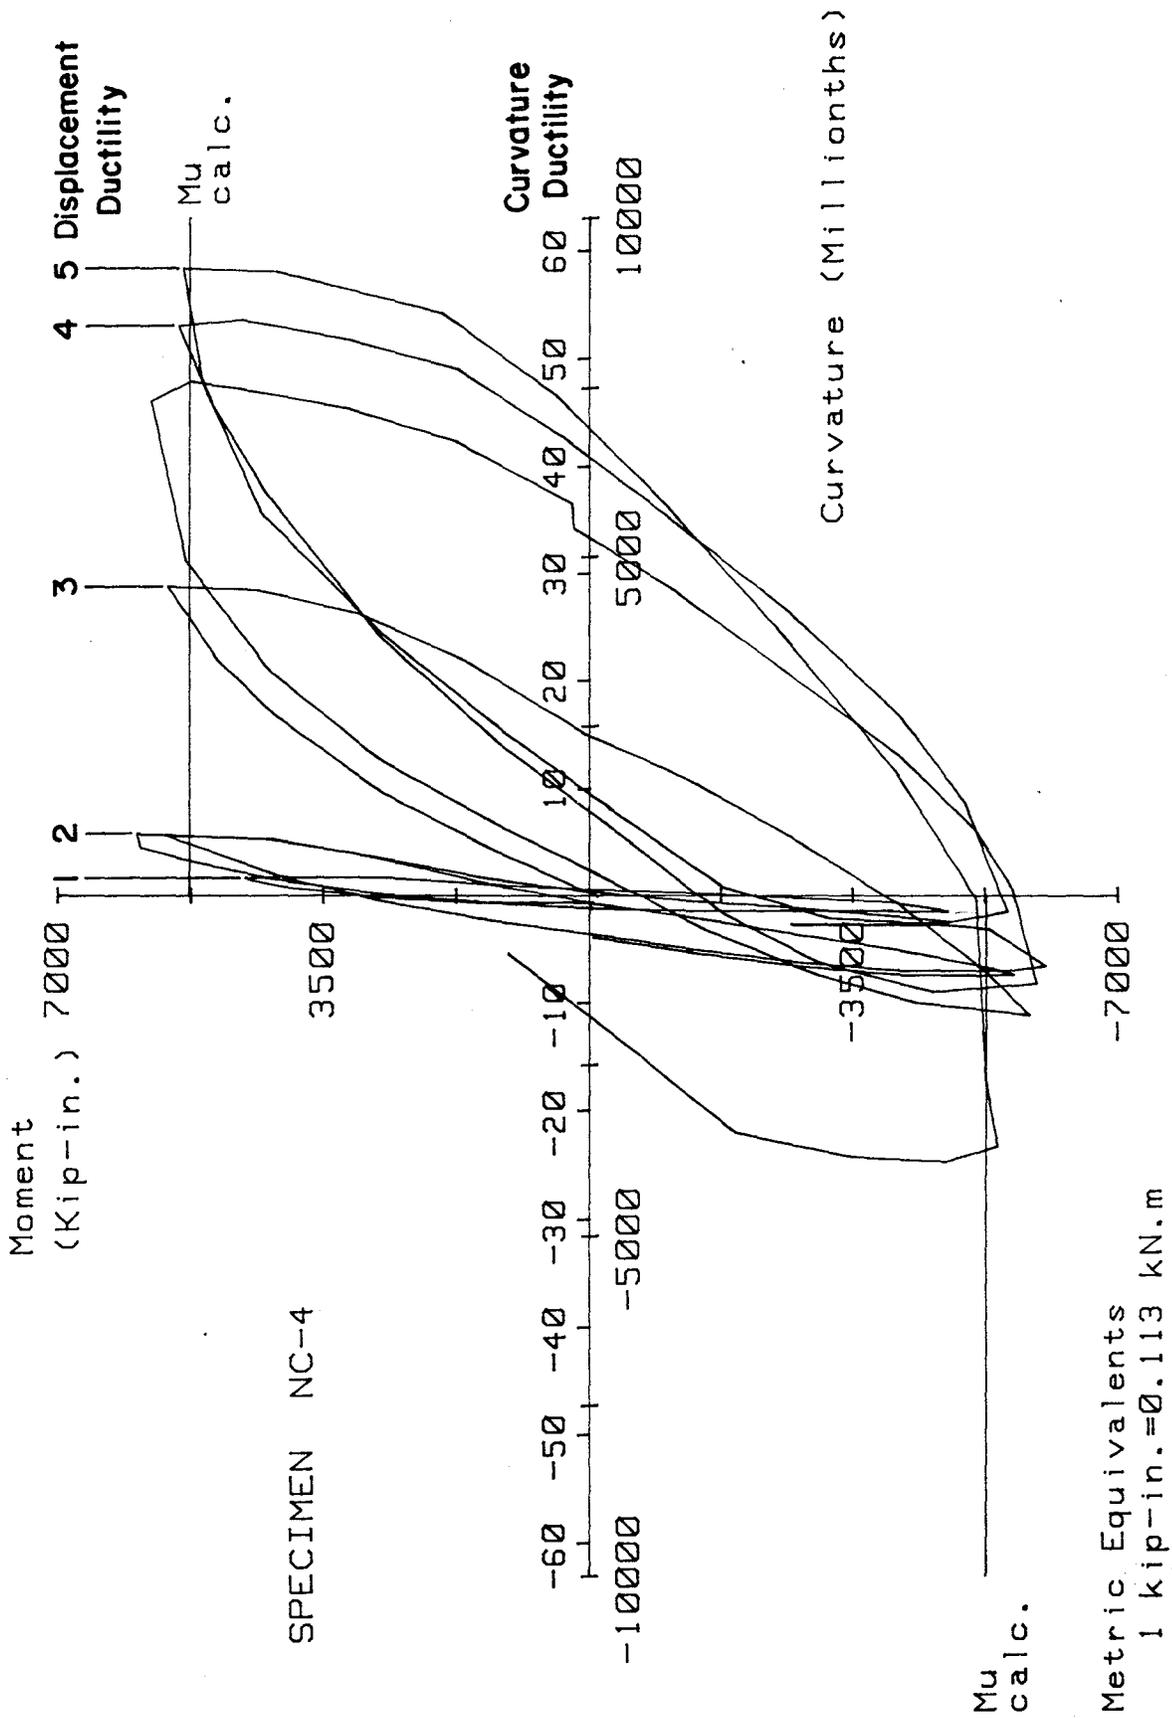
FIG. A-83 MOMENT VERSUS CURVATURE FOR SPECIMEN NC-4

Figure A-83 shows the moment-curvature characteristic of the specimen at the upper column-stub level. The theoretical value of the moment capacity of the column section using the procedure outlined in Section 4.8.2 was found to be 5268 in-kips. The maximum applied moment was 6152 in-kips. Negligible degradation in moment capacity of the column cross-section was observed as the peak applied moments at various displacement levels remained above the theoretical value. The ratio of the peak moment at the second cycle to the peak moment at the first cycle ranged between 0.9 to 0.95 at various displacement levels.

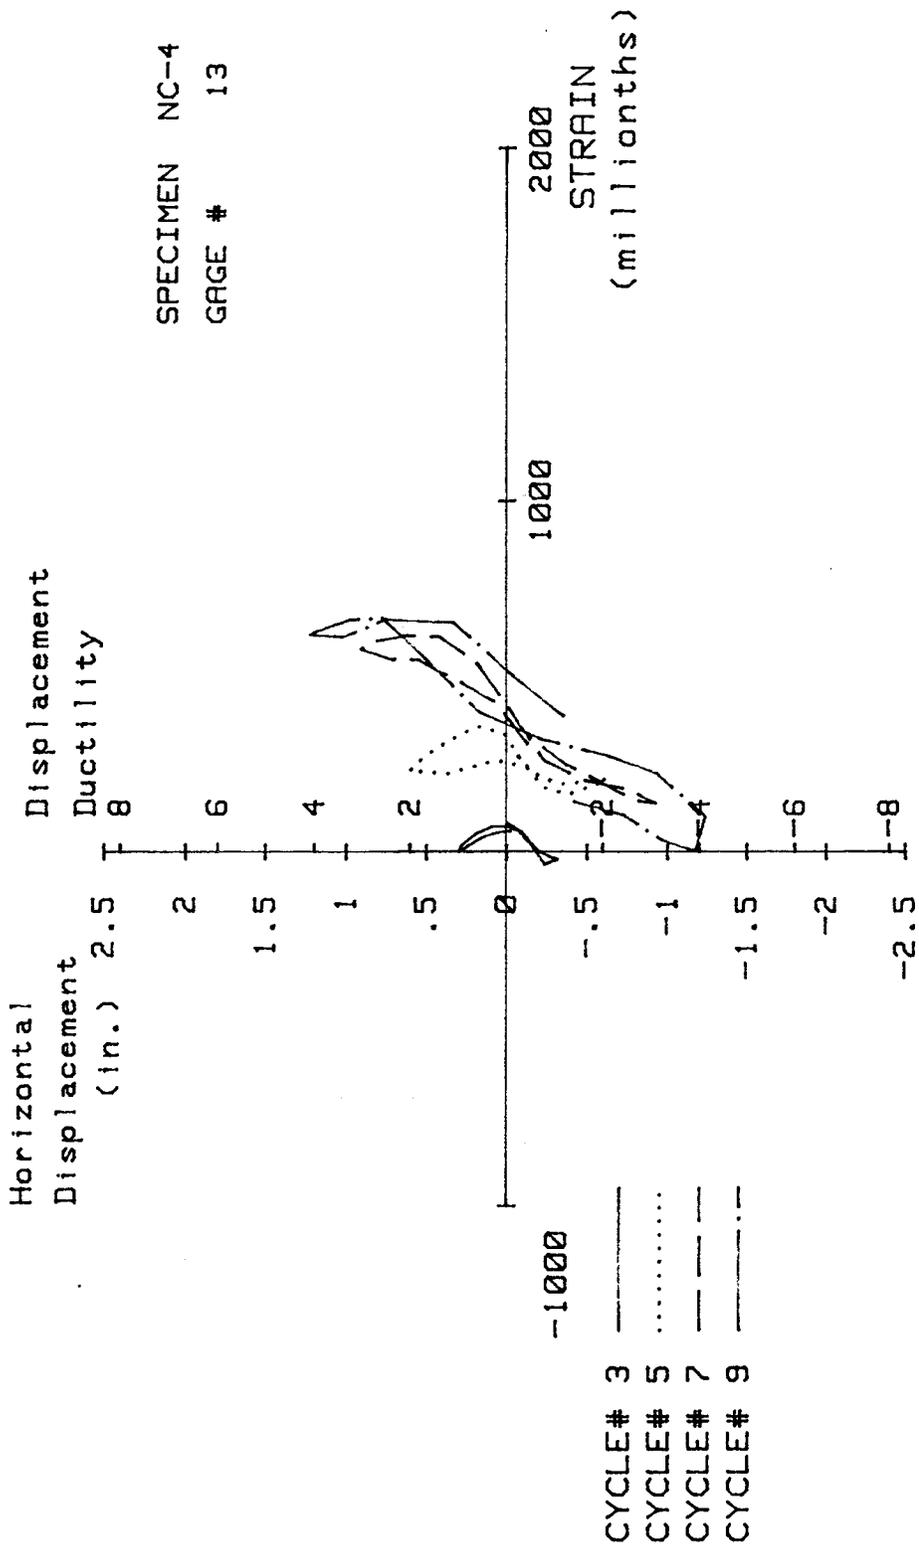
FIG. A-84 MEASURED STRAIN, GAGE #13, SPECIMEN NC-4

In general, during the early stages of loading ($\mu=4$), the maximum strain occurred at the transverse reinforcements located 14 and 18 in. above the stub. The strain on the interior hoops was generally smaller than the strain on the peripheral hoops.

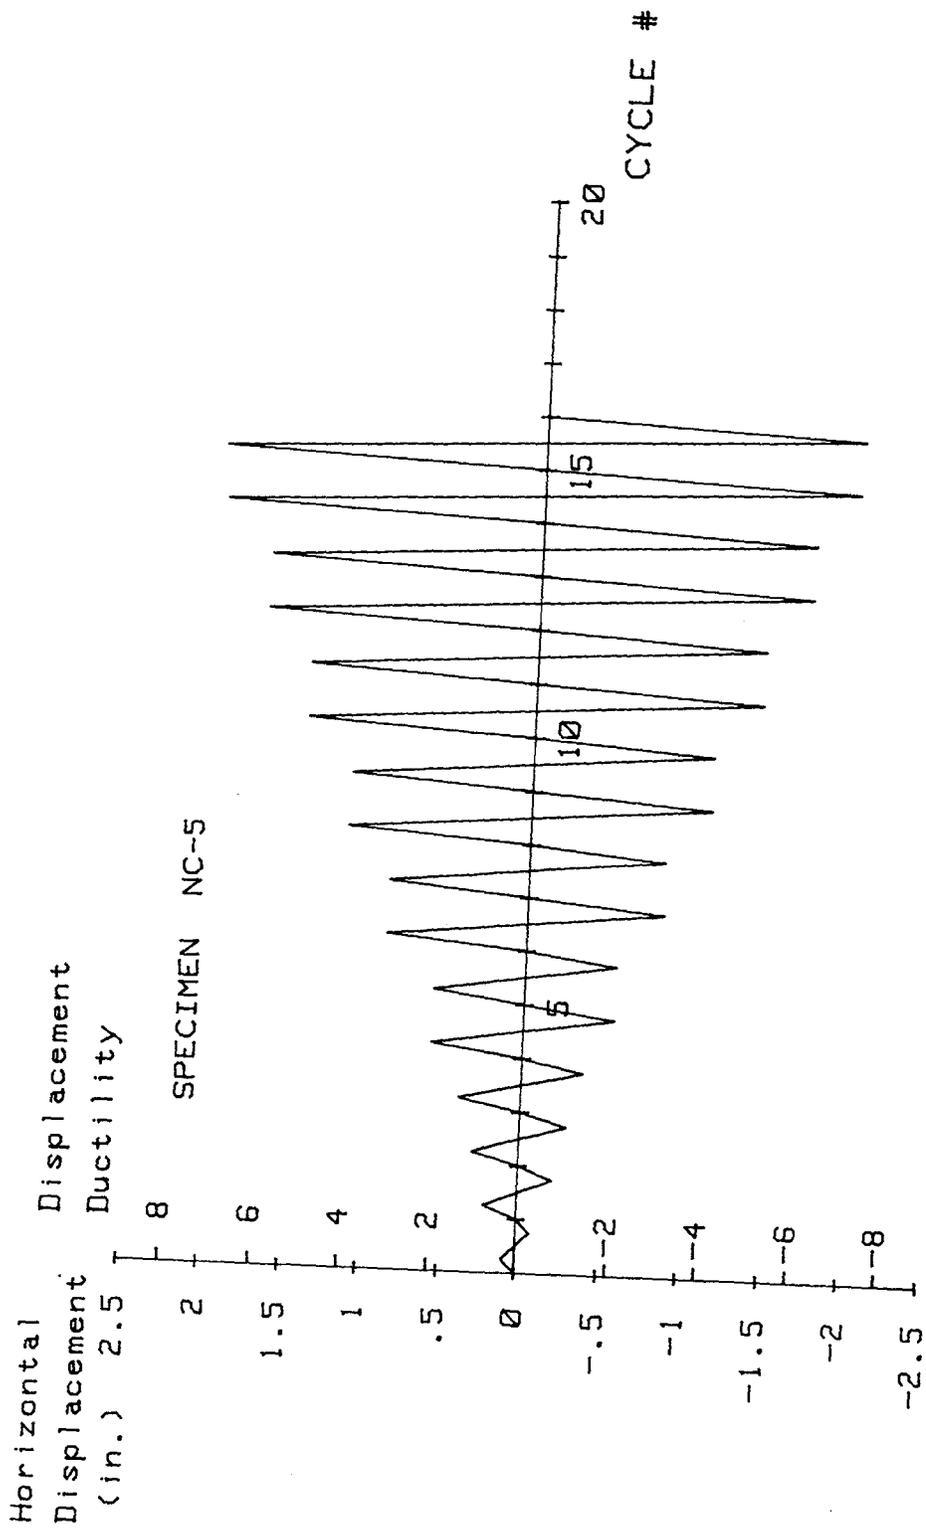
FIG. A-107 LOADING SCHEDULE, SPECIMEN NC-5

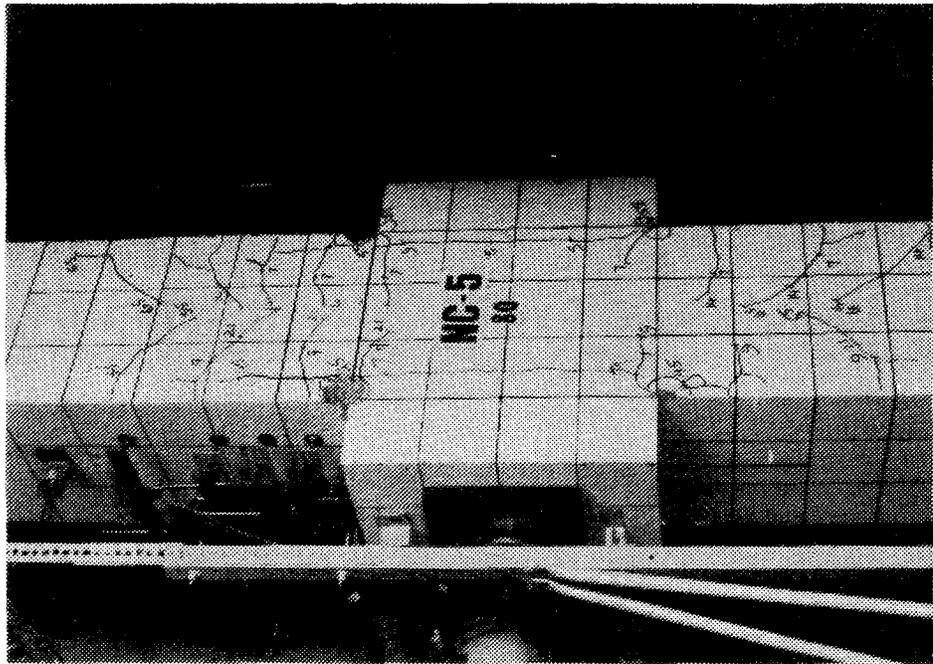
FIG. A-108 TEST SPECIMEN NC-5 AFTER CYCLE #6

Figure A-108 shows the specimen at the end of cycle #6 ($\mu=2$). Limited spalling of the cover concrete at the corners of the stub-upper column interface was visible. Increasing the horizontal displacement to a

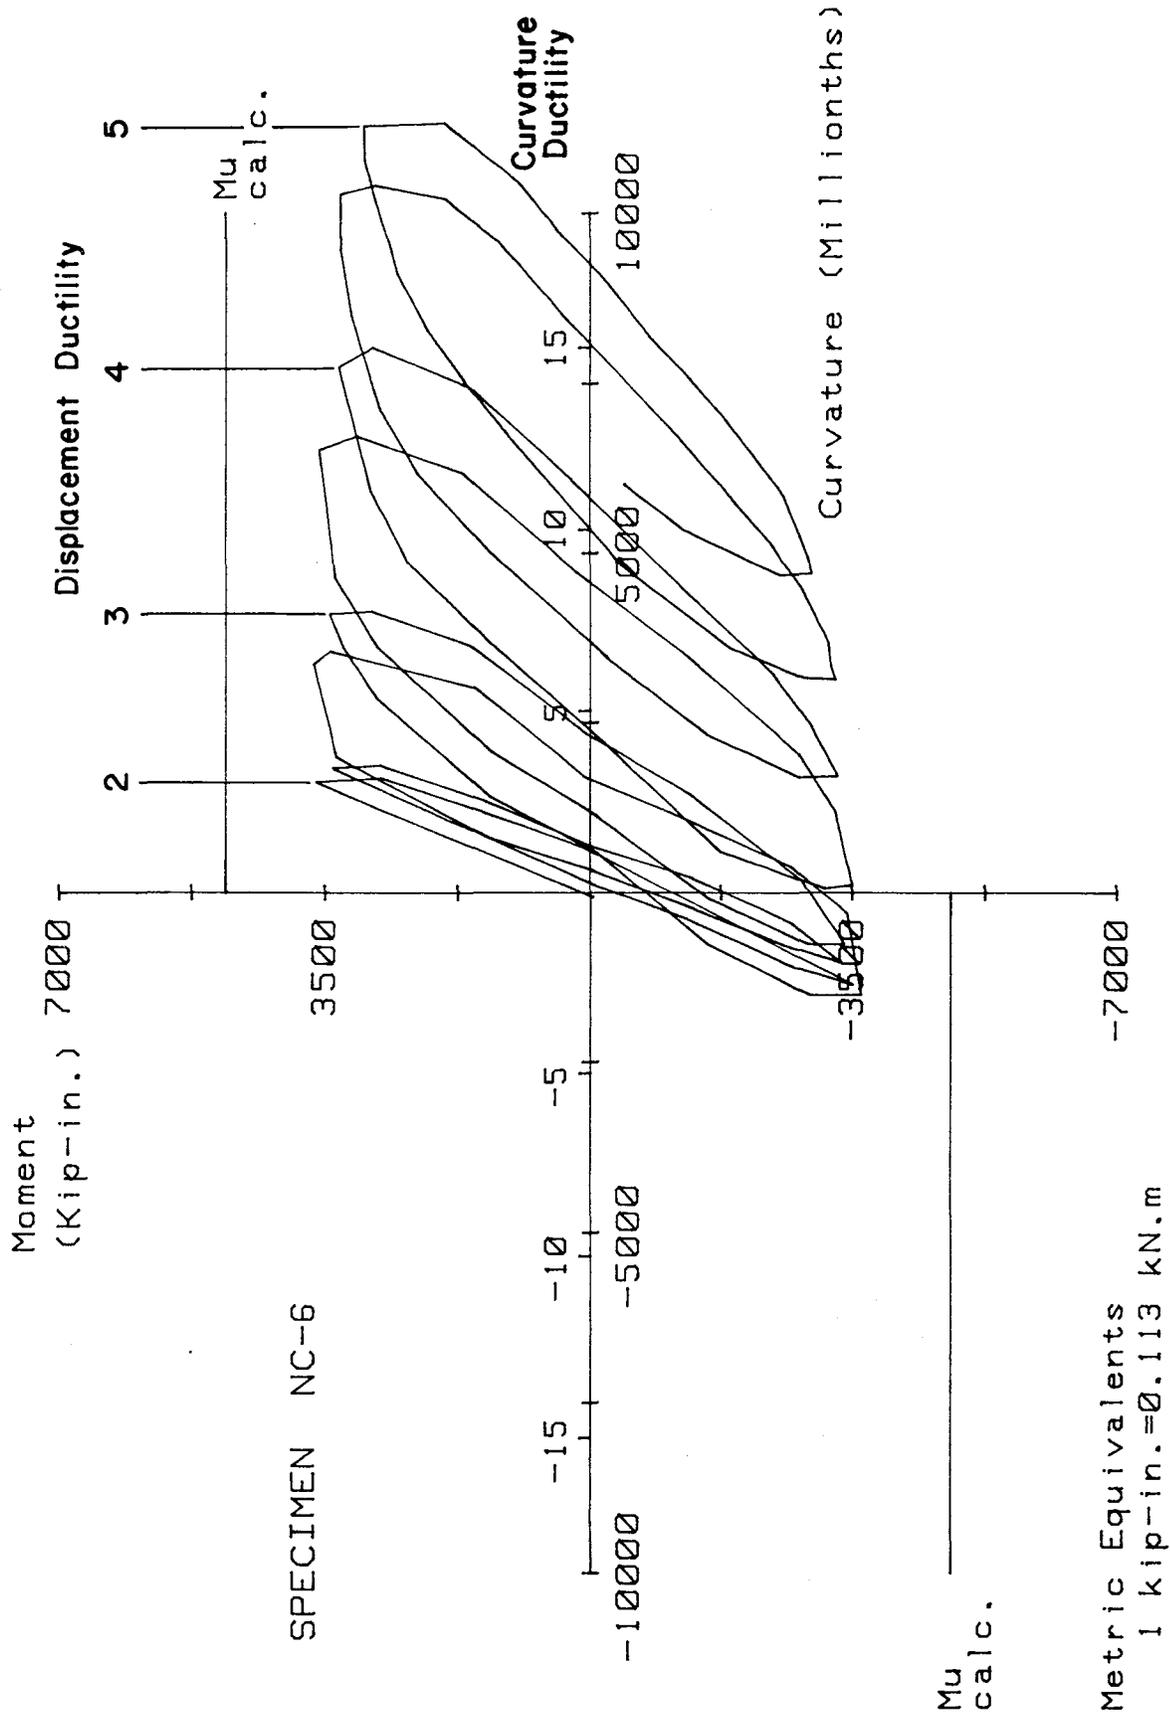
FIG. A-147 MOMENT VERSUS CURVATURE FOR SPECIMEN NC-6

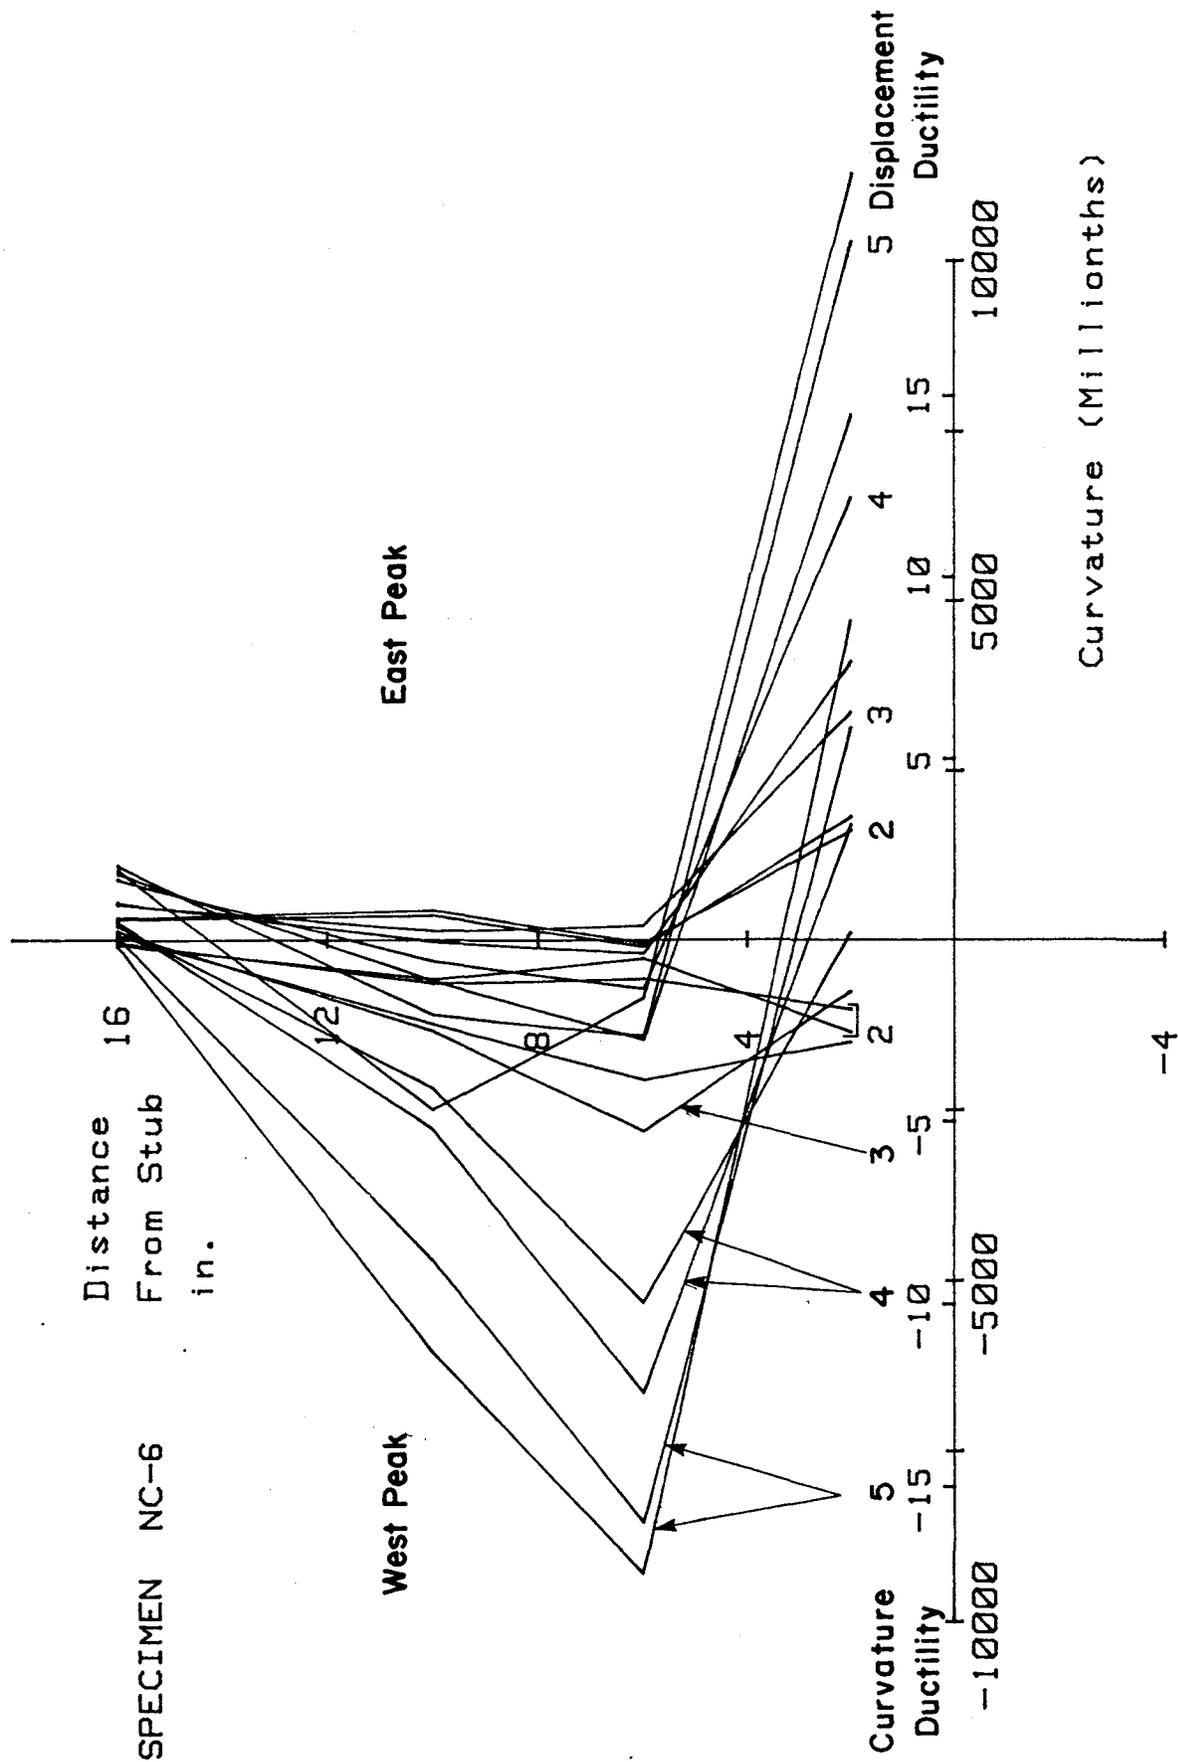
FIG. A-148 CURVATURE DISTRIBUTION ALONG UPPER COLUMN SPECIMEN NC-6

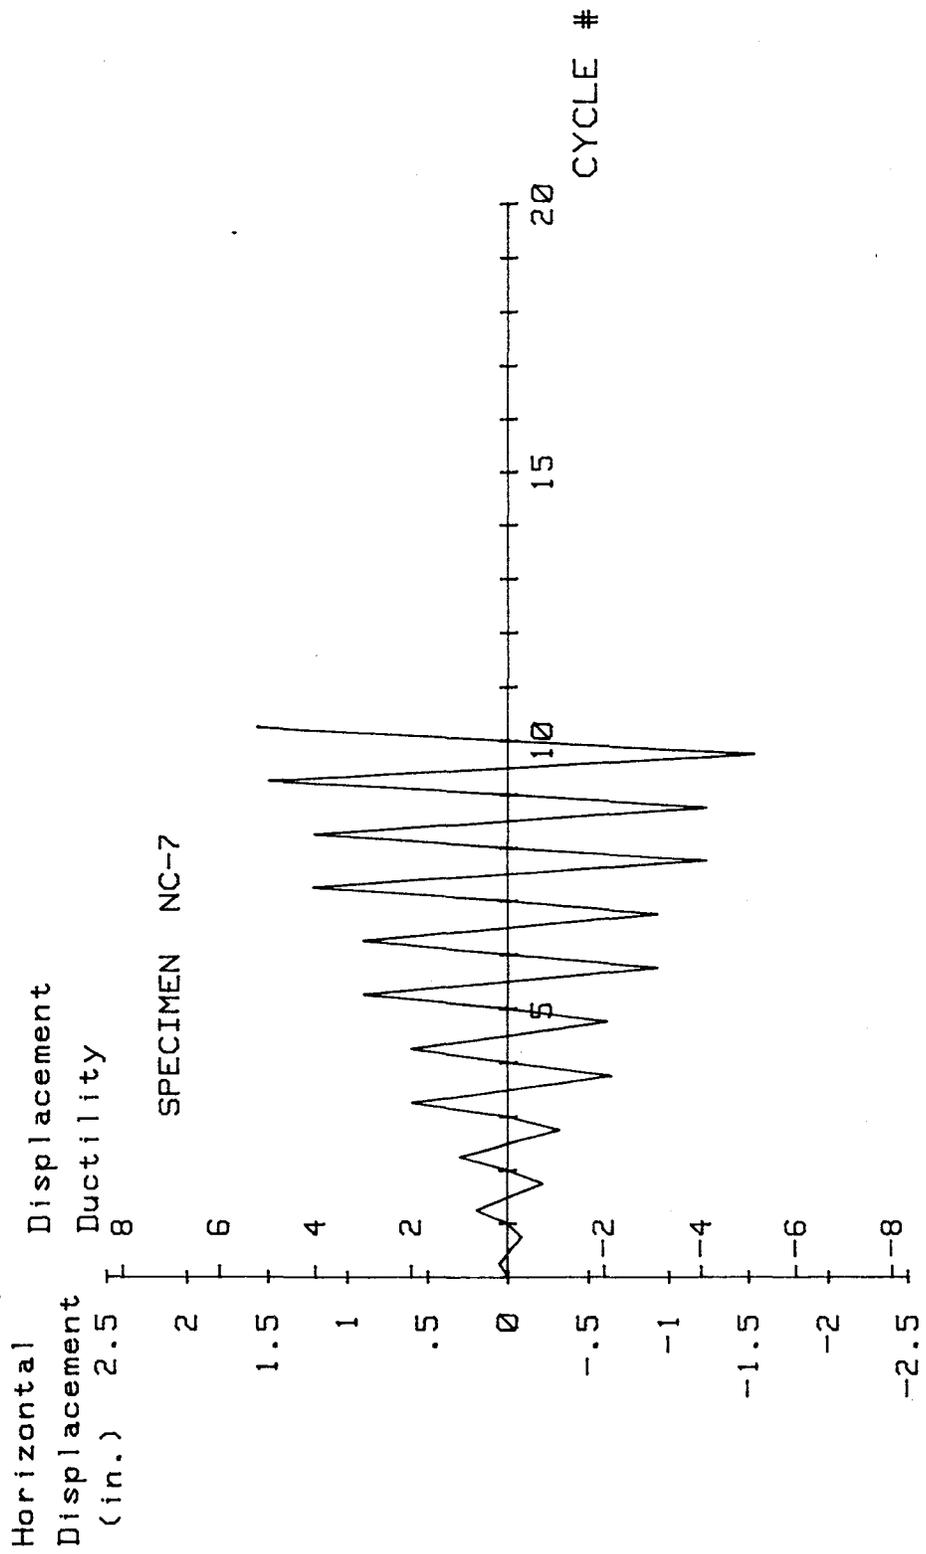
FIG. A-153 LOADING SCHEDULE, SPECIMEN NC-7

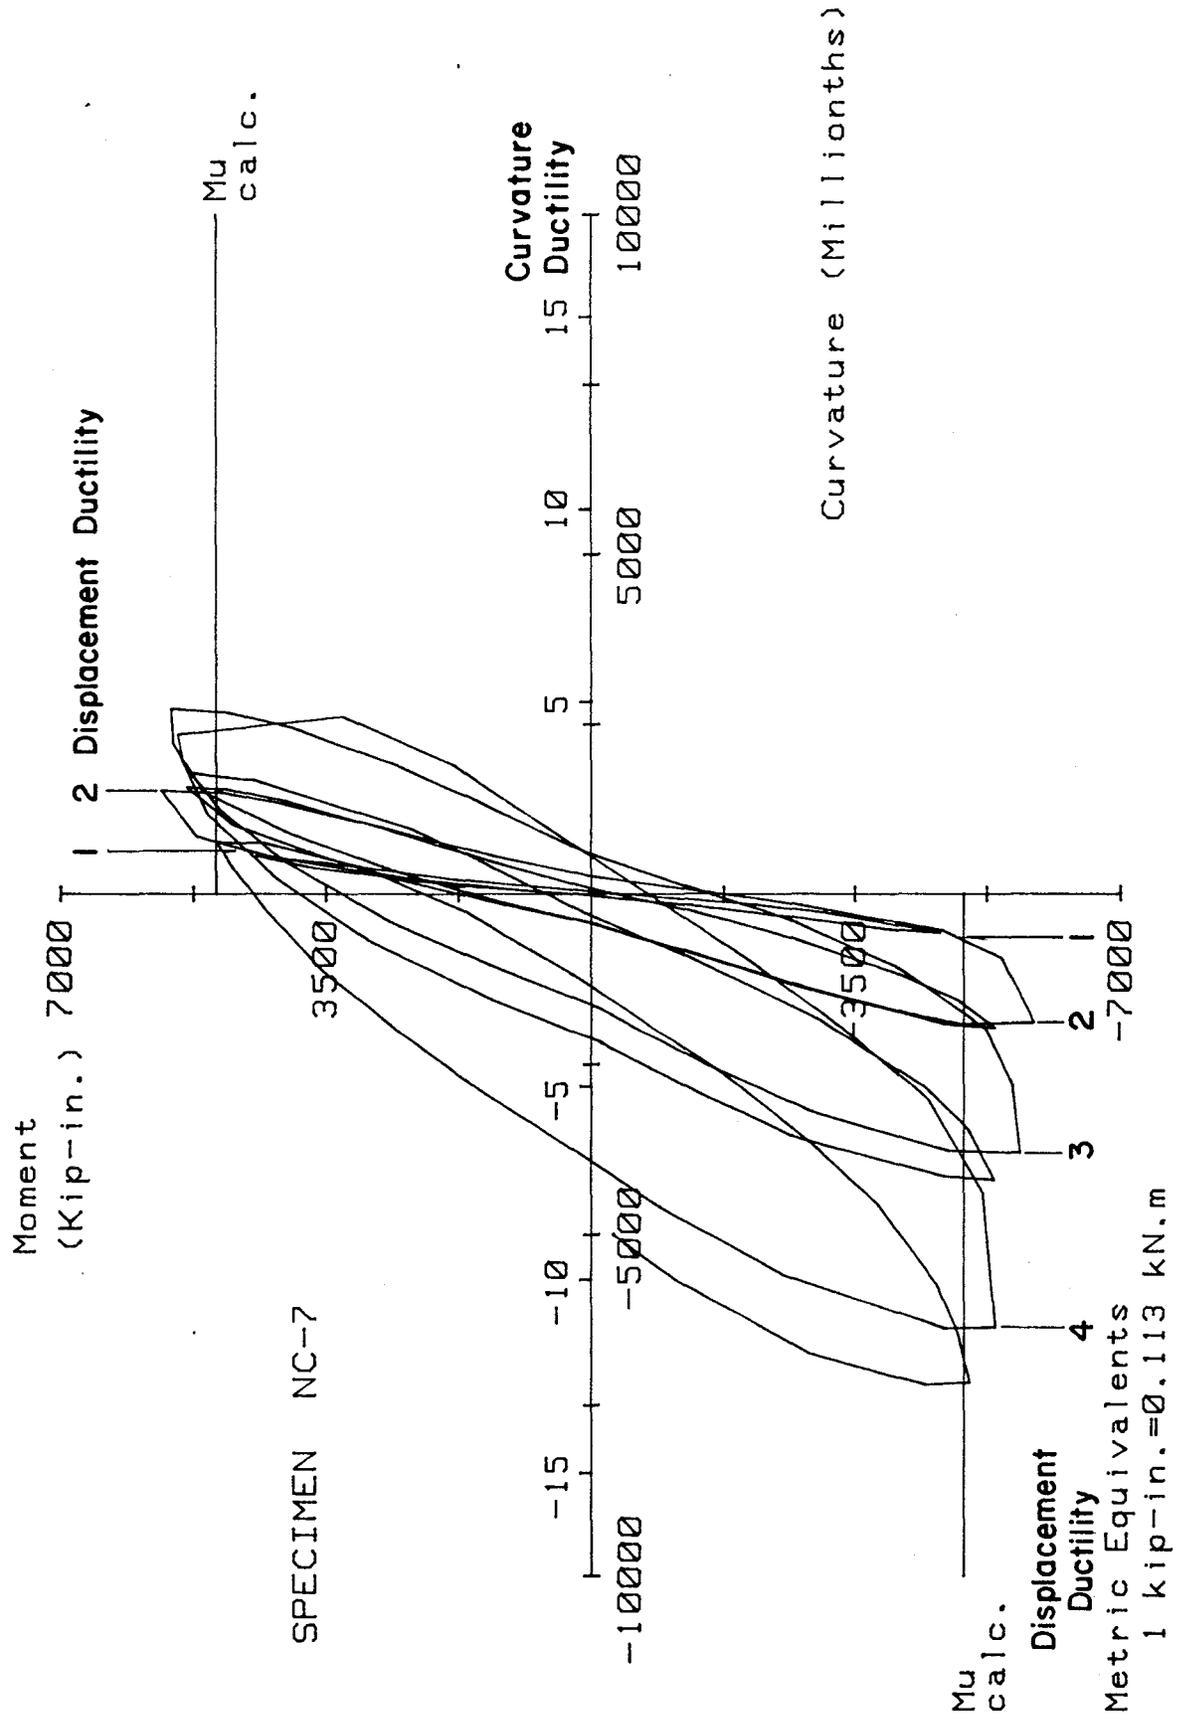
FIG. A-162 MOMENT VERSUS CURVATURE FOR SPECIMEN NC-7

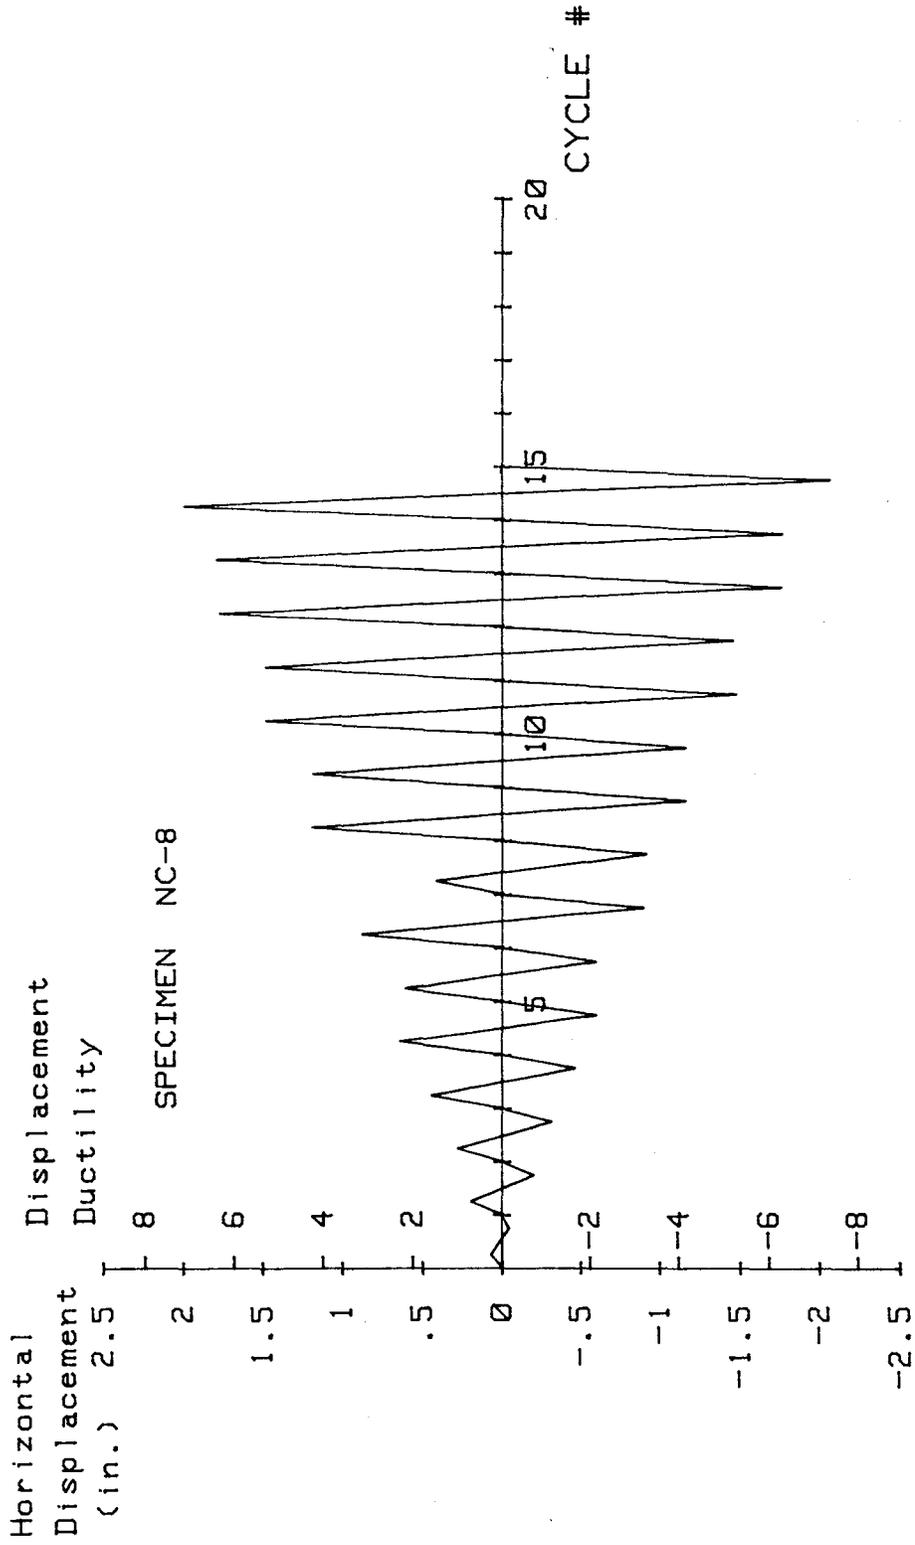
FIG. A-170 LOADING SCHEDULE, SPECIMEN NC-8

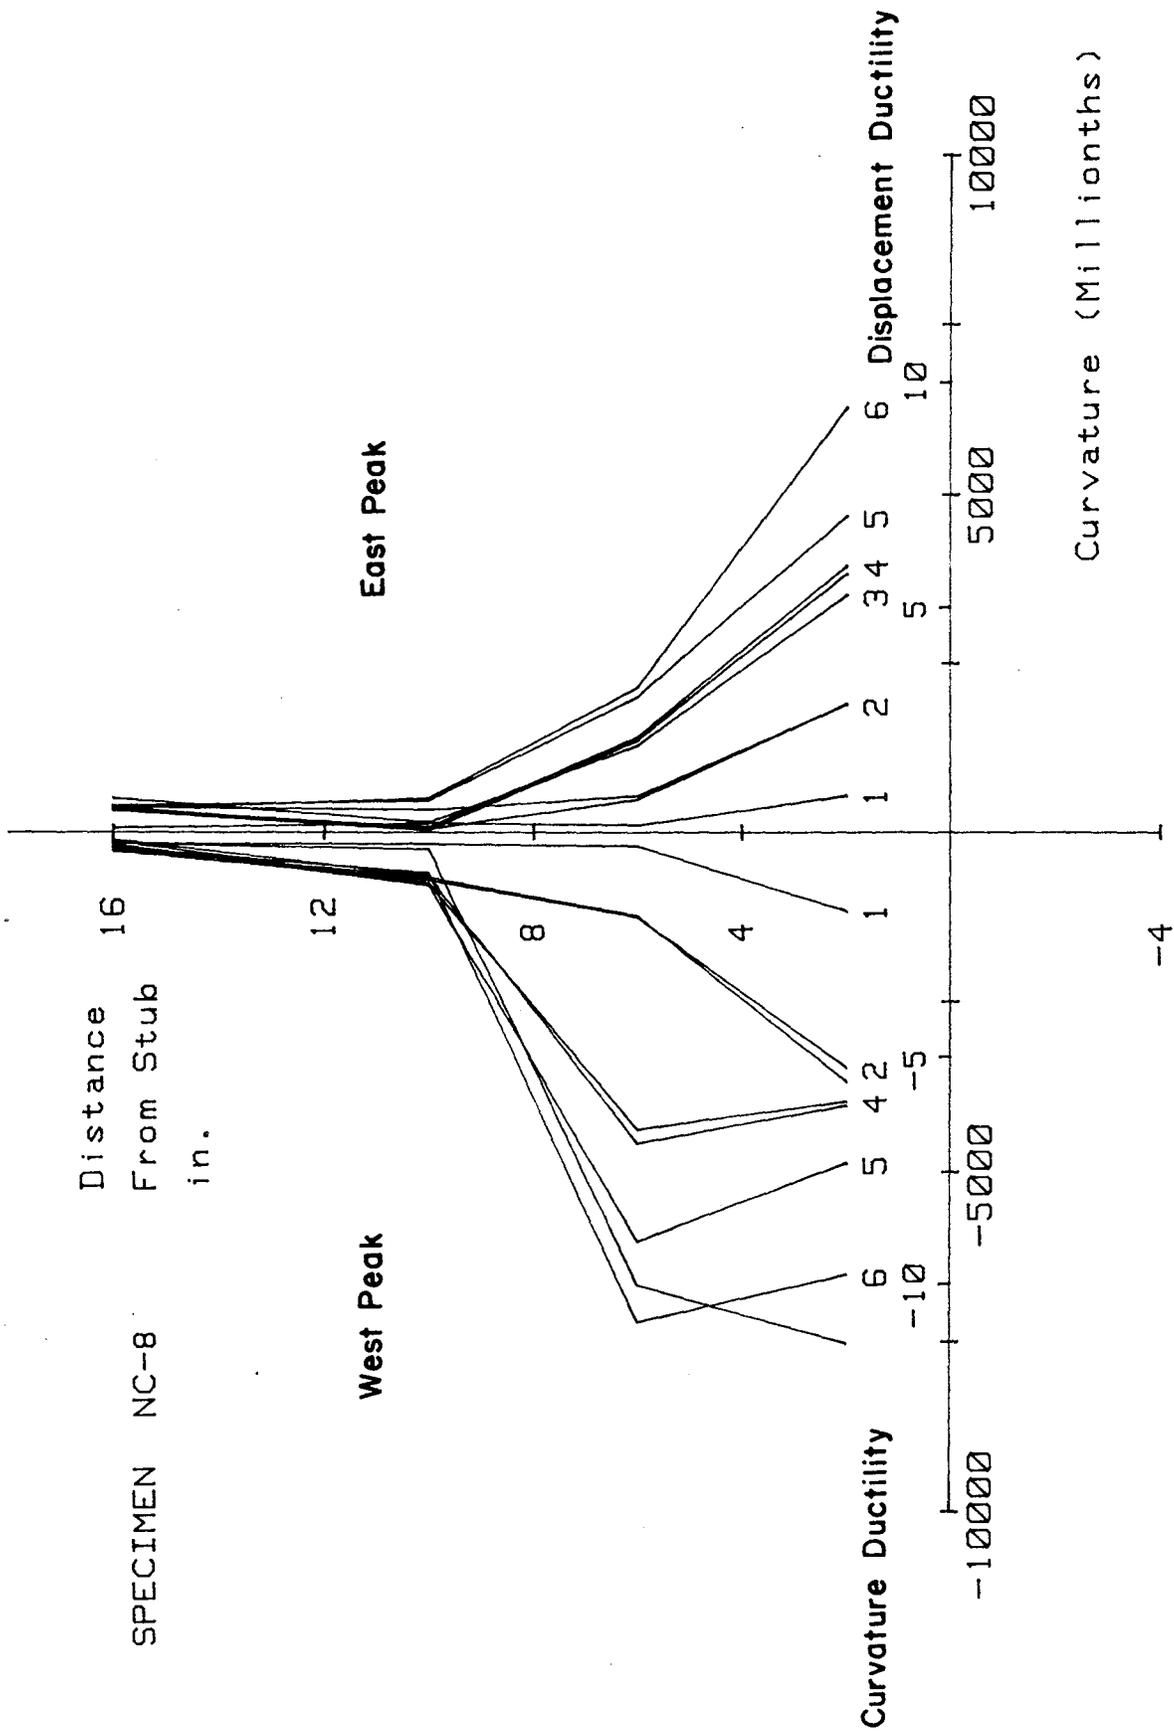
FIG. A-178 CURVATURE DISTRIBUTION ALONG UPPER COLUMN, SPECIMEN NC-8

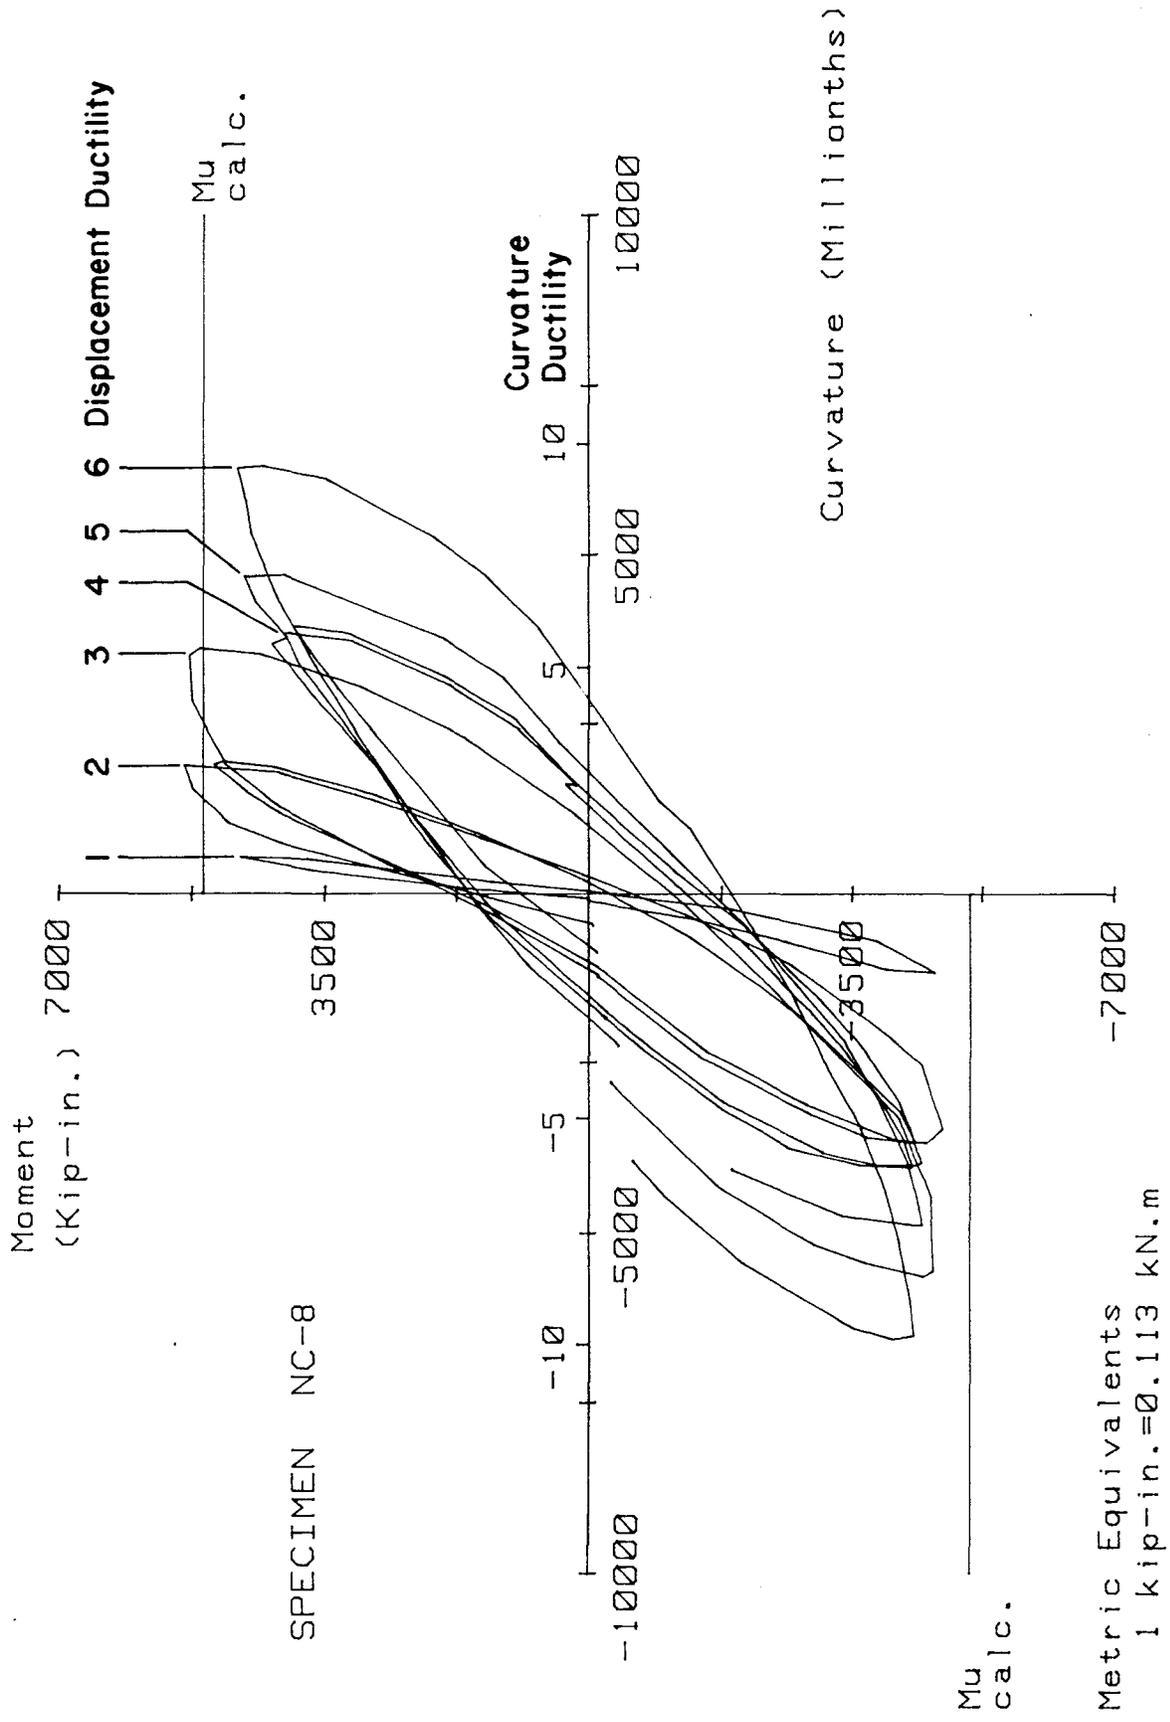
FIG. A-179 MOMENT VERSUS CURVATURE FOR SPECIMEN NC-8

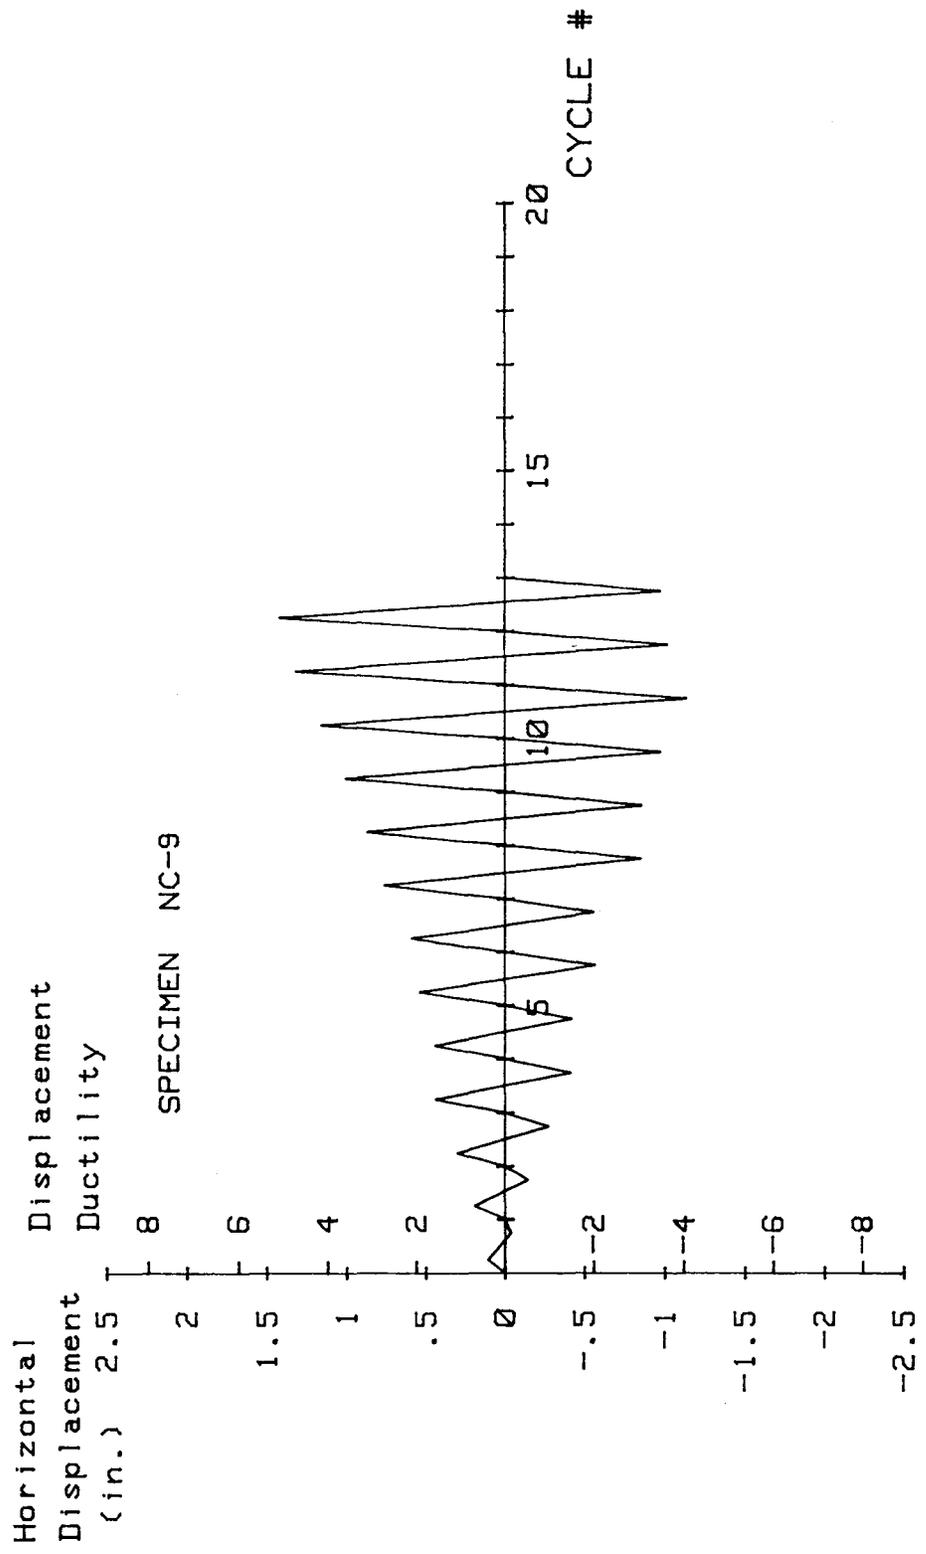
FIG. A-196 LOADING SCHEDULE, SPECIMEN NC-9

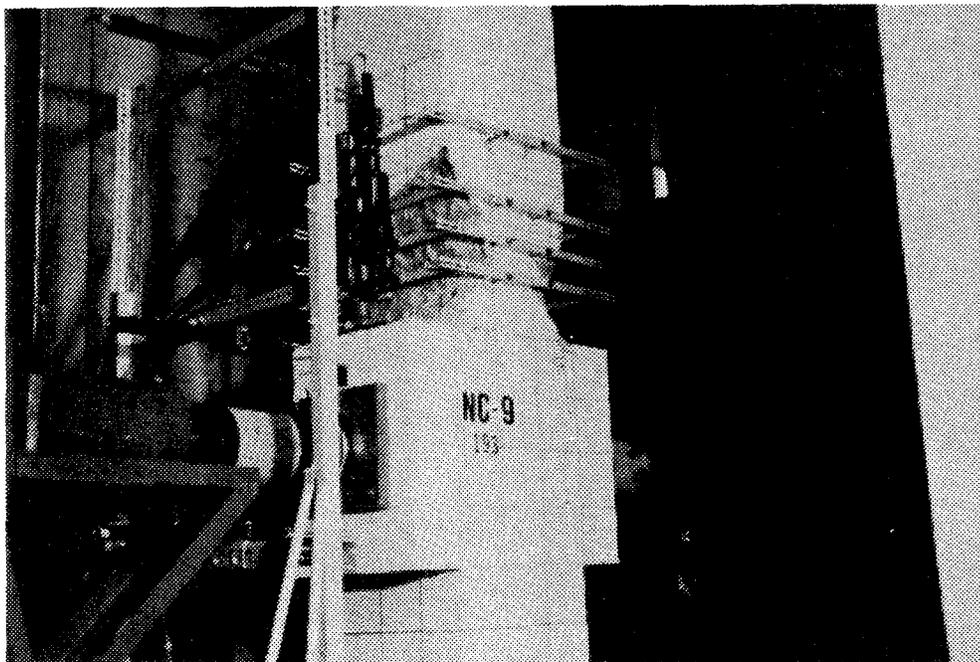
FIG. A-198 TEST SPECIMEN NC-9 AFTER CYCLE #9

The first hairline cracks were observed during cycle #2. Cracks formed primarily within 6 in. above the stub. Figure A-197 shows the specimen at the end of cycle #7 ($\mu=2$), at which point some crushing of the cover concrete at the stub-upper column interface was observed. Cracking extended to within 30 in. above the stub. At the end of cycle #9 ($\mu=3$), spalling of the cover concrete had extended to 18 in. above the stub as shown in Fig. A-198. Some of the corner bars were slightly visible.

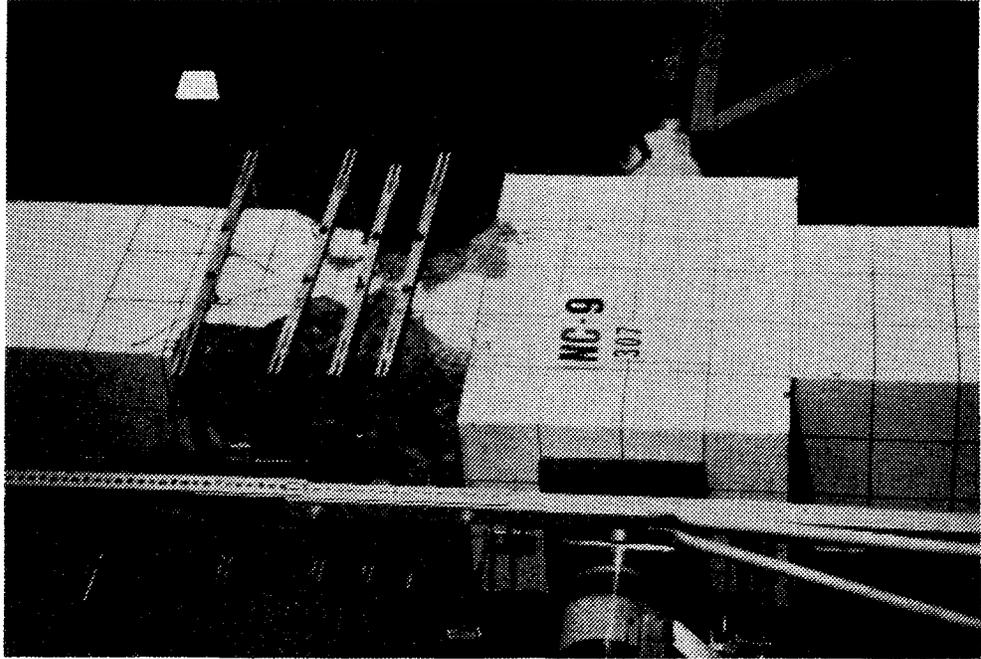
FIG. A-200 TEST SPECIMEN NC-9 AFTER CYCLE #13

The maximum degradation in moment capacity during cycle #13 ($\mu=5$) was 21% of the theoretical moment capacity. The ratio of the peak moment at the second cycle to the peak moment at the first cycle ranged from 0.86 to 0.96 at various displacement levels.
