***EFFECTS OF TRANSVERSE REINFORCEMENT
ON SEISMIC PERFORMANCE OF COLUMNS - A
PARTIAL PARAMETRIC INVESTIGATION***

September 1988

NATIONAL SCIENCE FOUNDATION
Washington, D.C.
Grant No. PFR-7902611

CONSTRUCTION TECHNOLOGY LABORATORIES, INC.
5420 Old Orchard Road
Skokie, Illinois 60077

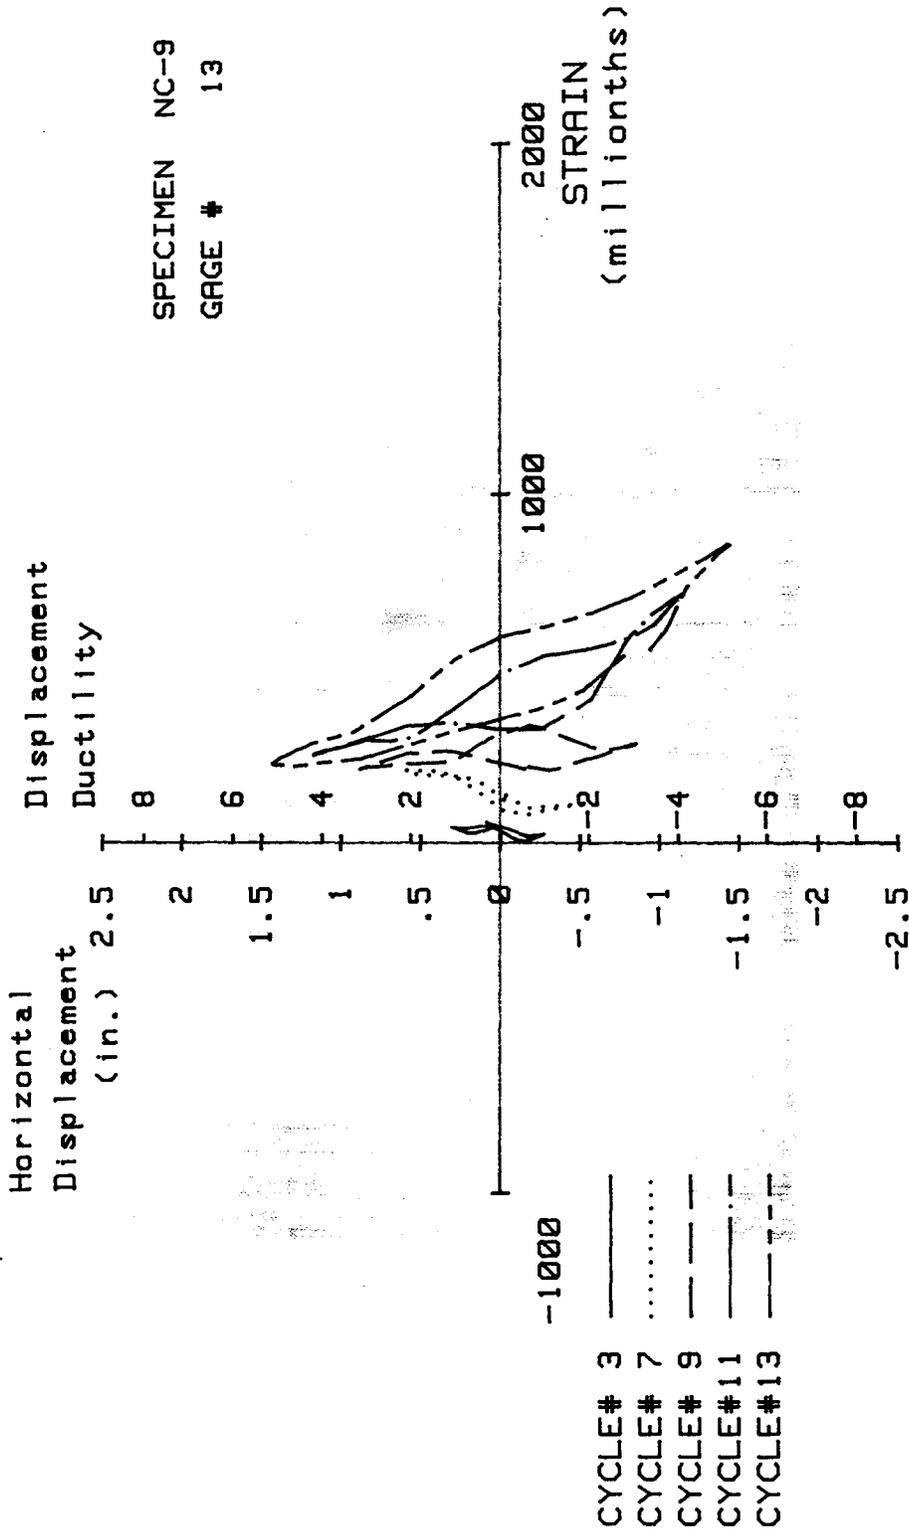
FIG. A-205 MEASURED STRAIN, GAGE #13, SPECIMEN NC-9

A total of 12 strain gages were attached to the #4 continuous helix transverse reinforcement. Strain gages #13 through #18 and #19 through #24 were attached to transverse reinforcement at approximately 2, 6, 10, 14, 18, and 22 in. above the stub, respectively. Figures A-205 through A-215 show the results obtained from these gages. During cycle #6 ($\mu=2$), a sudden increase in strains at all levels was observed. This increase is more pronounced at strain gages located more than 10 in. from the stub. The maximum strain through cycle #8 ($\mu=3$) was 78% of the specified minimum yield strain of the transverse reinforcement material.

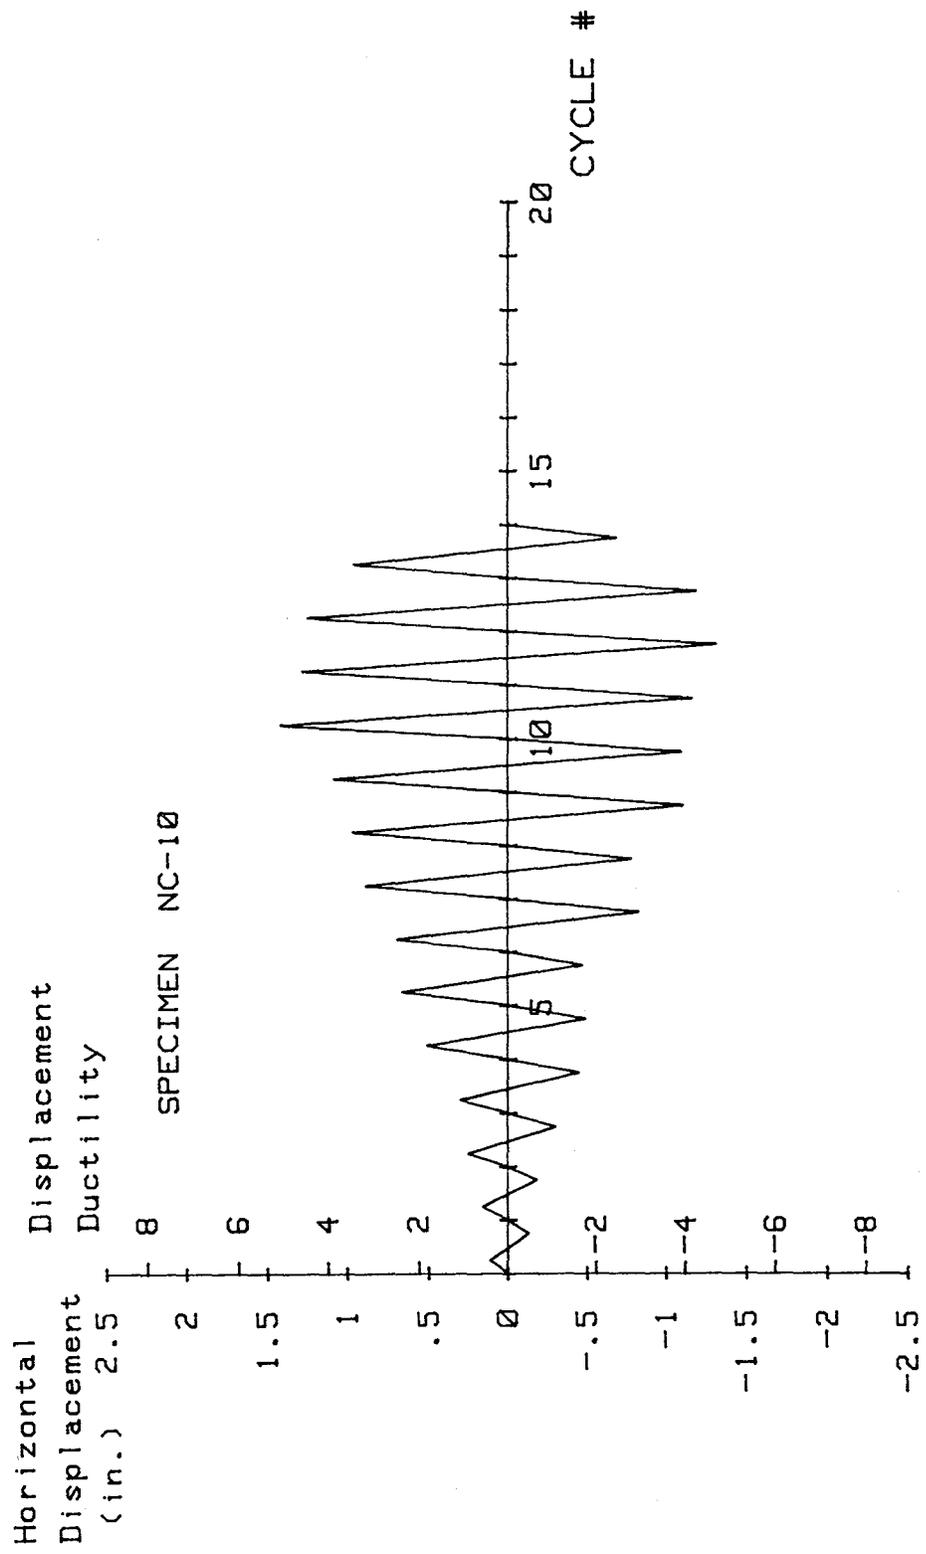
FIG. A-216 LOADING SCHEDULE, SPECIMEN NC-10

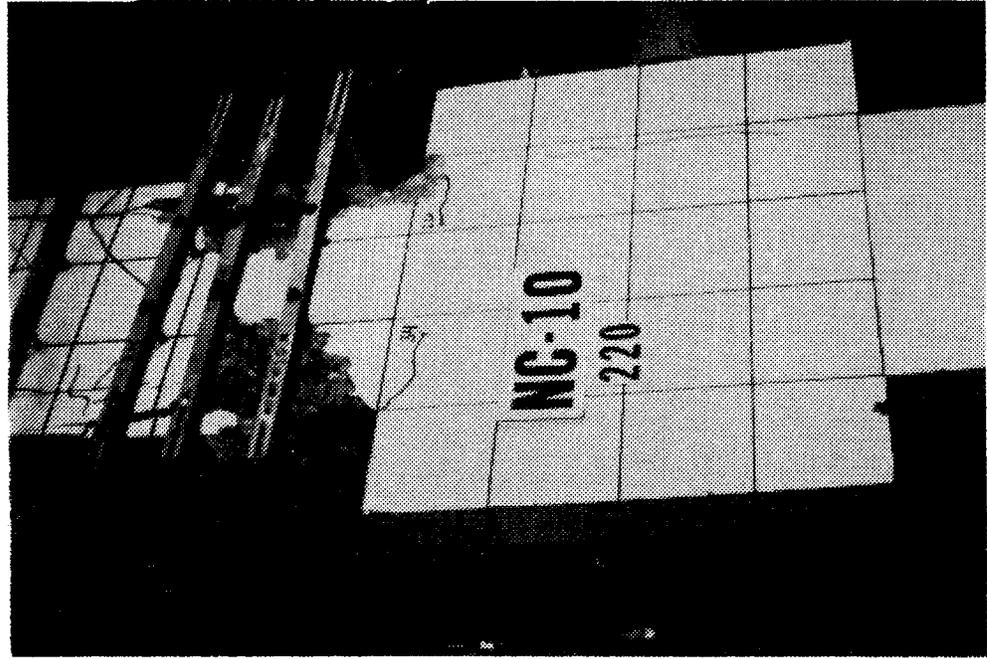
FIG. A-218 TEST SPECIMEN NC-10 AFTER CYCLE #10

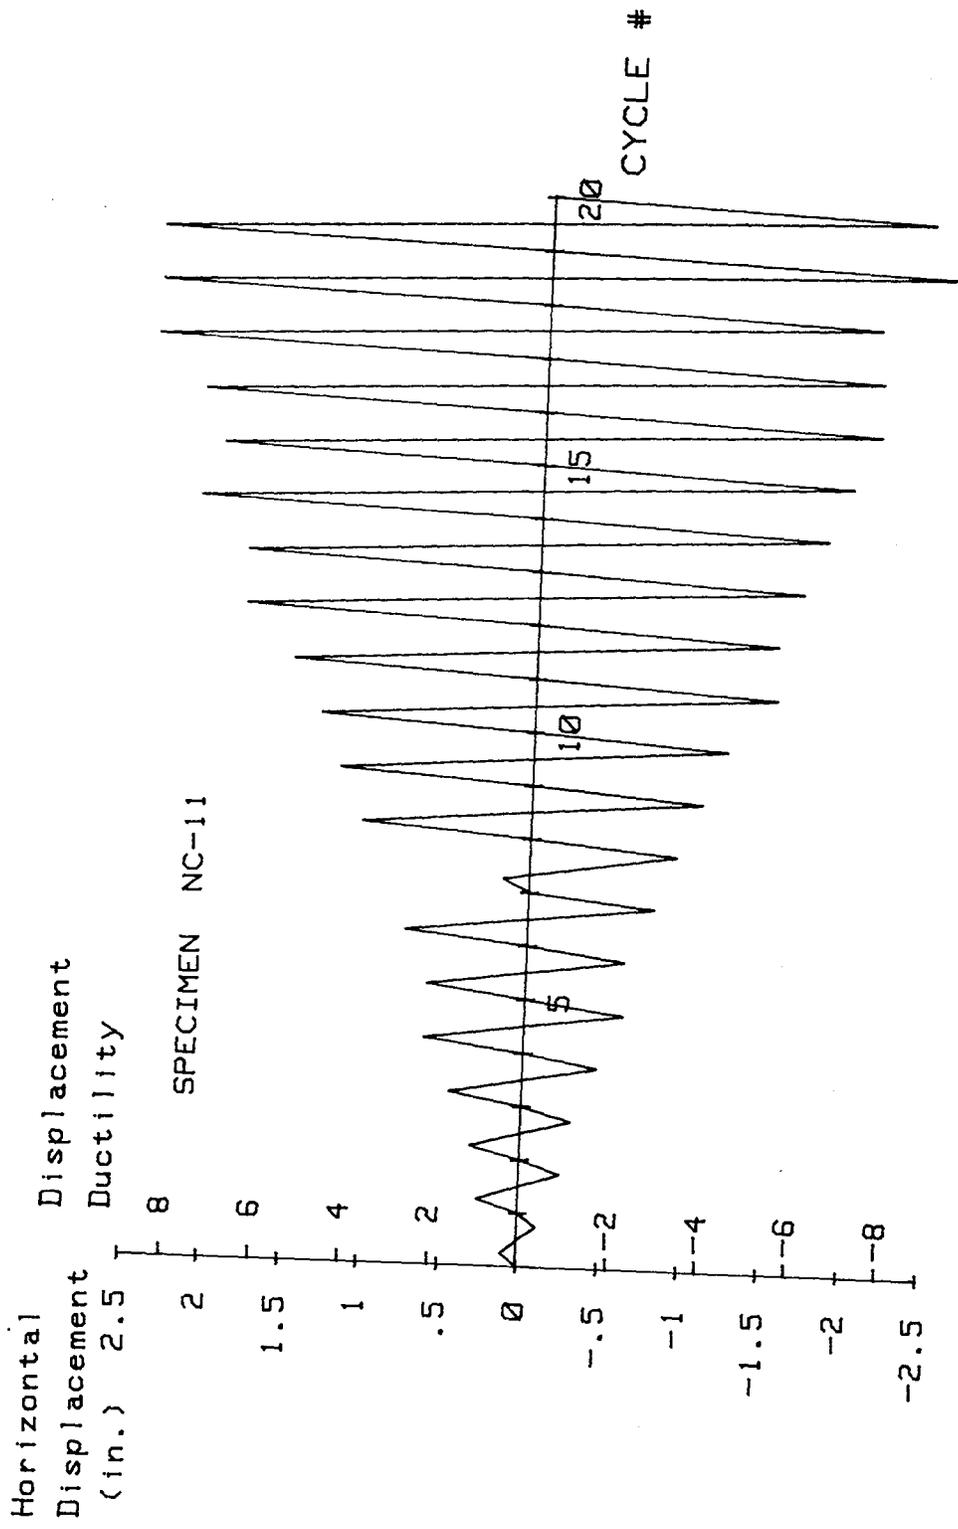
FIG. A-234 LOADING SCHEDULE, SPECIMEN NC-11

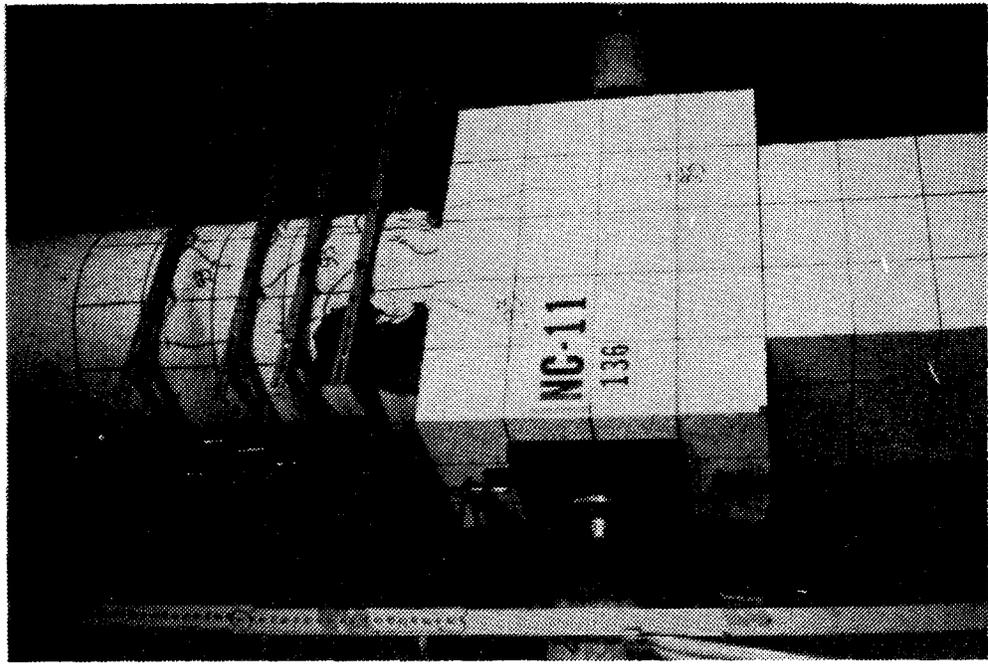
FIG. A-236 TEST SPECIMEN NC-11 AFTER CYCLE #8

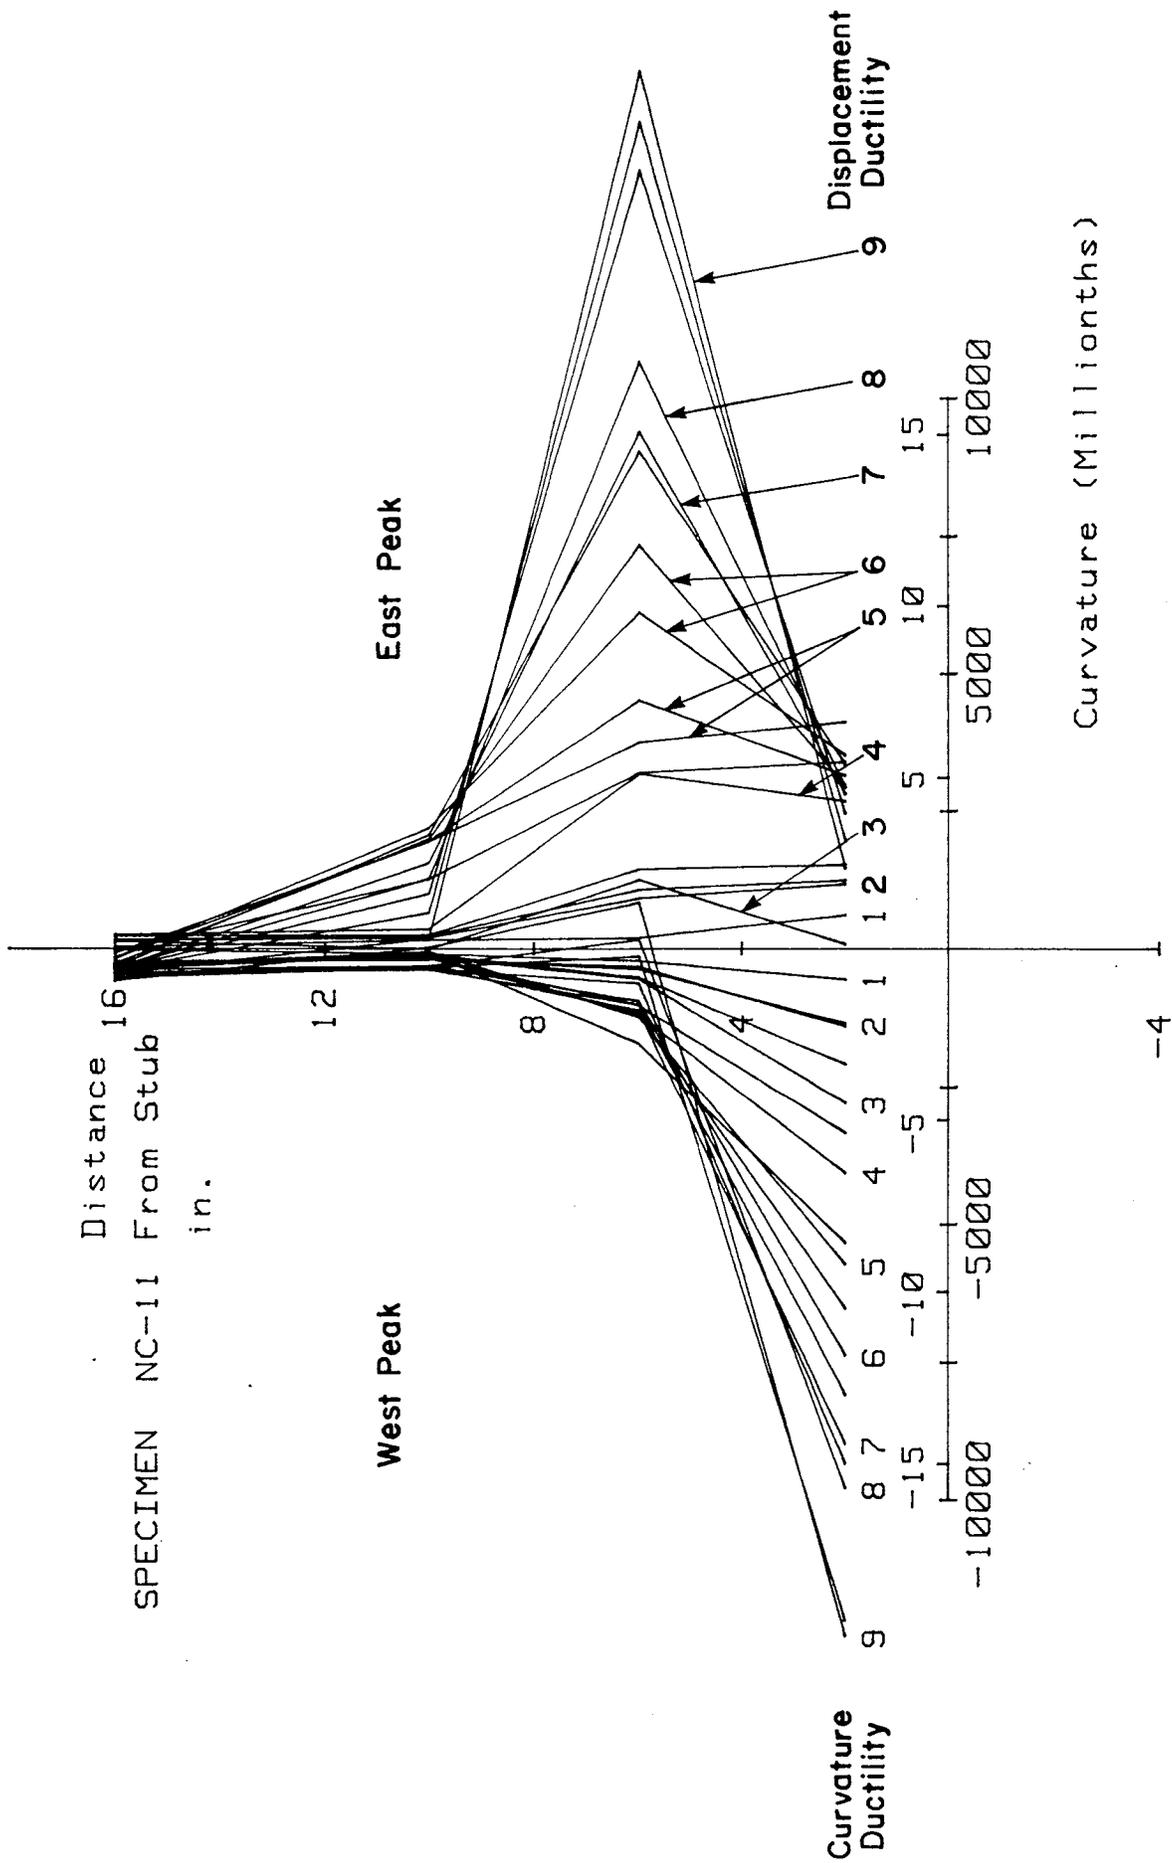
FIG. A-241 CURVATURE DISTRIBUTION ALONG UPPER COLUMN SPECIMEN NC-11

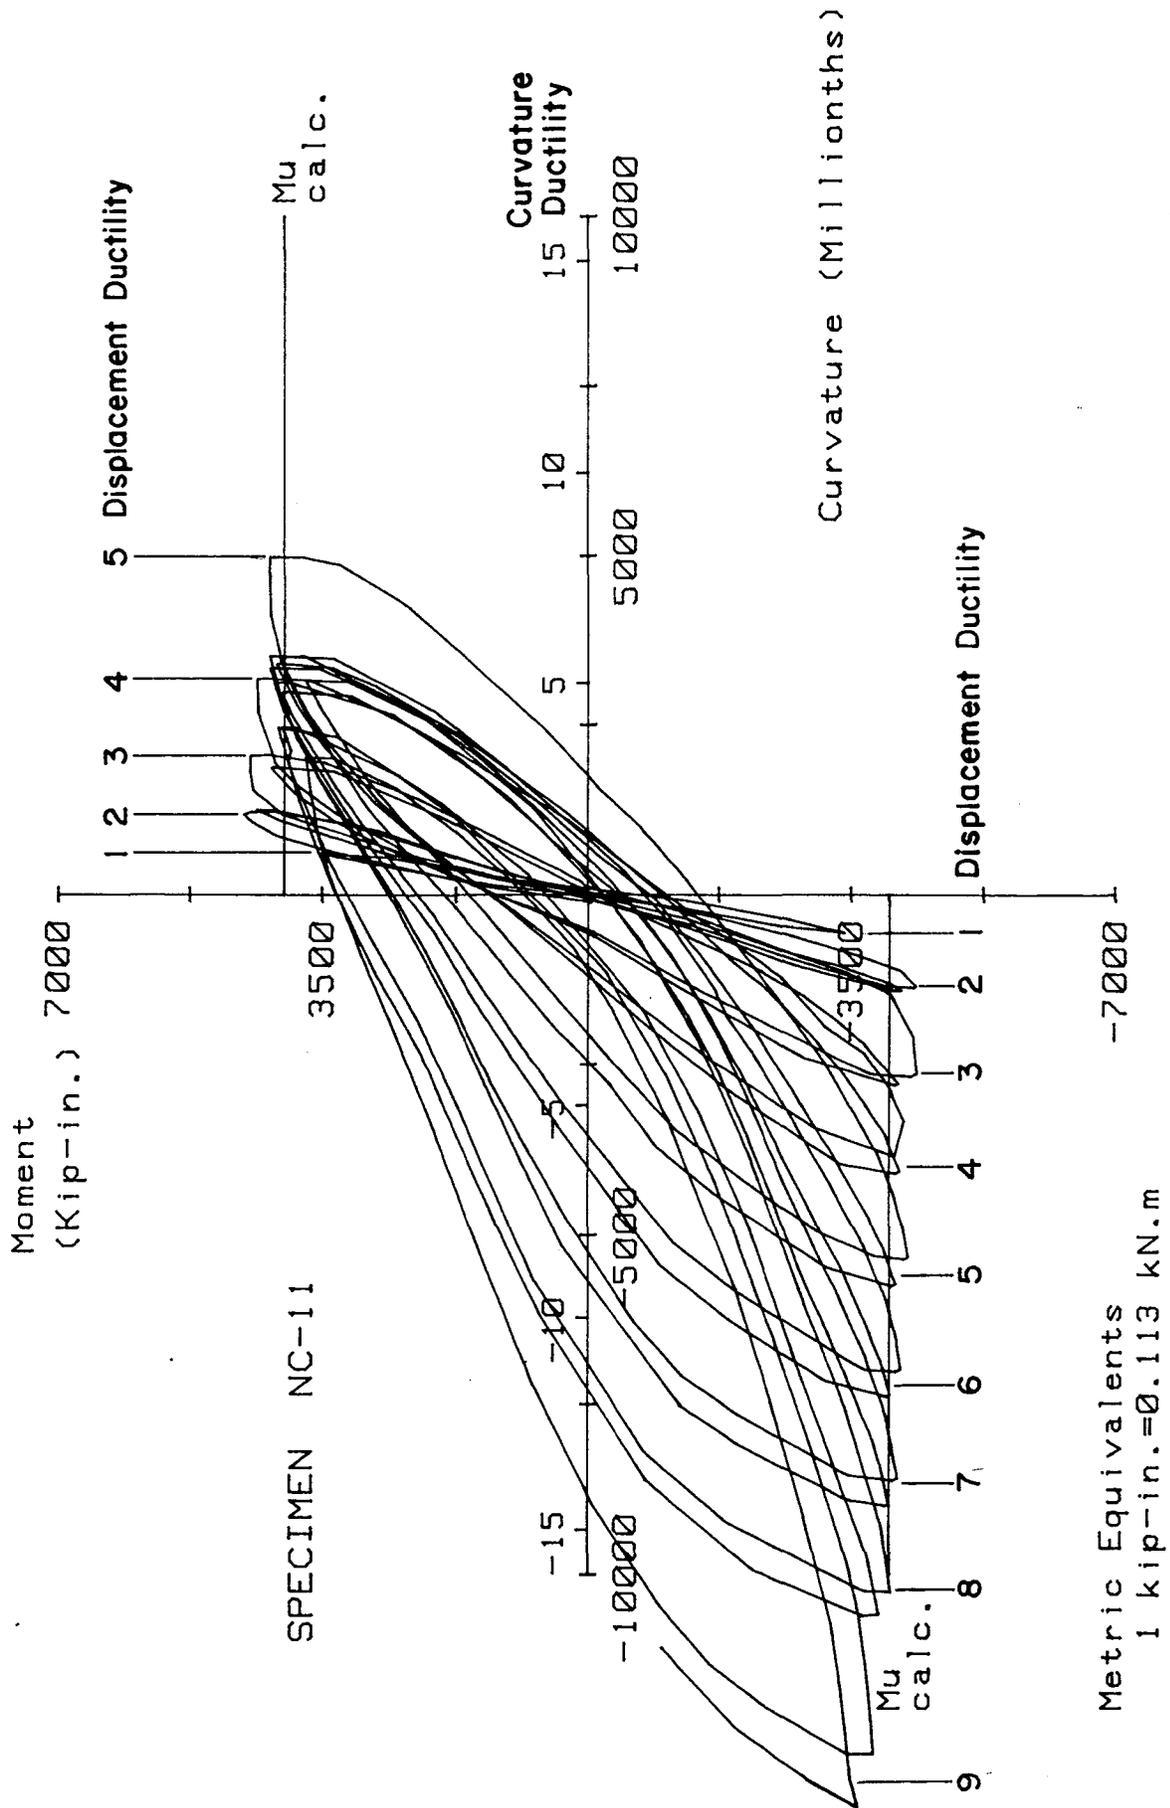
FIG. A-242 MOMENT VERSUS CURVATURE FOR SPECIMEN NC-11

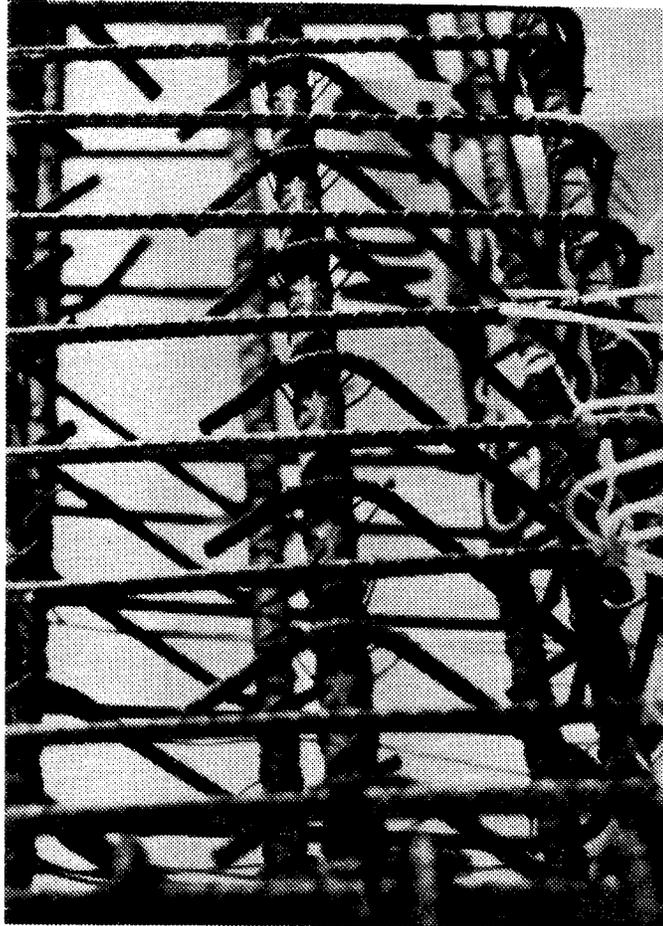
FIG. A-249 TRANSVERSE REINFORCEMENT DETAIL USED WITHIN
22 IN. ABOVE THE STUB, SPECIMEN NC-12

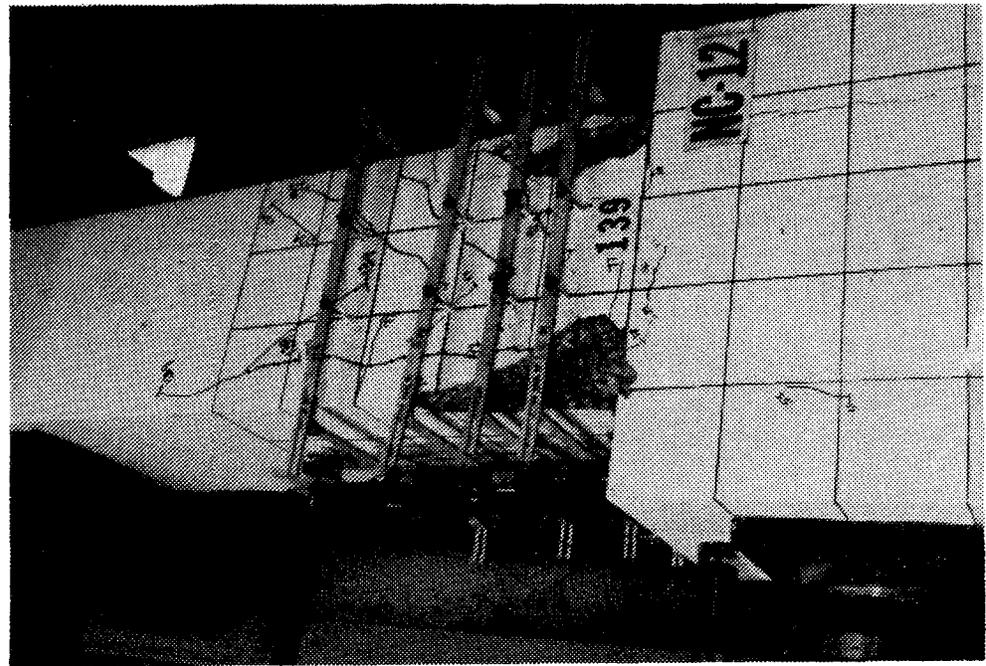
FIG. A-253 TEST SPECIMEN NC-12 DURING CYCLE #7

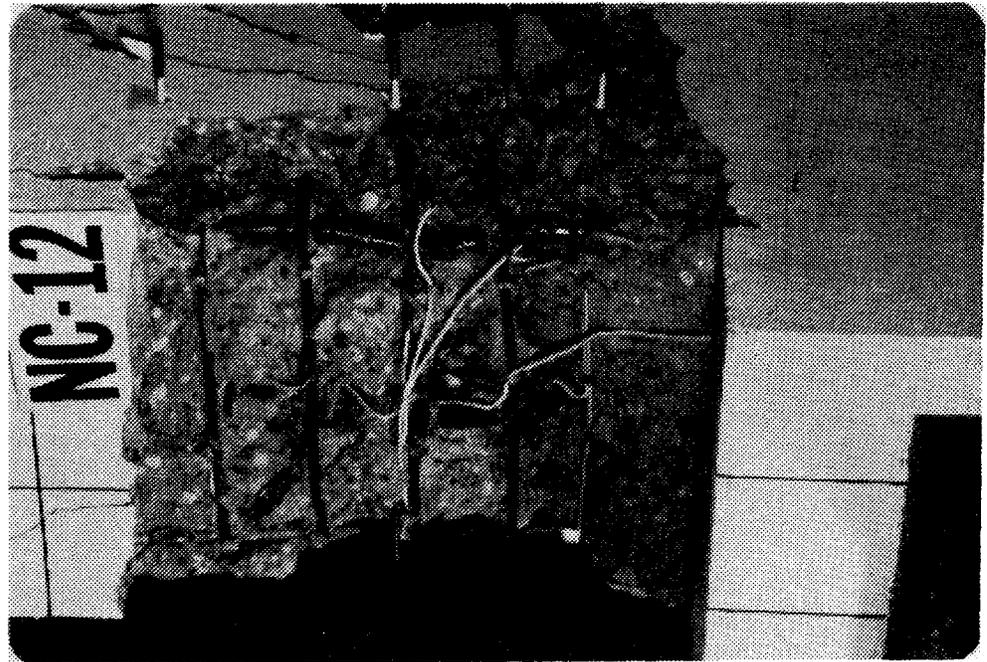
FIG. A-255 TEST SPECIMEN NC-12 AFTER TEST CONCLUSION

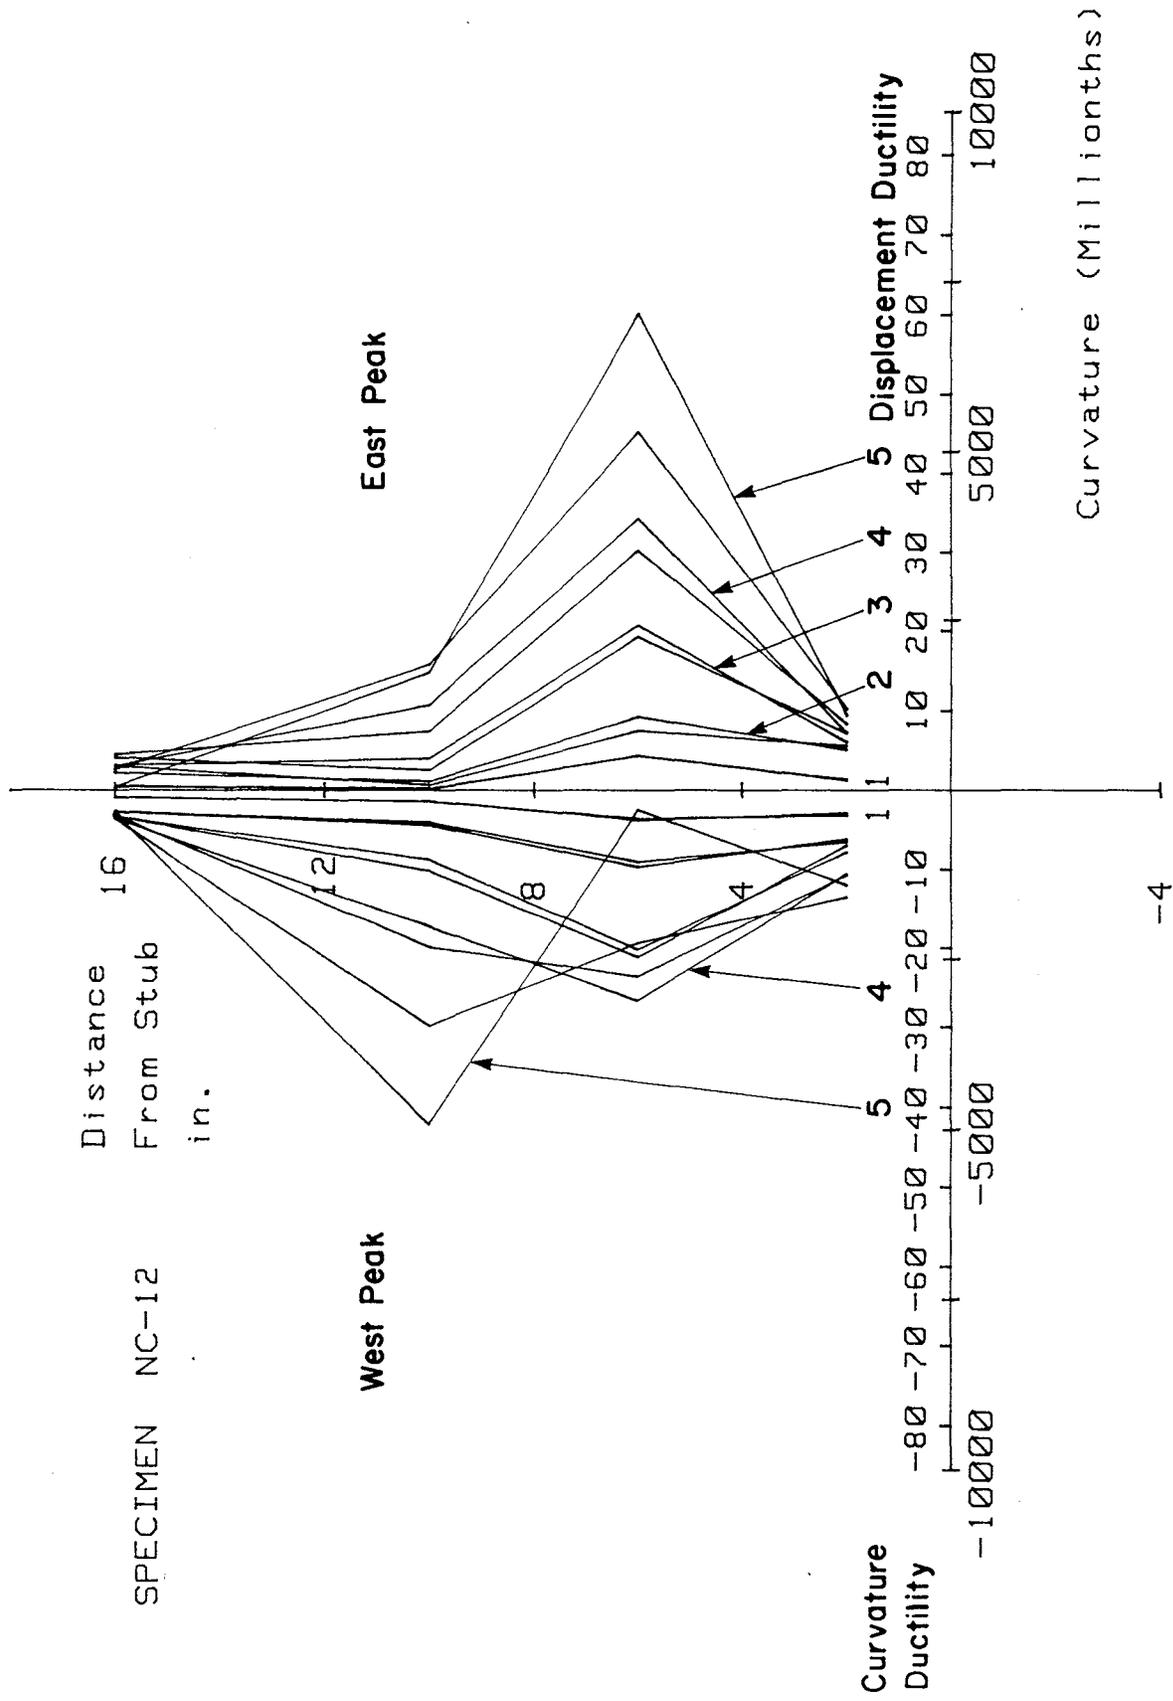
FIG. A-258 CURVATURE DISTRIBUTION ALONG UPPER COLUMN SPECIMEN NC-12

Figure A-258 shows the curvature distribution along the upper column. The location of the maximum curvature was generally located within 4 to 8 in. above the stub. This can be attributed to the fact that transverse reinforcement 4 in. above the stub was still covered with cover concrete at test conclusion, thereby providing good confinement at this region. Consequently, the plastic hinge and the region of high curvature were forced upward.

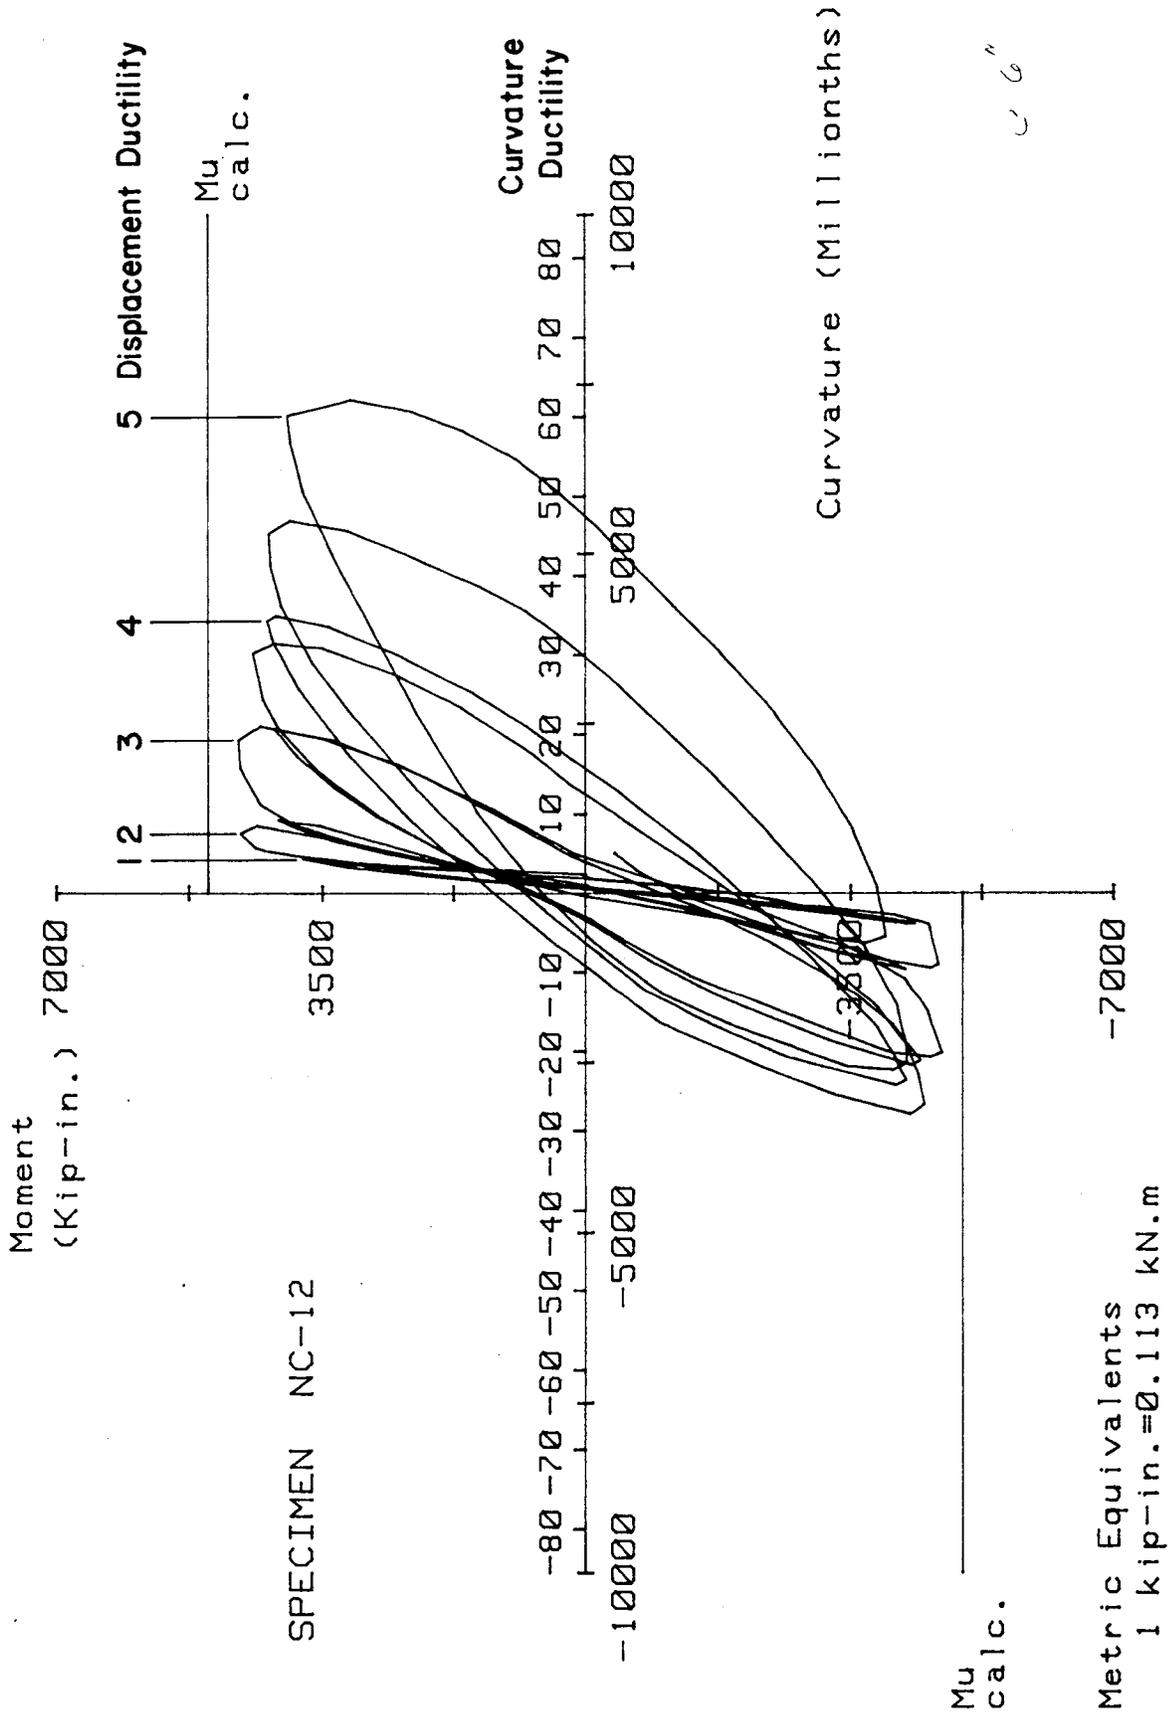
FIG. A-260 MOMENT VERSUS CURVATURE FOR SPECIMEN NC-12, 6 IN. ABOVE THE STUB
