**NATIONAL CENTER FOR EARTHQUAKE
ENGINEERING RESEARCH**

A Procedure for the Seismic Evaluation of Buildings in the Central and Eastern United States

Technical Report NCEER-92-0008

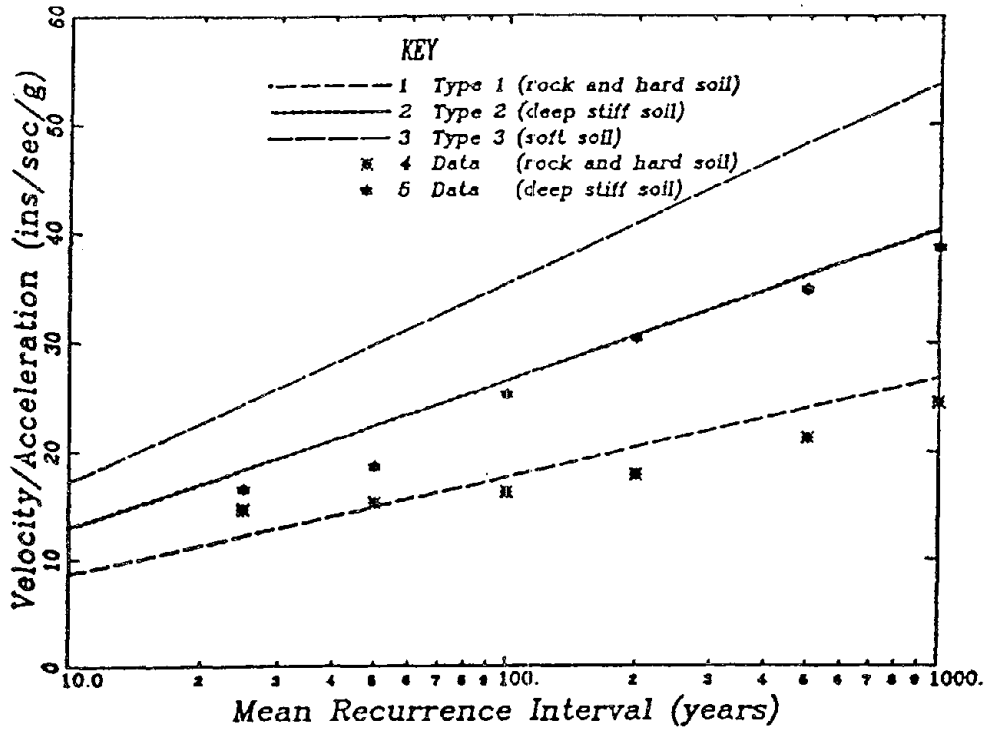
FIGURE 3.9

Recommended Variation of (v/a) Ratio for Changing Recurrence Intervals. Values at 475 Years Are Consistent with Basic Guidelines.

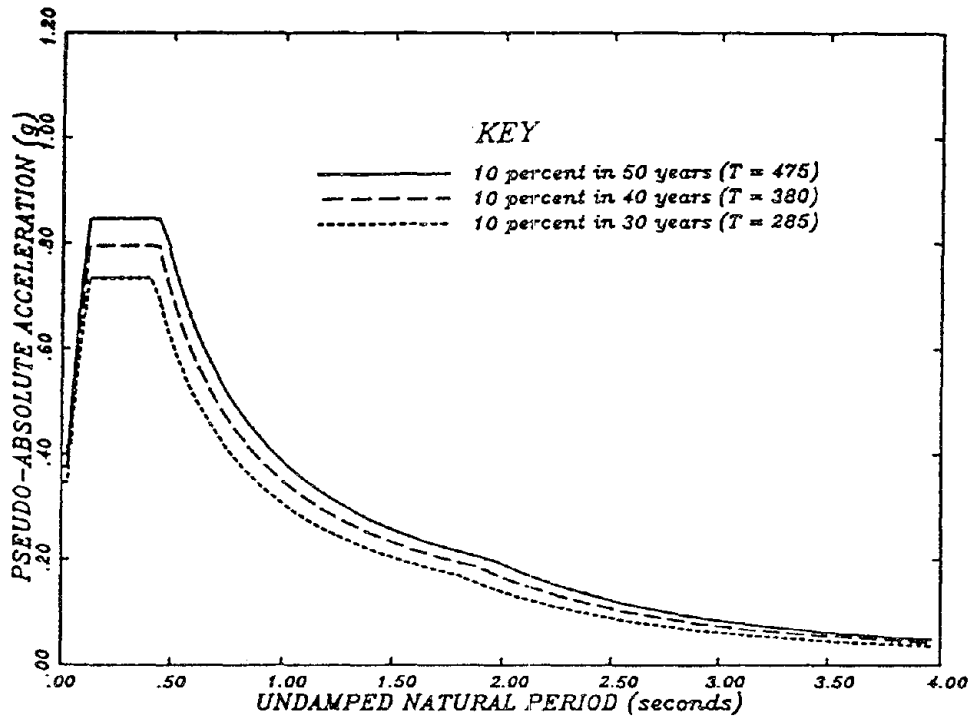
FIGURE 3.10

Comparison of 0.4 g Contour Spectra for Differing Probability Levels (Damping = 5%).

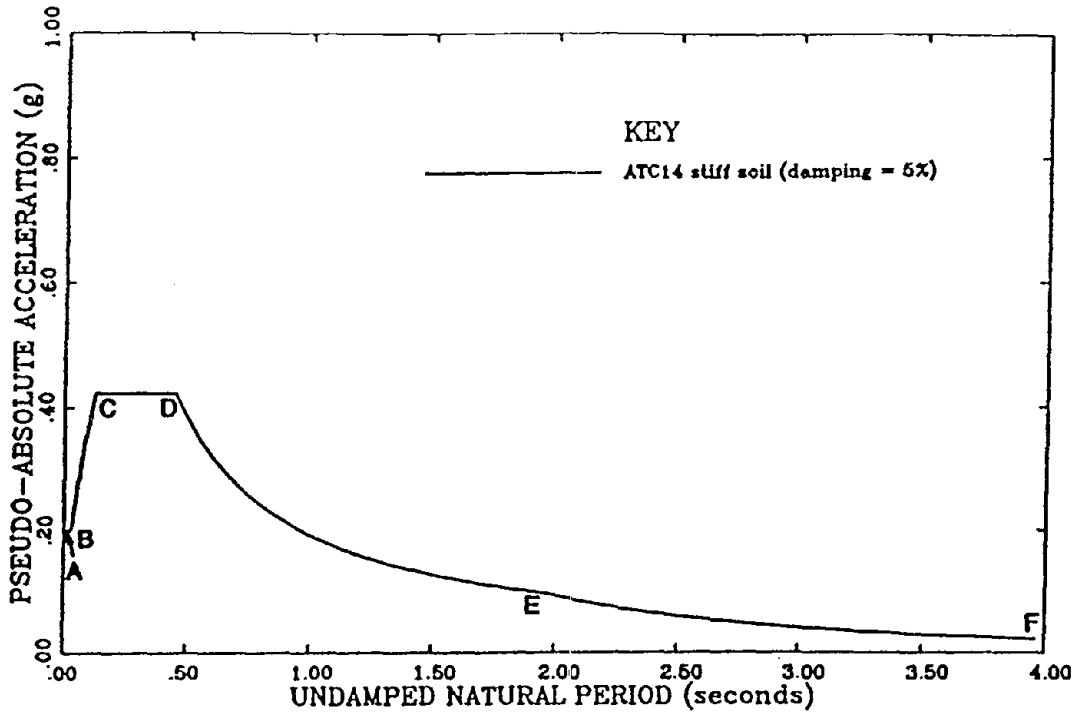
FIGURE 3.12

Arithmetical Acceleration Scale Presentation of Figure 3.11 Data (Damping = 5%).
