**U.S.-JAPAN COORDINATED PROGRAM  
FOR  
MASONRY BUILDING RESEARCH**

**Report No. 3.1(c)-1**

**IN-PLANE SEISMIC RESISTANCE  
OF TWO-STORY CONCRETE MASONRY  
COUPLED SHEAR WALLS**

**PMFSEL Report No. 89-3  
May 1990**

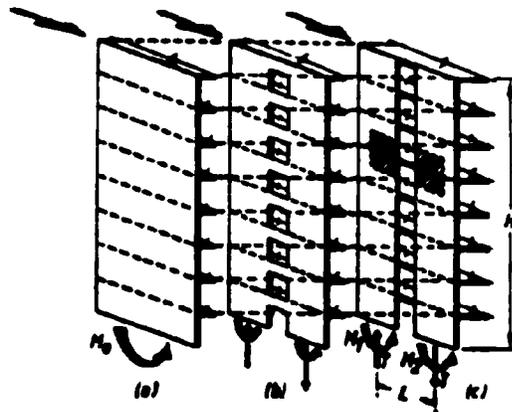
Figure 2.1 A Comparison of Flexural Resisting Mechanisms in Structural Walls [3].

Figure 2.1 compares the flexural resisting mechanisms of: (a) a solid cantilever wall; (b) coupled walls with strong coupling beams; and (c) coupled walls with weak coupling beams. The walls and the coupling system contribute some of the total overturning moment. At ultimate, the shear transferred between the walls varies with the strength of the coupling system. If the coupling system is weak, the amount of shear transfer will be small (Fig. 2.1(c)). The  $L * T$  parameter is small compared to  $M_1$  and  $M_2$ , and the walls behave almost as independent cantilever walls with a slight increment in axial load induced by the coupling system. With strong coupling beams, the shear transferred by the coupling system is large in relation to  $M_1$  and  $M_2$  (Fig. 2.1(b)). The contribution of the  $L * T$  term to the total overturning moment is significant, and the coupled walls behave more like a single cantilever wall [3].

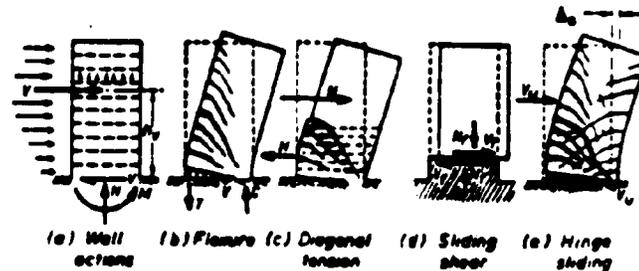
Figure 2.2 Failure Modes in Cantilever Walls [3].

The failure modes of the coupled wall include: failure of the coupling system; flexural failure of the walls; shear failure of the walls; and sliding shear of the walls. Figure 2.2 illustrates the failure modes which could occur in the individual walls of a coupled wall system.

Flexural failure of an individual wall involves crushing of its compression toe and/or the yielding or buckling of its vertical reinforcement.

Shear failure of an individual wall can involve diagonal tensile cracking and yield of transverse reinforcement, shear compression failure at the wall toe, or shear sliding of the wall. Shear sliding can occur at the base, or along flexural cracks that extend across the wall length.

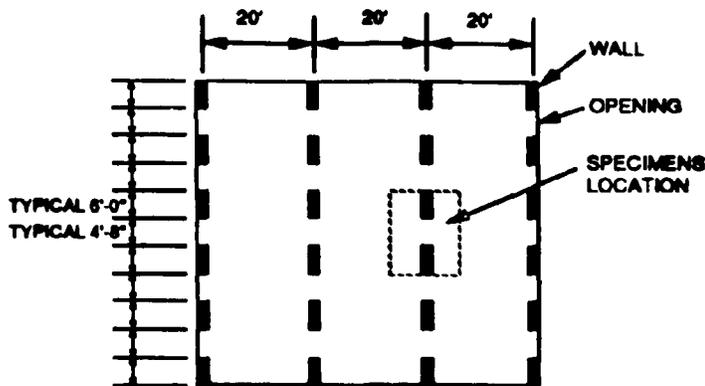
Figure 3.1 Prototype building floor plan.

The Type 2 specimens were intended to represent a coupled shear wall subassembly system in a two-story building with a flat roof. Each pair of coupled shear walls is 16.67 ft (5080 mm) long, and is assumed to be 20 ft (6096 mm) apart. A possible location of the specimen within a prototype building is shown in Figure 3.1. The walls of the prototype building are assumed to be rigidly connected to an immovable foundation.

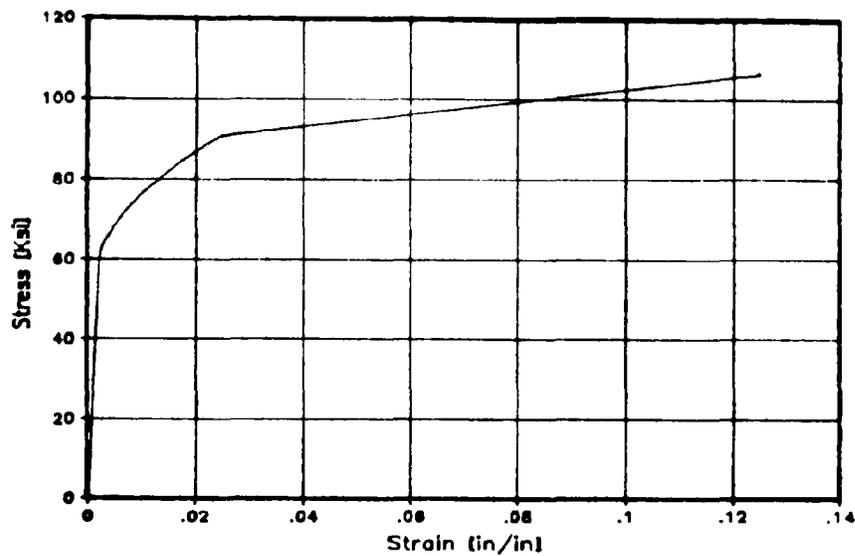
Figure 3.11 Typical stress-strain curve for Specimens 2a and 2b dowel reinforcement.

Specimens from each heat of reinforcement were tested in tension, and stress-strain curves were obtained. Deformations were measured using a Tinius-Olsen extensometer over a 8-in. gauge length. Only cases in which the specimen fractured within the gauge length were considered. Typical stress-strain curves are given in Fig. 3.11 - 3.14. Data are summarized in Table 3.8

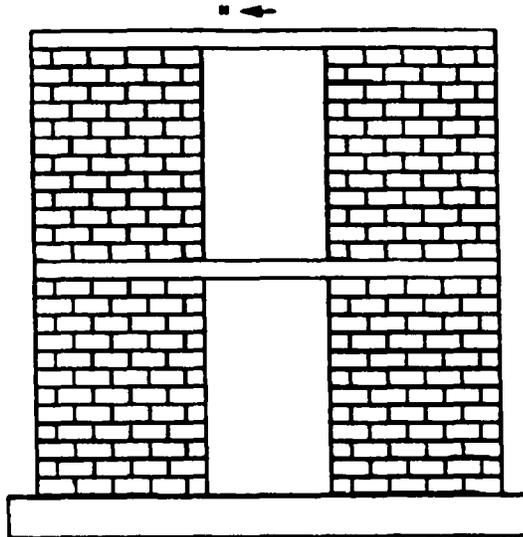
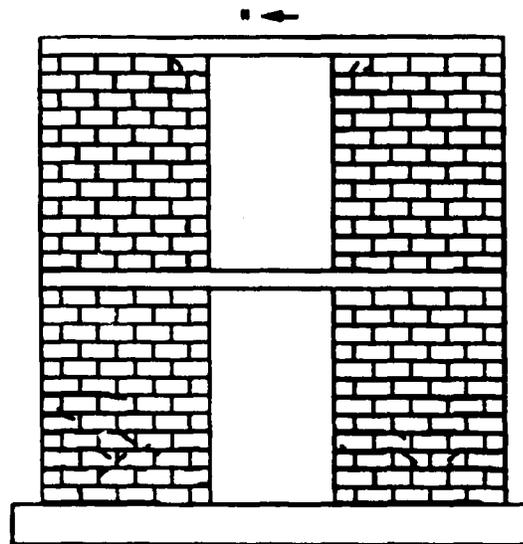
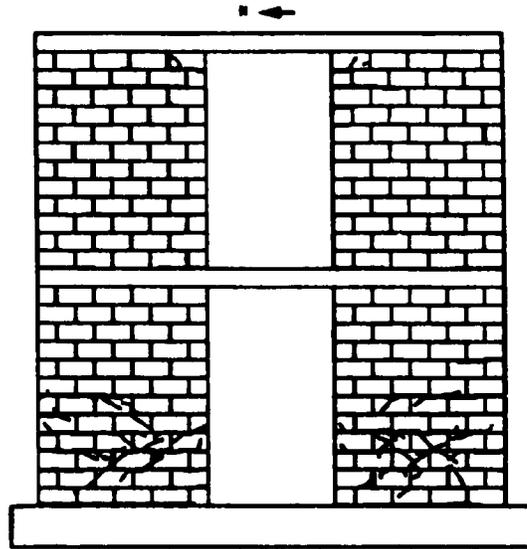
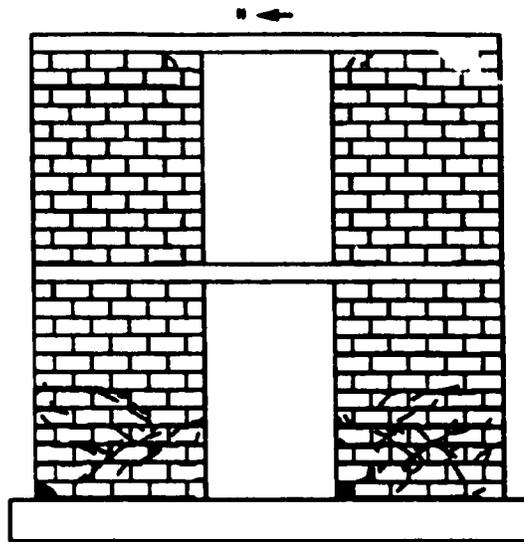
Figure 7.17a Sp. 2a: Progression of wall cracking at Load Point 361.

Figure 7.17b Sp. 2a: Progression of wall cracking at end of test.

Figure 7.17c Sp. 2a: Progression of wall cracking at Load Point 361.

Figure 7.17d Sp. 2a: Progression of wall cracking at end of test.

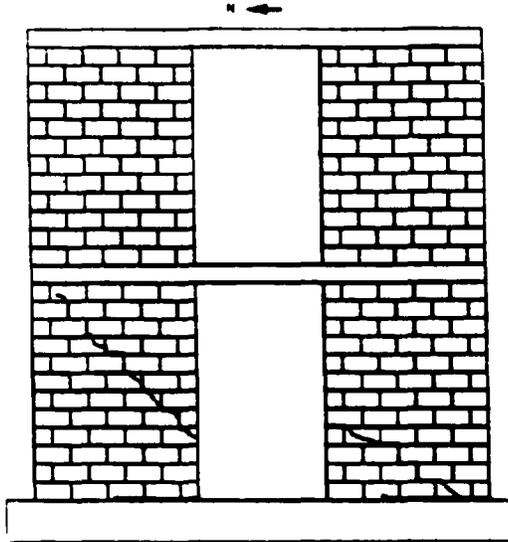
Figure 7.22 Sp. 2b: Cracking due to pretest loading.

side began to extend after being connected to the load transfer beam. As shown in Figure 7.22, hairline diagonal cracks formed in each wall. The bed joint on the concrete base beam was cracked at the south end of the south wall. Local cracking also occurred in the roof slab near the south sway brace plate. This problem was due to a malfunction of the Pegasus Closed Loop Servocontroller System's servo system module. The module was replaced, and the problem did not re-occur.
