Report No. 3.1(c)-2
IN-PLANE SEISMIC RESISTANCE
OF TWO-STORY CONCRETE MASONRY
SHEAR WALLS WITH OPENINGS

Gilberto Leiva
Richard E. Klingner

PHIL M. FERGUSON STRUCTURAL ENGINEERING LABORATORY
Department of Civil Engineering/Bureau of Engineering Research
The University of Texas at Austin

August 1991

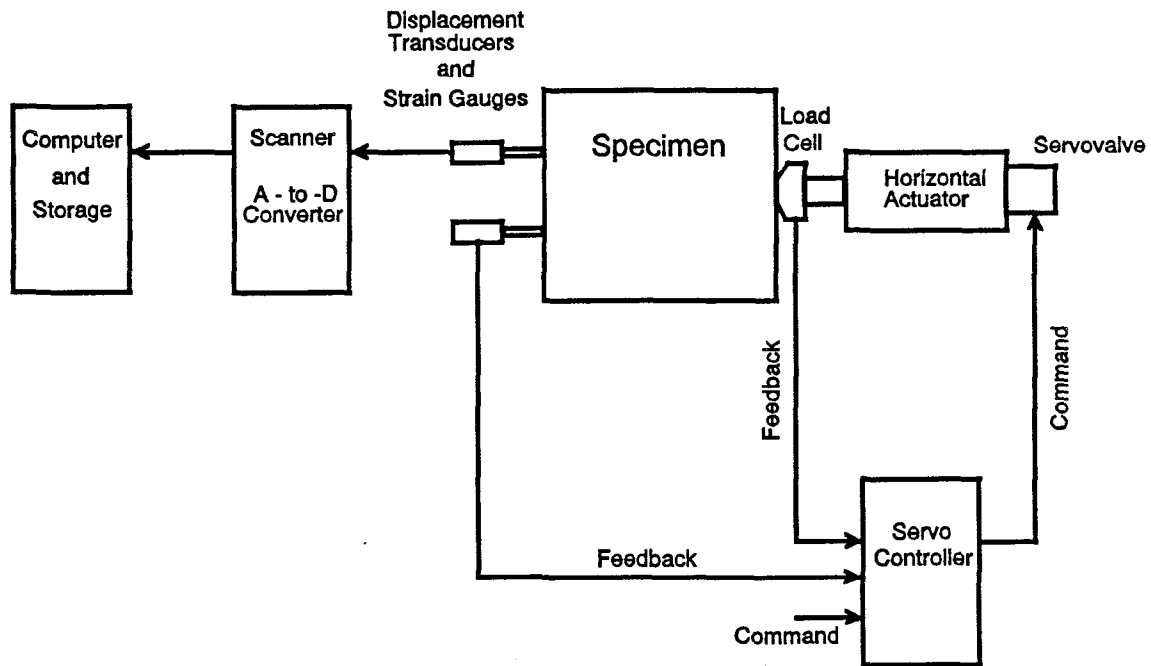
The input command was hand-generated by the system operator. The feedback signal was obtained either from a load cell attached to one of the actuators (in the case of a load-controlled test phase) or from a displacement transducer measuring the

Figure 4.11 Flowchart of control and data acquisition systems.

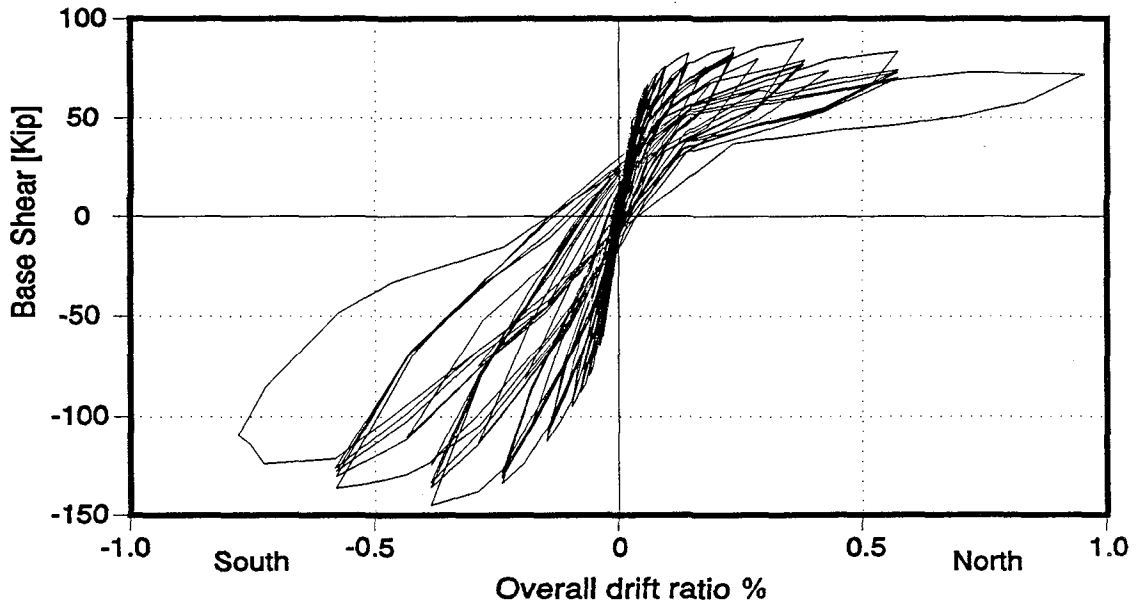
Figure 6.38: Specimen 1b: Base shear - Overall drift ratio history.

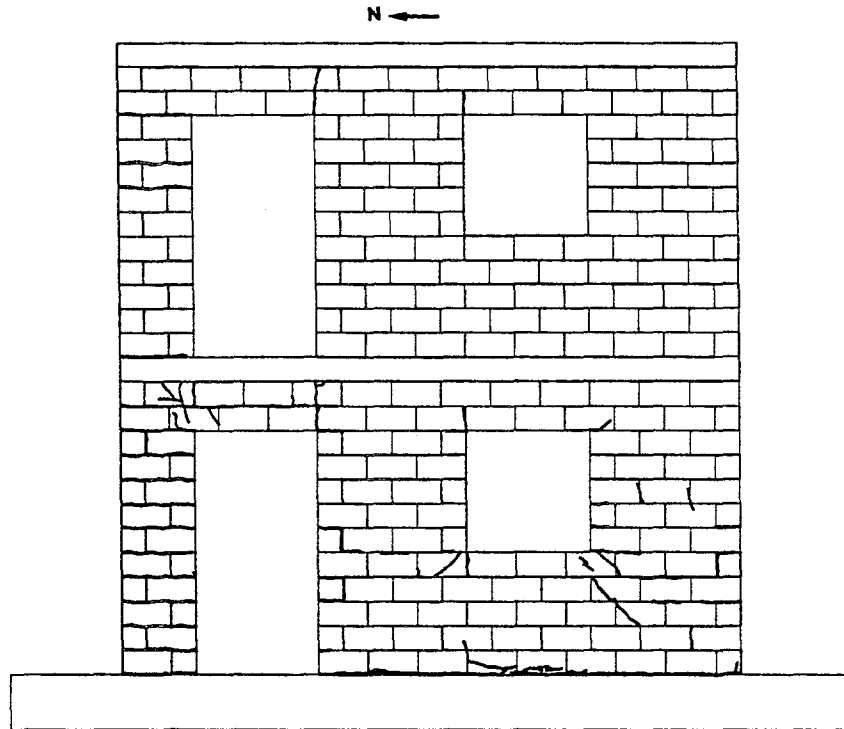
Figure 6.67: Specimen 1b: Cracking progression at overall drift ratio 0.24%.

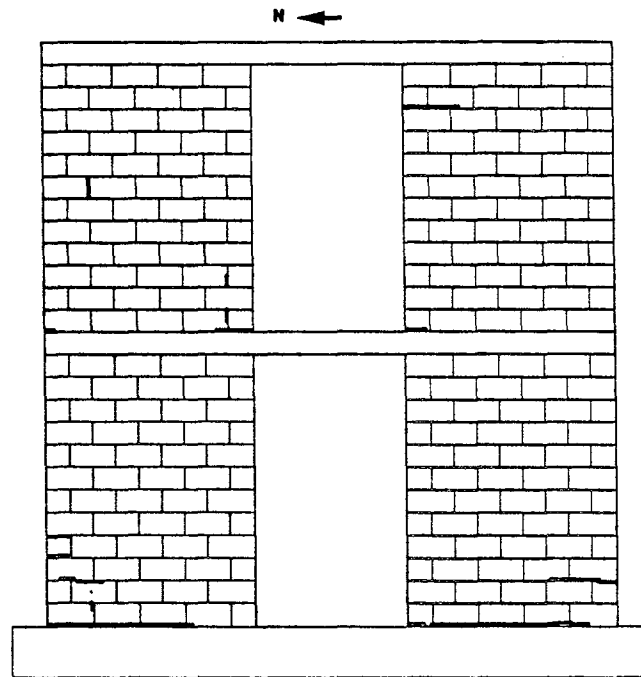
Figure 9.2: Specimen 2a: Cracking progression at overall drift ratio 0.42%.

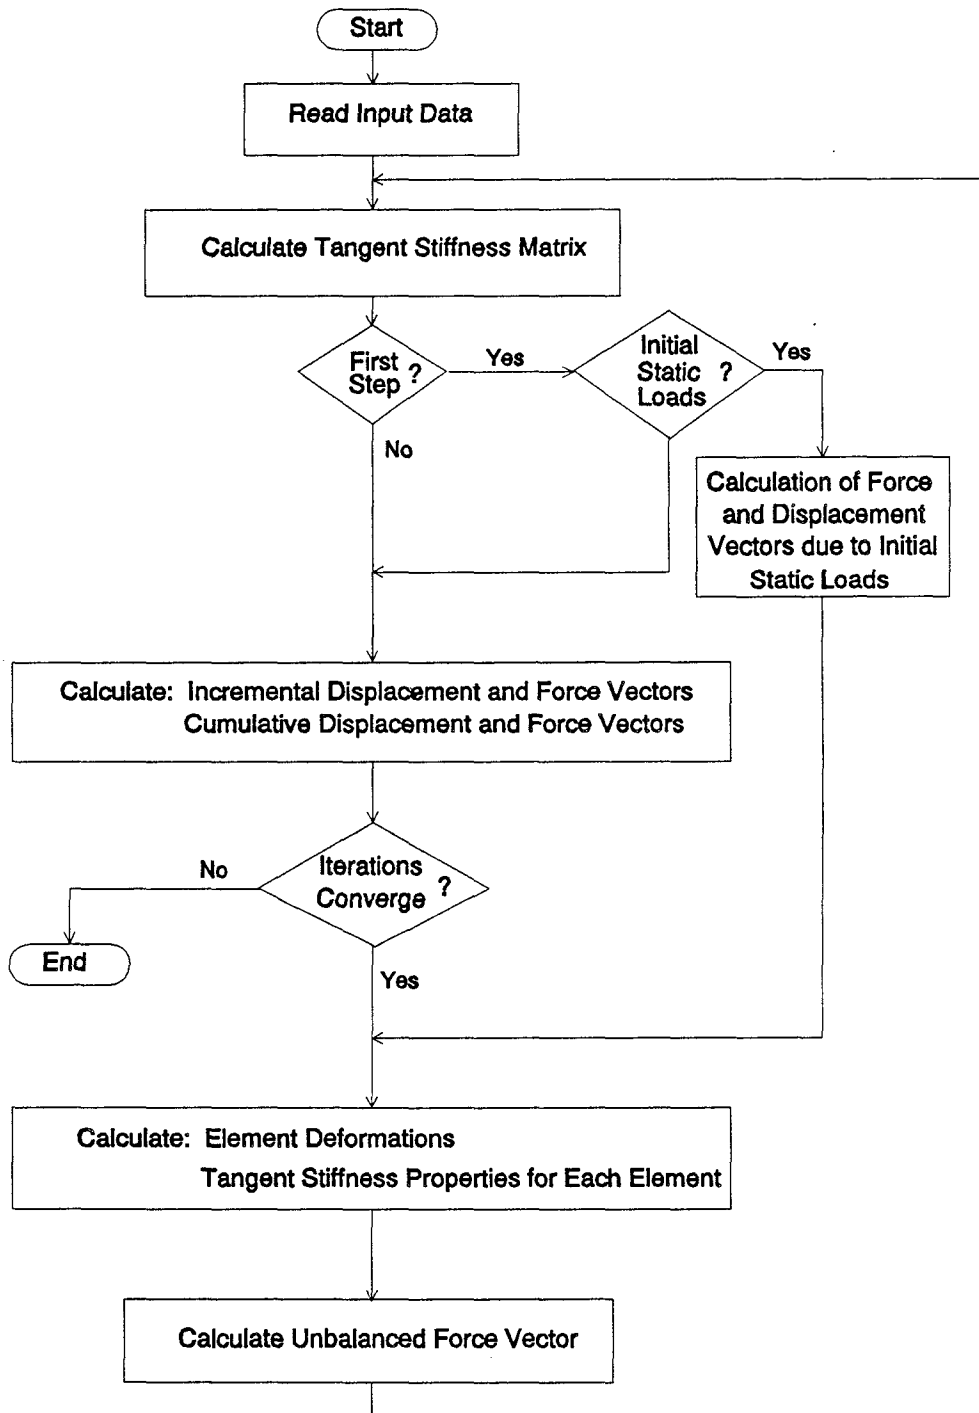
Figure B.4: Flow Chart of Computer Program SCAM
