**Experimental Results of Repaired and
Retrofitted Beam-Column Joint Tests
in Lightly Reinforced Concrete Frame Buildings**

A. Beres, S. El-Borgi, R.N. White and P. Gergely

**Department of Structural Engineering
School of Civil and Environmental Engineering
Cornell University
Ithaca, New York 14853-3501**

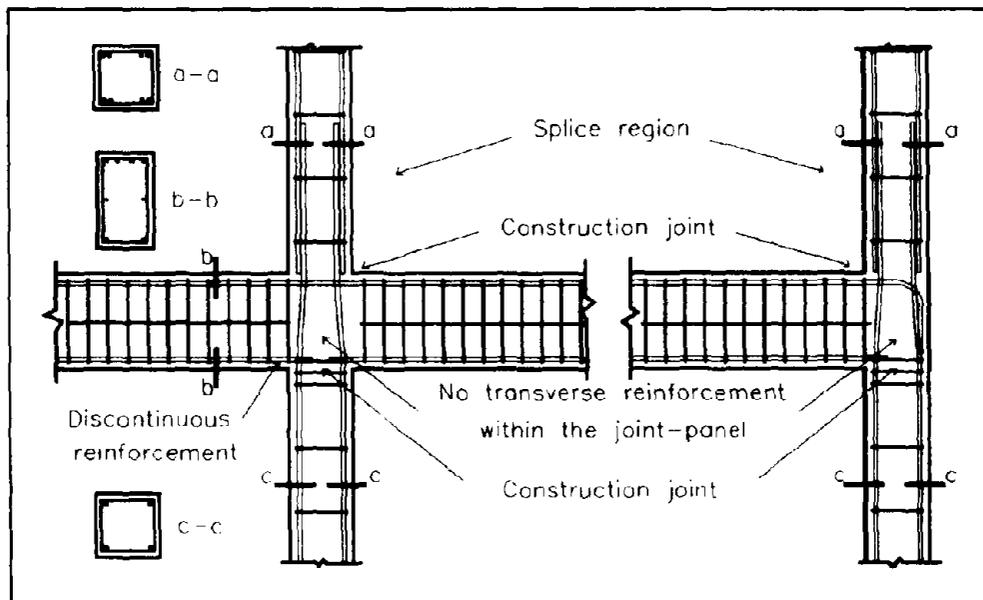
FIGURE 2-1 Elevation View of an Interior and an Exterior Beam-Column Connection

The most important specimen dimensions were: 14" x 24" beams with 2-#6 or 2-#8 (continuous or discontinuous) positive bars and with #3 stirrups at 5" spacing, 16" x 16" columns with 1% or 2% reinforcement and #3 ties at 14" and 16" spacing respectively (with the first tie placed 7" and 8" above the joints as specified in past ACI Codes), extra #3 ties at the lower bending point of the offset vertical reinforcement, and 1.5" cover over ties and stirrups. With the exception of four specimens no transverse reinforcement was placed within the joint panel. Nominal material strengths were $f'_c = 3500$ psi and $f_y = 60$ ksi. Some specimens had post-tensioned transverse beam stubs to simulate the presence of lateral confinement from transverse beams framing in from out of plane. No slabs were included in this study.

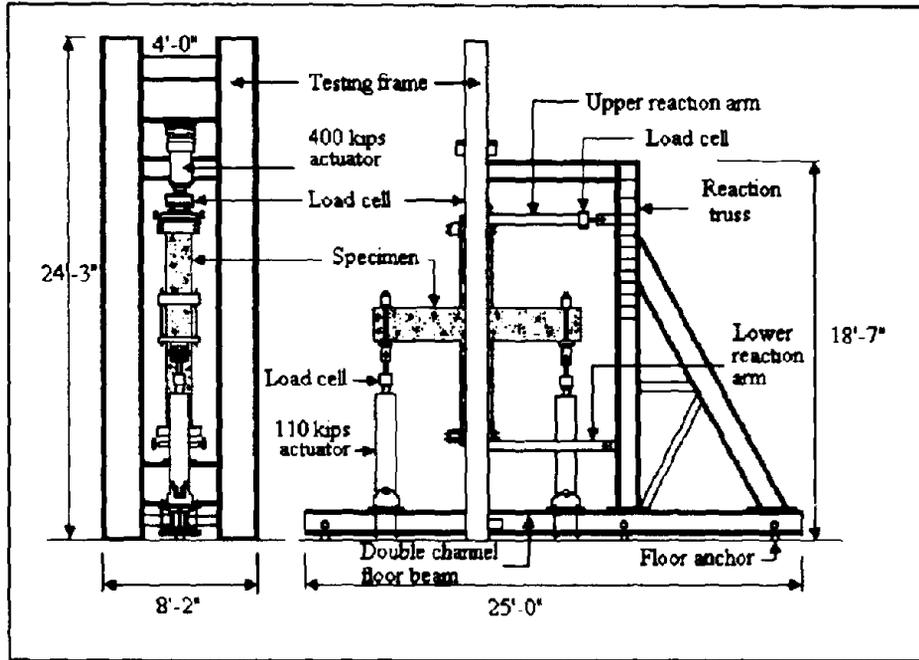
FIGURE 2-3 Two Elevation Views of the Testing Frame (after ref. Pessiki et al. 1988.)

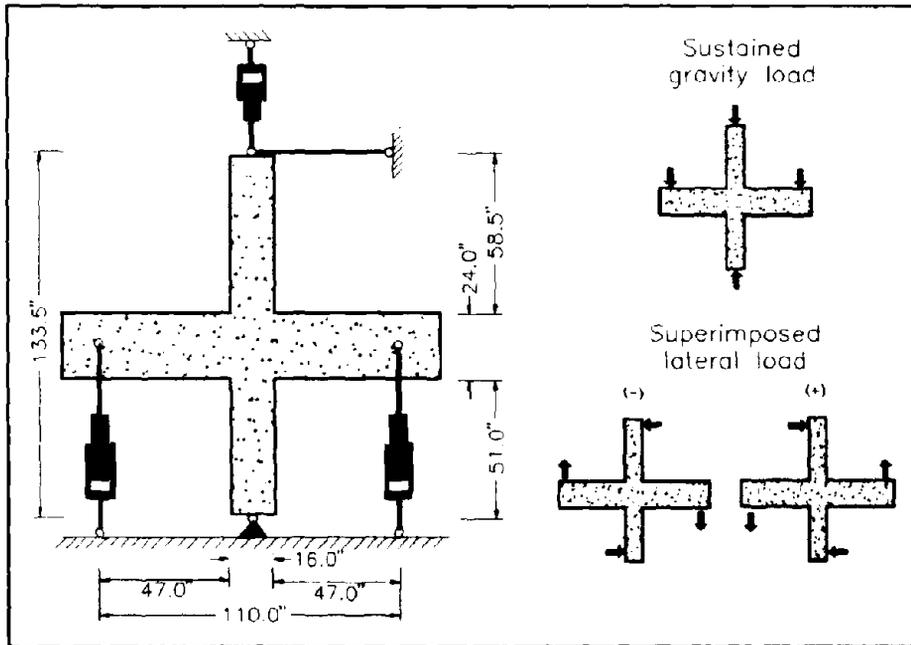
FIGURE 2-4 Idealization of the Force and Reaction System

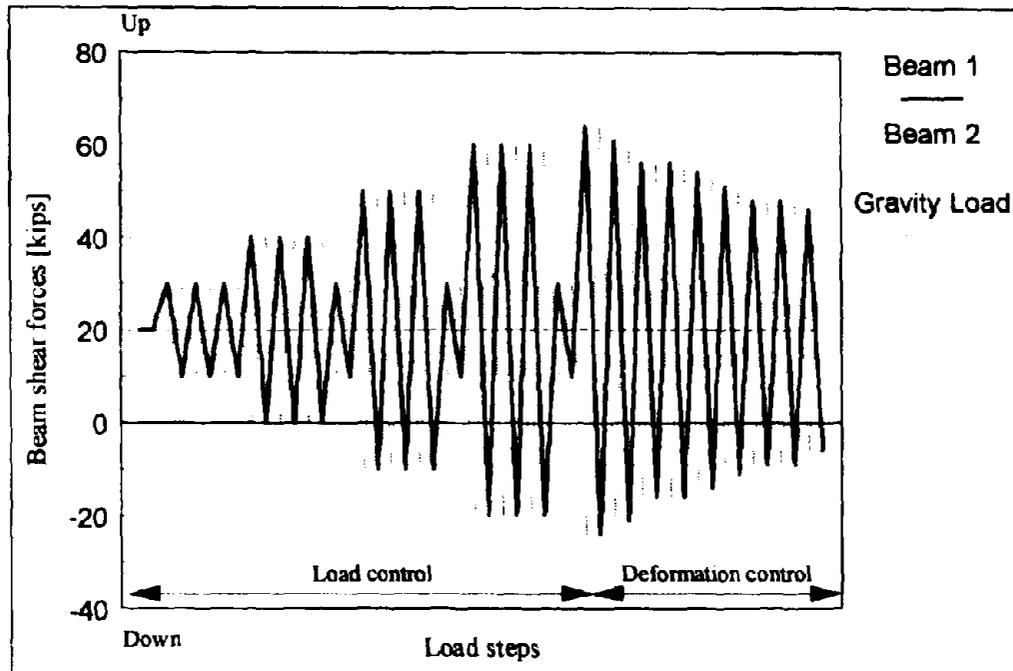
FIGURE 2-5 Typical Load History

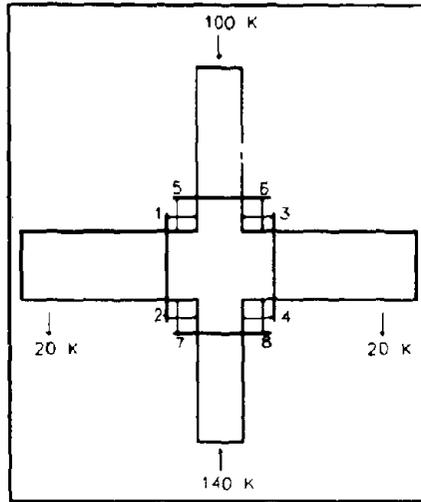
FIGURE 2-6 Arrangement of Instrumentation (DCDTs) for a Typical Interior Specimen with Gravity Load On

Member rotations were computed from measurements made with displacement transducers. These transducers measured relative displacements of points of member cross sections adjacent to the joint over a distance of 11" in the beam(s) and 13.5" in the columns as shown in figure 2-6. Bending moment values shown in the subsequent hysteresis graphs were measured at the interface of the joint-panel and the adjoining beam or column members (unless otherwise noted). Interstory drift was calculated as the total column height multiplied by the amount of rotation the entire specimen must undergo to restore the displaced positions of the end(s) of the beam(s) corresponding to gravity load alone. The retrofitted specimens had additional instrumentation such as strain gages (discussed in Section 5).

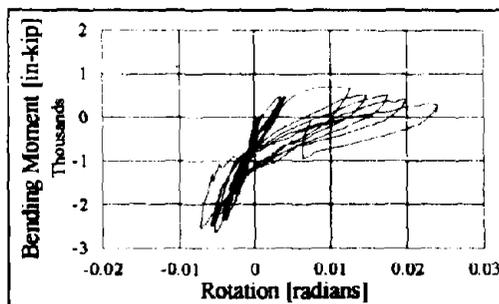
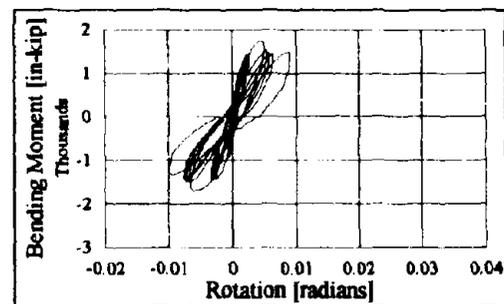
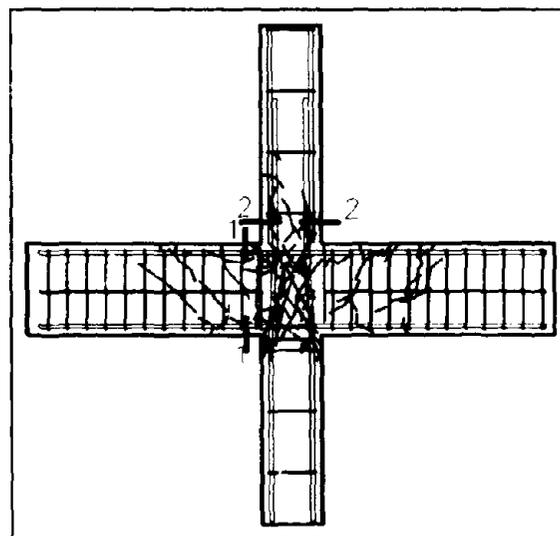
a. Beam Moment-Rotation (Zone 1.)

b. Column Moment-Rotation (Zone 2.)

c. Cracking Pattern

FIGURE 3-2 Typical Interior Joint with Discontinuous Reinforcement

Failure of the typical specimen was initiated by pullout of the discontinuous beam reinforcement from the beam-column joint. At early stages of the test, cracks appeared on the face of the joint in the vicinity of the embedded bars. These cracks progressed as the test continued, eventually merging with diagonal cracks formed also at lower load levels at the top

corners of the joint panel due to the downward forces on the beams (figure 3-2(c)). Subsequent cycles gradually opened the diagonal cracks further, causing loss in strength and stiffness. In a few cases, the dominant cracking pattern was different. The major fraction of the total deformation (interstory drift) was attributed to the large rotation caused by vertically propagating cracks at the beam-column interface. Spalling of concrete cover over a distance of 3 to 4 inches above and below the joint, and vertical cracking up to the first tie, occurred in the top column but the splices performed well.

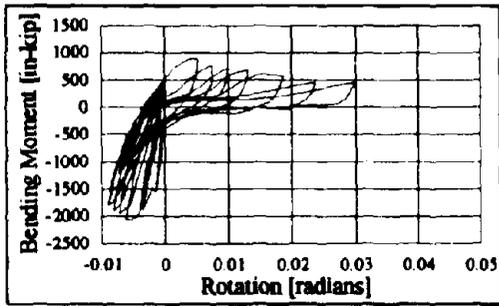
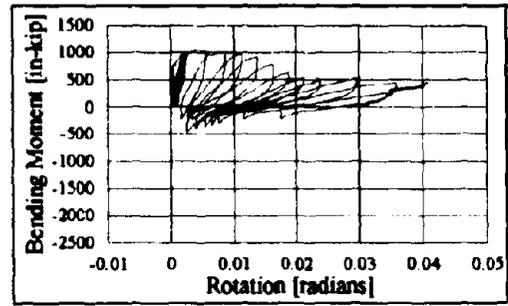
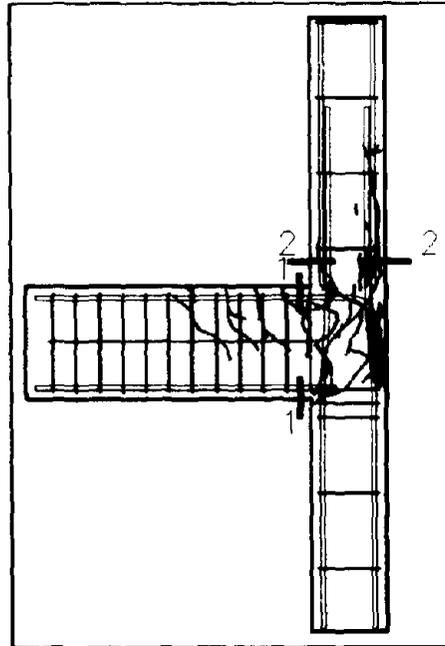
a. Beam Moment-Rotation (Zone 1.)

b. Column Moment-Rotation (Zone 2.)

c. Cracking Pattern

FIGURE 3-3 Typical Exterior Joint with Discontinuous Reinforcement

Moment-rotation plots for a typical specimen without transverse beam stubs are given in figures 3-3(a,b). Initial cracks appeared on the face of the joint near the embedded bars during

early load cycles. Under increasing loads, these cracks progressed diagonally across the joint into the splice region. The load carrying capacity dropped suddenly as cracking extended along the entire length of the splice revealing the buckling longitudinal column bars. Additional load cycles induced a large opening of the construction joint above the beam, and drove the cracks along the splice toward the bottom column. The prying action of the bent-down negative beam reinforcement produced full separation of the 2.5–4.0 ft high concrete cover layer opposite the beam (extending from the lower construction joint to the splice region), as shown in figure 3-3(c). In contrast to the interior joints, downward loading on the beams had a major contribution to the failure of the exterior joints.

In summary, failures occurred by a combination of excessive diagonal shear cracking followed by splice failure in the top column, spalling of the concrete cover due to the prying action of the bent-down negative beam reinforcement, and to a smaller extent, pullout of the embedded positive beam reinforcement.

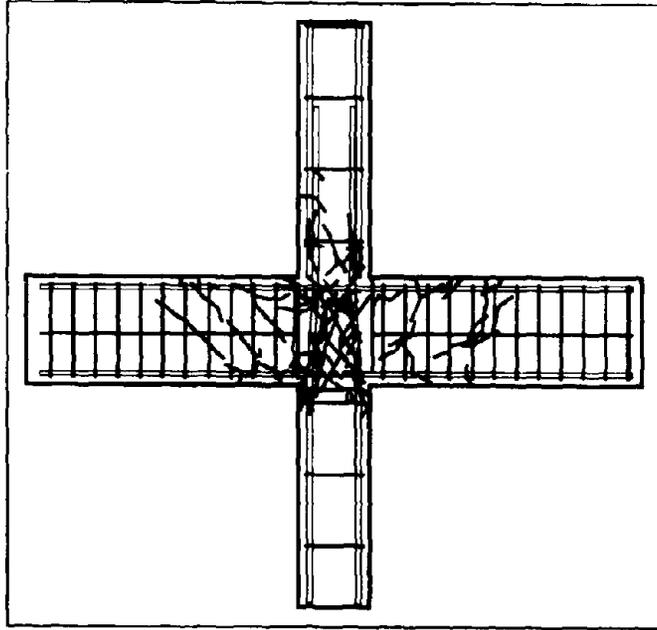
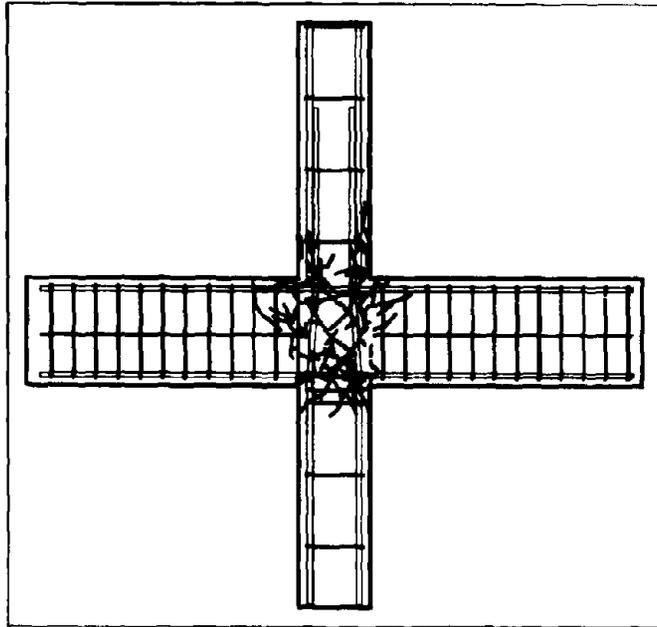
a. Specimen I-11

b. Specimen REP I-11

FIGURE 4-3 Cracking Patterns

At low force level cycles, cracks developed between the patching mortar and the original concrete at the joint surface. Although these cracks (see figure 4-3(a,b)) became increasingly apparent during the cycling, the first spalling of the patching mortar occurred at a relatively high beam rotation value of +0.0175 radian. Additional cycles caused extensive spalling at the concrete cover of the middle joint region and around the corners, especially at the adjacent column surfaces. After removing the loose pieces, the same main diagonal cracks as in the original specimen were found in the joint, and the concrete seemed to be extensively deteriorated as shown in figure 4-4. Compared to the crack pattern of the original specimen, new vertical cracks were found in the upper column extending from the joint beyond the first stirrup above the joint.

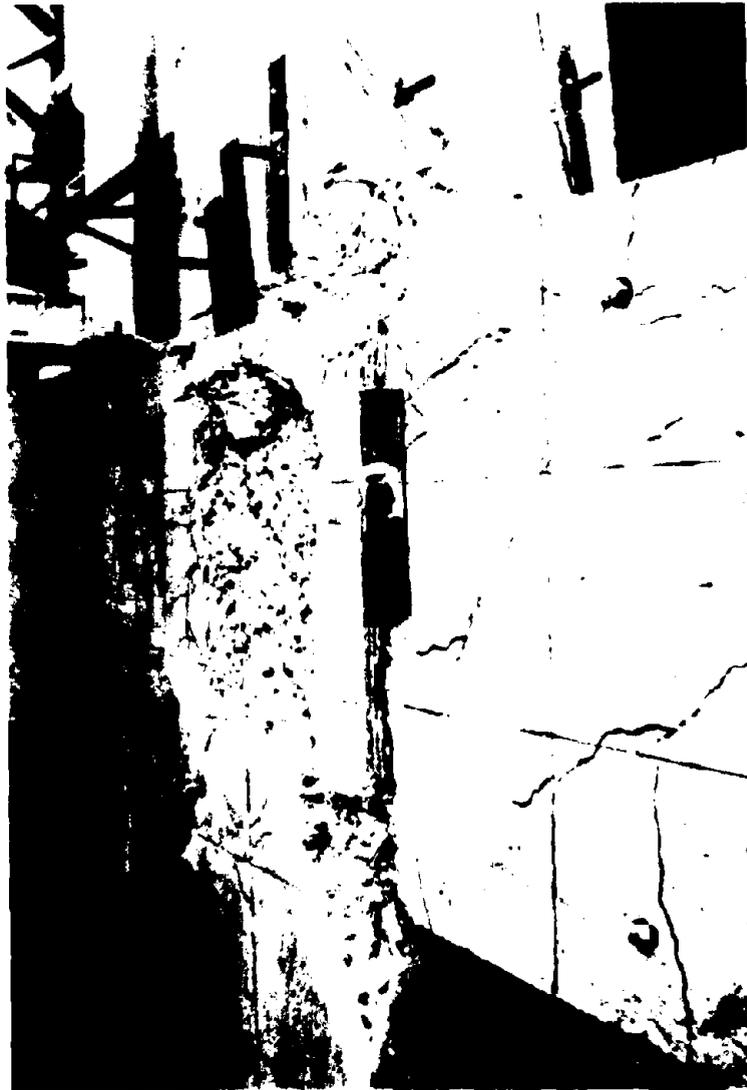
FIGURE 4-4 Photo Taken After the Test

The failure of the specimen to maintain load capacity was attributed to the pullout of the embedded bottom rebars of the beams in both the original and repaired specimens. The repaired specimen reached a value of about 72% of the peak column shear capacity of the original specimen. Heavy concrete damage was visible around the embedment zone and the main diagonal cracks went through this region as well, as can be seen in figure 4-4.

After the test, the loose concrete pieces were removed. In most cases it was impossible to tell where the original cracklines were because of the lack of visible color differences at the joint, except for some thin resin layers around the vertical rebars. Much of the concrete seemed to be "soaked" by the resin, having a dark gray color. Some parts of the concrete underwent a slight

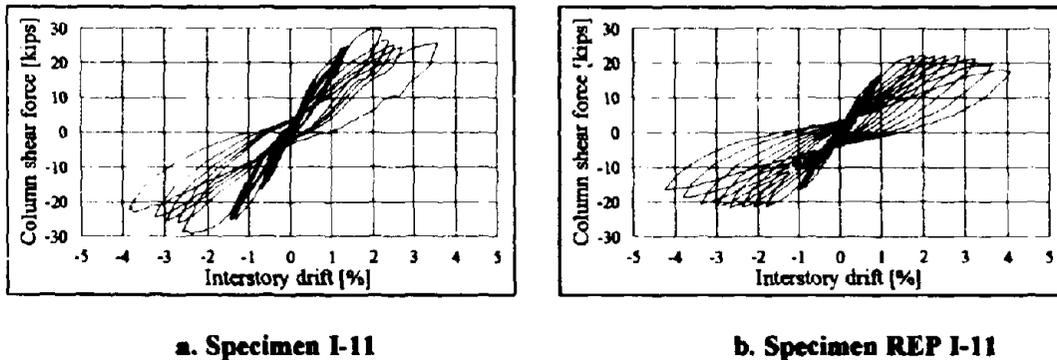
FIGURE 4-5 Column Shear Force Versus Interstory Drift Before and After Repair

Figures 4-5(a,b) show the relation between the shear force acting at the midheight of the column and the interstory drift, i.e. the relative lateral displacement of the adjacent floors, for the original and repaired specimens. The magnitude of story-drift can be related to the total damage of the structure. When the virgin specimen was loaded up to 3.8% interstory drift during the final cycle it experienced serious deterioration. The repair did restore about 72% of the column shear force capacity, with load levels remaining constant for 5 cycles.

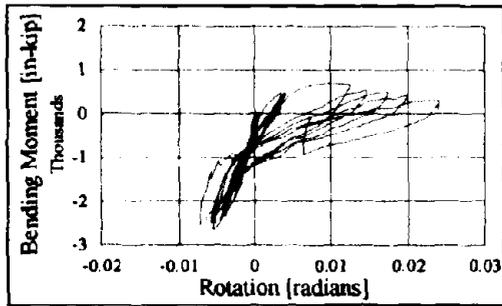
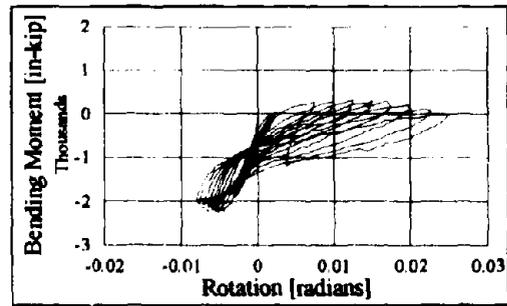
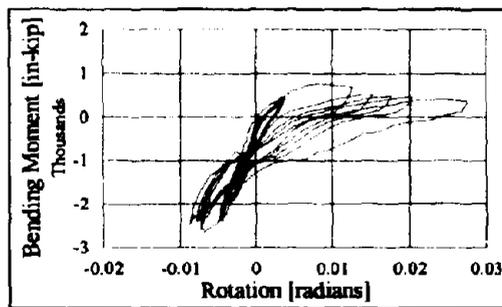
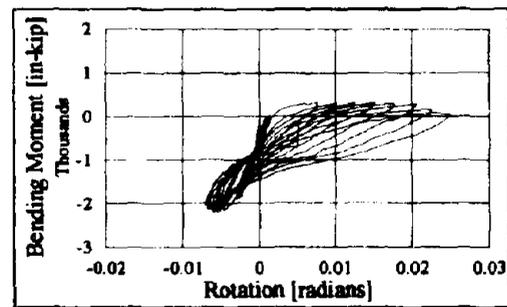
a. Specimen I-11 Beam #1

b. Specimen REP I-11 Beam #1

c. Specimen I-11 Beam #2

d. Specimen REP I-11 Beam #2

FIGURE 4-6 Bending Moment Versus Rotation in Beams Before and After Repair

The bending moment - rotation relations for the beam regions adjacent to the joint are shown in figures 4-6(a-d). The moment-rotation plots are of particular importance, because the failures of both specimens were attributed to the pullout of the embedded rebars at the bottom of the beams. From the bending moment - rotation plots it can be seen that in spite of the fact that only about 40% of the positive bending moment capacity of the original specimen was reached, this capacity was maintained through a relatively large rotation value of more than

+0.02 radian (see the positive moment and positive rotation region, because this part of the hysteretic action is related closely to the pullout action).

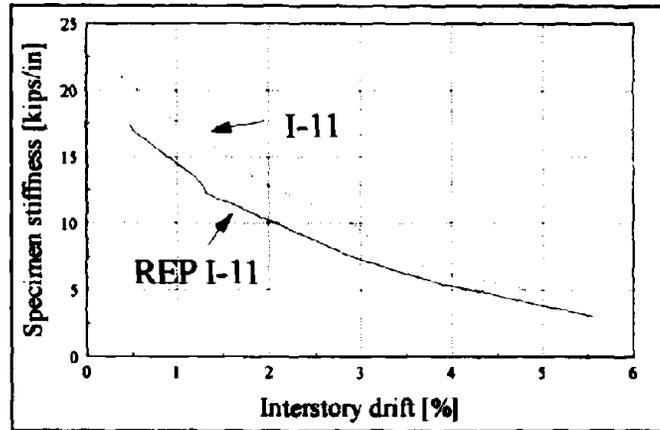
FIGURE 4-7 Stiffness vs. Maximum Interstory Drift Before and After Repair

Stiffness degradation is illustrated by a plot of the specimen stiffness versus the average of the maximum absolute values of the positive and negative interstory drifts (figure 4-7). The specimen stiffness corresponds to the peak-to-peak slope of each cycle in the column shear versus interstory drift. Since only a part of the cracked zones were repaired, the initial stiffness of REP I-11 was about 25% less than that of the virgin specimen. The repair scheme resulted in a similar degradation path with convergence at high deformations.

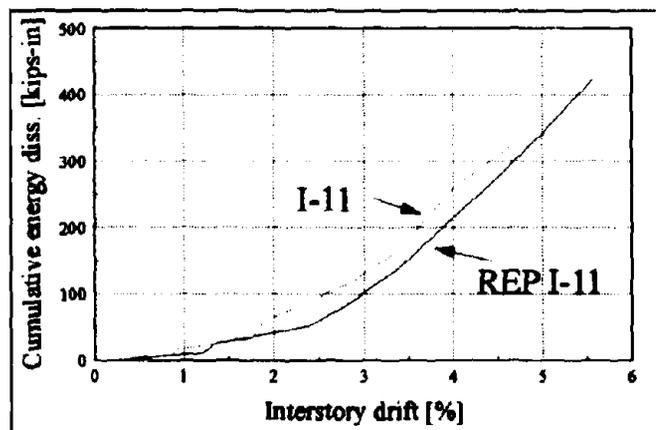
FIGURE 4-8 Cumulative Energy Dissipation vs. Interstory Drift Before and After Repair

Energy dissipation is represented by a plot of the cumulative dissipated energy versus the average of the absolute values of the maximum positive and negative interstory drifts (figure 4-8). The cumulative dissipated energy was computed by summing the area enclosed within the column shear versus average interstory drift. This is an approximation, because frictional losses induced are not accounted for during the test.

Figure 4-8 shows that energy dissipation was almost identical for the repaired and the virgin specimens. The slightly higher cumulative energy values for I-11 are attributed to the fact that only cracks close to the joint-panel zone were filled with resin and few new cracks developed outside this region during the retest. Beyond 2% drift, substantial cracking and loss of stiffness occurred in both cases. This caused an increase in the energy dissipation rate.

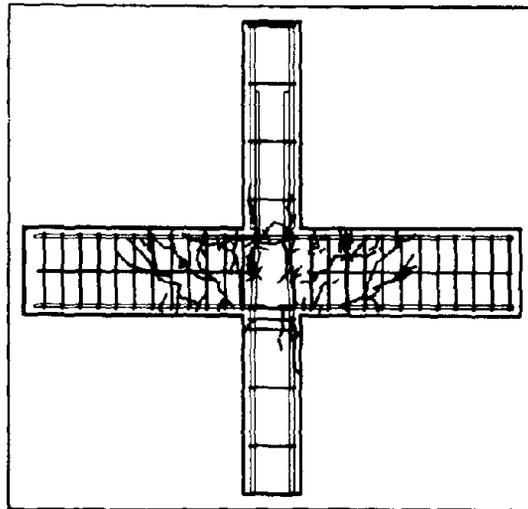
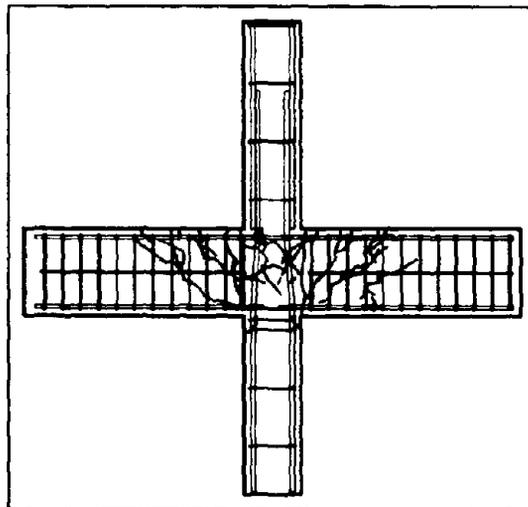
a. Specimen I-16

b. Specimen RI-1

FIGURE 5-3 Cracking Patterns (interior)

cracking patterns for both bare (I-16) and retrofitted (RI-1) specimens are shown in figures 5-3(a,b). After completion of the test (figure 5-4), no significant permanent deformations were noticed on the retrofitted specimen.

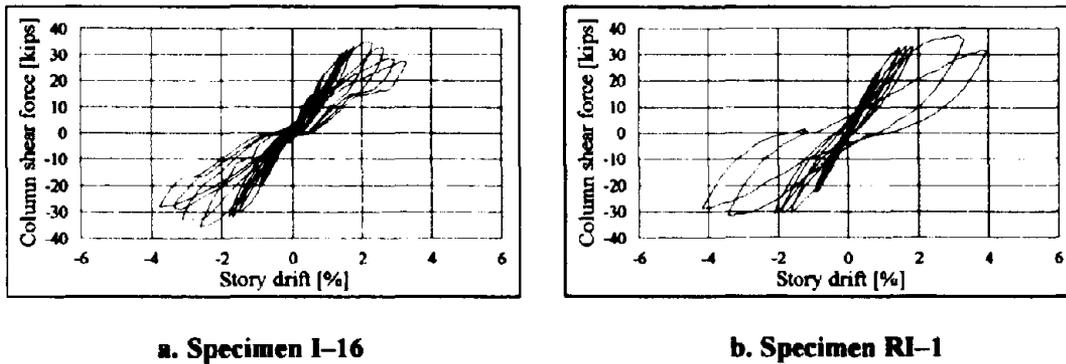
FIGURE 5-5 Column Shear Force Versus Interstory Drift (interior)

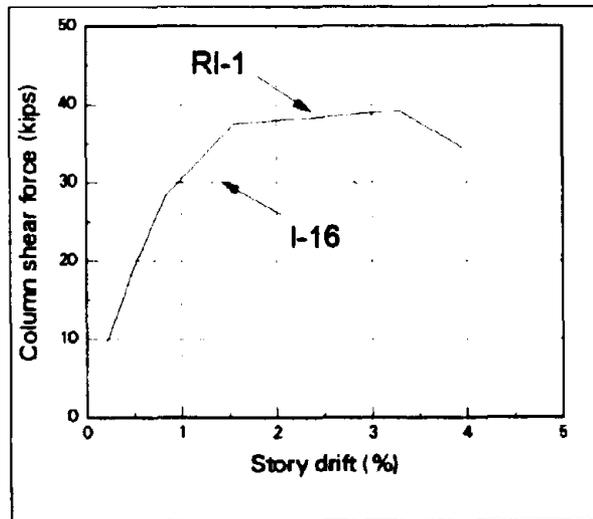
FIGURE 5-6 Column Shear Force Versus Interstory Drift Envelopes (interior)

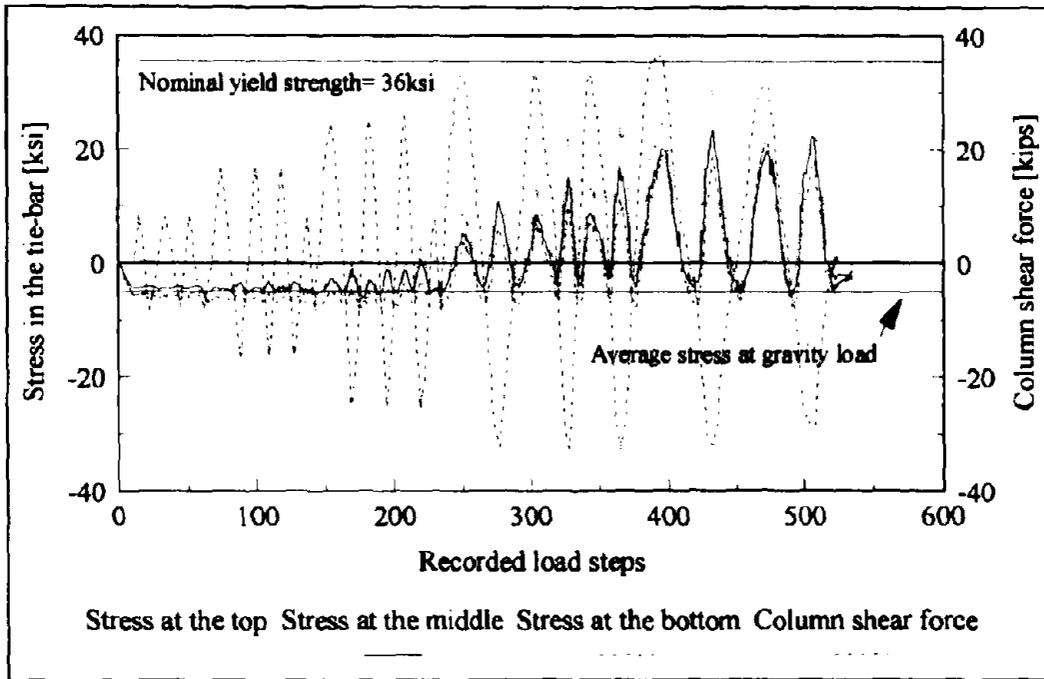
FIGURE 5-7 Longitudinal Stress in the Tie-bars (interior)

resulted in a measured compressive strain in the tie-bars. This compressive strain translates to about 5 ksi stress as shown in figure 5-7. In a real application, this initial shift would not happen.

During the test, there was no significant increase in compressive stress. The average maximum increase in tensile stress was about 33 ksi. This value is close to the nominal yield capacity of the A36 steel. The strain gage measurements showed about 15–25% lower peak tensile stresses at the bottom of the tie-bars compared to the top. At maximum load the anchor bolts were subjected to an average shear force of 5.5 kips (that is about 50% of their ultimate strength) without any noticeable damage.

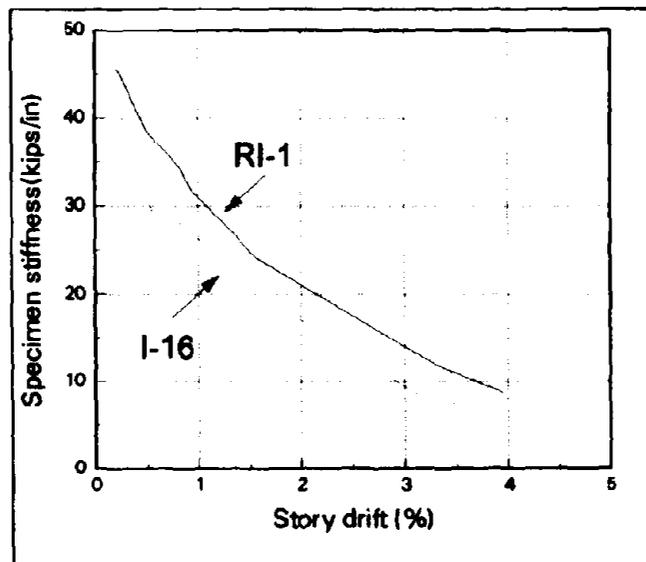
FIGURE 5-8 Stiffness vs. Maximum Interstory Drift (interior)

Stiffness degradation is illustrated by a plot of the specimen stiffness versus the average of the absolute maximum values of the positive and negative interstory drifts (figure 5-8). The specimen stiffness corresponds to the peak-to-peak slope of each cycle in the column shear versus interstory drift. The retrofit scheme resulted in 10 to 20% increase in stiffness. The rates of stiffness degradation for both specimens were similar.

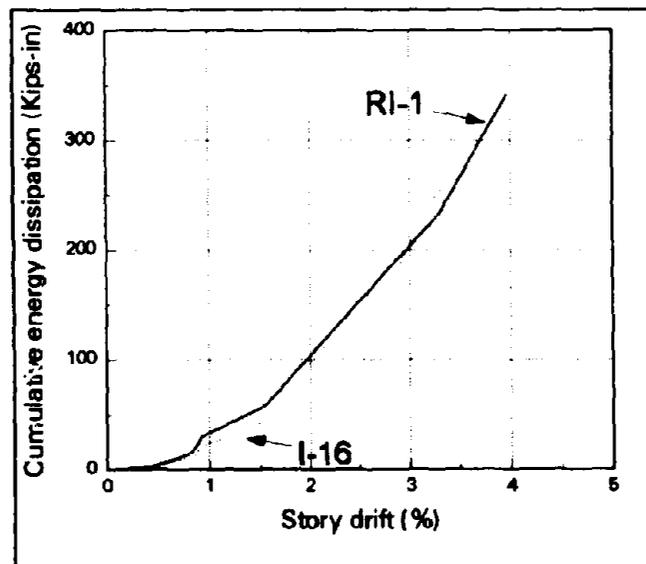
FIGURE 5-9 Cumulative Energy Dissipation vs. Interstory Drift (interior)

Energy dissipation due to the extensive inelastic action within and near the joint-panel is represented by a plot of the cumulative dissipated energy versus the average of the absolute values of the maximum positive and negative interstory drifts (figure 5-9). The cumulative dissipated energy was computed by summing the area enclosed within the column shear versus average interstory drift. This is an approximation because of frictional losses induced during the test.

Figure 5-9 shows that energy dissipation was almost identical for the retrofitted and non-retrofitted specimens. Although the tie-bars remained elastic and the embedment zone intact, damage was transferred to other parts of the joint because the close hierarchy of weaknesses. Beyond 2% drift, substantial cracking and loss of stiffness occurred in both cases. This caused an increase in the energy dissipation rate.

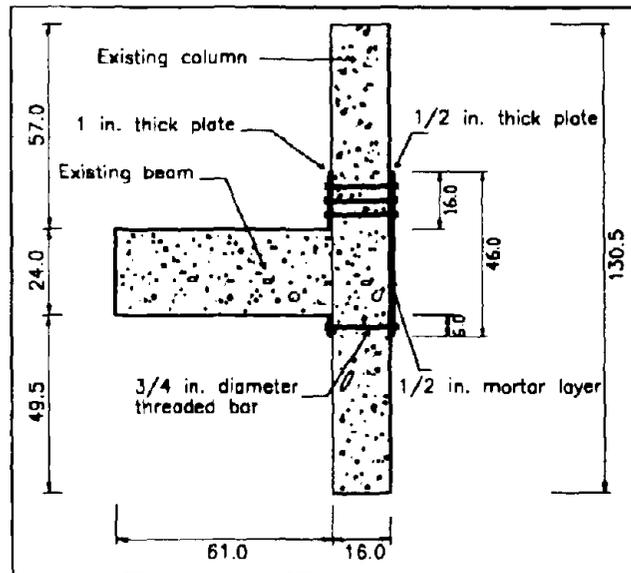
FIGURE 5-10 Retrofit Configuration (exterior)

The main objective of this scheme was to try to force the flexural hinges to form in the beam but not in the columns, to avoid the occurrence of the soft-story collapse mechanism. The other objectives were to add more confinement to the joint panel, to avoid any splice failure in the top column and to enhance the energy dissipation capacity of the joint. This was done by external steel plates attached along the opposite faces of the upper and lower columns (figures 5-10 and 5-13). An additional consideration in choosing this configuration was the least disturbance of the building facade.

As shown in figure 5-10, the steel plates were not bolted to the concrete but simply connected with threaded bars. A longer plate was used in the upper column because of the presence of the splice. A 1/2 inch thick film of grout was first placed between each plate and the concrete surface to provide a uniform bearing surface. The threaded rods were then tightened resulting in substantial confining stresses applied to the top and bottom columns.

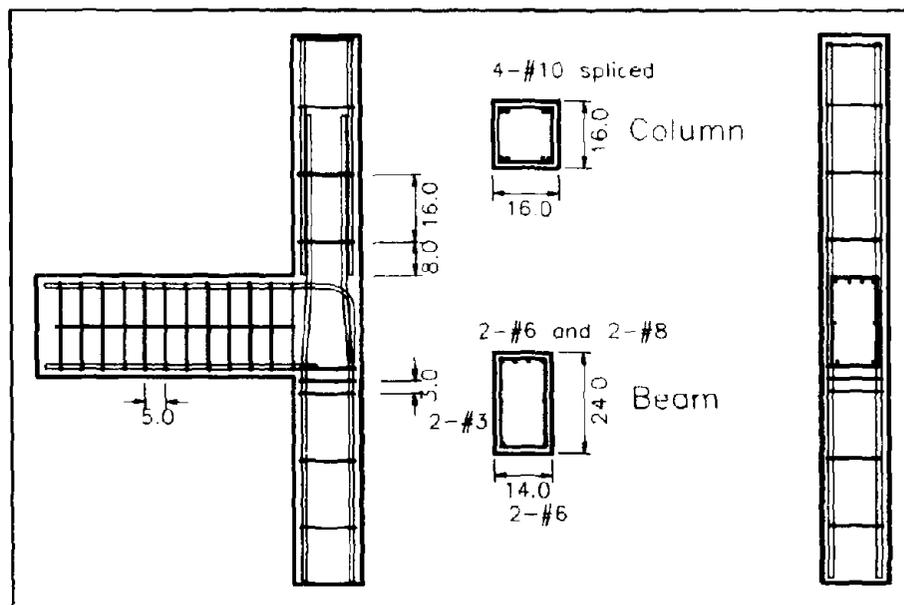
FIGURE 5-11 Specimen Reinforcement and Dimensions (exterior)

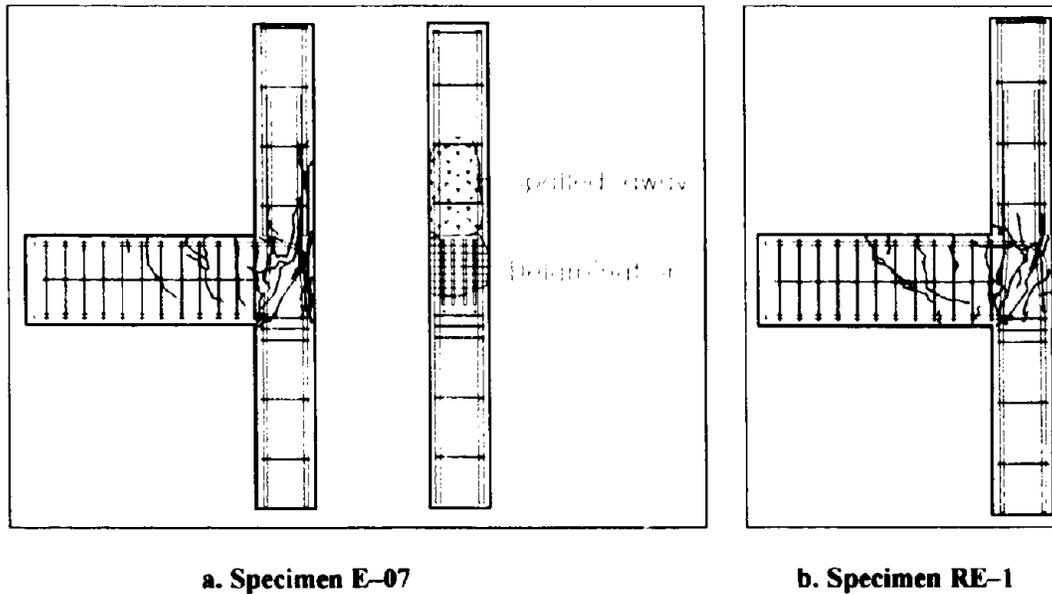
FIGURE 5-12 Cracking Patterns (exterior)

The implemented retrofit scheme markedly changed the damage pattern, especially toward the end of the test. Initial cracks developed similarly to the bare specimen. However, no major opening of the diagonal cracks were observed. Subsequent cycles caused few extensions of these cracks beyond the upper construction joint into the splice region. Cracks in that zone were effectively arrested by the steel plate confinement. Spalling of the concrete cover opposite to the beam was entirely prevented by the back side steel plate resulting in significantly less damage in the joint panel zone. At the final cycles, a major vertical crack developed in the joint panel close to the beam, resulting in the formation of a flexural hinge. This was followed by pullout of the positive beam reinforcement. Final cracking patterns for both bare (E-07) and retrofitted (RE-1) specimens are shown in figure 5-12(a,b).

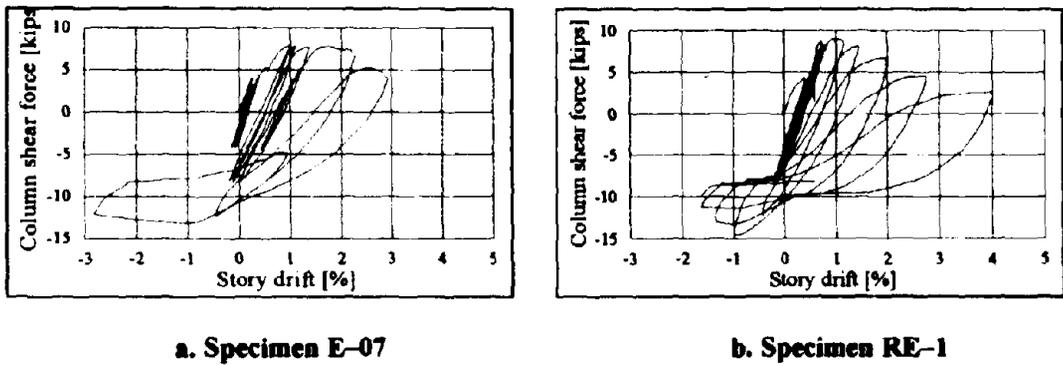
FIGURE 5-14 Column Shear-Interstory Drift (exterior)

to the shear force due to the gravity effects. From these hysteresis plots, column shear capacity envelopes were generated by connecting the peak points of each hysteresis loop. Figure 5-15 shows these envelopes for both the non-retrofitted and the retrofitted specimens. Since the concrete strength of the joint governed the overall capacity, plots starting from figures 5-15 to 5-17 were normalized by $\sqrt{f'_c}$ (f'_c is the measured compressive strength of the concrete in the joint-panel and the beams). The f'_c values were 4220 and 3070 psi for specimens E-07 and RE-1 respectively.

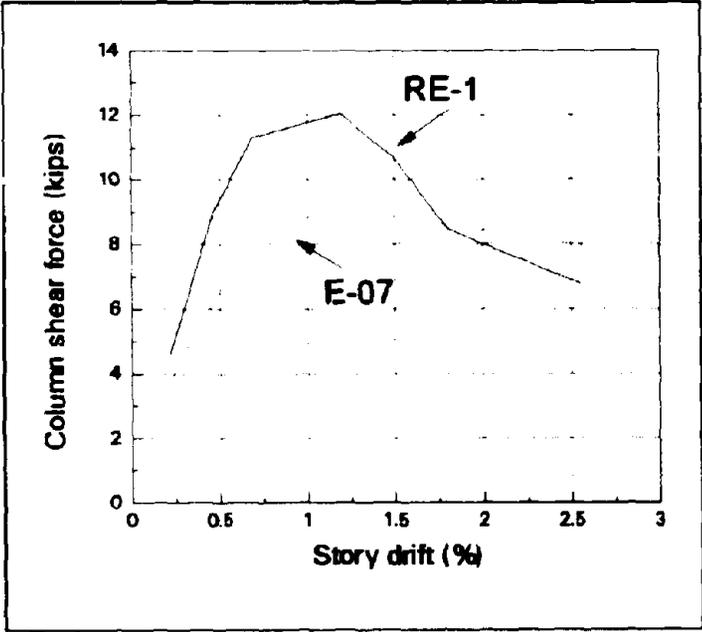
FIGURE 5-15 Column Shear Force Versus Interstory Drift Envelopes (exterior)

Figure 5-15 shows an increase in strength due to the retrofit up to about 1.75% interstory drift. The peak strength was increased by about 33%. The retrofitted specimen showed a higher rate of strength loss after the peak strength.

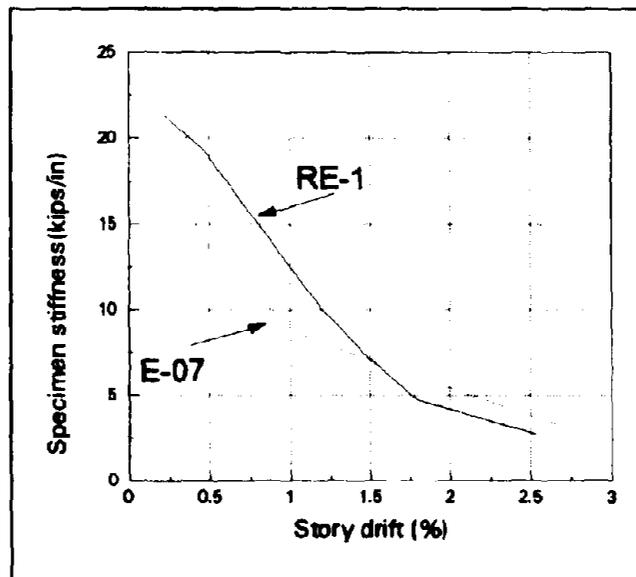
FIGURE 5-16 Stiffness vs. Maximum Interstory Drift (exterior)

Although stiffness degradation in an exterior joint might sound alarming, the overall stiffness degradation of an actual LRC building could be kept to a minimum if there were a sufficient number of interior joint regions in which only a small loss of stiffness takes place.

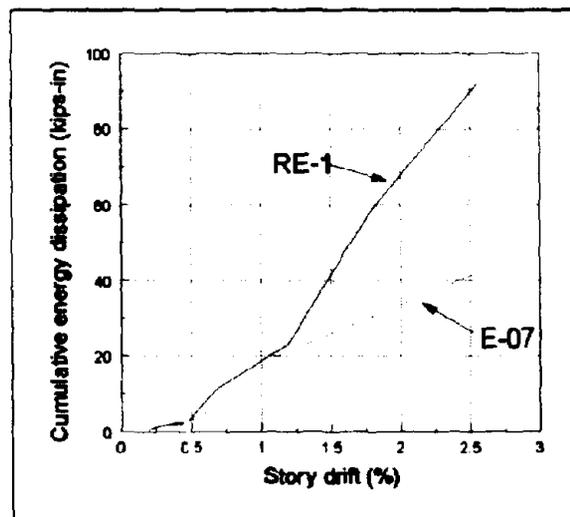
FIGURE 5-17 Cumulative Energy Dissipation vs. Interstory Drift (exterior)

Figure 5-17 shows that energy dissipation was about the same for both non-retrofitted and retrofitted specimens up to an average drift value of 1.3%. After that point, the retrofit scheme resulted in a significant (about 230%) increase in the rate of energy dissipation. This is due to the inelastic bending of the 1/2 inch thick back plate, as indicated on the permanent flexural deformations observed after the test. It is interesting to note that energy dissipation started to increase at about the same drift (1.3%) that stiffness started to decrease (comparing figures 5-16 and 5-17). Pullout of the embedded positive beam reinforcement resulted in higher bending rotations in the 1/2 inch thick back plate.
