# Wind and Seismic Effects

**NIST SP 871**

**PROCEEDINGS OF  
THE 26TH JOINT  
MEETING OF  
THE U.S.-JAPAN  
COOPERATIVE PROGRAM  
IN NATURAL RESOURCES  
PANEL ON WIND AND  
SEISMIC EFFECTS**

**Issued September 1994**

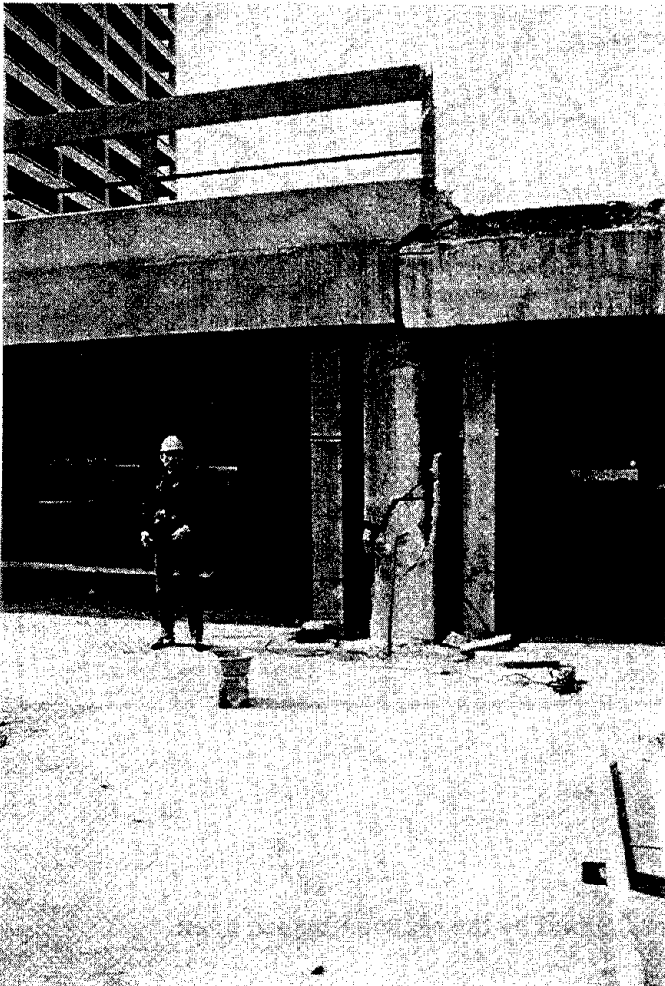
Figure 22 The exterior columns of the Trans World Bank parking garage, which had not been strengthened, were badly damaged.

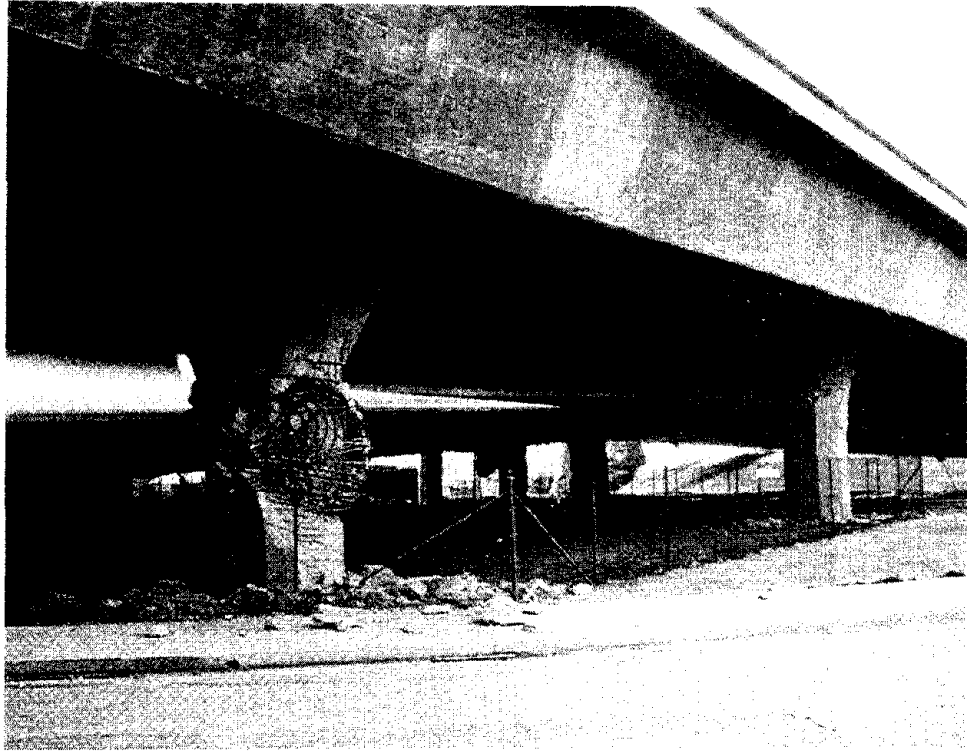
Figure 33. Damage to piers of the SR118 Mission-Gothic Undercrossing, looking to the northwest at the north face of the westbound bridge, Bents 3 (foreground) and 2.

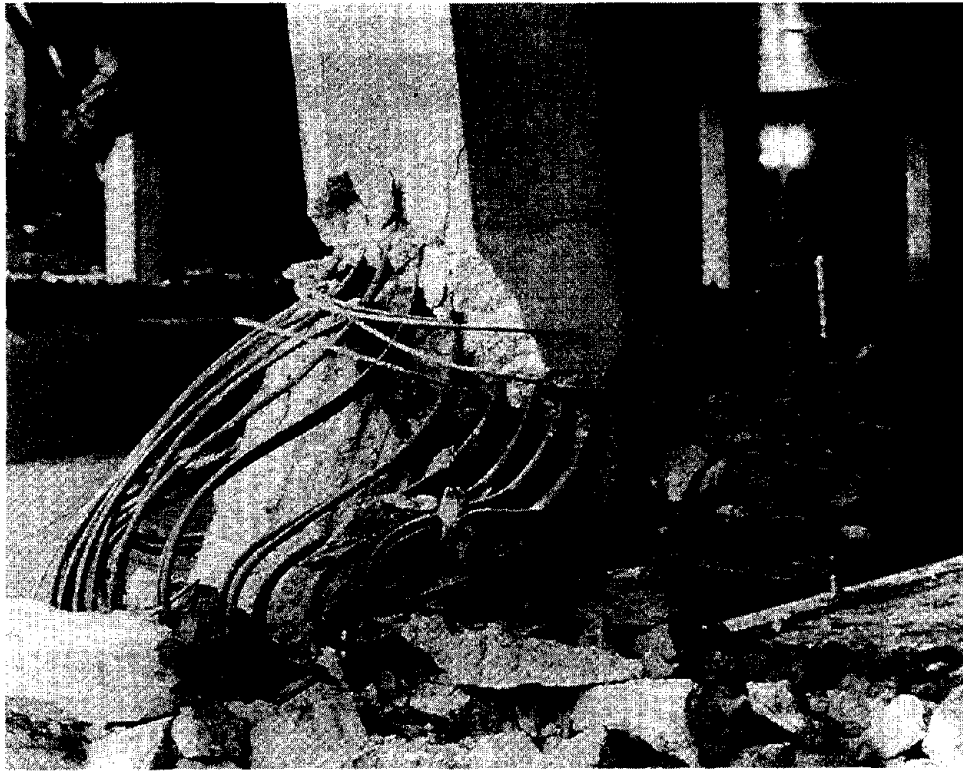
Figure 35 Damage to pier 3S-1 of State Route 118 at Bull Creek Canyon Channel, looking to the northwest

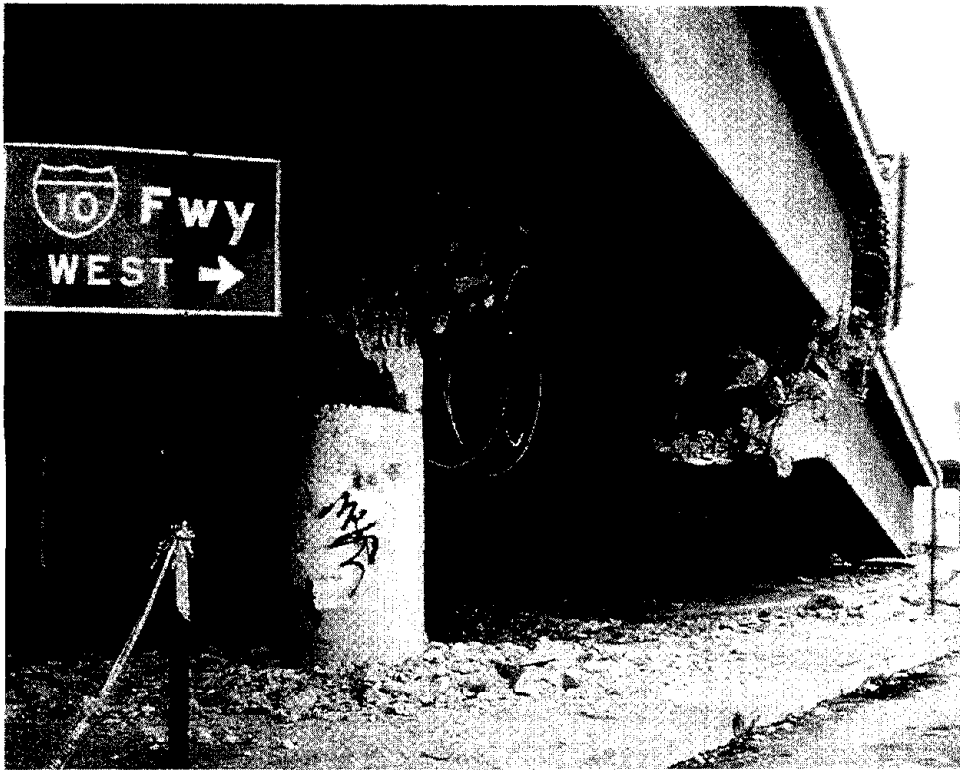
Figure 37 Collapsed westbound lane of I10 at Venice Blvd.; pier of Bent 7 in foreground

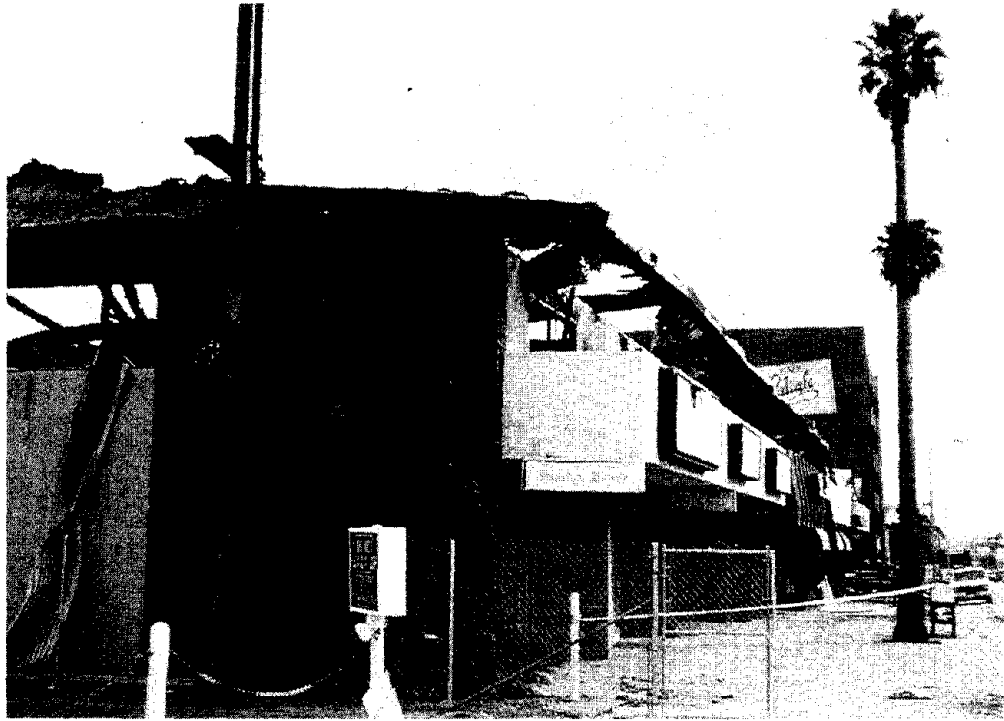
Figure 57 Fire damage in a two story commercial building.

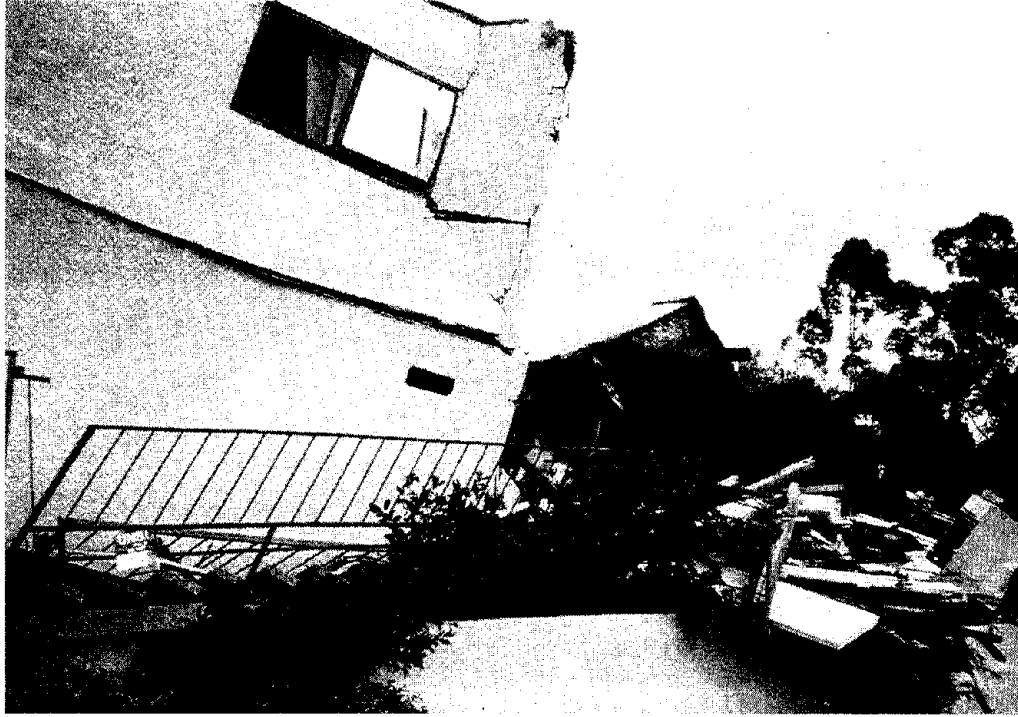
Figure 59 Partially collapsed apartment building with fire damage in the rear.

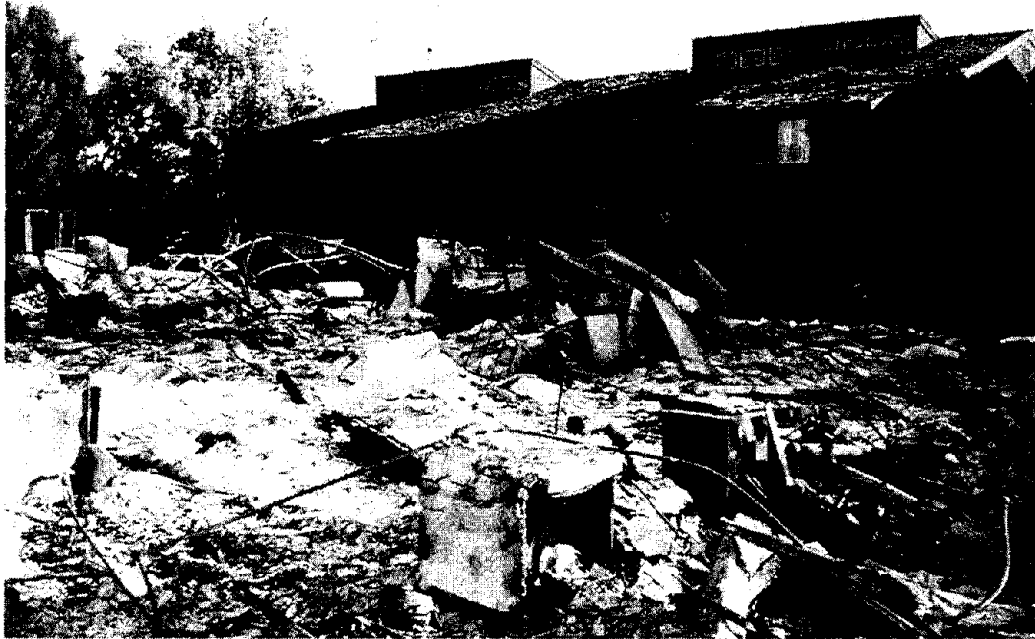
Figure 61 Multi-family residential building destroyed by fire.
