**NONDESTRUCTIVE AND DESTRUCTIVE TESTING  
OF A REINFORCED CONCRETE SLAB BRIDGE  
AND ASSOCIATED ANALYTICAL STUDIES**

**Report No. UC-CII 92/02**

**December 1992**

**A Report to Sponsors:  
Federal Highway Administration  
and  
Ohio Department of Transportation  
Contract No. 14482 (0)**

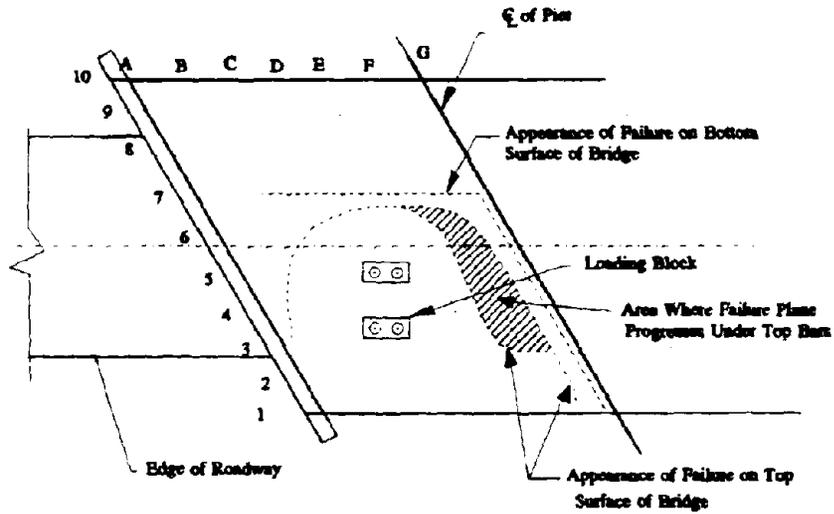
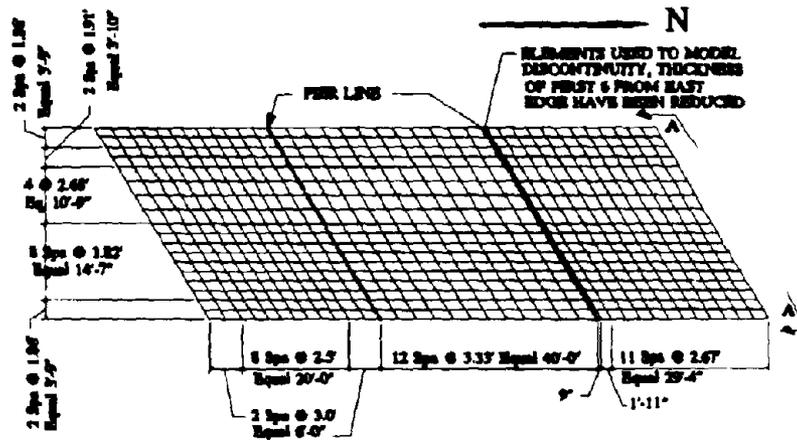
**FIGURE 5(a): TOP VIEW OF FAILURE PLANE**

**FIGURE 5(b): APPEARANCE OF BOTTOM AND TOP FAILURE PLANES**

**FIGURE 5: FAILURE PLANE**

Figure 5 shows the resultant failure plane of the bridge. The failure originated near the pier in the damaged region of the east shoulder and progressed from that point. It appears the failure was, in part, triggered by a change in the load path that was occurring between 17 and 21 trucks. Originally, the bridge carried load perpendicular to the traffic lanes until, at the 7 truck limit state, the rotational restraints at the abutment were released and the bridge began to carry the load parallel to the slab skew.

Once the load path shifted back to parallel to the traffic lanes, the shoulder which had been excluded from the load path since the 7 truck limit state now came back into the load path and had to carry load. The damaged shoulder concrete possessed very little shear strength and this triggered the failure since the damaged shoulder could not take the additional load.

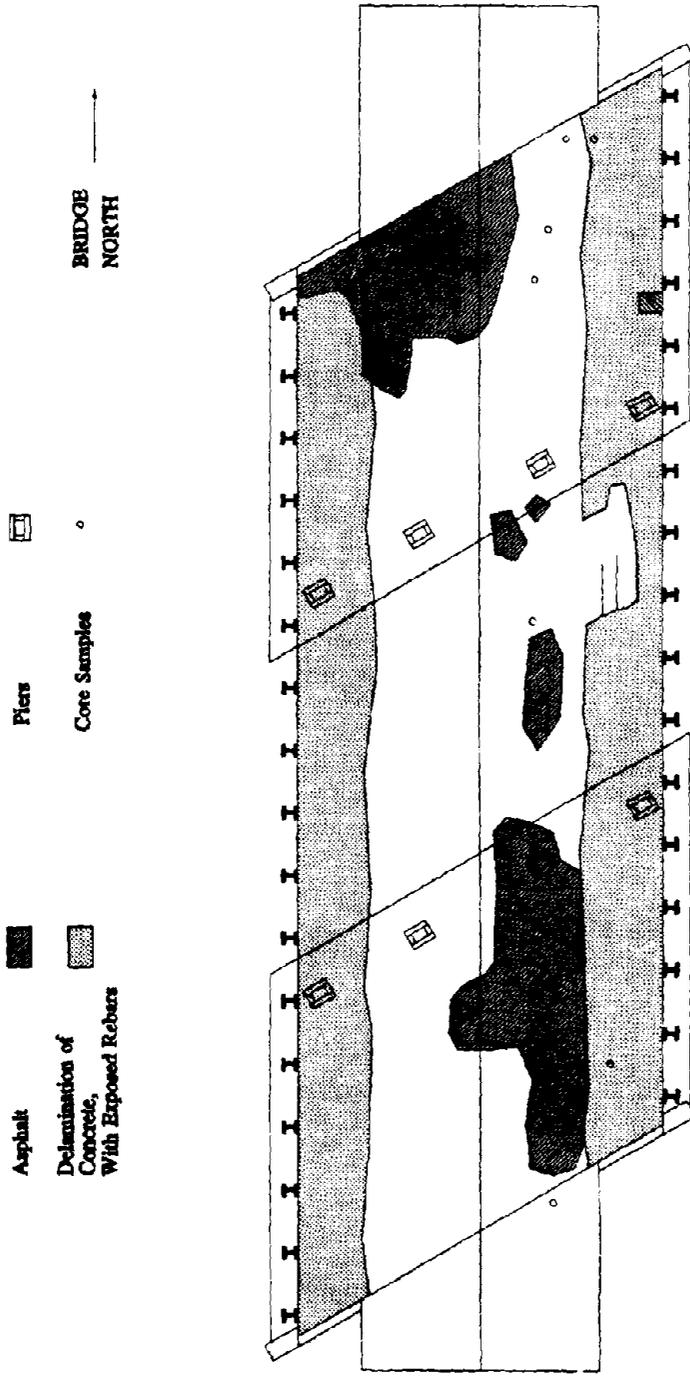
**FIGURE 3.1: BRIDGE DAMAGE-TOP VIEW**

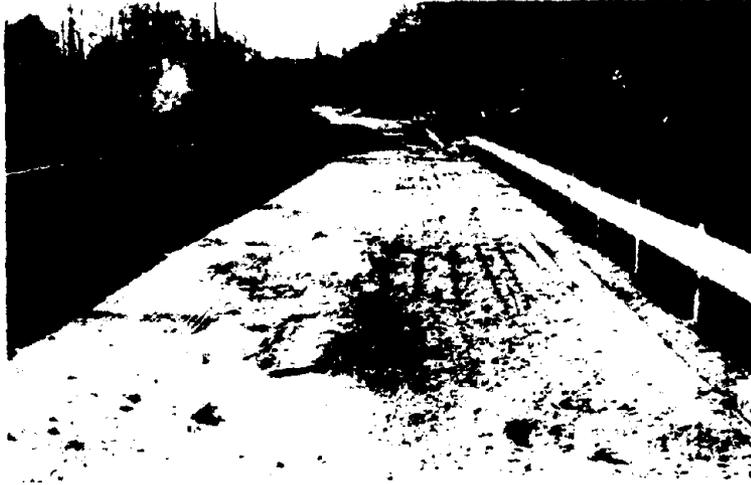
**FIGURE 3.3: TOP VIEW OF THE EAST SHOULDER OF THE DECK**

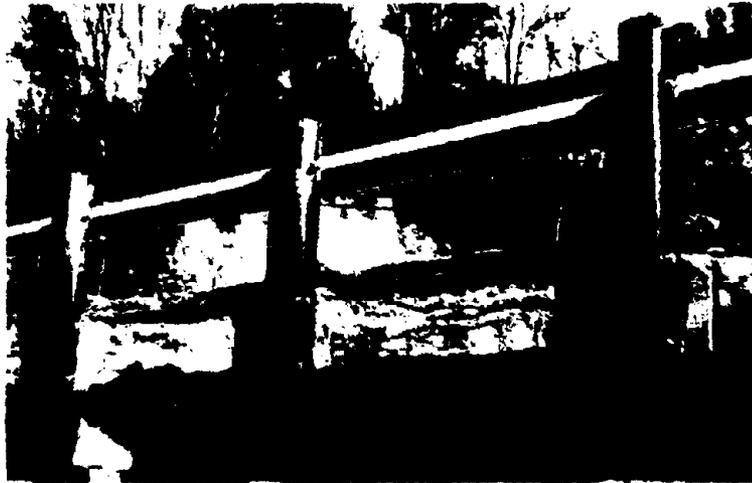
**FIGURE 3.4: SIDE VIEW OF DAMAGE TO EAST SIDE OF BRIDGE DECK**

NOTE: DETERIORATION IS APPROXIMATELY SYMMETRICAL ON BOTH SIDES OF THE CENTERLINE

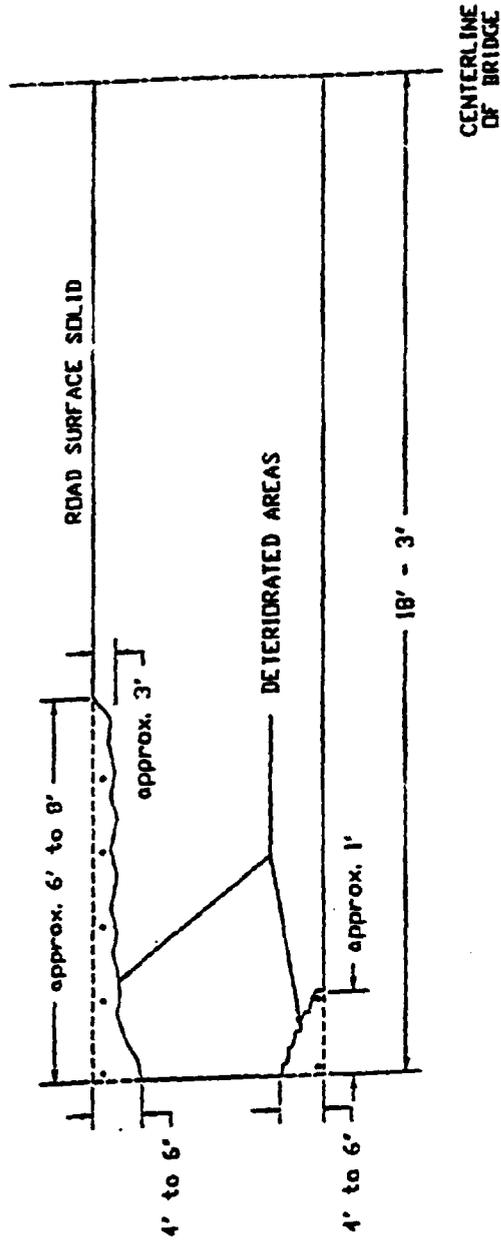
CROSS SECTION OF BRIDGE DECK  
CUT PERPENDICULAR TO DIRECTION OF SPAN

FIGURE 3.5: APPROXIMATE DAMAGE TO THE DECK, CROSS-SECTIONAL VIEW

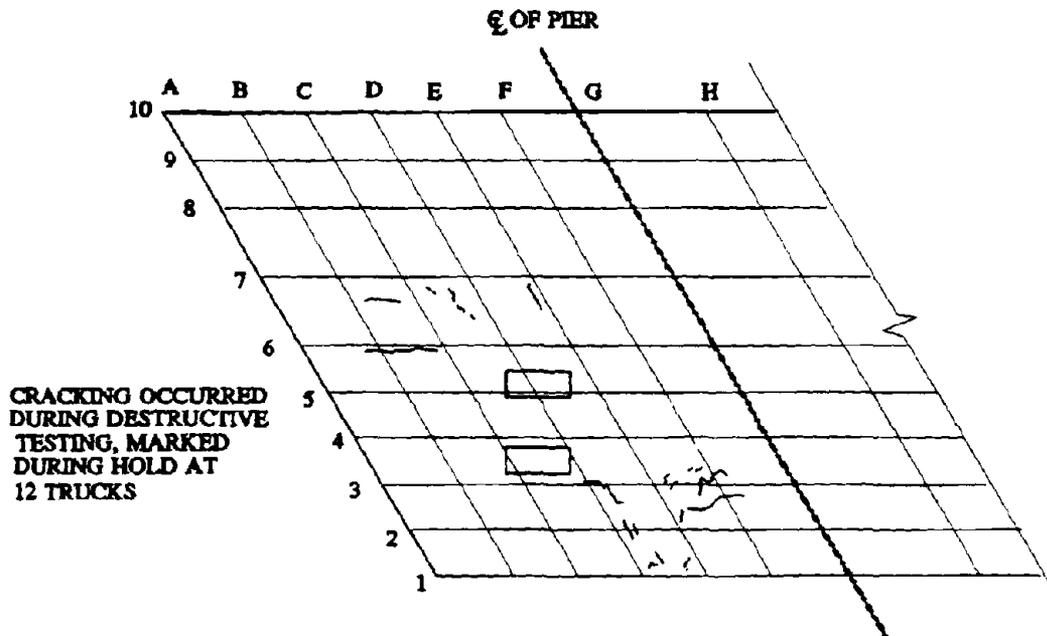
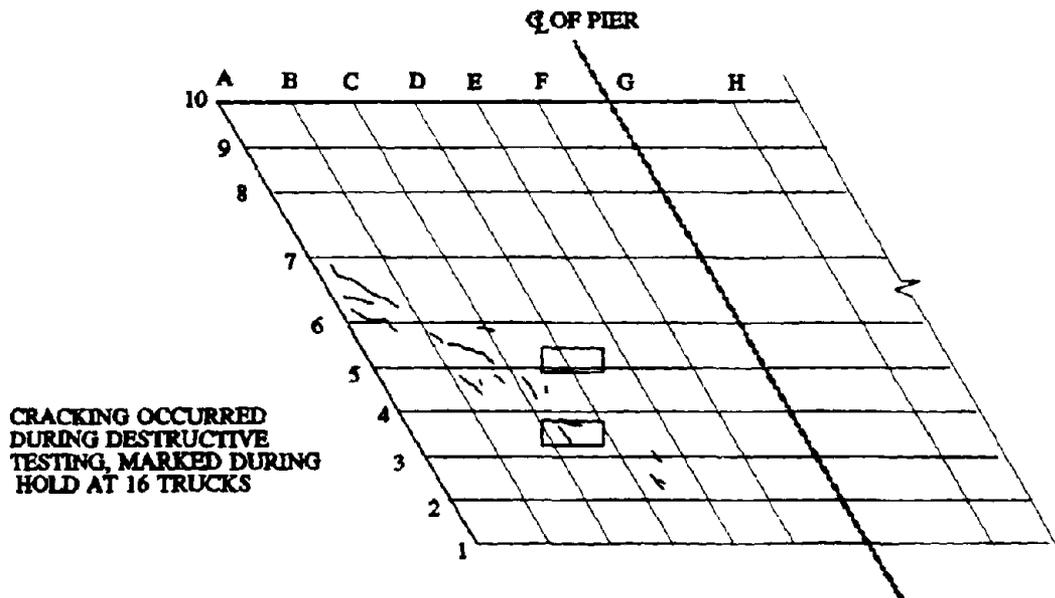
INCREMENTAL CRACKING BETWEEN 8 TO 12 TRUCK LOADS

INCREMENTAL CRACKING BETWEEN 12 TO 16 TRUCK LOADS

FIGURE 5.11: INCREMENTAL CRACKING MARKED AT 12 AND 16 TRUCK LOADS

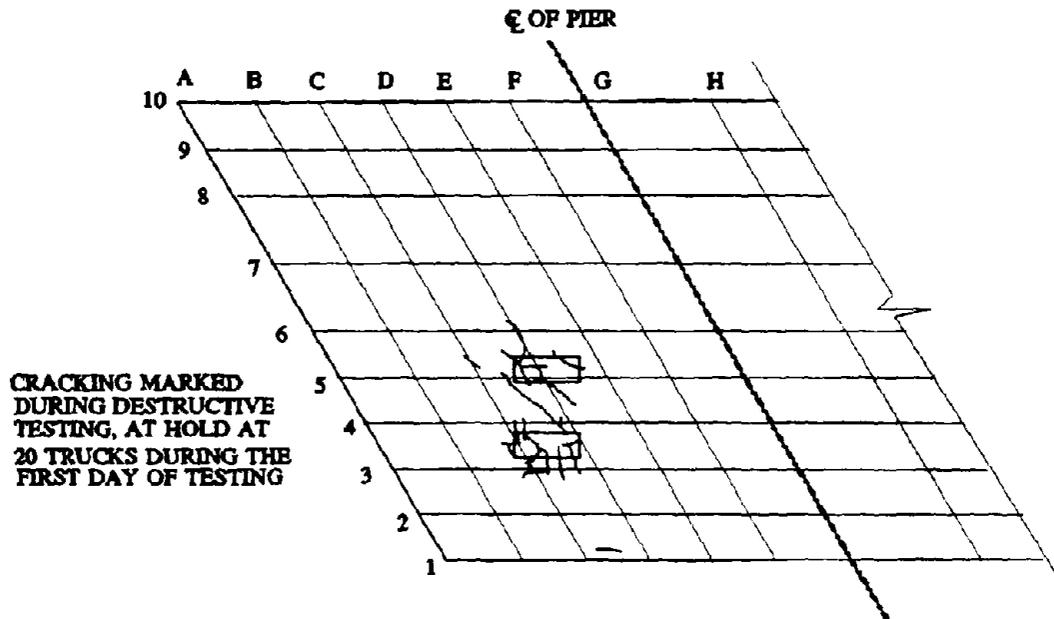
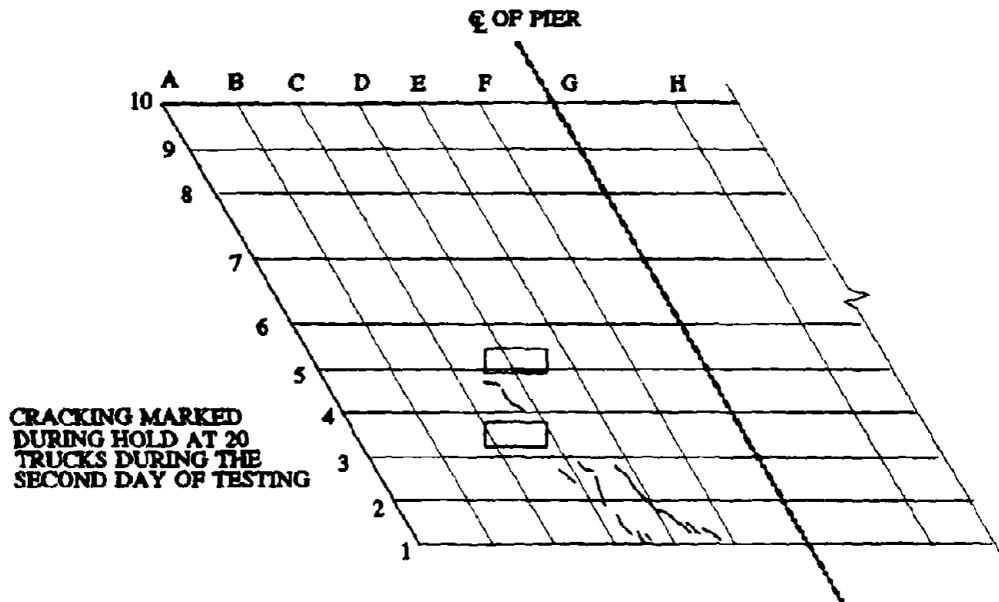
**INCREMENTAL CRACKING BETWEEN 16 TO 20 TRUCK LOADS**

**INCREMENTAL CRACKING AT 20 TRUCK LOADS DAY 2**

**FIGURE 5.12: INCREMENTAL CRACKING MARKED AT 20 TRUCKS**

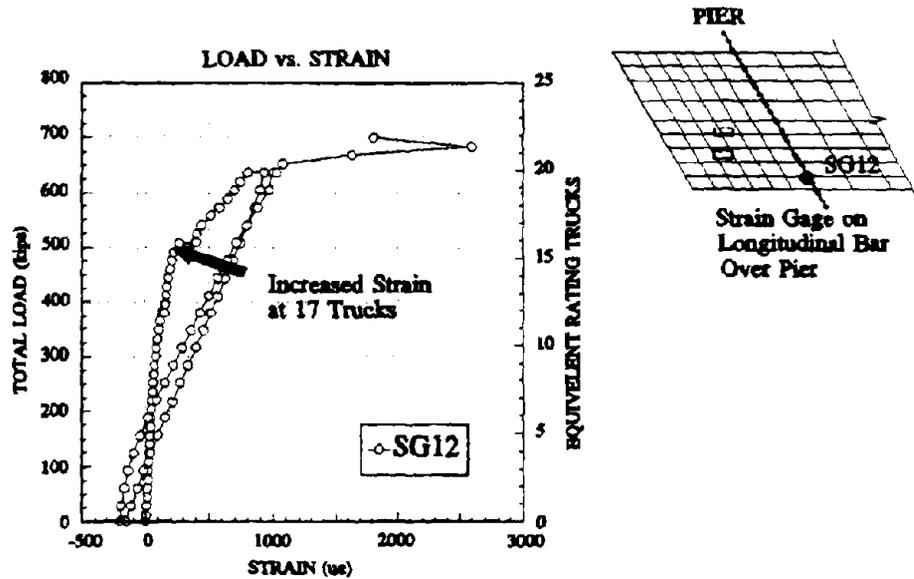
SG12 INDICATING INCREASED STRESS AT 17 TRUCKS

DIAGONAL CRACK PLANE VISIBLE ON SIDE

FIGURE 5.13: INITIATION OF DIAGONAL TENSION FAILURE FOLLOWING YIELDING AT CRITICAL REGION

However, at about 17 trucks the load path again began shift. The changing load path is revealed by the strain gage SG12 located on a top rebar over the pier in the damaged shoulder. As shown in Figure 4, at about 17 trucks this rebar began to see a rapid increase in stress; in fact, by 20 equivalent truck loads it had yielded. Strain gages placed on other bars reveal that bars near the loading blocks began to yield at 20 trucks. It is very possible that yielding began earlier than this at places and bars which were not instrumented. The onset of yielding seems to be the impetus for the shift of load path back to the direction perpendicular to the traffic lanes. This makes sense for two reasons: 1) The analysis which showed that skew bridges carry load parallel to the skew was linear. Yielding of the bars introduces a nonlinearity so it is expected that the linear solution is no longer valid; 2) Once the bars yield, they become dominant in defining the behavior. Since the bars are aligned with the traffic lanes, it is reasonable that the load path would shift parallel to the traffic lanes and the reinforcing bars.

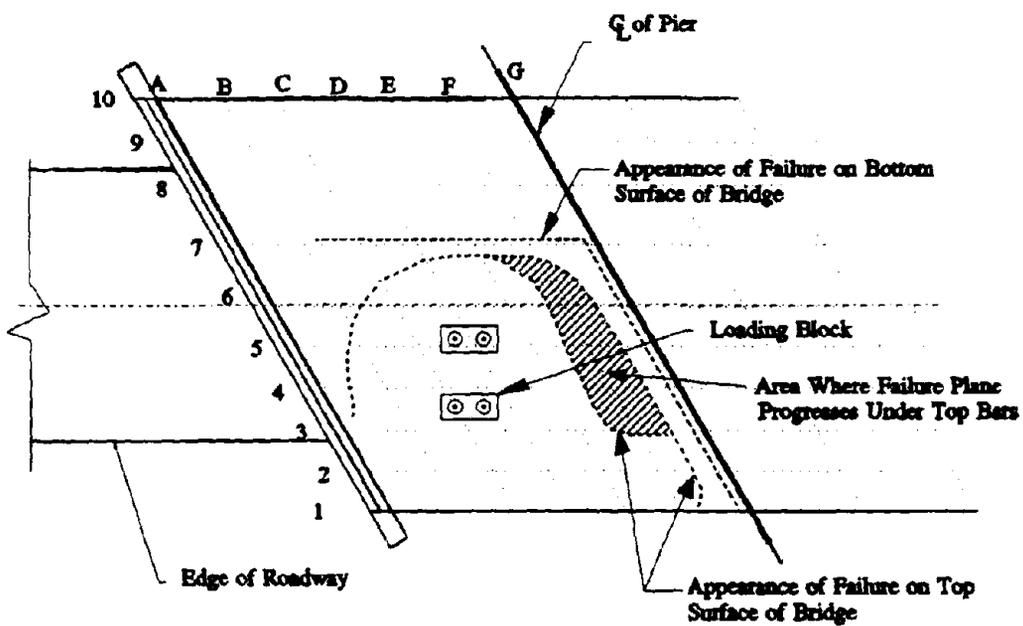
**TOP VIEW OF FAILURE PLANE**

**APPEARANCE OF BOTTOM AND TOP FAILURE PLANES**

**FIGURE 5.14: FAILURE PLANE**

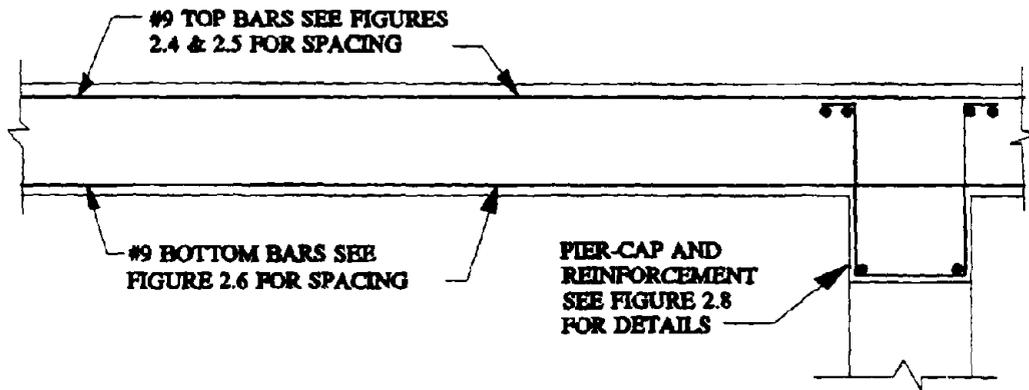
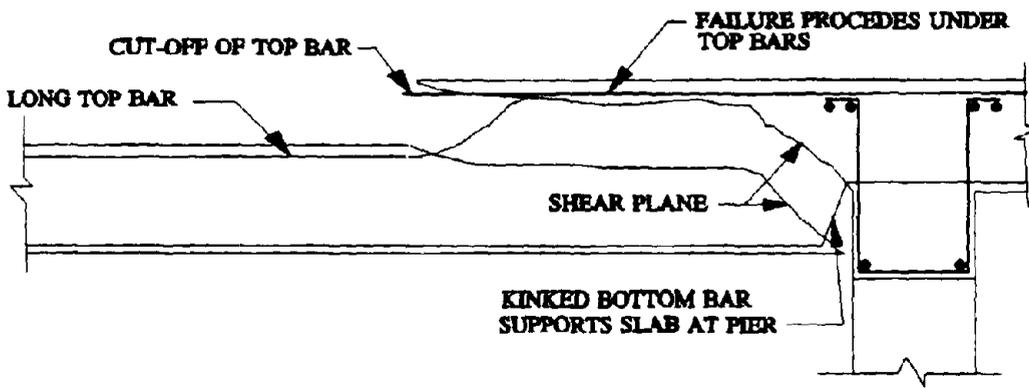
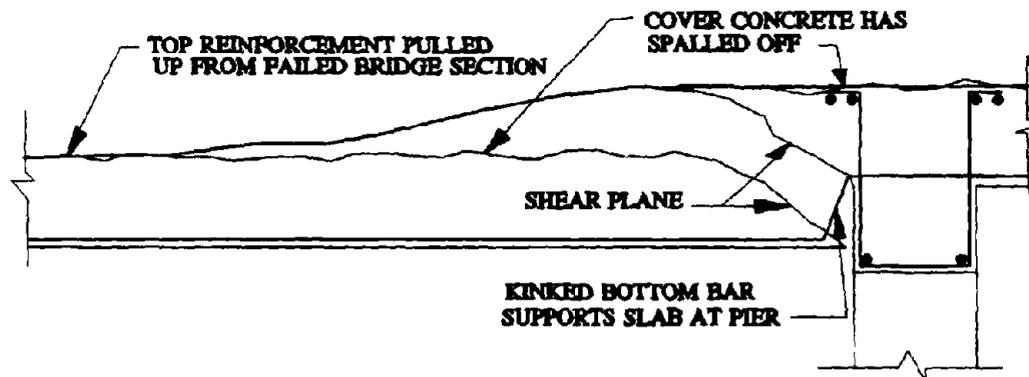
**UNDAMAGED TYPICAL SLAB CROSS-SECTION**

**TYPICAL DAMAGED CROSS-SECTION IN DRIVING LANES**

**TYPICAL DAMAGED CROSS-SECTION IN SHOULDER**

**FIGURE 5.15: TYPICAL CROSS-SECTIONS OF FAILURE**

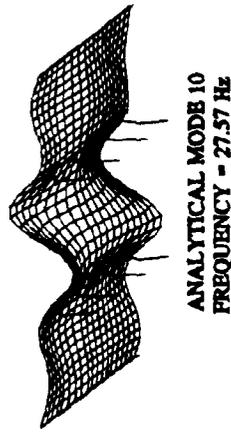
**FIGURE 6.17(b): RESULTS OF CALIBRATION OF TEST #2, MODES 6 TO 10**

the low levels of excitation in the impact testing and the stiffness retained by the shoulders in spite of deterioration. The nominal and final calibrated models are shown in Figures 6.16(a) and 6.16(b). Figures 6.17(a) through 6.17(d) compare the analytical and experimental mode shapes and frequencies.
