SEISMIC RESPONSE OF COLUMN/CAP BEAM TEE CONNECTIONS WITH CAP BEAM PRESTRESSING

Report No.
SSRP - 96/09

**SEISMIC RESPONSE OF COLUMN/CAP
BEAM TEE CONNECTIONS WITH CAP
BEAM PRESTRESSING**

Final Report on a Research Project funded by Caltrans
under Contract No. 59V374.

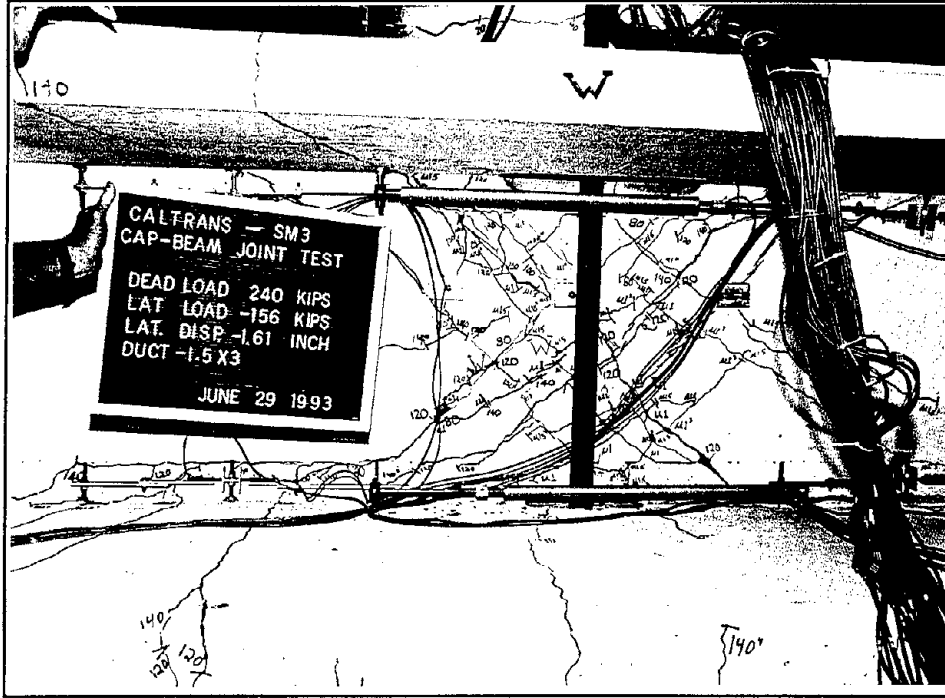
Figure 3.13 SM3 joint shear cracks on west side at $\mu_{\Delta} = -1.5 \times 3$.

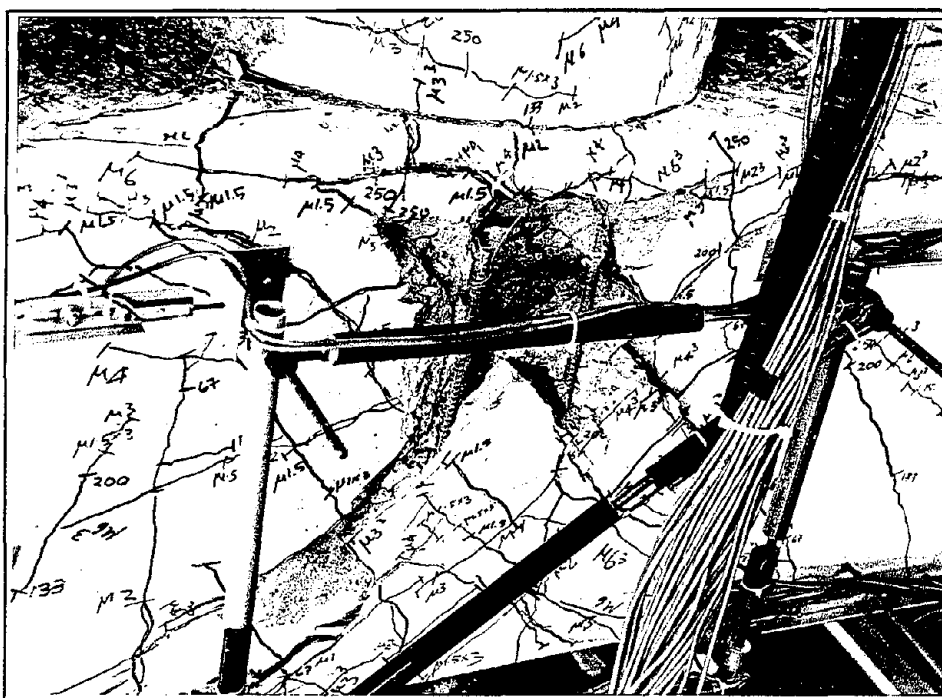
Figure 4.13 Condition of the joint at the end of first cycle at $\mu_{\Delta} = 8$.

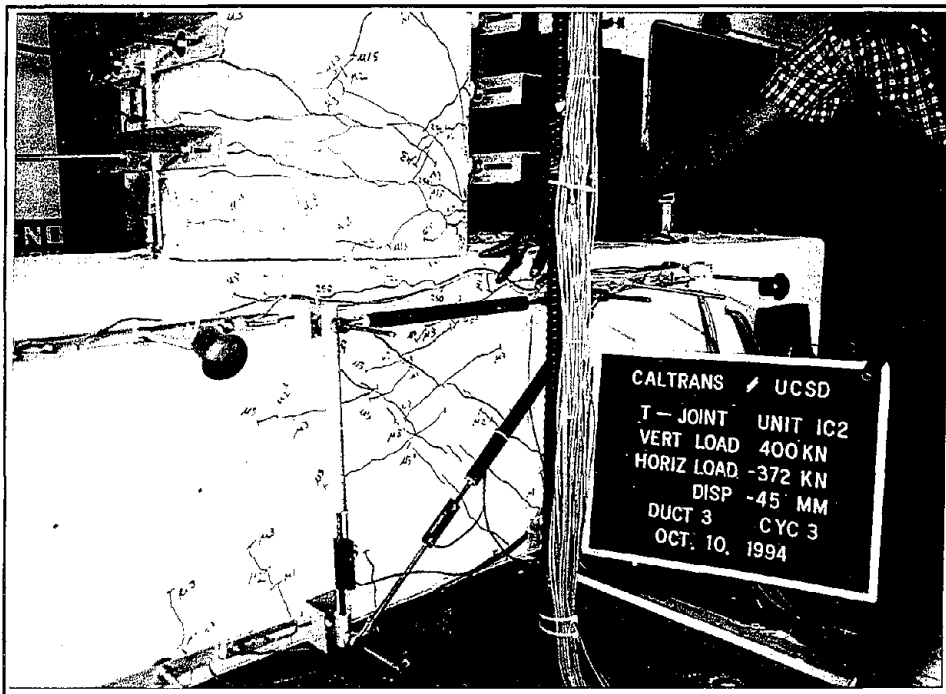
Figure 5.7 Condition of test unit IC2 at the end of testing at $\mu_{\Delta} = 3$.
