REPORT NO.
UCB/EERC-97/09
SEPTEMBER 1997

SECOND U.S.-JAPAN WORKSHOP ON SEISMIC RETROFIT OF BRIDGES

*January 20 and 21, 1994
Berkeley Marina Marriott Hotel
Berkeley, California*

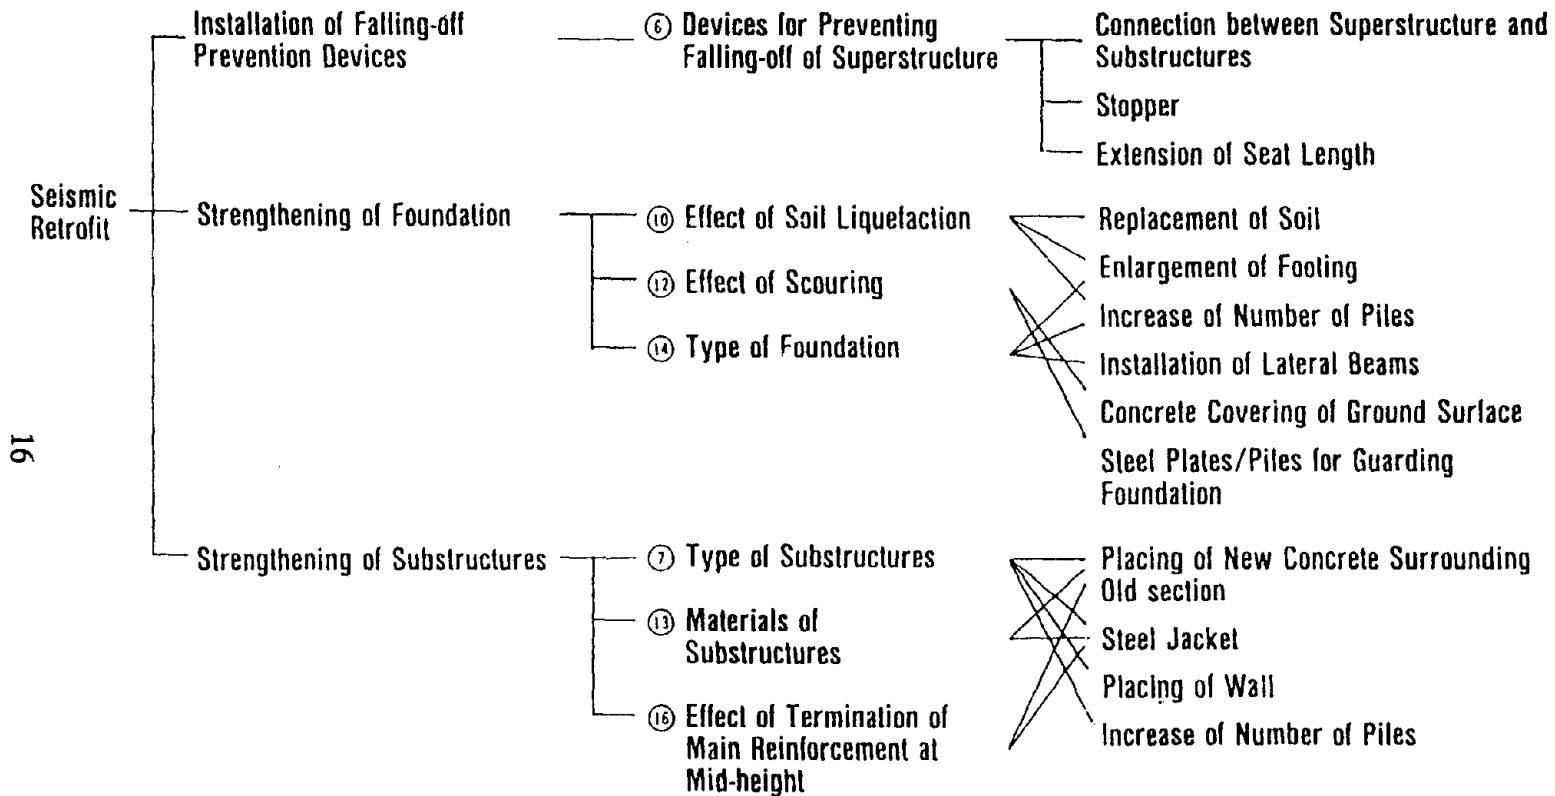
Fig. 1 Methods Adopted for Seismic Strengthening

Fig. 1 shows how the countermeasures can be made for the above 7 factors. Installation of the devices for preventing falling-off of superstructure, strengthening of foundations, and strengthening of piers and abutments are the measures which are most often adopted for seismic strengthening.

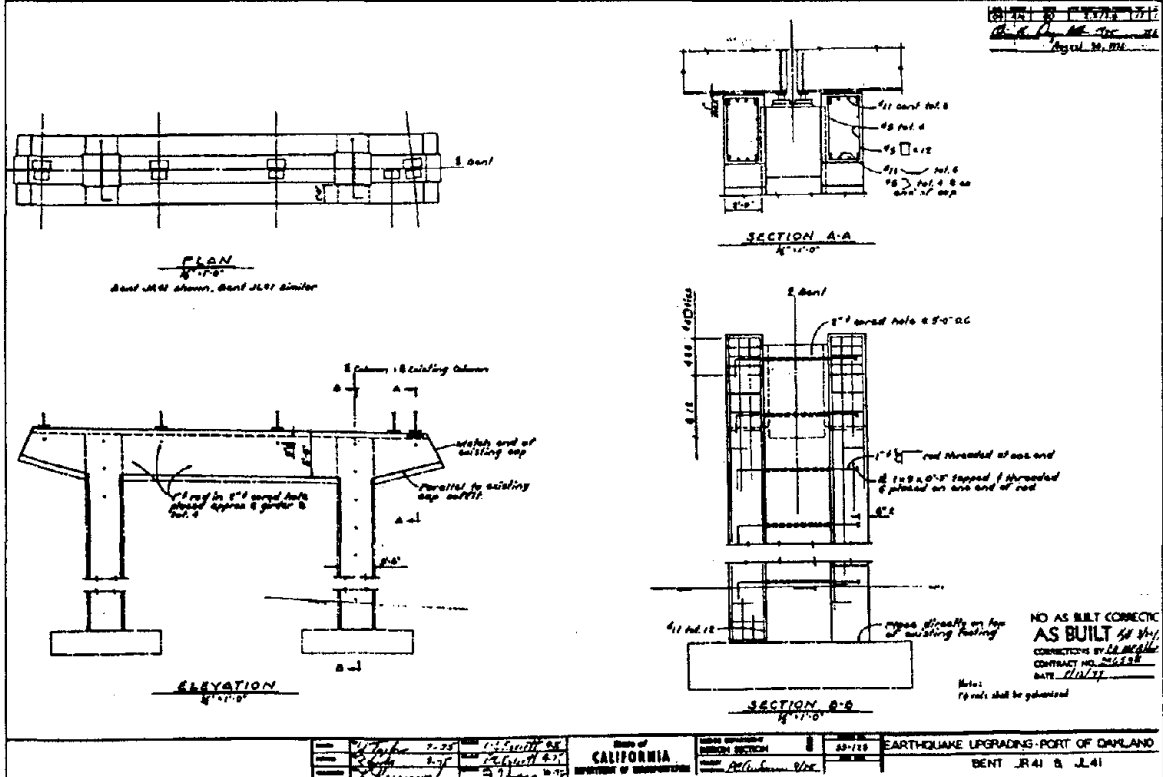
Figure 25. Port of Oakland Seismic Retrofit Details

At a couple of locations the bent cap was widened to provide a seat to catch the girder ends.

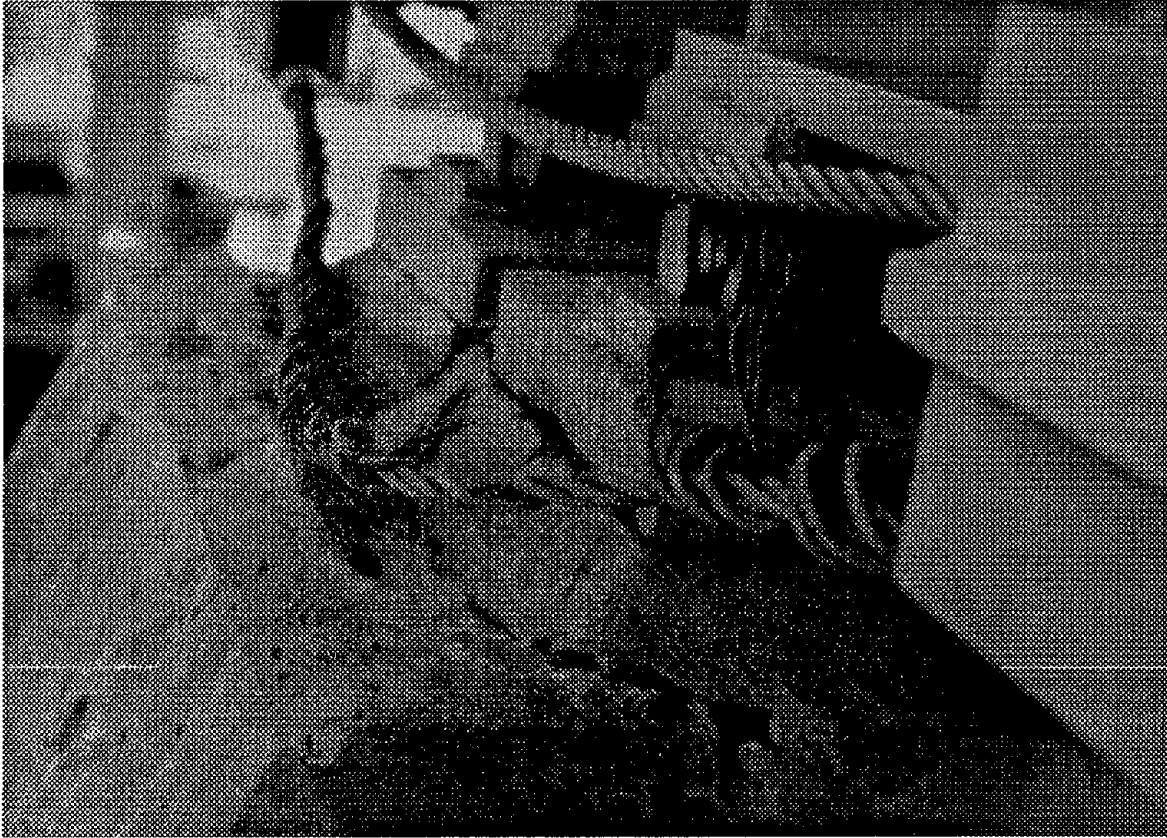
Figure 26. Loma Prieta Earthquake Damage to Port of Oakland Overcrossing

Although this bridge is about 80 miles north of the epicenter of the Loma Prieta Earthquake, the soft sediments of this area seem to have accentuated shaking of this bridge. We estimate a maximum ground acceleration for the area of about 0.30g. However, cable restrainers were routinely designed for 0.25g in the mid 70's. During the earthquake the girders moved diagonally up to 14 inches with most anchor bolts and keeper plates broken, buckled cross-bracing, and many cable restrainers broken or overstressed. There was also some spalling at a few columns.

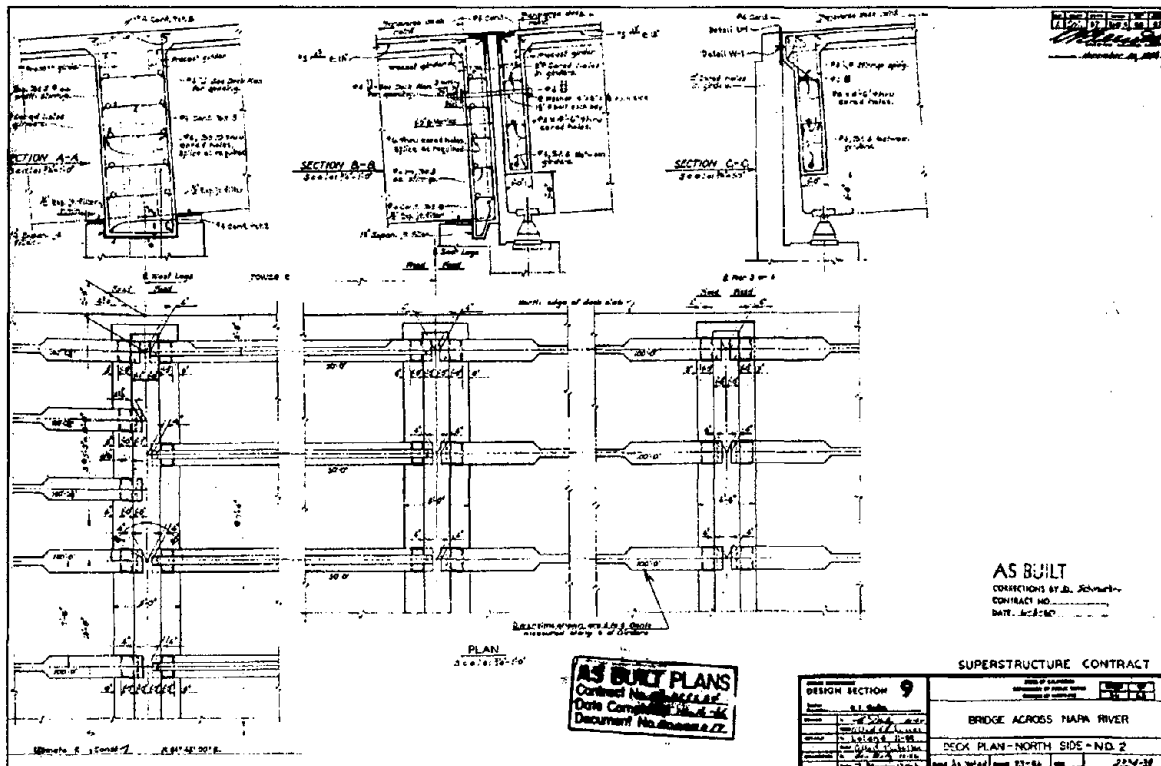
Figure 28. Precast Girder End Details for the Napa River Bridge

During construction two inch cored holes were drilled at the ends of the precast I girders and #6 bars were inserted. Then the bent caps were poured. At 8 locations an expansion joint was placed between the I girder spans. In these locations one of the girder end spans rests on a rocker bearing and 1-1/2" bolts were placed in each bay to hold the spans together.

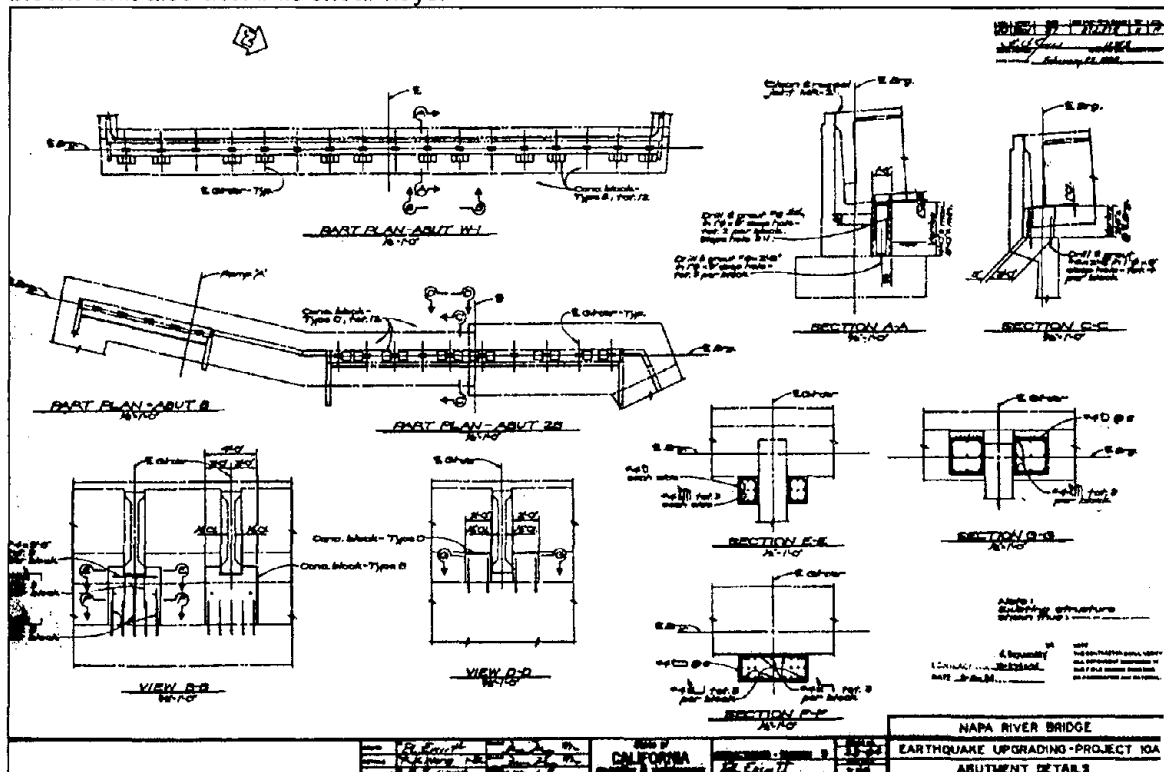
Figure 29 Napa River Bridge Earthquake Retrofit Details at Abutments

This bridge was seismically retrofitted in 1983. The retrofit consisted of restrainers at the expansion joints and the two hinges. Rocker bearings at abutments were replaced with concrete blocks that also acted as shear keys.

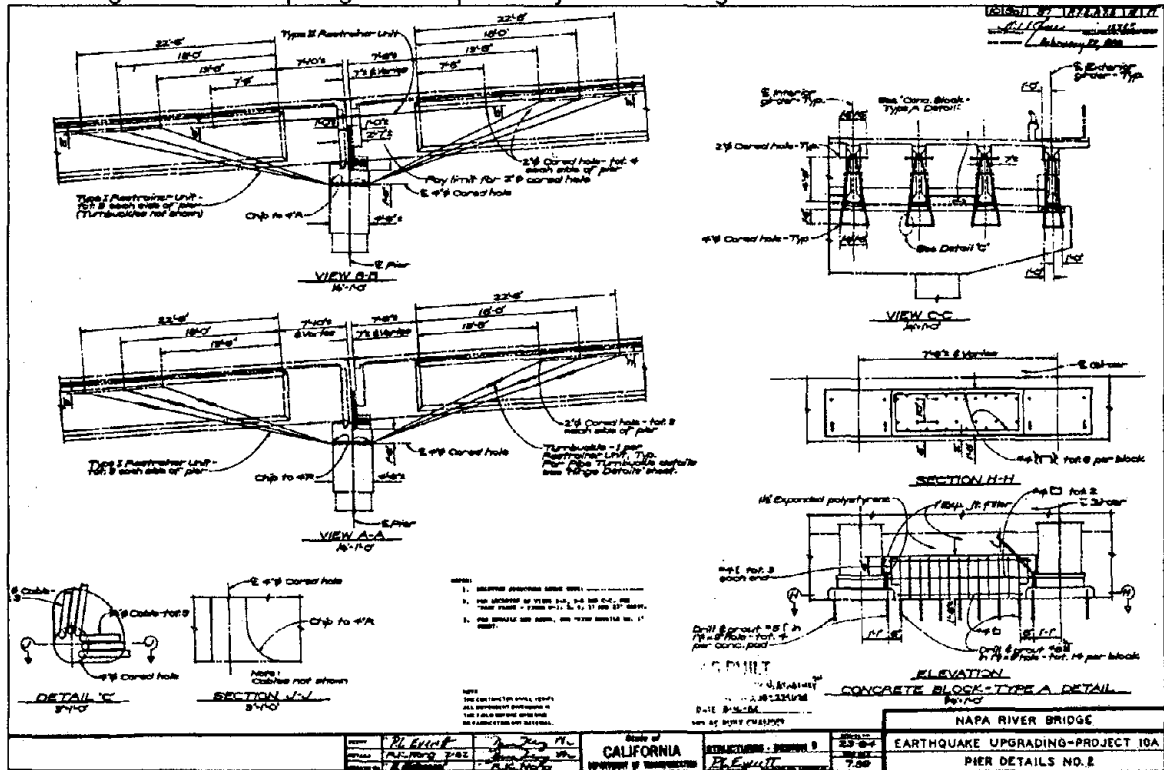
Figure 30. Napa River Bridge Cable Restrainer Details

The rocker bearings at the piers were replaced with elastomeric pads on new concrete pads doweled into the cap. Longitudinal and transverse cable restrainers were wrapped through cored holes in girders and diaphragms at expansion joints and hinges.

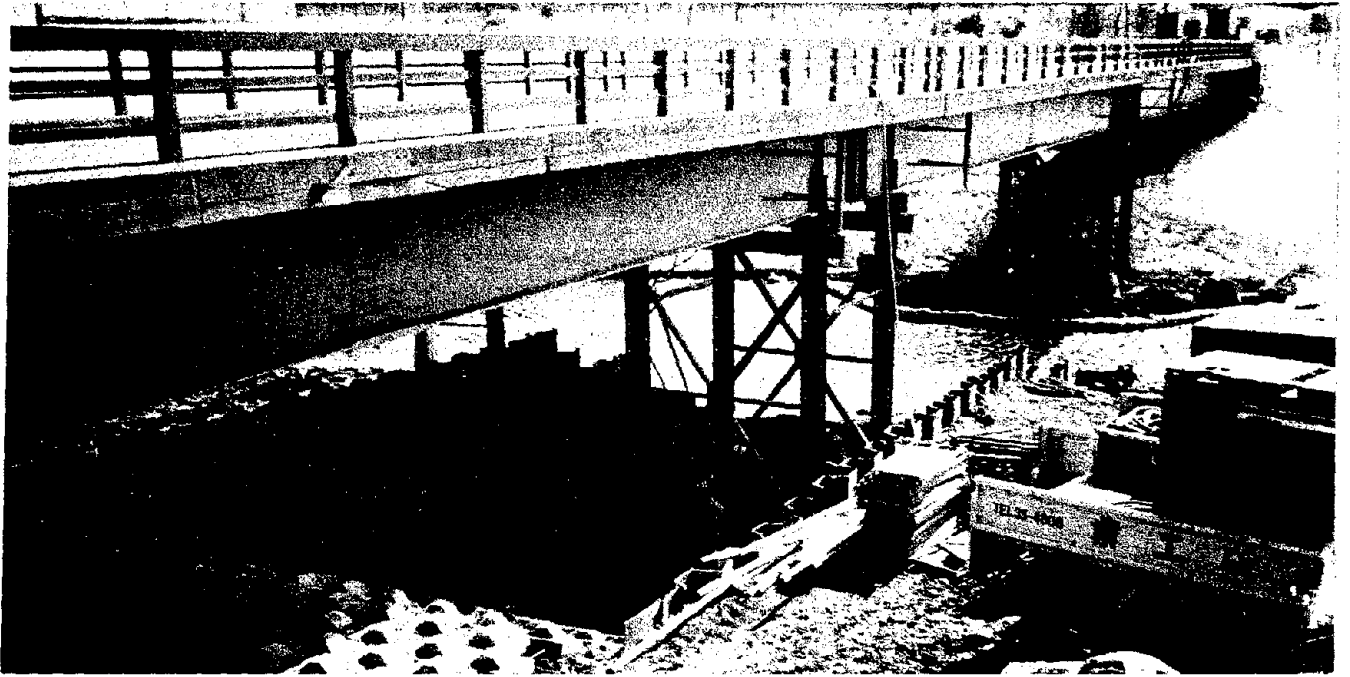
Photo 1 Repairing piers at Yoda Bridge

To repair the Yoda Bridge, we reconstructed the piers. For P1, the cable we used

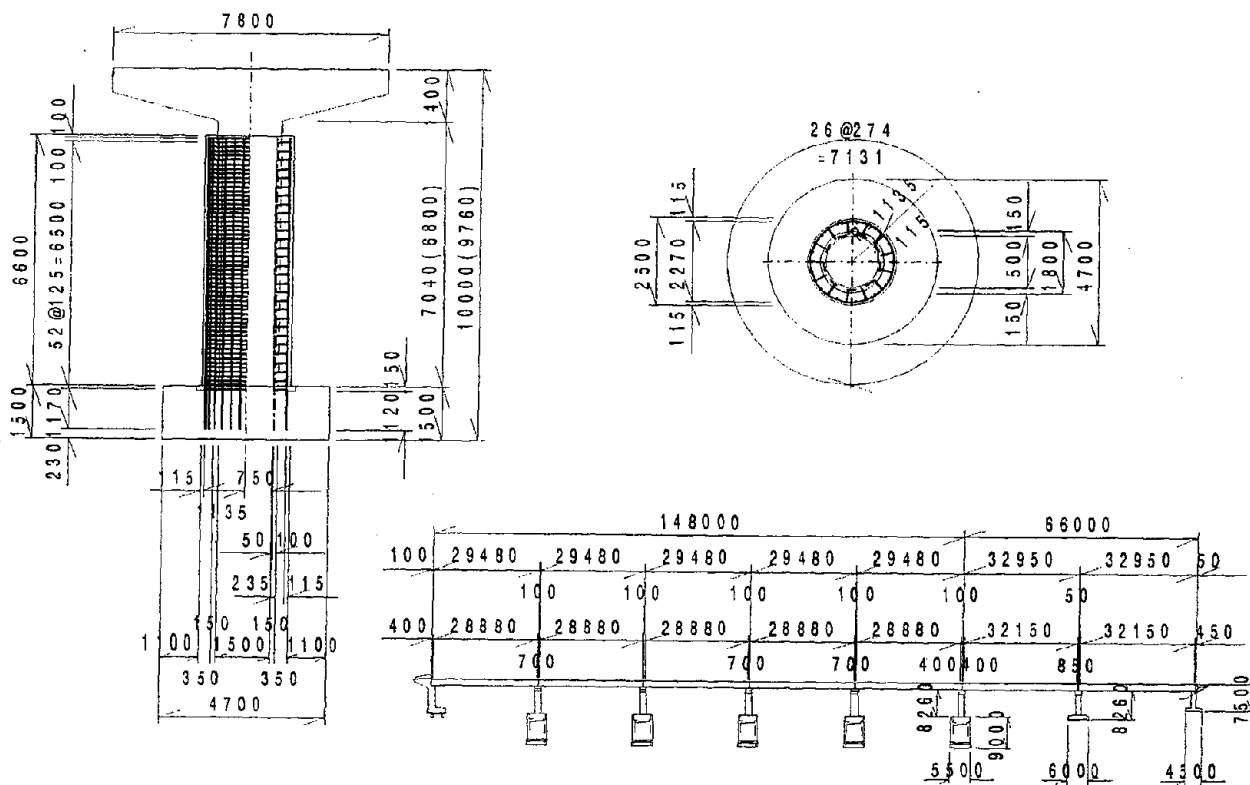
Fig. 7 Shin Shiriuchi Bridge

The old Shiriuchi Bridge was constructed in 1970 as a second-class bridge where the Motomachi Nakanogawa section of Shiriuchi Town Road 1 crosses the Shiriuchi River. In 1989 when river improvement was conducted, 2 spans were added to the right-bank side and the entire bridge was renamed the Shin-Shiriuchi Bridge. It is a 214-m-long, 6-m-wide, 7-span simple post-tension PCT-girder bridge. Columnar piers at points connecting the old pier part with the new bridge part are 1.8m wide, and columnar Pier 2 of the new bridge part is 1.5m wide. As main reinforcements, 2 layers of D22, 64 bars in total, had been distributed in the old piers. At 3.8m above the footings, the number of main reinforcements was designed to be half, and at 5m above, to be 1/4 (Fig. 7).

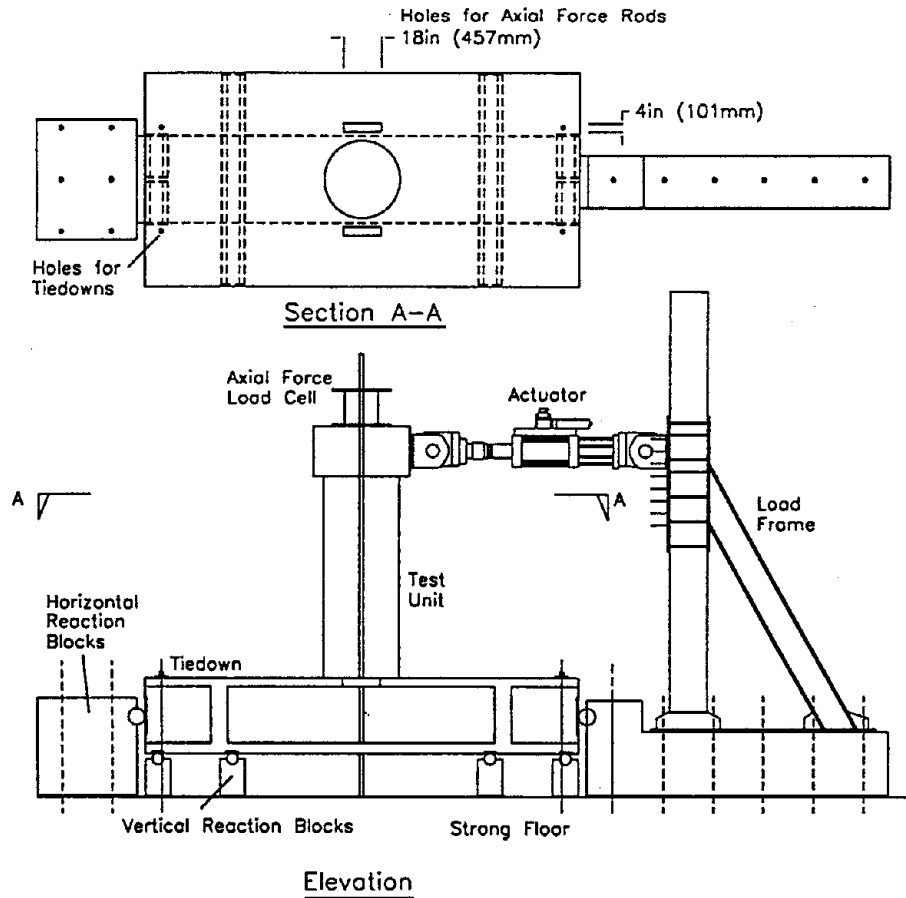
Figure 8. SM3 Overall Test Set-Up

The test configuration shown in Figure 8 was chosen to represent the prototype behaviour as closely as possible. The test regime is given in Figure 9. Lateral force and vertical force were applied to the top of the unit. Horizontal supports were provided at the height of the beam centre-line. A gap of 1/4in (6mm) was initially provided between the unit and reaction block on the south side to allow for the increase in length of the beam due to cracking. Cap-beam tie-down points were 96in (2438mm) from the column centreline as shown in Figure 10. Vertical supports at 62in (1575mm) and 98in (2489mm) each side of the column centreline ensured that a complete mechanism did not occur as soon as the beam hogging plastic hinge formed. A lap splice of the cap beam bars on one side of the column was provided in the soffit slab.

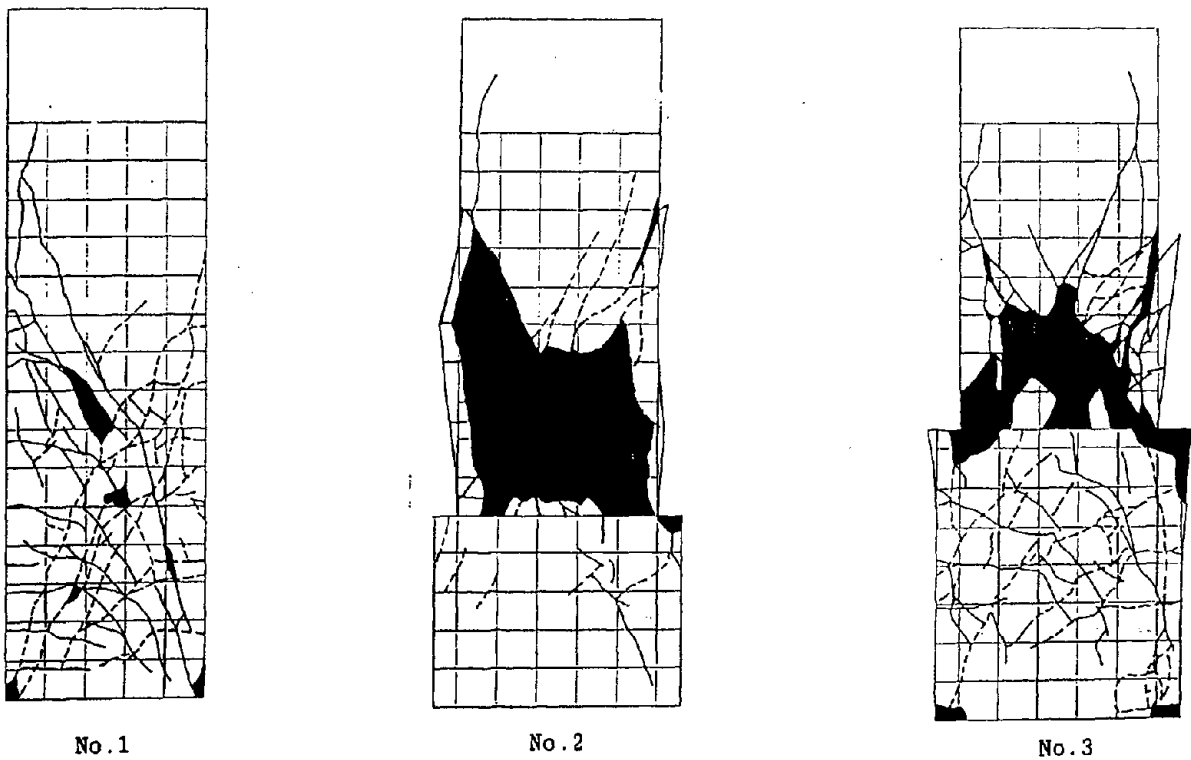
Fig.10 The Failure Modes

The failure zone moved upward as the area of retrofit increased. The figure shows that shear retrofit was effective, but the strength was insufficient for the shear forces acting on unreinforcing areas.

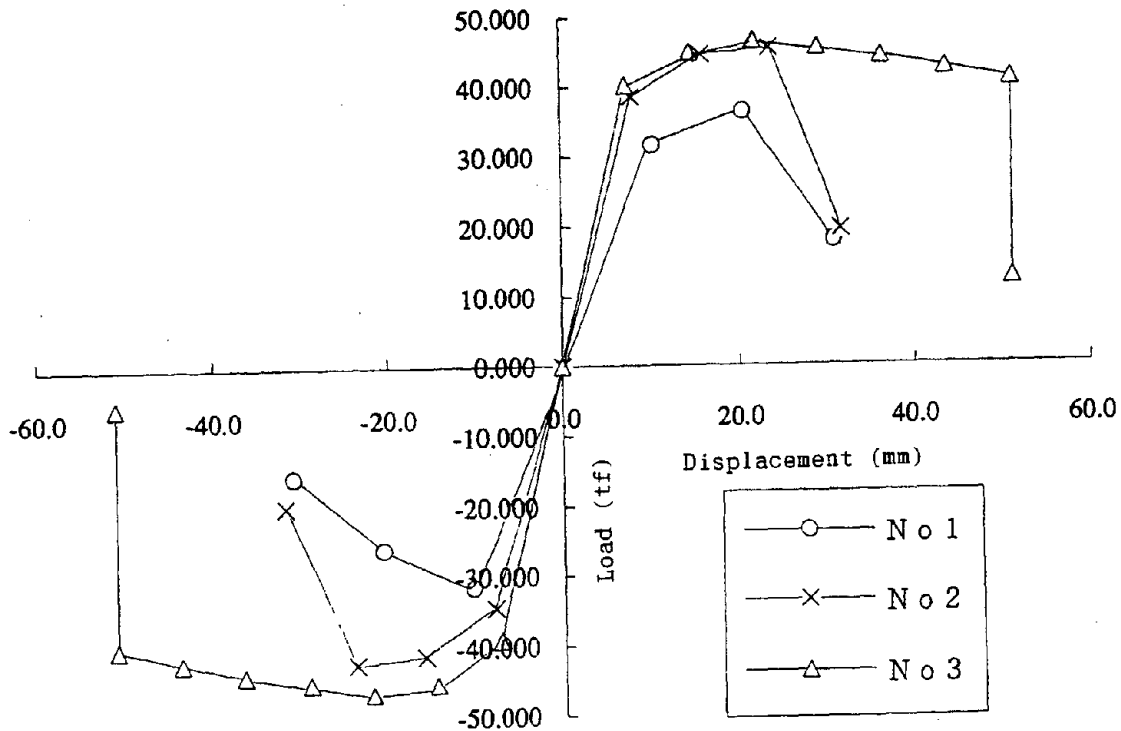
Fig. 11 Load–Displacement Envelope Curves

The ultimate strength nearly agreed with that obtained if the unreinforced areas are assumed to act as a corbel. It is presumed that this means that the ultimate strength after retrofit is obtained from the strength for shear of unreinforced area or flexural strength of the column base, whichever is smaller, because specimens retrofitted for shearing force have a sufficient strength.

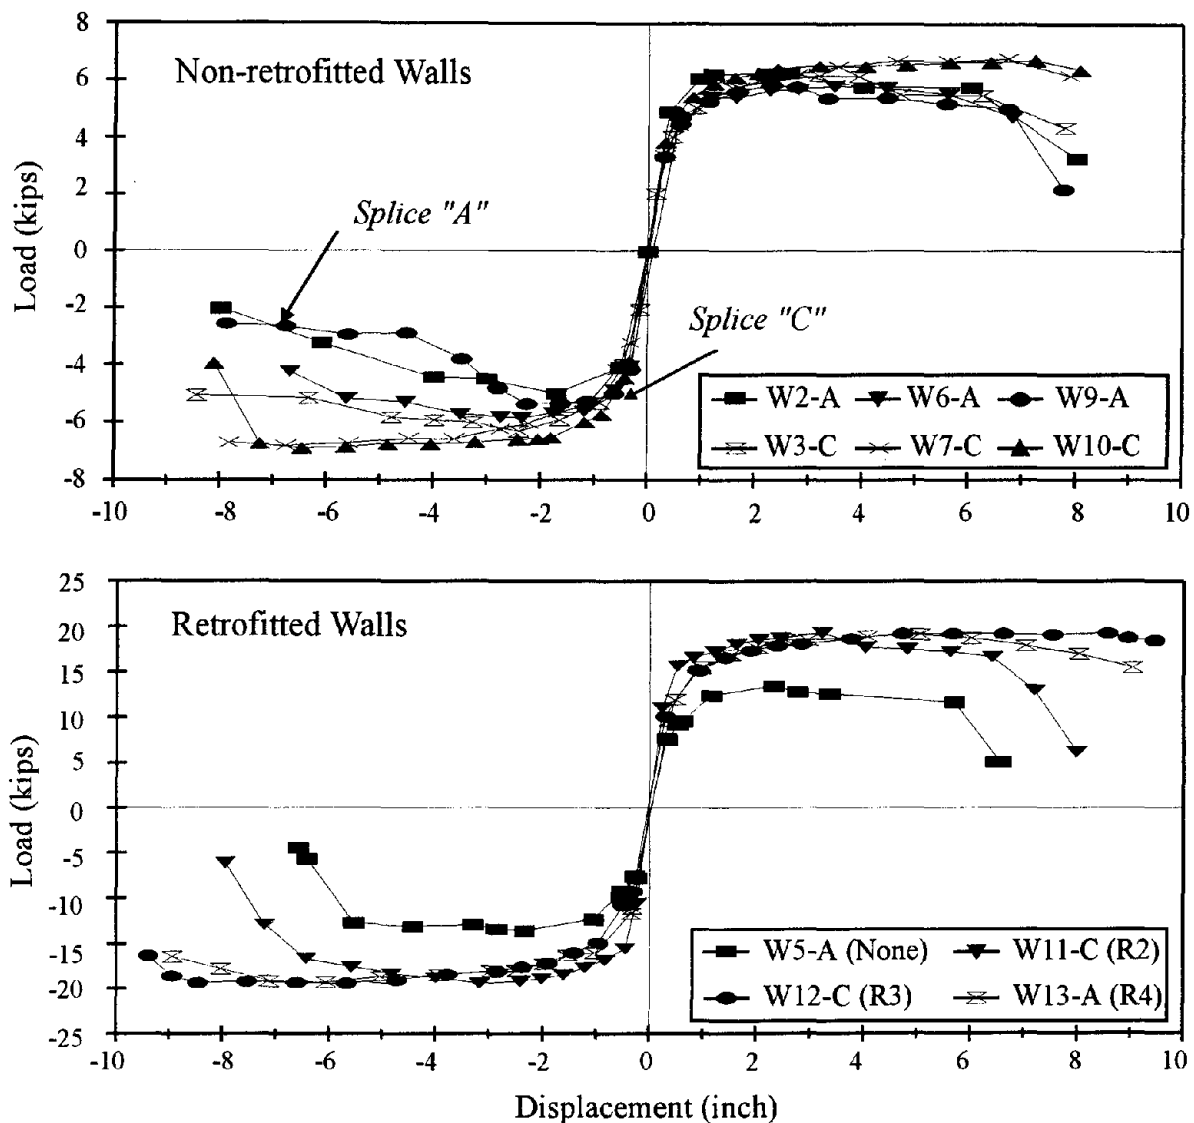
Figure 4: Envelopes of Hysteresis Loops.

- In general, specimens with class “C” splice exhibited more ductility and strength than those with class “A” splice. A substantial reduction in stiffness was observed at the intermediate stage of testing for specimens with splice “A” as compared with splice “C” specimens due to bond loss. In addition, the observed average value of Δ_{ue} (the displacement just prior to a significant reduction in the horizontal

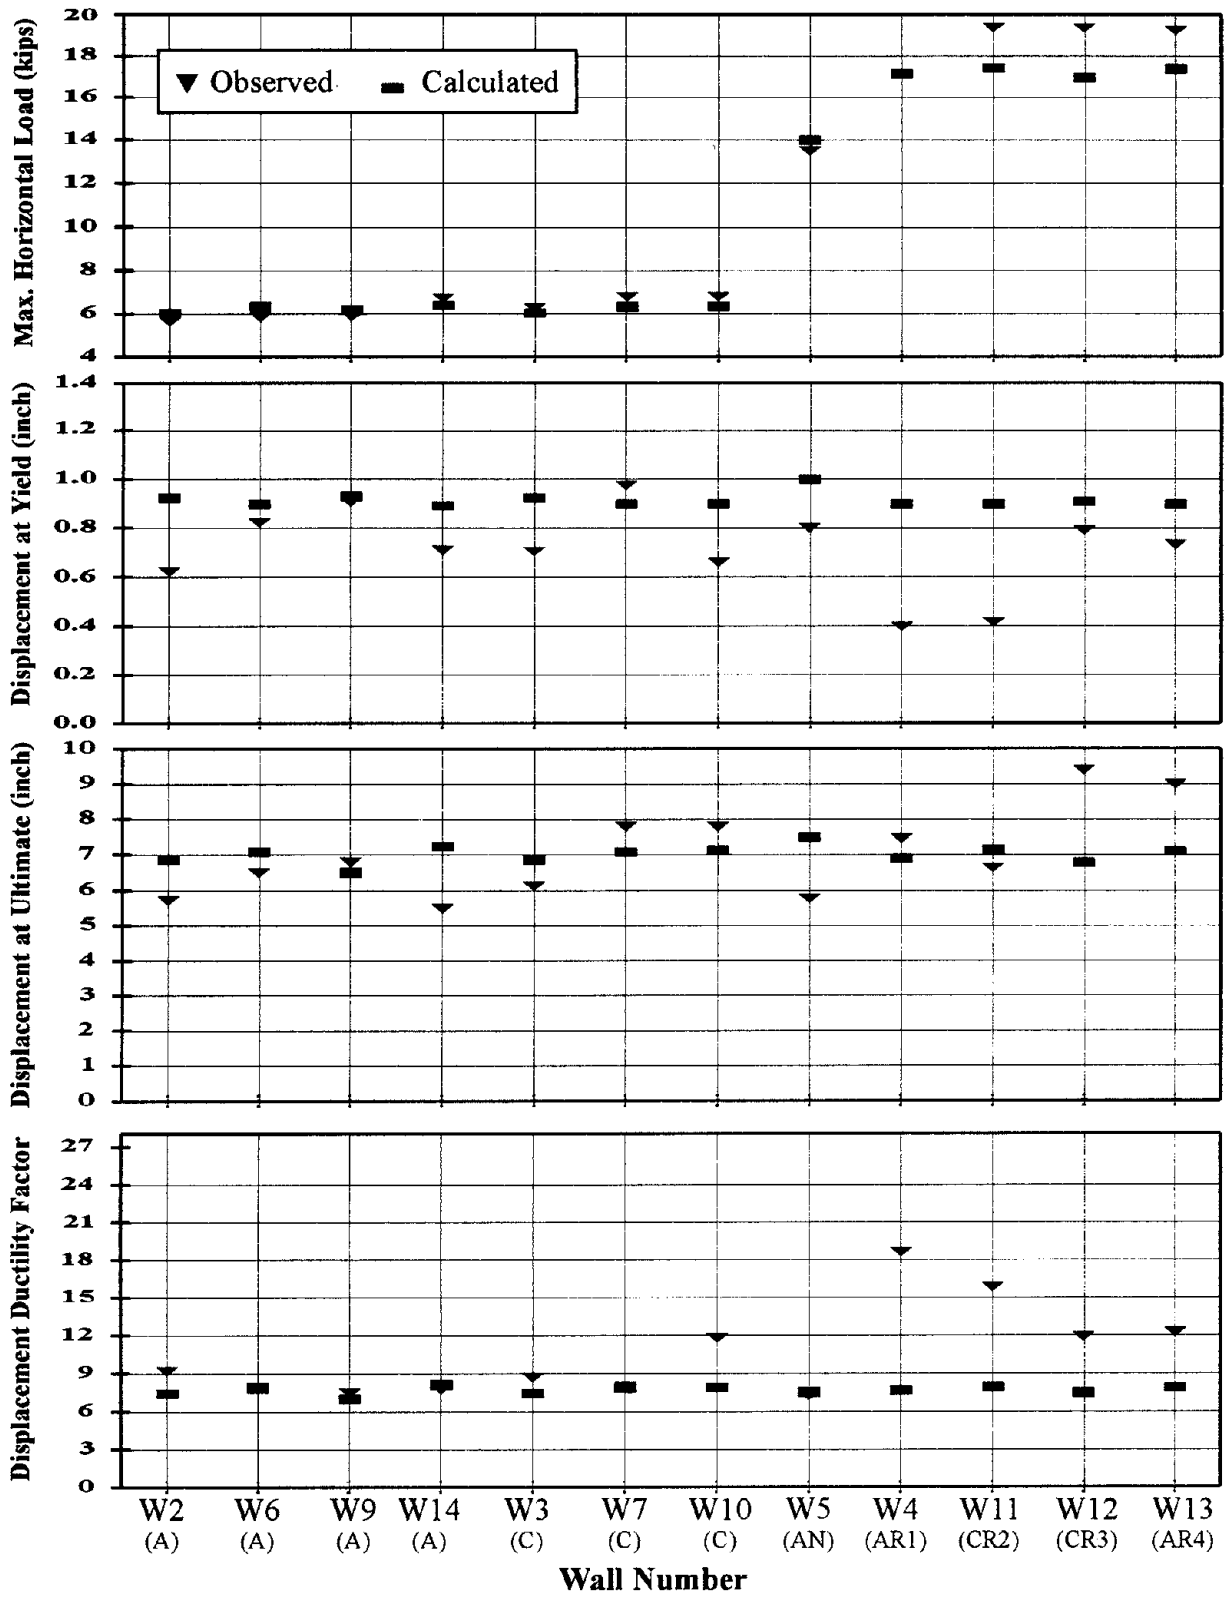
Figure 5: Observed and Calculated Response Parameters.

Figure 5 presents a comparison between computed and measured response parameters: the maximum horizontal load, the displacement at yield, the displacement at ultimate and the displacement ductility factor. The calculated horizontal loads at ultimate and the corresponding experimental values are generally in good agreement. To determine the horizontal displacement at yield experimentally, it was suggested in the literature that Δ_{y_e} be evaluated at 75% of M_i , and consequently, $\Delta_{y'_e}$ is $1.33 \Delta_{y_e}$. However, it was found that this procedure provides relatively smaller values than anticipated

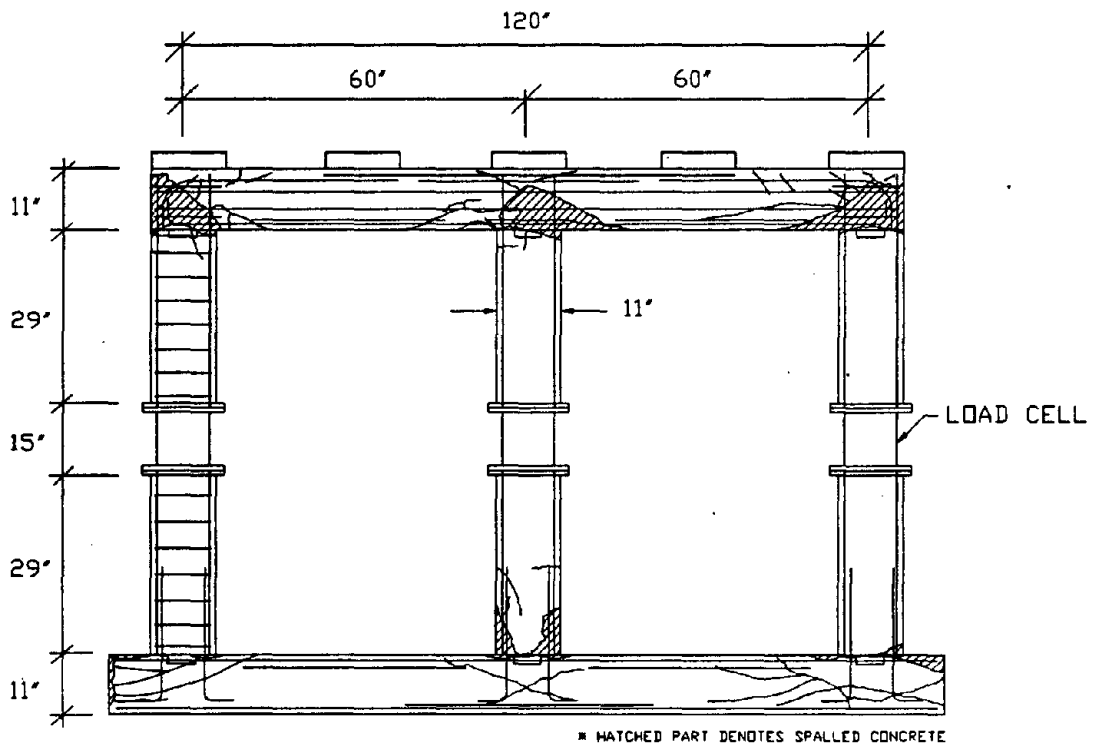
(a) DAMAGED BRIDGE PIER BY CYCLIC LOADING

It was evident that due to the failure of the connection zones, traditional California-type steel jacketing retrofits would be detrimental to the performance rather than providing any improvement in seismic resistance. Such a retrofit would only place a higher shear demand on the joint zones. As the columns exhibited a reasonable measure of ductility, these were left untouched and the pier was retrofitted by jacketing the capping beam and providing longitudinal prestress to enhance column rebar anchorage and improve the joint core shear capacity. From that figure it will also be noted that the spread footing was strengthened as shown in Fig. 2(b) by casting a new beam around the column lap splice zone. This effectively overcame any potential column anchorage problems and moved the plastic hinge into the column above the lap splice.

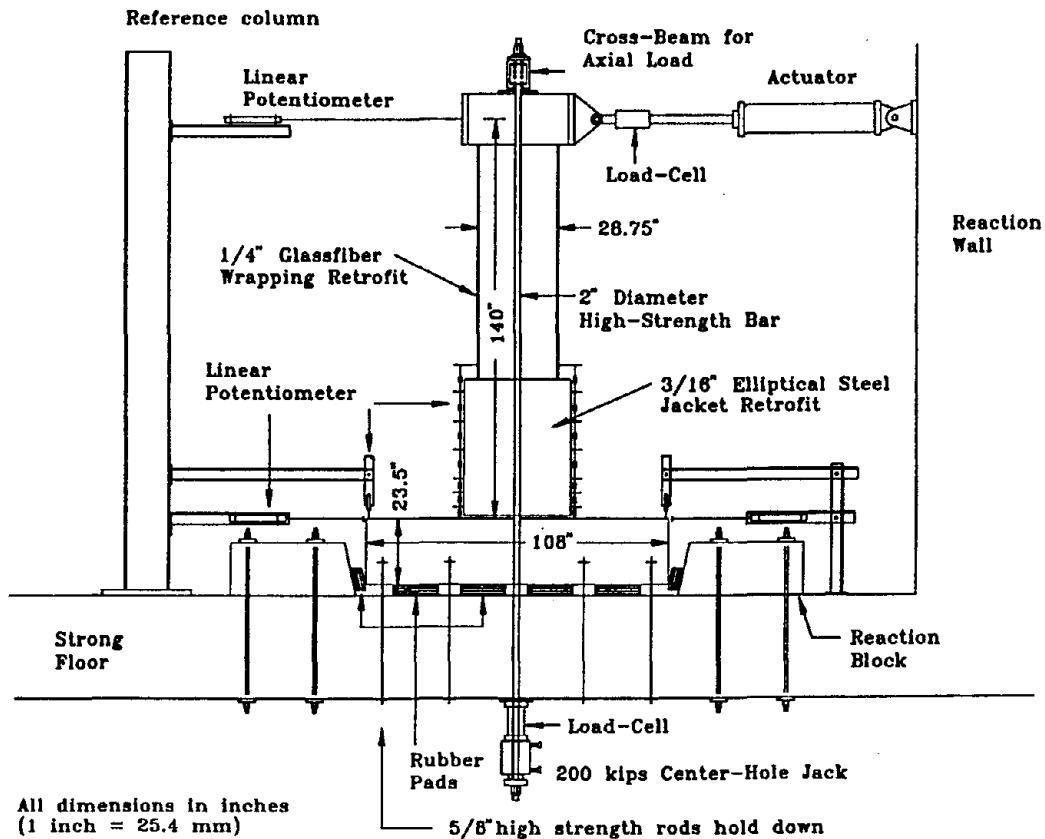
Fig.4 Test Setup (1in.=25.4mm, 1kip=4.45kN)

The test setup is shown in Fig.4. The footing was supported on 2.2in.(56mm) thick fiberglass-reinforced elastomeric pads, which were chosen to represent the flexibility of the pile foundation. In the rocking tests of F1RA, the footing was sat on the pad and was free of uplifting. However, in the capacity tests of "as built" column footing F1RA and retrofitted column footings, the rocking of the footing was restrained by 5/8in.(15.9mm) diameter high strength rods attached to the test floor. The rods were first snug tightened over a piece of 1/8in.(3.2mm) steel packing material. The packing material was then removed in order to allow the footing to have some uplift before the rods started to stretch and apply forces. The resulting 1/8in.(3.2mm) gap was provided to allow elastic unloading of the compressed elastomeric pads simulating the pile compression stiffness.

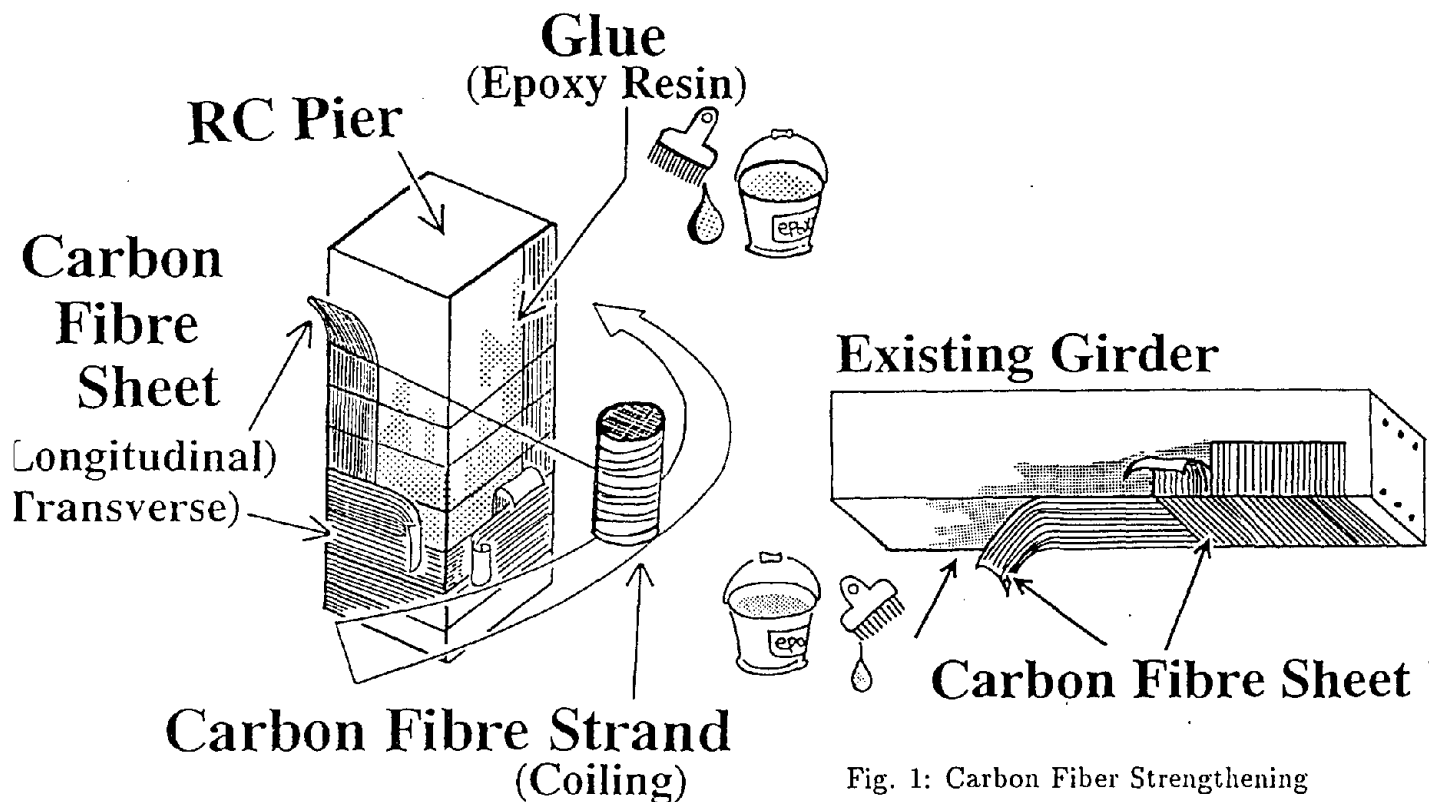
Fig. 1: Carbon Fiber Strengthening

The need to strengthen superstructures has also become necessary as a result of increased motor vehicle weight and traffic volume. We reviewed the carbon fiber strengthening method to the superstructure and verified its potential through beam model testing.

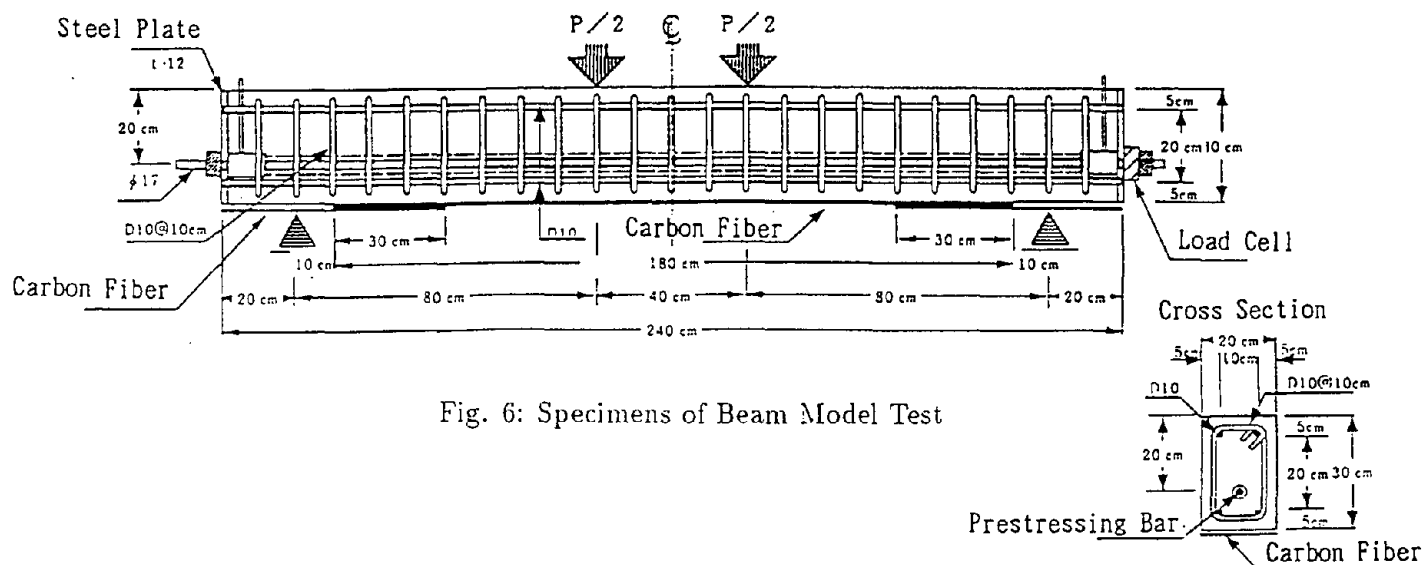
Fig. 6: Specimens of Beam Model Test

Specimens were set up as shown in Table 3 for actual reinforced concrete and prestressed concrete bridges. Shapes and dimensions are shown in Fig. 6. Cracks were created in advance by applying a bending load, and strengthening carried out by bonding two layers of 20cm-wide, 0.1mm-thick carbon fiber. The design load was set such that the reinforcing bars would reach the allowable tensile stress ($= 1,800\text{kgf}/\text{cm}^2$). Strengthening was originally to be applied to the whole area of the bottom surface 10cm inwards from both supports. However carbon fiber began to peel off at the interface with the concrete of No.2 specimen during static loading; therefore for Nos.3 to 5 an overlapped carbon fiber portion was made at each end of bonding portion and the reinforcement area extended up to the end of the beam member.

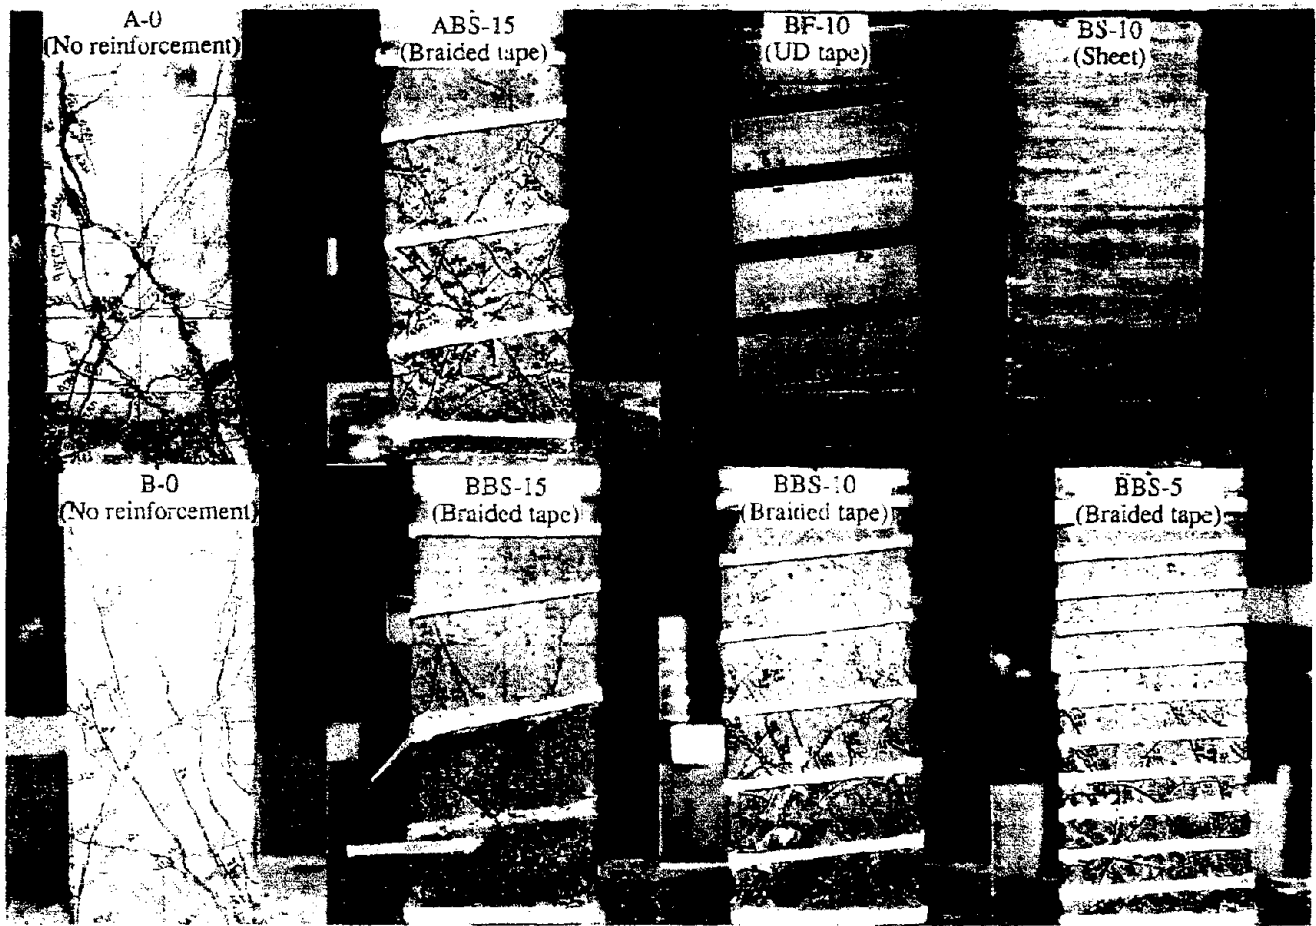
Photo.2 Failed conditions

The final failure condition is shown in Photo. 2. Specimens which showed shear failure were the three of A-0, B-0, and BBS-15. Although in the case of BBS-15 fiber broke at corners, breaking of fiber did not occur in other specimens reinforced with Braided tape. With BBS-10, depressing concrete at corners by fiber material was observed. In contrast, this was not seen with BF-10 using UD tape and BS-10 using Sheet and it is considered the restraining effects on concrete were greater than for the case of Braided tape (BBS-10). However, with BS-10, the sheet material ruptured from near column base corners to upward direction at the ultimate stage.

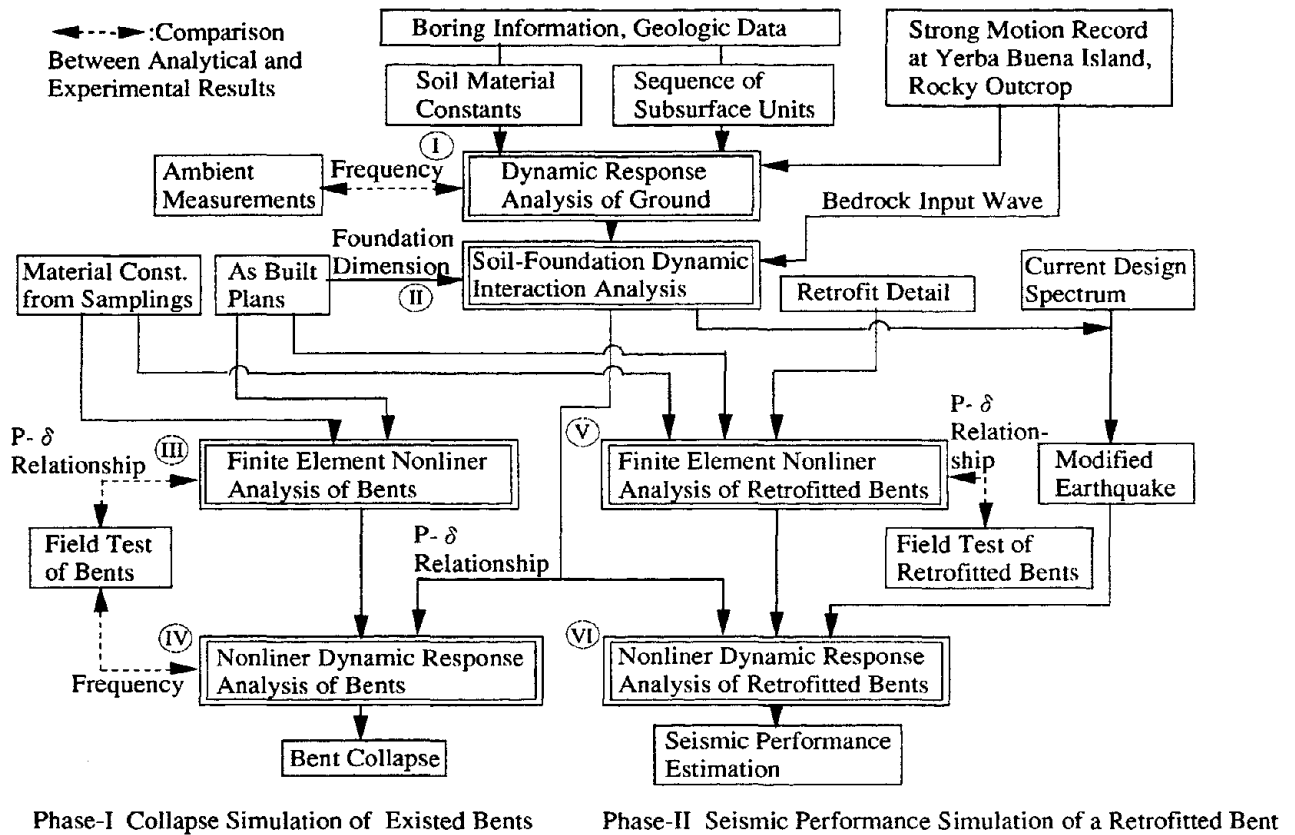
Fig.2 Analytical Study Procedure

As shown in Fig.2, analytical studies for this simulation consist of two parts :V) Static nonlinear
