Preliminary assessment of landslide-induced wave hazards:

Tidal Inlet, Glacier Bay National Park, Alaska

U. S. Geological Survey Open-File Report 03-100

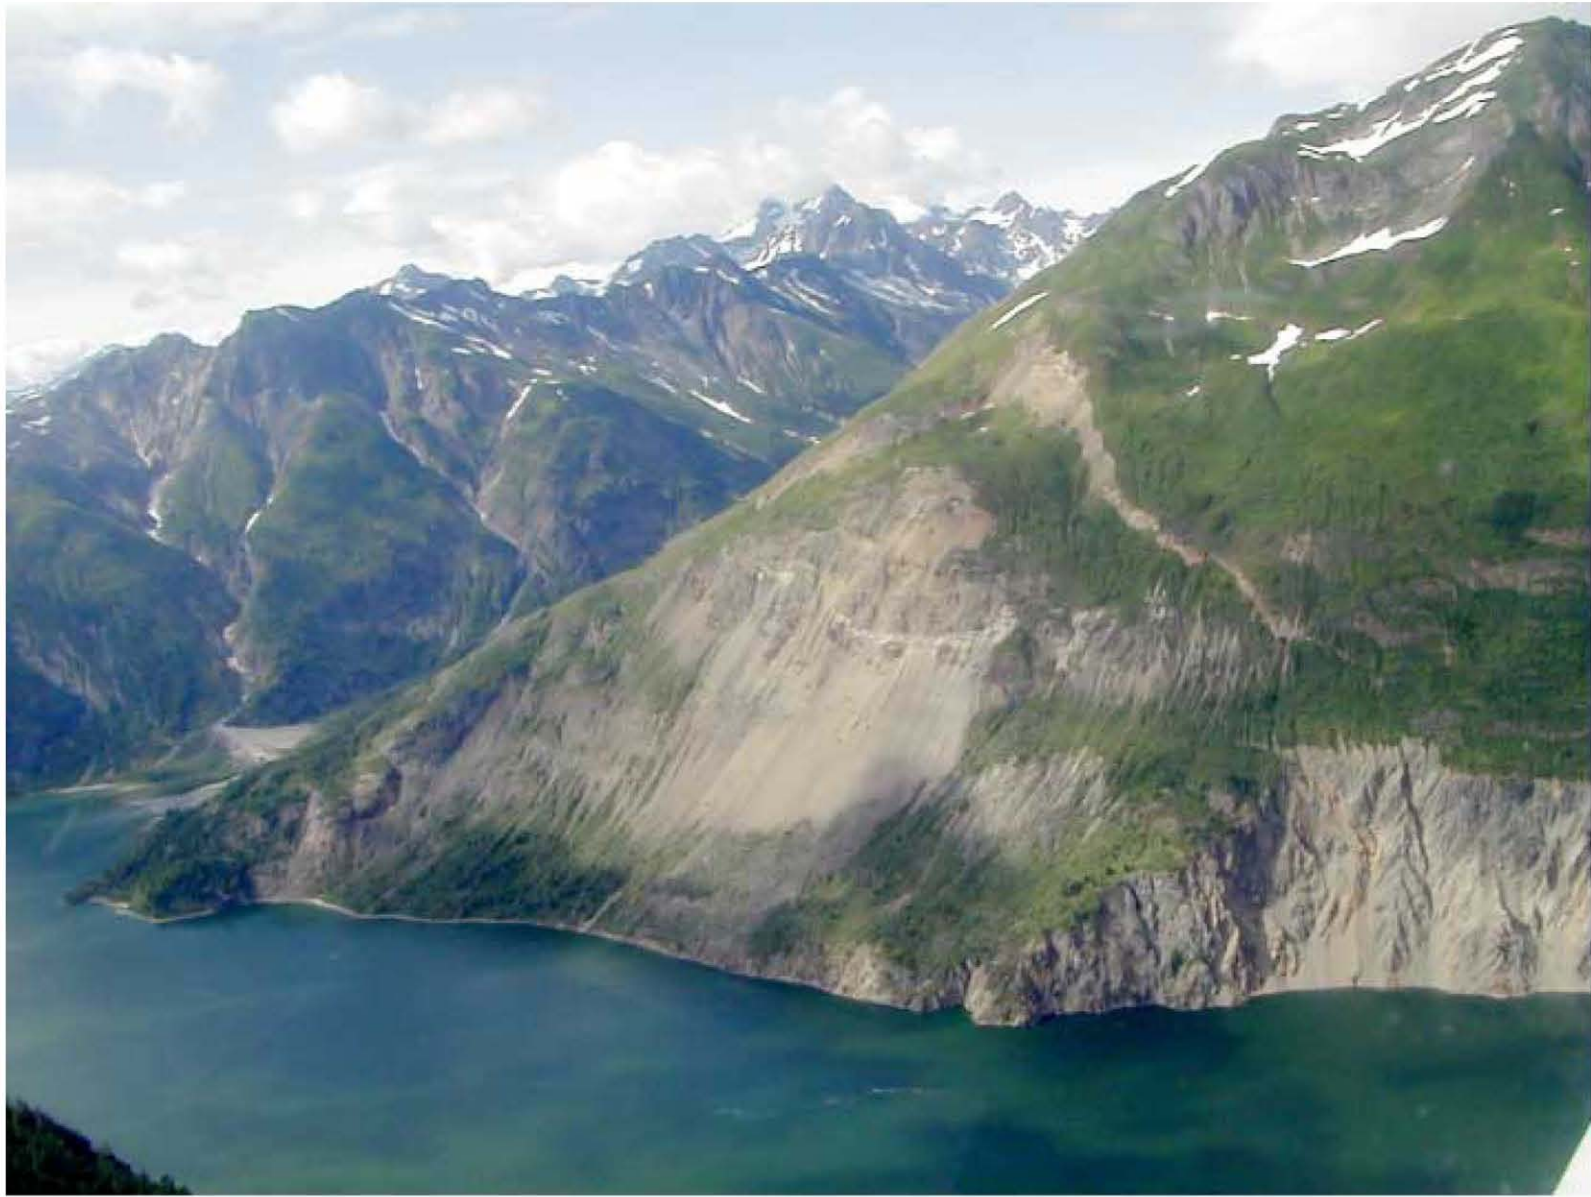
Figure 1.-- Detached landslide mass perched above the northern shore of Tidal Inlet, Glacier Bay National Park, Alaska. Peak at top right edge of photo is about 1130 m high. In the lower left, the distance across Tidal Inlet is about 800 m. Photograph taken on July 12, 2002.

A large detached mass of rock and debris ([fig. 1](#)) above the northern shore of Tidal Inlet, Glacier Bay National Park in southeastern Alaska ([fig. 2](#)) was recognized in 1964 by geologist David Brew (pers. commun., 2002). Brew et al. (1995) suggested that this perched mass of rock posed a threat similar to what occurred in Lituya Bay, Alaska ([fig. 2](#)). On July 9, 1958, a magnitude M 7.9 earthquake on the Fairweather Fault triggered a rock avalanche at the head of Lituya Bay. The landslide generated a wave that ran up 524 m on the opposite shore and sent a 30-m high wave through Lituya Bay sinking two of three fishing boats and killing two persons (Miller, 1960). In 1995, after Matthias Jakob recognized the unstable mass of rock above Tidal Inlet, he submitted a proposal (EBA Engineering, 1997) to the National Park Service (NPS) to assess the potential risks that this landslide posed to visitors and ships. Between May and September cruise ships carry several thousand passengers daily past Tidal Inlet. In 2002 the NPS supported this investigative field research team to assess the potential hazards and risks in Tidal Inlet. This preliminary report focuses on the hazards posed by the Tidal Inlet landslide; a later report will include a detailed wave model analysis and risk assessment.

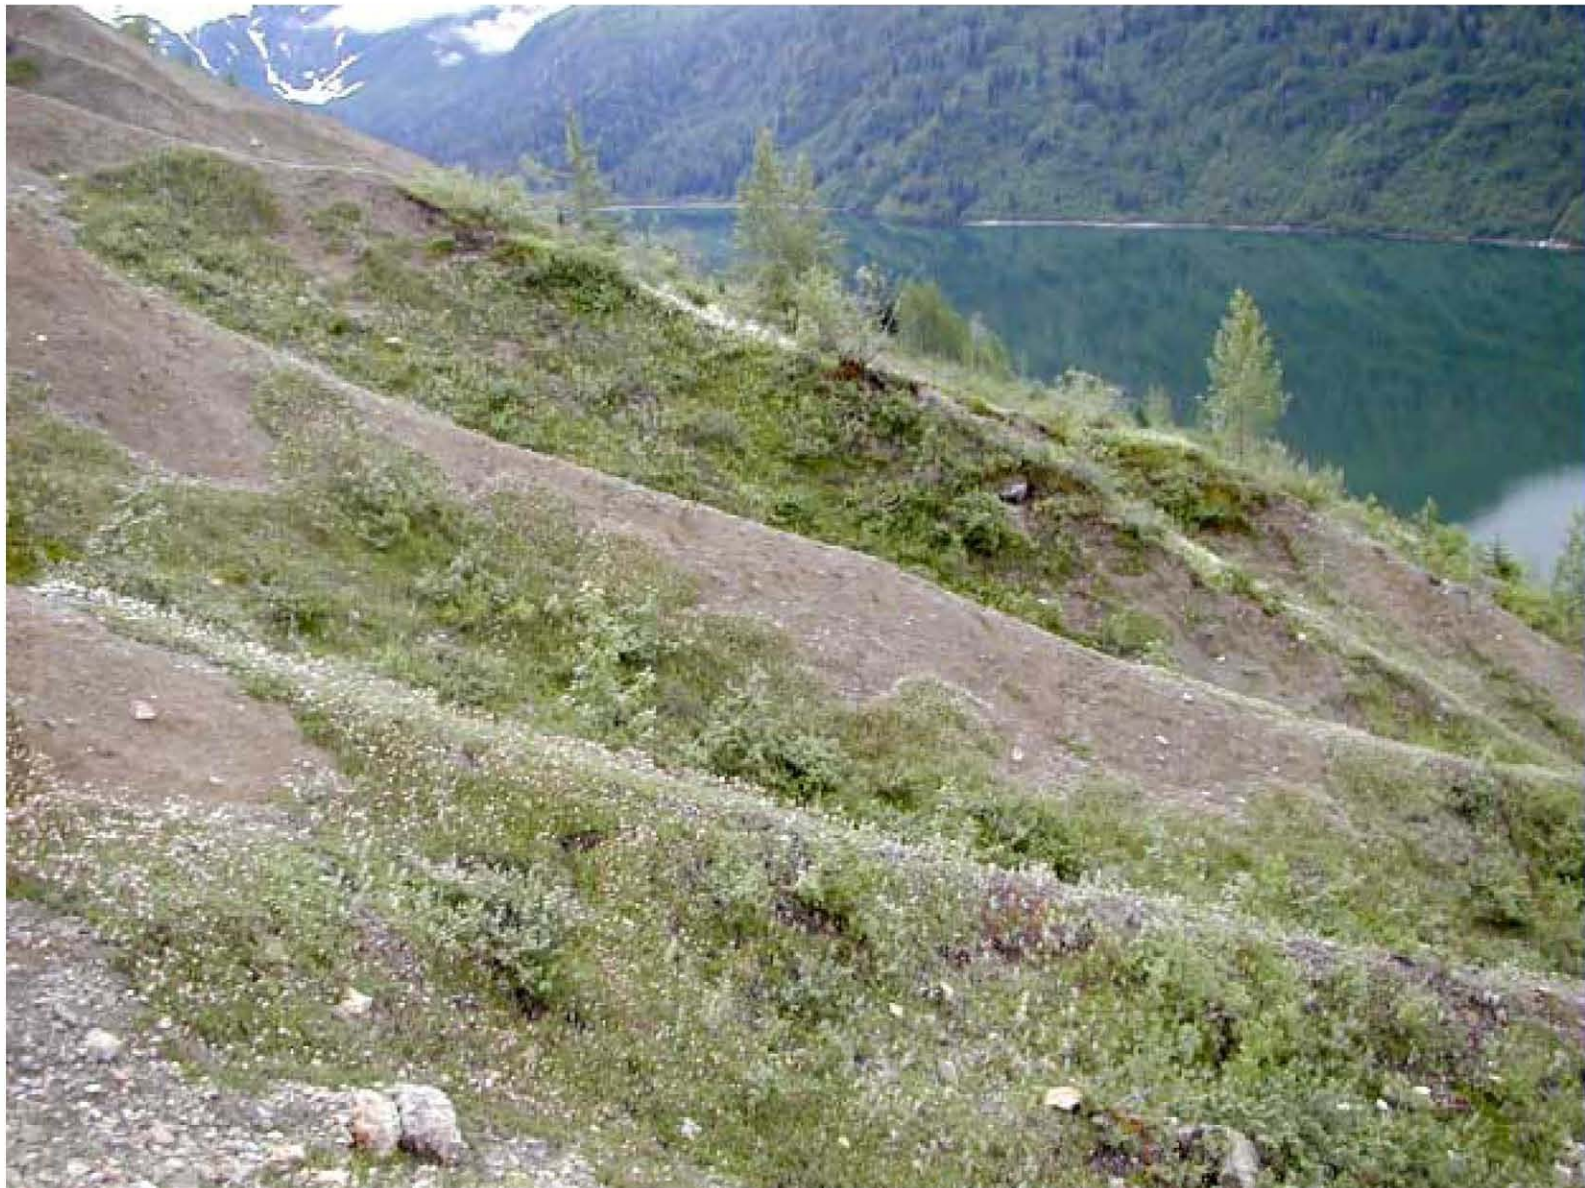
Figure 5.-- Deeply eroded LIA glacial till below the left (east) flank and toe of the recent Tidal Inlet landslide. Distance between small ridge tops is about 15 m. View southeast towards Tidal Inlet.

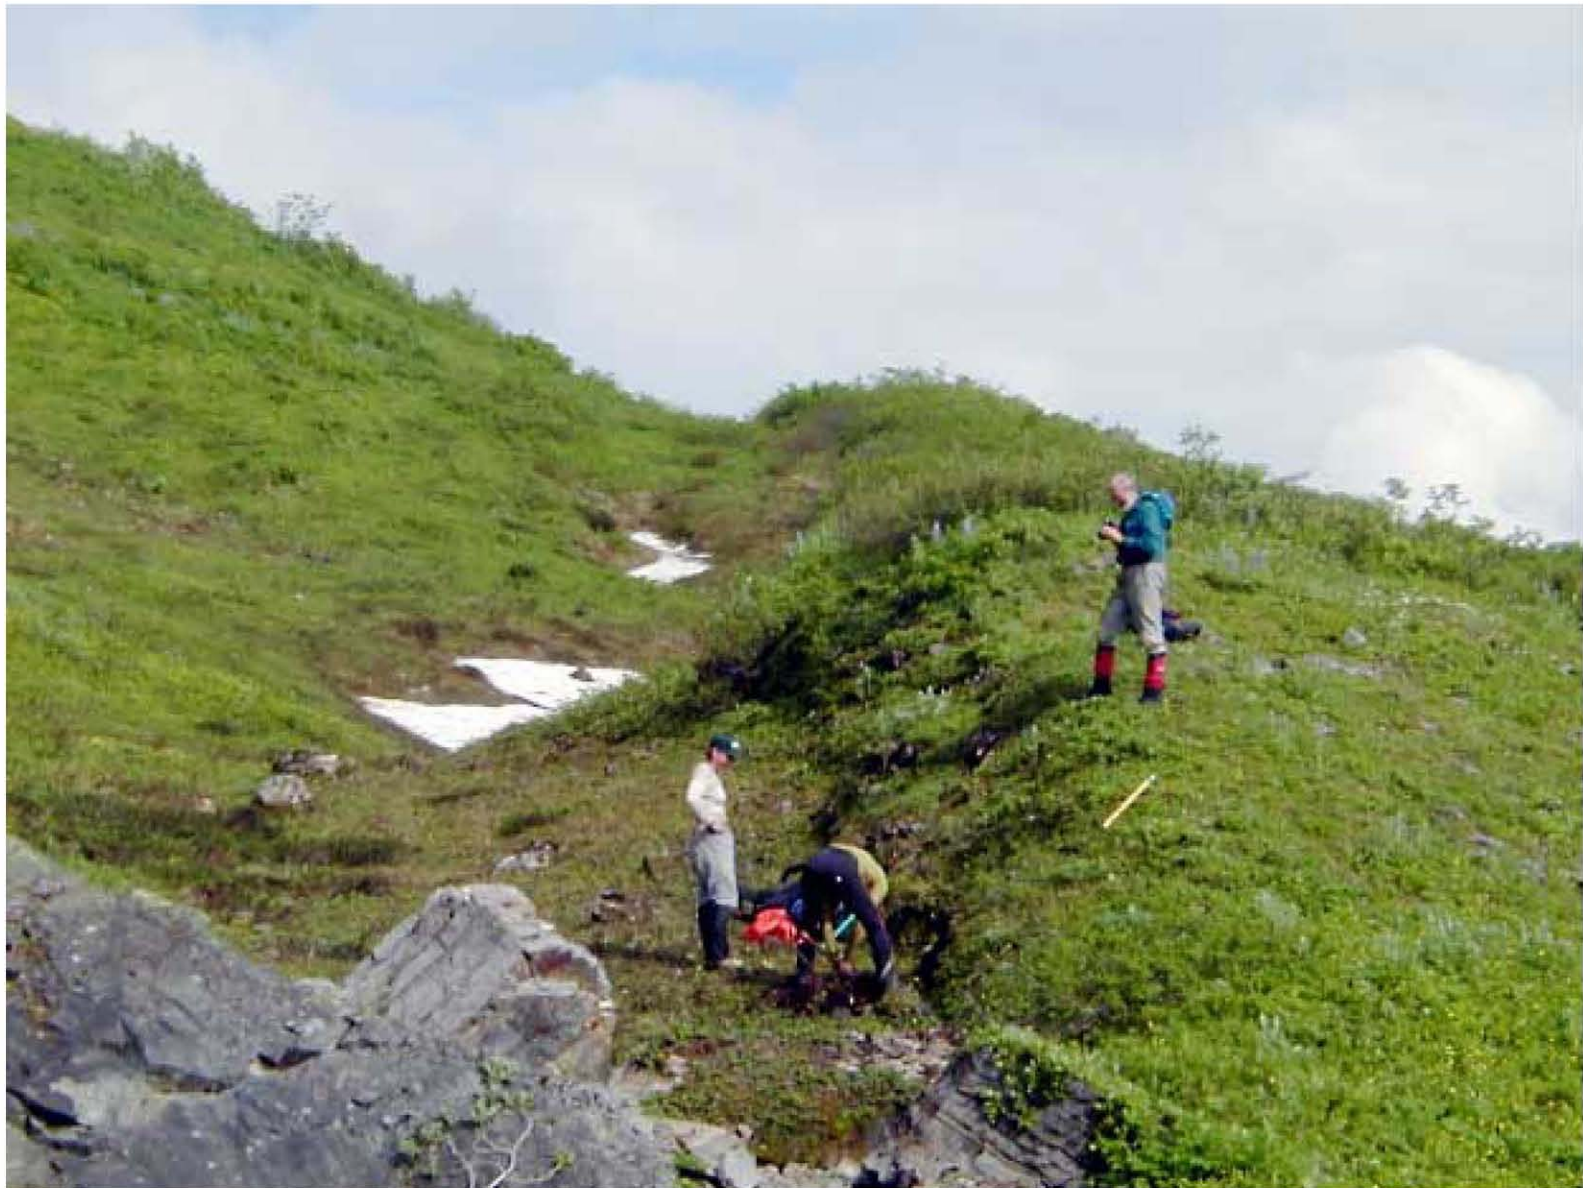
Figure 7.-- View looking east along lineament L1 with its steep, backfacing escarpment. The general downslope profile can be seen from left to right along the horizon.

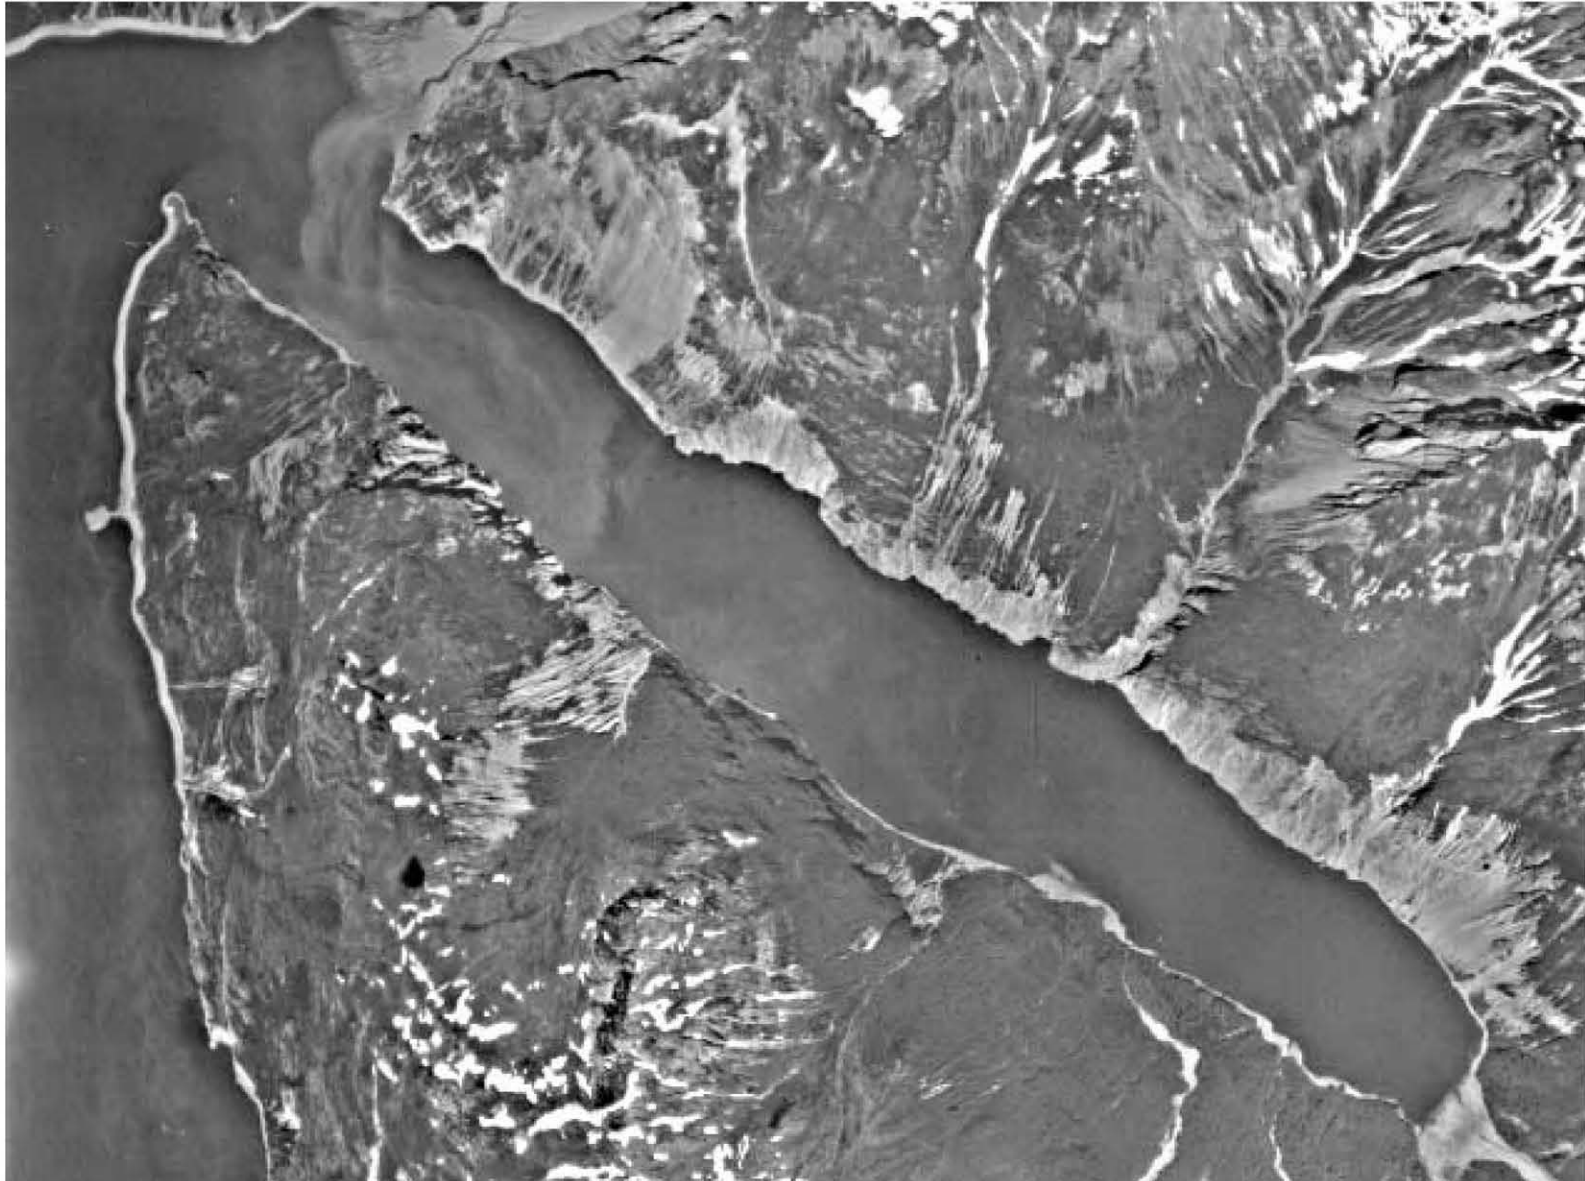
Figure 8.-- Portion of aerial photograph showing Tidal Inlet and eastern side of west arm Glacier Bay taken July 6, 1948. Note talus (bright light color) below recent landslide mass above northern shore (upper left corner) extending from landslide toe to shore of Tidal Inlet below central portion of landslide. Photograph taken by US Navy at 1:40,000-scale.

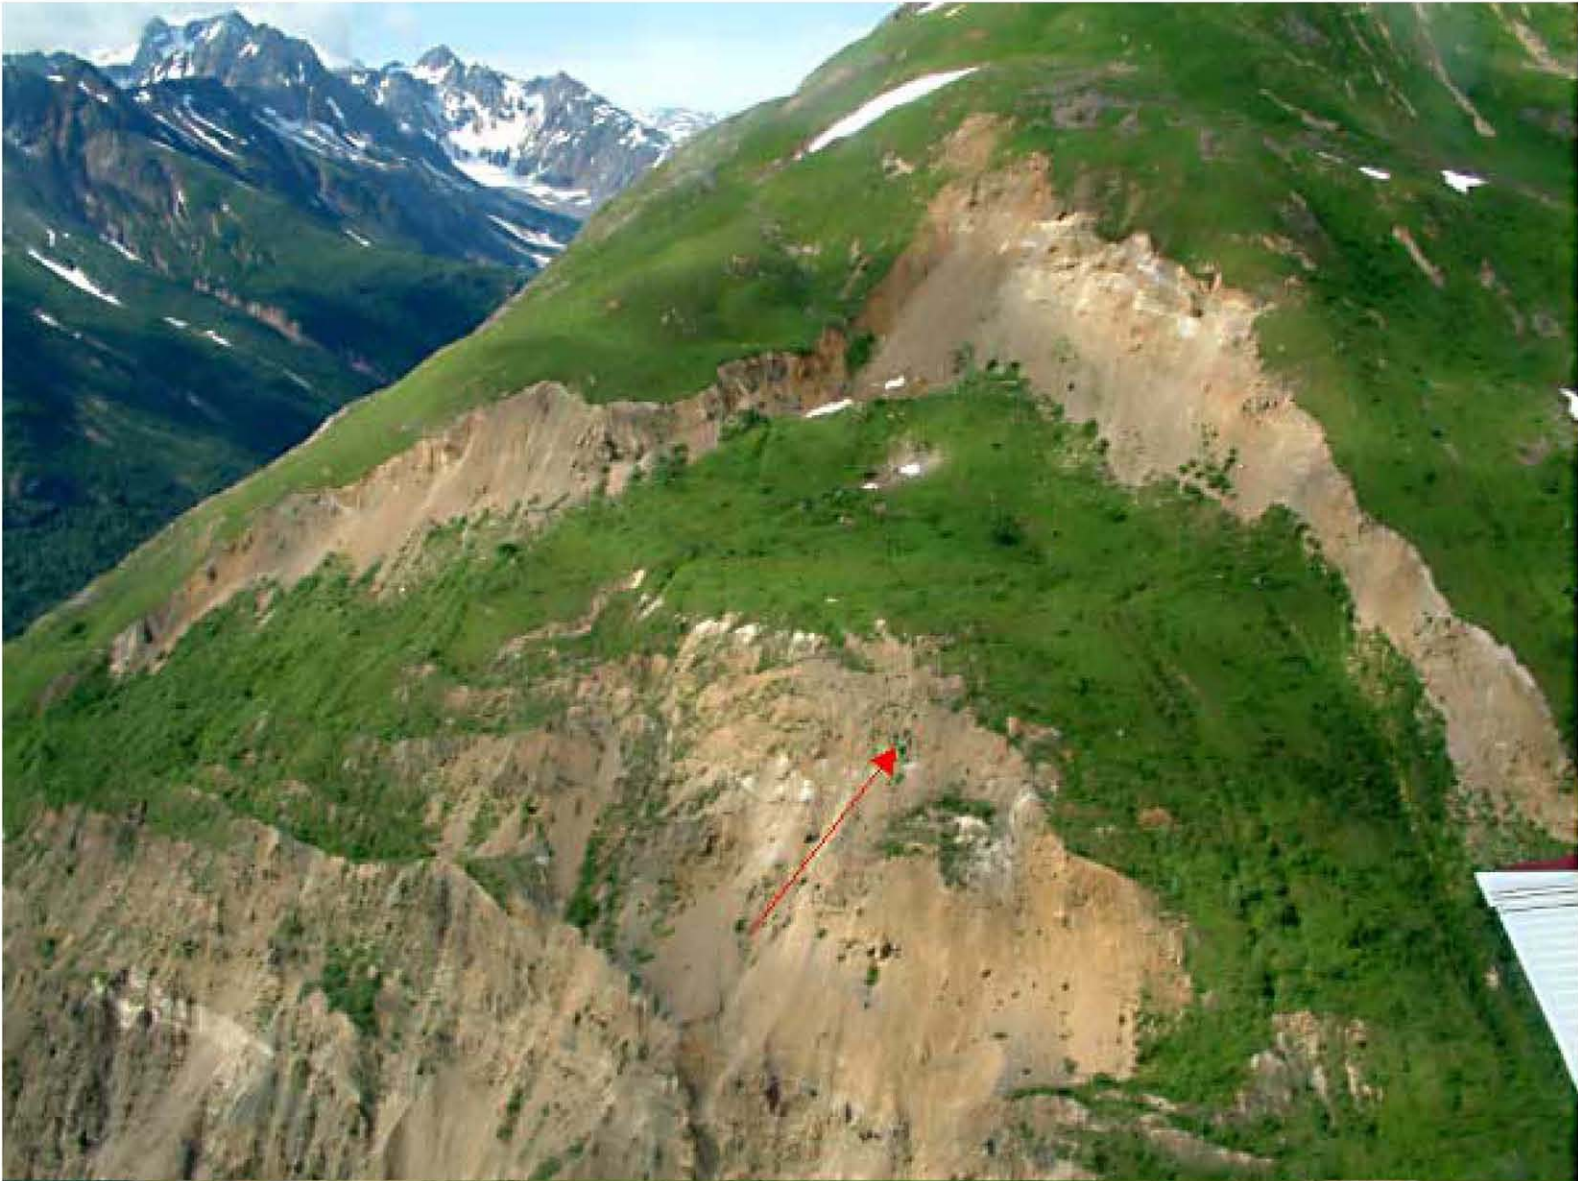
Figure 9.-- Main (upper) and minor (lower) scarps of recent Tidal Inlet landslide. Evidence of the secondary landslide movement is the lighter bare slope in center of the photograph (arrow). Photograph taken July 12, 2002.

In the center of the main body of the landslide there is evidence of a secondary landslide movement that has removed surficial material from some of the rotational blocks on the lower section of the landslide ([fig. 9](#)). The depth of this secondary landslide movement appears to be relatively shallow, and principally involves glacial till. The secondary movement appears on the 1919 Mertie photography, so the timing of the secondary movement in relation to the initial movement of the main body of the landslide is unknown. Cracks and fissures coincident with this secondary movement, with a maximum lateral displacement on the order of one meter, extend up through portions of the rotational blocks within the main body of the landslide.

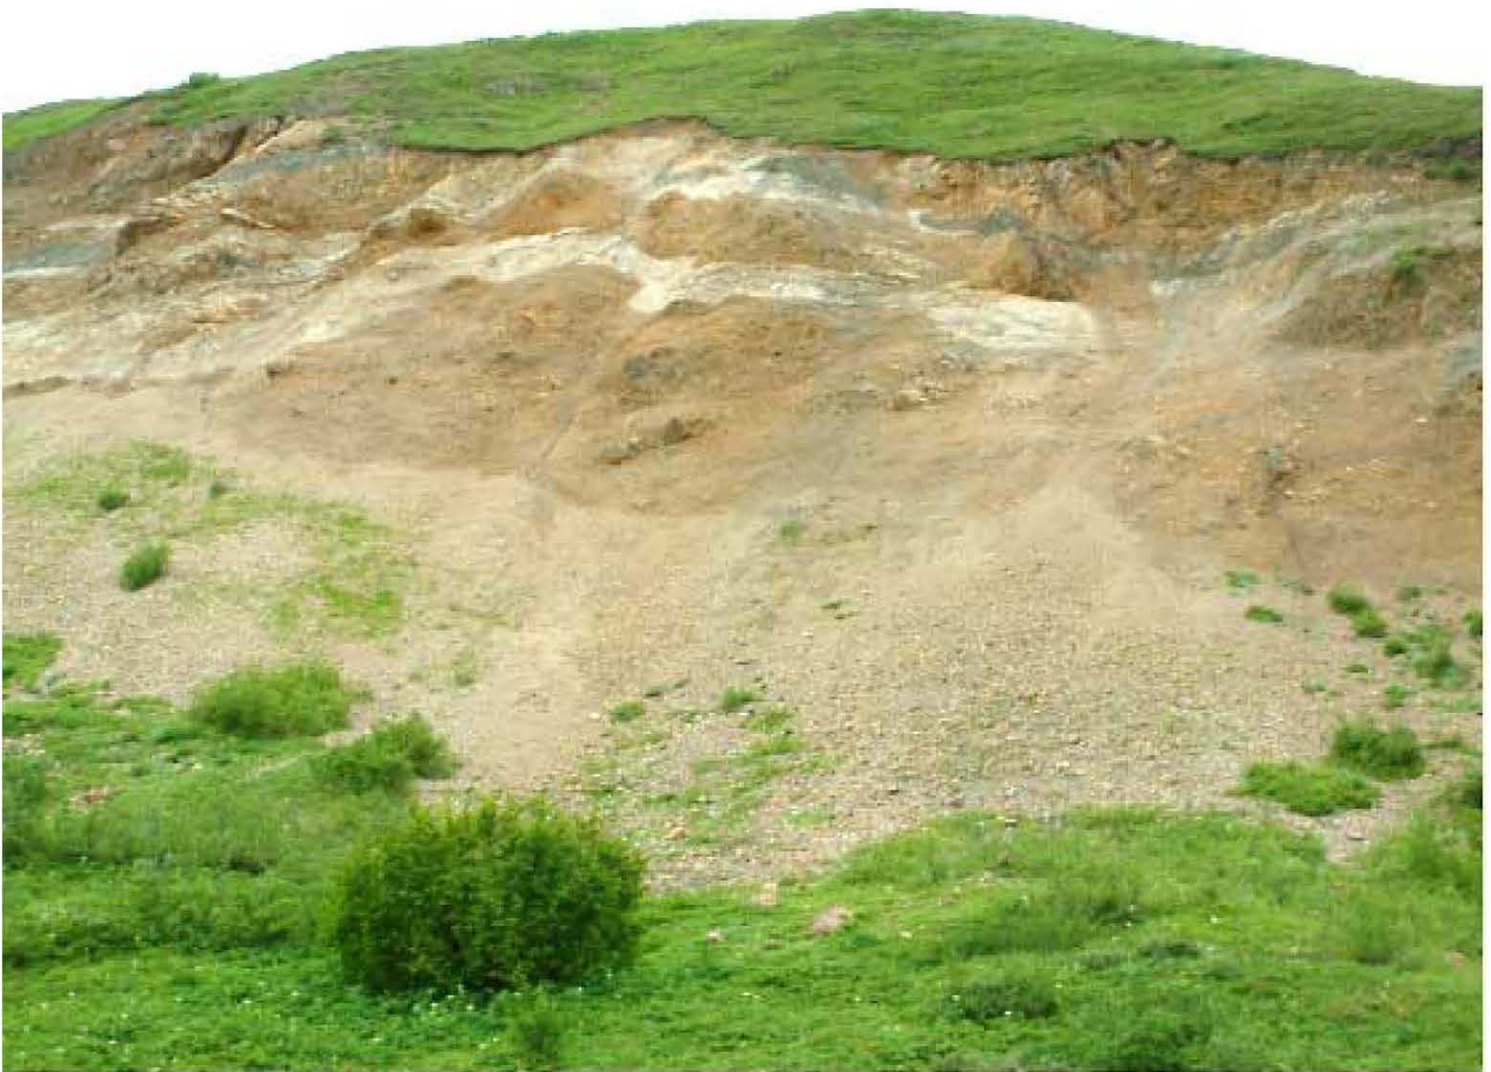
Figure 10.-- Eastern section of the main scarp. Note the subsequent accumulation of rockfall talus below the main scarp. Photograph taken July 15, 2002.

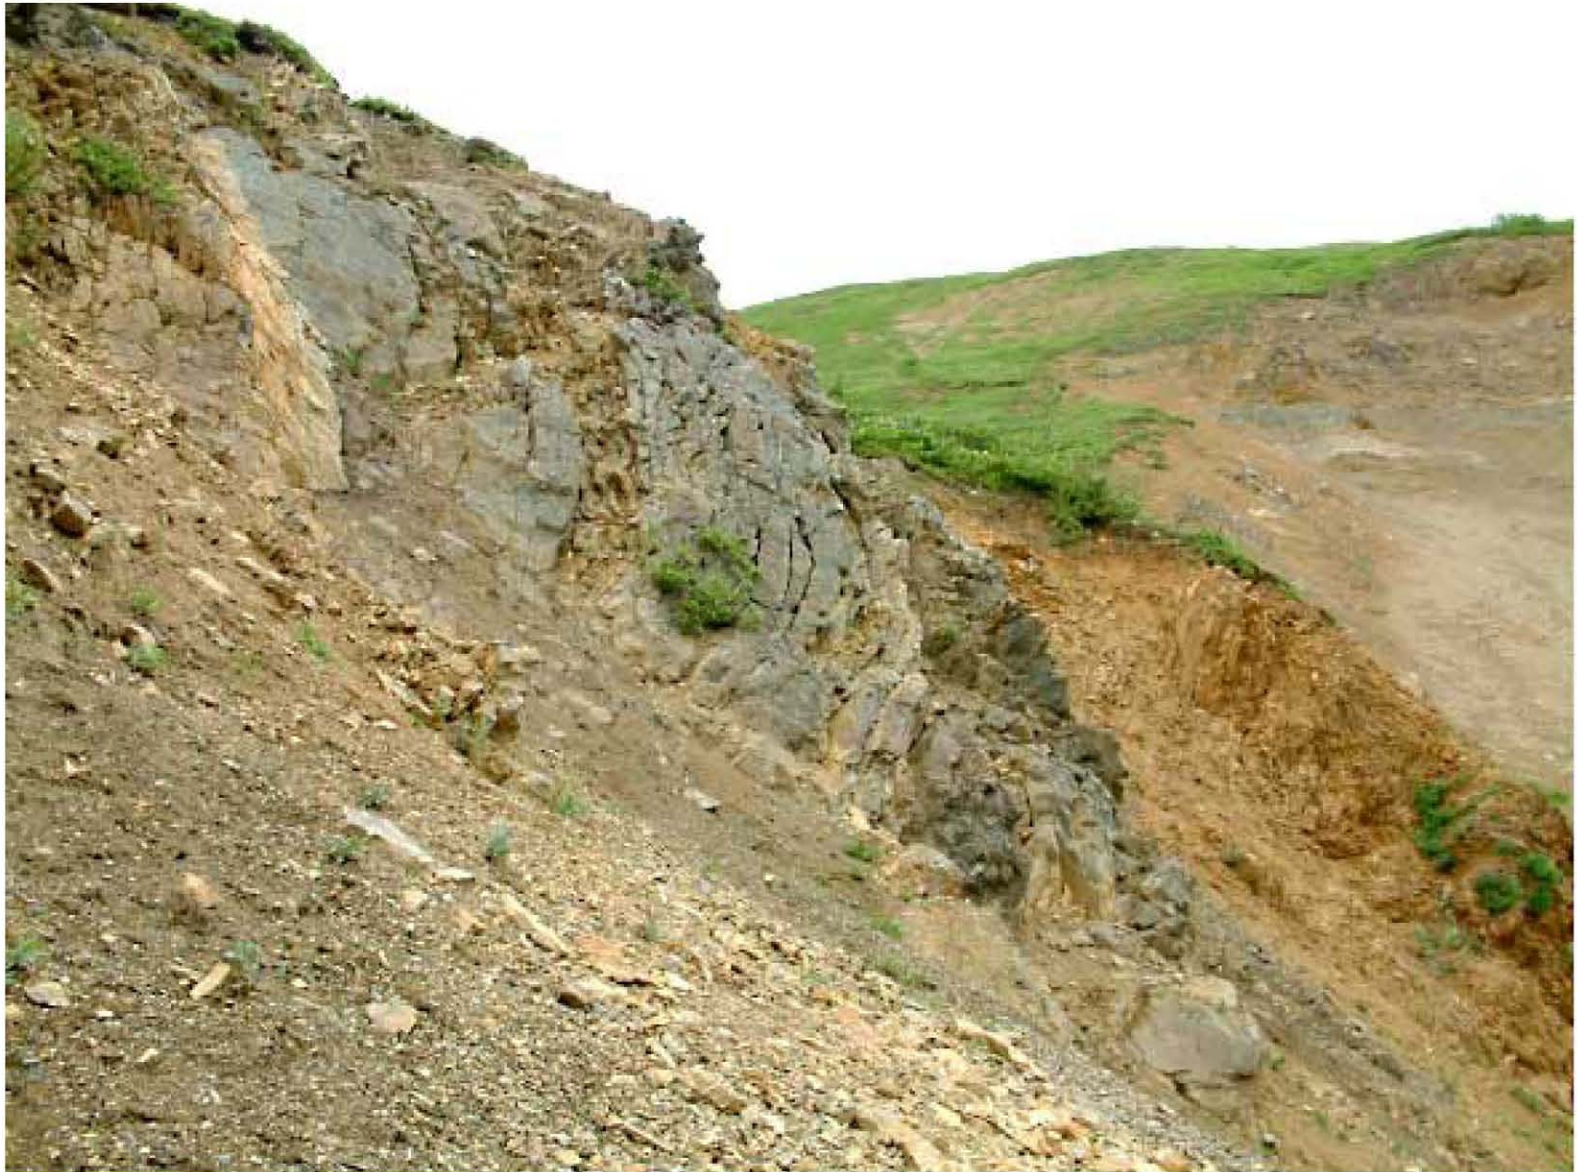
Figure 11.-- Western portion of the main scarp in thinly layered, slightly folded and fractured bedrock, turbidite of Tidal Formation. Note the small revegetation (bushes) in the center of the escarpment. Photograph taken July 15, 2002.

[Figure 11.](#) Western portion of the main scarp in thinly layered, slightly folded and fractured bedrock, turbidite of Tidal Formation. Note the small revegetation (bushes) in the center of the escarpment. Photograph taken July 15, 2002.

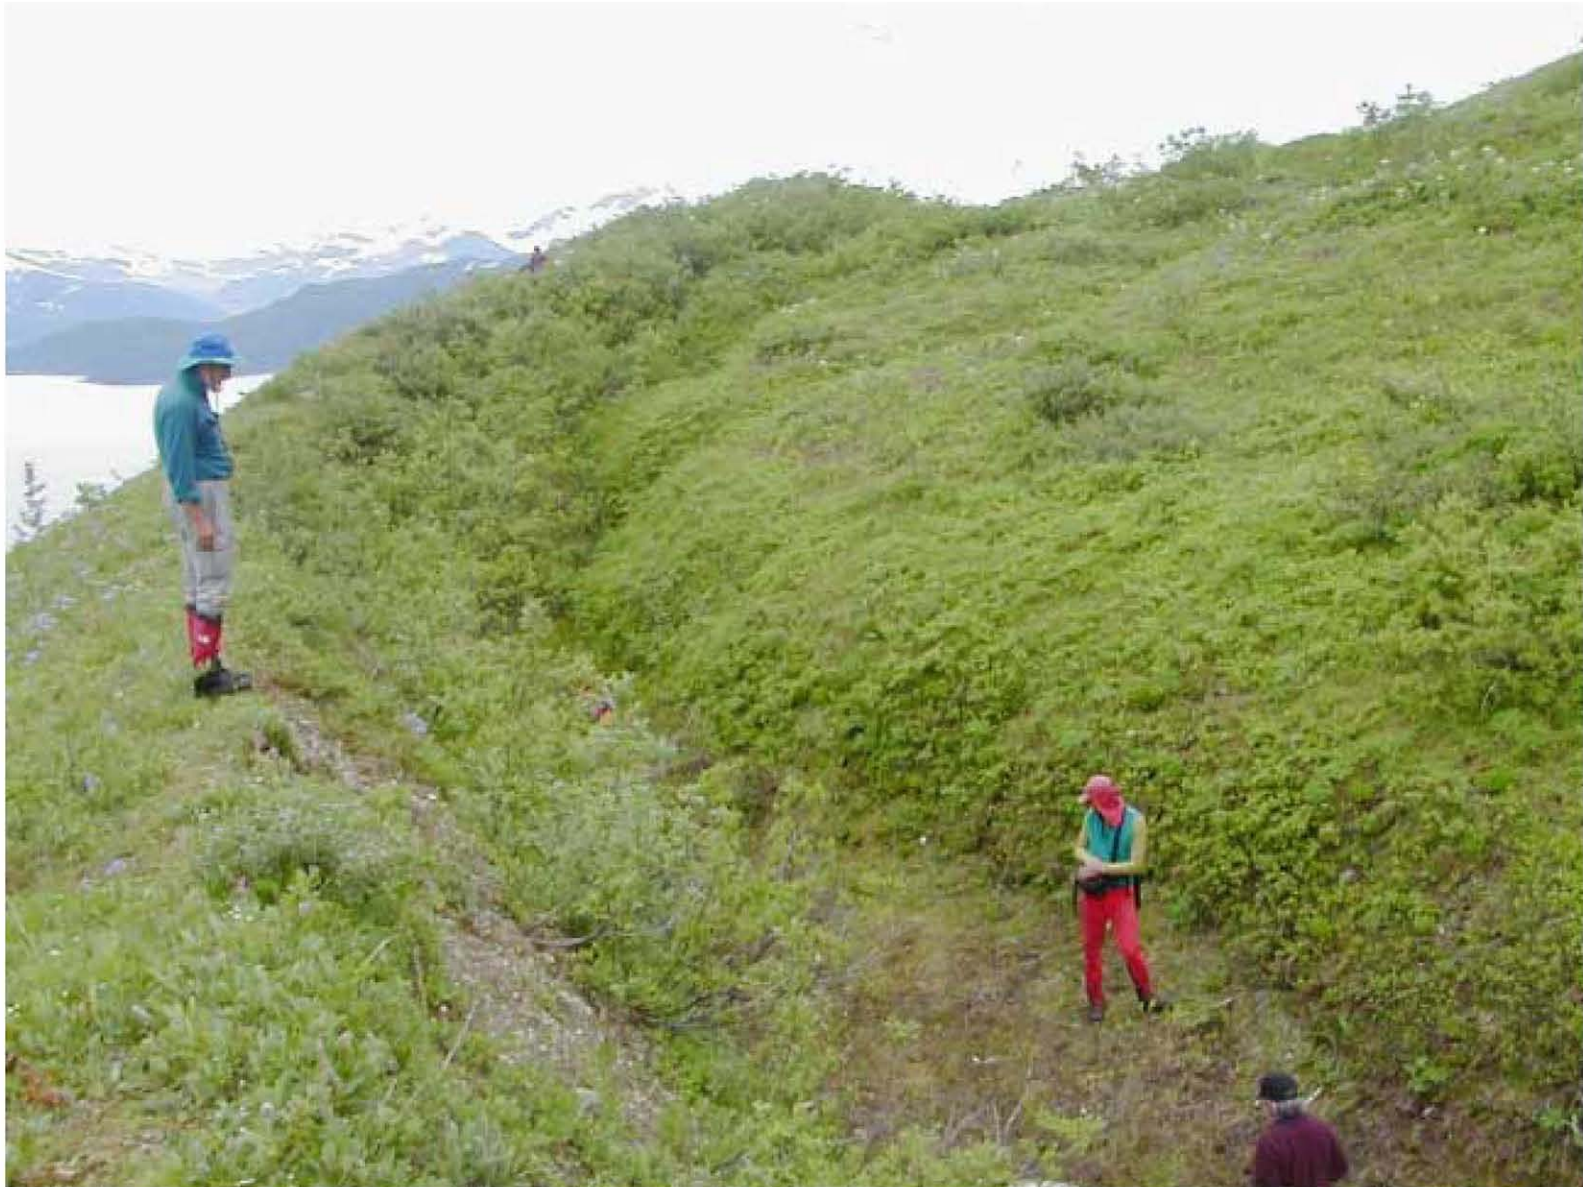
Figure 12.-- Back-facing rotational escarpments and resulting trough, roughly perpendicular to the downslope direction within the main body of the Tidal Inlet landslide. Direction of landslide movement is to the left, the same as the predominant downslope direction.

Within the main body of the landslide the surface topography is severely disrupted by many (13?) rotational blocks with prominent back-facing scarps ([figs. 6, 12](#)). In the upper portion of the main body the exposed portions of these blocks are within glacial till, but further downslope bedrock can be seen within the blocks. The back-rotated faces of these blocks are quite steep, ranging several meters in height with slope angles of 35 to 50 degrees. These north-facing backscarps are thinly vegetated in places suggesting relatively recent movement. The troughs formed by these blocks tend to collect snow and because of lack of downslope stream runoff, result in increased infiltration of water into the main body of the landslide. Several drainage channels through glacial till were found to be truncated at the crest of the rotational blocks, with the previous originally continuing channels displaced further downslope. Such disrupted drainage features indicate sudden rather than slow rotation, which would of course have allowed incision through the erodible till cover. Fluvial erosion could not keep pace with the upthrusting of the blocks, which now is leading to water accumulation in the ditches parallel to the elevation contours. Consequently, the degree of saturation and ground-water level(s) within the landslide mass remains higher than on adjacent slopes, which reduces the relative stability of the landslide mass. Below the escarpment at the toe of the landslide ([fig. 3](#)-Pt. 5), two springs were observed (07/16/02) flowing from the base of the landslide talus with an estimated rate of about 0.01 m³/s each. These springs had built up calcareous deposits on talus debris indicating that some groundwater flow was probably issuing from the limestone of the Pyramid Peak Formation above the main scarp of the landslide, although limestone is also present in the Tidal Formation.

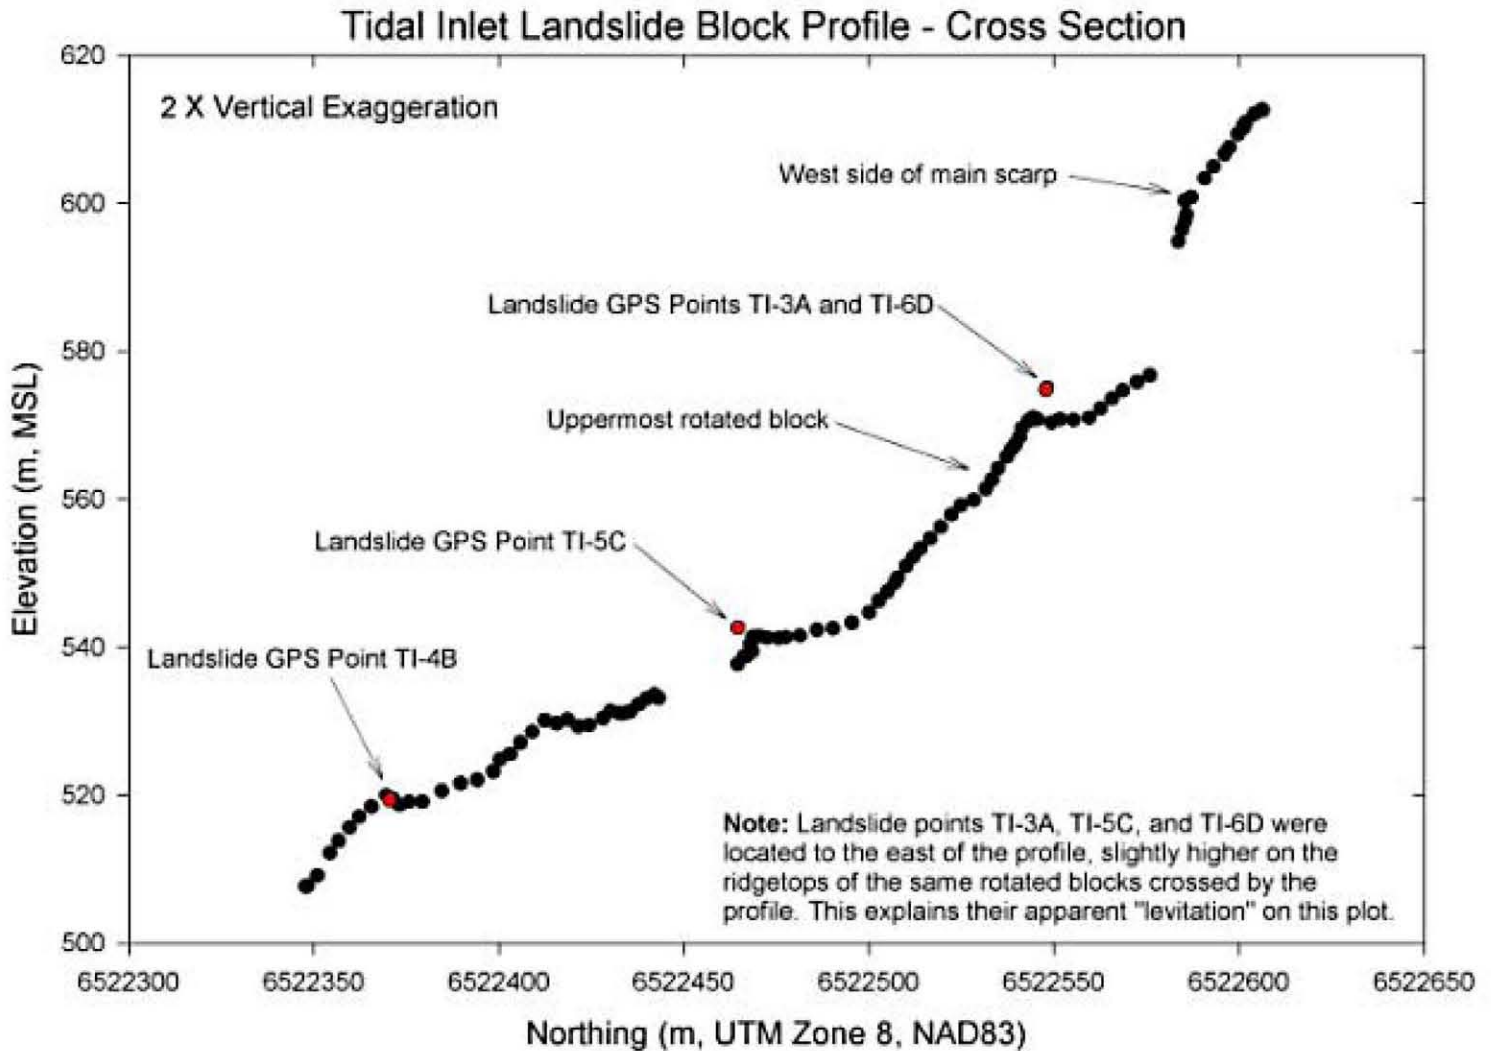
Figure 13 A)-- Profile from hand-held GPS with locations of permanent GPS monitoring stations (red dots) on upper portion of landslide. Irregular surface profile is indicative of movement of multiple rotational blocks within landslide mass. Link to [Figure 13 B](#).

The depth or thickness of the landslide is more difficult to estimate. Using a GPS profile of the main scarp and minor scarps on the main body of the landslide (fig. 13), the maximum depth to the bottom, along the surface of rupture for a circular failure was estimated to be about 40 m, whereas an ellipsoidal shape would result in 20 m depth (perpendicular to the original ground surface). Although the till exposed in many of the minor scarps is weak, the bedrock (Tidal Formation) evident in the major escarpment at the toe of the surface of rupture (and some of the lower minor scarps), indicates stronger material at depth, suggesting an ellipsoid shaped rupture surface rather than a deeper circular failure. Given the uncertainty associated with depth estimates, a value of 30 m is assumed as an approximation of the maximum depth of the surface of rupture, D_r . Using a geographic information system (GIS) and correcting for slope angle, the area of the landslide is approximately 293,000 m².

Four monuments were installed on the Tidal Inlet landslide to assess landslide movement ([fig. 13](#)). These points were surveyed with Trimble 4000 SI and SSI, geodetic-quality, GPS receivers and dual-frequency (L1/L2) antennas. GPS data were collected for durations of one hour and collection intervals of 30 seconds at each monument. Two base stations were set up over permanent benchmarks (CINCO and MART) along the shores of the west arm of Glacier Bay, and continuously collected data at intervals of 30 seconds for a period of about 7 days. These permanent benchmarks are being used in a project for monitoring crustal motion in the Glacier Bay region (Larsen et al., 2001), and their locations are known within a horizontal accuracy of 7 mm and a vertical accuracy of 13 mm. Very accurate baseline solutions between CINCO and each of the landslide monuments were calculated, yielding

[Figure 13 A\)](#) Profile from hand-held GPS with locations of permanent GPS monitoring stations (red dots) on upper portion of landslide. Irregular surface profile is indicative of movement of multiple rotational blocks. [B\)](#) Enlarged aerial photographic view of upper part of Tidal Inlet landslide showing GPS profile points (green dots) starting from top of main scarp and proceeding to location of secondary failures. Labels for red dots show GPS monitoring points. Points TI-6D and TI-3A are so close to each other that they are shown as a single red point. Linear shadows across portions of width of photo show rotational blocks, some of which disrupted by secondary failure in middle of view.

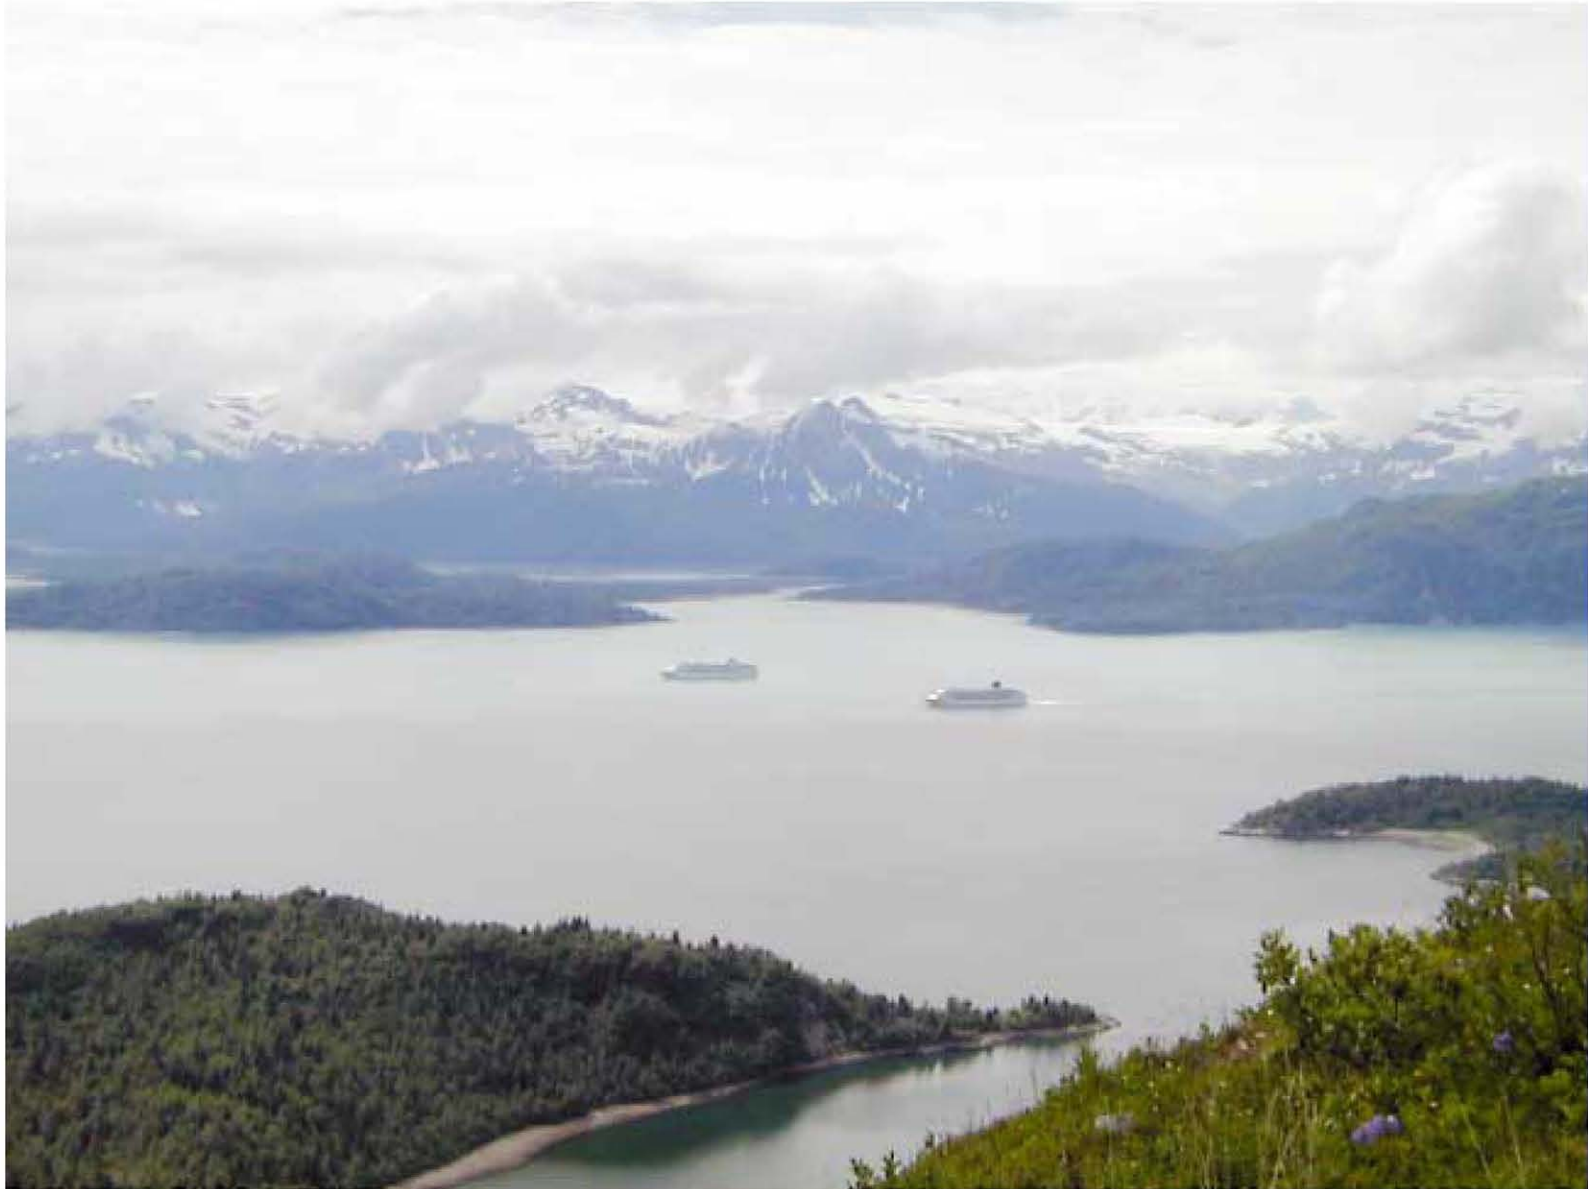
Figure 15.-- View from Tidal Inlet landslide looking westward towards Blue Mouse Cove of two cruise ships in the western arm of Glacier Bay passing Tidal Inlet (lower center).
