Seismic Fragility of Suspended Ceiling Systems

Technical Report MCEER-06-0001

February 4, 2006

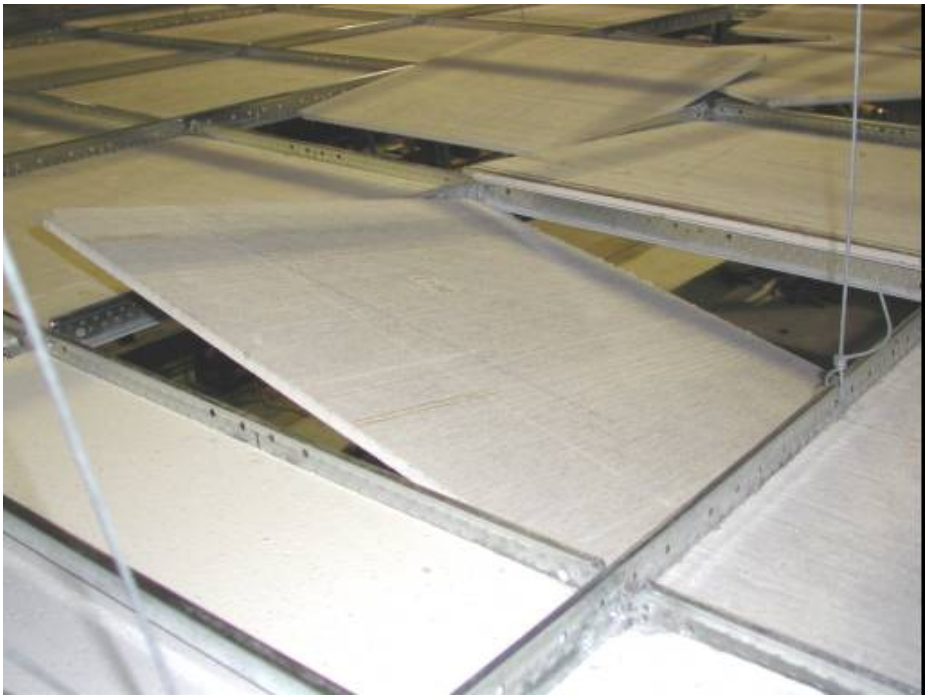
two corners of the tile that remain supported on the grid. Figure 6-6 shows the tile of figure 6-5 falling to the simulator platform during the combined shaking test corresponding to S_S = 2.5g, in Series C.

FIGURE 6-5 Tile rotating before falling, configuration 1

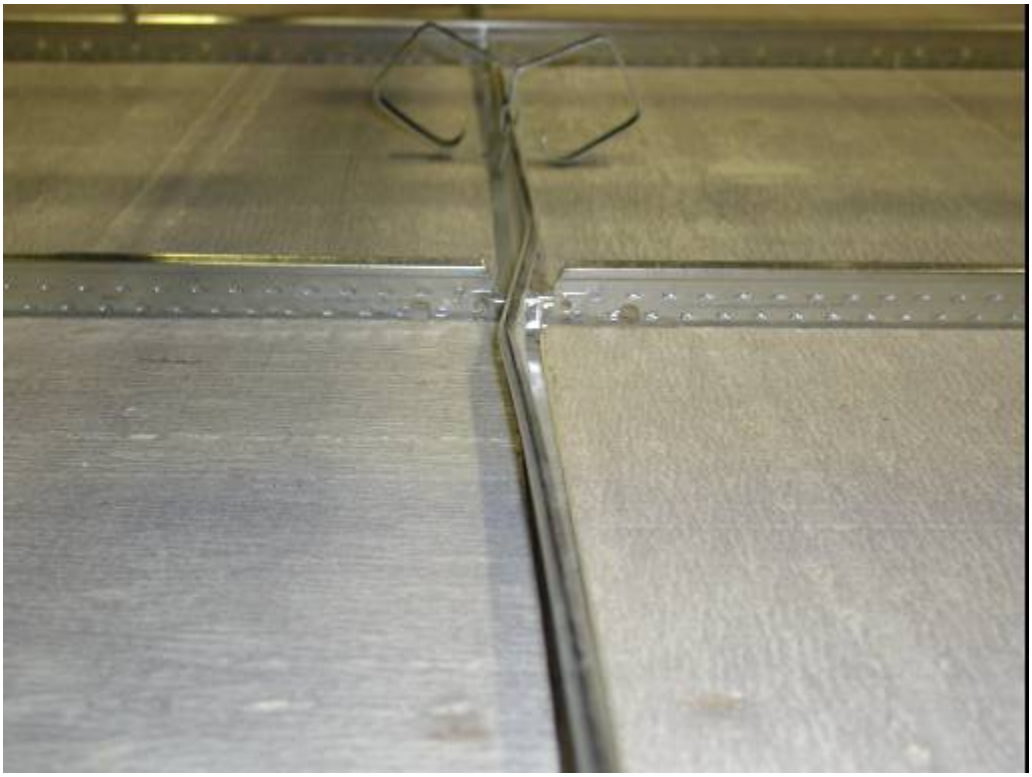
[2] The definition of failure of the cross tees included components that: (1) fell, (2) were bent, and (3) had to be replaced because they compromised the structural integrity of the entire grid if they were left in place.

FIGURE 6-7 Damage to the cross tees installed in the East-West direction, configuration 2

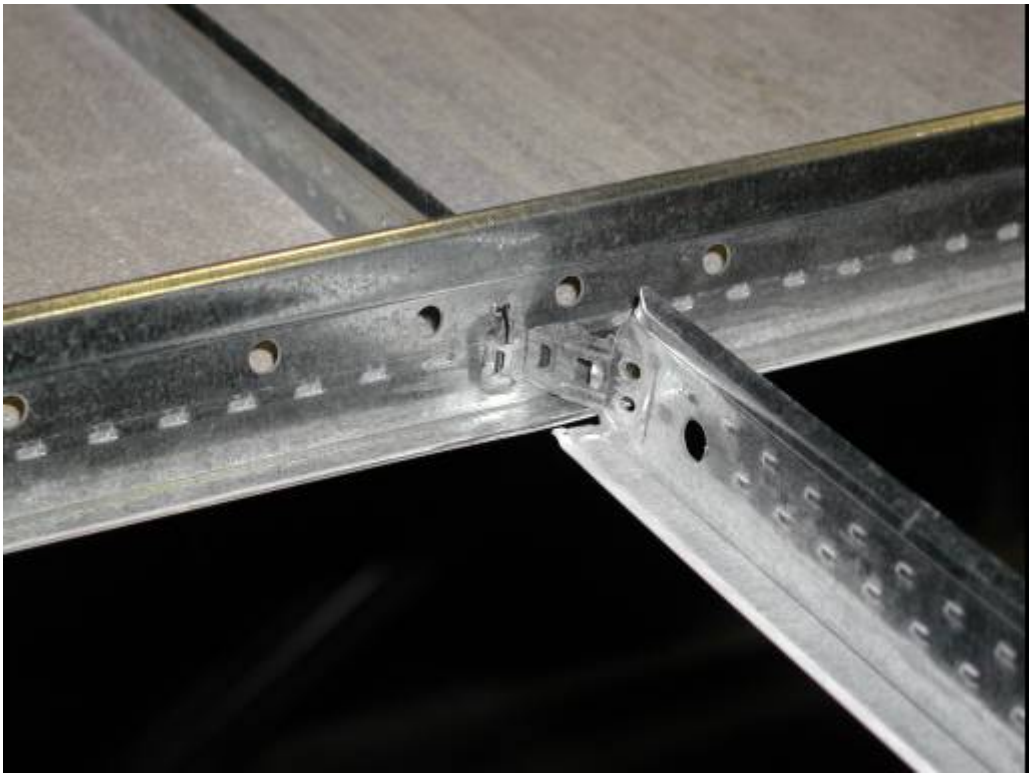
FIGURE 6-8 Damage to the latches on the cross tees in configuration 2

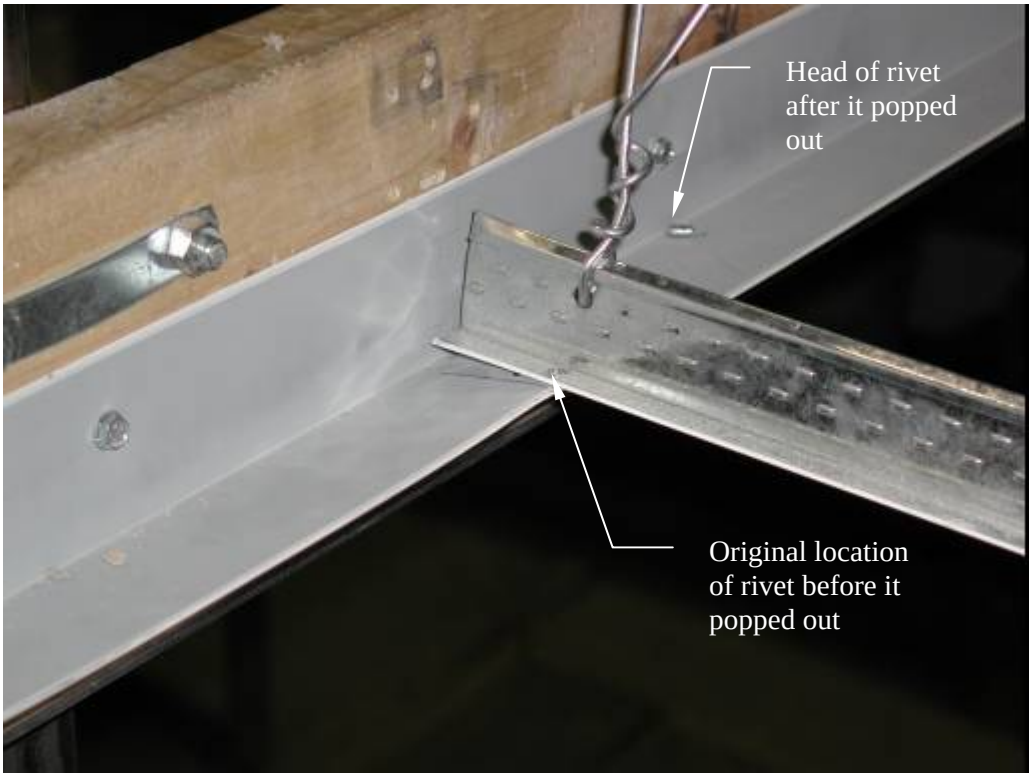
1. The rivets that attached the main runners and cross tees to the wall molding on the South and West sides of the test frame played a very important role in the seismic performance of the suspended ceiling systems. When a rivet came loose or was destroyed during shaking, the damage in the ceiling system in terms of loss of tiles was much larger than when all of the rivets were undamaged and the cross tees remained firmly attached to the wall molding. The arrowhead in figure 6-13 identifies the location of one of the rivets destroyed during shaking.

FIGURE 6-13 Rivets on the South side wall molding destroyed during shaking

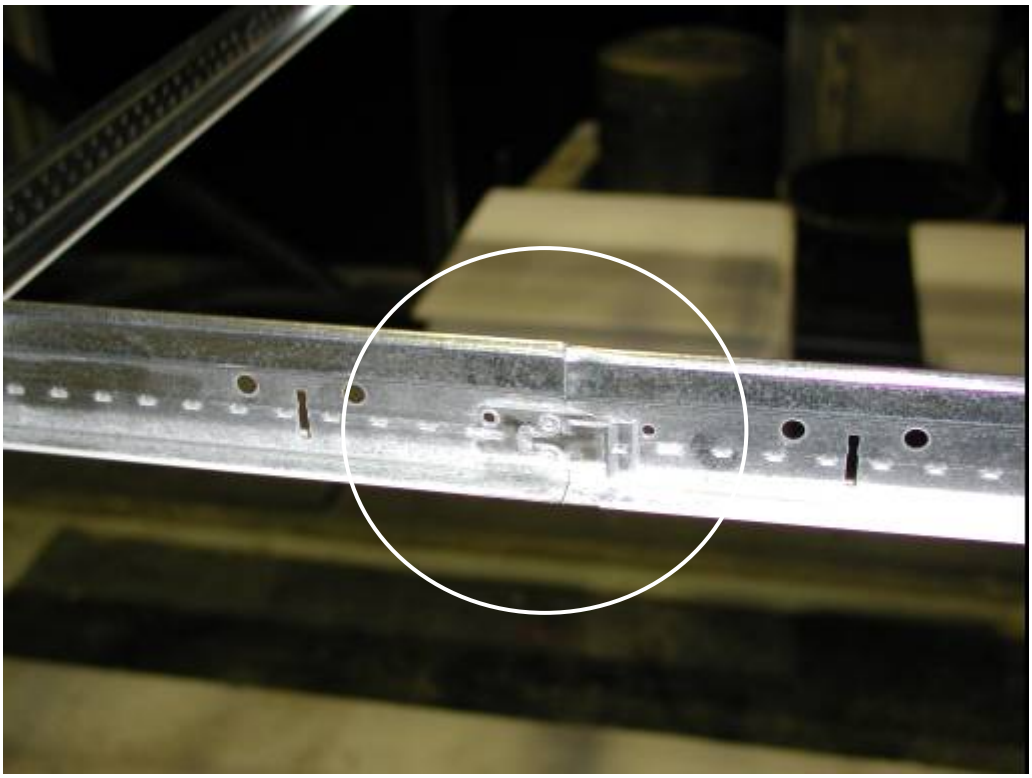
2. The main beams provide most of the stiffness in the suspension grid in the horizontal and vertical directions. However, the connections between the main beams were substantially more flexible than the main beams. This is clearly reflected in the performance of the ceiling systems in terms of loss of tiles because the first tiles to fall in most of the tests were the tiles located around the connections between two main beams. The circle in figure 6-14 identifies the connection between two main beams.

FIGURE 6-14 Connection between two main beams
