REPORT DOCUMENTATION PAGE	1. REPORT NO. NCEER-94-0008	2.	PB94-193851

4. Title and Subtitle
The Northridge, California Earthquake of January 17, 1994: Performance of Highway Bridges

7. Author(s)
I. G. Buckle

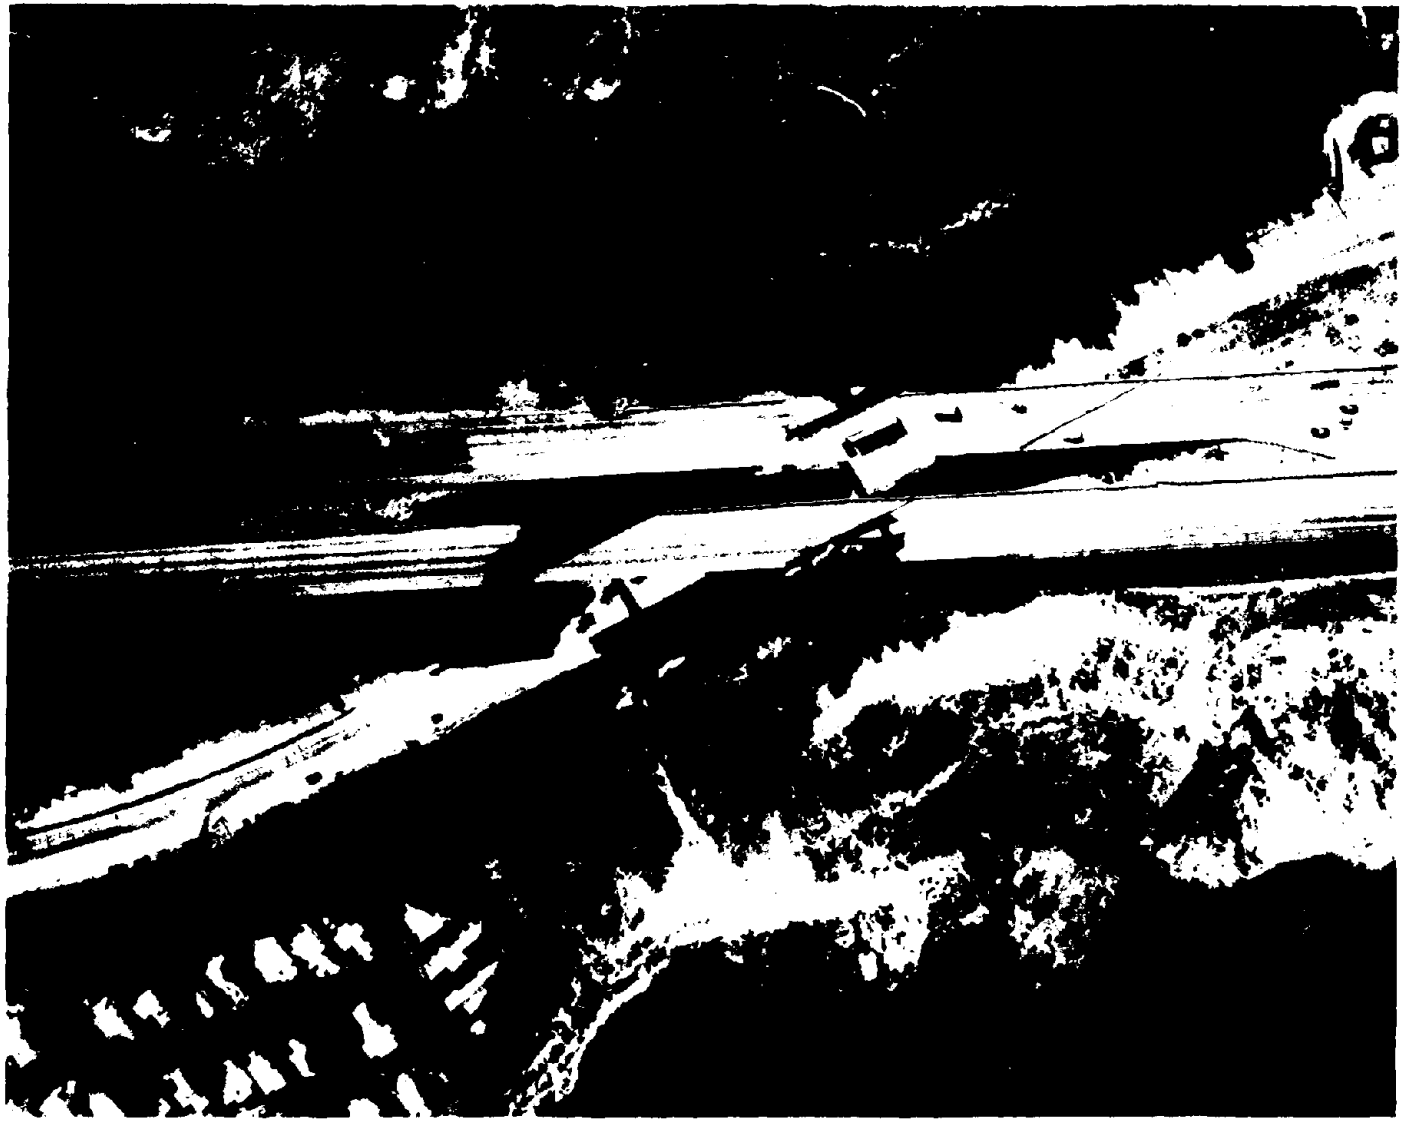
FIGURE 3-4 Gavin Canyon Undercrossing - Aerial View of Collapse

Both structures suffered failures due to total or partial loss of support at the expansion joint hinges. The acute corner of the supported span tended to become unseated first due to a counterclockwise rotation of each the structural sections about a vertical axis (Figure 3-4).

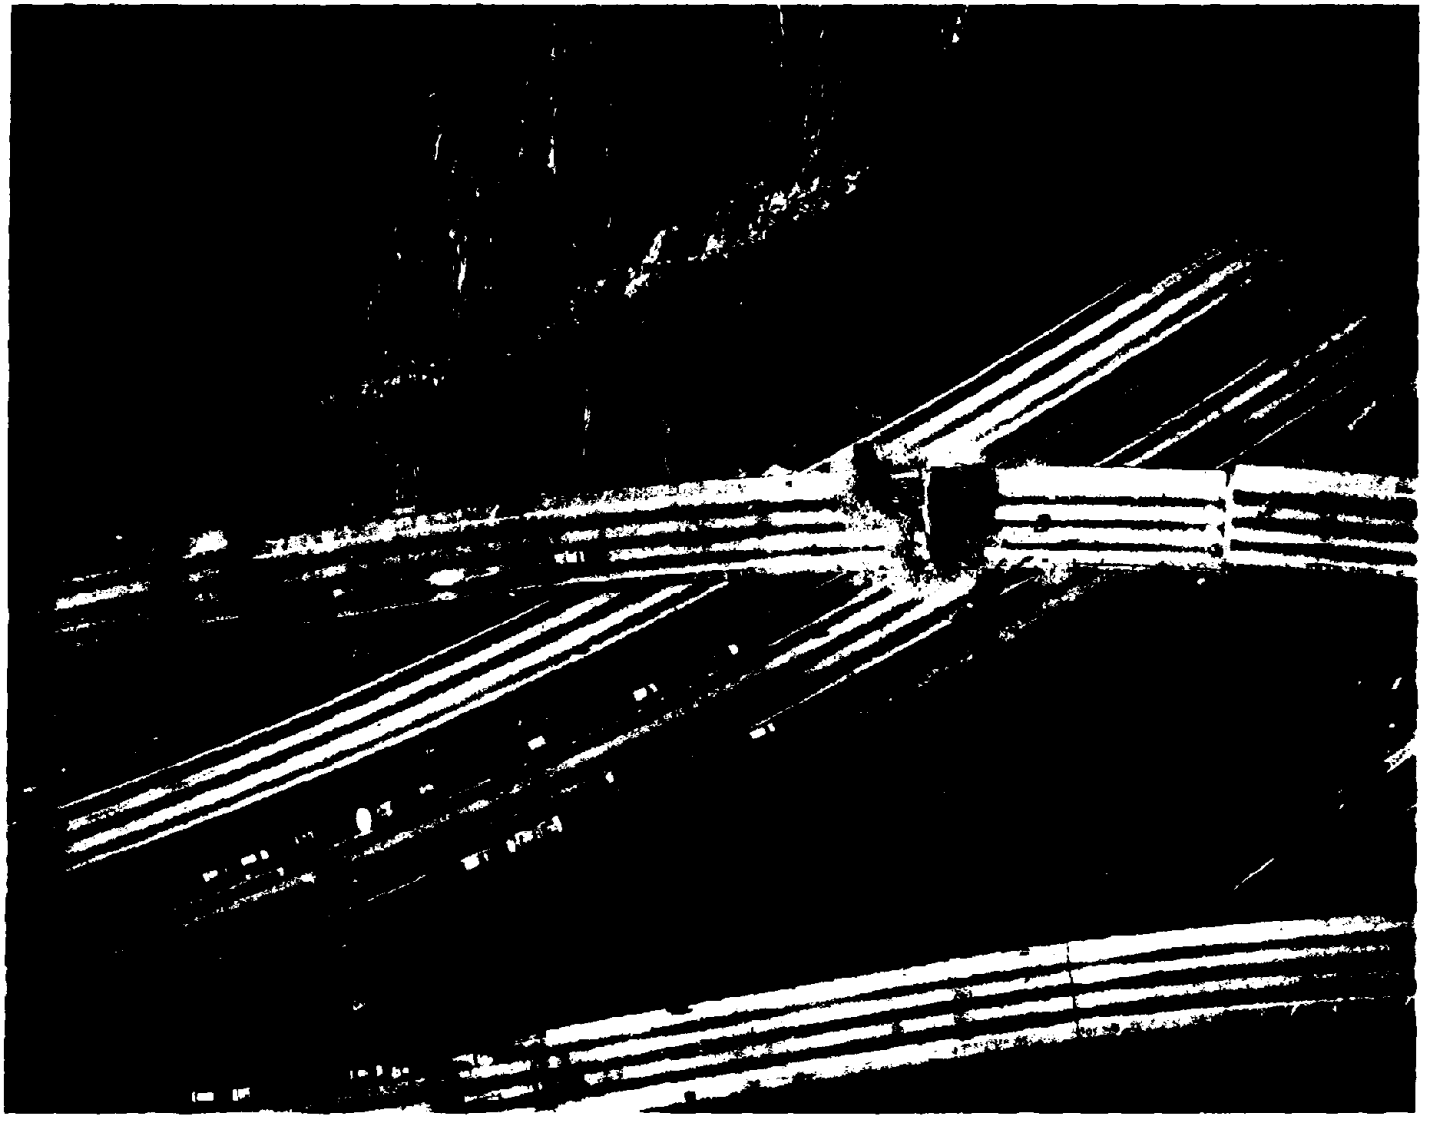
FIGURE 4-7 SR14/I-5 Separation and Overhead (Southbound) - Aerial View of Collapse

The circumstantial evidence available at the site, especially the damage sustained by the face of pier 3, suggests that mechanism 1. is the likely failure mode.

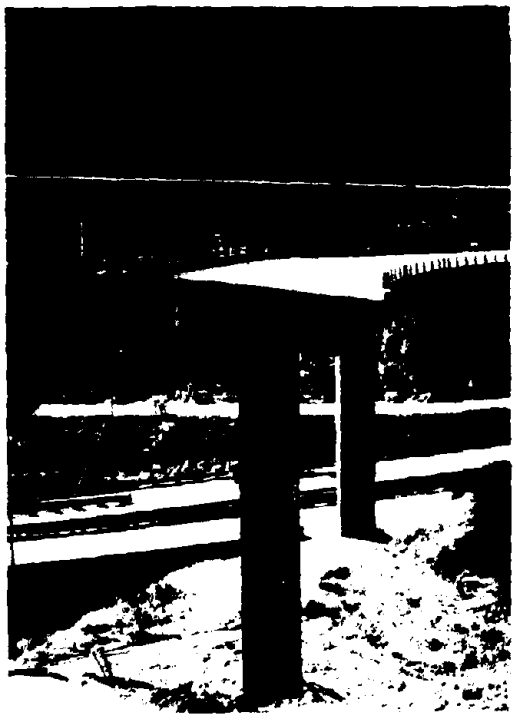
Without analysis, the sequence of failure is uncertain but it seems likely that pier 2 failed first followed by the collapse of the two spans. It is possible that pier 2 attracted a much higher proportion of the lateral load than assumed in design because of its relatively short height. Further, there was probably a significant reduction in the axial load in the pier due to both the severe curvature in the bridge and the high vertical accelerations in the ground motion. This reduction in axial load may have reduced the capacity of the column to less than the demand leading to the failure of the pier.

FIGURE 5-2 SR14/I-5 North Connector - Collapsed End Spans After Demolition

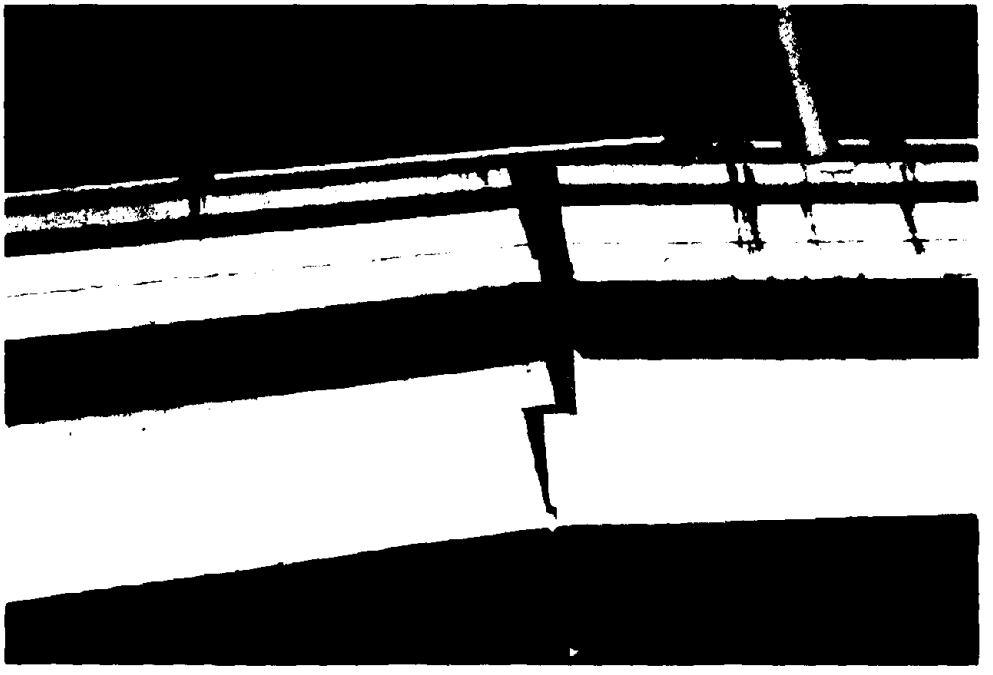
FIGURE 9-5 Fairfax-Washington Undercrossing - Rotation at Hinge in Span 3
