# **Supporting Document for Rehabilitation Cost Estimates of FEMA Existing Buildings**

H. S. Lew

Prepared for

March 1999

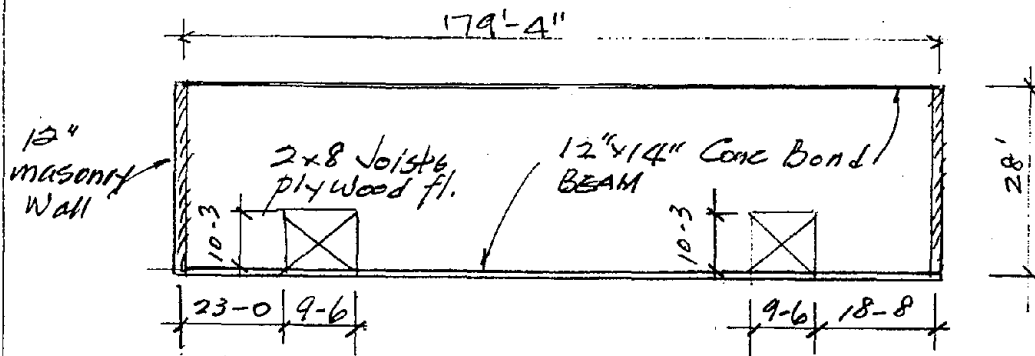
CREEK DIAPHRAGM SECTION AT 2<sup>ND</sup> FL.

Even w/ snow load acting  $v$  would be very low.

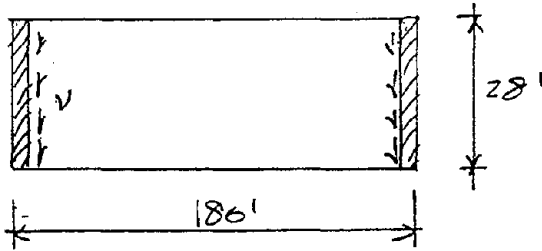
CHECK shear in the plywood diaphragm @ 2nd fl

$$= 0.29" + 0.81" + 2.61" = 3.71" \quad \text{N.G. too close.}$$

Controlling factor is nail deformation

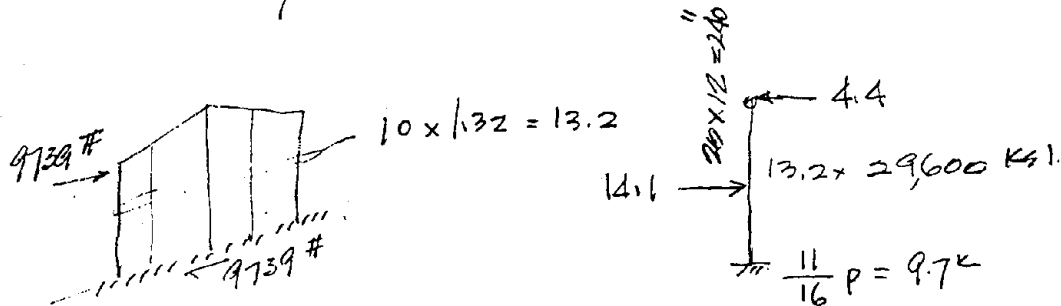
Check simple cantilever beam defl.

$$\Delta = \frac{PL^3}{3EI} = \frac{9.7 \times 240^3}{3 \times 13.2 \times 29600} = 114'' = 0.475 \text{ l. (high)}$$
