NBS SPECIAL PUBLICATION **592**

U.S. DEPARTMENT OF COMMERCE / National Bureau of Standards

An Investigation of the Miyagi-ken-oki, Japan, Earthquake of June 12, 1978

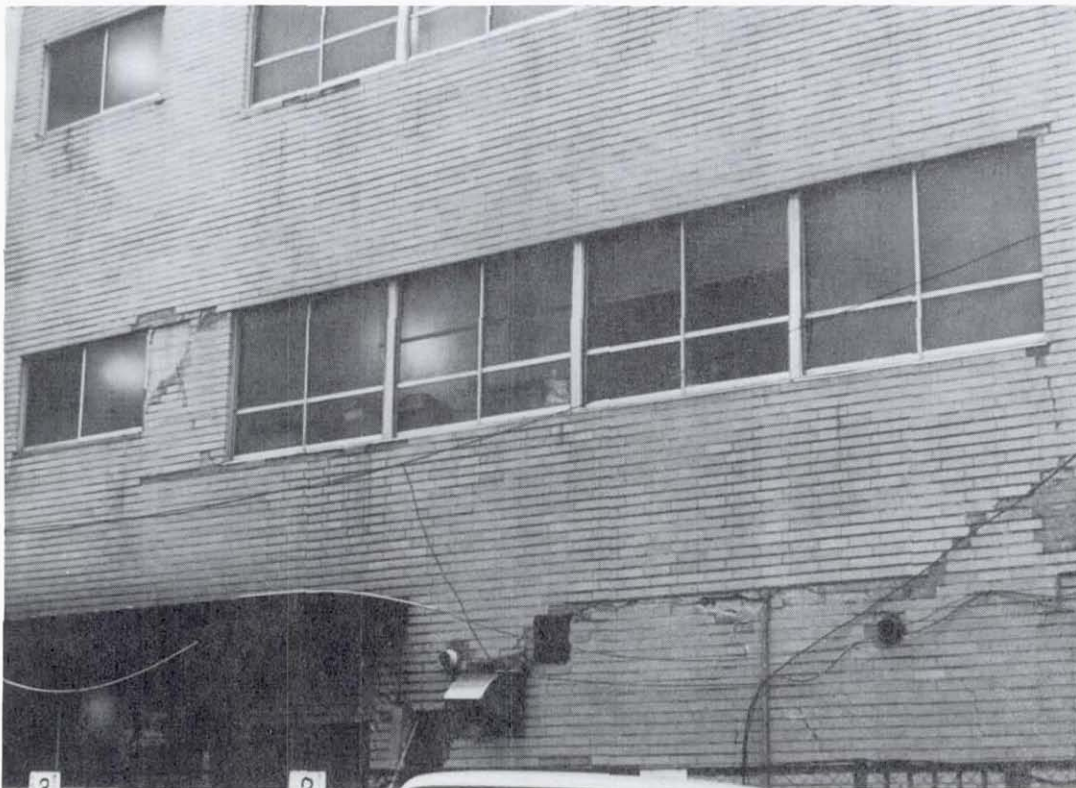
Figure 5.6 Second Eastern Building Company Building, Sendai. A typical modern building in Sendai; the only apparant damage to the glazed tile veneer on the exterior was cracking on spandrels and shear walls.

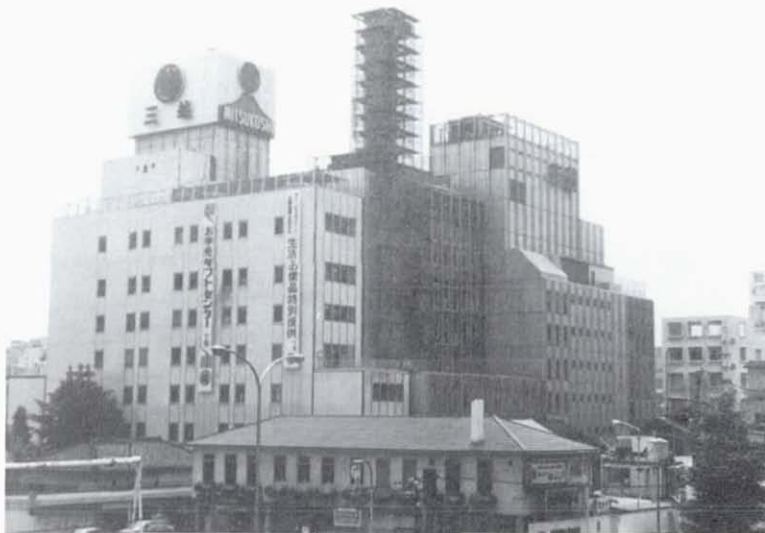
Figure 5.8 Chimney damage to the Mitsukoshi Department store. Numerous such chimneys suffered such damage.

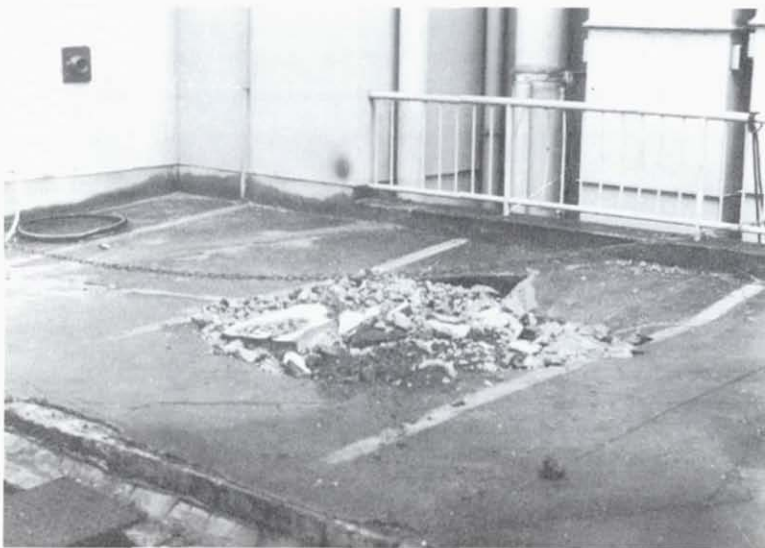
Figure 5.10 Impact area of chimney failure (see Figure 5.9)

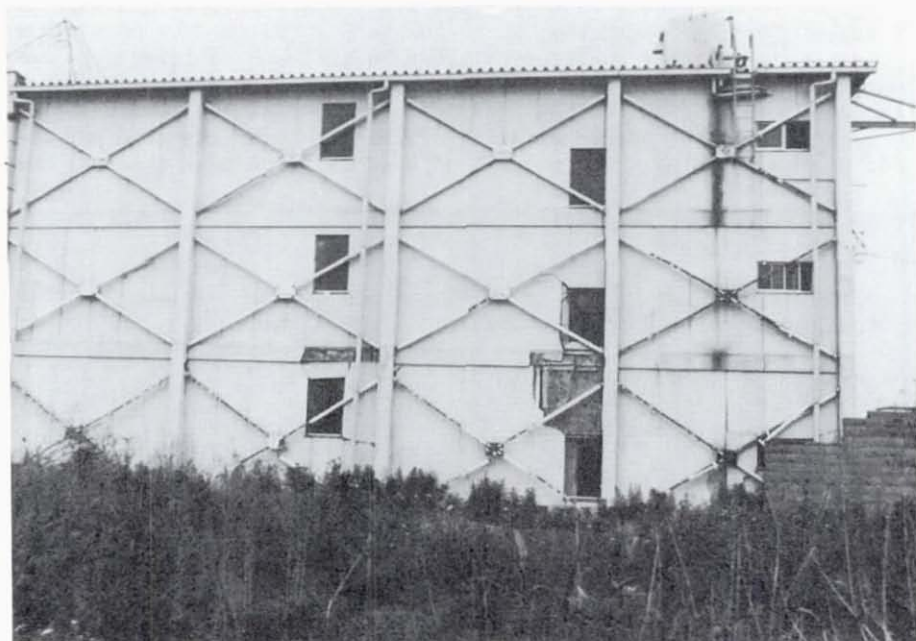
Earthquake resistance in steel buildings is provided either through the use of moment-resisting frames or through diagonal bracing. When braces are used as earthquake resisting elements, it is normal practice to design them so as to carry all of the horizontal force. An example of such a structure is a steel framed furniture warehouse on the outskirts of Sendai shown in Figure 5.11. There were many examples where the bracing members buckled under stress reversal or the connections failed. A number of the transverse diagonal braces used in this warehouse sheared at their bolted cross connections (Figure 5.12).

Figure 5.11 A damaged steel-framed furniture warehouse on the outskirts of Sendai.

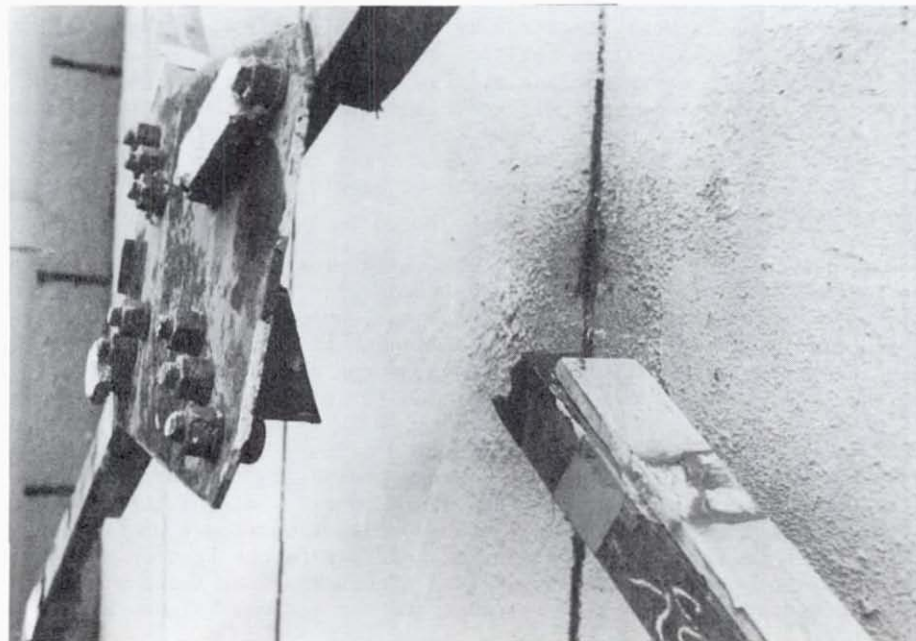
Figure 5.12 Detail of failure in transverse diagonal braces.

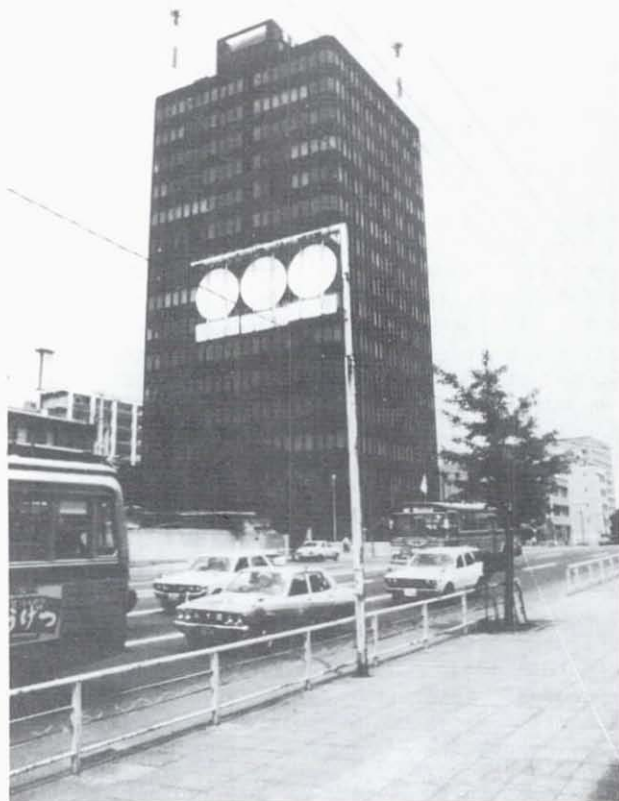
Many modern high-rise buildings in Sendai have steel frames, and these generally performed very well during the earthquake. One example is the Sendai Second Government Building in the downtown area (No. 2 in Figure 5.3), a 17-story structure built in 1973 (Figures 5.13 and 5.14.) The building is situated on a raft foundation, where the underlying soil conditions are good. The frame was designed by dynamic analysis for a maximum base acceleration of 0.2 g. The building is instrumented with strong motion accelerometers at the 15th floor and second basement levels, and a downhole at 40 m below grade. The building suffered virtually no damage, although there was some minor diagonal cracking in the concrete stairwells leading to the basement.

Figure 5.13 Sendai Second Government Building. This modern steel frame structure suffered no damage.

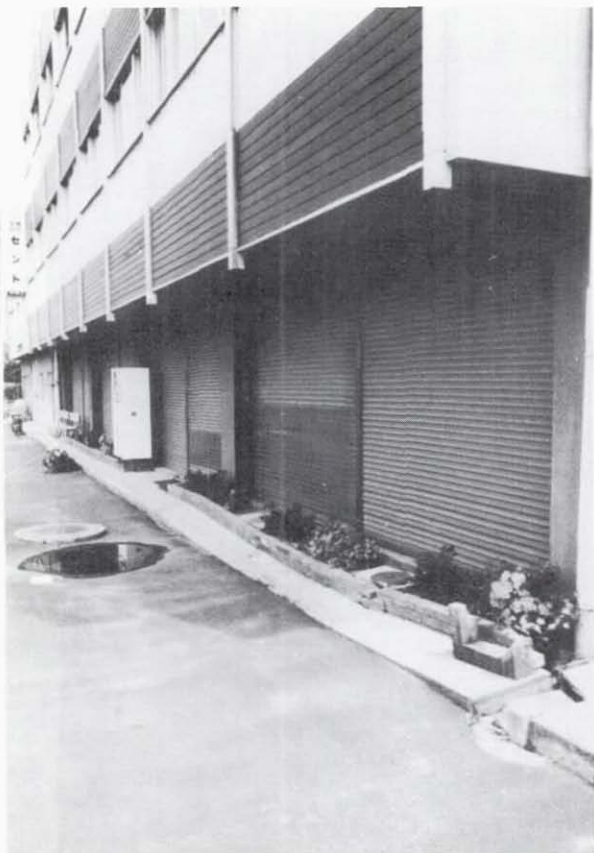
There was extensive evidence of ground settlement in the Oroshicho area, including settlement of asphaltic concrete sidewalks and slumping around building foundation walls, as in Figures 5.20, and 5.21.

Figure 5.20 Oroshicho area, Sendai.
Ground settlement.

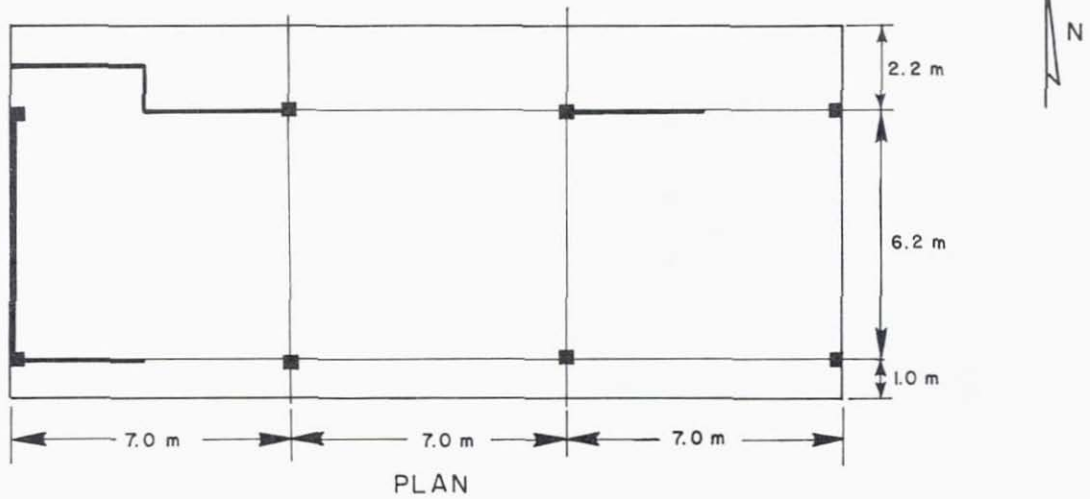
Figure 5.22 Plan view of Maruyoshi Building, Oroshicho area. Note overhang to the north.

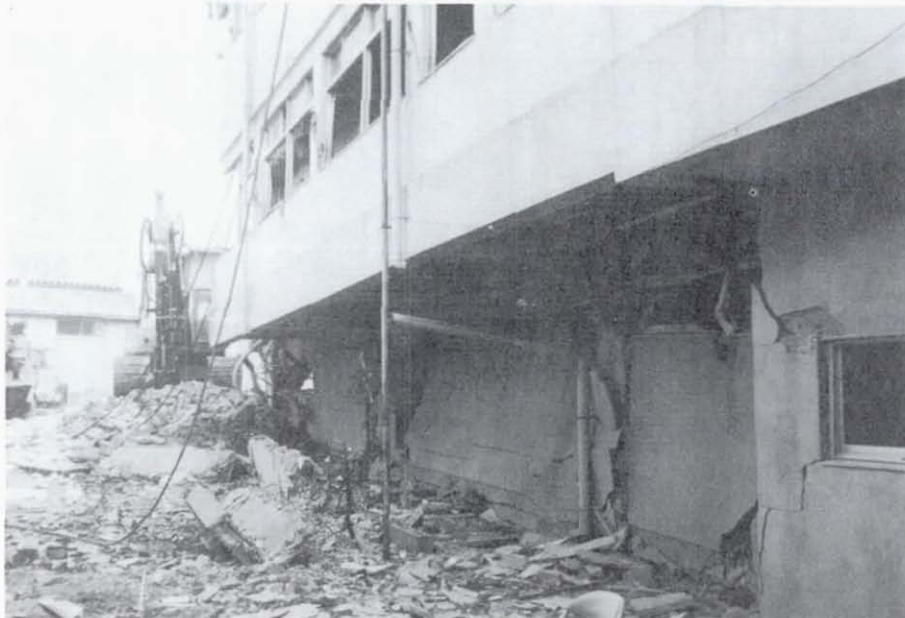
Figure 5.23 Maruyoshi Building, view from the northwest. This three story reinforced concrete frame, one span by three, suffered almost total collapse of the first floor.

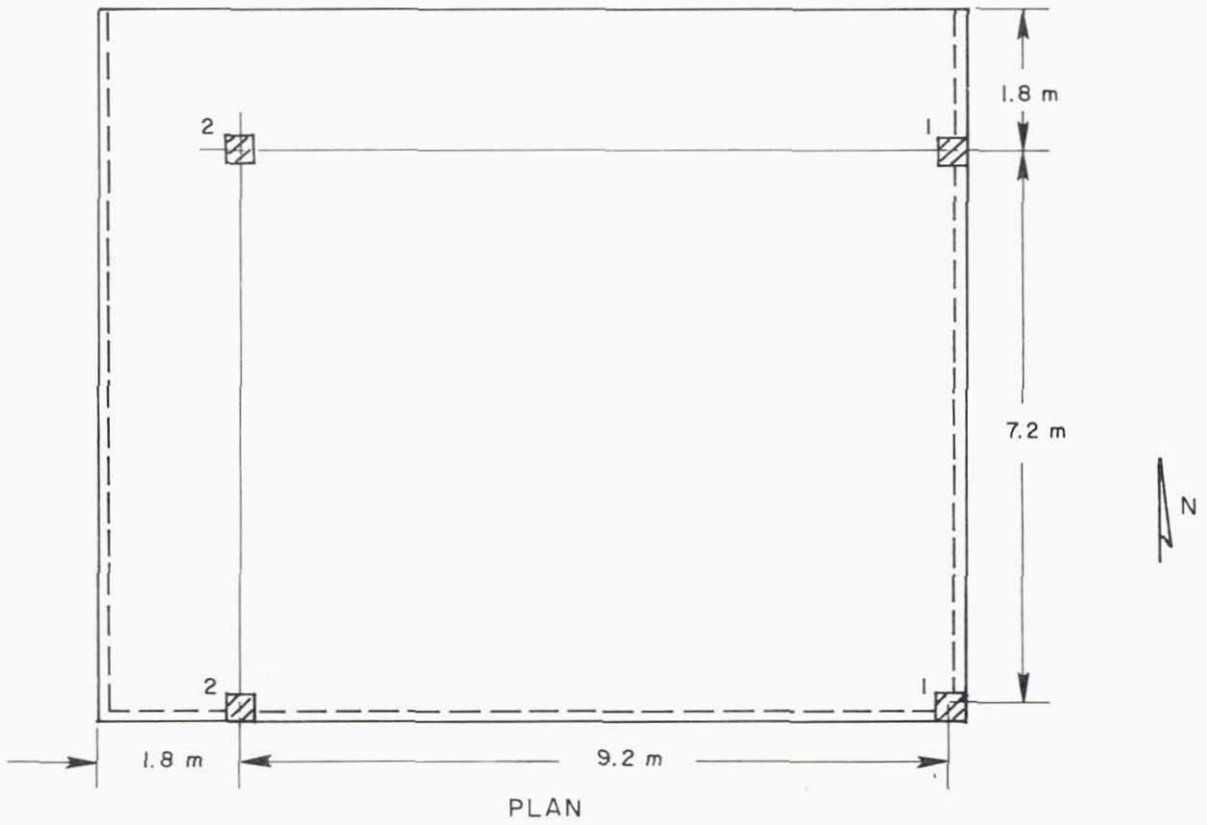
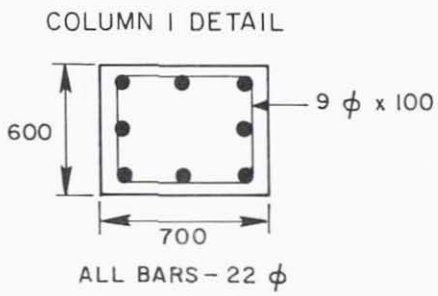
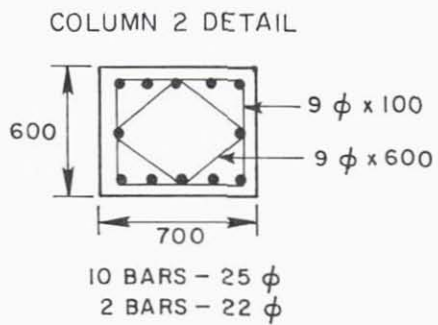
Figure 5.26 Plan and column details of Obisan Building, Oroshicho area.

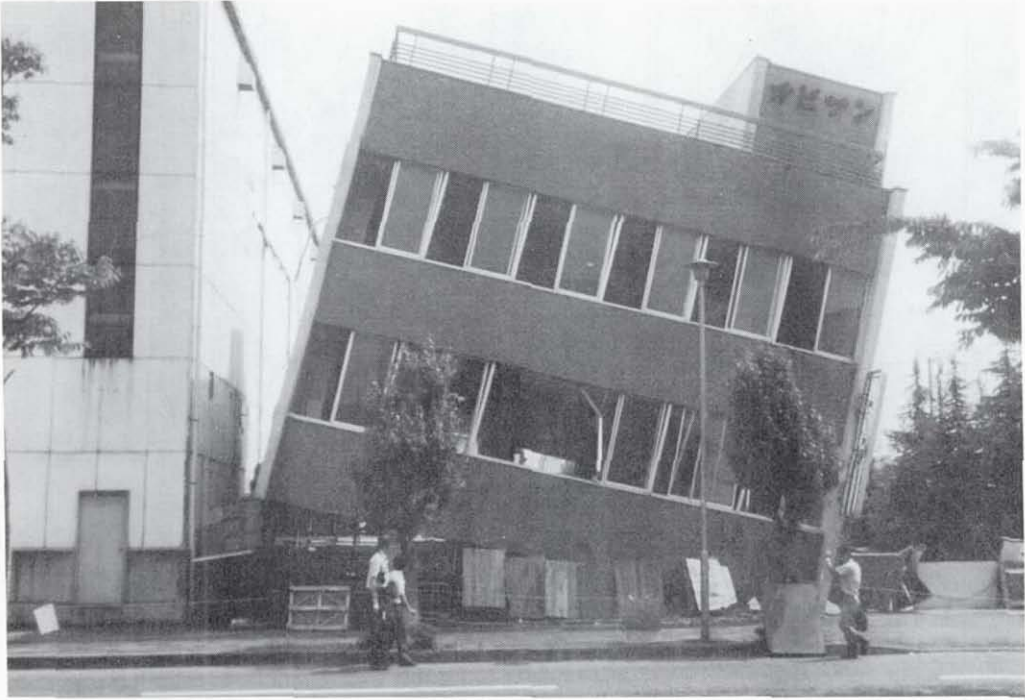
Figure 5.27 Obisan Building, viewed from the North. This three story reinforced concrete frame building had a heavy eccentric stairwell cantilevered over the column line at the right end of the building.

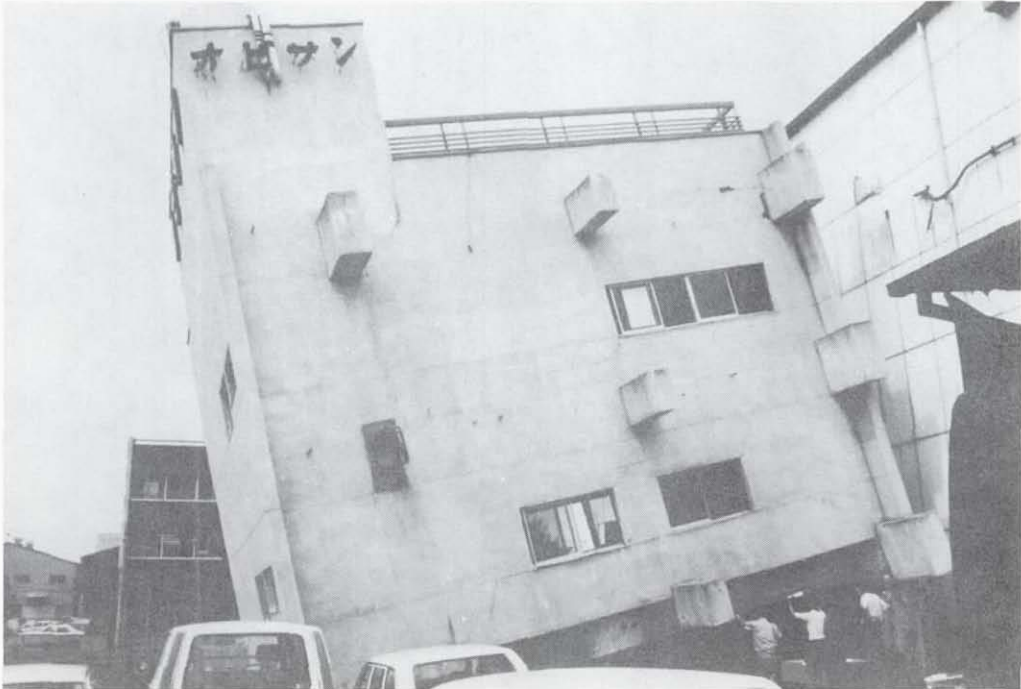
Figure 5.28 Obisan Building, viewed from the south. The upper stories rotated as a rigid body when the first floor column support was lost.

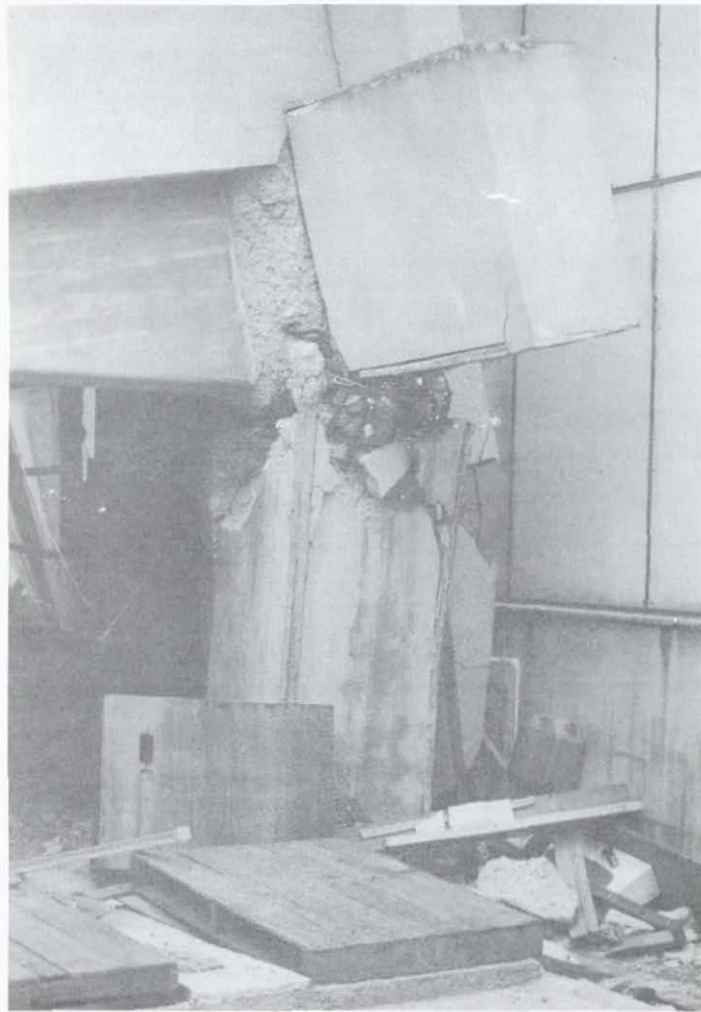
Figure 5.29 Obisan Building, detail of southeast column.

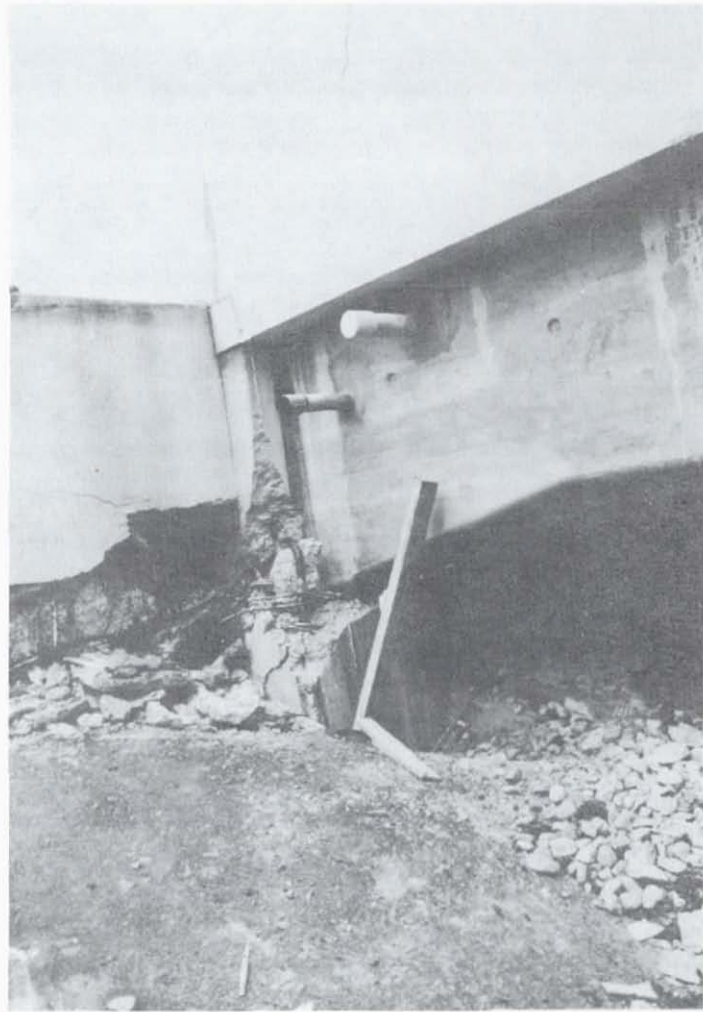
Figure 5.30 Obisan Building, detail of southwest column adjacent to overhang.

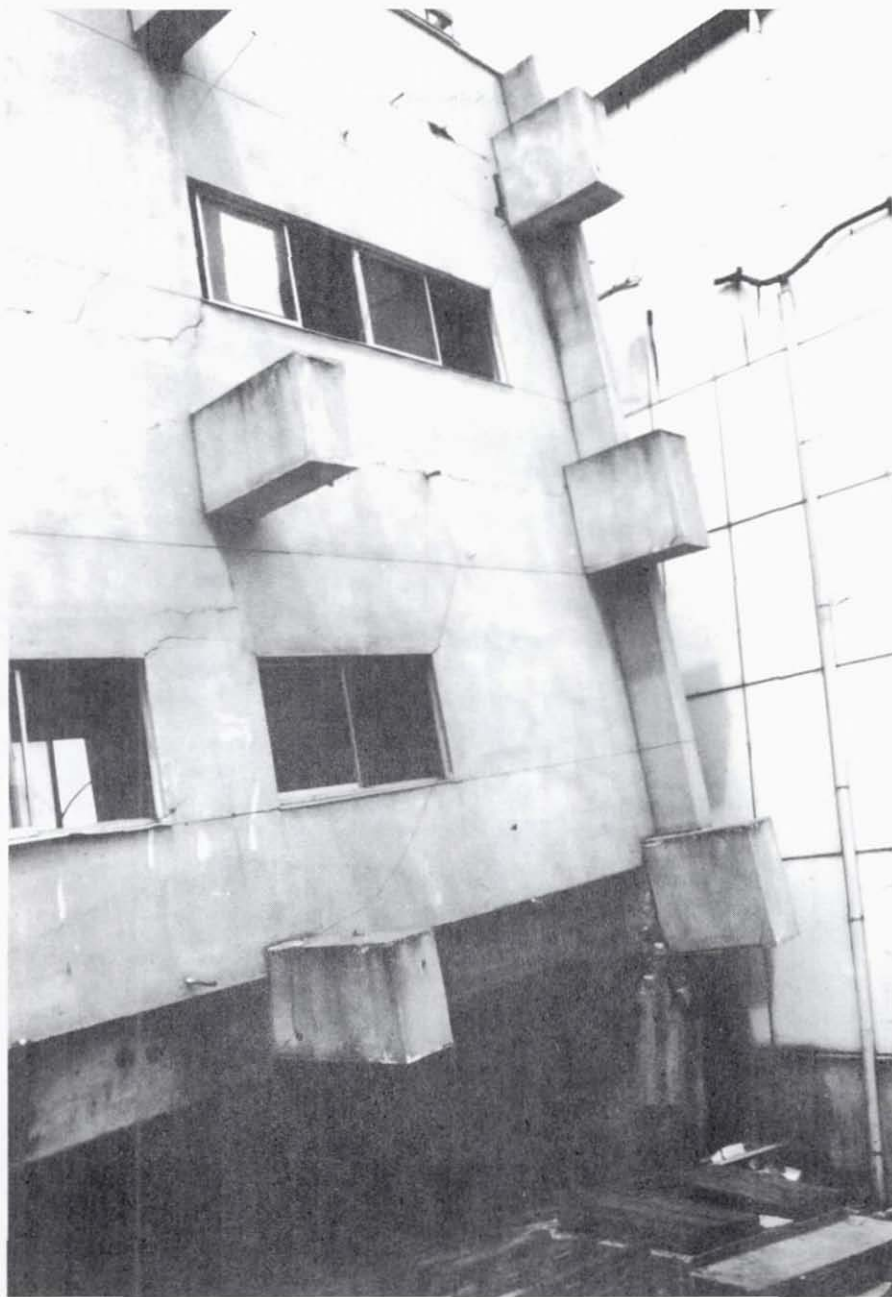
Figure 5.31 Obisan Building, south face. Walls above first story remained essentially intact.

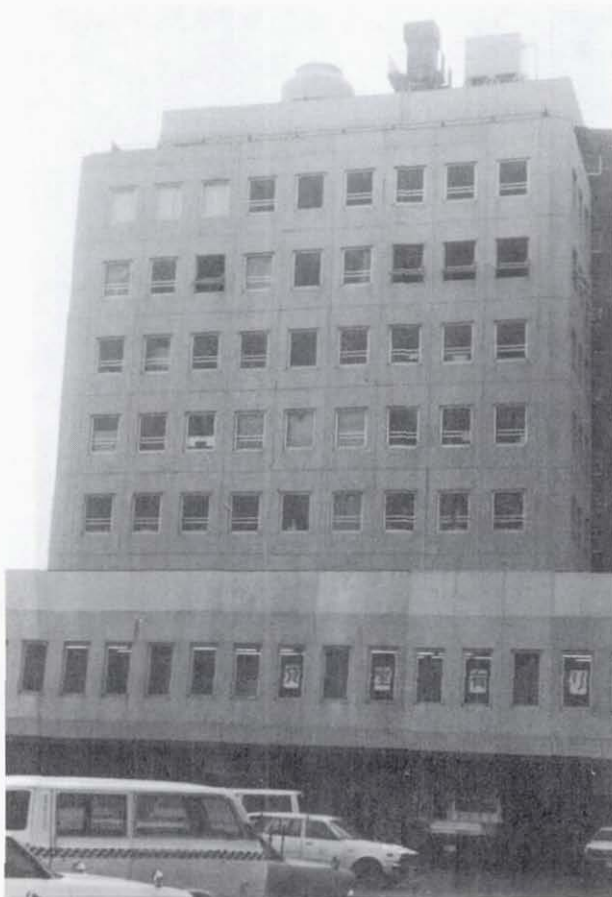
Despite the level of damage in the Oroshicho area, many buildings performed quite well. As an example, Figure 5.37 illustrates a 9-story building which was only slightly damaged. No details about its construction are known.

Figure 5.37 A slightly damaged 9 story building in the Oroshicho area of Sendai.

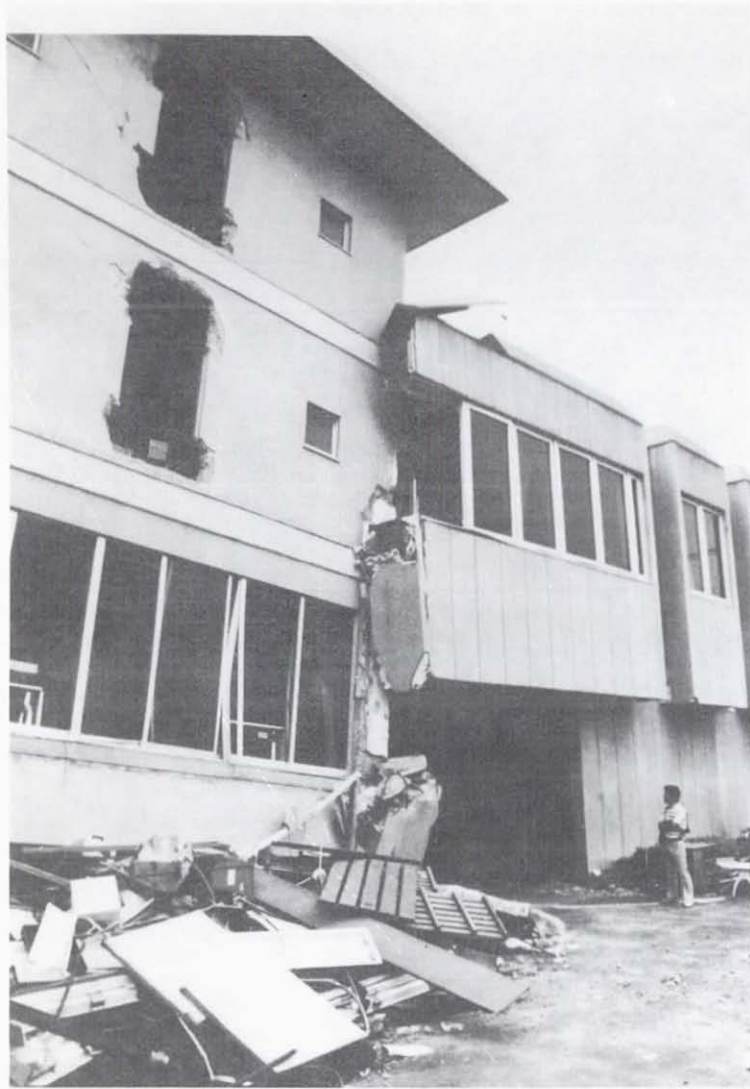
Figure 5.40 Yazaki Industries, showing area of impact between steel and reinforced concrete frames.

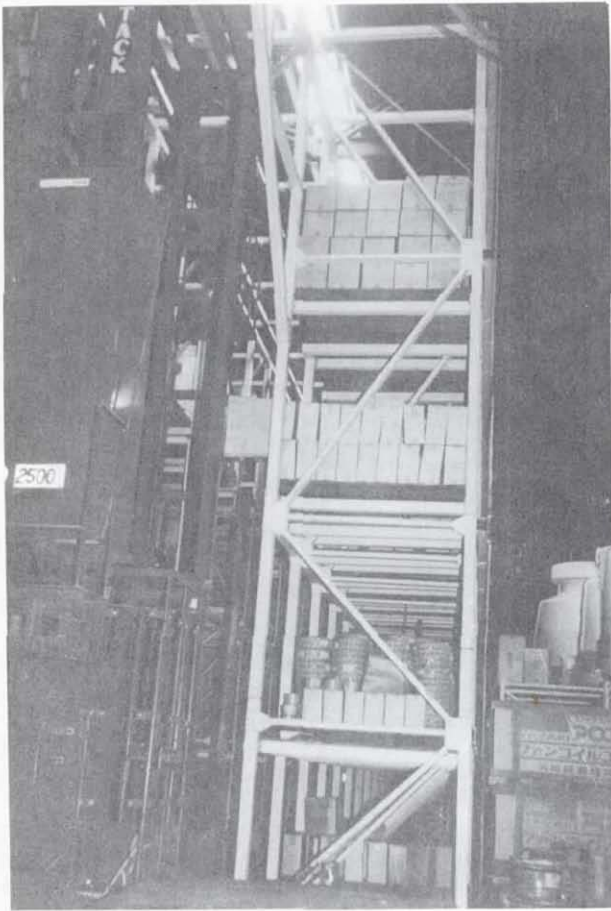
The steel frame warehouse behind the collapsed building (Figure 5.38) did not appear to be damaged. The warehouse contained numerous heavy tubular steel frame storage racks with diagonal braces, as shown in Figure 5.44. The storage racks stand approximately 7 m in height and are anchored to the concrete floor by being bolted or welded to steel plates in the floor. Although none of the racks had collapsed, the bottom diagonal braces appeared to have buckled on several racks, as shown in Figure 5.45.

Figure 5.44 Yazaki Industries warehouse building. A number of multi-level tubular steel storage racks had damaged transverse braces at ground level.

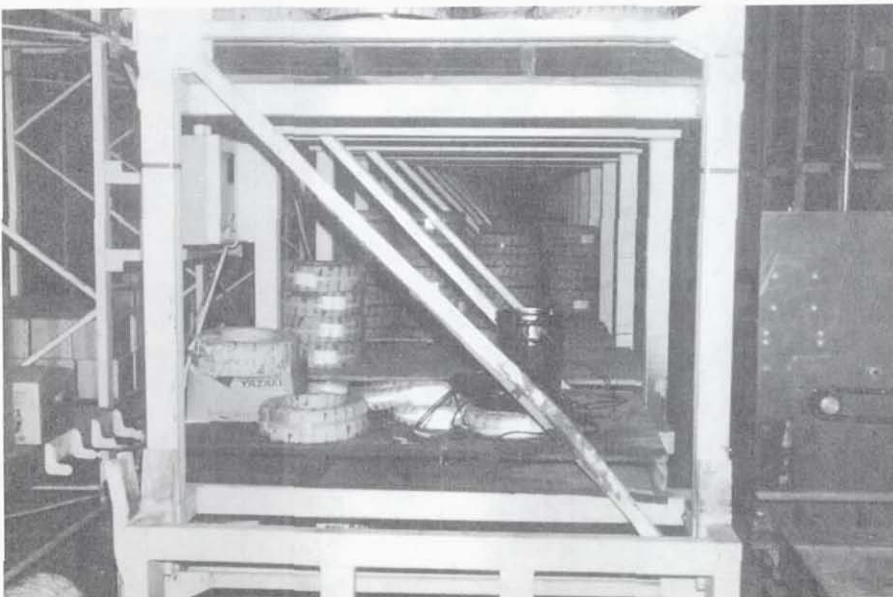
Figure 5.45 Yazaki Industries warehouse. Detail of diagonal brace at bottom of storage rack.

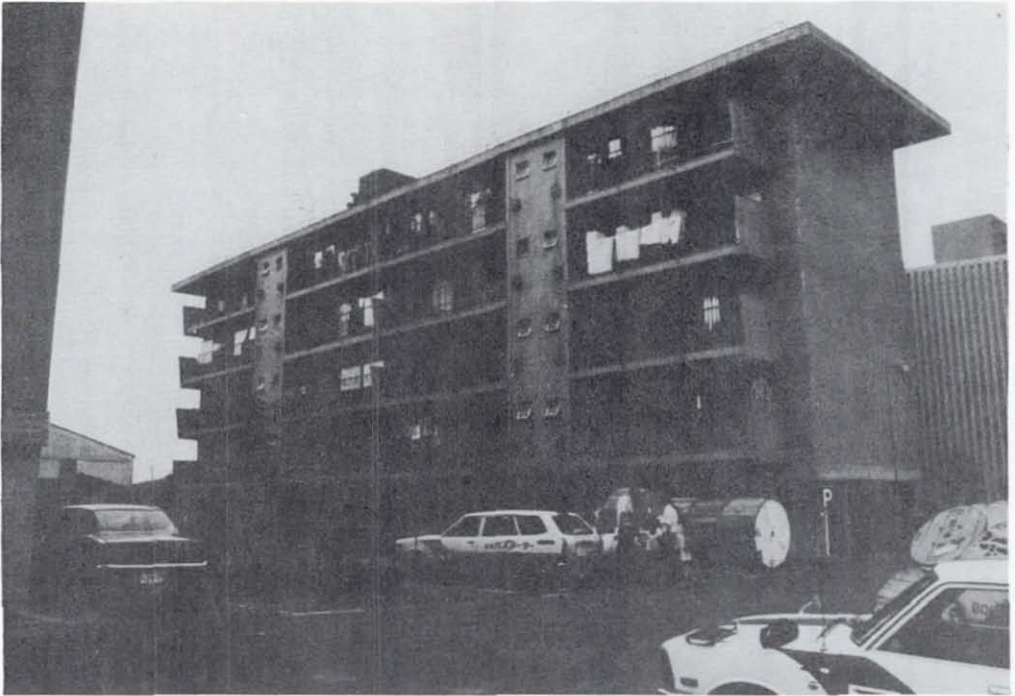
On an adjacent site to the south of the warehouse, there are two five-story reinforced concrete frame apartment buildings with shear walls oriented in the N-S direction. There was no apparent damage to either of these buildings, one of which is shown in Figure 5.46.

Figure 5.46 Apartment building adjacent to Yazaki Industries warehouse building to the south. The building was undamaged.

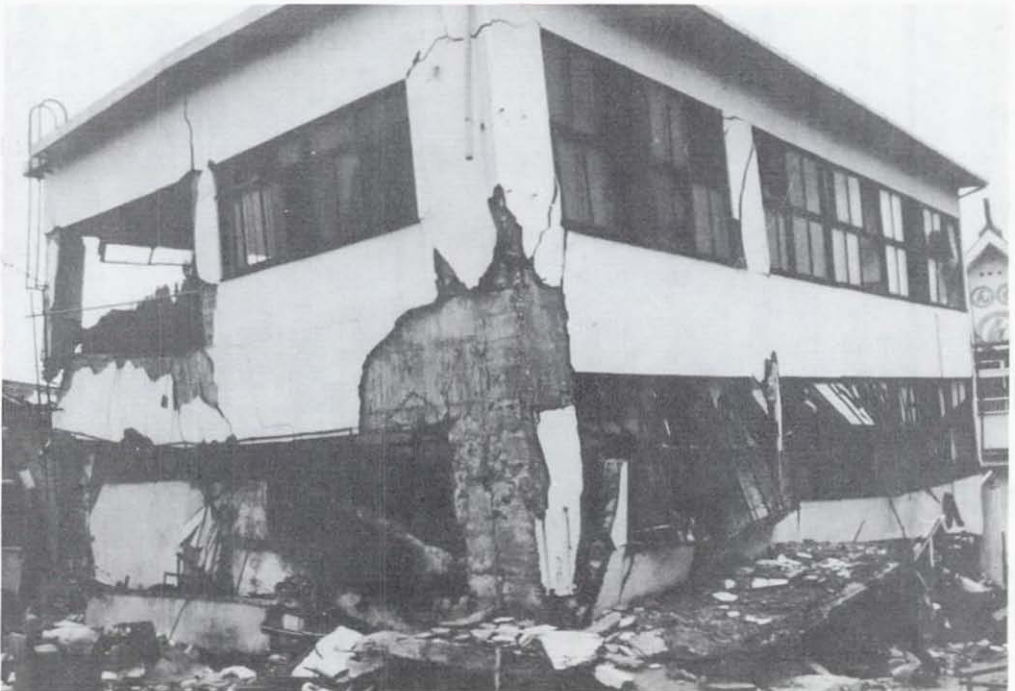
Paloma Building (No. 12, Figure 5.3). This reinforced concrete frame structure faced north and was located on Japan National Highway 45. It was a three-story rectangular building, two spans by three, with a shear wall on the west end of the building. The first floor was used for display, and had a large open area on the north and east side of the first floor. The main axis of the building ran in the E-W direction. Figures 5.4 and 5.48 show the Paloma Building viewed from the east following the earthquake. Failure occurred in the columns at this end of the building, causing the building to tilt toward the east. However, the shear wall at the west end of the building was also badly damaged (Figures 5.49 and 5.50). It is likely that the eccentricity caused by the presence of the shear wall on only one end of the building caused a torsional mode of failure for the structure.

Figure 5.47 Paloma Building - Viewed from the east. Collapse occurred at the east end of the building.

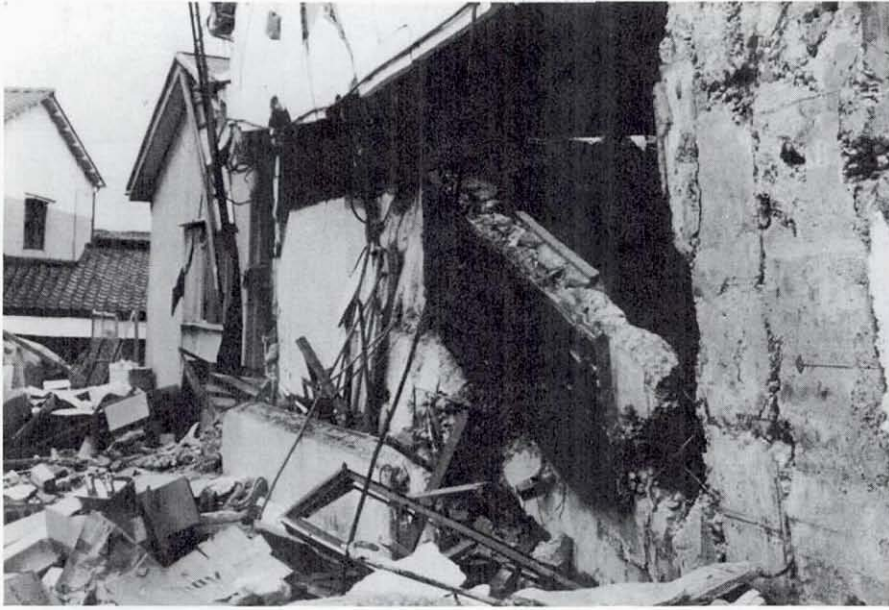
Figure 5.48 Paloma Building. - Detail of first story, east end, showing inferior quality concrete.

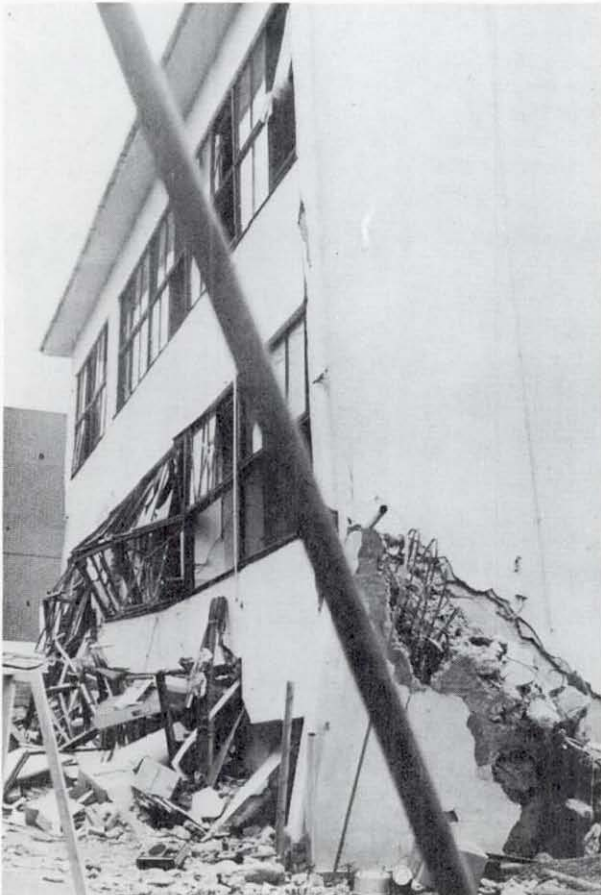
Figure 5.49 Paloma Building, west face.

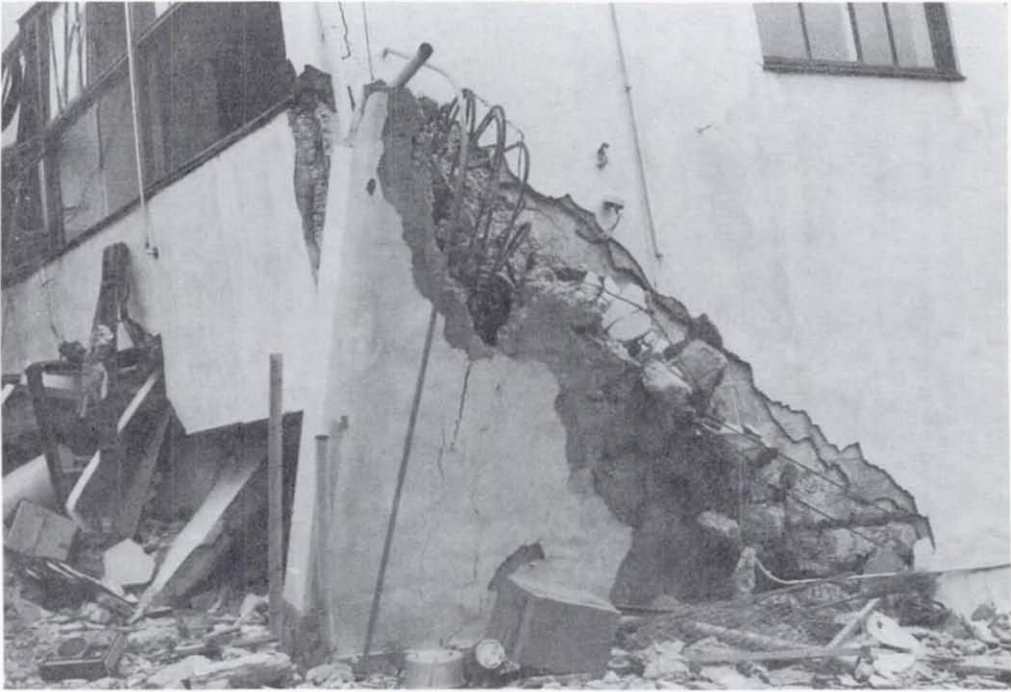
Figure 5.50 Paloma Building, detail of shear wall on west end of building.

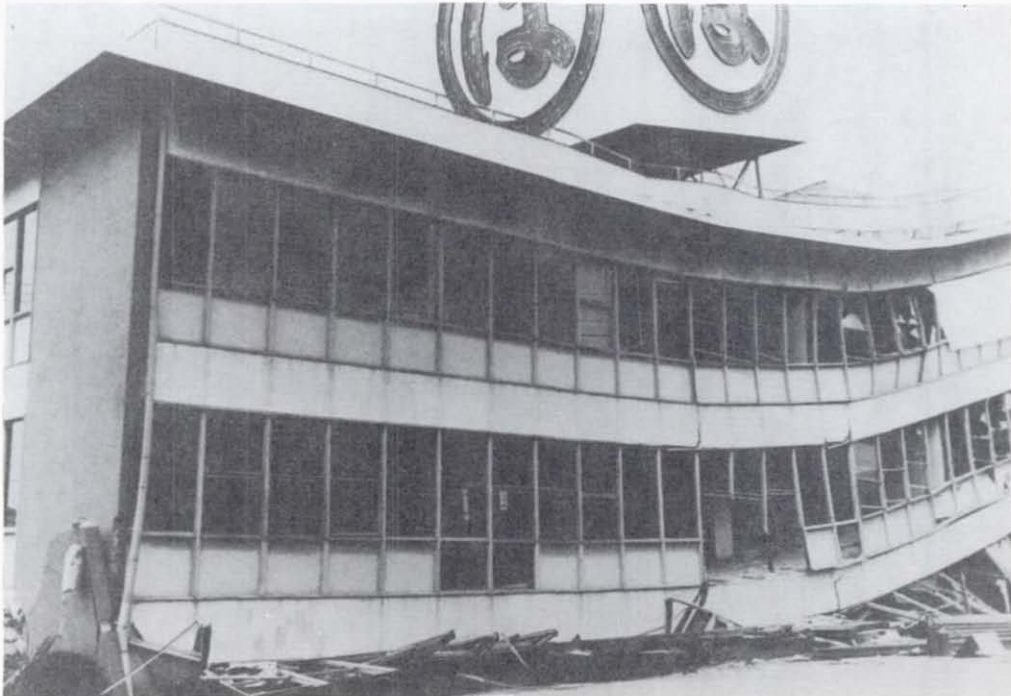
Taiyo Fisheries Plant (No. 11, Figure 5.3). This was a three-story building with a reinforced concrete frame, one span by five, the main axis of which was in the N-S direction. There were shear walls on the north and south ends of the structure. As shown in Figures 5.51 and 5.52, the first-story columns in the middle of the building failed, causing the central portion of the building to collapse but leaving the ends standing. The shear walls at the north end of the structure (running in the E-W direction) were badly cracked. At the time the site was visited, the building was being demolished.

Figure 5.51 Taiyo Fisheries Plant, viewed from the west. The first story columns in the center portion of the building failed, leaving the ends of the building standing. (Japan National Land Agency photograph)

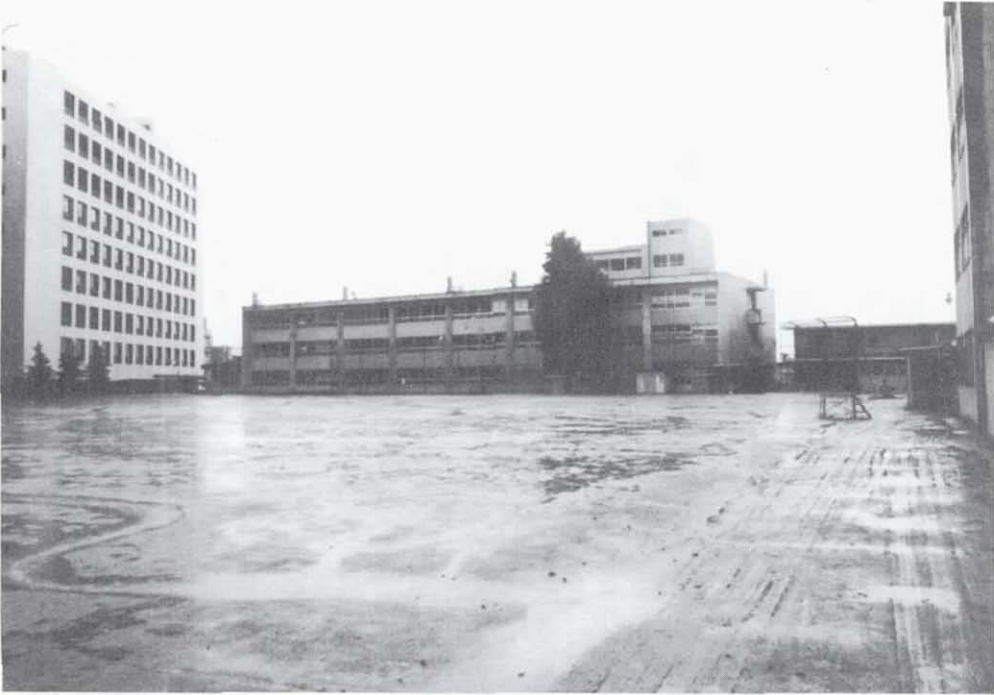
The school is located on the east side of the city where the soil conditions are relatively poor. The east side of the building sits on a small bluff approximately 6 m in height. This may have amplified the ground motion at the site. The school was badly damaged by the earthquake and has been closed.

Much of the damage at Tonan High School may be attributed to the unfavorable orientation of the shear walls with respect to the direction of strongest shaking (N-S). A building adjacent to the school but oriented perpendicular to it, which was constructed about the same time and in which the shear walls run in the N-S direction, was undamaged, aside from a few broken windows.

Figure 5.53 Tonan High School, west face. A small bluff on the opposite side of the building may have amplified ground motion. The adjacent structures were undamaged.

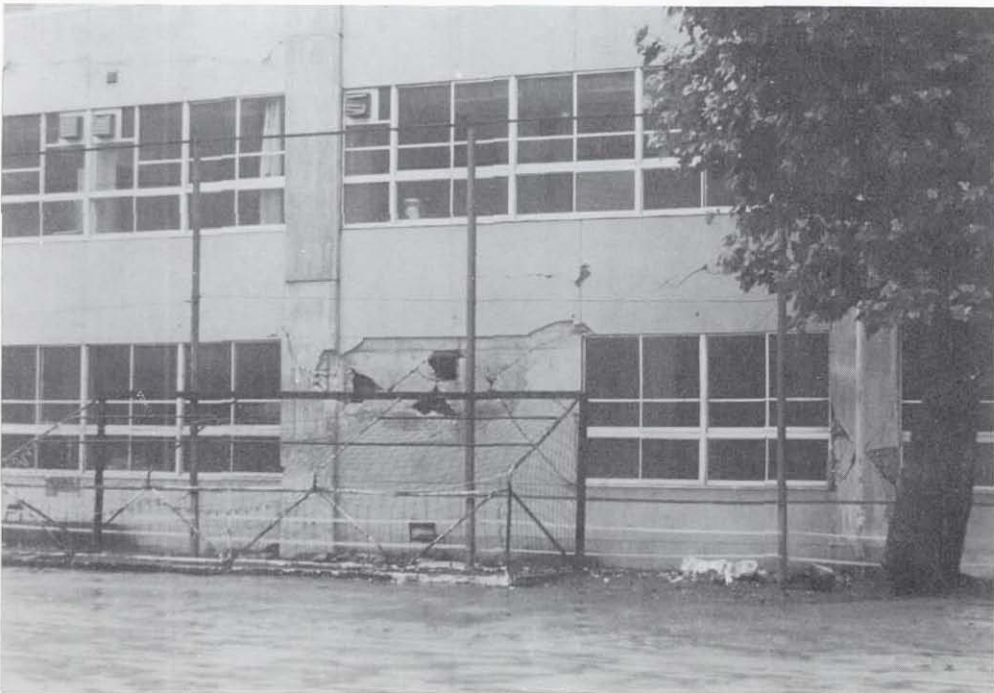
The west face elevation and the school yard are shown in Figures 5.53 and 5.54. The exterior first-story columns were all severely damaged, the shear cracks occurring just above the infill panels, (Figures 5.55 and 5.56). In many cases the width of the cracks was over 20 mm. The upper story columns showed less shear cracking. The interior columns did not appear to be damaged. They lacked the stiffening provided by the infill panels. A corridor ran along the length of the building in the middle, and the shear walls were not continuous across the width of the building. Undeformed reinforcing bars were used in the columns. The ties in the exterior columns were spaced at roughly one-half the maximum dimension of the column.

Figure 5.54 Tonan High School - Detail of damage to west face.

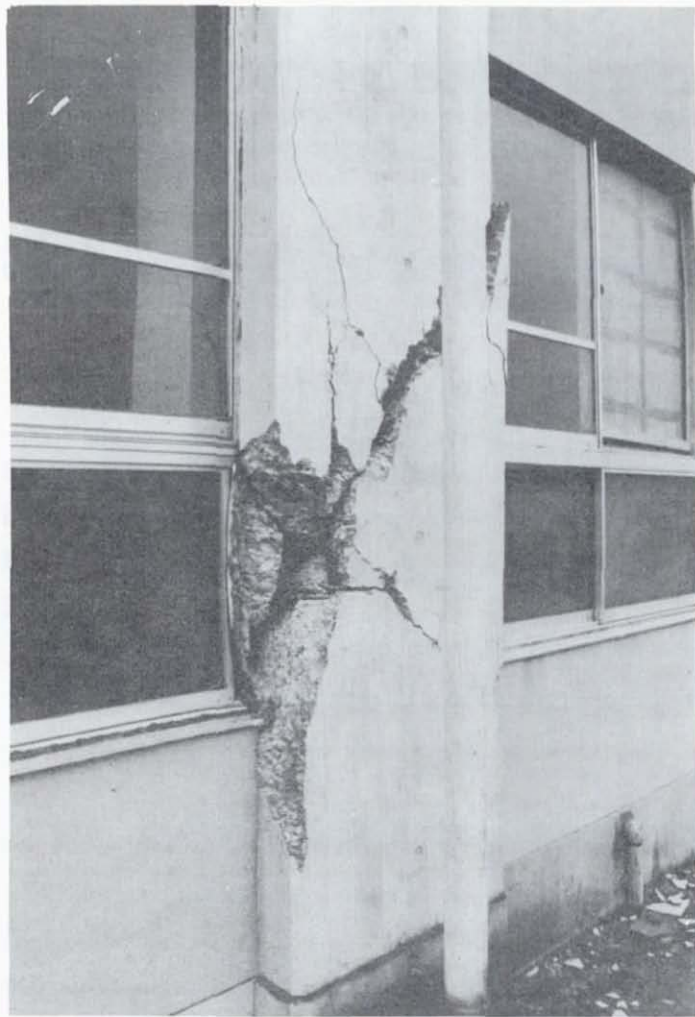
Figure 5.55 Tonan High School. Detail of shear cracking in exterior column above partial infill panels on east face

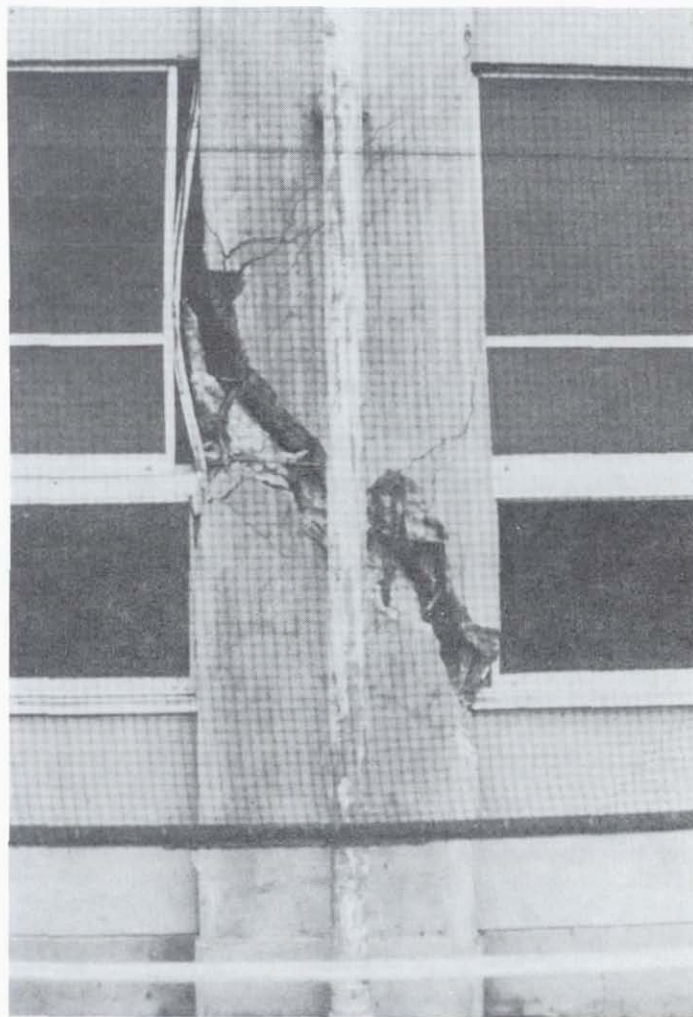
Figure 5.56 Tonan High School. Detail of column damage, exposing reinforcement.

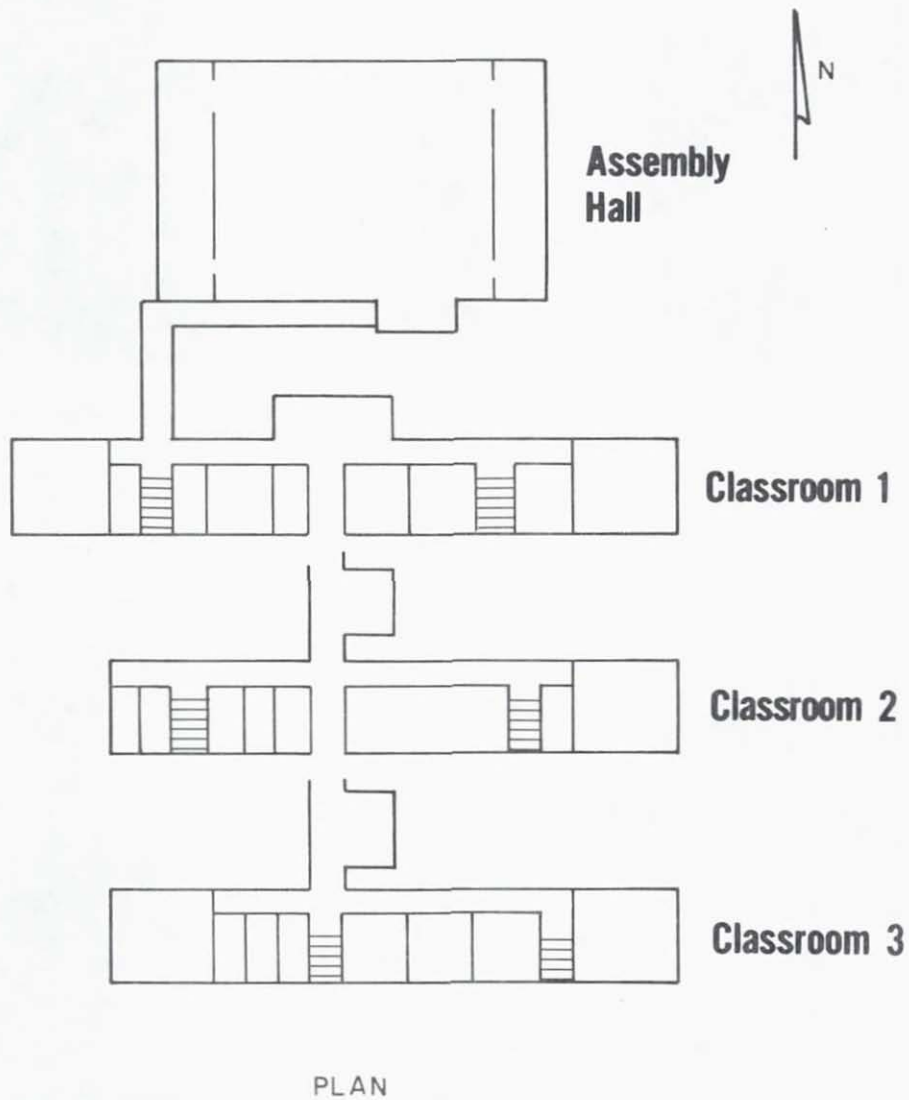
The building plan in Figure 5.57 shows three interconnected classroom buildings, and a steel frame assembly hall (auditorium or gymnasium). The steel frame building appeared to be only lightly damaged from the outside. The classroom buildings are three-story reinforced concrete frame structures with transverse shear walls (not shown, but coinciding with the end classroom walls and stairwells). Classroom corridors extend along the north side of each building.

Note from Figure 5.57 that the interior shear walls do not run the width of the building, as they are interrupted by the corridor on the north side of the building. The cracking was less severe on the open side of the building, where the shear walls connect to the columns.

Figure 5.57 Izumi High School, Izumi City. Plan view of steel frame assembly hall and three reinforced concrete classroom buildings.
