NBS SPECIAL PUBLICATION **592**

U.S. DEPARTMENT OF COMMERCE / National Bureau of Standards

An Investigation of the Miyagi-ken-oki, Japan, Earthquake of June 12, 1978

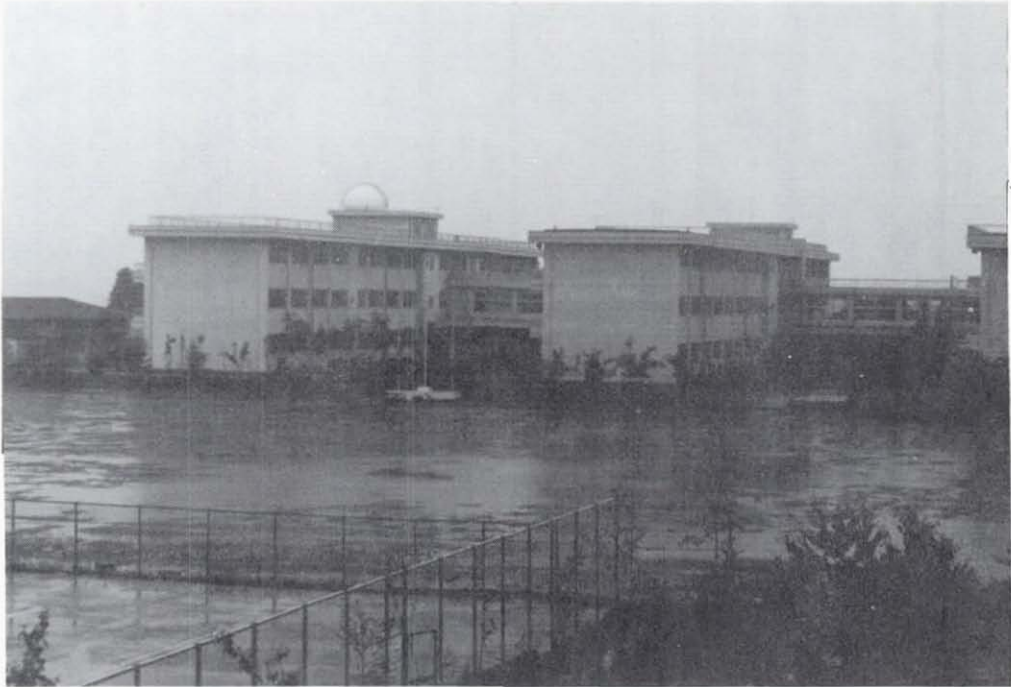
Figure 5.58 shows the east elevation of the three classroom buildings, and Figure 5.59 shows the front entrance on the north side of building 1. The badly cracked panel above the entrance is not connected to the ground floor. The interior corridor walls in the building had extensive diagonal cracks, as shown in Figure 5.60. Figure 5.61 shows the northeast corner of building 2 along the foundation. The diagonal crack at the corner of the exterior wall indicates that either uplifting or settlement of the foundation took place. Figures 5.62 and 5.63 show typical damage on the north and south sides of one of the classroom buildings. Damage was relatively greater on the north side of the building where the columns were stiffened by the infill panels. Although there were numerous diagonal cracks emanating from window openings on the north side, the main columns did not appear to be badly cracked.

Figure 5.58 Izumi High School. Three adjacent reinforced concrete frame buildings with shearwalls suffered minor damage.

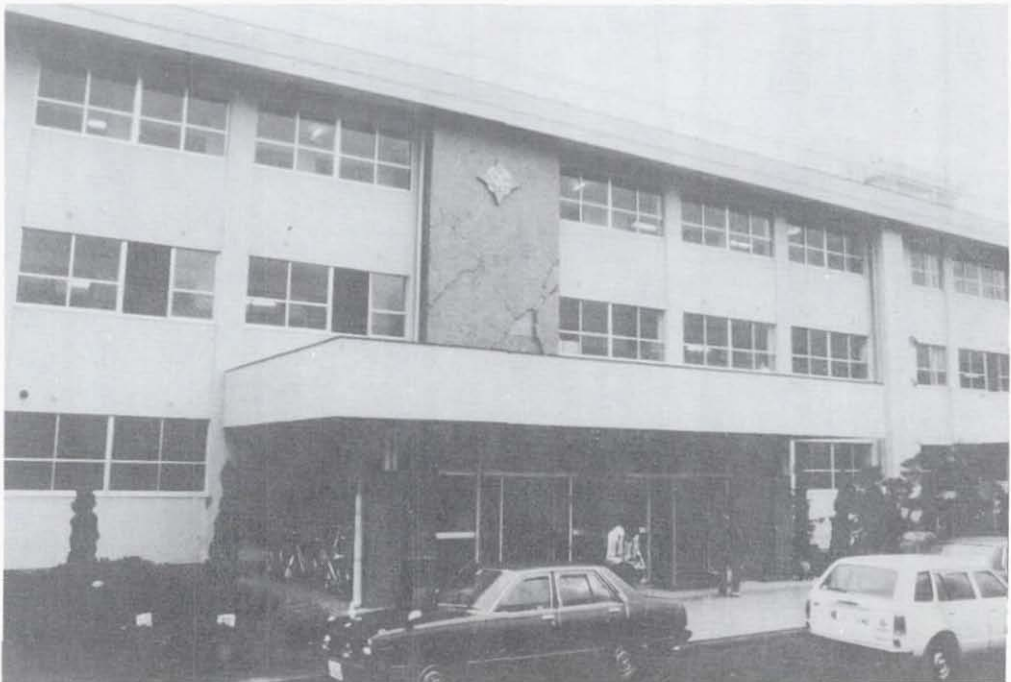
Figure 5.59 Izumi High School. Detail of panel over north entrance to building 1.

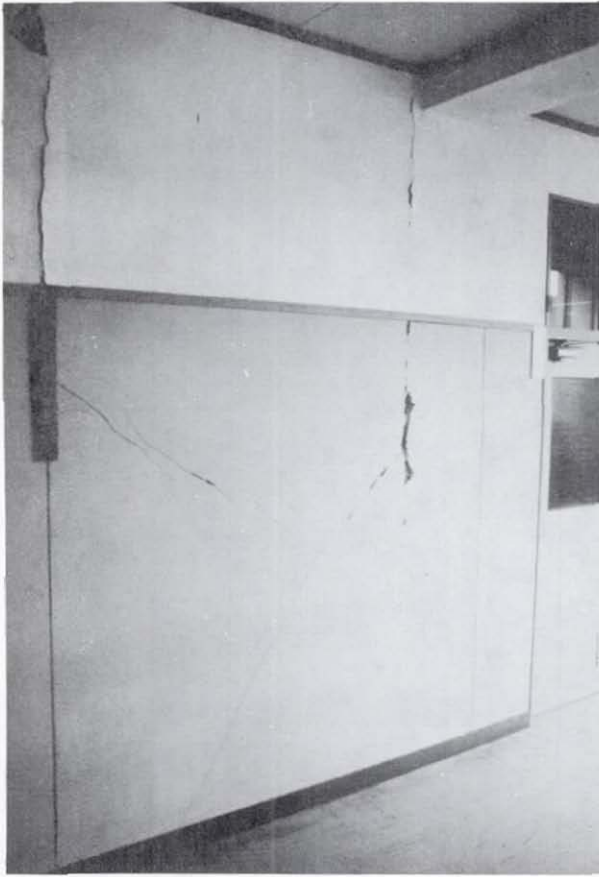
Figure 5.60 Izumi High School. An interior corridor wall in classroom building 1 aligned in the longitudinal direction of the building.

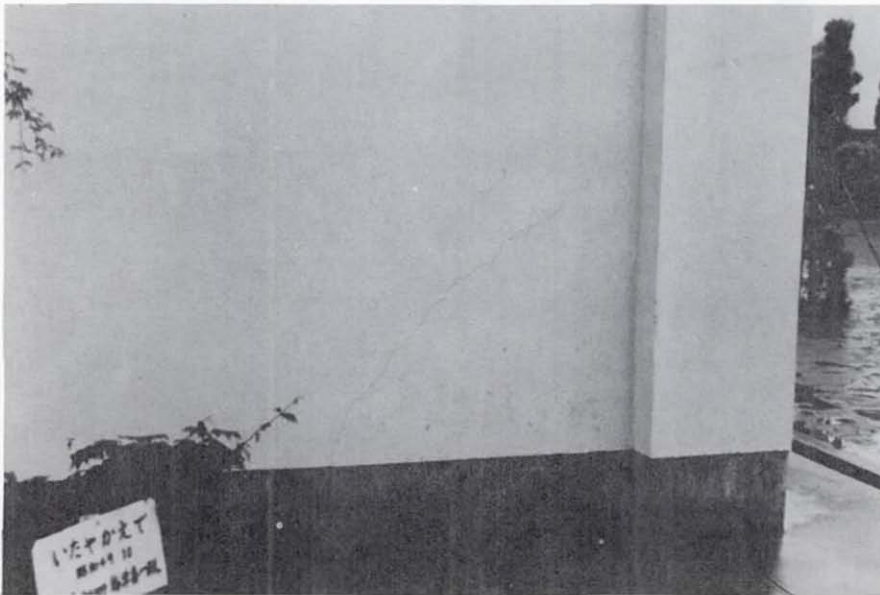
Figure 6.61 Izumi High School. The diagonal crack in the exterior wall shows that foundation settlement or uplift took place at the corner.

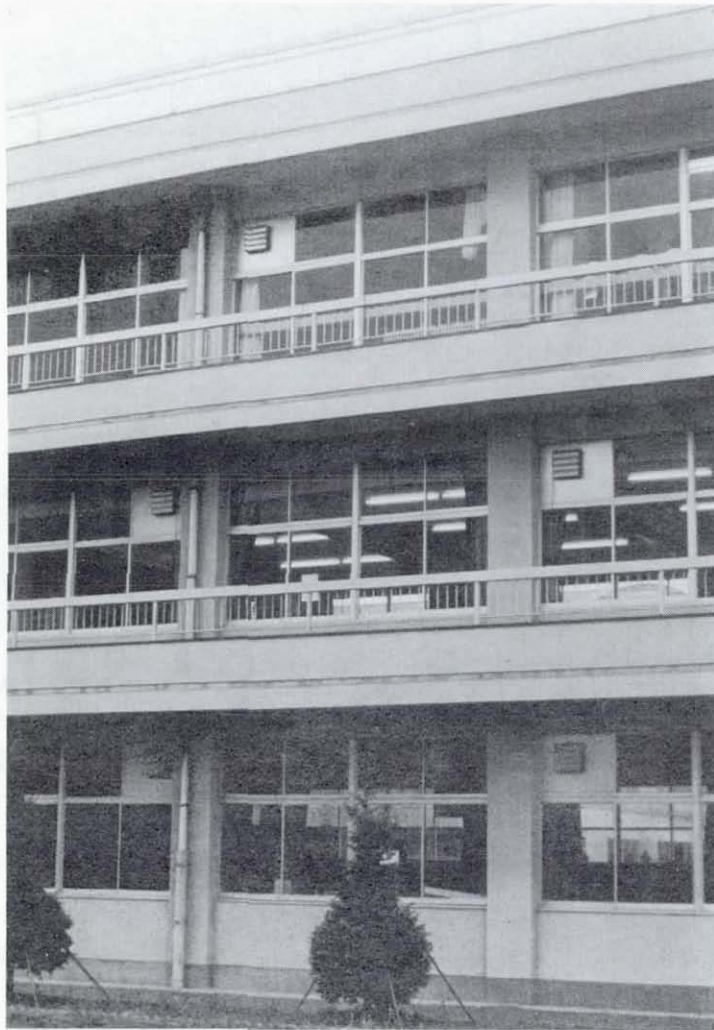
Figure 5.62 Izumi High School, typical classroom building, south face. This side of the building, which is relatively open, suffered little damage.

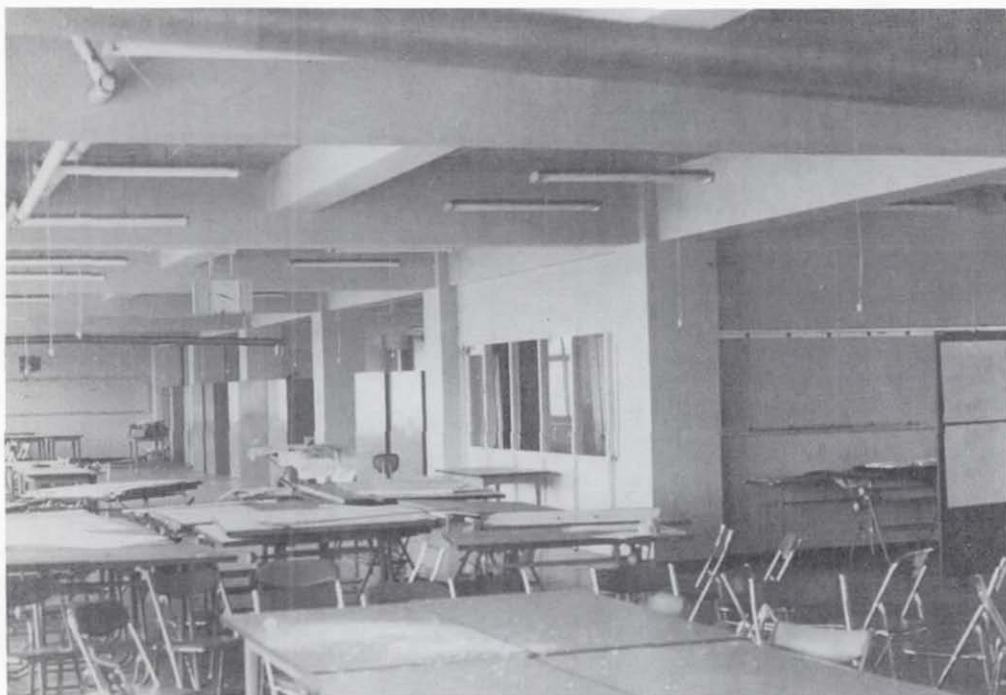
Figure 5.69 Tohoku Institute of Technology, Building 5. Seventh story interior, looking towards the lightly damaged southern exterior frame.

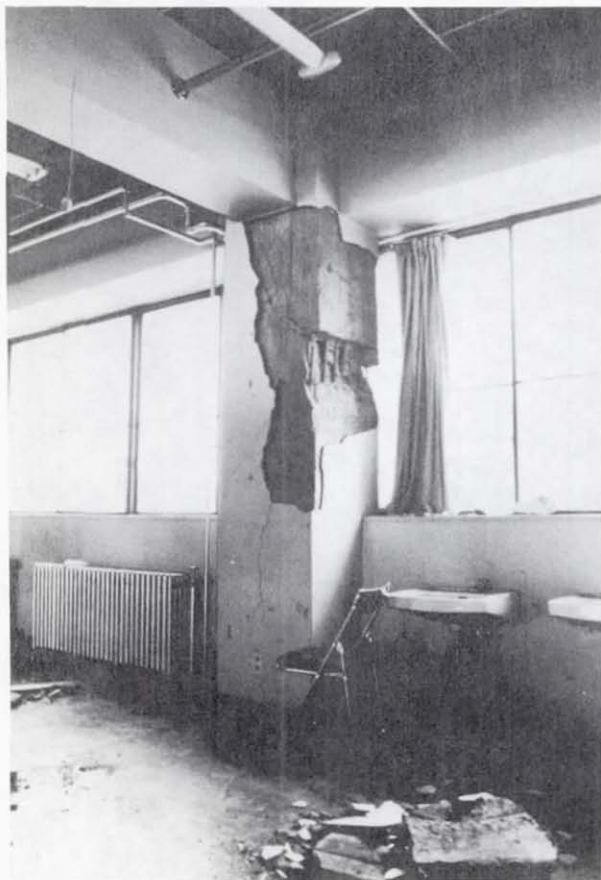
Figure 5.70 Tohoku Institute of Technology, Building 5. Damage to column on north side of third story. The tie spacing is 25 cm.

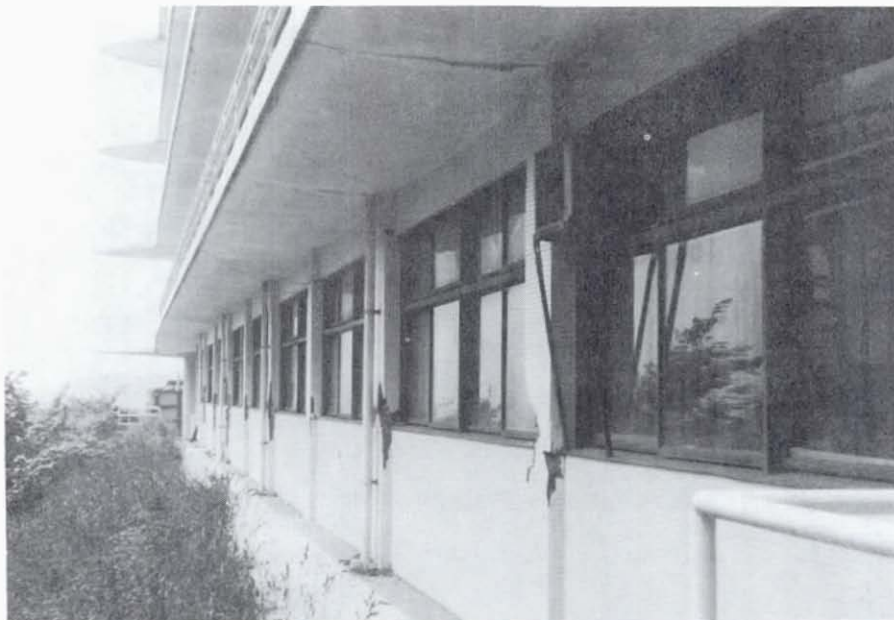
The northeast facade of building 3 is shown in Figure 5.74. This is a four-story reinforced concrete frame building, ten spans by two. While the relatively flexible interior columns were undamaged, all of the exterior columns on the first-story cracked in shear just above the infill panels, as shown in Figure 5.75. Figure 5.76 illustrates this more clearly at one of the first-story columns on the northeast side of building 3. As can be seen, the reinforcement is undeformed. We were informed that core samples taken out of the spandrels showed no apparent damage to the concrete.

Figure 5.75 Tohoku Institute of Technology, Building 3. Damage to the ground floor columns on the south side of the building. Similar damage is present on the opposite side of the building.

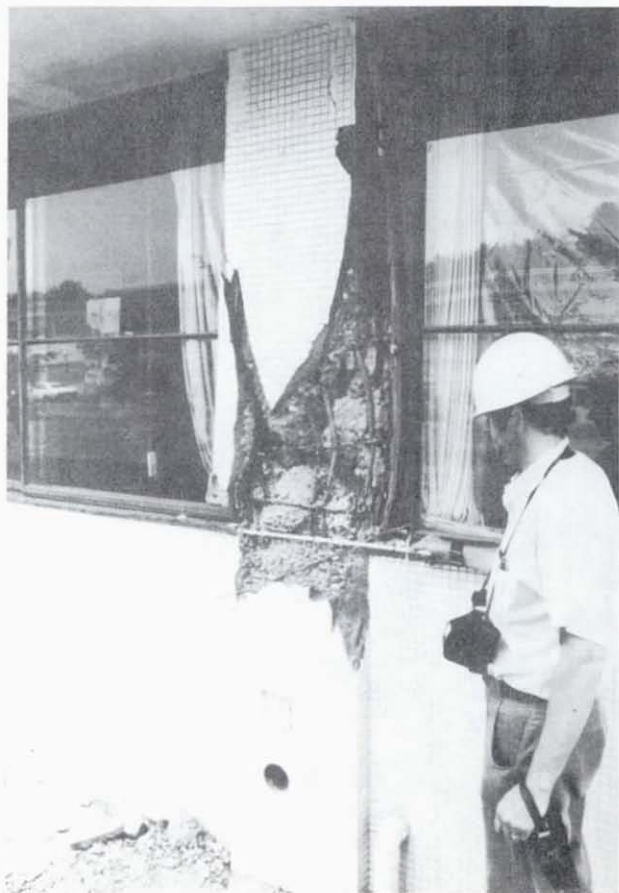
Figure 5.76 Tohoku Institute of Technology, Building 3. Typical damage to ground story exterior column on north side of building.

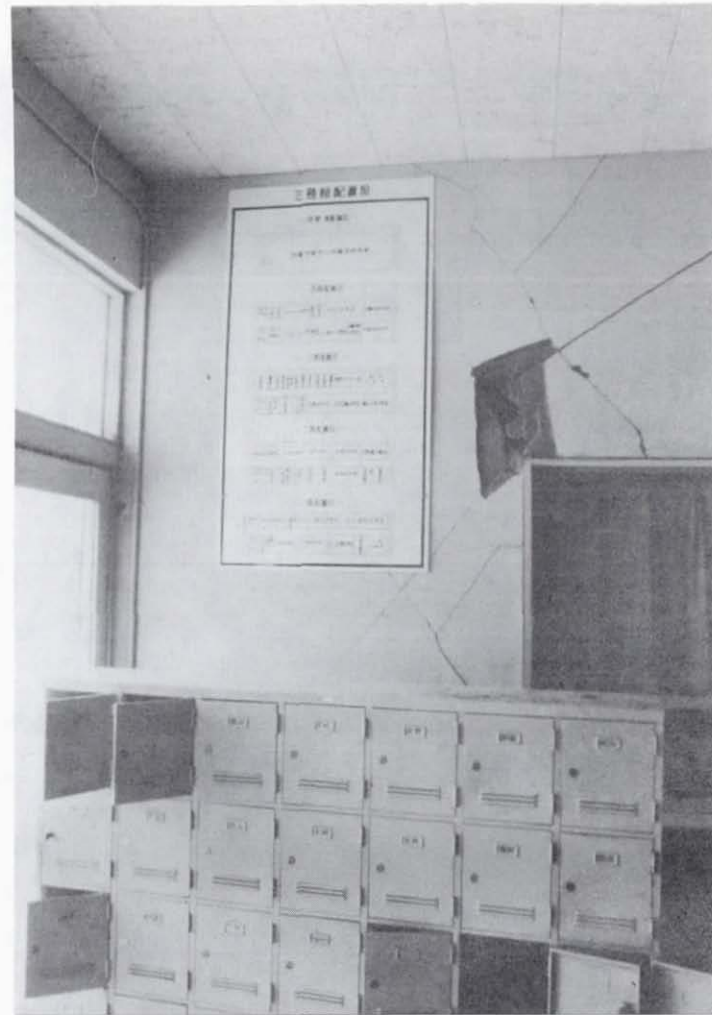
Figure 5.78 Tohoku Institute of Technology, Building 3. Interior surface of shear wall at east end of building.

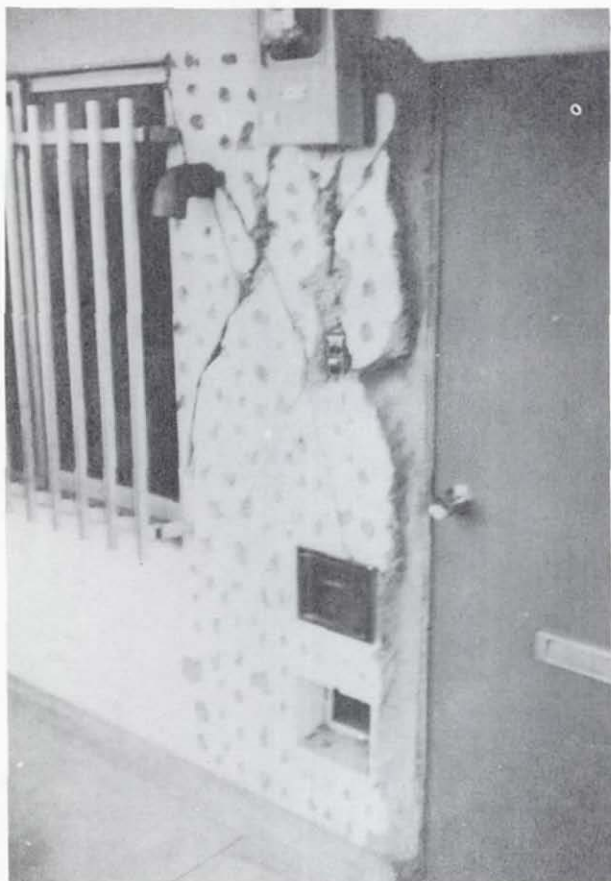
Figure 5.82 Sunny Heights Apartment Building. Detail of cracking of panels adjacent to doorways. Such cracking was typical at all levels on the east facade of the structure.

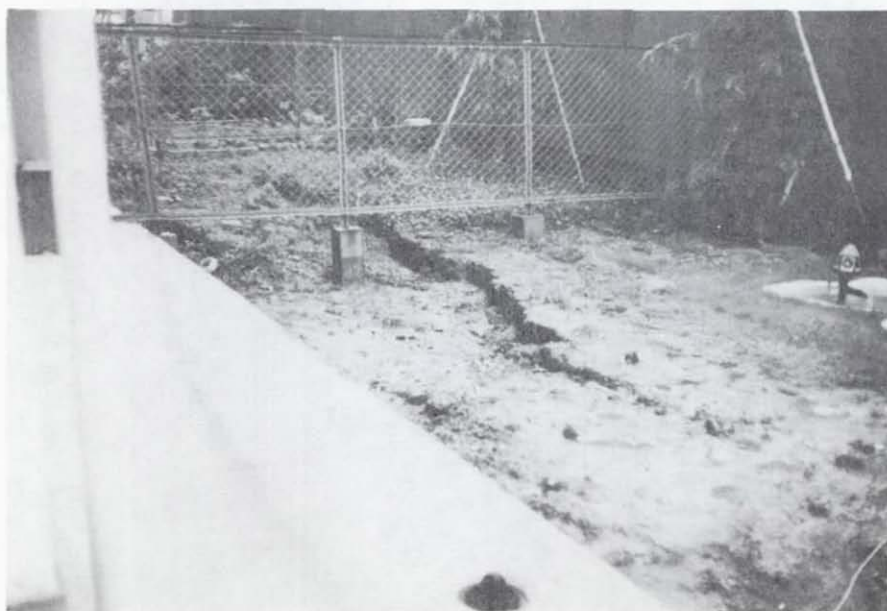
There was extensive evidence of ground cracking and settlement adjacent to the foundation and the walkway surrounding the building, as can be seen in Figure 5.83, where the support post below the bottom rail of the fence is exposed. The ground adjacent to the foundation subsided several inches in some cases. Portions of the parking area around the building appeared to have settled about 18 in (460 mm). There was a large water shortage tank located on top of the roof. It was shaken loose from its anchorage when the anchor bolts failed and the horizontal movement also caused the supply pipe to be damaged.

Figure 5.83 Sunny Heights Apartment Building. Ground cracking and settlement adjacent to walkway surrounding the building.

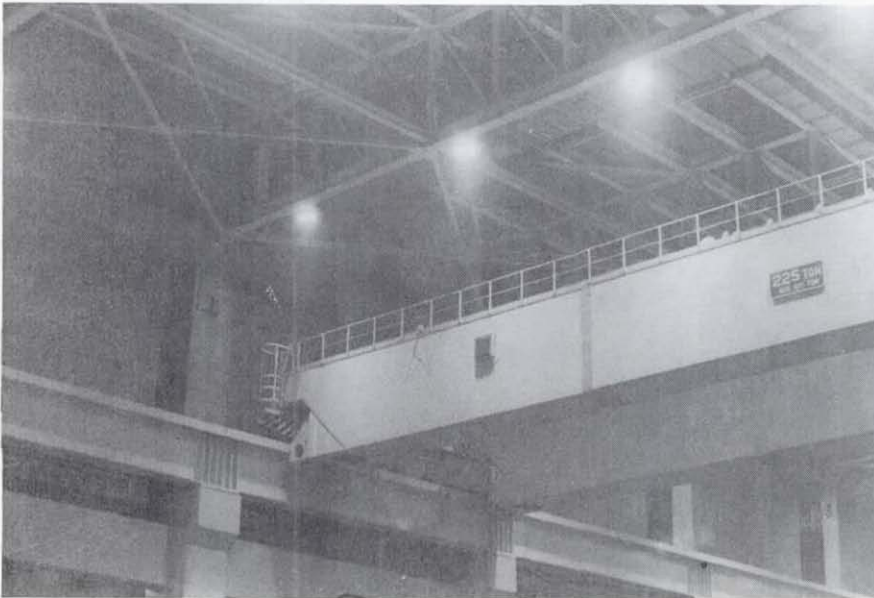
Figure 6.7 Fukushima Nuclear Power Plant: a partial view of the Unit 6 control rod drive and its supports. The unit is still under construction and was more than 95% completed at the time of the reconnaissance. There was no apparent damage or any evidence of working connections at this system or at the other systems of Unit 6 that were examined.

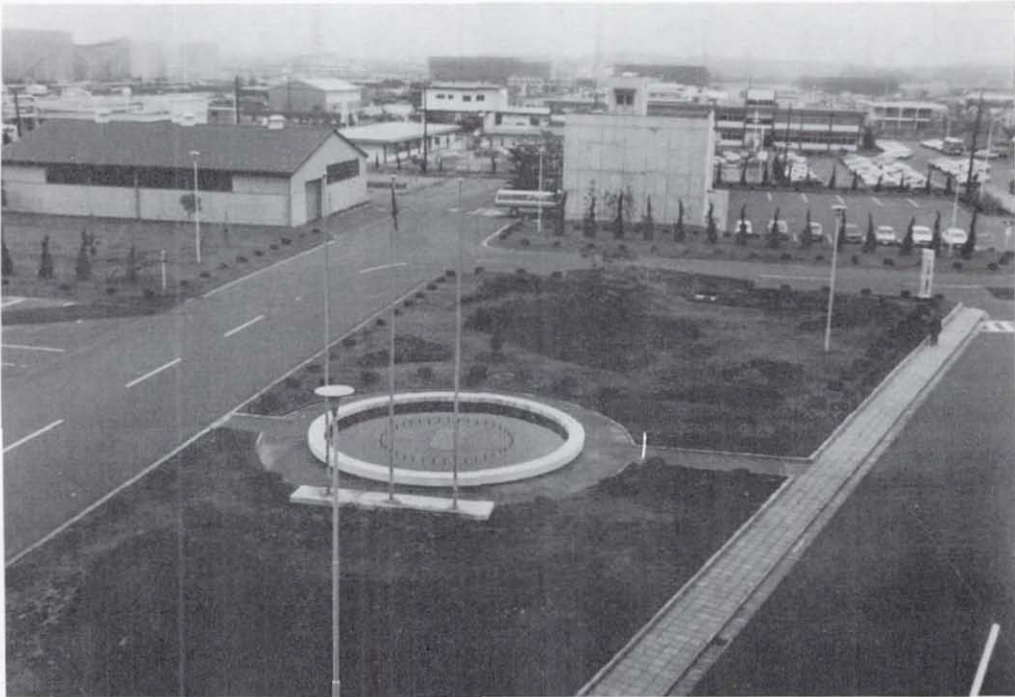
Minor settlement occurred throughout the site. Much of this settlement occurred in the vicinity of buried piping (Figure 6.14). About 1 cm of settlement occurred at the intake structure and the paving around the structures was cracked; however the structure was operational and did not seem to require repairs (Figure 6.15).

Figure 6.14 New Sendai Power Plant; Tohoku Electric Power Company: A view of the entrance area to the power plant showing settlement of fill and subsequent repair work to the pavement. The pavement settled approximately 15 cm (6 in) and was primarily in the vicinity of a backfilled underground pipeline.

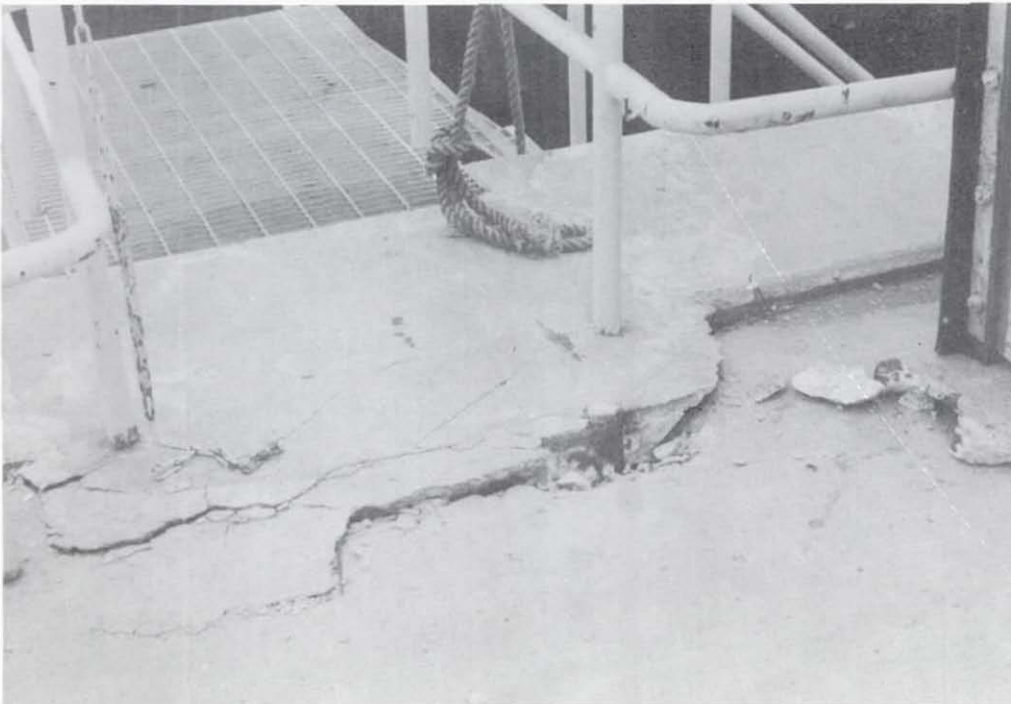
Figure 6.15 New Sendai Power Plant, Tohoku Electric Power Company: damage around the water intake structure from minor settlement. Other examples of minor settlement were observed throughout the site.

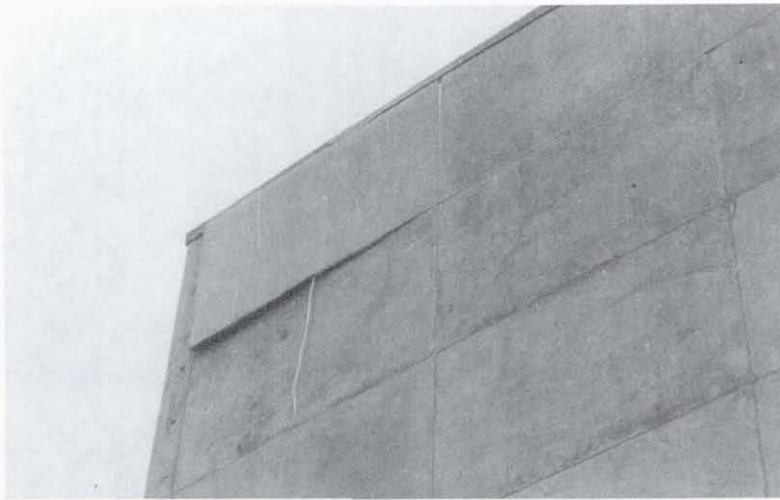
Figure 6.16 New Sendai Power Plant, Tohoku Electric Power Company: a loosened exterior facing panel in the turbine building. This was the only obvious damage to the exterior of the structure. The shear walls of the adjacent administration building showed extensive cracking.

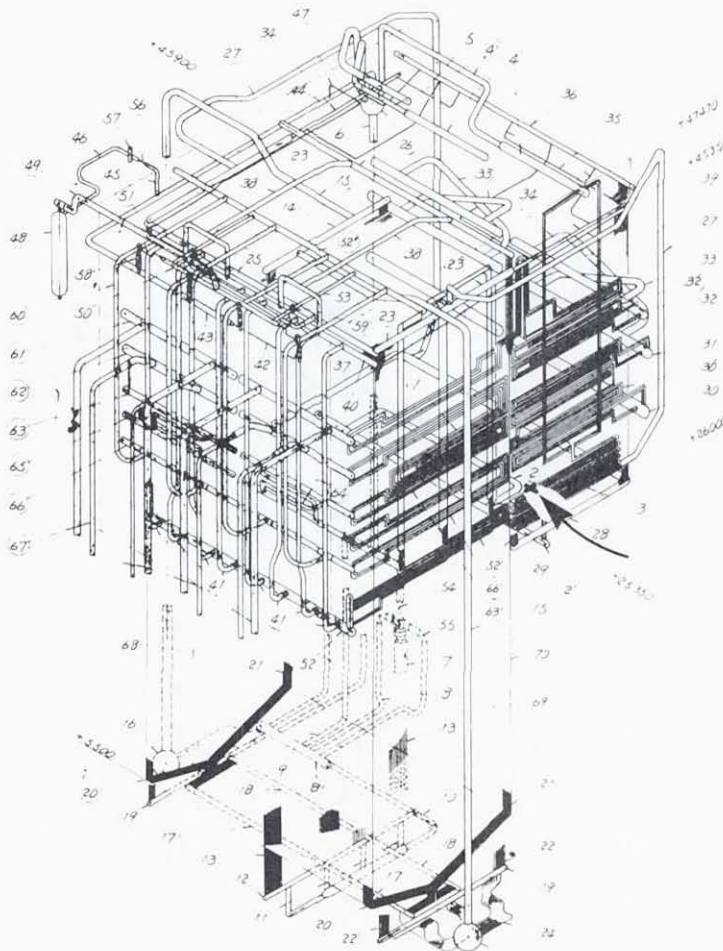
Figure 6.17 New Sendai Power Plant, Tohoku Electric Power Company. The arrow points to the location of the damaged horizontal spacer tubes in the 600-MW boiler of Unit No. 2. (See Figure 6.18).

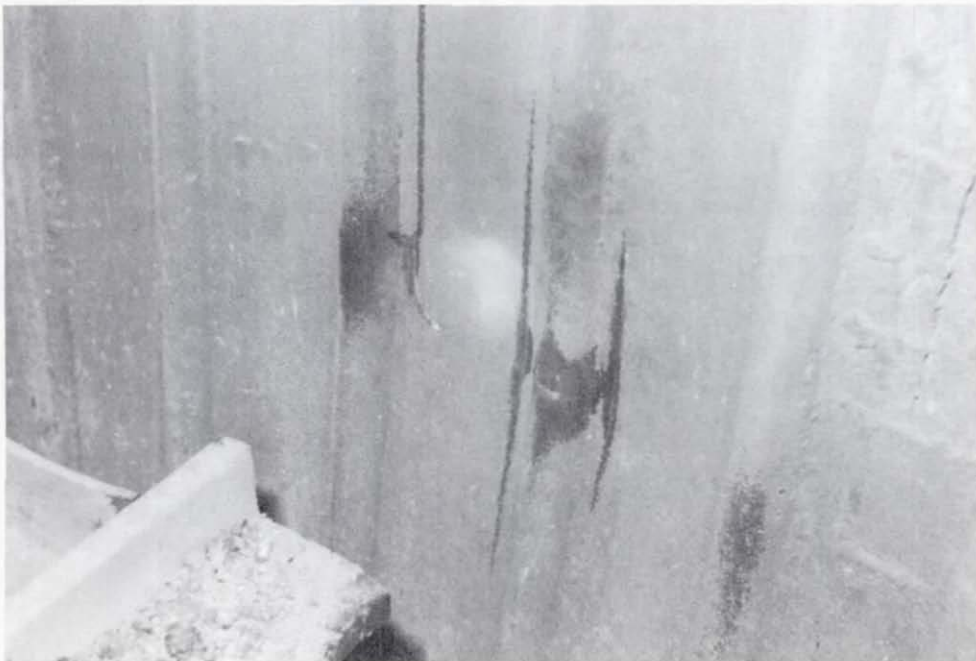
Figure 6.19 New Sendai Power Plant, Tohoku Electric Power Company: a view of the exterior of the boiler walls showing evidence that the suspended boiler had pounded against the surrounding support structure. (Tohoku Electric Power Company photograph)

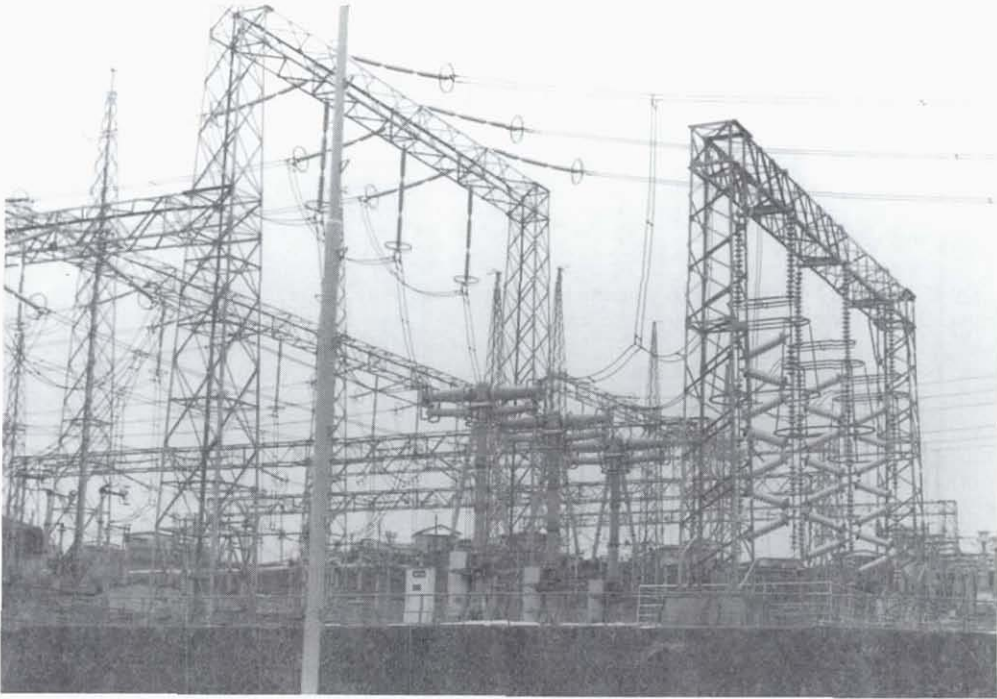
Figure 6.22 Sendai Substation, Izumi: three replaced 3-phase circuit breakers. This type of T-shaped circuit breaker suffered a high percentage of damage. Often the three symmetrical guides broke before the main stem. In all cases the structural steel supports appeared to be undamaged.

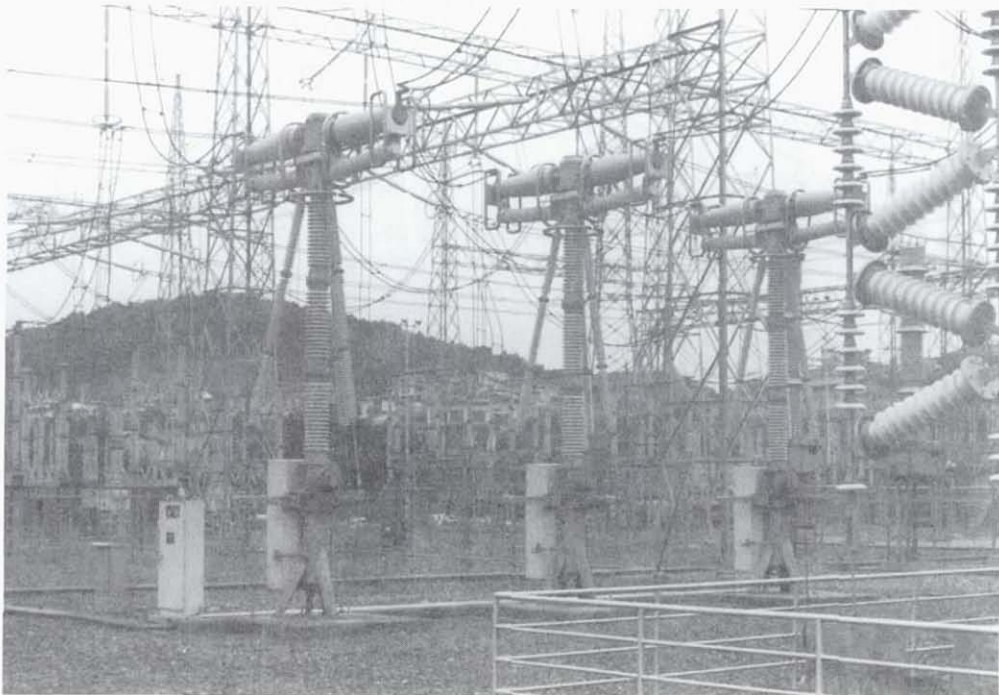
Figure 6.23 Sendai Substation, Izumi: typical damage to 3-phase T-shaped circuit breakers (as shown in previous figure). Note the complete failure of one and the damage to the three guides of the second circuit breaker. All steel supports appear to be undamaged. The photograph was taken immediately after the earthquake before repairs were initiated. (Tohoku Electric Power Co. photograph)

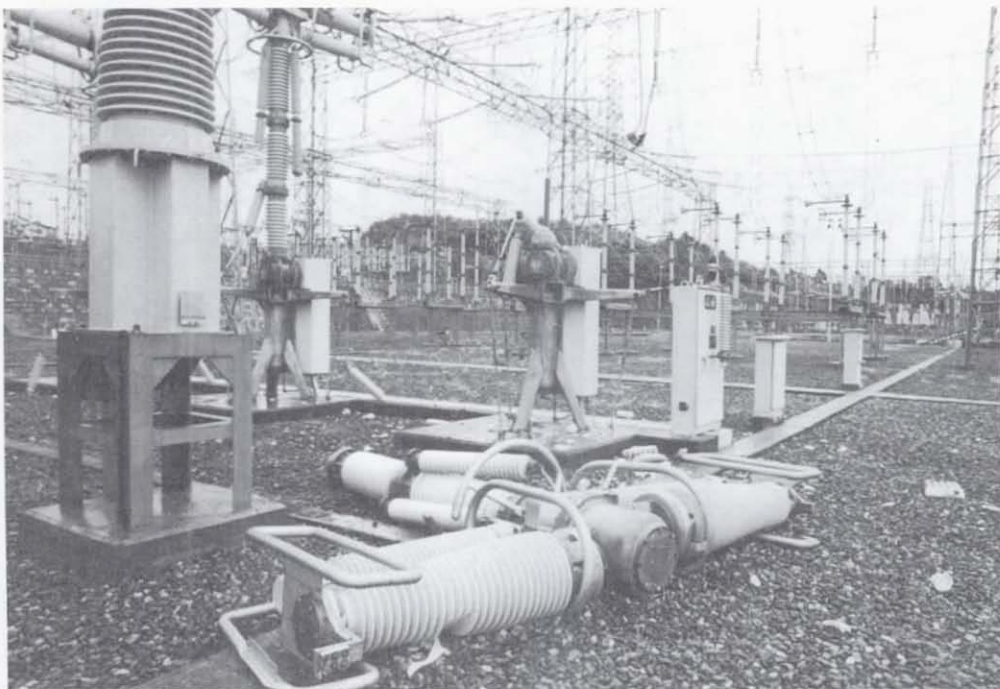
Figure 6.24 Sendai Substation, Izumi: another three failed 3-phase, T-shaped circuit breakers. Note the failed main stems, the loose guide wires and the undamaged steel supports which are attached to their foundations. (Tohoku Electric Power Co. photograph)

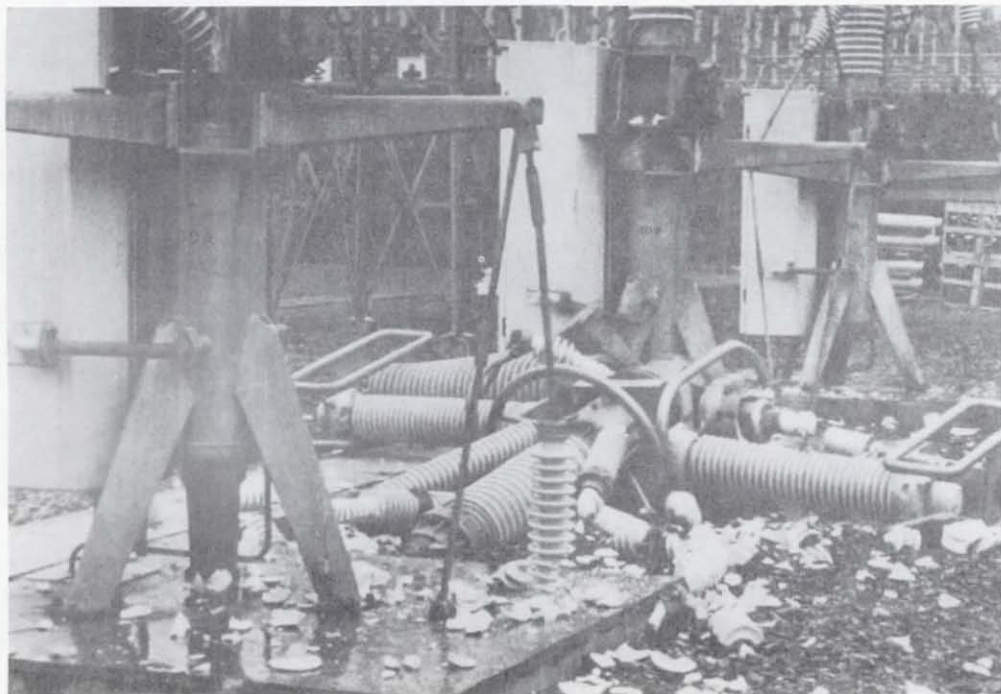
Figure 6.25 Sendai Substation, Izumi: damage to a circuit breaker (right), and two lightning arresters (center). The bushings of the transformer in the background appear to be undamaged; however, the lightning arrester is leaning. (Tohoku Electric Power Co. photograph)

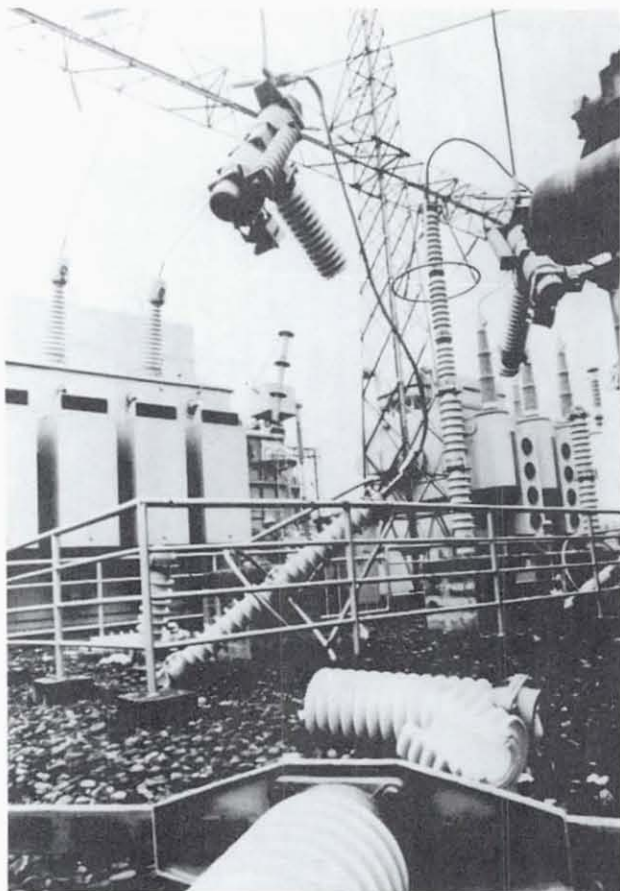
Figure 6.26 Sendai Substation, Izumi: Severe damage to circuit breakers (center of photograph - note the failed columns of live tank design, probably with gas reservoirs), current transformers (with the tapered bushings - some of the stems are also damaged), and reactors (to the left) with presumably broken connections. (Tohoku Electric Power Co. photograph)

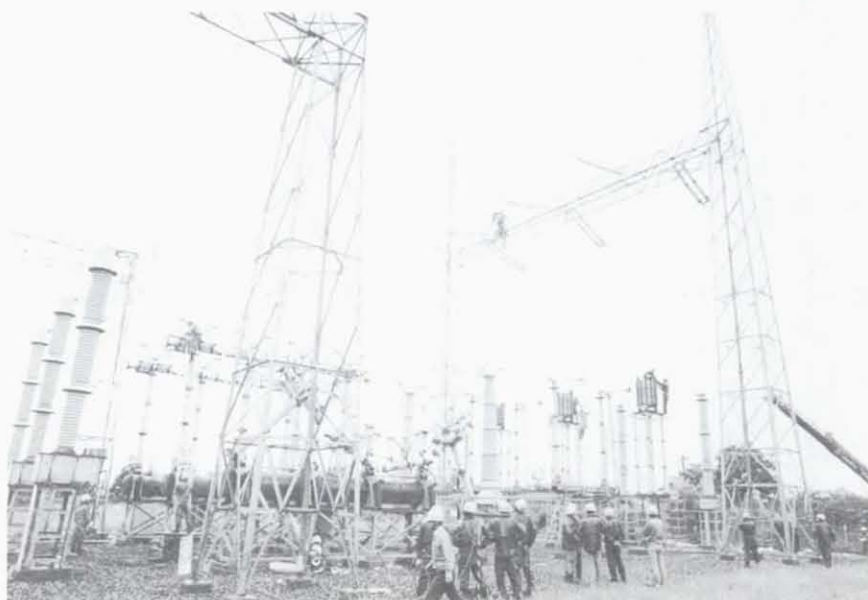
Figure 6.27 Sendai Substation, Izumi. Severe damage to several circuit breakers of live tank design. Note the lack of damage to the structural steel supports and the steel components of the equipment. (Tohoku Electric Power Co. photograph)

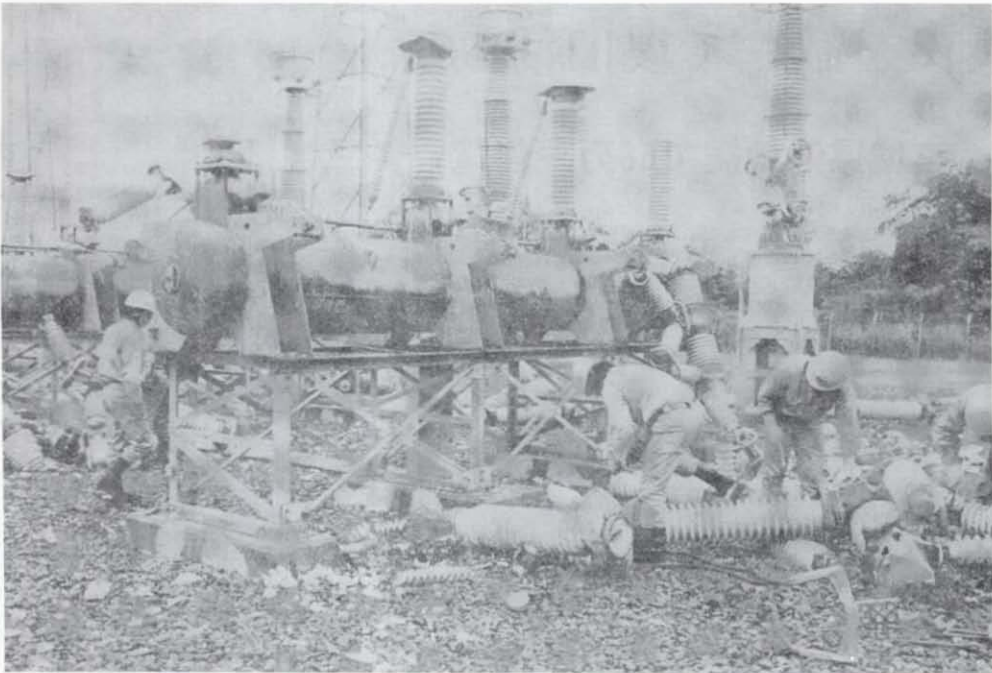
Figure 6.28 Sendai Substation, Izumi; one of several piles of broken equipment, including several line traps or reactors in the back (note the damaged base of the left stem) and the horizontal tanks of several circuit breakers of the live tank type (in the foreground are the failed columns of the circuit breakers and of other equipment).

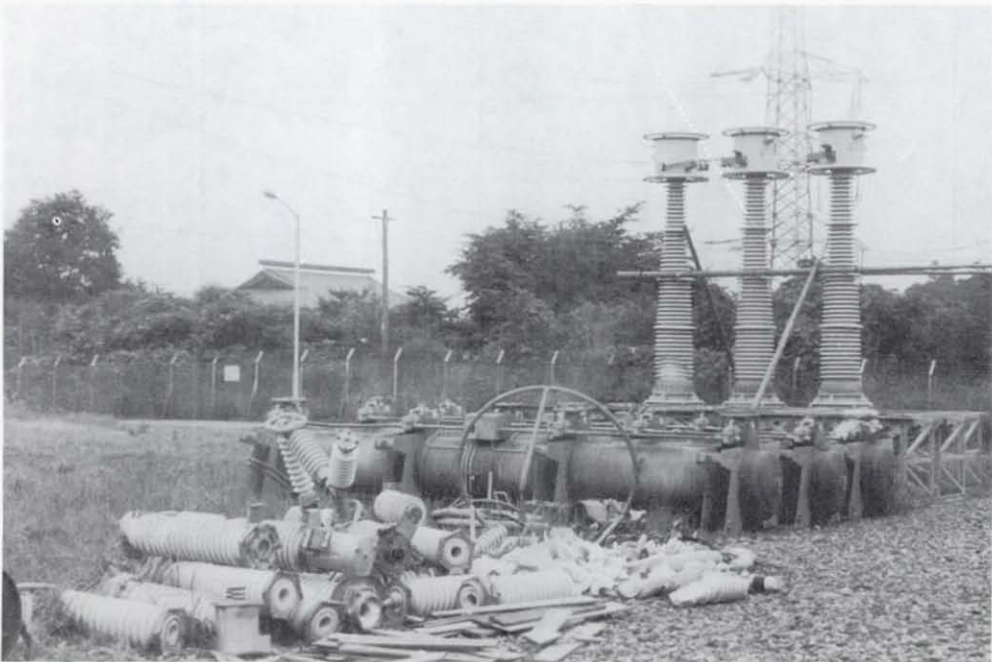
Figure 6.29 Sendai Substation, Izumi; a repaired but still disconnected transformer. All of the transformers at the substation lost some bushings or lightning arrestors. Some damaged parts were being replaced at the time of the investigation.

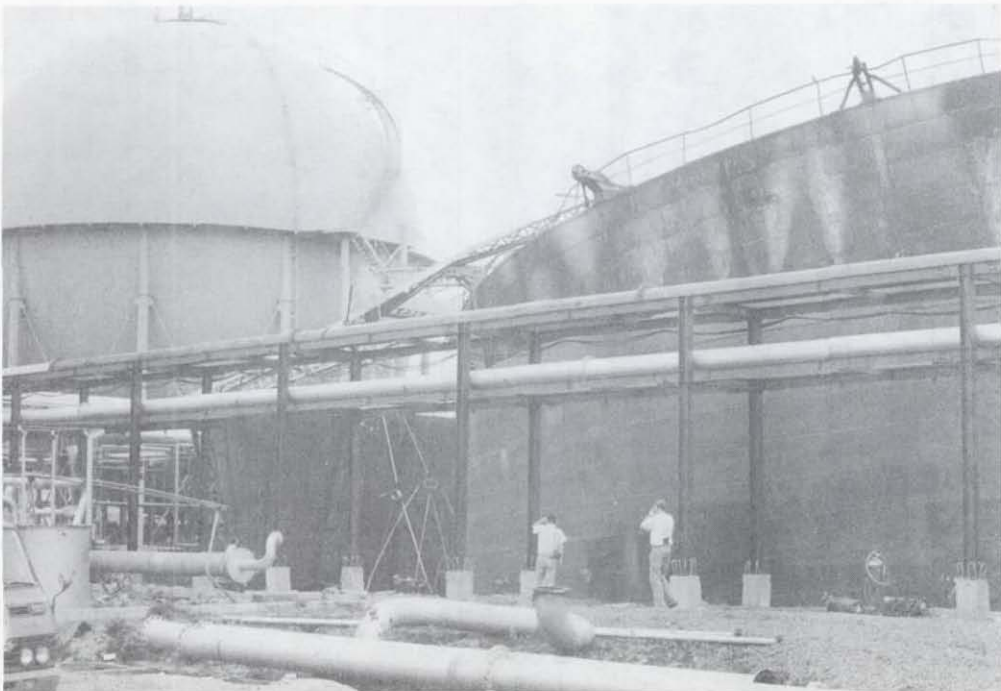
Figure 6.33 Haranomachi Plant, Sendai City Gas Bureau: damage to piping and other equipment and supports caused by impact from the collapsed gas holder and the adjacent pipeway. The newly erected pipeway is to the right.

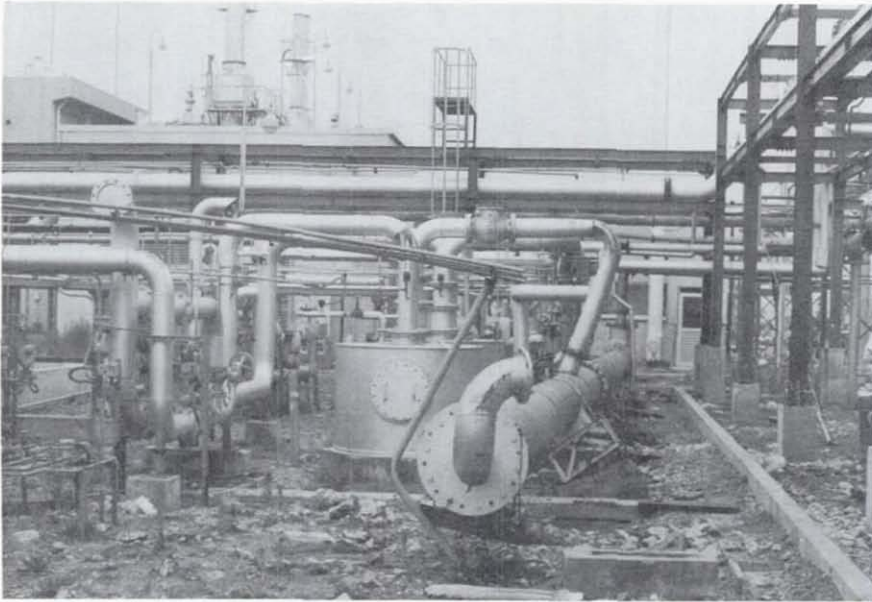
Figure 6.34 Haranomachi Plant, Sendai City Gas Bureau: damage to the telescoping gas holder and to some of the nearby pipeways and equipment. The trusses are portions of the original support structure that had surrounded the tank.

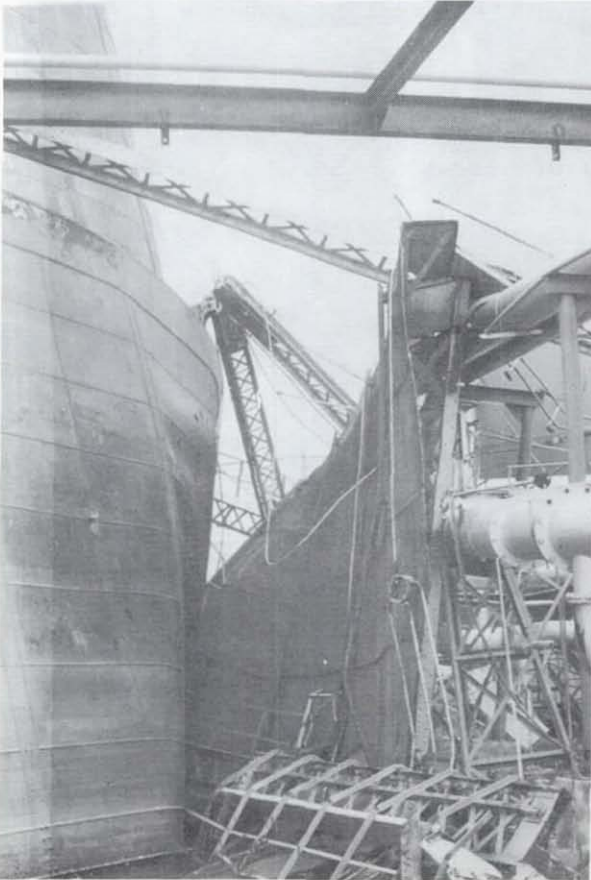
Figure 6.35 Haranomachi Plant, Sendai City Gas Bureau: buckling damage to the lower portion of one segment of the gas holder.

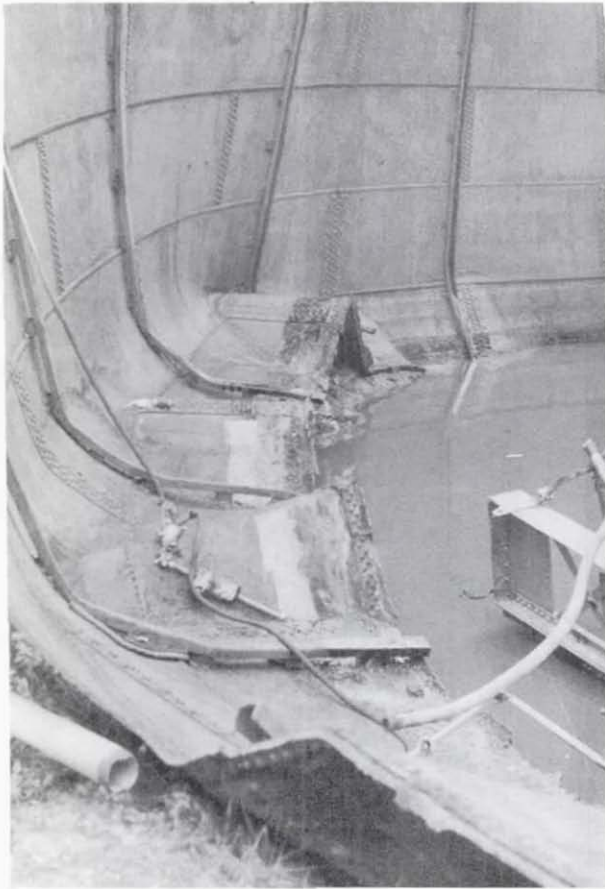
Figure 6.36 Haranomachi Plant, Sendai City Gas Bureau: a fracture of the 3/8-in. plate wall of the collapsed gas holder. The length of the fracture is approximately 1.5 m (5 ft).

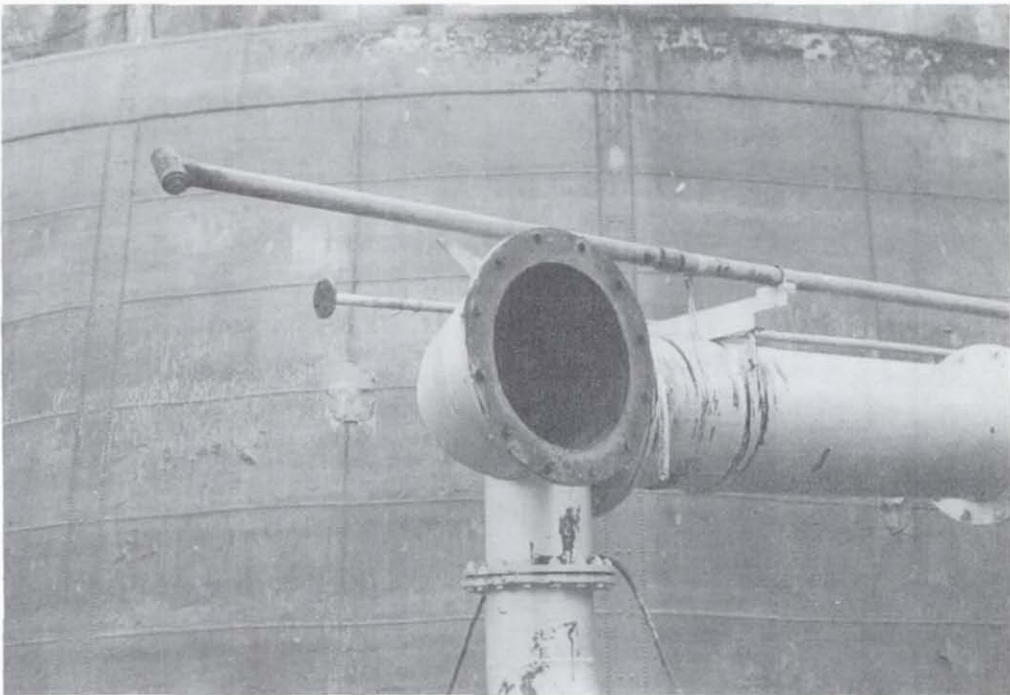
Figure 6.38 Haranomachi Plant, Sendai City Gas Bureau: undamaged expansion bellows that moved several inches during the earthquake.

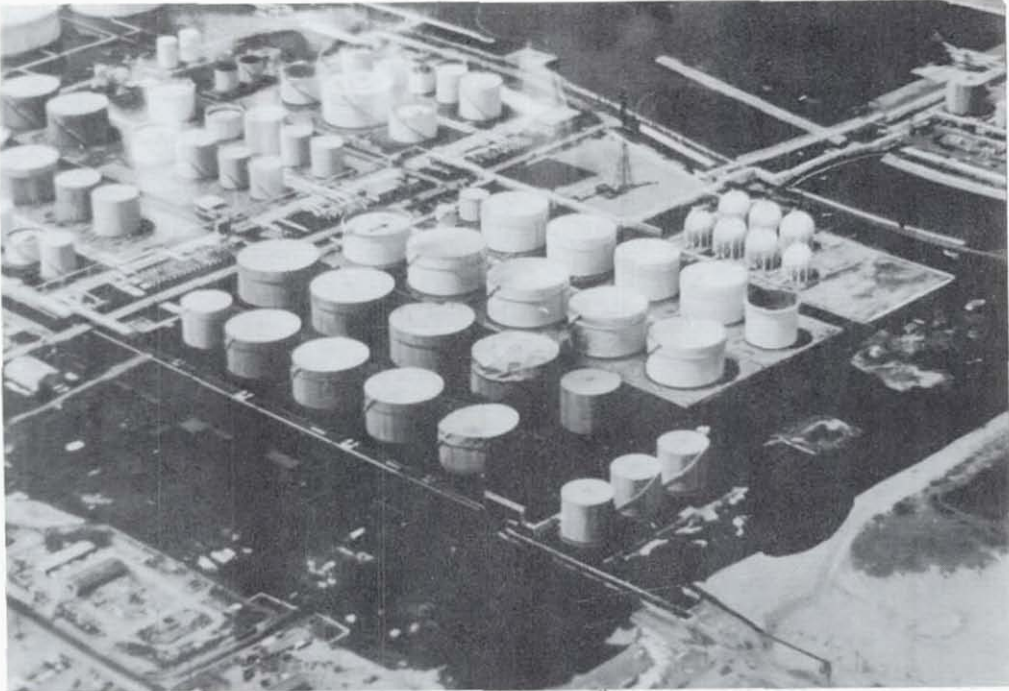
Figure 6.41 Sendai Refinery, Tohoku Oil Company, Ltd.: an overall view of the refinery's tank farm. The spilled oil appears as the dark area of the photograph. (Tohoku Oil Company photograph)

There are at least 87 storage tanks in the facility. The tanks have different designs, and different functions; some stored oil, others stored liquid propane gas (LPG); some had fixed roofs, others had movable roofs. Three large tanks containing refined fuel called Top Crude (TC) failed, spilling approximately 68,100 kl of oil. The capacity of the tanks was 85,000 kl. The surrounding reinforced concrete dike could accommodate only 35,000 kl. The oil overtopped the dike, inundated much of the refinery area, and spilled over into the port (Figure 6.41). Because the surface soils are sandy, it is believed that much of the oil that was contained in the dike subsequently leaked under the walls and contributed to the spill.
